# THE GUILDHALL BUTCHERS ROW BARNSTAPLE DEVON

Historic Building Recording

South West Archaeology Ltd. report no. 170830

By E. Wapshott & N. Boyd  
Report Version: FINAL  
7<sup>th</sup> September 2017

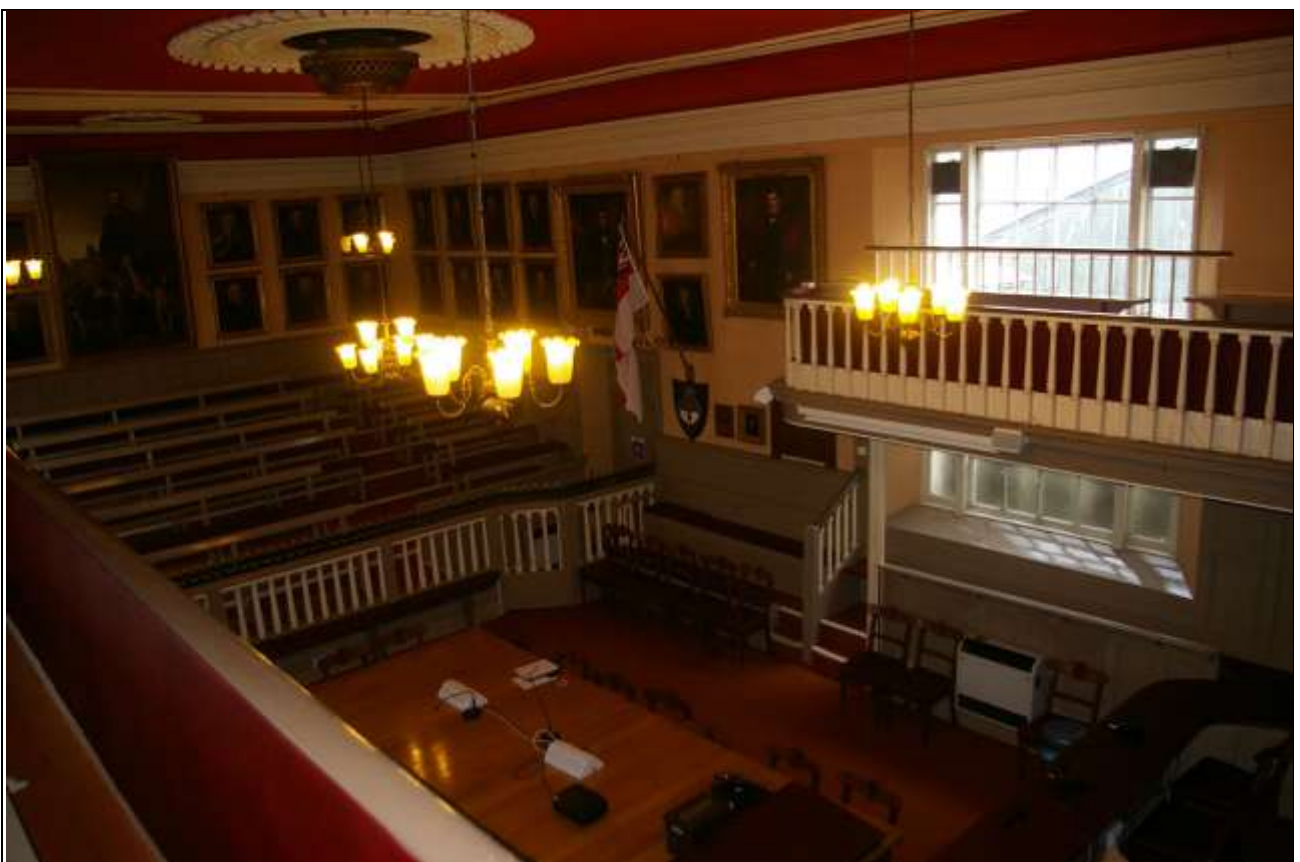
VIEW DOWN INTO THE MAIN COURTROOM CHAMBER (ROOM 6) FROM THE WEST BALCONY; FROM THE SOUTH-WEST

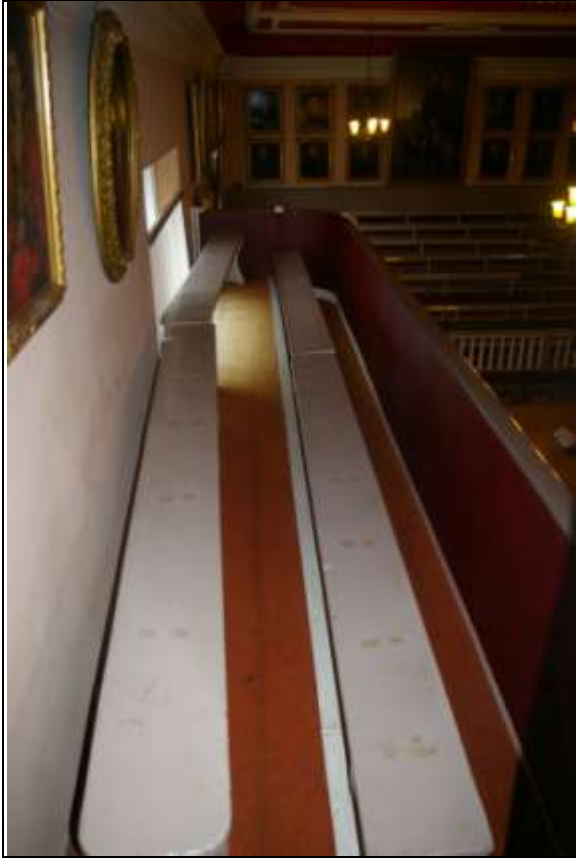
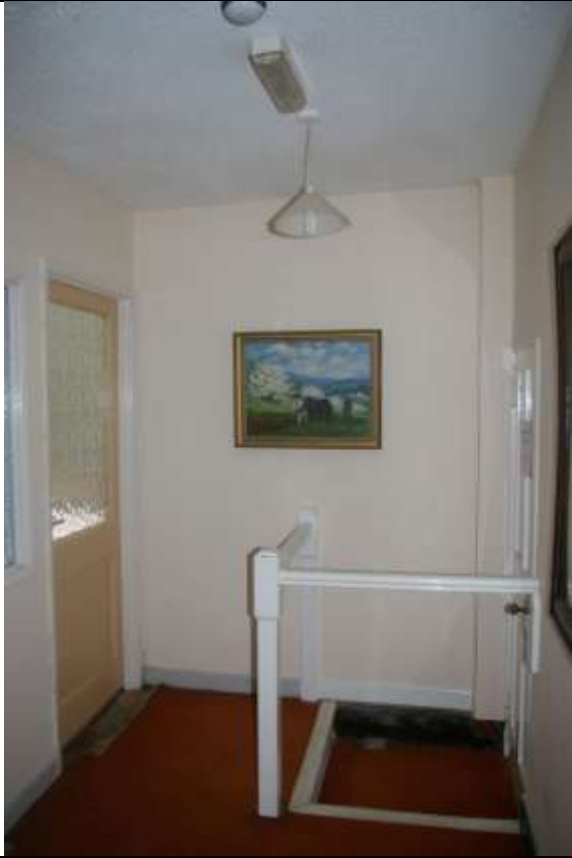
LEFT: ROOM 6; THE WEST SECOND FLOOR BALCONY, WITH FREE STANDING BENCHES AND LEATHER PADDED BALUSTER RAIL; FROM THE SOUTH.  
RIGHT: ROOM 2; THE DOOR TO THE SMALLER FORMER JUDGE'S OFFICE, NOW STORE ROOMS; FROM THE EAST.

Dating Evidence:		The style and general form of the decorative balcony structures is cohesive with the rest of the main chamber, room 6.
Comments:		The balcony on this side, has pulled away from the wall, a small timber fillet has been inserted. There is also some cracking to the plaster at the south end of the balcony where it adjoins the wall and where the door frame has dropped. This may be evidence of structural movement and ought to be checked.
<b>Balcony 2 (east) Main Chamber</b>		
Function:		Viewing gallery over main guildhall chamber.

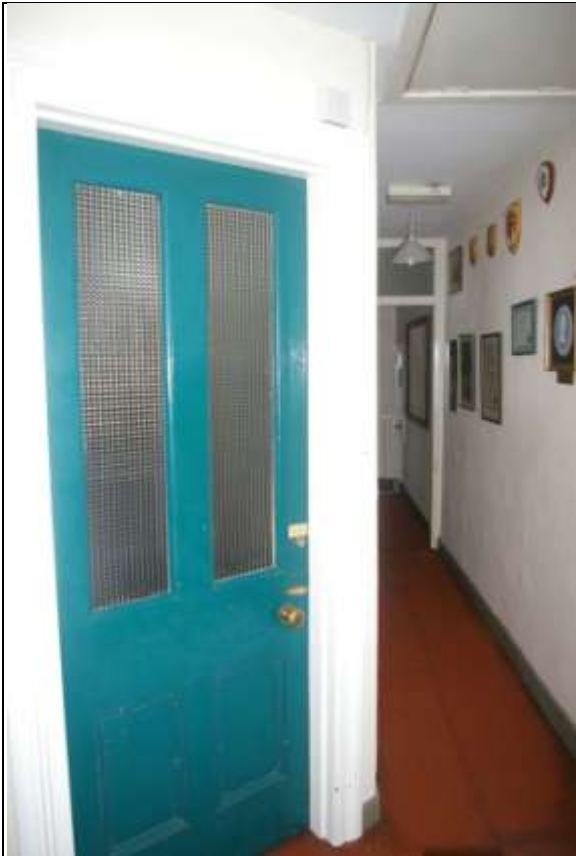
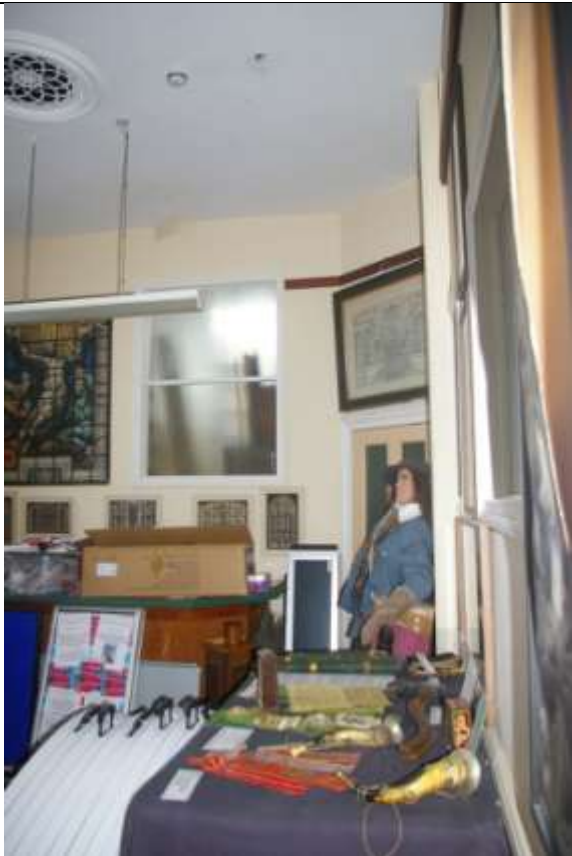
LEFT: ROOM 2; THE CORRIDOR SERVING THE MEETING ROOM AND OFFICE SPACE ON THE SECOND FLOOR; FROM THE EAST.  
RIGHT: ROOM 1; THE 20<sup>TH</sup> CENTURY JURORS MEETING ROOM, WITH BAR AND GLAZED PANELS WITHIN PARTITION WALLS; FROM THE EAST.

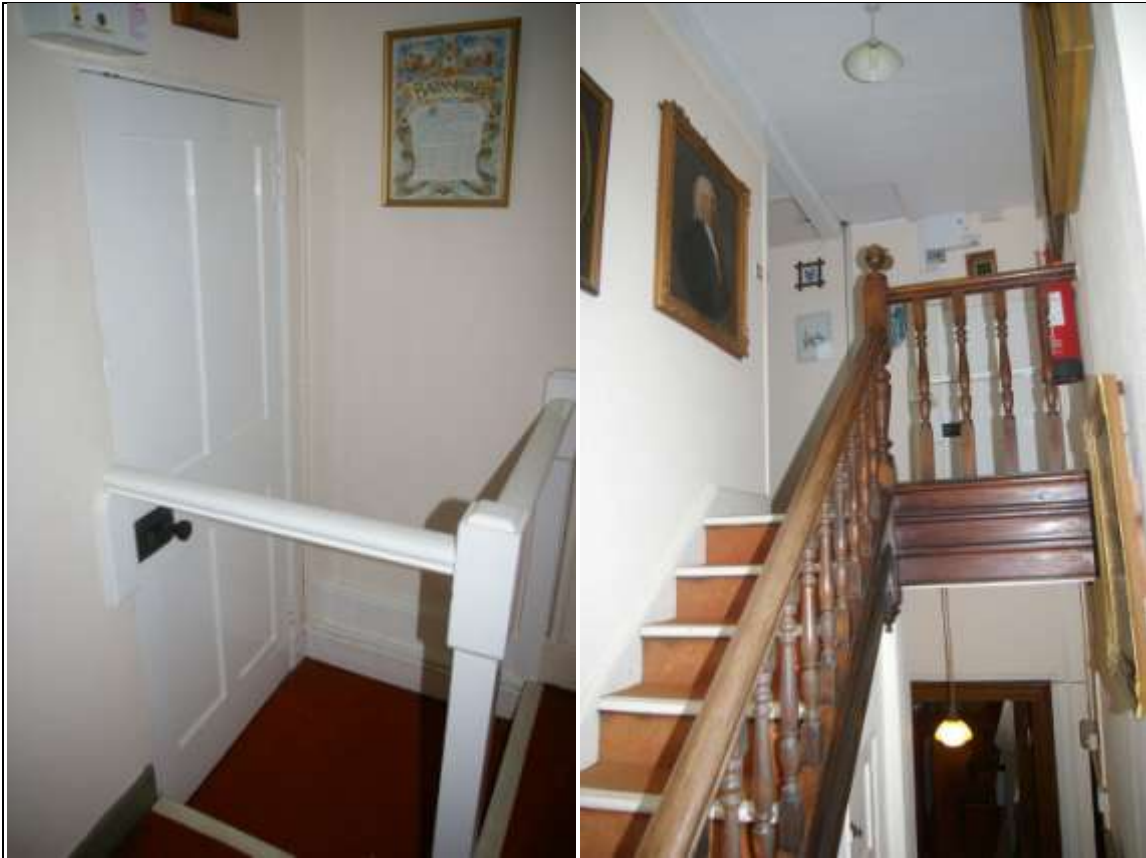
LEFT: ROOM 2; THE SMALL 19<sup>TH</sup> CENTURY PANELLED DOOR LEADING TO THE EAST SECOND FLOOR BALCONY; FROM THE SOUTH-WEST.  
RIGHT: ROOM 4/ROOM 2; THE STAIRS TO THE SECOND FLOOR, A 20<sup>TH</sup> CENTURY STAIR, A HISTORIC COPY; FROM THE SOUTH.

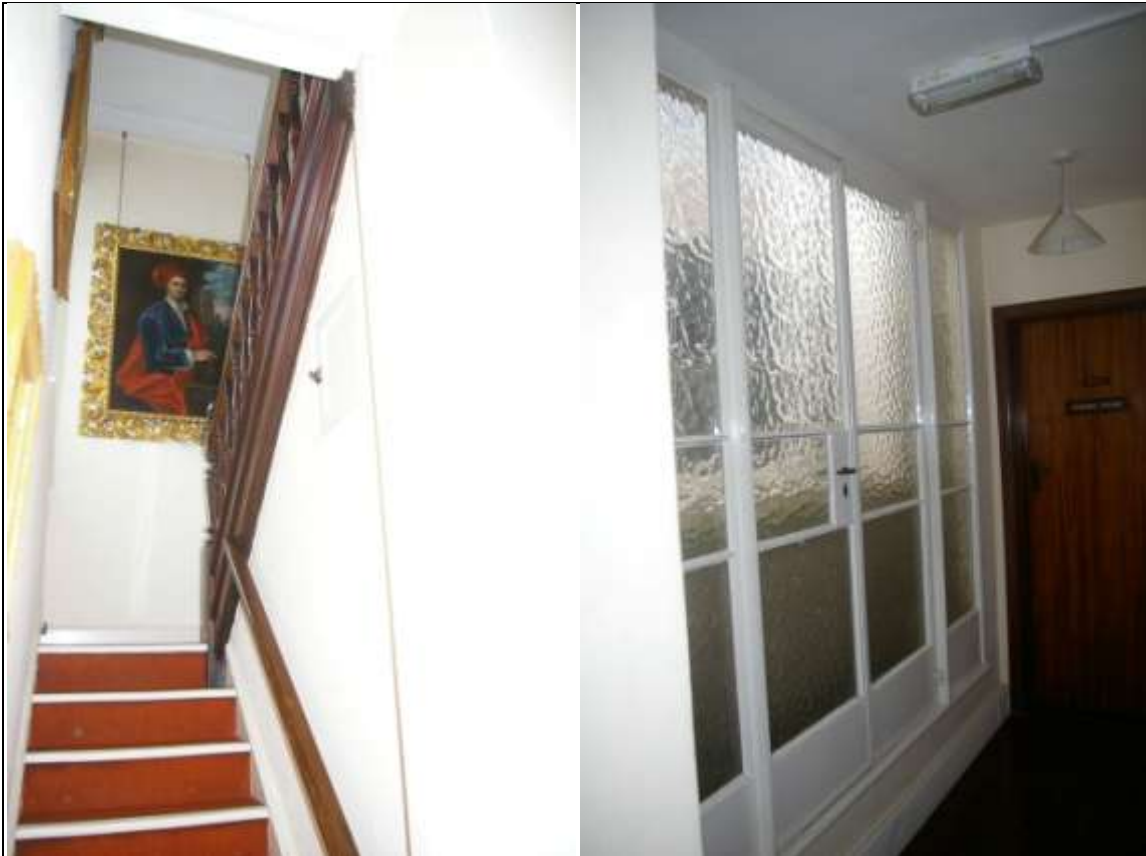
LEFT: ROOM 4/ROOM 2; THE STAIRS TO THE SECOND FLOOR, A 20<sup>TH</sup> CENTURY STAIR, A HISTORIC COPY; FROM THE NORTH.  
RIGHT: THE GLAZED WALL WITHIN ROOM 8, OF METAL FRAMED CRITTAL STYLE; FROM THE SOUTH-EAST.

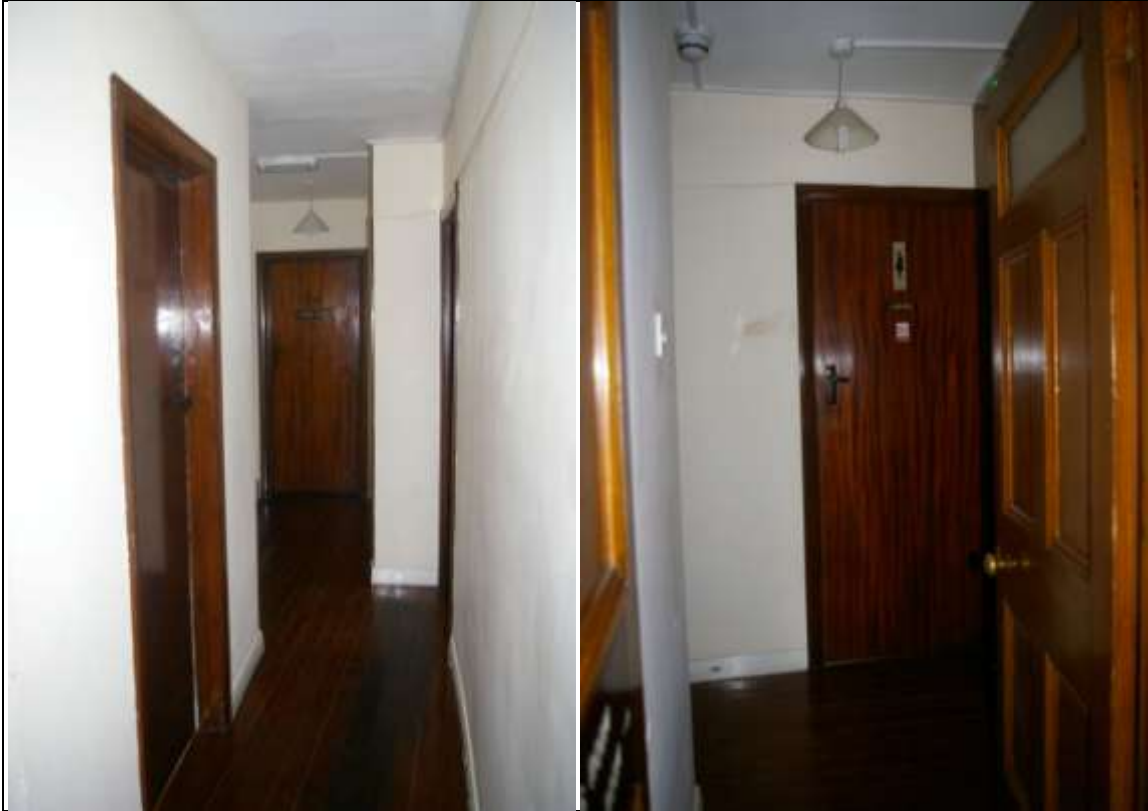
LEFT: ROOM 8; VIEW TO THE ROBING ROOM (ROOM 7) AND KITCHEN (ROOM 10); FROM THE SOUTH.  
RIGHT: THE DOORWAY FORCED IN THE EAST WALL ACCESSING ROOMS 7-12, RESET WITH PANELLED DOOR CASEMENT; FROM THE WEST.

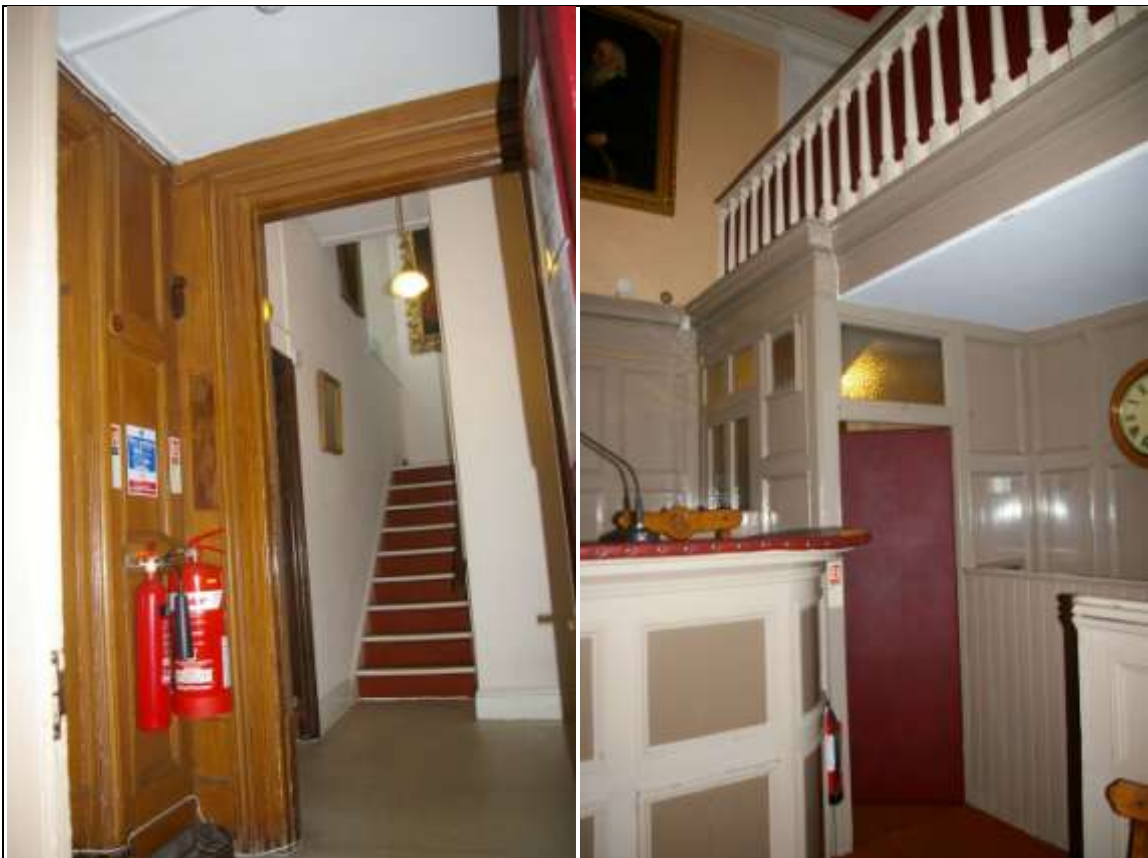
LEFT: ROOM 4A; THE MOULDED DOORCASE WITHIN THE SOUTH-EAST LOBBY TO THE MAIN CHAMBER; FROM THE NORTH-WEST.  
RIGHT: ROOM 6; THE LOBBY FORMED IN THE SOUTH-WEST CORNER OF THE MAIN CHAMBER, OBSCURING THE LARGE MOULDED DOORCASE; FROM THE NORTH-EAST.

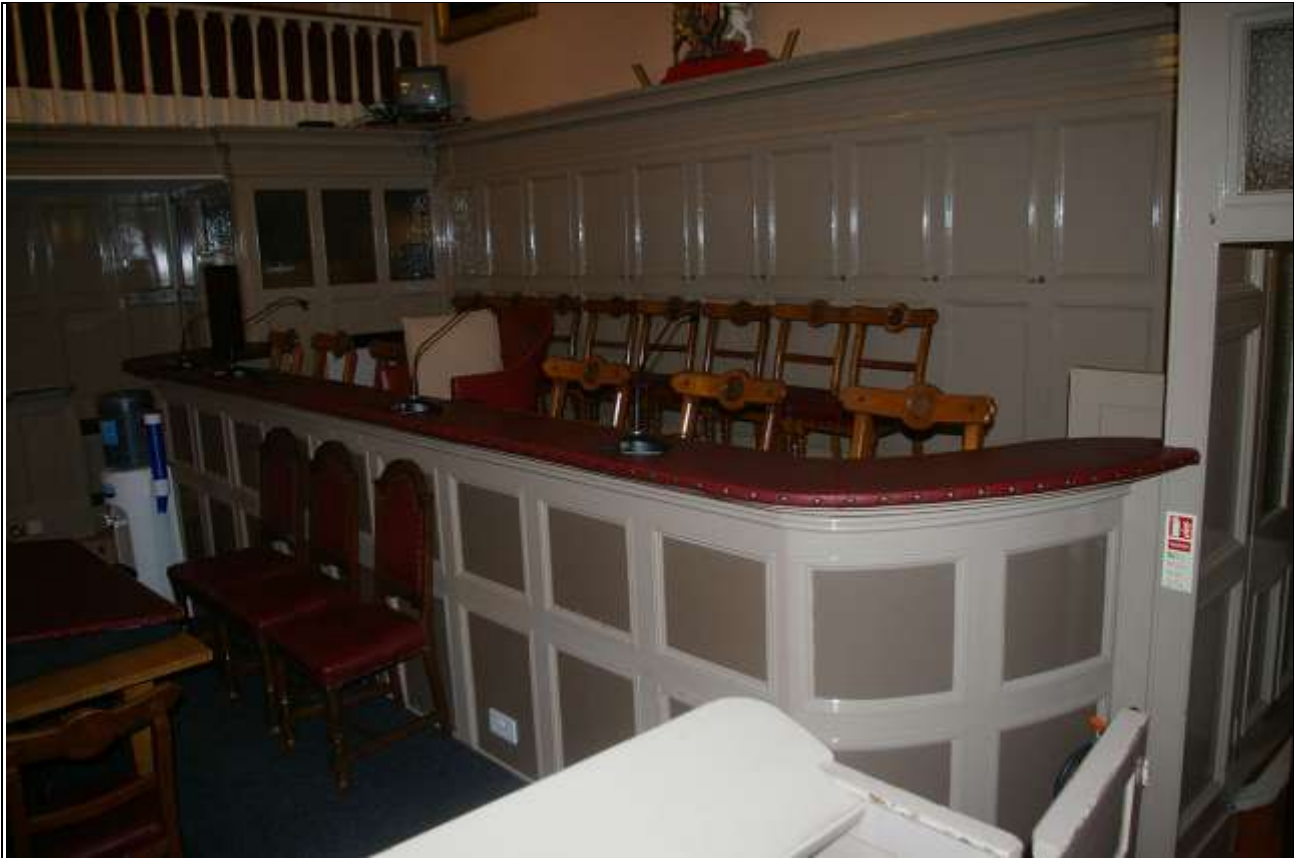
ROOM 6; THE JUDGE'S BENCH IN THE MAIN CHAMBER; FROM THE WEST-NORTH-WEST.

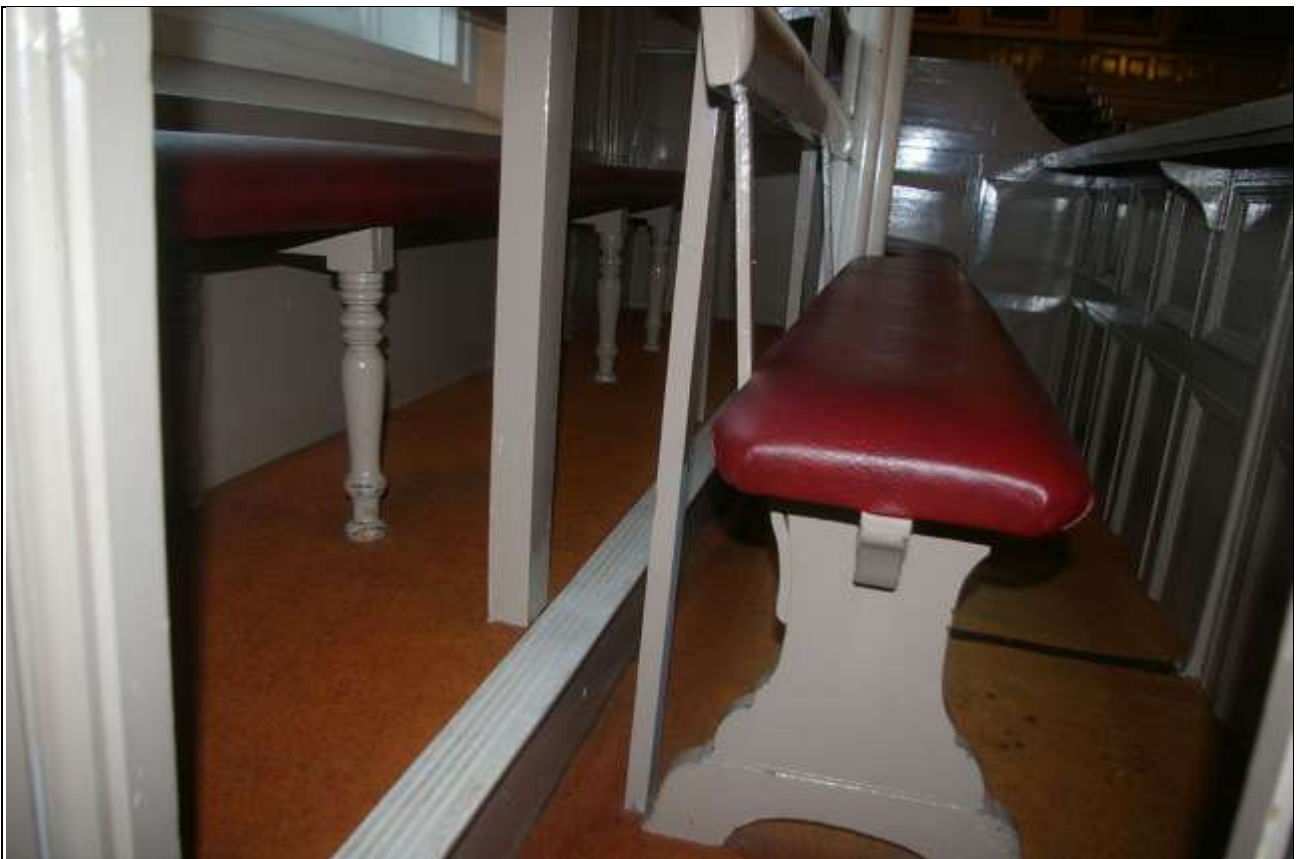
ROOM 6: THE FIXED PILASTER BENCHES WITH TURNED LEGS AND THE CHUNKIER FREE STANDING BENCHES WITHIN THE PANELLED SEATING AREA; FROM THE SOUTH.

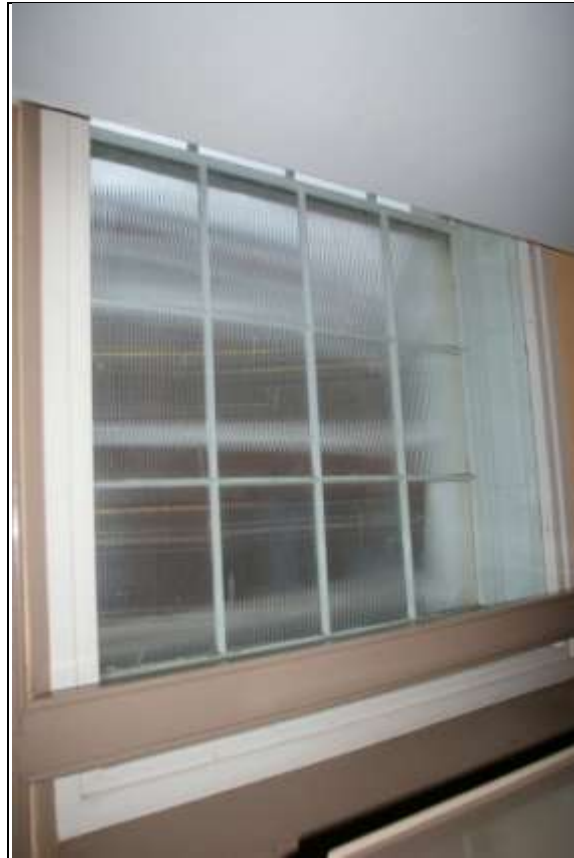
ROOM 6; ONE OF THE EAST SASH WINDOWS WHICH LIGHT THE MAIN CHAMBER; FROM THE SOUTH-EAST.

Opening – Windows:	1	The large, double height sash window which lights the main chamber also lights this gallery. It has a chunky beaded frame and is a relatively lightweight hornless sash with fine beaded glazing bars, 12x12 panes to each sash. Much of the glass in the lower sash has been replaced with modern obscured glass. The opening has a chunky timber beaded moulding to its edge and the windows have shallow sloping plastered reveals. A modern timber frame and polystyrene sound proofing panels have been inserted into the window opening to reduce sound in the chamber from the street. The window opening is braced by a single polished wood moulded handrail, possibly rosewood or mahogany, with simple plain stick balusters.
Significant Details:		Simple, timber plank, free standing benches occupy the two tiers of seating in the balcony, they have crude scroll bracket-shaped legs and pegged frames; the plank seats have been covered with padded leather. The interior face of the balusters has been infilled with boarding covered by padded leather, to reduce noise. A simple rail covers the window opening for safety, with exposed polished wood hand rail and painted stick balusters.

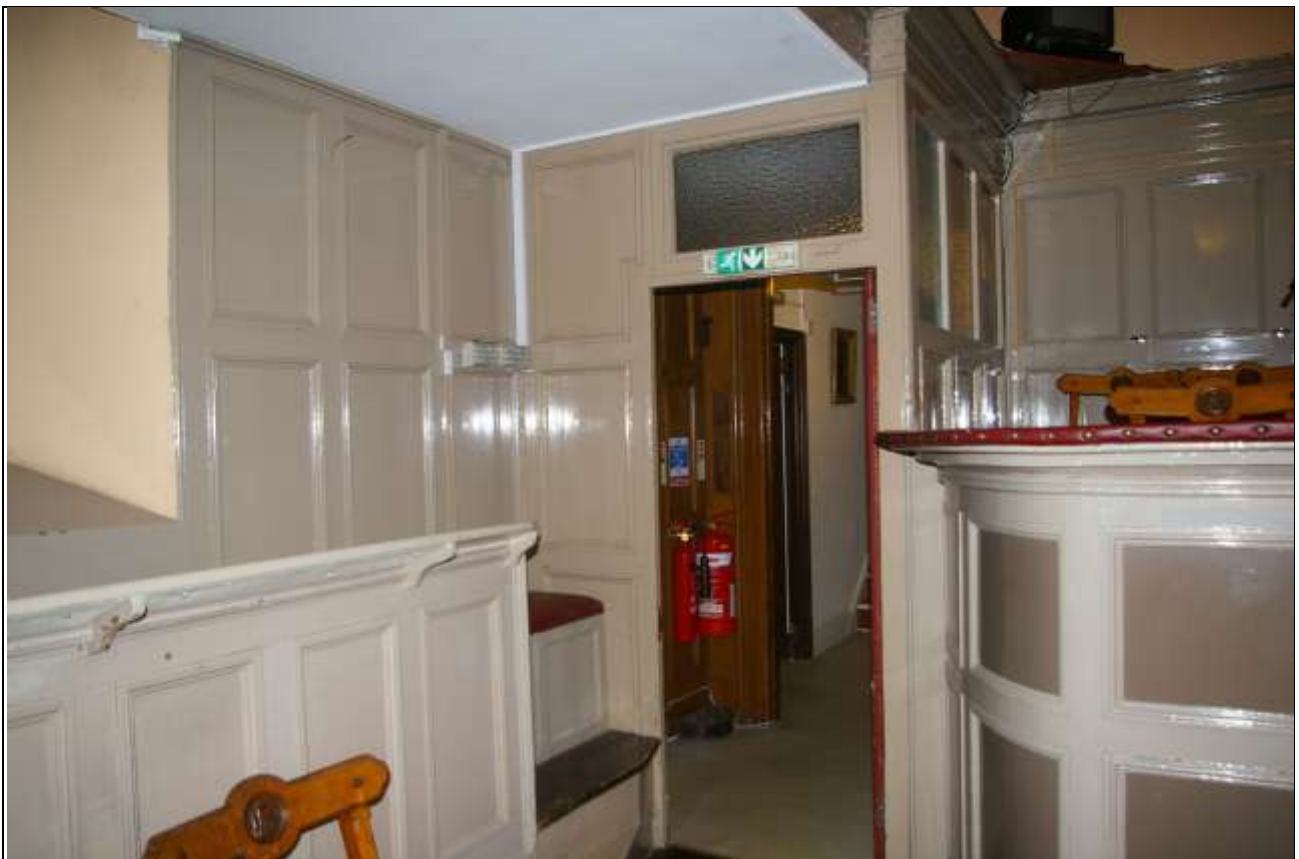
THE LOBBY (ROOM 4A) IN THE SOUTH-EAST CORNER OF THE MAIN CHAMBER (ROOM 6), OBSCURING THE LARGE MOULDED DOORCASE; FROM THE NORTH-WEST.

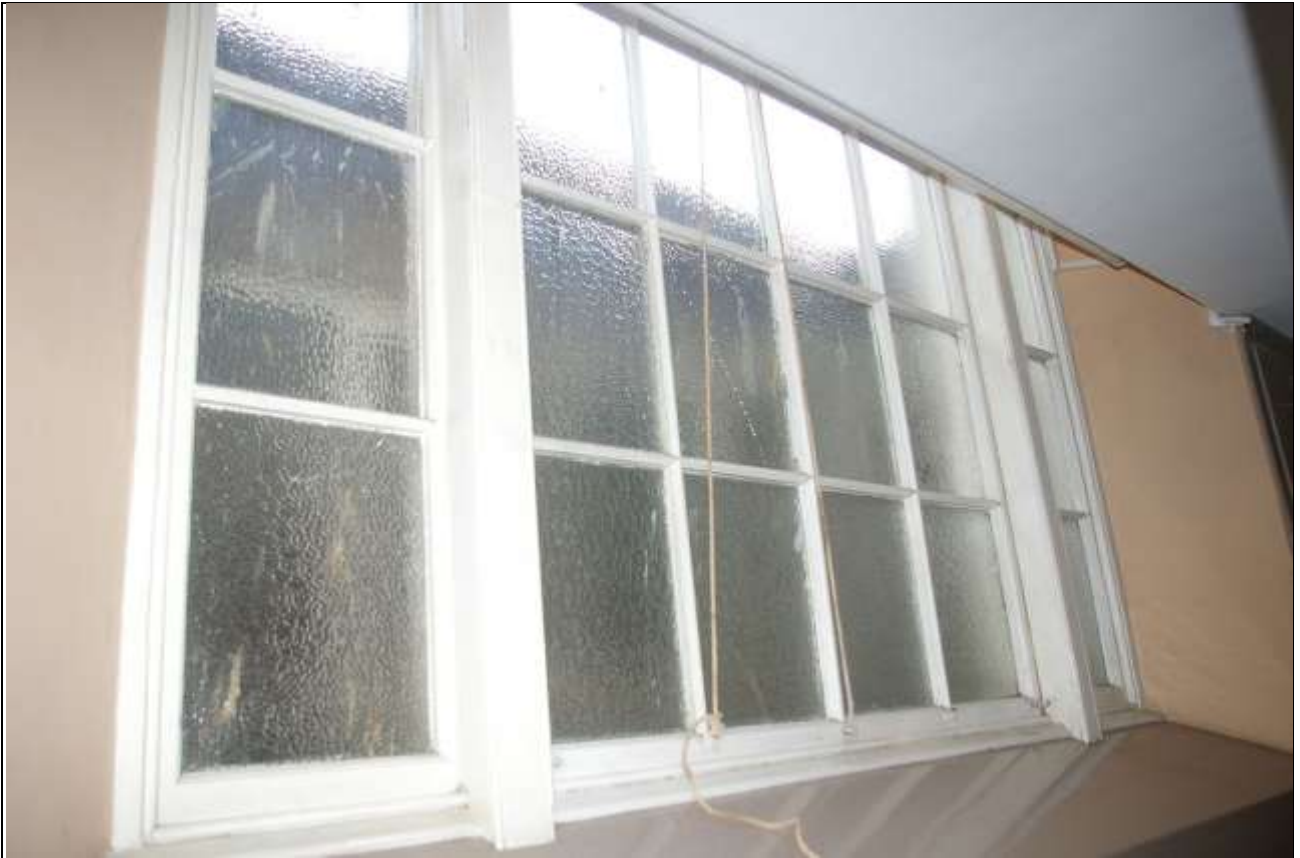
ROOM 6; THE POST-1855 THREE-LIGHT HORNED SASH WINDOW IN THE EAST WALL OF THE MAIN CHAMBER; FROM THE NORTH-WEST.

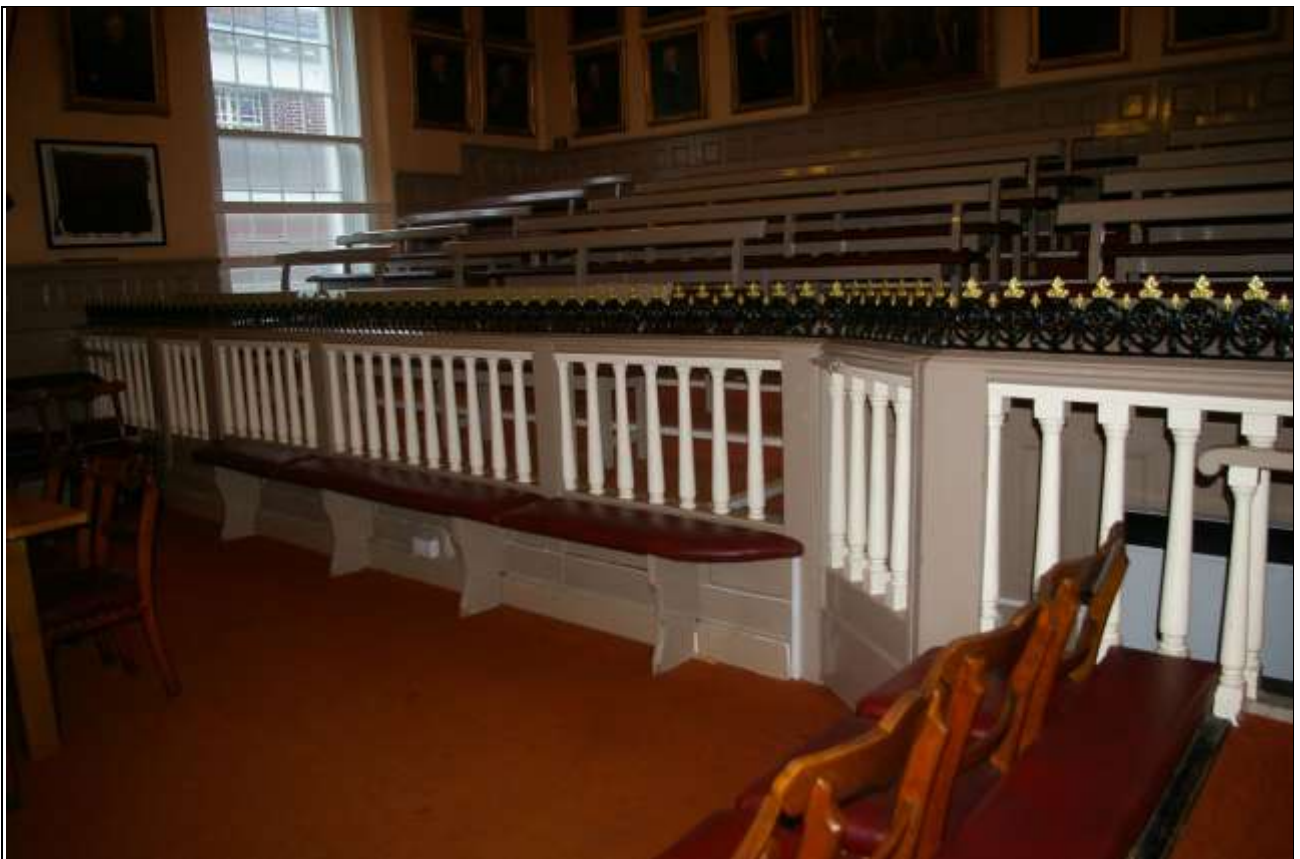
ROOM 6; THE HEAVY TIMBER BALUSTER RAIL WHICH DEFINES THE PUBLIC GALLERY SEATING AND COURTROOM SPACES; FROM THE SOUTH-EAST.

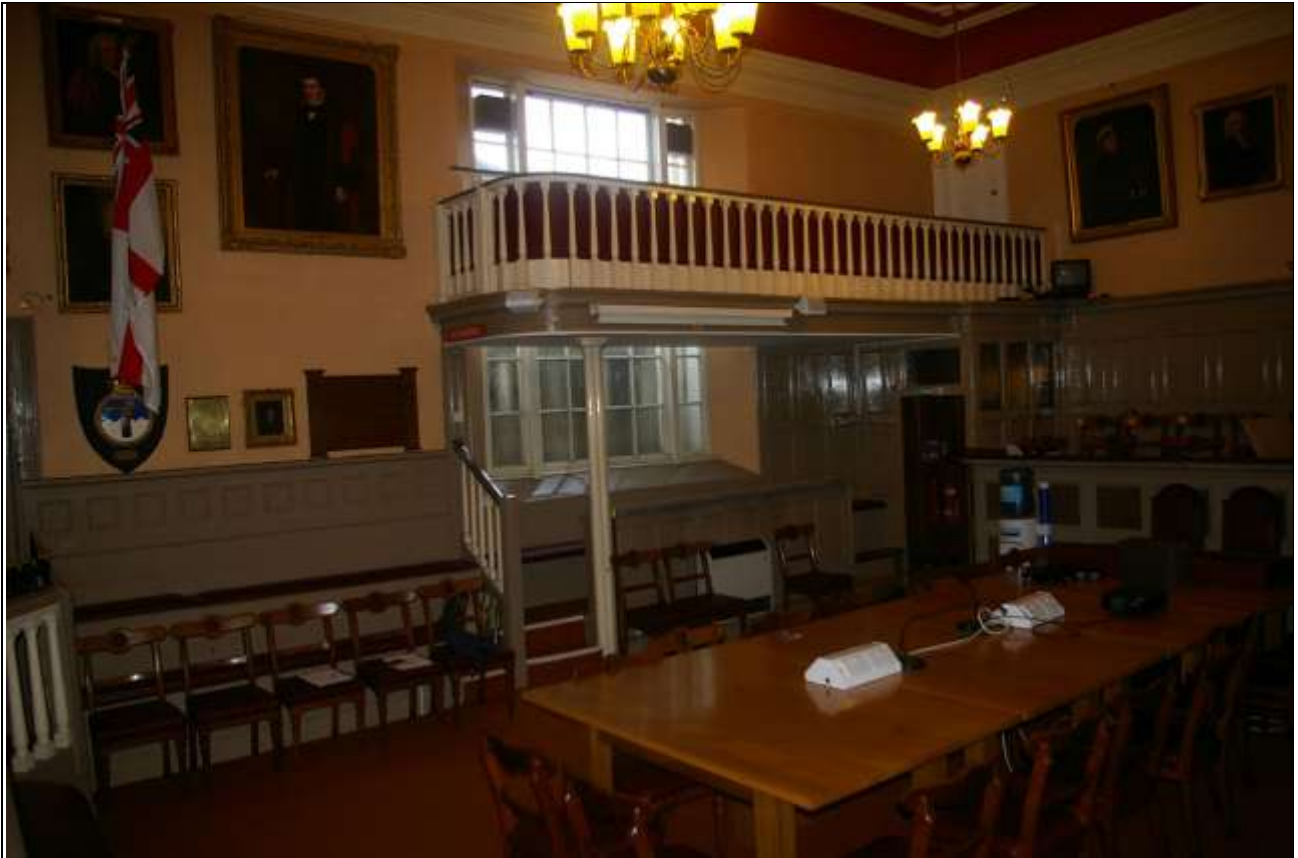
ROOM 6; THE EAST SECOND FLOOR GALLERY, SUPPORTED ON SLENDER COLUMN, AND PANELLED SEATING BELOW, WITH OPEN BENCHES TO THE NORTH; FROM THE NORTH-WEST.

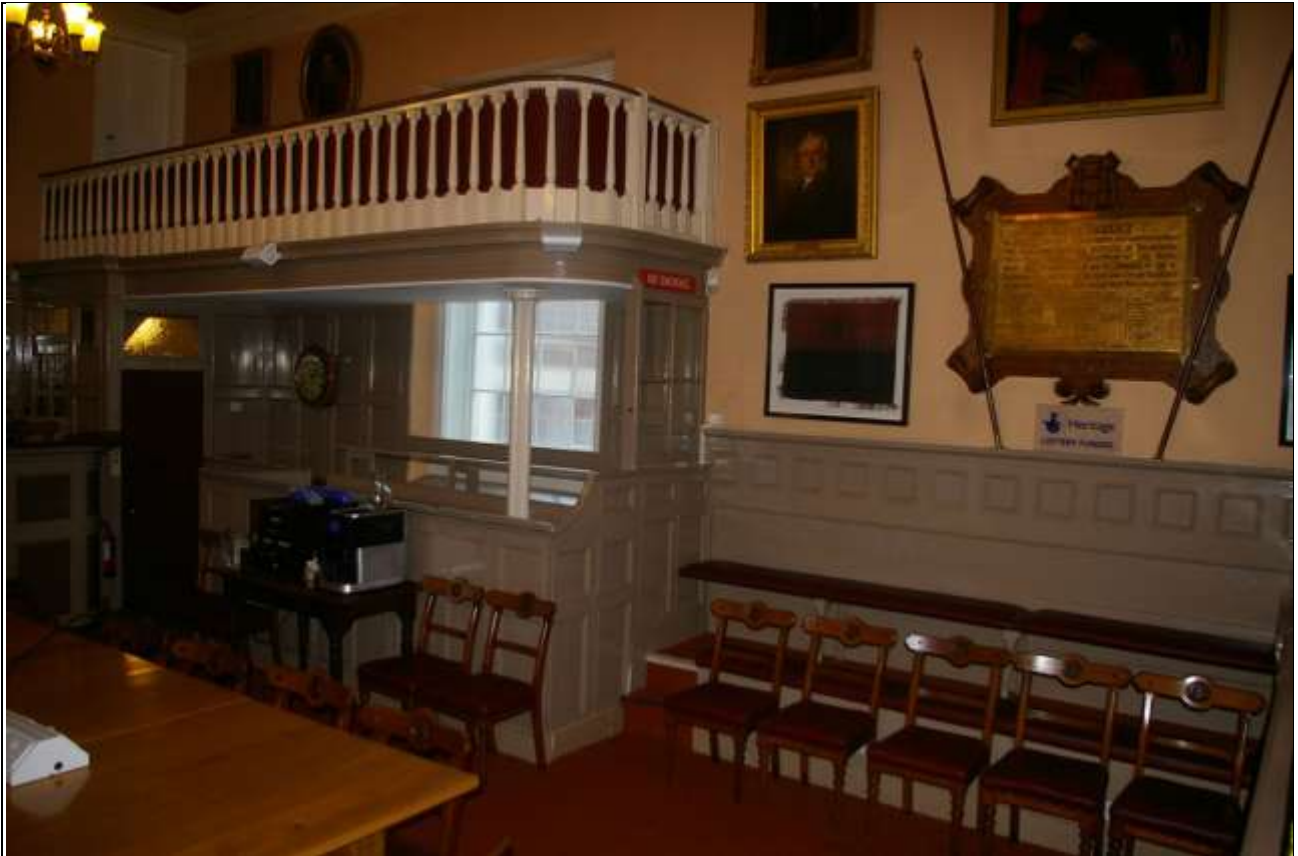
ROOM 6; THE WEST SECOND FLOOR GALLERY, SUPPORTED ON SLENDER COLUMN AND PANELLED SEATING BELOW, WITH OPEN BENCHES TO THE NORTH; FROM THE NORTH-EAST.

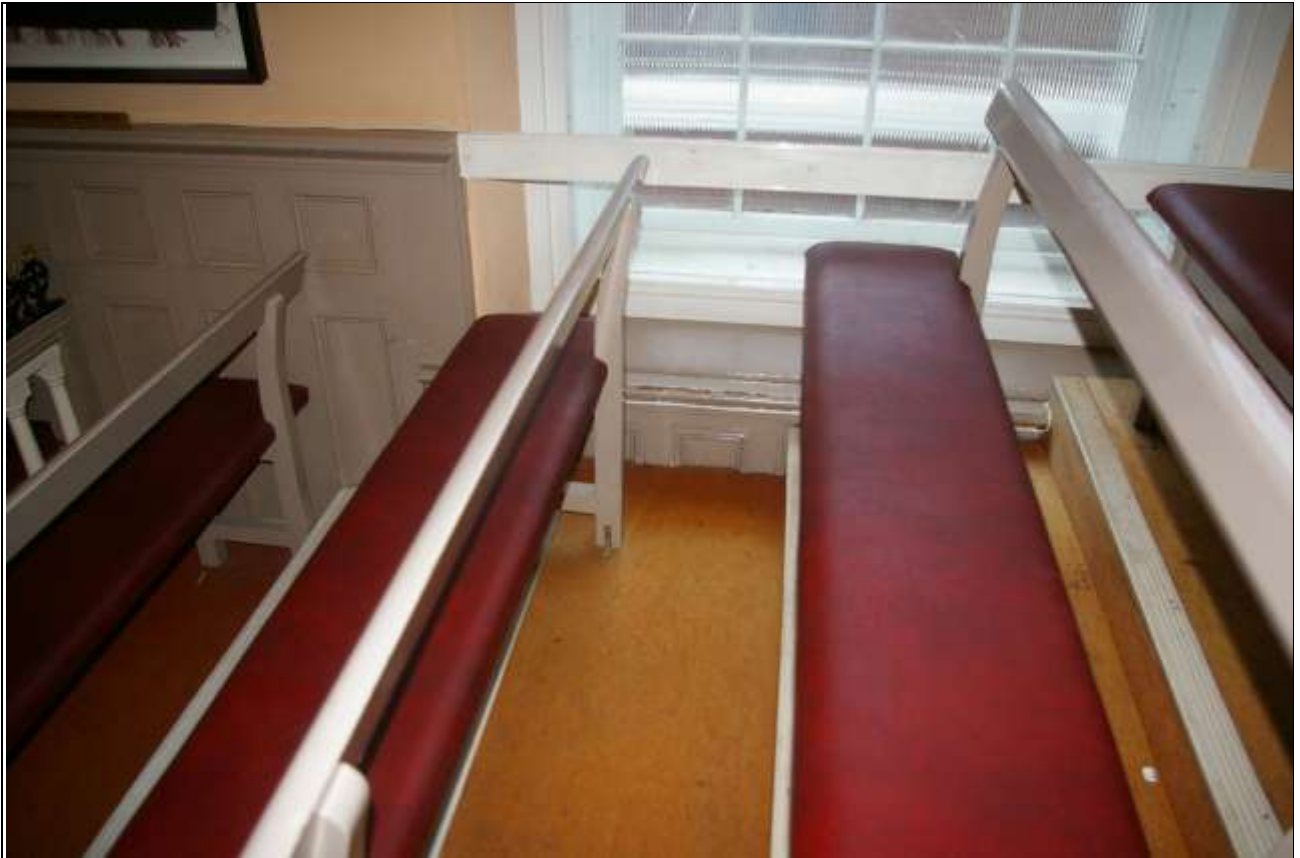
ROOM 6; THE PANELLING TO THE SIDES OF THE TIERED PUBLIC GALLERY SEATING, SHOWING PANELS CUT IN HALF, SUGGESTING THE TIERS OF SEATING HAVE BEEN RESET OR RECONFIGURED; FROM THE EAST-NORTH-EAST.

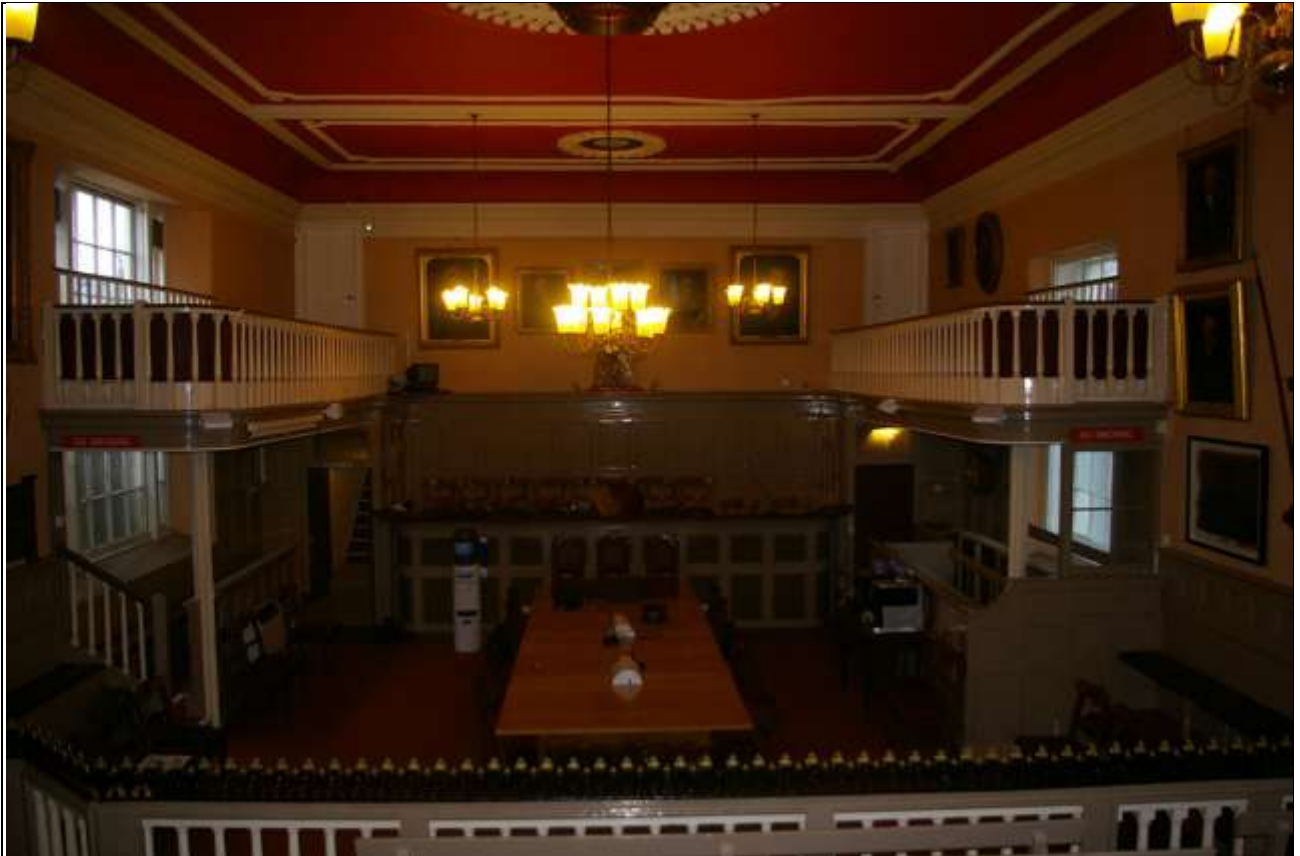
THE MAIN COURTROOM CHAMBER IN THE GUILDHALL (ROOM 6); FROM THE NORTH.

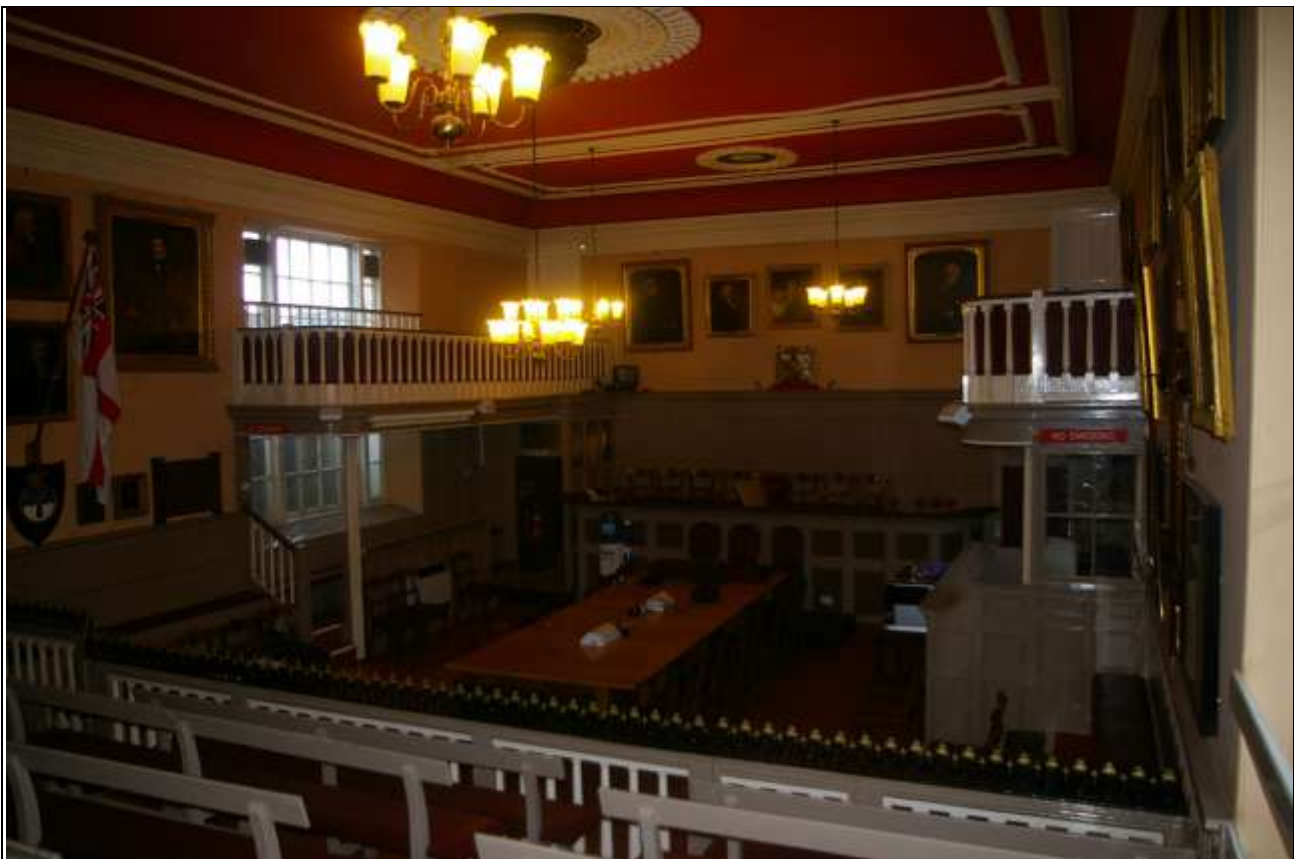
THE MAIN COURTROOM CHAMBER IN THE GUILDHALL (ROOM 6); FROM THE NORTH-WEST.

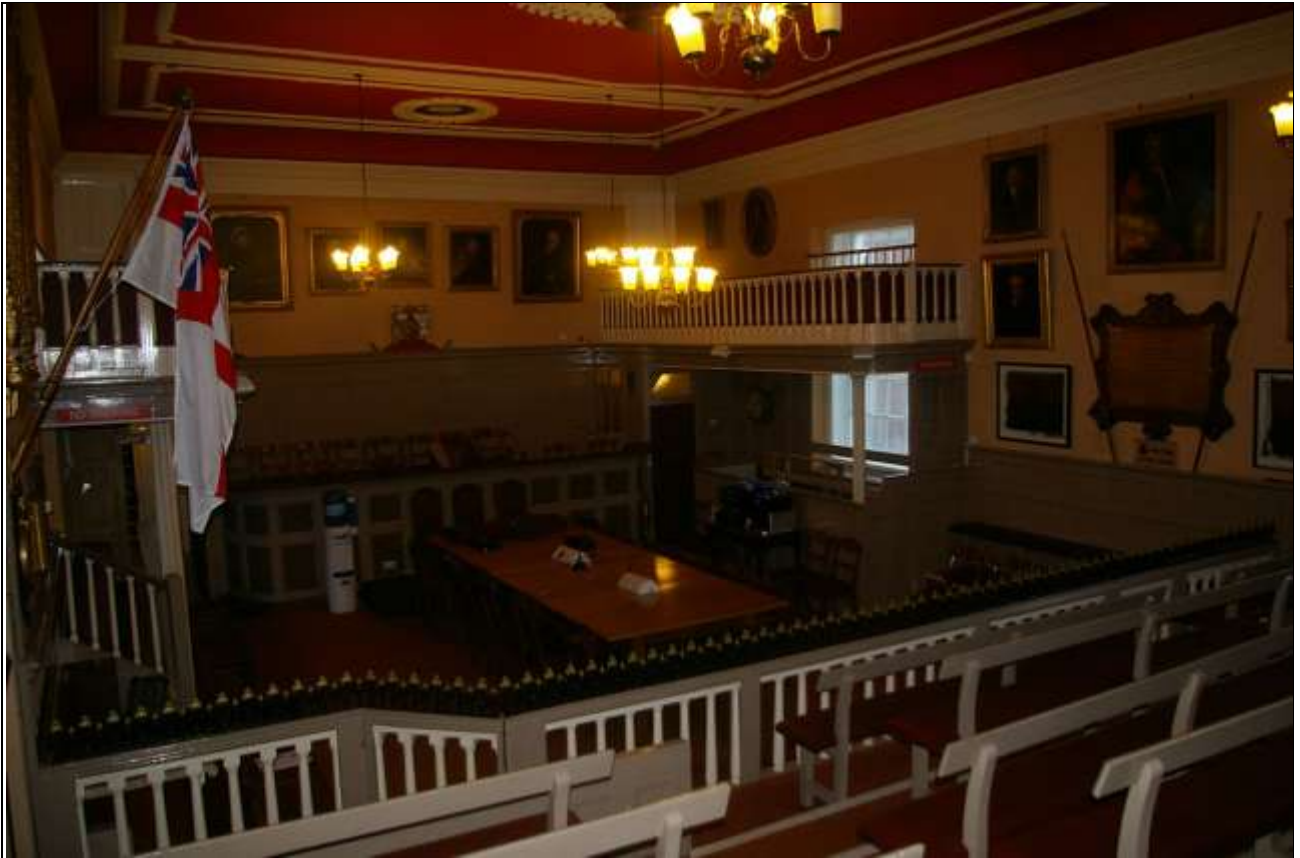
THE MAIN COURTROOM CHAMBER IN THE GUILDHALL (ROOM 6); FROM THE NORTH-EAST

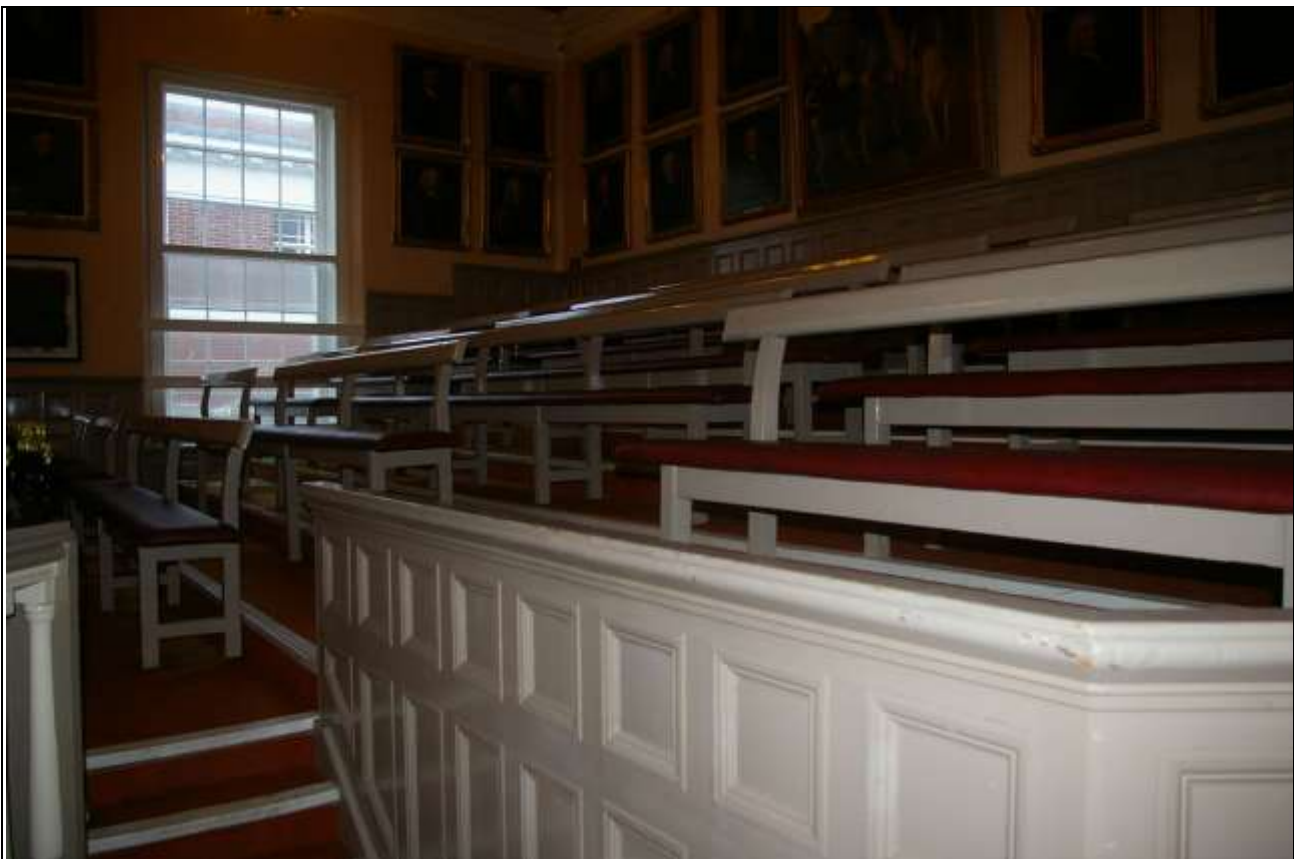
THE TIERED PUBLIC GALLERY AREA OF THE MAIN CHAMBER (ROOM 6), WITH REFITTED 20<sup>TH</sup> CENTURY BENCHES; FROM THE EAST, SOUTH-EAST.
