# THE GUILDHALL BUTCHERS ROW BARNSTAPLE DEVON

Historic Building Recording

South West Archaeology Ltd. report no. 170830

By E. Wapshott & N. Boyd  
Report Version: FINAL  
7<sup>th</sup> September 2017

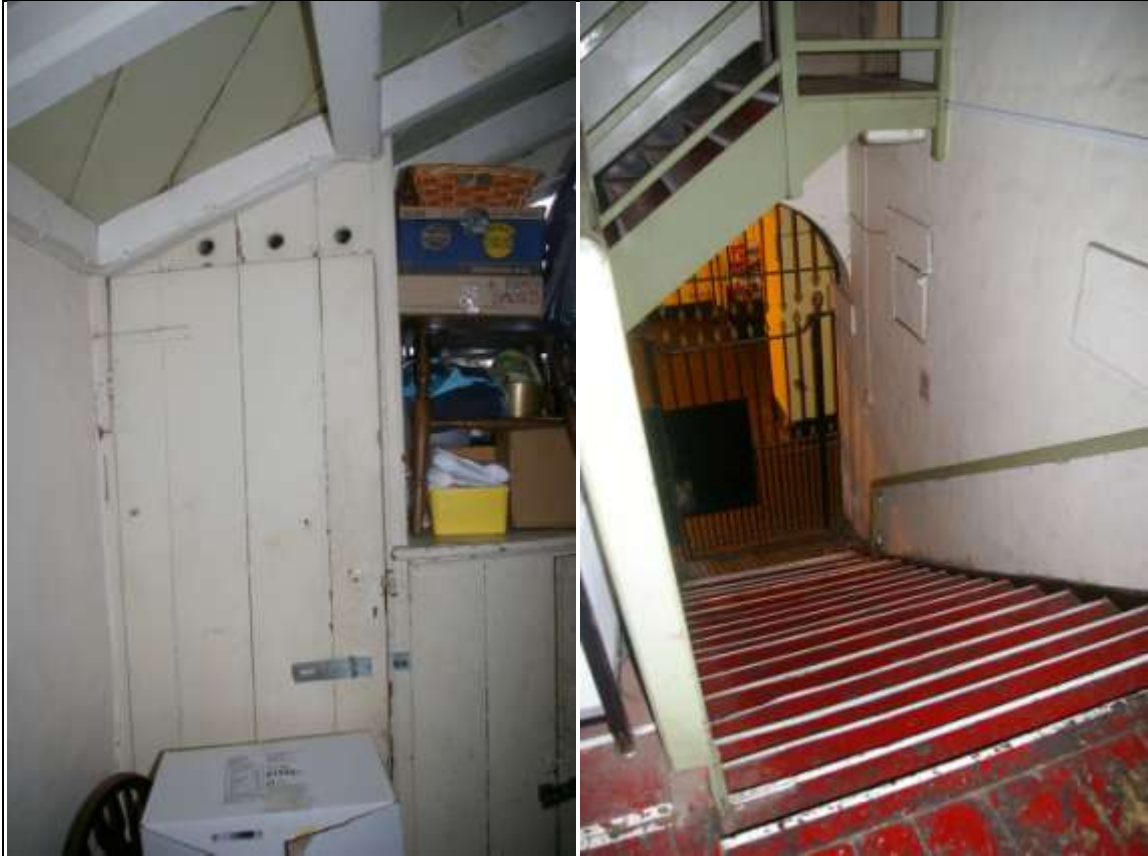
LEFT: THE PUBLIC GALLERY STEPS (ROOM 13) DROPPING TO THE GROUND FLOOR OF THE GUILDHALL; FROM THE NORTH-NORTH-EAST.  
RIGHT: THE BEADED PLANK BOARDED CUPBOARDS ON THE LANDING OF THE PUBLIC GALLERY STEPS (ROOM 13); FROM THE WEST.

Room 13 is the Public Stair. These 19<sup>th</sup> century stairs are in good condition and restoration or minor adaptations which do not affect the character of the stairs would be feasible. The stairs ought not to be significantly altered as they allow the building to be read correctly. The grand doorway which leads to the chamber, with double doors and air vents, is also important to understanding the privileged access of the room beyond.

On the first floor, Option B retains the public gallery stairs as a shop store, Room 13, which is far from advisable, with both weight and the damp from water condensation caused by fridges detrimental to the wooden structure. It also shows the forcing of a door in the wall of the stairhall, giving access to the stairs for a new kitchen. The kitchen and toilets, as in Option A, would be located within the 20<sup>th</sup> century extension (Rooms 7-12) and access through the existing main chamber doorway would be provided. It is not clear how the privacy of a shop store and required public access to kitchen and toilets would be achieved, division of the stairhall space will affect interpretation of the area and impact the historic fabric of the timber structure. The kitchen and new toilets (Rooms 7, 10 & 12) will respect the large window in the main chamber, fitted into the space between the Guildhall and Pannier Market. A new display room formed to the south, (Rooms 11, 8 & 9) will necessitate the blocking of the doorway in Room 4A and the forcing of a doorway at the top of the stairs, Room 14. Further historic fabric would be lost, which would fundamentally alter the flow of the building and the main chamber focus of the first floor. The war memorials on the formal stairs (Room 14) would have to be moved elsewhere; these are of immense communal value and potential damage to these must be considered. A suitable relocation site for both must be considered, as it would not be appropriate to divide the two boards. The lift would be remodelled, providing public access to the second floor. It is not clear how the option would aid access for wheelchairs into the main chamber, but access to the newly formed display room would be easier than at present.

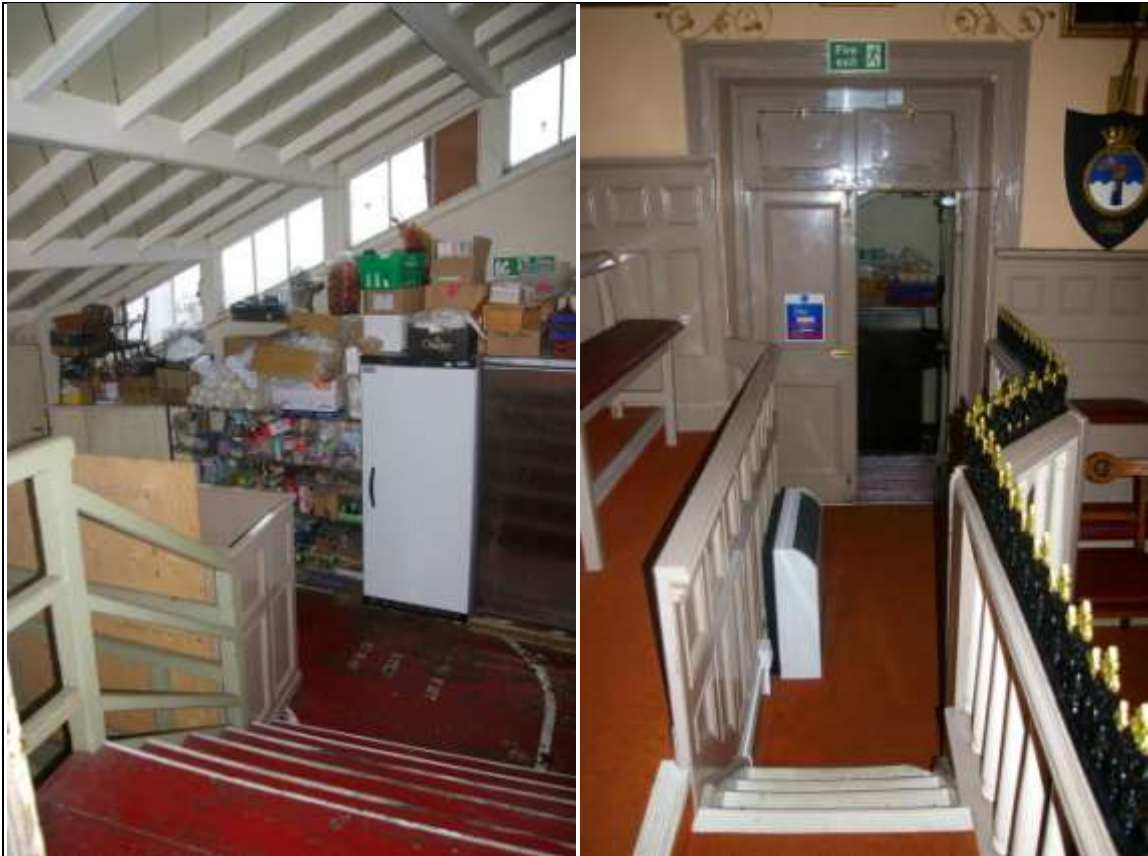
LEFT: THE STAIR PROJECTION (ROOM 13) SERVING THE PUBLIC GALLERY IN THE MAIN CHAMBER; FROM THE WEST  
RIGHT: THE DOORS TO THE PUBLIC GALLERY STAIRS (ROOM 13) FROM THE MAIN CHAMBER (ROOM 6); FROM THE WEST.

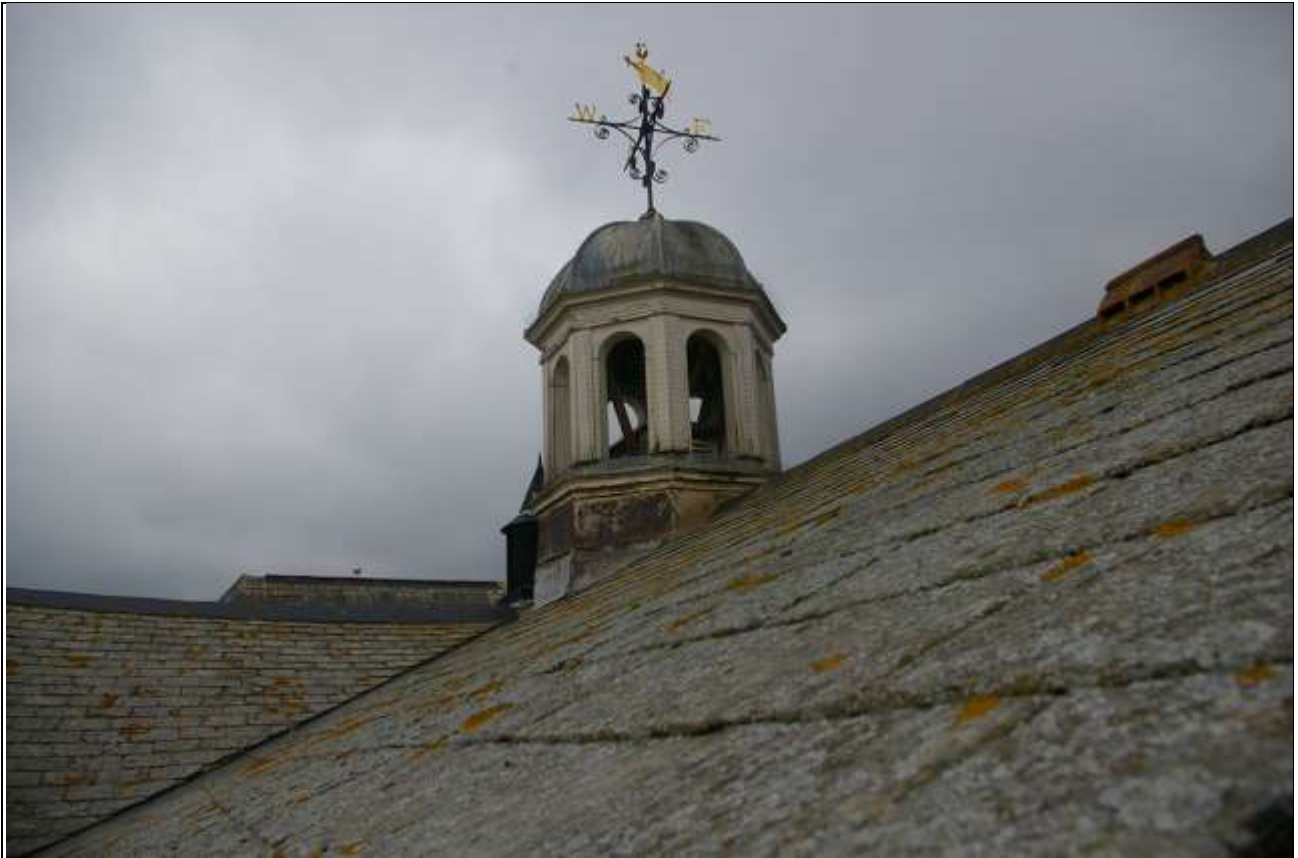
THE OCTAGONAL TIMBER BELL CUPOLA ON THE ROOF OF THE GUILDHALL WITH 1714 FORMER BUTCHERS' YARD BELL; FROM THE SOUTH, SOUTH-WEST.
