# NORRINGTON YARD SOUTH MOLTON DEVON

Results of a Desk-Based Assessment, Walkover Survey &  
Heritage Impact Assessment

South West Archaeology Ltd. report no. 170925

By B. Morris  
Report Version: 01  
25<sup>th</sup> September 2017

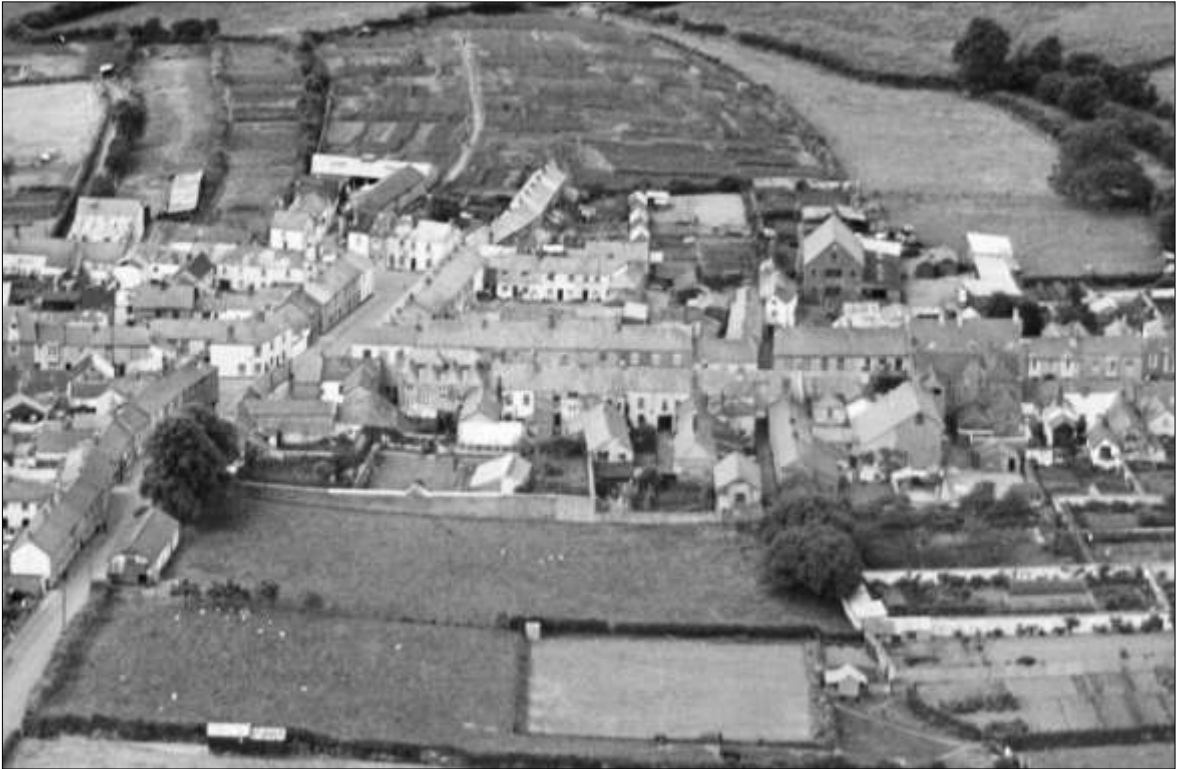
FIGURE 8: HISTORIC PHOTOGRAPH OF C.1930 (©HISTORIC ENGLAND).

There are a number of historic photographs of South Molton, but most focus on the main streets and civic buildings. One historic aerial photograph shows the site from the east (Figures 7-8). This shows the layout of the site in c.1930, and it is virtually identical to that of 1904. The main part of the site is shown as a simple pasture field, devoid of interest. The buildings on the western part of the site to the rear of South Street are still largely extant. The gardens to the north are neatly-kept and defined by walls; the walls of one garden appear to be whitewashed. These may be pleasure or market gardens. The small square enclosure immediately to the east may be a bowling green or similar civic space.

There is a single buttress of pale orange brick. This is a fragment of garden wall which appears in the c.1930s photograph above (Figure 8-9).

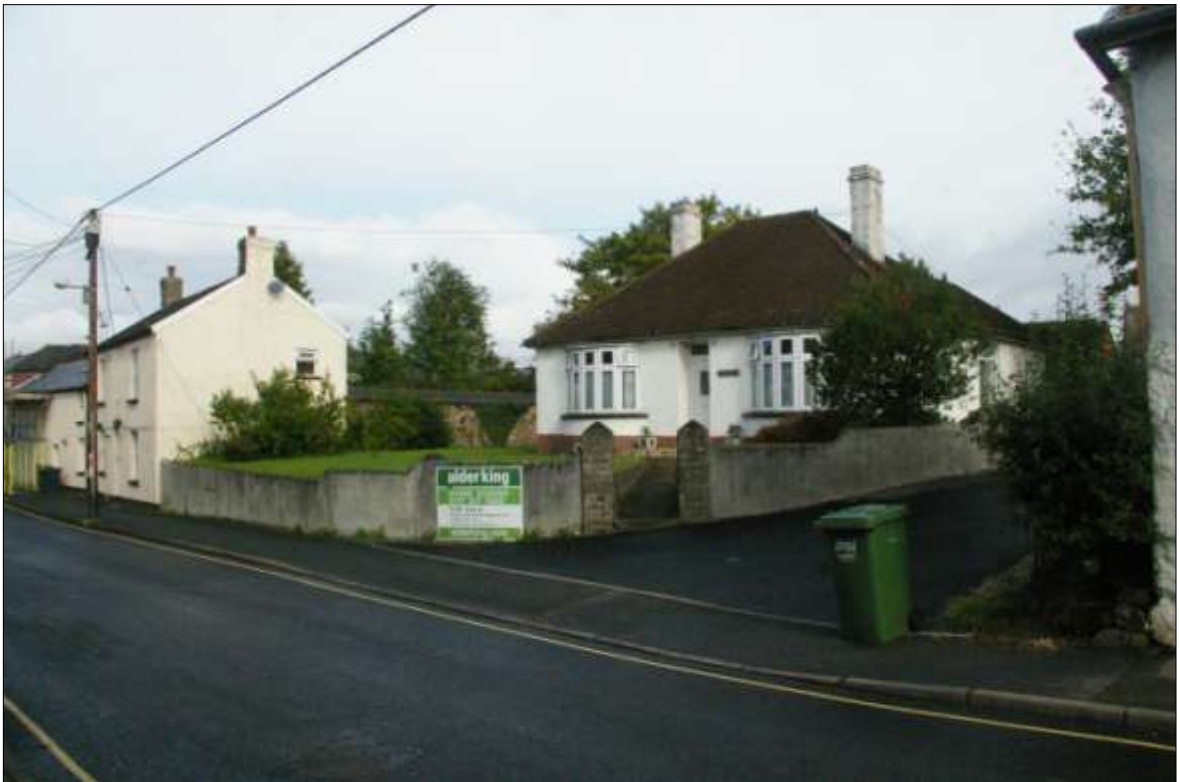
FIGURE 13: THE BUNGALOW (TOWER VIEW), VIEWED FROM THE SOUTH-EAST.

The southern part of the site, adjacent to Mill Street, comprises a single bungalow, garden and garage with access to the adjacent property (Barn Close). The garden and house sit at a higher level than the road and adjacent properties; the garden is retained by a rendered concrete block wall pierced by a single gate. The bungalow is a relatively pleasing 1930s era symmetrical building with two bow windows either side of a central door (all uPVC), with whitewashed rendered walls over a brick plinth and a hipped tiled roof with tall chimney stacks to each side. The historic west wall of the property is a tall stone rubble wall capped with a pitched roof of slate with dark blue ridge tiles. Immediately to the east, and just outside the site, is a rather mutilated historic field barn (shown on the tithe map, above) of whitewashed cob on a stone base. Below the western gable is a fragment of hedgebank with a face of pitched stone; on close inspection, however, it is bonded with concrete and likely to be relatively recent.

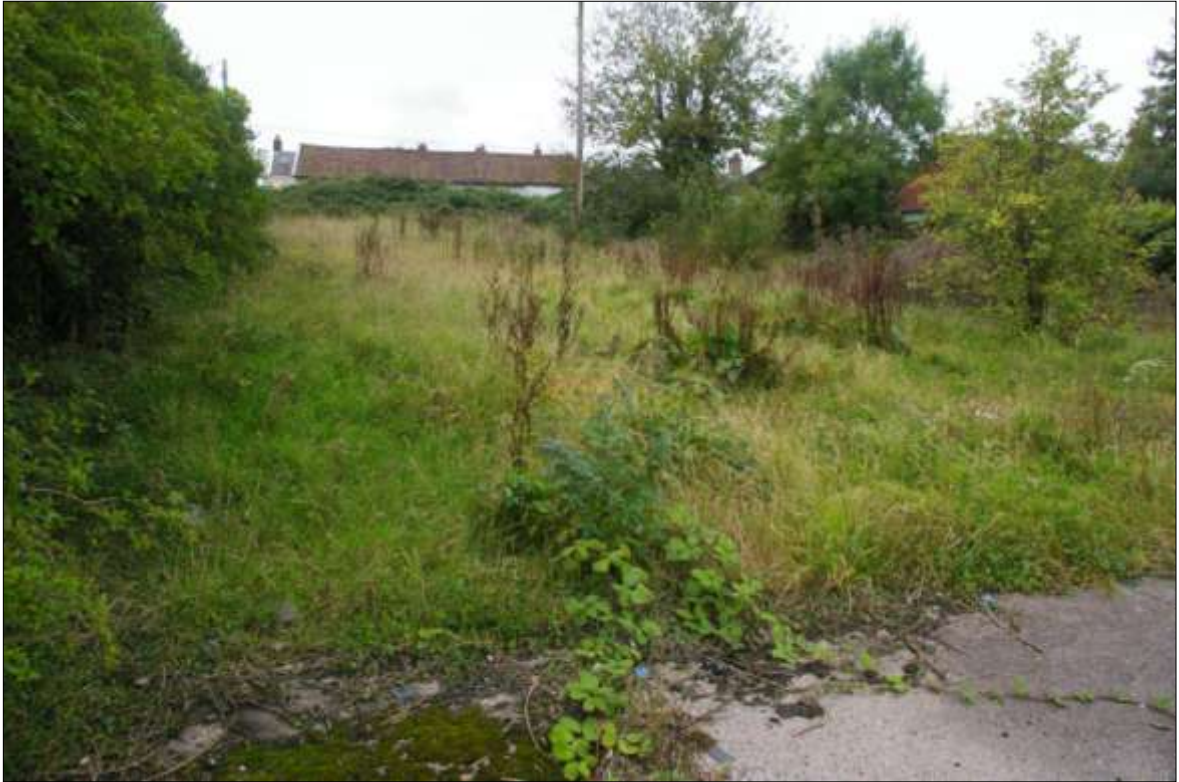
at the southern end. The area is enclosed on three sides by a chain-link fence with concrete posts; to the east this is encased by a tall hedge. No features of historic interest are present.

FIGURE 14: THE SOUTH YARD, VIEWED FROM THE NORTH.

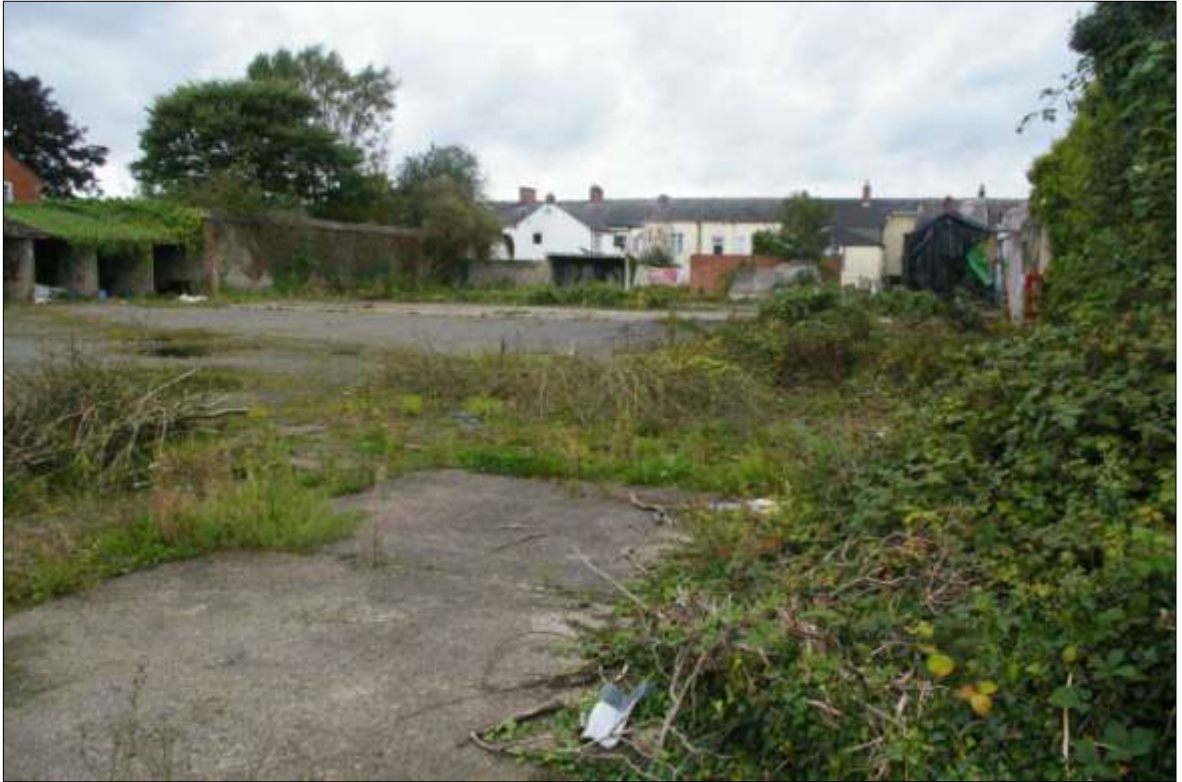
The site boundary to the south-west consists of a tall stone rubble wall of crudely-coursed slabby slatestone capped with slate and dark blue ridge tiles. At its western end it turns to the north and has been truncated; it is supported here by a wide but shallow buttress of concrete block. At its eastern end it turns to the south; the corner of the wall has been rebuilt with quoins of modern brick (Figure 15), but the east-west wall does appear to abut the north-south wall. The north-south wall is a continuation of that observed in the garden of the bungalow, and is comprised of crudely-coursed blocky slatestone dissimilar to that of the east-west section. East of this wall is a line of former garages built of concrete block with concrete floors and with a pitched roof of corrugated 'big six' asbestos sheets.

FIGURE 15: THE CENTRAL YARD, VIEWED FROM THE EAST.

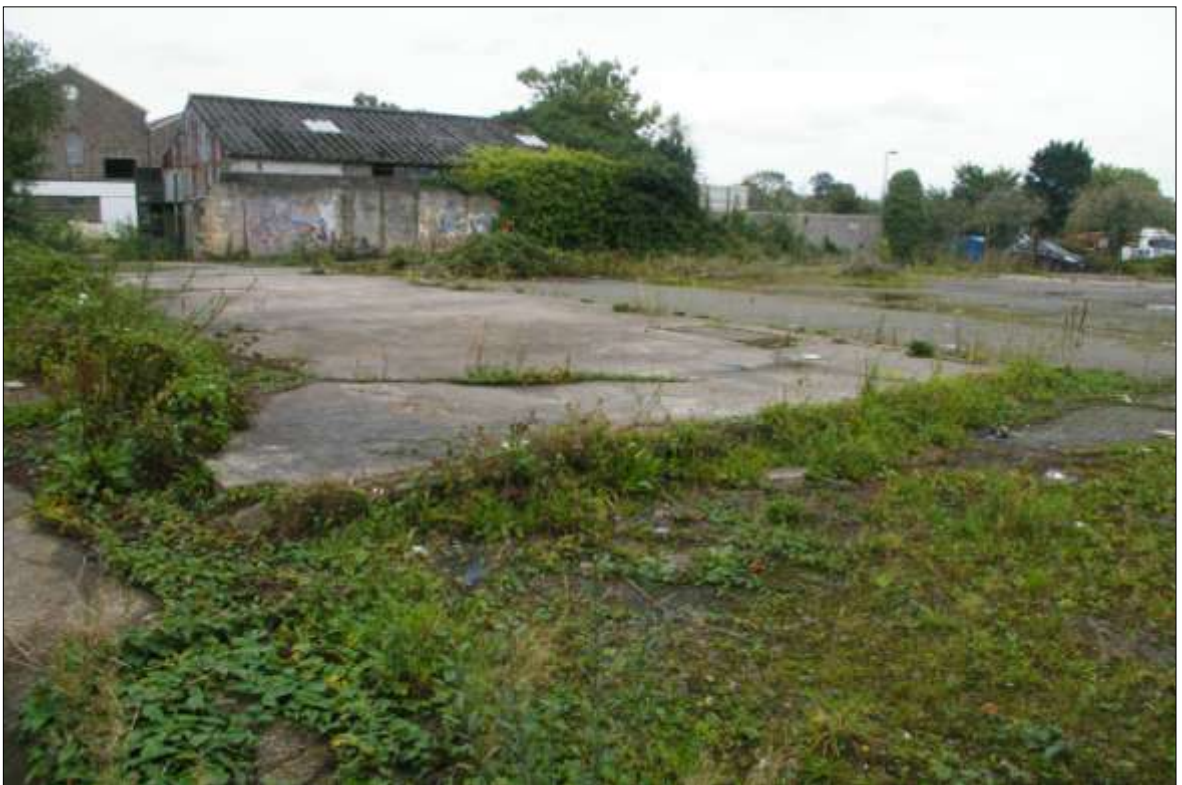
FIGURE 16: THE CENTRAL YARD, VIEWED FROM THE SOUTH-WEST.

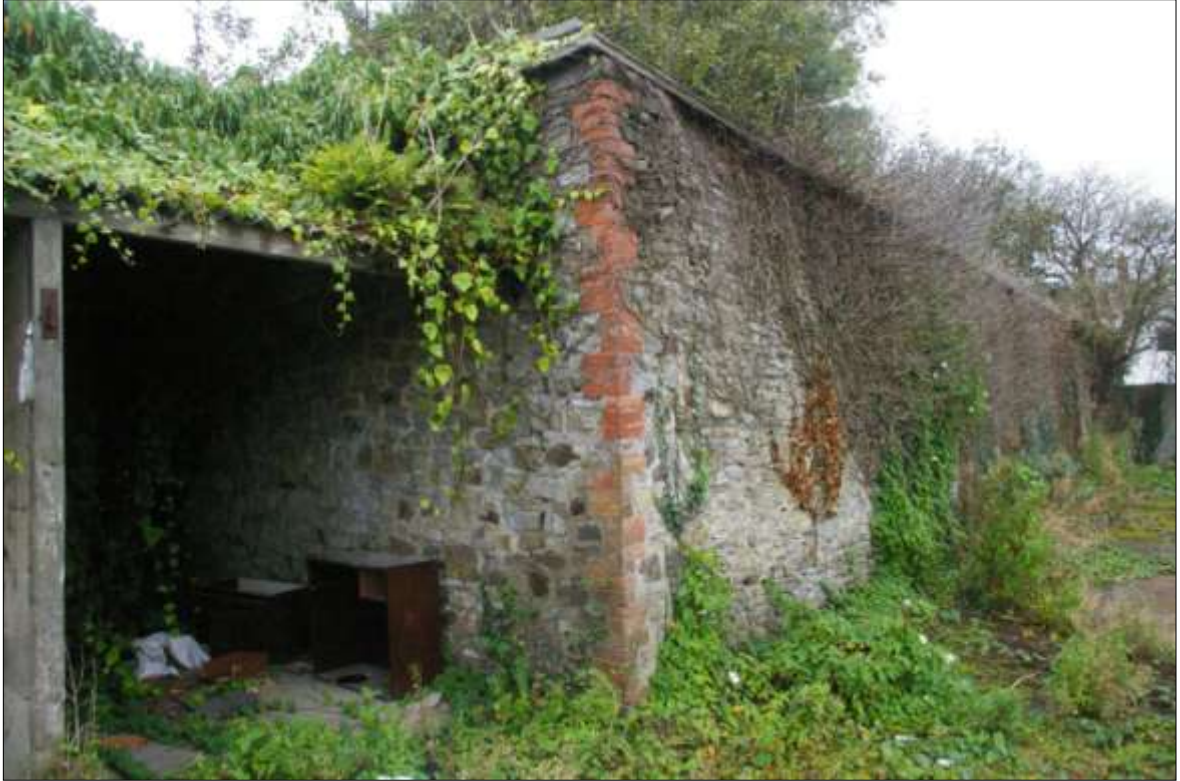
FIGURE 17: THE HISTORIC WALLS AT THE SOUTH-WEST ANGLE OF THE CENTRAL YARD; VIEWED FROM THE ENE.

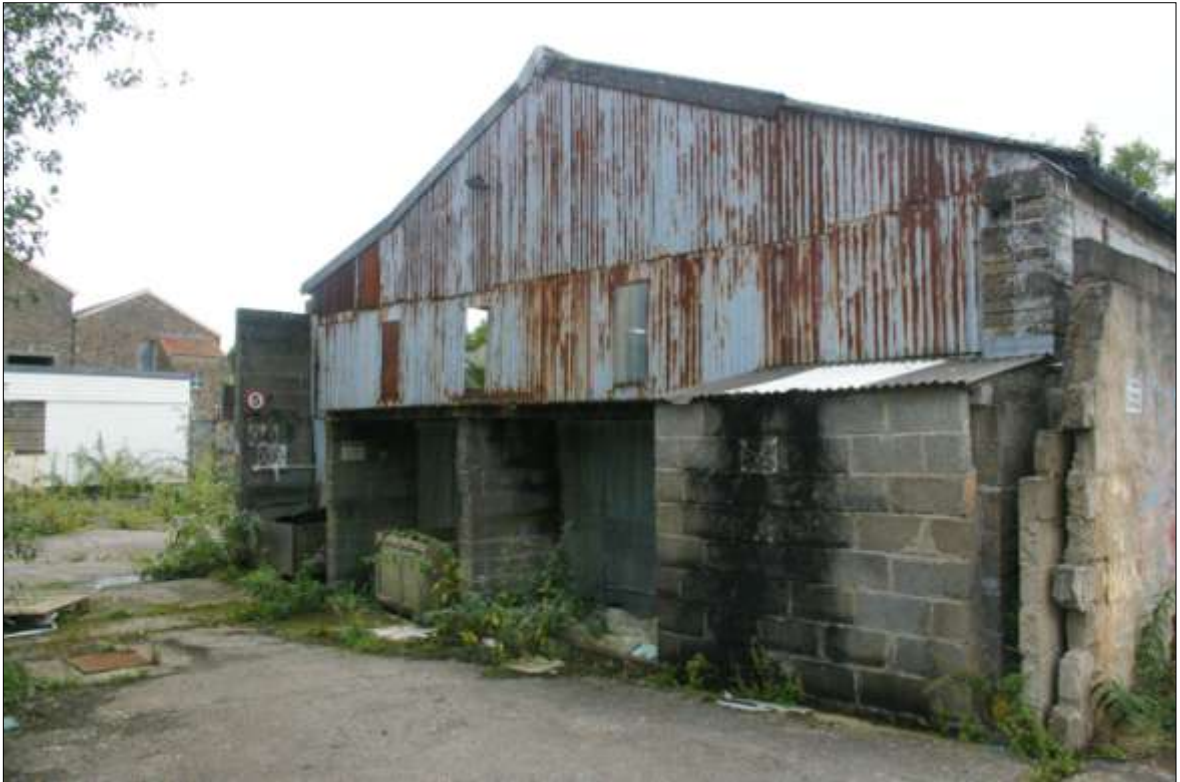
FIGURE 19: THE WEST GABLE OF B1; VIEWED FROM THE SOUTH-WEST.

The northern yard consists of a central concrete yard surface flanked by buildings, all with concrete floors. Building 1 is a large shed with walls of concrete block and corrugated iron. The shallow pitched roof of asbestos sheets is supported by an iron frame supported by pillars of

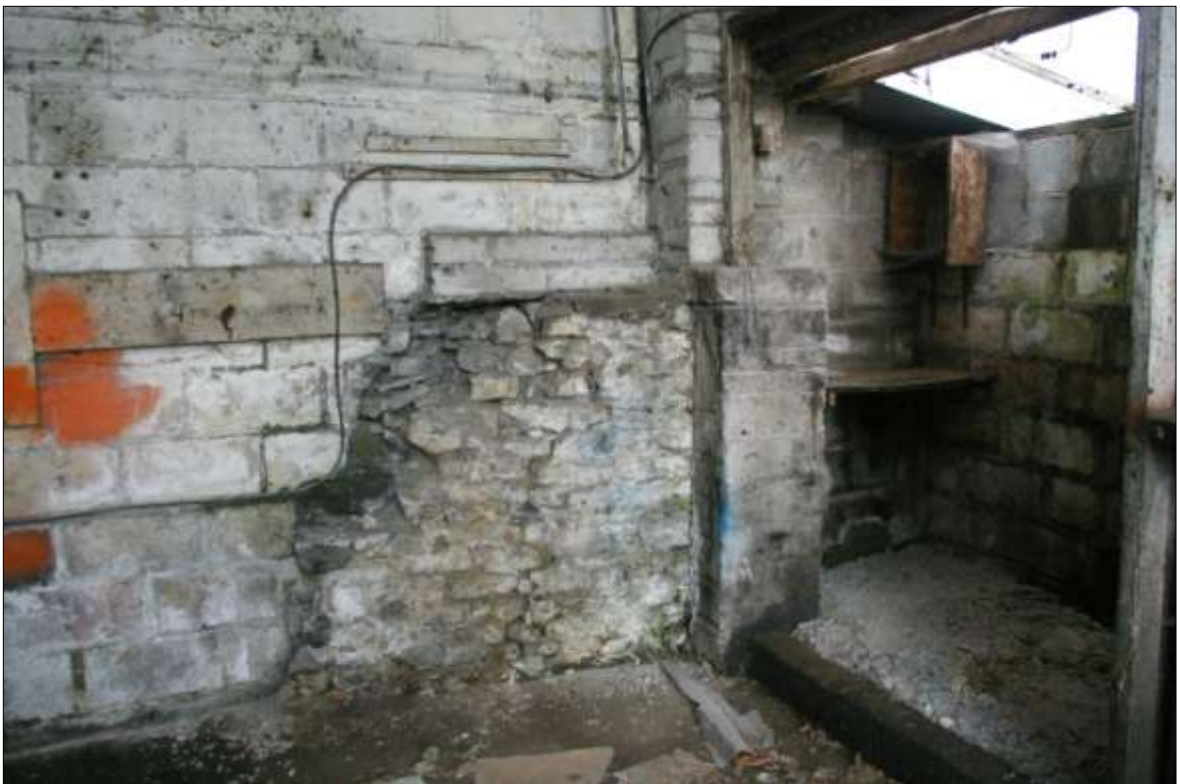
FIGURE 20: THE INTERIOR OF B1, SHOWING THE REMNANT STONE WALL IN THE SOUTH-WEST CORNER; VIEWED FROM THE NORTH.

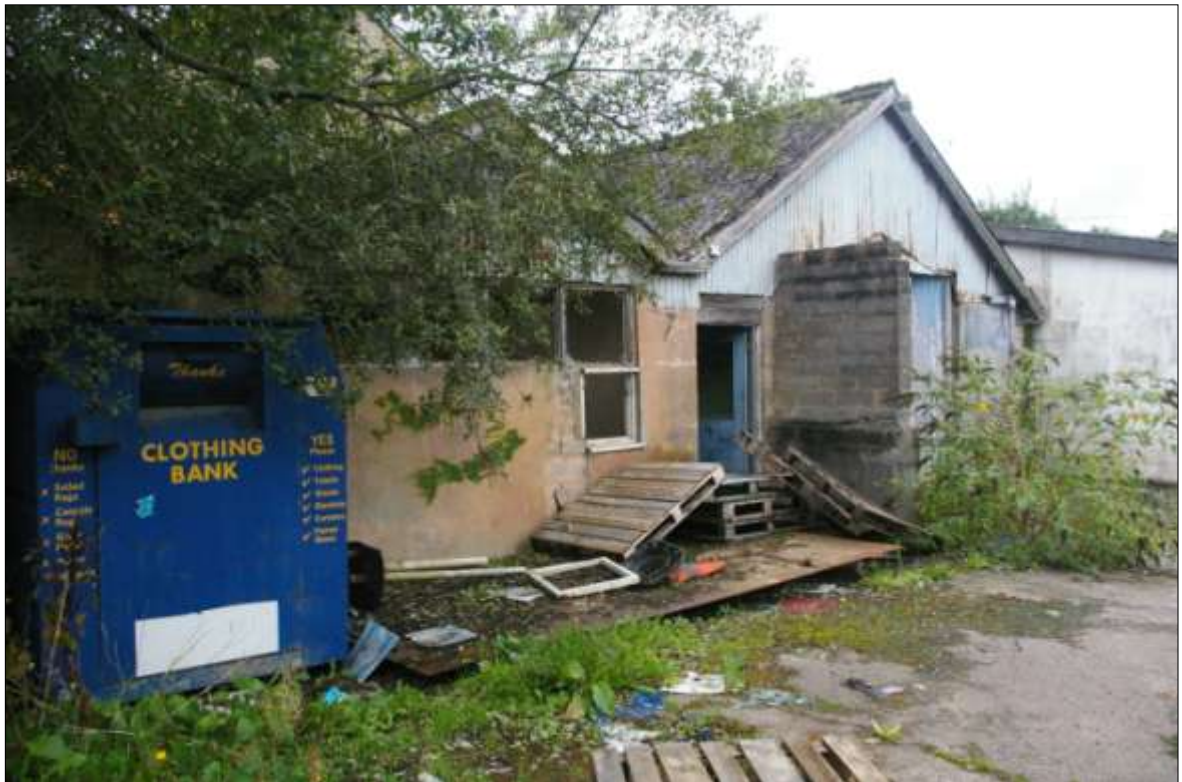
Building 2 (former offices) is rendered externally and dry-lined internally, with internal stud wall partitions. The south and east walls are of rendered concrete block; the west wall is likely to be the back wall of the adjacent burgage plot, and is therefore likely to be of stone rubble, but this could not be determined. It has a mono-pitch roof of corrugated iron sheets, with a window and door in the east elevation. There is a historic sign reading *Way Fuels and Transport Office*.

FIGURE 21: THE EAST GABLES OF B2 AND B3; VIEWED FROM THE SOUTH-EAST.

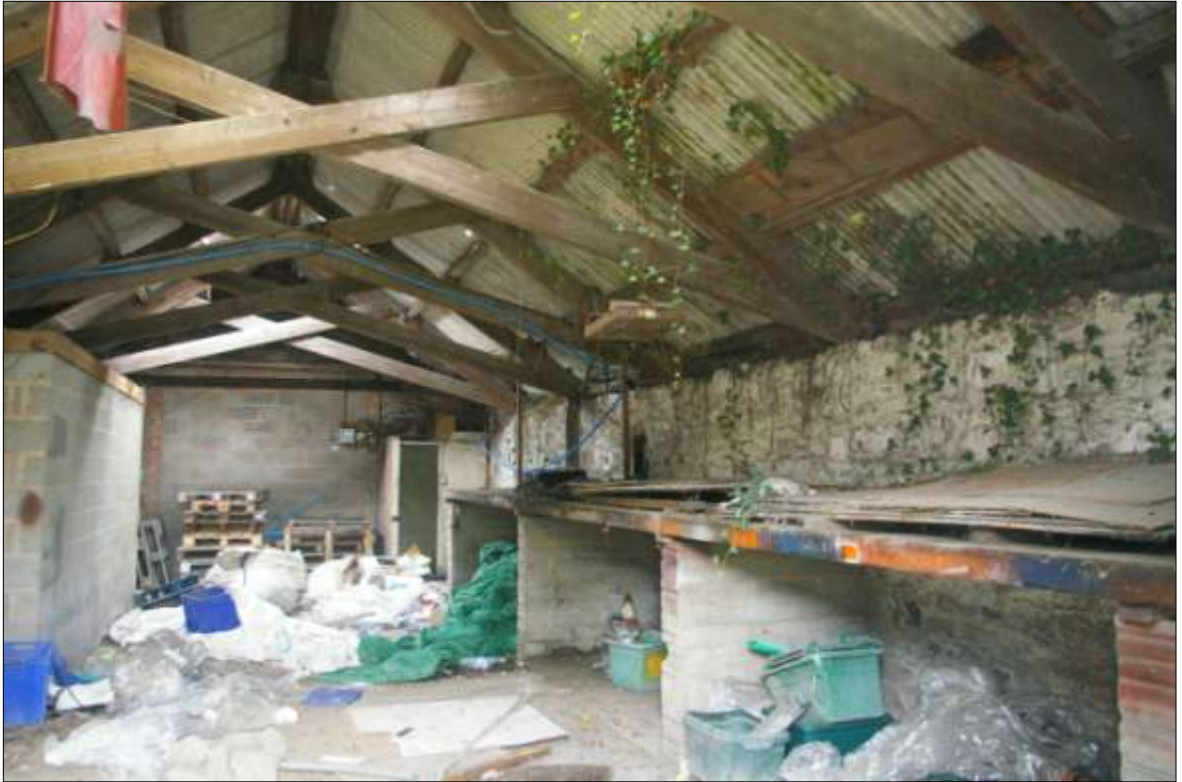
Buildings 3 and 4 are located on the western side of the northern yard. Building 3 has large double garage doors in the eastern (gable) elevation, matched by a large blocked forced opening in the elevation of no.20 South Street to the west. The north wall of this building reuses a historic stone wall of stone rubble with a plinth that steps out slightly to its base. The south wall of the building was formerly open, with the roof trusses sitting on pillars of concrete block. After Building 4 was constructed a wall of concrete block separating the two was built, set back within Building 3 to create alcoves in Building 4. Building 3 has a wide raised bench/alcoves along its northern side supported by walls of concrete block; there is a small cubicle of red brick in the north-west angle of the structure. The roof of Building 3 is of pitched corrugated asbestos sheets supported by pine scissor-trusses, bolted, and half-lapped at the apex (Figure 19). Building 4 is a smaller structure that was added to the south side of Building 3, with walls of concrete block and a pitched roof of corrugated asbestos sheets on simple bolted pine trusses. It is divided into three compartments, the one at the eastern end a probable office. There is a blocked doorway in the south-west wall.

FIGURE 22: THE INTERIOR OF B3, SHOWING THE SCISSOR-TRUSSES RESTING ON A HISTORIC STONE WALL; VIEWED FROM THE EAST.

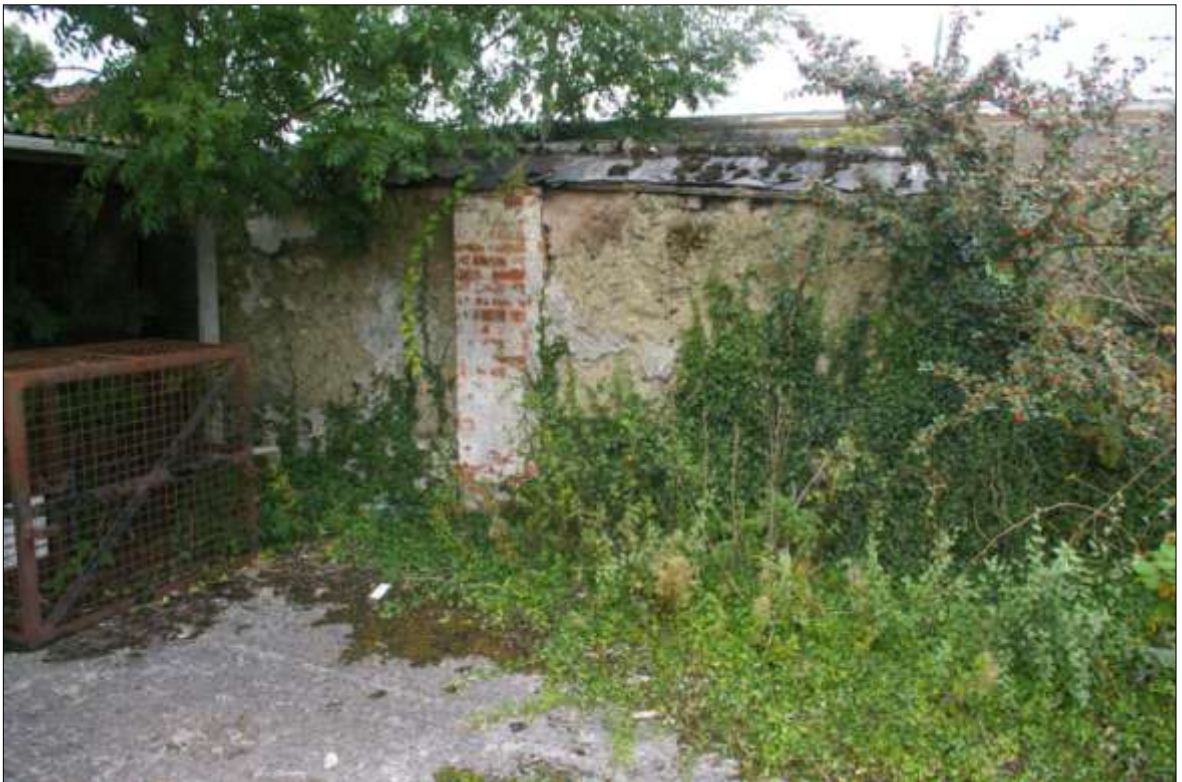
FIGURE 23: THE REMNANT STONE AND COB WALL ALONG THE NORTH-EASTERN EDGE OF THE SITE; VIEWED FROM THE WEST.

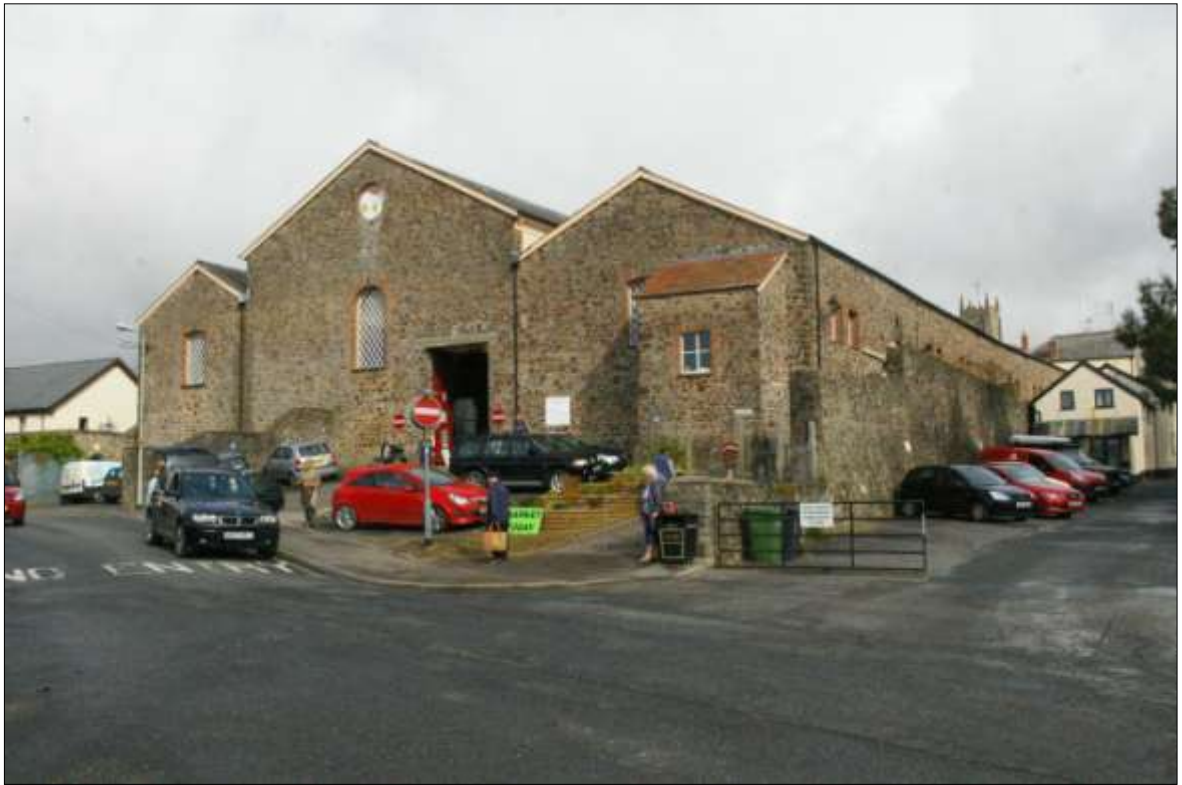
FIGURE 24: THE SOUTH ELEVATION OF THE MARKET HOUSE/PANNIER MARKET; VIEWED FROM THE SOUTH-EAST.

<p>cornice. Parapet with balustrading. First floor has 3 cambered headed windows with moulded architraves, keystones and 2 oculi. First floor central window has curved pediment. Rusticated ground floor having 3 round-headed arches with ram's head keystones. These lead through to the Pannier Market on the ground floor. On the first floor is the New Assembly Room which has a cast iron and glazed ceiling and gilded brackets and 2 fireplaces with good Victorian cast iron grates. Inscription on facade "Erected AD 1863. J E JACKSON Esq. MAYOR".</p>
<p><i>Supplemental Comments:</i> Corporate property was sold in 1862 to raise £1600 to buy the dwelling house of Mr John Elworthy Cutcliffe, which stood next to the Guildhall. A prize of £25 was offered for the design of a new market hall, which was won by W.F. Cross of Exeter. It was built by the lowest bidder, John Cock junior, for £6677 (Cock 1893). The market hall is monumental in terms of scale and massing. While relatively recessively from Broad Street, the pannier market to the rear is highly visible and disproportionately large in comparison with the smaller structures to the rear of the other properties. The current doorway to the rear of the building is a more recent forced opening; the original door was in the east wall, where there is a large segmental arch of dressed stone.</p>

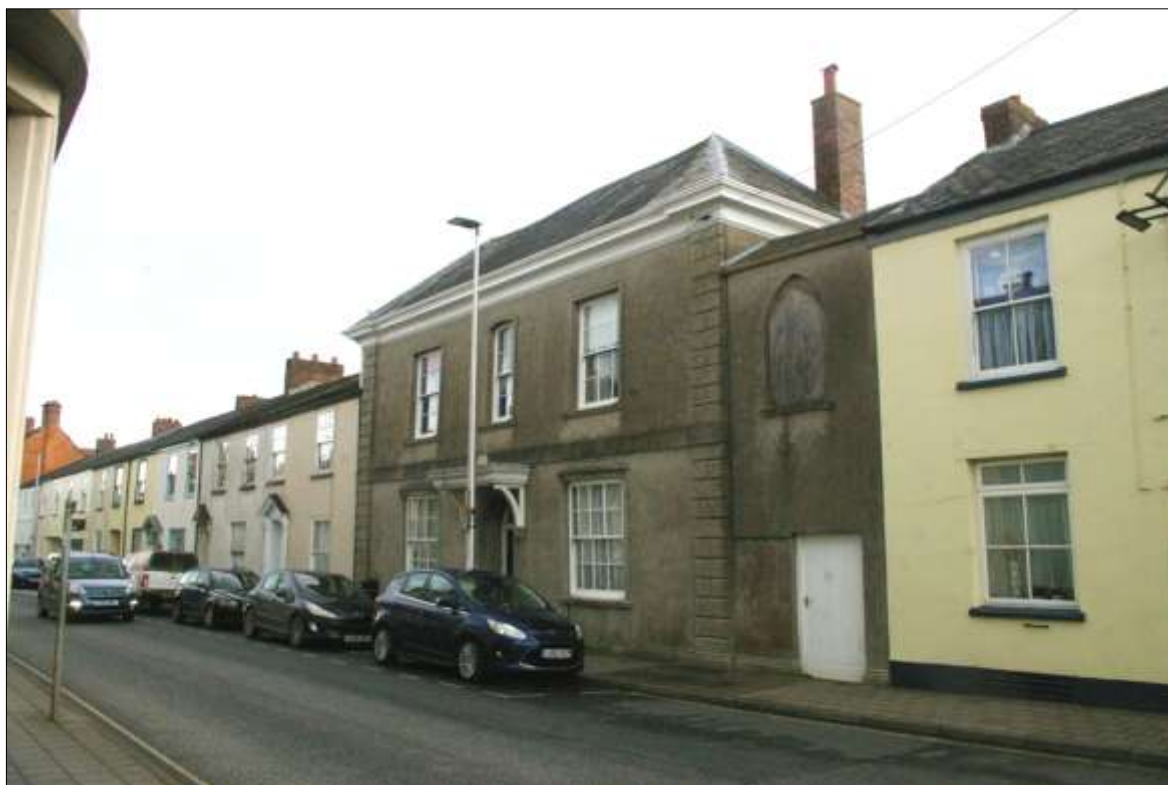
FIGURE 32: NO.27 SOUTH STREET; VIEWED FROM THE SOUTH-WEST.

<b>Asset Name: 27 South Street</b>	
<i>Parish:</i> South Molton	<i>Value:</i> Medium
<i>Designation:</i> GII	<i>Distance to Development:</i> 20-105m
<p><i>Summary:</i> Listing: Early C18 altered in early C19. Two storeys cement rendered. Hipped slate roof. Coved eaves cornice. Stringcourse and rusticated quoins. Three sashes with glazing bars intact, the centre one cambered. Ground floor has two slightly curved bow windows. Central doorcase with round-headed arch, fanlight and heavy wooden weather hood on brackets. Roof in four hips to rear. Pevsner notes: altered ground floor but with apparently a substantial five-bay house of c.1700.</p>	
<p><i>Conservation Value:</i> A fairly ornate historic building of architectural interest. Inherent evidential value as the building appears to be relatively grand compared to adjacent structures. Archaeological features dating back to the 12<sup>th</sup> century may be present.</p>

<p><i>Authenticity and Integrity:</i> Externally the building retains its historic character. The interior was not accessed, and the Listing notes only external details. Pevsner notes alterations but otherwise a relatively good interior.</p>	
<p><i>Setting:</i> The building stands on the eastern side of South Street. This is essentially a street scene composed of quite similar two-storey buildings with attractive detailing. This building is taller than other buildings with a hipped roof. The rusticated quoins set it apart from adjacent houses.</p>	
<p><i>Contribution of Setting to the Significance of the Asset:</i> A townhouse within the context of a historic urban street scene. The surrounding buildings contextualise the structures.</p>	
<p><i>Magnitude of Effect:</i> The regeneration of the former recycling centre would have no affect on the buildings as viewed from South Street. Subject to design proposals could have either a positive or an adverse effect.</p>

<p><i>Magnitude of Impact:</i> Medium value asset and Negligible change = Neutral/Slight</p>	
<p><i>Overall Impact Assessment:</i> <b>Negligible</b></p>

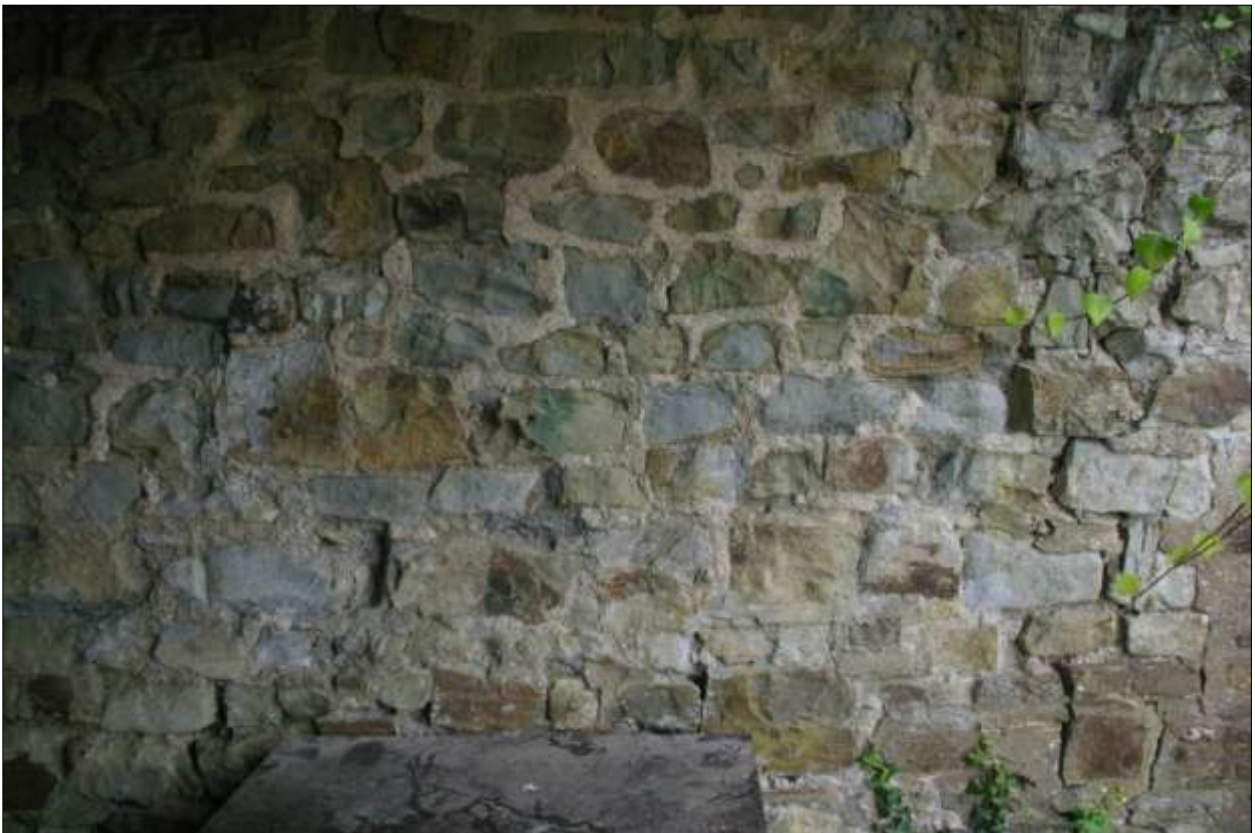
Detail of the west wall of the garages/rear wall of the burgage plots; viewed from the east.

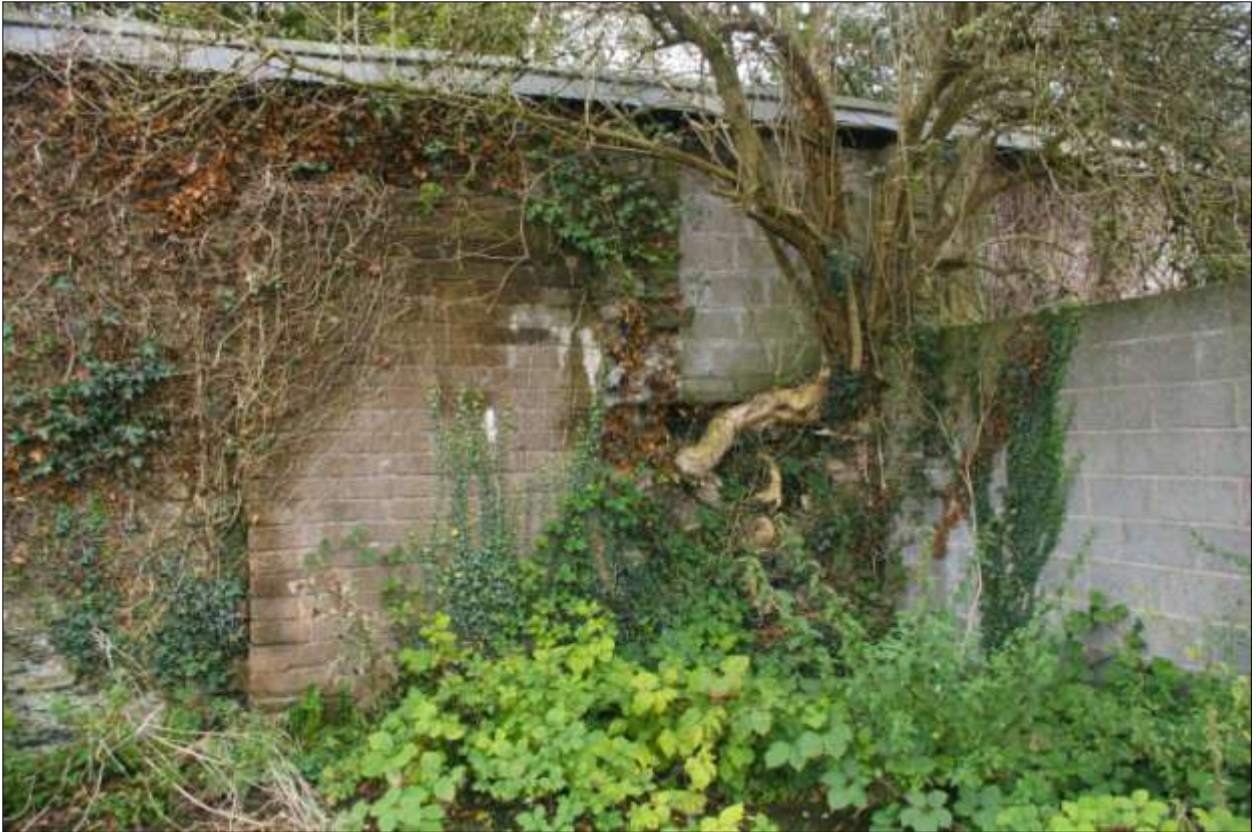
As above, showing a buttress in concrete block, and a return on the stone wall; viewed from the NNE.

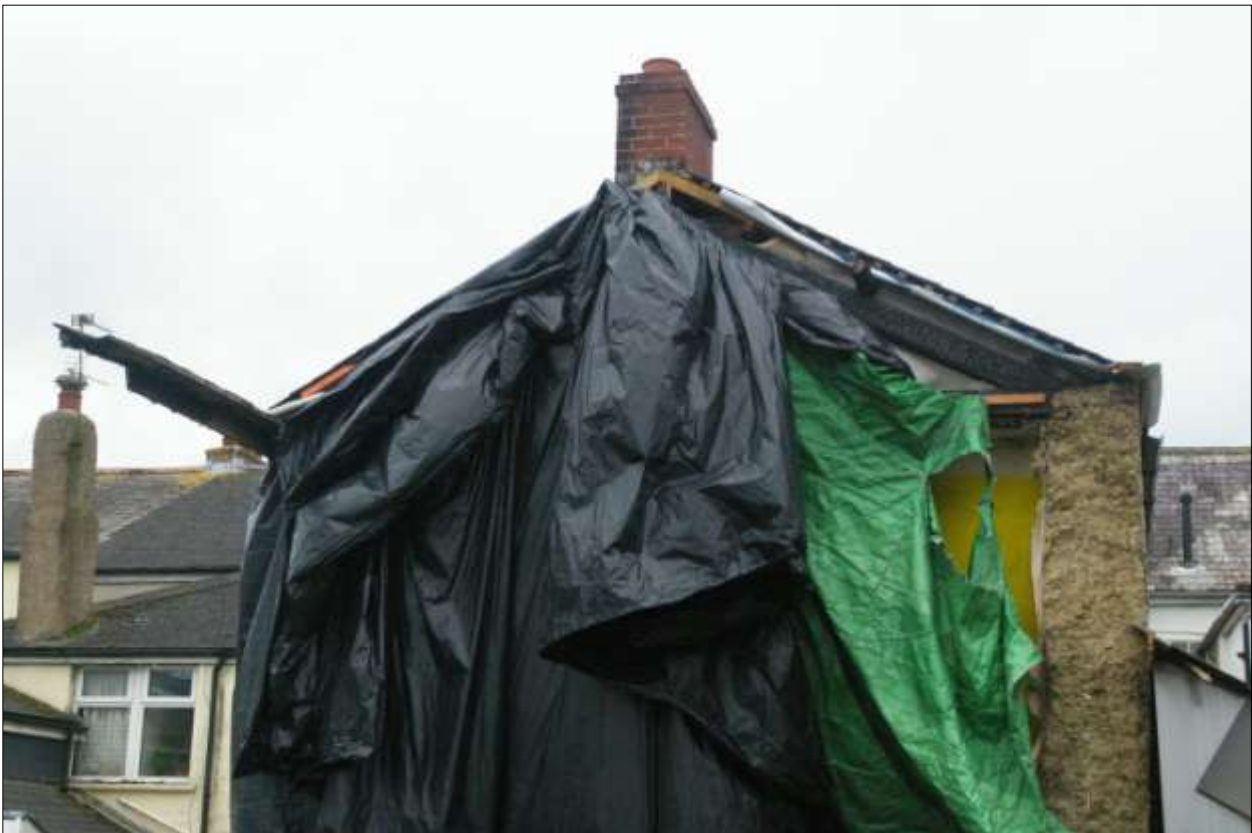
As above, showing the cob wall and burnt roof trusses.

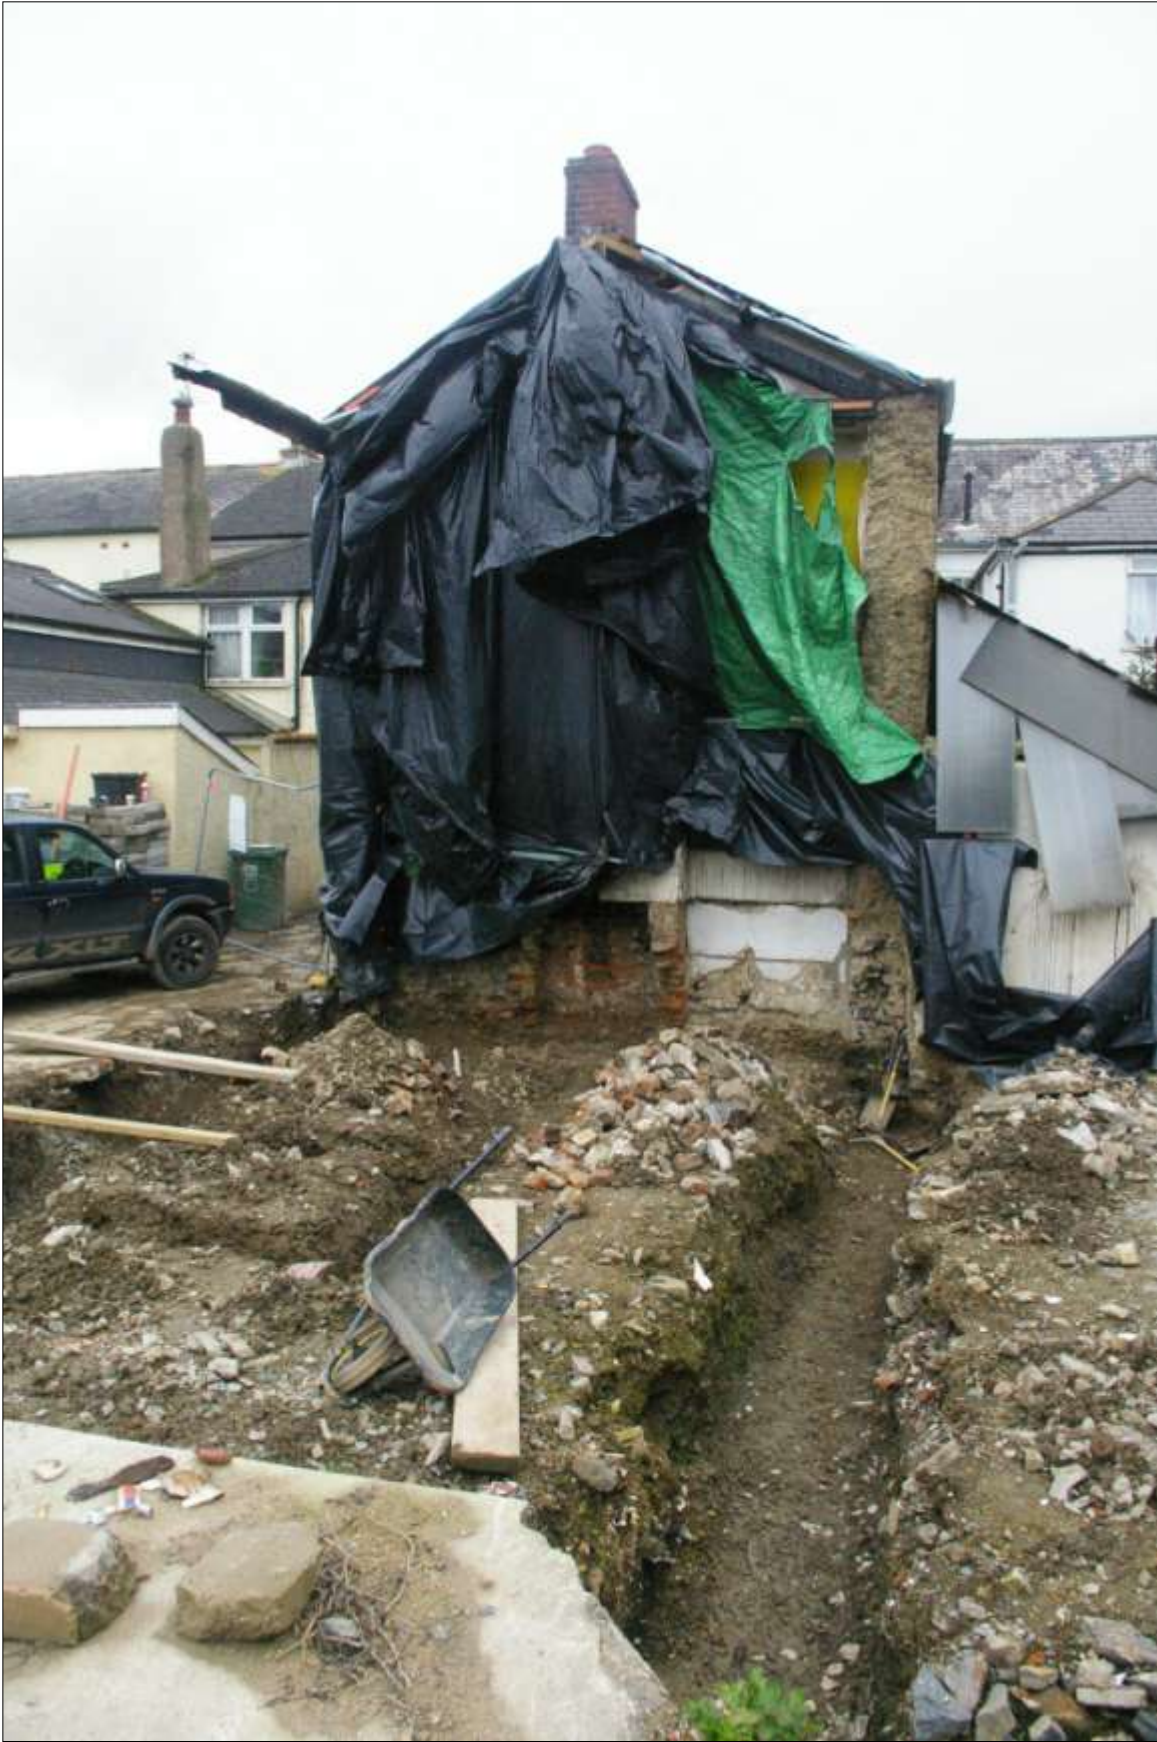
As above, showing the new foundation trenches.

To the west of the site a structure on Albion Place is being rebuilt following a serious fire. Examination of the foundation trenches for the replacement structure would indicate the western part of the yard is 0.4-0.5m higher than ground level in Albion Place, and that ground levels in Albion Place are only c.0.35m above solid rock (see Figure 16). It seems likely the western yard sits on made ground, perhaps derived from demolished structures.

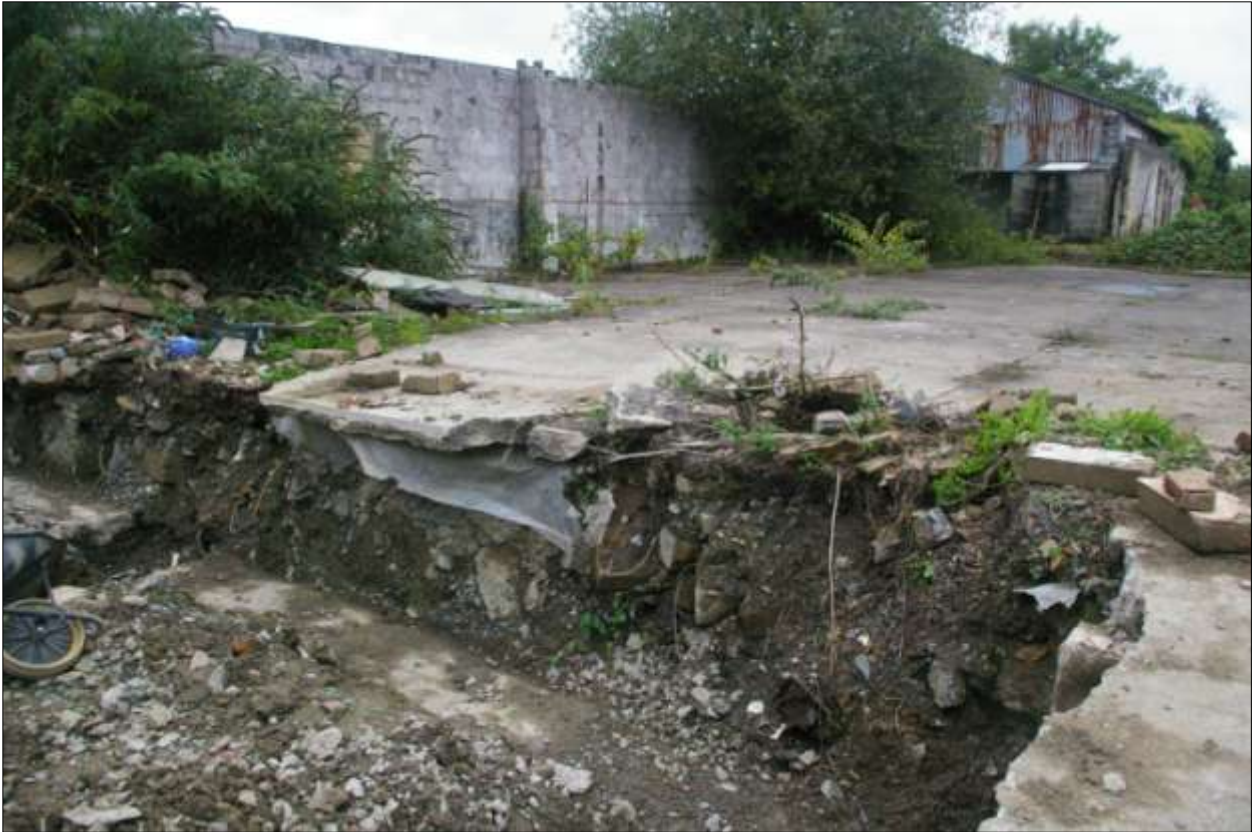
As above, but viewed from the west; showing the depth on made ground across the western part of the central yard.

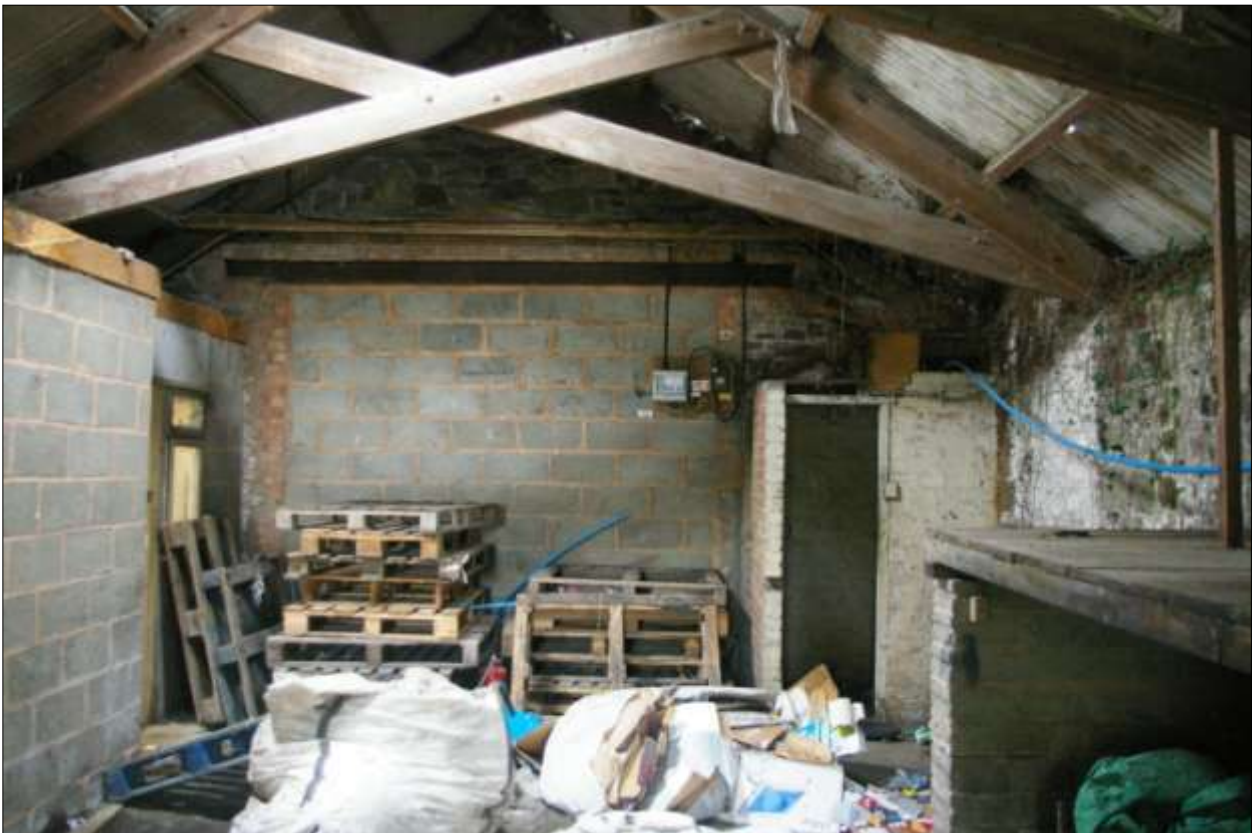
The western end of the interior of Building 3, showing the blocked forced opening in the wall of the adjacent building; viewed from the east.
