# NORRINGTON YARD SOUTH MOLTON DEVON

Results of a Desk-Based Assessment, Walkover Survey &  
Heritage Impact Assessment

South West Archaeology Ltd. report no. 170925

By B. Morris  
Report Version: 01  
25<sup>th</sup> September 2017

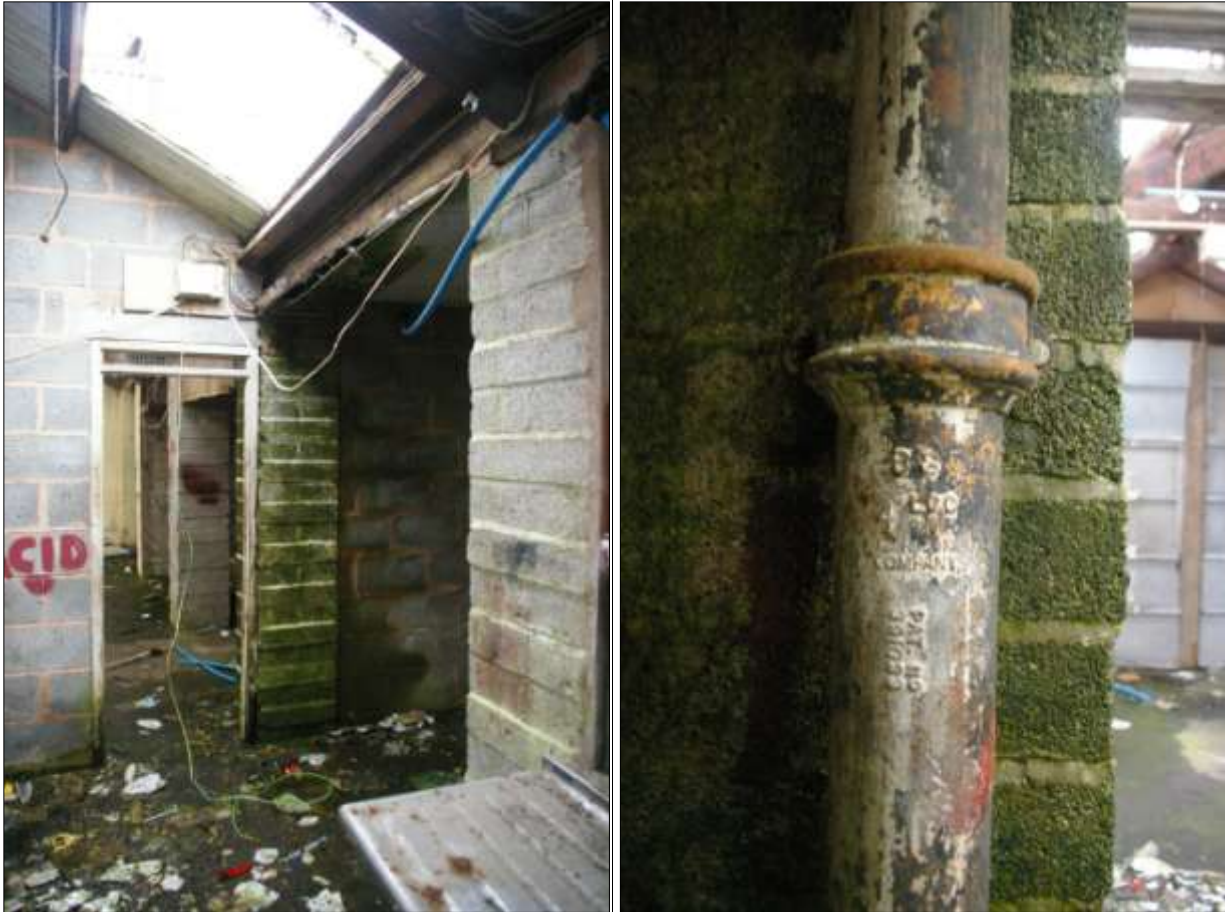
LEFT: Building 4, showing the line of concrete block pillars; viewed from the east.  
RIGHT: Building 4, detail of a cast iron downspout; viewed from the west.
