FISH HOEK AND WATERSIDE DARTMOUTH SOUTH HAMS DEVON

Results of a Desk-Based Assessment and Archaeological Test-Pitting

South West Archaeology Ltd. report no. 180309

Work undertaken by SWARCH
for
O'Brien Developments Waterside Ltd (the Client)

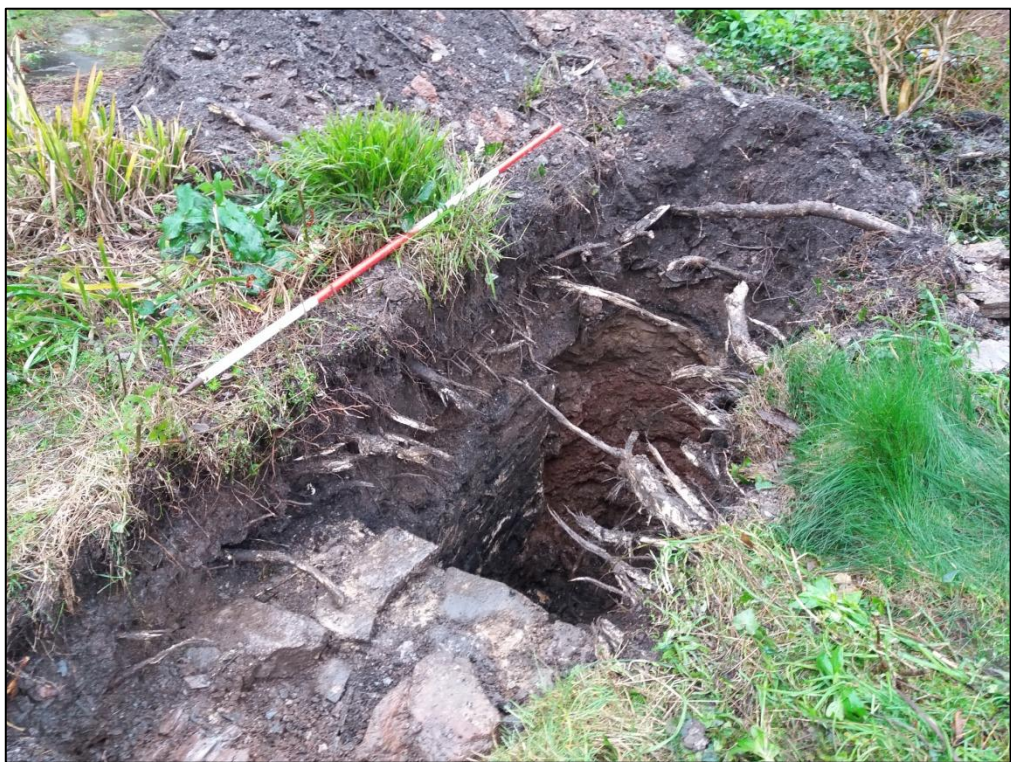
Cover plate: Test-Pit 04 showing walls {404} and {405}; taken facing the south.

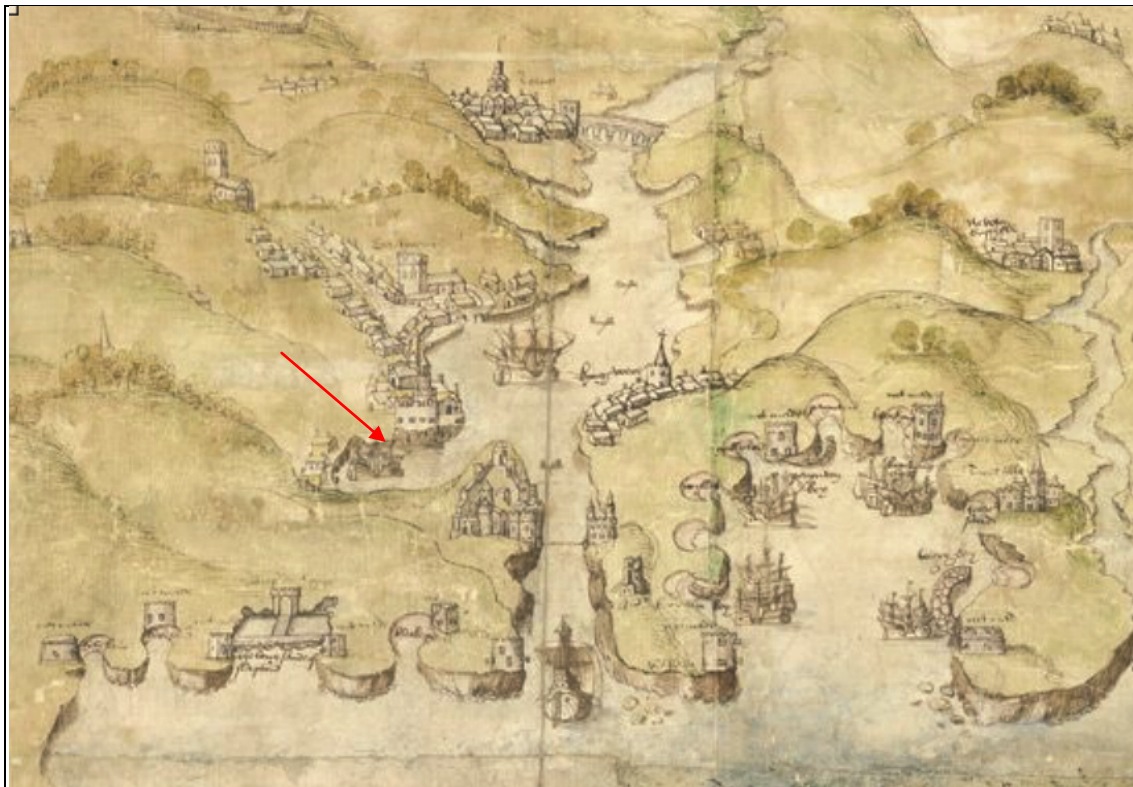
FIGURE 2: EXTRACT FROM A 1539-40 MAP OF THE SOUTH-WEST COAST OF ENGLAND (BL) (THE APPROXIMATE LOCATION OF THE SITE IS INDICATED).

There are a number of early maps for Dartmouth, many including the harbour and detailing sailing conditions, but none of these depict the landscape around Dartmouth in any meaningful detail (see Figure 2); the first source to show the landscape in any detail is the 1804 Ordnance Survey surveyors draft map (Figure 3). This shows the site at the southern tip of the main settlement of Dartmouth, with limited development appearing to continue to the west of the road to Warfleet, and an unclear extent of development to the east of the road. The town is situated within a wider landscape depicted as being largely agricultural: small farmsteads surrounded by fields with gently-curving boundaries suggestive of earlier medieval strip-field origins.

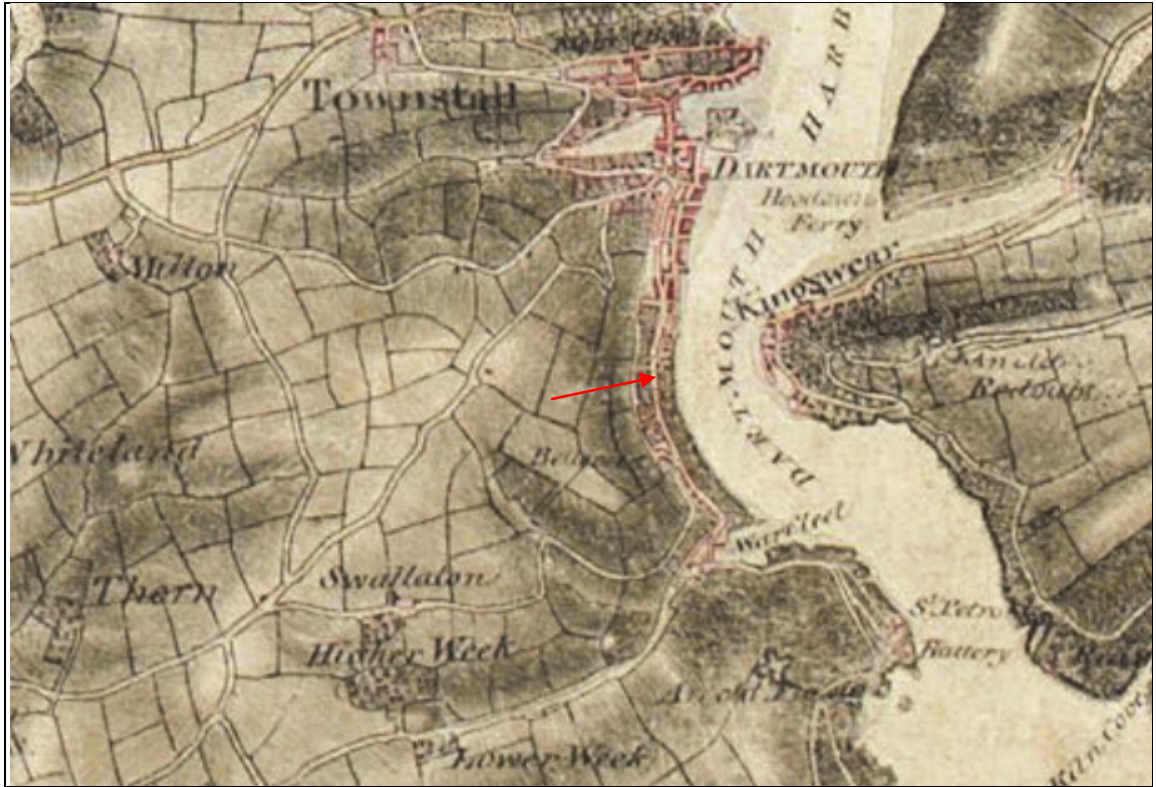
FIGURE 3: EXTRACT FROM THE 1804 ORDNANCE SURVEY SURVEYORS DRAFT MAP FOR DARTMOOR (BL) (THE APPROXIMATE LOCATION OF THE SITE IS INDICATED).

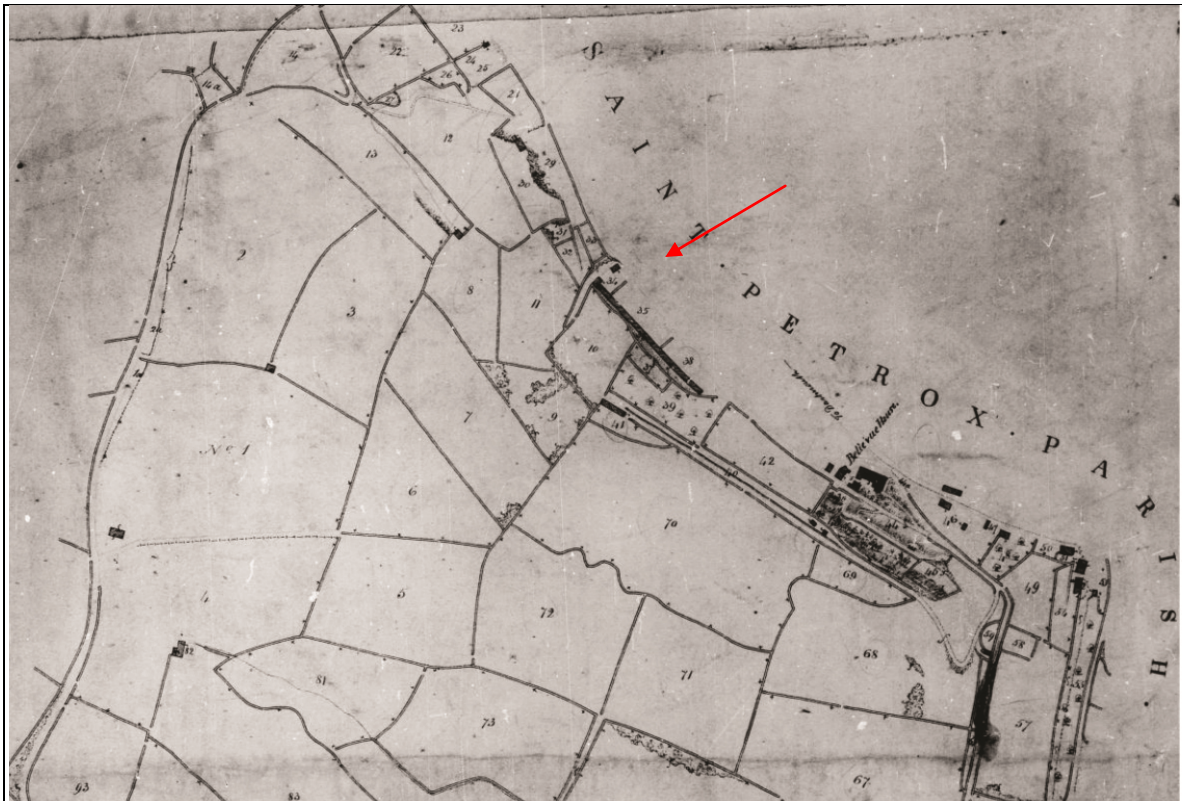
FIGURE 4: EXTRACT FROM THE 1840 STOK FLEMING TITHE MAP (SOURCE: THE GENEALOGIST) (THE APPROXIMATE LOCATION OF THE SITE IS INDICATED).

Whilst usually detailed cartographic sources, the parish of St. Petrox was tithe-free, though the 1840 Stoke Fleming tithe map (Figure 4) shows the wider landscape. It appears to confirm the impression of the curving boundaries of medieval strip fields divided through later enclosure suggested by the earlier Ordnance Survey map; but shows it in more detail and the straighter boundaries reflect a greater amount of later enclosure. The corresponding apportionment (Table 1) indicates that most of the field names were relatively prosaic, relating to land-use, nearby features, or the local topography; it also shows that the land to the immediate west of the site was owned by Sir John Henry Seale, with plots occupied by Thomas Tucker, John Lavers, Amos Peeke, and Richard Fox. The apportionment lists the land here as largely being garden with vegetable plots, including potato.

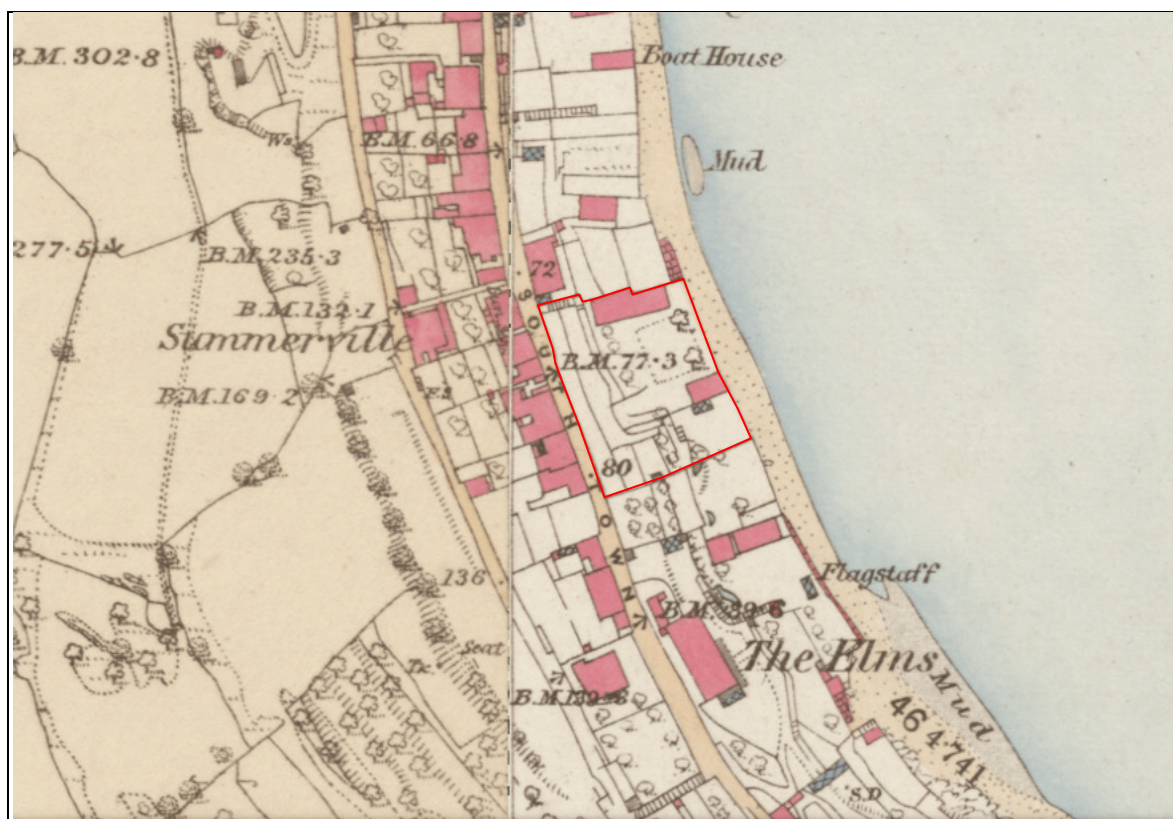
FIGURE 5: EXTRACT FROM THE 1873-88 ORDNANCE SURVEY 1ST EDITION MAP (NLS) (THE SITE IS INDICATED).

The 1873-88 1st edition Ordnance Survey map (Figure 5) is the first accessible map providing significant detail of the site itself. It shows that the buildings of both Fish Hoek and Waterside are already in existence, Fish Hoek with a glasshouse/conservatory to its southern façade. The 1880s town map (Figure 6) shows the site in much greater detail, including access to the well laid-out tree lined garden with well, seat and glasshouse via a winding terraced footpath.

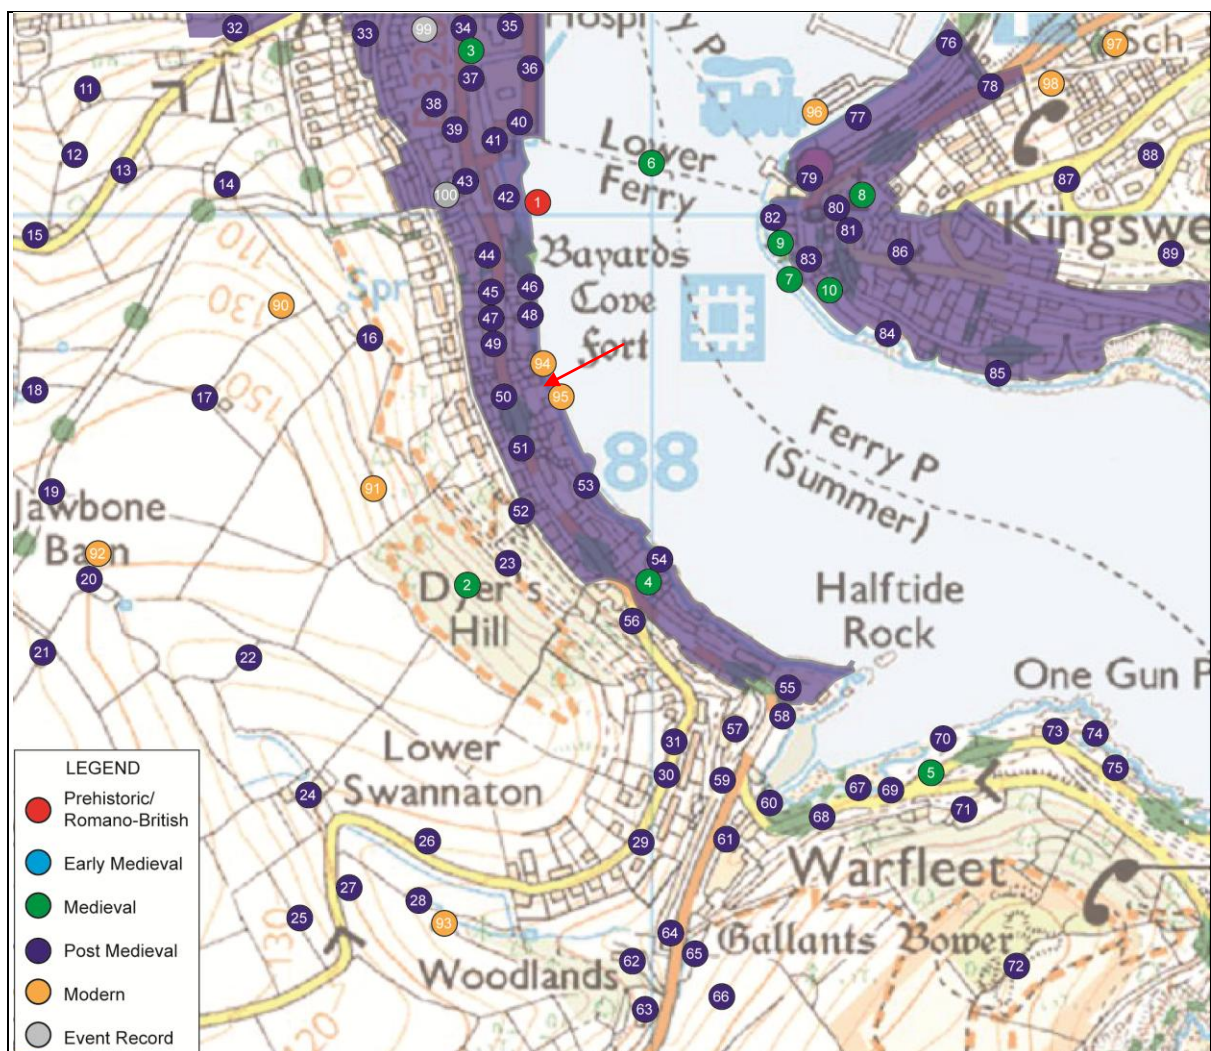
FIGURE 8: MAP OF NEARBY HERITAGE ASSETS (SOURCE: DEVON AND DARTMOOR HER) (CONTAINS OS DATA © CROWN COPYRIGHT AND DATABASE RIGHTS 2016) (THE LOCATION OF THE SITE IS INDICATED).

The site is located to the south of the main historic core of Dartmouth, on the western bank of the River Dart, south of Bayards Cove Fort and opposite the western bank of Kingswear, all of which have historic origins. A limited amount of archaeological investigation has been carried out in the area: archaeological monitoring during works carried out at Evelyn Cottage and St Barnabus' Church, identifying structural remains associated with the post-medieval development of the town. The majority of the evidence for the archaeological background of the area is derived from documentary and upstanding remains, the Devon and Dartmoor HER identifying activity and settlement in the region dating from the Prehistoric through to the Post-medieval and modern periods (see below).

No archaeological investigations have been carried out on the proposal site itself, and the only monuments recorded adjacent to the site reflect World War II defences.

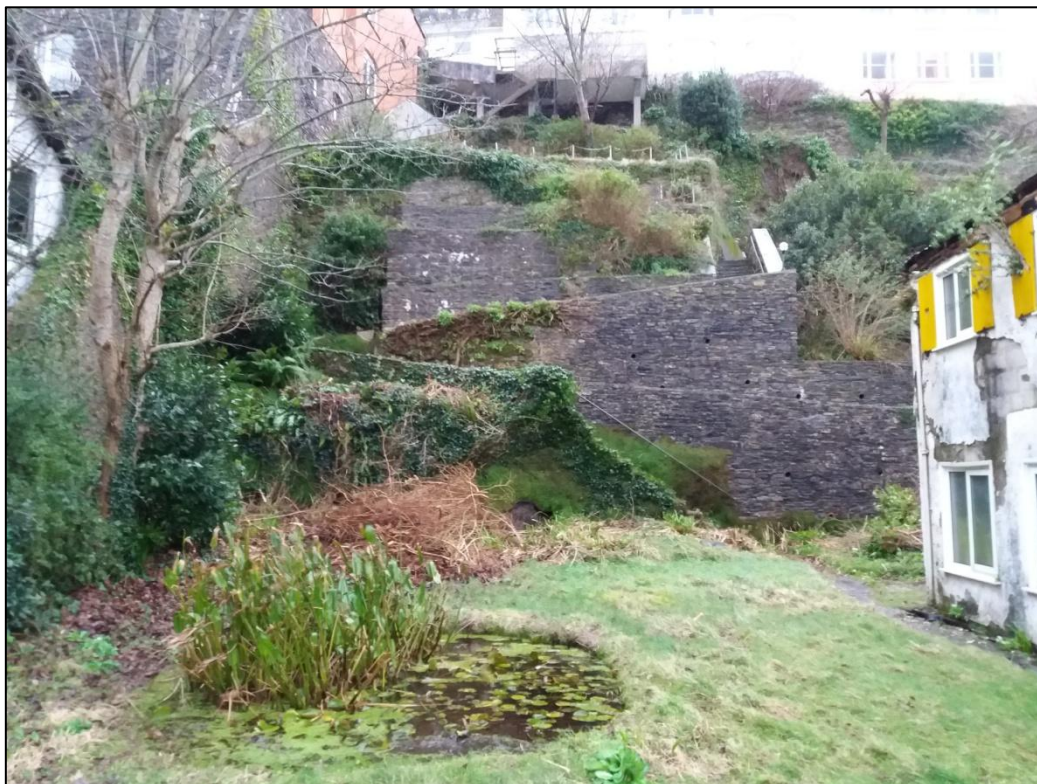
SITE SHOT, TEST-PIT 01 AND 02 LOCATIONS; VIEWED FROM THE NORTH-EAST (NO SCALE).

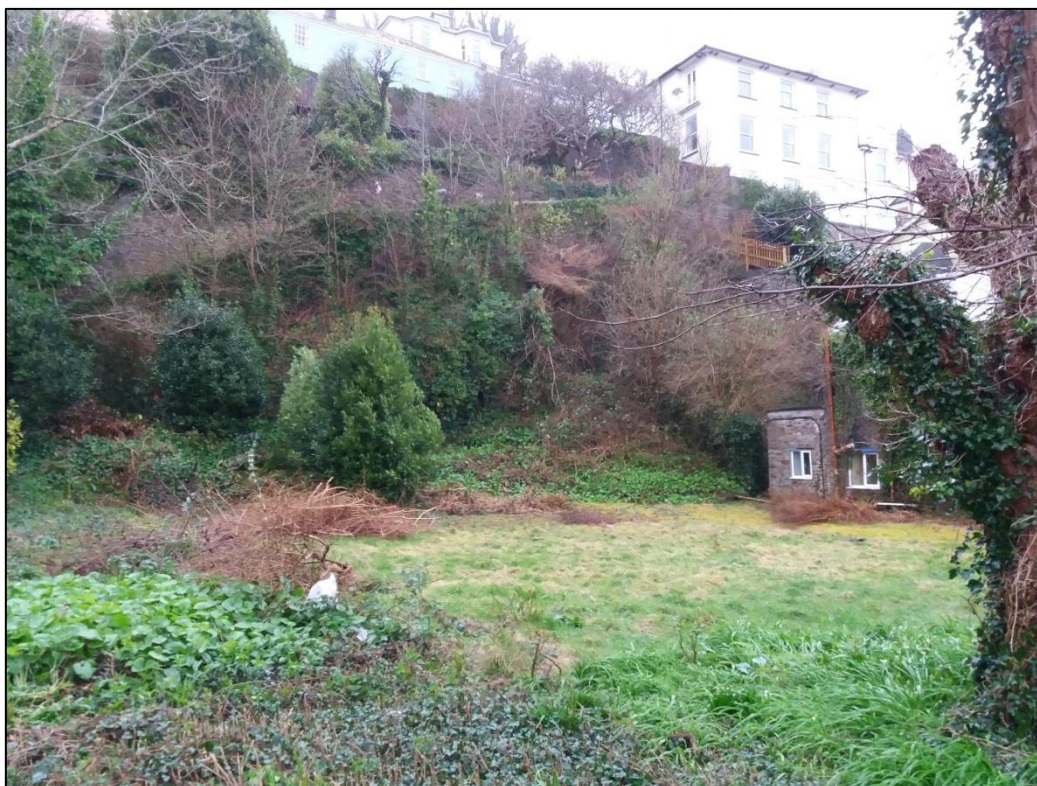
SITE SHOT, TEST-PIT 03 AND 04 LOCATIONS; VIEWED FROM THE EAST (NO SCALE).

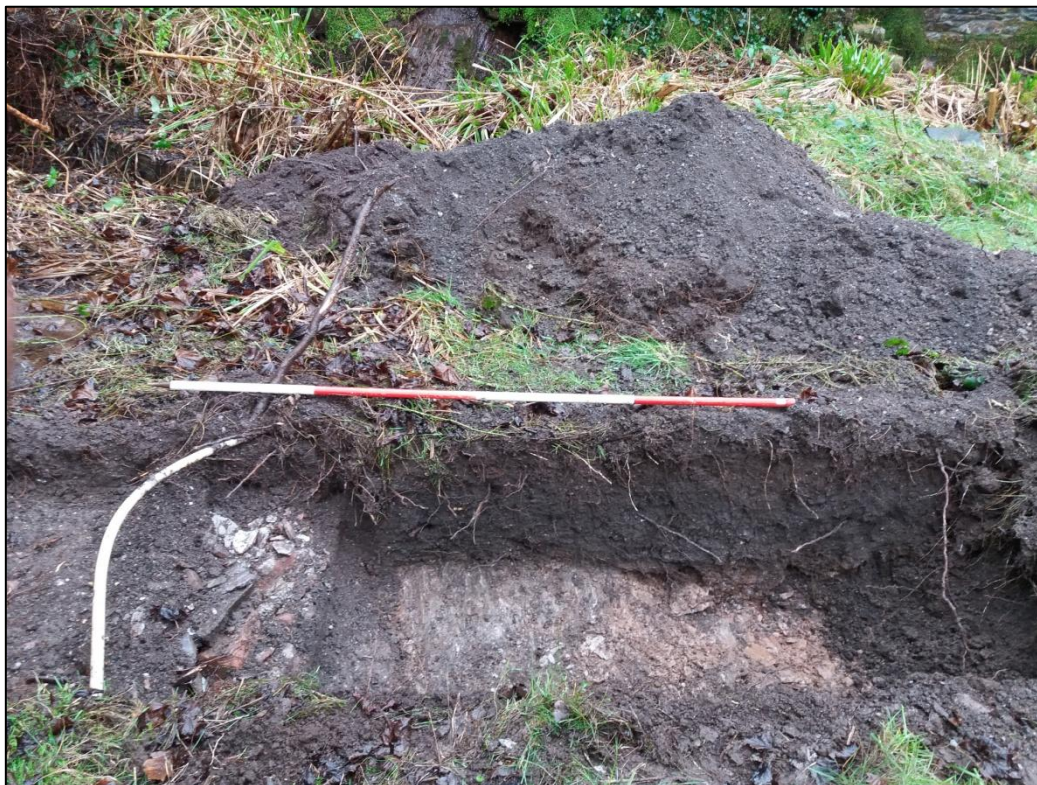
TEST-PIT 01 NORTH-EAST FACING SECTION SHOWING THE MODERN SERVICE PIPE AND SOIL LAYERS OVERLYING THE NATURAL BEDROCK; VIEWED FROM THE NORTH-EAST (2M SCALE).

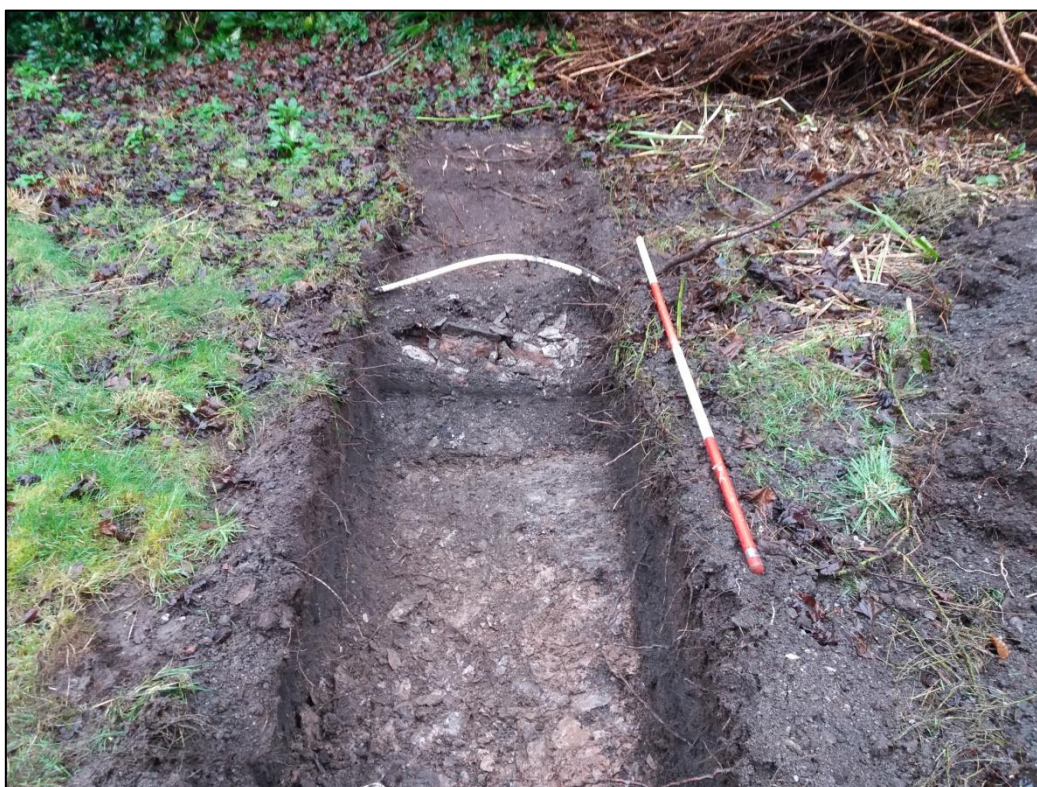
TEST-PIT 01, POST-EXCAVATION PLAN SHOT SHOWING MODERN SERVICE PIPE AND NATURAL BEDROCK; VIEWED FROM THE NORTH-WEST (2M SCALE).

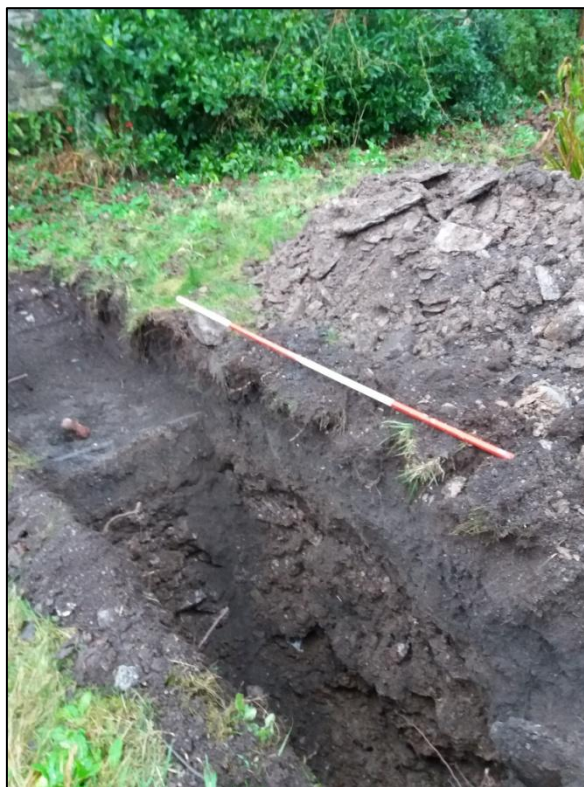
TEST-PIT 02, NORTH-EAST FACING SECTION, OBLIQUE, SHOWING THE MODERN SERVICE PIPE AND SOIL LAYERS OVERLYING MADE-GROUND DEPOSITS; VIEWED FROM THE NORTH (2M SCALE).

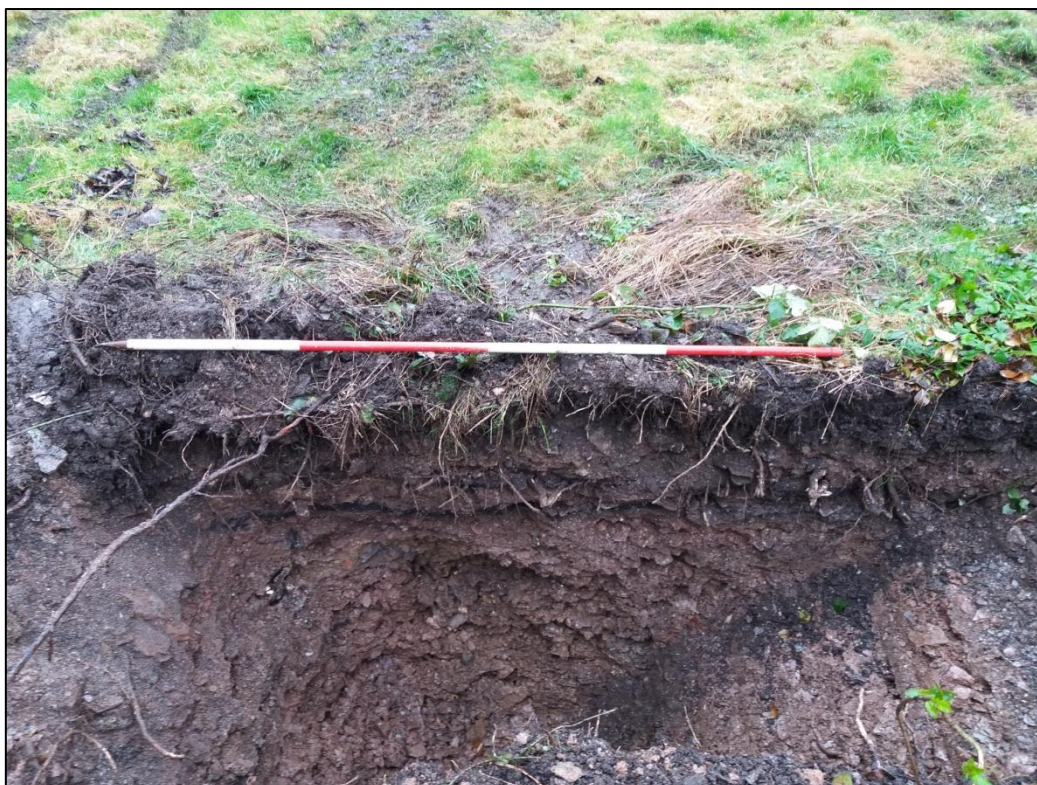
TEST-PIT 03, SOUTH-EAST FACING SECTION SHOWING THE SOIL LAYERS OVERLYING THE MADE-GROUND DEPOSITS; VIEWED FROM THE SOUTH-EAST (2M SCALE).

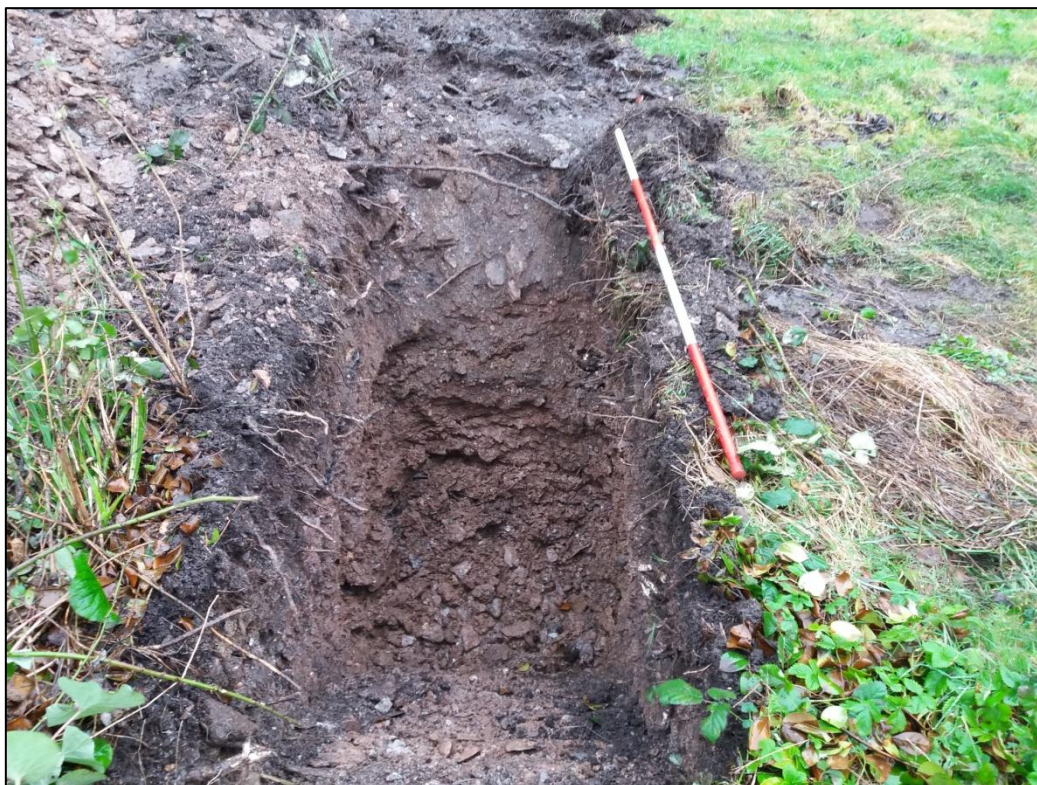
TEST-PIT 03, POST-EXCAVATION PLAN SHOT SHOWING THE MADE-GROUND DEPOSITS ; VIEWED FROM THE NORTH-EAST (2M SCALE).

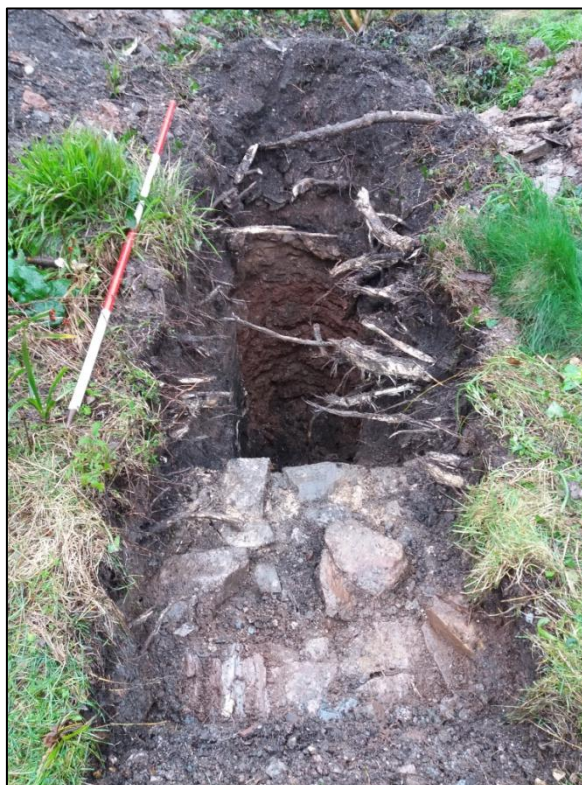
TEST-PIT 04, POST-EXCAVATION PLAN SHOWING WALL {404}; VIEWED FROM THE NORTH-EAST (2M SCALE).

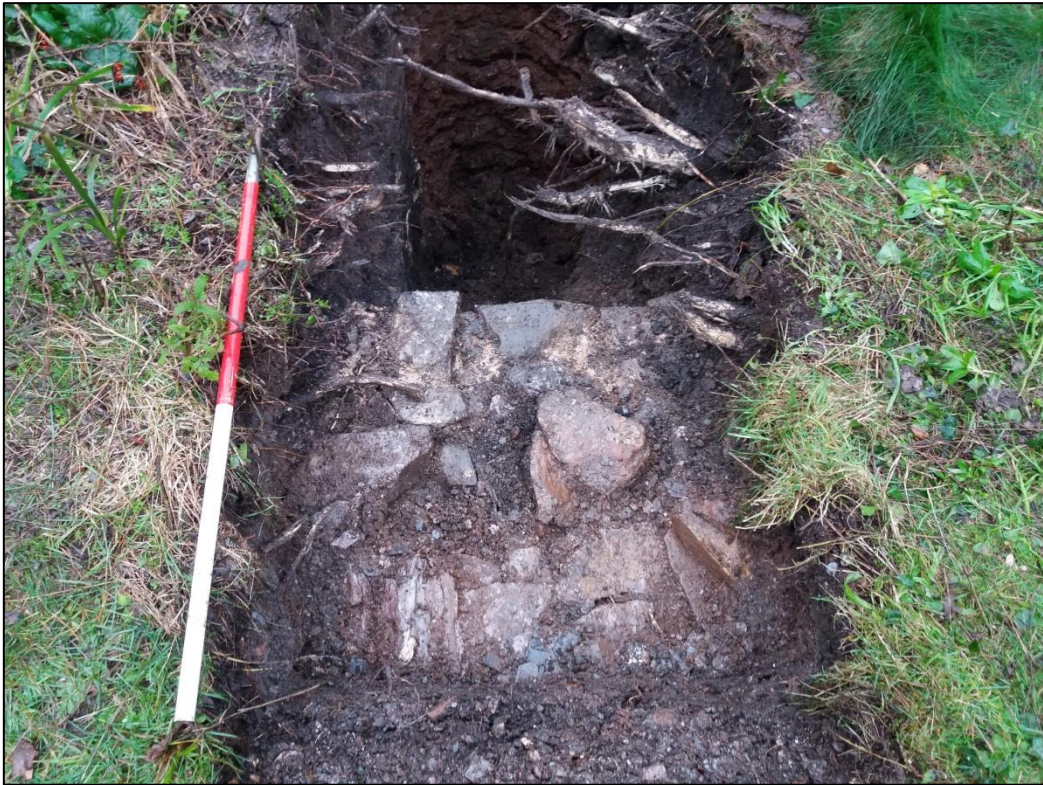
TEST-PIT 04, DETAIL OF WALL {404}; VIEWED FROM THE NORTH-EAST (1M SCALE).

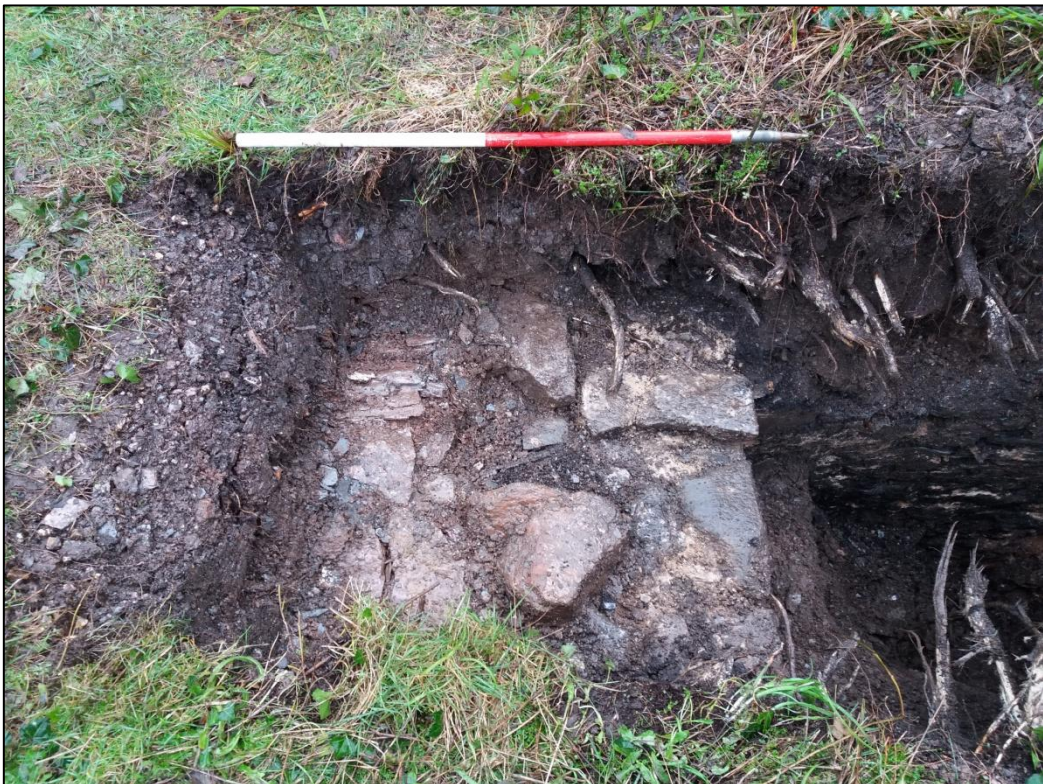
TEST-PIT 04, DETAIL OF WALL {404} WITH OVERLYING SOIL LAYERS; VIEWED FROM THE NORTH-WEST (1M SCALE).

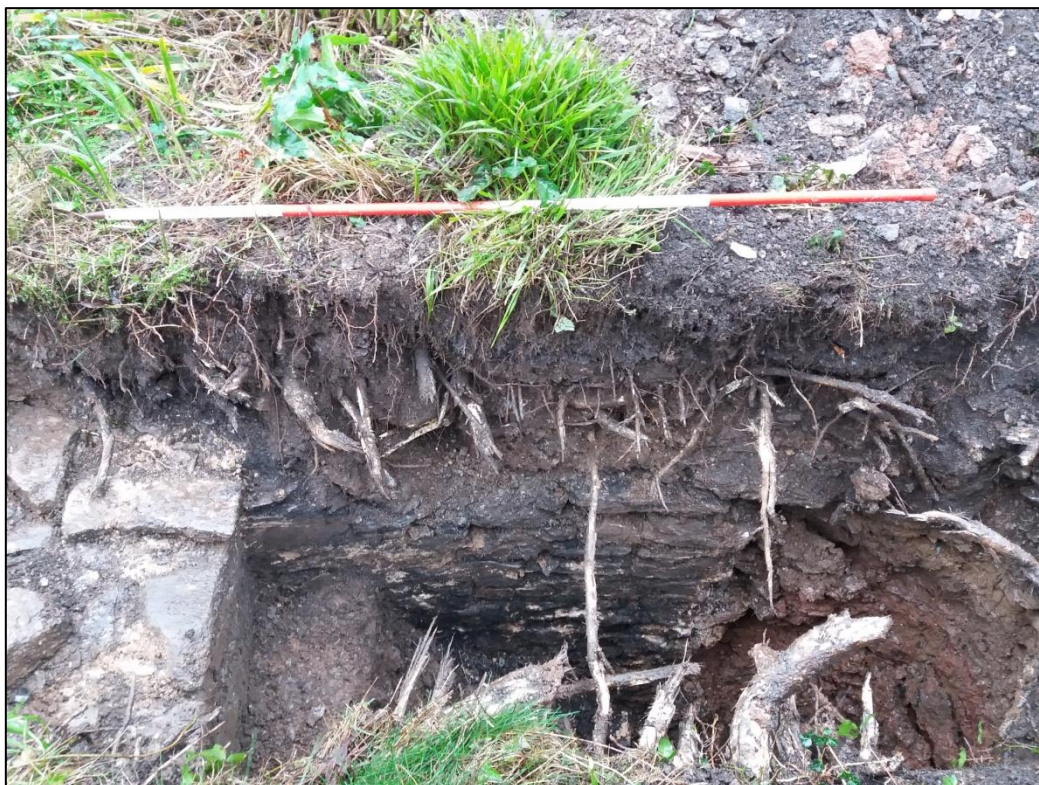
TEST-PIT 04, DETAIL OF WALL {405} NORTH-WEST FACING ELEVATION; VIEWED FROM THE NORTH-WEST (2M SCALE).

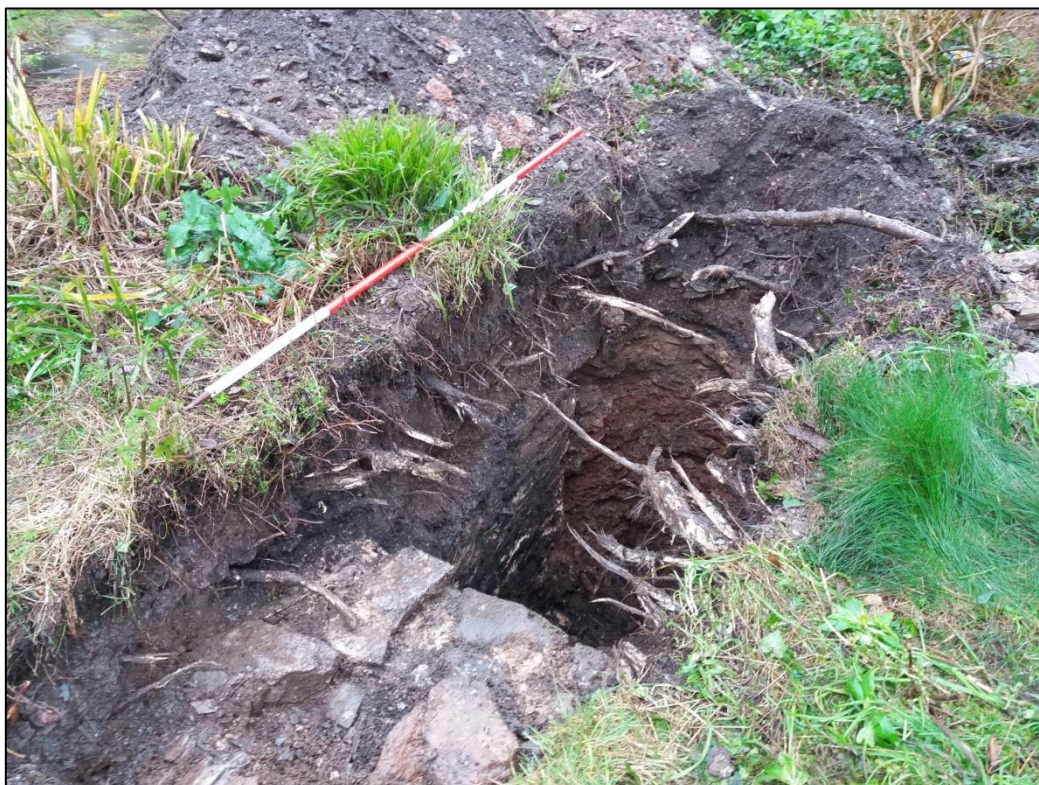
TEST-PIT 04, DETAIL OF WALLS {404} AND {405}, POST-EXCAVATION; VIEWED FROM THE NORTH (2M SCALE).

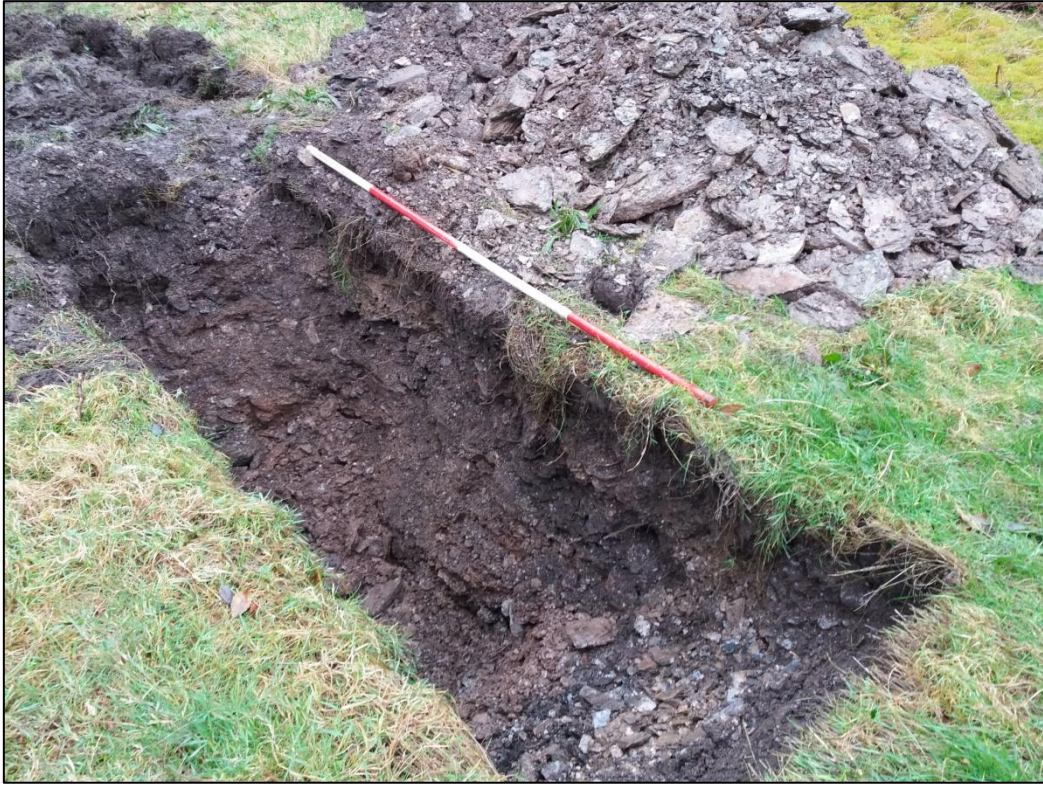
TEST-PIT 05, SOUTH-EAST FACING SECTION, OBLIQUE SHOWING SOIL LAYERS OVERLYING MADE-GROUND DEPOSITS AND THE NATURAL BEDROCK; VIEWED FROM THE EAST (2M SCALE).

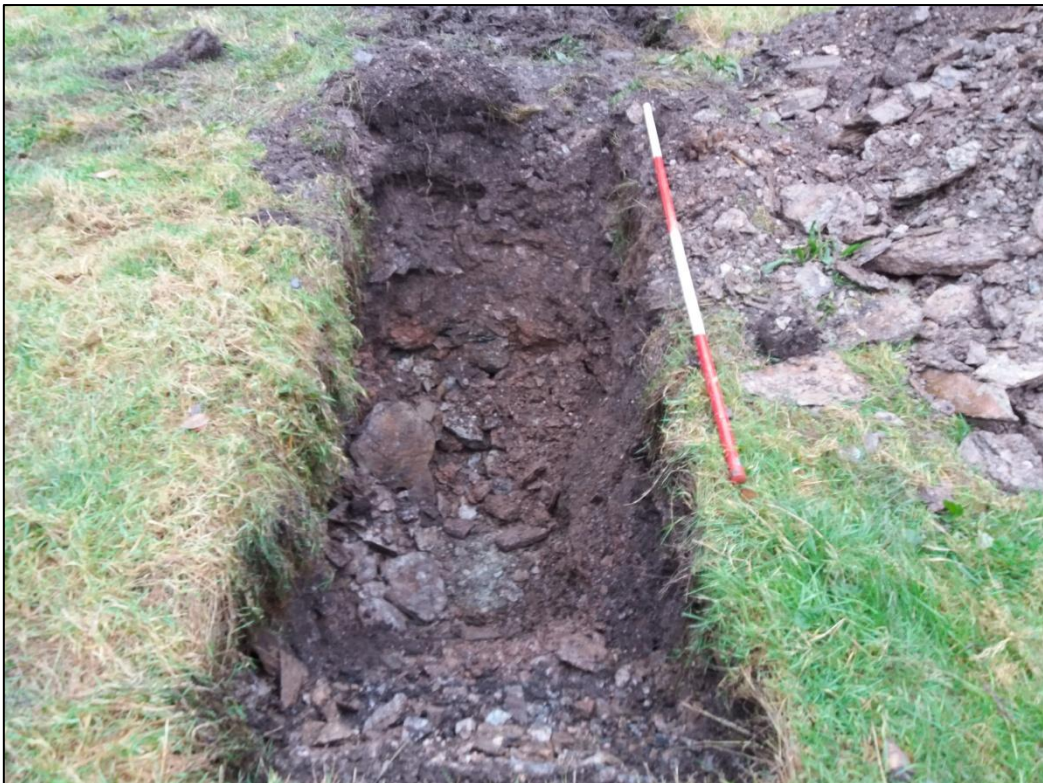
TEST-PIT 05, POST-EXCAVATION SHOT SHOWING MADE-GROUND DEPOSITS OVERLYING THE NATURAL BEDROCK; VIEWED FROM THE NORTH-EAST (2M SCALE).

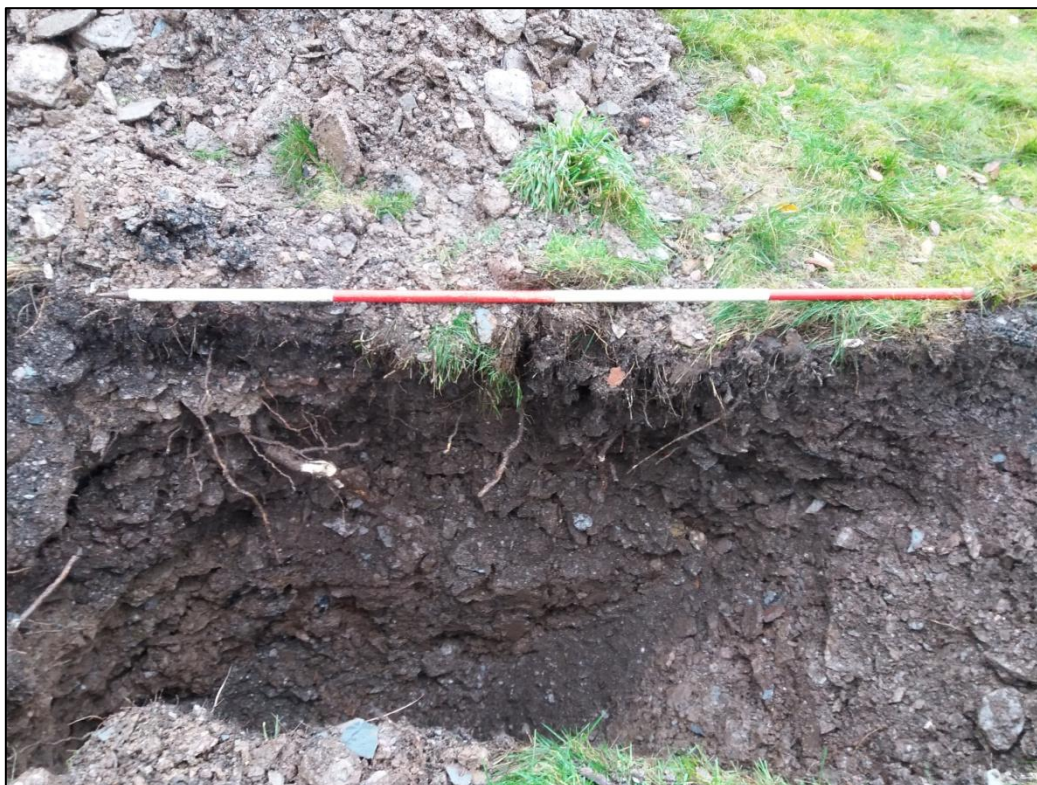
TEST-PIT 06, NORTH-WEST FACING SECTION SHOWING THE SOIL LAYERS OVERLYING MADE-GROUND DEPOSITS; VIEWED FROM THE NORTH-WEST (2M SCALE).

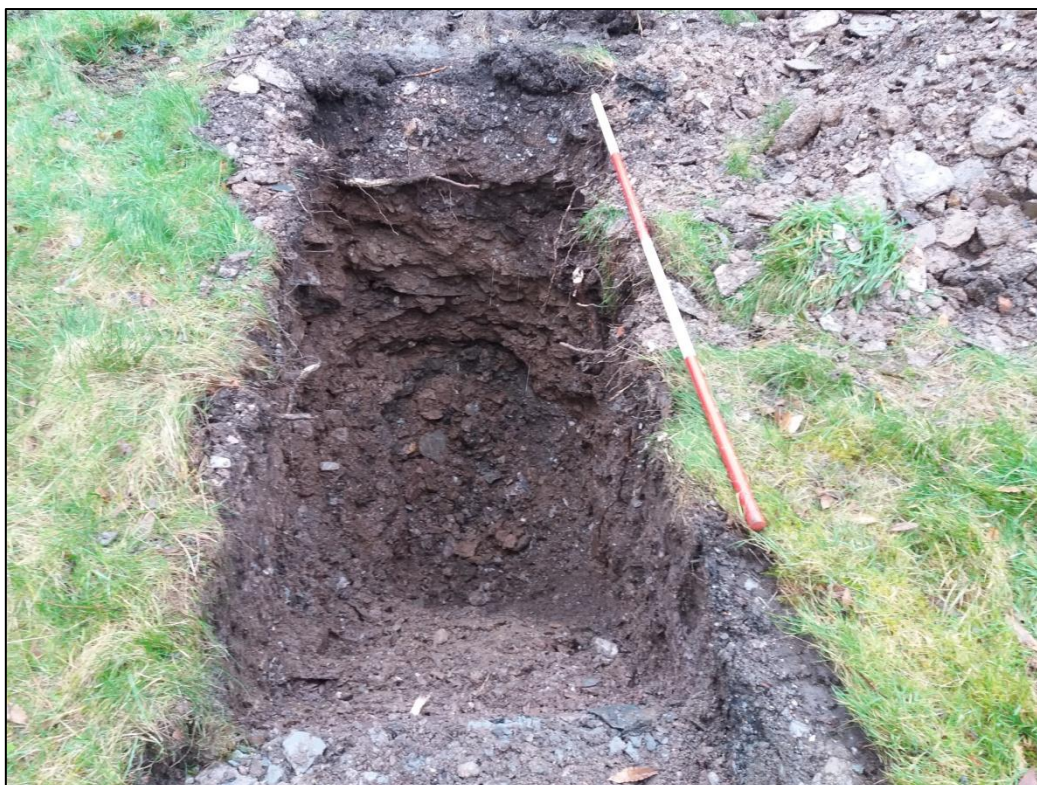
TEST-PIT 06, POST-EXCAVATION SHOT SHOWING MADE-GROUND DEPOSITS; VIEWED FROM THE NORTH-EAST (2M SCALE).
