# WHEAL FRIENDLY WHEAL FRIENDLY LANE ST AGNES CORNWALL

Historic Building Recording

# Wheal Friendly, Wheal Friendly Lane, St Agnes, Cornwall

## Historic Building Recording

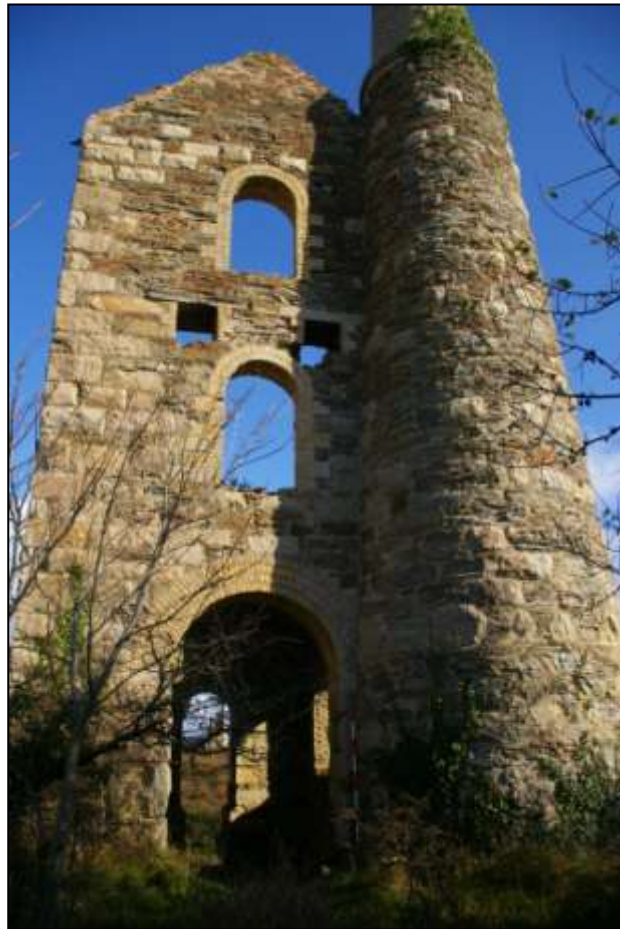
*COVER PLATE*: THE SOUTH-WEST GABLE ELEVATION AND CHIMNEY; VIEWED FROM THE WEST.

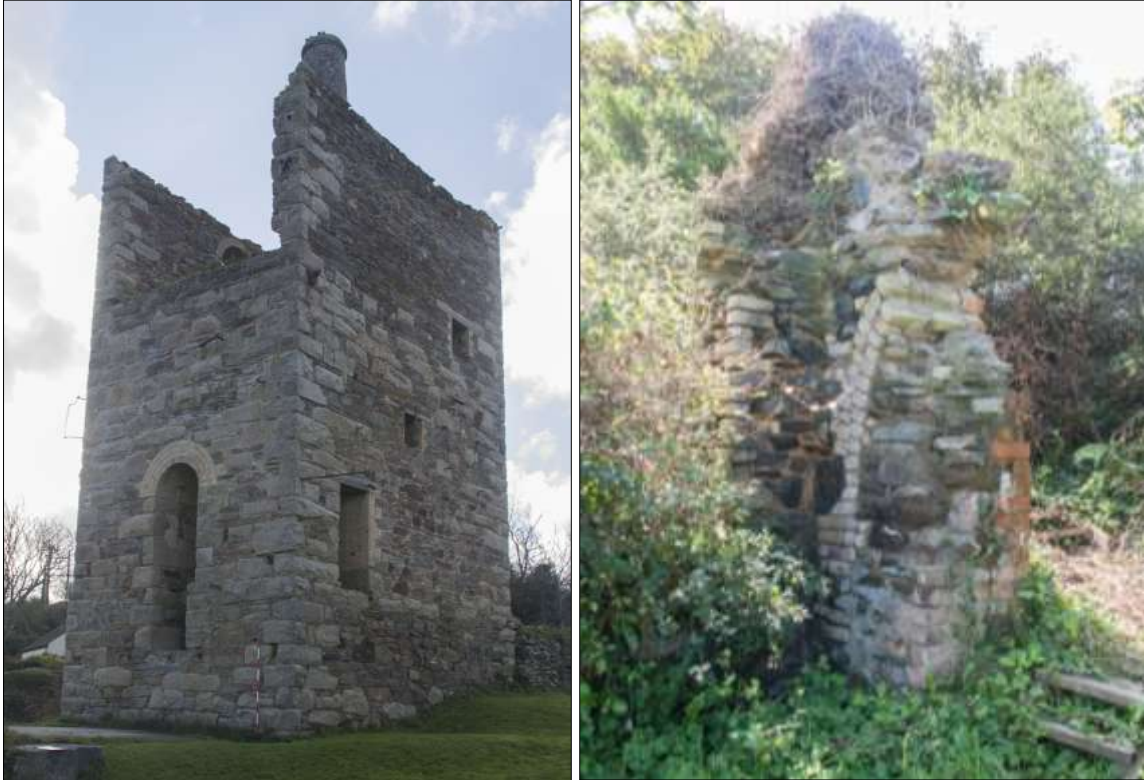
(LEFT) FIGURE 9: THE NORTH-WEST AND NORTH-EAST ELEVATIONS OF THE ENGINEHOUSE; VIEWED FROM THE NORTH-EAST.

(RIGHT) FIGURE 10: THE SURVIVING REMNANTS OF THE BOILERHOUSE; VIEWED FROM THE NORTH-EAST (SCALE 2M).

The enginehouse is built of a heterogeneous mixture of roughly-coursed mottled pale-blue to brown slatestone and/or killas with dressed and shaped granite blocks to the corners (quoins). The bob wall also contains a high proportion of granite for the required structural strength to support the beam of the engine. However, granite is also employed rather randomly throughout the fabric of the structure; this is most obvious in the north-west elevation, which is also notable for containing the least consistent stonework overall. Given the boilerhouse was built abutting the enginehouse on this side, it is likely that the heterogeneous build on this side reflects both the availability of materials and the fact it would have been concealed from public view. The nature of the granite blocks used in the build (dressed and shaped, with some suggestion of rustication, particularly those used in the chimney) would imply they are re-used. There are two lines of putlogs in the south-east elevation; historic photographs indicate these were to carry a timber gantry facilitating access to the headgear and an aerial tramway.

There are iron plates to the north-eastern end of both the north-west and south-east elevations, indicating an iron tie-rod was inserted to strengthen the sides of the bob wall. Other iron fittings survive attached to the walls.

The boilerhouse was built abutting the enginehouse to the north-west. The only visible element that survives is the south-east corner, between two door openings, one partly-blocked. The surviving fabric is of mottled pale blue to brown slatestone/killas, with quoins of yellow brick to the corner. One side of a door opening is visible in the south-east elevation, which has yellow bricks to the reveal. The doorway in the south-west elevation features part of a round segmental arch of yellow brick, partly blocked in brick and stone rubble to create one side of a narrower opening; this incorporates some red brick to its reveal. Historic photographs indicate the boilerhouse had an asymmetric pitched slate roof, monopitch where it abutted the enginehouse wall. The historic photographs also indicate the roof structure was removed, rather than decayed *in situ* (to remove the boiler/other machinery in 1916?).

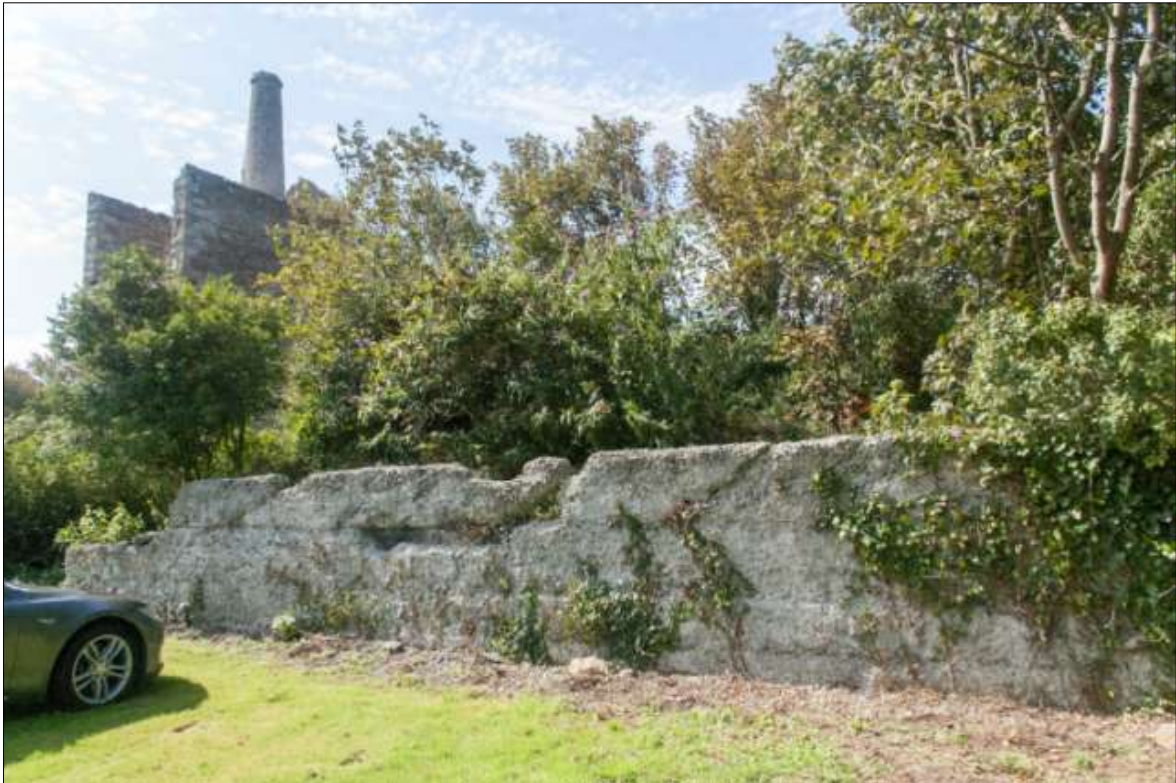
FIGURE 11: THE NORTH-EAST WALL OF THE STAMPS; VIEWED FROM THE NORTH-EAST.

North of the boilerhouse was the whim/compressor house, extended after 1906 by the addition of the mass-concrete walls of the stamps. The surviving walls of the whim/compressor house are fairly narrow (c.0.5m) and are built of mottled pale blue to brown slatestone/killas bonded with an off-white lime mortar. There is a blocked doorway towards the western end in the north-west elevation, with a round segmental arch of yellow brick; it is blocked in stone rubble. The whim was a twin-cylinder horizontal non-condensing engine with a single-cylinder air compressor to supply the rock drills. The mass concrete walls are in poor condition (mundic) and are located on the north and east side of the earlier building. Historic photographs would suggest the earlier structure was partly rebuilt in mass concrete, rather than simply reused.

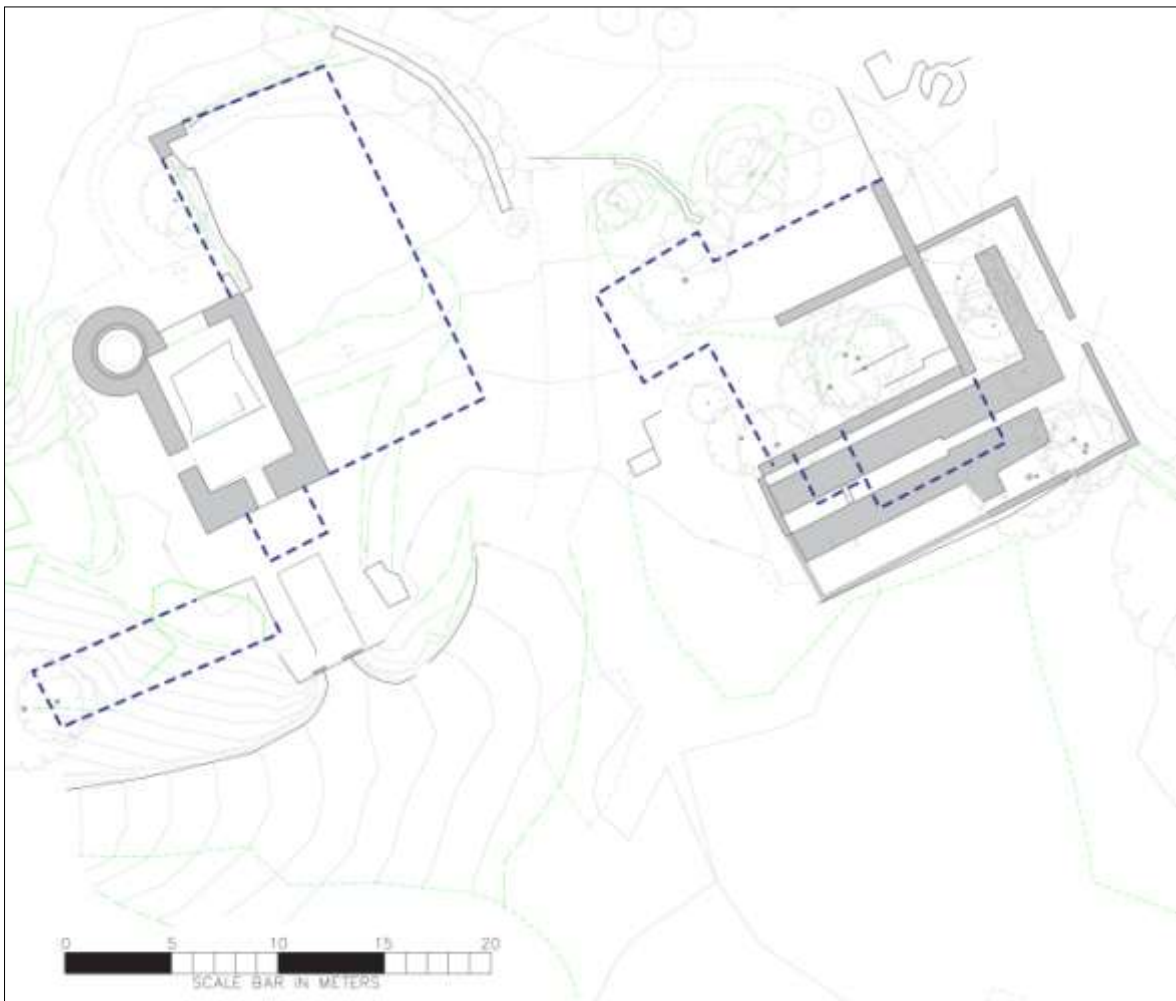
FIGURE 14: SITE PLAN SHOWING THE SURVIVING STRUCTURES ON THE SITE, AND THE ORIGINAL EXTENT OF THOSE STRUCTURES (SHOWN IN DASHED BLUE LINES) (BASED ON THE 1906-7 OS MAP; SITE PLAN SUPPLIED BY ARCHITECT).

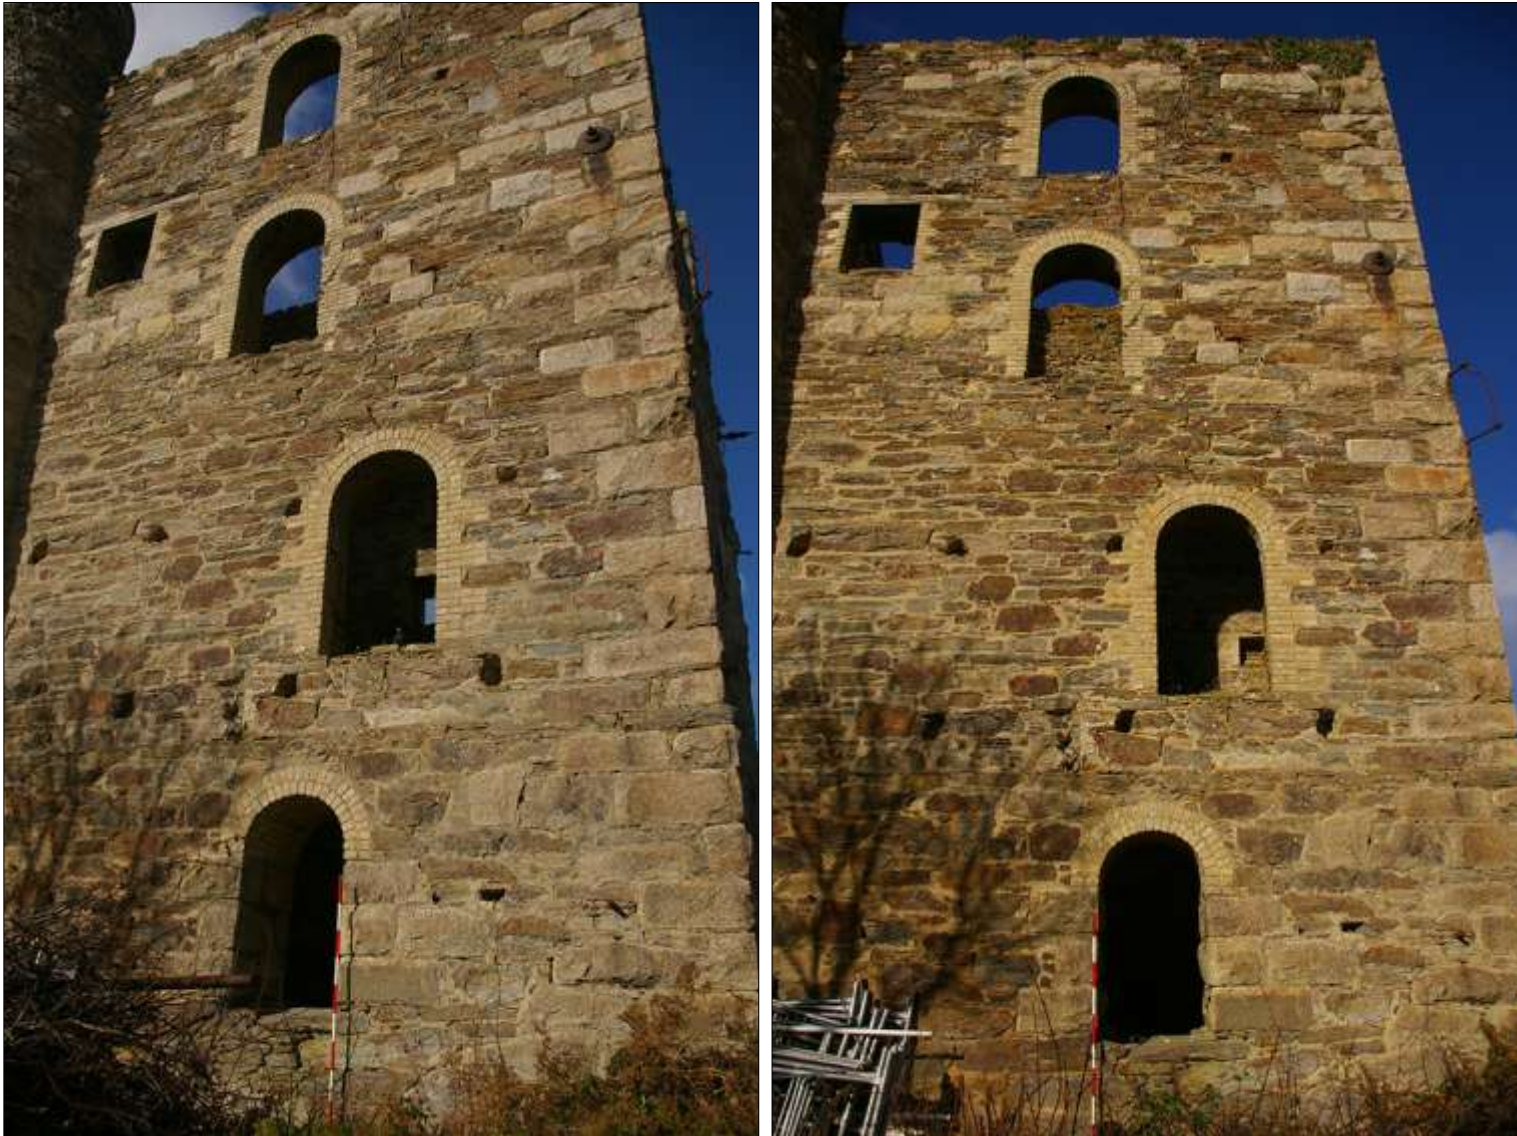
THE SOUTH-EAST ELEVATION OF THE ENGINE HOUSE; VIEWED FROM THE EAST-SOUTH-EAST (SCALE 2M).

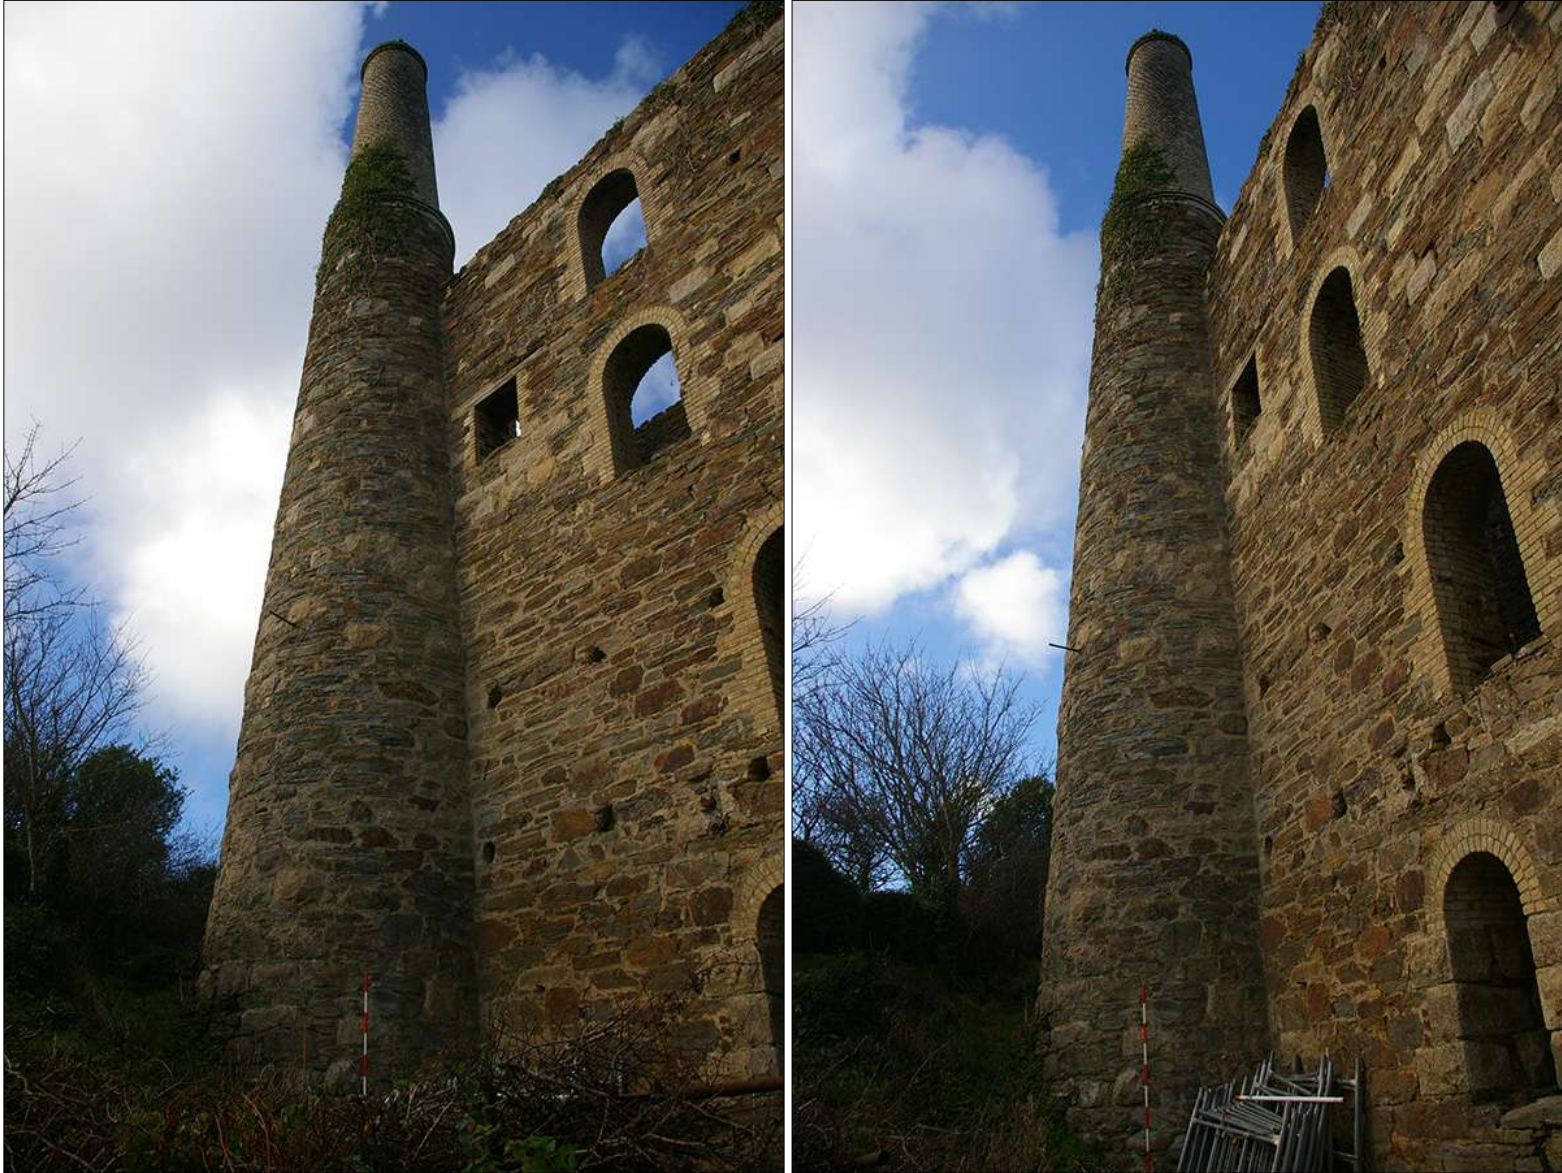
THE SOUTH-EAST ELEVATION AND CHIMNEY STACK; FROM THE EAST (SCALE 2M).

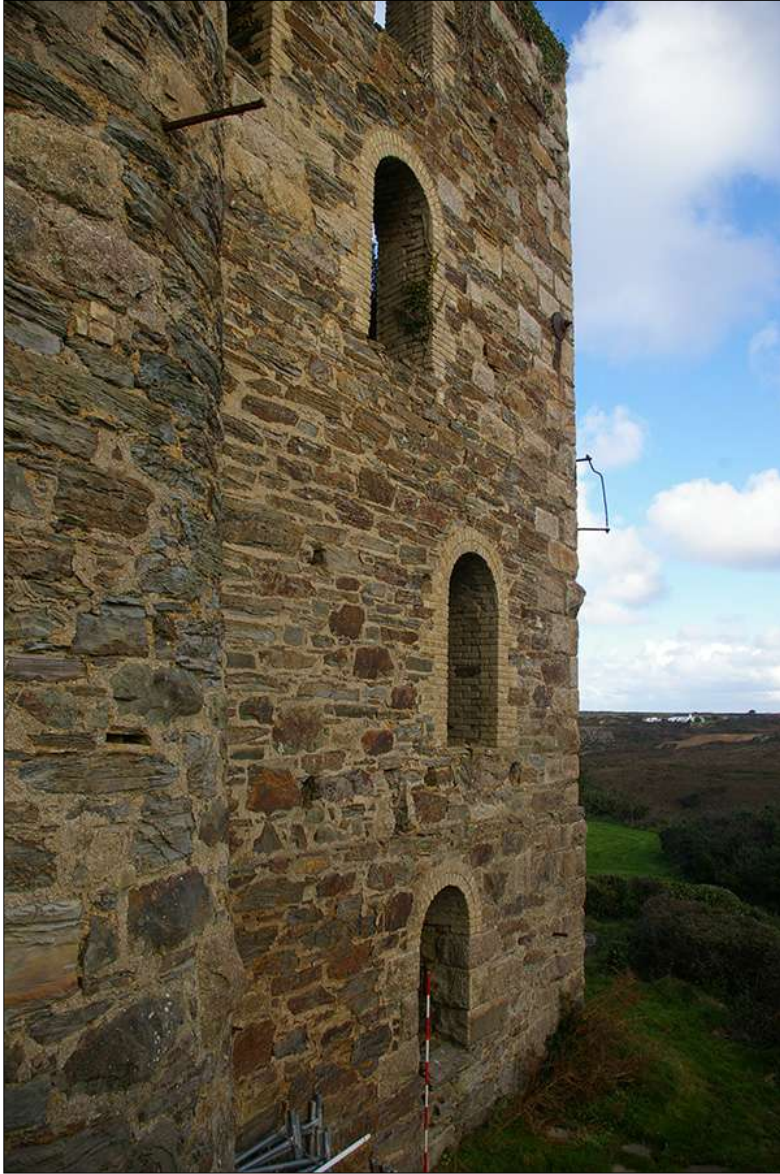
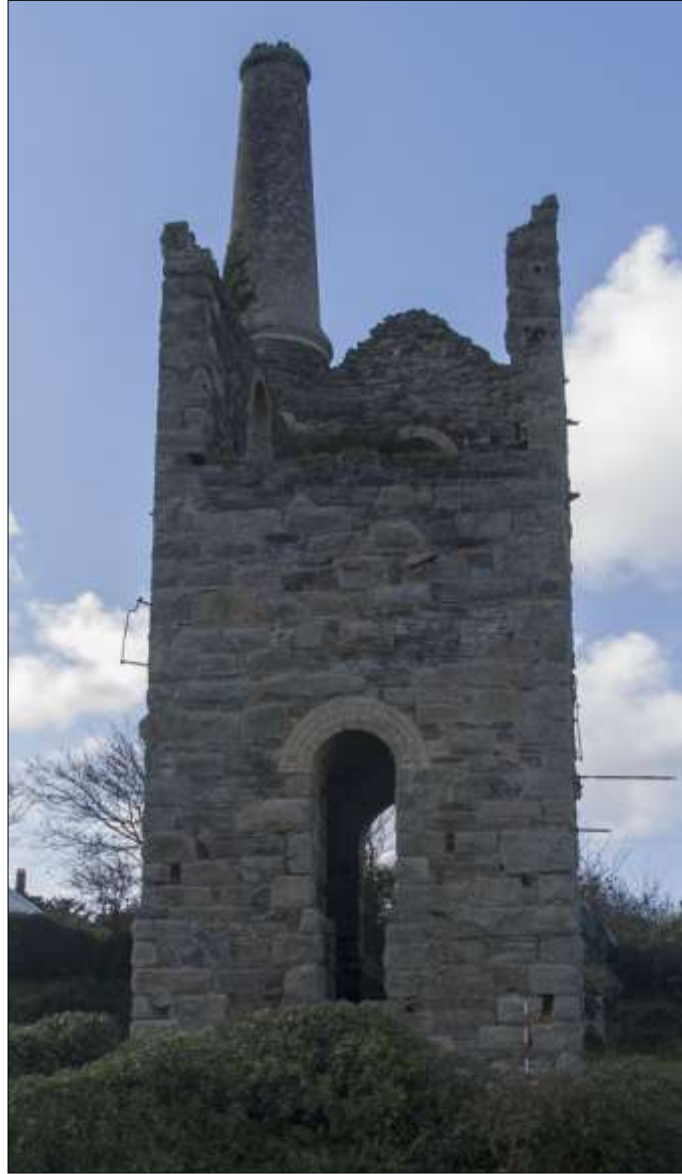
LEFT: THE SOUTH-EAST ELEVATION; FROM THE OBLIQUE, FROM THE SOUTH (SCALE 2M).

RIGHT: THE PRINCIPAL NORTH-EAST GABLE OF THE ENGINE HOUSE, FACING ACROSS THE VALLEY; FROM THE NORTH-NORTH-EAST (SCALE 2M).

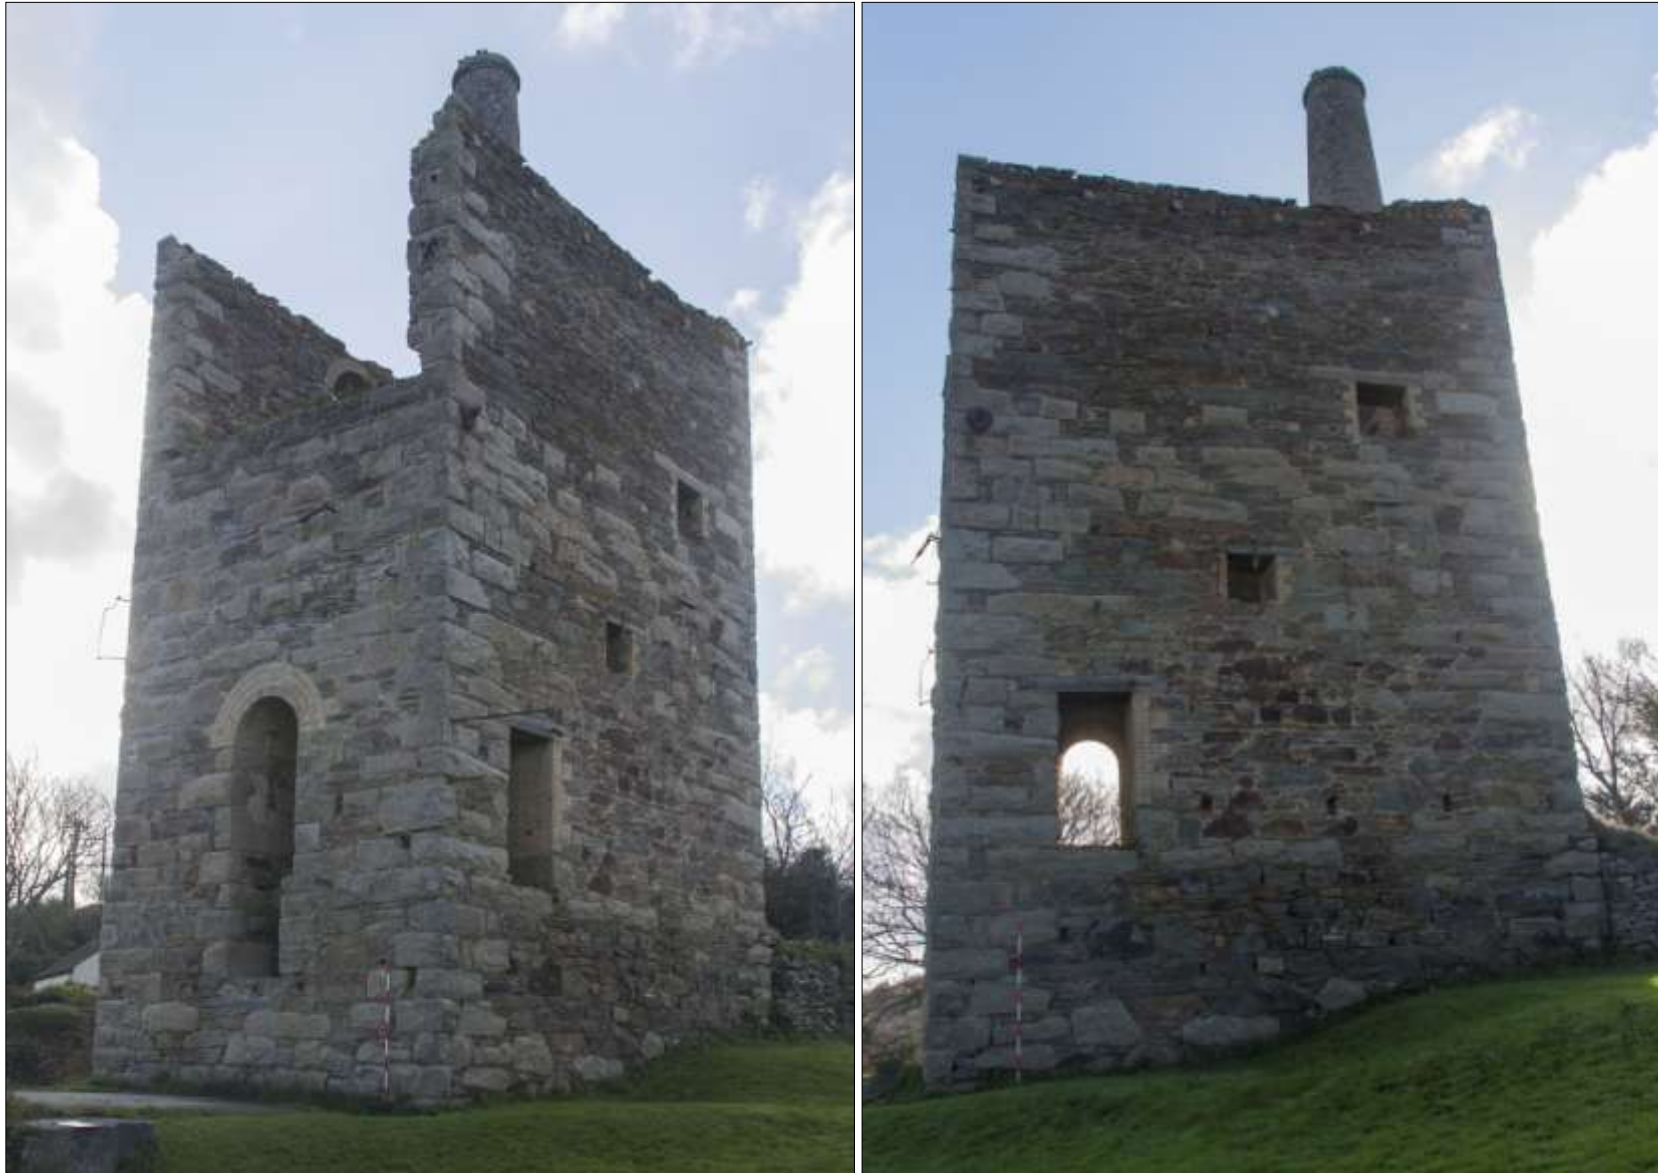
LEFT: THE NORTH-WEST AND NORTH-EAST ELEVATIONS OF THE ENGINE HOUSE; VIEWED FROM THE NORTH (SCALE 2M).

RIGHT: THE LONG NORTH-WEST ELEVATION OF THE ENGINE HOUSE; VIEWED FROM THE NORTH-WEST (SCALE 2M).

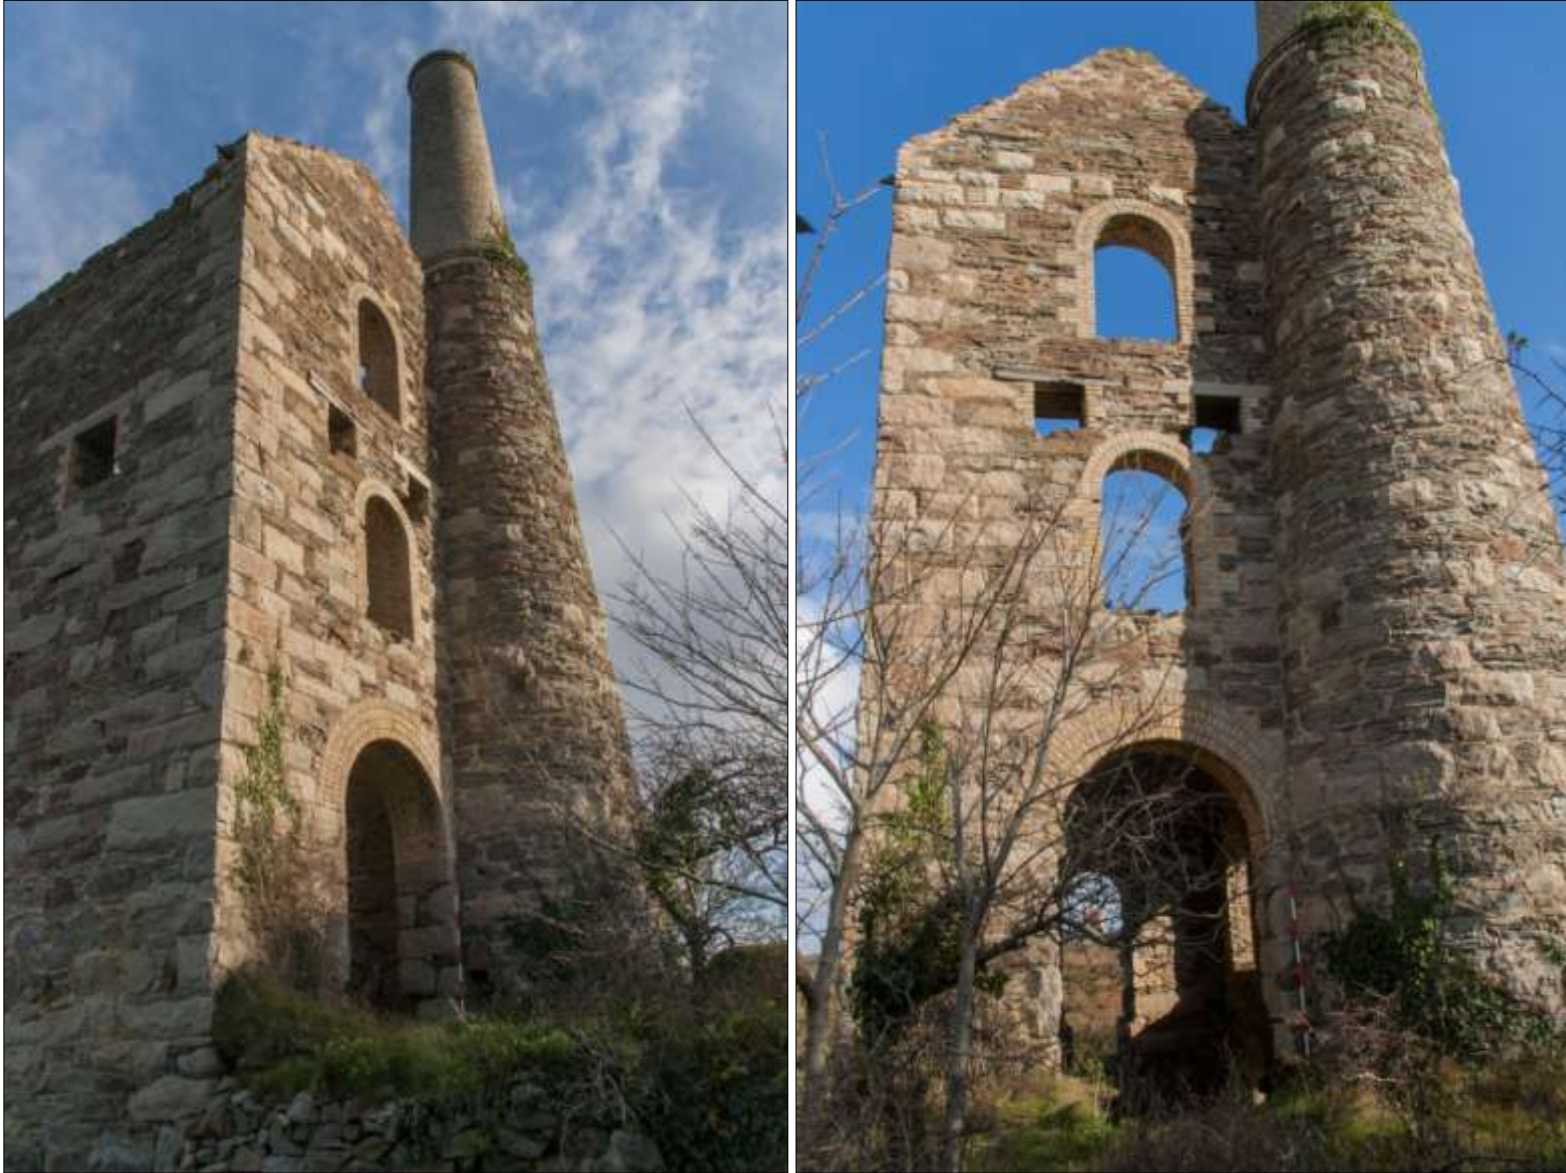
LEFT: THE NORTH-WEST AND SOUTH-WEST ELEVATIONS OF THE ENGINE HOUSE; FROM THE WEST (SCALE 2M).

RIGHT: THE SOUTH-WEST GABLE ELEVATION AND CHIMNEY; VIEWED FROM THE WEST (SCALE 2M).

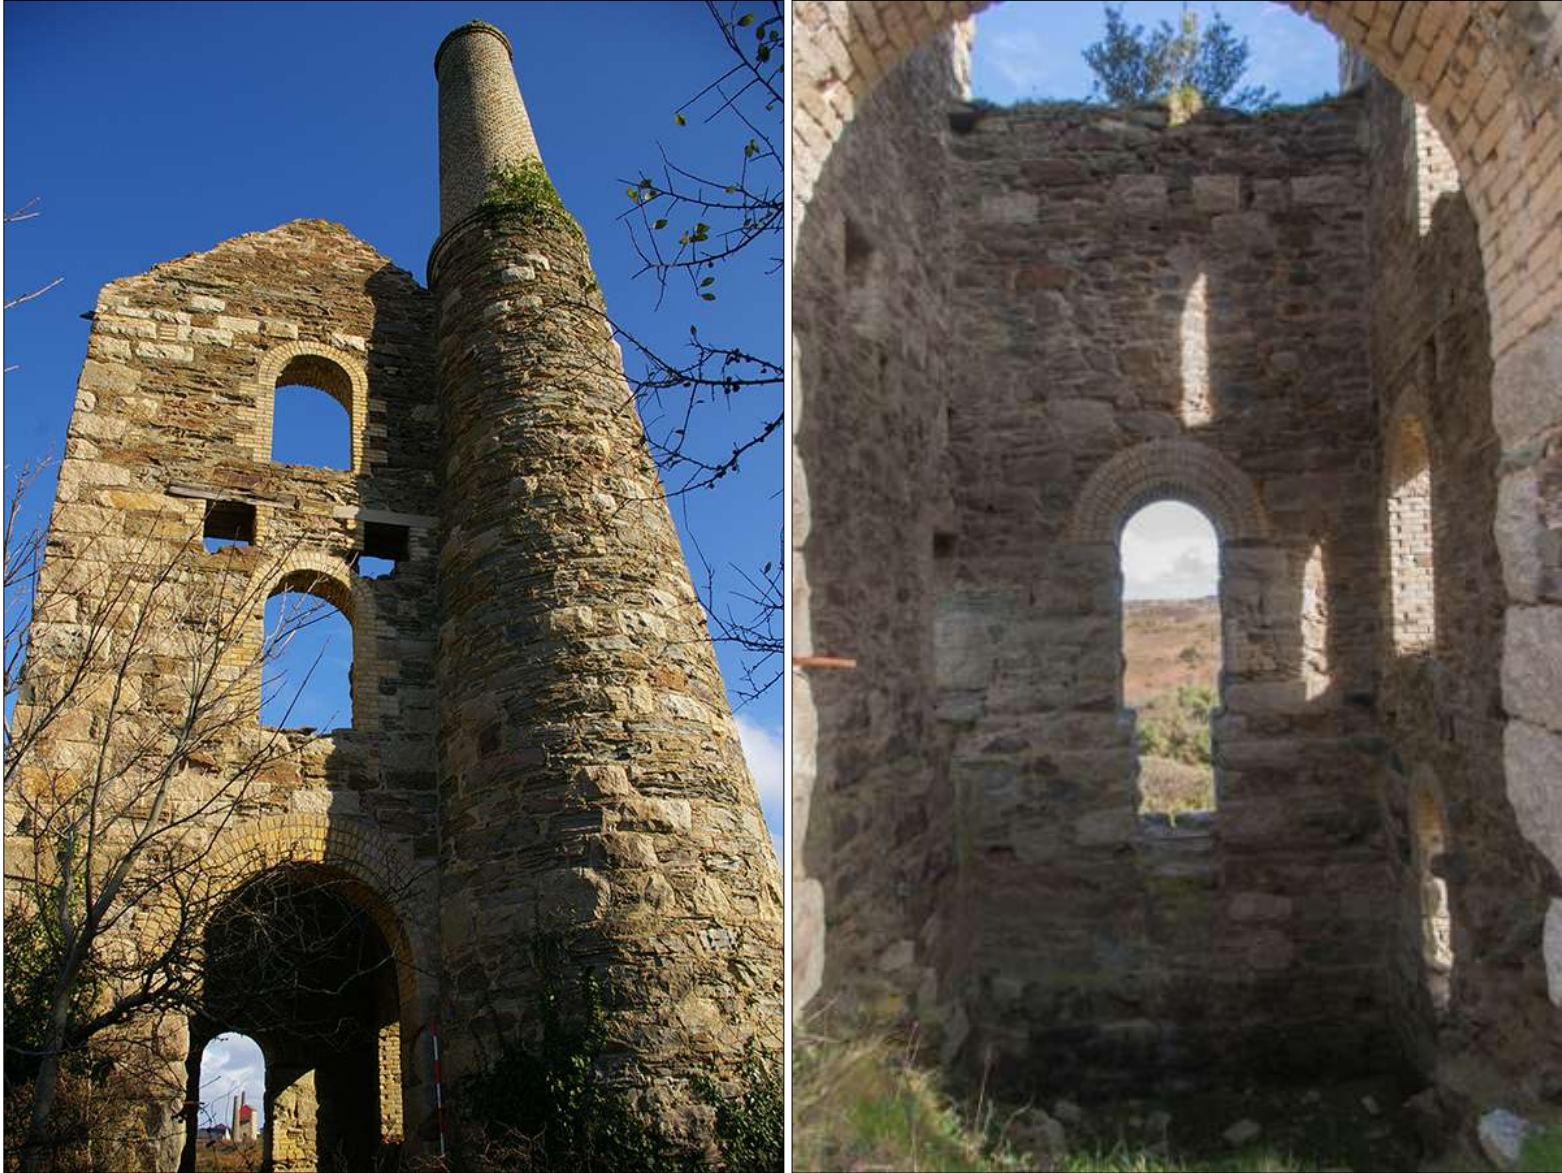
LEFT: THE SOUTH-WEST GABLE ELEVATION AND CHIMNEY; VIEWED FROM THE WEST (SCALE 2M).

RIGHT: THE INNER FACE OF THE NORTH-EAST OF THE ENGINE HOUSE; FROM THE SOUTH-WEST.

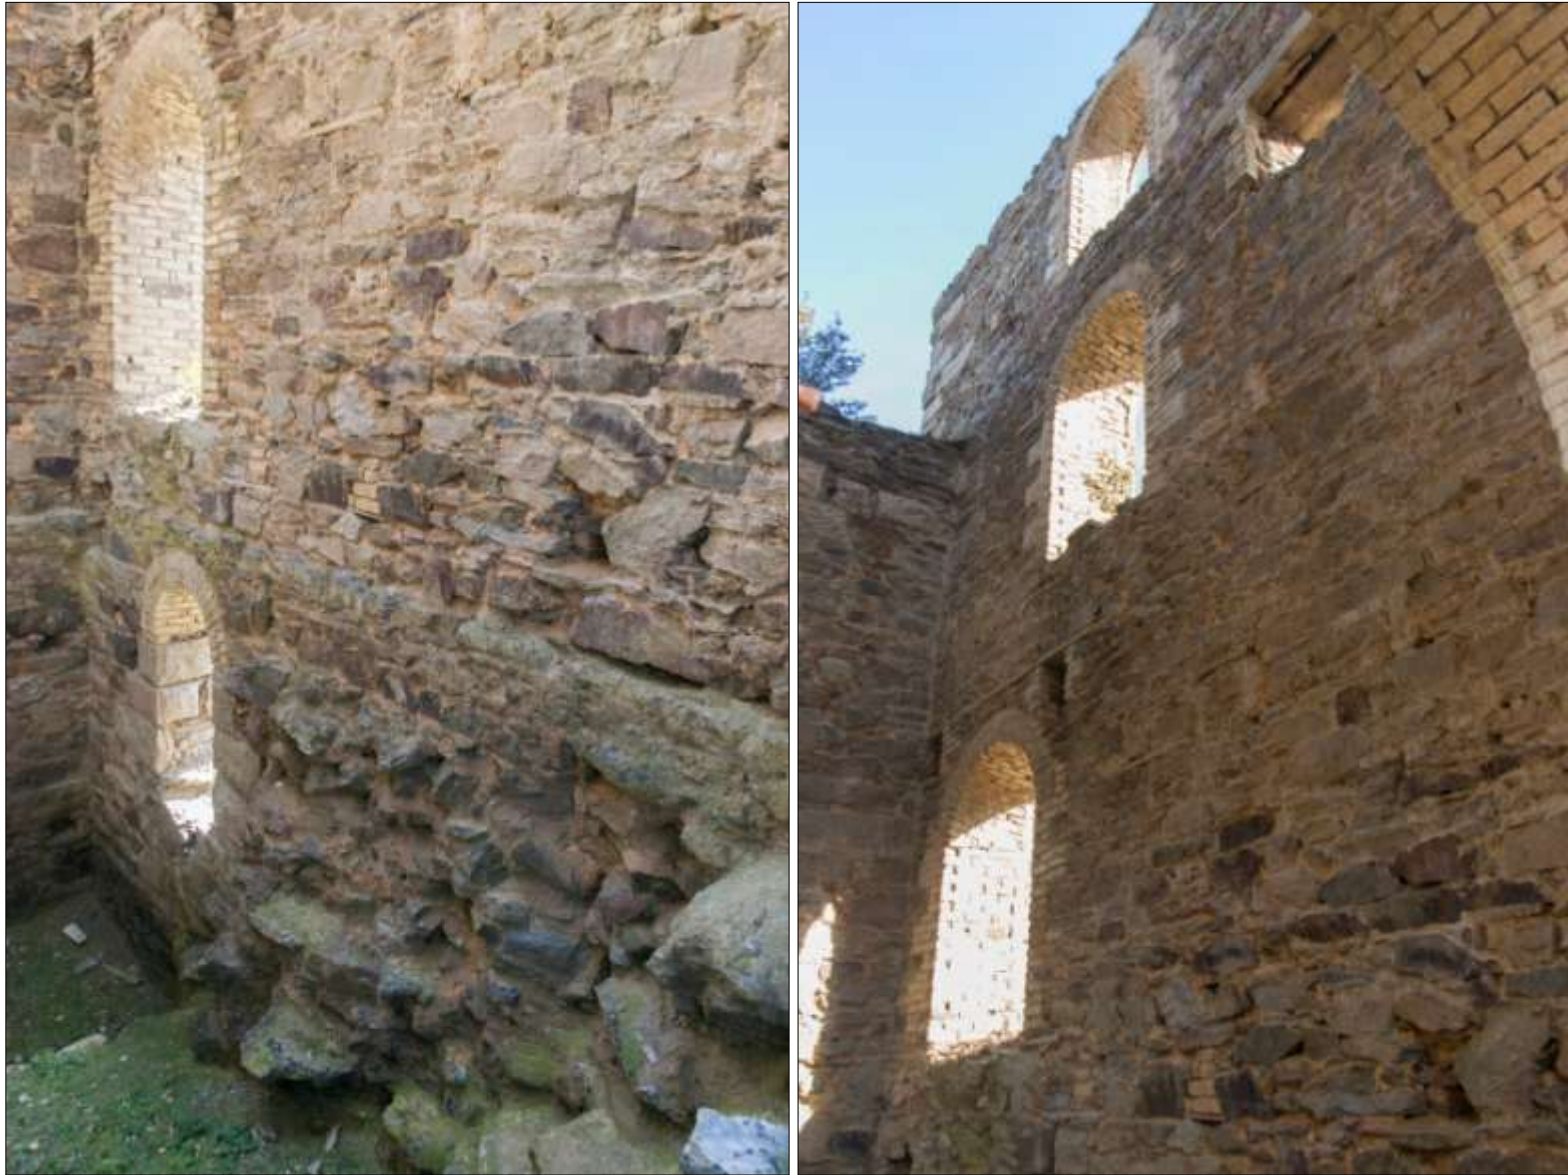
THE INNER FACE OF THE SOUTH-EAST OF THE ENGINE HOUSE; FROM THE WEST.

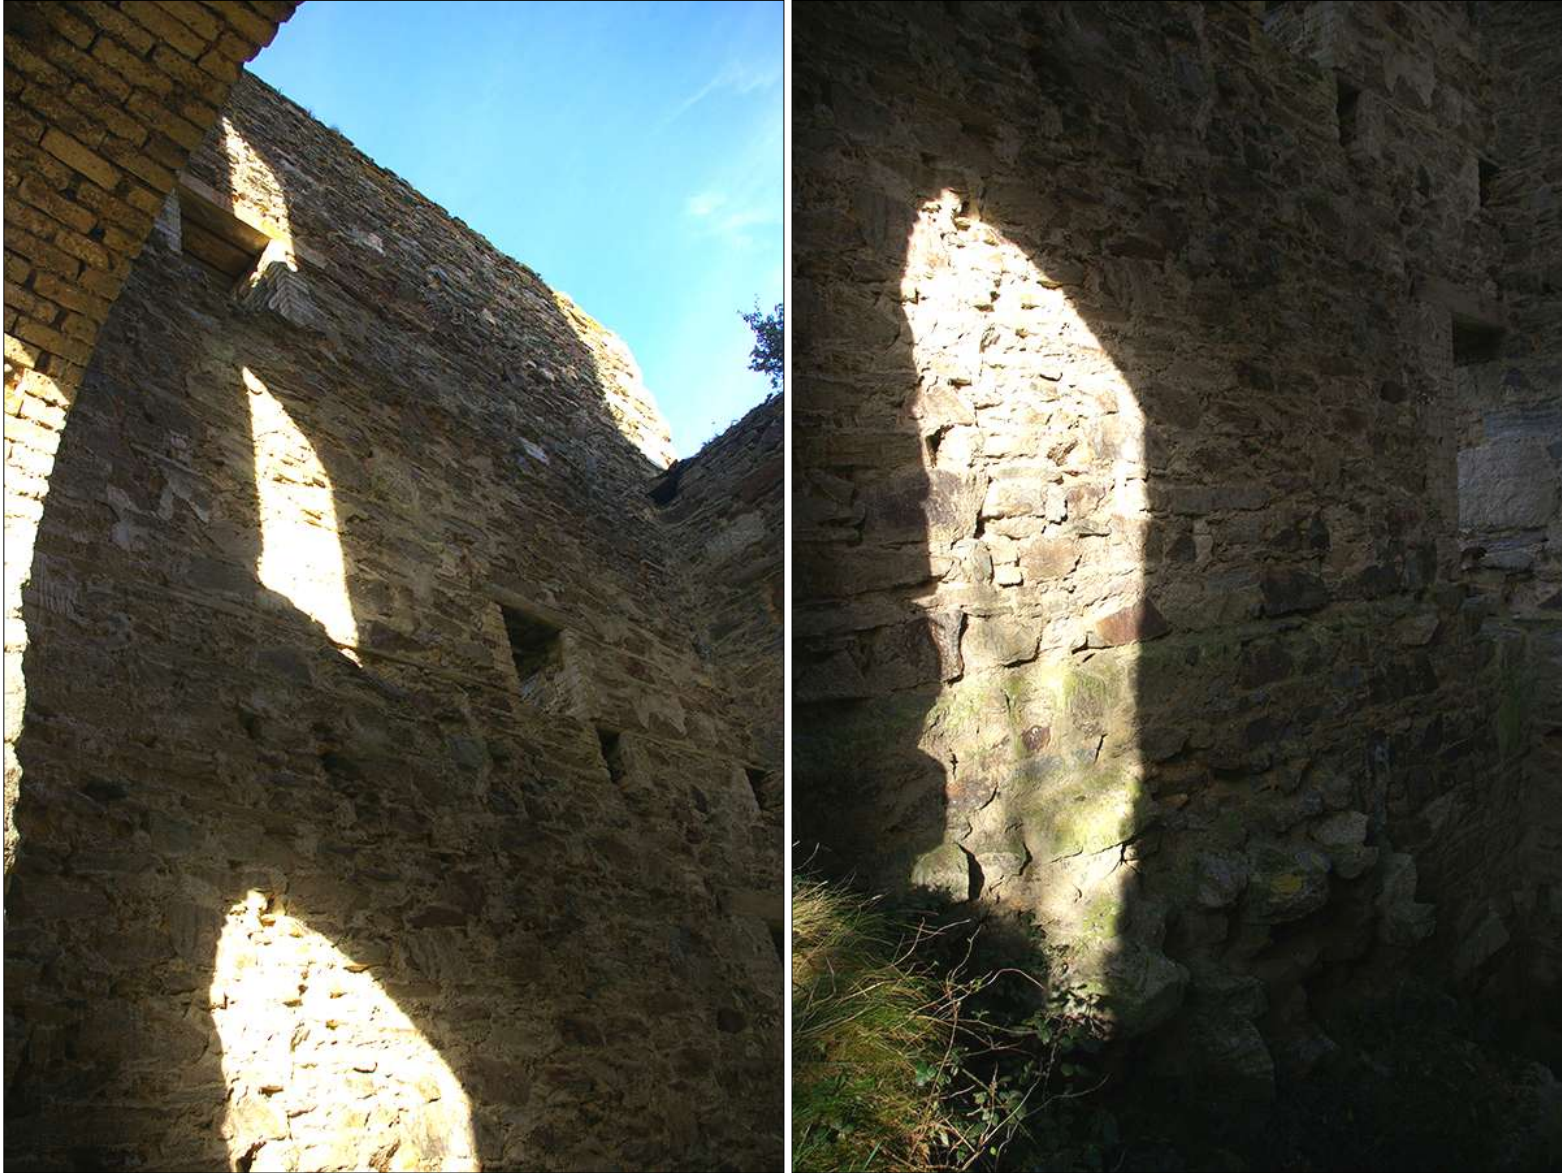
THE INNER FACE OF THE NORTH-WEST OF THE ENGINE HOUSE; FROM THE SOUTH.

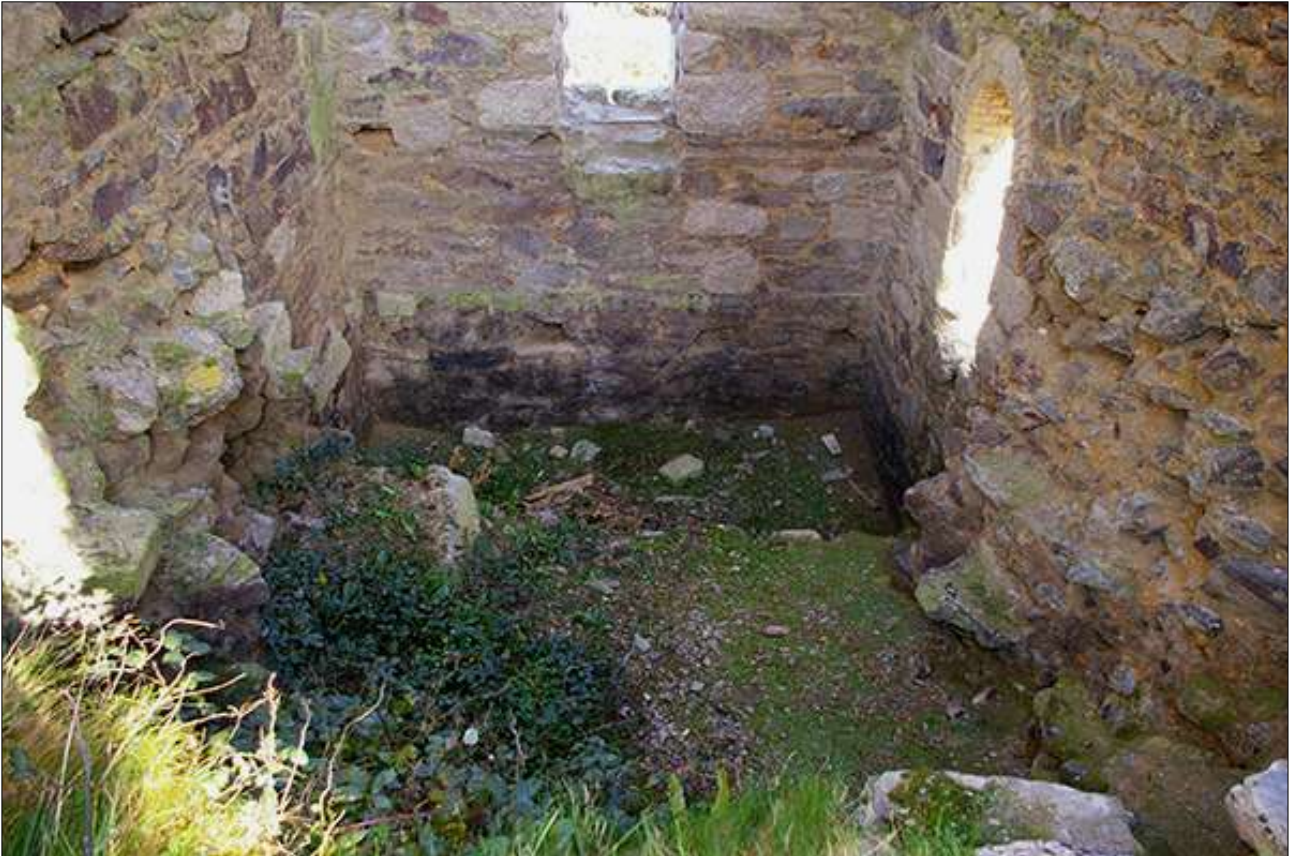
THE FLOOR OF THE ENGINE HOUSE SHOWING DEEP ENGINE PIT TO THE NORTH END; FROM THE SOUTH-WEST.

The interior of the enginehouse is stripped and bare; the engine and all fittings were removed in 1916 leaving a ragged void in the floor open to the cataract pit. The enginehouse may have been re-purposed in 1926-30, but lifting was done at Sara's Shaft and pumping at Wheal Friendly was by electric motor.

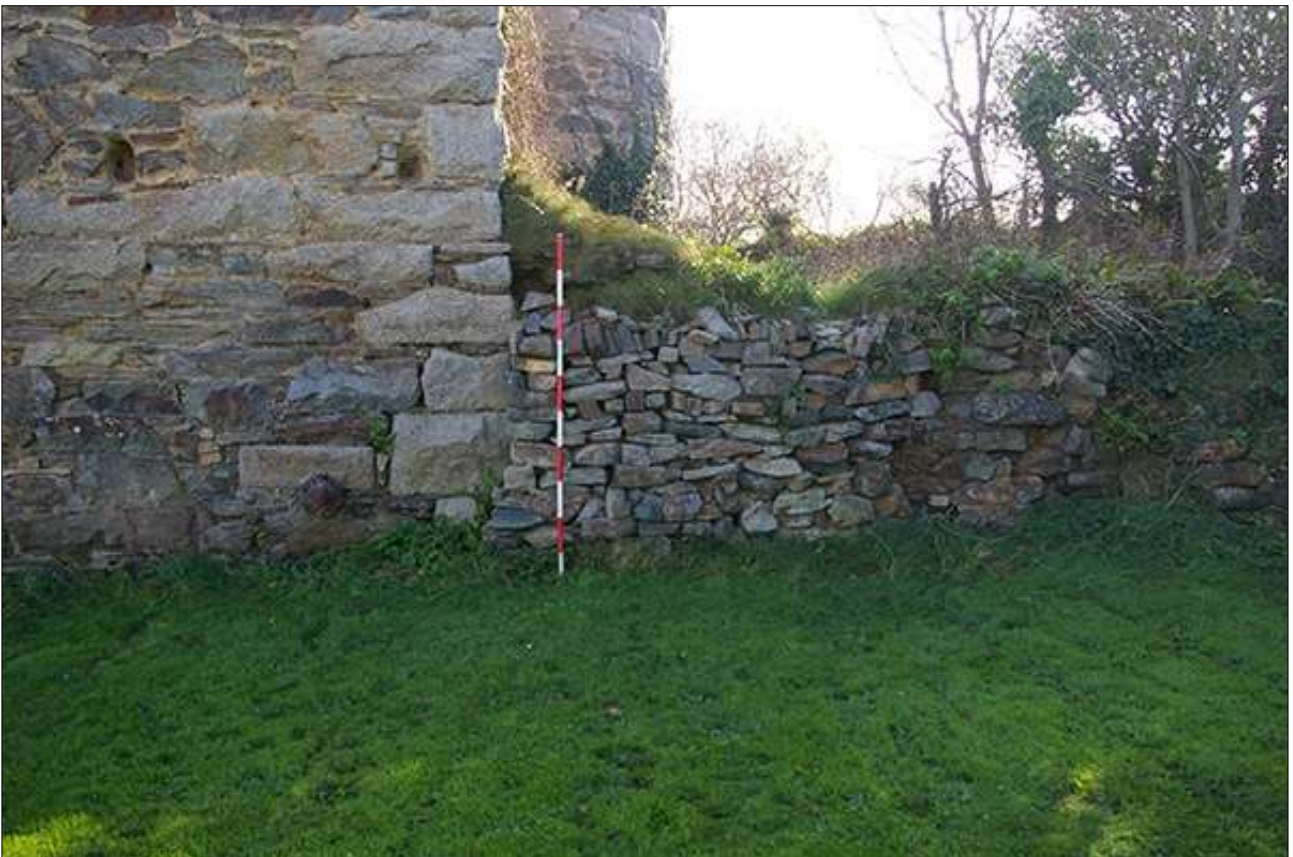
THE ENGINE HOUSE AND THE REBUILT WALL OF THE BOILERHOUSE; FROM THE NORTH-WEST (SCALE 2M).

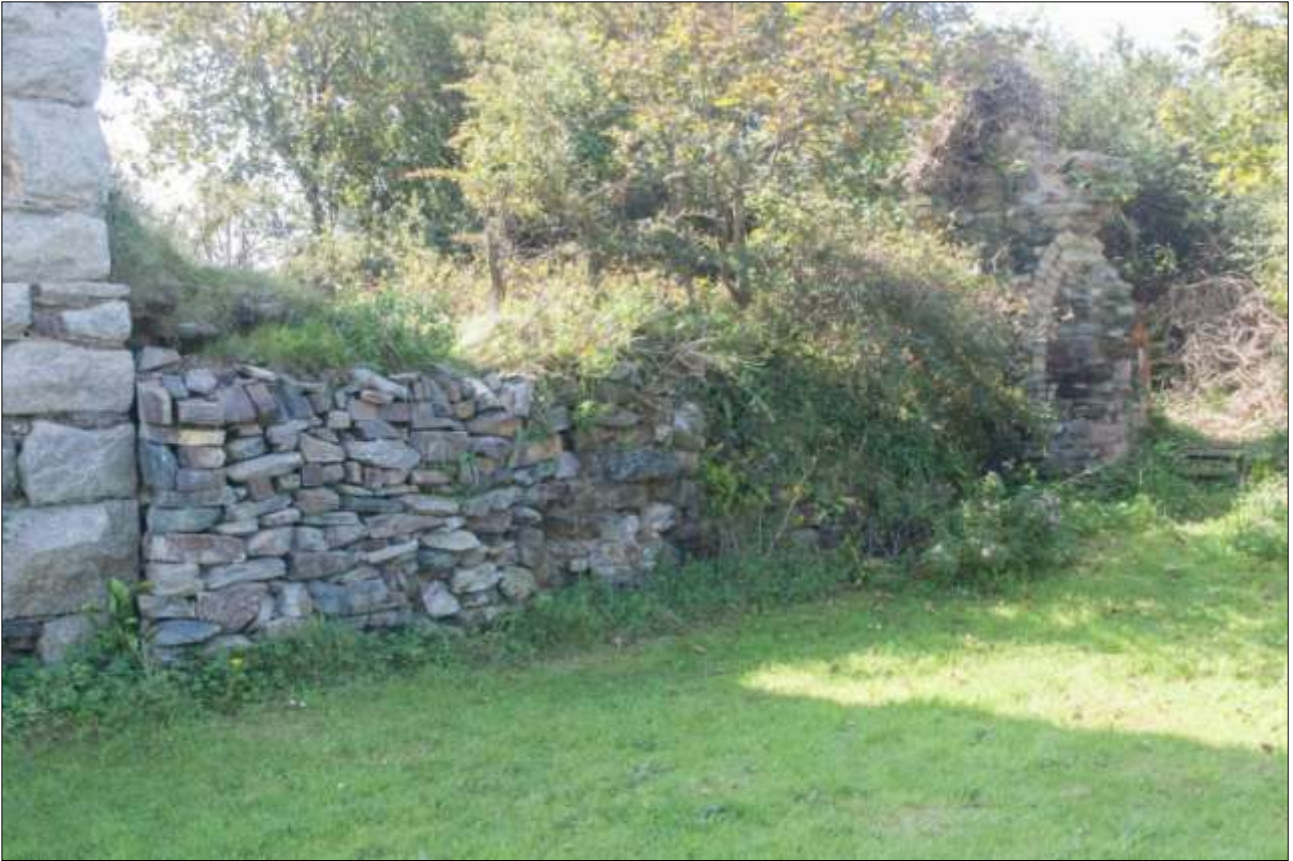
THE SURVIVING REMNANT OF THE BOILERHOUSE WALL; VIEWED FROM THE NORTH-NORTH-WEST.
