# WHEAL FRIENDLY WHEAL FRIENDLY LANE ST AGNES CORNWALL

Historic Building Recording

# Wheal Friendly, Wheal Friendly Lane, St Agnes, Cornwall

## Historic Building Recording

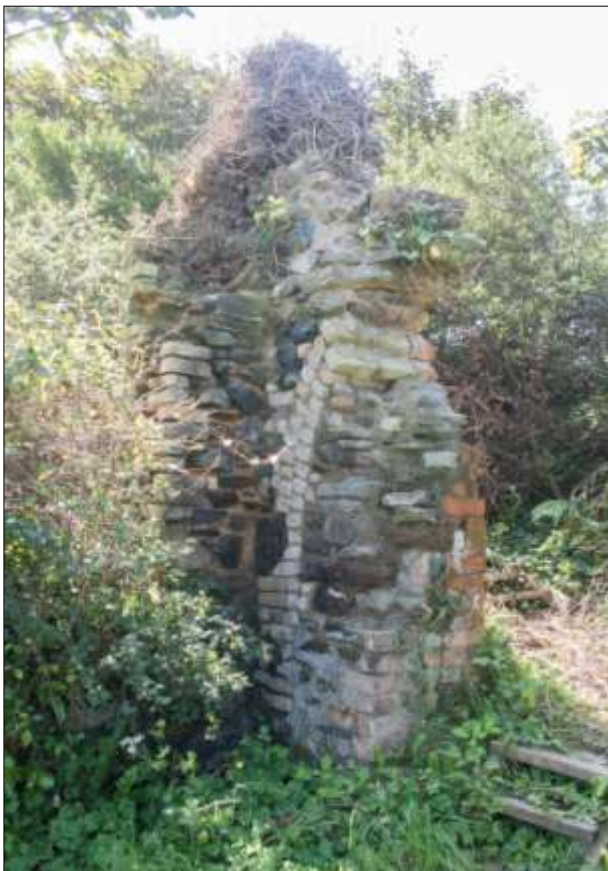
THE SOUTH-EAST INTERNAL CORNER OF THE BOILERHOUSE, SHOWING THE NARROWED PHASE 3 OPENING WITHIN A PARTLY-BLOCKED PHASE 2 OPENING; VIEWED FROM THE NORTH-WEST.

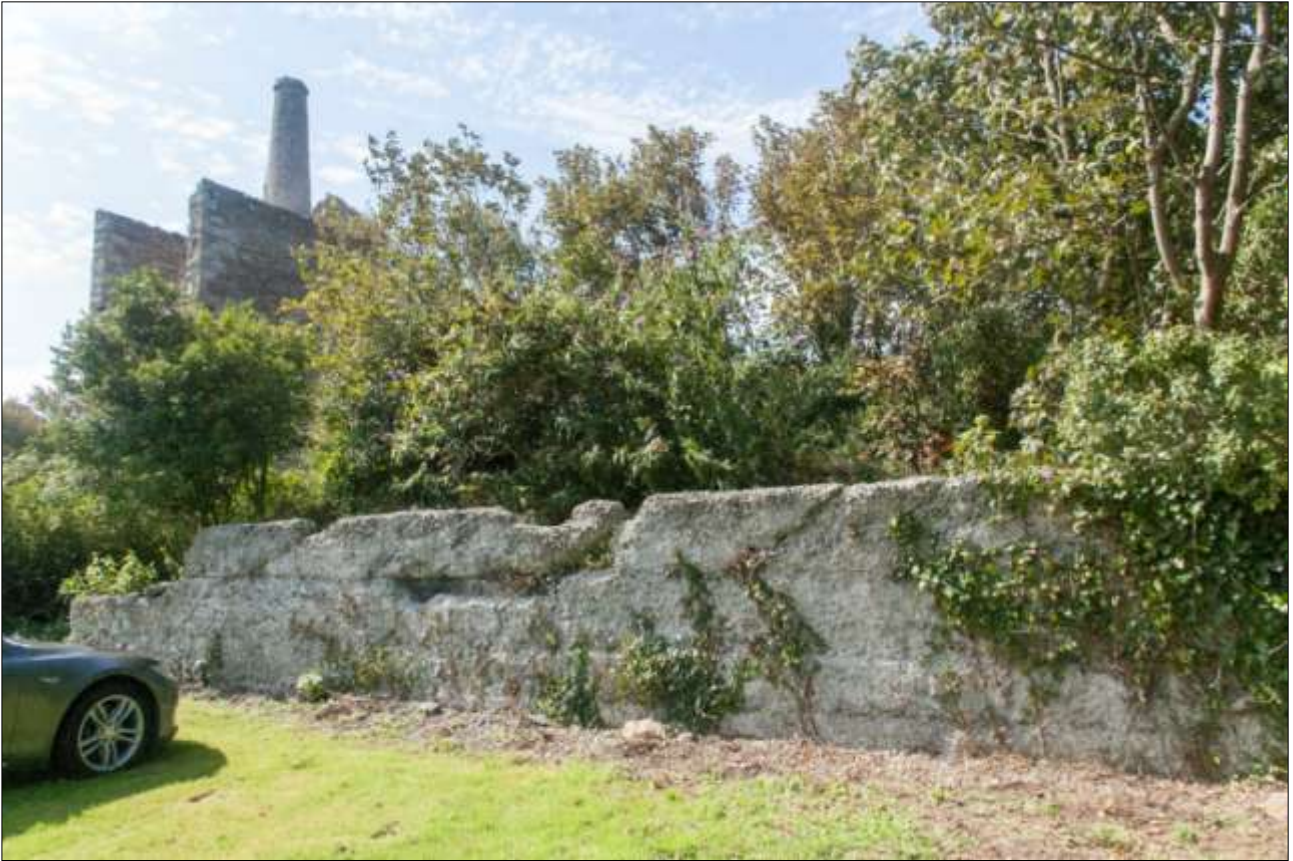
THE NORTH-EAST FACING ELEVATION OF THE PHASE 3 STAMPS; VIEWED FROM THE NORTH-EAST.

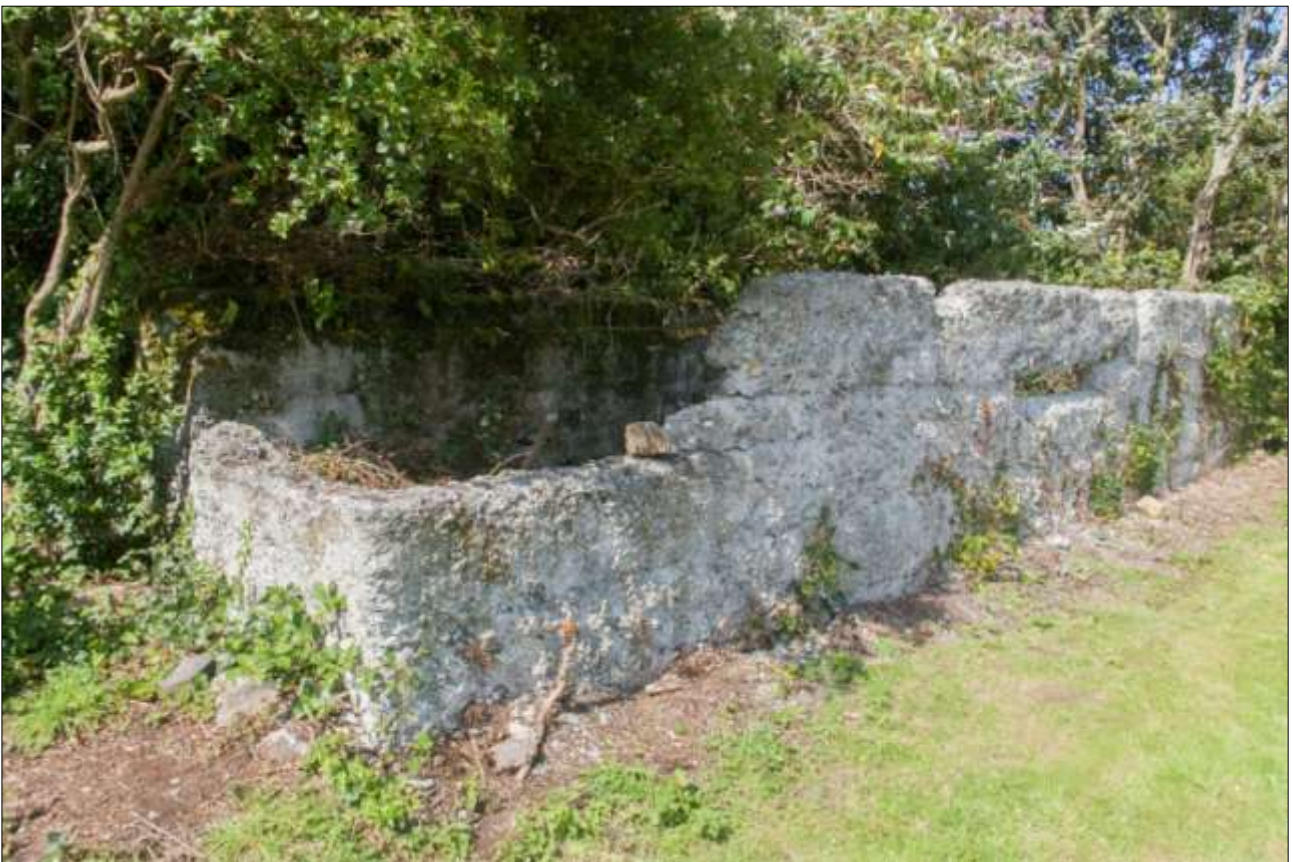
AS ABOVE, THE SOUTH-EAST ANGLE; VIEWED FROM THE SOUTH-EAST.

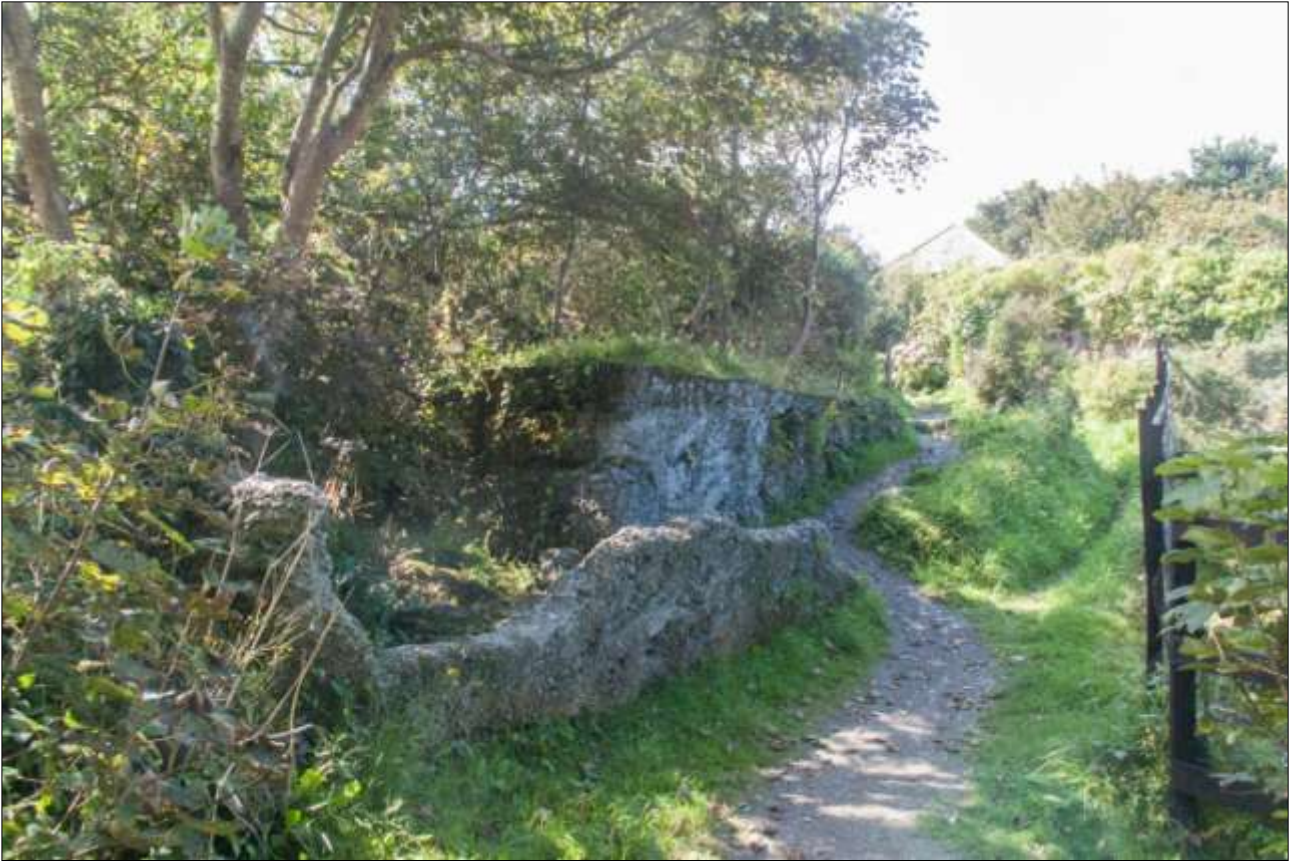
THE NORTHERN ANGLE OF THE PHASE 3 STAMPS; VIEWED FROM THE NORTH.

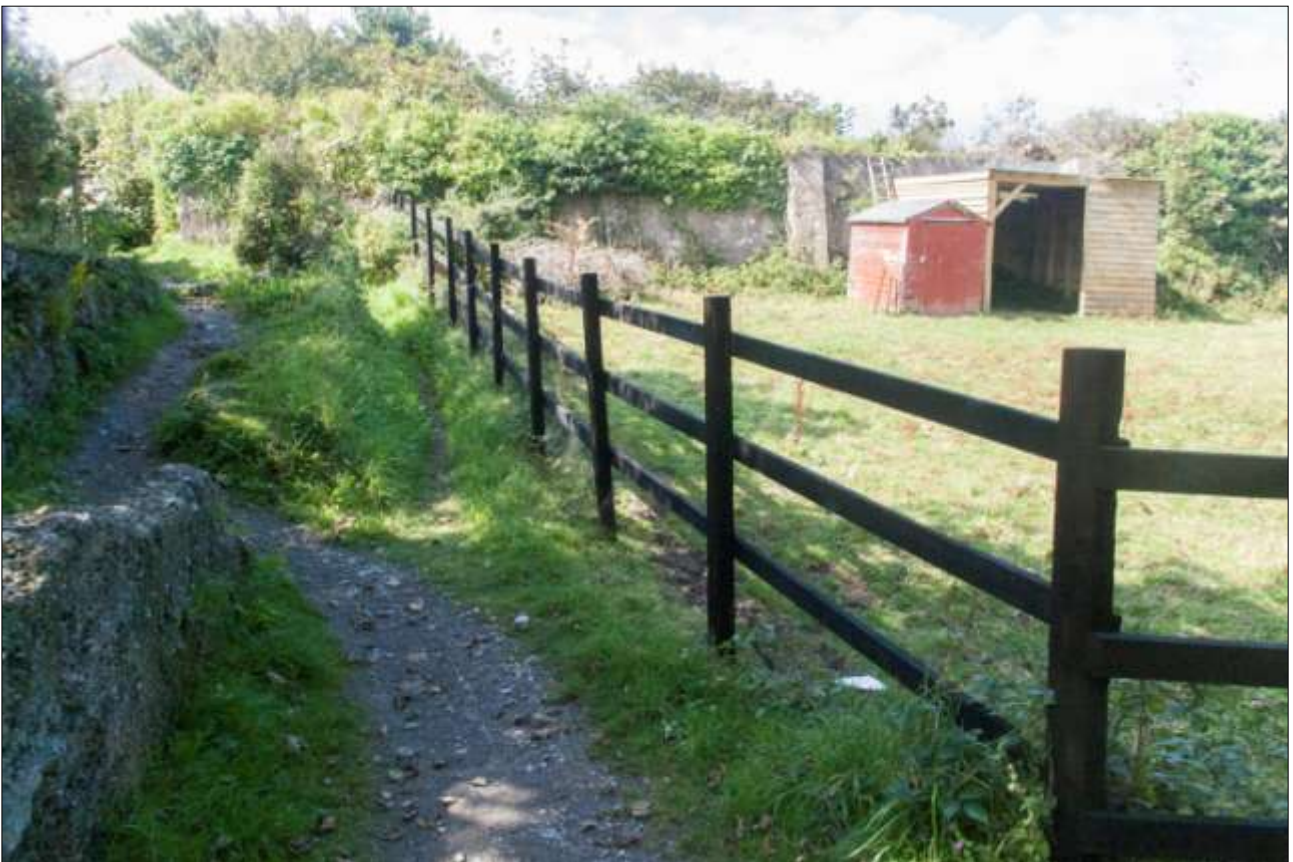
AS ABOVE, SHOWING THE PHASE 3 CONCRETE RESERVOIRS AND PHASE 2 DRYING HOUSE TO THE NORTH-WEST; VIEWED FROM THE NORTH-EAST.

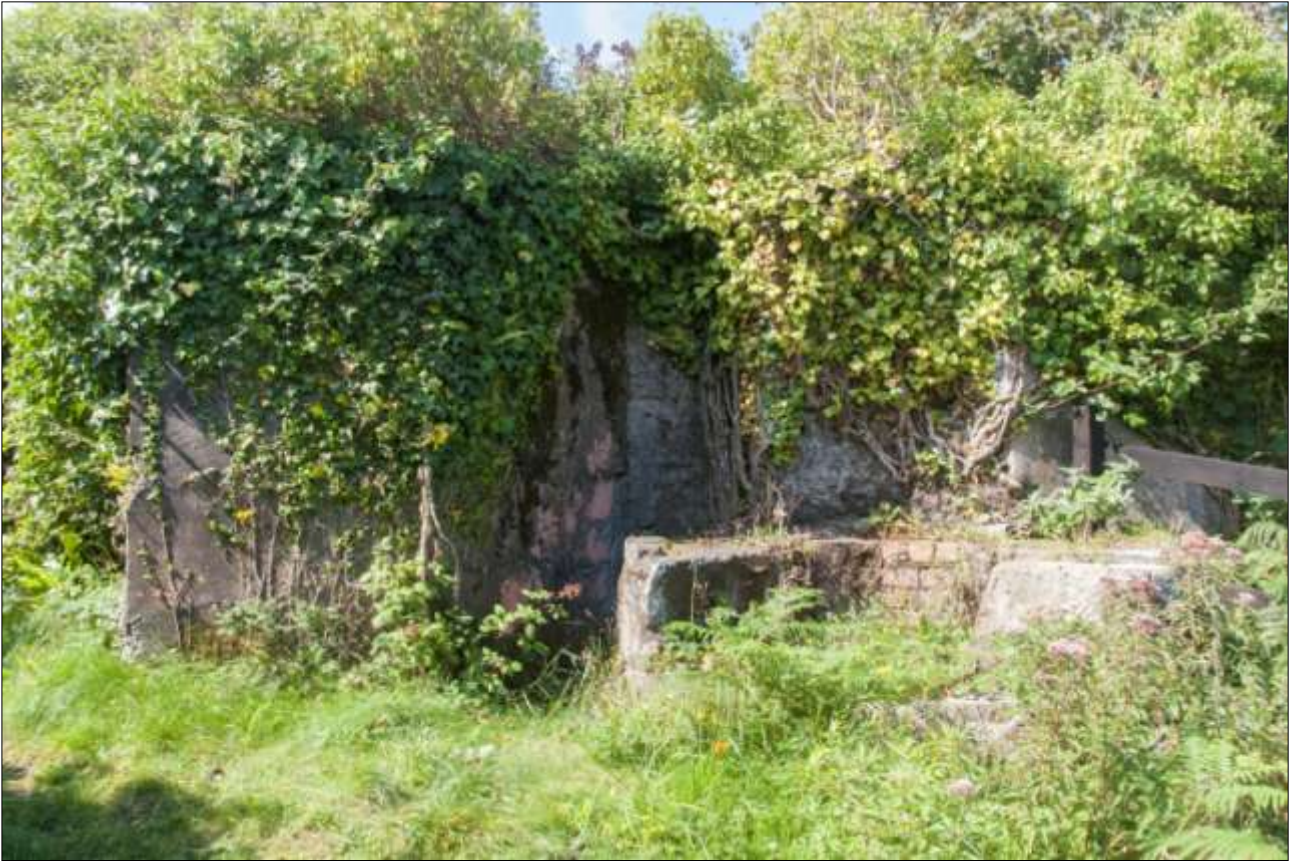
THE SOUTH-EAST CORNER OF THE PHASE 3 CONCRETE RESERVOIR, WITH PROBABLE CHIMNEY BASE; VIEWED FROM THE NORTH-EAST.

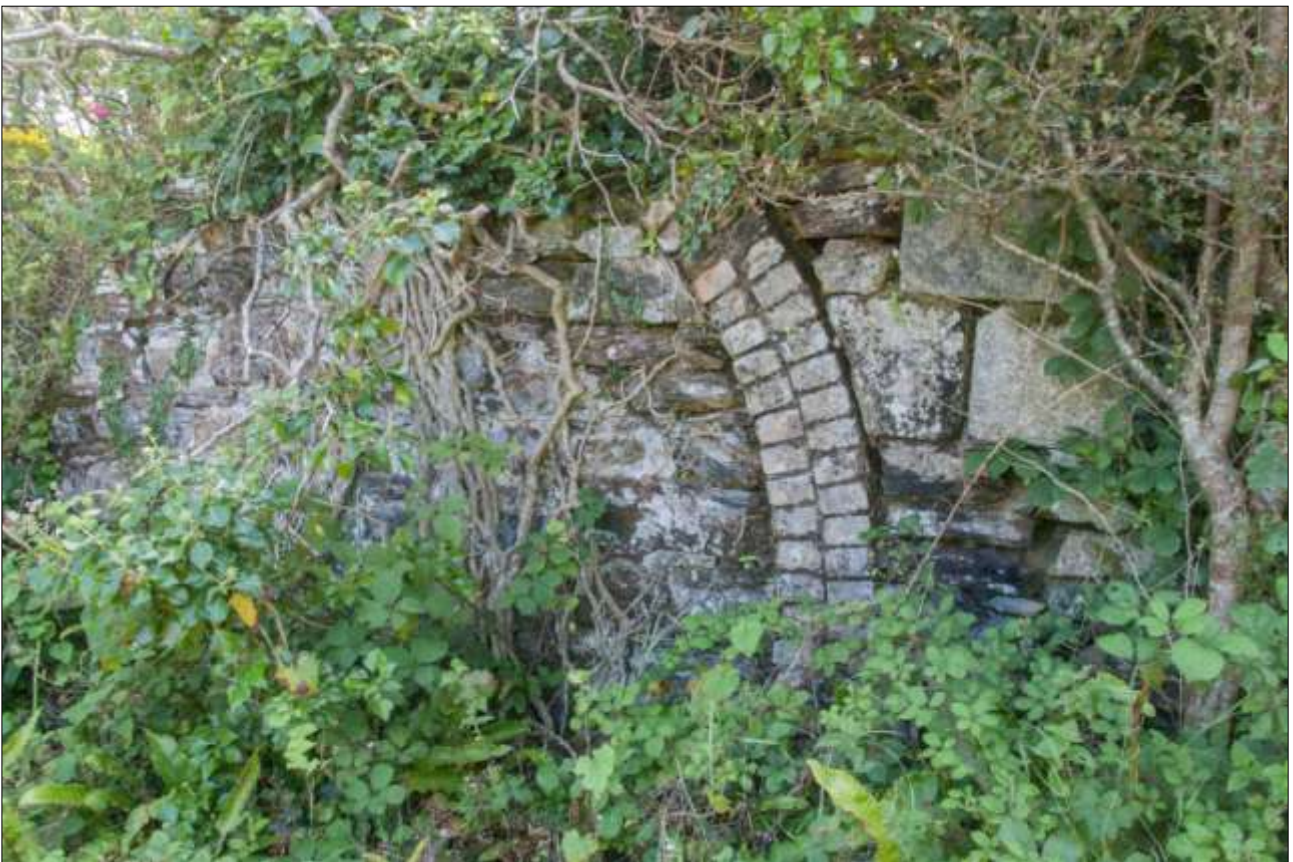
THE NORTH-WEST CORNER OF THE PHASE 2 COMPRESSOR HOUSE/WHIM OPENING WITH BRICK ARCH, BLOCKED IN PHASE 3; VIEWED FROM THE NORTH-WEST.
