BARN AT SPECCOTT BARTON FARM

DESK BASED APPRAISAL AND HISTORIC BUILDING RECORDING

SOUTH WEST ARCHAEOLOGY LTD. REPORT NO. 180314

HISTORIC BUILDING RECORDING

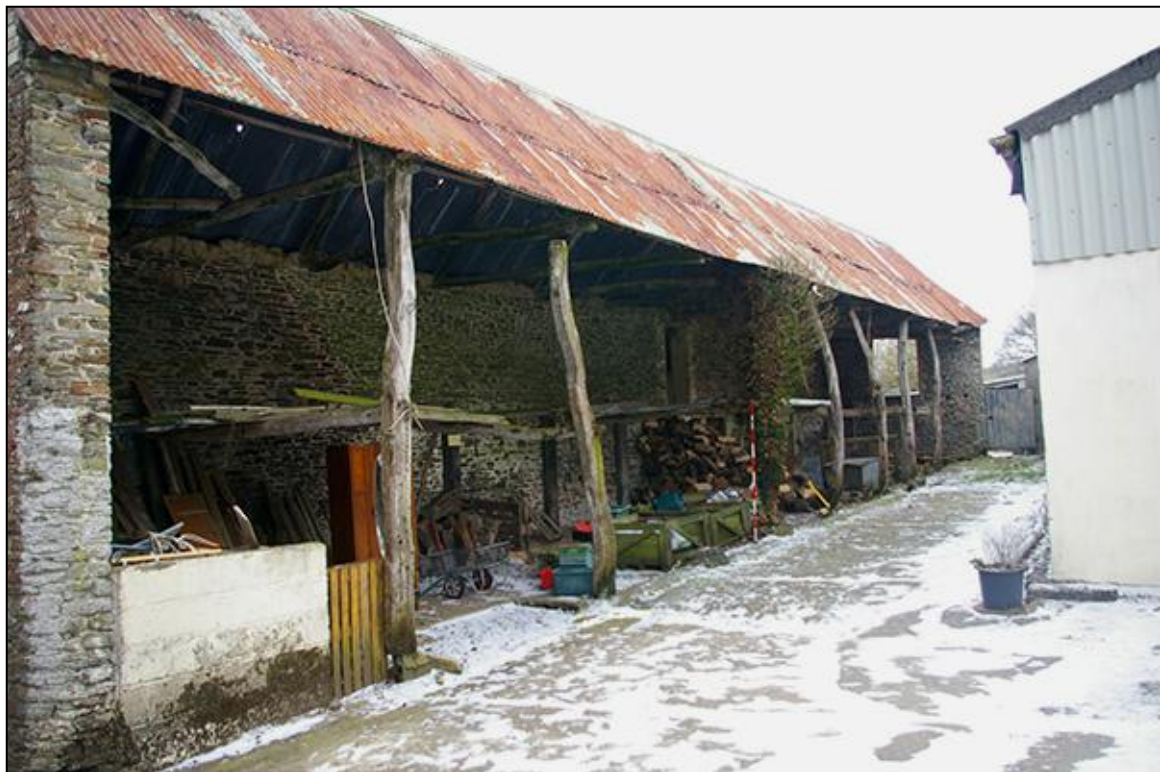
COVER PLATE: THE OPEN EAST ELEVATION, FROM THE SOUTH-EAST (2M SCALE).

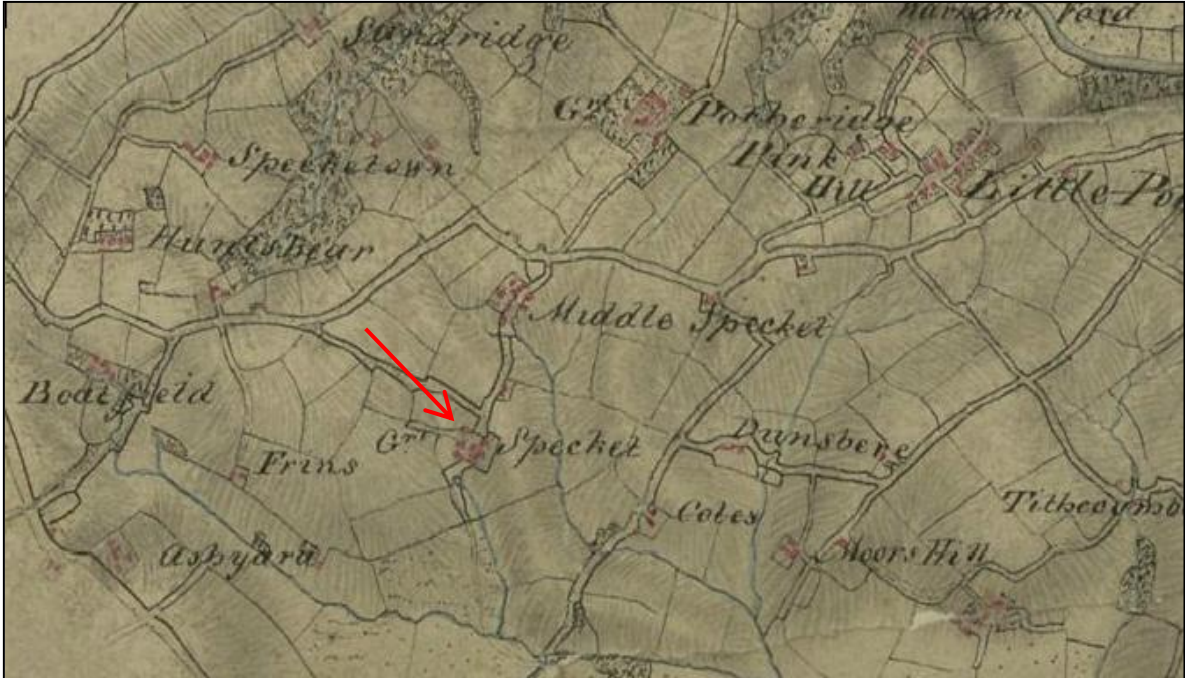
The 1804 Roborough Ordnance Survey surveyor's draft map (Figure 3) shows the farmstead of Great Specket, with Middle Specket (now Little Speccott) also shown. The roads follow broadly the modern layout although a return to the north of Speccott is now a farm track rather than a road connecting to the main road.

FIGURE 3: EXTRACT FROM THE 1804 OS SURVEYOR'S DRAFT MAP (BL); THE APPROXIMATE LOCATION OF THE SITE IS INDICATED.

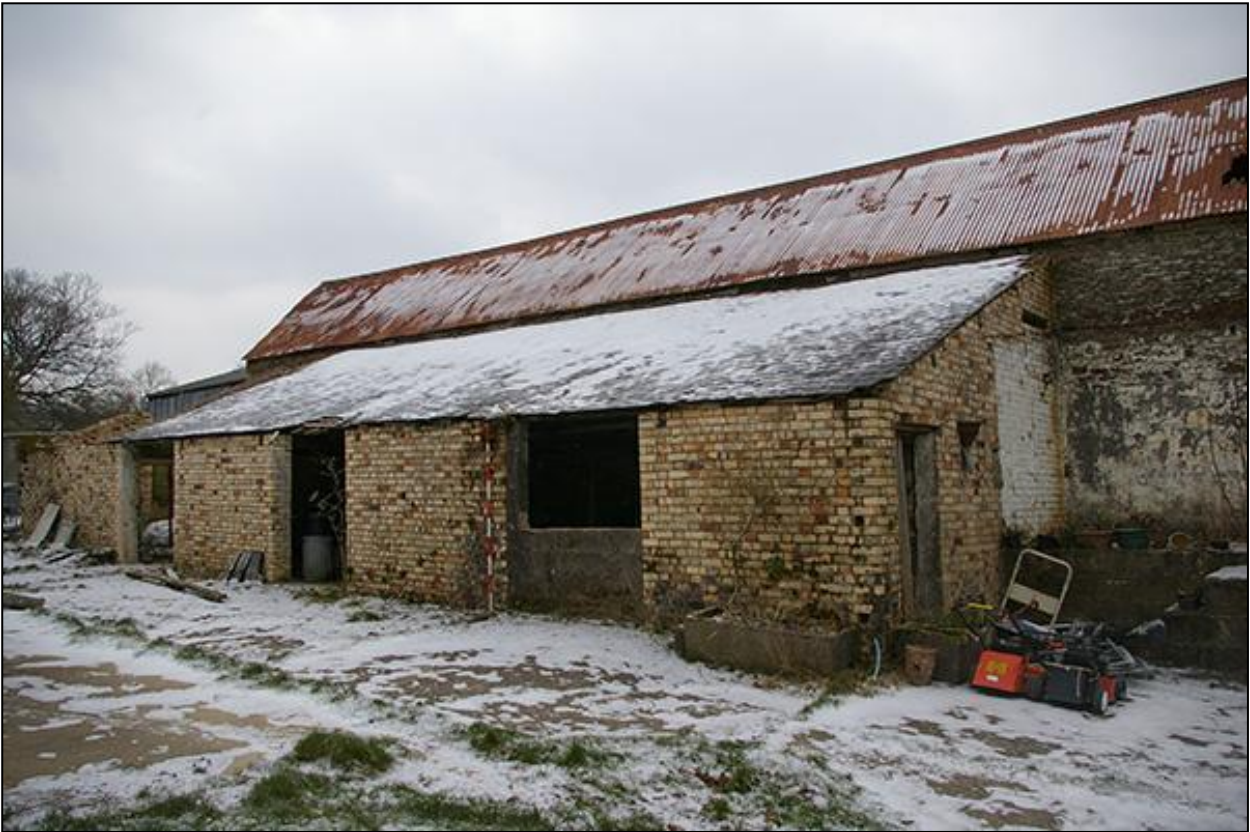
THE BRICK LEAN-TO AND WEST ELEVATION OF THE BARN, FROM THE SOUTH-WEST (2M SCALE).

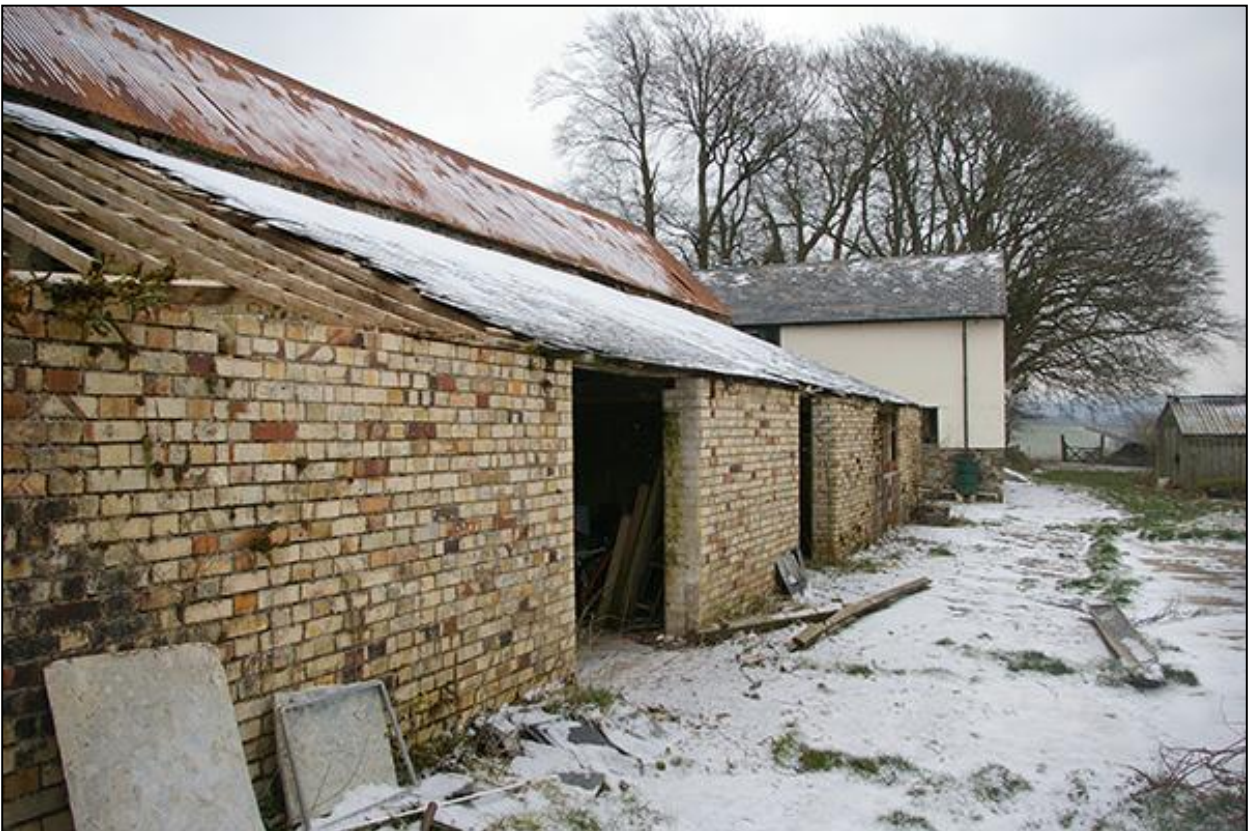
THE BRICK LEAN-TO, FROM THE NORTH-NORTH-WEST (2M SCALE).

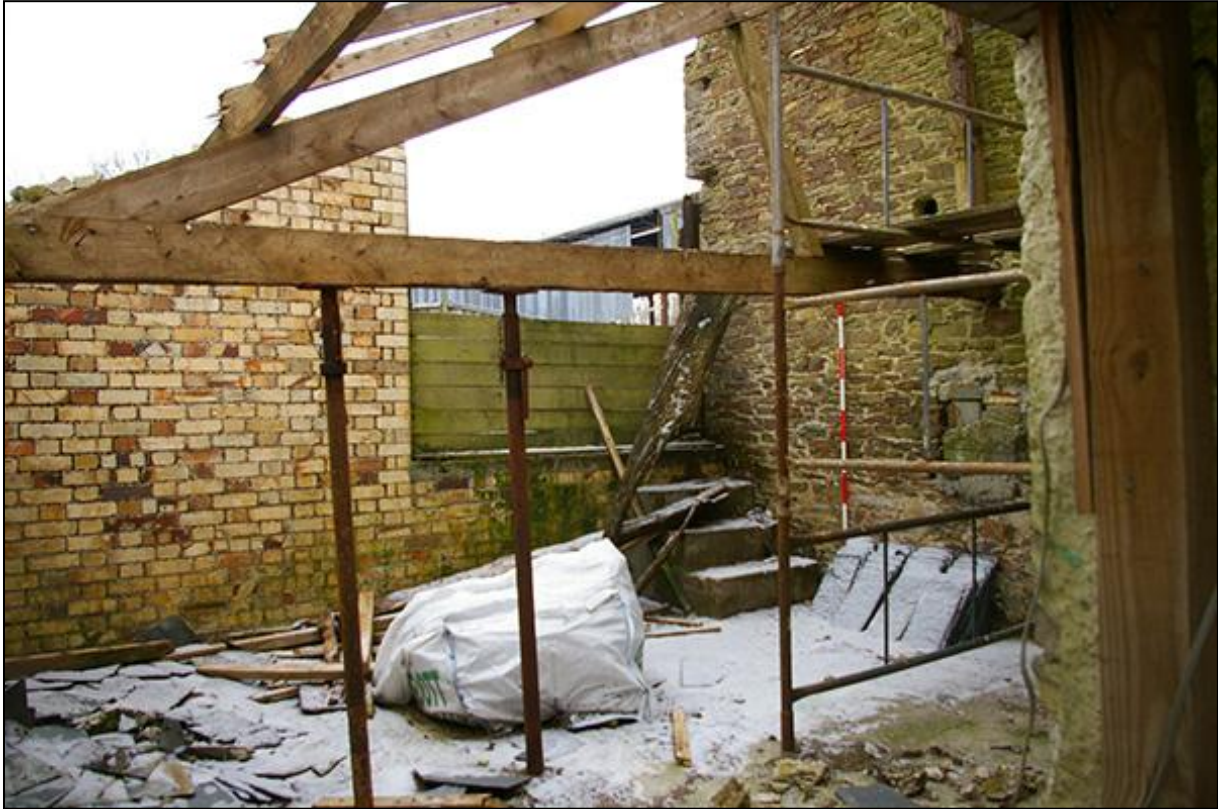
THE ROOM TO THE NORTH OF THE LEAN-TO, WITH LARGE OPENING TO THE NORTH PART OF THE YARD AND FEED ROOM/ROOT HOUSE; FROM THE WEST-SOUTH-WEST (2M SCALE).

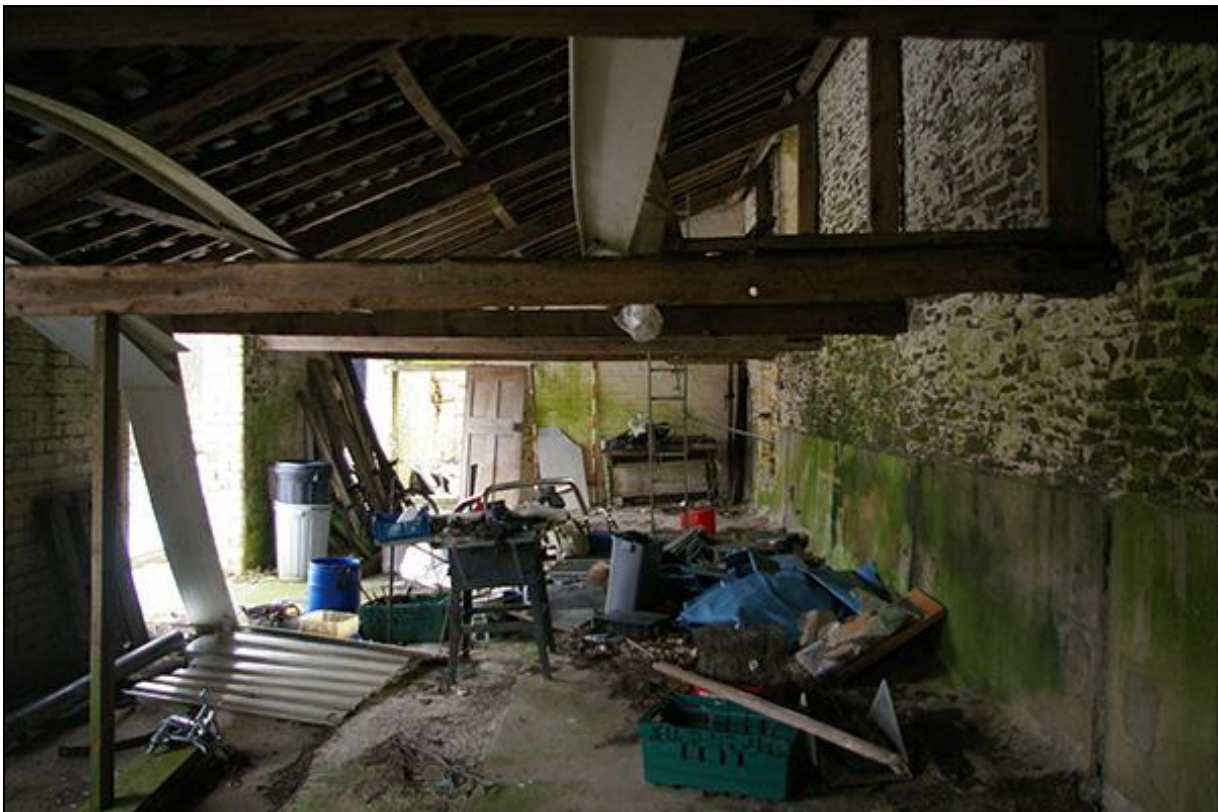
THE INTERIOR OF THE COW BYRE LEAN-TO, FROM THE SOUTH (2M SCALE).

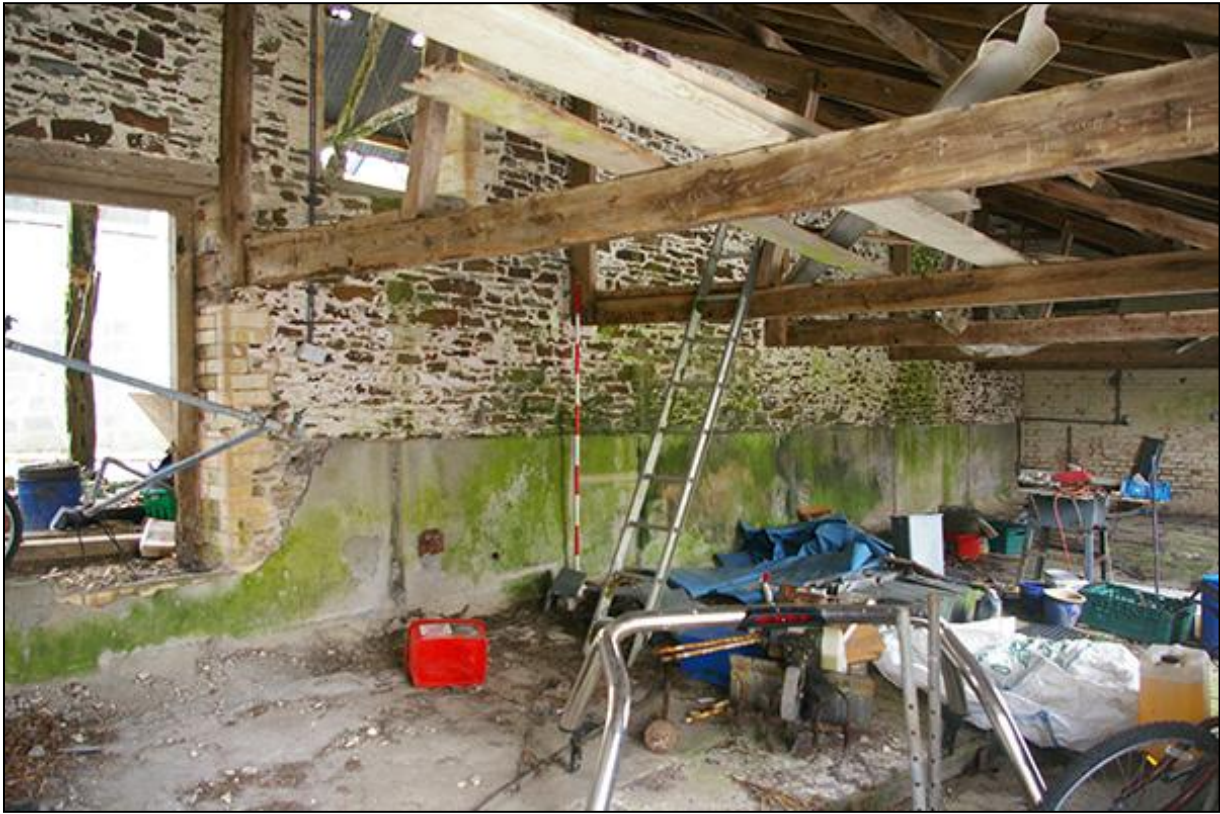
THE WEST WALL OF THE LINHAY BARN, AS SEEN WITHIN THE LEAN-TO, WITH FORCED DOORWAYS GIVING ACCESS TO THE EXTENSION, FROM THE WEST-NORTH-WEST (2M SCALE).

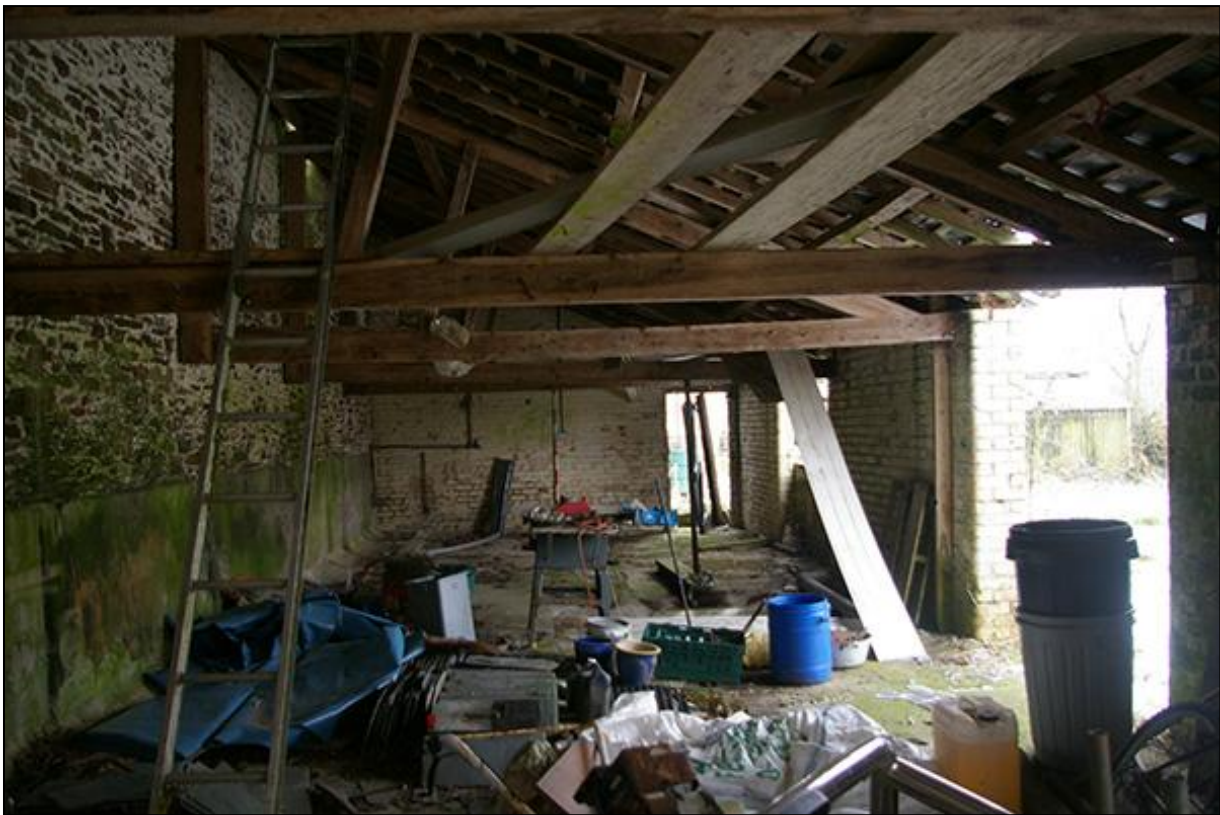
THE INTERIOR OF THE COW BYRE LEAN-TO, FROM THE NORTH (2M SCALE).

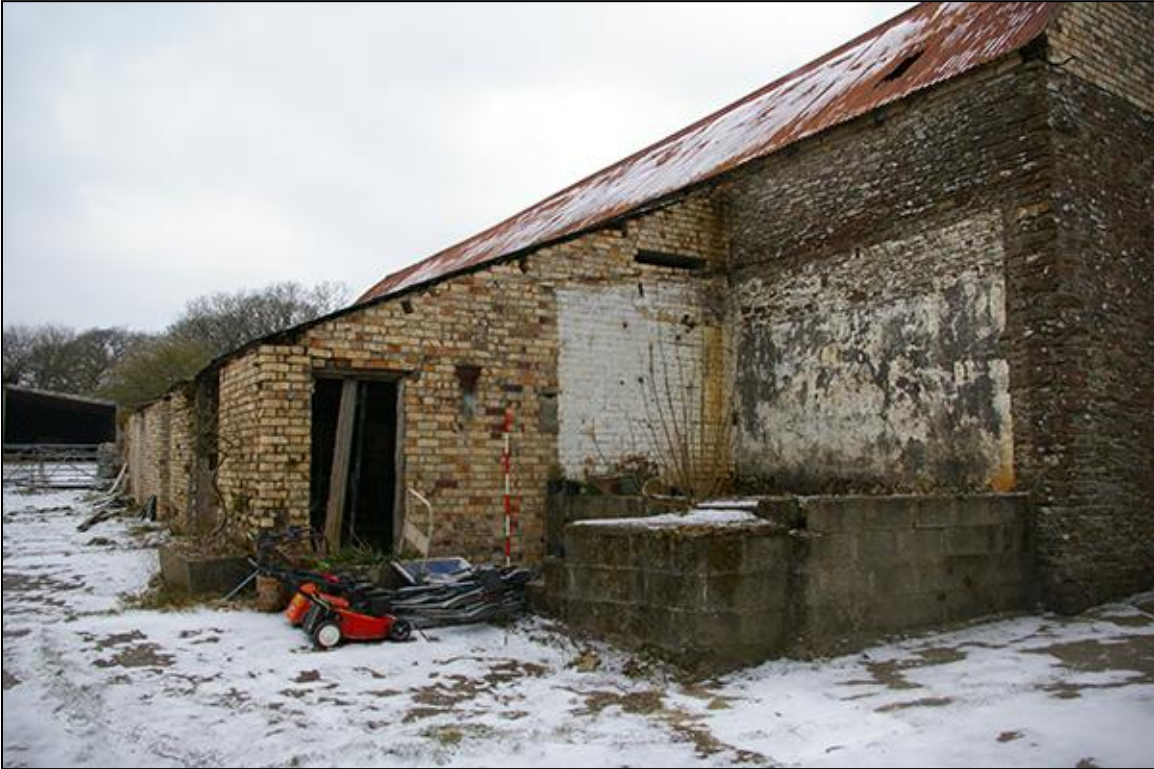
THE SOUTH ELEVATION OF THE BRICK LEAN-TO AND SOUTH-WEST END OF THE LINHAY; FROM THE SOUTH-WEST (2M SCALE).

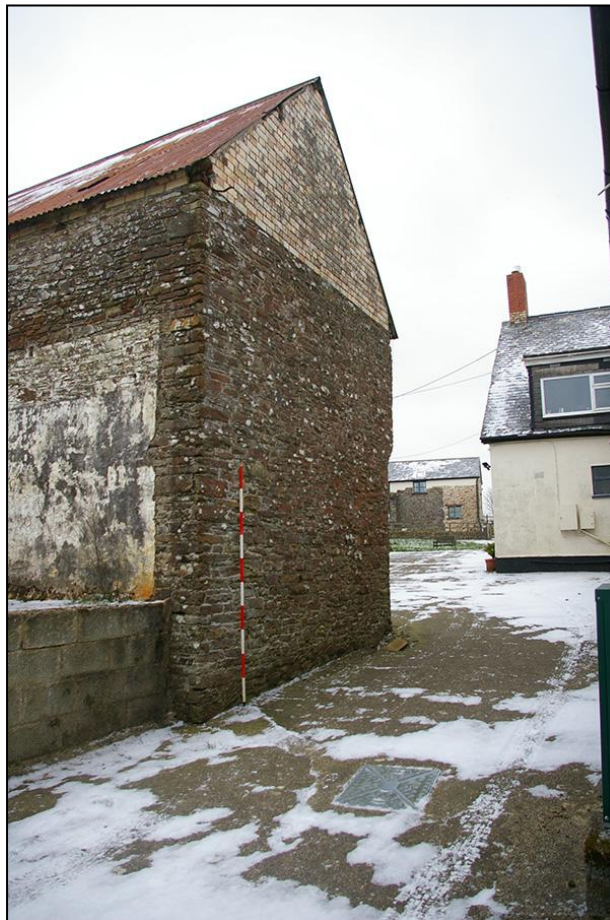
THE SOUTH ELEVATION OF THE LINHAY BARN, GOOD SLATESTONE STONEMWORK, WITH IN FILLED APEX, PROBABLY REPLACING WEATHER BOARDING, WITH BRICK, FROM THE SOUTH-WEST (2M SCALE).

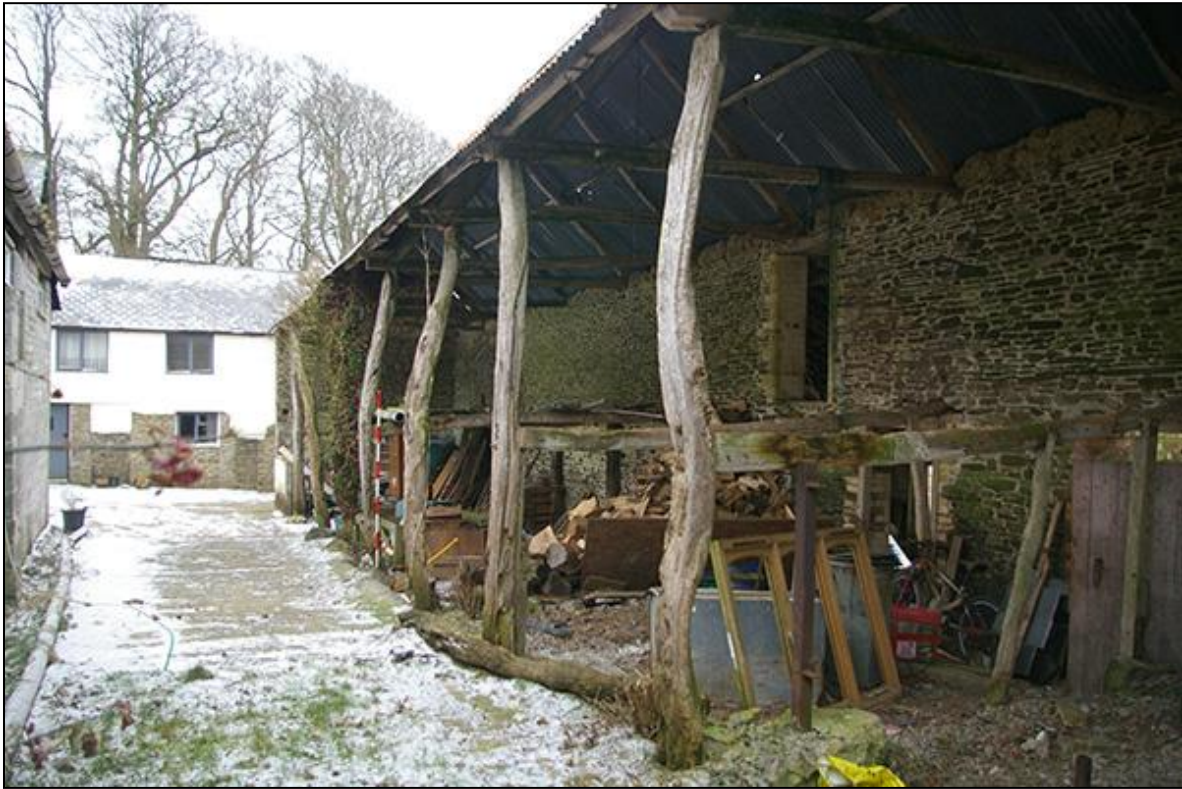
THE OPEN EAST ELEVATION, WITH STRONG TIMBER POSTS, FROM THE NORTH-EAST (2M SCALE).

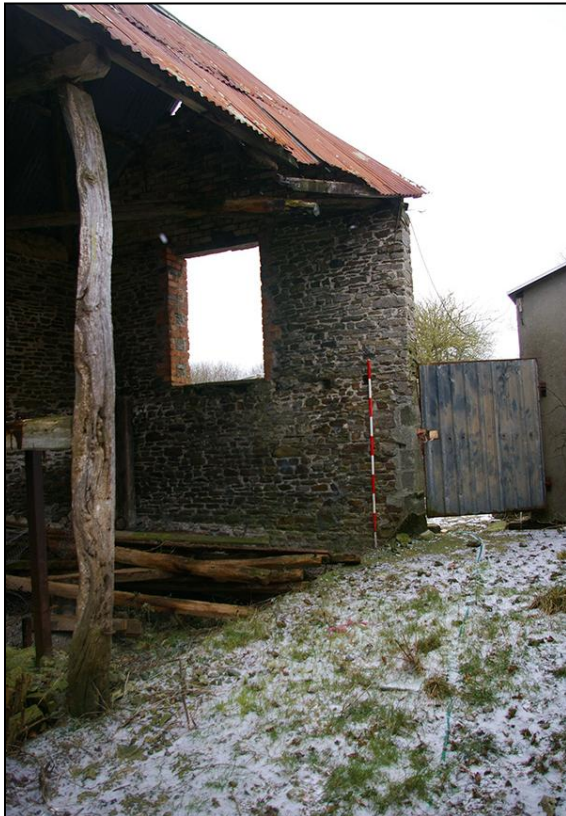
LEFT: THE NORTH ELEVATION OF THE LINHAY BARN, WITH LARGE LOADING DOOR WITH BRICK REVEALS, FROM THE EAST-SOUTH-EAST (2M SCALE).

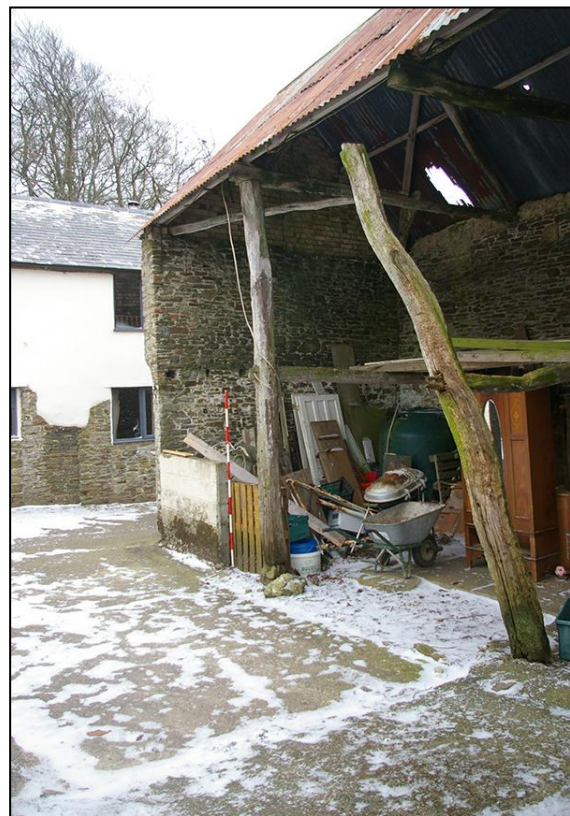
RIGHT: THE SOUTH GABLE END WALL, WITH ABUTTING CONCRETE PEN. SOCKET HOLES FOR JOISTS SUGGEST THE LOFT HERE REQUIRED MORE STRENGTH; ALSO SHOWING SLIGHT HACKING ON THE SOUTH-EAST CORNER, TO ALLOW FOR SAFE PASSAGE OF ANIMALS AND VEHICLES/CARTS AFTER THE OPPOSITE OUTBUILDINGS WERE BUILT; FROM THE EAST-NORTH-EAST (2M SCALE).
