LAND OFF MAUDLINS LANE TAVISTOCK WEST DEVON DEVON

Historic Building Recording and Archaeological Monitoring and Recording

South West Archaeology Ltd. report no. 200603

By E. Wapshott, F. Balmond, & P. Webb
Report Version FINAL
3rd June 2020

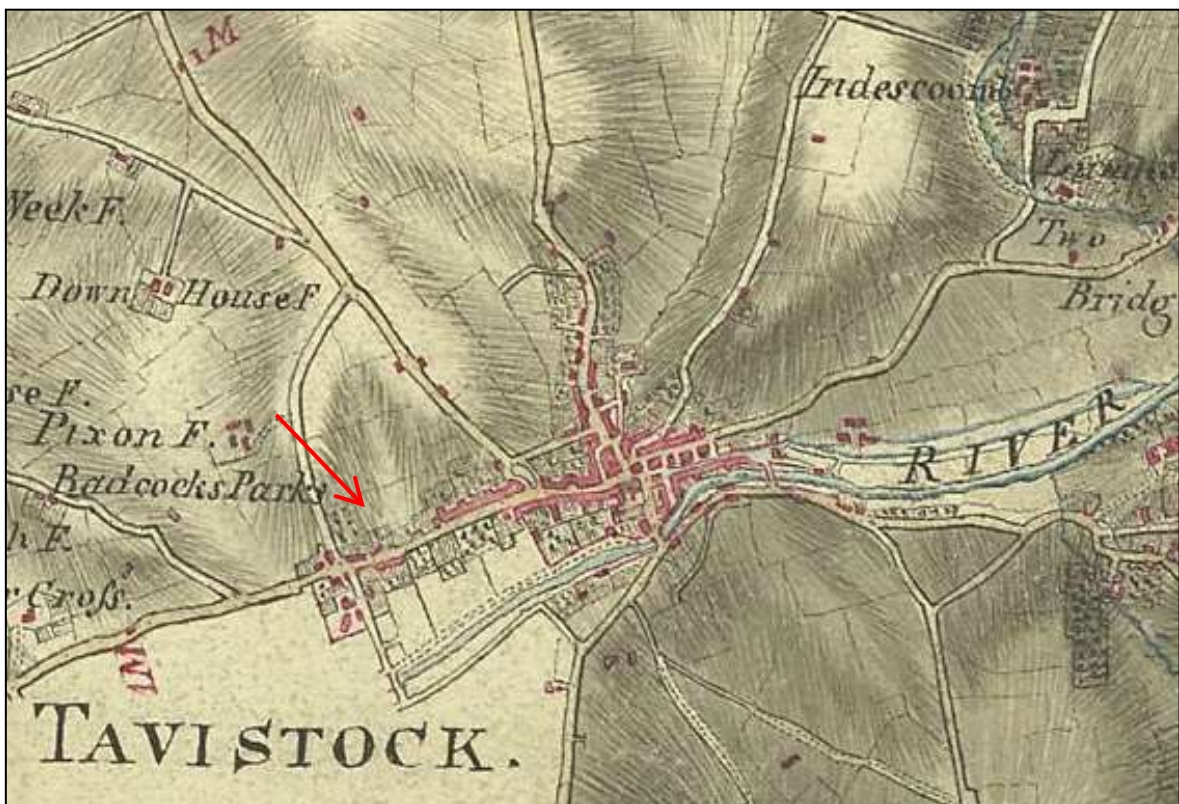
FIGURE 2: EXTRACT FROM THE 1802 OS SURVEYOR'S DRAFT MAP (BL); THE APPROXIMATE LOCATION OF THE SITE IS INDICATED.

The 1802 Tavistock Ordnance Survey surveyor's draft map (Figure 2) shows Tavistock as a relatively linear settlement along the river Tavy, spreading out long roads to the north and surrounded by enclosed agricultural fields and farmsteads. It is difficult to discern individual buildings on this map however the development sites appear to be located in an area of enclosed fields to the west of the town.

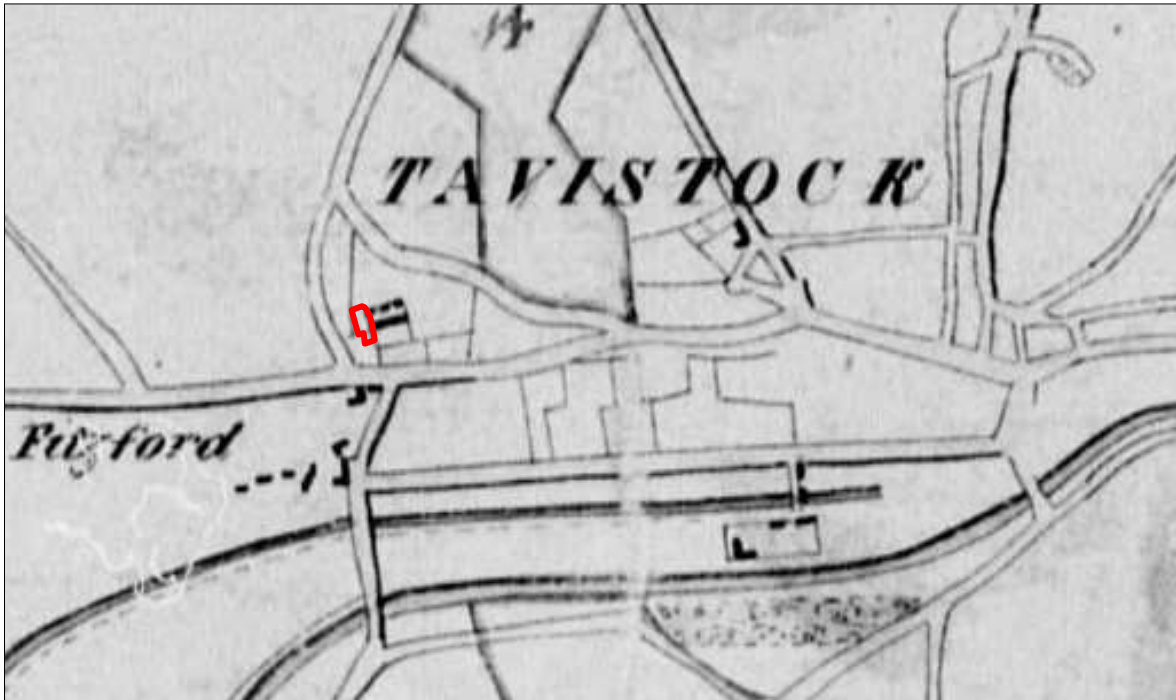
FIGURE 3: EXTRACT FROM THE 1842 TAVISTOCK TITHE MAP (BL).

The 1842 Tavistock Tithe map (Figure 3) shows the buildings of the old workhouse but no other buildings or structures in this area. Due to the nature of the ownership of much of the land in and

around Tavistock at this time it was exempt from tithes and therefore is not shown in detail on the tithe map. The Wynne map of the Bedford estate dating from the mid eighteenth century (not depicted) also shows little detail in the area of the development site, not illustrating the leper hospital which is documented.

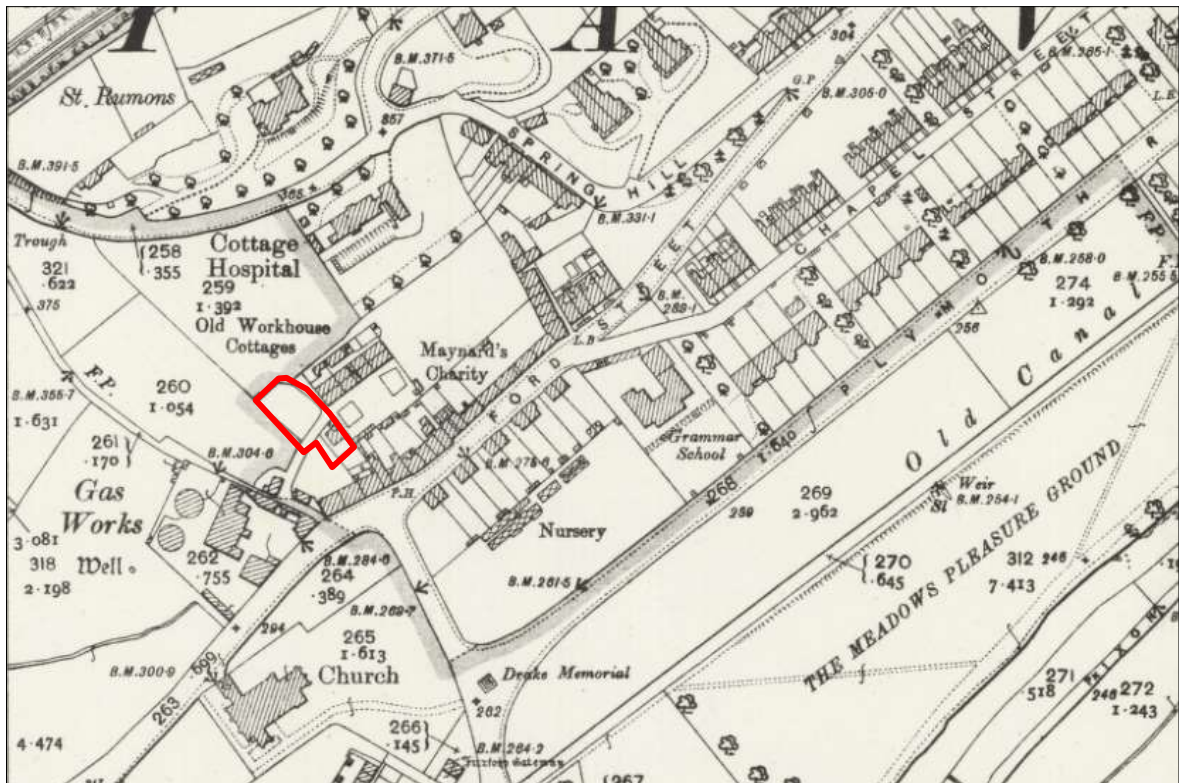
FIGURE 5: EXTRACT FROM THE 1905 OS 2ND EDITION 25INCH MAP (NLS); THE SITE IS INDICATED.

The 2nd edition OS map (Figure 5) indicates that little change had taken place since 1883 although the building in the garden to the rear of the property fronting onto Ford Street appears to have been enlarged or replaced with a bigger building as this now occupies much of the plot. The London and South Western Railway has been constructed to the north west of the site and the cottage hospital is shown to the north.

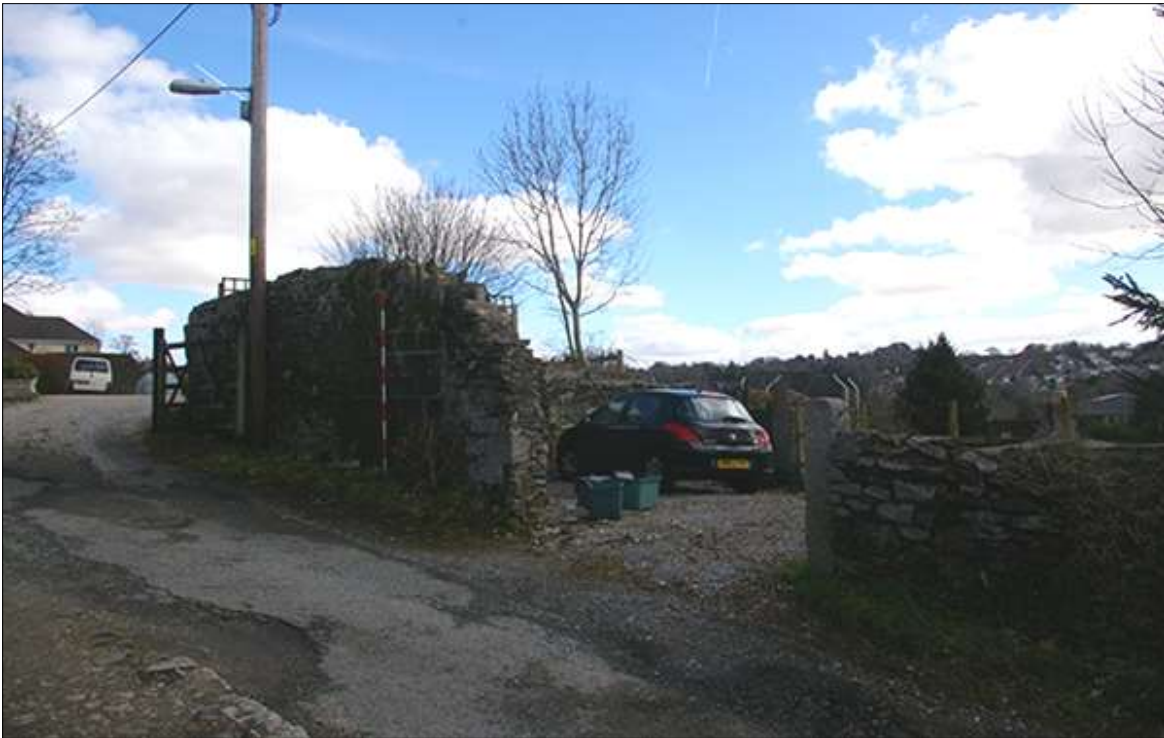
6. THE LOWER SITE, SHOWING THE ENTRANCE ONTO MAUDLINS PARK; VIEWED FROM THE WEST-SOUTH-WEST.

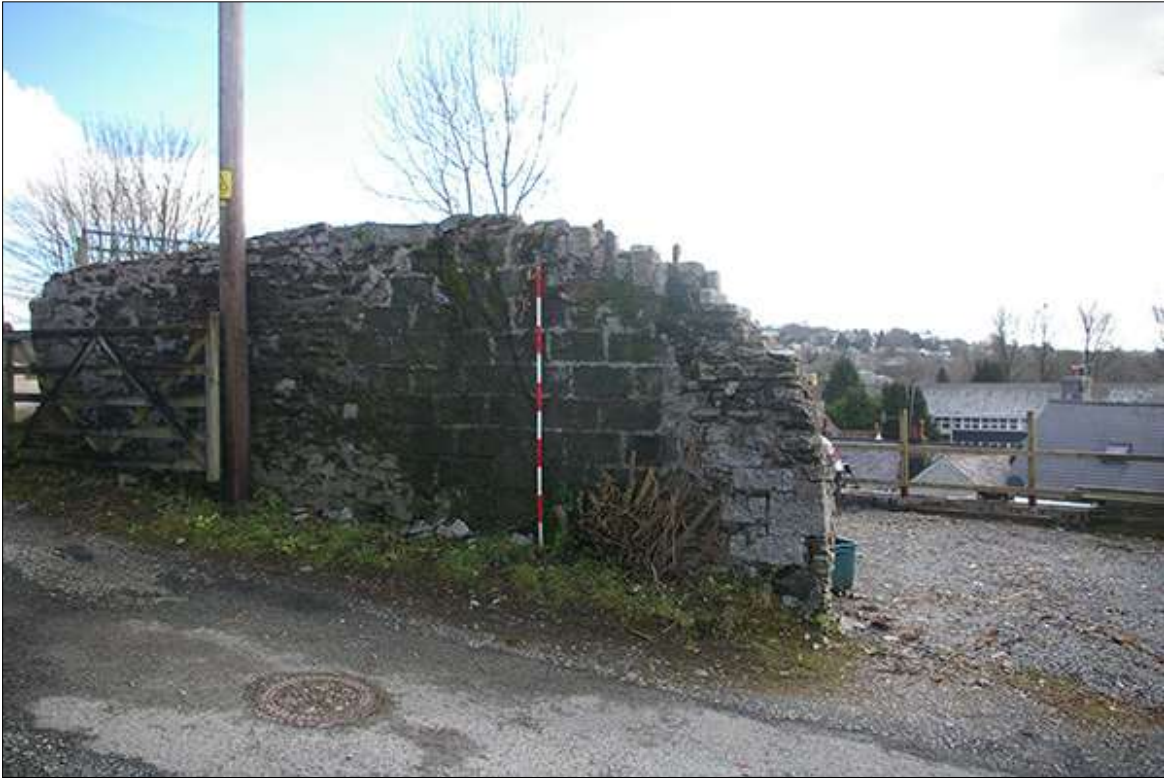
7. THE LOWER SITE, THE NORTH-WEST WALL FACING ONTO MAUDLINS PARK; VIEWED FROM THE WEST (SCALE 2M).

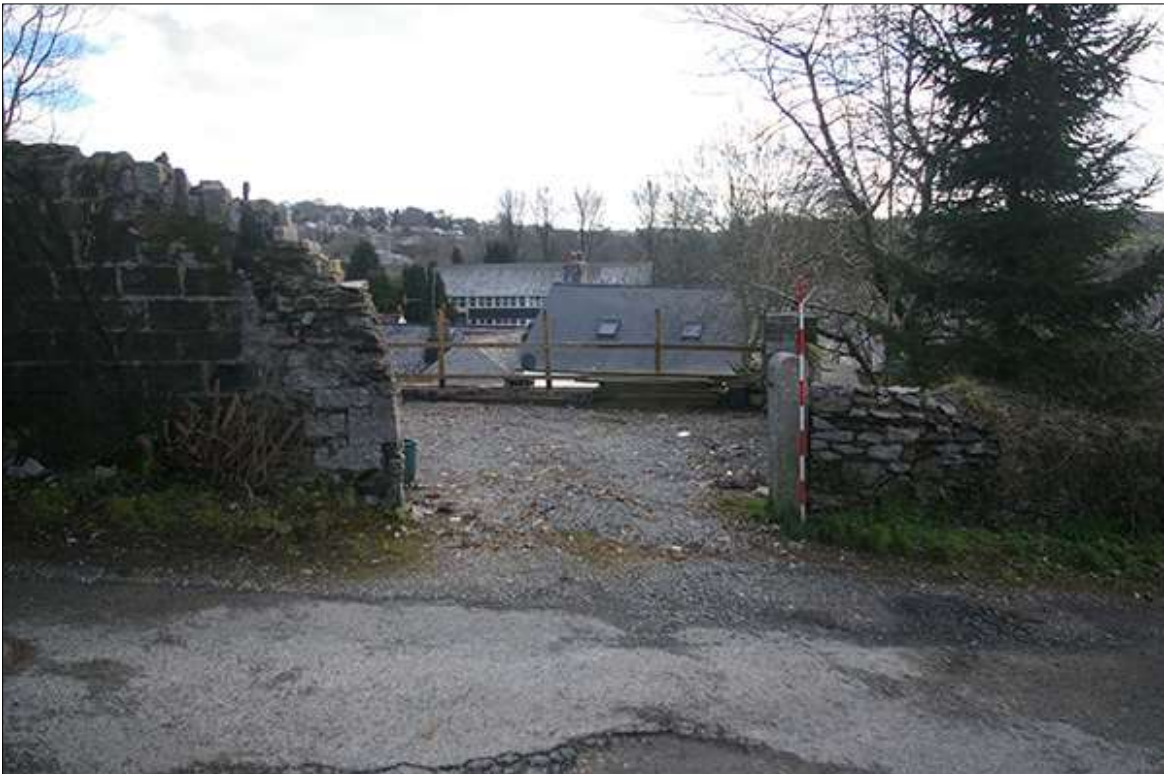
8. AS ABOVE, SHOWING THE REUSED GRANITE POST; VIEWED FROM THE WEST (SCALE 2M).

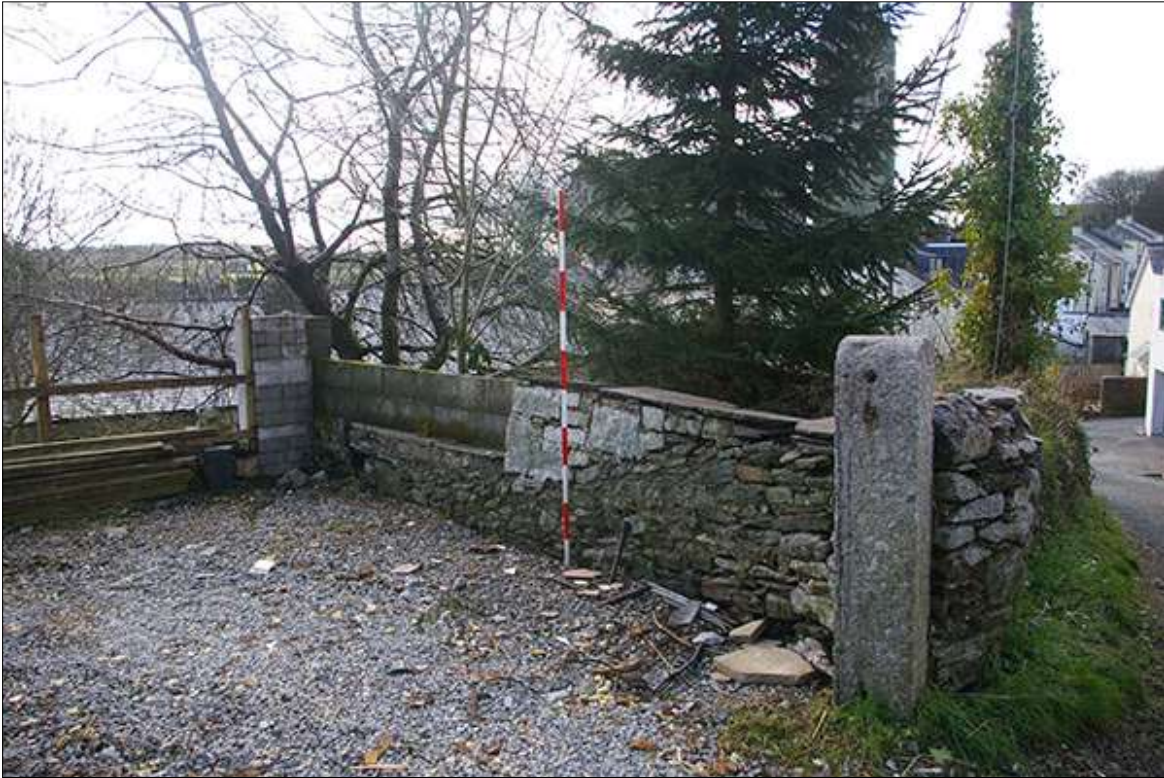
9. THE LOWER SITE, THE SOUTH-WEST WALL, SHOWING HOW THE SLOPING TOP OF THE WALL HAS BEEN BUILT UP WHICH REUSED GRANITE BLOCKS AND CONCRETE BLOCK; VIEWED FROM THE NORTH (SCALE 2M).

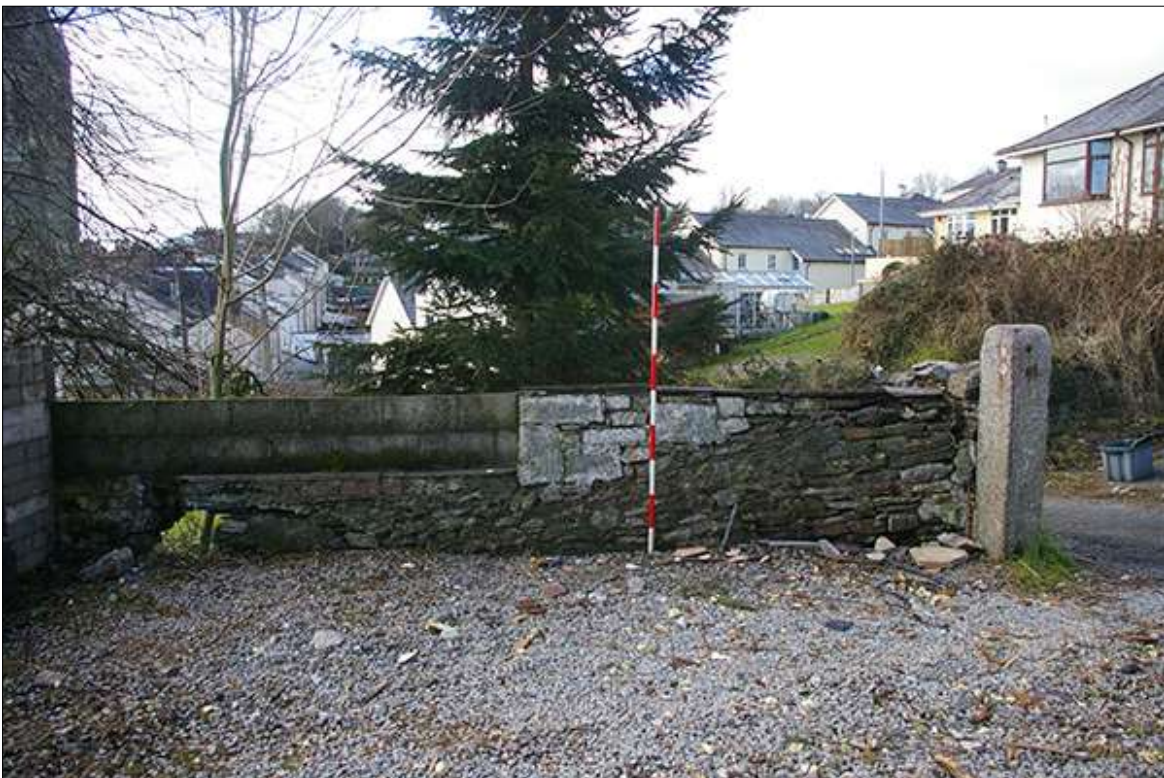
10. AS ABOVE; VIEWED FROM THE NORTH-EAST.

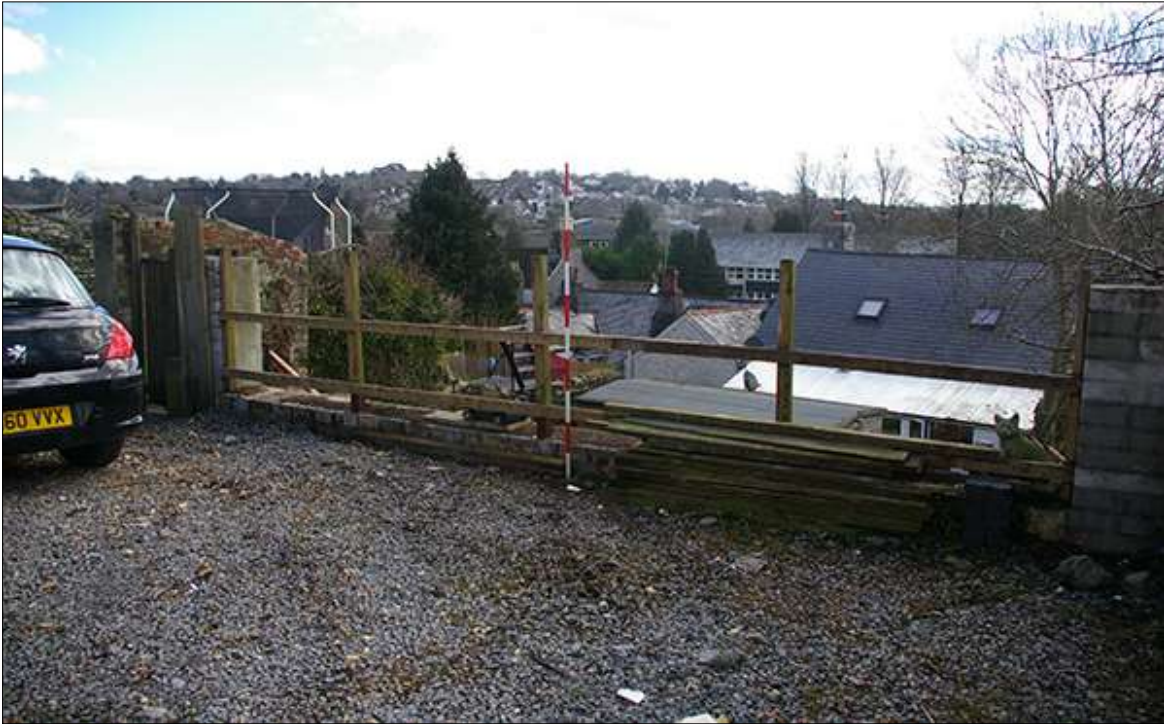
11. THE LOWER SITE; THE EAST SIDE; VIEWED FROM THE WEST-SOUTH-WEST (SCALE 2M).

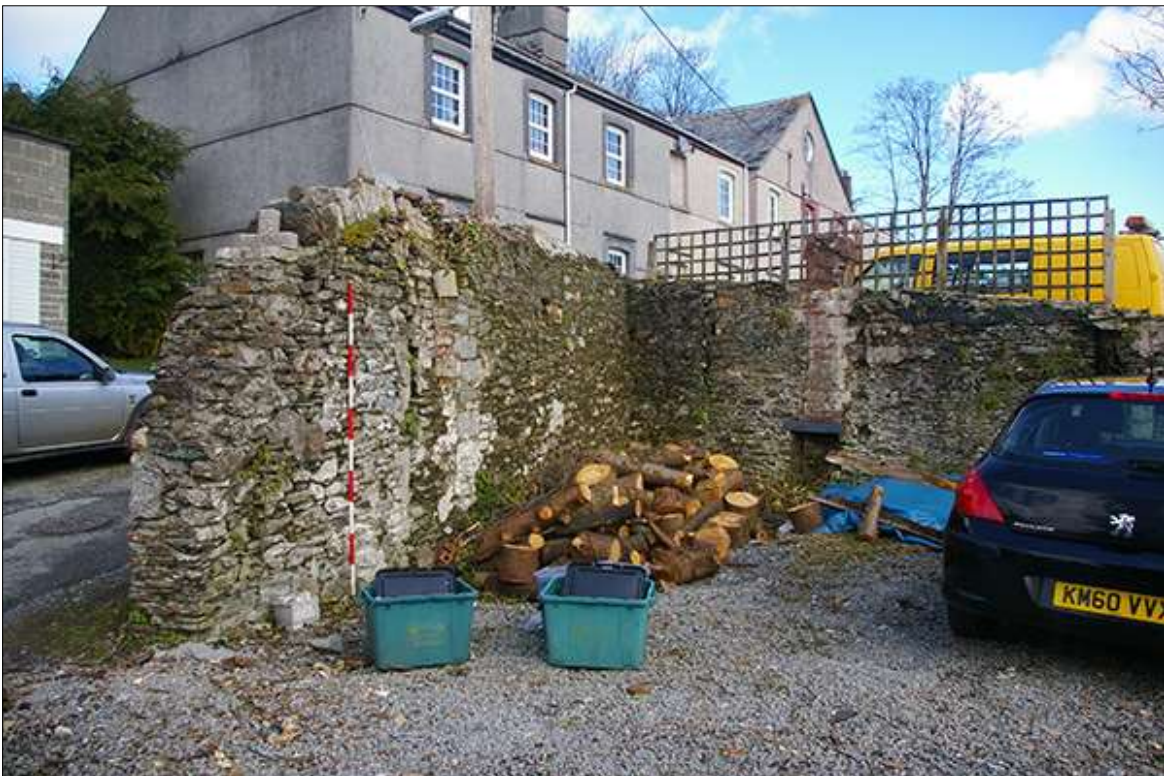
The surviving elements of the 'old ruins' are as two relatively tall slate and shale rubble stone walls, surviving to almost first floor height, with a small brick returning outshut to the east side and a further low section of garden wall to the south. The tallest section of wall runs alongside the road to the north-west; there is a short stretch of looser slate rubble that runs up to the north corner and has been heavily repointed in cement. There are patches of recycled dressed granite blocks, bricks and looser rubble mixed in with rough granite and concrete blocks. A section of broken granite memorial cross is embedded in cement at the entrance to the site; this section of stonework was built in the early 20th century, bonded with a coarse grey cement mortar. Within the southern part of the north-west wall there is a blocked flue, filled with terracotta blocks and bricks.

12. THE LOWER SITE; THE NORTH-WEST AND NORTH-EAST WALLS OF THE 'OLD RUINS', SHOWING A BLOCKED FLUE, WALL SCARS FROM DEMOLISHED STRUCTURES, AS WELL AS AN *IN SITU* FLUE AND FIREPLACE; VIEWED FROM THE SOUTH (SCALE 2M).

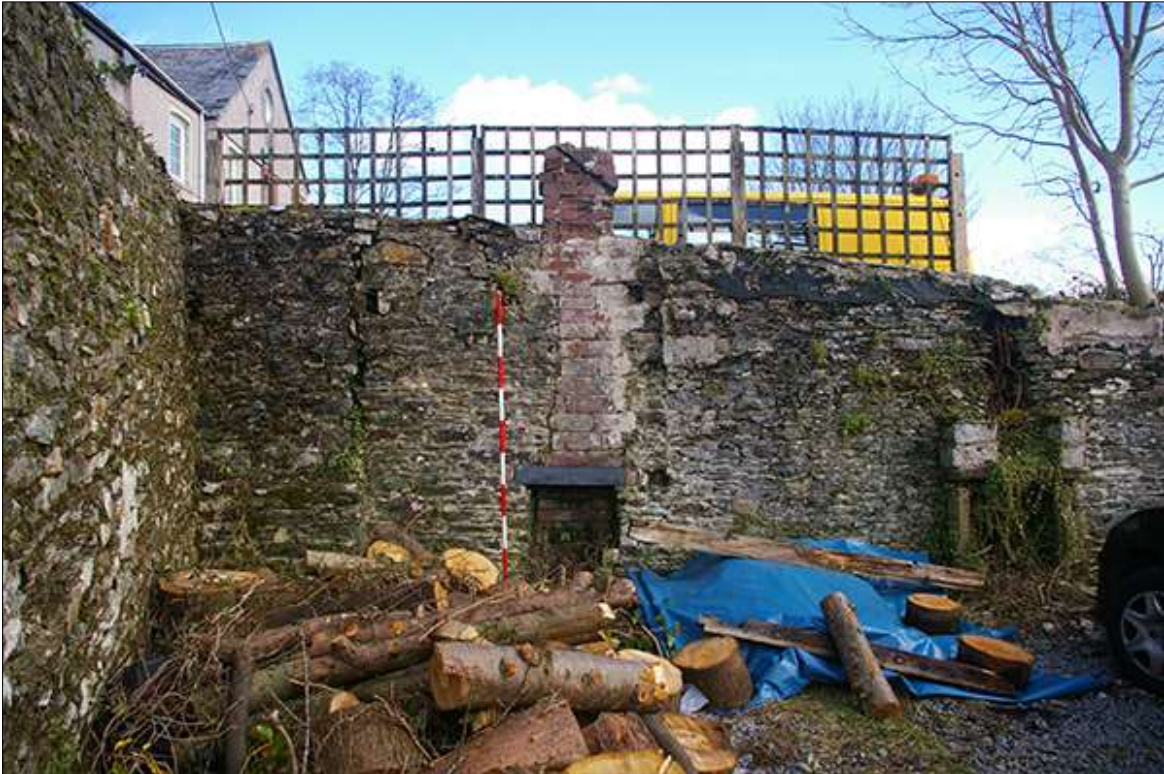
13. THE LOWER SITE; THE NORTH-EAST WALL, SHOWING THE INSERTED FLUE AND FIREPLACE, AND CLEAR BUILD LINE TO THE LEFT; VIEWED FROM THE SOUTH-SOUTH-WEST (SCALE 2M).

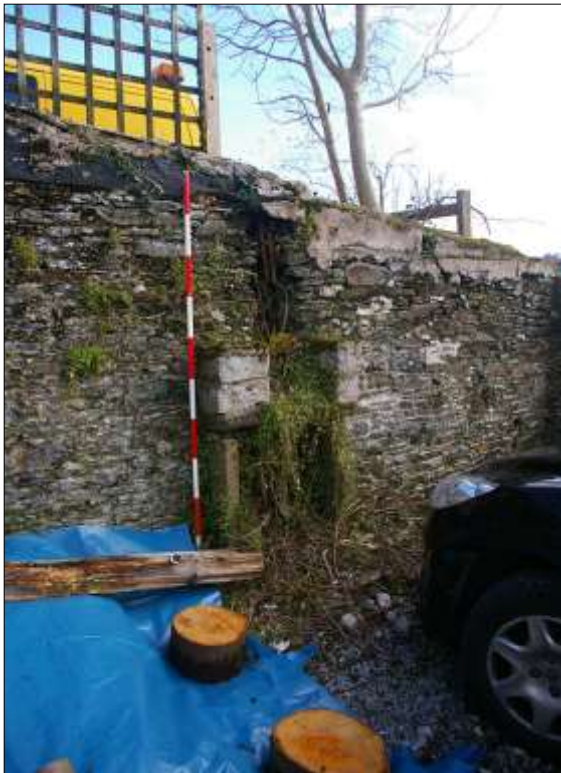
14. (LEFT) THE LOWER SITE; VIEW OF THE TERRACOTTA PIPE USED AS A FLUE SERVING A SMALL GRATE OR COPPER, CUT INTO THE NORTH-EAST WALL; VIEWED FROM THE WEST (SCALE 2M).

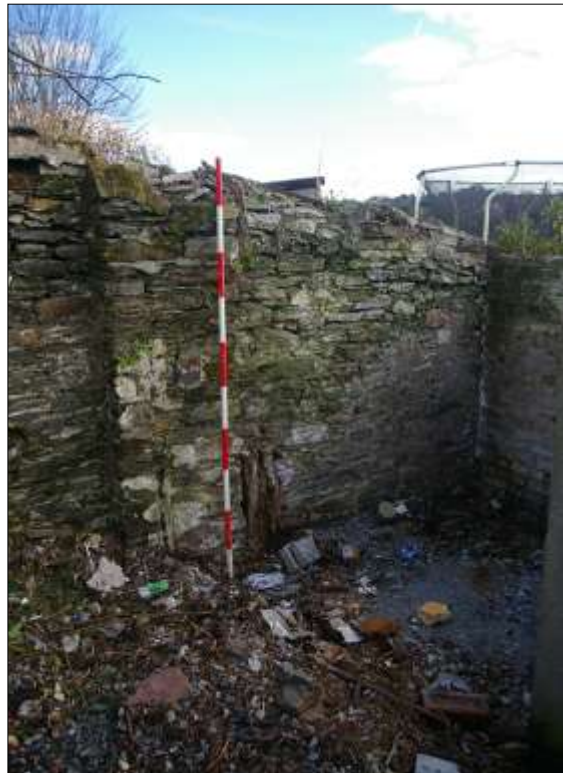
The long north-east wall is a slate rubble garden wall with some shallow buttresses. It runs from the plinth down to the houses along Ford Street and is obviously associated with the 19th century growth of the southern part of that street. This wall has two interesting details: the lower 1.25-1.50m is of a denser darker slate and may be slightly earlier than the looser top at the west end; perhaps when the outbuilding was built up against it the wall needed to be raised. It also has two flues forced in: one to the west has terracotta bricks and blocks infilling, with a round terracotta flue in the wall, the stonework hacked and patched. This flue serves a small fireplace with stone-built sides and a cast-iron barred grate; a short section of brick chimney sits on the width of the wall. To the east there is another flue. This is wider and also of brick but with some concrete and cement. It has an open fire braced by two recycled pieces of grey-green sandstone slab with an iron bar for a lintel, under a series of stacked granite blocks in cement mortar, which may have braced a copper. There is a raised flue, again of rounded terracotta pipe, which serves this. To the east side the stone boundary wall is abutted by two brick walls at right angles, forming a sub-square space. It has a blocked door in its south wall with a narrow timber lintel and is built of a

15. (RIGHT) THE LOWER SITE; DETAIL OF THE EAST END OF THE NORTH-EAST WALL; VIEWED FROM THE WEST-NORTH-WEST (SCALE 2M).

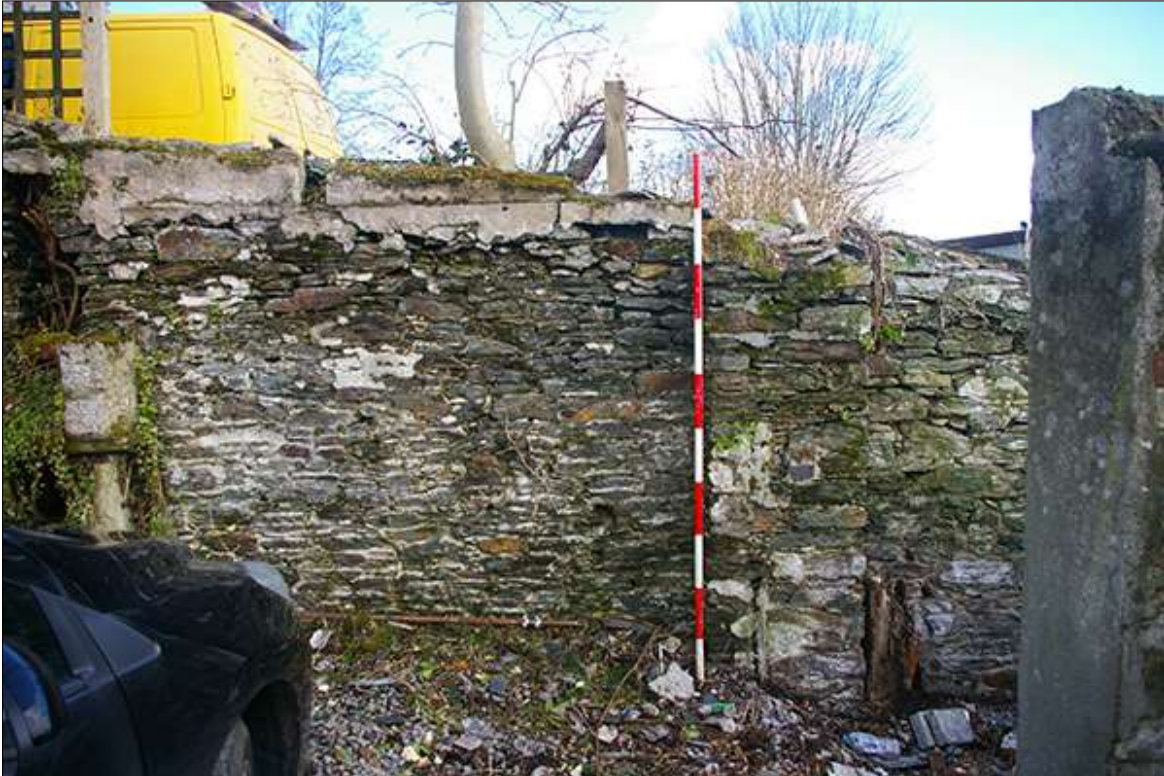
16. THE LOWER SITE; SHALLOW BUTTRESS TO THE EAST OF THE NORTH-EAST WALL, WITH 2M SCALE; FROM THE SOUTH-WEST.

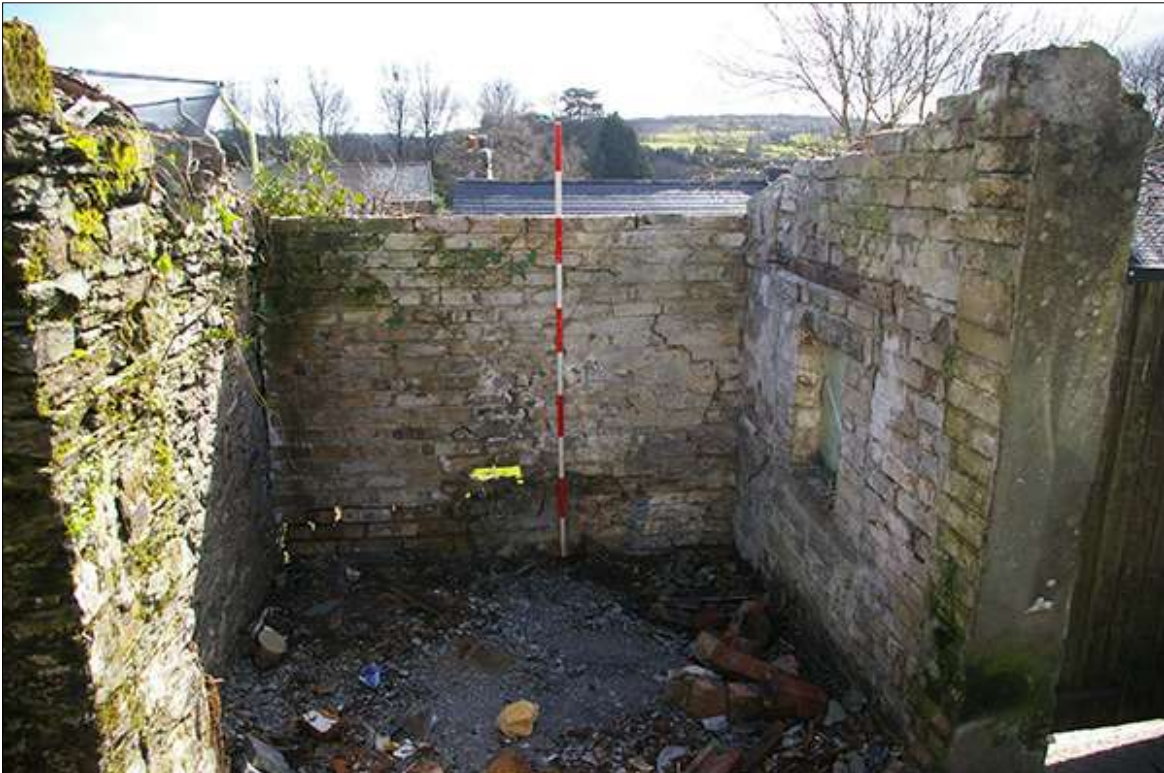
mix of English garden wall bond and irregular brick bonds; this may be a former outside privy. The eastern part of the site is bounded by an open timber post and rail fence.

17. THE SMALL SUB-SQUARE BUILDING, FORMED FROM TWO BRICK WALLS ABUTTING THE EARLIER STONE RUBBLE BUILDING, WITH 2M SCALE; FROM THE NORTH-WEST.

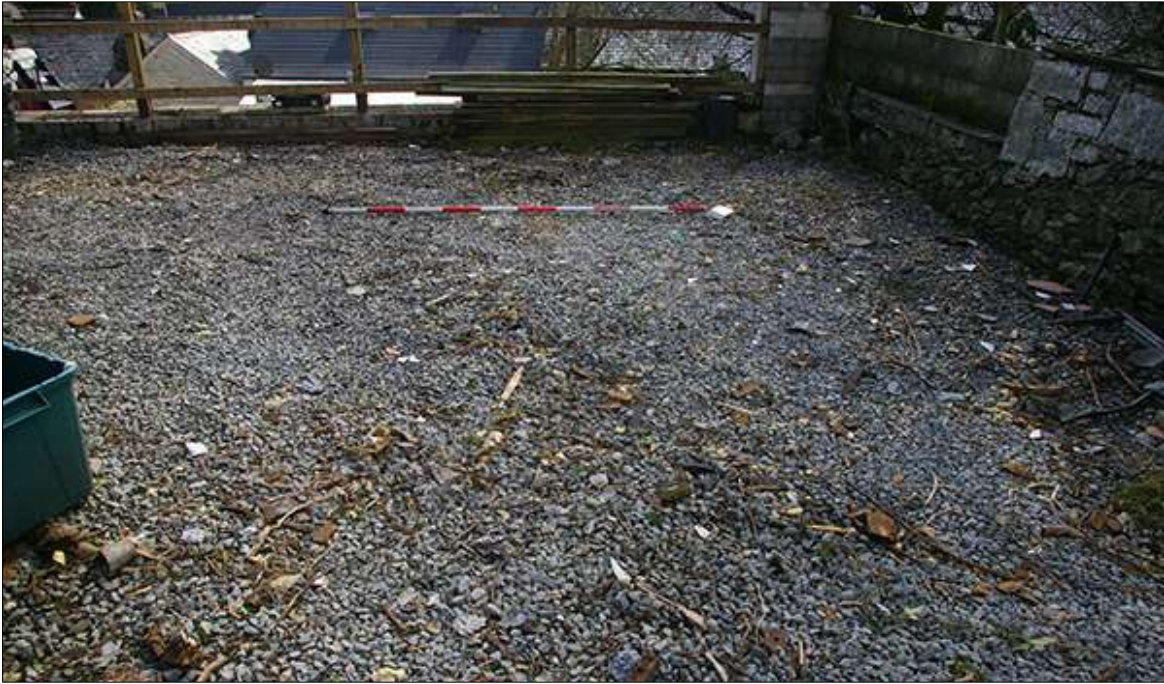
18. THE GROUND SURFACE OF THE SITE, AT PRESENT IS BUILT UP WITH SOIL AND GRANITE GRAVEL, WITH 2M SCALE; FROM THE WEST NORTH WEST

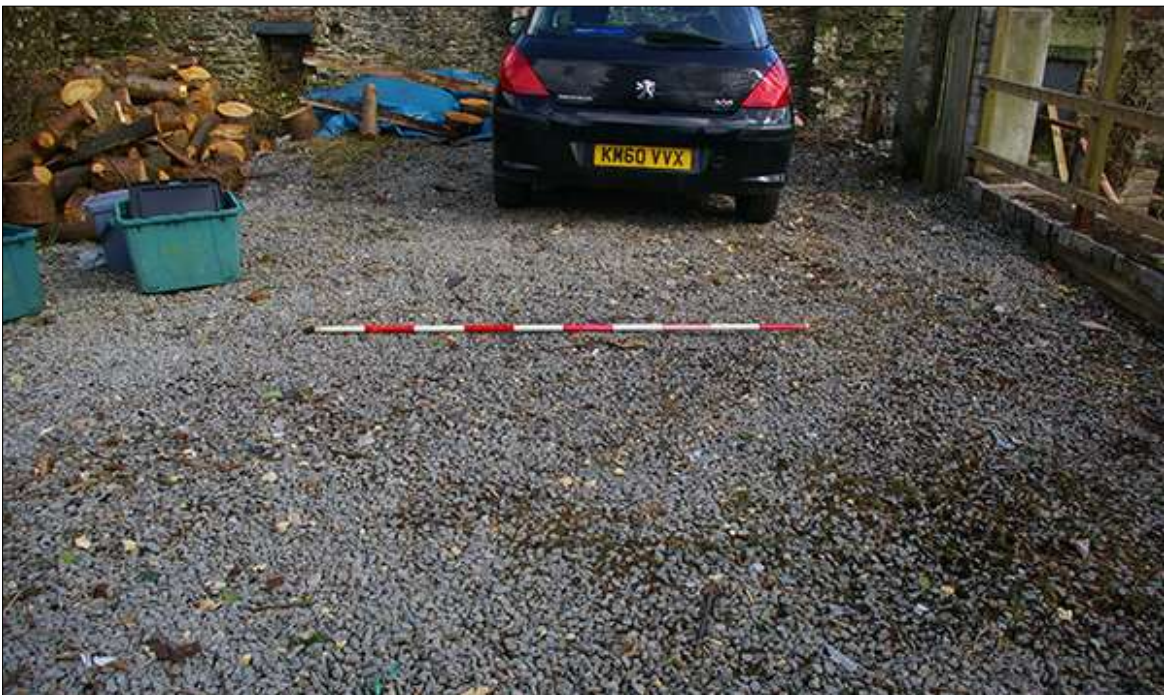
As noted, the footprint of the site has been levelled. The gravel surface may conceal a cobbled floor, but if so, it was not observed.

19. THE GROUND SURFACE OF THE SITE, AT PRESENT IS BUILT UP WITH SOIL AND GRANITE GRAVEL, WITH 2M SCALE; FROM THE SOUTH-WEST.

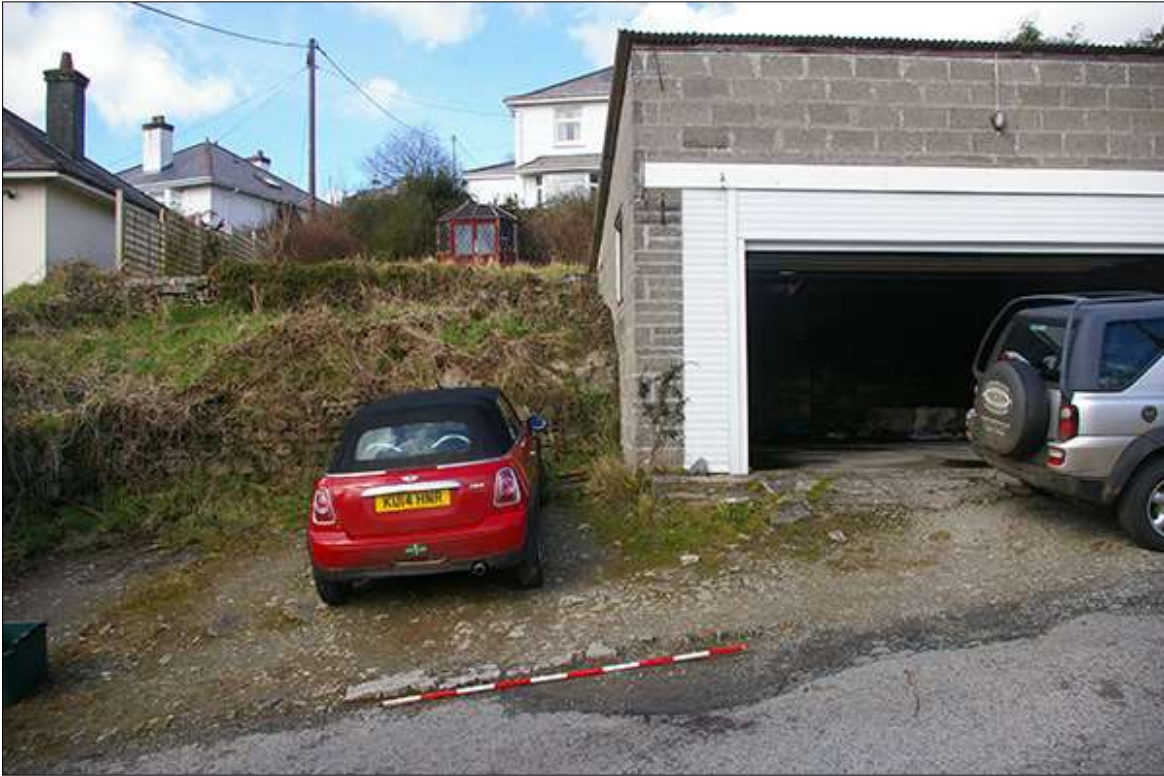
20. THE PLOT ACROSS THE ROAD, WITH RAISED KERB OF SLATE COBBLED AND SOME GRANITE AND SLATESTONE RUBBLE WALLING, INDICATING THERE MAY HAVE BEEN ANOTHER WALL ENCLOSING THAT SITE (POSSIBLY THE WORKHOUSE GARDEN WALL) OR ANOTHER BUILDING AT SOME POINT, WITH 2M SCALE; FROM THE SOUTH-EAST.

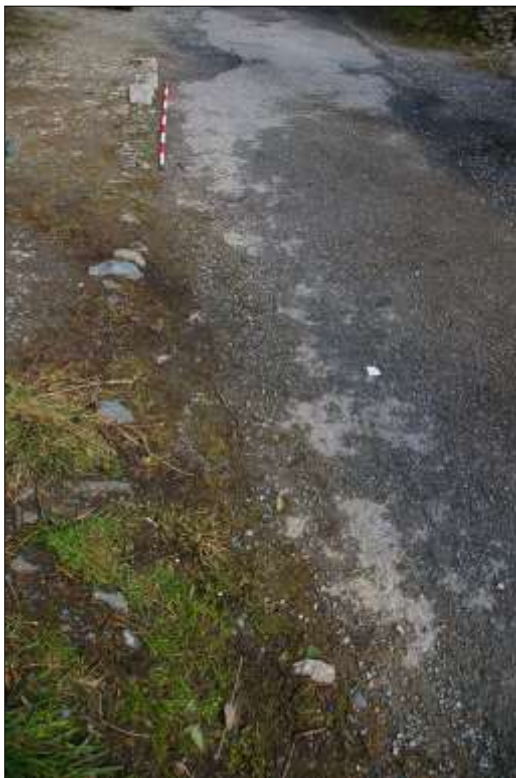
21. THE RAISED EDGE ALONGSIDE THE ROAD, INDICATIVE OF A POSSIBLE FORMER WALL HERE, WITH 2M SCALE; FROM THE SOUTH-WEST.

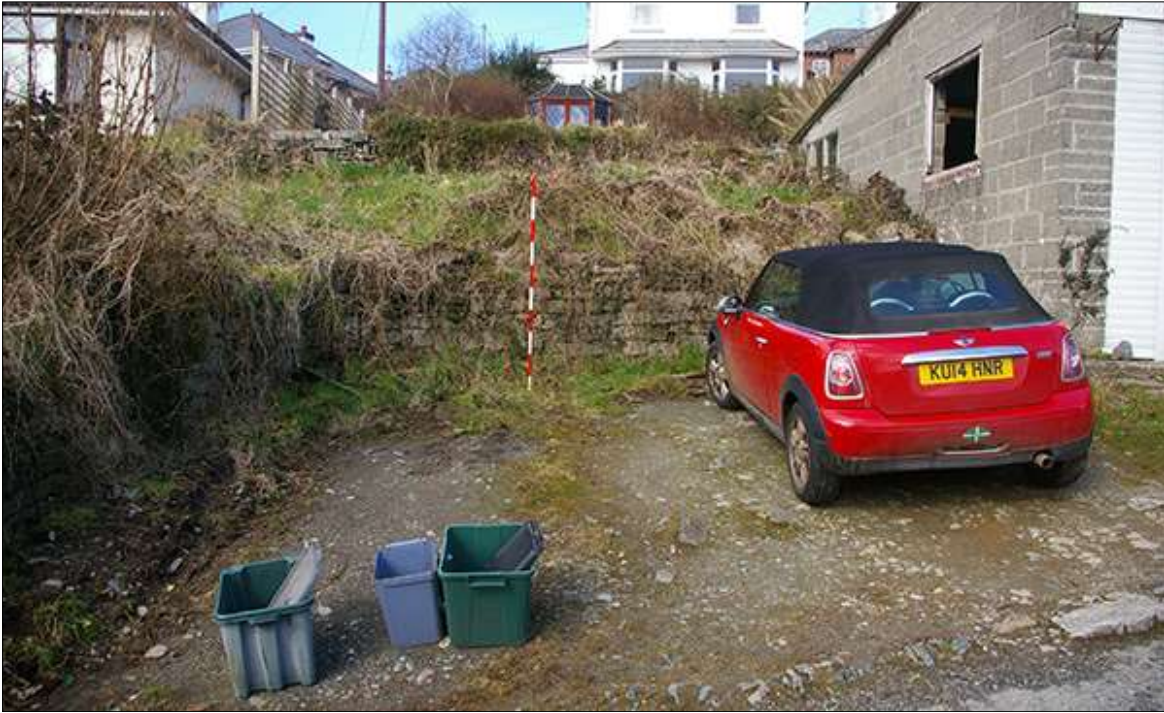
22. THE STEEP TERRACING WHICH CUTS INTO THE SLOPE OF THE HILLSIDE, OF 19TH AND 20TH CENTURY DATE. MUCH OF THIS AREA TO THE WEST WAS DEVELOPED IN THE 1920S AND 1930S BUILDING SPACIOUS CHALET BUNGALOW STYLE HOUSES; FROM THE EAST, NORTH-EAST.

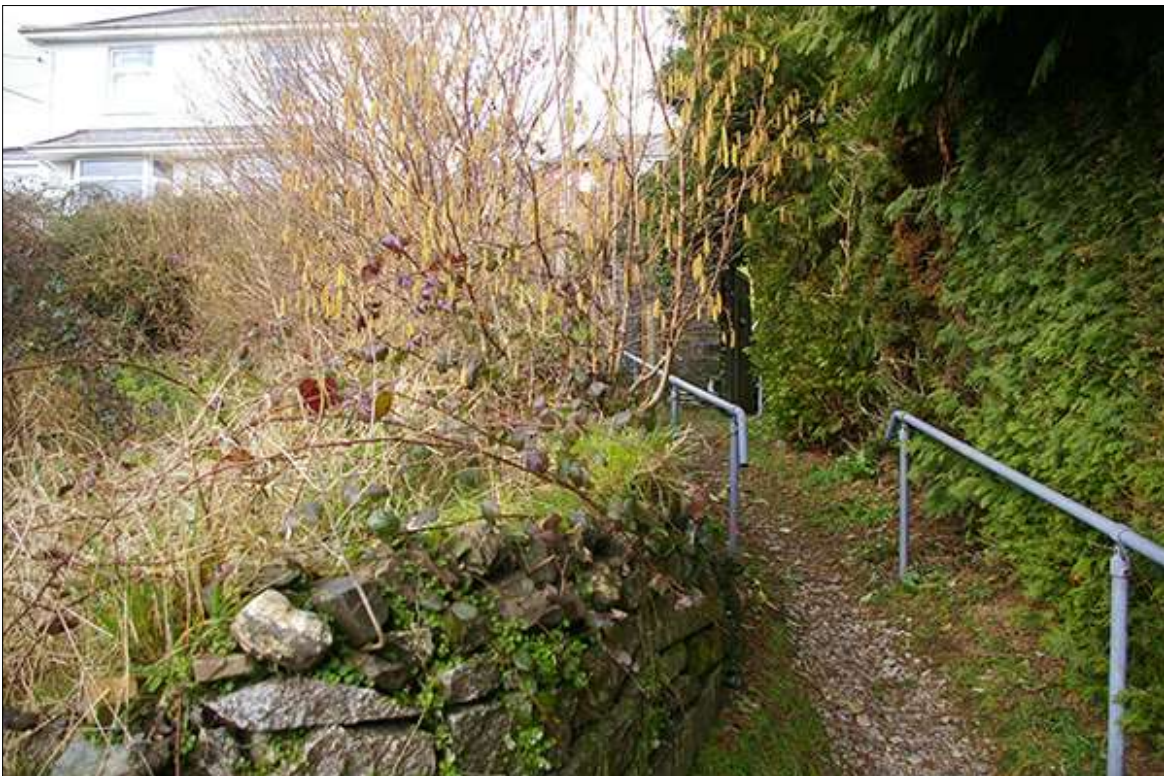
23. THE TOP PLOT, WITH LESS TERRACING AND ACCESS PATH ALONGSIDE THE CONCRETE GARAGE.

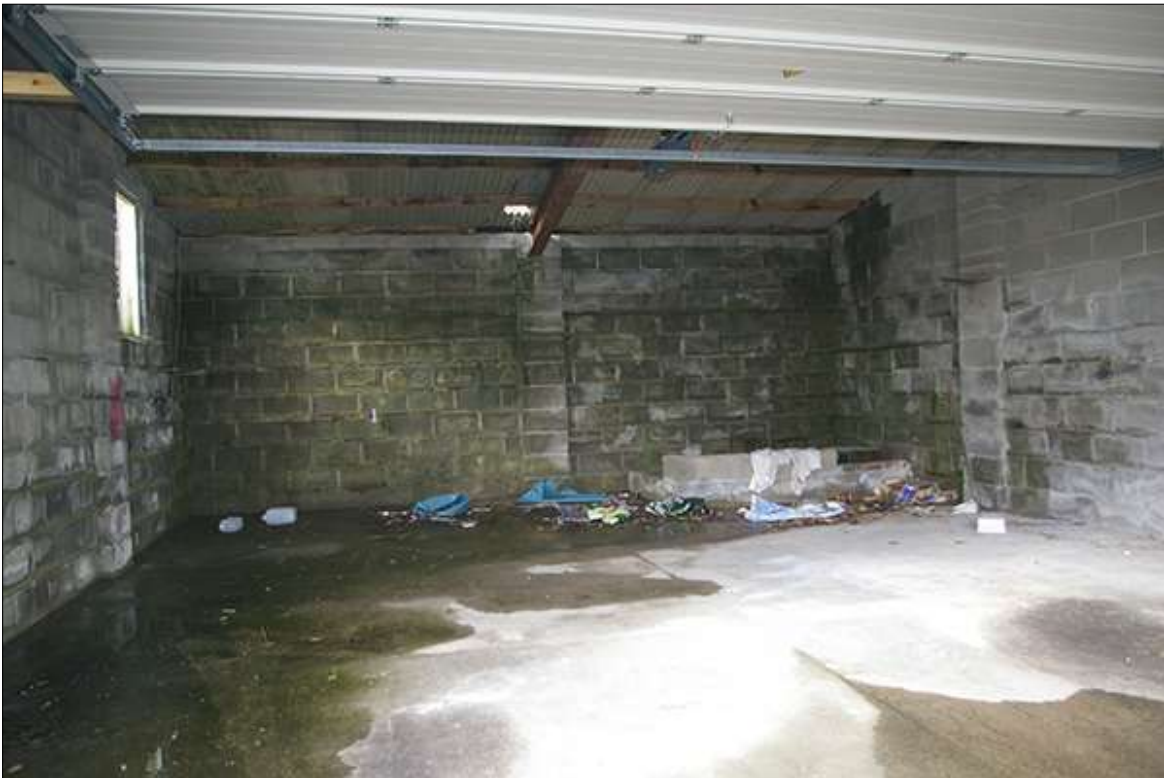
27. THE CONCRETE GARAGE BUILDING DUE TO BE DEMOLISHED ON THE SECOND PLOT; FROM THE EAST.

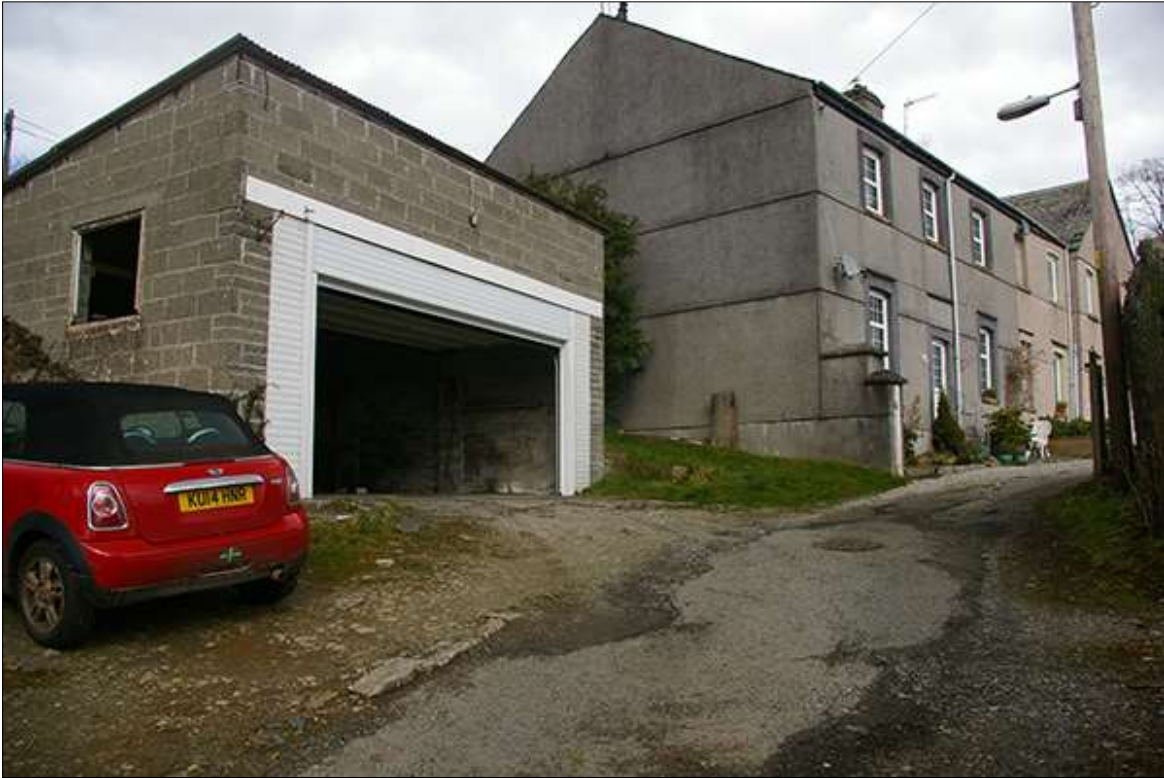
28. THE CONCRETE GARAGE BUILDING DUE TO BE DEMOLISHED ON THE SECOND PLOT; FROM SOUTH, SOUTH-WEST.

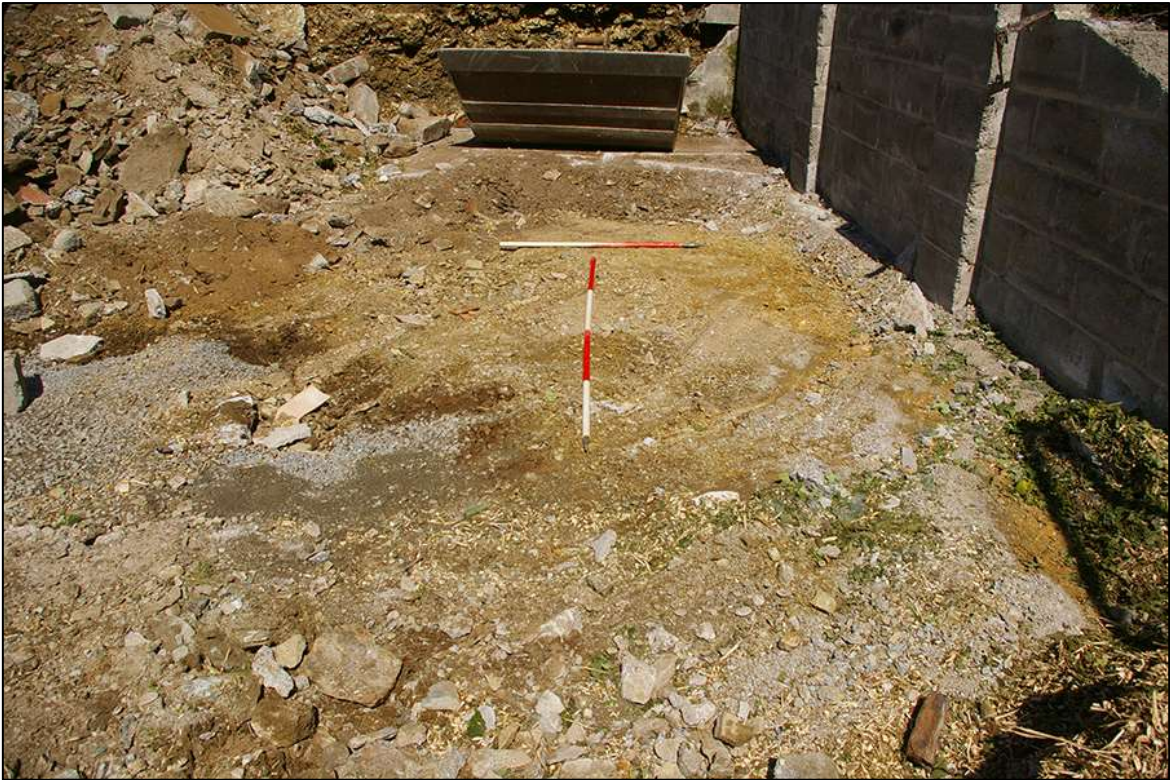
30. AREA 01, SOUTH-EAST END POST-EXCAVATION; VIEWED FROM THE SOUTH-EAST (1M & 2M SCALES).

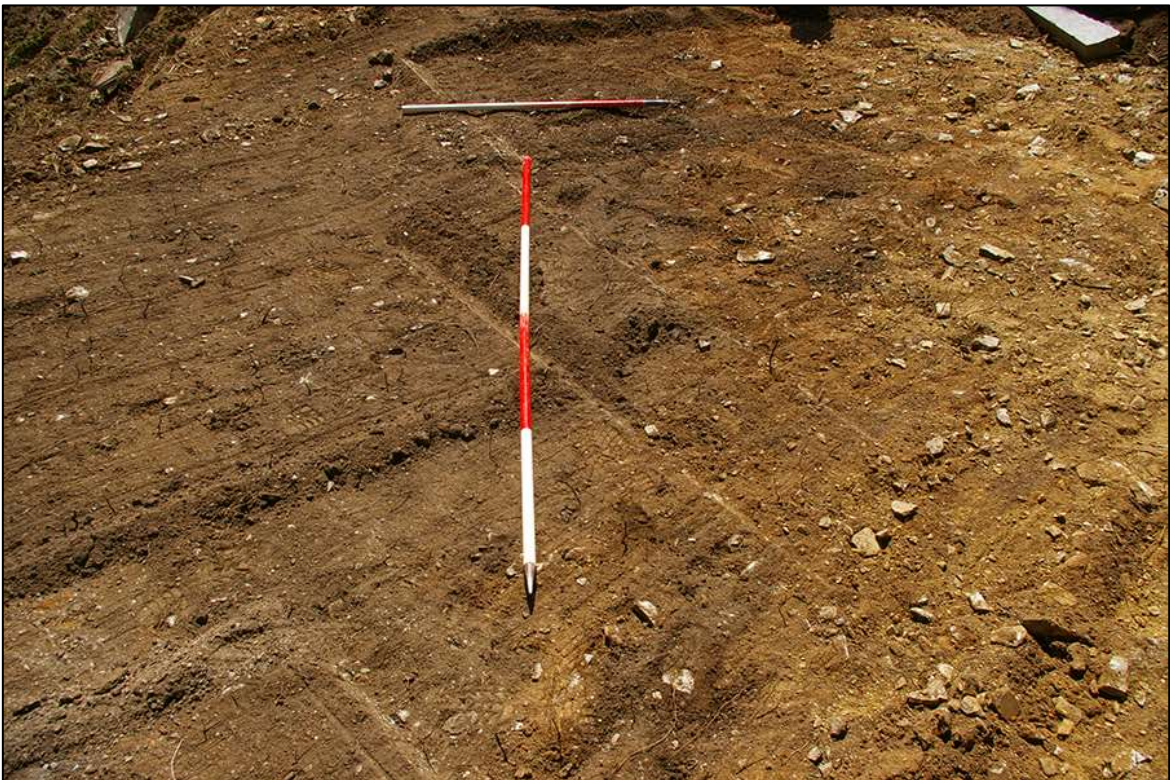
31. MODERN DISTURBANCE FEATURE [106]; VIEWED FROM THE NORTH-EAST (1M & 2M SCALES).
