LAND OFF MAUDLINS LANE TAVISTOCK WEST DEVON DEVON

Historic Building Recording and Archaeological Monitoring and Recording

South West Archaeology Ltd. report no. 200603

By E. Wapshott, F. Balmond, & P. Webb
Report Version FINAL
3rd June 2020

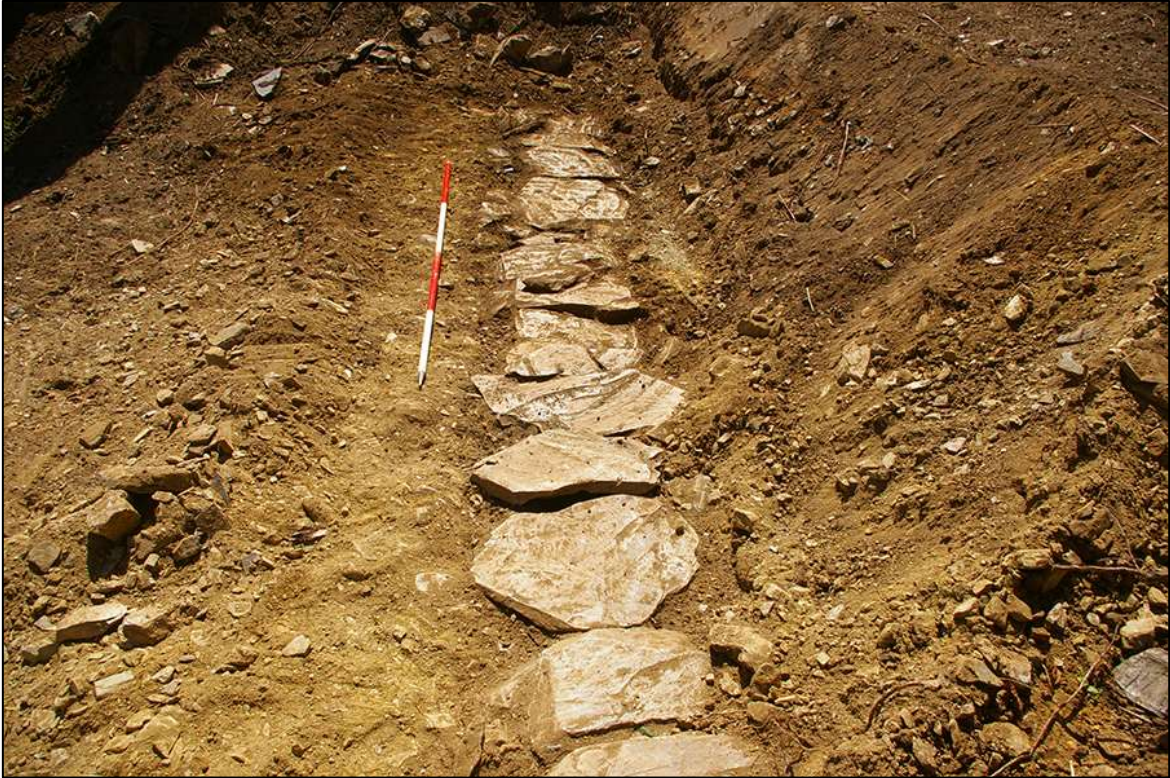
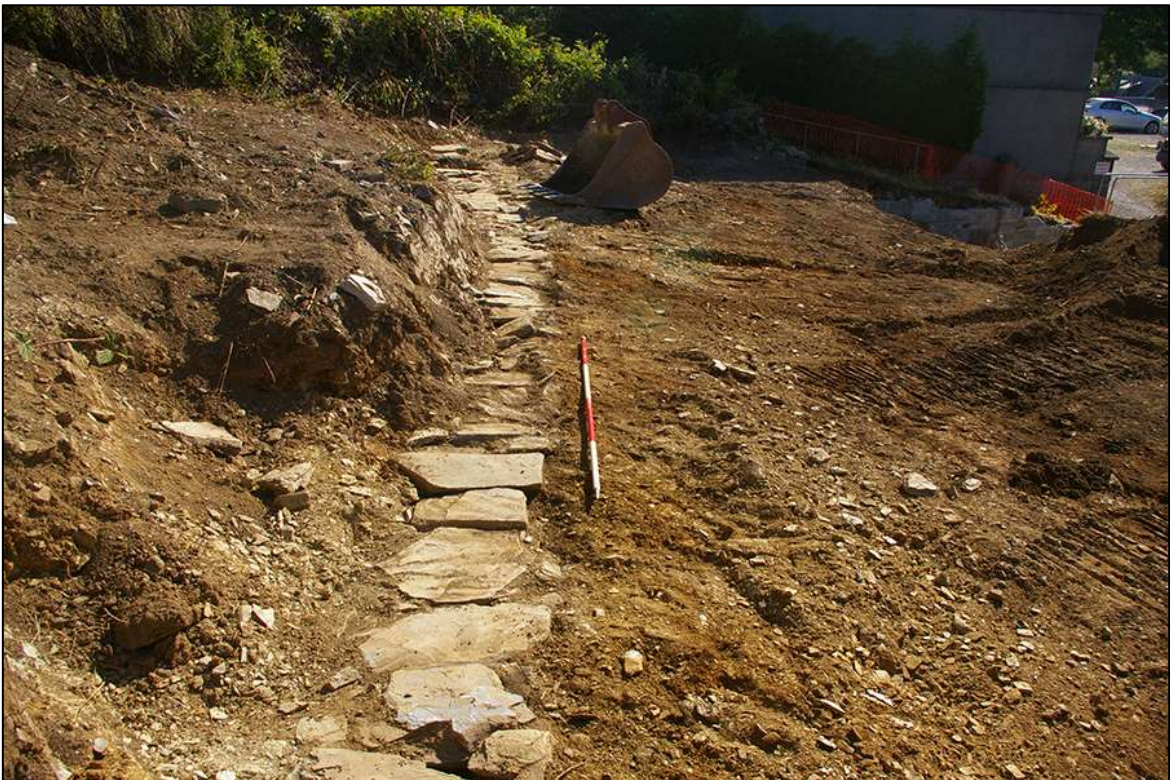
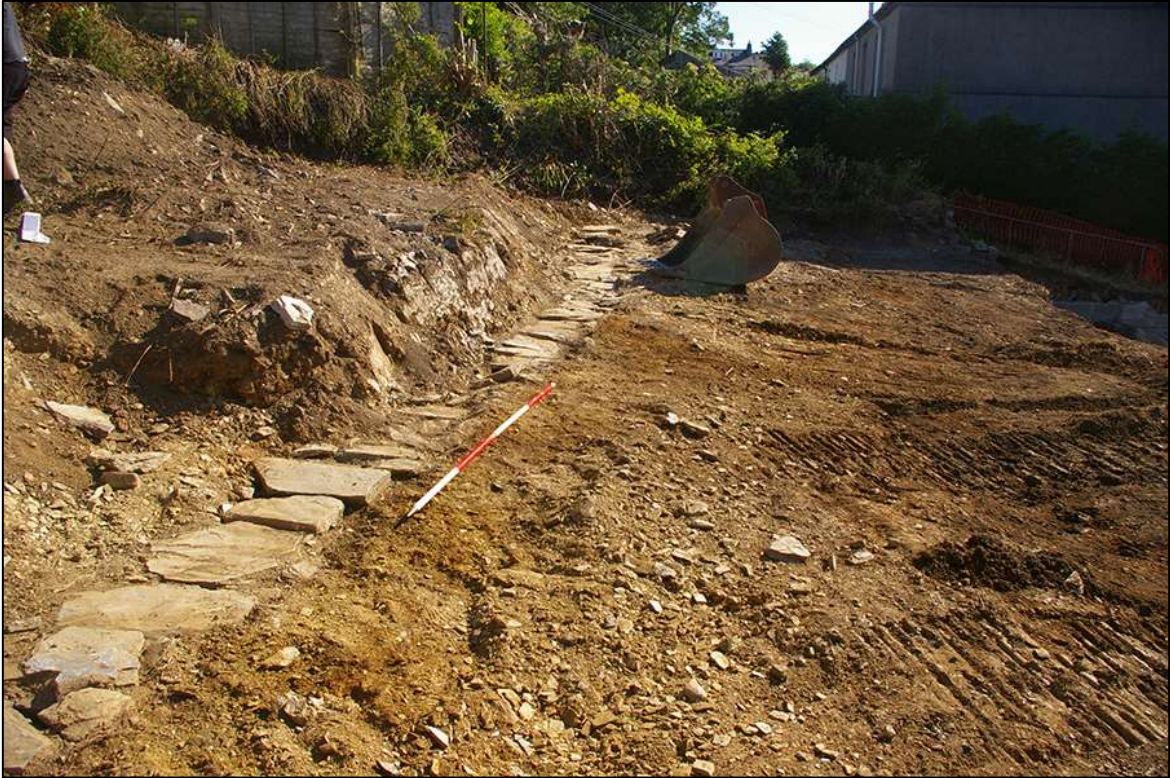
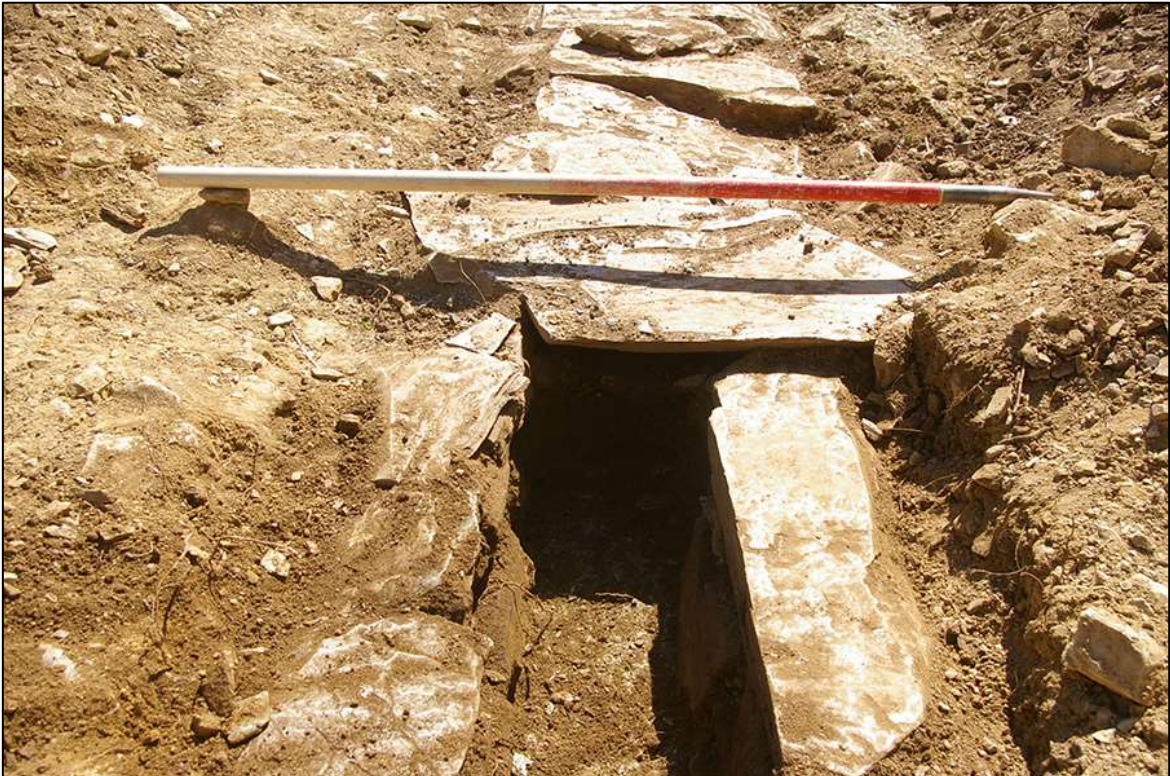
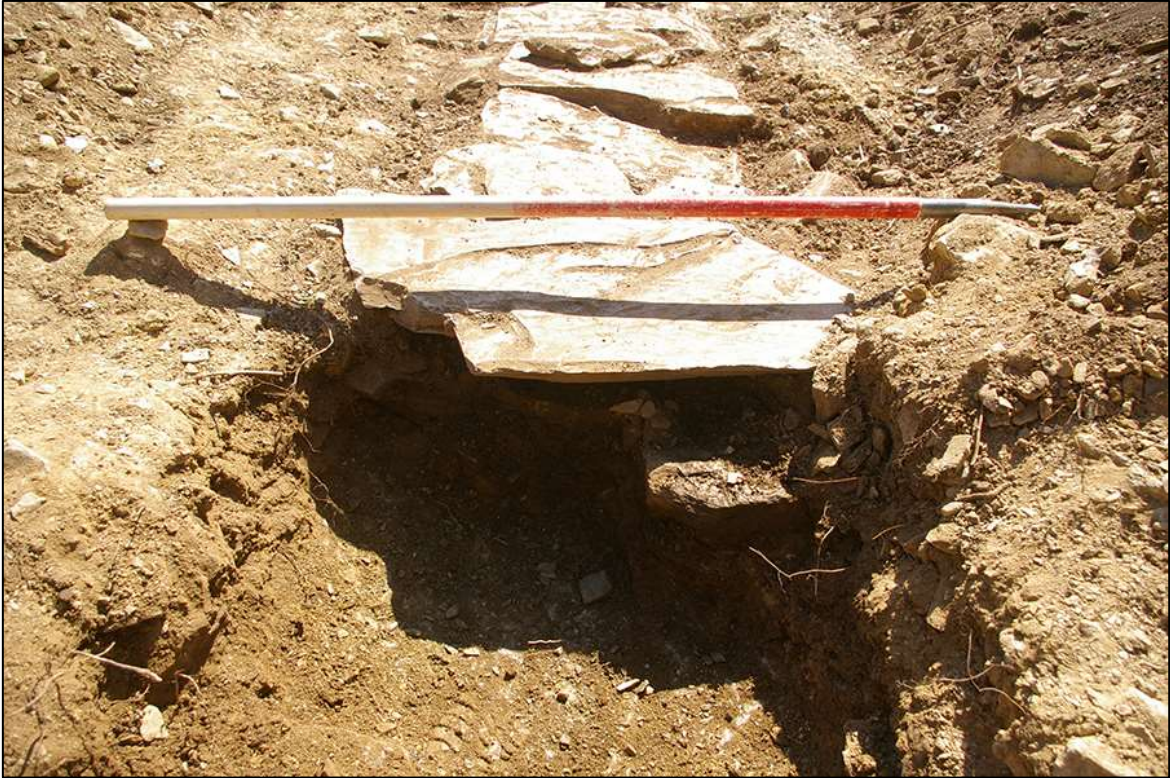
A single drain [108] was located along the north-western edge of the site. It was slightly sinuous in plan on an approximate north-east to south-west alignment, running the full width of the site. It was identified for a length of 15m, measuring 0.80m wide and 0.28m deep with vertical sides and flat base. It was of stone-built construction {109}, with angular stone blocks forming the sides and large slatestone capping; and the cut had been backfilled with (110), mid yellow-brown to brown friable silt. The drain had been infilled with (111), mid-dark brown friable clay silt with patches of firm dark brown clay.

32. DRAIN [108], NORTH-EAST END; VIEWED FROM THE NORTH-EAST (2M SCALE).

33. DRAIN [108], POST-EXCAVATION; VIEWED FROM THE SOUTH-WEST (2M SCALE).

34. DRAIN [108], POST-EXCAVATION; VIEWED FROM THE SOUTH-SOUTH-WEST (2M SCALE).

35. DRAIN [108], NORTH-EAST FACING SECTION (WITH SIDES *IN SITU*); VIEWED FROM THE NORTH-EAST (1M SCALE).

36. DRAIN [108], NORTH-EAST FACING SECTION; VIEWED FROM THE NORTH-EAST (M SCALE).

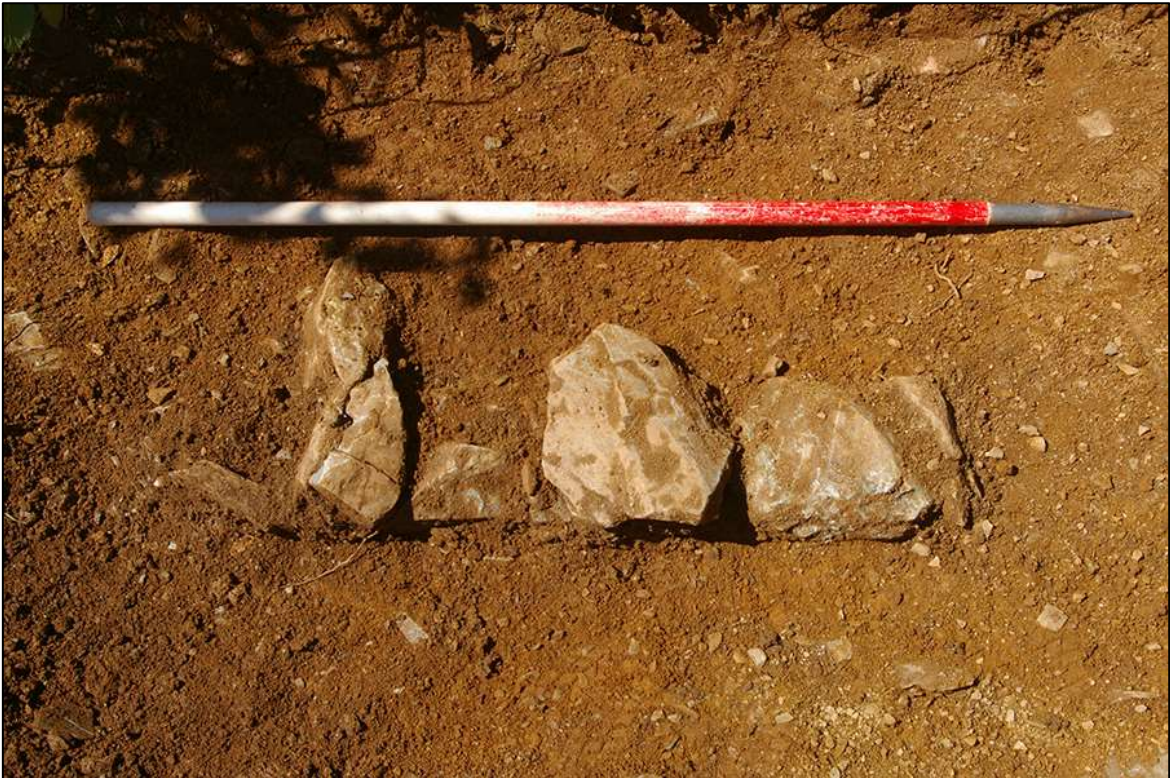
A single short section of stone wall footing {114} was identified towards the western corner of the site. It survived for a length of 1.10m, measuring 0.30m thick and up to a height of 0.10m (a single 'course') on an approximate north-west to south-east alignment. The wall was set within a construction cut [113], up to 0.05m deep with steep to vertical sides and flat base; the remains being backfilled over with (115), mid-dark brown soft-friable silt-clay.

37. WALL SECTION {114}; VIEWED FROM THE NORTH-EAST (1M SCALE).

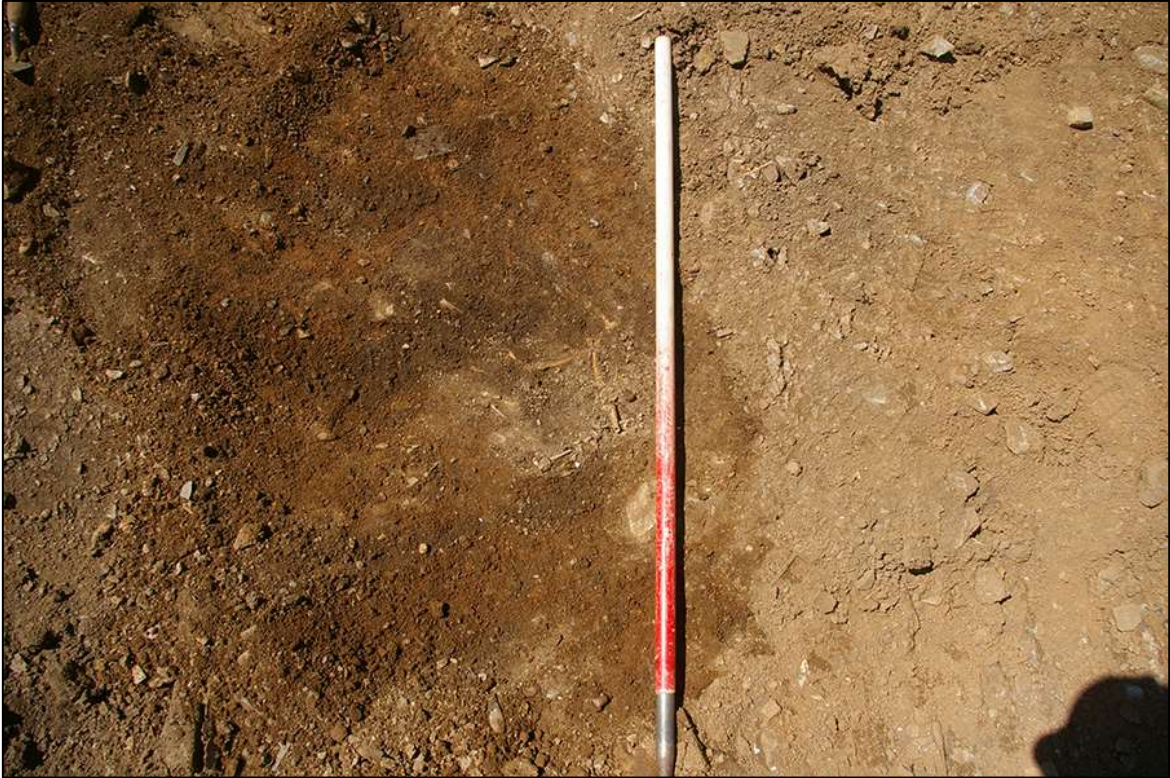
A single animal grave [116] was identified towards the centre of the site. It was sub-circular in plan, measuring 0.40m in diameter and 0.05m deep with steep sloping side and undulating but broadly flat base. It contained a single fill: (117), dark brown friable silt with the largely articulated remains of a small animal, probably a cat.

38. GRAVE [116], PRE-EXCAVATION; VIEWED FROM THE NORTH-EAST (1M SCALE).

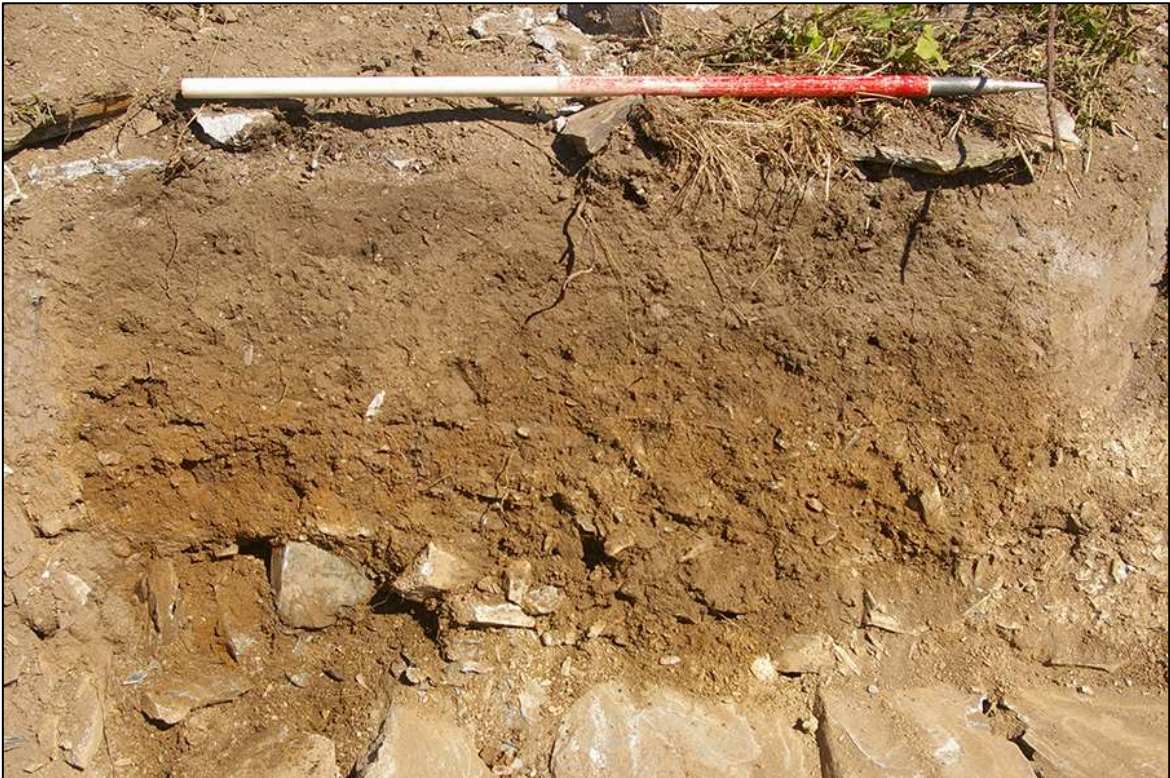
39. AREA 01, SOUTH-EAST FACING SECTION OVER DRAIN [108]; VIEWED FROM THE SOUTH-EAST (1M SCALE).

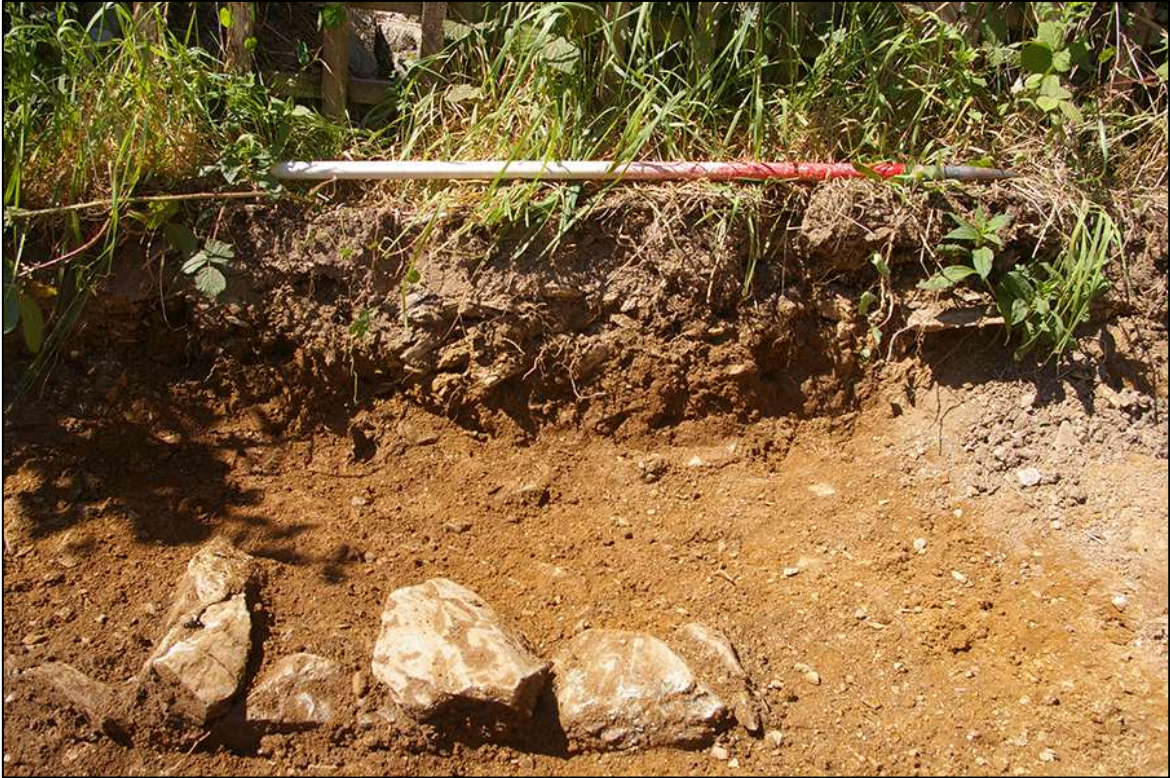
40. AREA 01, NORTH-EAST FACING SECTION; VIEWED FROM THE NORTH-EAST (1M SCALE).

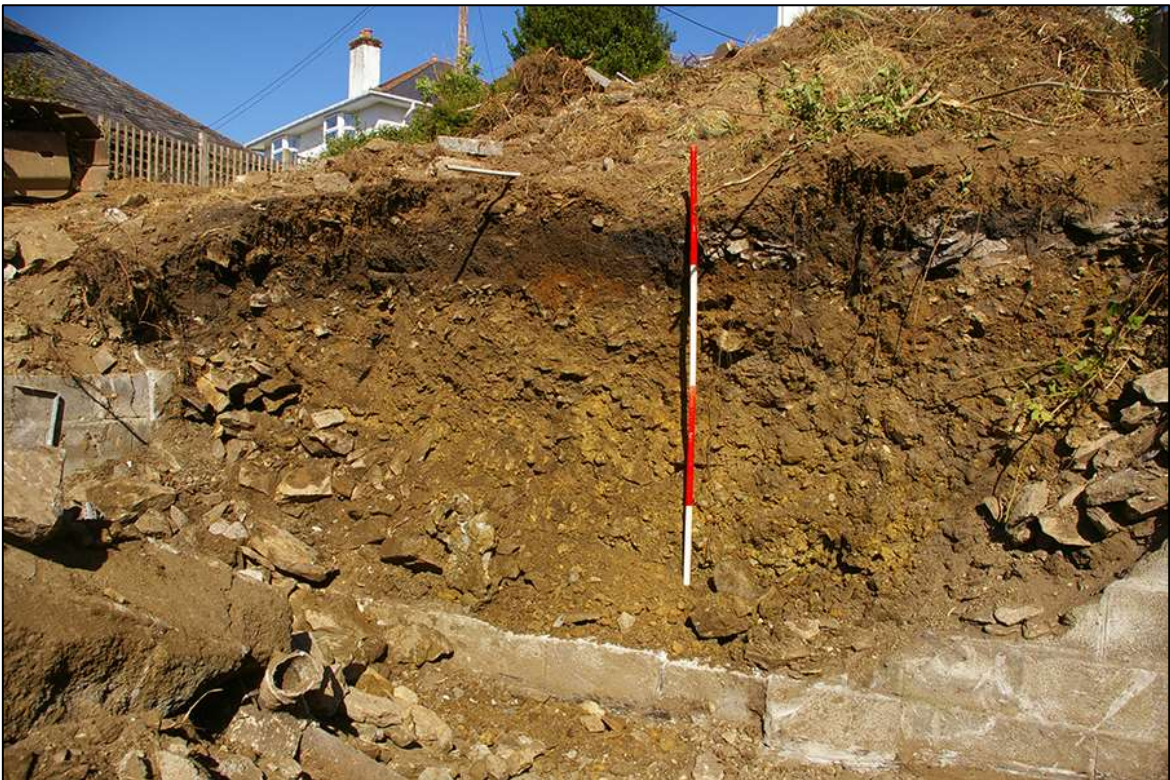
The excavation of Area 01 identified that the south-eastern half of the site had been heavily disturbed through episodes of construction and terracing. The 20th century garage was set within a square terrace cut [118], measuring 8m × 8m and up to 2.20m deep with vertical sides and flat base. The garage had been constructed of concrete block walls {119} 0.15m thick, with concrete floor surface (120) overlying a rubble/stone bedding layer (121). Behind the garage, the terrace cut had been backfilled with (122), large angular and sub-angular stone.

41. AREA 01, SOUTH-EAST FACING SECTION BEHIND GARAGE {119}; VIEWED FROM THE EAST-SOUTH-EAST (2M SCALE).
