BUDE CAMPING AND CARAVANNING CLUB

Results of a Geophysical Survey

Bude Camping and Caravanning Club, St Genny's, Bude, Cornwall

Results of a Desk-Based Assessment, Walkover Survey & Geophysical Survey

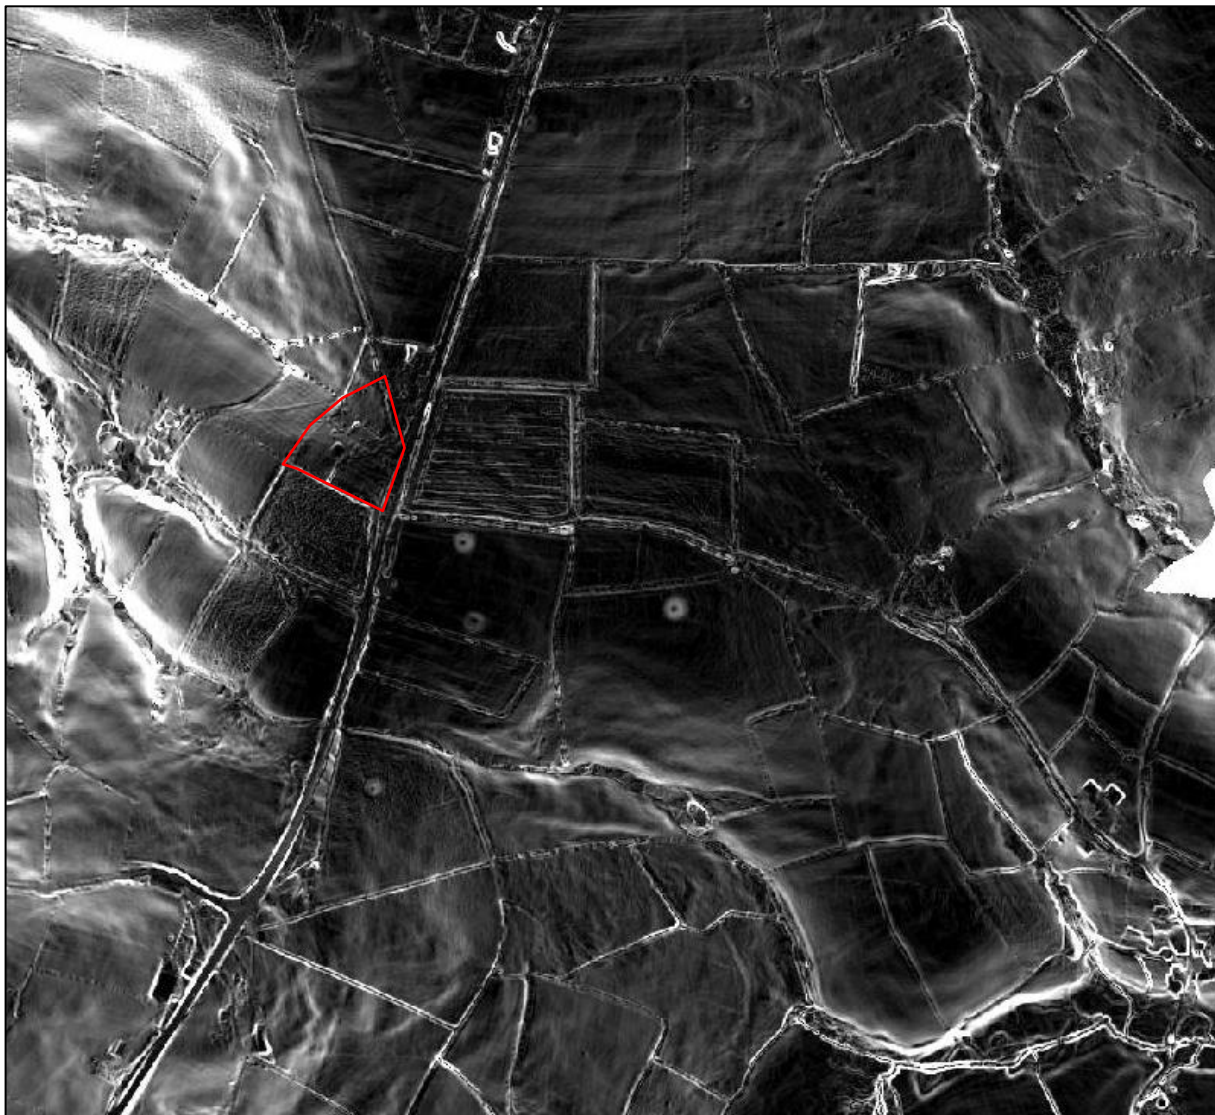
FIGURE 11: TOPOGRAPHICAL IMAGE BASED ON LIDAR DATA. THIS IS A QGIS-GENERATED IMAGE (TERRAIN ANALYSIS>SLOPE) OF TELLUS LIDAR SURVEY DATA [CONTAINS FREELY AVAILABLE LIDAR DATA SUPPLIED BY NATURAL ENVIRONMENT RESEARCH COUNCIL (CENTRE FOR ECOLOGY & HYDROLOGY; BRITISH ANTARCTIC SURVEY; BRITISH GEOLOGICAL SURVEY), ©NERC.
