FORMER BUTLER, TANNER & DENNIS PRINTWORKS

HISTORIC BUILDING RECORDING

FORMER BUTLER, TANNER & DENNIS PRINTWORKS,
CAXTON ROAD, FROME, SOMERSET
HISTORIC BUILDING RECORDING

Work undertaken by SWARCH for Acorn Property Group

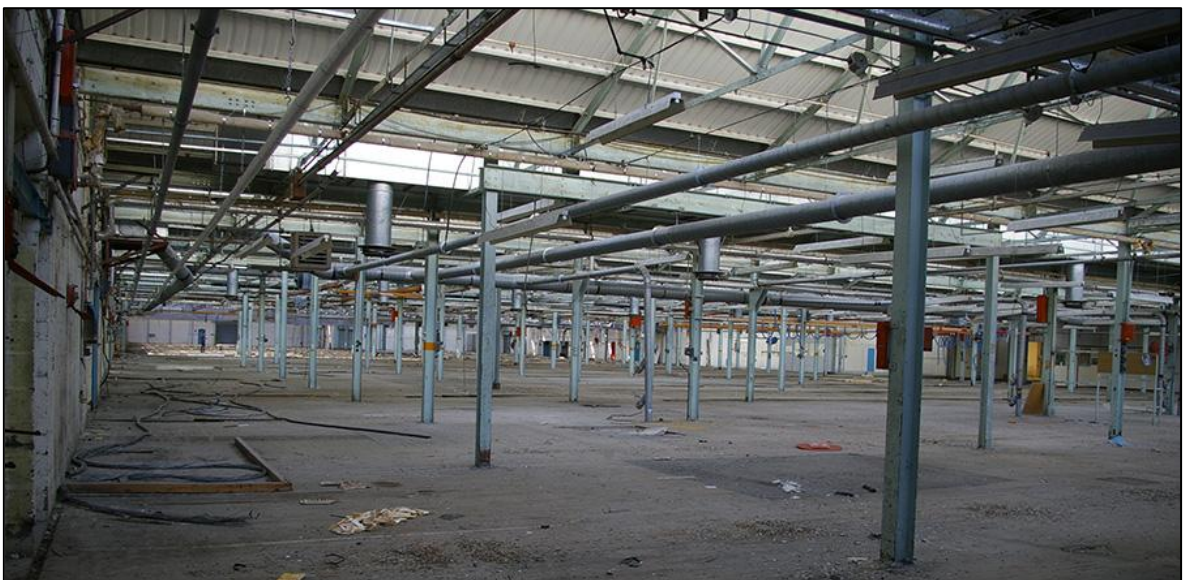
This is a large, tall one and a half storey early 20th century wrought-iron girder framed and riveted structure of 20 bays, with an open-plan factory floor. Built in stone rubble, with concrete copings, with a metal framed saw tooth part glazed roof, the south-east elevation is partially clad in stone composite tiles. The rubble walls are exposed to the north-west face, but clad in a later stone composite tile to the rear, a later alteration. It has brick detailing to the elevations, such as segmental round brick air vents and rounded bullnose bricks to door reveals. Terraced into the slope, this has concrete retaining walls to the rear, later additions. A good pair of wrought iron staircases, with fretwork treads and coiled handrail give access to a former lower rear yard. All doors and fittings have been refitted and updated. The wood block floor of the printing works has survived, complete with markings indicating the position of machinery and some functions of areas. There are some heavy duty pine plank boarded and framed sliding doors and opening doors, with chamfered edges and good iron thumb latches throughout the complex, all of which are reset but may have been re-sited from an earlier slightly more vernacular phase.

FIGURE 2: INTERIOR OF MAIN FACTORY (BUILDING 1); VIEWED FROM THE NORTH-EAST.

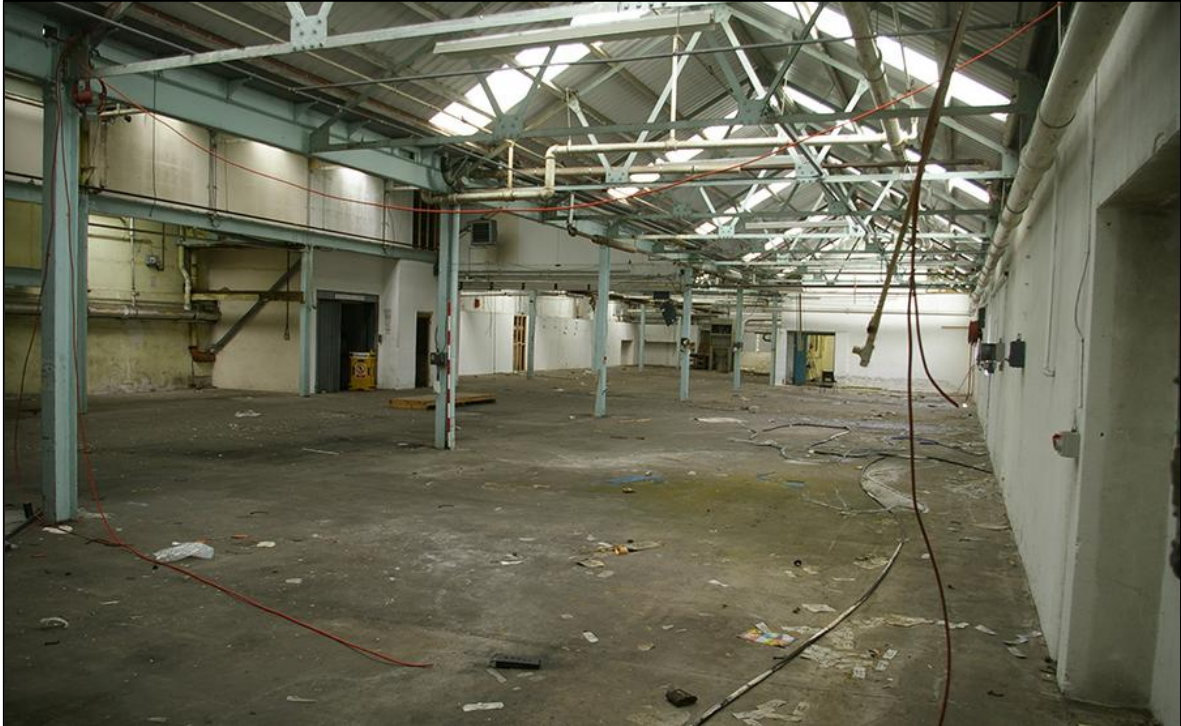
Rear Yard infill behind main Factory building with metal portal-frame, braced off the walls of existing brick and concrete block sheds; essentially a roof spanning over a yard between defined buildings. The structure can clearly be seen to be inserted between the high rear factory wall and earlier brick shed, particularly where it has required the truncation of the west corner of the earlier brick building.

FIGURE 3: INTERIOR OF INFILL BEHIND MAIN FACTORY (BUILDING 1A); VIEWED FROM THE SOUTH.

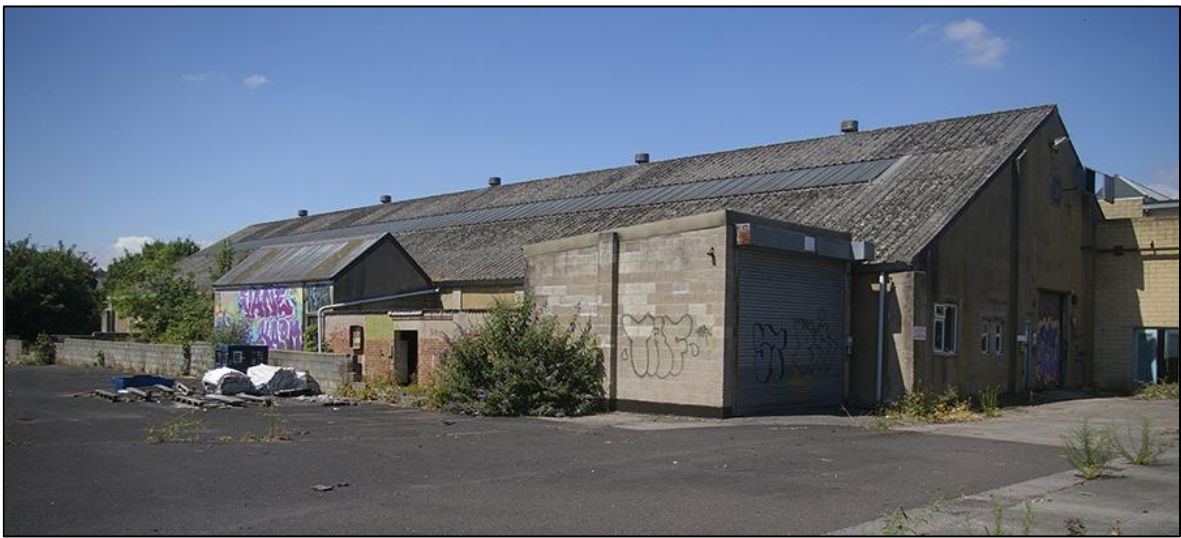
An expansive un-partitioned shed, built of an early style of 'modern' grey concrete block, set in cement. Partially rendered and painted to the interior, it has a massive metal span shallow pitched roof, of riveted strut braced roof trusses. These carry a corrugated asbestos roof with two long strips of inset glazing set high on each pitch. It has a poured concrete solid floor. It contains some original piping and ducting to the north corner, associated with air venting or air conditioning, no fittings survive, a modern roller door is inserted into the north-east elevation, a narrow plain timber door is in the south-west elevation. The building was abutted by later concrete lean-tos and sheds to south side, as well as an enclosed oil tank and possible heating system with a small brick external chimney.

FIGURE 4: EXTERIOR OF BAY 10 (BUILDING 4); VIEWED FROM THE EAST.

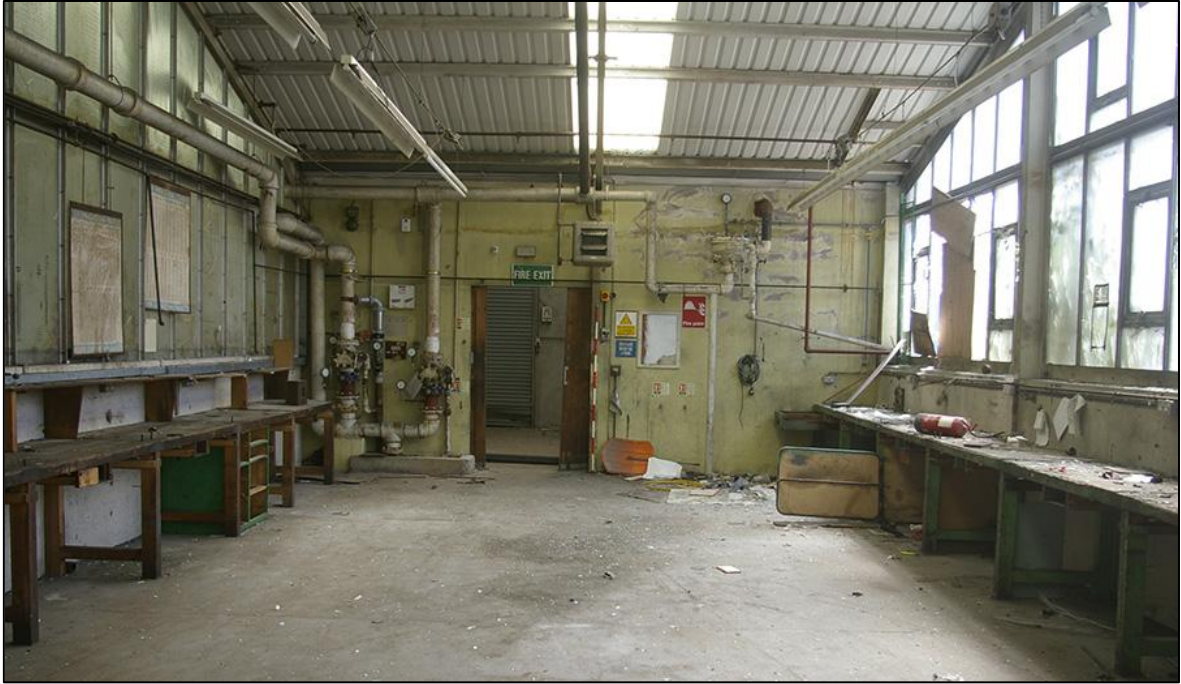
A cinder block and riveted iron girder framed shed with three compartments, two parallel workshops and one end service shed or similar with old fashioned iron sheet sliding doors on rollers. Half height rendered and painted cinder block and concrete block walls with wired glass panels above and to the roof. It had a concrete poured floor. The roof covering had been replaced with relatively modern box-profile corrugated plastic sheeting. Timber free standing workbenches survived in the first workshop to the west, as did the heavy pipework for the air conditioning or cooling system and a ceramic sink. Concrete block walls formed a changing room and staff room to the north side, against the rear wall of the main factory. To the east the fittings have been stripped out but signage and tool racks remained. Heavy leather swing doors serve a short section of partitioned passage which links to the infilled rear yard behind the main factory: these doors have curved irregular and rounded glazed cutouts, of a 1960s psychedelic character.

FIGURE 5: INTERIOR OF WORKSHOP (BUILDING 5), SOUTH-WEST ROOM; VIEWED FROM THE NORTH-WEST (2M SCALE).

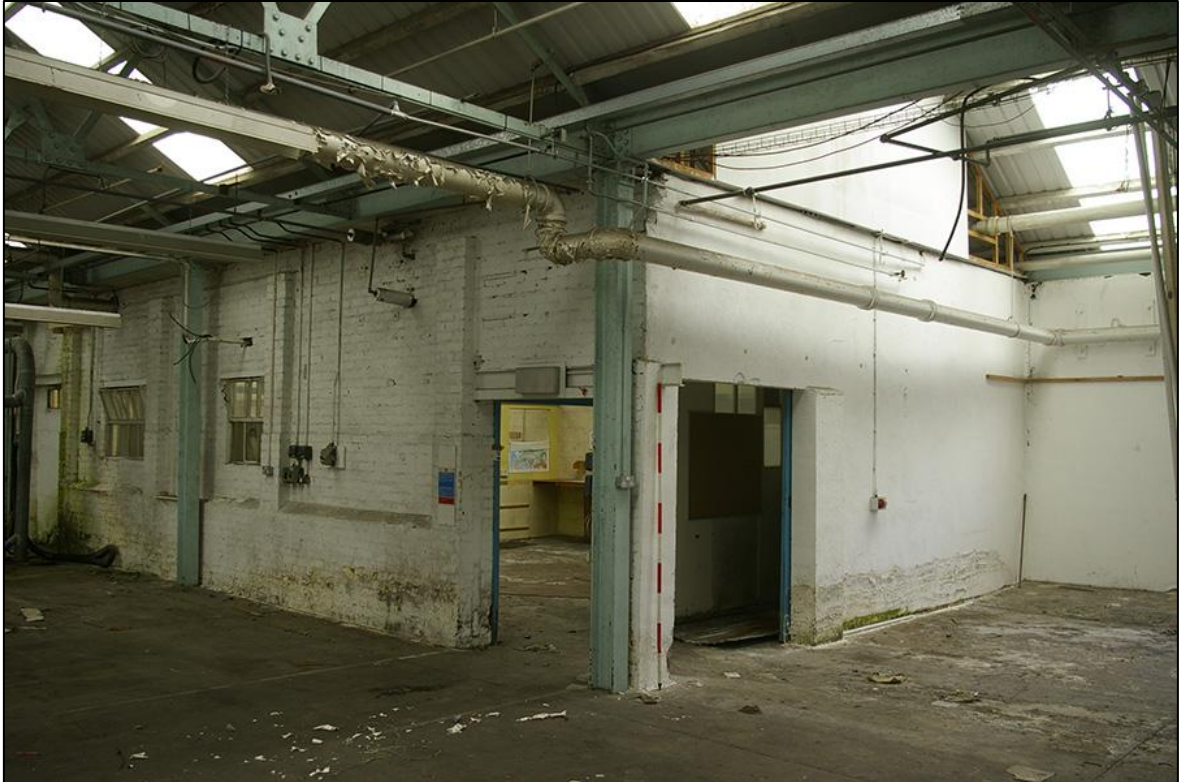
To the rear, south-east of the main factory building is a tall single storey brick shed. Its surviving north-west elevation wall was divided into five bays, with upright thicker piers between, intended to carry the original metal roof trusses, and a thick lower plinth along its length with single skim brick wall panels between. The interior is cement-rendered and the exterior painted. It had a cement floor and a replaced later portal framed roof, with three trusses. Metal crittal-style windows, survive in the north wall; three fixed panes with hopper casement above. It contained one good timber internal door, of four panes, the upper two glazed; and one good external door, to the north-west wall, north-east end, with plank boarding and framing, on heavy strap hinges and iron bolts, with chamfered details. The majority of the building is open-plan, with lightweight glazed half partitions to a cubicle in the east corner. A cinder block wall has been inserted to the north-east end, with a large brick round air vent set with a metal mesh covered propeller fan. Beyond this wall the space has been divided into a set of toilets and a storage room.

FIGURE 6: FORMER EXTERIOR OF BRICK SHED (BUILDING 7); VIEWED FROM THE WEST (2M SCALE).

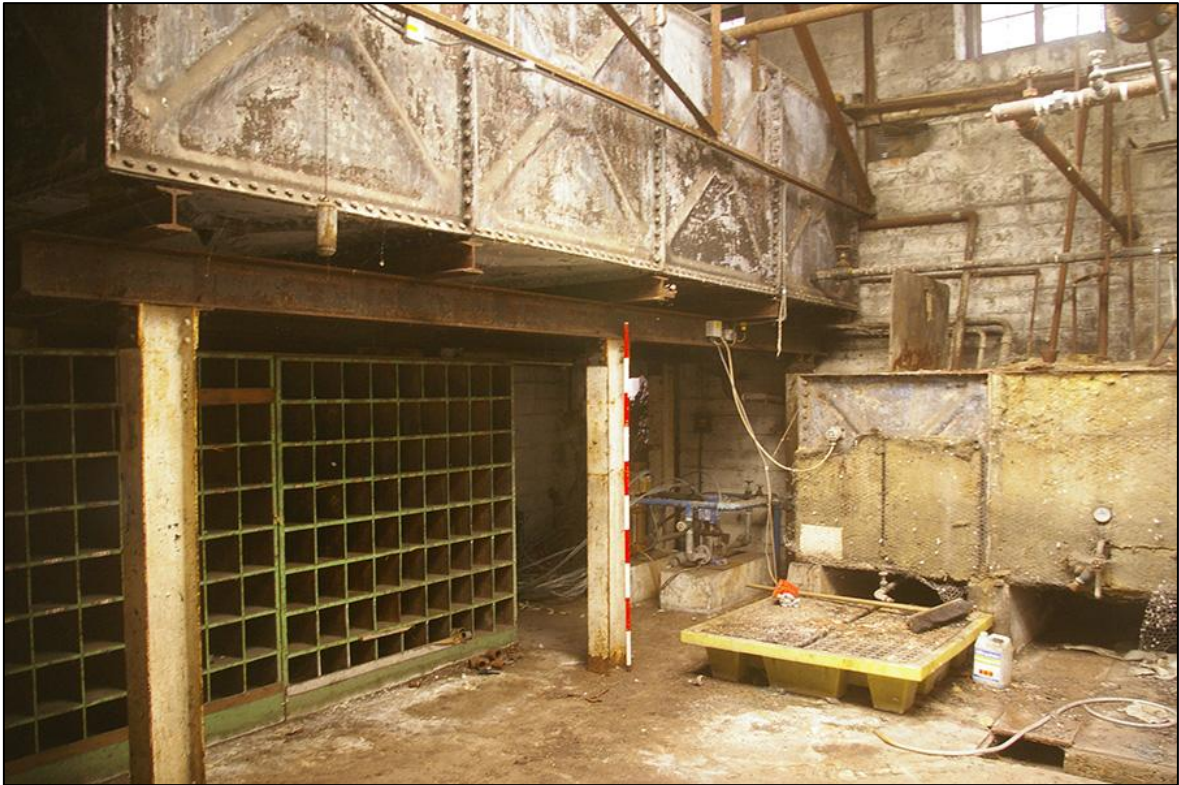
Dark coarse-mix cinder block built single storey sheds, with small concrete block and metal framed upper extension. Massive riveted iron girder framework. Concrete and fibre slab roof carrying first floor, which was not accessible due to a broken staircase. This plant building is divided into two, the first space with a massive open front, with rails for lost iron concertina doors. This room has massive iron pipework for the various air condition and venting systems. The next room is accessed via a narrow timber plank boarded door in the east corner of the first room and in turn has another timber door to a rear yard in its west corner. This room was formerly painted internally in white and has a massive lead riveted water tank, and series of pipe-linked smaller tanks, with a brick chimney to the rear in a small courtyard. There is also a generator and testing equipment. The roof here is of massive timber rafters and metal framework, probably asbestos sheeting.

FIGURE 7: INTERIOR OF PLANT ROOM (BUILDING 8), NORTH-EAST ROOM; VIEWED FROM THE EAST (2M SCALE).

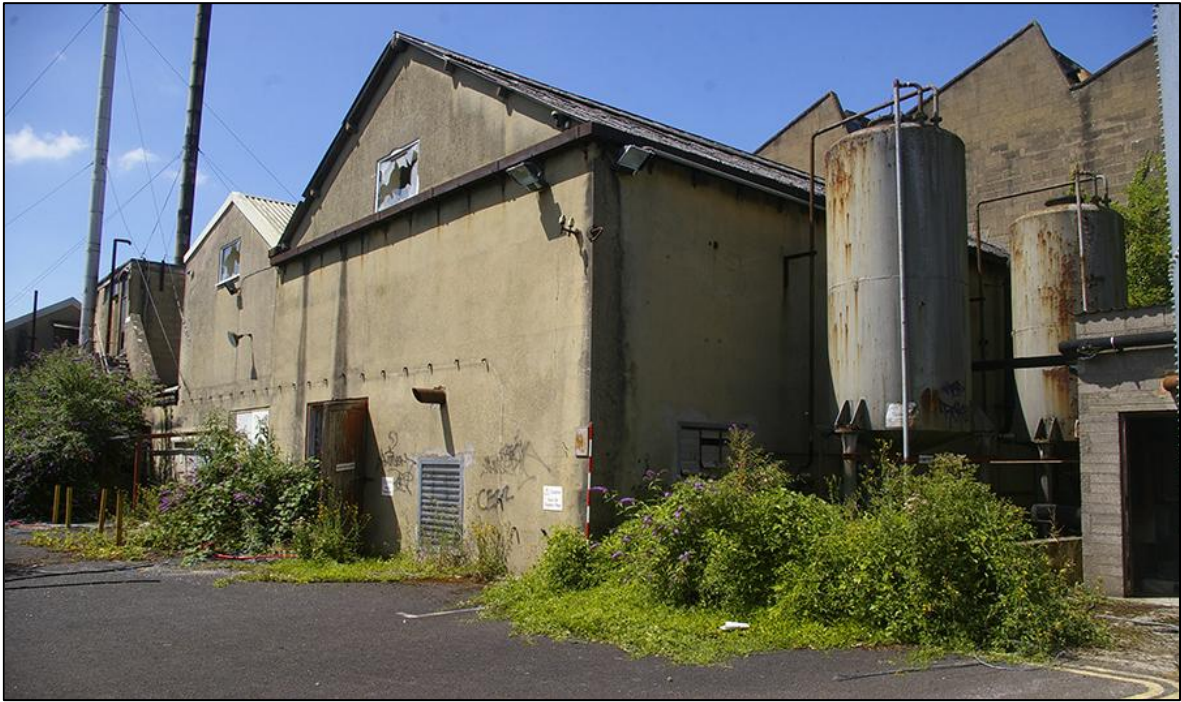
The machinery shed and generator shed were previously a pair of matched buildings, of cinder blocks and brickwork, with timber and iron girder mixed internal frameworks. The machinery shed has had its roofline raised to the west side and a plastic corrugated roof with plastic barge boards has been installed. The front is cement rendered. A modern glazed single pane window lights the first floor.

FIGURE 8: EXTERIOR OF MACHINERY SHED (BUILDING 9); VIEWED FROM THE EAST-NORTH-EAST (2M SCALE).

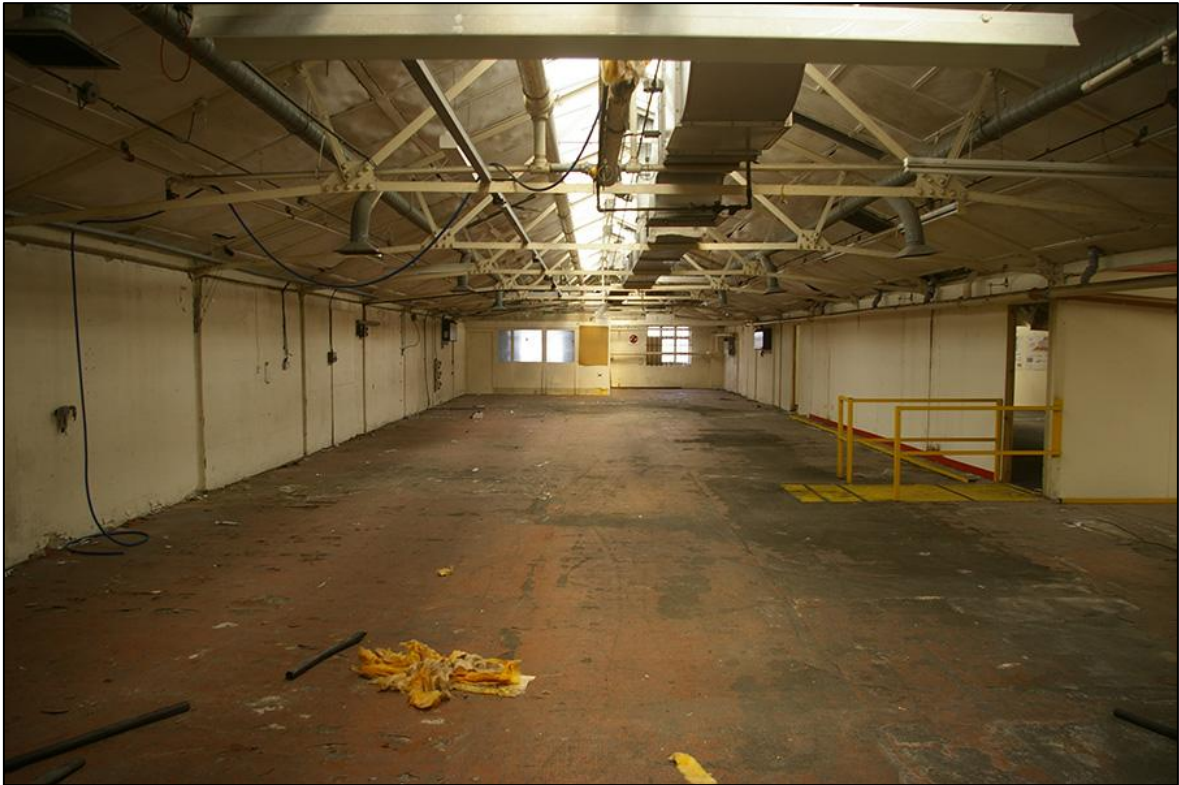
To the north-east of the main factory floor and abutted by the later warehousing there is a low long single storey shed built of the long cinder blocks which characterise the mid 20th century phase of first extensions to the factory complex. It may include bays abutted by the warehouses on the north-west; however, these narrow bays may be earlier forms of the warehouses. The walls are framed along their length by shallow projecting piers, which formerly carried an earlier roof structure. The current roof is a later replacement; now relatively recent corrugated sheeting with clear plastic rooflight panels. It is rendered on its outer faces and rendered and painted on the interior. The render is later, over a metal mesh. There are nine metal span roof trusses. There are two timber windows to the west wall, set with iron bars. There are three lights, with a small central hopper opening above the central light with two side lights with opening casements. The floor is solid concrete and all fitments have been stripped out. There is a small cupboard to the east corner, accessed via a panelled door, which is painted blue with a glazed upper panel.

FIGURE 9: INTERIOR OF ONE OF THE BAYS WITHIN THE SINGLE STOREY BUILDING 11; VIEWED FROM THE SOUTH-WEST.

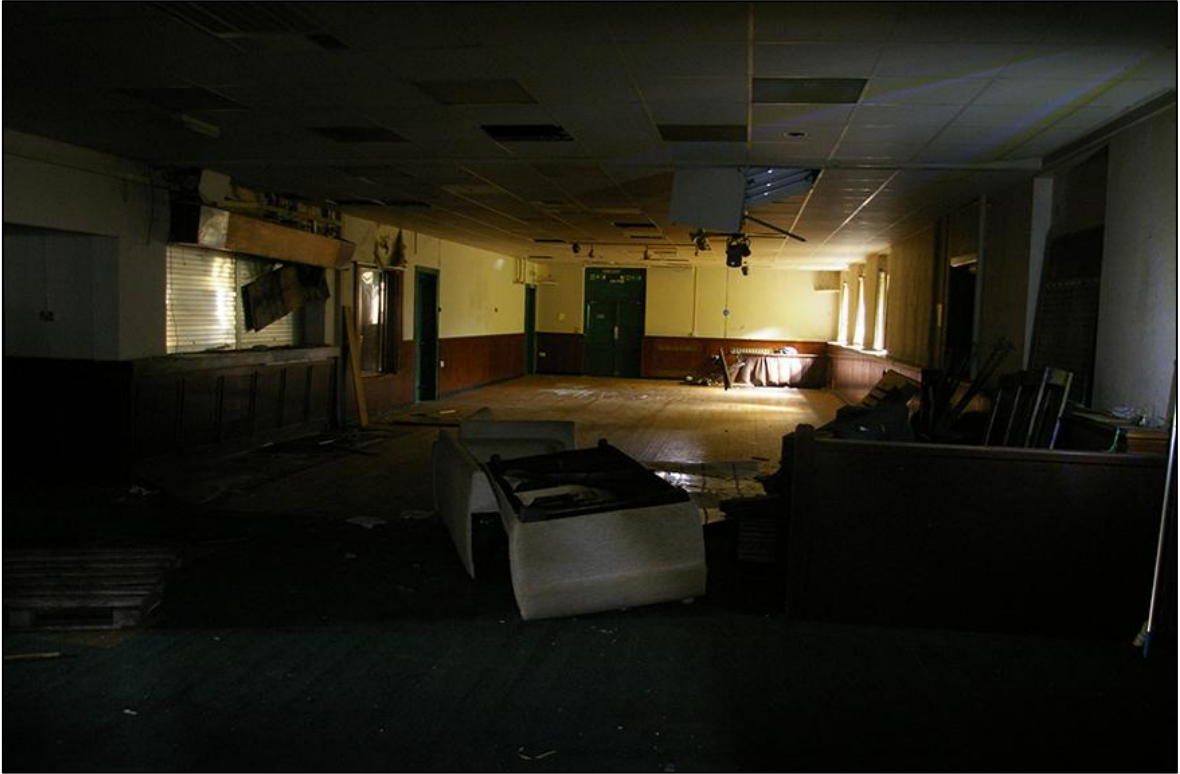
A large much-extended club house has at its core a weather boarded 1930s building, of a scout hut type, with a pitched roof with deep timber barge boards. Extended in concrete block to the north-west and south-east ends. The main space is a bar and dance-floor with an original entrance lobby projecting to south-west with boarded double doors and a good sign with 'club rules'. In the interior of the main room, the walls are plastered and painted, with a moulded dado rail framing plank panelling to the lower walls and there are some fine early darts boards and club signage. There is a suspended timber dance-floor and later panelled and mirrored bar area. An events kitchen to the north is kitted out in good formica 1950s/1960s units, with some later industrial cooking equipment.

FIGURE 11: INTERIOR OF CLUBHOUSE (BUILDING 14); VIEWED FROM THE NORTH-WEST.

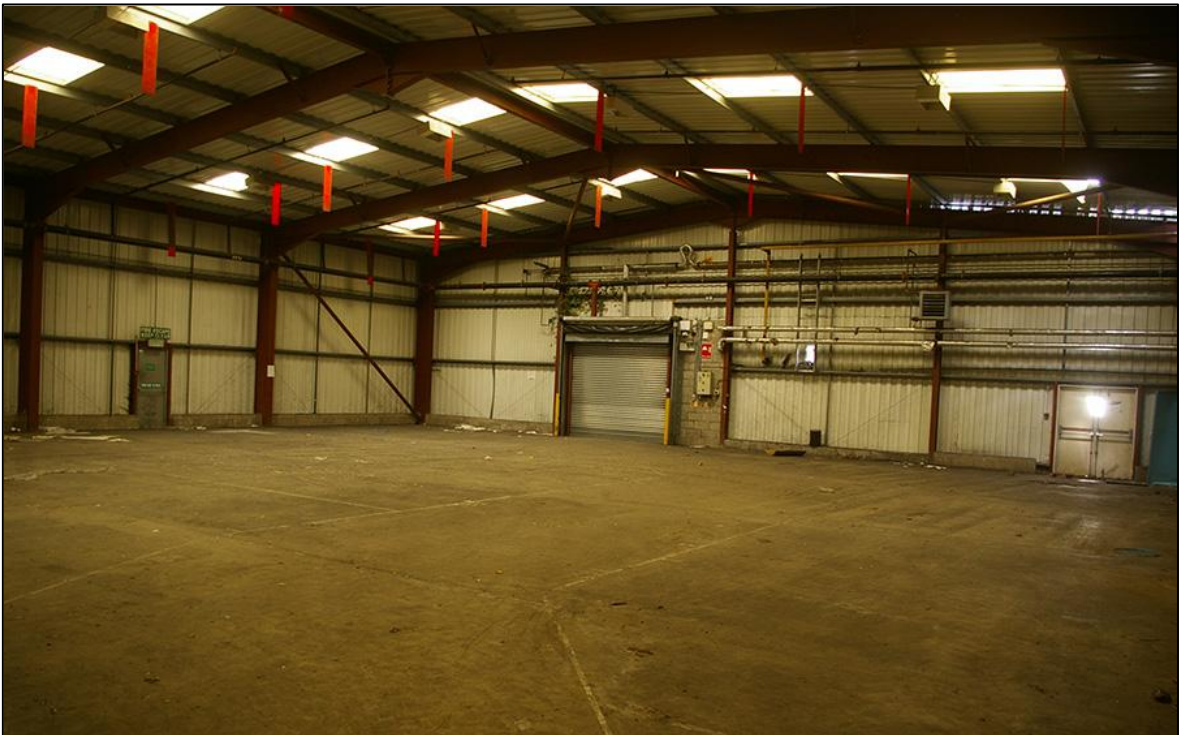
Three vast linked relatively modern warehouses of portal-framed structure, with half height concrete blocks and upper walls and roof of box-section corrugated sheeting. They have poured concrete floors, with connecting and external roller doors.

FIGURE 12: THE MOST RECENT WAREHOUSE (BUILDING 15); VIEWED FROM THE SOUTH.

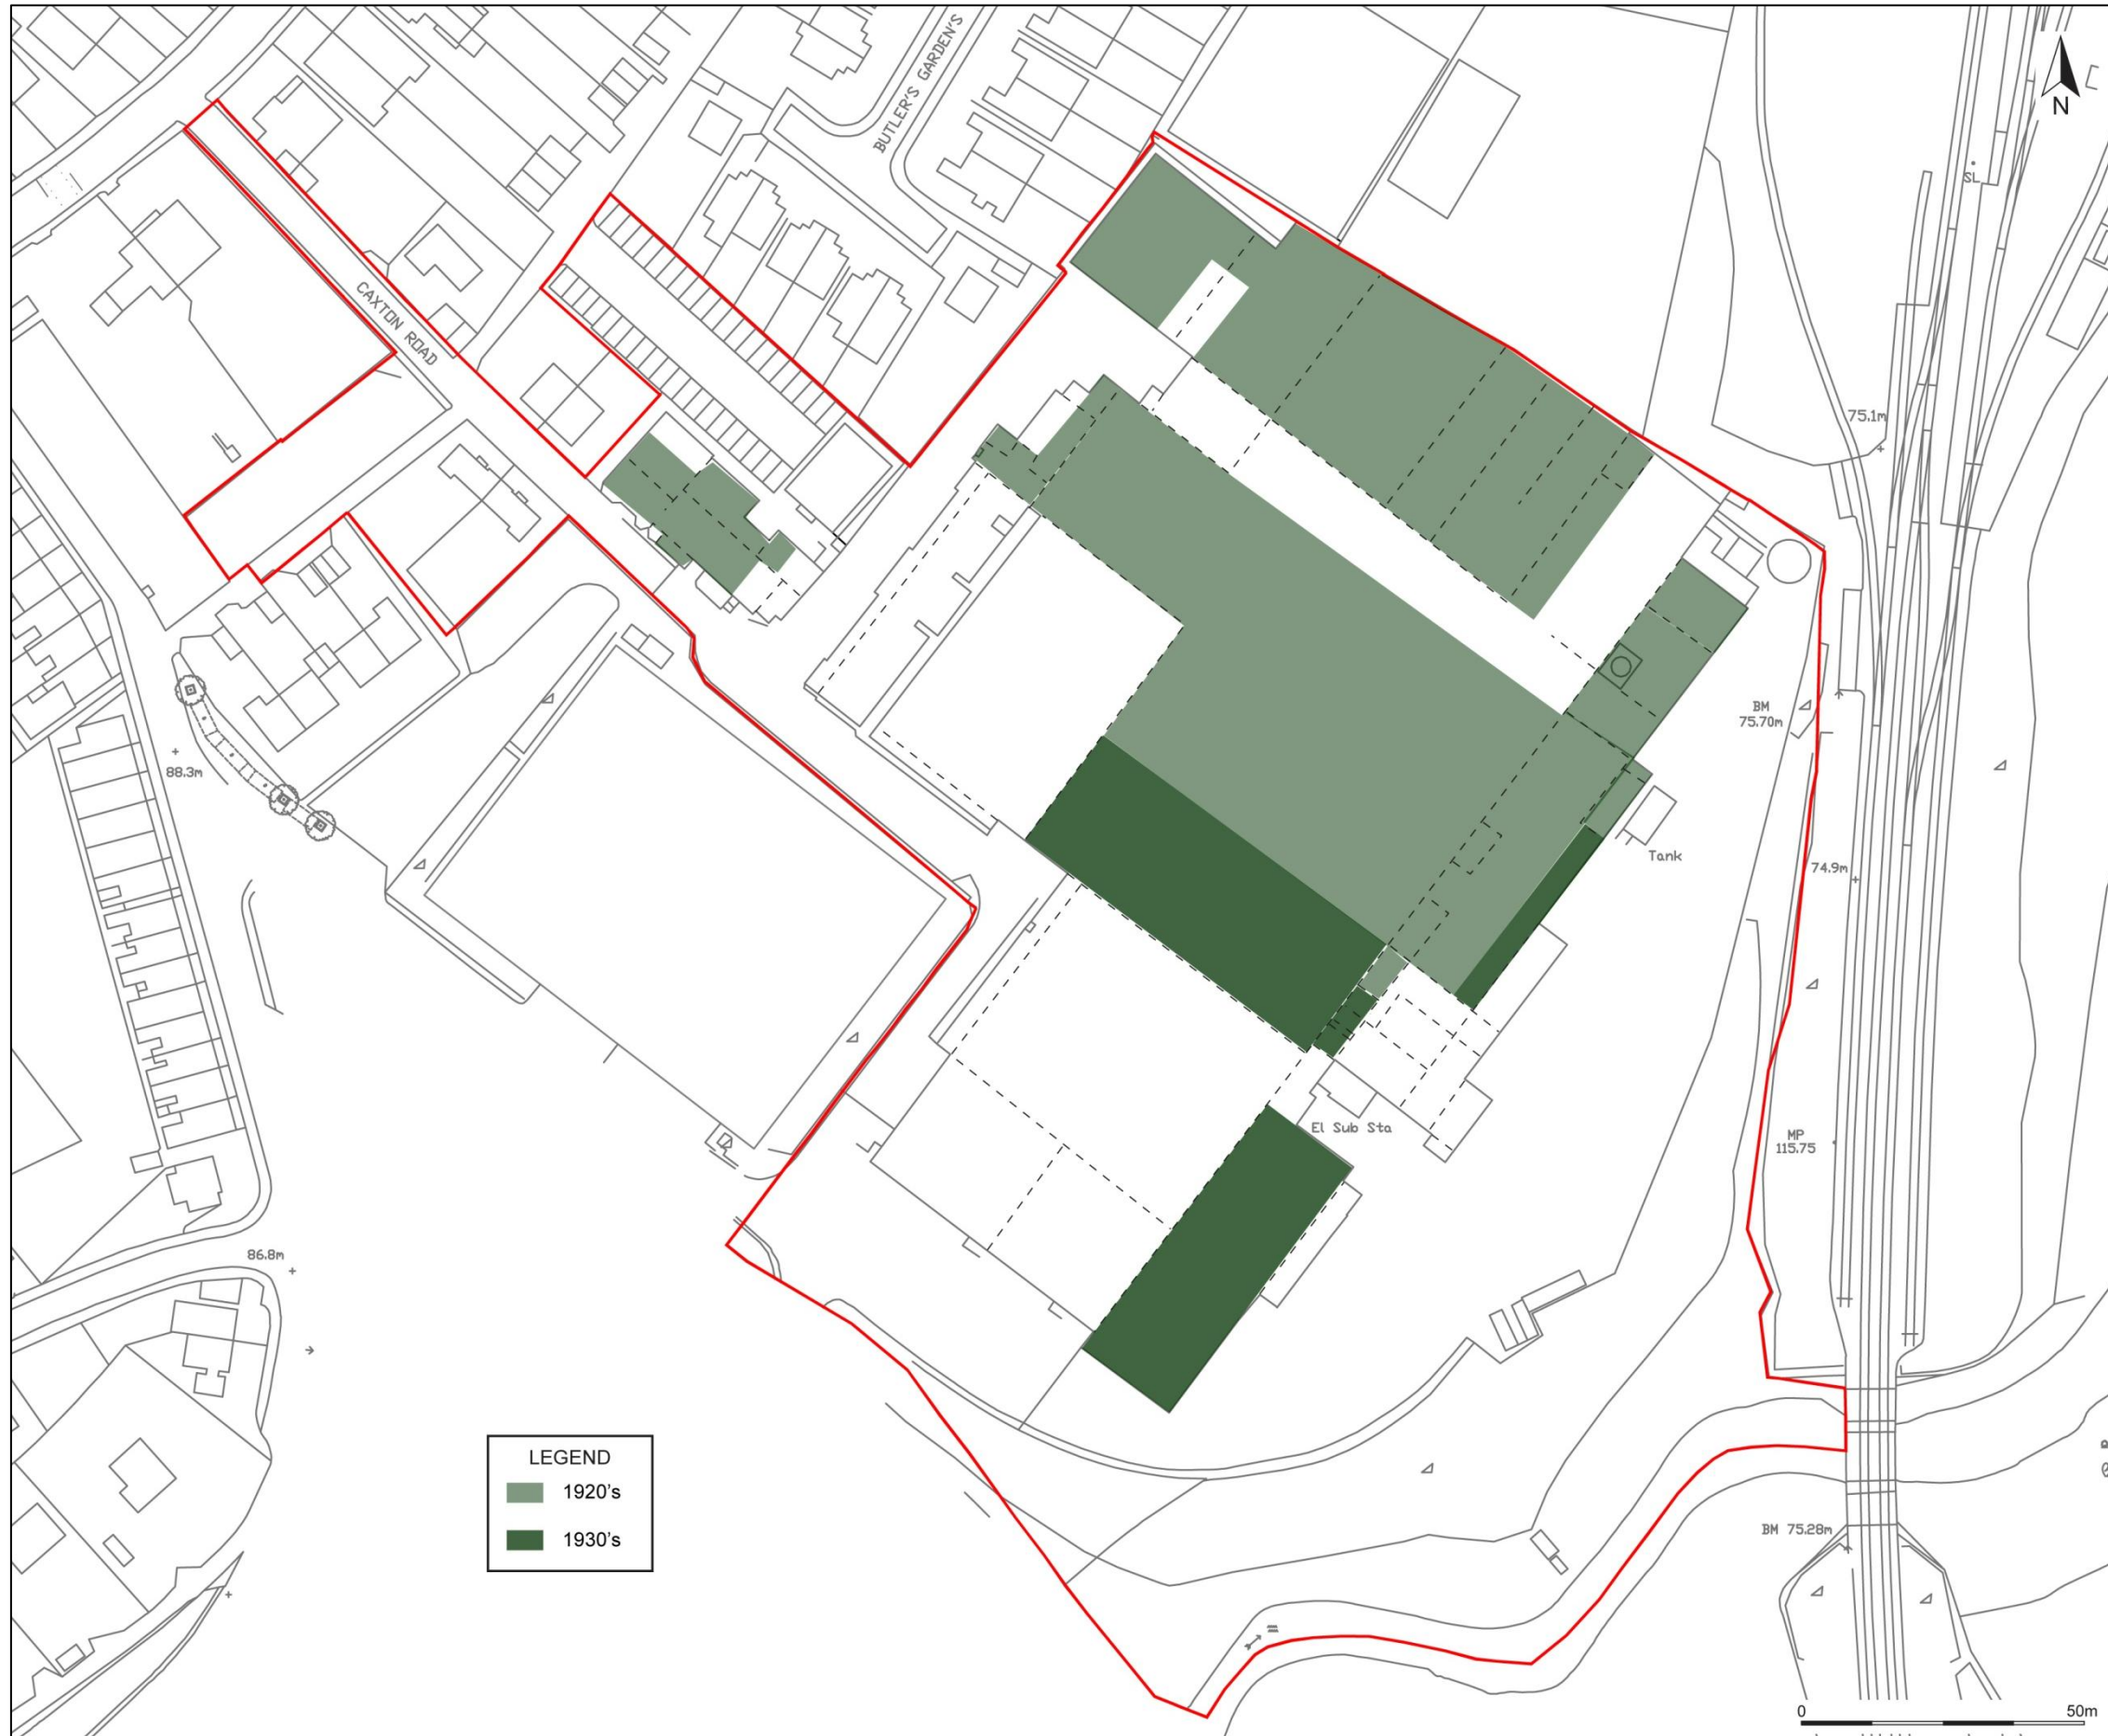
Phase plans, one showing the earliest layout of the site and another showing the subsequent phases of the site can be seen in Figures 14 and 15.

FIGURE 14: PLAN OF THE INITIAL PHASES OF THE PRINTWORKS AT CAXTON ROAD, BUILT BETWEEN 1920 AND 1937; POSSIBLY AS EARLY AS 1910 IN PARTS; THE SITE IS OUTLINED IN RED.

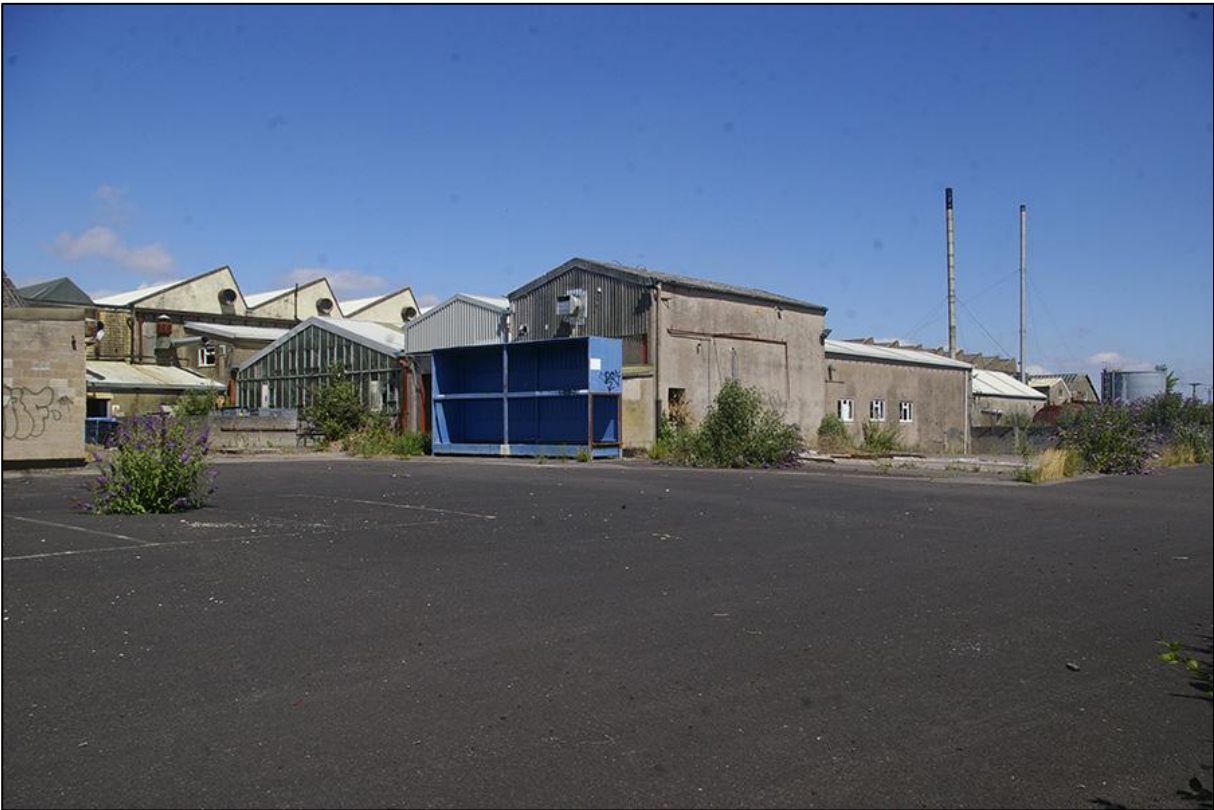
SITE SHOT SHOWING WORKSHOPS (BUILDING 5) AND ROOF OF MAIN FACTORY (BUILDING 1) BEHIND; VIEWED FROM THE SOUTH.

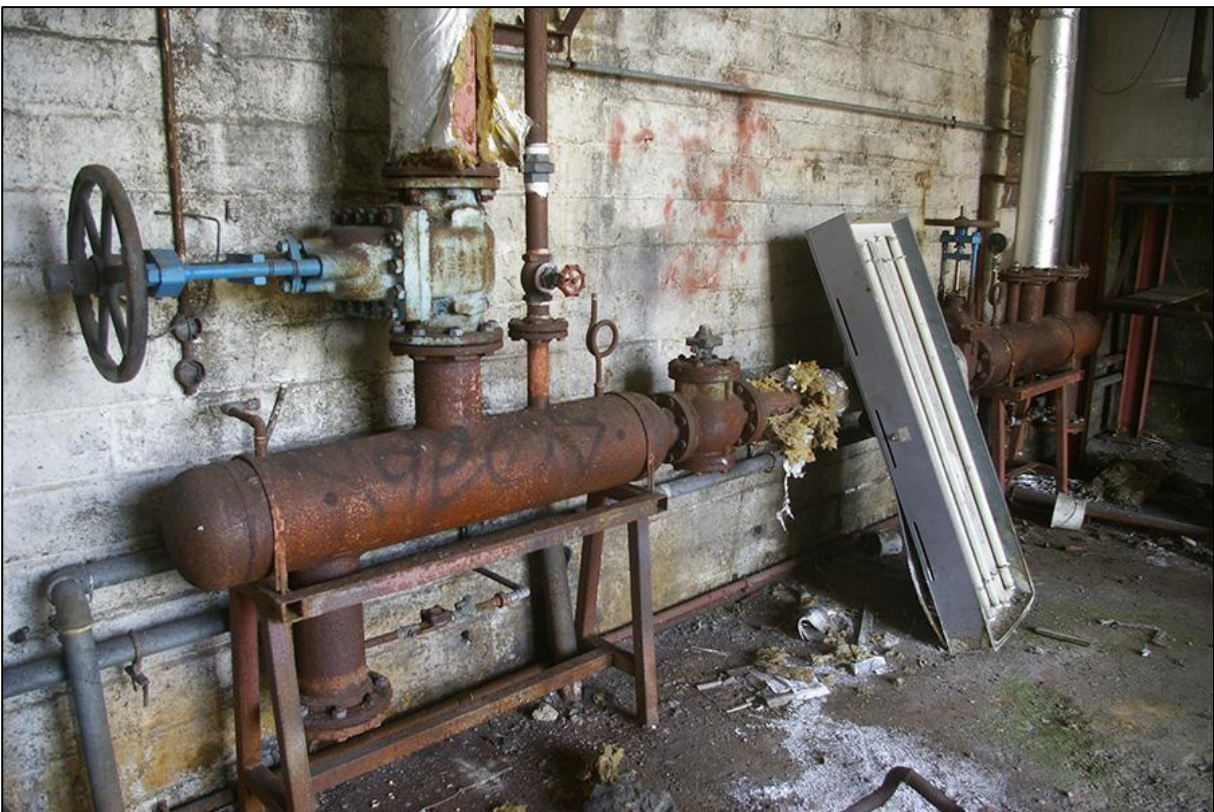
PLANT WITHIN SOUTH-WEST SIDE OF BUILDING 8 (PLANT ROOM); VIEWED FROM THE SOUTH.

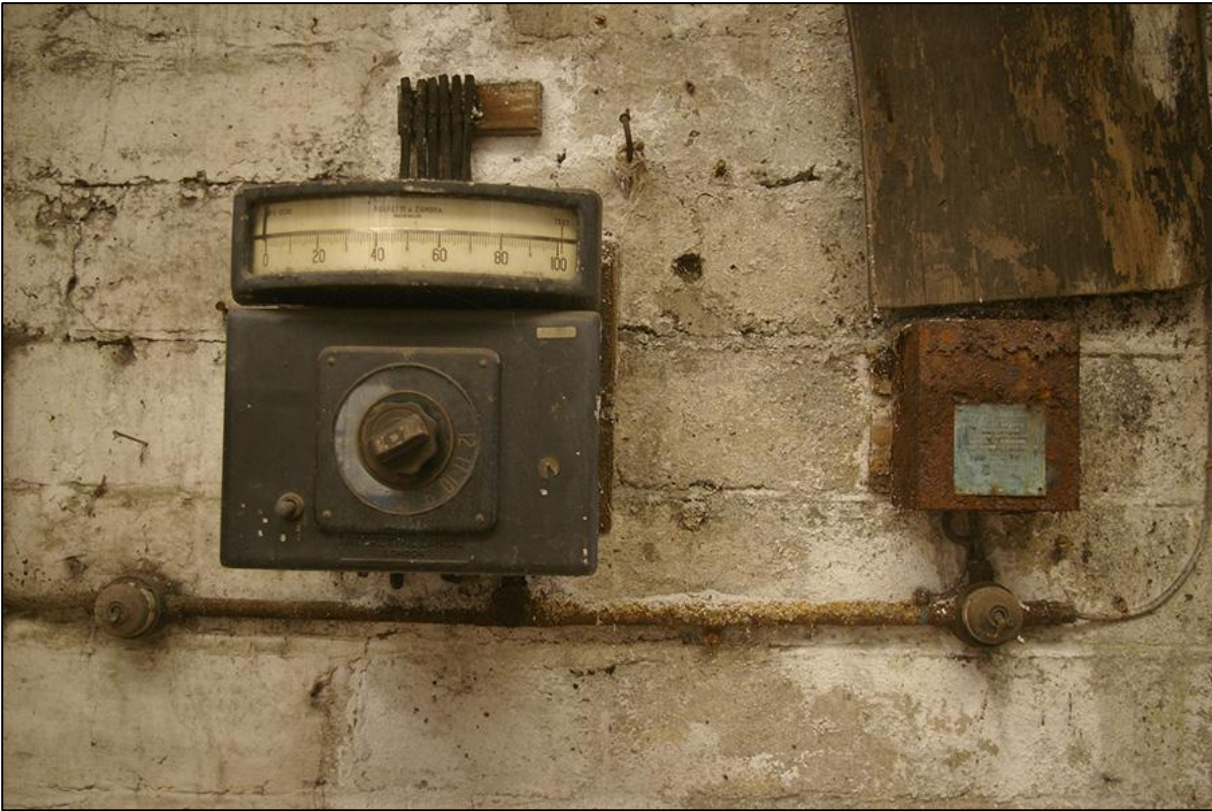
MACHINERY ON SOUTH-EAST ELEVATION WITHIN NORTH-EAST SIDE OF BUILDING 8 (PLANT ROOM); VIEWED FROM THE NORTH-WEST.

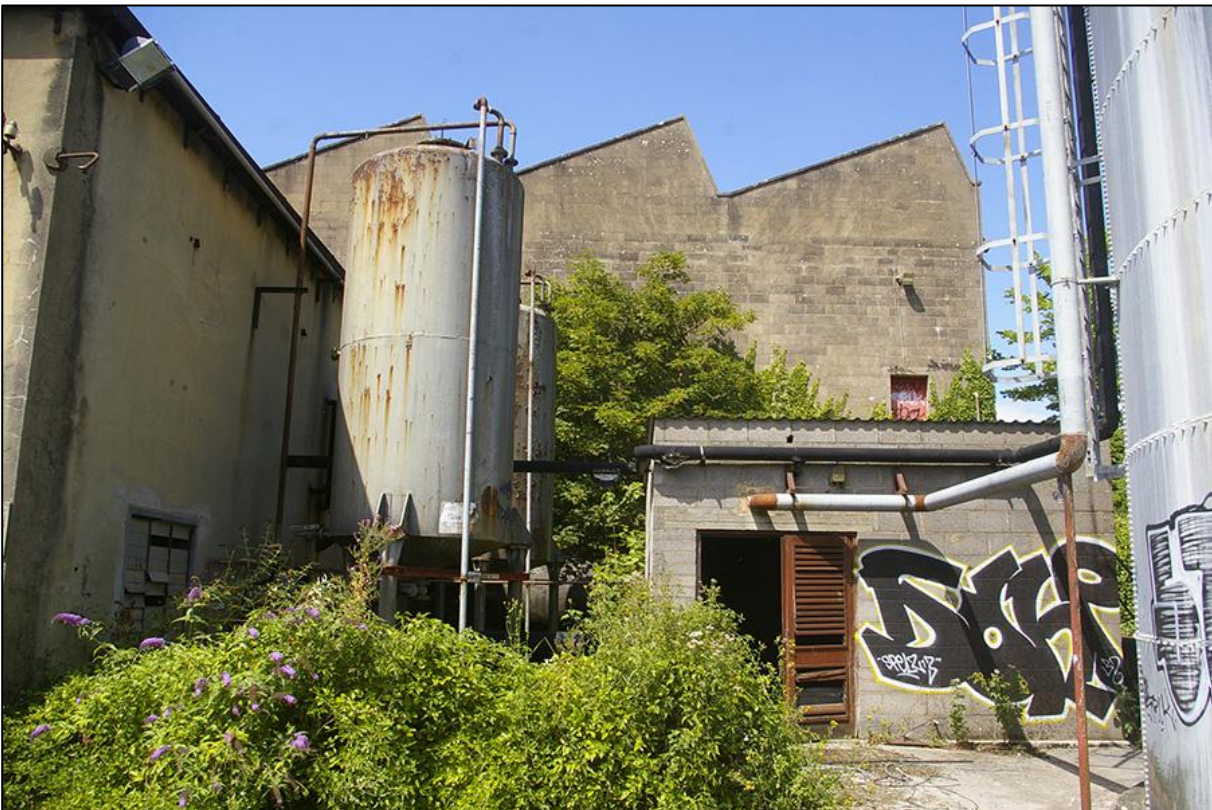
GENERATOR SHED (BUILDING 10), EDGE OF TANK AND SOUTH-EAST ELEVATION OF BUILDING 11; VIEWED FROM THE SOUTH-EAST.

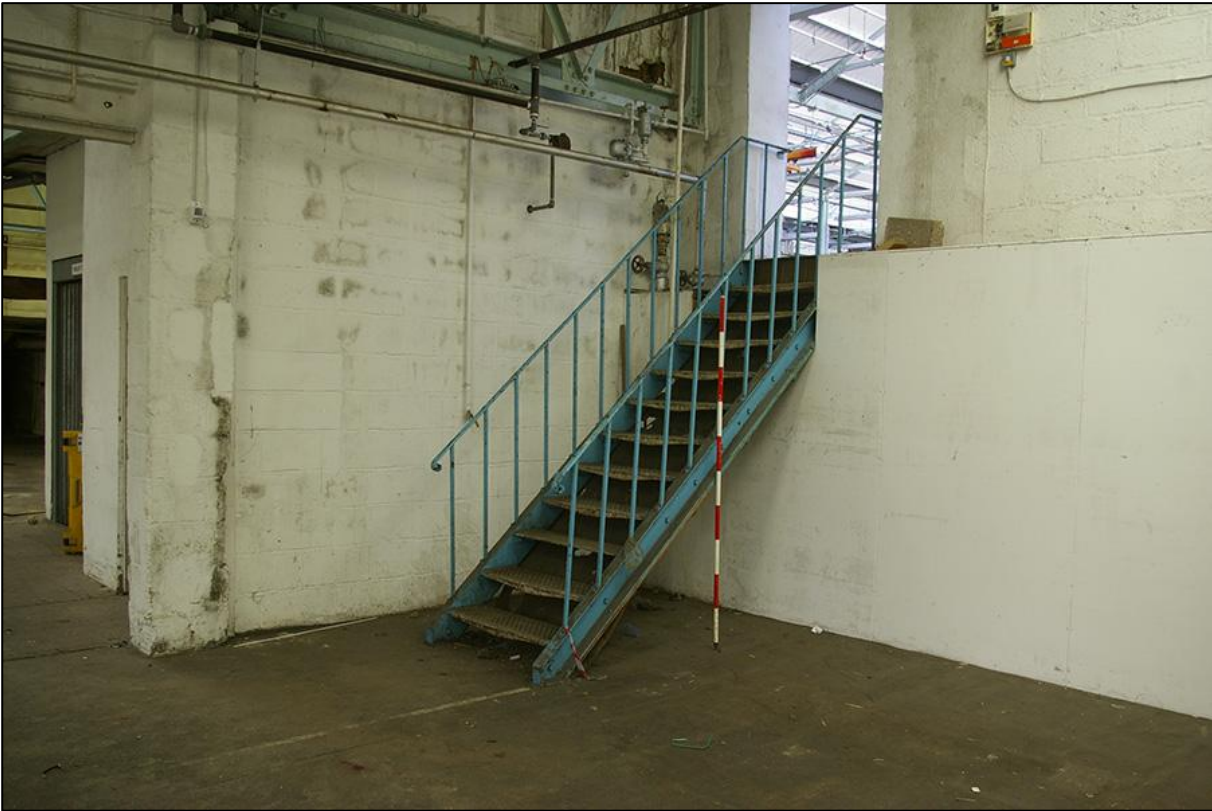
WROUGHT IRON STAIRCASE IN NORTH-EAST HALF OF BUILDING 1A, LEADING TO THE MAIN FACTORY (BUILDING 1); VIEWED FROM THE EAST (2M SCALE).

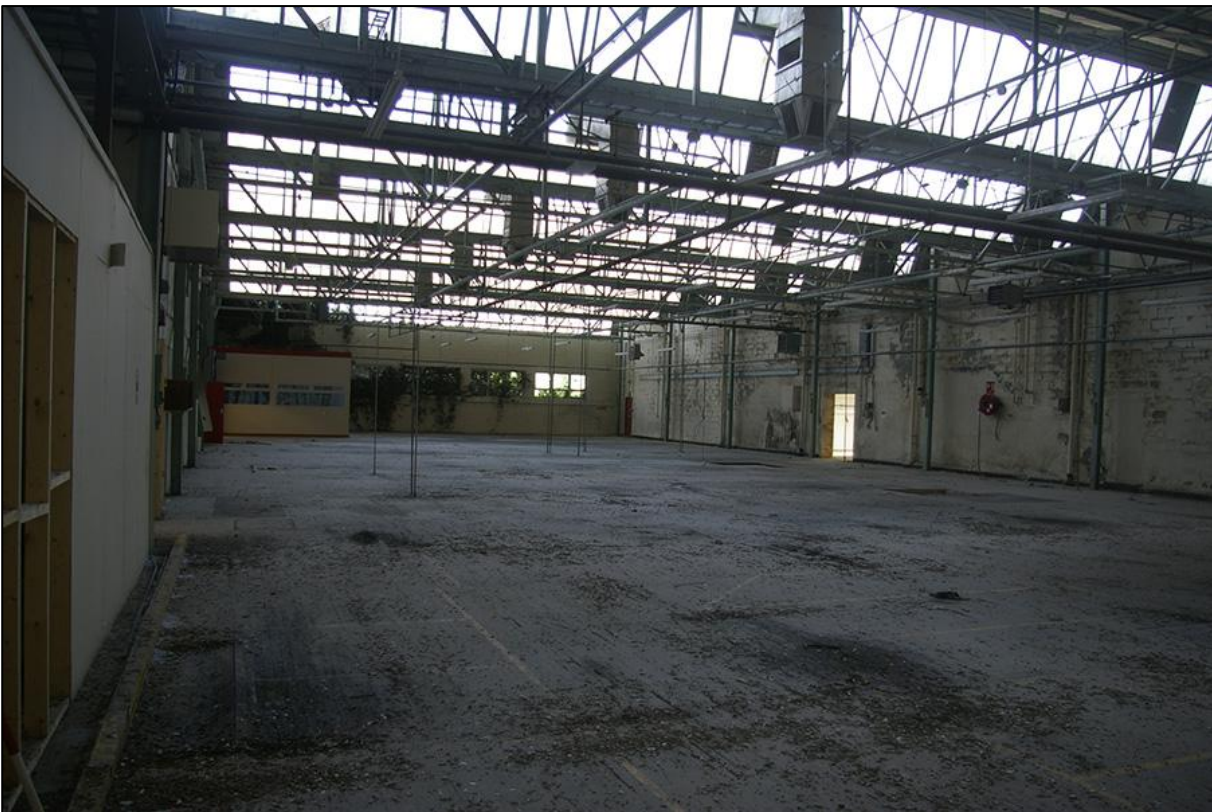
SOUTH-EAST END OF BUILDING 11, WHERE THE ORIGINAL ROAD BETWEEN THE WAREHOUSES AND MAIN FACTORY WAS INFILLED WITH THIS AND OTHER STRUCTURES; VIEWED FROM THE WEST-SOUTH-WEST.

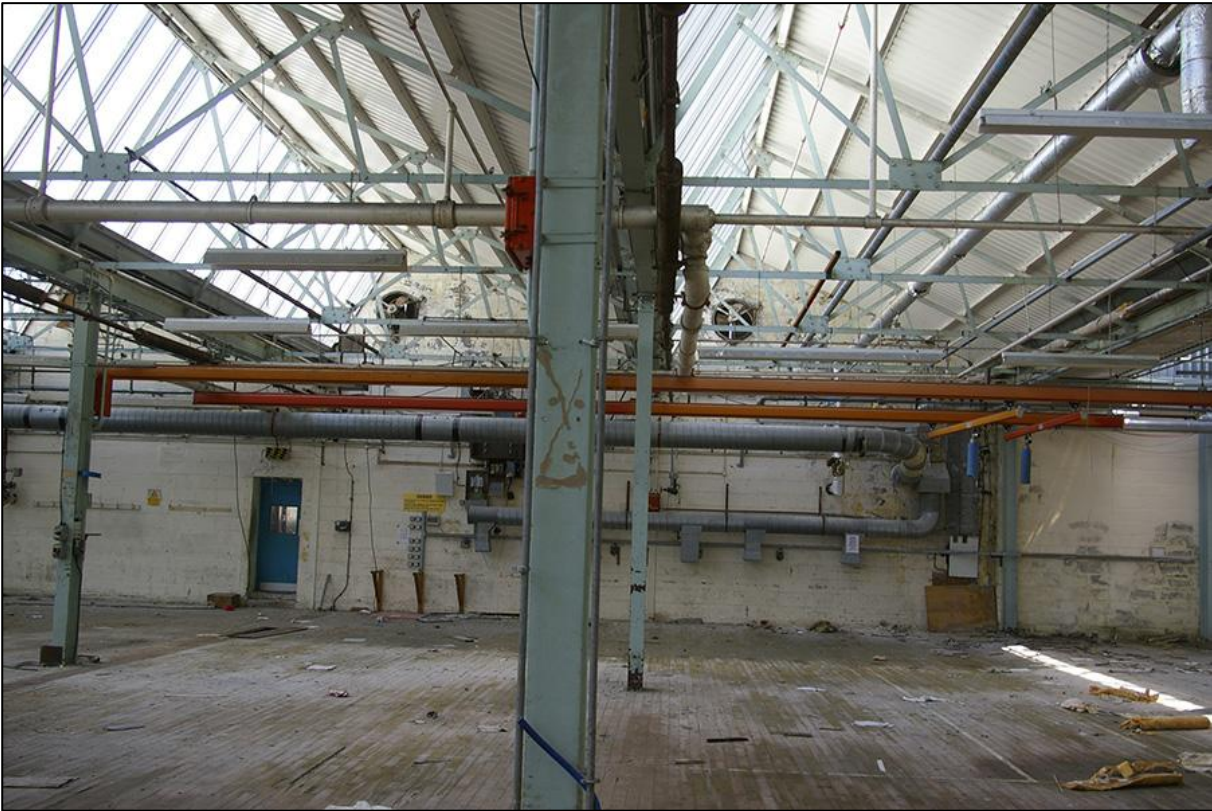
MAIN FACTORY (BUILDING 1), SHOWING BAY STYLE ROOFING AND AIR DUCTS/VENTS IN BRICK ROUNDELS; VIEWED FROM THE NORTH-WEST.

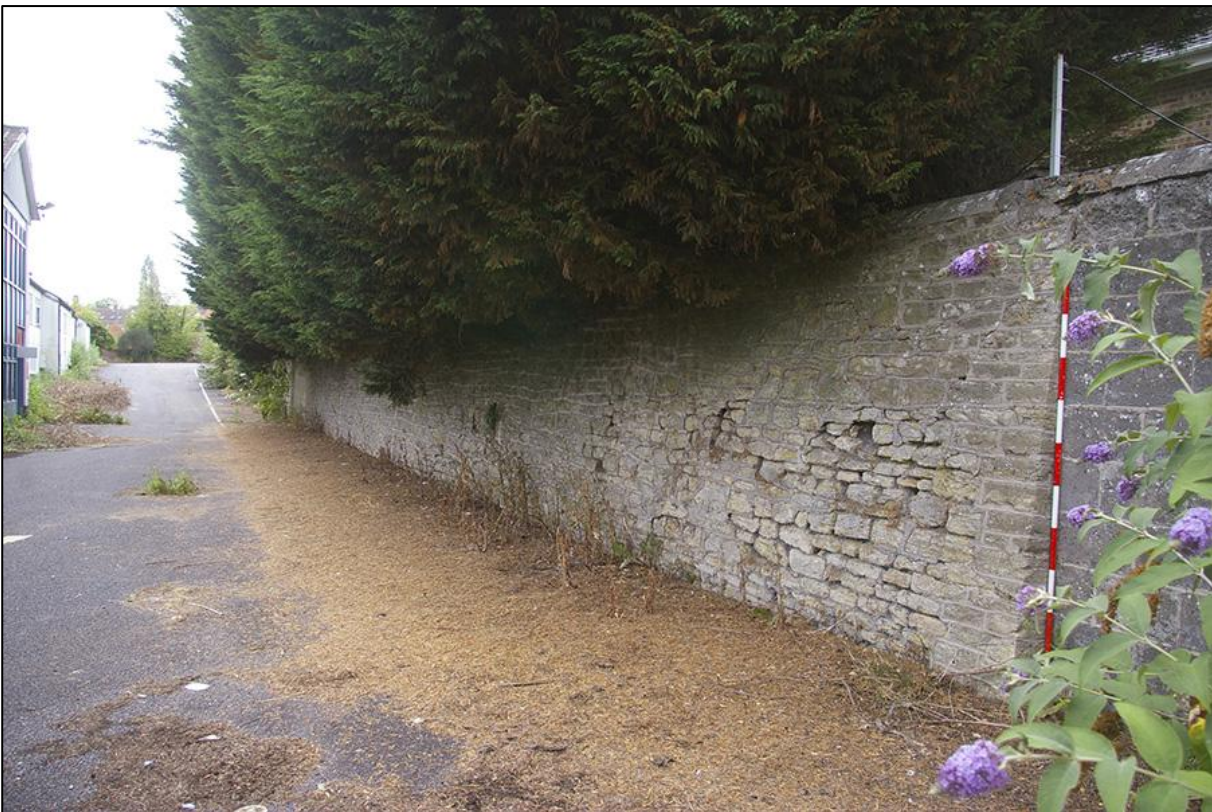
BOUNDARY WALL OPPOSITE ENTRANCE TO OFFICE BLOCK (BUILDING 13); VIEWED FROM THE EAST-NORTH-EAST (2M SCALE).
