FORMER BUTLER, TANNER & DENNIS PRINTWORKS

HISTORIC BUILDING RECORDING

FORMER BUTLER, TANNER & DENNIS PRINTWORKS,
CAXTON ROAD, FROME, SOMERSET
HISTORIC BUILDING RECORDING

Work undertaken by SWARCH for Acorn Property Group

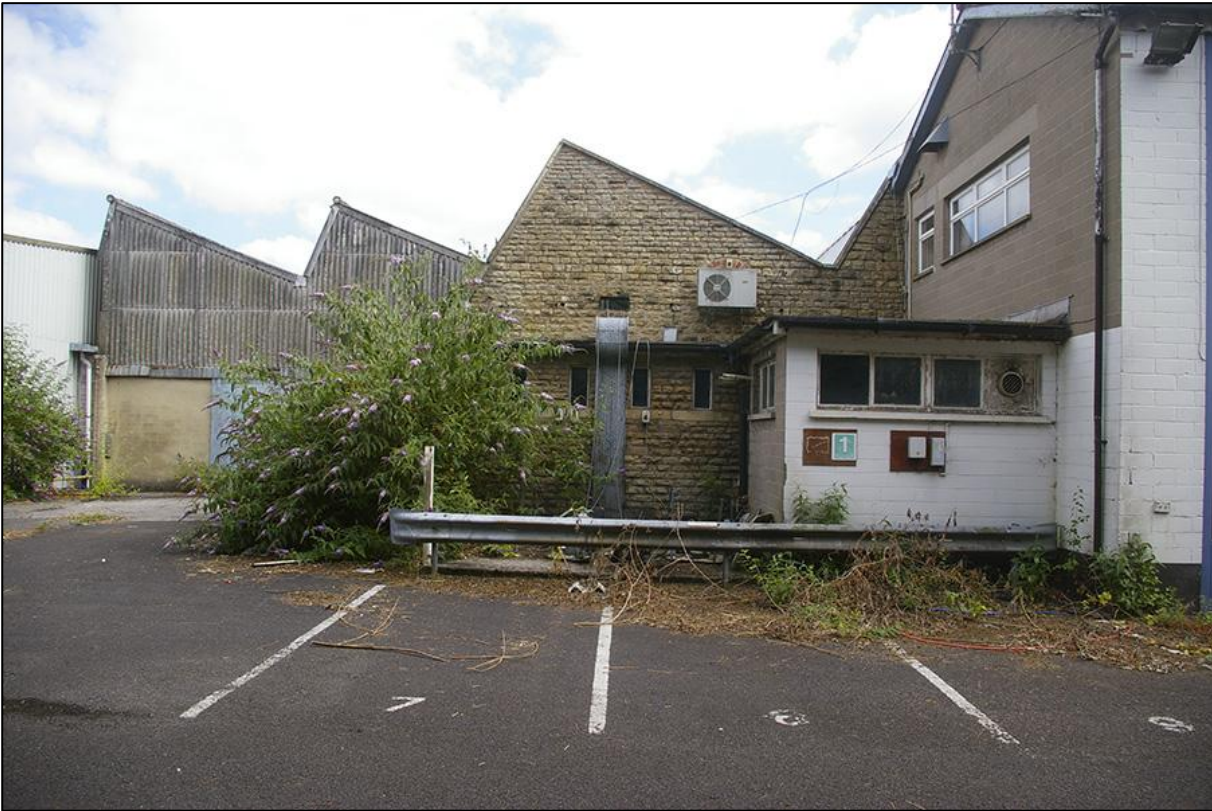
ELEVATION OF MAIN FACTORY (BUILDING 1) NORTH-EAST OF OFFICE BLOCK (BUILDING 13); VIEWED FROM THE NORTH-WEST.

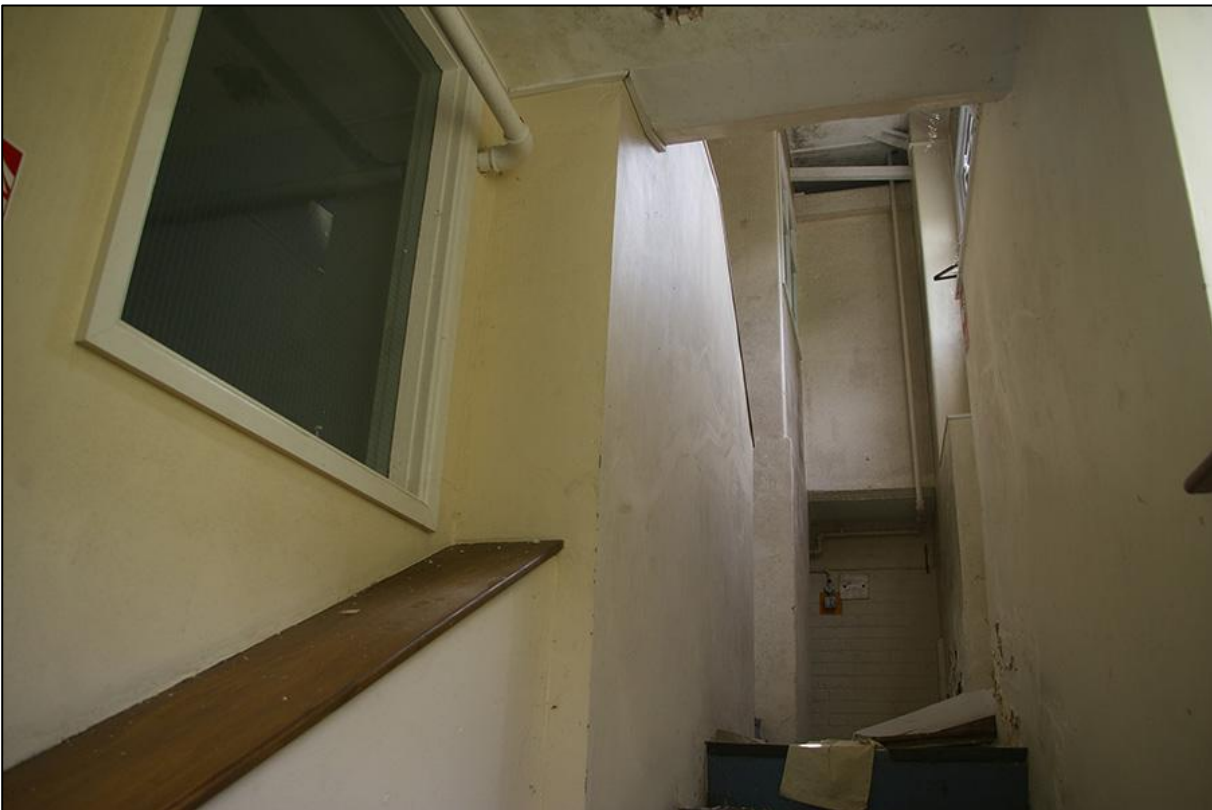
ORIGINAL DEFENSIBLE/BLAST DEFENSE, CENTRAL STAIRED ENTRANCE TO OFFICE BLOCK (BUILDING 13); VIEWED FROM THE NORTH-EAST.

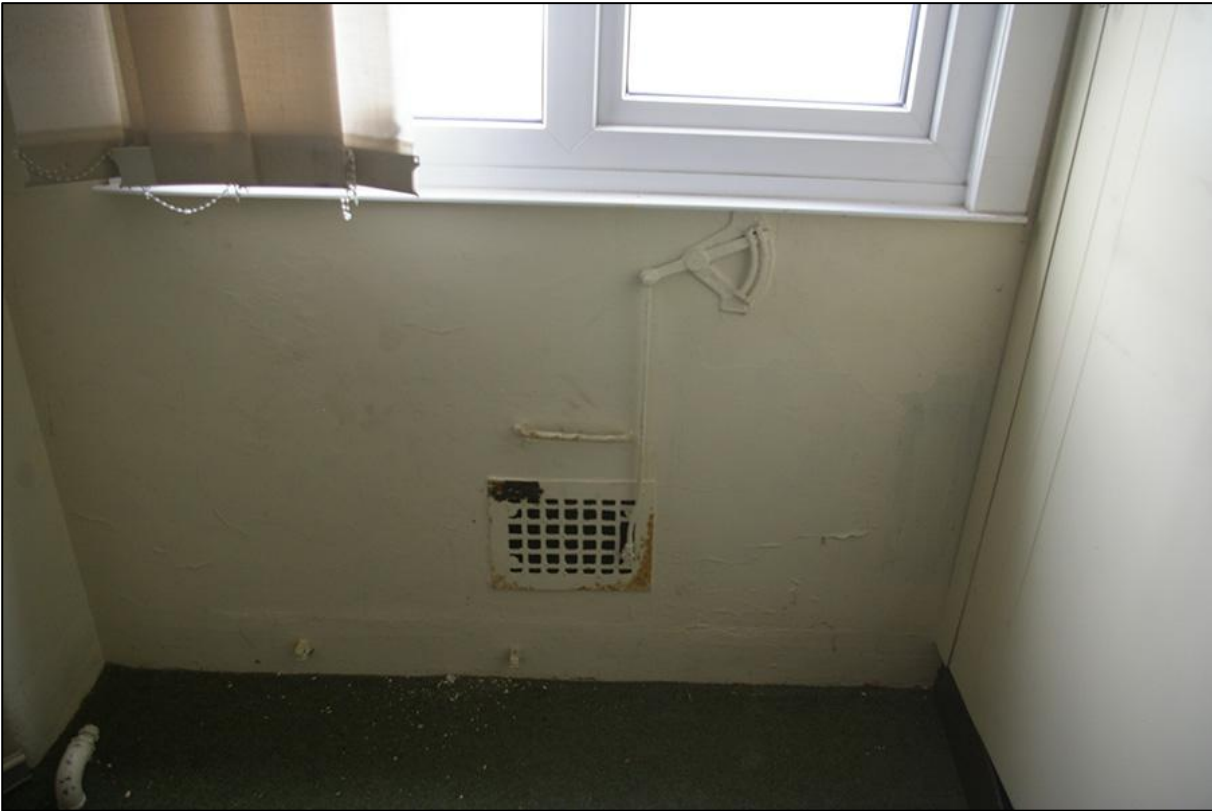
VENT IN FIRST FLOOR OFFICE OF OFFICES (BUILDING 13); VIEWED FROM THE NORTH-WEST.

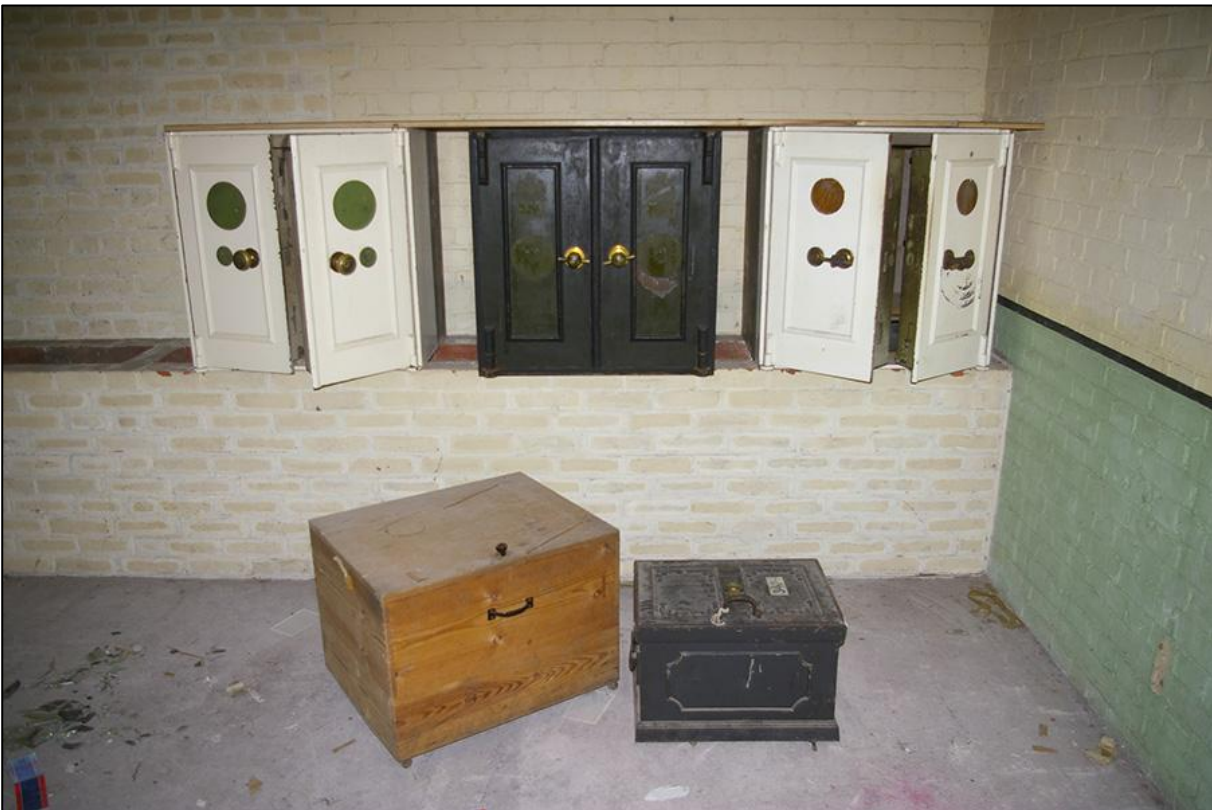
SAFES IN BASEMENT OF OFFICE BLOCK (BUILDING 13), SHOWING PROBABLE ORIGINAL PAINT WORK.

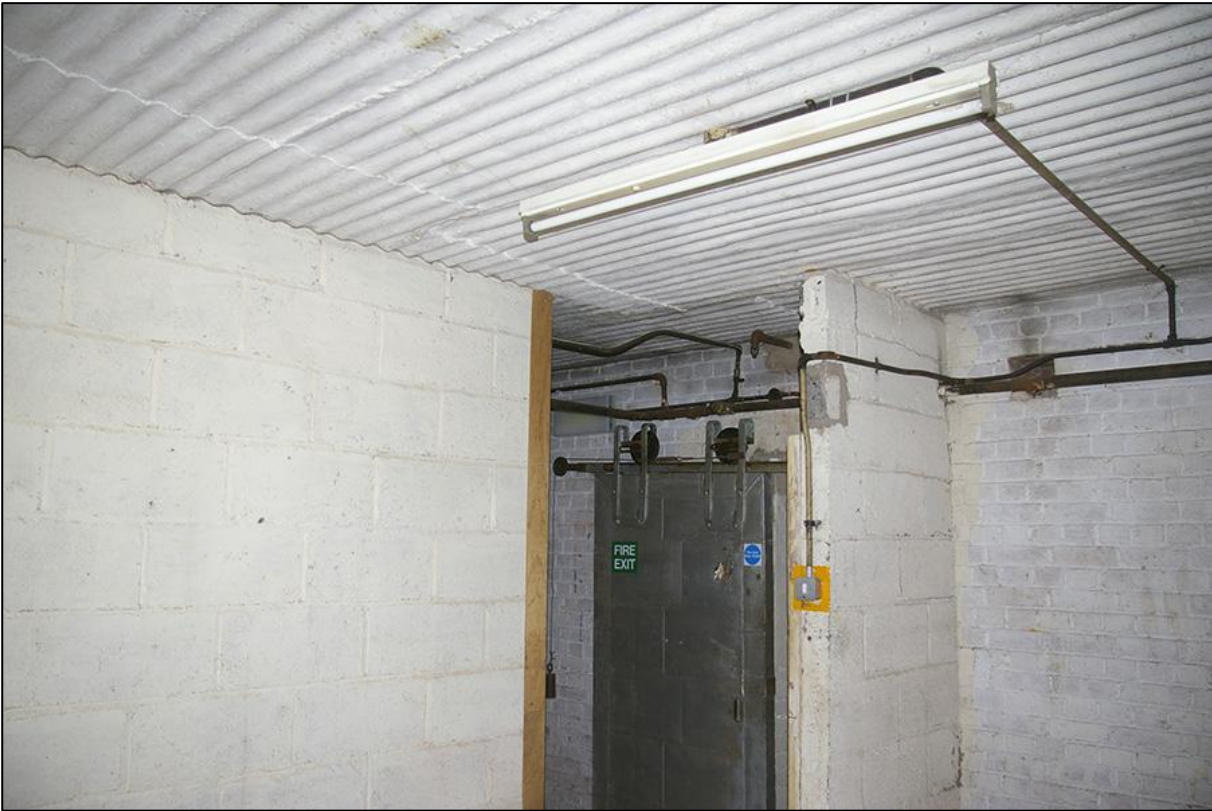
ENTRANCE TO CELLAR; VIEWED FROM INSIDE CELLAR.

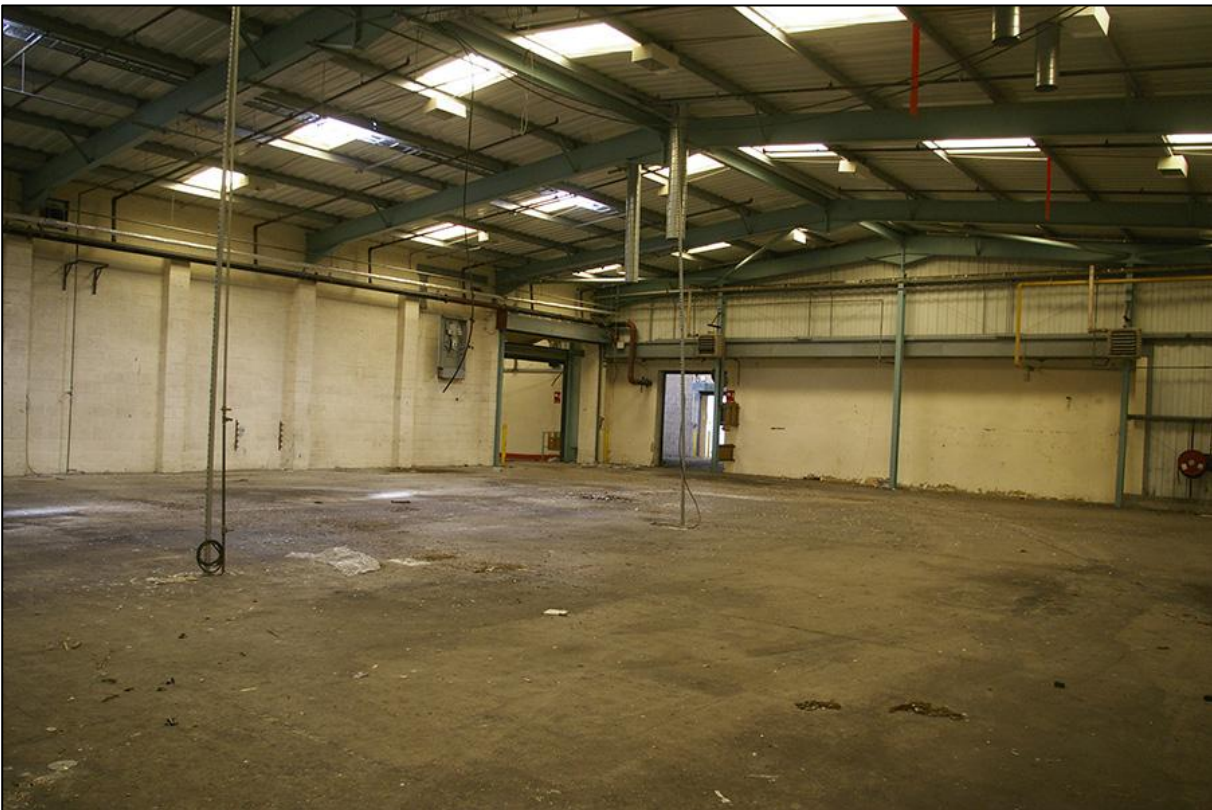
MIDDLE WAREHOUSE TO BUILDING 15; VIEWED FROM THE NORTH.
