29-31 DAMERS ROAD

Results of Archaeological Monitoring and Recording

South West Archaeology Ltd. Report no 181115

29-31 Damers Road, Dorchester, Dorset Results of Archaeological Monitoring and Recording

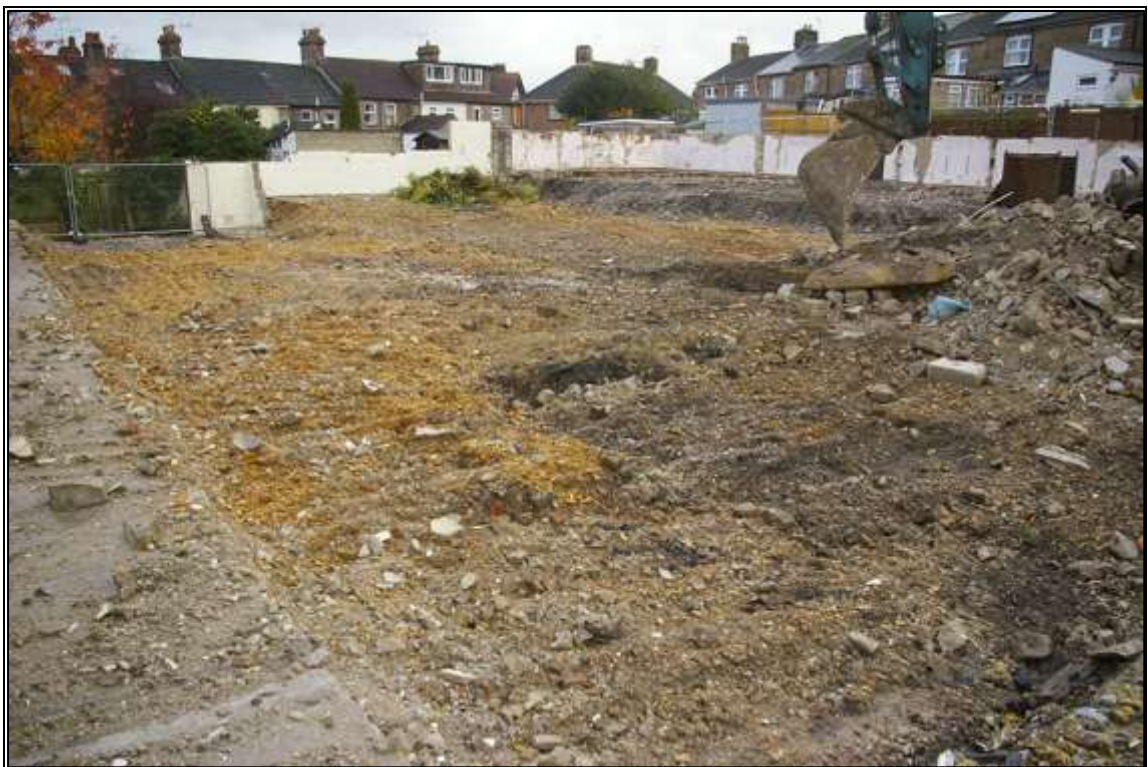
COVER PLATE: SITE SHOT POST DEMOLITION OF STRUCTURE; VIEWED FROM THE NORTH-EAST (NO SCALE).

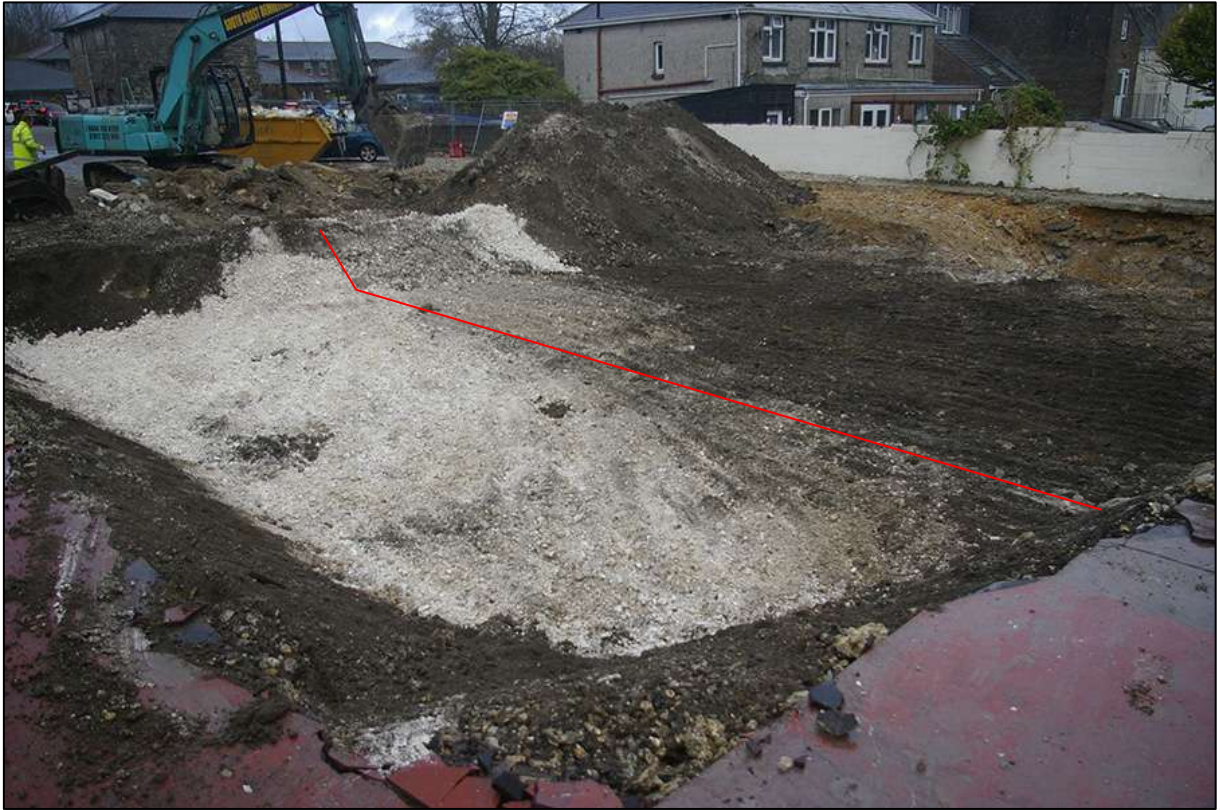
FIGURE 3: SITE SHOT MID REDUCTION OF LEVELS, THE APPROXIMATE LINE OF DEEPER TRUNCATION/FOOTING TO THE EASTERN TWO BAYS OF THE DEMOLISHED STRUCTURE IS SHOWN IN RED; VIEWED FROM THE SOUTH-WEST (NO SCALE).

An area c.25m×20m was monitored during the reduction of ground levels on site. An area c.24m×14m across the site, within the footprint of the main part of the demolished building (two eastern bays), had suffered deep truncation of the natural to below the level of formation. This area had then been made-up in the 20th century. Across the less truncated parts of the site a soily made-ground directly overlaid the natural. No archaeological features or deposits were present.

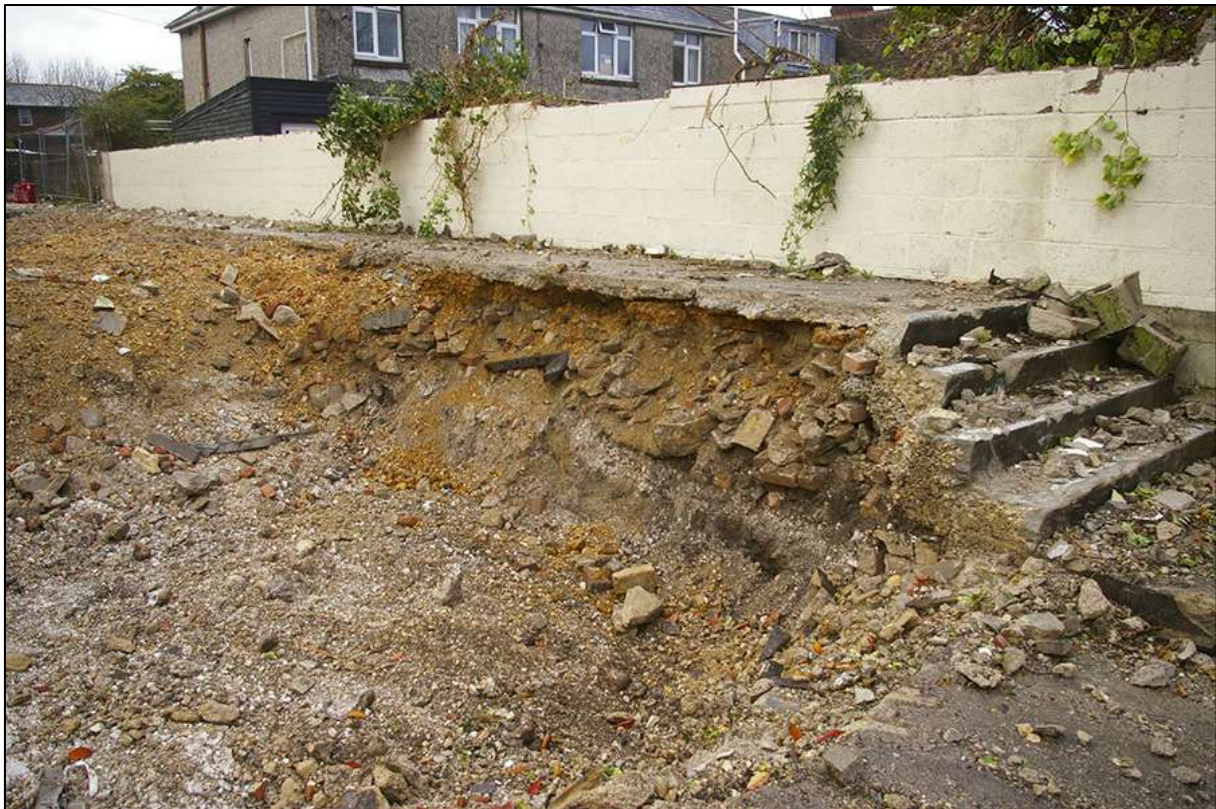
FIGURE 10: INSPECTION PIT IN SOUTH-EAST CORNER OF DEMOLISHED STRUCTURE; VIEWED FROM THE SOUTH-WEST (NO SCALE).

A building that contained a vehicle inspection pit in its south-east end had extended across the width of the site and had been demolished prior to the site visit. The sites concrete floors had also been removed, although the footings were left until the archaeological monitoring of the site could begin. A working walk way approximately 2m wide had been left around the edge of the site and excavated area. The removed concrete floor levels were c.0.25cm deep (approximately half the depth of formation. The west edge of the site was stepped up across the footprint of a later extension to the original building on the site. The Damers Road-side front of the site contained a skip, plant and security fencing limiting the works in that area.

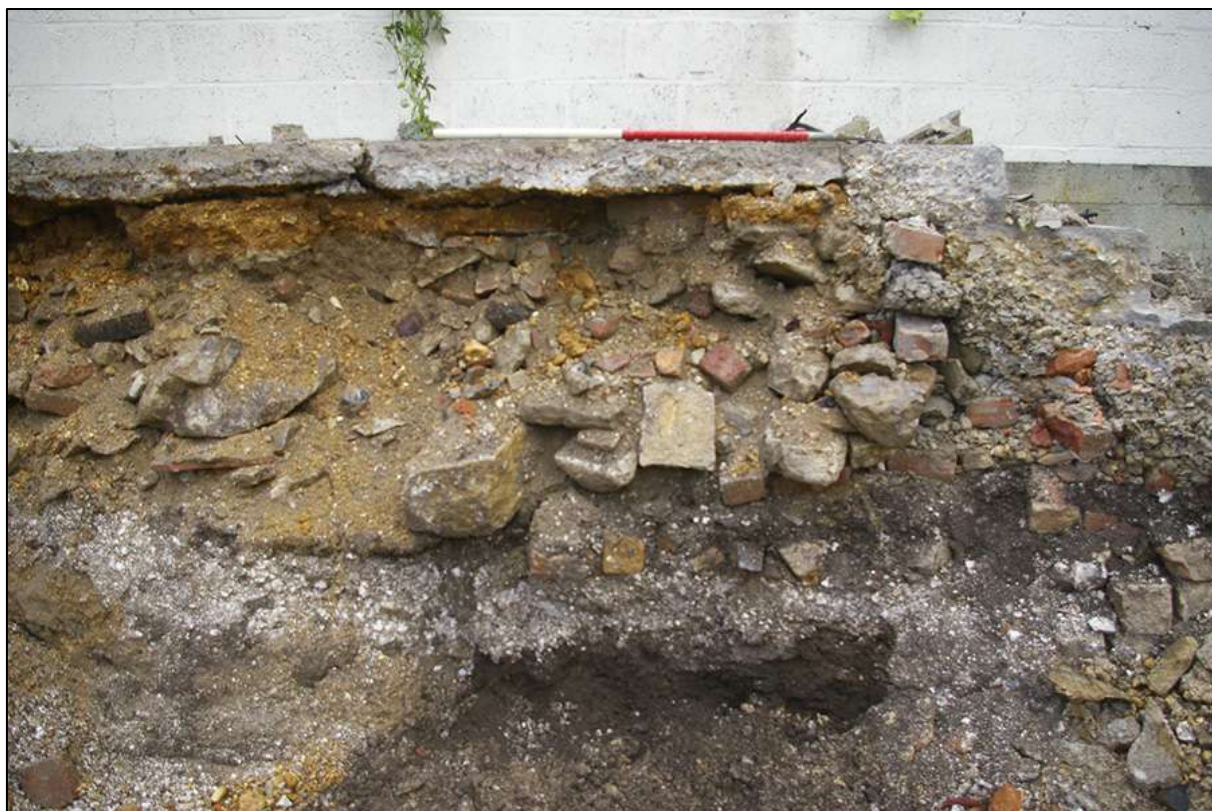
FIGURE 12: SAMPLE SECTION IN INSPECTION PIT; VIEWED FROM THE WEST (1M SCALE).

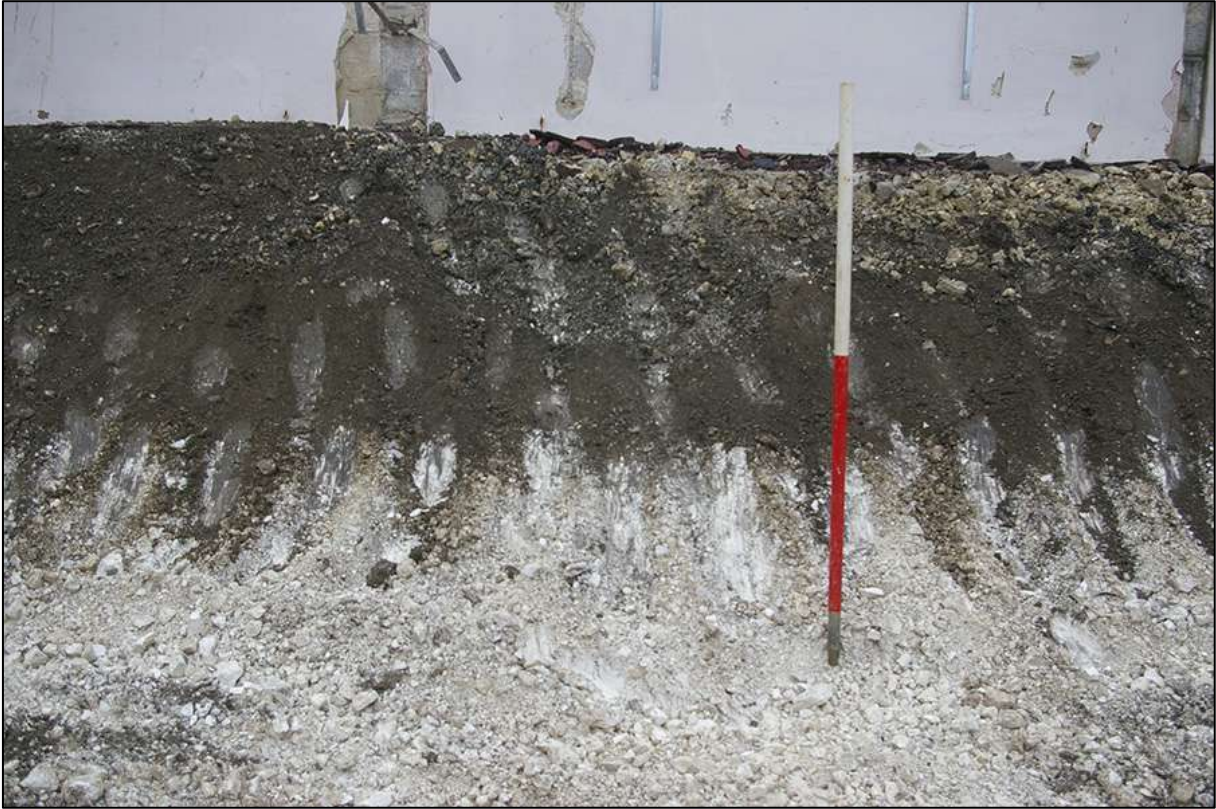
FIGURE 13: WESTERN LIMIT OF EXCAVATION/SAMPLE SECTION; VIEWED FROM THE EAST (1M SCALE).

Along the western side of the site c.0.26m of modern concrete floor, (100), overlaid c.0.46m of a soily made-ground, (101), which overlaid the Natural, a compact chalk, (102). The Natural occurred at a depth of c.0.76m although this was deeper at the south end of the site and became shallower towards the north. A relatively large 20th century block-work footing divided this western edge of the site from the rest of the site. This footing cut the Natural and on the eastern side of the footing, within the footprint of the demolished building, it contained a greater depth of made-ground, (106). An inspection pit in the south-east of the site, the floor level of which was already c.0.75m lower than the floor surfaces on the western edge of the site, was excavated to a depth of c.1.45m and was still within made-ground deposits. In this corner of the site; concrete floor (103) overlaid made-ground (104), which was made-up of rubble and waste material; which overlaid a mixed chalk and topsoil made-ground (105), which overlaid made-ground (106), which was similar to made-ground (101), although containing more abundant modern, 20th century, debris.

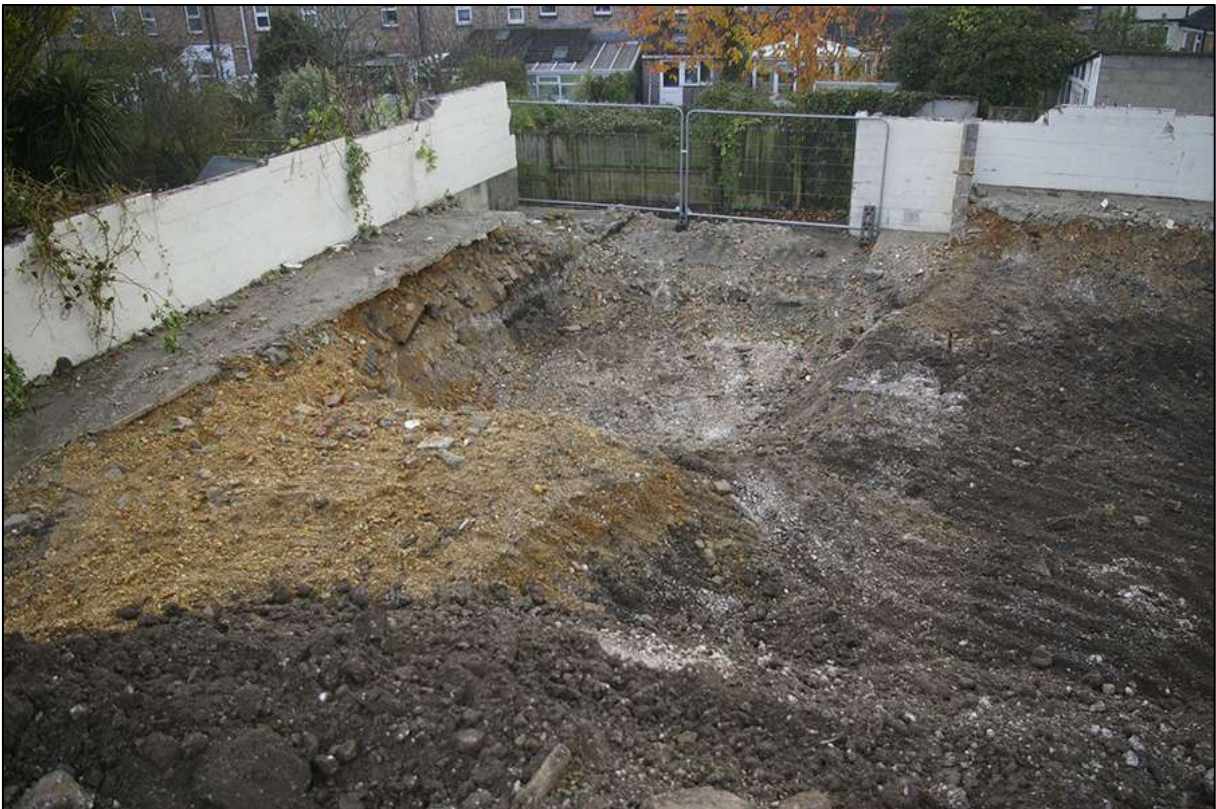
FIGURE 14: INSPECTION PIT; VIEWED FROM THE NORTH-NORTH-WEST (NO SCALE).

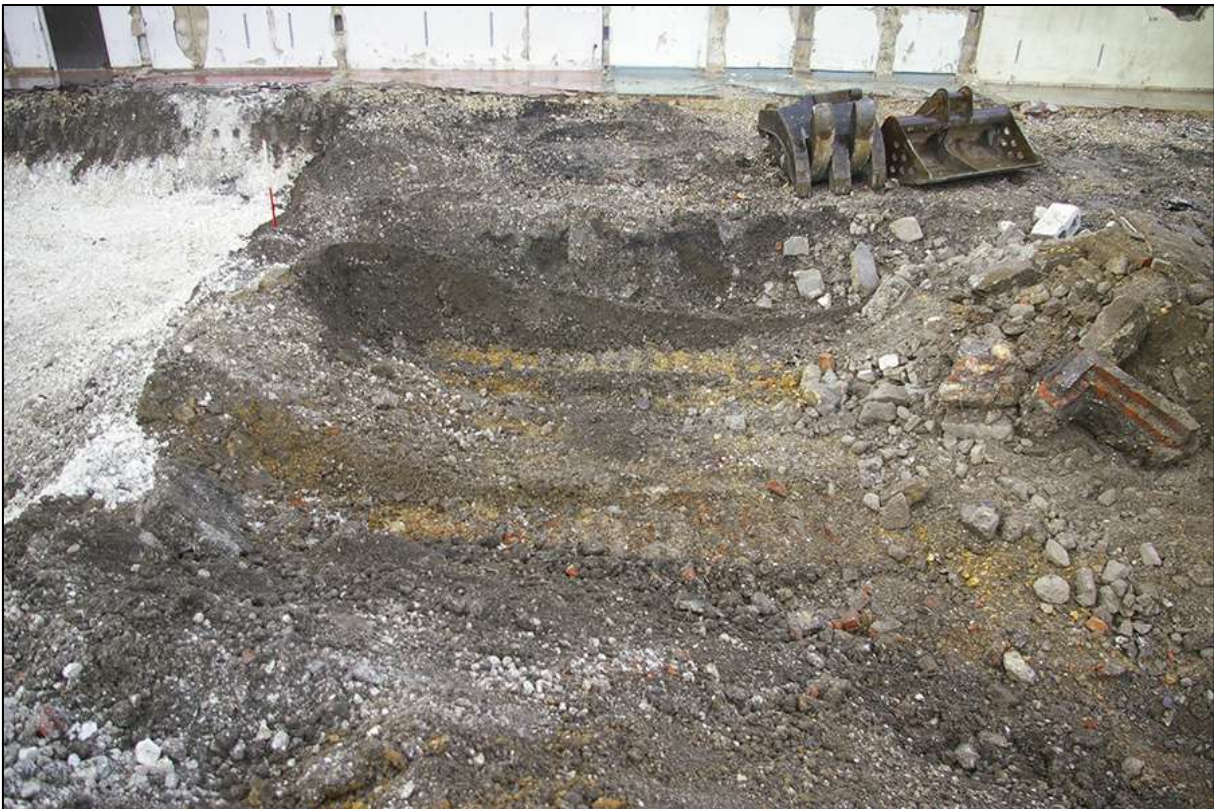
FIGURE 16: MADE-GROUND IN NORTH HALF OF SITE; BELOW THE DEPTH OF NATURAL IN THE SOUTH-WEST OF THE SITE DUE TO TRUNCATION AND IN-FILL; VIEWED FROM THE EAST (1M SCALE).
