# FARM BUILDINGS AT GREAT POTHRIDGE

RESULTS OF A HERITAGE IMPACT ASSESSMENT

SOUTH WEST ARCHAEOLOGY LTD. REPORT NO. 180921

By E. Wapshott and S. Walls  
Report Version: Final  
21<sup>st</sup> September 2018

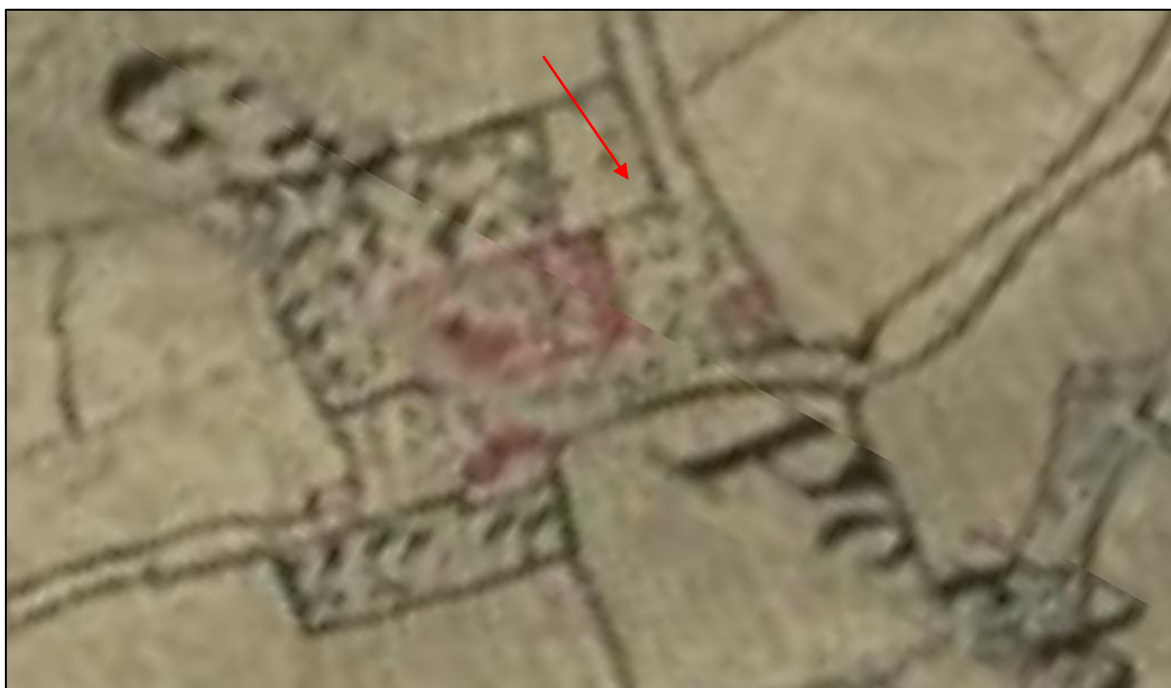
FIGURE 3: EXTRACT FROM THE ORDNANCE SURVEY SURVEYORS DRAFT MAP OF 1804 (BL); THE APPROXIMATE LOCATION OF THE SITE IS INDICATED.

The first detailed depiction of the site is the 1804 Surveyor's draft map of the Roborough area (Figure 3), which shows Great Potheridge as a complex of a house, with structures to its east-north-east and to its south. These early draft maps lack fine detail but are typically a fair representation of road networks, field-scapes and spread of buildings. More detail is afforded by the c.1841 Tithe map for Merton (Figure 4). It shows *Potheridge Barton* as a square structure with a wing/range on its north-west side with an adjacent barn (north is orientated to the top-right hand corner of this map) with a range of two larger barns to its north-east, forming a yard with a

shed to the north of these barns, in the approximate area of the proposed development. Two other structures are depicted to the south-west, towards the main road and a shed and possible linhay to the north-east. The tithe apportionment lists relatively prosaic names for the fields surrounding *Potheridge Barton* and the land use is not stated. However, plot 161, to the west of the property is named *Shippen Park* and this may refer to the use of nearby barns or the range beside the north-west corner of the house as a shippen (cattle shed); the fields practicality for keeping cattle near to the farm seems obvious. The apportionment lists the owner of *Potheridge Barton* as Representatives of the Right Honourable Lord Rolle and the occupant as William Collihole.

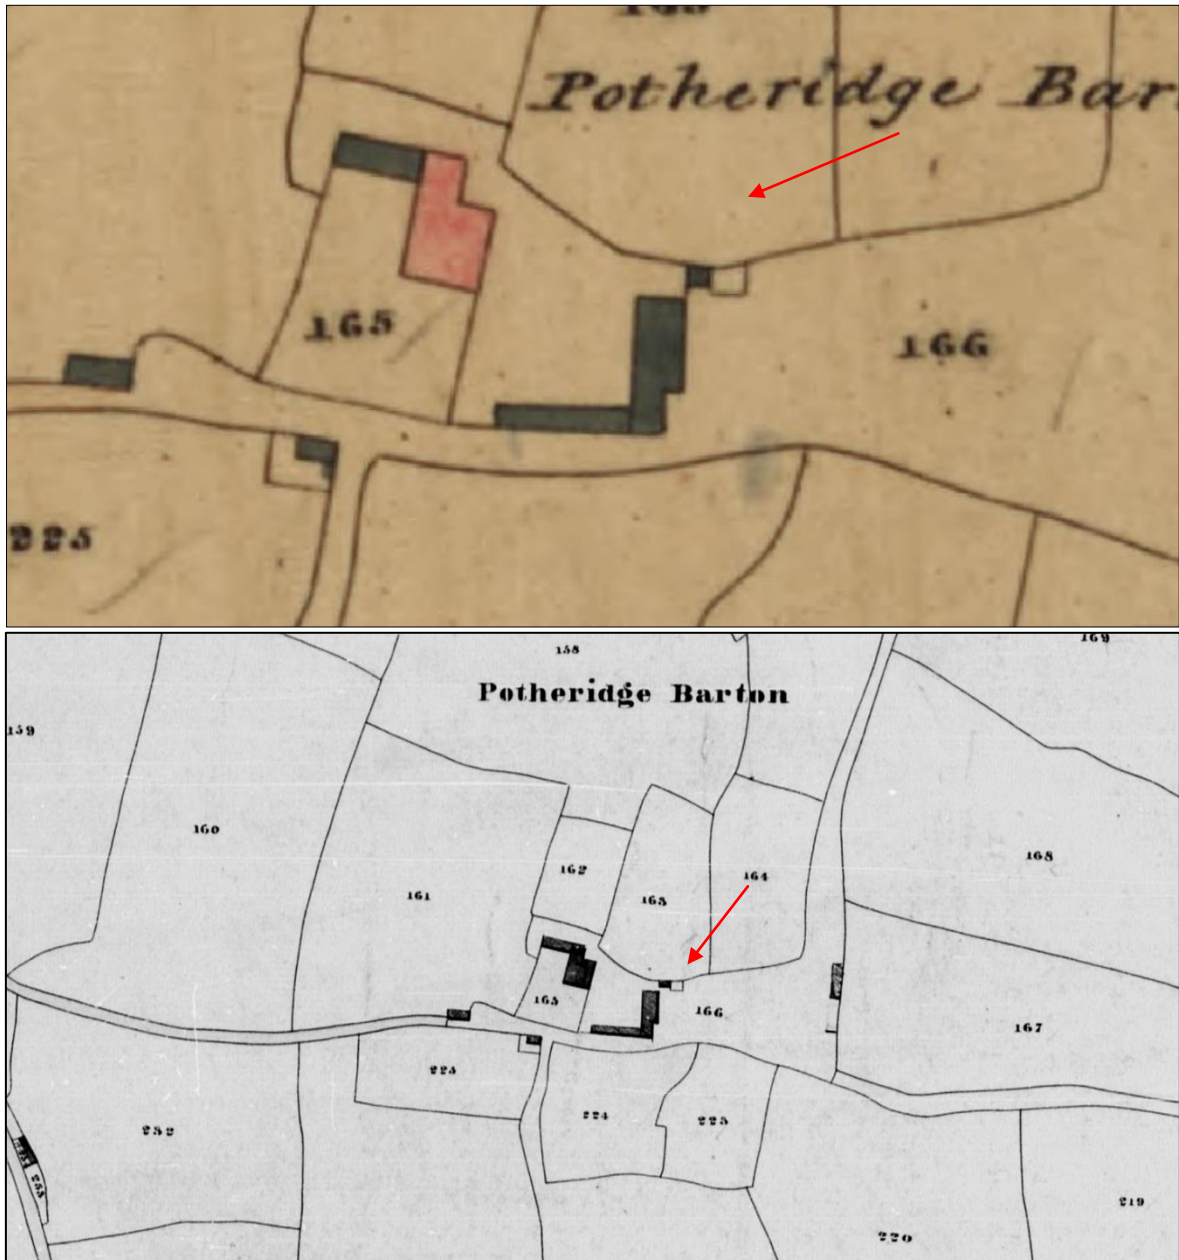
FIGURE 4: EXTRACTS FROM THE 1841 MERTON TITHE MAP; THE APPROXIMATE LOCATION OF THE SITE IS INDICATED (DHC).

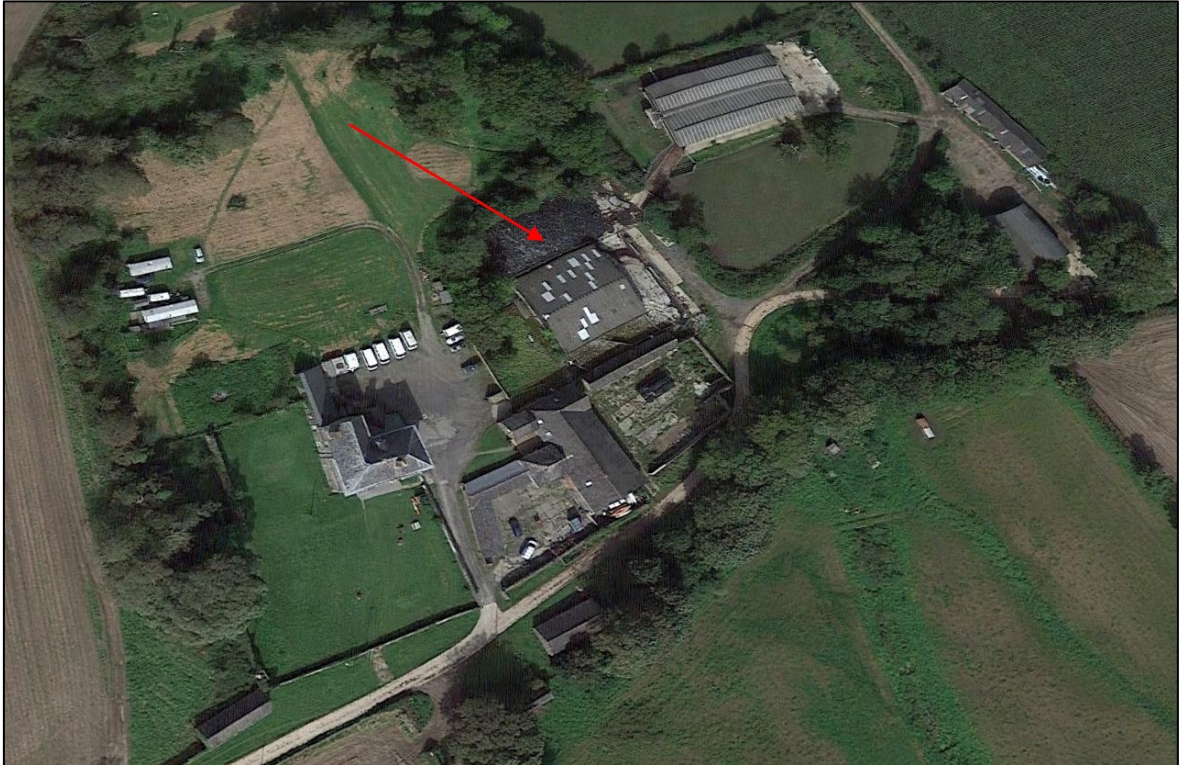
FIGURE 7: SATELLITE IMAGE OF THE SITE TAKEN IN 2017 (©GOOGLE 2018); THE APPROXIMATE LOCATION OF THE SITE IS INDICATED

Satellite imagery from 2002 shows that the southern range of the original barns (east of the house) had fallen into disrepair with only its outer- and some internal walls surviving; the roof lost by this date. The large barn to the north-east of the main complex was also present on this image. By 2017 (see Figure 7) the southern and eastern ranges of the barns added to the rear of the original barns have fallen in to disrepair with only their outer- and some internal walls surviving; their roofs also having gone. The existing silage clamp can be seen under tyres against the modern square barn.

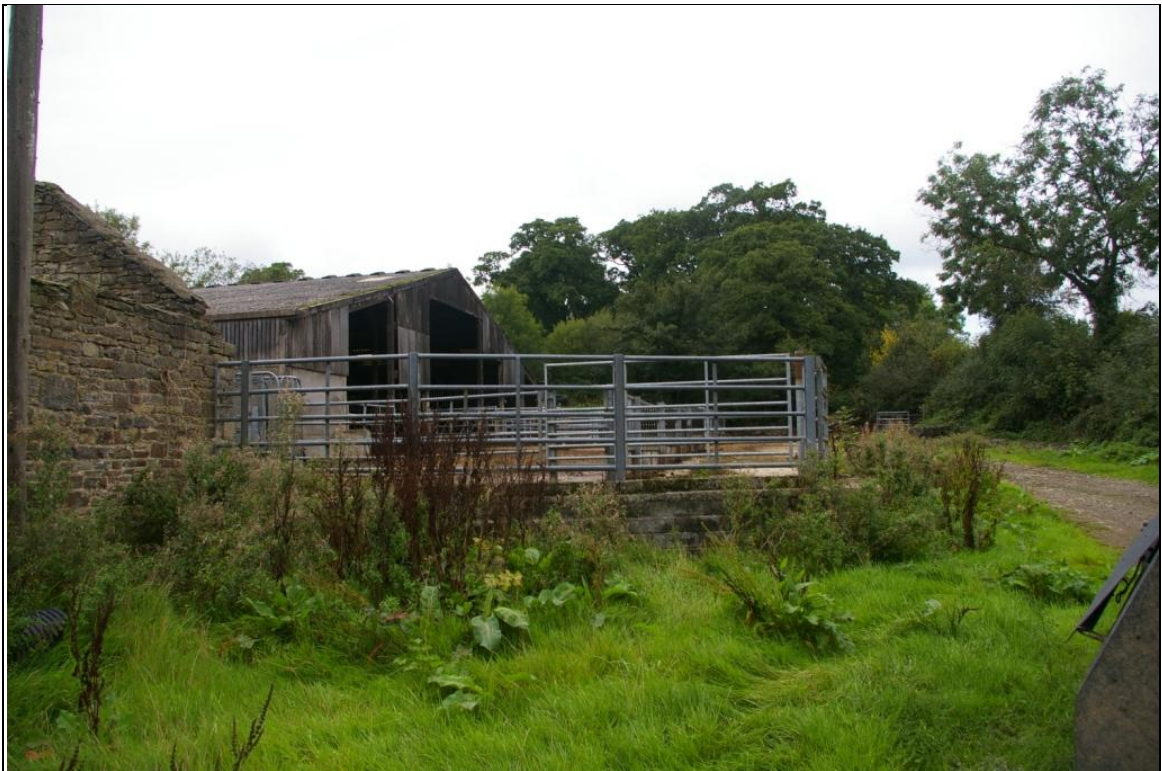
6. DETAIL OF THE CURRENT BUILDING AND ITS RAISED CONCRETE YARD; FROM THE SOUTH.

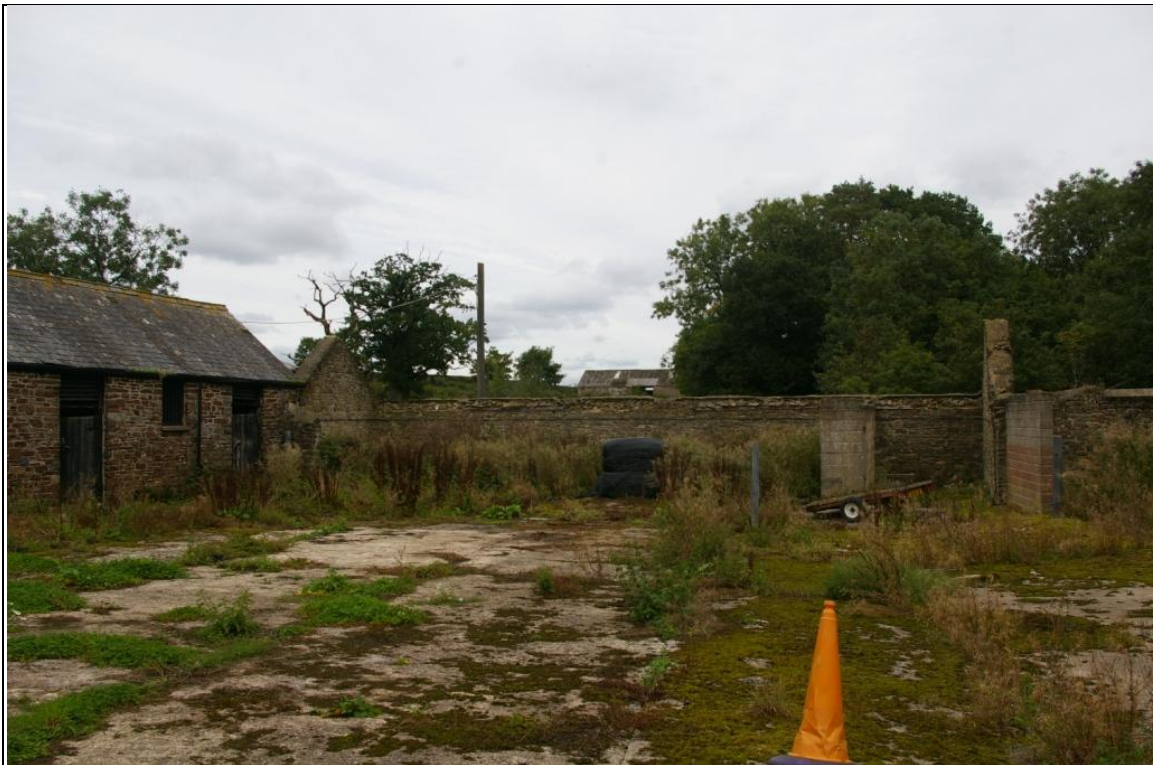
14. VIEW OF THE RUINED EASTERN BUILDING IN THE 19<sup>TH</sup> CENTURY FARMYARD AND VIEWS OVER ITS RUINS TO THE OUTBARN; FROM THE SOUTH-WEST.

The 19<sup>th</sup> century farmyard is not in use by the tenant and has not been maintained by the wider estate, aerial mapping showing the ruined barns here were still standing and roofed in the early 2000s, so are recent losses. The poor condition and lack of maintenance to these barns, damages the overall narrative of the site by their risked loss and also their scruffiness visually lowers the status of the wider holding.

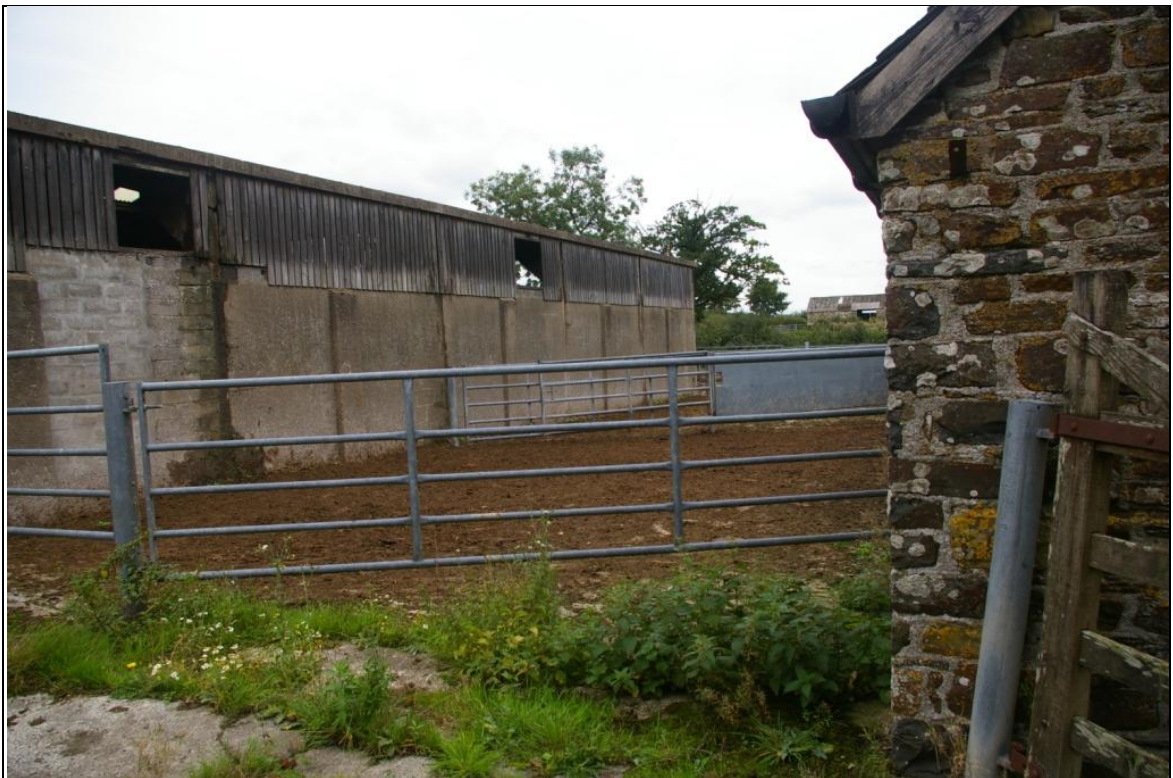
18. PART OF PROPOSAL AREA BETWEEN THE EXTANT MODERN BUILDING AND THE NORTH ELEVATION OF THE LOW 19<sup>TH</sup> CENTURY NORTH RANGE; FROM THE SOUTH-WEST.

*Magnitude of Effect:* The new building will just fall short of abutting the historic north cow byre range by a matter of a few metres. The other buildings have no direct effects. It is important that the historic cow byre is not damaged by the building or there could be a very substantial and negative direct effect. Otherwise it is more an inherent visual effect on the dominance of the modern farm buildings over the historic and therefore a slight shift to modern visuals across the site. The views within the farmyard will largely remain the same. The buildings will become further derelict it is expected by the creation of newer practical spaces, removing them further from usefulness.

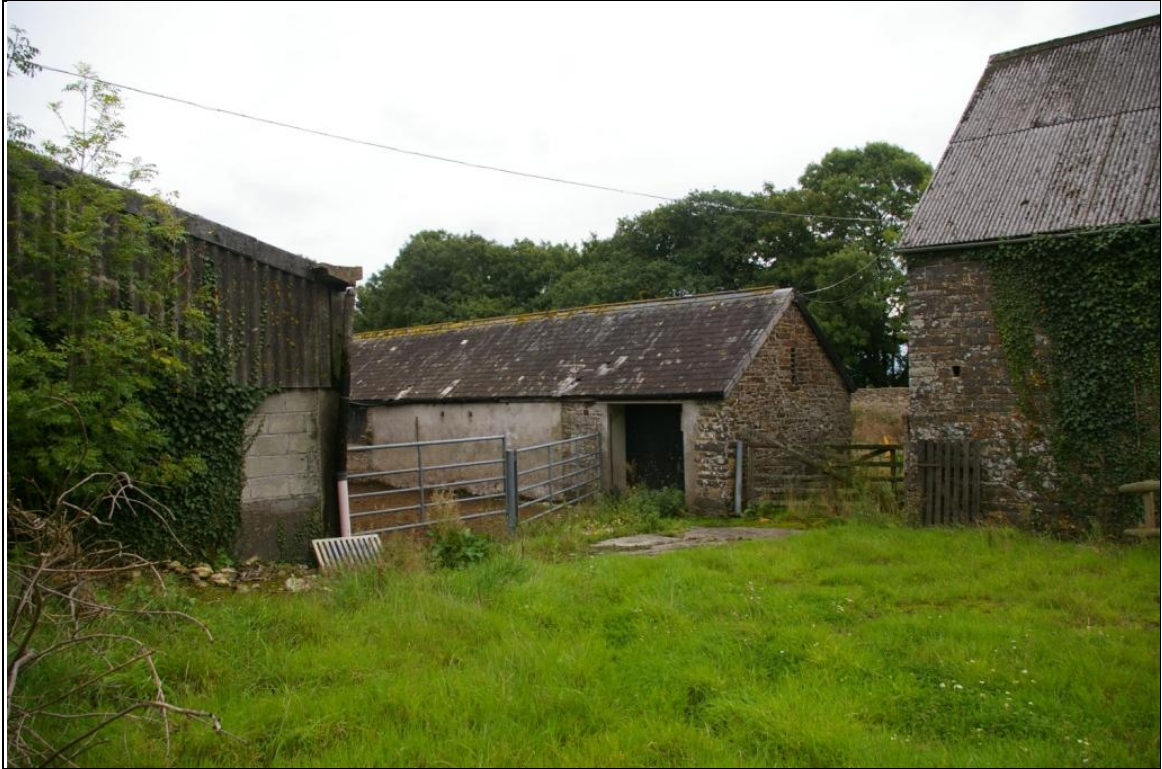
19. THE NORTH ELEVATION OF THE NORTH RANGE OF THE 19<sup>TH</sup> CENTURY FARMYARD WHICH WILL BE ABUTTED AND SCREENED BY THE PROPOSALS; FROM THE NORTH-WEST.

*Overall Impact Assessment:* **Negative/minor**, if the north building is damaged, as the cumulative impact on the 19<sup>th</sup> century phase of the site would be significant and irreversible.

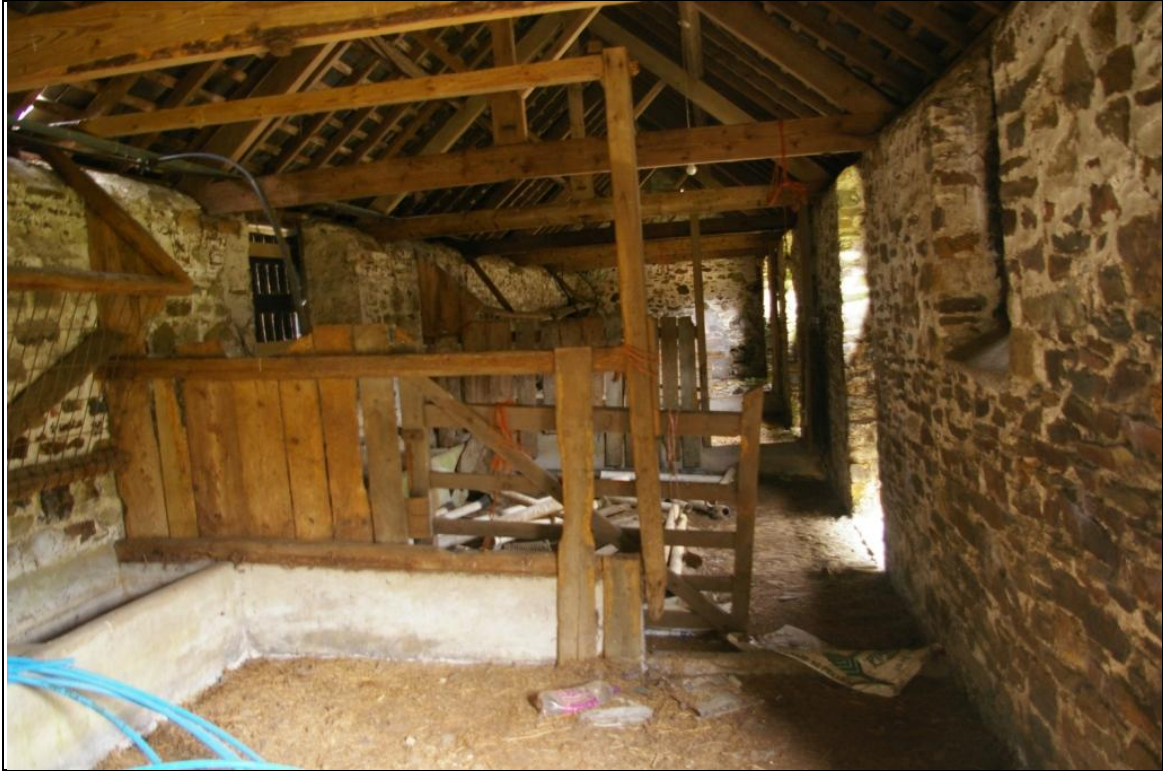
23. THE INTERIOR OF THE NORTH RANGE, WHICH IS THE CLOSEST TO THE DEVELOPMENT; FROM THE WEST.

building has been forced on its east side to create an open cattle shelter and a section of wall with two doors with louvers over and a hopper casement window can be seen to survive to the north end. To the north side of the yard is a low single storey range of cow byres, its front stone wall punctured by alternative heavy plank doors and chunky louvered windows. This rubble stone range, with a slate roof, has a cobbled floor throughout, although damaged in places to the interior with timber partitions forming large two cow compartments with troughs and hayricks to the north wall.
