ASHCOMBE GARDEN SIMONSBATH EXMOOR SOMERSET

Results of an Archaeological Evaluation

South West Archaeology Ltd. report no. 181115

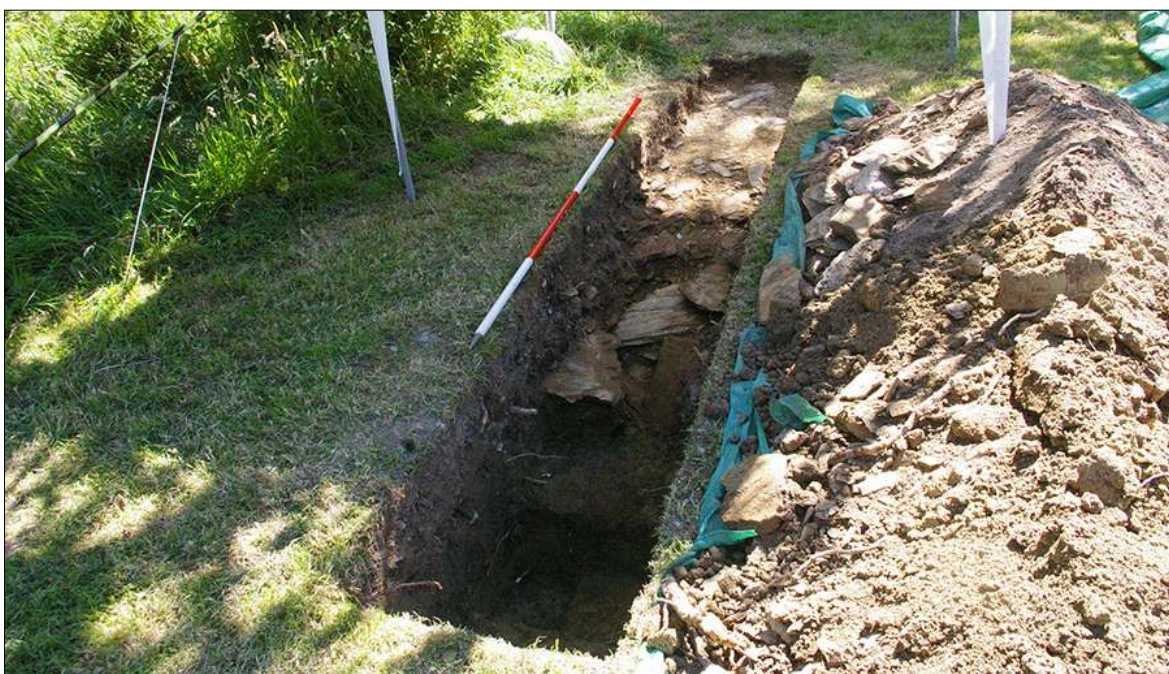
FIGURE 2: TRENCH 1; VIEWED FROM THE NORTH-EAST (2M SCALE).

Trench 1 (4.10m long × 0.60m wide), aligned approximately north-east by south-west, was located in the south of the garden to target the path depicted on the 1889 OS map. It was located close to the river bank in order to confirm the location of a bridge destroyed in the flood of 1952. The trench exposed geological deposits of river clays and a weathered band of stone that was overlaid by a made-ground of re-deposited garden soil (101). See Figures 2, 8 and 12. No archaeological features appeared to be present. However, based on the results from Trench 2 it is likely the natural material encountered to the west end of the trench formed the solid base of the path shown on the historic OS maps. Layer (101) contained three sherds of post-medieval and modern pottery and very small fragments of coke and anthracite.

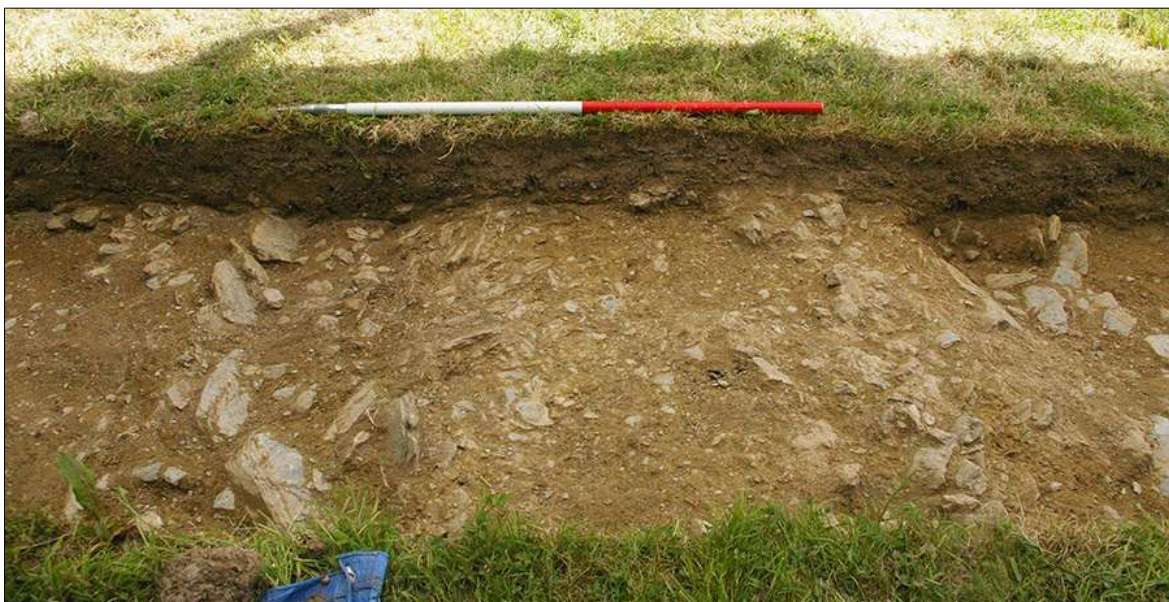
FIGURE 3: PATH [203]; VIEWED FROM THE WEST (1M SCALE).

Trench 2 (5m long × 1m wide), aligned approximately north-south, was located to the middle-north part of the meadow and targeted the footpath shown on the historic OS maps. It was visible as an earthwork on the ground. The trench contained Footpath [203]. See Figures 3, 9 and

12. Footpath [203] consisted of a patchy linear spread of (mainly quartz) gravel (204) 1.74m wide with a pronounced camber, flanked by shallow concave gullies, each roughly lined with the local slate stone (205) and (206). All of the deposits that constitute the path appeared to be pressed directly into the natural substrate, which appeared compacted through use. Given that the line of the path is marked by a fairly distinct earthwork it is probable that the natural material is redeposited and was deliberately formed to provide a solid base. That being the case, the natural in Trench 1 probably performs a similar function. Topsoil (200) contained a modern corroded iron tool; a sample of angular quartz was taken from path layer (204).

The archaeological evaluation clarified some aspects of the garden at Ashcombe. The main footpath leading from Simonsbath House across the meadow was located and its form and build established. The location and build of the wall that once formed the north-eastern boundary of the site was also determined. The precise location of the paths crossing Ashcombe stream, and therefore the site of the bridge abutments, was not established. It is possible the path here was damaged or swept away in 1952, and the deposits encountered in Trenches 3 and 4 were all clean shale gravels. The 'natural' encountered in Trench 1 may represent the solid base of the path here, but this was not confirmed. Images and photographs in support of the following discussion can be found in Appendices 3 and 4.

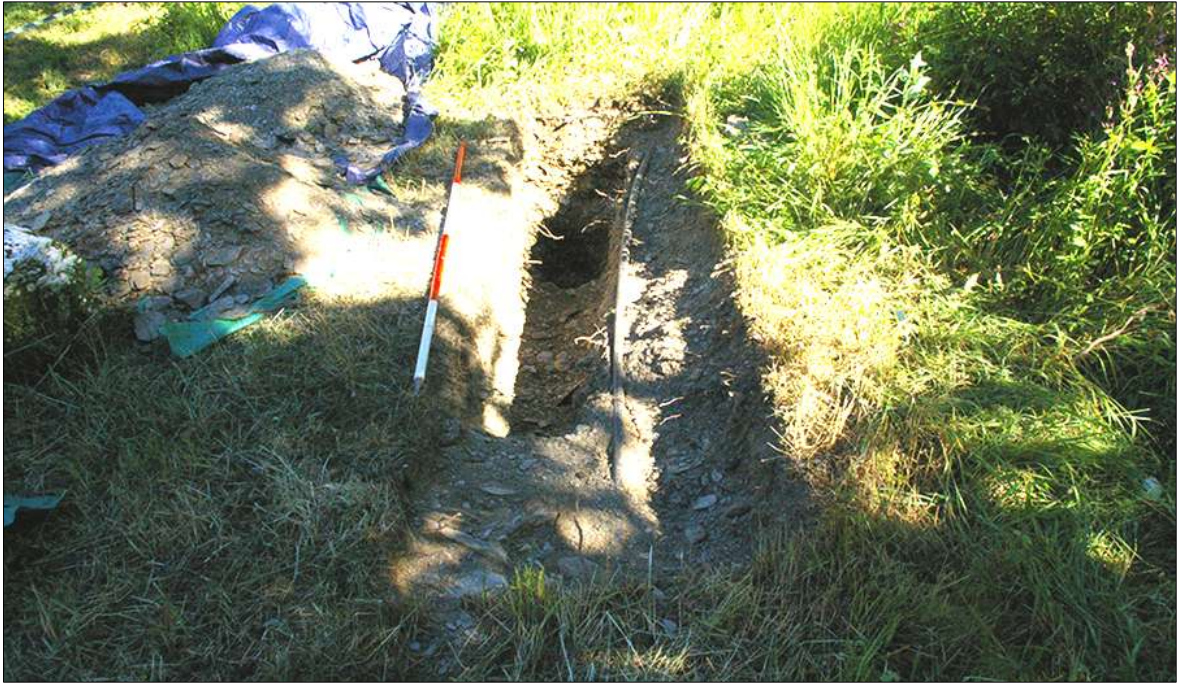
FIGURE 4: TRENCH 4, POST-EXCAVATION; VIEWED FROM THE SOUTH (2M SCALE).

Trench 4 (4m long × 0.60m wide), aligned approximately north-south, was located on the eastern side of the garden to target where the path may have crossed the Ashcombe stream. It contained geological deposits of river gravels and large stones that may have accumulated over time or been removed from the water channel and used to expand and level the gardens. Some of the larger stones may be from the demolished bridge. A modern black alkathene water pipe, aligned approximately north-south, ran along the eastern half of the trench. See Figures 4, 10 and 12. No archaeological features were present, including any evidence of a path. Topsoil (400) contained a small amount of modern debris and ceramic building material.

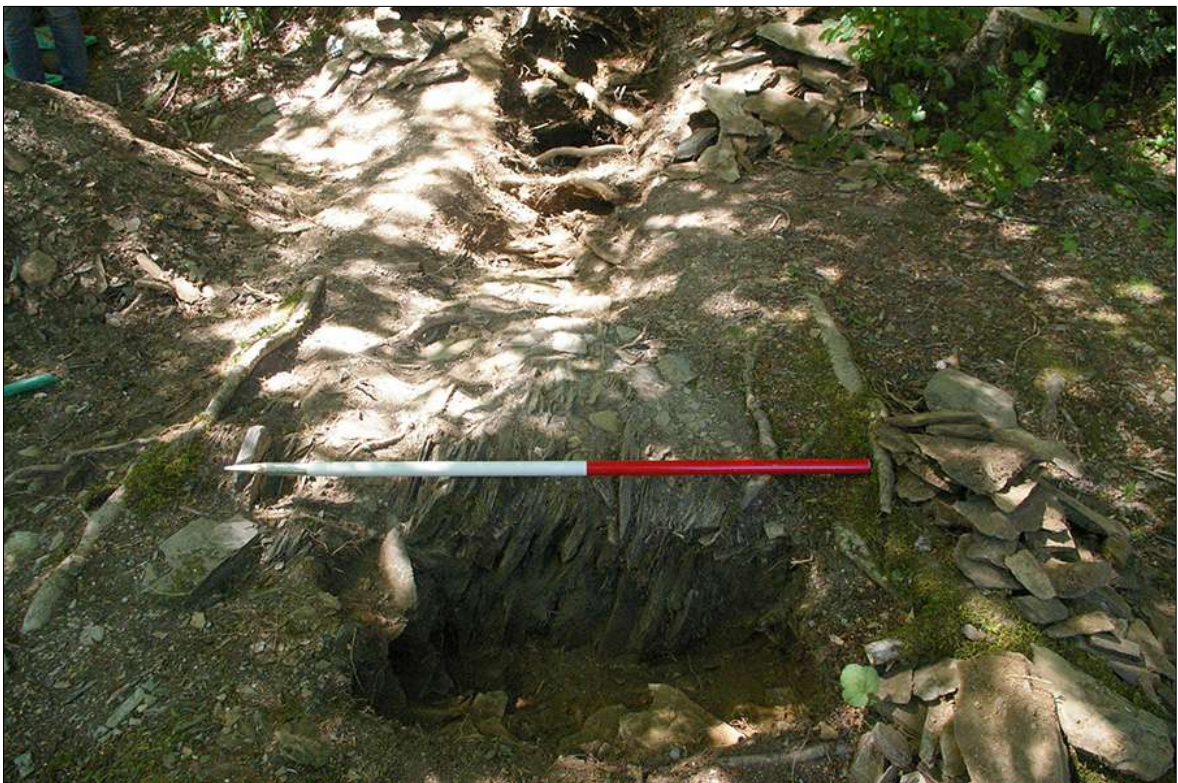
FIGURE 5: WALL {504}; VIEWED FROM THE SOUTH-EAST (1M SCALE).

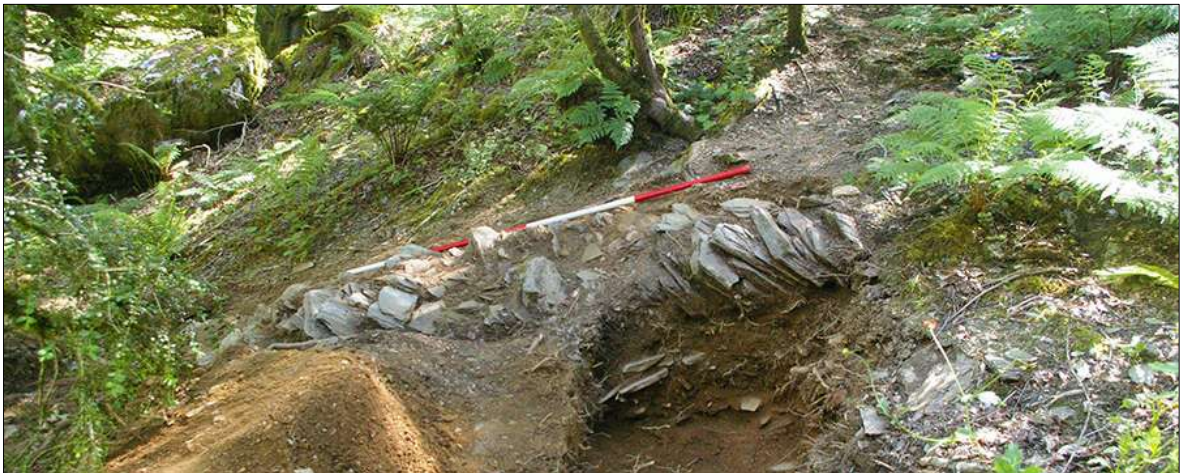
FIGURE 6: WALL {603}; VIEWED FROM THE NORTH-EAST (2M SCALE).

Trench 6 (1.85m long × 0.75m wide), aligned approximately north-east by south-west, was located across a surviving segment of boundary wall at the northern end of the Gardens. In addition, a 2.85m length of the surviving wall, {603}, was cleaned back in order to examine its build. Excavation revealed a single course of pitched and flat laid stones at the approximate depth of the topsoil, with no discernible construction cut or bond. See Figures 6, 7, 11 and 12. Wall {603} was approximately 0.90m wide and comprised a single course (c.0.26m) of slatestone. It overlay a subsoil of weathered natural and there was no discernible construction cut; however, bioturbation of the topsoil and subsoil, and the insubstantial nature of the wall itself, may have obscured a clear construction cut. The stones of the upper section of wall tilt downslope at a 45° angle, but were presumably vertical when first built. The stones of the lower section of wall were laid horizontally; it is possible these stones were also once vertical, but it is more likely they were laid flat for stability. No finds were present.

The remains of the north-east boundary wall proved highly ephemeral. With the caveat that very little survives, excavation of the wall would imply it comprised sections of pitched and laid stonework. Examples of both are to be found around the Garden, though walls of pitched stone are usually more substantial as they tend to be stone-faced banks rather than freestanding walls *per se*. The wall appears on the historic OS maps and locals recall an integral arch over the

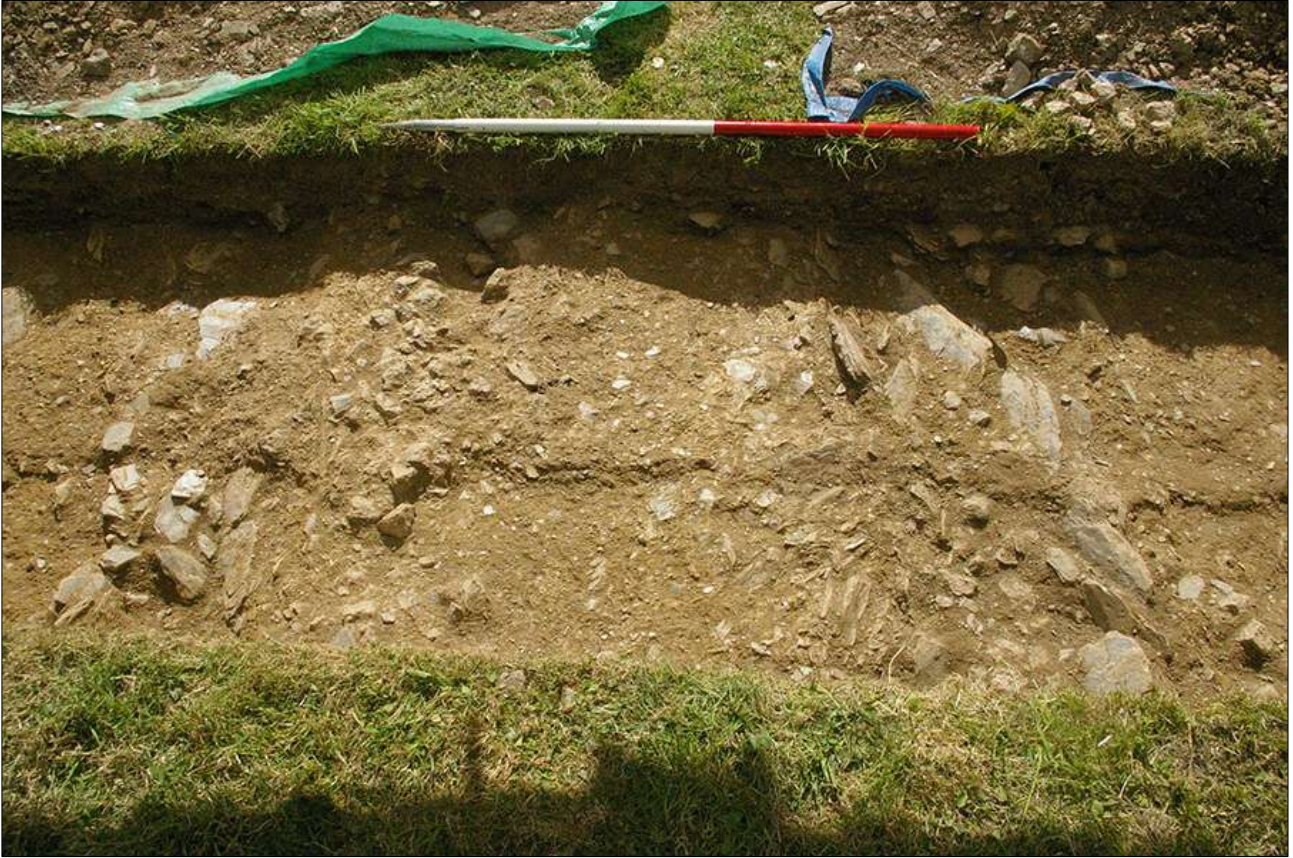
7. PATH [203]; VIEWED FROM THE EAST (1M SCALE).

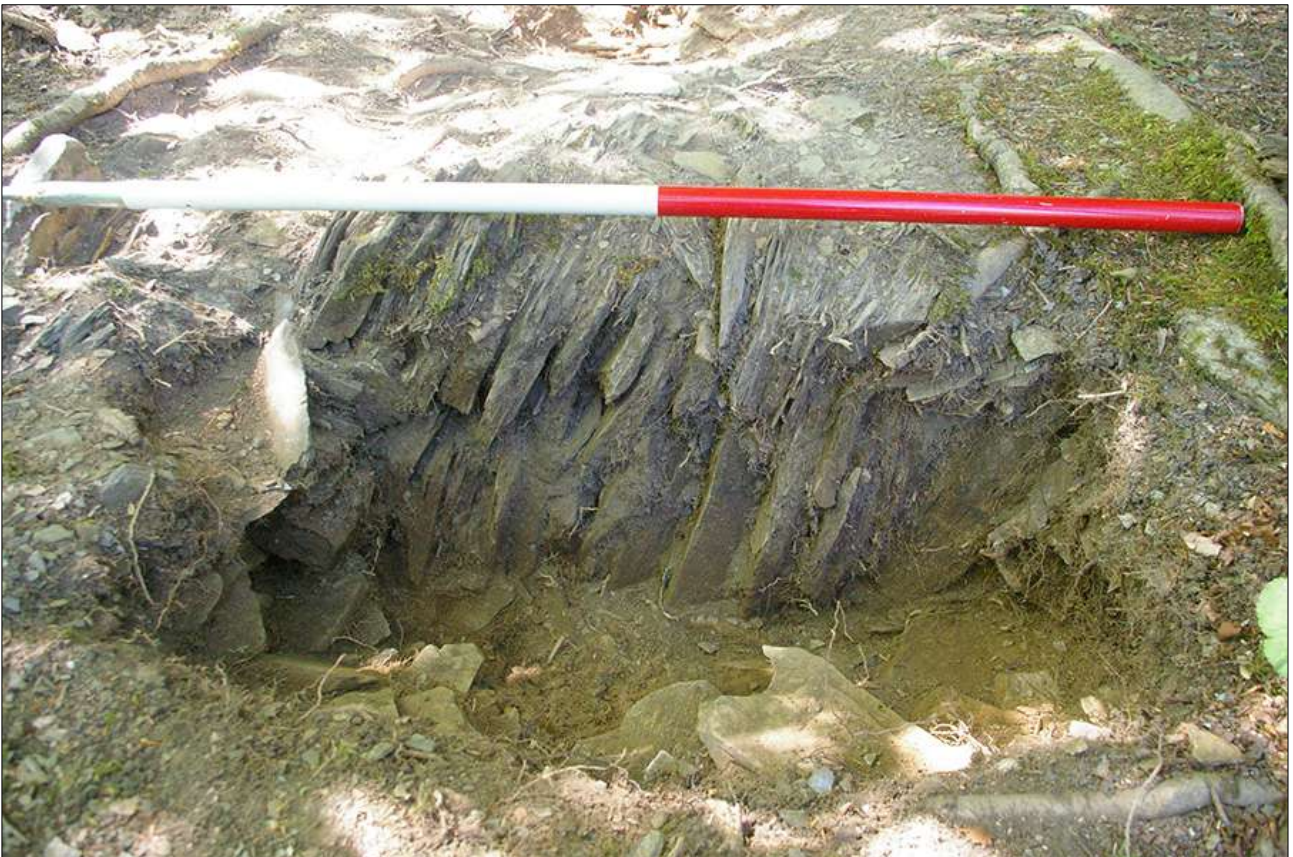
21. WALL {504}; VIEWED FROM THE SOUTH-EAST (1M SCALE).

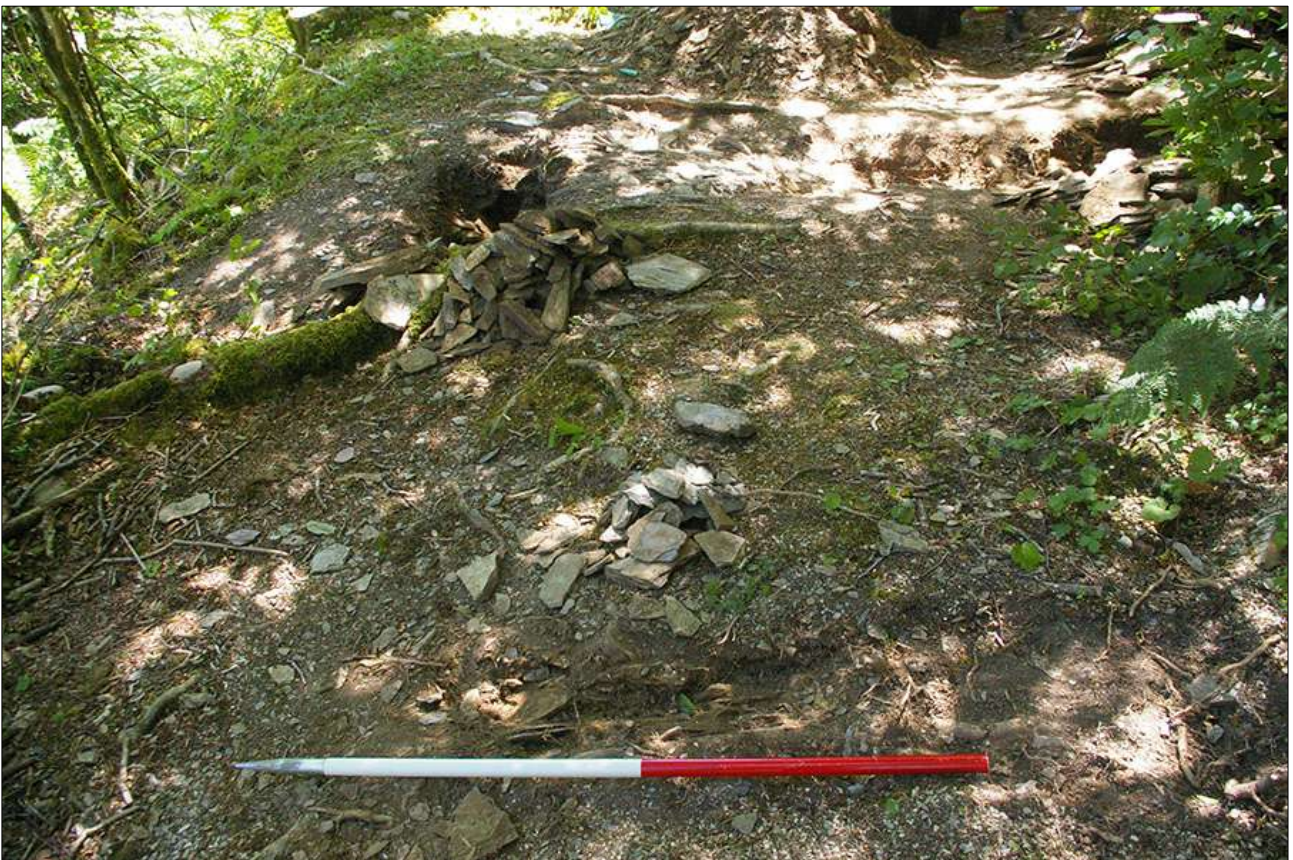
25. VIEW OF PITCHED STONES ALIGNED WITH WALL {504}; VIEWED FROM THE NORTH-EAST (1M SCALE).

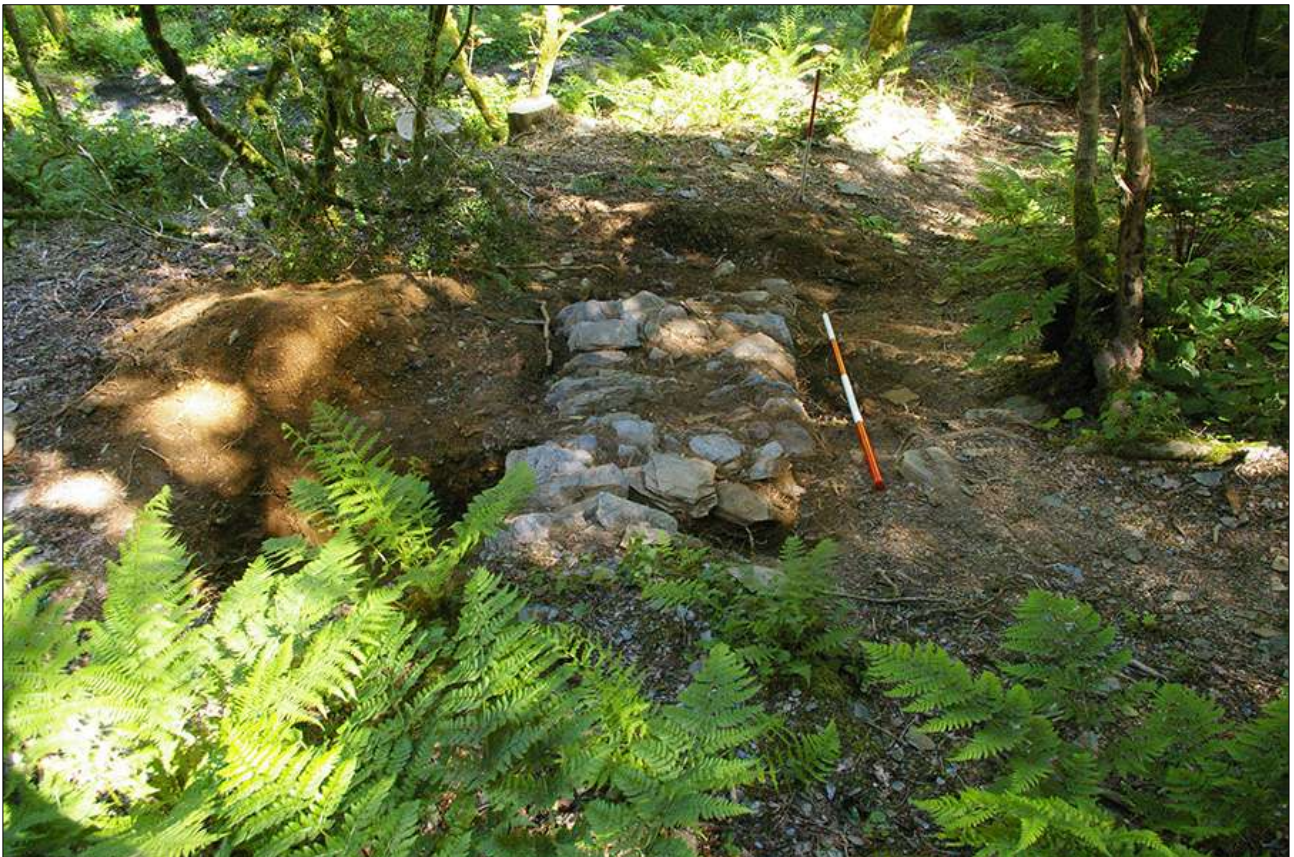
28. WALL {603}; VIEWED FROM THE NORTH-WEST (2M SCALE).

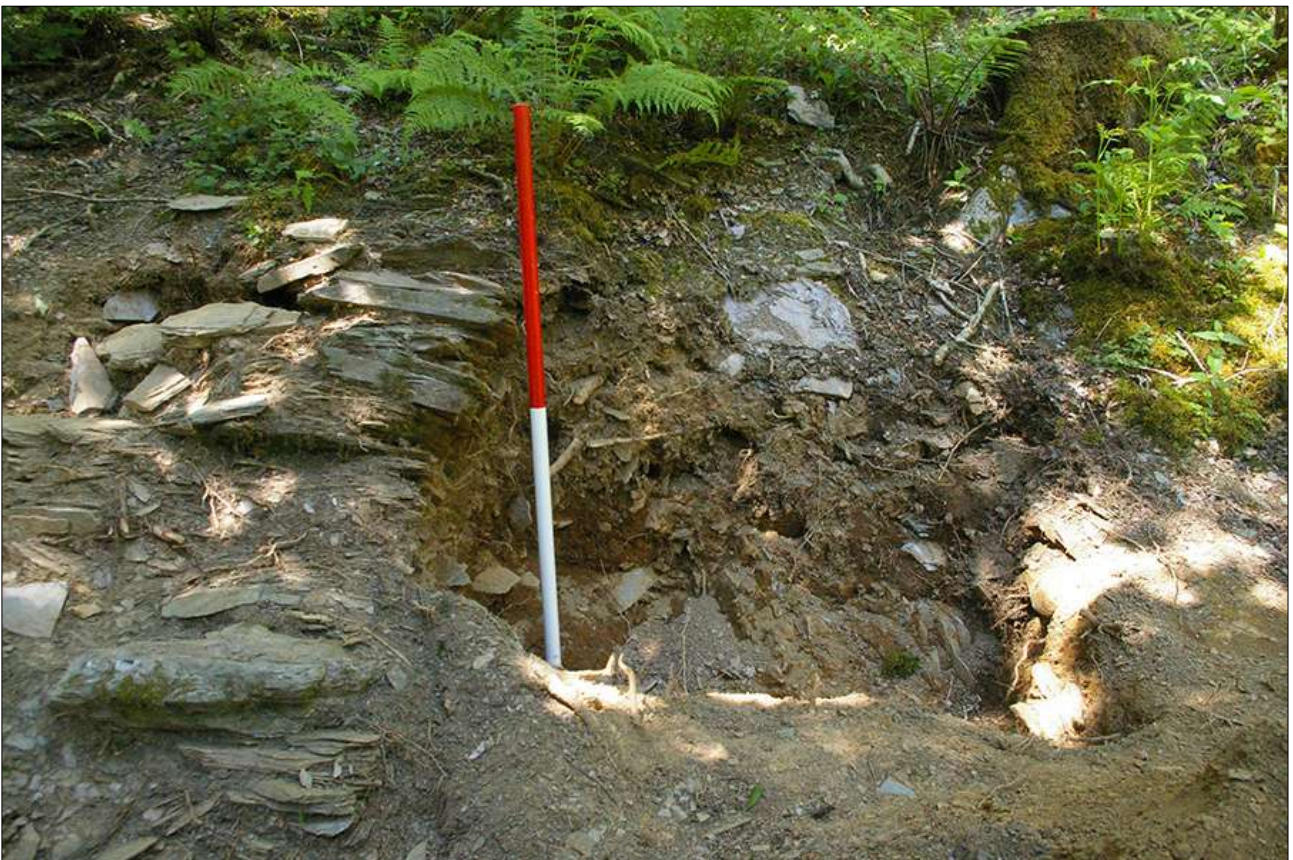
34. WALL {603}; VIEWED FROM THE SOUTH-EAST (1M SCALE).

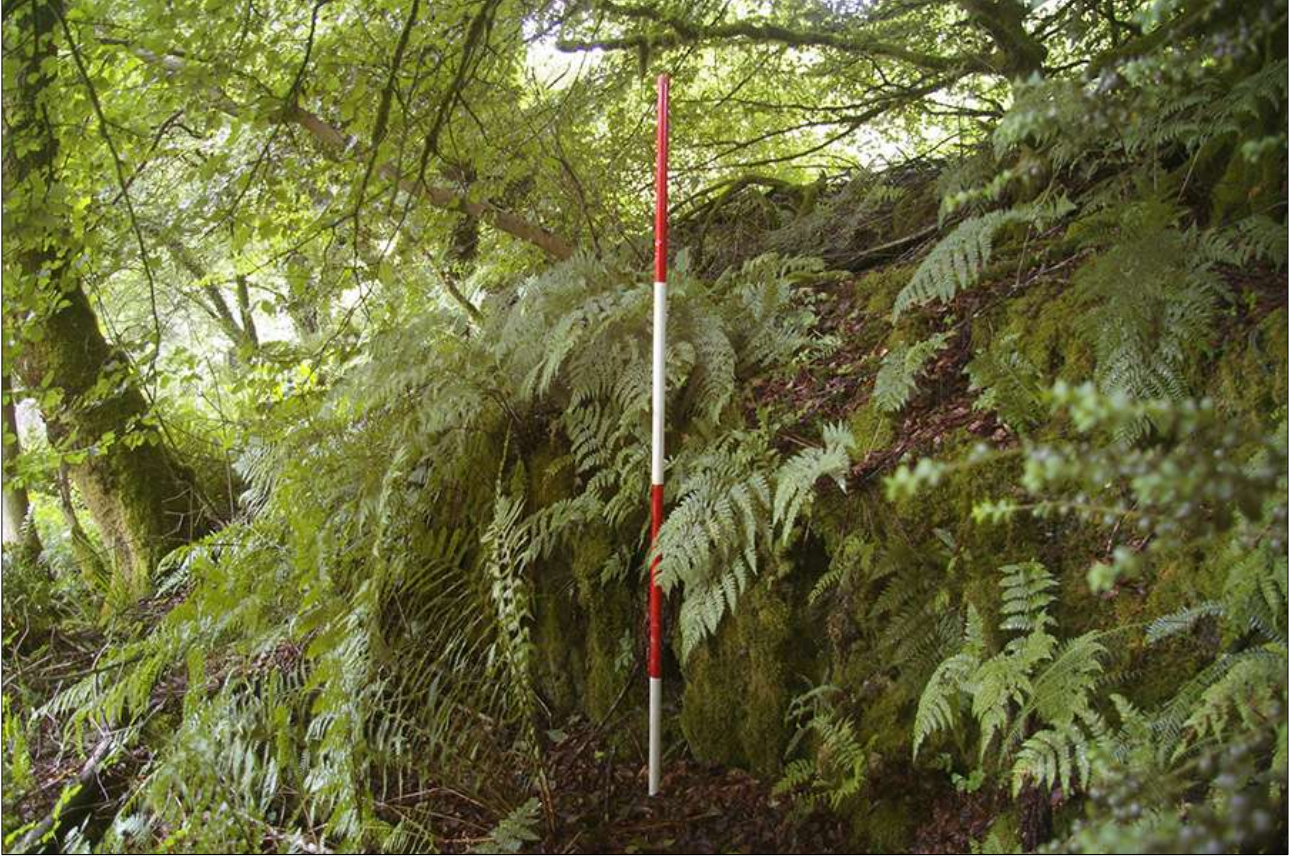
35. BOUNDARY WALL ADJACENT TO PUBLIC TOILETS AND NORTH-WEST OF ASHCOMBE COTTAGE; VIEWED FROM THE SOUTH (2M SCALE).

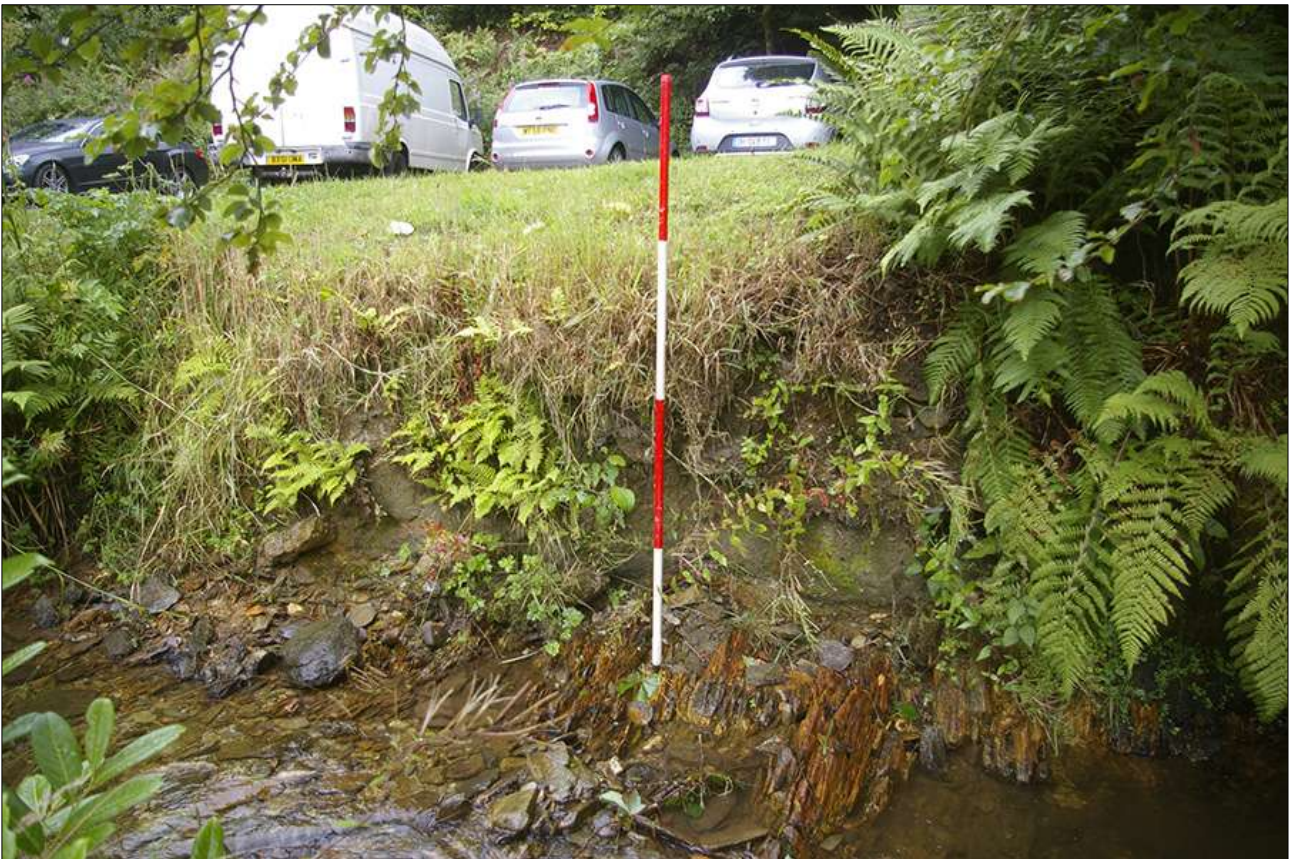
36. RIVER BANK ADJACENT TO ASHCOMBE CAR PARK; VIEWED FROM THE WEST (2M SCALE).

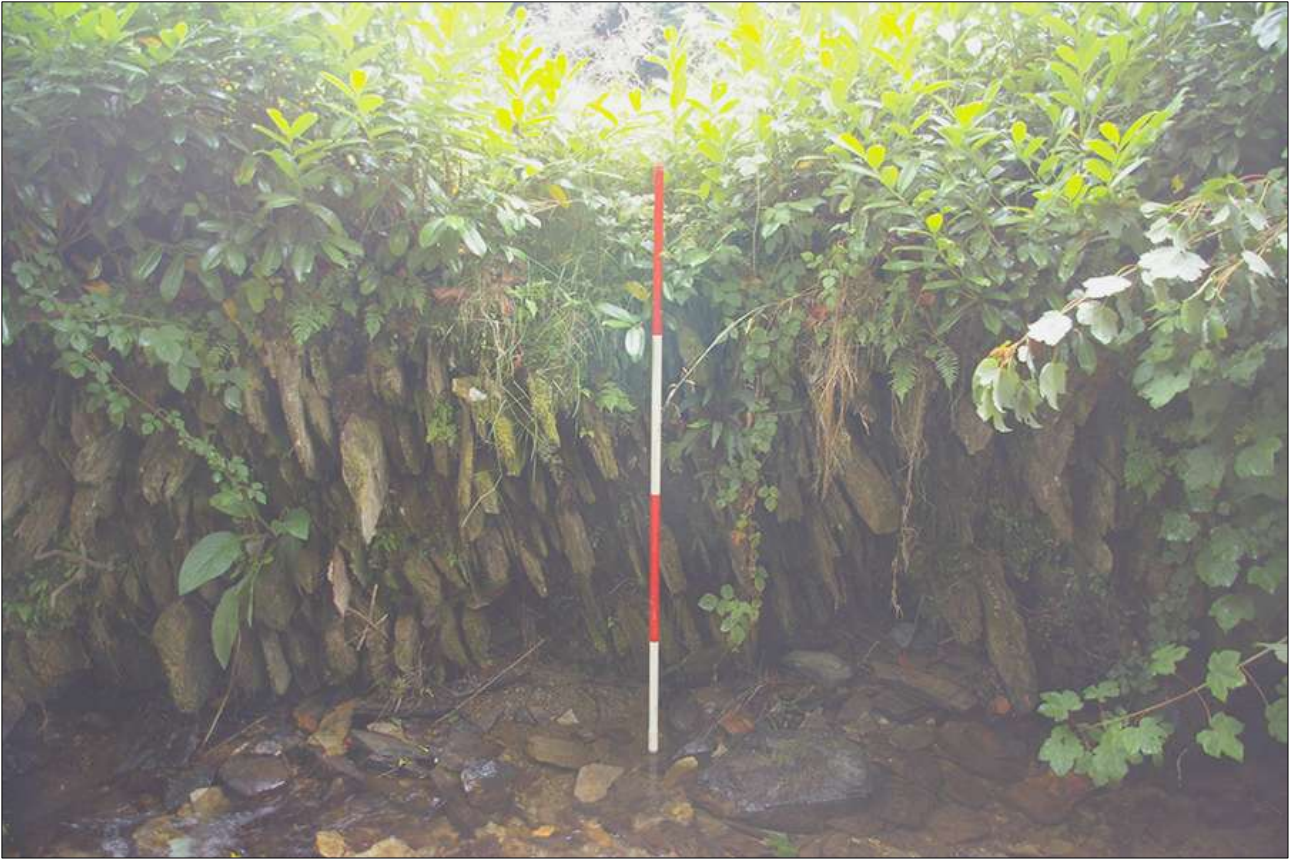
37. SECTION OF CANALISED ASHCOMBE STREAM ADJACENT TO WHITE ROCK COTTAGES; VIEWED FROM THE SOUTH (2M SCALE).

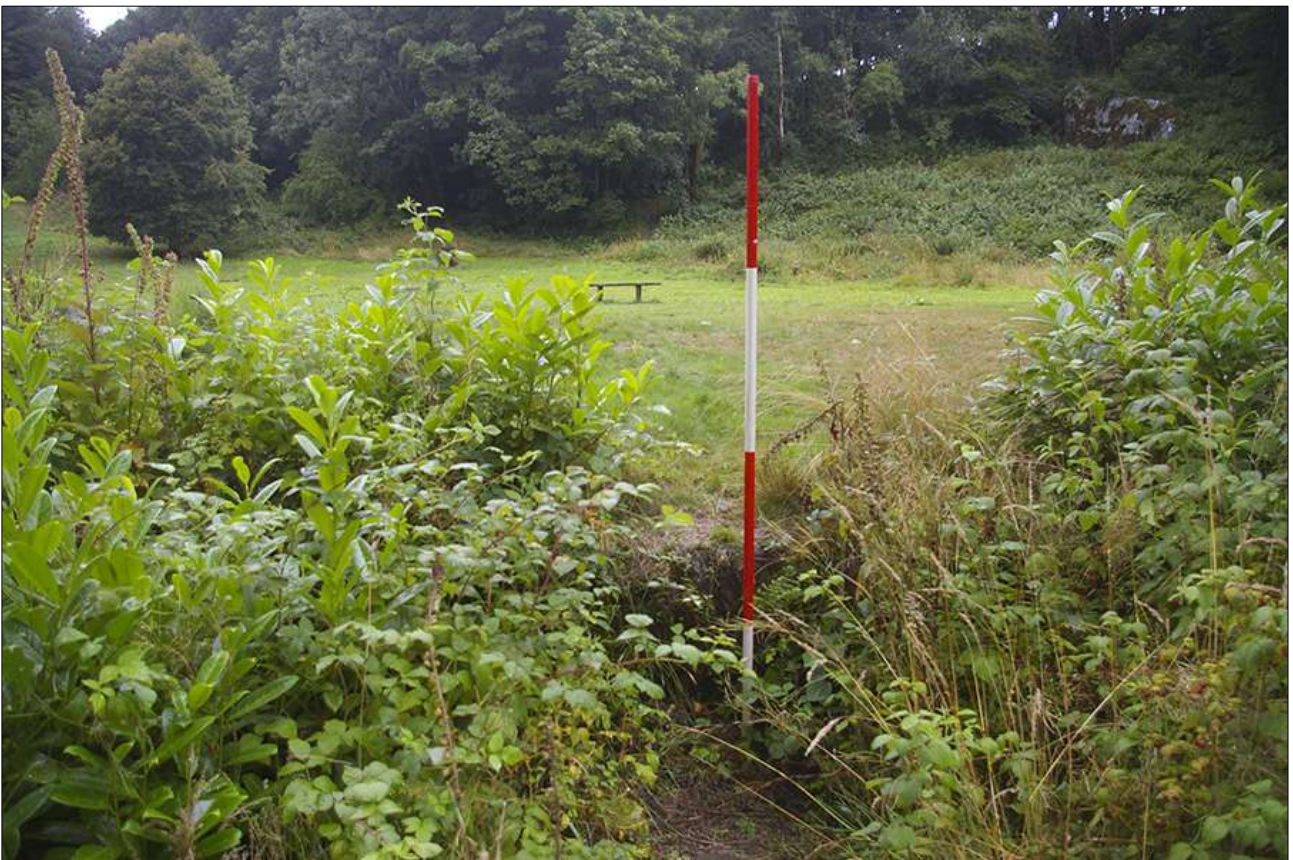
38. PITCHED STONE TO CANALISED PART OF ASHCOMBE WATER IN SOUTH-EAST OF MEADOW, NOW SILTED-UP; VIEWED FROM THE SOUTH-EAST (2M SCALE).

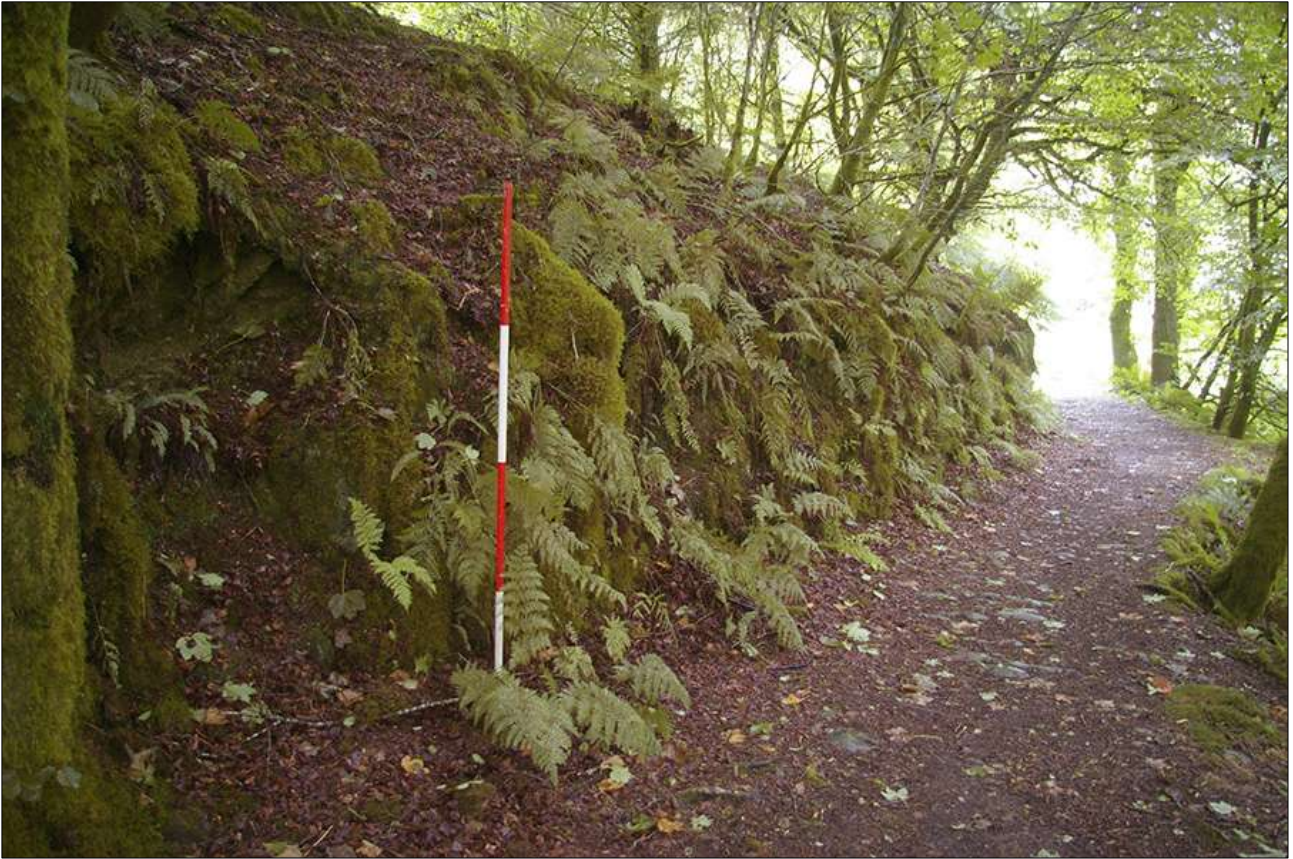
39. PATHWAY FROM SIMONSBATH HOUSE LEADING TO ASHCOMBE GARDEN, JUST SOUTH OF THE GARDEN, SHOWING NATURAL ROCK BEHIND THE REVETMENT FACE; VIEWED FROM THE SOUTH-SOUTH-WEST (2M SCALE).

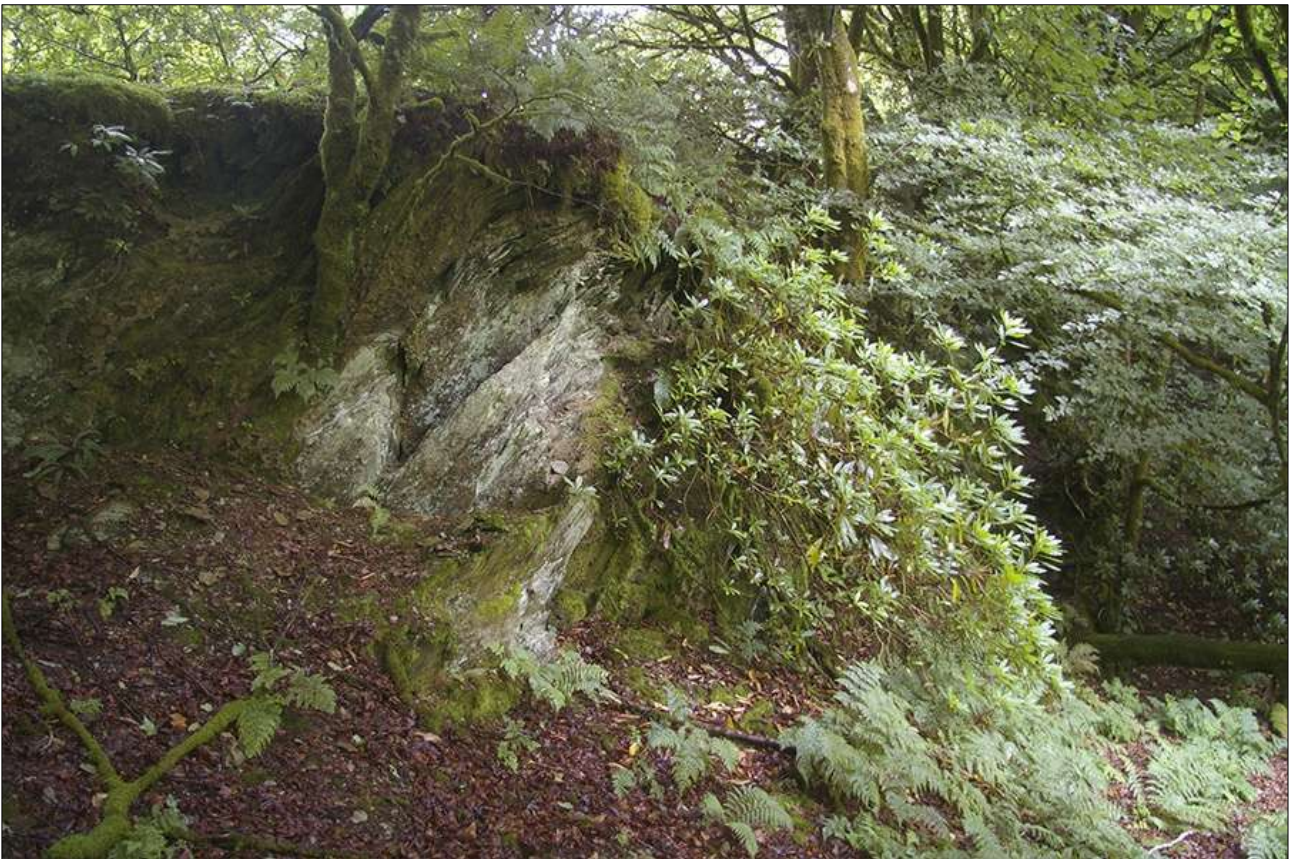
40. SOUTH SIDE OF QUARRY TO THE WEST SIDE OF THE GARDENS SHOWING THE STRATA OF THE BEDROCK AND FOLDS WITHIN IT; VIEWED FROM THE EAST (NO SCALE).

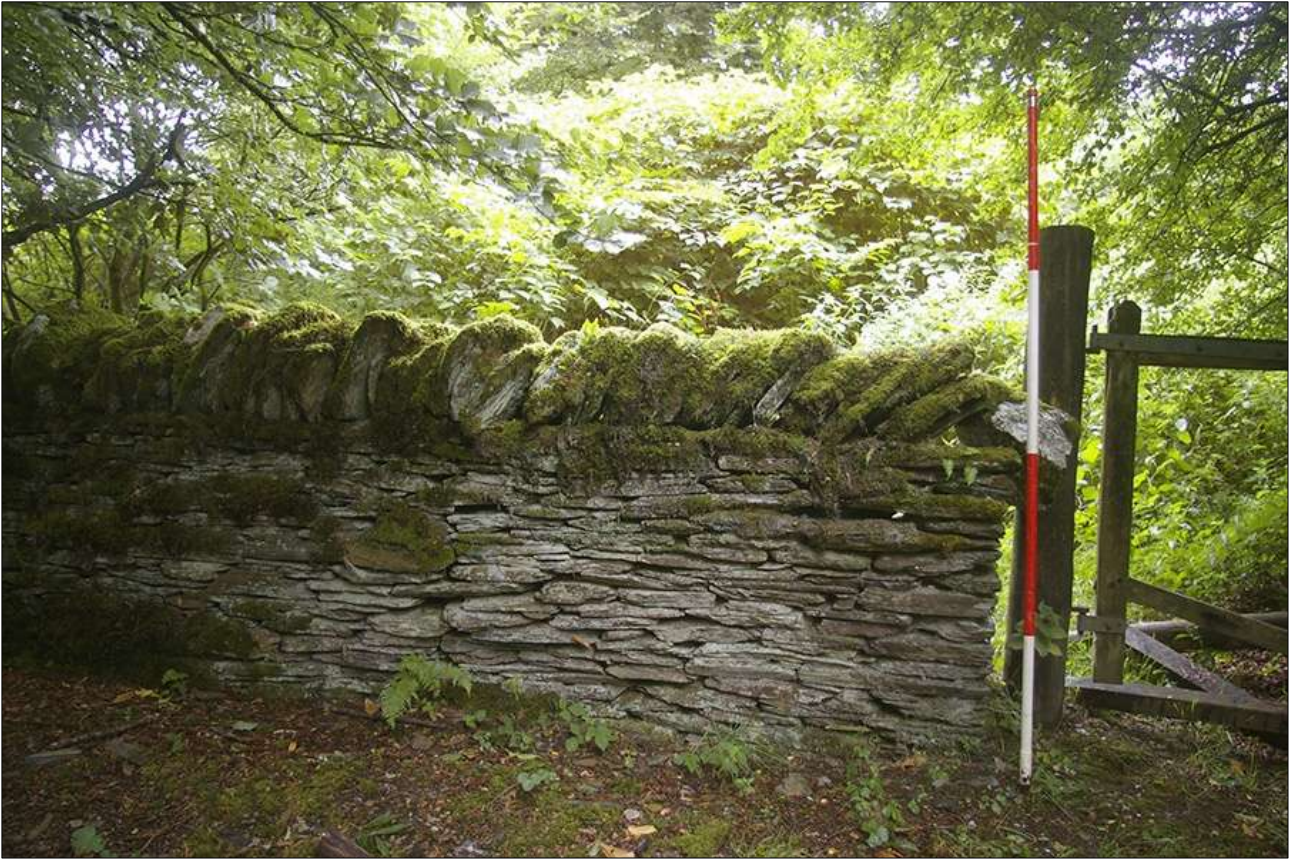
41. EXAMPLE SECTION OF DEFINITIVE BOUNDARY WALLS TO THE FIELDS NORTH-WEST OF THE SITE AND IN THE AREA OF SIMONSBATH; VIEWED FROM THE SOUTH (2M SCALE).

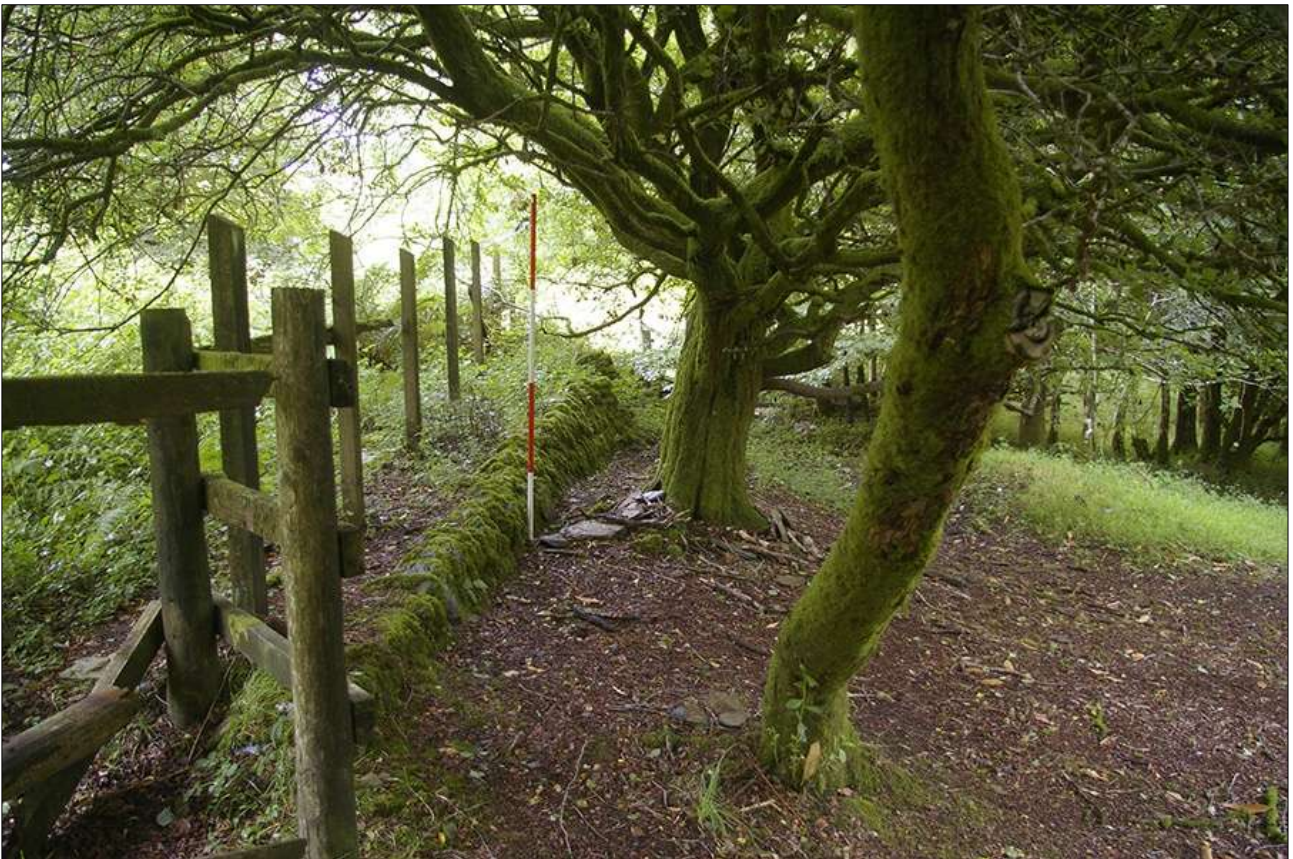
42. PITCHED STONE WALLING WHERE THE LEAT NORTH OF THE SITE MEETS THE FIELD BOUNDARY TO THE NORTH-NORTH-WEST OF THE SITE; VIEWED FROM THE SOUTH-WEST (2M SCALE).

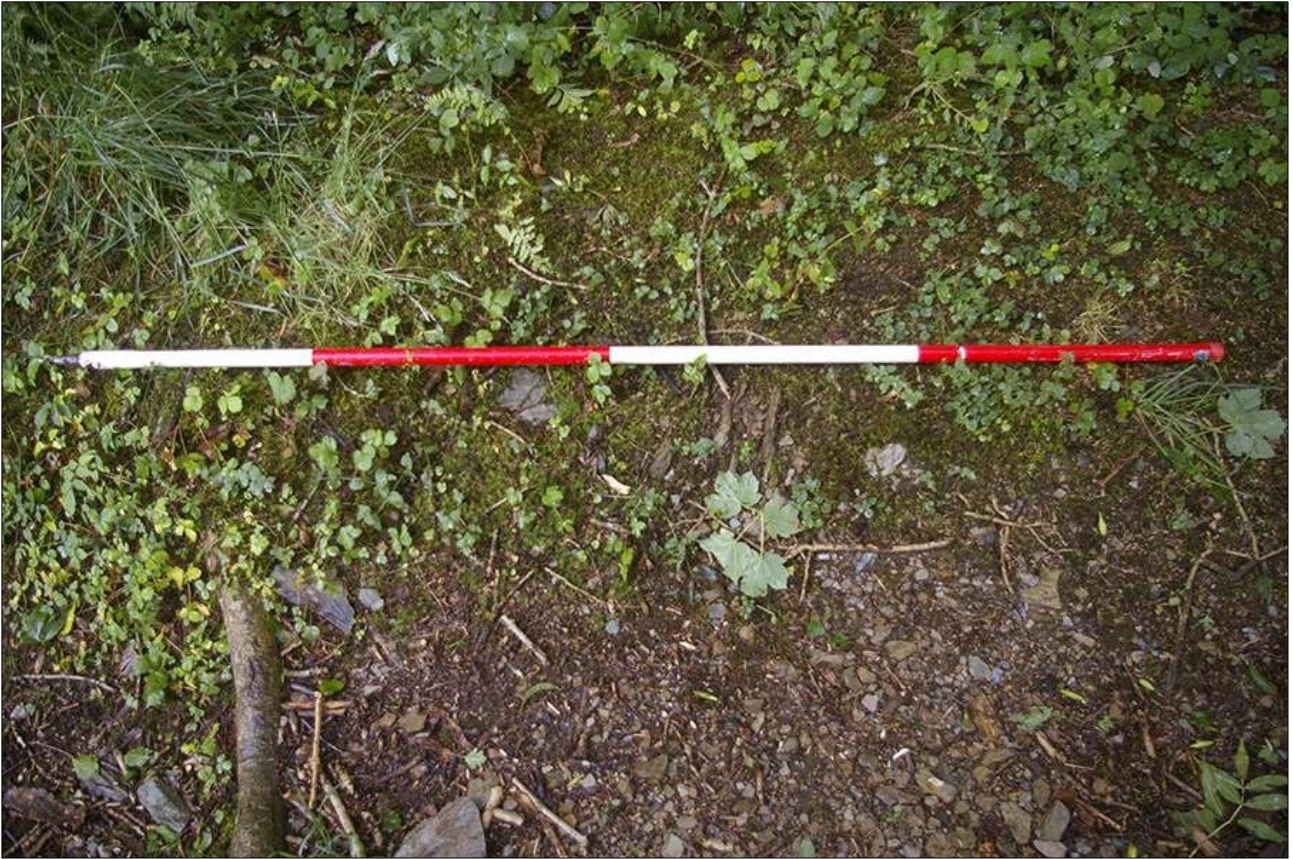
43. MOSS COVERED, POSSIBLE PITCHED CURB OR WALLING IMMEDIATELY SOUTH-WEST OF TRENCH 5; VIEWED FROM THE SOUTH-EAST AND ABOVE (2M SCALE).

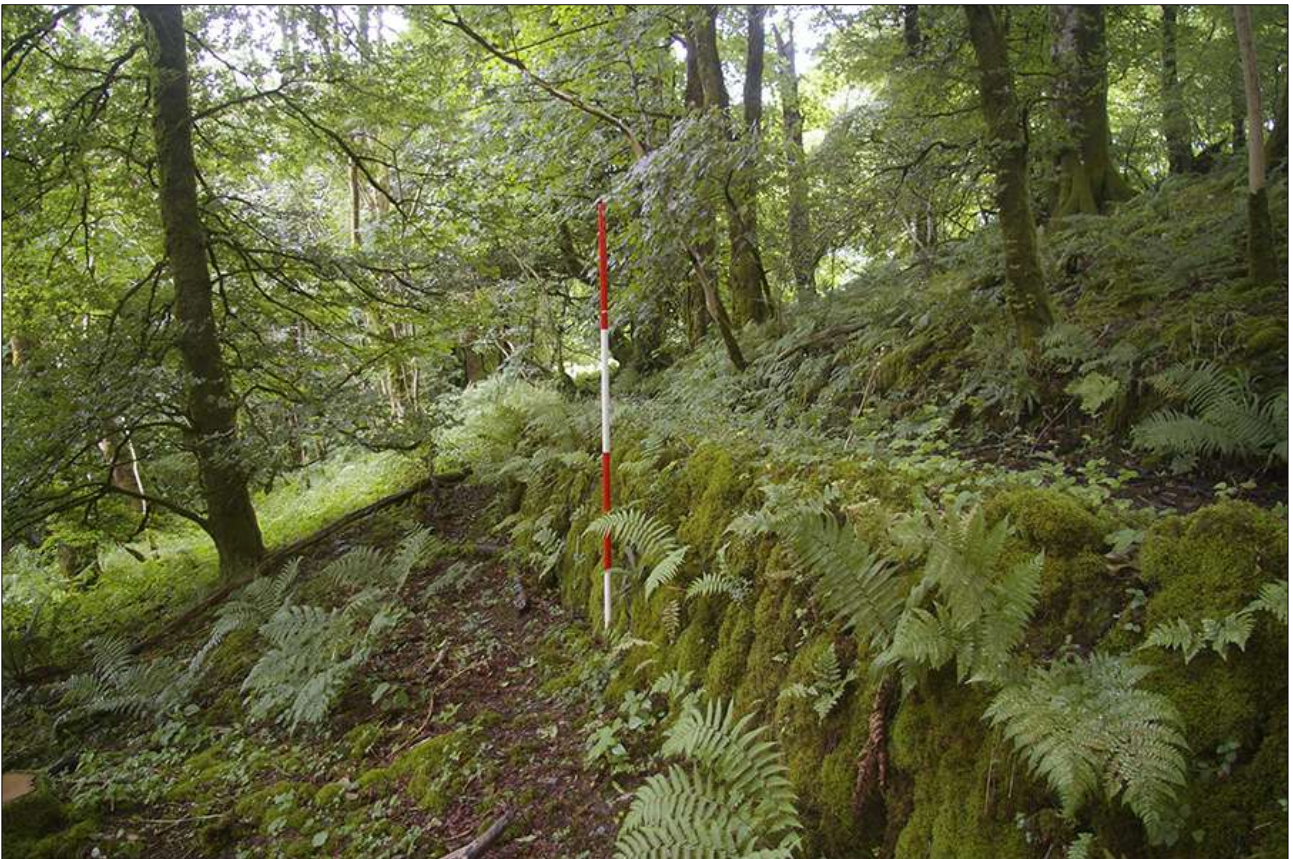
44. LEAT NORTH OF TRENCH 5; VIEWED FROM THE EAST (2M SCALE).

The terrace in its current form is fairly broad and clearly did fulfil a function as a walkway and viewing platform. However, 15m to the north of the terrace runs a defunct leat contained on its downslope side by a narrow wall of pitched stone; this leat is connected to a (mill)pond that later fed a sawmill in the valley below. 15m to the south of the upper terrace is a lower terrace/path that also follows the contour, and traces of a stone retaining wall or curb may also be observed. These three parallel earthworks are clearly visible on LiDAR imagery (see Figure 13), and the question naturally arises: were they all conceived and built in a single operation, or is the apparent coherence of plan no more than the fortuitous juxtaposition of unrelated elements built at different times for different purposes?
