ASHCOMBE GARDEN SIMONSBATH EXMOOR SOMERSET

Results of an Archaeological Evaluation

South West Archaeology Ltd. report no. 181115

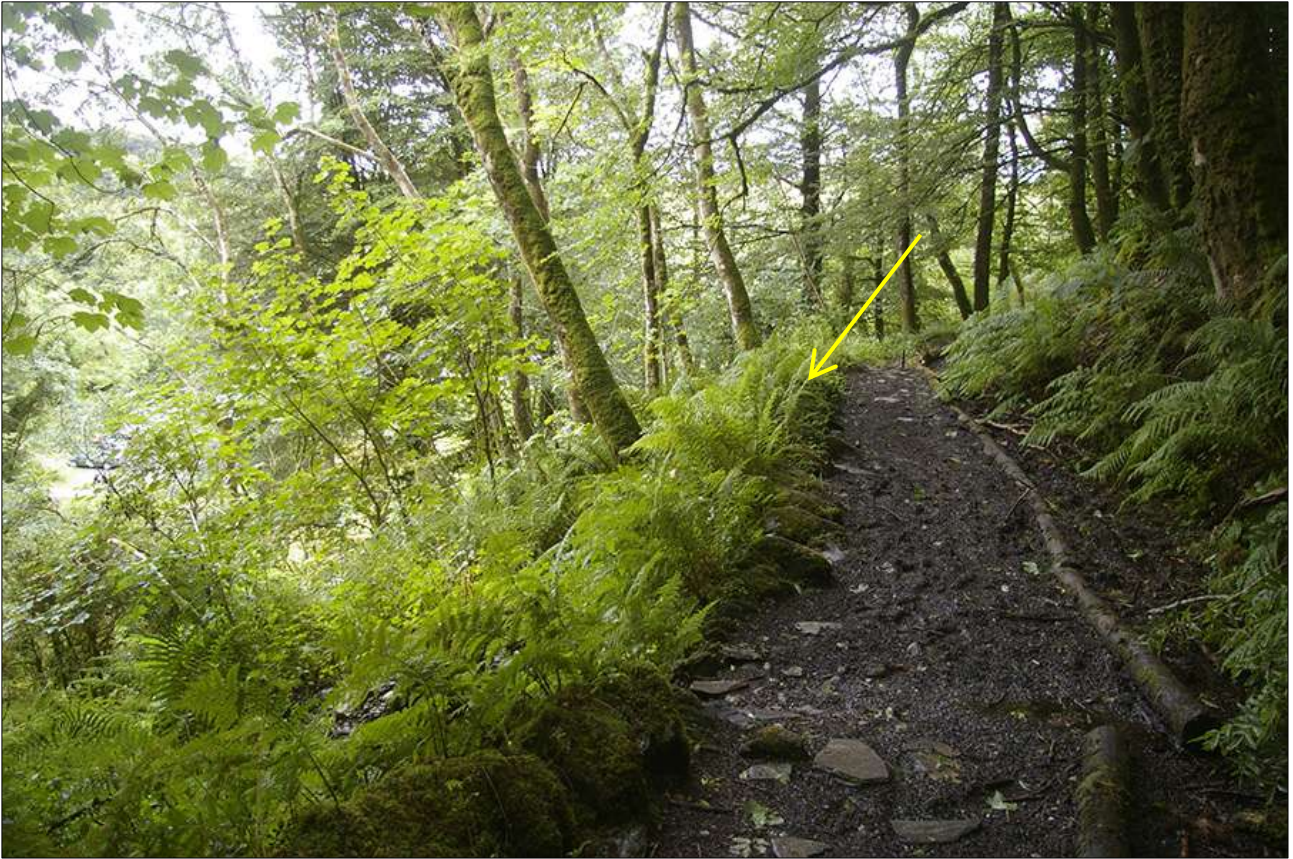
45. THE LEAT TO THE NORTH OF TRENCH 6. AT THE POINT INDICATED THE FLOW MAY HAVE BEEN DIVERTED TO A LOWER LEVEL; VIEWED FROM THE NORTH-NORTH-EAST (NO SCALE).

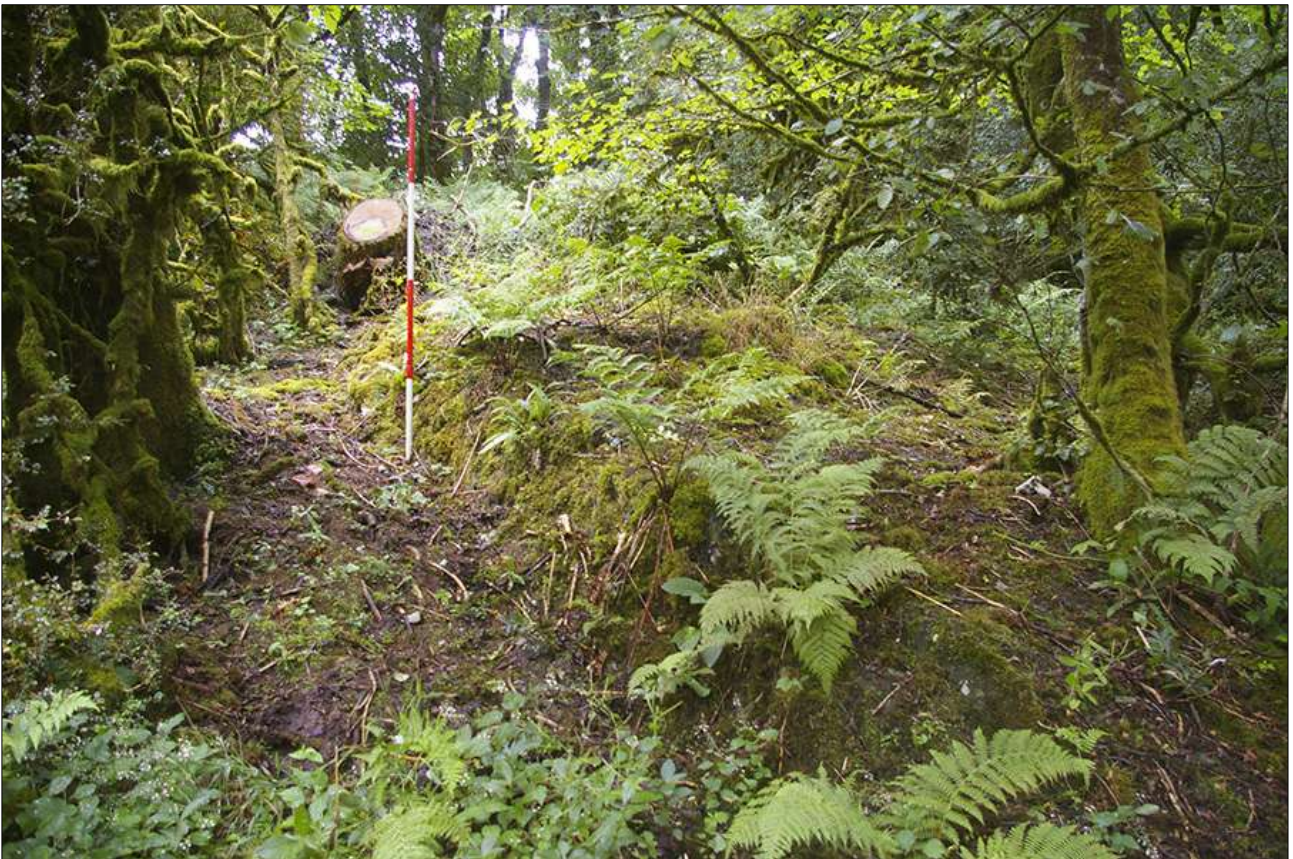
46. POSSIBLE NATURAL ROCK-CUT CHANNEL, PARALLEL TO AND NORTH-EAST OF, THE LOST WALL ALONG THE NORTH-EAST SIDE OF THE GARDEN. SOME BOX PLANTS WERE NOTED ACROSS THIS SLOPE. VIEWED FROM THE SOUTH-EAST (2M SCALE).

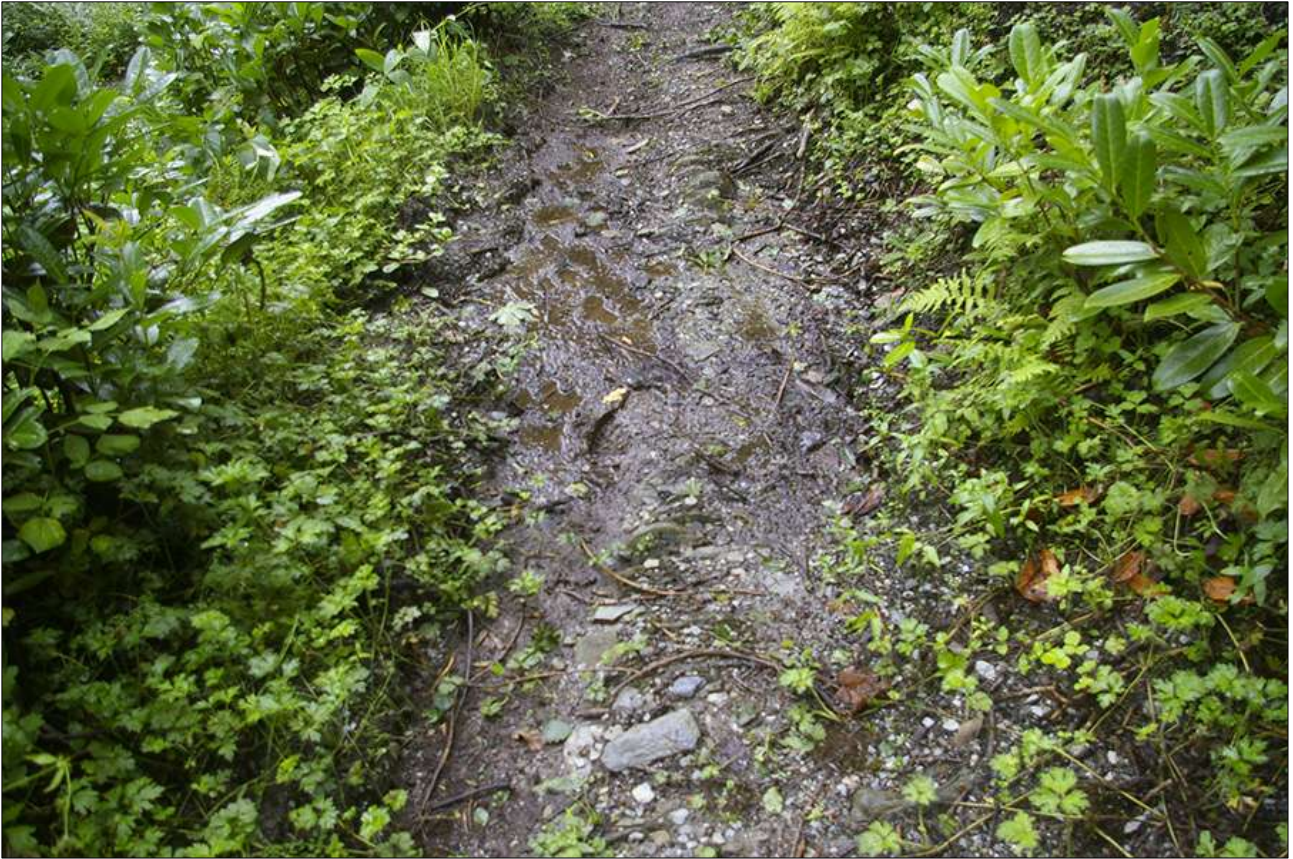
47. NATURAL OR PITCHED STONE ALONG PATH BETWEEN ASHCOMBE WATER AND NORTH BOUNDARY LINE; VIEWED FROM THE NORTH-EAST (NO SCALE).

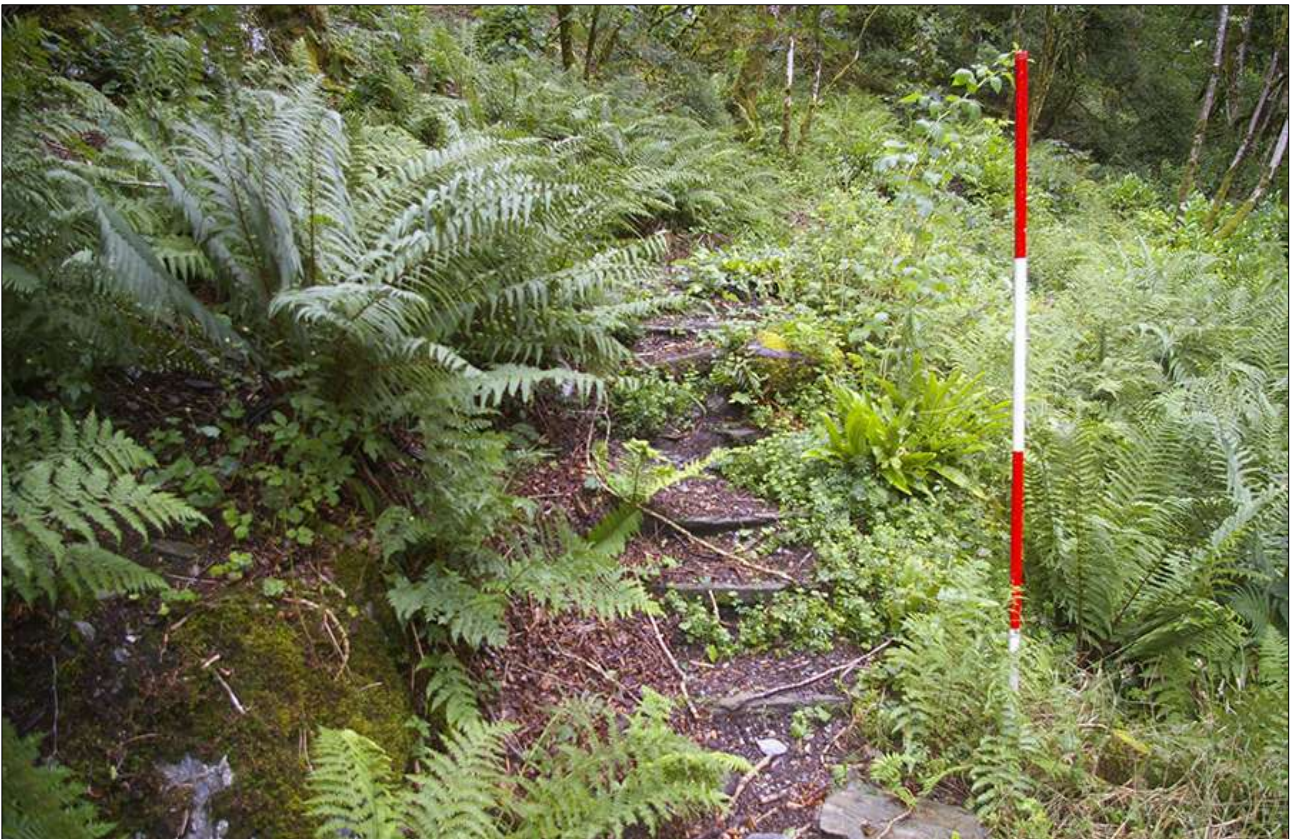
48. NORTH-EAST CORNER OF THE MEADOW, STEPS FROM THE LOWER PATH; VIEWED FROM THE SOUTH-EAST (2M SCALE).

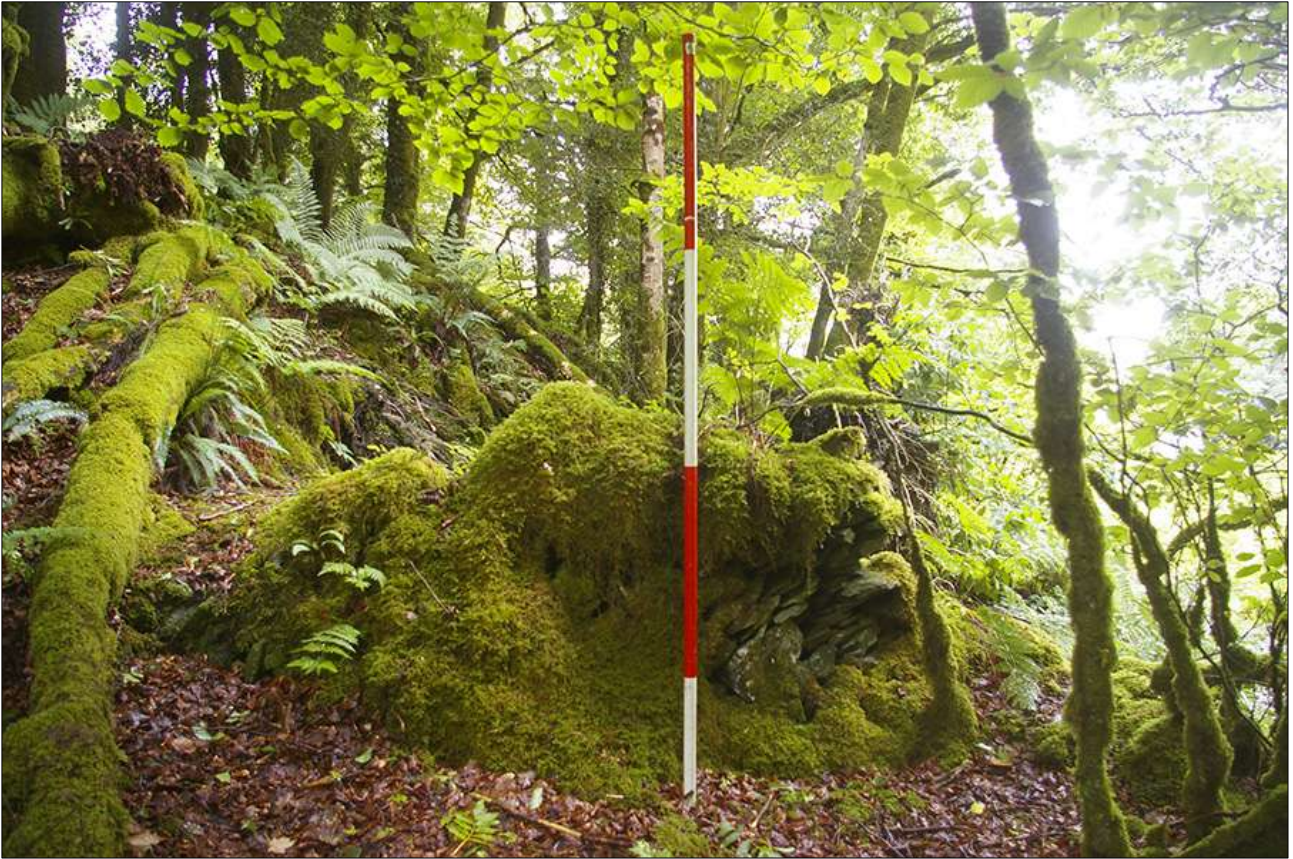
49. SOUTH-EAST END OF RUINED NORTH-EAST BOUNDARY WALL (AS INVESTIGATED IN TRENCH 6); VIEWED FROM THE NORTH (2M SCALE).

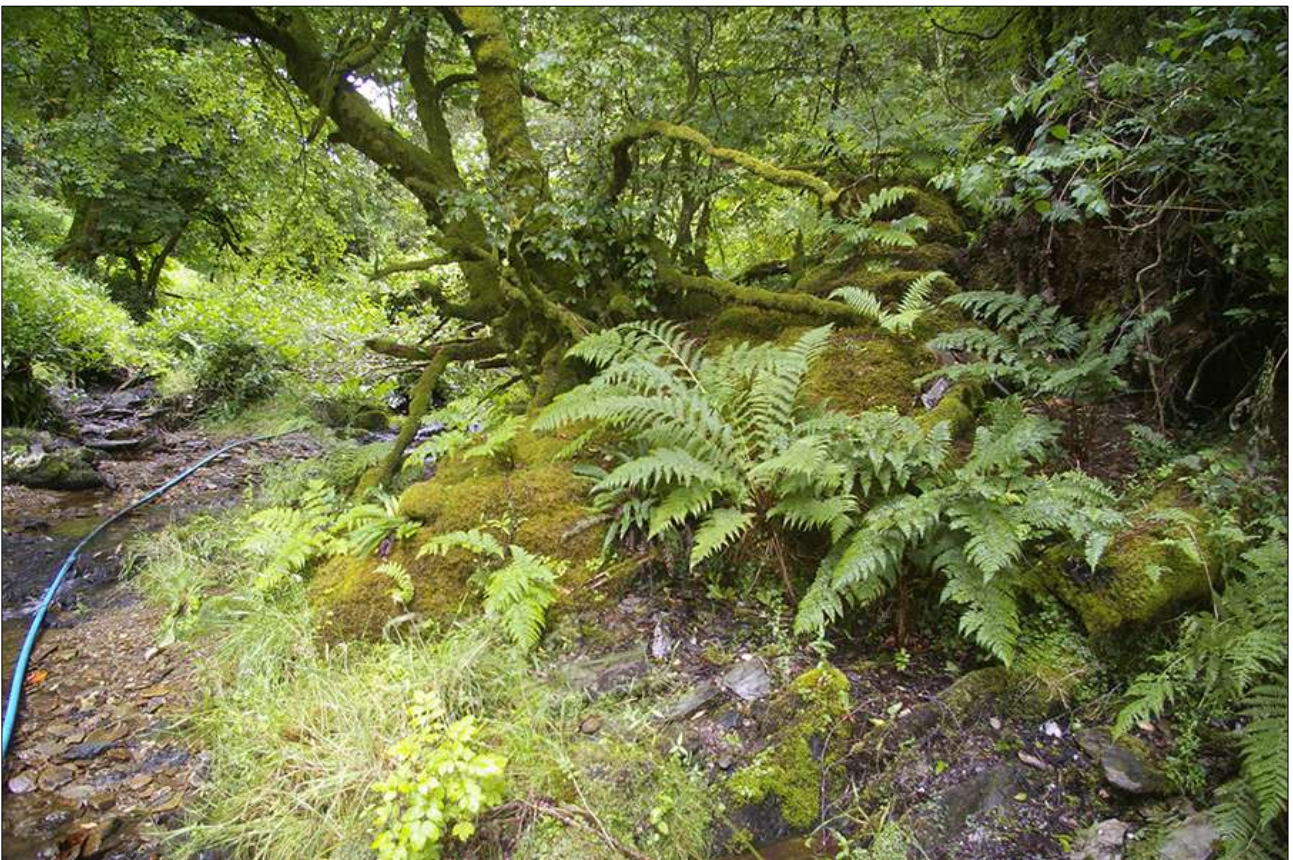
50. SOUTH-EAST END OF RUINED NORTH-EAST BOUNDARY WALL (AS INVESTIGATED IN TRENCH 6); VIEWED FROM THE SOUTH (NO SCALE).

The remains of the north-east boundary wall proved highly ephemeral. With the caveat that very little survives, excavation of the wall would imply it comprised sections of pitched and laid stonework. Examples of both are to be found around the Garden, though walls of pitched stone are usually more substantial as they tend to be stone-faced banks rather than freestanding walls *per se*. The wall appears on the historic OS maps and locals recall an integral arch over the

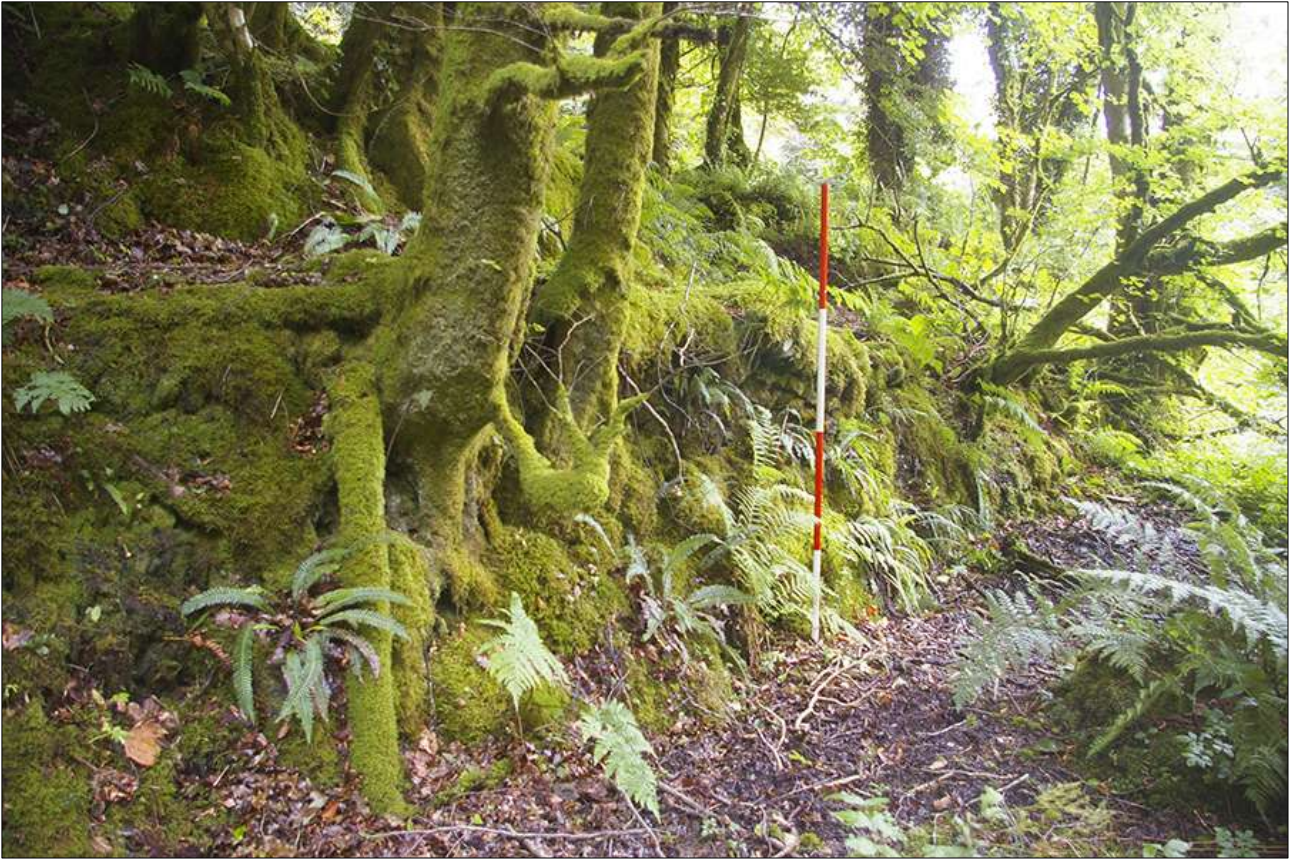
51. BOUNDARY ADJACENT TO/SOUTH OF THE RUINED WALL PHOTOGRAPHED ABOVE; VIEWED FROM THE NORTH-WEST (2M SCALE).

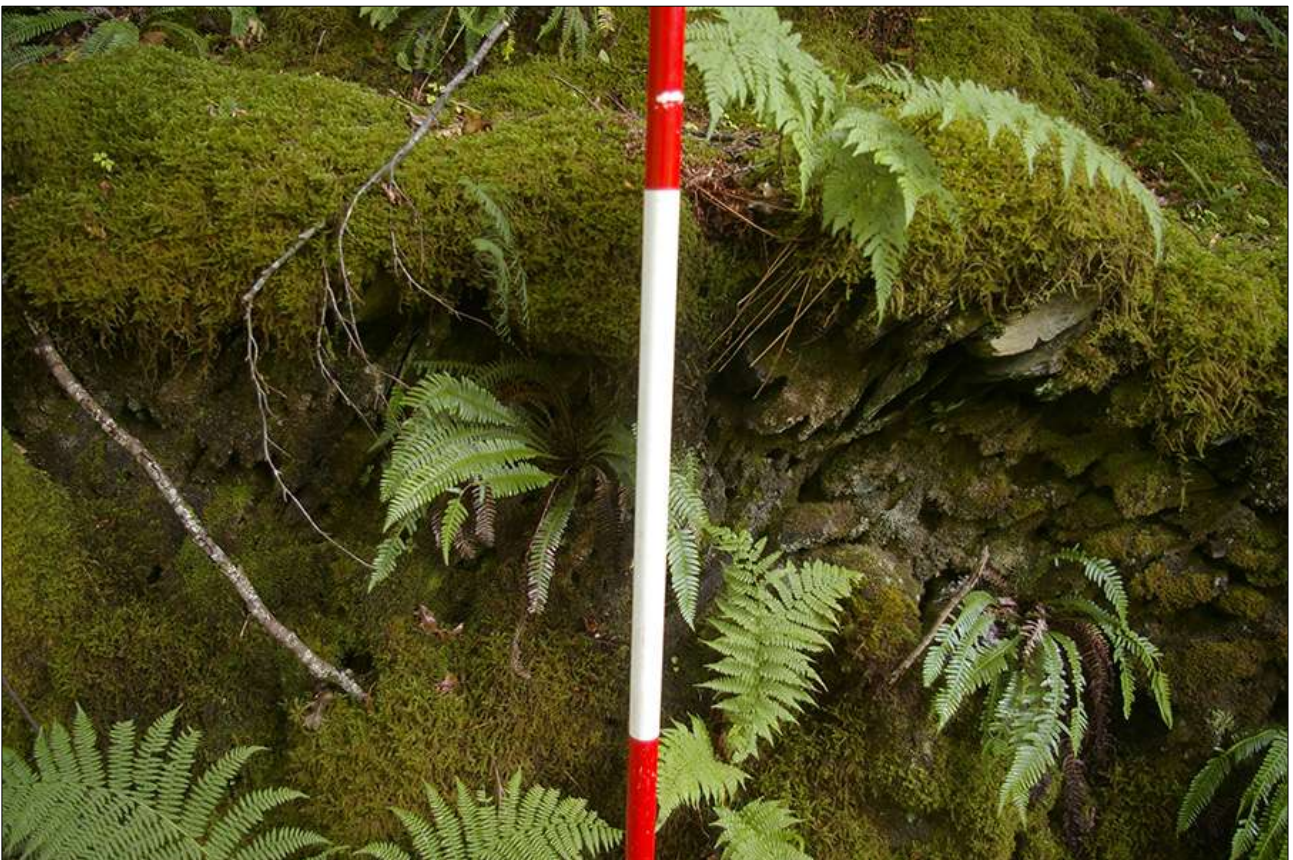
52. DETAIL OF BOUNDARY ADJACENT TO/SOUTH OF THE RUINED WALL PHOTOGRAPHED ABOVE; VIEWED FROM THE WEST (0.5M OF A 2M SCALE).

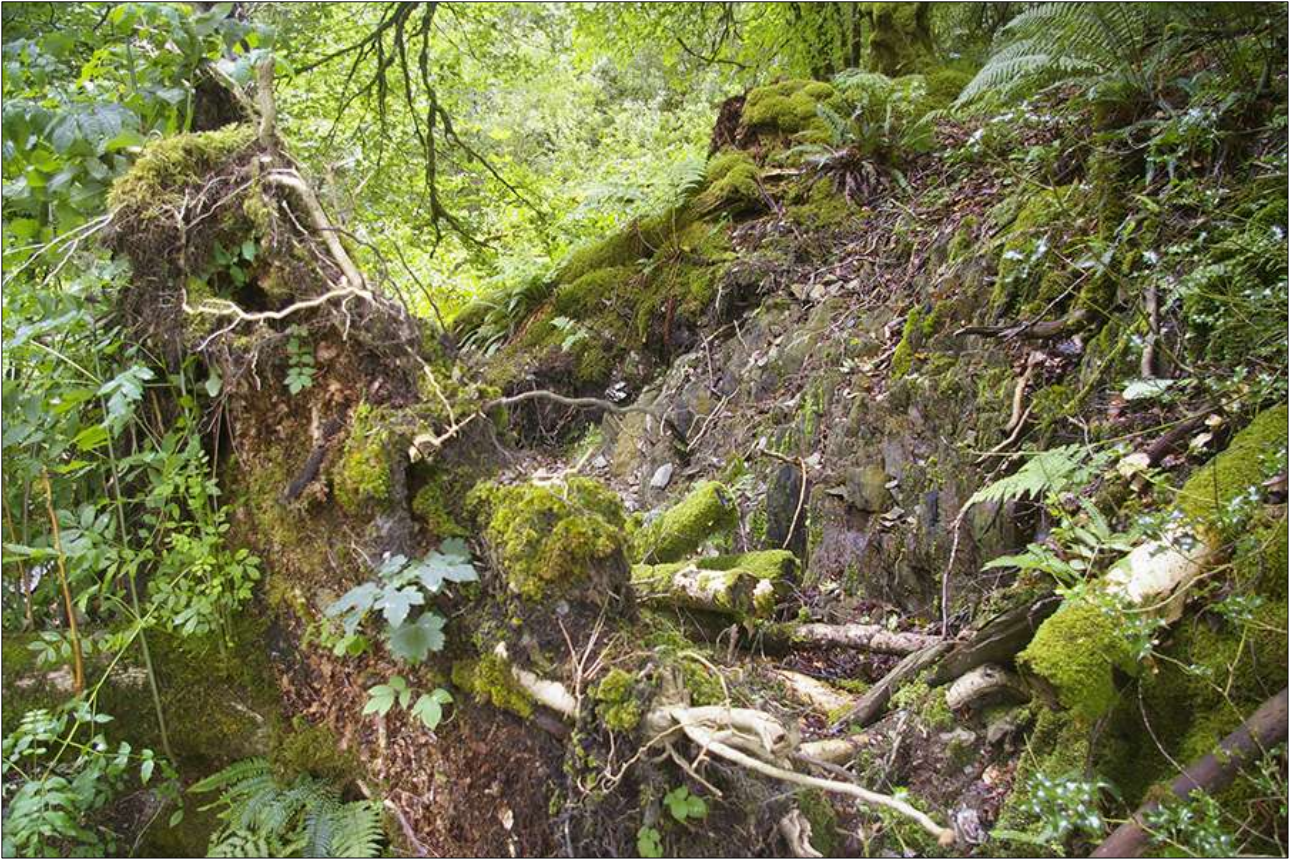
53. EXPOSED BEDROCK BEHIND TREE-THROW ADJACENT TO THE SOUTH-EAST SEGMENT OF RUINED NORTH-EAST BOUNDARY; VIEWED FROM THE SOUTH-SOUTH-WEST (NO SCALE).

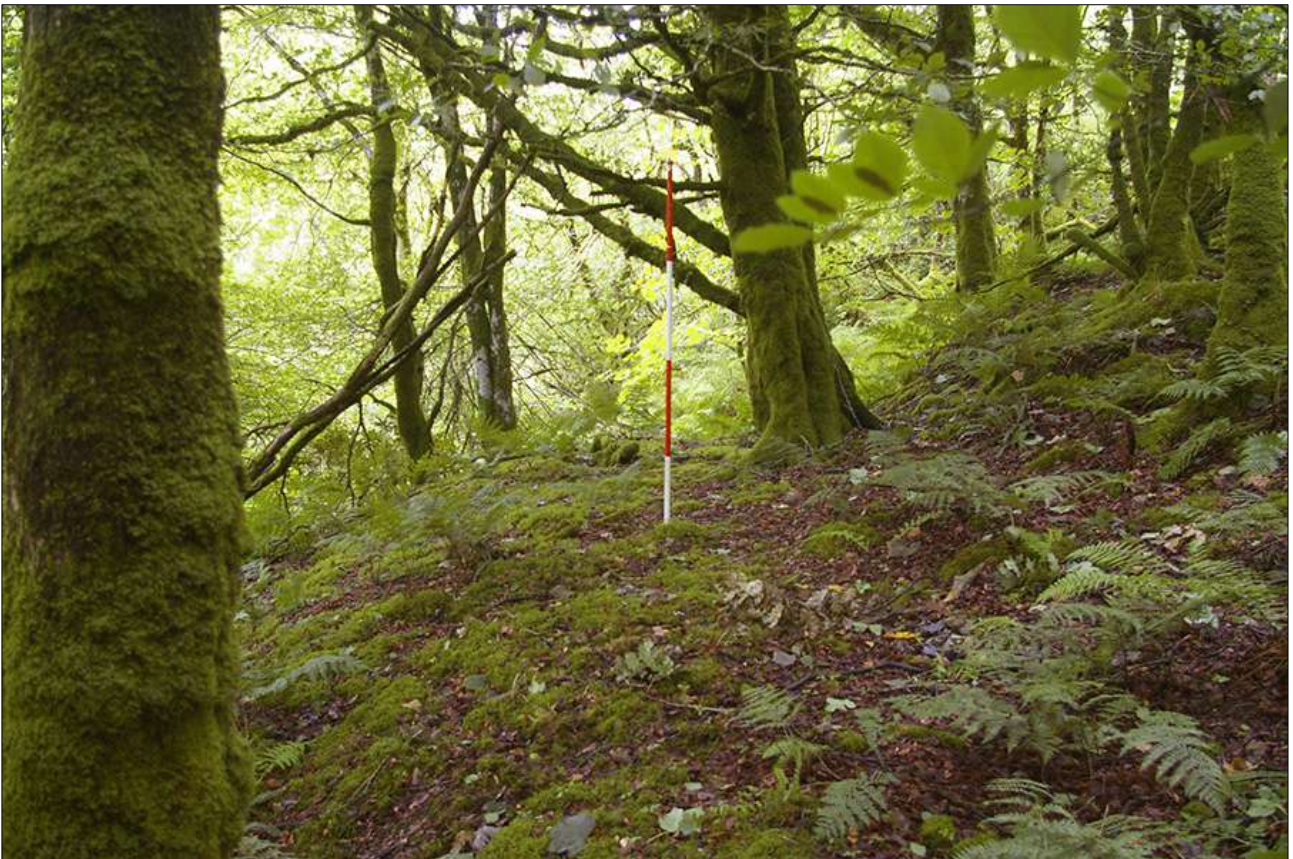
54. POSSIBLE RELICT CATCH-MEADOW/PATH NORTH-EAST OF ASHCOMBE CAR PARK; VIEWED FROM THE SOUTH (2M SCALE).

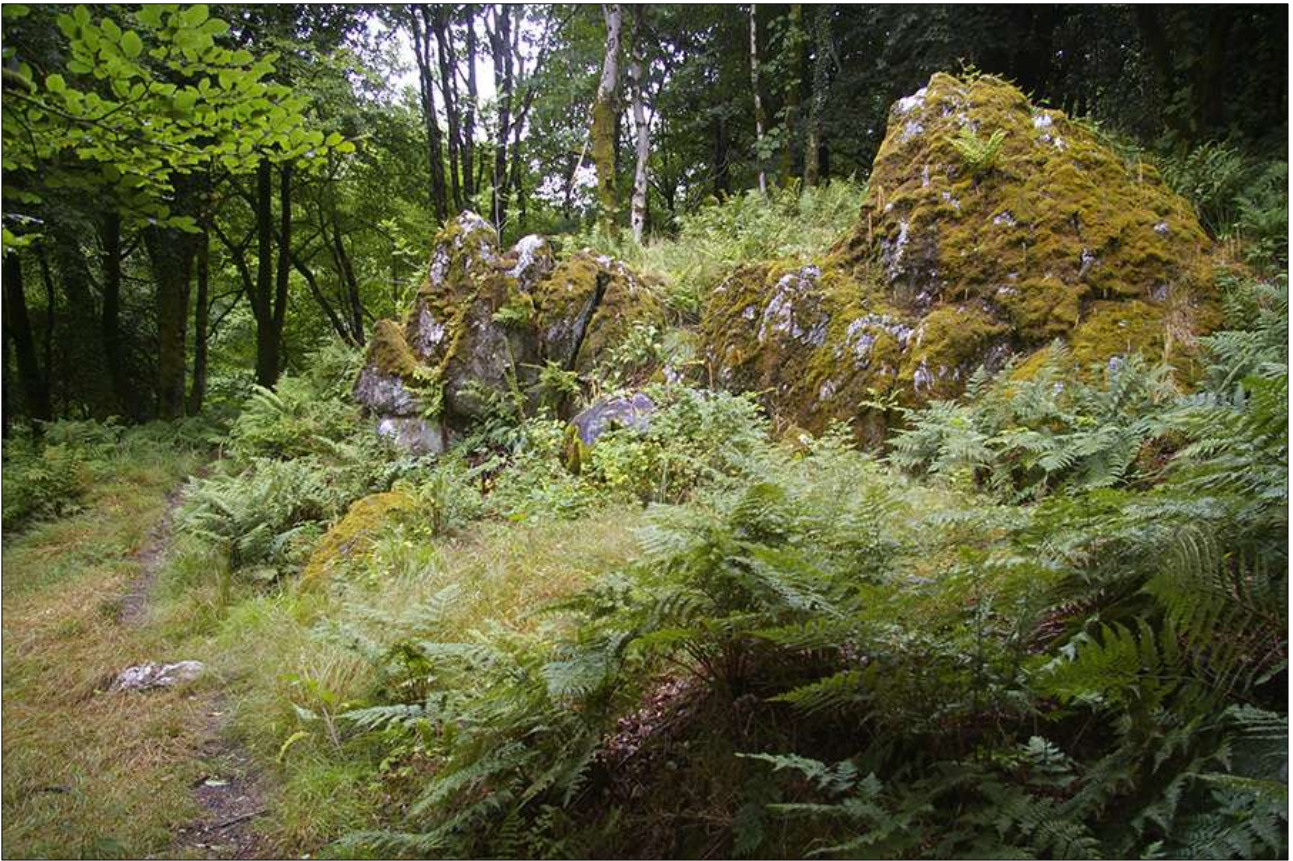
55. OUTCROP OF 'WHITE ROCKS' TO NORTH OF ASHCOMBE CAR PARK; VIEWED FROM THE SOUTH-WEST (NO SCALE).
