Devon County Council Historic Environment Record

Civil Parish & District: Galmpton, Torbay	National Grid Reference SX 90426 56417		Number:		
Subject: Archaeological monitoring and recording during exploratory works in advance of opening up the Western Door at Churston Ferrers Church, Galmpton, Torbay, Devon Photo attached? Yes					
Planning Application no: P/2018/0929		Recipient museum: N/A			
OASIS ID: southwes1-335951		Museum Accession no: N/A			
Contractor's reference number/code: CFC18		Dates fieldwork undertaken: 4 th March 2019

Description of works.

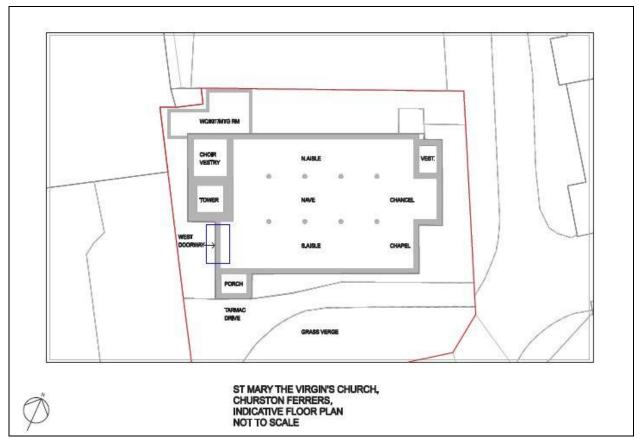
Figure 1: Site plan showing location of the West Door (By Apse Architects).

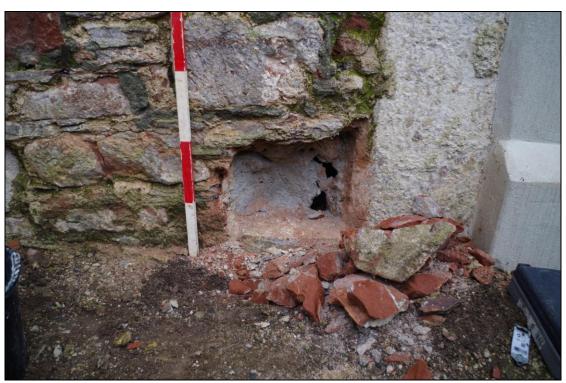
The opening up work consisted of excavating a small hole (c.0.3m x 0.2m) just outside of the blocked doorway and breaking through the door blocking material to fully gauge the nature of its build and the thickness. The door is blocked with a mix of limestone rubble in a cement bond, and does not appear to contain any materials or architectural fragments of interest. The stone rubble infill was only 0.25m thick and was revealed to be built upon a concrete foundation. The need for a concrete foundation appears to have been as the earlier (19th century?) rainwater drainage had formerly run immediately in front of the west elevations footing. The drainage has subsequently been moved to run in its present location further away from the building, along the approximate centre of the narrow strip of churchyard west of the church. The small excavated hole simply exposed the void of this redundant drain.

FIGURE 2: PHOTO OF THE OPENED UP AREA, VIEWED FROM THE WEST (1M SCALE).

The presence of a largely cement bond, and concrete footing confirm a late 19th century if not 20th century date for the blocking and there appears to be little merit in monitoring the rest of the material being removed once the works progress. There is nothing of archaeological significance which will be impacted by the proposed works. Furthermore, whilst there will be some minimal groundworks to match the levels and create a wheelchair accessible access between inside the church and the slightly higher churchyard these will all be within the modern and disturbed made-ground levels.
