Devon County Council Historic Environment Record

| Subject: Archaeological monitoring during service trenching at Church of St Peter, Ashford, Devon | | Photo attached? YES |
| Contractor's reference number/code: APC18 | Dates fieldwork undertaken: 1 st March-8 th August 2019 | |

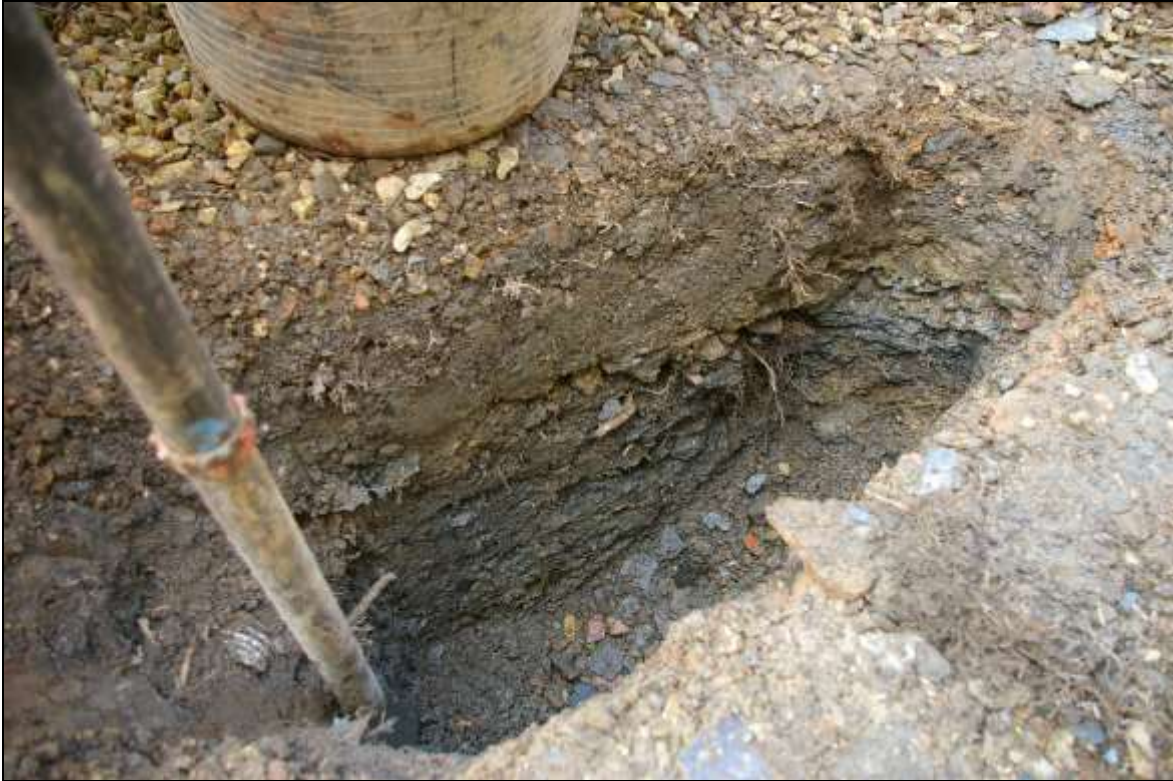
FIGURE 2: TEST PIT 04, NORTH-EAST FACING SECTION; VIEWED FROM THE EAST.

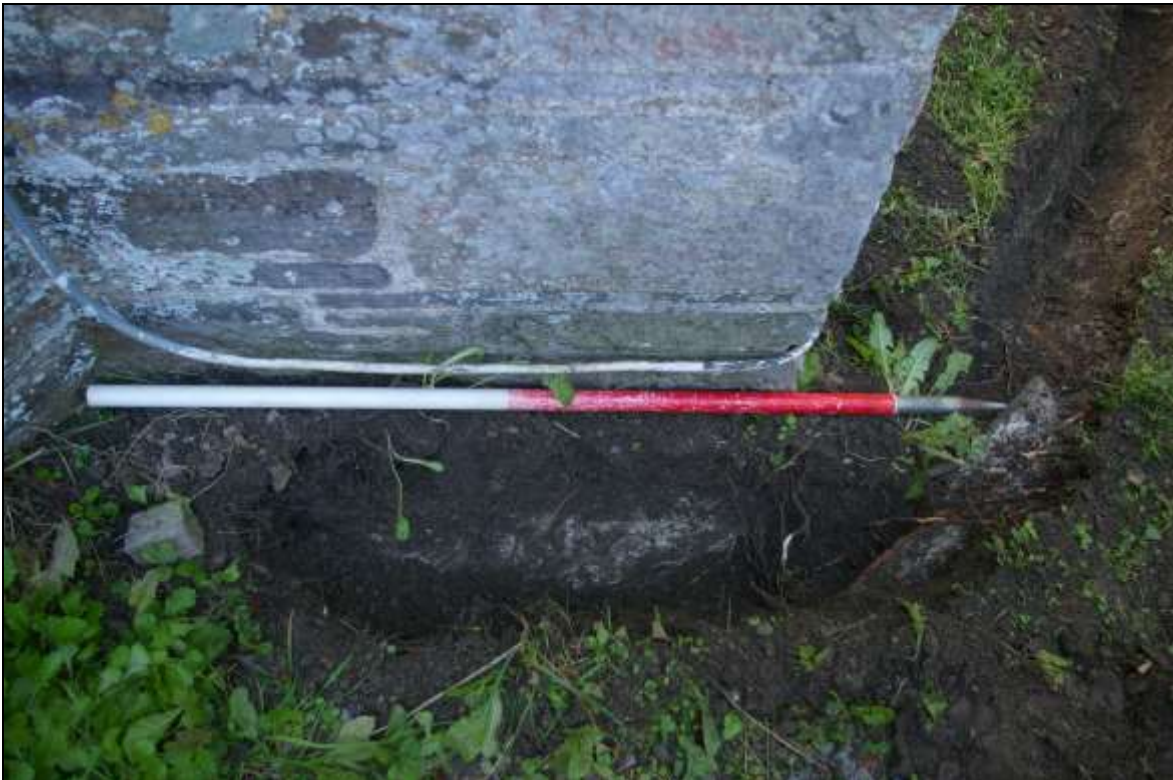
FIGURE 3: AREA 06, NORTH END SHOWING BUTTRESS FOUNDATIONS AND WALL {608} TO THE RIGHT OF THE SHOT; VIEWED FROM THE NORTH-WEST (1M SCALE).
