WYATT HOUSE KILLERTON BROADCLYST DEVON

Results of an Earthwork Survey and Archaeological Evaluation

South West Archaeology Ltd. report no. 190102

By J. Bampton
Report Version Final
2nd January 2019

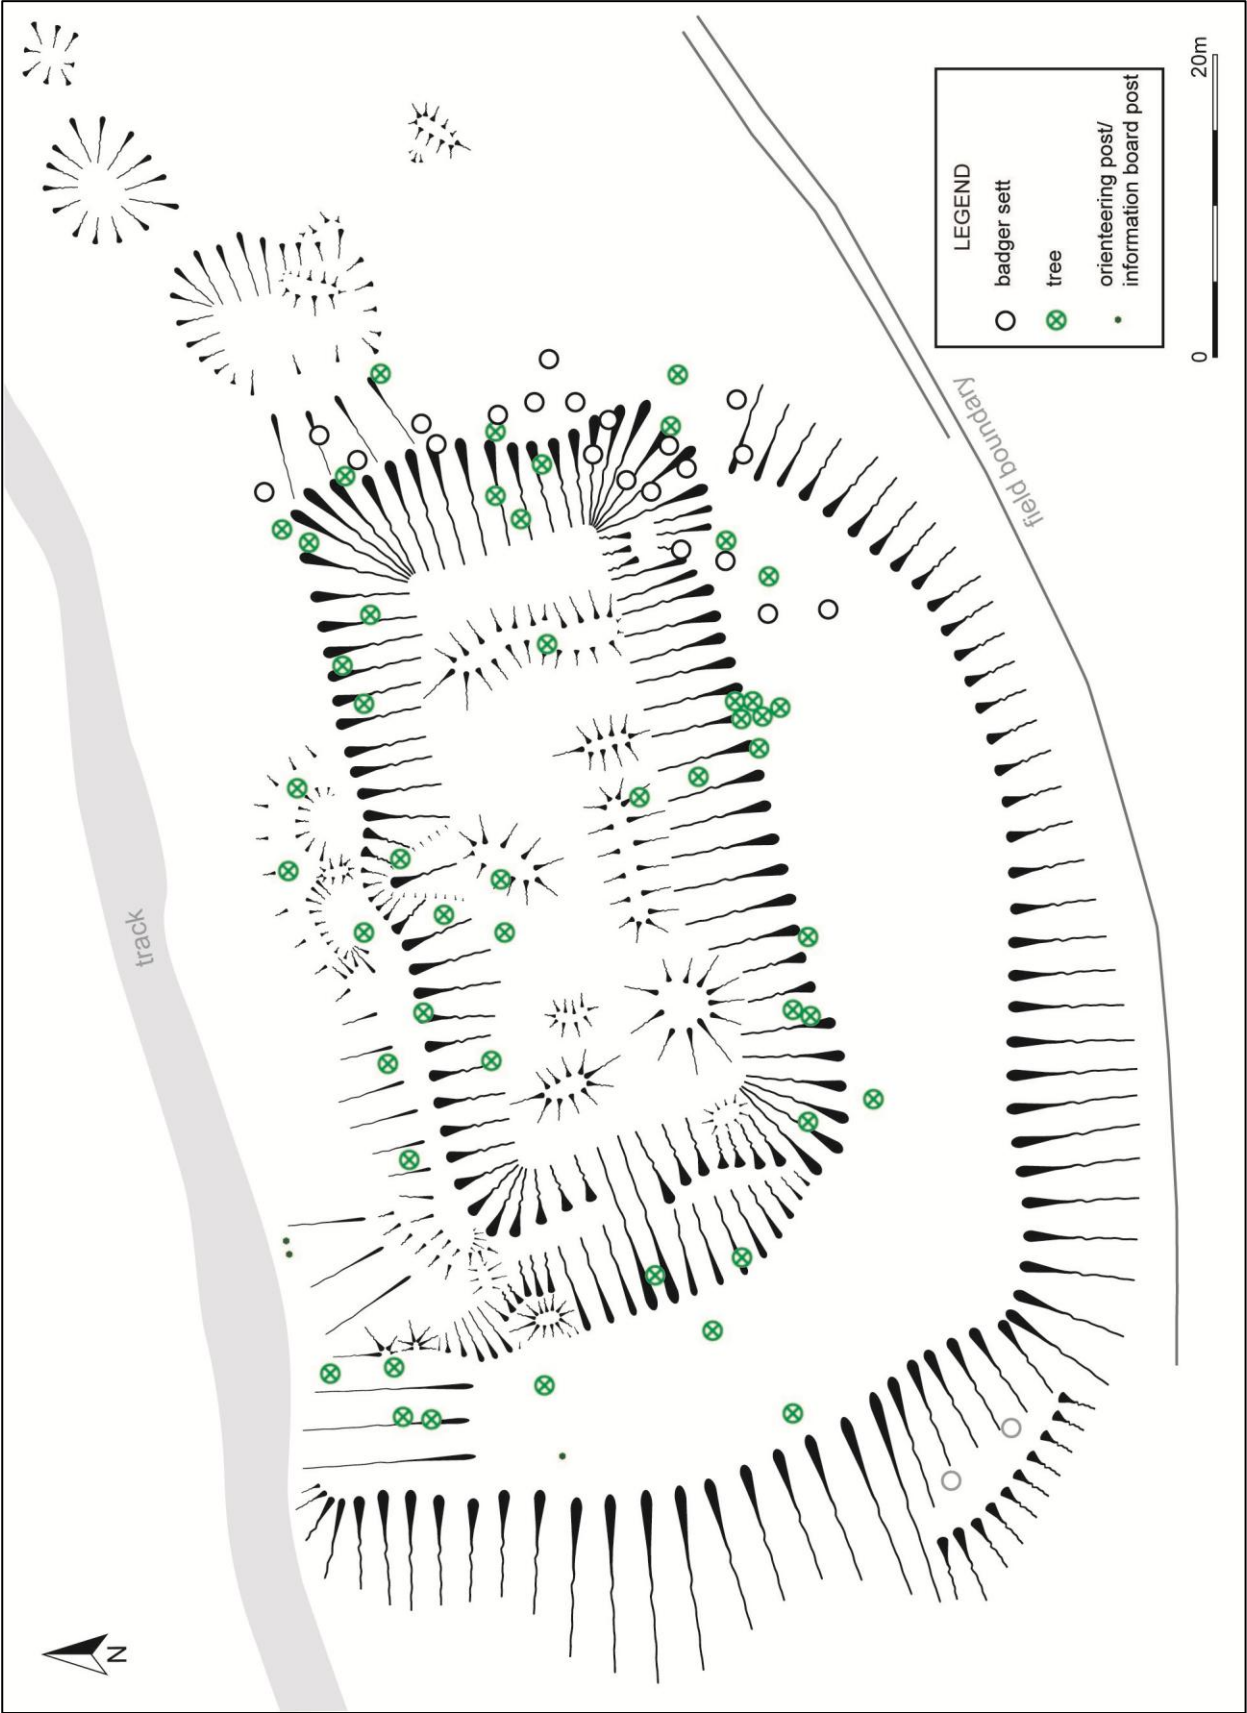
The site consists of a sub-rectangular quarry-like depression c.50m×27m across associated with three smaller depressions to the east. The site had been heavily overgrown with laurel; this was removed prior to the survey. The depression has variably steep sides, with a slight step to the western side, and a relatively flat and level base. It is cut into the slope to the north and east, and defined by a massive artificial bank to the south and west; this drops down to a stone-faced field boundary. To the north-west the depression features a slight bank that conceals the interior from the causal view, and at the north-west corner there is a worn probable access track. On its eastern side, the earthwork is pockmarked by a large badger sett of 21 holes.

The base of the depression is littered with discrete linear and oval piles of stone and brick rubble that were presumed to define parts of a demolished structure. Immediately to the north, a raised arc of stone rubble was identified, assumed to correspond with a semi-circular portico shown on the original drawings.

FIGURE 2: HACHURE PLAN OF EARTHWORK SURVEY OF THE WYATT HOUSE SITE.

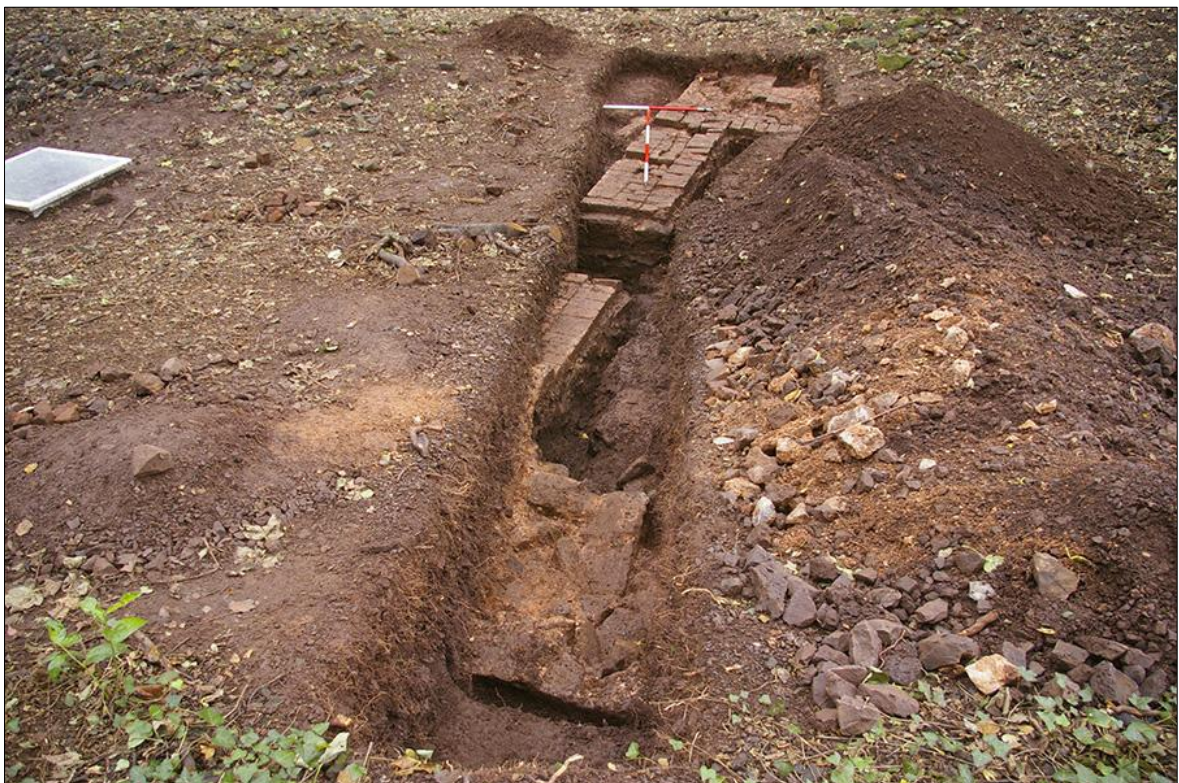
Construction cut [103] contained exterior wall foundation {111} and backfills (104) and (105). It cut made ground (102), which overlaid a platform associated with the terracing of the site. Wall Foundation {111} was 1.46m wide and up to 0.72m deep with squared, possibly dressed stone sides and a stone and occasional brick rubble core bonded with a sandy lime mortar.

FIGURE 3: TRENCH #1; VIEWED FROM THE WEST-SOUTH-WEST (1M & 2M SCALES).

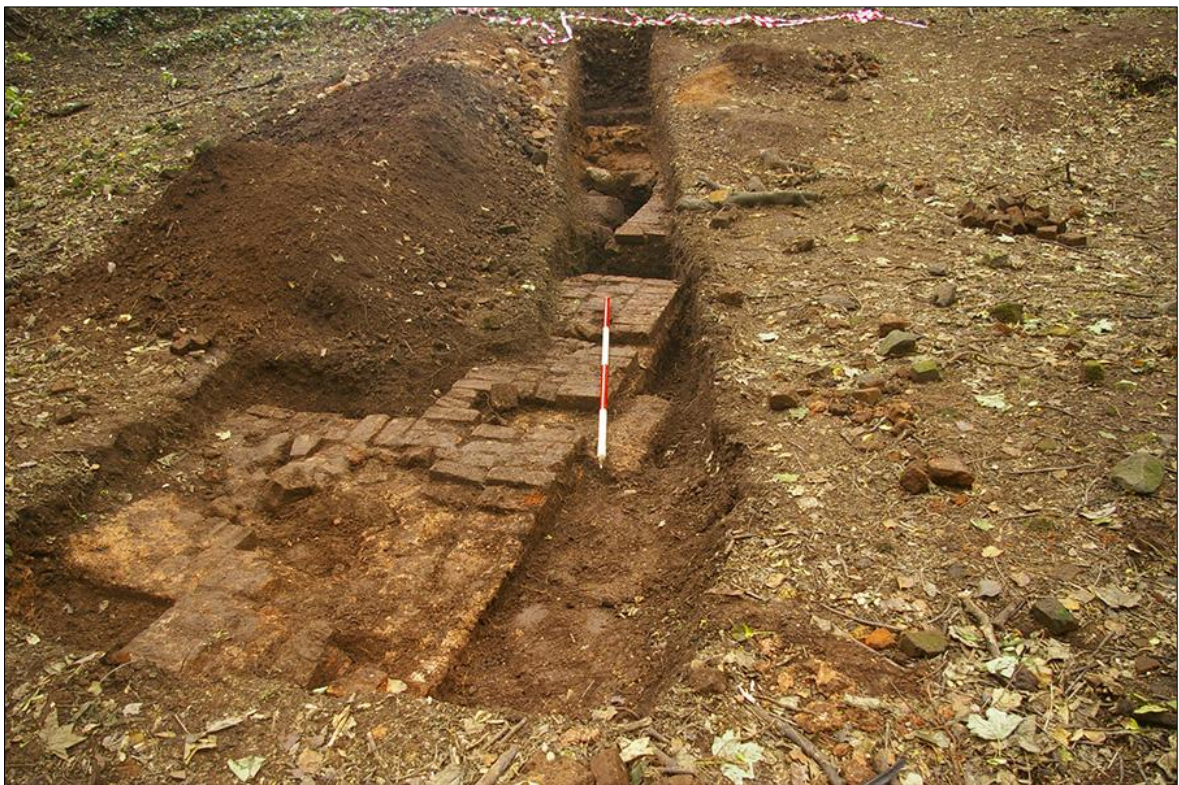
Construction cut [114] contained backfill (109) and interior wall foundations {110}, {112} and {113}. It cut natural (101) and was contiguous with construction cut [103]. The interior wall foundations were of stone with rubble cores bonded with lime mortar, c.0.86m wide and 0.60m deep. These were topped by a wall 0.74m wide formed of a single course of bricks; some bricks were missing or damaged, and there was a thin overlaying wash/remnant of mortar. The soils were relatively shallow, with topsoil (100) overlying the walls for much of the trench. The exception was wall foundations {111} and {112}, which were sealed by a spread of demolition material (106). (106) was in turn sealed by building debris layer (107) and made-ground layer (108), both of which contained frequent stone.

FIGURE 4: TRENCH #1, MID-EXCAVATION; VIEWED FROM THE EAST (2M SCALE).

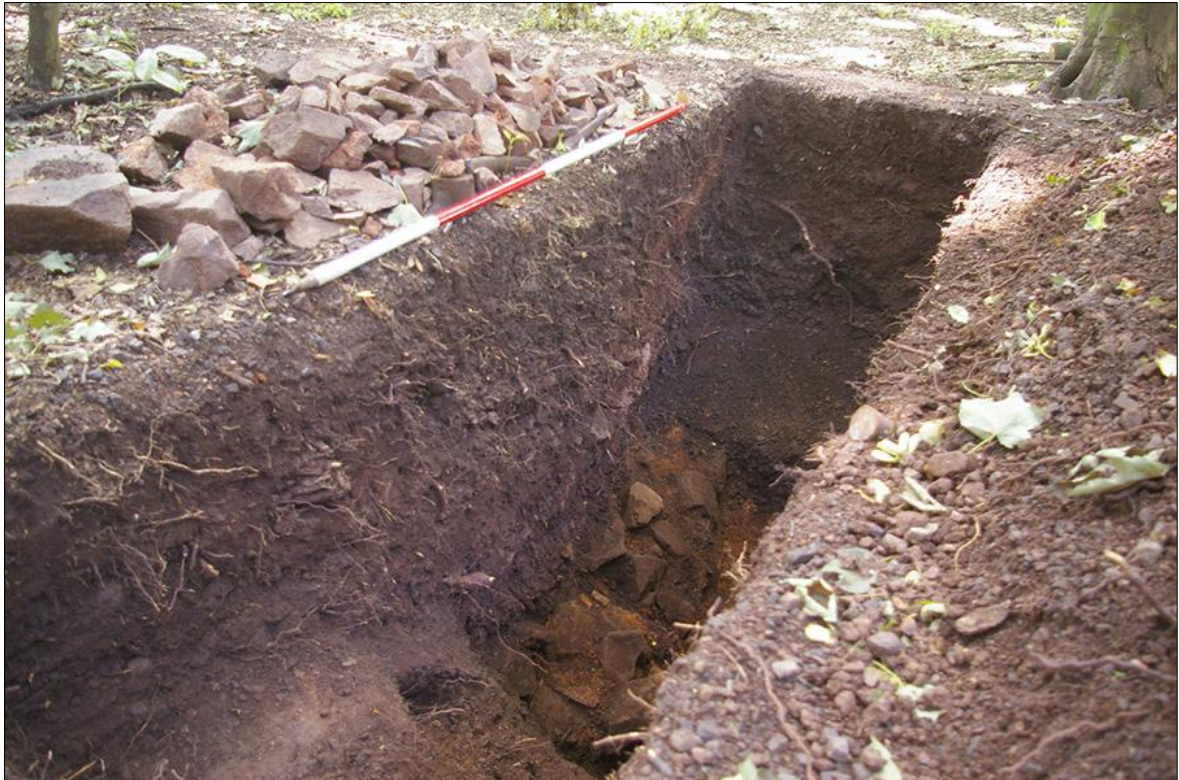
Construction cut [203] contained exterior wall foundation {212}; this appeared to have a slight curve and to be aligned at a slight angle to the trench. It was overlaid by made-ground (209), a redeposited natural that was sealed by soil layer (208). The depression above the foundation

FIGURE 5: TRENCH #2; VIEWED FROM THE NORTH-WEST (2M SCALE).

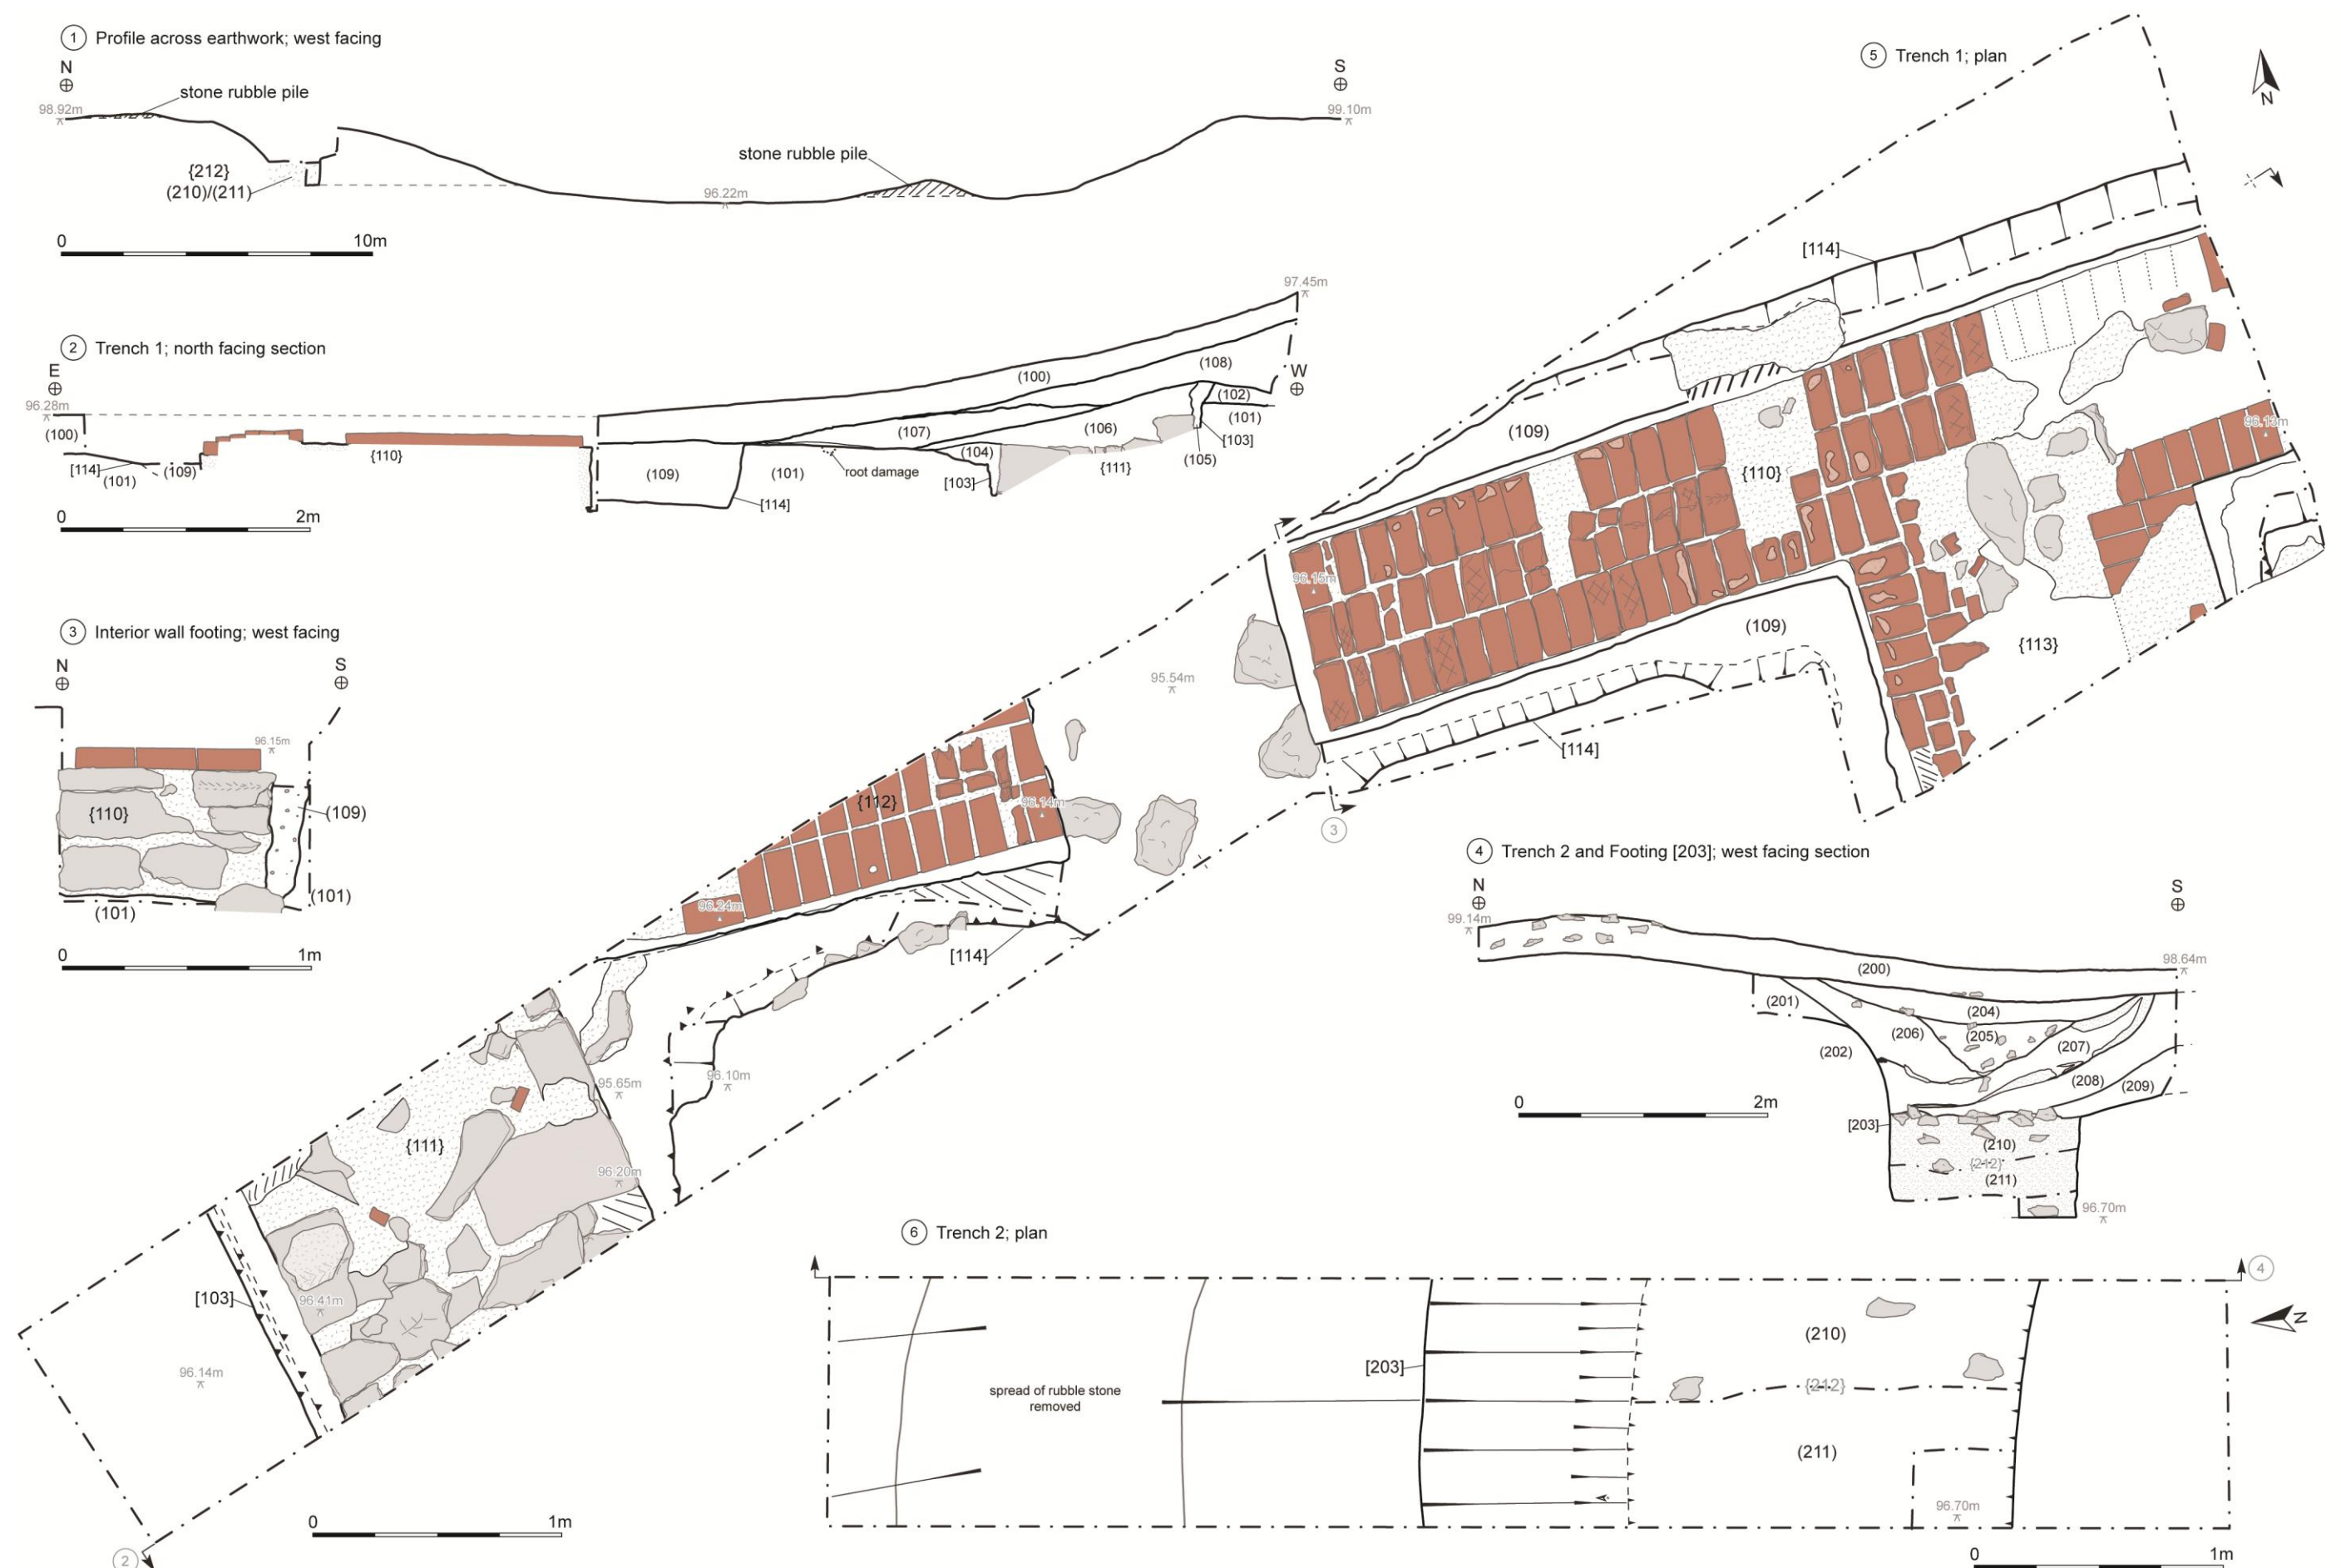
FIGURE 6: PROFILE ACROSS THE EARTHWORK AND PLAN AND SECTION DRAWINGS FOR TRENCHES #1 AND #2.

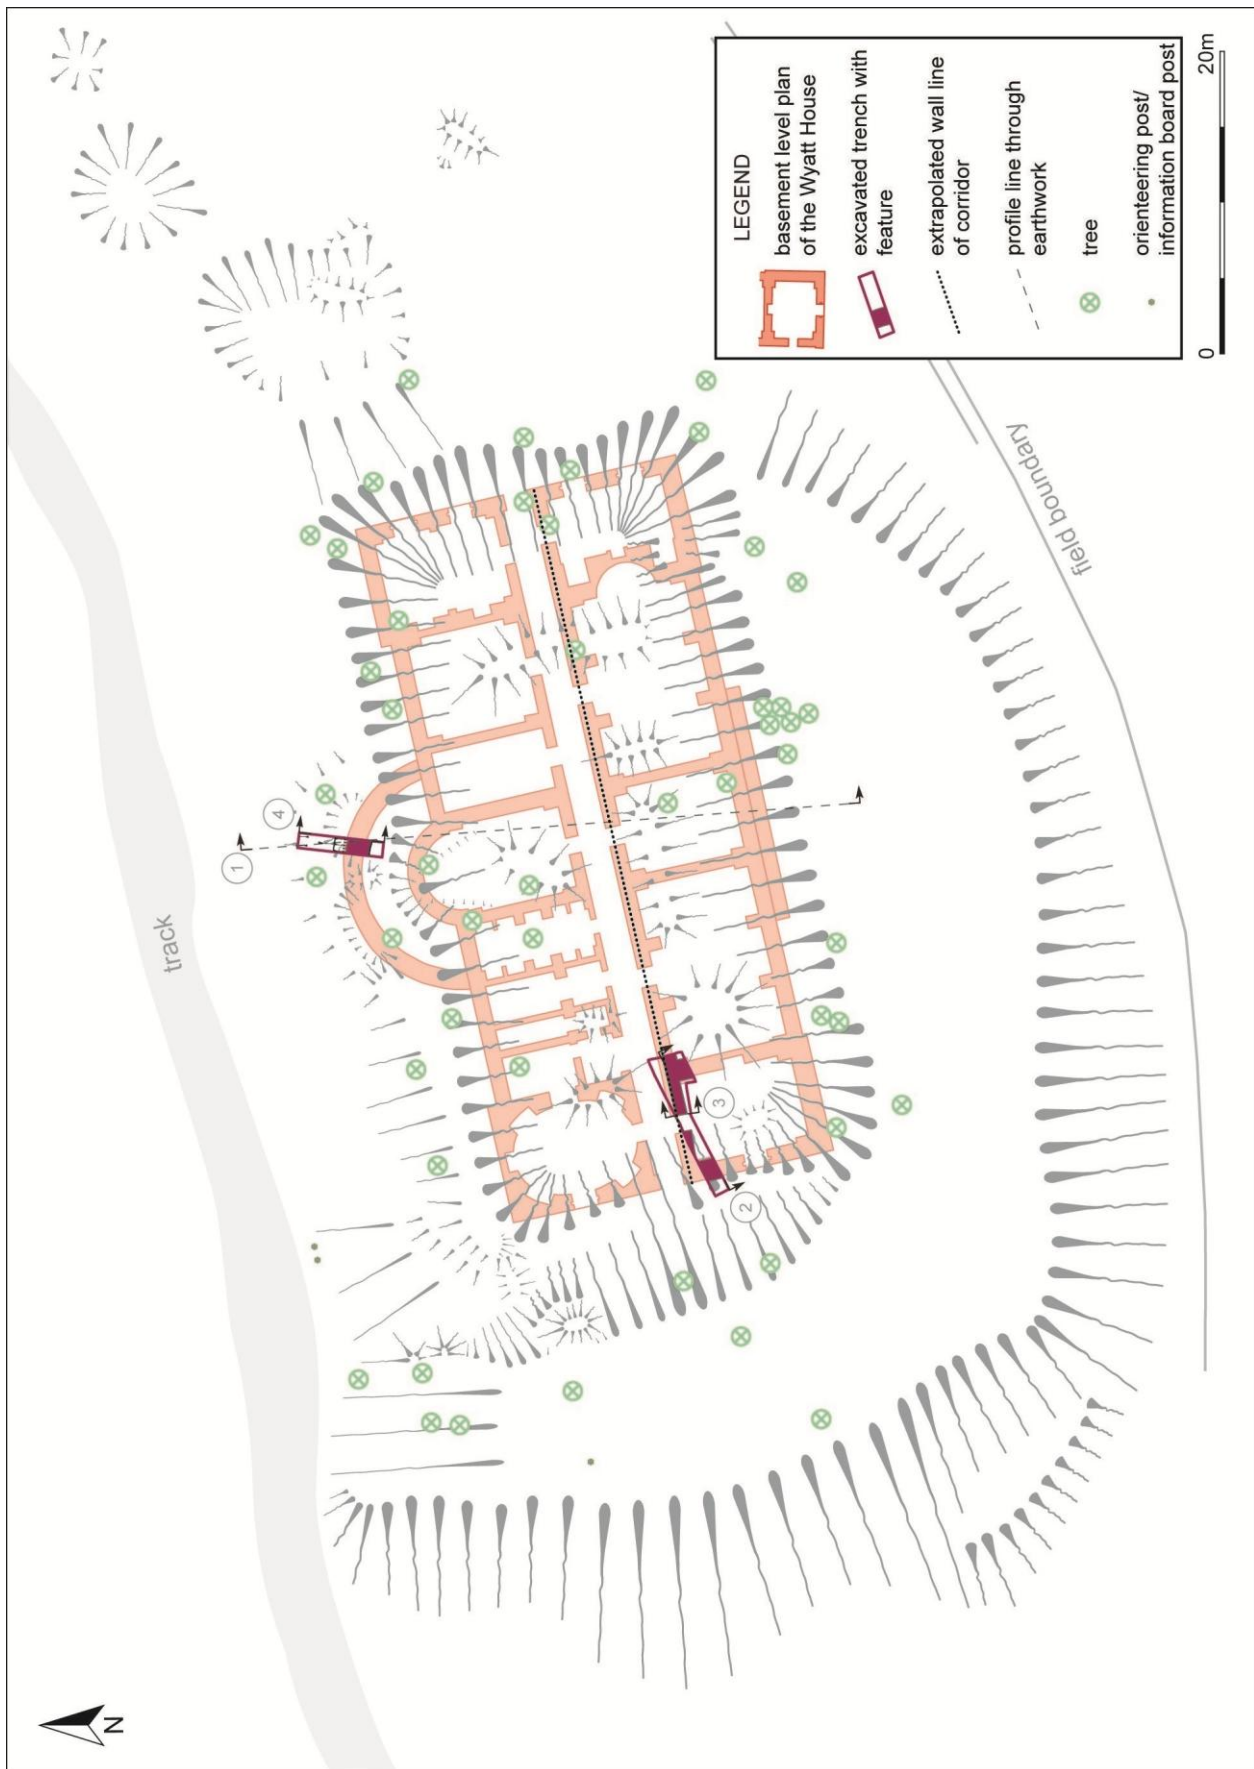
FIGURE 7: TRENCH AND FEATURE LOCATIONS AND LOCATED BASEMENT LEVEL PLAN OF THE WYATT HOUSE, c.1776, OVERLAYING AN EARTHWORK SURVEY; SECTION NUMBERS REFER TO THOSE IN FIGURE 5.

The original plans show the basement to be divided into 14 rooms accessed from a single axial corridor. The rooms are labelled by function (*Ale Cellar* etc.), with most intended for the storage of alcoholic drinks (beer, ale and wine). The exception to this would have been the two western rooms, labelled *Billiard Room* and *Dressing Room to Bath*. At ground-floor level the western rooms were given over to the family; the eastern rooms – not labelled on the plans – probably had a service function but appear insufficient for a residence of this size.

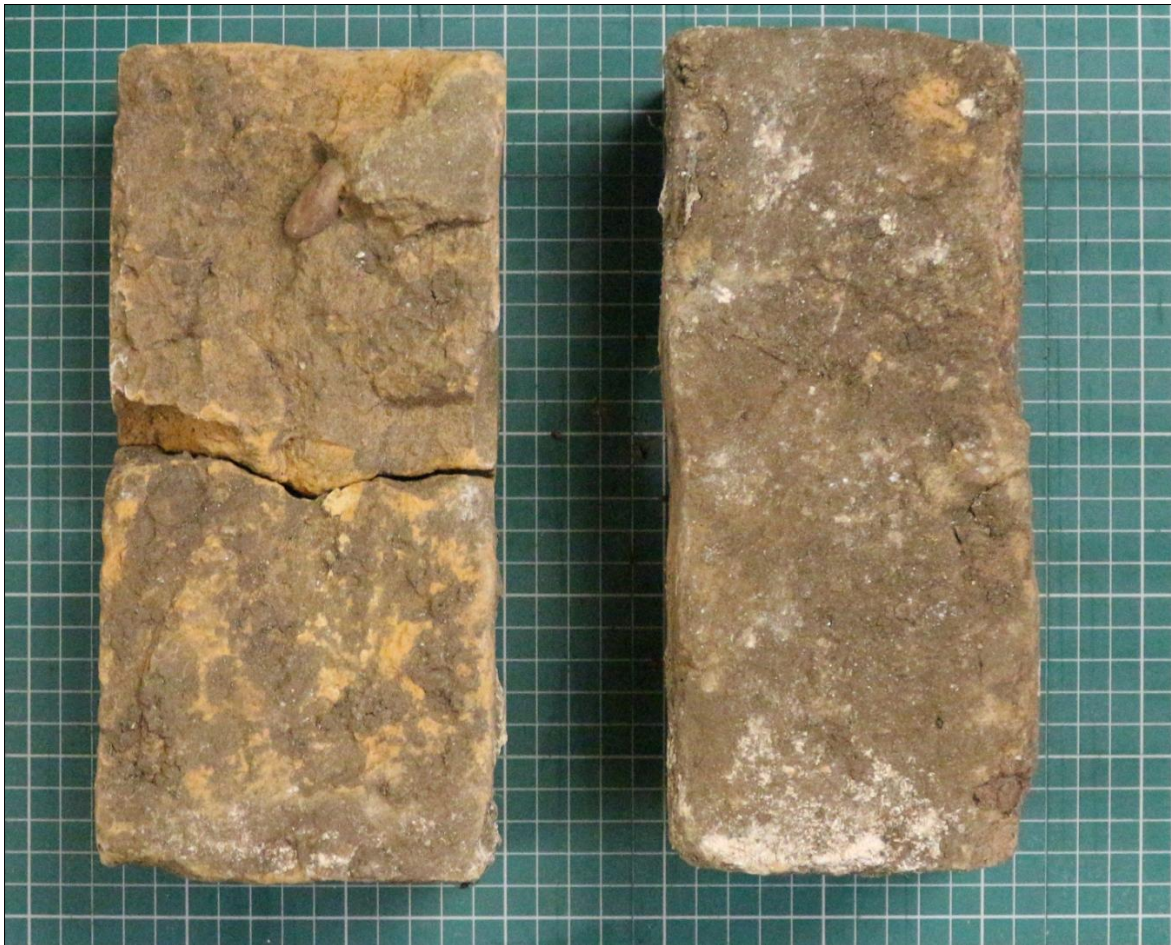
The character of the building debris was consistent across the two trenches, with minimal variation between contexts but with some marked concentrations of material. Yellowish-white and pinkish-white lime mortar was used across the features in Trench #1 to bond the wall foundations and brick work. These walls were solid and the mortars tough but brittle. In contrast, the mortar adhering to material from the foundation cut in Trench #2 was particularly sandy and had a more orange hue. In general, the bricks used appear poor in quality, being rather soft and containing coarse inclusions. This would appear to be in accordance with the views of James Wyatt as expressed in a letter to Sir Thomas Acland in 1775: *'Johnson gives me so bad an Acct. of the Brick that I cannot by any means advise you to use it in the foundations and Basement Story'* (DRO 1148M add/Correspondence/29/8-9). Broadly speaking, these bricks fall into two size categories: 240×105×70mm; and 235×115×70mm. The slightly wider brick appeared to be of inferior quality, more often broken and less dense, with relatively large stone inclusions (20mm). Examples of broken and misfired brick were present in the piles of debris within the earthwork and the rubble infill of the walls. Fragments of roof slate with notches and mortar were also noted.

FIGURE 8: EXAMPLES OF THE TWO KINDS OF BRICK ENCOUNTERED (10MM SCALE IN BACKGROUND).

The hand-made frogless bricks recovered during the evaluation are of inferior quality, and this appears to be in accordance with the opinion of James Wyatt as expressed in a letter to Sir Thomas Acland in 1775: '*Johnson gives me so bad an Acct. of the Brick that I cannot by any means advise you to use it in the foundations and Basement Story*' (DRO: 1148M add/Corresp./29/8-9). Broadly speaking, the bricks fall into two categories based on size; this may imply two phases of production, two sources of manufacture, for two distinct functions. It is most probable that the clay was sourced in the valley below and the bricks clamp-fired close to the site; however, as the unfinished house was later plundered for stone and brick, an element of recycling is also possible. Later correspondence relating to developments on the estate in the 19th century imply the sourcing and procurement of necessary materials from within nine miles of Killerton; in this instance referring to plans for a new hothouse in 1845-6 (DRO 1148M/add/10/6). The earliest brick structure in Exeter (the Custom House on the Quay) was built in 1680-1, so construction using brick would have been no great novelty, if rarely pursued.

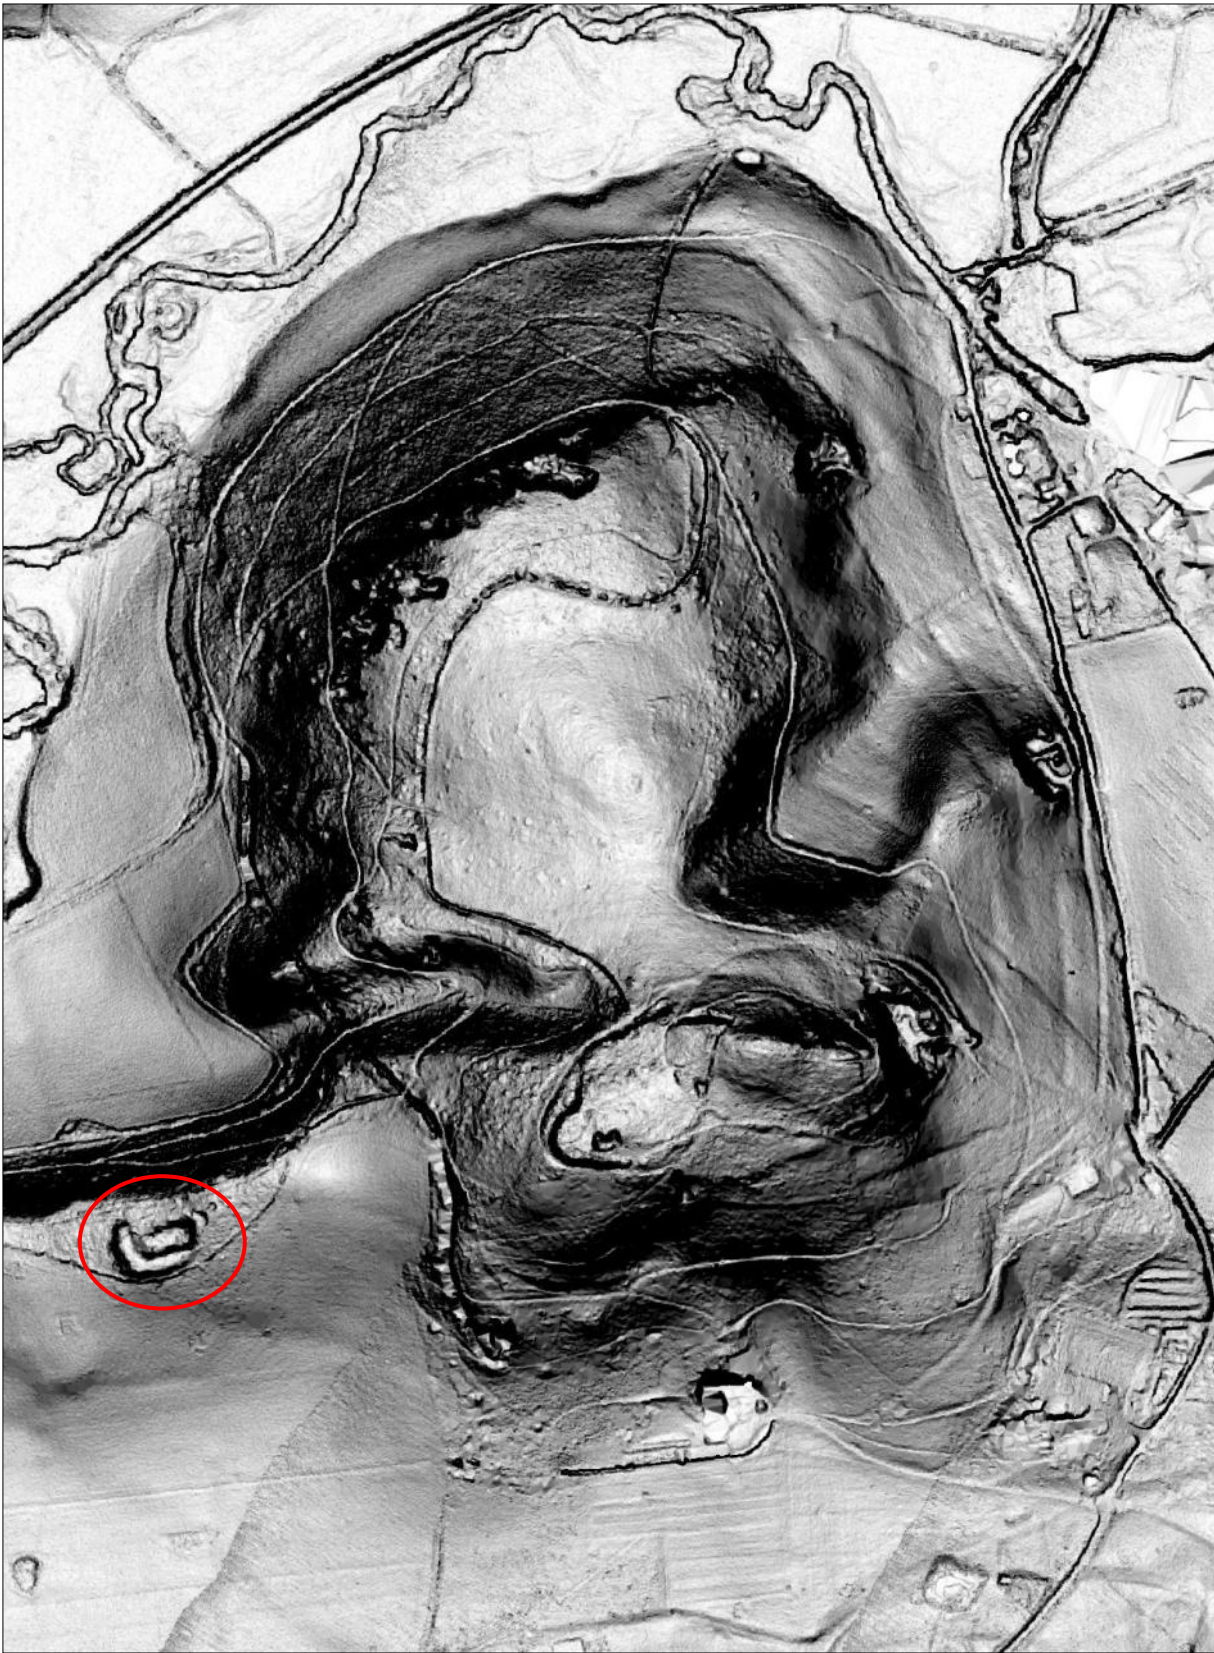
FIGURE 9: LIDAR IMAGE PRODUCED DURING THE KILLERTON DEERPARK SURVEY (WAPSHOT & WEBB 2016) IN WHICH THE EARTHWORK OF THE WYATT HOUSE WAS IDENTIFIED (INDICATED). IMAGE PRODUCED ON QGIS V2.18.2 TERRAIN ANALYSIS/SLOPE. THE LIDAR DATA USED IS FREELY AVAILABLE DATA SUPPLIED BY NATURAL ENVIRONMENT RESEARCH COUNCIL (CENTRE FOR ECOLOGY & HYDROLOGY; BRITISH ANTARCTIC SURVEY; BRITISH GEOLOGICAL SURVEY); ©NERC (CENTRE FOR ECOLOGY & HYDROLOGY; BRITISH ANTARCTIC SURVEY; BRITISH GEOLOGICAL SURVEY).

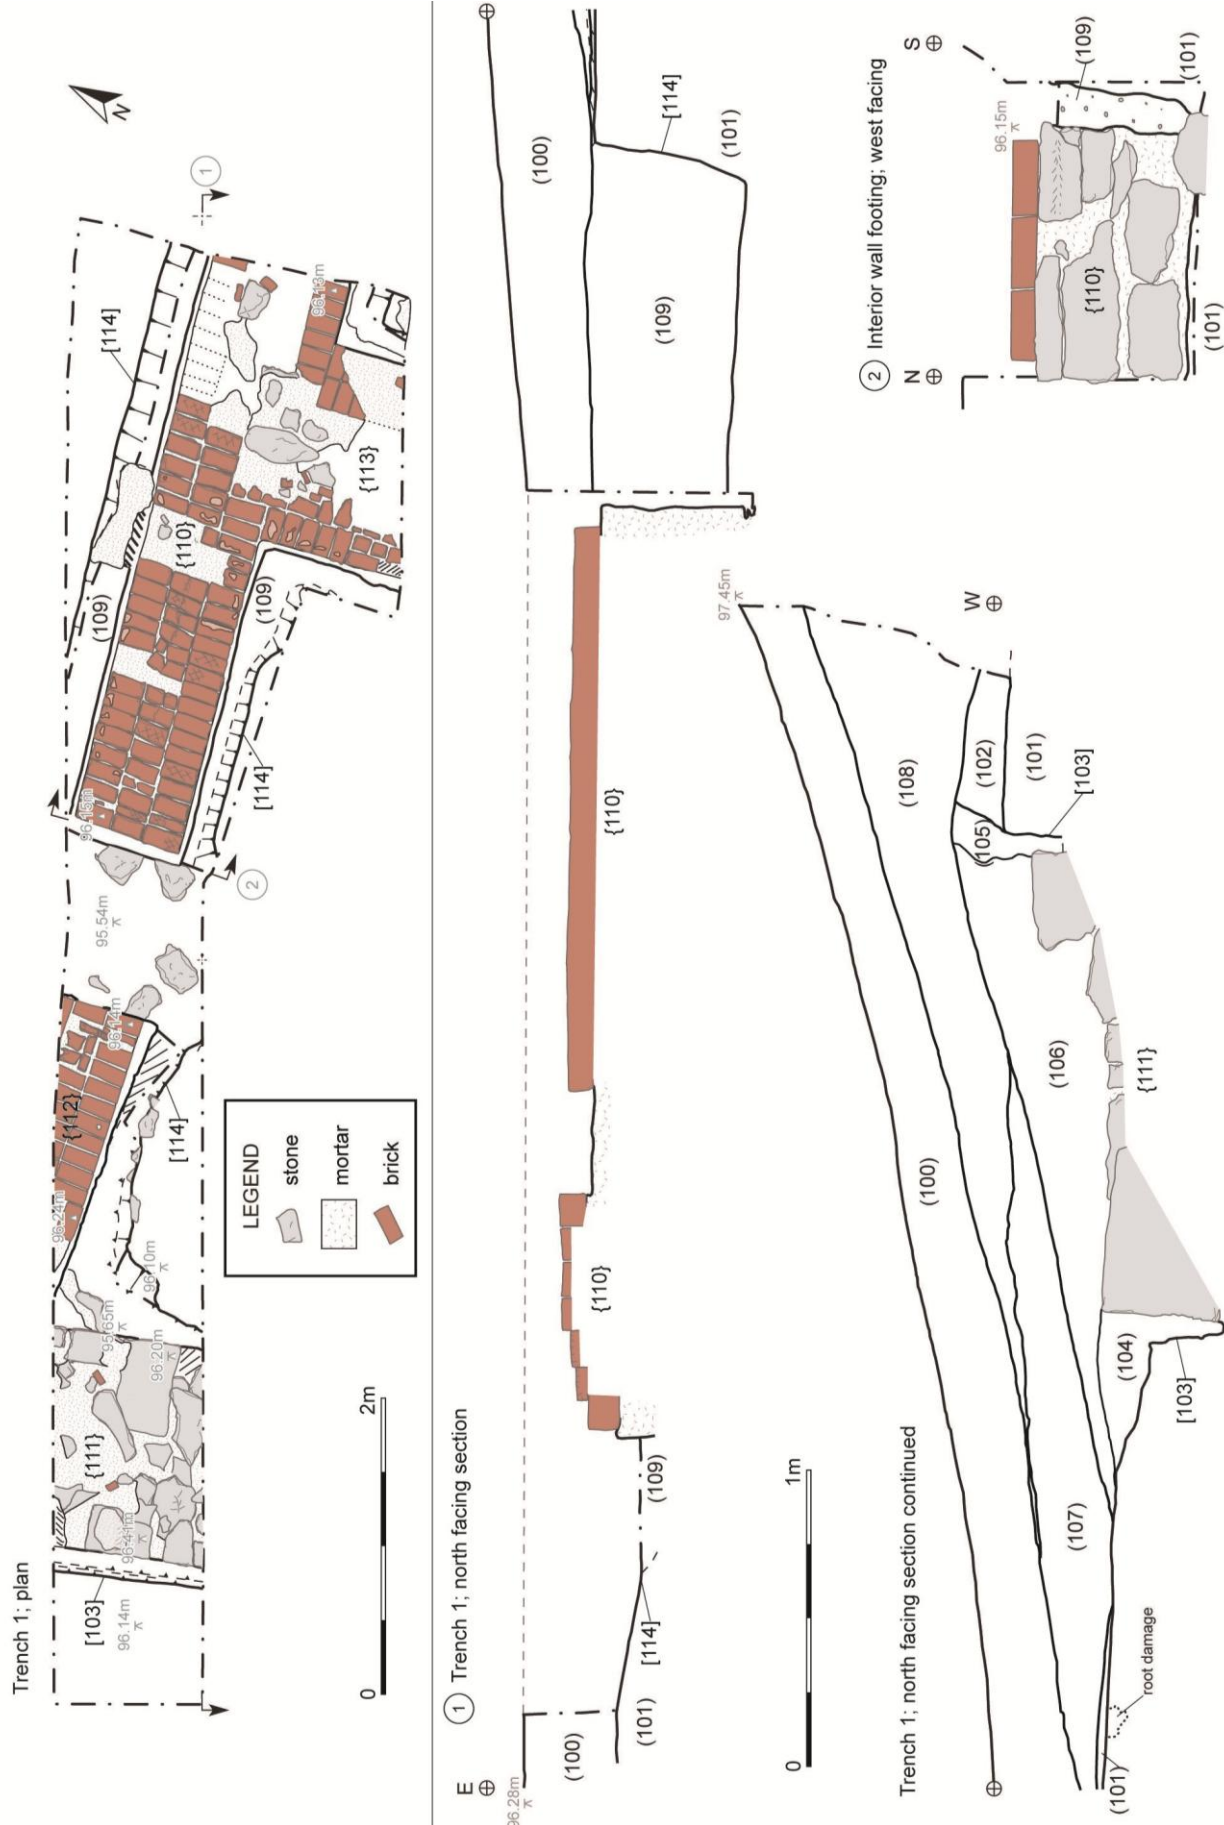
FIGURE 10: PLAN AND SECTION DRAWINGS OF TRENCH #1.

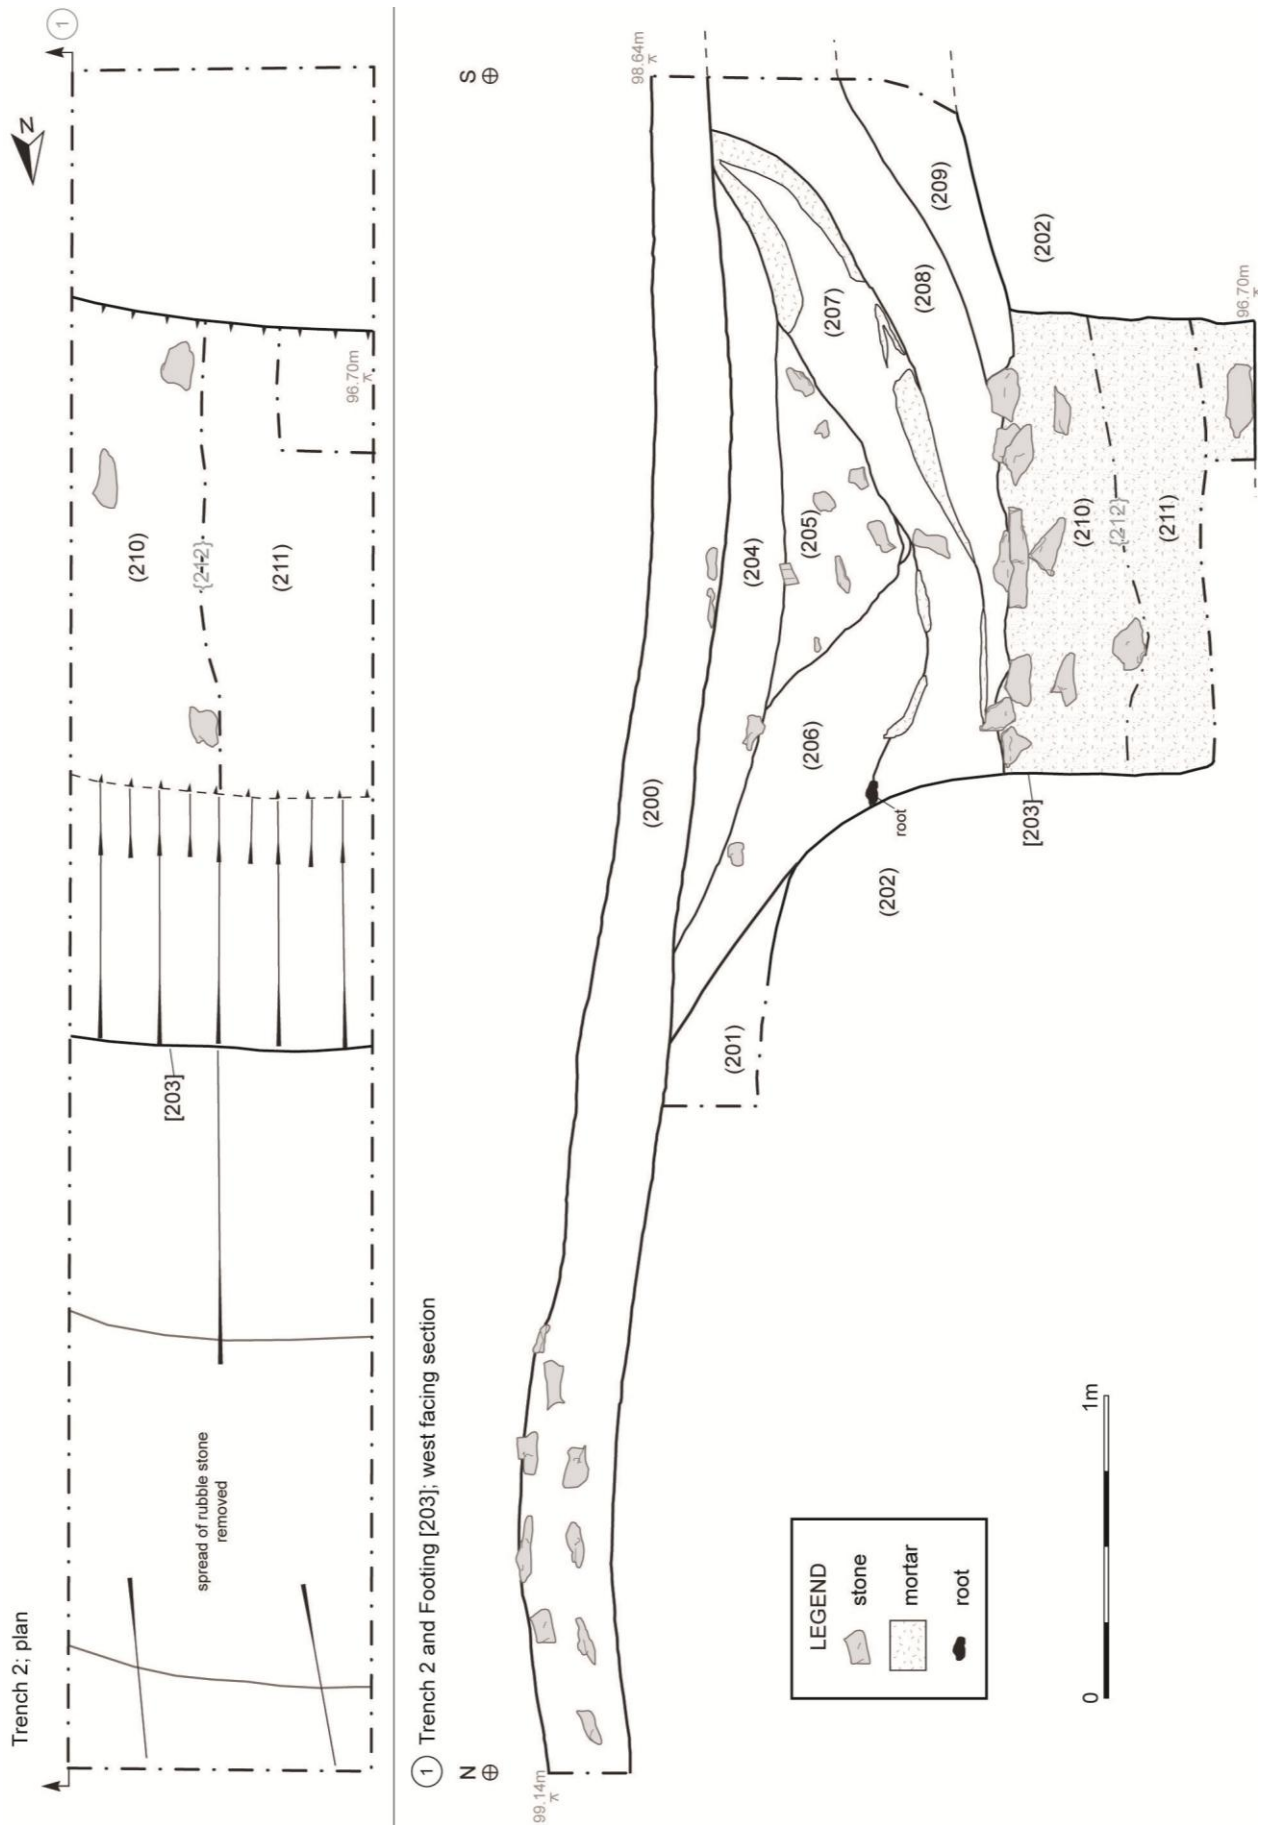
FIGURE 11: PLAN AND SECTION DRAWING OF TRENCH #2.

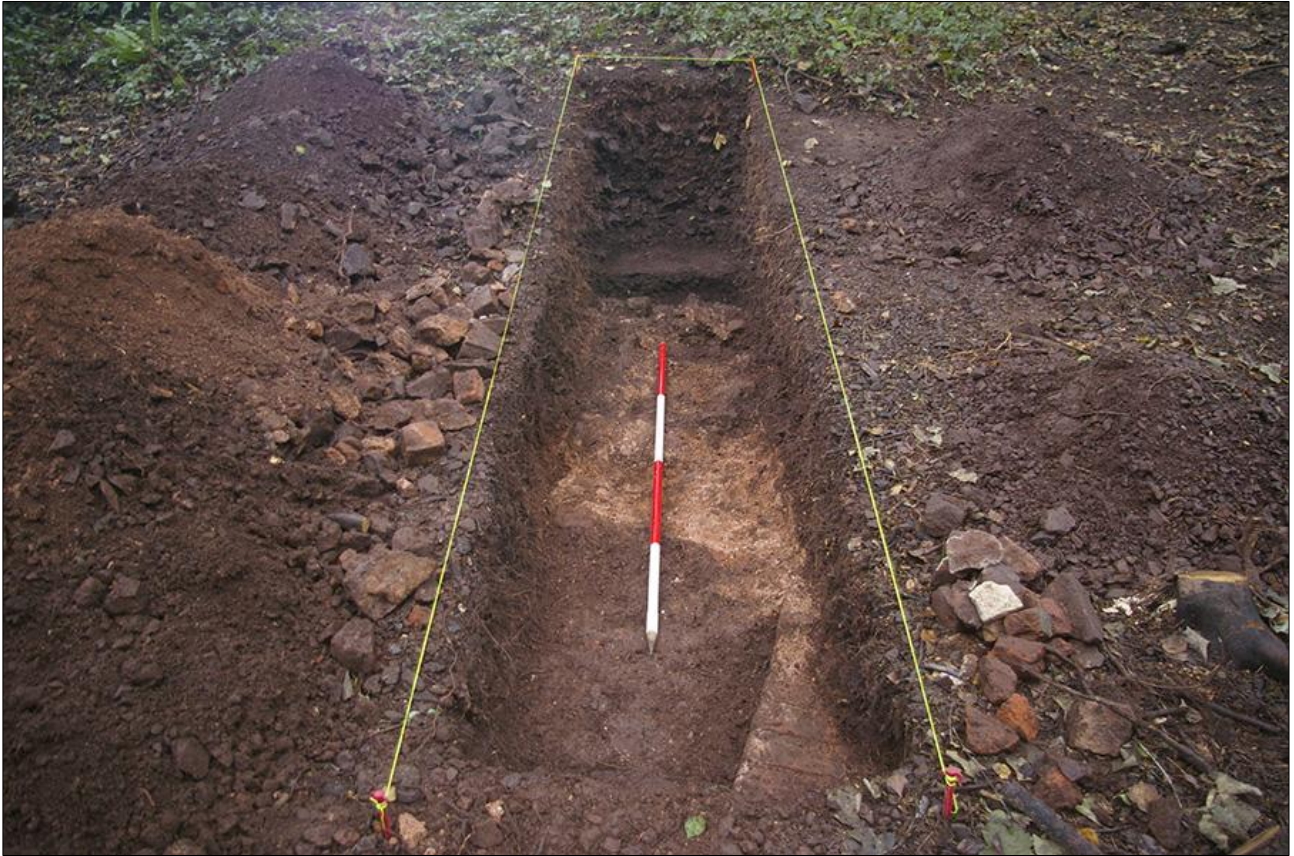
{111}	Wall Foundation	Outer Wall; linear aligned approximately north-south, 1.46m wide, shaped and built stone sides with rubble stone and brick infill, bonded with lime mortar, although with a sandy mixed mortar	Fill of [103]; Abuts (104)(105); Overlain by (107)	0.38-0.72m	Late C18
{112}	Wall Foundation	Inner Wall; as {110}, but the west side of the doorway to the billiard room. The 7 th brick from the east end has a hole, possibly drilled, c.0.02m dia. and 0.02m deep.	Fill of [114]; Abuts (109); Overlain by (106)	0.66m	Late C18
{113}	Wall Foundation	Inner Wall; wider section of foundations at the east end of {110}, defining the north-east corner of the billiard room, changes in wall width possibly indicated on the original plans; rubble/debris interiors of these wider sections of wall lined with built stone and brick are visible; <1.44m wide, aligned approximately north-south; foundations appear contiguous with {110}, possibly due to the liberal spread of mortar bonding and the bricks appear to abut it	Fill of [114]; Abuts (109); Overlain by (100)	-	Late C18

1. TRENCH #1, WALL FOUNDATION {111}, MID-EXCAVATION; VIEWED FROM THE EAST (2M SCALE).

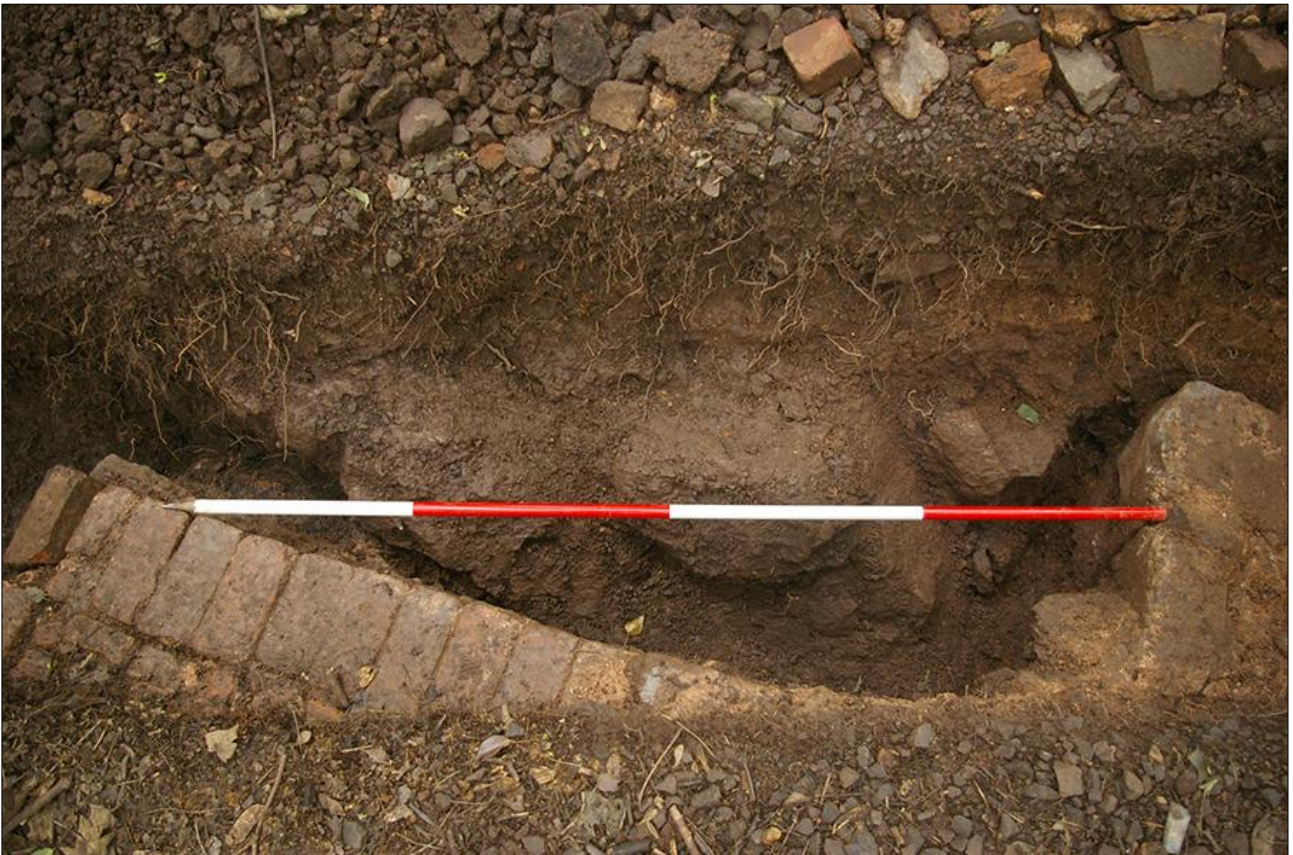
25. TRENCH #1, CONSTRUCTION CUTS [103] AND [114], ADJACENT TO WALL FOUNDATIONS {111} AND {112}; VIEWED FROM THE NORTH (2M SCALE).
