WYATT HOUSE KILLERTON BROADCLYST DEVON

Results of an Earthwork Survey and Archaeological Evaluation

South West Archaeology Ltd. report no. 190102

By J. Bampton
Report Version Final
2nd January 2019

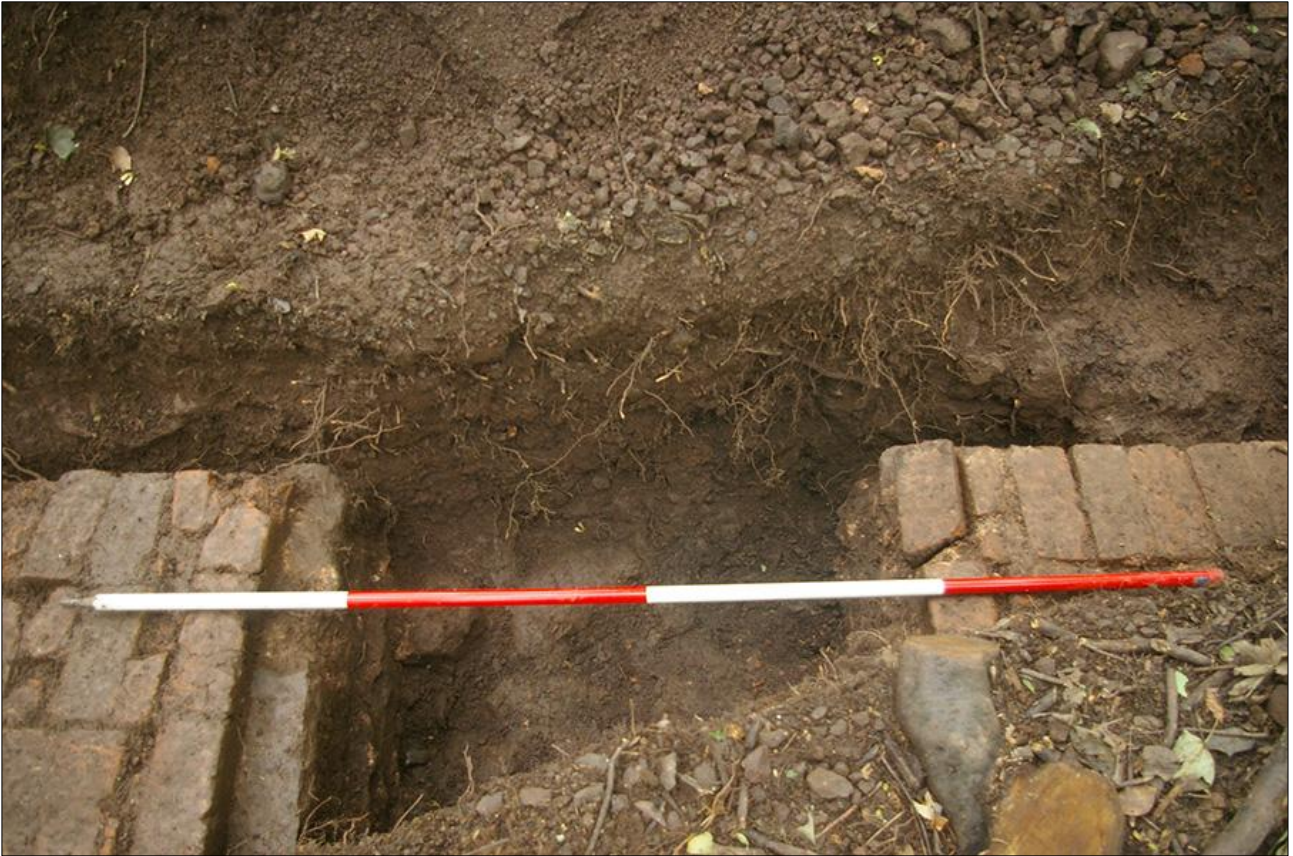
Both trenches feature an initial terracing cut: in Trench #1 at its western end and in Trench #2 at its southern end. In Trench #2 the cut is higher than the base of the hollow and thus the terrace must be stepped at this location. No historic floors or surfaces were identified in Trench #1. This would make sense for a building site, as finished floors would be installed near the end of the job to avoid damage. Some spreads of mortar in Trench #1 may relate to flooring, but more probably to waste material from wall construction. The entrance to the Billiard Room survives as a gap in the wall foundation.

30. TRENCH #1, DOORWAY LOCATION BETWEEN WALL FOUNDATIONS {110} AND {112}; VIEWED FROM THE NORTH (2M SCALE).

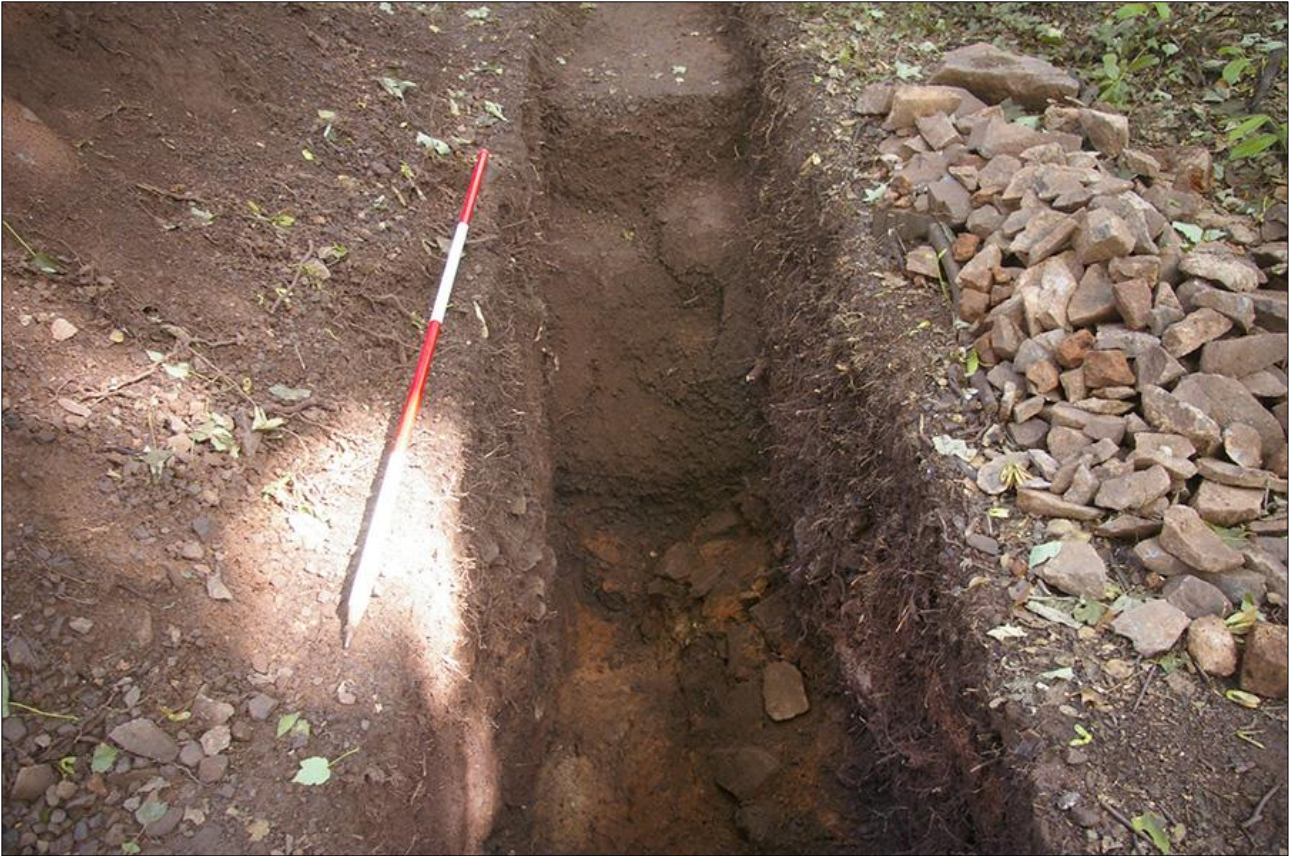
43. TRENCH #2, WALL FOUNDATION {212}; VIEWED FROM THE SOUTH (2M SCALE).
