LAND AT CASTLE CARY RAILWAY STATION

Results of a Desk-Based Assessment and Walkover Survey

South West Archaeology Ltd. report no. 190109

Land at Castle Cary Railway Station, Ansford, Castle Cary, Somerset

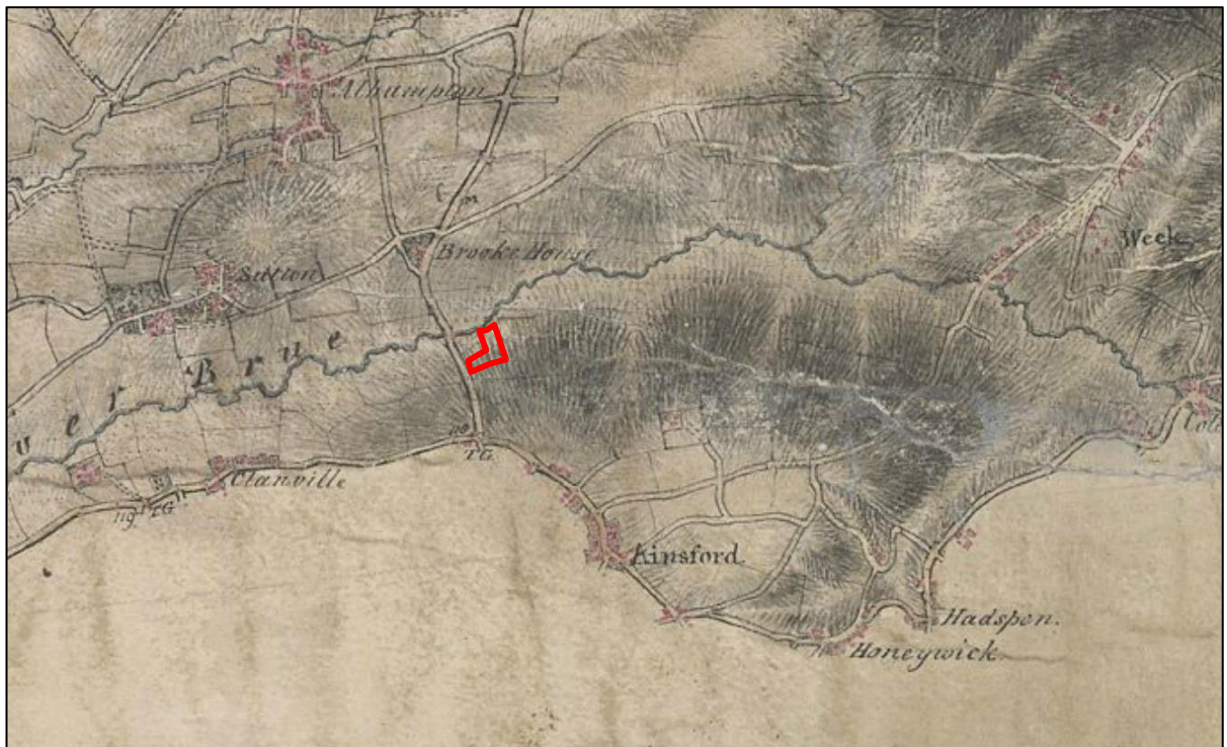
Figure 2: Extract from the 1811 Ordnance Survey surveyor’s draft map for the Glastonbury area (the approximate location of the site is indicated) (BL).

The earliest cartographic source available to this study is the 1811 Surveyor’s Draft map (Figure 2). These draft maps are generally a reliable depiction of road layout, extent of development and location of farms, and the general field-scape/pattern. Ansford, spelt *Ainsford* on the map, is located south of the mapped area, with only the edge of the settlement shown. The map shows the turnpike road running directly south over Ansford Bridge, before an alternate route, seen in the tithe mapping, was constructed. Some field divisions appear south of the Brue and Ansford Park appears to be enclosed.

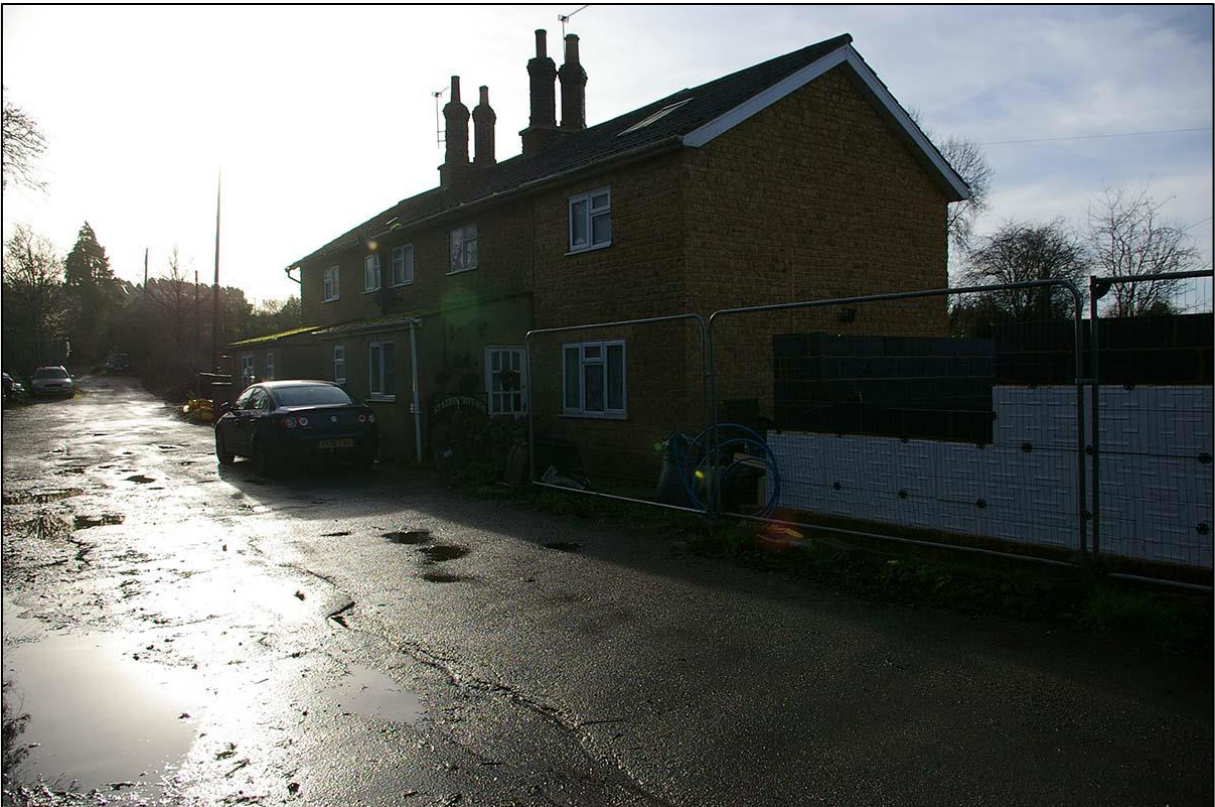
RAILWAY COTTAGES WHICH FLANK THE TRACK TO THE PROPOSED SITE (STATION ROAD), 19TH CENTURY BUT MUCH ALTERED AND EXTENDED; VIEWED FROM THE NORTH-EAST.

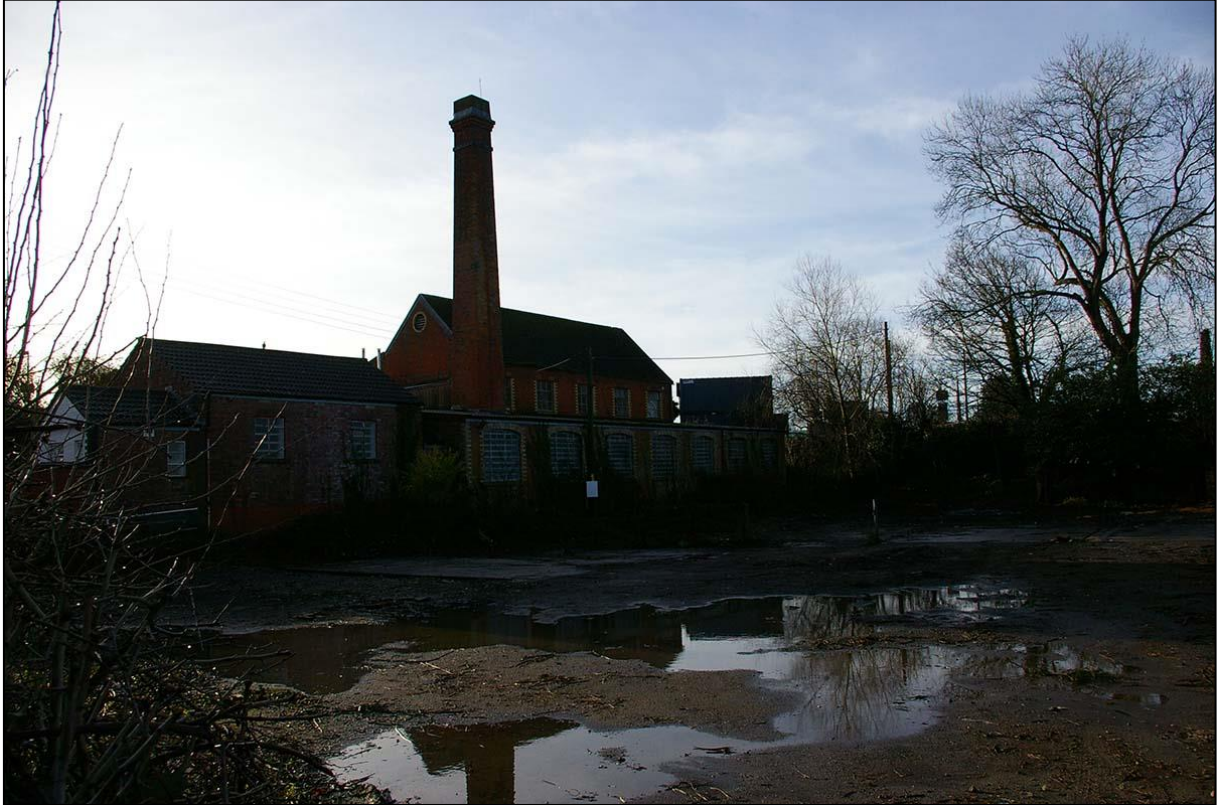
FACTORY/MILL TYPE STRUCTURE NEXT TO THE RAILWAY STATION; VIEWED FROM THE NORTH-EAST.

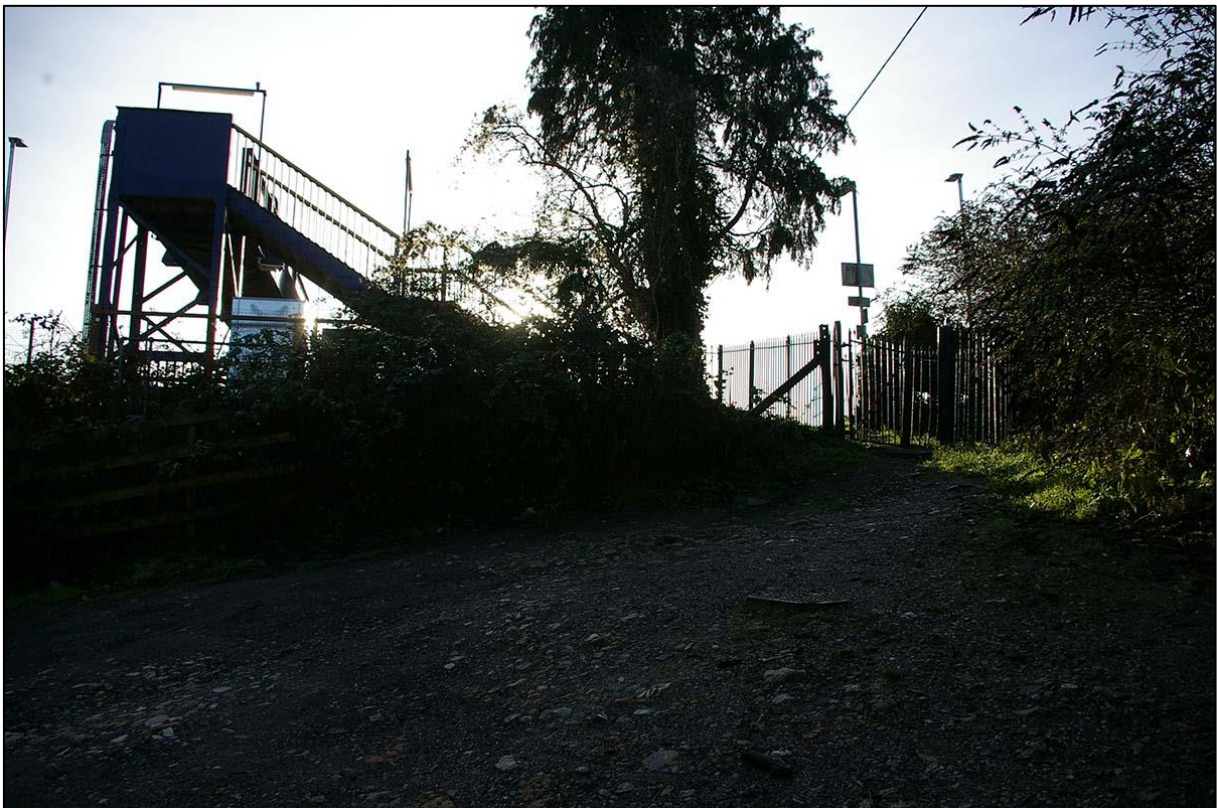
VIEW OF THE BANK, WITH THE GATE TO THE PLATFORM AND THE OVERBRIDGE AT THE STATION; VIEWED FROM THE
NORTH.

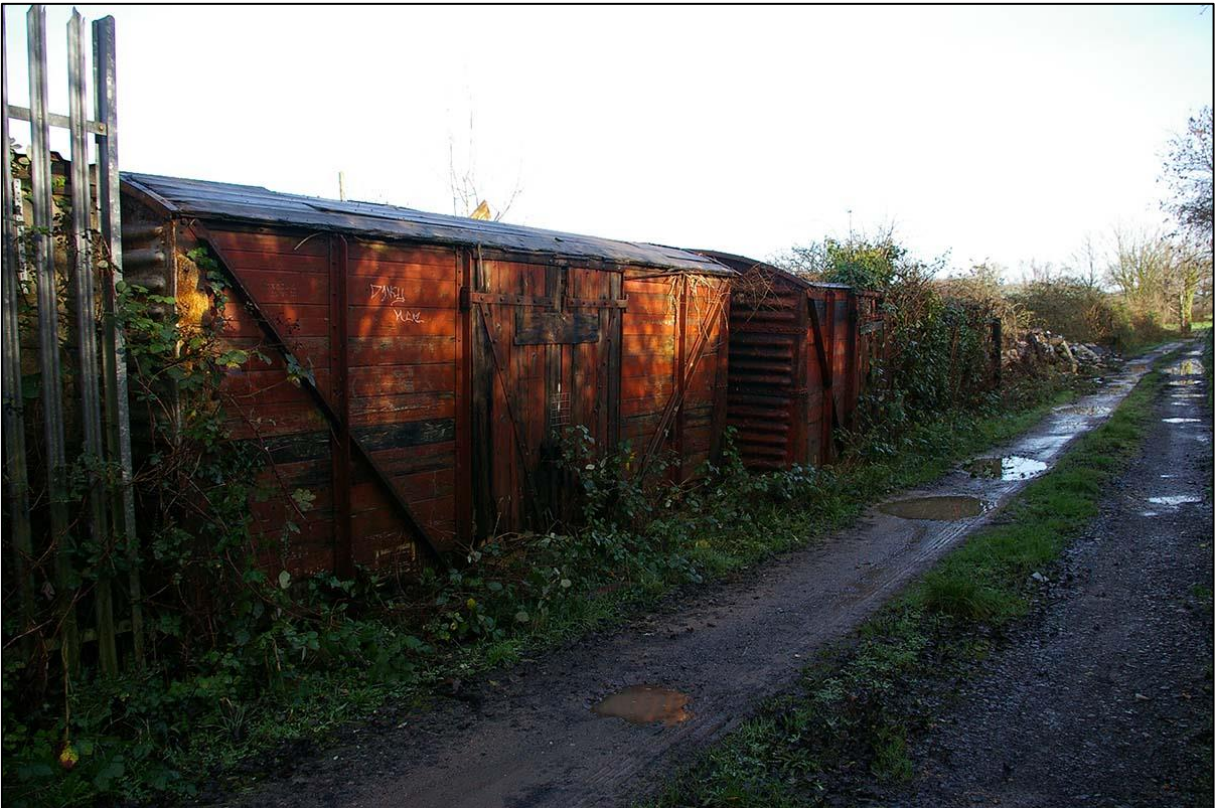
VIEW OF THE THREE HISTORIC WOODEN AND IRON FREIGHT CARRIAGES, WHICH FORM THE SOUTH BOUNDARY OF THE WESTERN PART OF THE SITE; VIEWED FROM THE WEST-SOUTH-WEST.

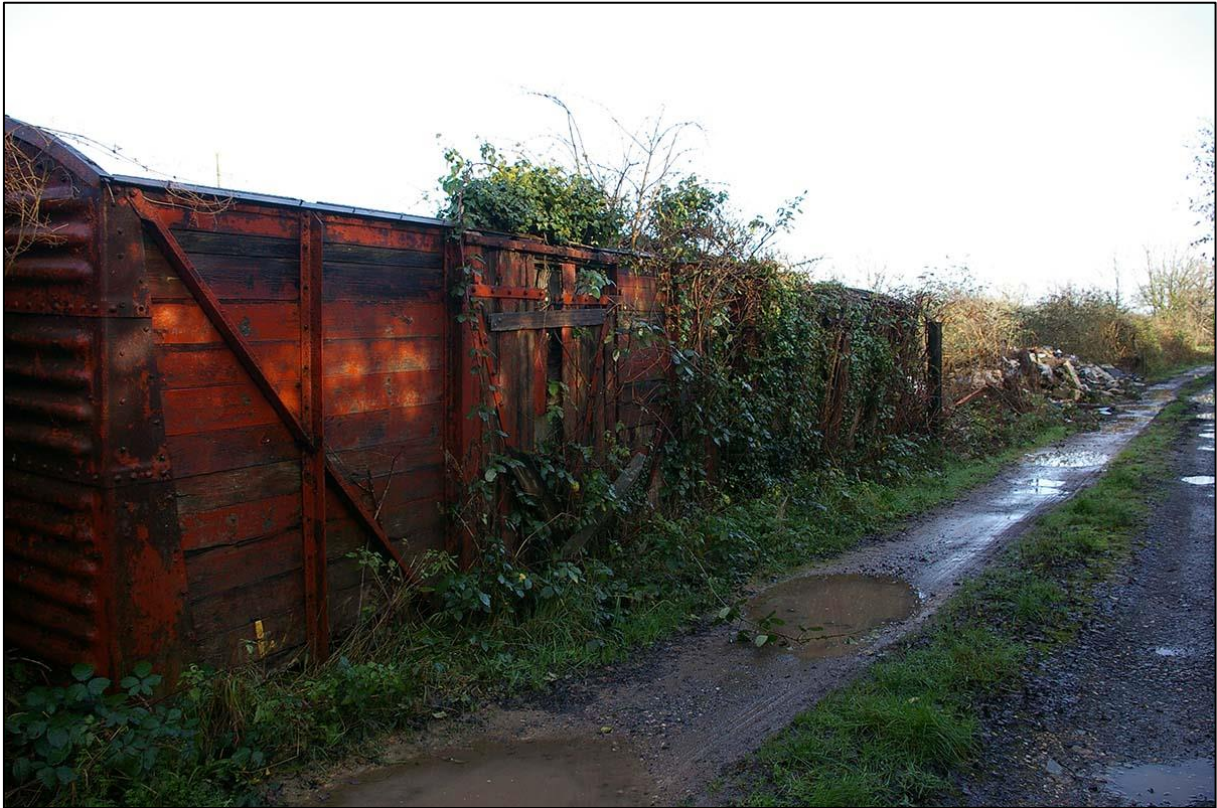
MORE DETAILED VIEW OF THE THREE HISTORIC CARRIAGES; VIEWED FROM THE SOUTH-WEST.

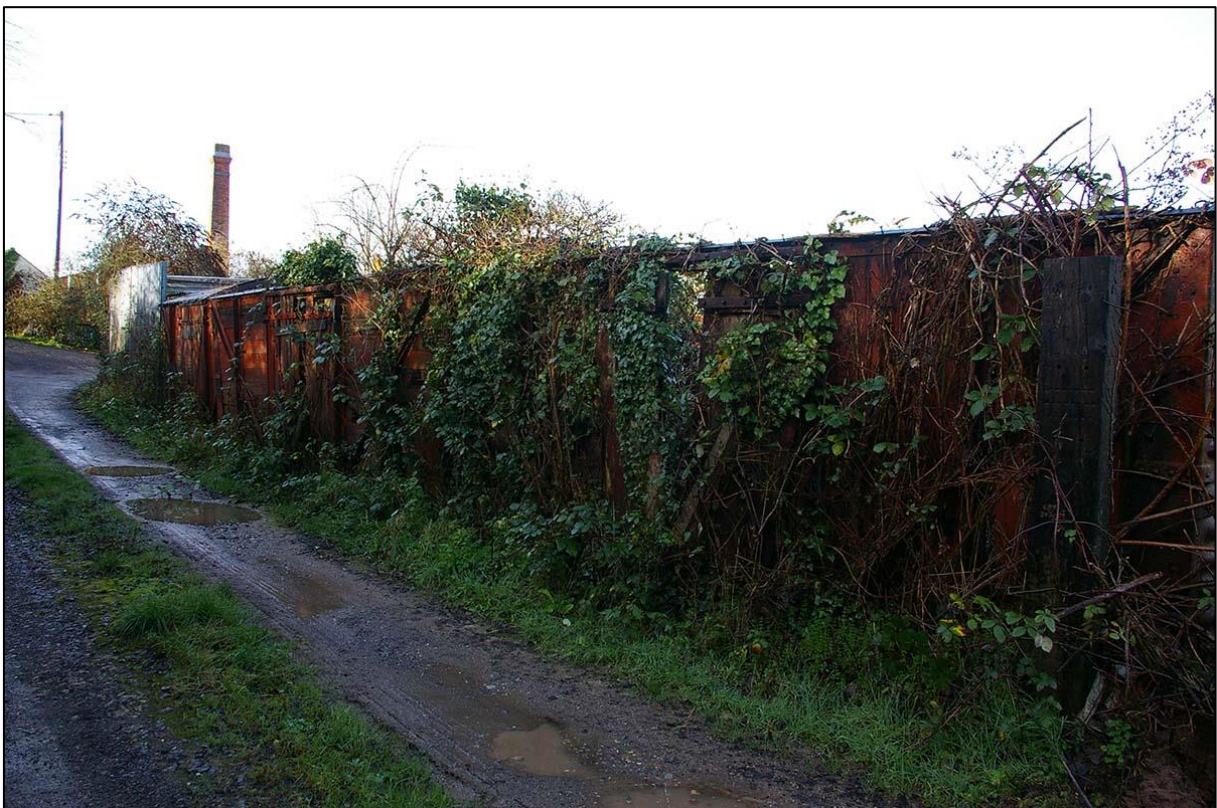
VIEW OF THE THREE HISTORIC WOODEN AND IRON FREIGHT CARRIAGES, NOTED ON THE SITE; VIEWED FROM THE EAST-SOUTH-EAST.

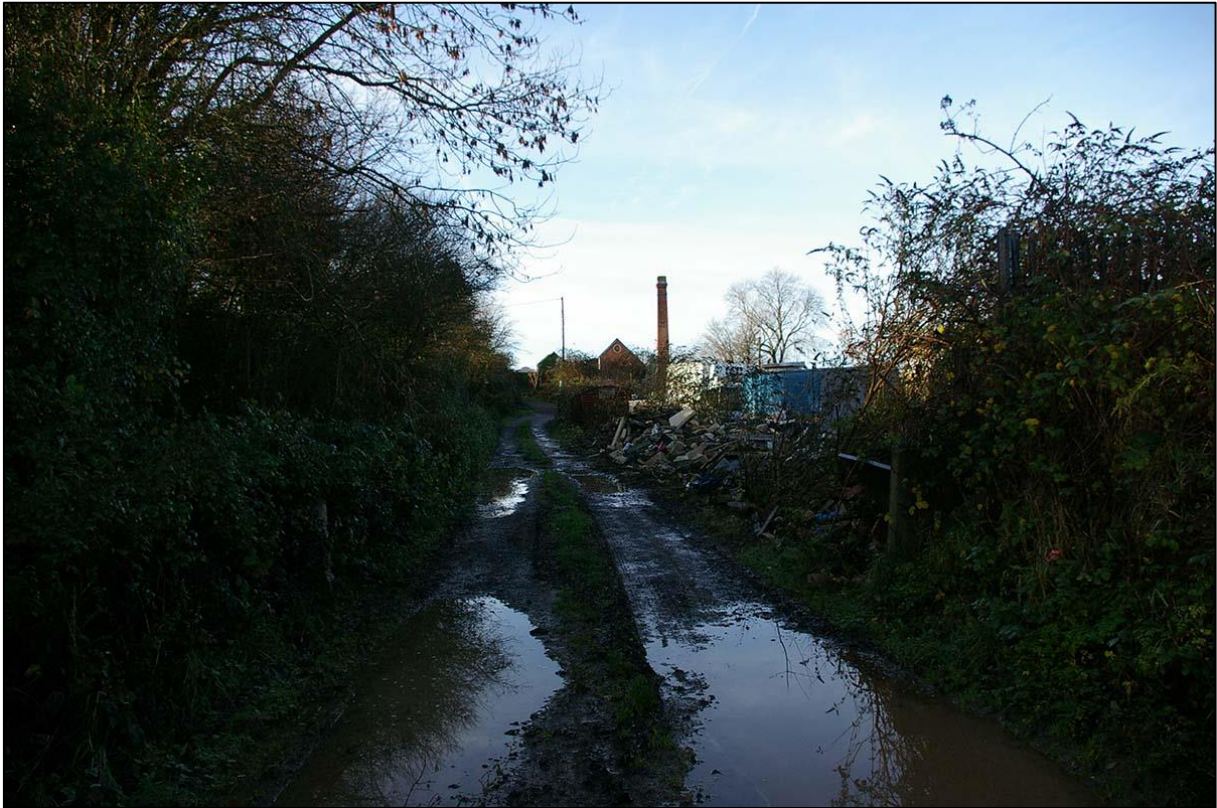
VIEW ALONG THE PARTLY OPEN AND PARTLY ENCLOSED SOUTH BOUNDARY OF THE WESTERN ENCLOSURE ON THE SITE, SHOWING SIGNIFICANT TIPPING OF MATERIALS; VIEWED FROM THE EAST.

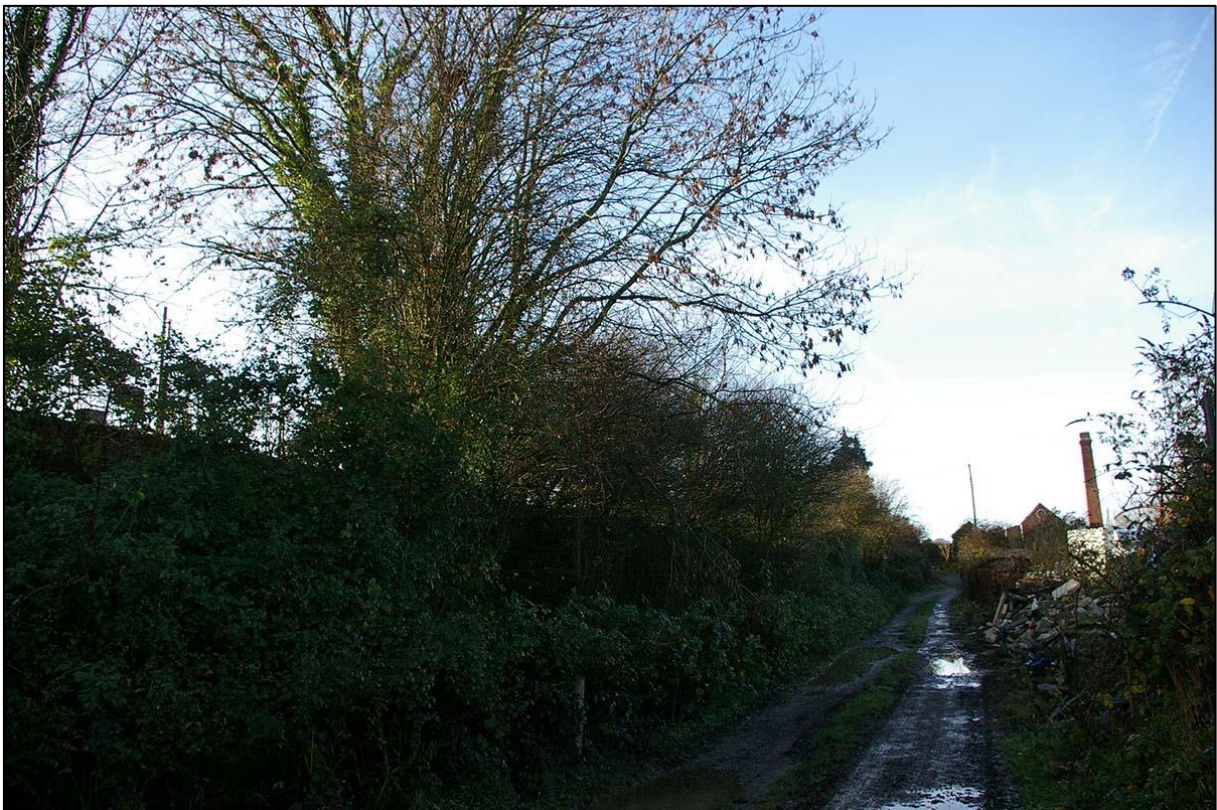
THE EMBANKMENT TO THE RAILWAY LINES, WITH BEECH TREE, SOME HAZEL AND OTHER SMALL TREES ON THE SLOPE, WITH CONCRETE POST AND WIRE FENCE; VIEWED FROM THE EAST.

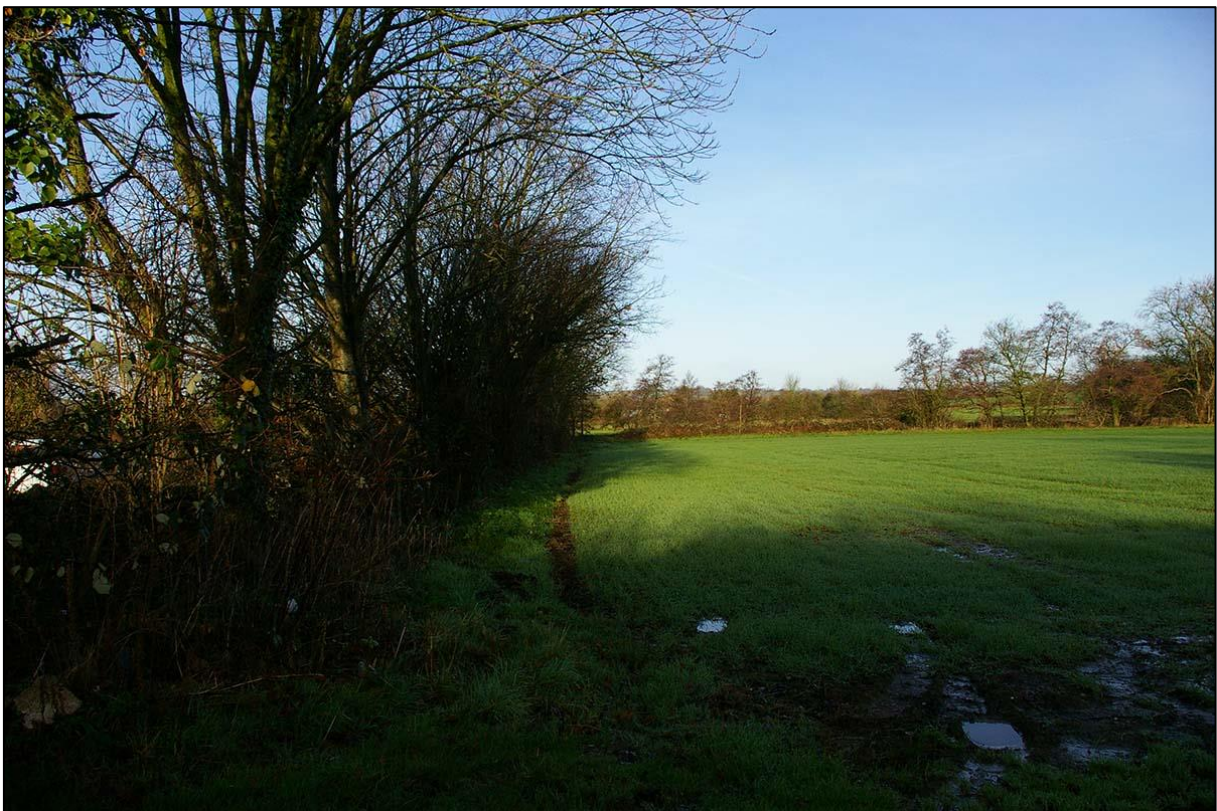
VIEW ALONG THE EASTERN BOUNDARY OF THE PROPOSED SITE, BETWEEN IT AND THE ADJACENT FIELDS, AN OVERGROWN BEECH HEDGE; VIEWED FROM THE SOUTH.

The enclosure is framed on its east side by an established earth bank, mixed with stone, topped by an overgrown beech hedge. In places, particularly to the south, the bank is better preserved and here stands as high as c.1.25m, to the centre it has slumped to c.0.6m and to the north the bank is patchy.

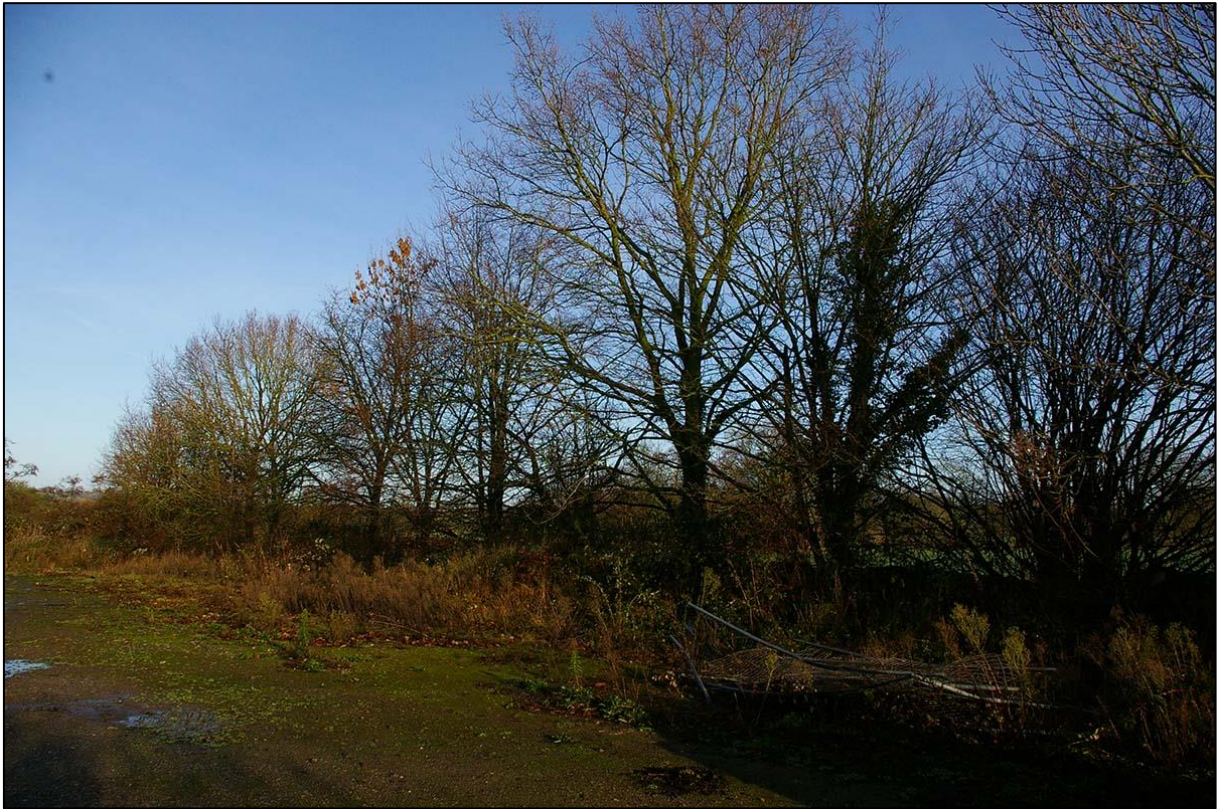
THE OVERGROWN EASTERN HEDGE BOUNDARY; VIEWED FROM THE SOUTH.

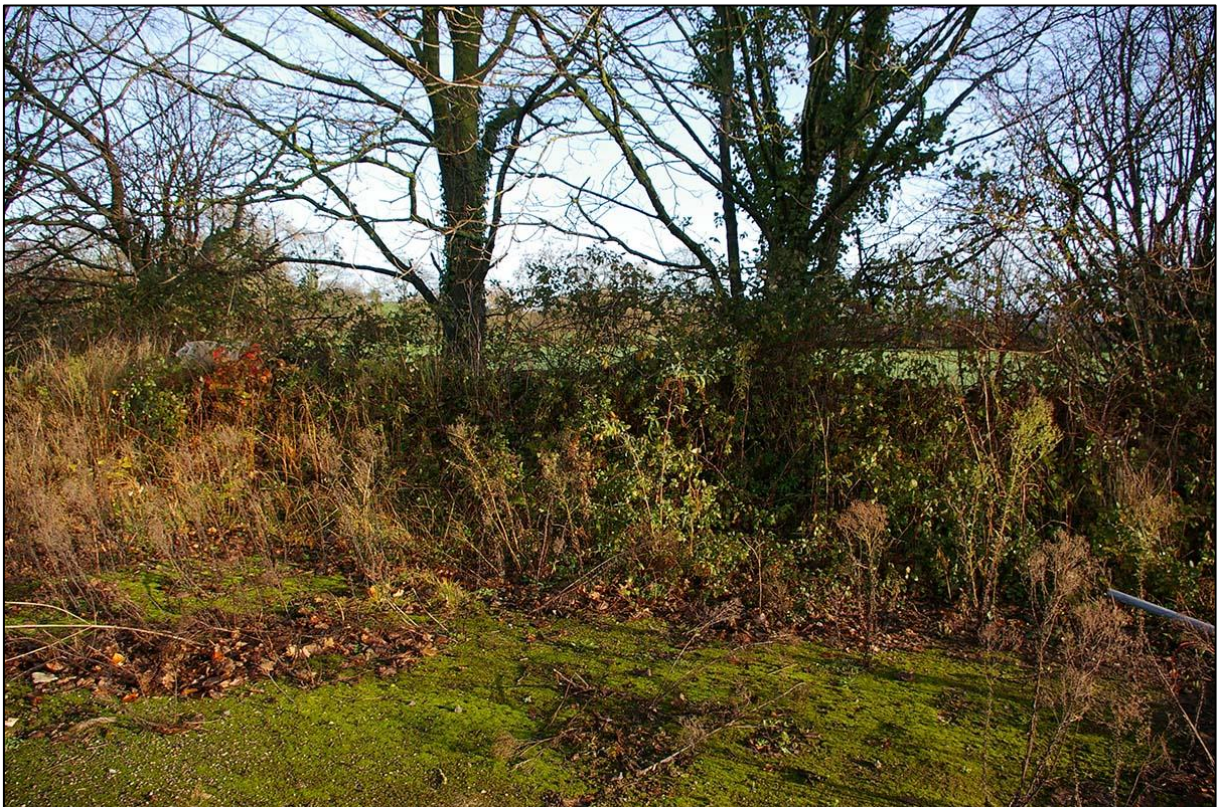
VIEW OF THE EASTERN BANK ON THE BOUNDARY, WHERE IT SURVIVES WELL; VIEWED FROM THE WEST-SOUTH-WEST.

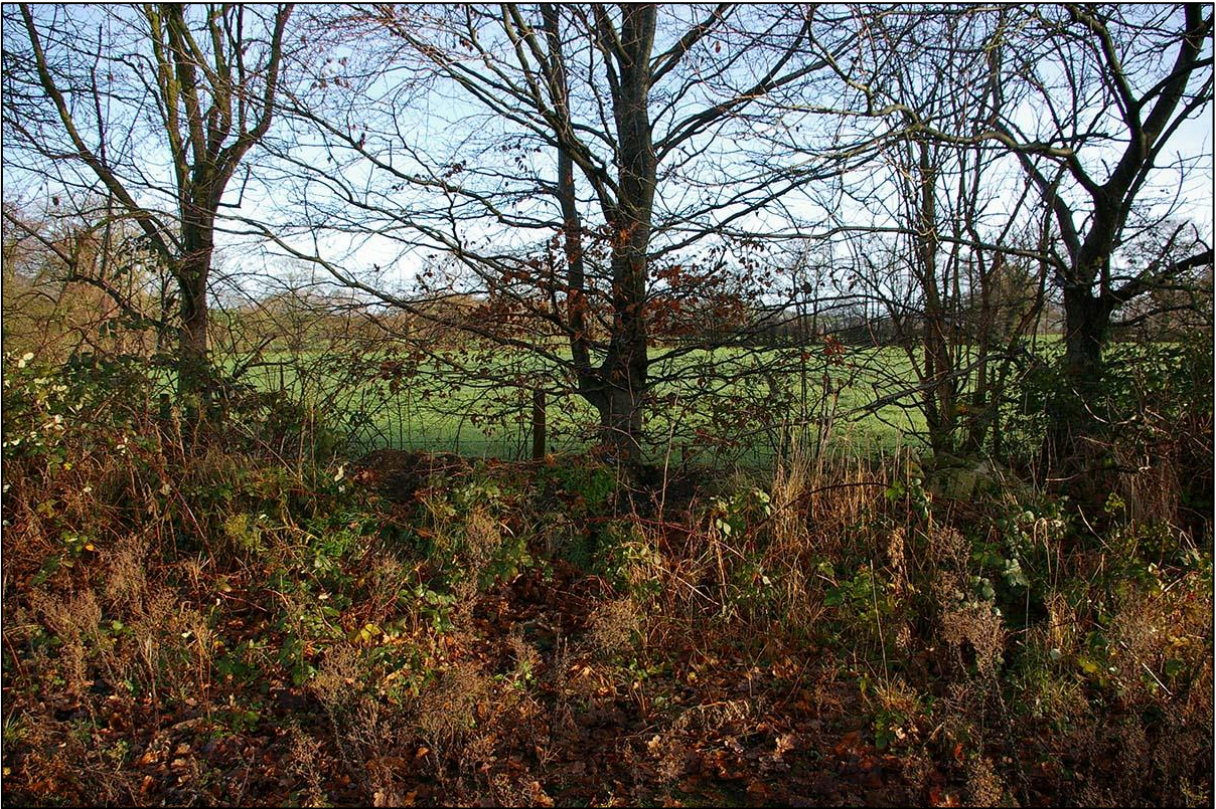
THE BANK WHERE IT HAS SLUMPED, SHOWING THE RECENT POST AND WIRE FENCE BEYOND; VIEWED FROM THE WEST.

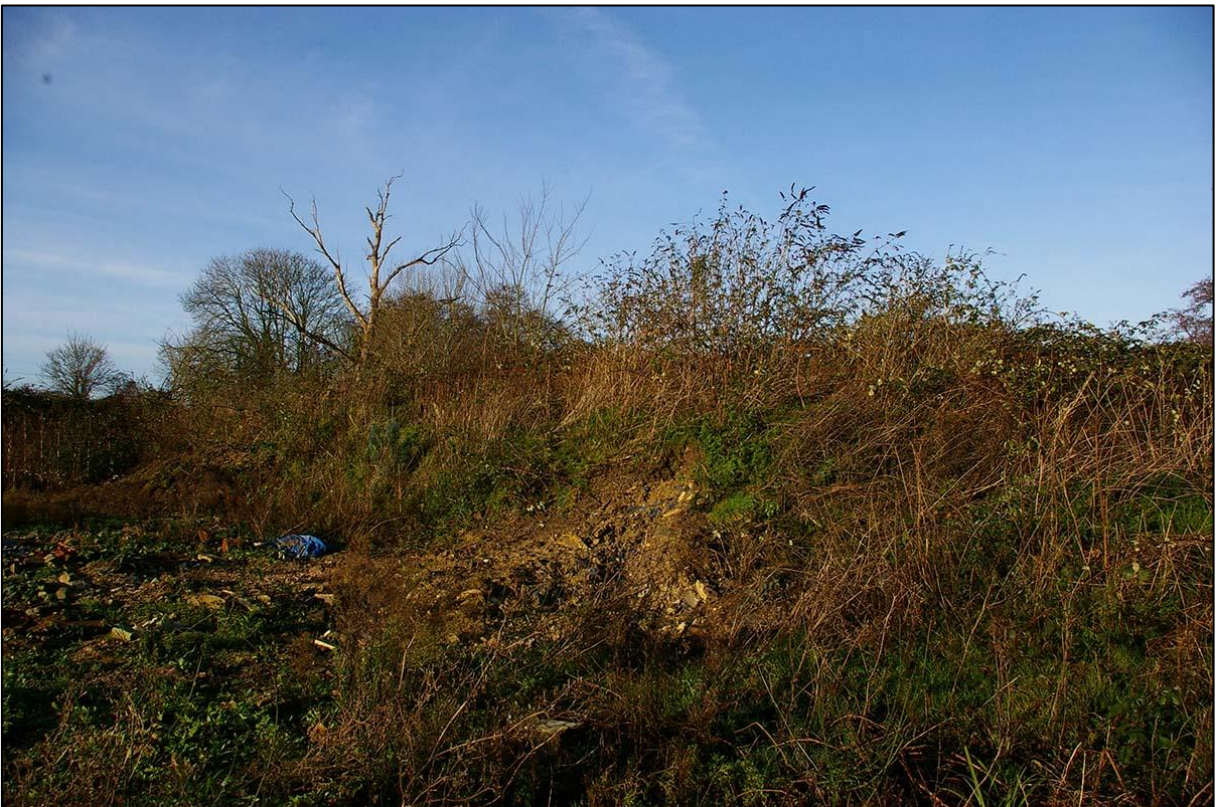
THE TALL SPOIL BANKS TO THE NORTH END OF THE EASTERN ENCLOSURE; VIEWED FROM THE EAST.

To the north there is a large area of spoil, probably the original topsoil from this field, scraped off when the yard was created or extended. This mound has been further built up by a lot of dumping of building materials and waste here too. The banking is well established as it has moss and grass growing on it, with thistles, brambles, nettles, docks and buddleia. Beyond this high banking which probably rises to 2.5m in places, is the River Brue.

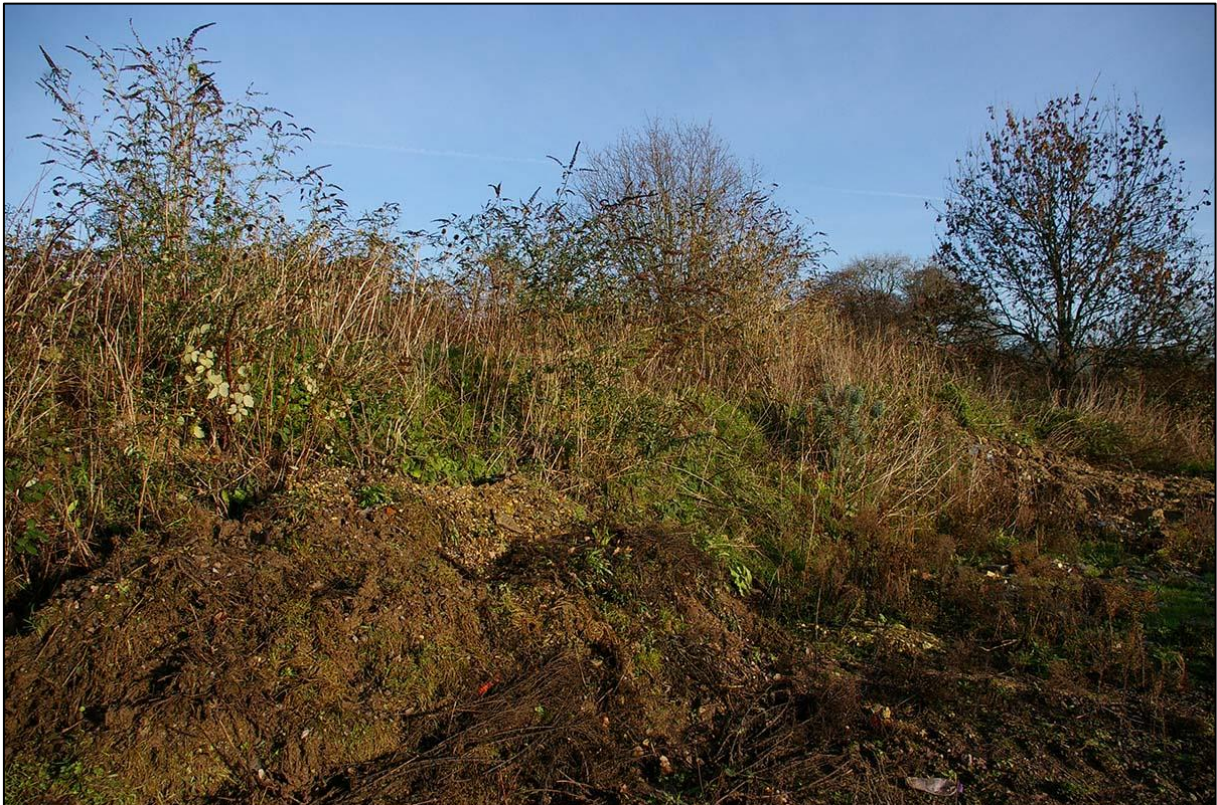
THE TALL SPOIL BANKS TO THE NORTH END OF THE EASTERN ENCLOSURE; VIEWED FROM THE WEST.

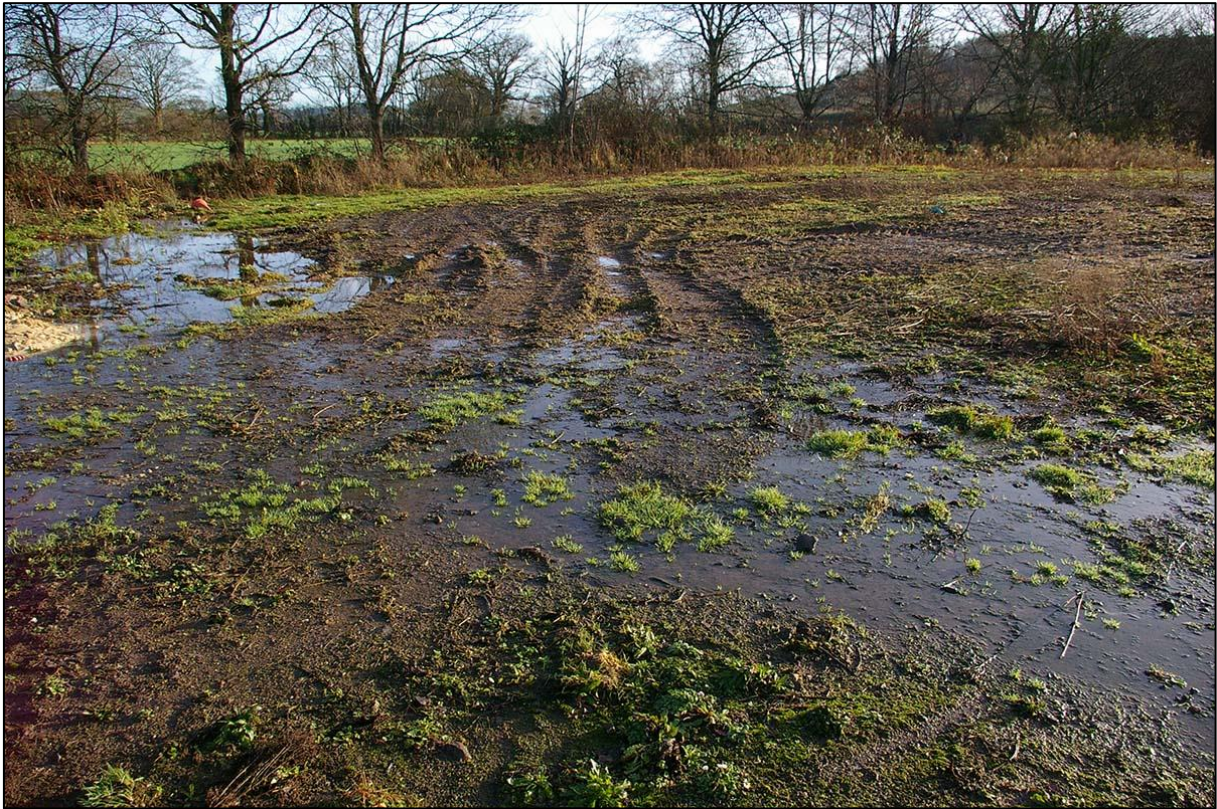
THE GROUND SURFACE OF THE EASTERN ENCLOSURE; VIEWED FROM THE NORTH-EAST.

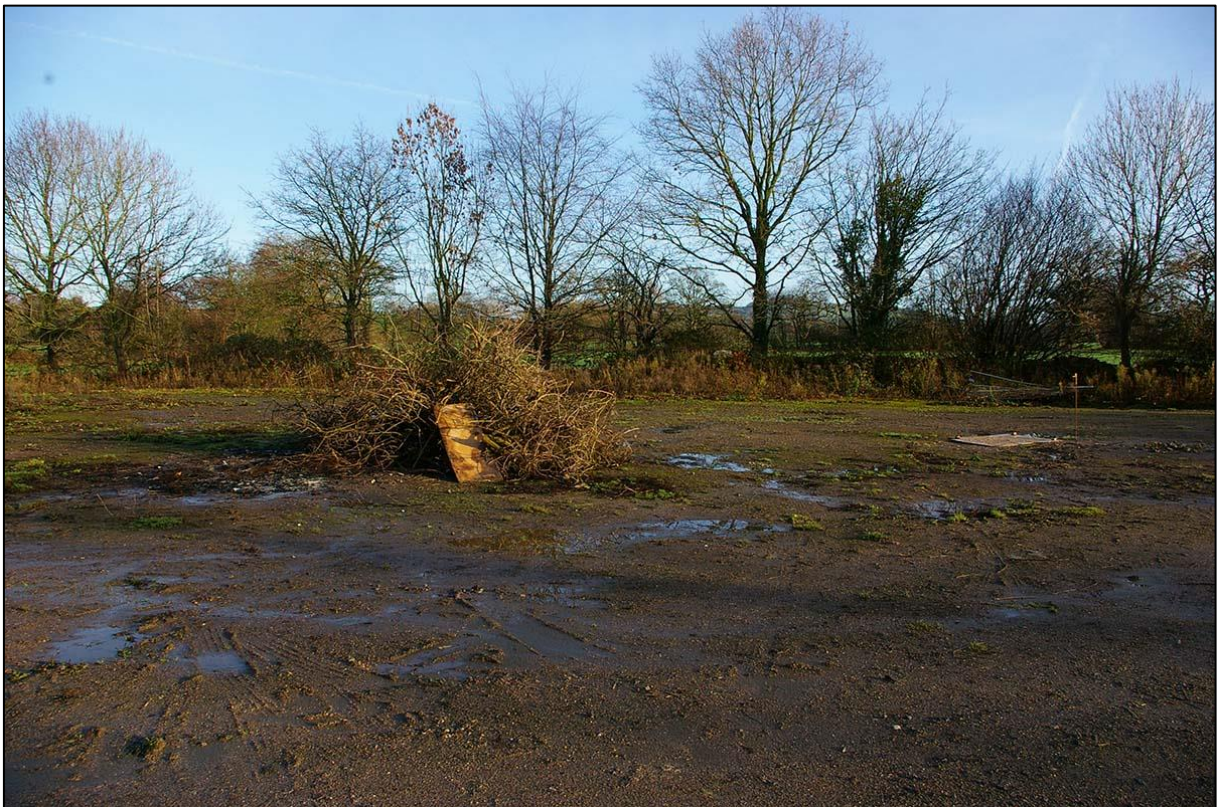
THE GROUND SURFACE OF THE EASTERN ENCLOSURE; VIEWED FROM THE WEST.

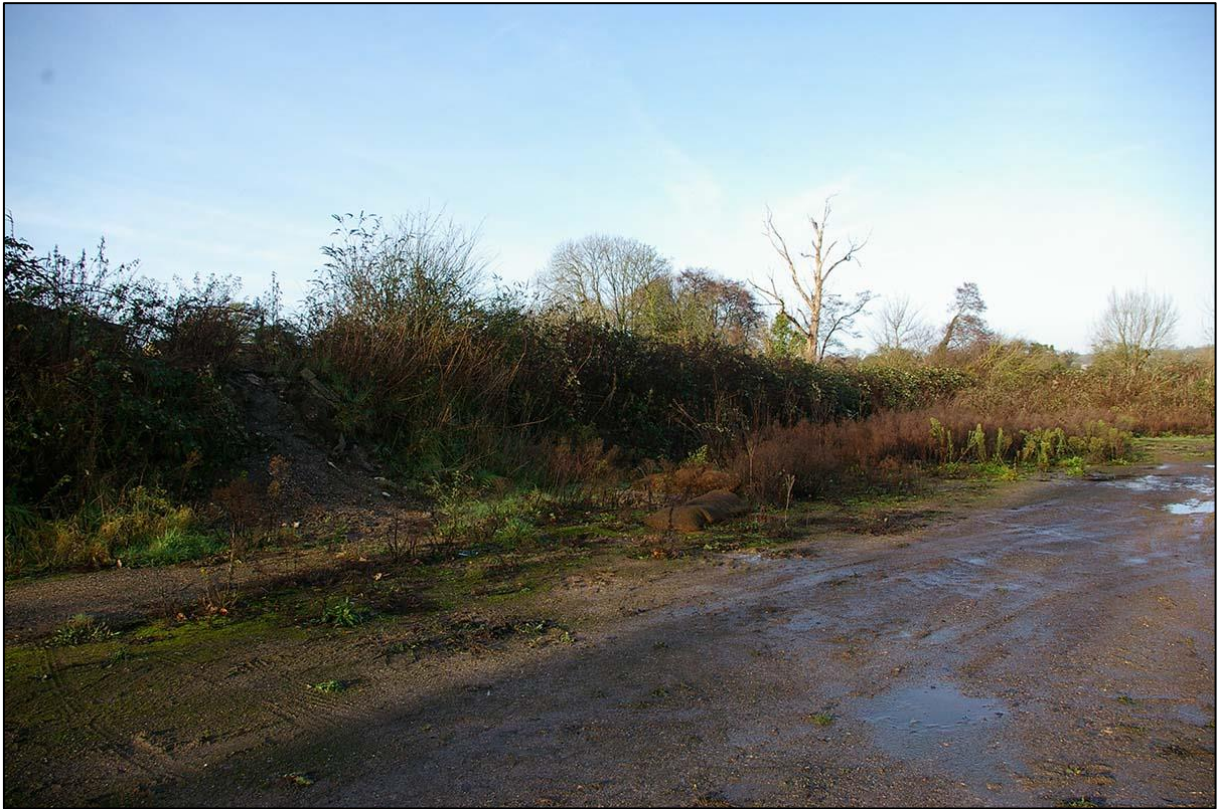
THE BOUNDARY HEDGE BETWEEN THE TWO ENCLOSURES ON THE SITE, PART HEDGE, WITH BRAMBLES AND PART MESH FENCING; VIEWED FROM THE SOUTH-SOUTH-EAST.

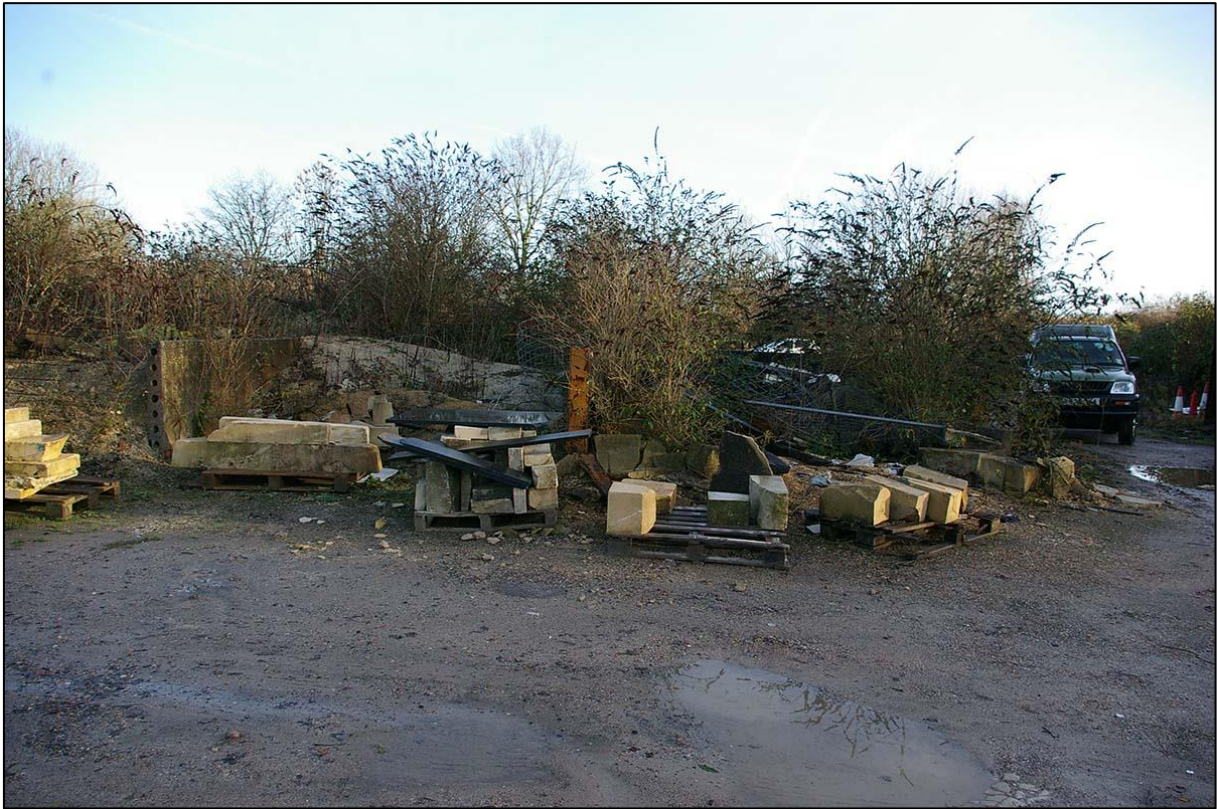
SOME OF THE CONCRETE 'SILOS' HOLDING SAND AND GRIT; VIEWED FROM THE WEST.

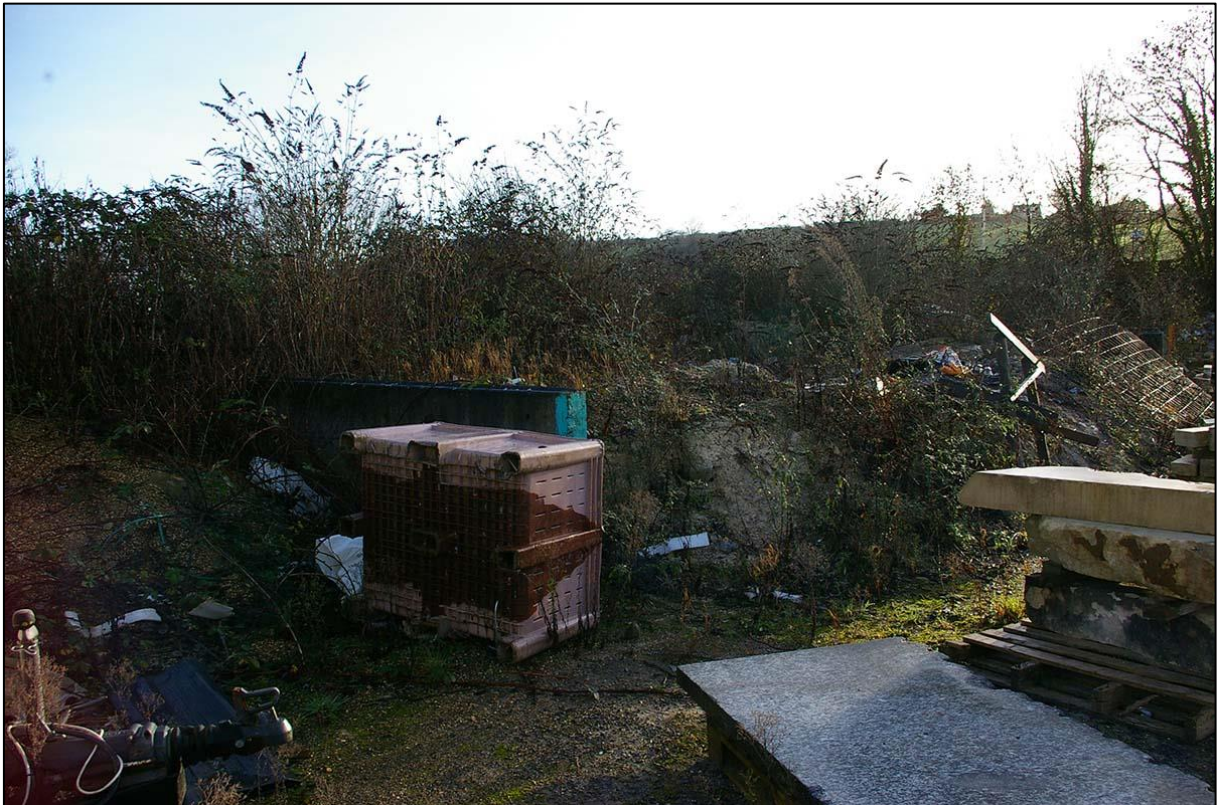
VIEW OF THE CONCRETE 'SILOS' WITH GRIT AND SAND DEPOSITS; VIEWED FROM THE NORTH-WEST.

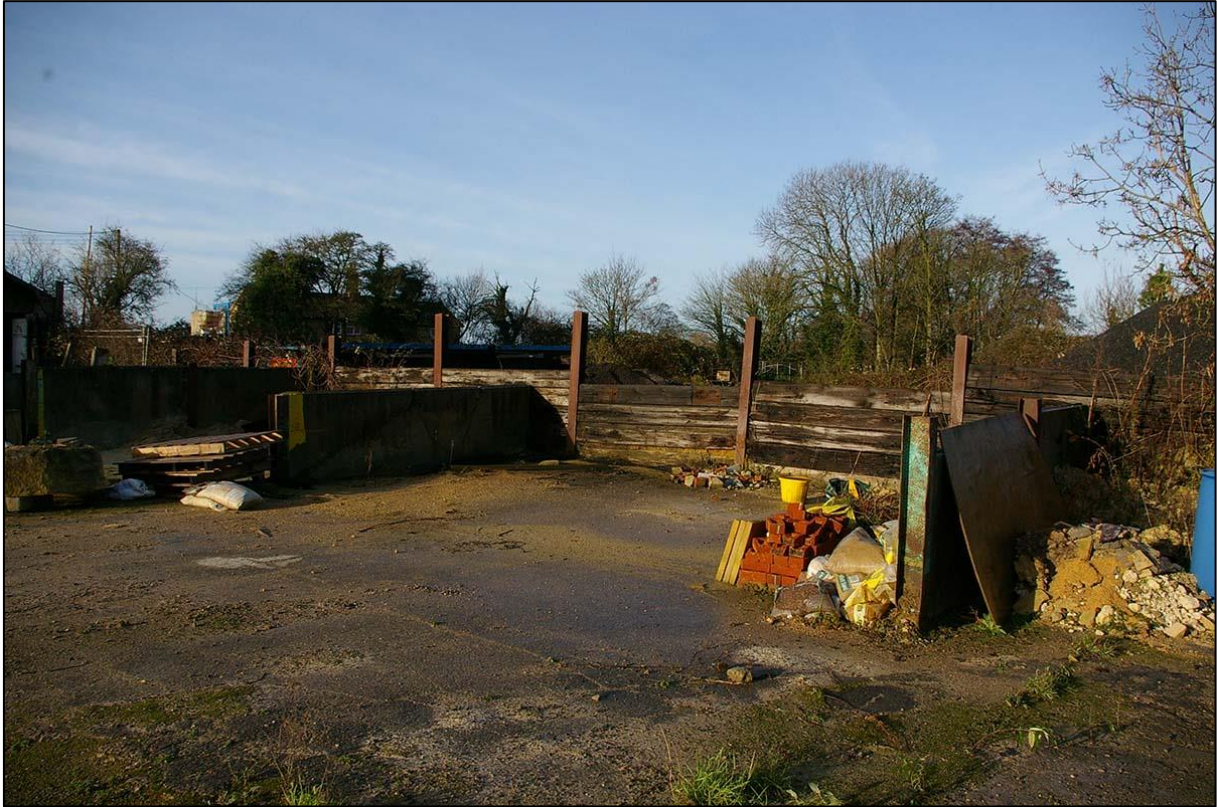
THE NORTHERN BOUNDARY OF THE WESTERN ENCLOSURE MADE OF LARGE SLEEPERS AND IRON POSTS, AS WELL AS FURTHER CONCRETE EMPTY SILOS; VIEWED FROM THE SOUTH-EAST.

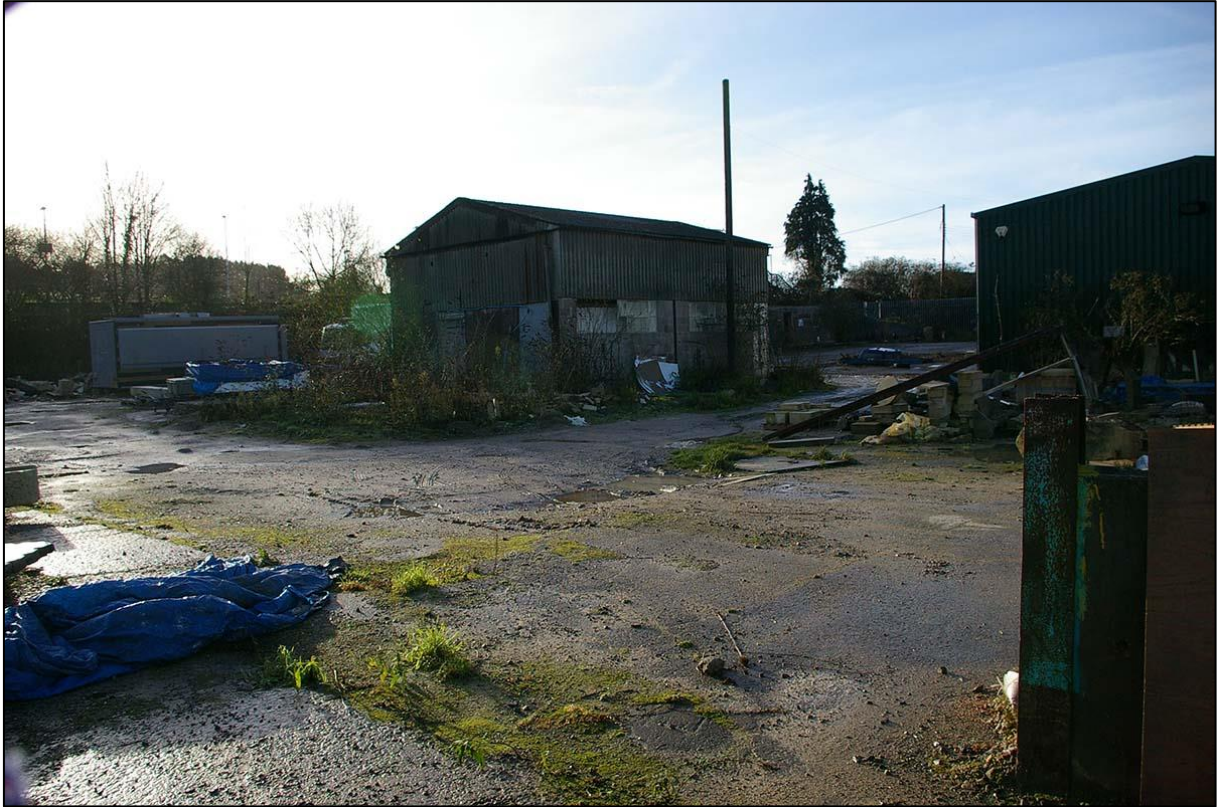
VIEW ACROSS THE WESTERN ENCLOSURE, SHOWING THE CONCRETE AND METAL FRAMED BUILDING AND SMALLER MORE MODERN BUILDING TO THE NORTH; VIEWED FROM THE NORTH-EAST.
