LAND AT CASTLE CARY RAILWAY STATION

Results of a Desk-Based Assessment and Walkover Survey

South West Archaeology Ltd. report no. 190109

Land at Castle Cary Railway Station, Ansford, Castle Cary, Somerset

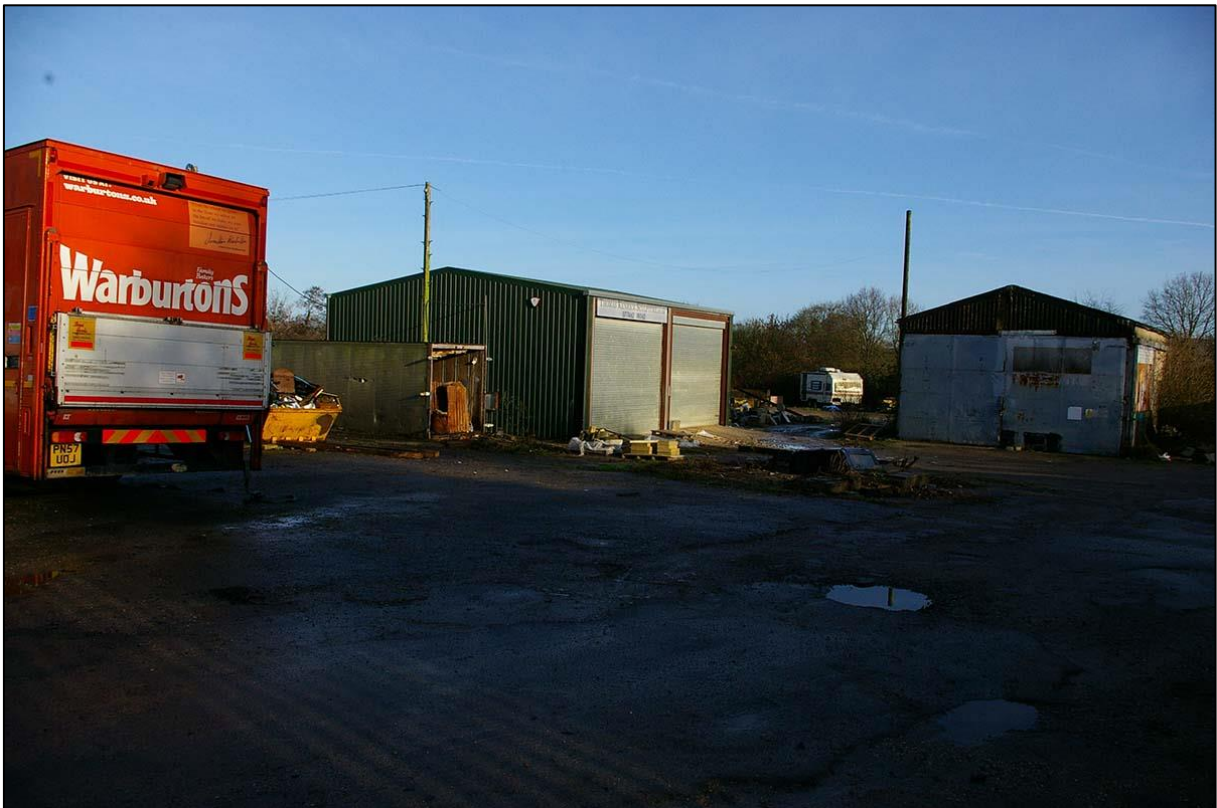
THE BUILDINGS TO THE CENTRE AND NORTH OF THE SITE; VIEWED FROM THE SOUTH-WEST.

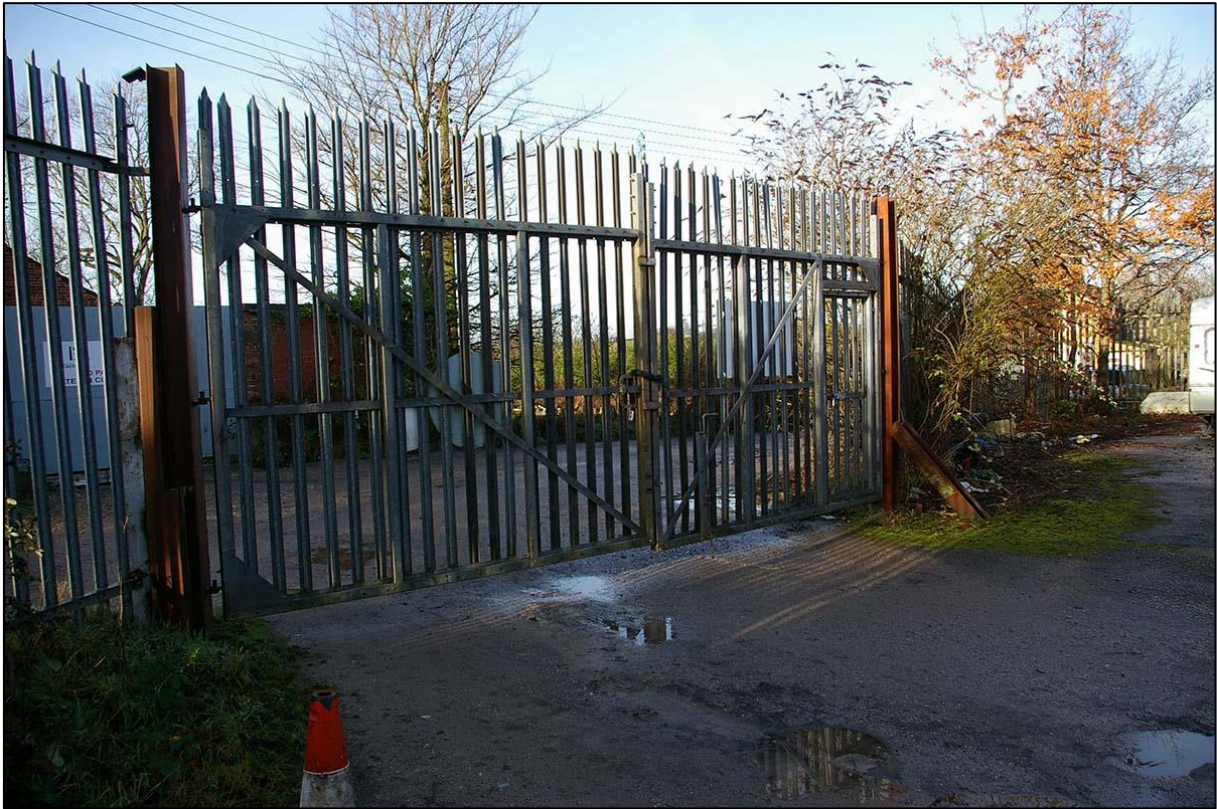
THE SOUTH-WEST SECURE GATE TO THE WESTERN ENCLOSURE; VIEWED FROM THE SOUTH-EAST.

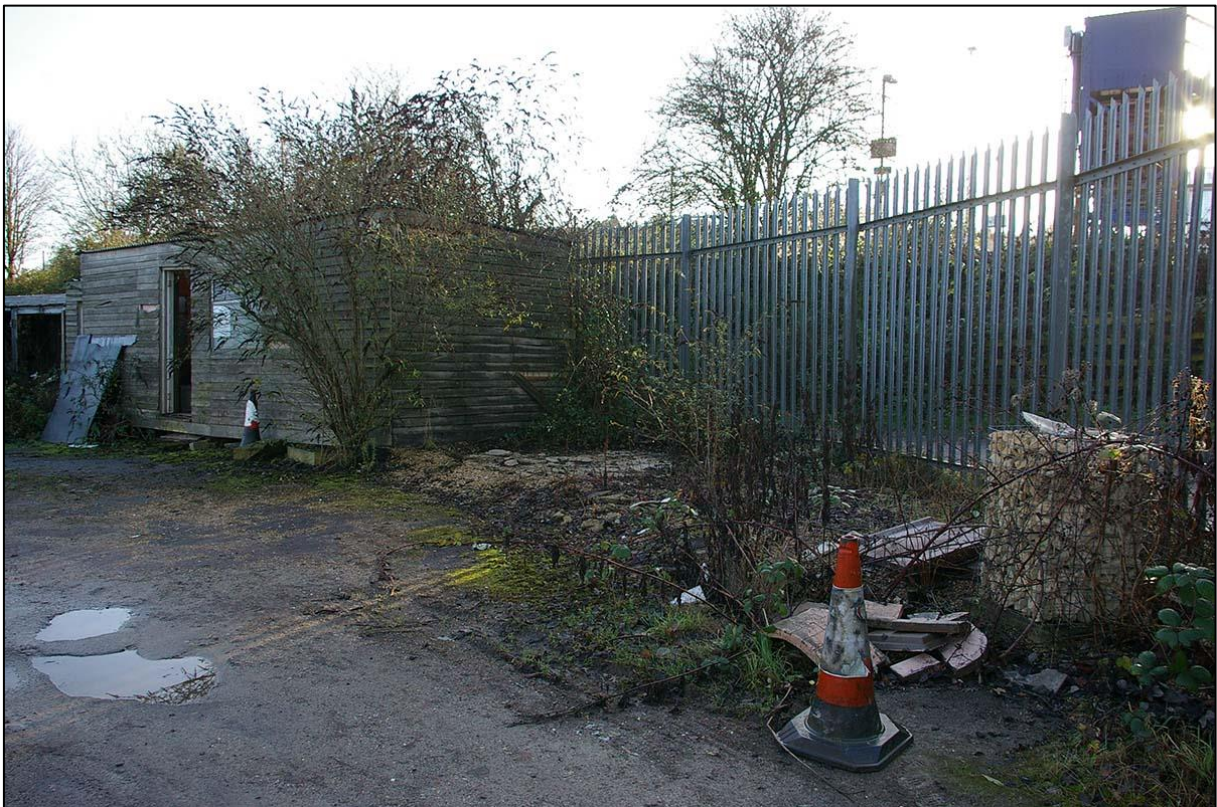
VIEW OF WHERE THE SECURE FENCING, WHERE IT WRAPS AROUND THE SOUTH-WEST CORNER; VIEWED FROM THE NORTH-NORTH-WEST.

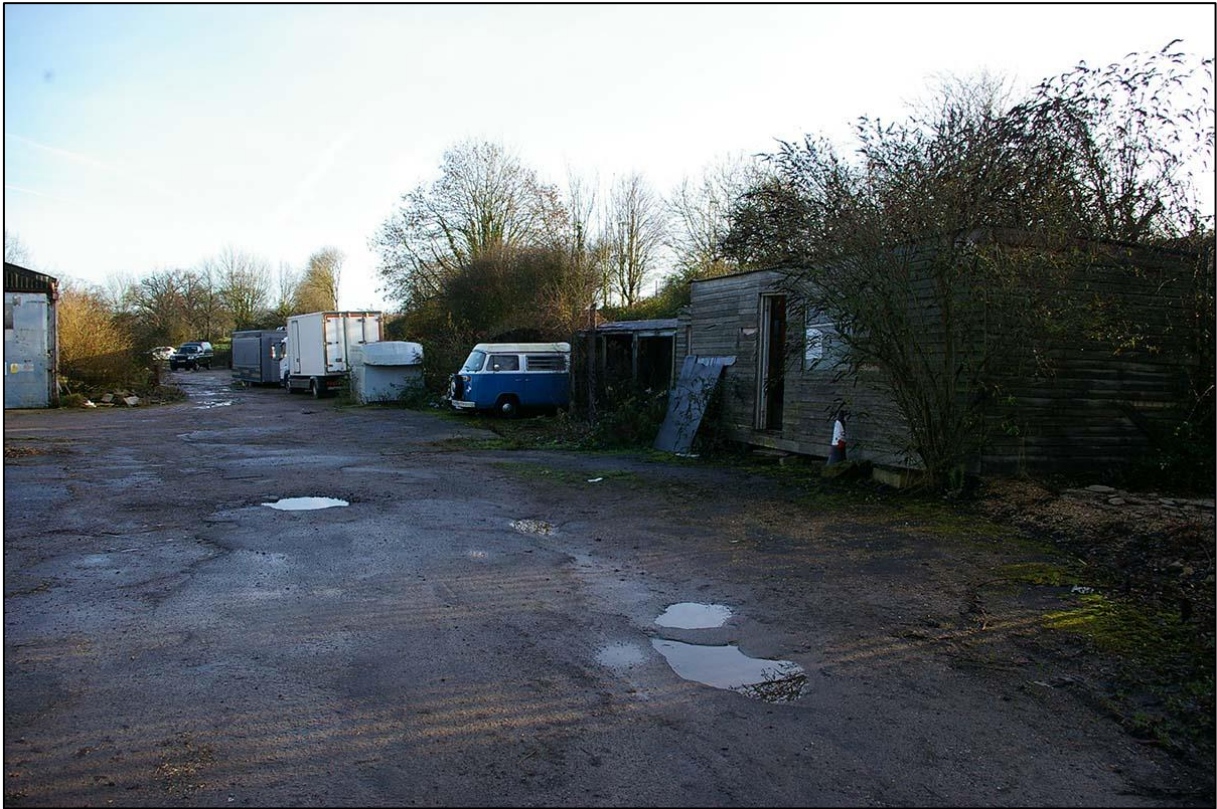
VIEW ALONG THE SOUTHERN BOUNDARY OF THE WESTERN ENCLOSURE, SHOWING THE COLLECTION OF SHEDS AND LORRIES, TRUCKS; VIEWED FROM THE WEST-NORTH-WEST.

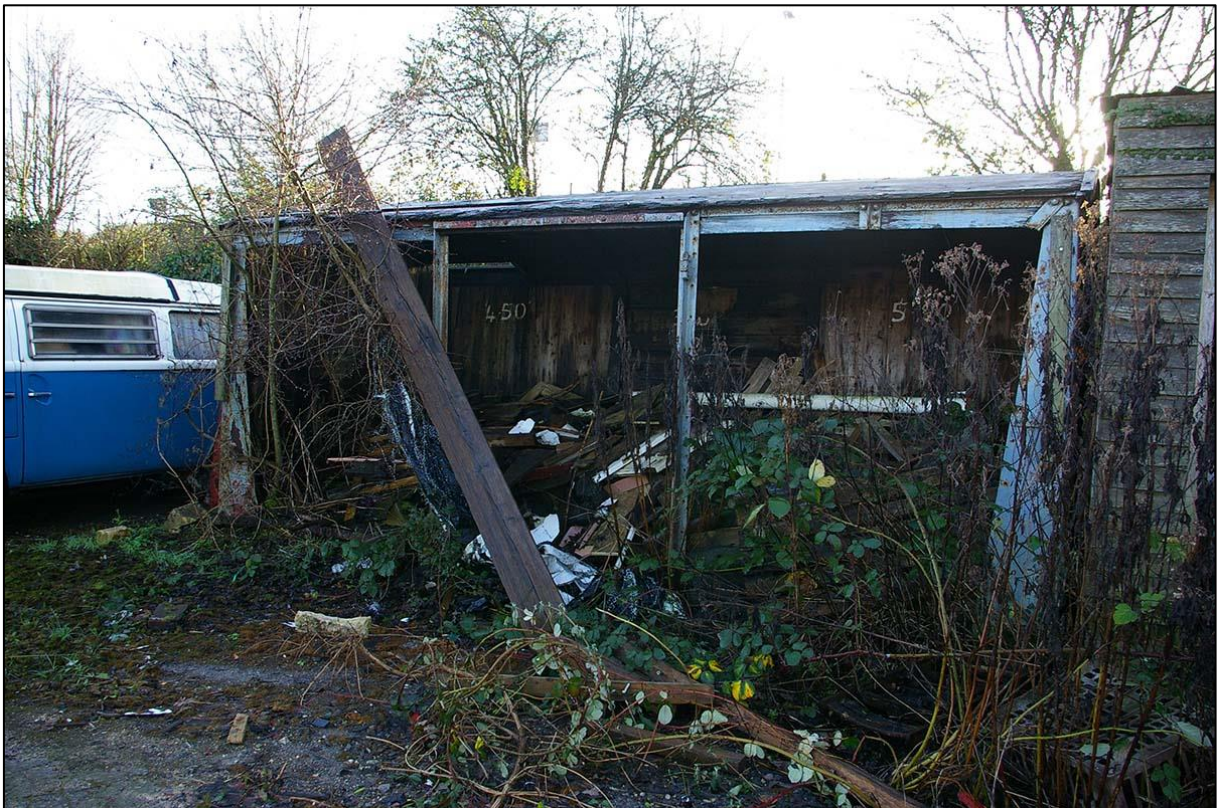
THE BEST PRESERVED OF THE FREIGHT CARRIAGES, WHICH HAS RETAINED ITS ROOF AND ITS HEAVY CORRUGATED ENDS; VIEWED FROM THE NORTH-WEST.

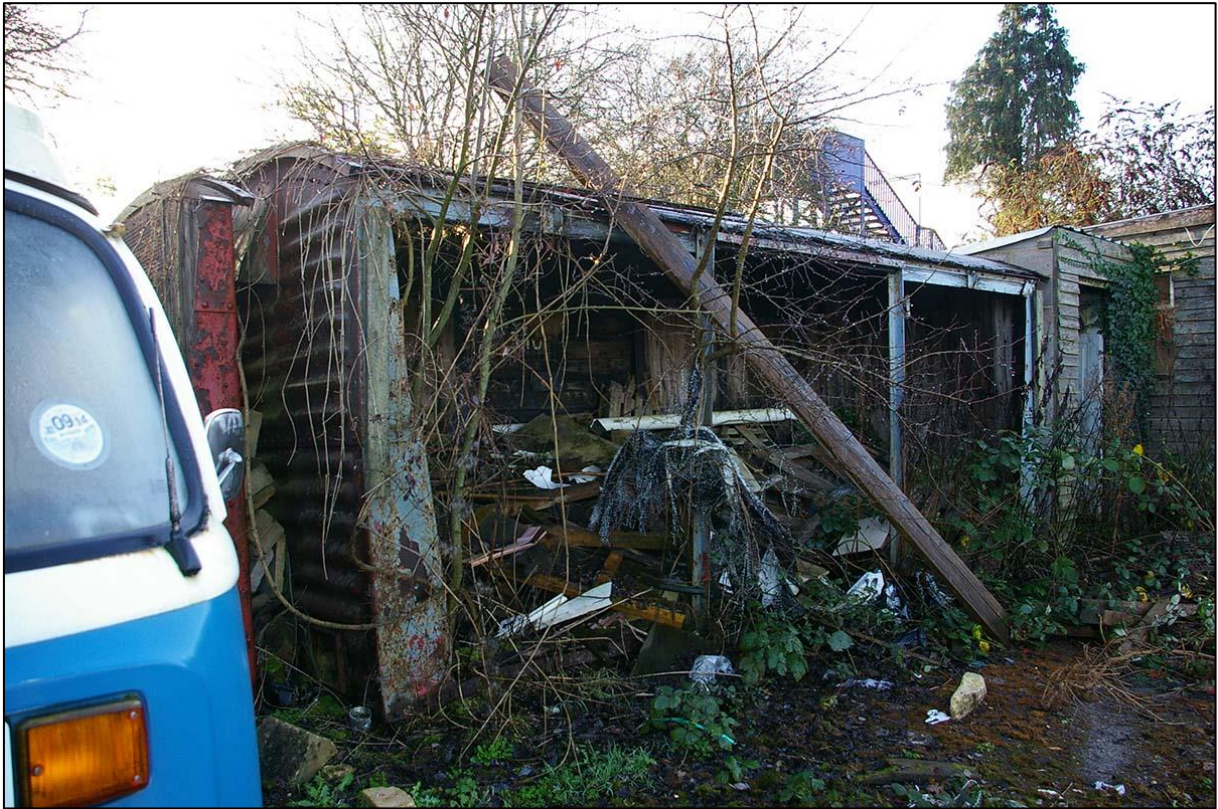
THE BEST PRESERVED OF THE FREIGHT CARRIAGES, WHICH HAS RETAINED ITS ROOF AND ITS HEAVY CORRUGATED ENDS; VIEWED FROM THE NORTH-EAST.

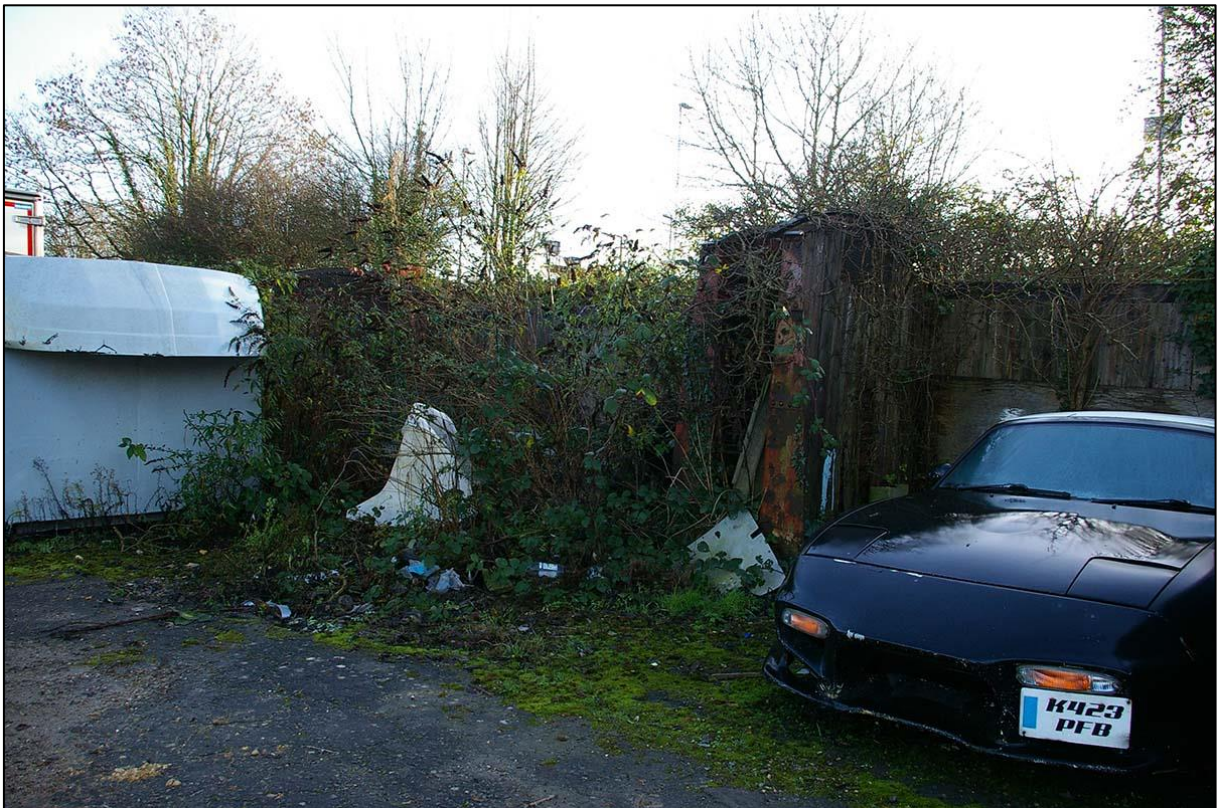
THE TWO CARRIAGES WHICH HAVE LOST THEIR ROOFS; VIEWED FROM THE NORTH-WEST.

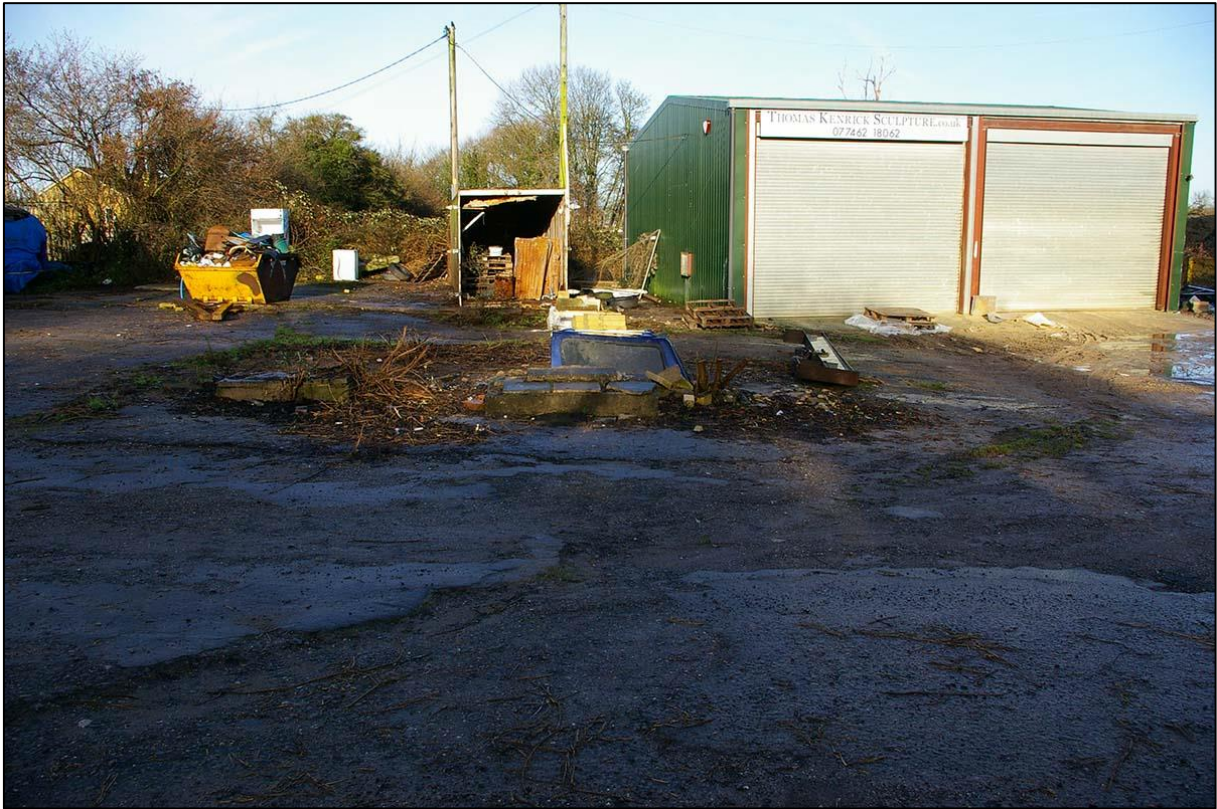
THE CENTRAL SEPTIC TANK IN THE WESTERN ENCLOSURE; VIEWED FROM THE SOUTH.

This site slopes down into the septic tank to the west, rising slightly to the north-east, towards the adjacent private yard. The ground is again stony, but this appears to be remnants of historic 'stoned' ground, clearly broken local stone, packed down to create rough surfaces. Over this to the west there are areas of tarmac and some areas of older thin poured concrete.

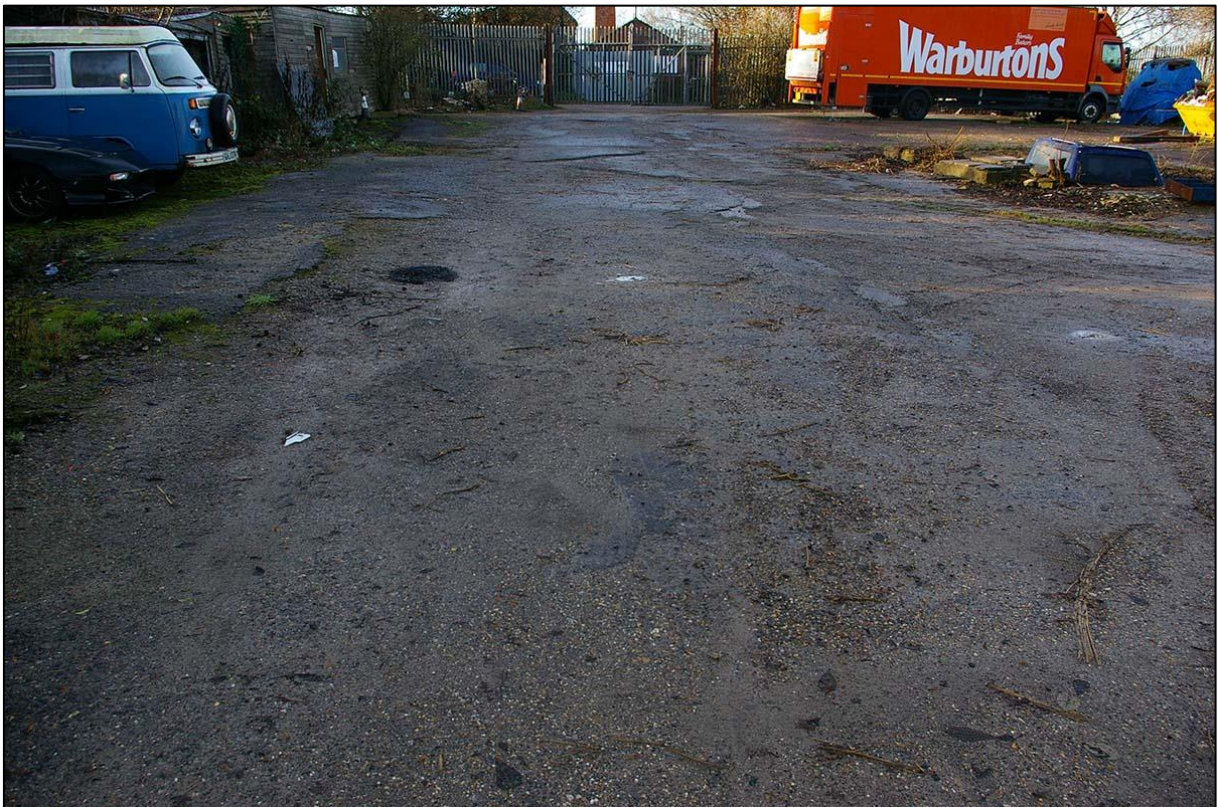
THE HARD CORED GROUND IN THE WESTERN ENCLOSURE, WITH PATCHES OF TARMAC AND CONCRETE, SHOWING SIGNS OF RESURFACING; VIEWED FROM THE EAST.

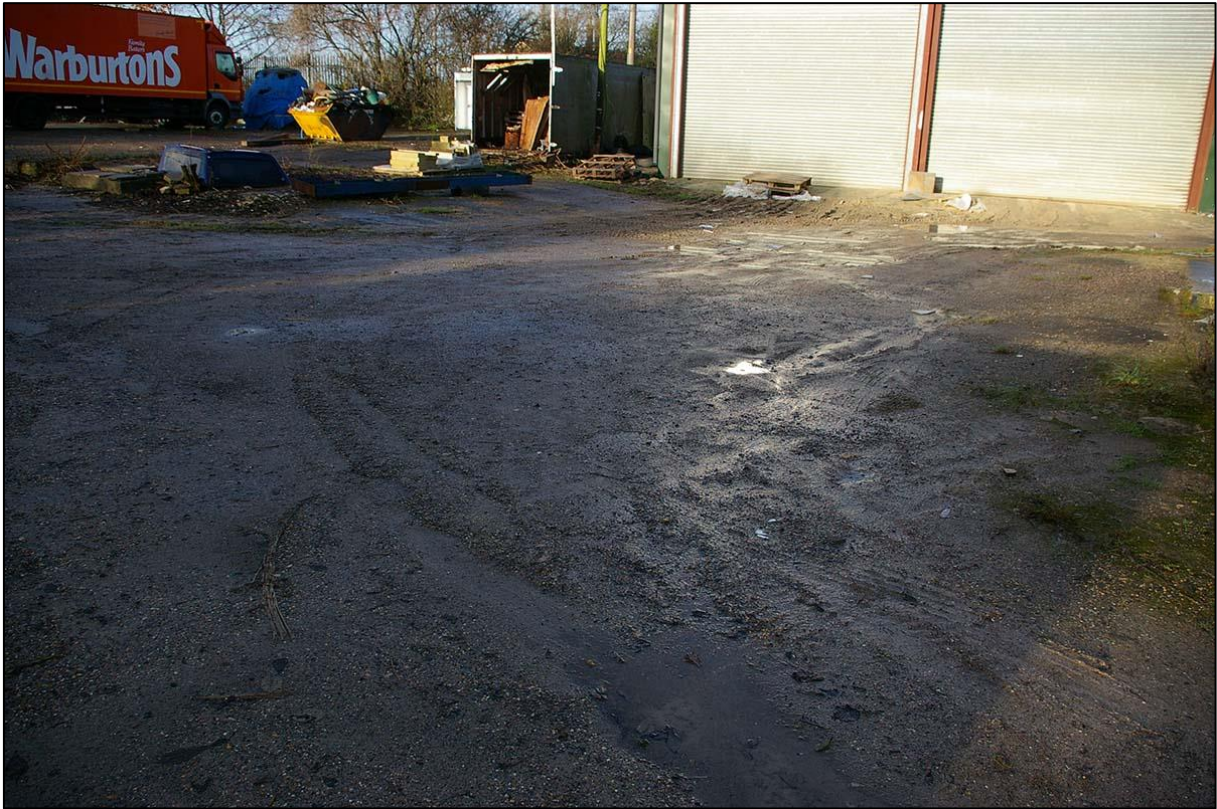
THE HARD CORED GROUND IN THE WESTERN ENCLOSURE, WITH PATCHES OF TARMAC AND CONCRETE, SHOWING SIGNS OF RESURFACING; VIEWED FROM THE SOUTH-EAST.

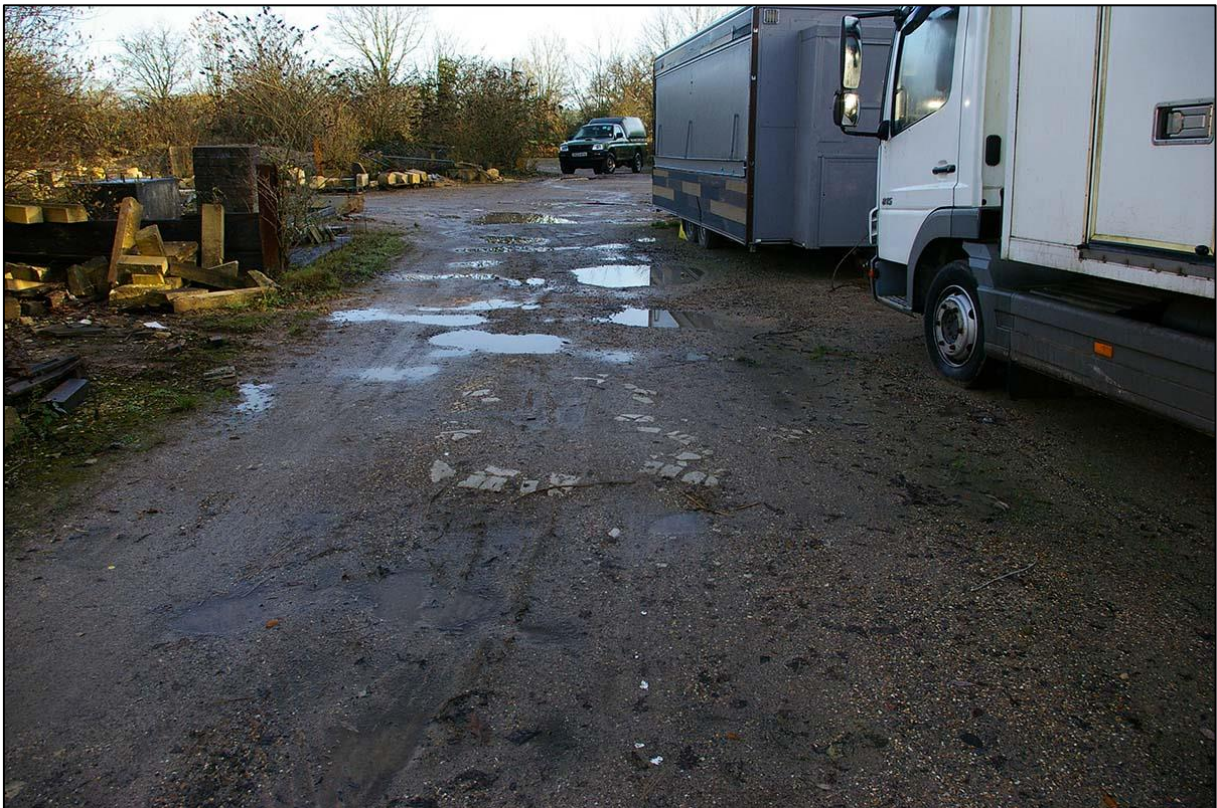
THE HARD CORED GROUND IN THE WESTERN ENCLOSURE; VIEWED FROM THE WEST.

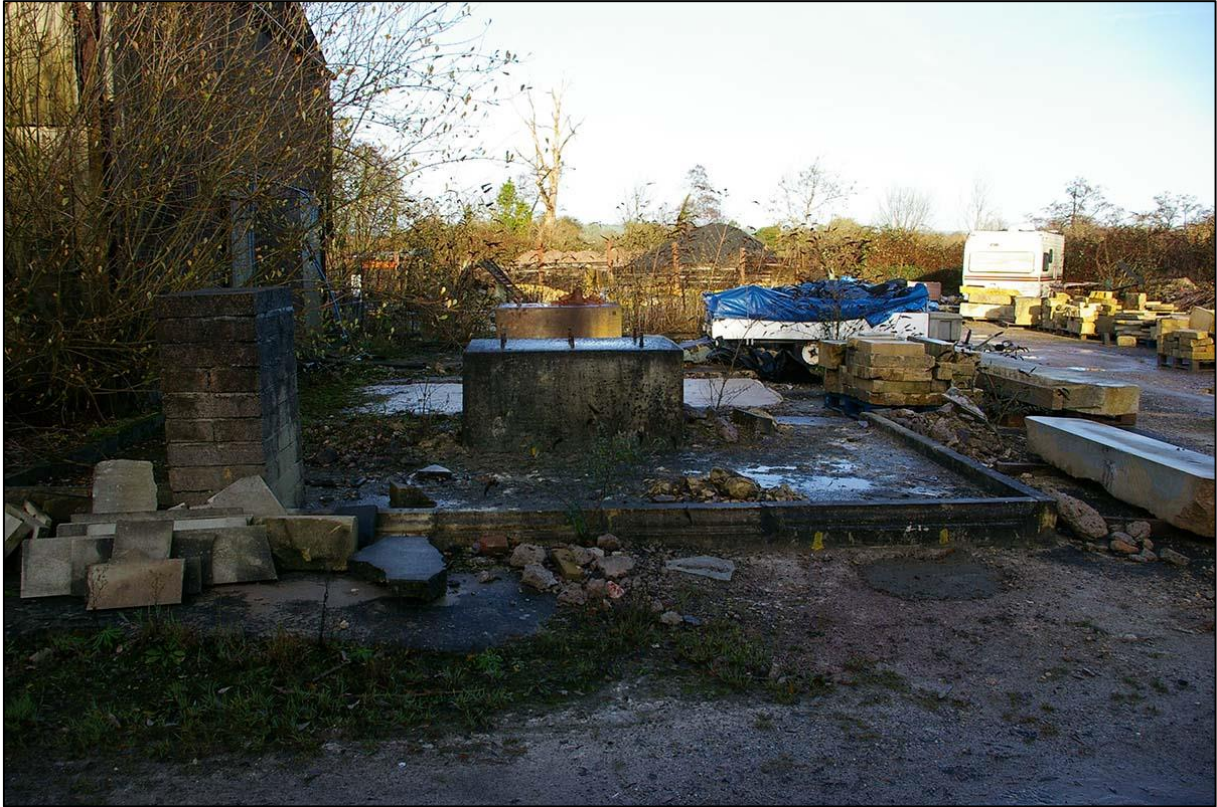
VIEW OF SOME OF THE CONCRETE PADS WITH FIXINGS FOR MACHINERY; VIEWED FROM THE SOUTH.

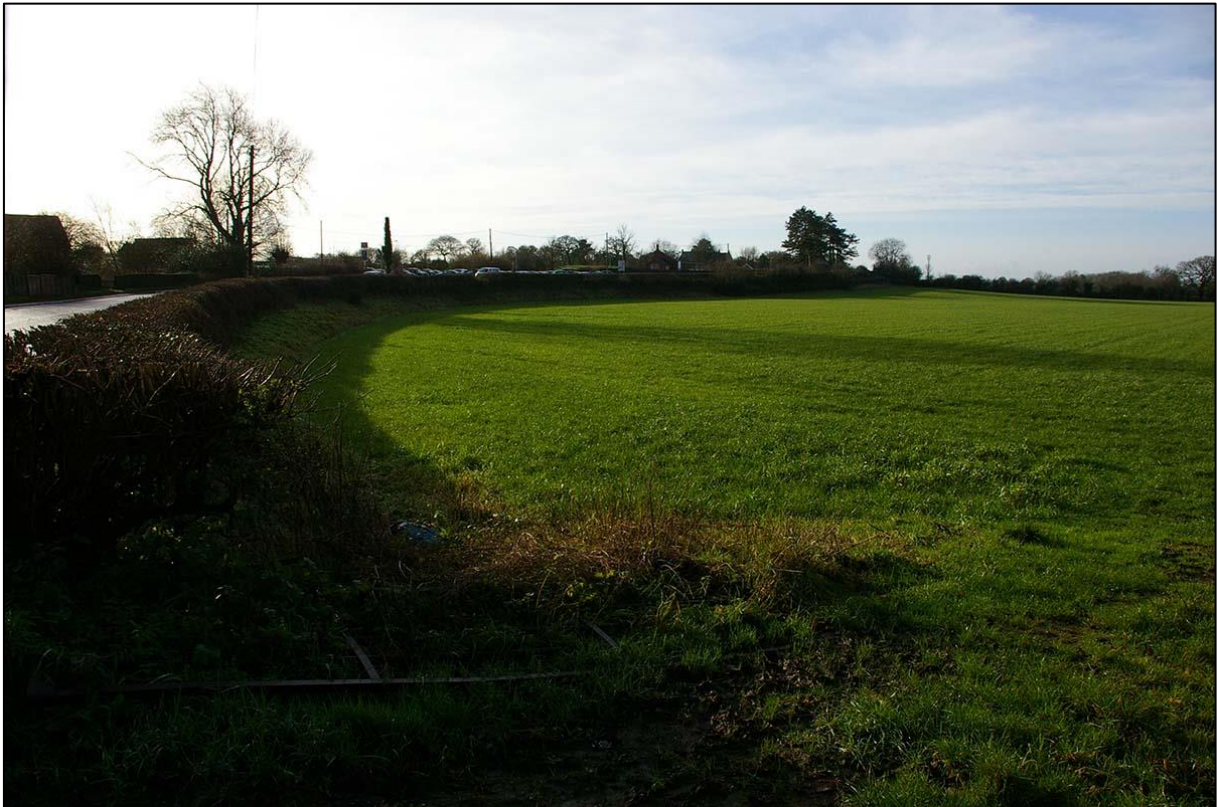
THE FIELD ON THE OTHER SIDE OF THE ROAD FROM THE SITE, WHERE THE HEDGE LINE MIGHT HAVE TO BE ALTERED OPPOSITE THE OPENING; VIEWED FROM THE NORTH.

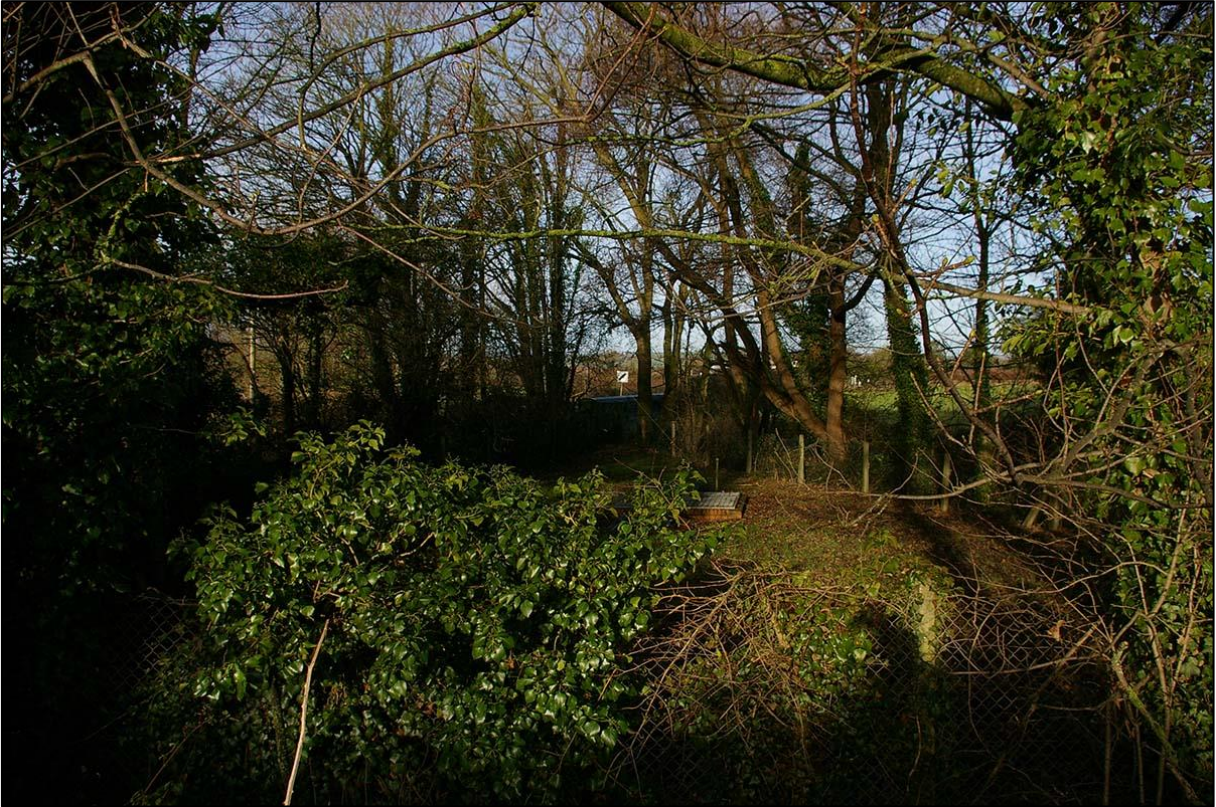
VIEW THROUGH THE SMALL TRIANGULAR PLANTATION NEXT TO THE RIVER AND BRIDGE, WHICH HAS A WESSEX-WATER SEWAGE WORKS AND ALSO SHOWS FAIRLY REDUCED INTERVISIBILITY BETWEEN THE PROPOSED SITE AND BRIDGE; VIEWED FROM THE SOUTH.

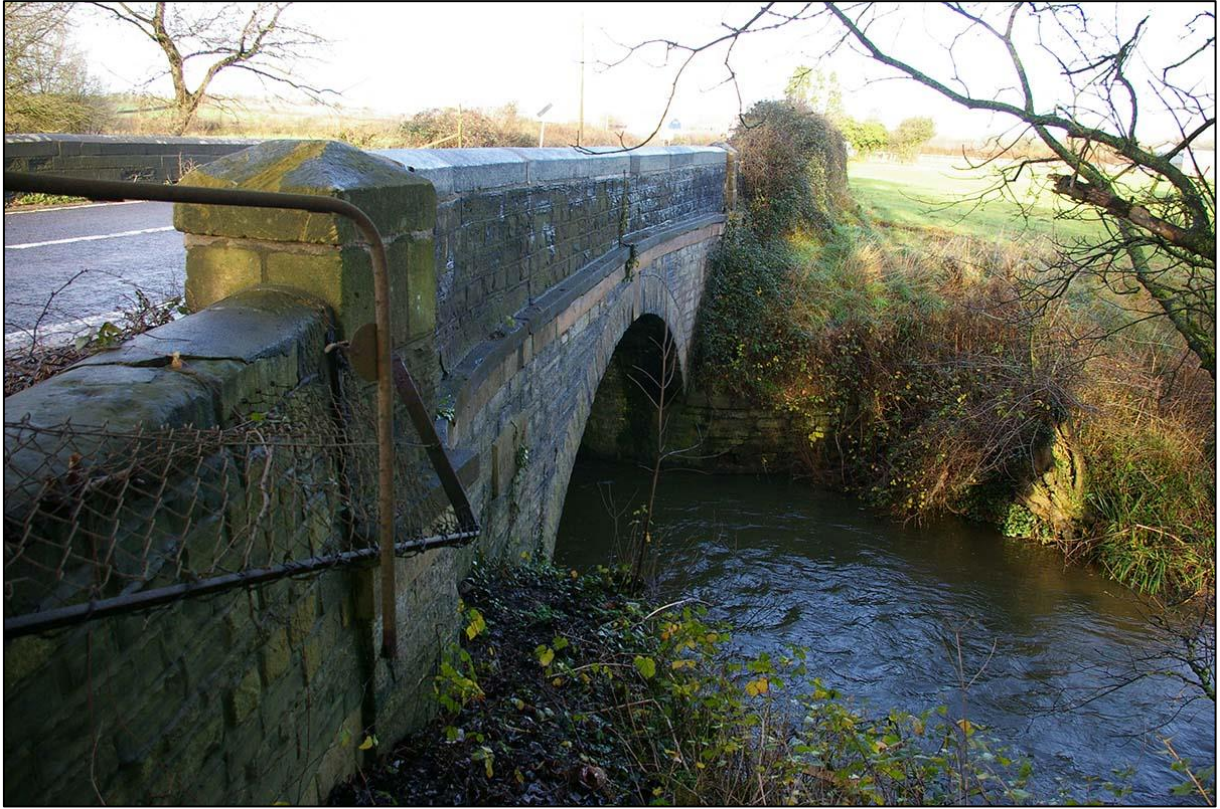
MORE DETAILED VIEW OF ANSFORD BRIDGE; VIEWED FROM THE SOUTH-EAST.

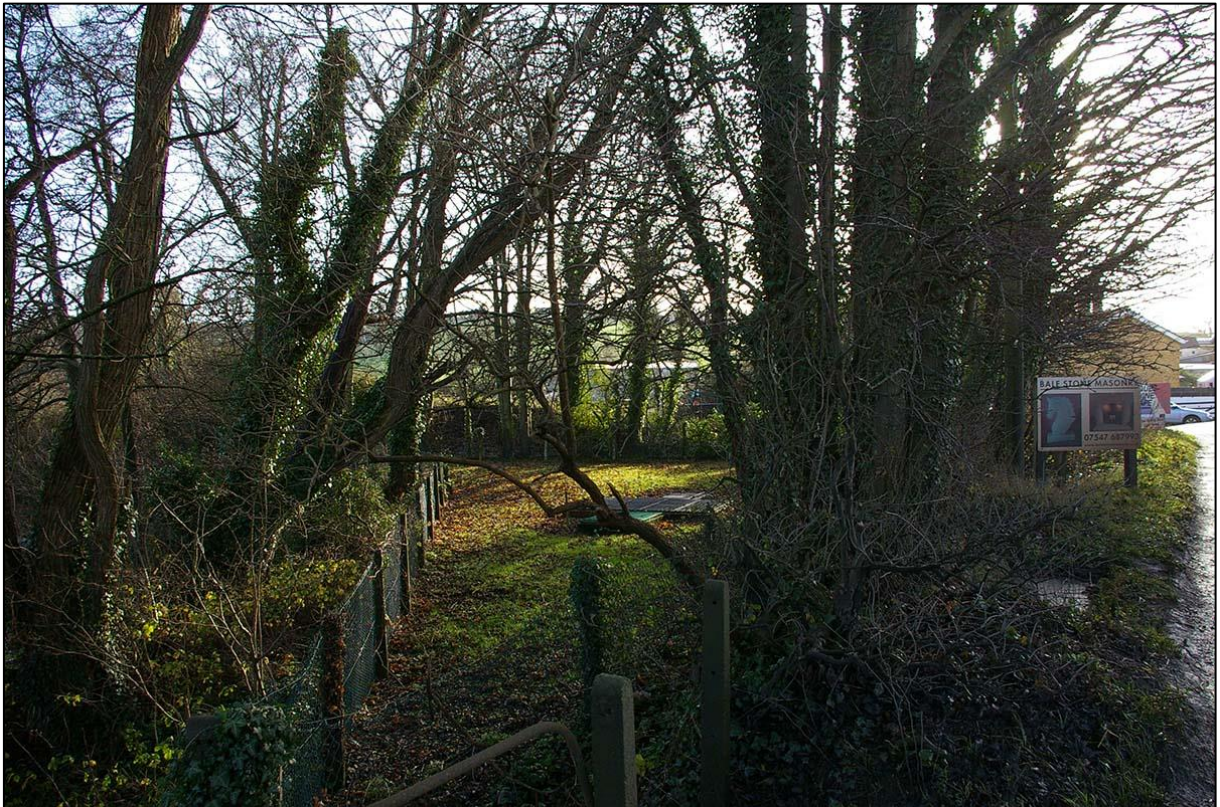
VIEW BACK FROM ANSFORD BRIDGE, ACROSS TO THE PROPOSED SITE; VIEWED FROM THE NORTH, NORTH-WEST.

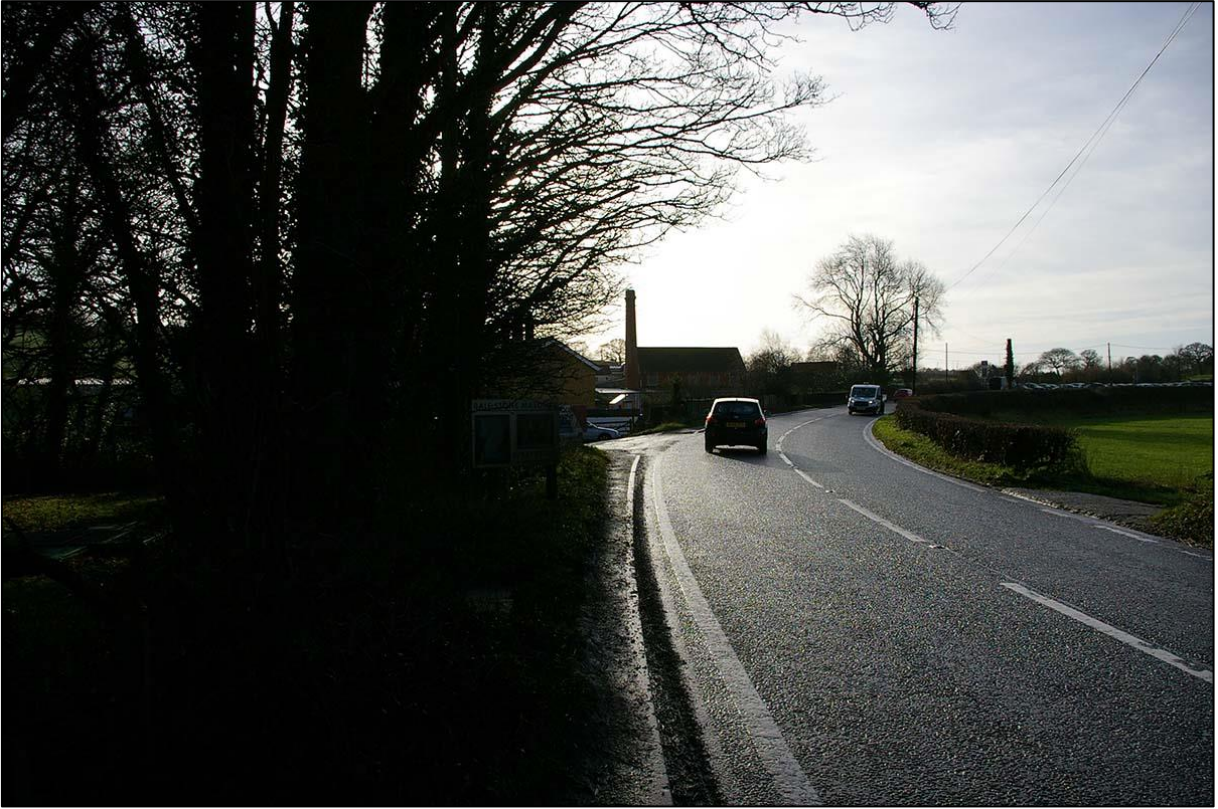
VIEW FROM ANSFORD BRIDGE TOWARDS THE RAILWAY STATION, RAILWAY COTTAGES AND FACTORY AT CASTLE CARY STATION; VIEWED FROM THE NORTH.

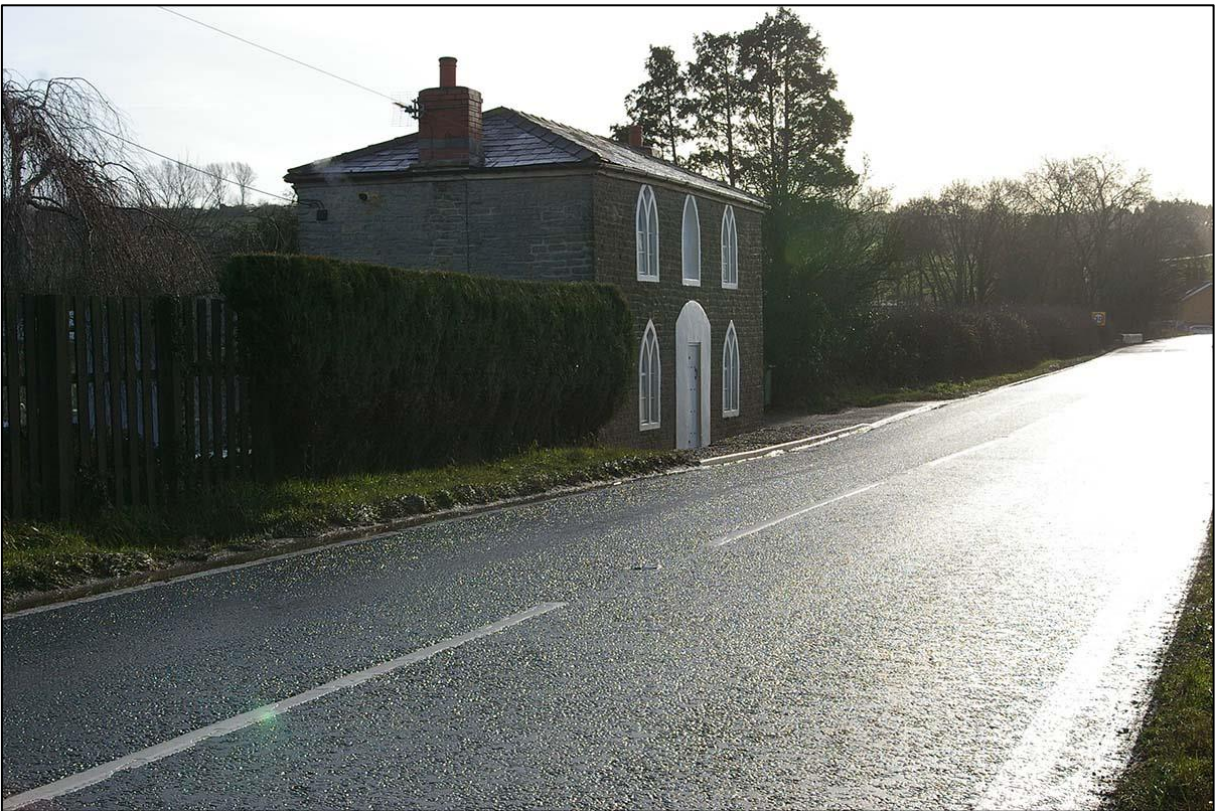
THE LISTED TOLLHOUSE JUST ALONG THE ROAD FROM THE PROPOSED SITE, WITH FINE GOTHIC WINDOWS; VIEWED FROM THE NORTH-WEST.

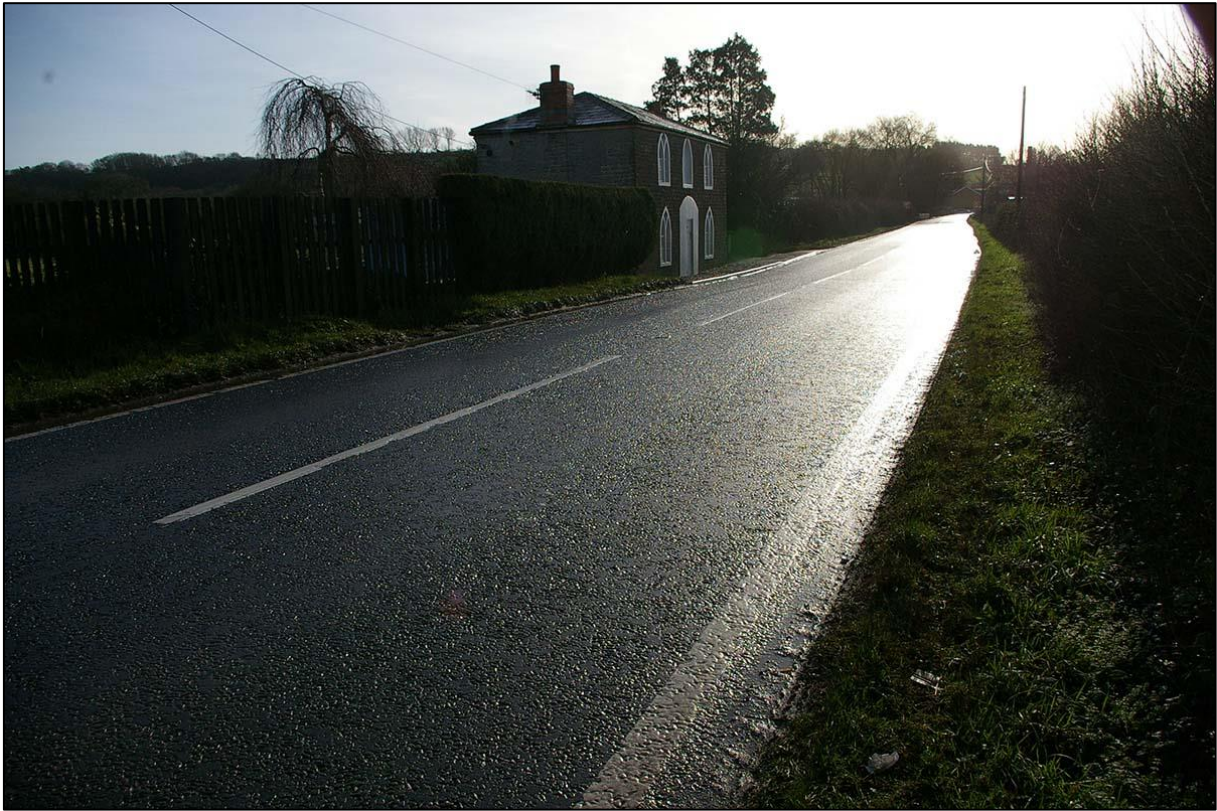
THE TOLLHOUSE IN IT'S SETTING ALONGSIDE THE ROAD, WITH VIEWS DOWN TO THE RAILWAY STATION AND PROPOSED SITE; VIEWED FROM THE NORTH-WEST.

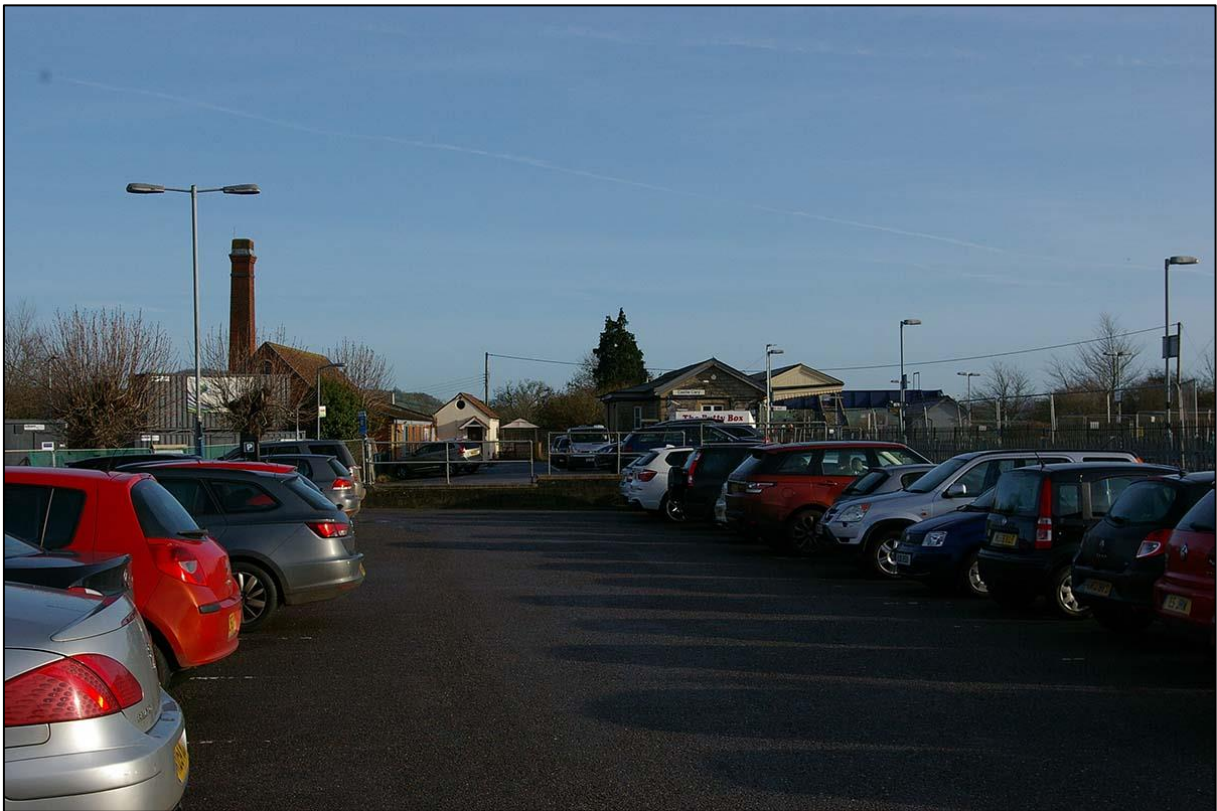
VIEW THROUGH THE RAILWAY STATION SITE, LOOKING PAST THE HISTORIC STATION TOWARDS THE PROPOSED SITE; VIEWED FROM THE WEST.
