# LAND ADJACENT TO FILLEIGH VILLAGE HALL

RESULTS OF AN ARCHAEOLOGICAL EVALUATION

South West Archaeology Ltd. report no. 190531

# Land adjacent to Filleigh Village Hall, Filleigh, North Devon, Devon

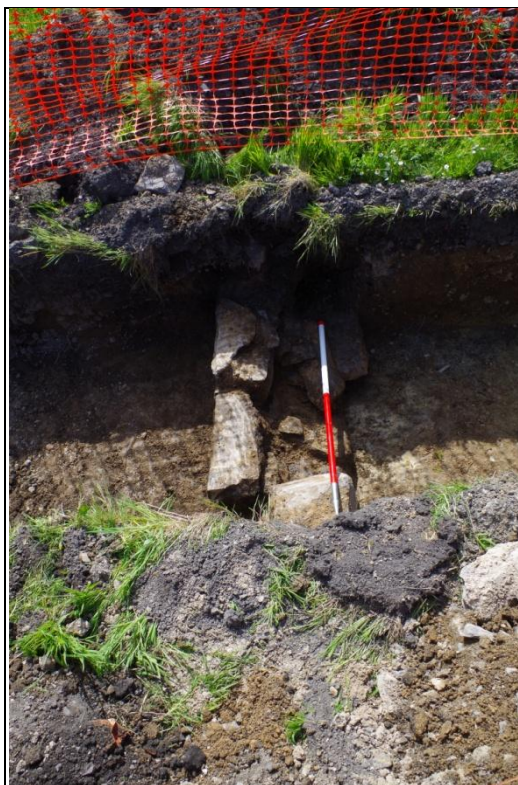
FIGURE 3: WALL {103}; VIEWED FROM THE EAST (1M SCALE).

A single wall {103} (Figures 3 and 4) was identified towards the centre of the trench. It was orientated approximately east to west, measured 0.60m wide, and survived to a height of 0.43m. The wall was constructed of large angular slatestone blocks in a loose yellow-brown silt-clay bond. It had been set within a linear cut [102] with steep to moderate sloping sides and flat base, which had been backfilled by (104), mid grey-brown friable silt. On its southern side the wall was abutted by a dump of 19<sup>th</sup> century waste material (105), including sherds of post-medieval pottery.

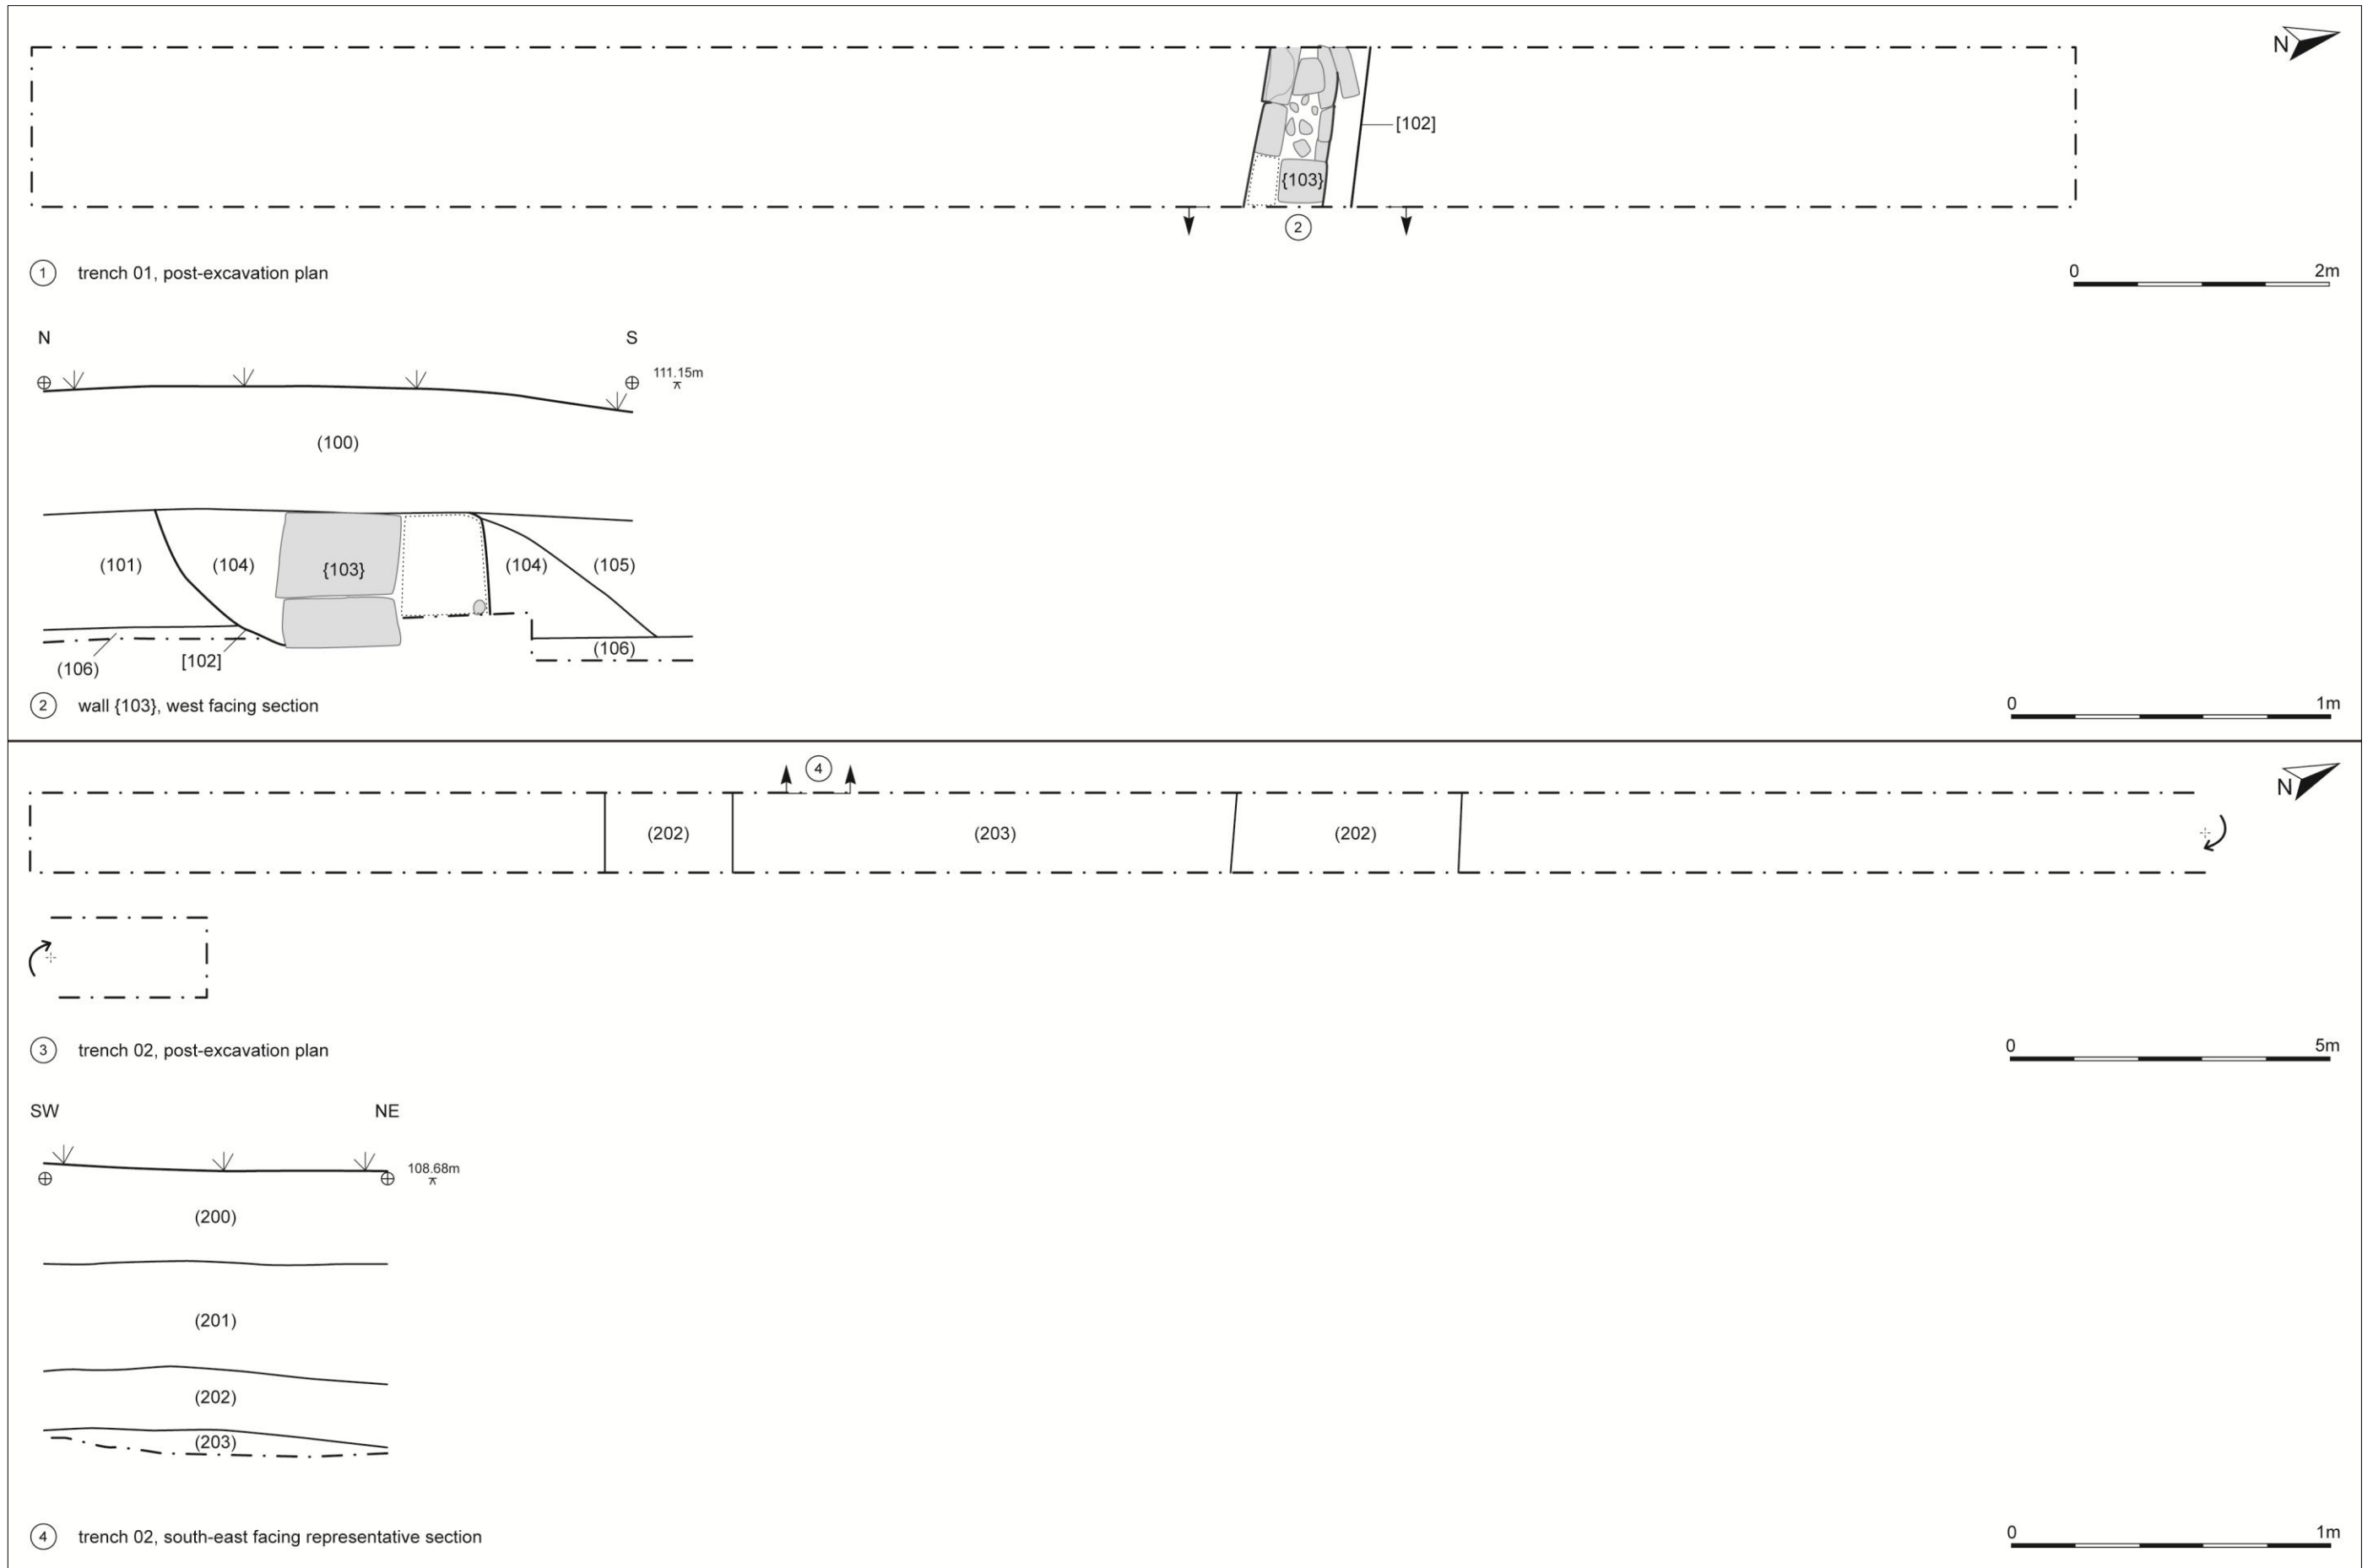
FIGURE 4: TRENCHES 01 AND 02; PLANS AND SECTIONS. HEIGHTS AT AOD.

Trench 02 was located centrally towards the northern end of Field 2 and was positioned to target the sinuous positive and negative anomalies identified in the geophysical survey and interpreted as a possible holloway, along with a discrete positive anomaly, possibly a pit. This trench was slightly foreshortened to avoid overhead cables. The trench was orientated north-east to south-west and measured 36.50m long; the topsoil was c.0.30m thick and the subsoil was up to 0.30m thick. No finds were recovered from this trench. No features (Figure 4) were identified within the trench: the sinuous positive and negative anomalies identified on the geophysical survey appeared to be related to natural deposits of alluvial (203) and colluvial (202) clays presumably relating to an extinct watercourse.

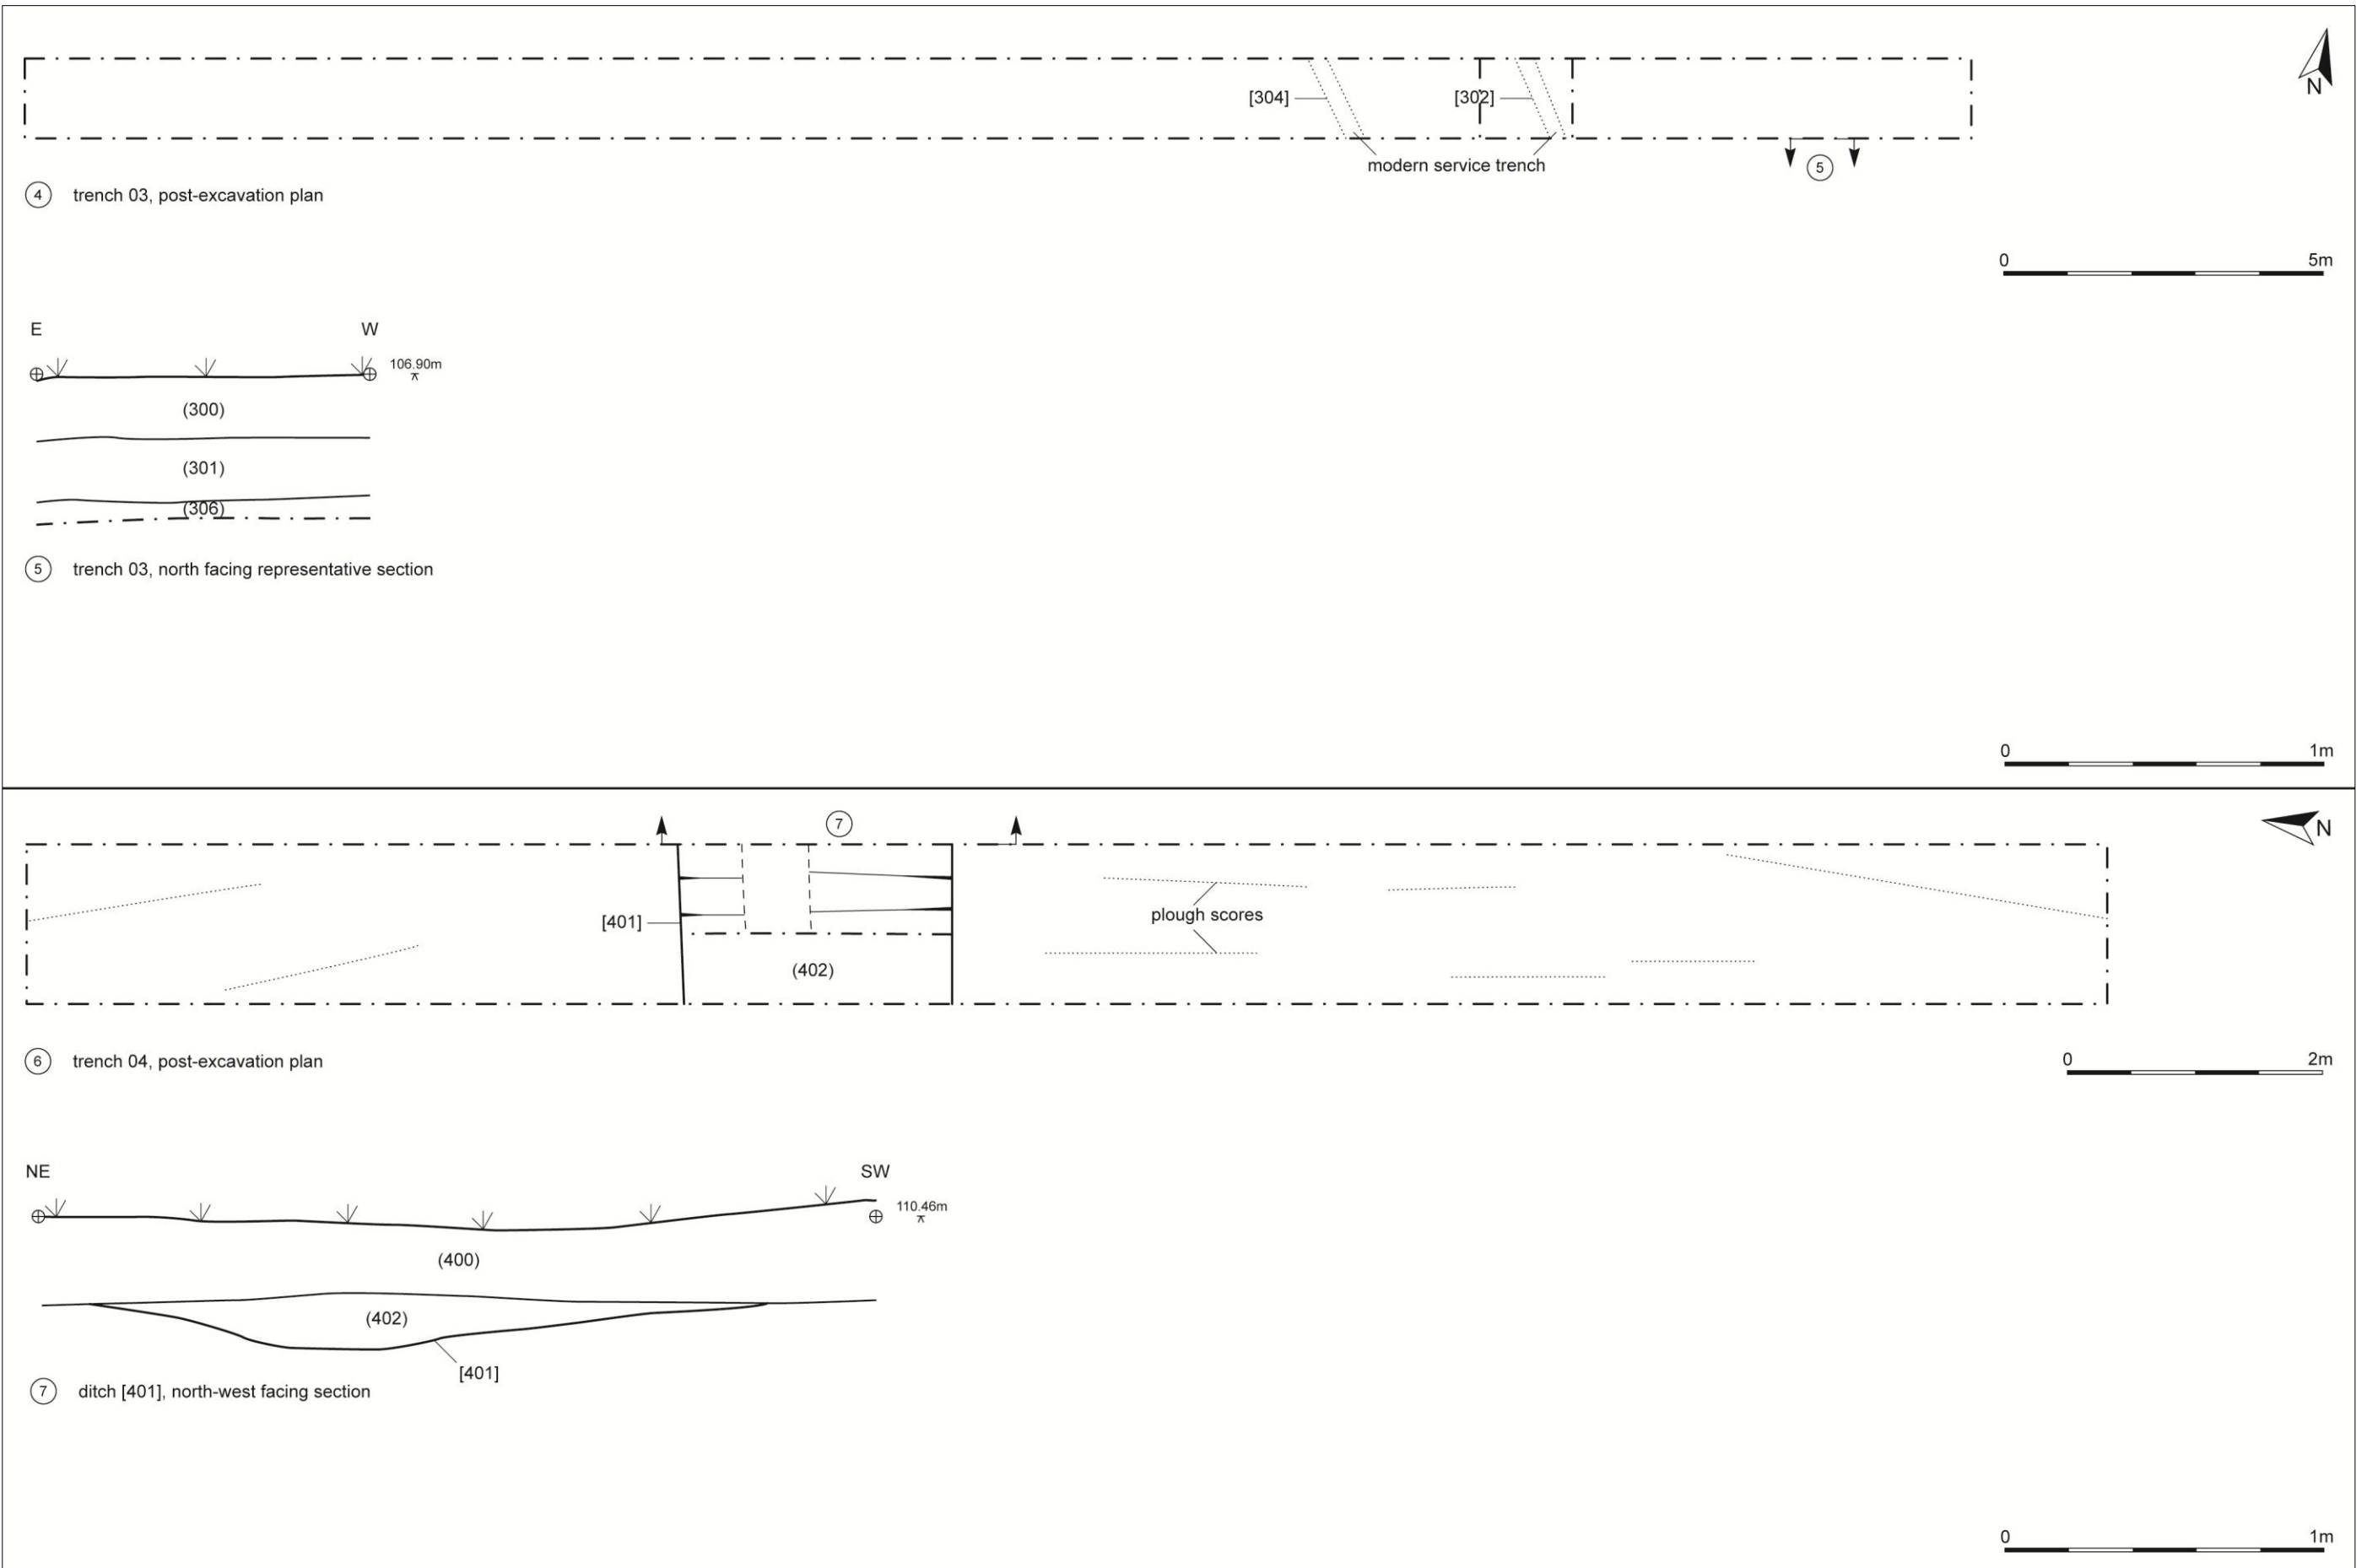
FIGURE 5: TRENCHES 03 AND 04; PLANS AND SECTIONS. HEIGHTS AT AOD.

Trench 03 was located towards the north-eastern corner of Field 2 within an area that the geophysical survey identified as containing negative linear anomalies possibly representing drainage features. It, too, was moved to avoid overhead cables. The trench measured 30.50m long and was orientated approximately north-west to south-east; the topsoil was c.0.20m thick, and the subsoil was c.0.20m thick (Figure 5). No archaeological features were observed, although two modern utility service trenches were identified in the vicinity of the geophysical anomaly. No finds were recovered from the trench.

Trench 04 was located towards the south-western corner of the site and located to target a pair of linear positive anomalies identified on the geophysical survey and interpreted as a historic field boundary. The trench was 16.30m long and orientated north-north-east to south-south-west; the topsoil was up to 0.28m thick and directly over the natural. A single feature, ditch [401] (Figures 5 and 6) was identified towards the northern end of the trench. It was orientated west-north-west to east-south-east and measured 2.20m wide and 0.17m deep with shallow sloping sides and a concave base. It contained a single fill: (402) mid brown-grey soft friable silt-clay. Finds recovered from (402) included post-medieval pottery and ceramic roof/floor tile.

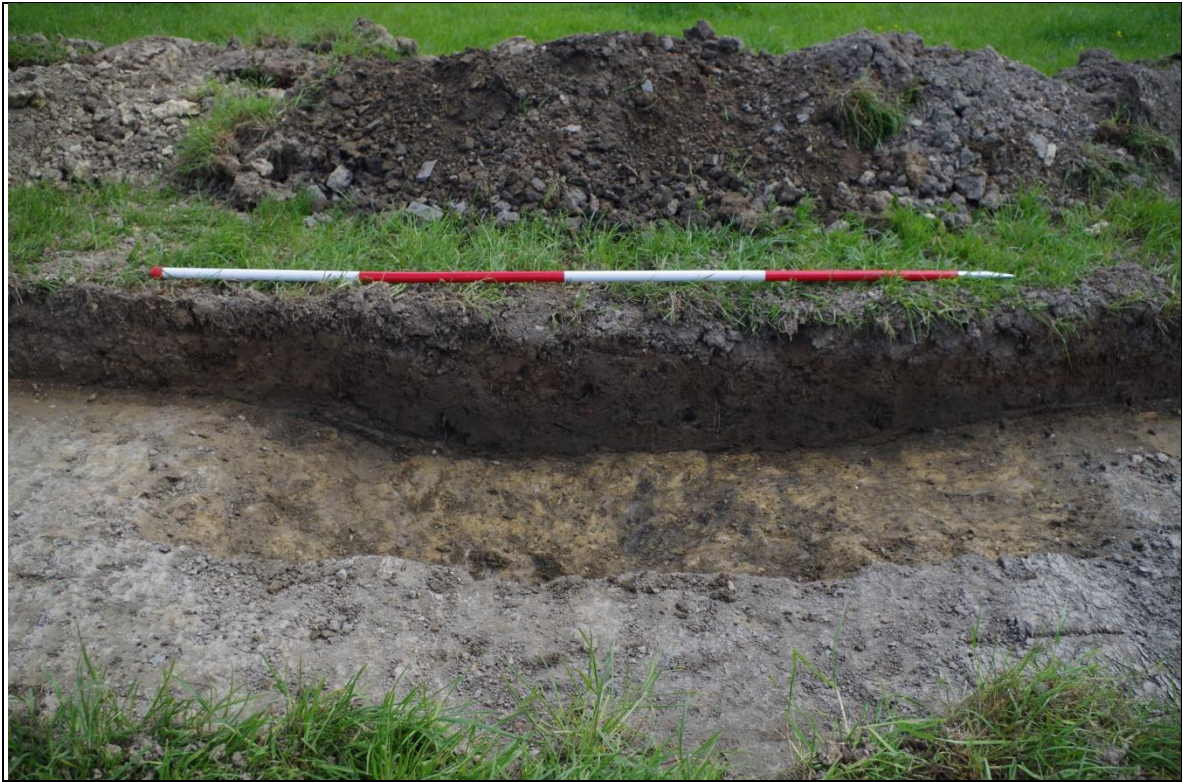
FIGURE 6: DITCH [401], POST-EXCAVATION; VIEWED FROM THE WEST (2M SCALE).

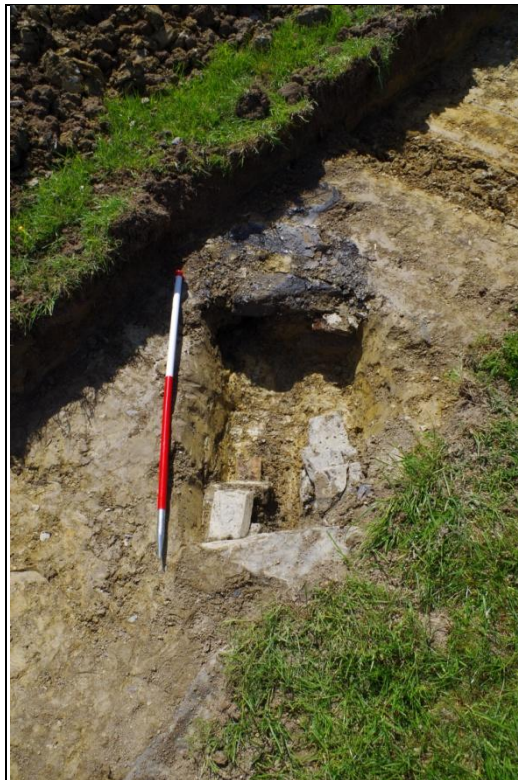
FIGURE 7: DRAIN [501], POST-EXCAVATION; VIEWED FROM THE NORTH-EAST (1M SCALE).

[501] (Figures 7 and 8) was identified towards the eastern end of the trench. It was orientated north-east to south-west, measuring 0.86m wide and 0.34m deep with steep sloping sides and flat base. The cut contained a built stone drain {502} of angular stone blocks, and which contained a single fill (503), grey friable-soft silt-loam. This feature formed the south-eastern of the pair of linear anomalies identified by the geophysical survey.

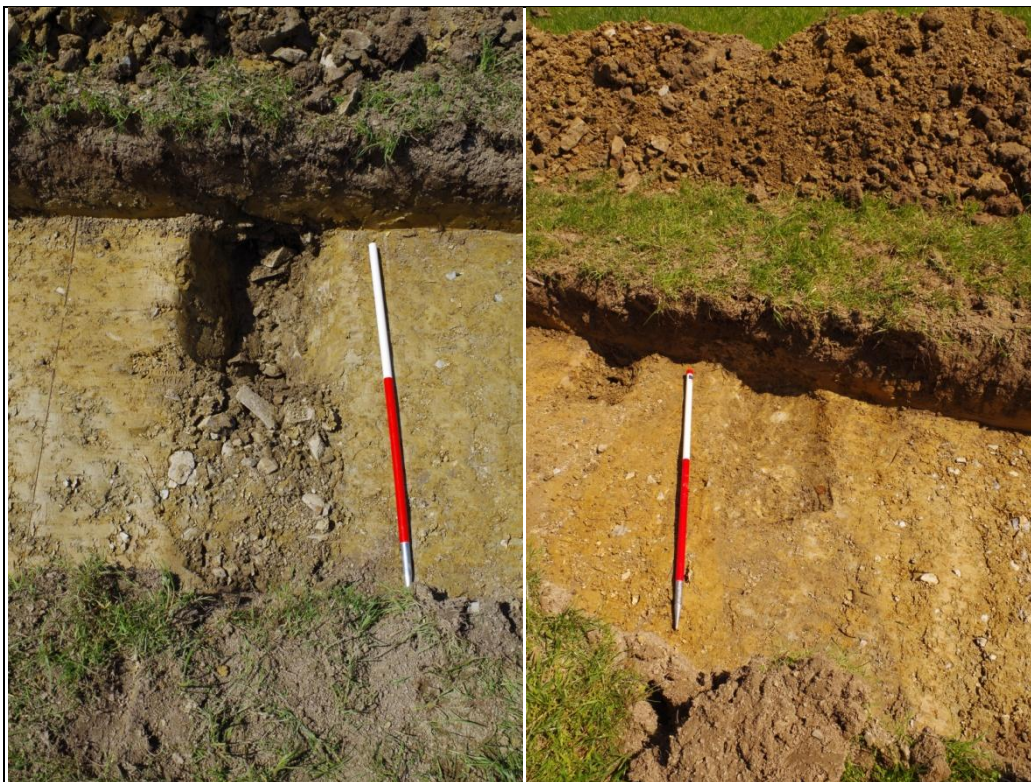
LEFT FIGURE 8: LAND DRAIN [601], POST-EXCAVATION; VIEWED FROM THE EAST (1M SCALE).

RIGHT FIGURE 9: DITCH [605] (CENTRE) WITH LAND DRAIN [603] (LEFT), POST-EX; VIEWED FROM THE WEST (1M SCALE).

A total of three features (Figures 8-10) were identified within the trench, one ditch and two land drains. Ditch [605] was located towards the centre of the trench. It was orientated east to west and measured 0.56m wide and 0.20m deep with steep sloping sides and slightly concave base. It contained a single fill (606), mid grey re-deposited natural clay with yellow clay mottling. No features had been identified at this location by the geophysical survey.

Land drain [601] was located towards the northern end of the trench. It was orientated north-west to south-east and measured 0.50m wide and c.0.25m deep with steep sloping sides and broadly flat base. It contained a single fill (602), of loose sub-angular stone and brown-grey friable silt. No features had been identified at this location by the geophysical survey.

Land drain [603] was located towards the centre of the trench. It was orientated north-west to south-east and measured 0.35m wide and c.0.20m deep with steep sloping sides and broadly flat base. It contained a single fill (604), of loose sub-angular stone and brown-grey friable silt. This appears to be the feature identified by the geophysical survey.

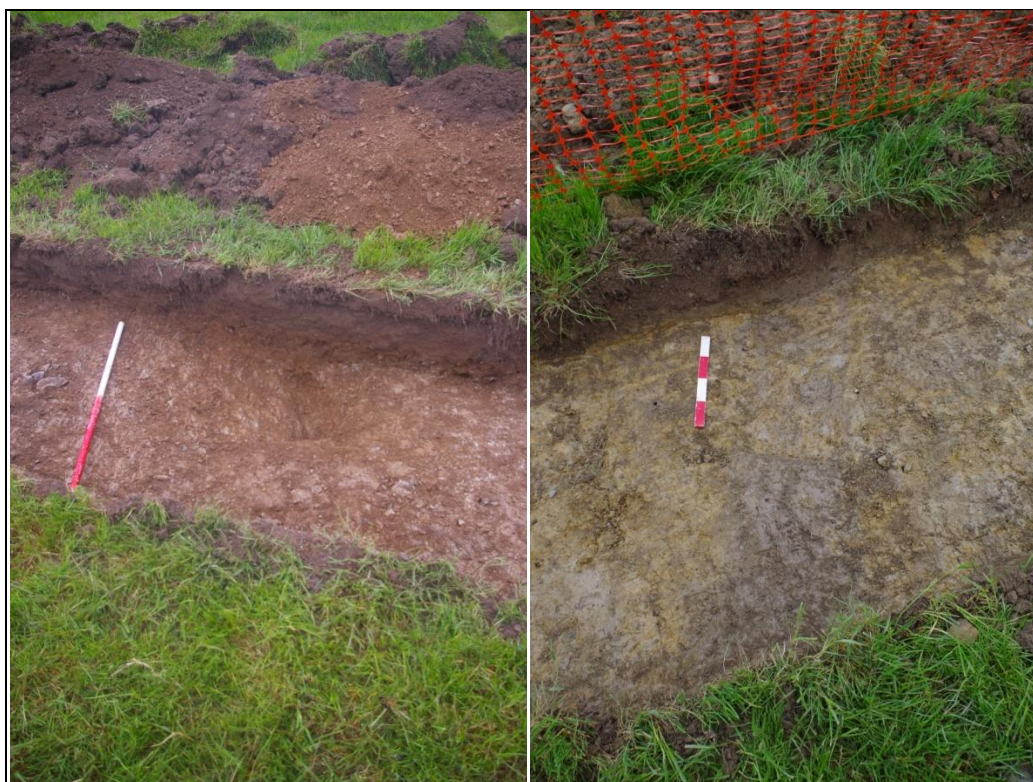
LEFT FIGURE 11: DITCH [702]; VIEWED FROM THE WEST (1M SCALE).

RIGHT FIGURE 12: DITCH [706]; VIEWED FROM THE WEST (0.40M SCALE).

Three features (Figures 11-14) were identified in the trench, all of which were ditches. Ditch [702] was located towards the northern end of the trench. It was orientated east to west and measured 1.18m wide and 0.33m deep with shallow to moderate sloping sides and broadly concave base; there was a narrow channel running along the base. It contained a single fill (703), mid grey-brown friable-soft silt-clay. No features had been identified at this location by the geophysical survey. Ditch [704] was located towards the southern end of the trench. It was orientated east-north-east to west-south-west and measured 1.02m wide and 0.12m deep with moderate sloping sides and concave base. It contained a single fill (705), mid yellow-grey friable-soft silt-clay. This feature formed the southernmost feature of the pair of linear positive geophysical anomalies targeted by this trench. Ditch [706] was located at the southern end of the trench. It was orientated north-west to south-east and measured 0.55m wide and c.0.11m deep with moderate sloping sides and concave base. It contained a single fill (707), mid grey friable-soft silt-clay. No features had been identified at this location by the geophysical survey. The sinuous positive and negative anomalies identified by the geophysical survey proved to be natural deposits of alluvial (709) and colluvial (708) clays consistent with the anomalies representing an extinct watercourse rather than an archaeological feature.

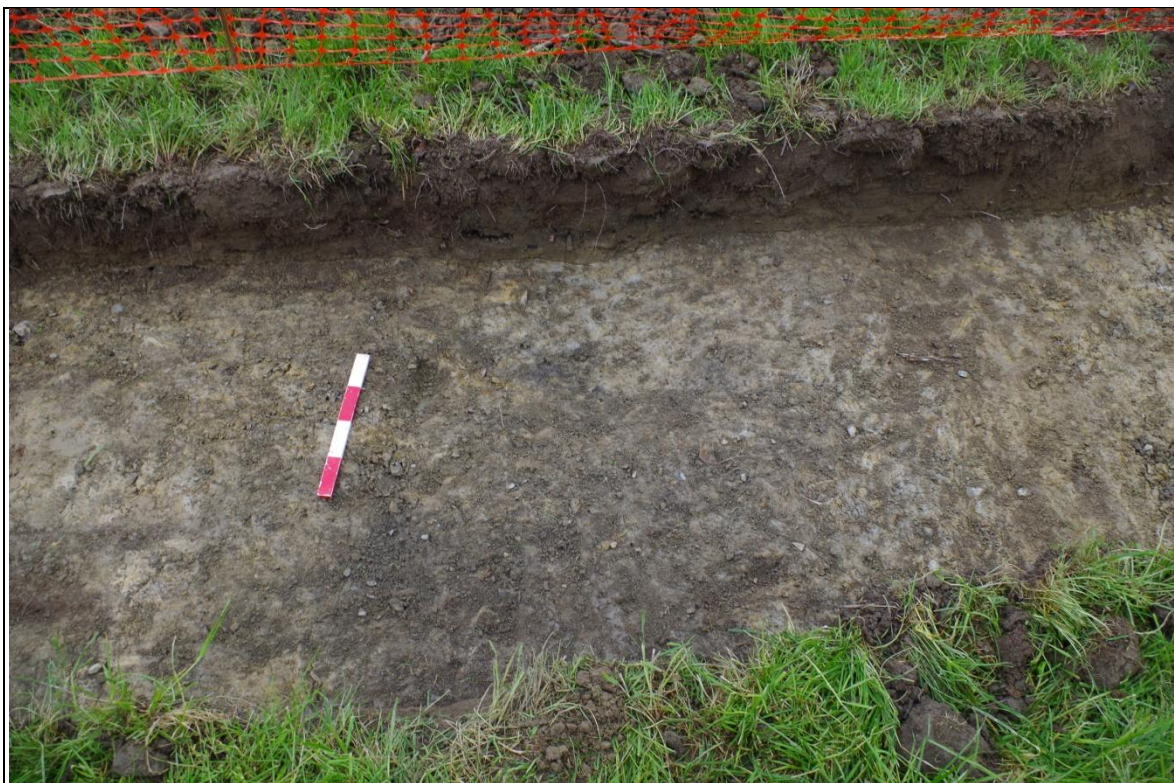
FIGURE 13: DITCH [704]; VIEWED FROM THE WEST (0.40M SCALE).

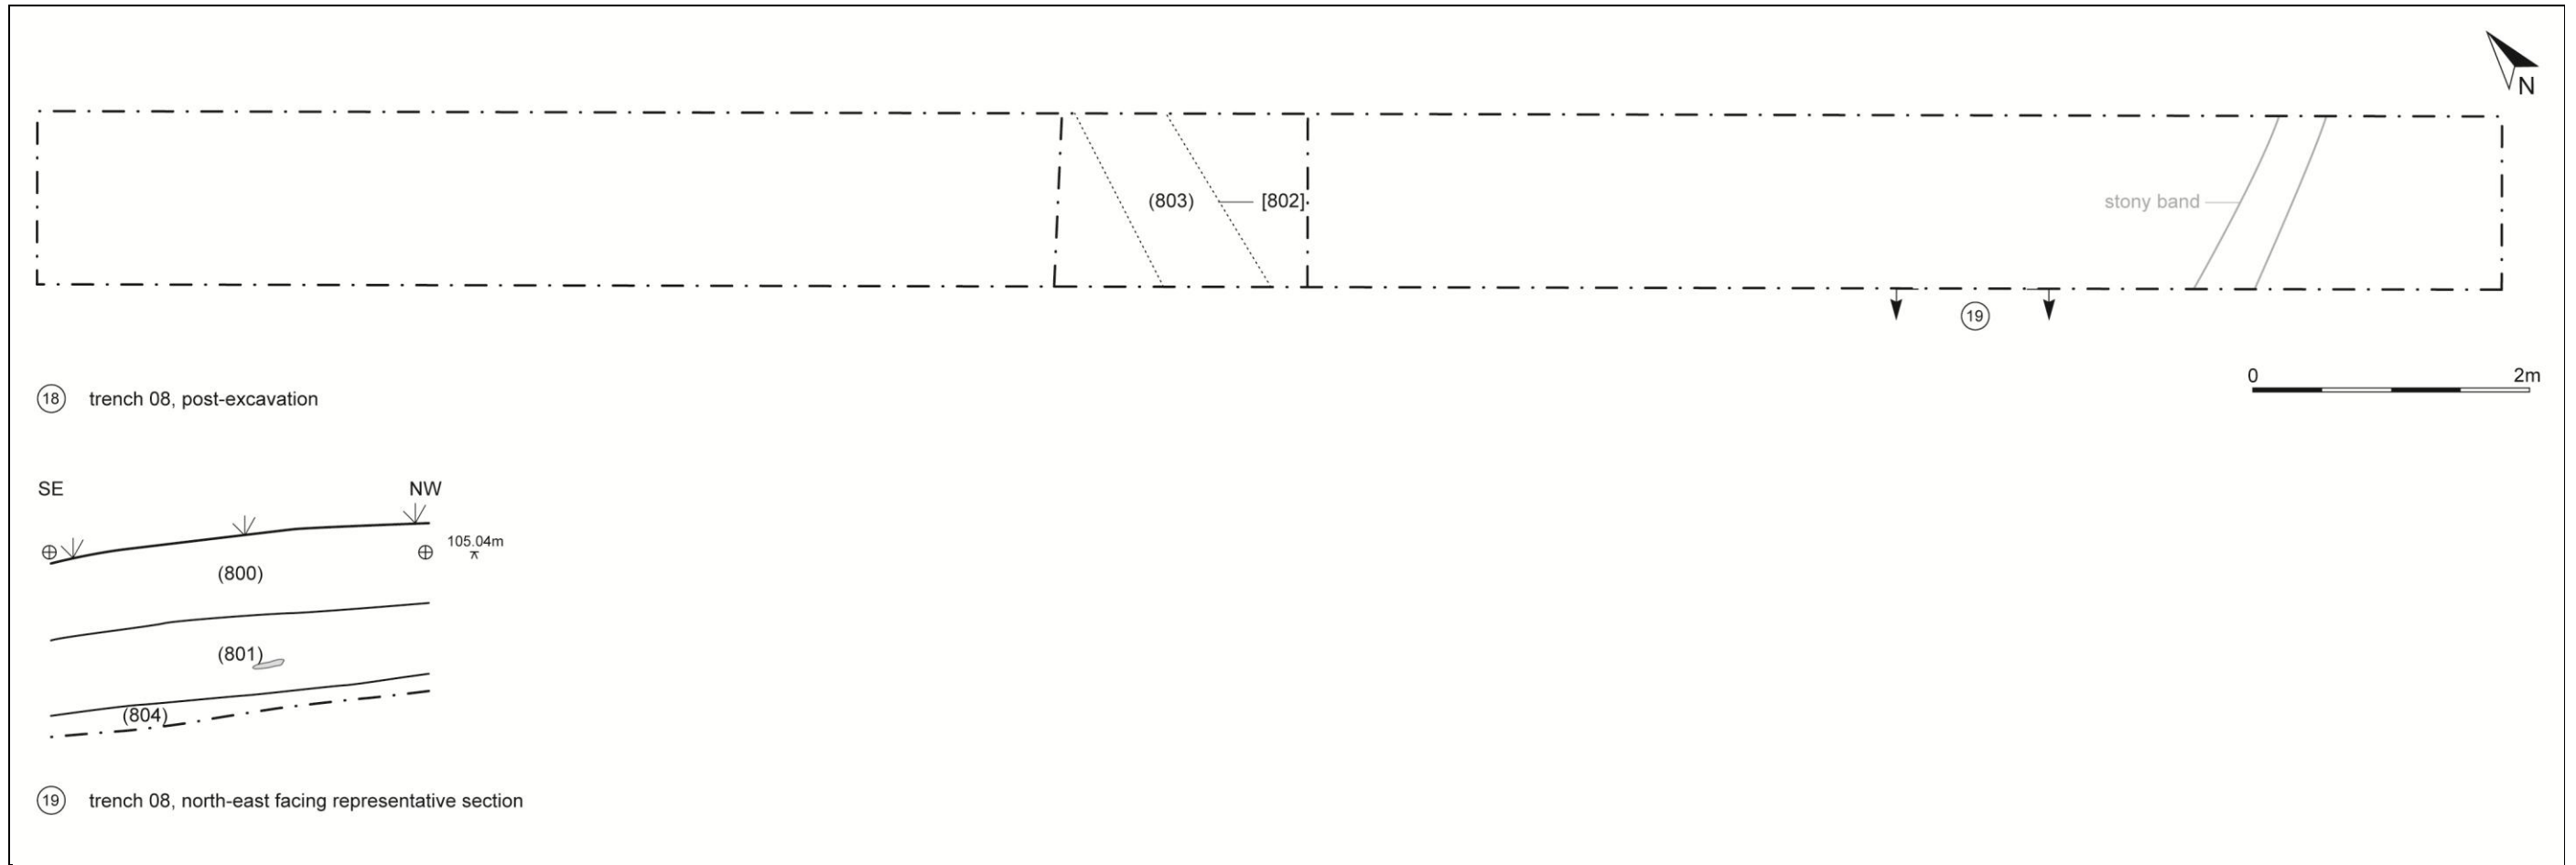
FIGURE 15: TRENCH 08; PLANS AND SECTIONS. HEIGHTS AT AOD.

Trench 08 was located towards the south-eastern corner of the site within an area the geophysical survey identified as containing modern services. The trench was 17.8m long and was orientated; the topsoil was c.0.22m thick and the subsoil c.0.22m thick (Figure 15). No archaeological features were identified, although a modern utility service trench was identified in the location of the geophysical anomaly. No finds were recovered from the trench.

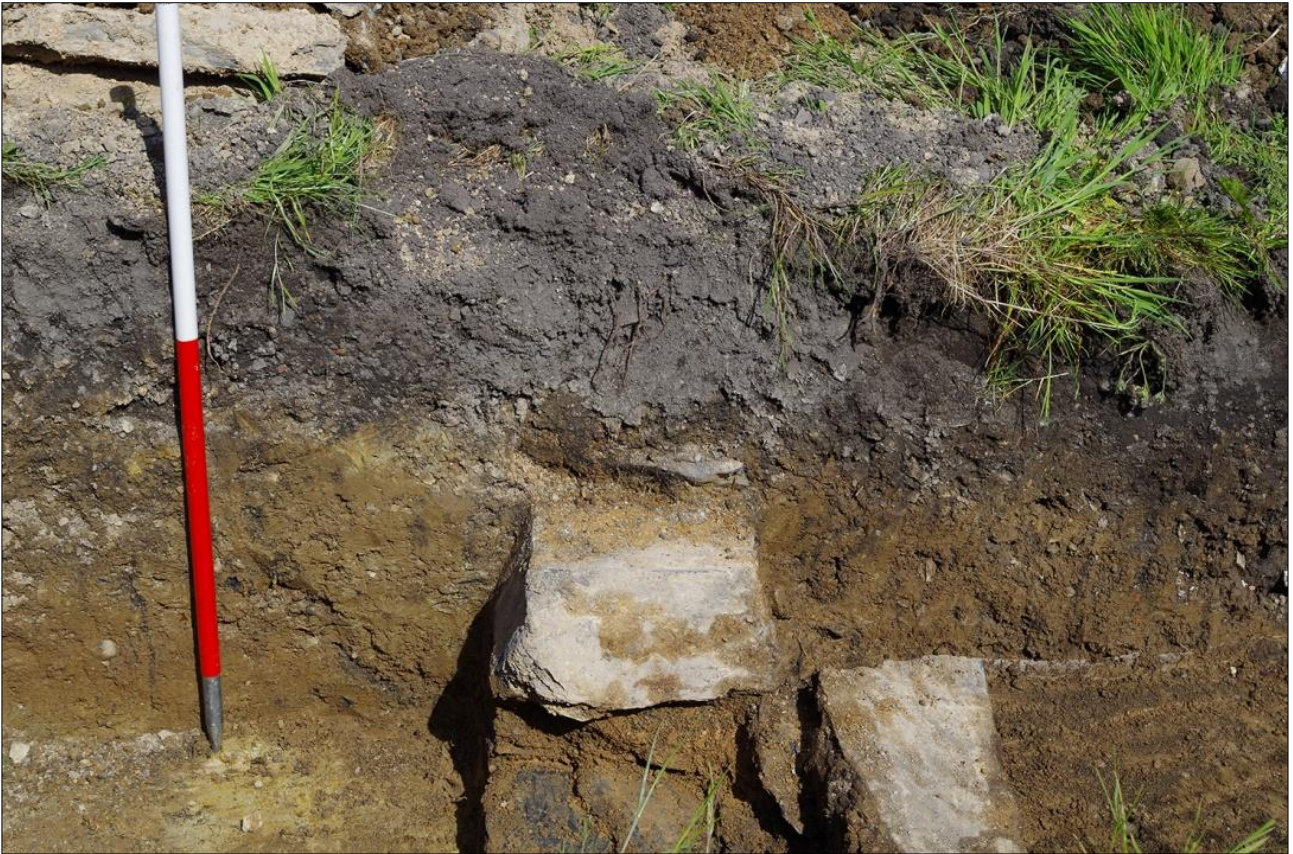
1. WALL {103}, WEST FACING SECTION OVER; VIEWED FROM THE WEST (PART 1M SCALE).

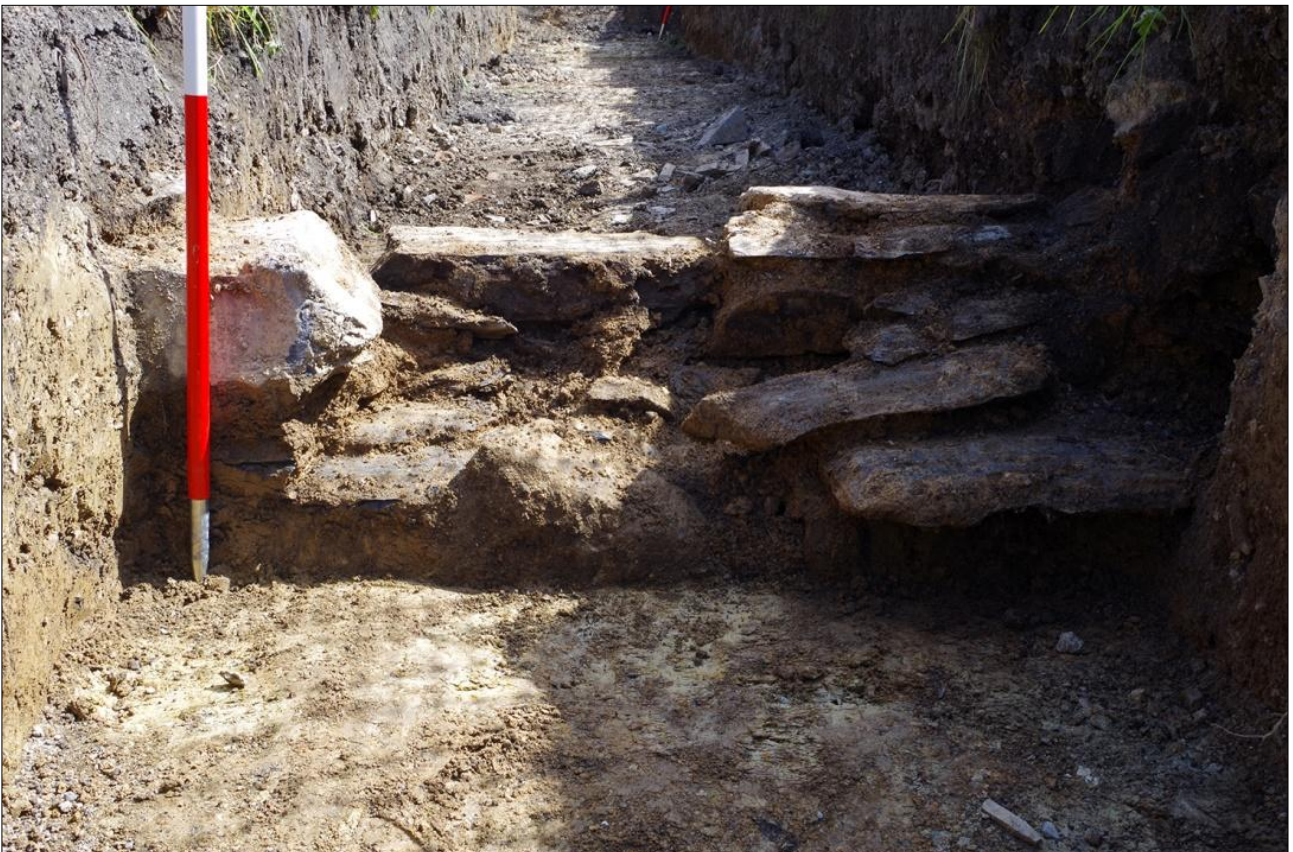
2. WALL {103}, NORTH FACING ELEVATION; VIEWED FROM THE NORTH (PART 1M SCALE).

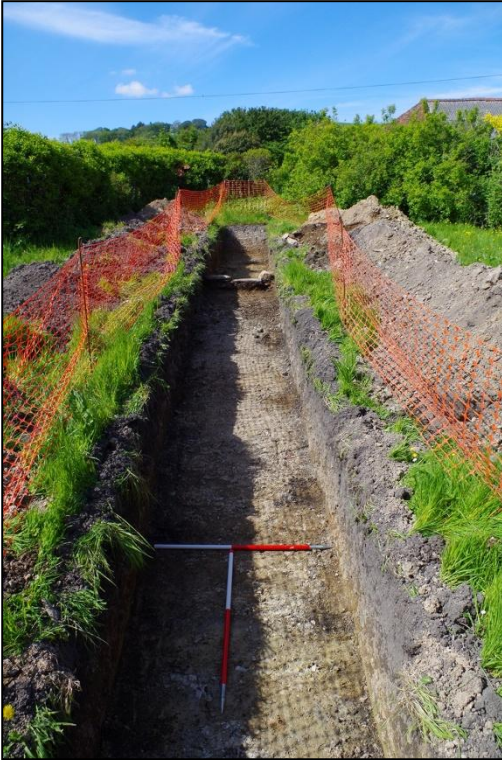
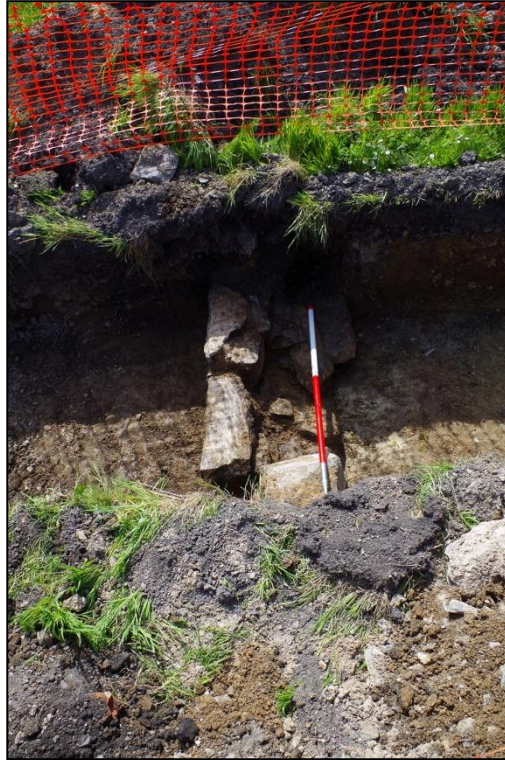
3. (LEFT) WALL {103}, POST-EXCAVATION; VIEWED FROM THE WEST (1M SCALE).

4. (RIGHT) TRENCH 01, POST-EXCAVATION; VIEWED FROM THE SOUTH (1M & 2M SCALES).

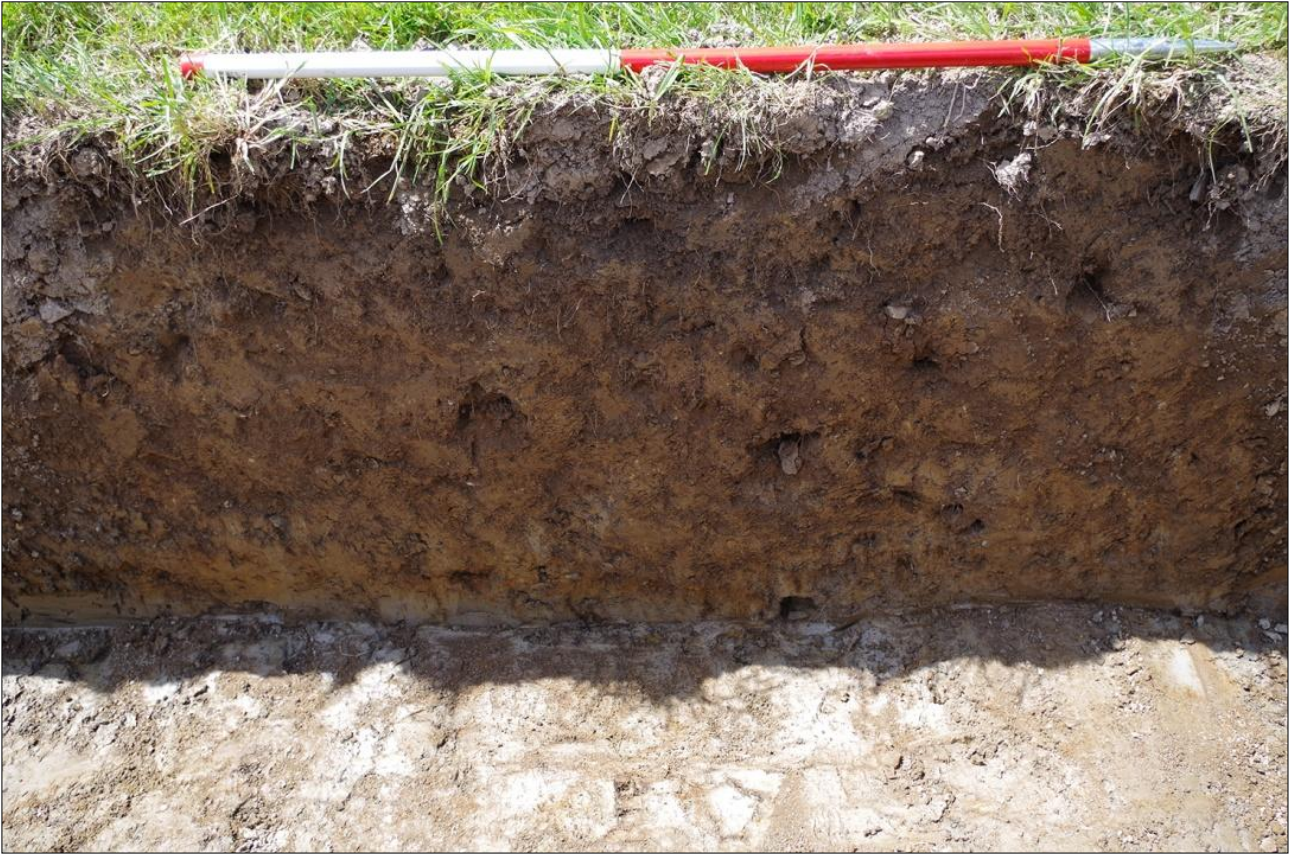
6. TRENCH 02, SOUTH-EAST FACING REPRESENTATIVE SECTION; VIEWED FROM THE SOUTH-EAST (1M SCALE).

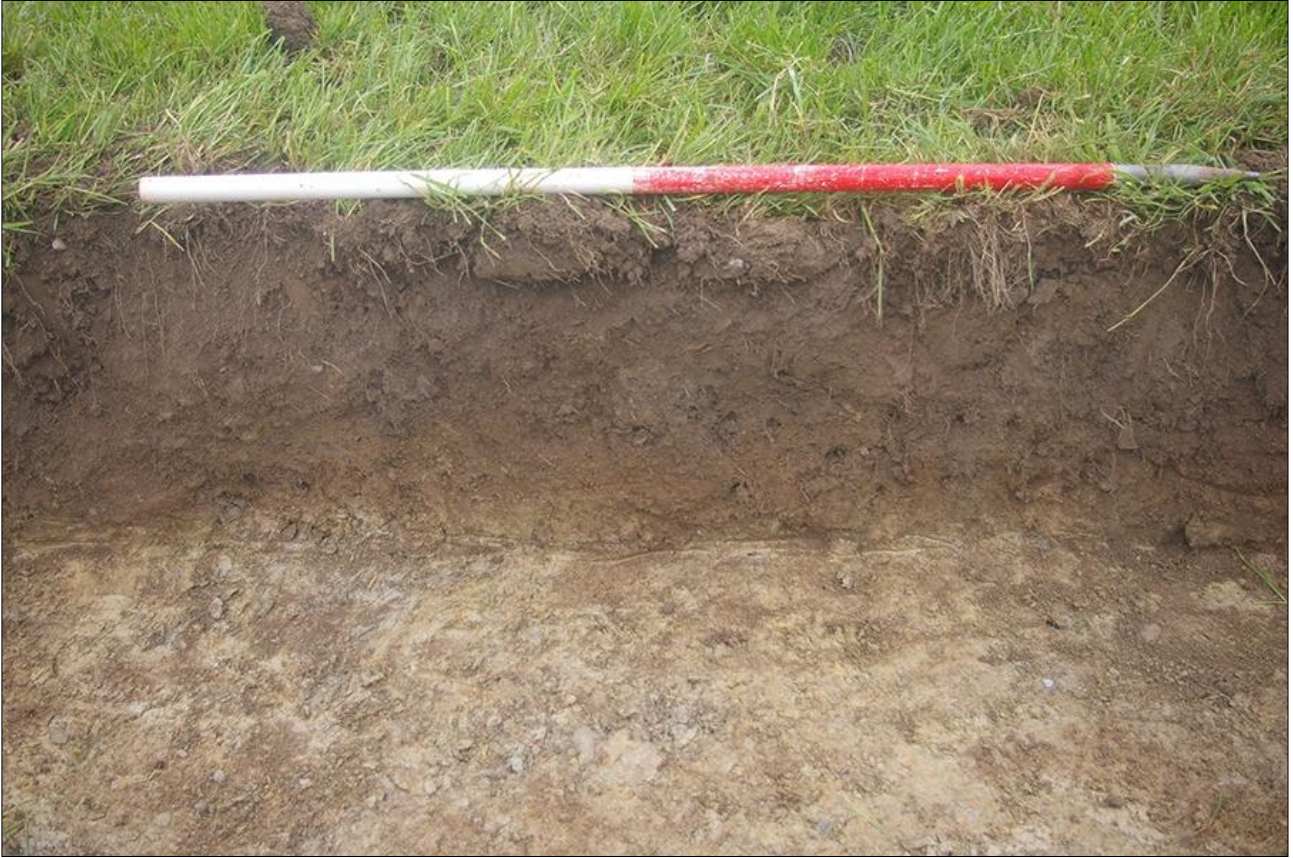
9. TRENCH 03, NORTH FACING REPRESENTATIVE SECTION; VIEWED FROM THE WEST-NORTH-WEST (1M SCALE).

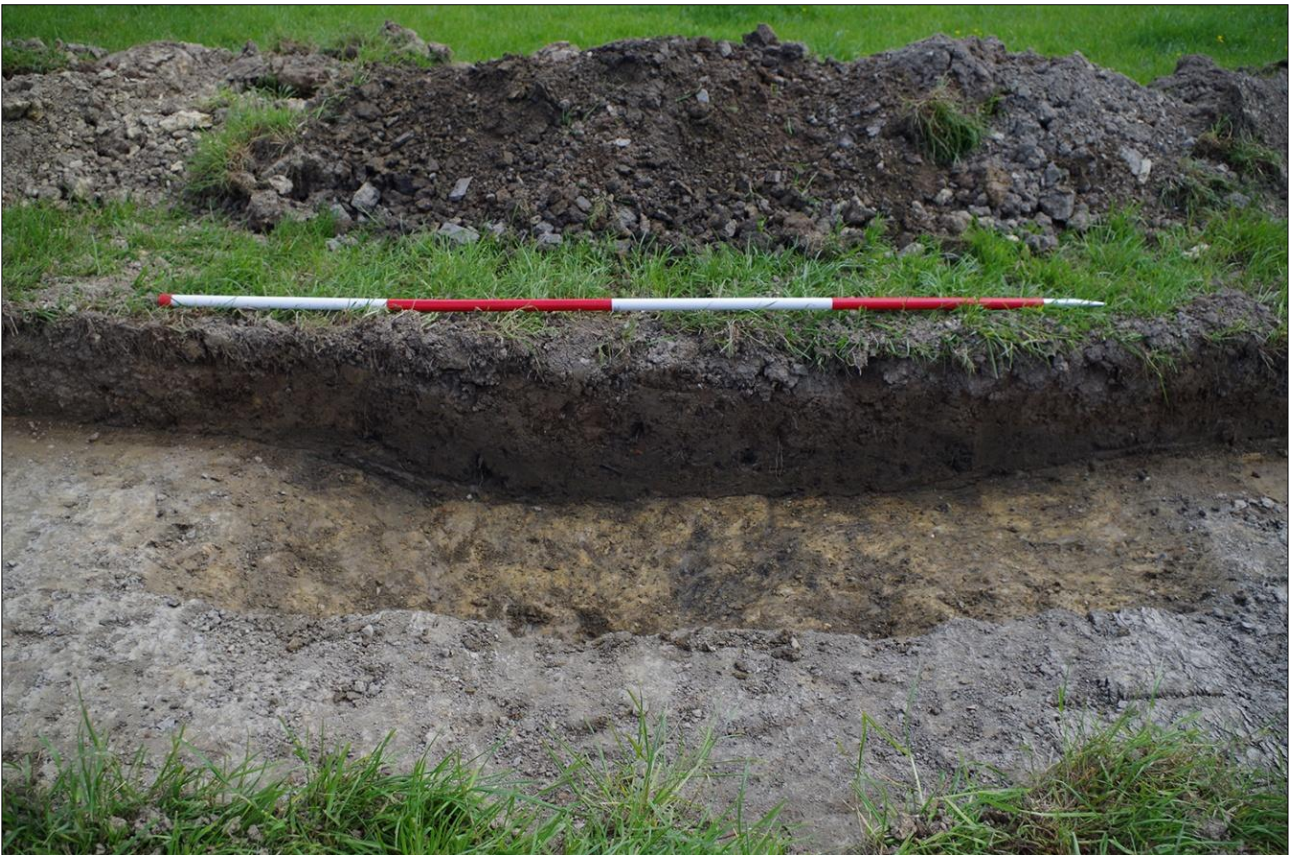
10. DITCH [401], NORTH-WEST FACING SECTION; VIEWED FROM THE NORTH-WEST (2M SCALE).

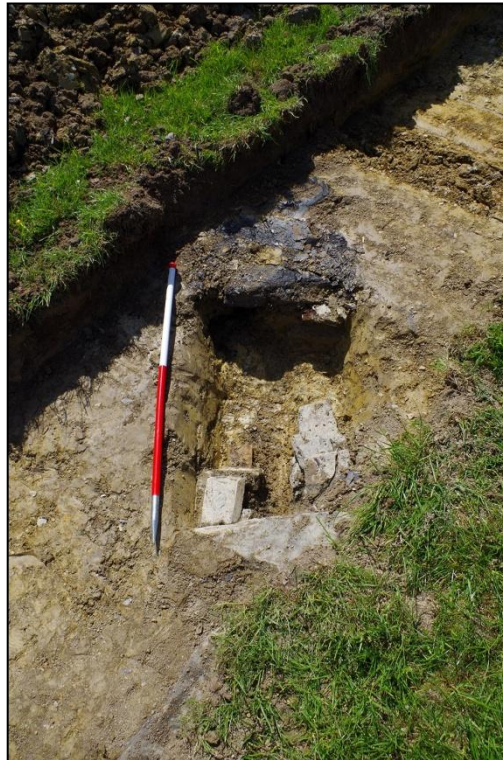
13. (RIGHT) STONE-LINED DRAIN [501], POST-EXCAVATION; VIEWED FROM THE NORTH-EAST (1M SCALE).
