# LAND ADJACENT TO FILLEIGH VILLAGE HALL

RESULTS OF AN ARCHAEOLOGICAL EVALUATION

South West Archaeology Ltd. report no. 190531

# Land adjacent to Filleigh Village Hall, Filleigh, North Devon, Devon

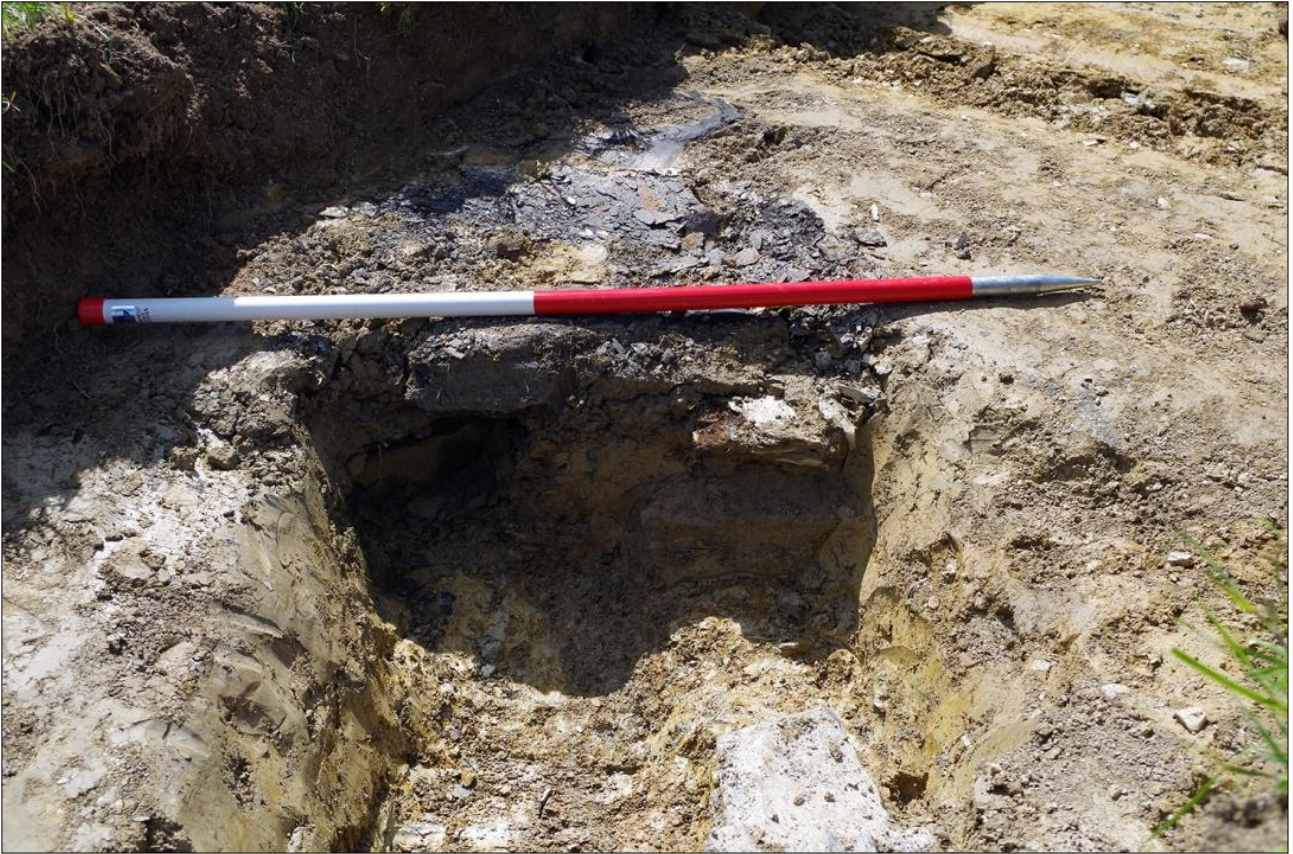
14. STONE DRAIN [501], NORTH-EAST FACING SECTION; VIEWED FROM THE NORTH-EAST (1M SCALE).

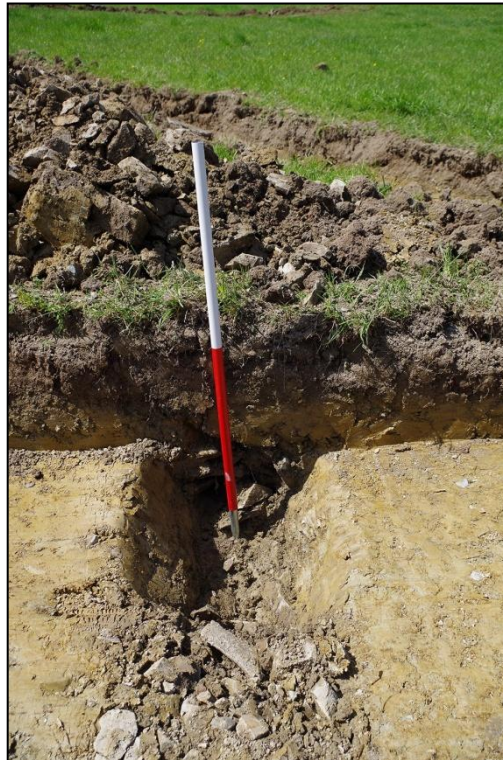
16. (RIGHT) LAND-DRAIN [601], SOUTH-EAST FACING SECTION; VIEWED FROM THE SOUTH-EAST (1M SCALE).

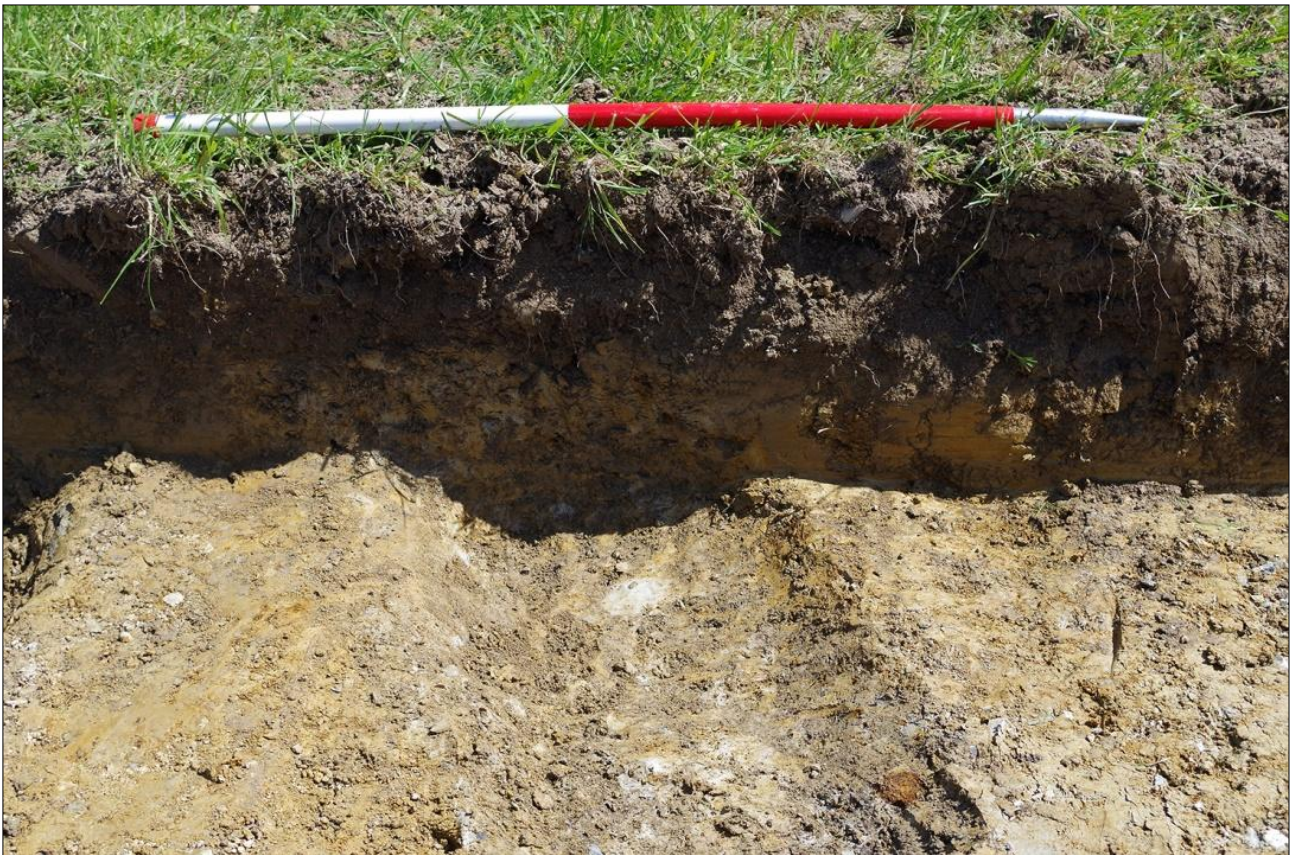
19. DITCH [605], NORTH-WEST FACING SECTION; VIEWED FROM THE NORTH-WEST (1M SCALE).

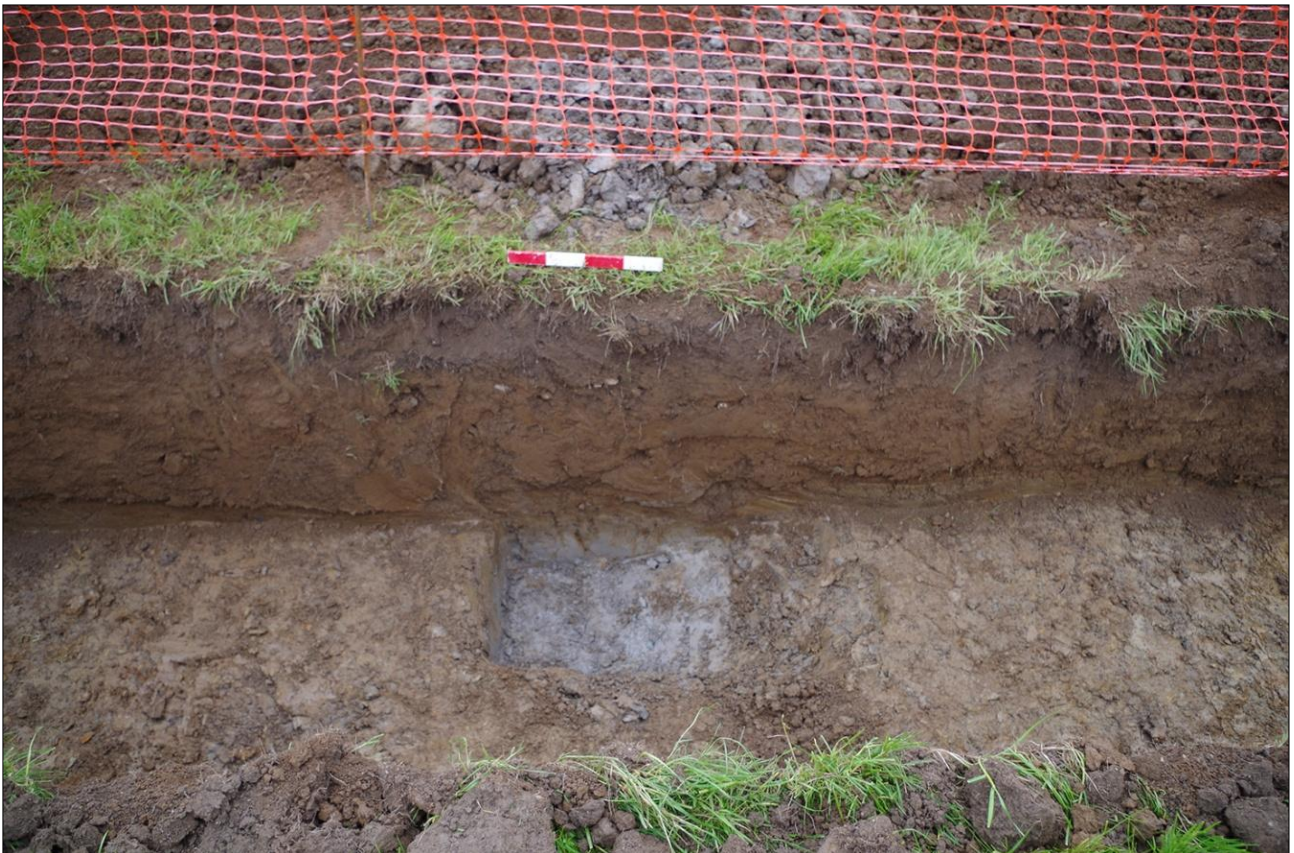
22. TRENCH 07, WEST-NORTH-WEST FACING SECTION SHOWING ALLUVIAL CLAY DEPOSIT; VIEWED FROM THE WEST-NORTH-WEST (0.40M SCALE).

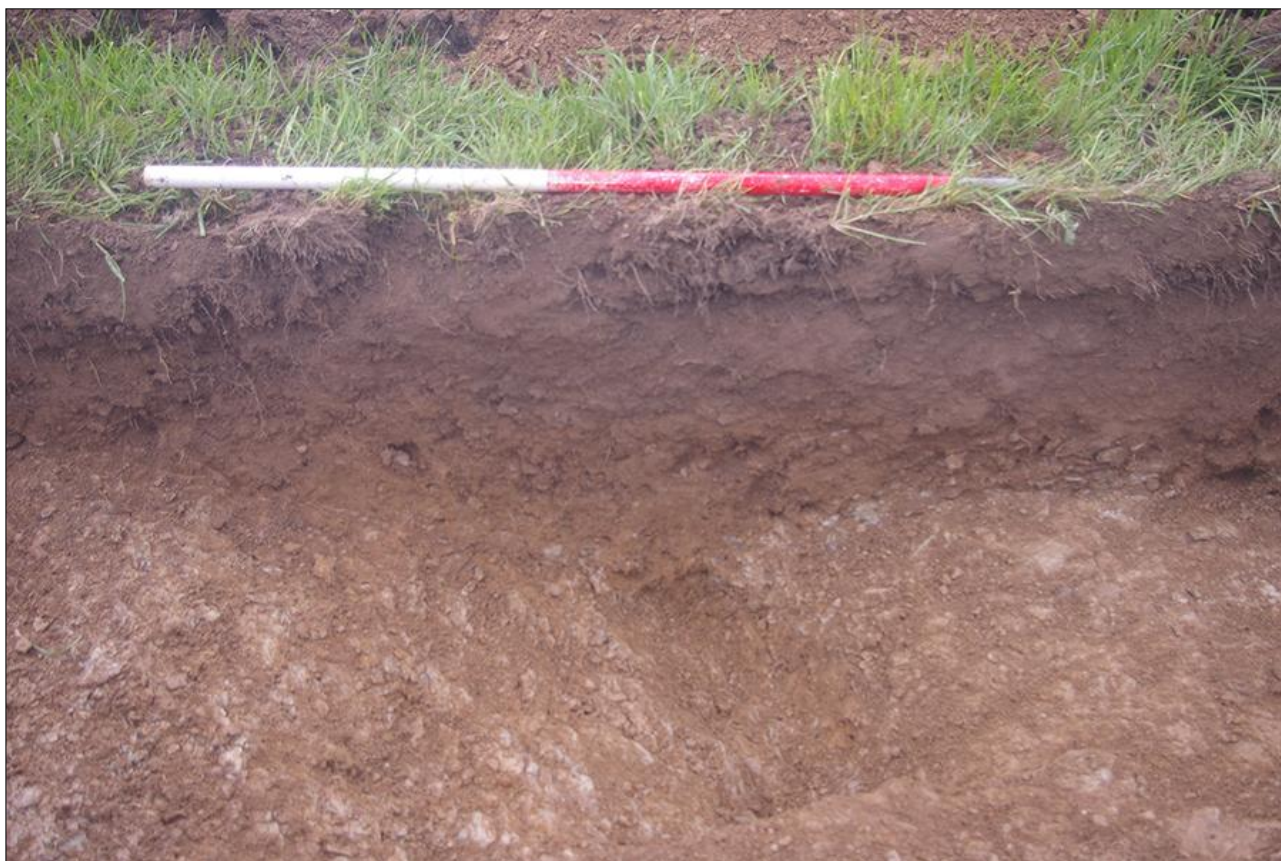
23. DITCH [702], WEST-NORTH-WEST FACING SECTION; VIEWED FROM THE WEST-NORTH-WEST (1M SCALE).

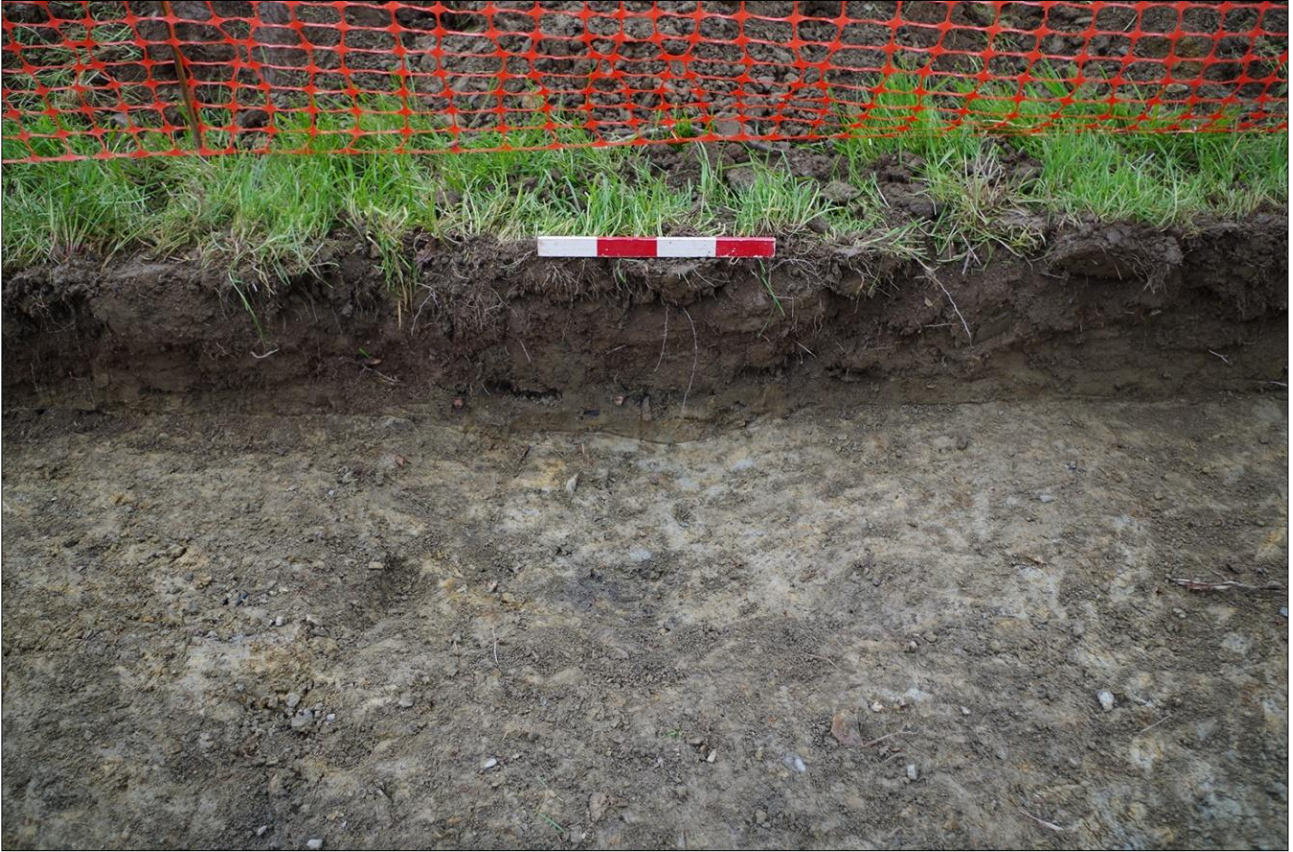
25. DITCH [704], WEST-NORTH-WEST FACING SECTION; VIEWED FROM THE WEST-NORTH-WEST (0.40M SCALE).

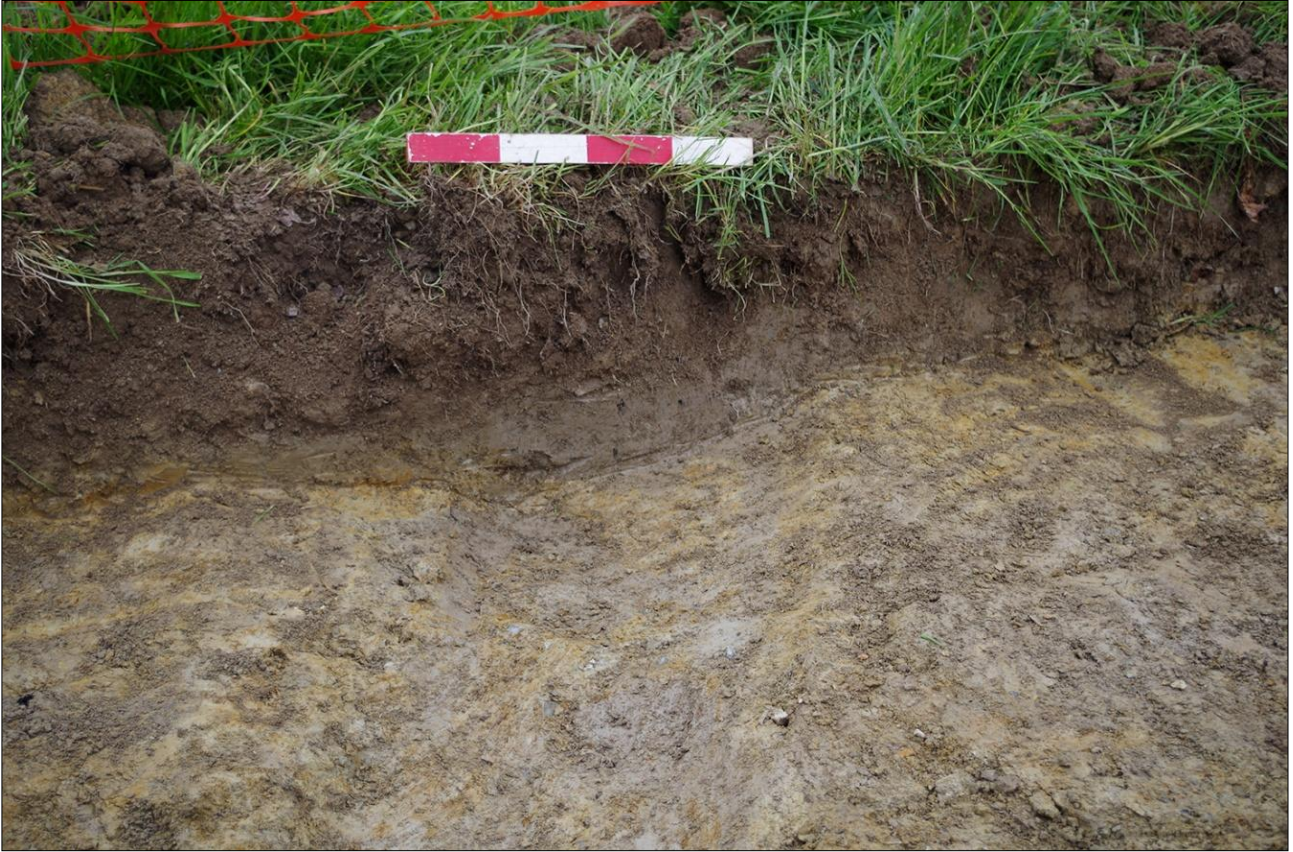
27. DITCH [706], WEST-NORTH-WEST FACING SECTION; VIEWED FROM THE WEST-NORTH-WEST (0.40M SCALE).

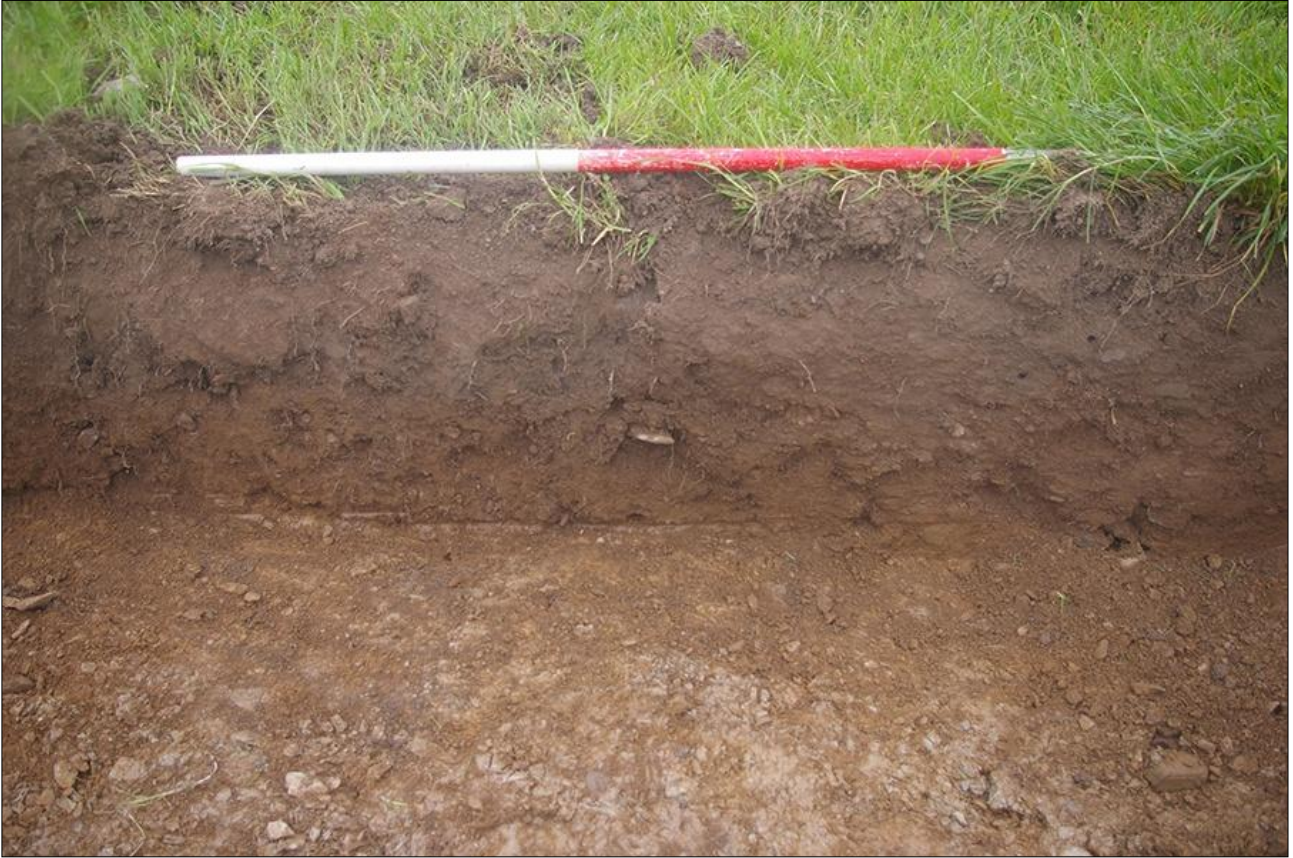
30. TRENCH 08, NORTH-EAST FACING REPRESENTATIVE SECTION; VIEWED FROM THE NORTH-EAST (1M SCALE).
