HILLTOWN FARM WARKLEIGH NORTH DEVON DEVON

Results of Archaeological Monitoring & Recording

South West Archaeology Ltd. report no. 200213

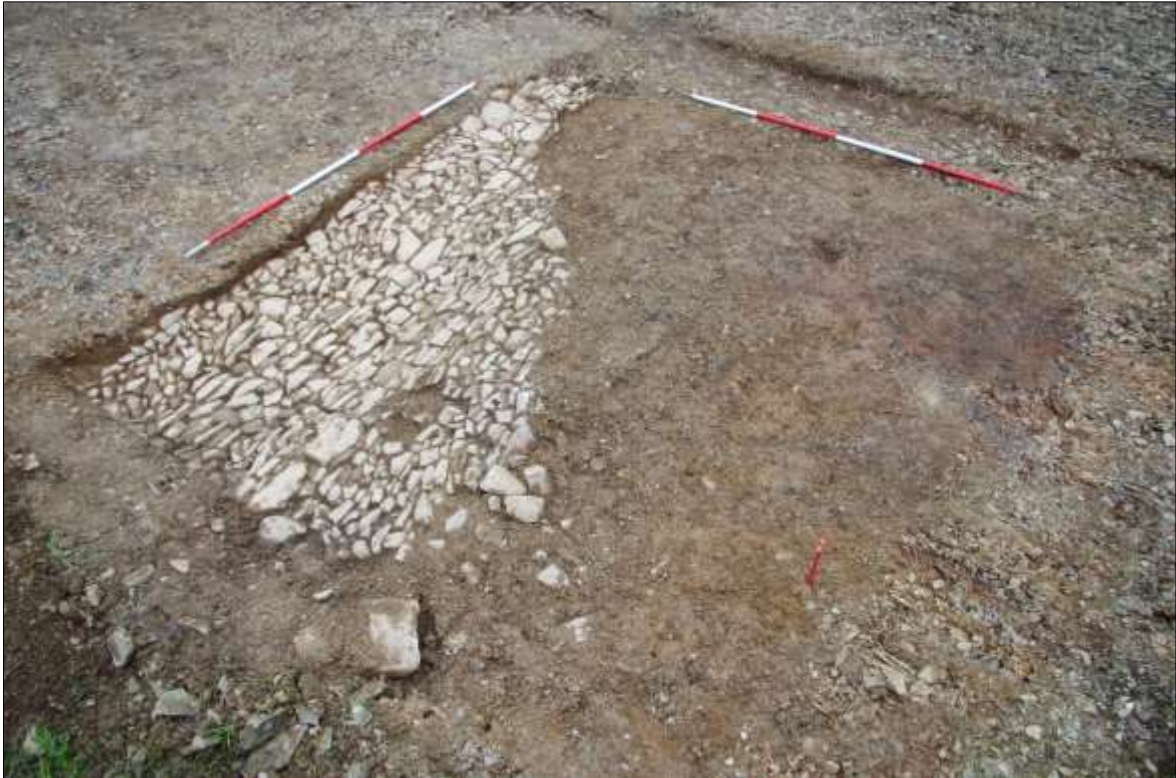
FIGURE 7: COBBLE SURFACES (104), (127) AND (137) SET WITHIN FEATURE [110], WITH FIRE PIT [128]; VIEWED FROM THE SOUTH-EAST (2M SCALES).

In the south-east corner of the site was a large sub-square feature 4.40m+ by 3.30m across, feature [110] (see Figures 6-8, 10). This broad, shallow cut contained a series of other features, and while for the most part it did sit within the footprint of the destroyed farmhouse, it did appear to extend beneath of the south-east wall of the house.

Cobbles (104) had been cut down the centre by linear slot [131] and the cobbles re-set (127). This slot was orientated north-west to south-east and measured 2.70×0.44-0.66m wide and 0.12m deep with vertical sides and flat base. It contained two fills: (125), a firm basal yellow-grey clay-silt up to 0.05m thick, over which was cobble surface (127), consisting of tightly packed poorly sorted sub-angular slatestone cobbles up to 0.25×0.10×0.10m in size, had been laid. These cobbles were similar to those of (104), though slightly more irregularly laid. Layer (125) produced three sherds of North Devon medieval coarseware.

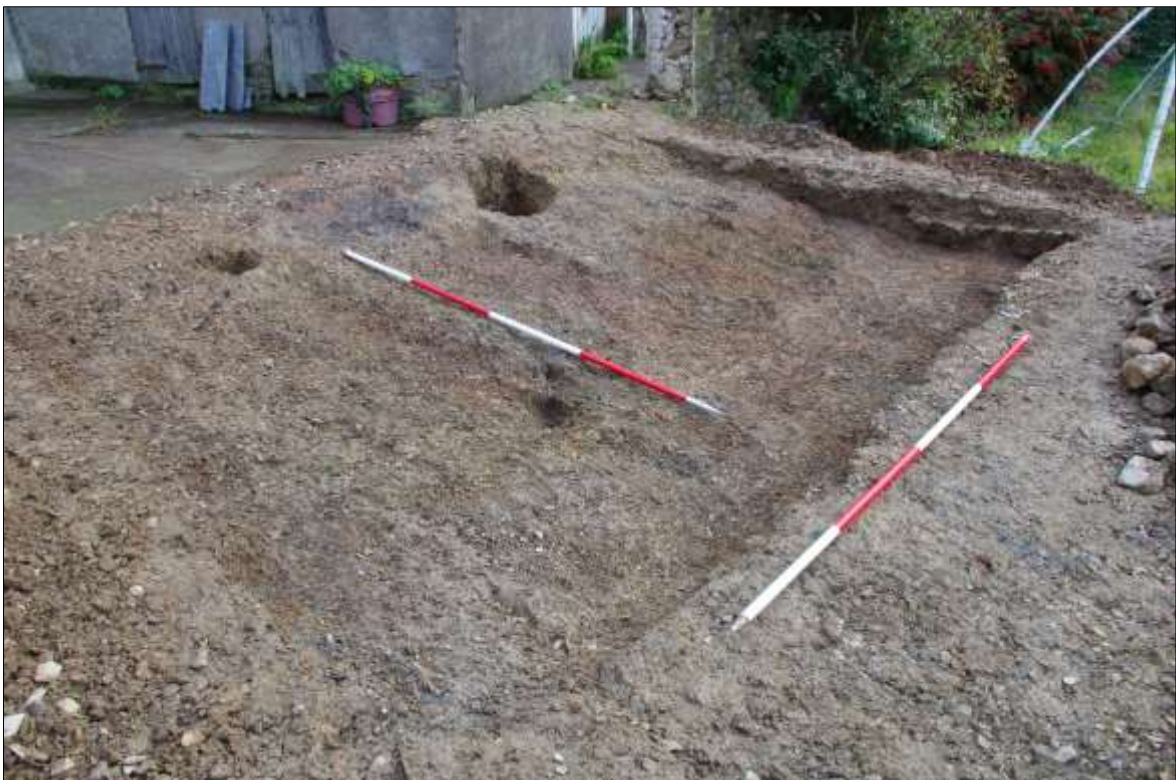
FIGURE 8: FEATURE [110] POST-EXCAVATION; VIEWED FROM THE NORTH-WEST (2M SCALES).

Feature [110] had an uneven, undulating base up to 0.28m deep, marked by a strong steep, often vertical cut to the south-west, but with less well defined and more gently sloping edges to the north-west and north-east; the south-eastern edge lay somewhere beyond the edge of excavation. For the most part, the base of the feature was fairly rough; however, along its south-western side it descended to its lowest point via a series of well-defined hollows, and the natural appeared worn as if it had been used as a surface. In the south corner a thin layer of firm mid-to-dark reddish-brown clay-silt 0.04m thick was present (126); this lay above a section of the natural which had been discoloured and appeared baked (140), and which extended across much of [110] (see Figure 6). The purpose and function of this feature is difficult to determine; layers above the base of the hollow produced small abraded sherds of North Devon medieval coarseware, but these are likely to relate to the cobbled surfaces above rather than the date and use of this hollow. The hollow

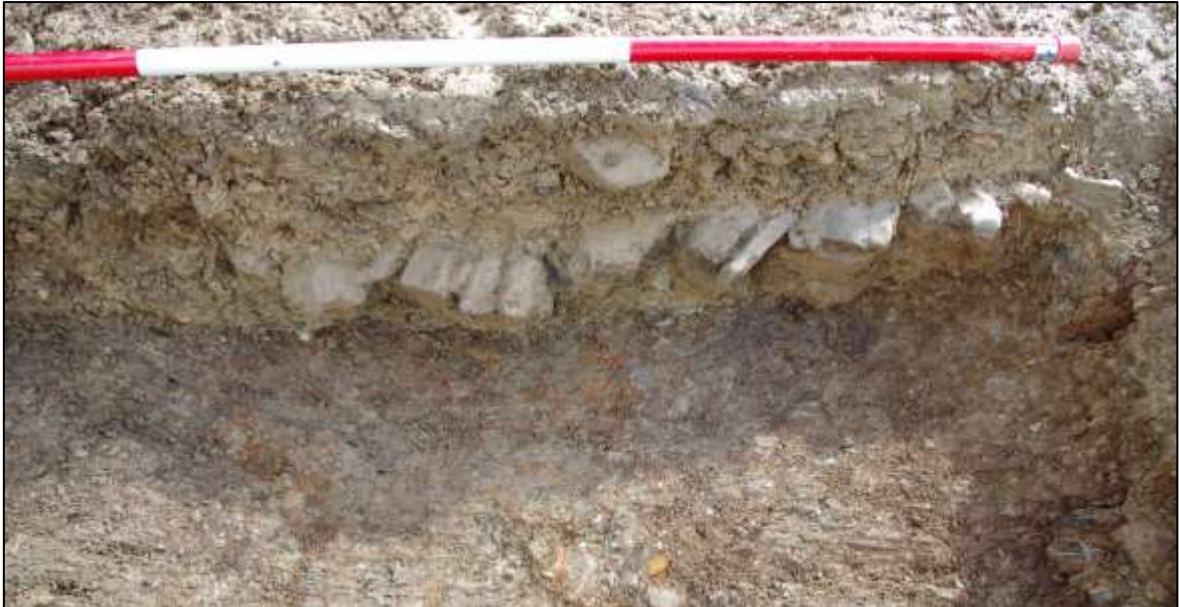
FIGURE 9: DETAIL OF THE SOUTH-WEST CORNER OF FEATURE [110], SHOWING THE HEAT AFFECTED NATURAL BENEATH COBBLED SURFACES (104) AND (127); VIEWED FROM THE NORTH-WEST (PART 2M SCALE).

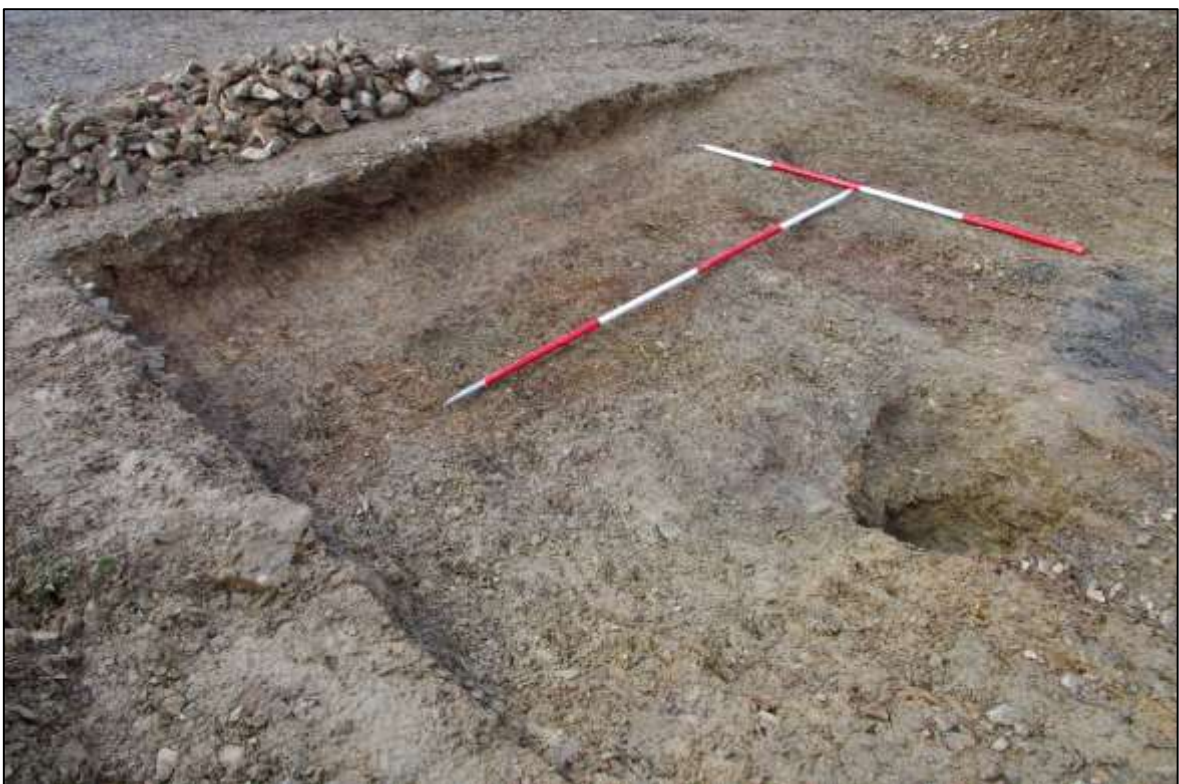
FIGURE 10: FEATURE [110], POST-EXCAVATION; VIEWED FROM THE EAST-SOUTH-EAST (2M SCALES). NOTE THE WORN SHILLET/ POSSIBLE SURFACE APPEARS RESTRICTED TO THE SOUTH-WESTERN SIDE OF [110] (TOP LEFT).

It is also possible that the observed hollow [110] could have been enlarged from an earlier, smaller feature. The clear wear pattern in the base of [110] is restricted to a c.1m band parallel with the south-west side of the feature (see Figure 10). Therefore, it is possible we have one side and the base of a rock-cut linear feature, the north-eastern side (where the shillet looks ragged) being dug out at a later point to install the kerb in the cobbles. However, the posited original cut is too narrow for a cross passage and is highly unlikely to have been a foundation trench as all the other farmhouse walls were built off the top of the shillet.

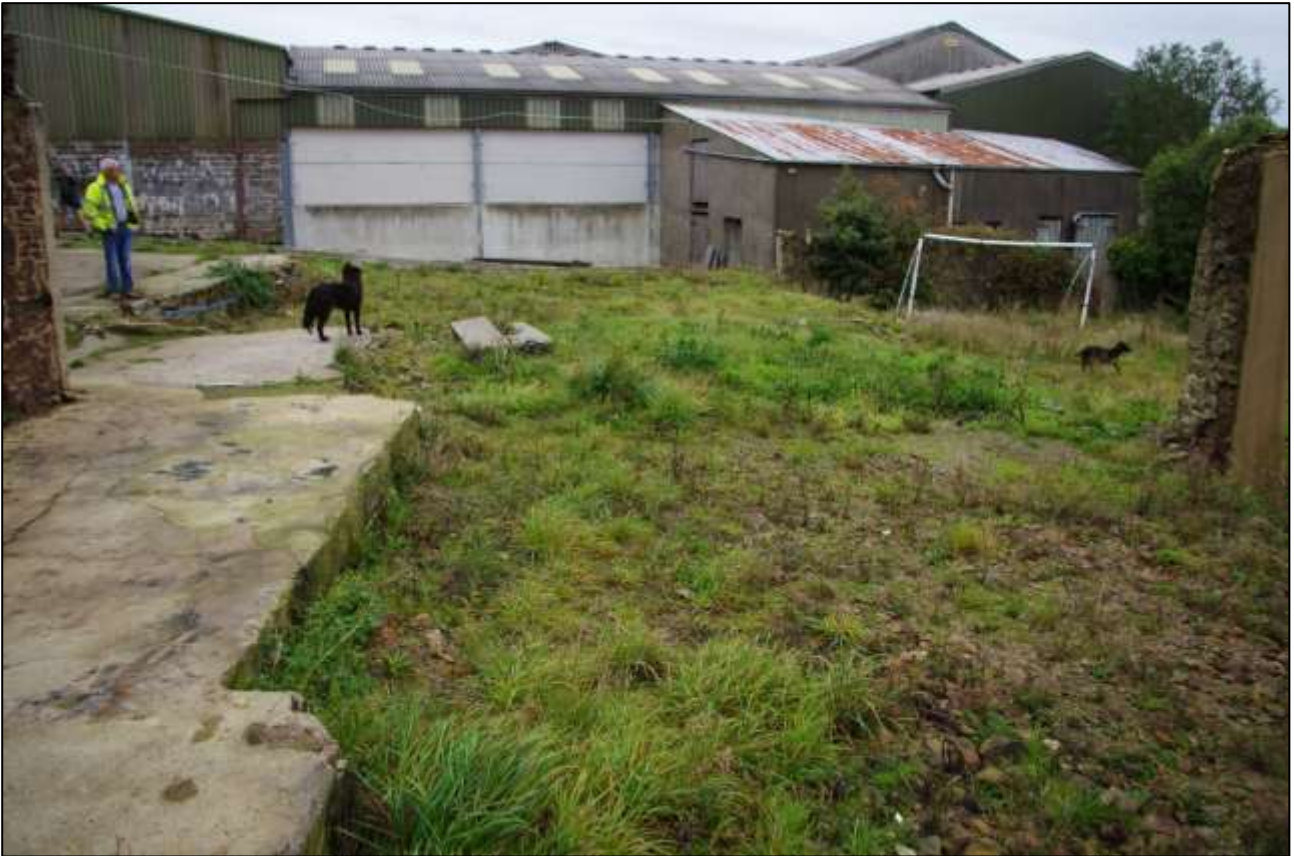
3. SITE OF THE FORMER HOUSE PRE-EXCAVATION, DEMONSTRATING THE TERRACING OF THE FLOOR COMPARED TO THE SURROUNDING YARD; VIEWED FROM THE SOUTH-WEST (NO SCALE).

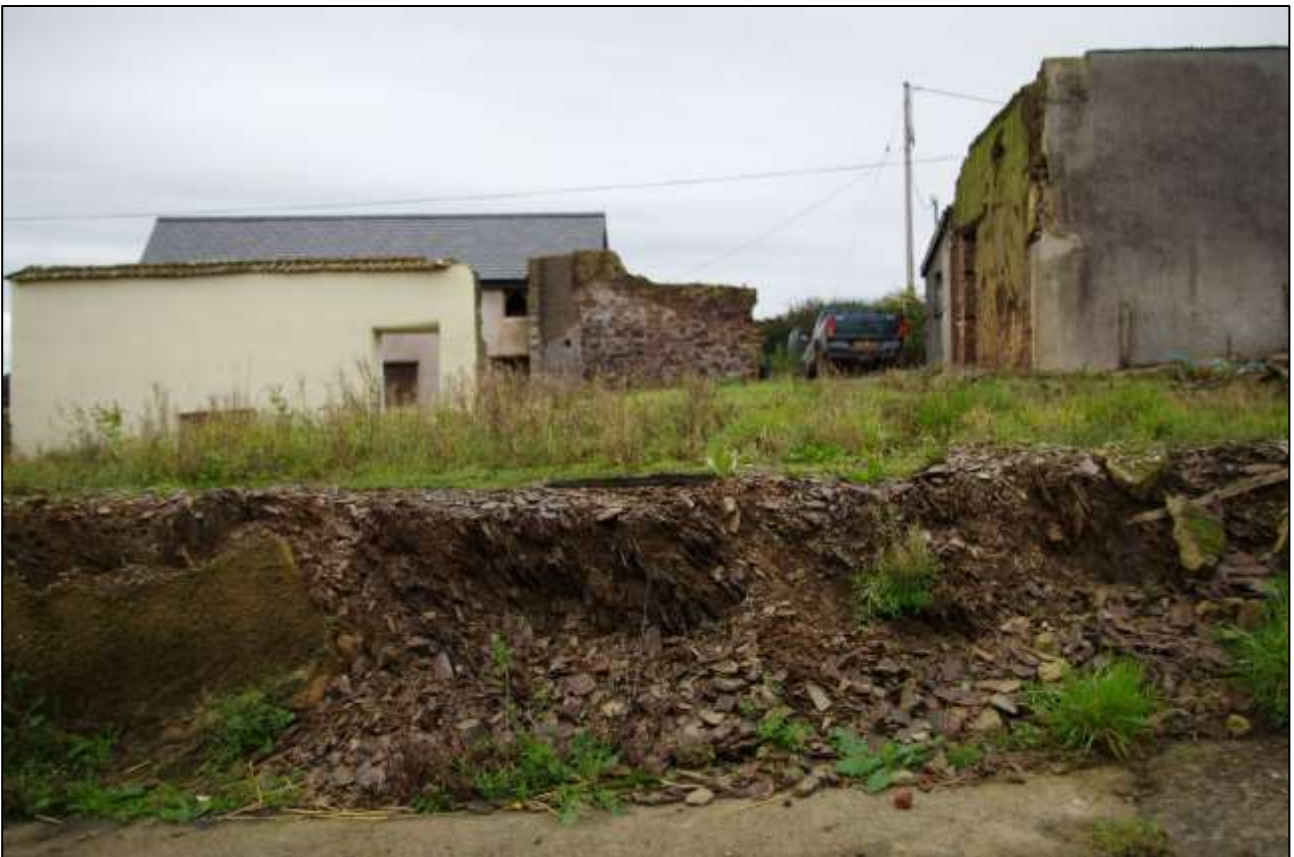
4. THE NORTH-EAST GABLE END OF THE FORMER HOUSE, SHOWING HOW THE COB WALLS OF THE BUILDING HAD BEEN PERCHED UP ON A STEP CUT INTO THE SHILLET BEDROCK; VIEWED FROM THE NORTH-EAST (NO SCALE).

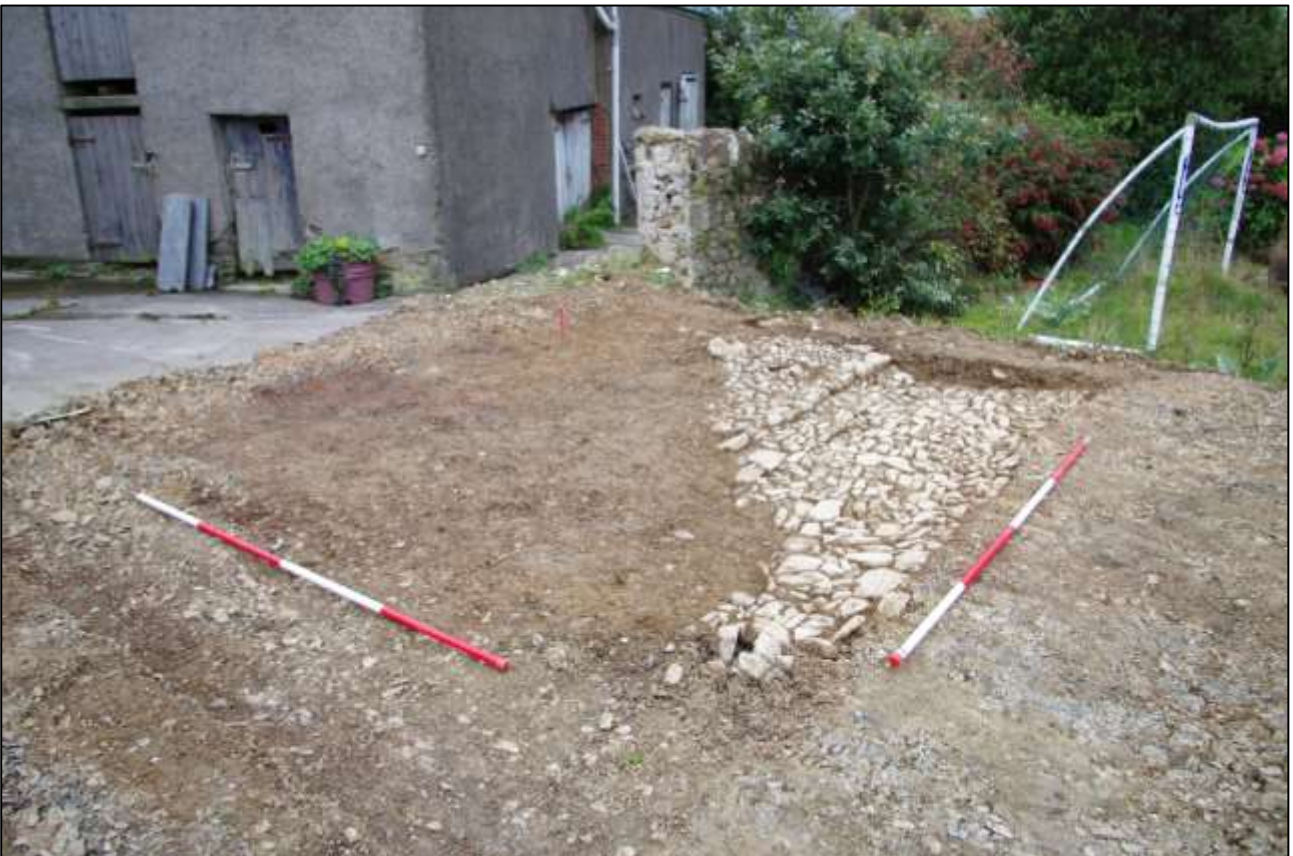
8. COBBLE SURFACES (104), (127), AND (137) WITHIN CUT [110]; VIEWED FROM THE NORTH-WEST (2M SCALES).

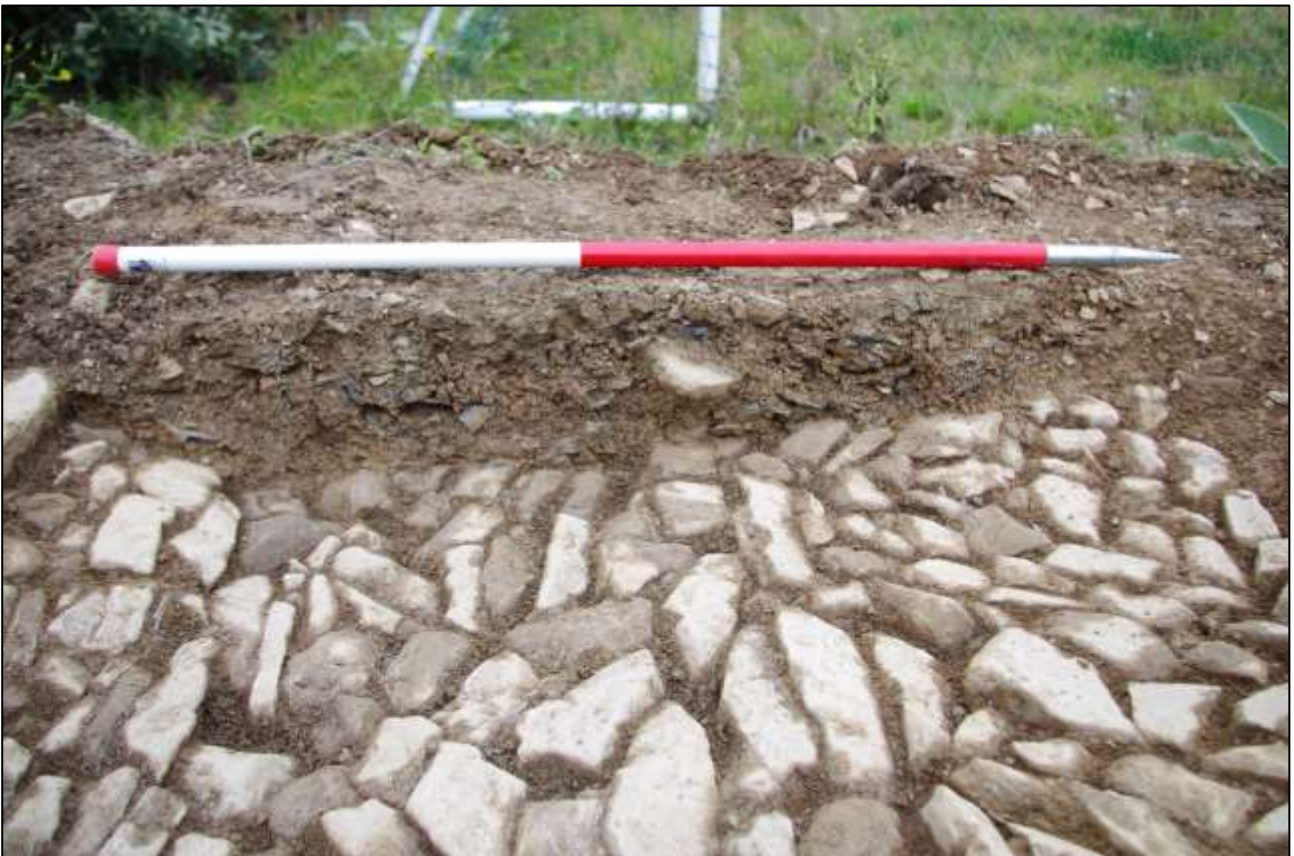
13. NORTH-WEST FACING SECTION OVER COBBLES (104) AND (127); VIEWED FROM THE NORTH-WEST (1M SCALE).

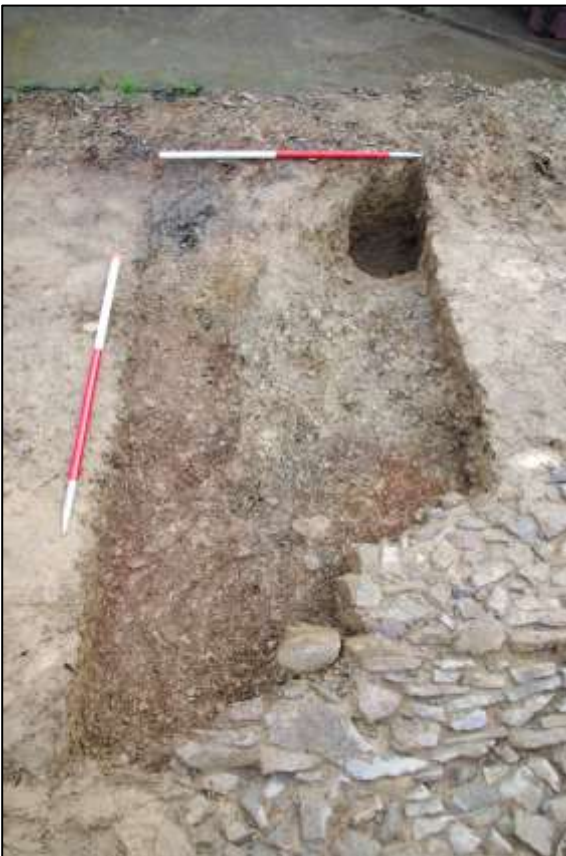
15. SONDAGE CUT THROUGH LAYERS (107) AND (108), WITH POSTHOLE [117] IN THE BACKGROUND; VIEWED FROM THE SOUTH-WEST (1M SCALES).

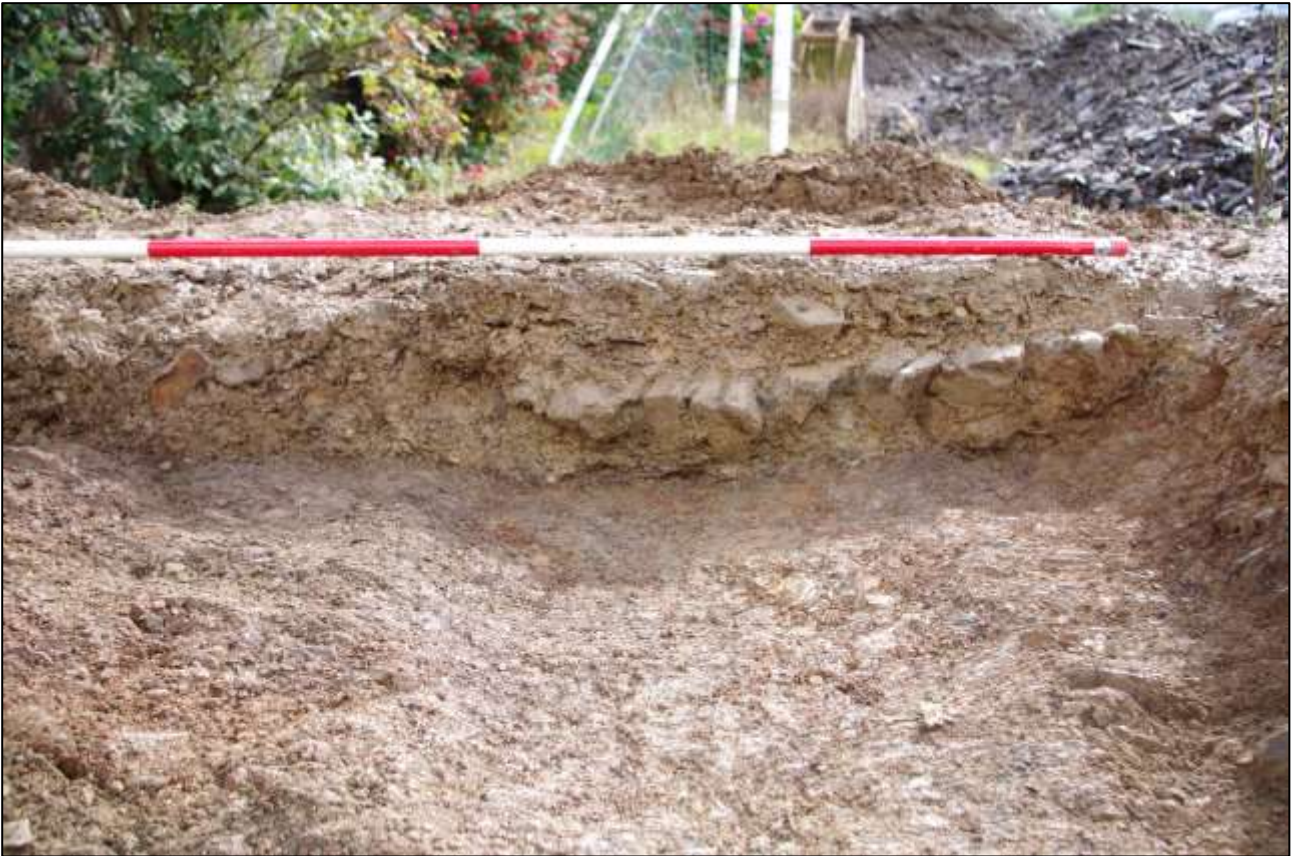
16. FEATURE [110], NORTH-WEST FACING SECTION SHOWING COBBLE SURFACES (104) AND (127); VIEWED FROM THE NORTH-WEST (PART 2M SCALE).

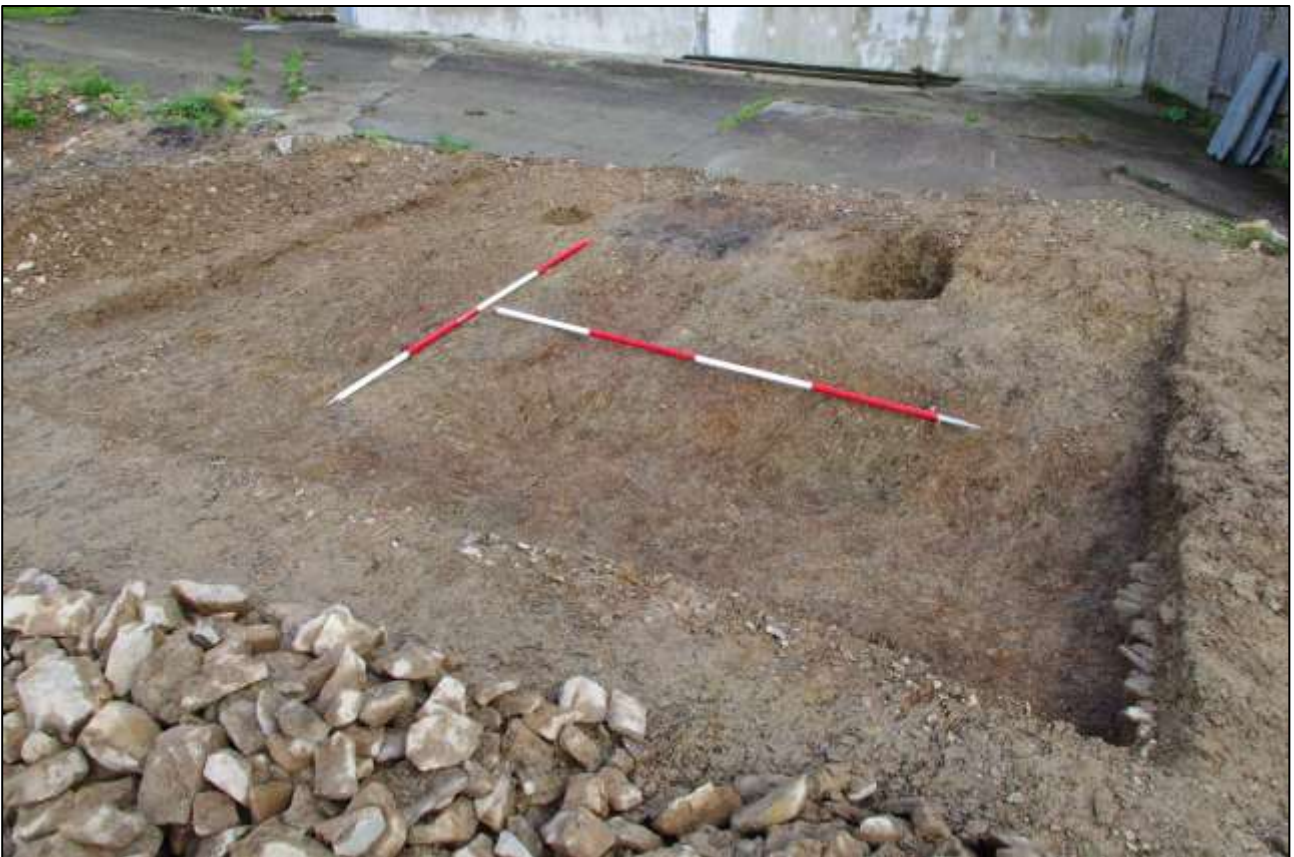
17. FEATURE [110], POST-EXCAVATION SHOWING HEAT AFFECTED AREAS; VIEWED FROM THE SOUTH-SOUTH-WEST (2M SCALES).

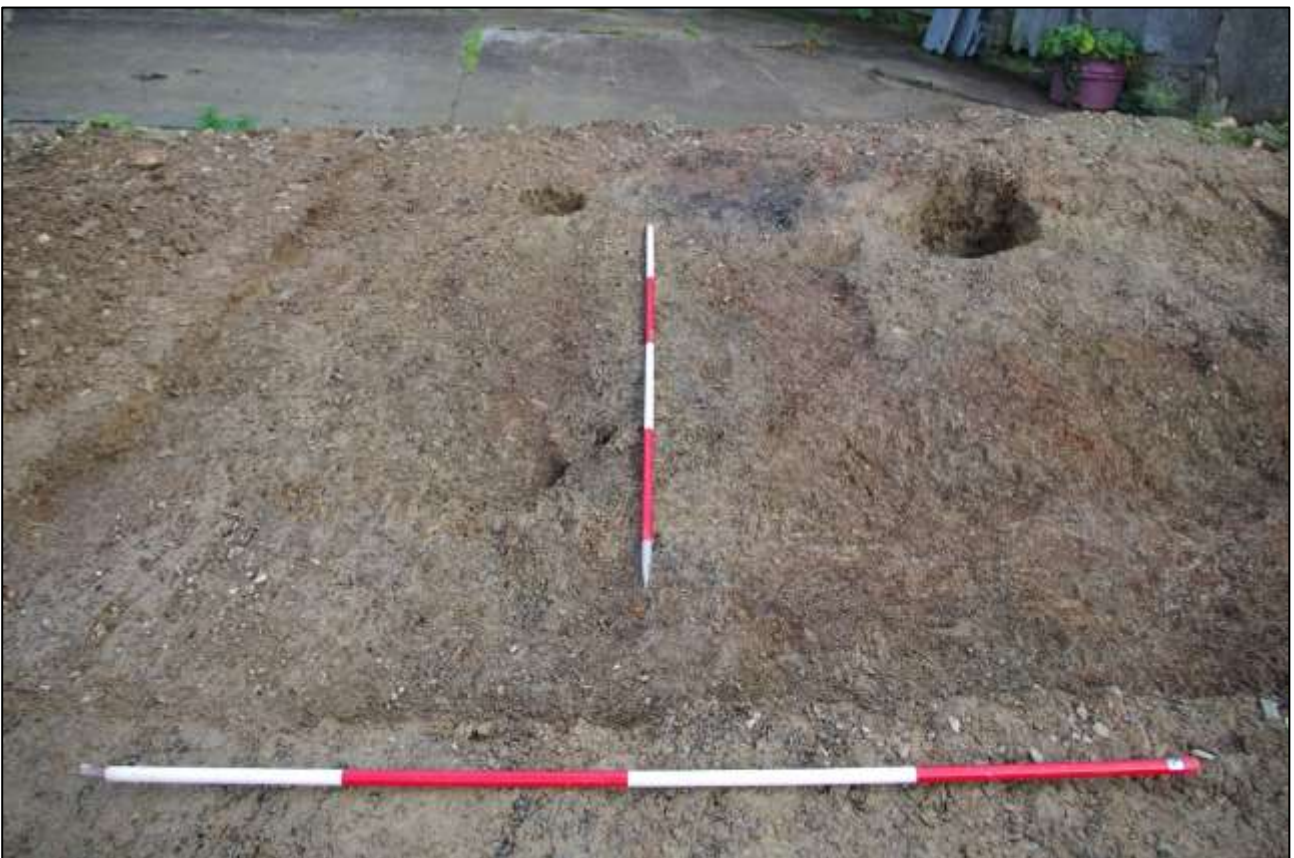
19. FEATURE [110], POST-EXCAVATION SHOWING FEATURES CUT INTO THE NATURAL AND HEAT AFFECTED AREAS; VIEWED FROM THE SOUTH-WEST (2M SCALES).

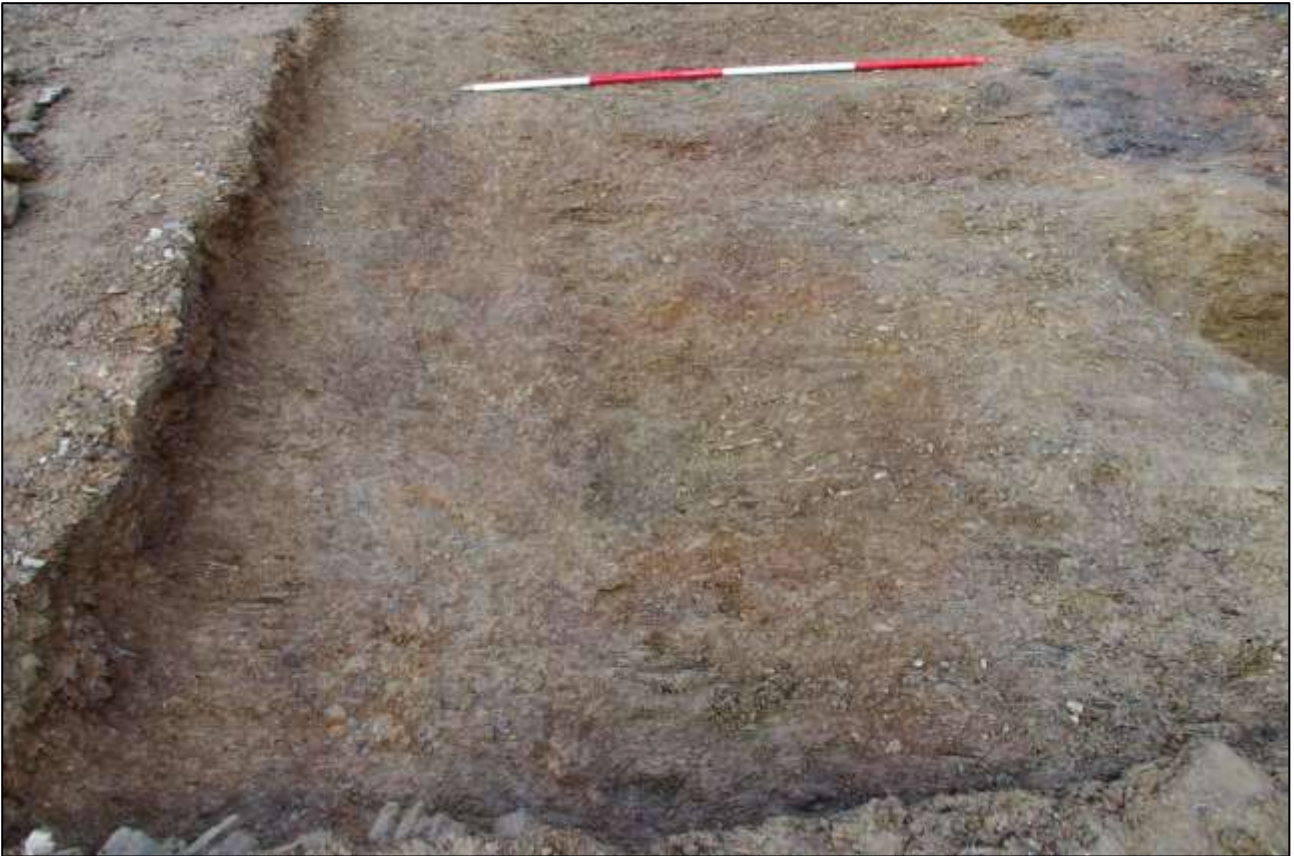
20. FEATURE [110], POST-EXCAVATION SHOWING DETAIL OF THE HEAT AFFECTED SOUTH-WEST CORNER; VIEWED FROM THE SOUTH-EAST (2M SCALE).

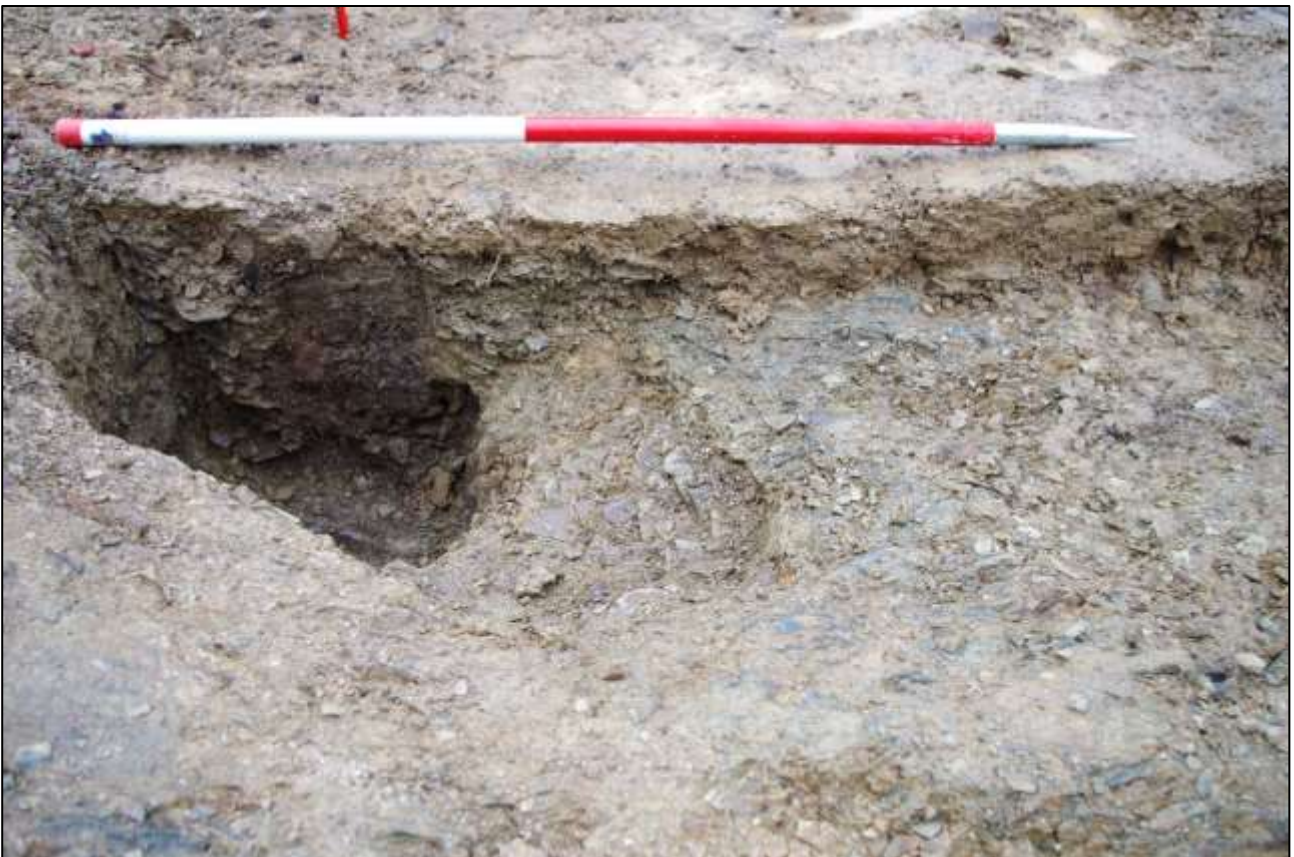
21. POST-HOLE [117], NORTH-WEST FACING SECTION; VIEWED FROM THE NORTH-WEST (1M SCALE).

Posthole [117] was located to the eastern side of hollow [110]. It was sub-square in plan, 0.54×0.44m across and 0.37m deep with near vertical sides and a flat base. It contained two fills: packing material (118), a loose grey shillet with packing stones; and post-pipe (119), dark grey soft slightly clayey silt which contains fragments of decaying wood. Fill (119) was overlain by layer (108); normally this would indicate the posthole predated layer (108), but the survival of decayed wood in the post-pipe would suggest it is a later feature and that (108) was redeposited or spread when its posited cobbling was taken up.

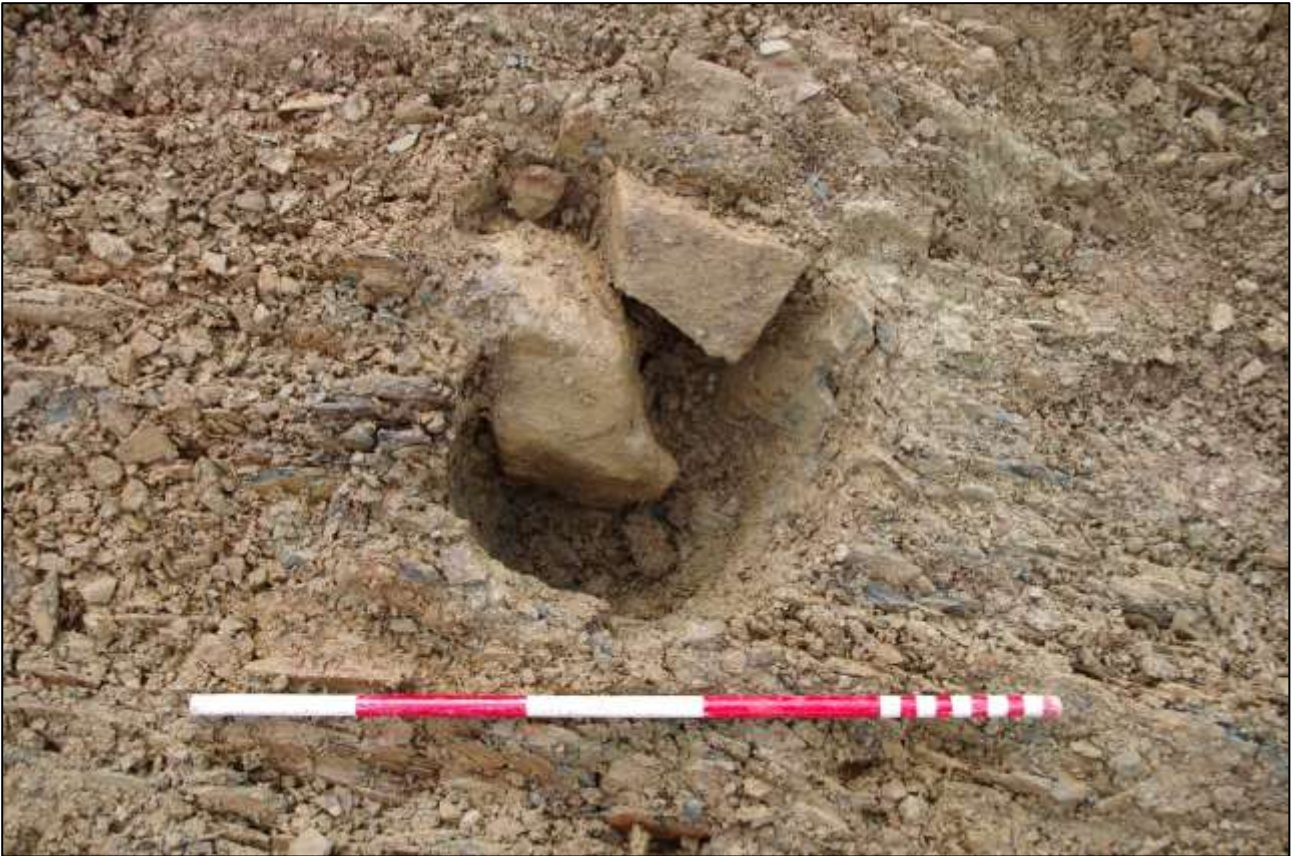
24. POST-HOLE [120], SHOWING POST PACKING; VIEWED FROM THE NORTH-WEST (0.50M SCALE).

A small posthole [120] was identified at the eastern end of slot [122]. It was circular in plan, measuring 0.30m in diameter and 0.32m deep with near vertical to vertical sides and irregular base. It contained a single fill (121), a firm mid red-brown clay-silt with a number of packing stones, including a fragment of perforated slate. There may have been a matching posthole at the western end of the slot, but it was shallow and poorly defined.

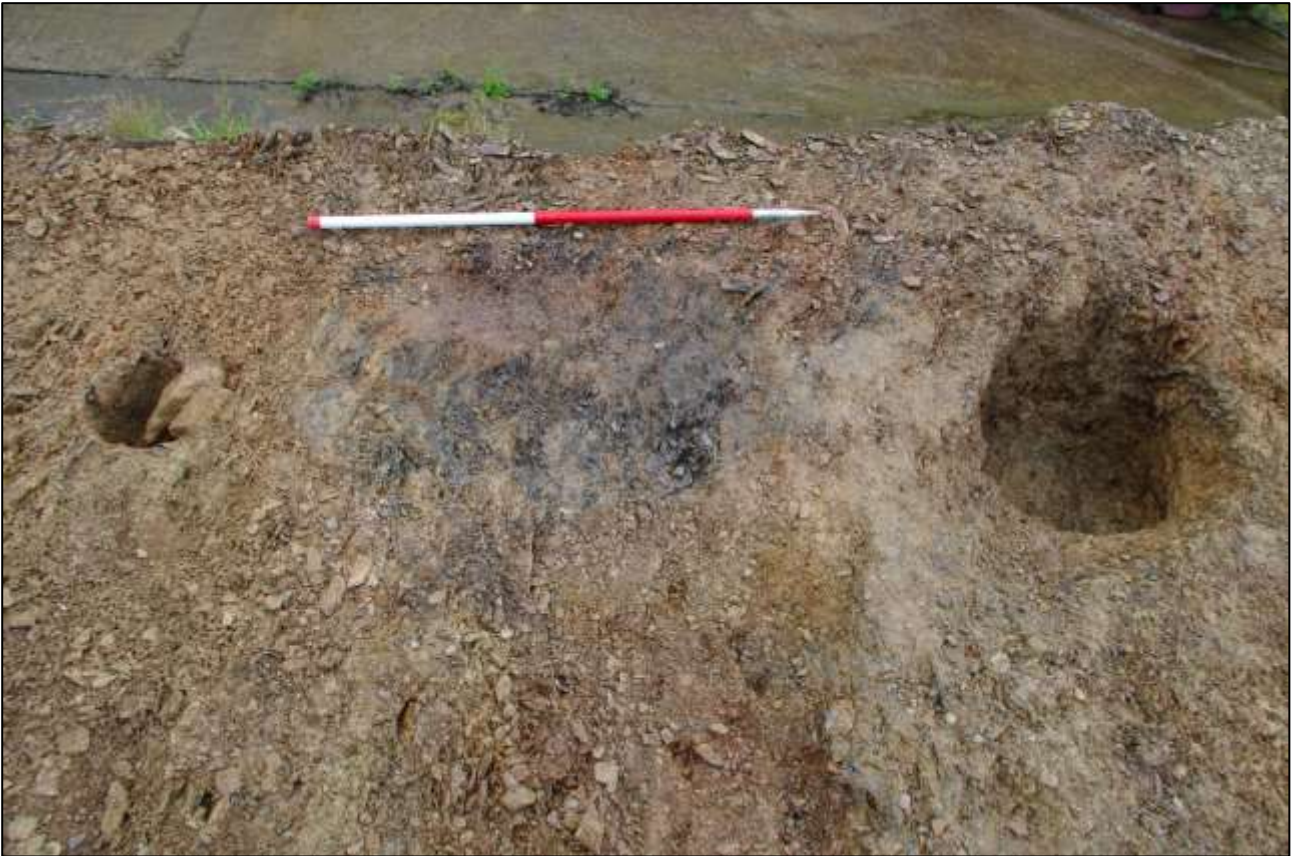
26. FIRE PIT [128] WITH POST-HOLES [117] AND [120], POST-EXCAVATION; VIEWED FROM THE SOUTH-WEST (1M SCALE).

The last feature, hollow [128], was located just to the north of [117]. It was sub-oval in plan on an approximate north-west to south-east alignment and measured 1.38×0.72m across and up to 0.10m deep. It survived as a shallow feature with a gently concave profile, and whilst it did not have a fill *per se* it formed of an area (109) of blackened and pinkish shillet, suggestive of having been under a hot/consistent heat source, and that the feature represents the seat of a fire.

Locating hollow [128] within the former farmhouse indicates it is positioned directly beneath the fireplace with the late 17th century ovolo moulded timber lintel with incised X, bar and scroll stops; postholes [120] and [117] would be located to either side. The evidence for heating clearly relates to this historic fireplace, and the two postholes *could* relate to posts positioned either side of the hearth (for supporting the lintel, during construction, or perhaps supporting a spit etc.).

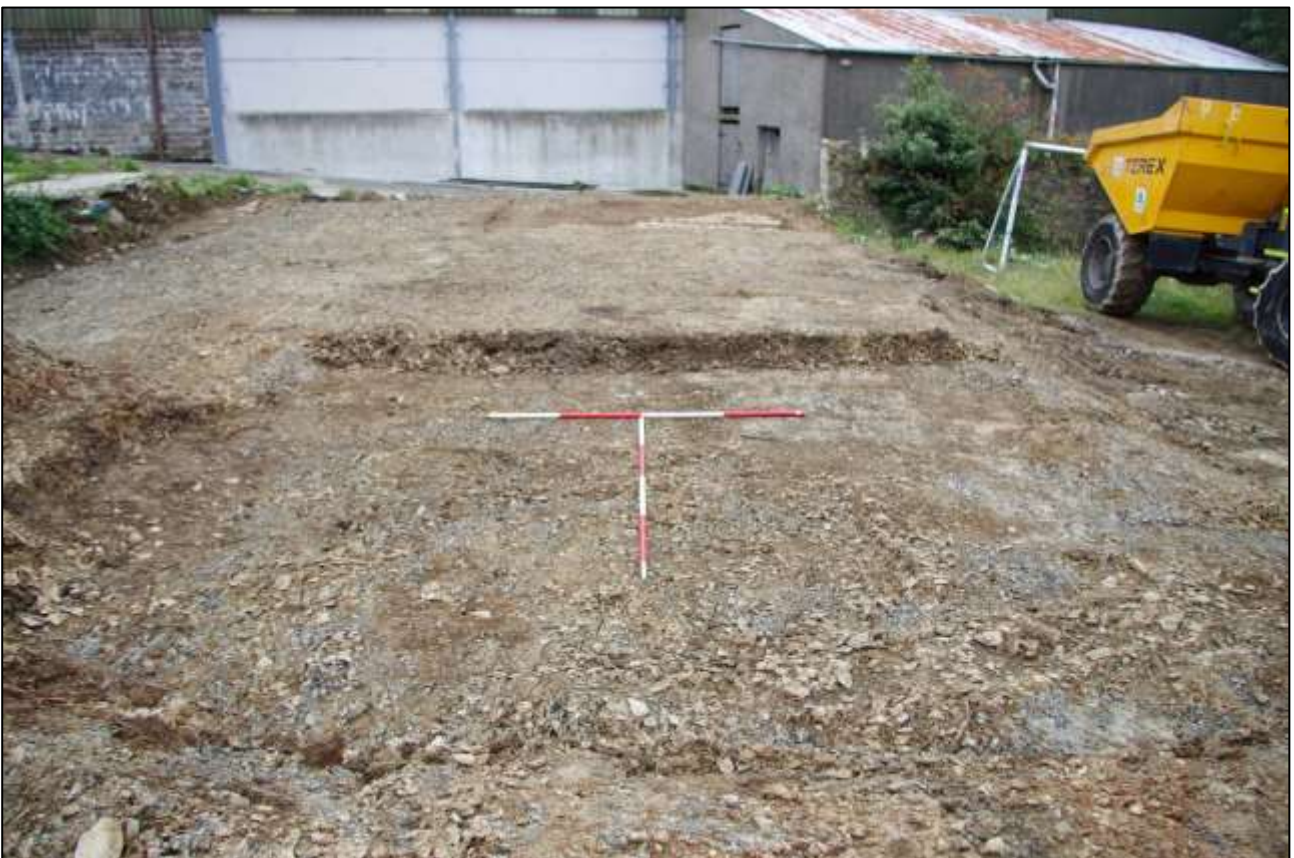
27. SUNKEN FEATURE BUILDING/ROOM [139] POST-EXCAVATION; VIEWED FROM THE SOUTH-WEST (2M SCALES).

At the western end of the farmhouse was feature [139], a large sub-rectangular cut measuring up to 5.65m x 5.20m across and 0.32m deep with near vertical sides and flat base (see Figure 5). In the centre of its north-western side a recess measuring 1.90m wide and extending out 0.40m was present; this was set with concrete slabs and may have formed the base of a fireplace or perhaps a threshold. However, the post-fire architect's drawings and aerial photographs show neither a stack nor a doorway at this location. Cut [139] was filled with demolition material from the levelling of the farmhouse; some wooden joists survived indicating there had been a 19th century suspended timber floor here.

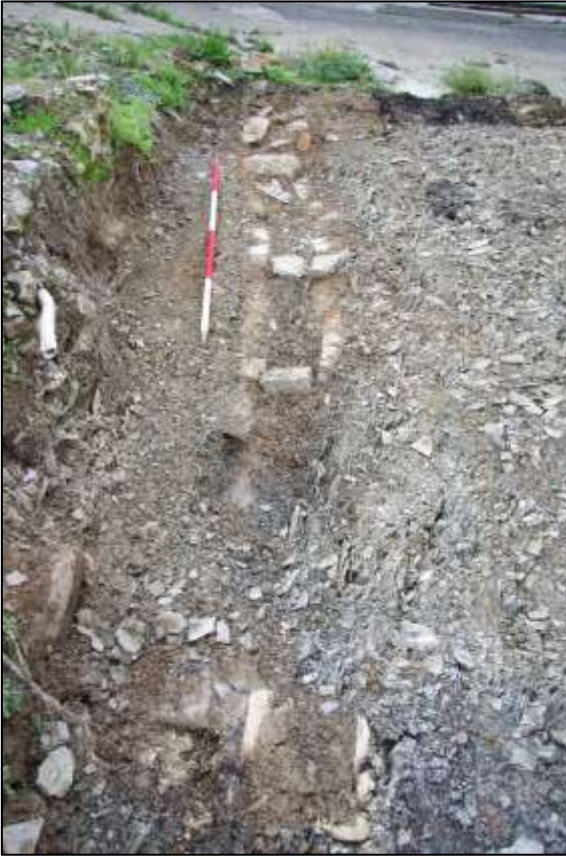
28. DRAIN [111] POST-EXCAVATION; VIEWED FROM THE SOUTH-WEST (2M SCALE).

At the north-eastern corner of the farmhouse was a linear drain [111] (see Figure 5). It ran parallel to the back of the house and was 5m long and 0.50m wide with a surviving depth of 0.15m, with near vertical sides and flat base. It was formed of a stone-built structure {113} of angular and sub-angular stones up to 0.25x0.10x0.10m in size with a central channel 0.10m wide filled with (112), a soft mid grey-brown silt. At the western end was a 20th century ceramic drain/sump, and the feature terminated at a modern manhole to the east within the concrete yard. This drain passed beneath what is *assumed* to have been early outshut/possible stair turret but runs between clearly later features and the fill contained blue transfer-printed pottery (i.e. post 1770 and probably post 1850). Thus, it is interpreted as a 19th century drain, despite its archaic build.

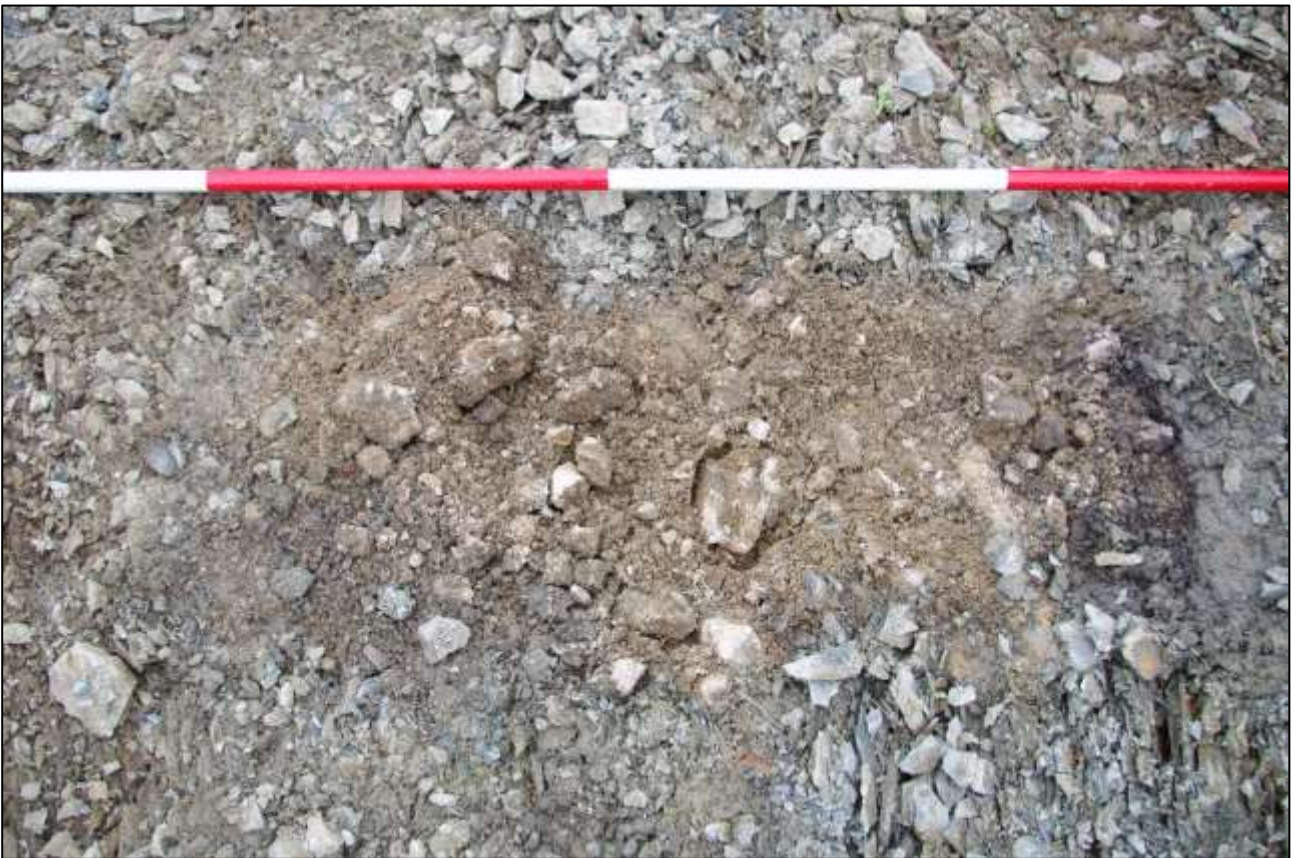
29. PIT [114] PRE-EXCAVATION; VIEWED FROM THE NORTH-EAST (PART 2M SCALE).

Adjacent to this drain was pit [114] (see Figure 5). This was sub-rectangular in plan, measuring 1m x 0.42m across on a north-west to south-east orientation. It contained an upper fill: (115), loose mortar-rich shillet with large angular stone inclusions; this feature appeared clearly recent (i.e. 20th century) in date and was not excavated.
