THE CIDER BARN RUGGADON FARM CHUDLEIGH DEVON

Historic Building Recording

South West Archaeology Ltd. report no. 200323

SITE NAME:	THE CIDER BARN, RUGGADON FARM
PARISH:	CHUDLEIGH
COUNTY:	DEVON
NGR:	SX 85903 81612
PLANNING APPLICATION No:	18/00563/FUL
OASIS NUMBER:	SOUTHWES1-348889
SWARCH REF:	CRB19

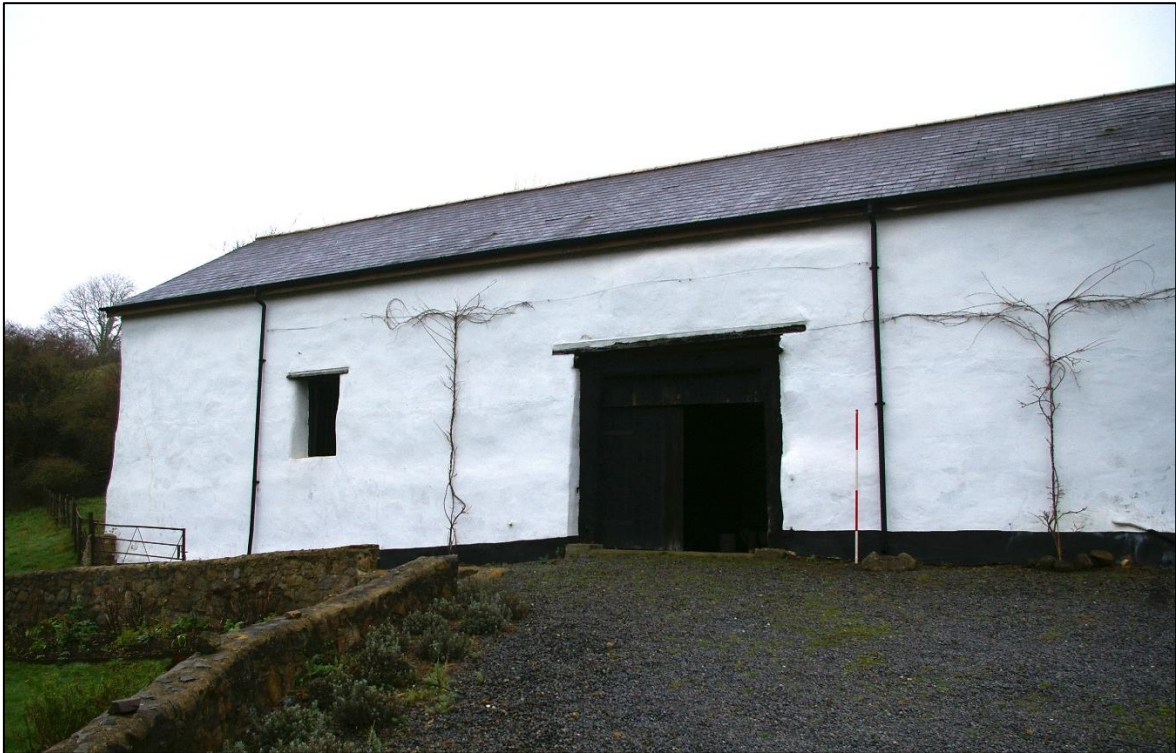
FIGURE 7: THE FRONT ELEVATION OF THE CIDER BARN WITH YARD WALL AND FIELD GATE TO LEFT; FROM THE SOUTH-EAST (2M SCALE).

The south elevation appears continuous, with no obvious joint where the eastern Pound House adjoins it. Both are rendered and painted, the barn having a large threshing door to right of centre, its lintel set at about two-thirds of the eaves height: this contains a heavy chamfered oak frame with pegged mortice and tenon joints, incorporating narrow chamfered shoulders at the tops of each post. The decayed stumps of two joists, presumably once supporting a pentice roof of a projecting porch were noted just above the door-frame. There is a modern pair of plank doors with strap hinges and concrete threshold. A barred unglazed window with a plain wooden frame is set half-way up the wall about half-way between this door and the west end of the elevation.

A change in the wall's profile can be seen where the stone rubble plinth gives way to cob walling above, showing that the building was not rendered in the past and that some surface erosion occurred. Faint vertical cracks and other slight variations in the wall surfaces may indicate where integral cob buttresses have subsequently been cut back and rendered over. Their positions are suggested below (see Figure 12).

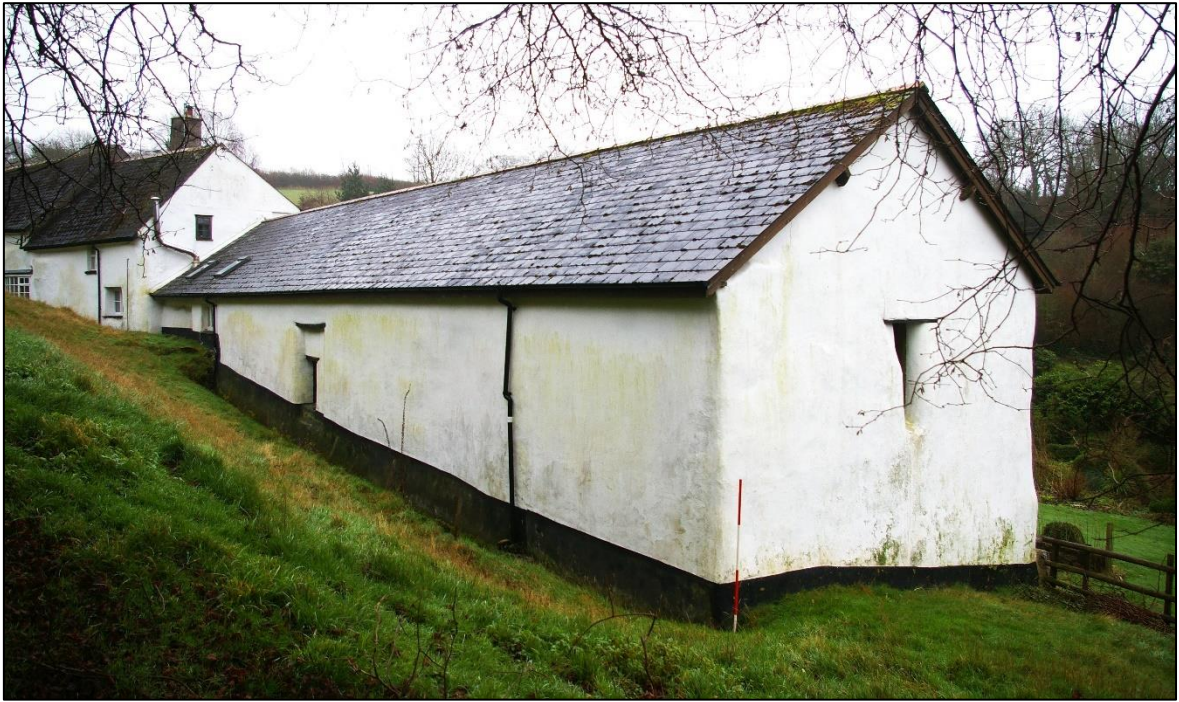
FIGURE 8: THE REAR ELEVATION OF THE BARN SCARPED INTO THE VALLEY SIDE; FROM THE NORTH-WEST (2M SCALE).

To the right of the retaining wall, the Cider Barn's rear elevation is blank except for the partly blocked draught door for the threshing floor to left of centre. This has an old, slightly bowed oak lintel and sill raised about 70cm above current ground level; its blocking is inset slightly with a small unglazed window to its lower left. A two-light oak framed 18th century window frame with one surviving vertical iron bar and rebates for leaded glazing is reset here. The black band at the wall foot is carried up as far as the windowsill. This wall face also has vertical cracks and undulations suggesting the locations of former buttresses; their positions are again shown on Figure 12.

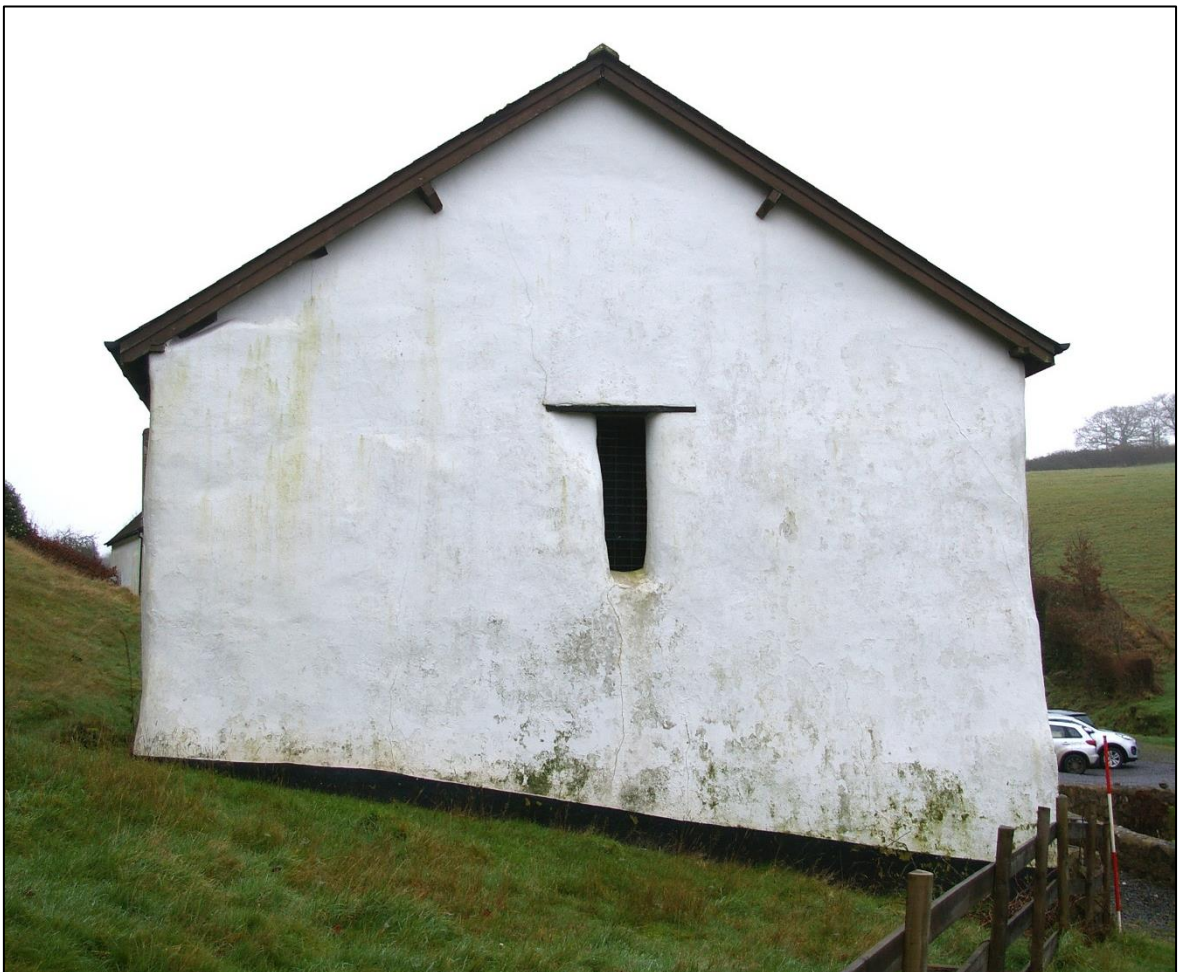
FIGURE 9: WEST END ELEVATION OF THE CIDER BARN SHOWING GROUND SLOPE; VIEW FROM WEST (2M SCALE).

The west gable of the Cider Barn is treated in the same manner as the front elevation: the ground sloping steeply up to the left (north), rising about 1.80m over its width. The rubble plinth course appears to remain horizontal, from a height of 2m at the south-west corner to just above ground level on the north-west corner. Both corners are roughly radiused where they are within the cob, the south-west corner tapering in rapidly before becoming vertical up to the eaves. A central slit window has a replacement lintel: its apex is wider than its sill and again it has radiused jambs and sill, suggestive of significant weathering before render was applied. Disturbances and cracks just below the roof verges show where the cob, once higher, was cut down and dressed back when the current shallow-pitched roof was formed in the later 19th century. All the woodwork here is modern, lightweight wallplates and narrow but deep purlins projecting from the wall face and supporting stepped but plain painted barge-boards. Several cracks can be seen in the render, but it is not known to what extent these are structural or relate to surface tensions between the render and the underlying cob.

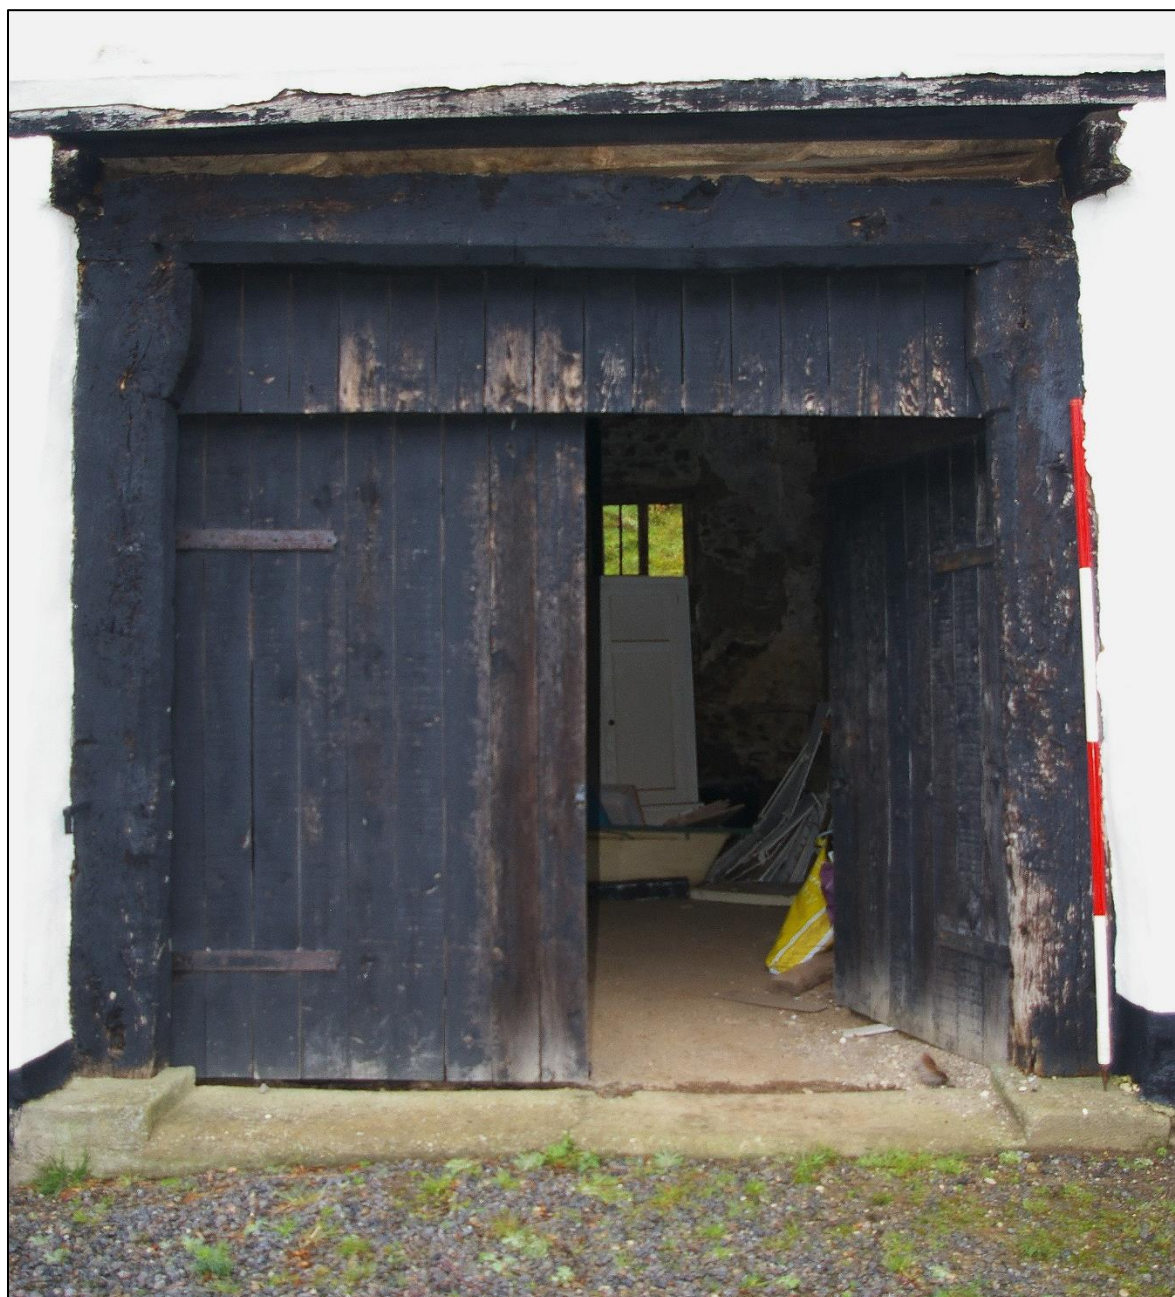
FIGURE 10: LATE MEDIEVAL FRAME OF SOUTHERN THRESHING DOOR WITH SHOULDERED POSTS; VIEW FROM SOUTH (2M SCALE).

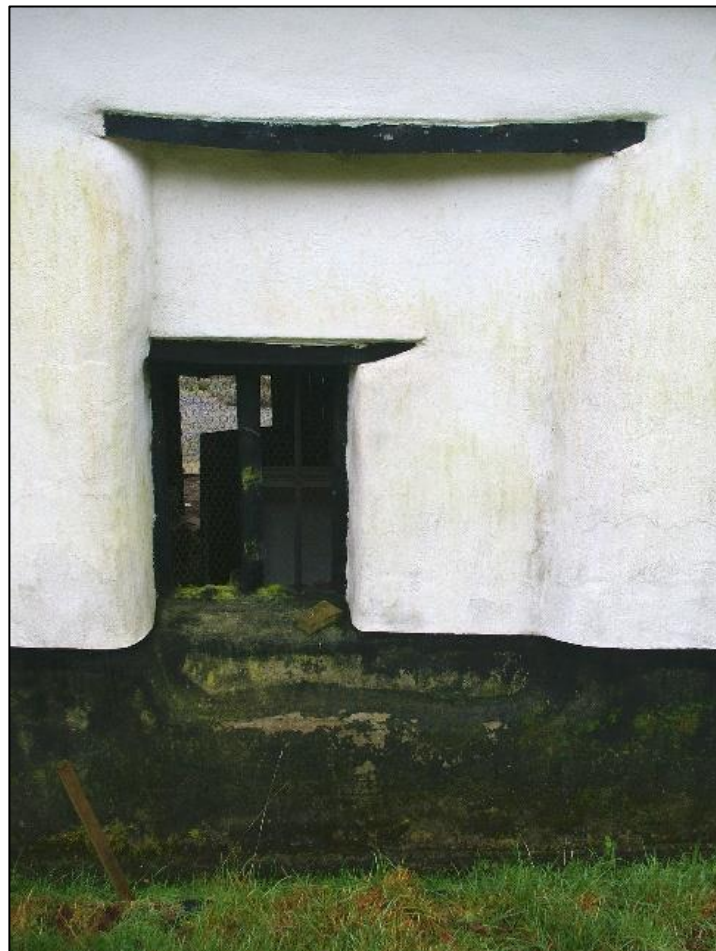
6. DRAUGHT DOOR AT REAR OF CIDER BARN, BLOCKED IN C19. VIEW FROM NORTH.

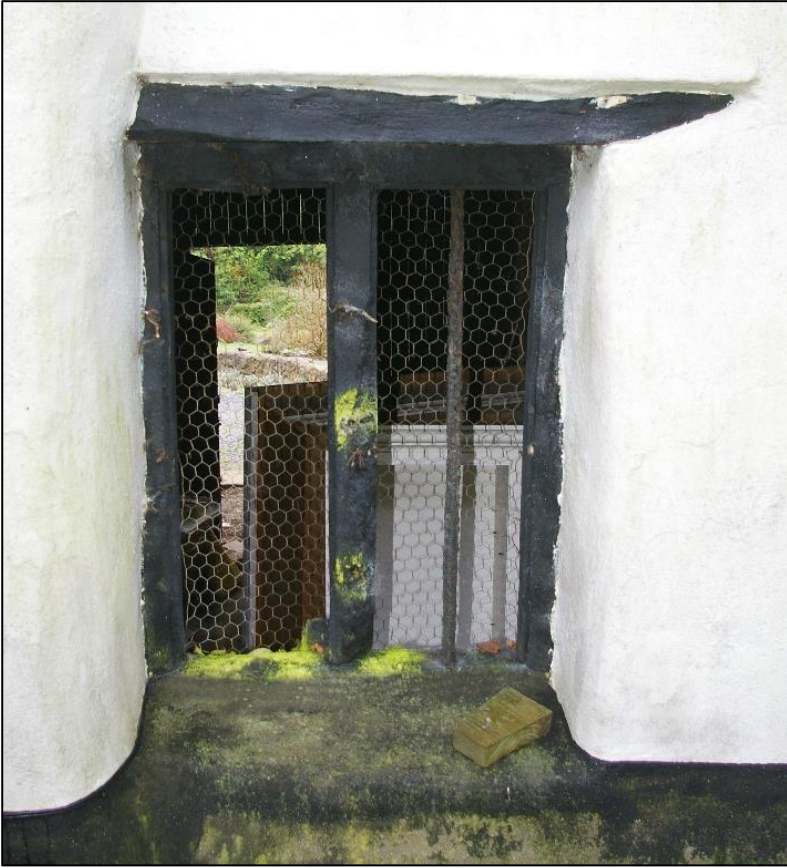
7. C18 WINDOW RE-USED IN C19 IN REAR WALL OF BARN, VIEW FROM NORTH.

Rear (north) Elevation		Barn part of this has small window in blocked threshing door, two-light re-used C18 domestic window, formerly glazed with vertical iron bar on right-hand light, rebates for leaded glazing around edges of each light. Modern chickenwire on inside. Wall undulates in three places and with vertical cracks in some of these, suggests former locations of vertical buttress positions.
Left end (west) Elevation		Gabled, with central slit window, wider at top, tapers down to narrower base. Now with mesh, no frame. Some vertical cracks in render seem to be caused by settlement of footings, not outward movement. Rubble plinth (rendered) visible at c.1-1.8m above sloping hillside, render slopes in very slightly above its top, suggesting cob was once unrendered and had weathered.
Right end (east) Elevation		Obscured within Pound House, cob on stone rubble plinth. Small part visible internally in lobby at rear left (Room 1a), where it is clearly abutted by mortared rubble north wall of Pound House. Part of right-hand gable of Pound House projects forward of house, which it appears to abut. Wall is rendered and painted, possibly cob. Flight of modern stone rubble steps up to first floor doorway.

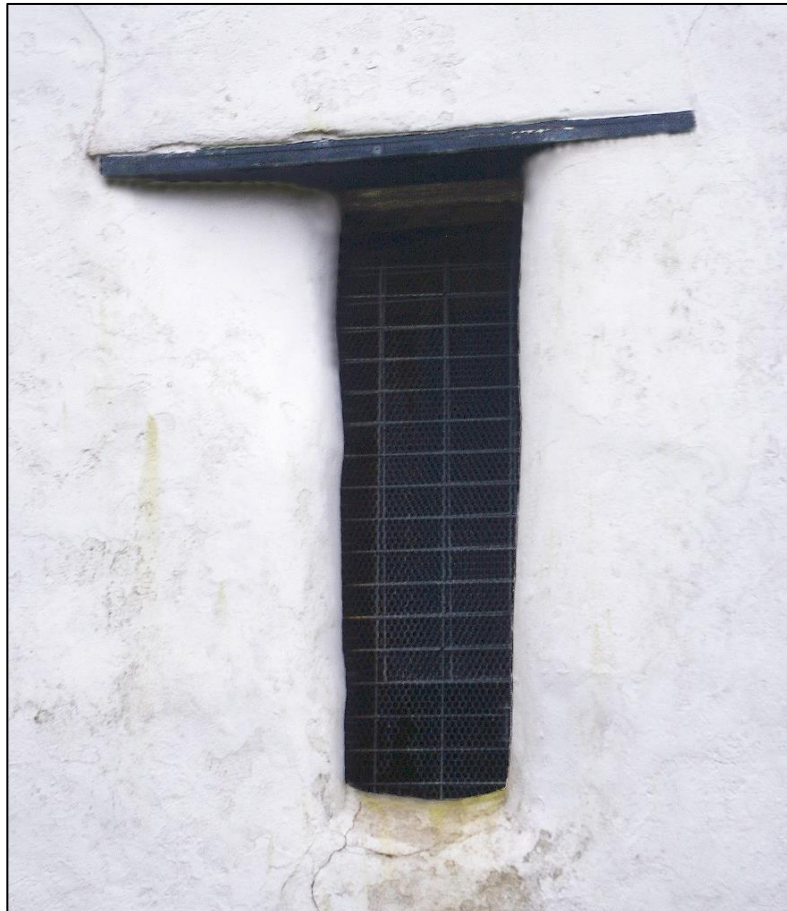
8. C15-C16 VENTILATION SLIT IN WEST GABLE OF BARN. VIEW FROM WEST.

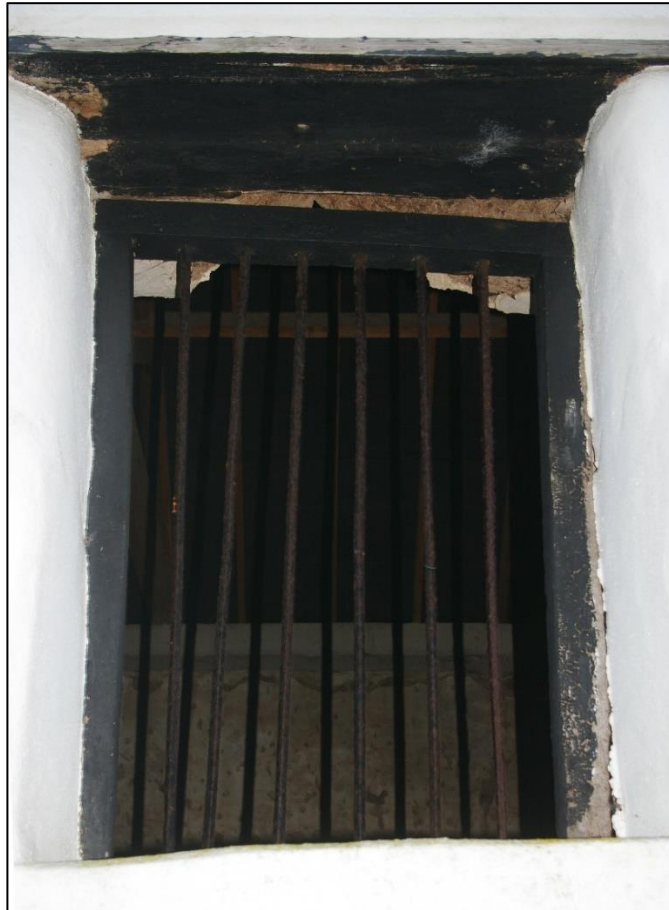
9. INSERTED C18 WINDOW IN SOUTH WALL OF CIDER BARN. VIEW FROM SOUTH.

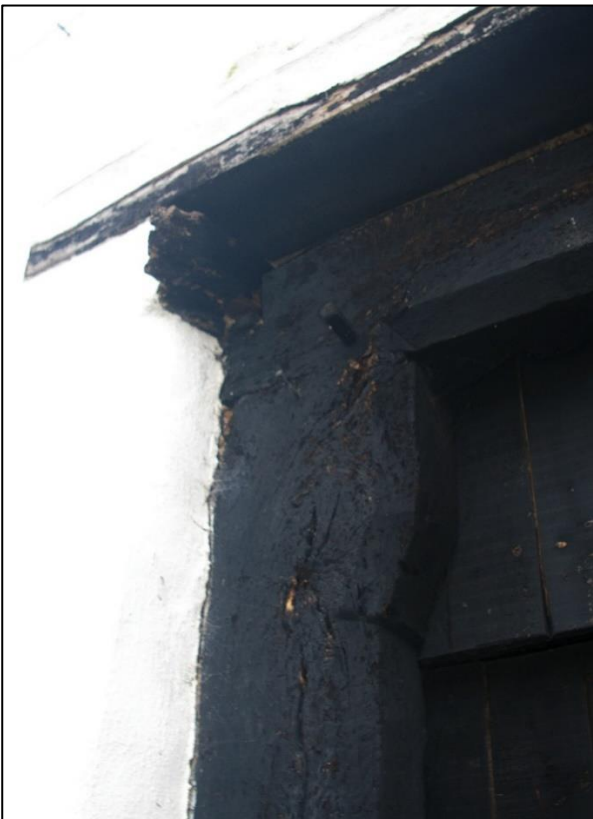
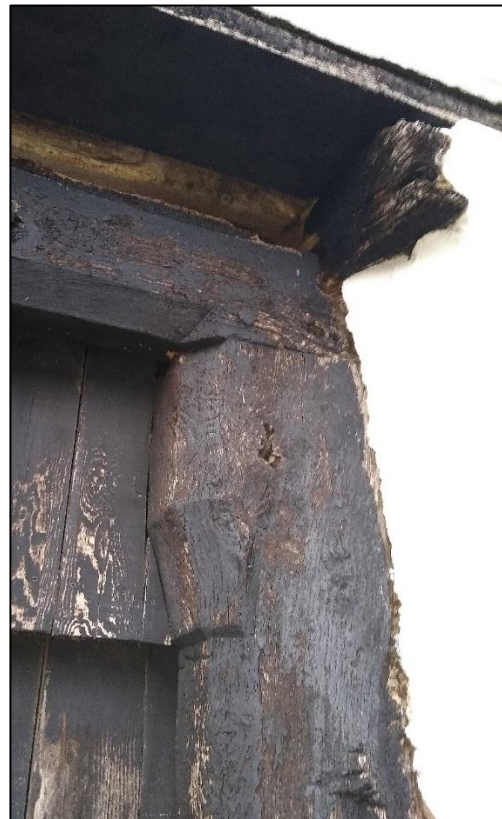
10 & 11. CHAMFERED SHOULDERS OF LEFT AND RIGHT JAMBS OF THRESHING DOOR D1 IN SOUTH WALL. VIEWS FROM SOUTH-EAST AND SOUTH-WEST RESPECTIVELY.

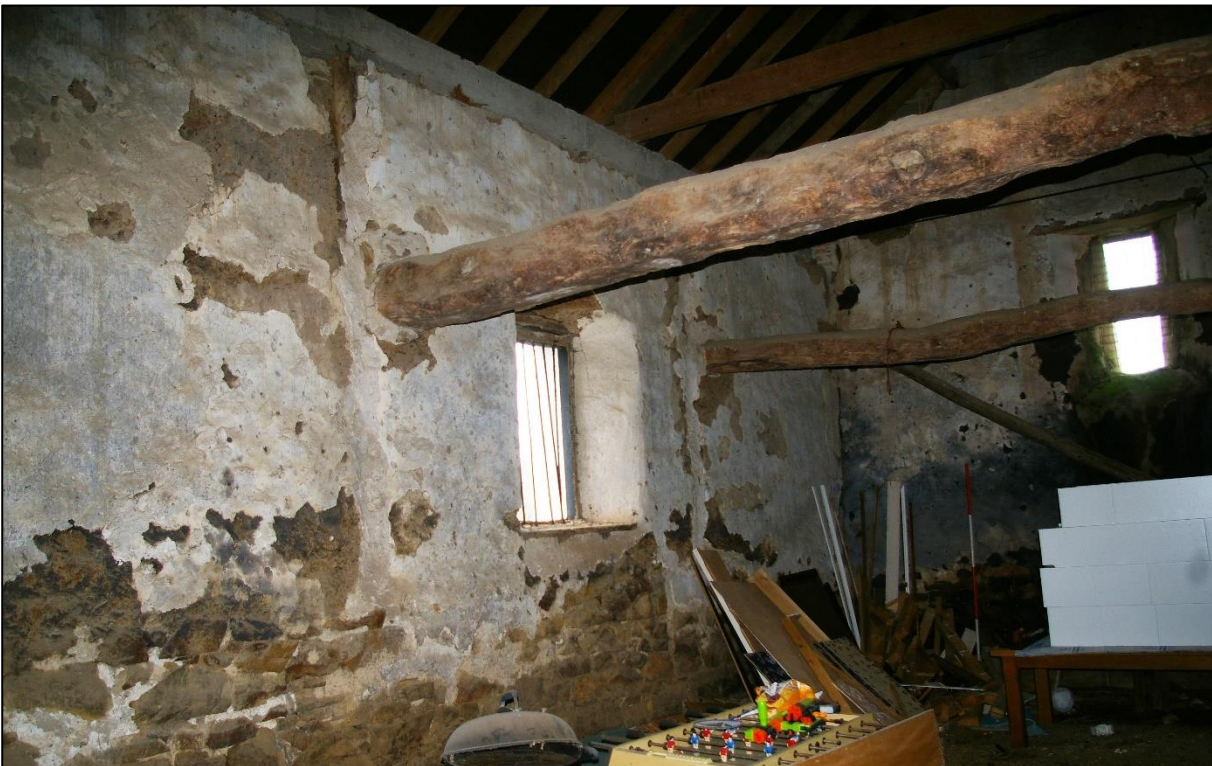
13. SOUTH WALL OF CIDER BARN TO WEST OF THRESHING DOOR, VIEWED FROM NORTH-EAST. VERTICAL INDENTATIONS SHOW POSITIONS OF CRUCK FEET, WITH C18 LOFT FLOOR BEAMS CUT INTO OLDER PLASTER.

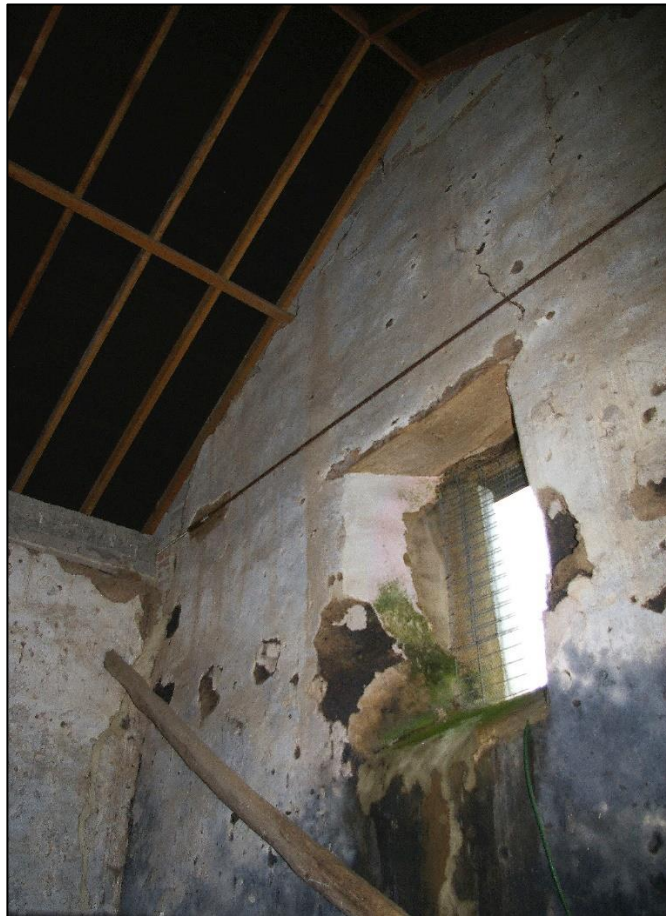
15. WEST GABLE OF CIDER BARN, LOOKING UP FROM NORTH-EAST WITH C15-C16 PRIMARY VENTILATION SLIT. NOTE URINE-BLACKENED COB IN POST-MEDIEVAL JOIST-HOLES UNDER C18 PLASTER.

West End Elevation:		<p>Cob gable above exposed rubble plinth. Joist holes for inserted first floor at c.3.5m above ground floor level cut into face at an early date, urine-blackened along with lower half of wall, then smooth-plastered. Plaster covered plank lintel to central slit window, respects position of lost window frame towards front of splays. Black urine-staining up to 2.5m high on plaster, covers an apotropaic mark (No. 8, see above) at bottom right. Grey bloom goes higher, up to first floor level, but not above. Pitchfork scars in places, a few visible up to 6m above ground floor level.</p> <p>Cob gable cut down in mid-late C19 when roof lowered, but vertical marks visible in plaster to either side, showing that eaves were at least 70cm higher than at present and ridge of steeper roof was at least 1.5m higher. Cemented brick and concrete block patching at bases and apex and modern steel tie-bar just inside.</p>

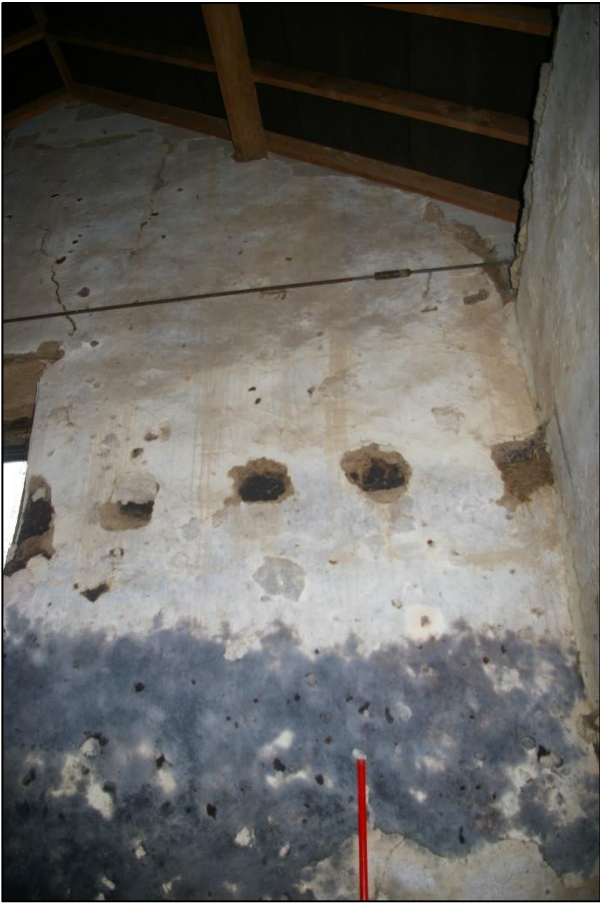
16. NORTH HALF OF WEST GABLE, LOOKING UP FROM EAST. NOTE OLD JOIST HOLES AND BLACK URINE-STAINING.

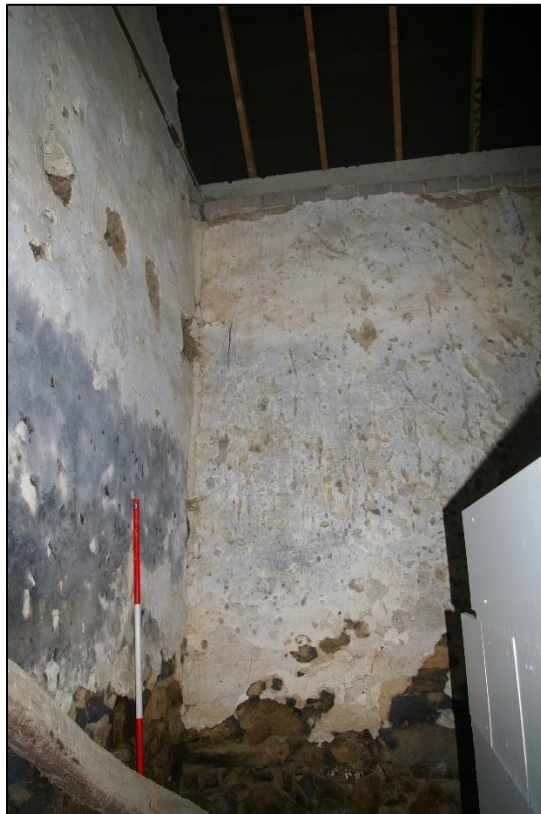
17. WESTERN BAY OF NORTH WALL, FROM SOUTH. NOTE EXTENSIVE PITCHFORK SCARS AND DAISY-WHEEL AT BOTTOM CENTRE.

<p>Multiple stab-marks in other walls were probably also caused by forks during stacking or retrieval of sheaves or hay. There are also many small holes cut into the walls, especially several forced in north wall behind cider press and so presumably associated with it, perhaps for a stair? 2x possible sockets for a stair leant against north wall just west of eastern beam. Beams in west end are all part-squared roundwood, eastern has forked north end. Possibly all elm, inserted in C18? No blocked-in sockets.</p> <p>Vertical plaster-lines in east and west end walls show that eaves and gables have been cut down c.70cm, perhaps in later C19. Original profile was c.45-50 degrees for thatch. Primary roof structure cut down in C19 to current eaves – see wall descriptions.</p>
Floor:		<p>Earth, slopes slightly down to west. Low concrete blockwork plinths to north, south and west to west of threshing doors, have plastic gutters set into their tops to pick up groundwater seeping through the walls, especially on the north. A damp patch was visible on the floor here during the site visit.</p>

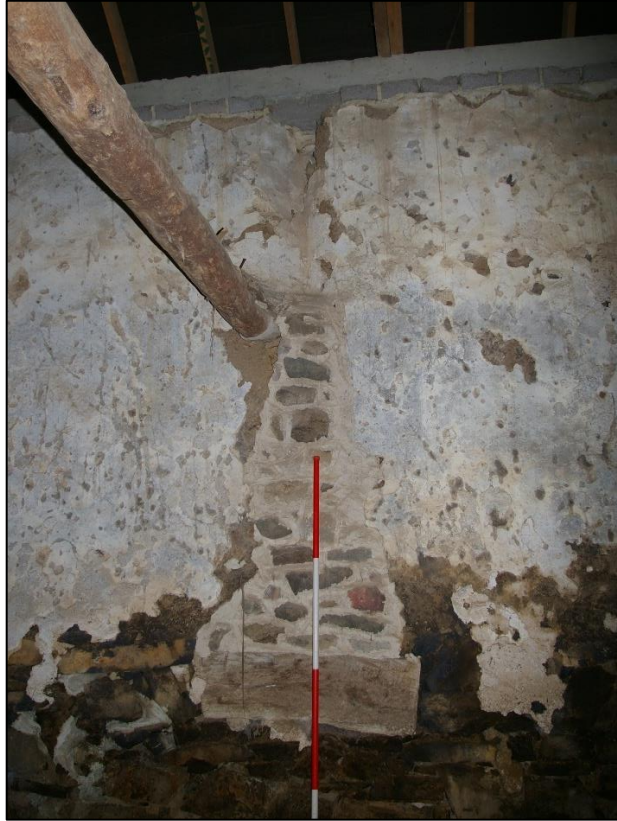
18. SITE OF WESTERN CRUCK FOOT IN NORTH WALL, WITH LARGE ELM PAD UNDER C19 RUBBLE PATCH. VIEW FROM SOUTH.

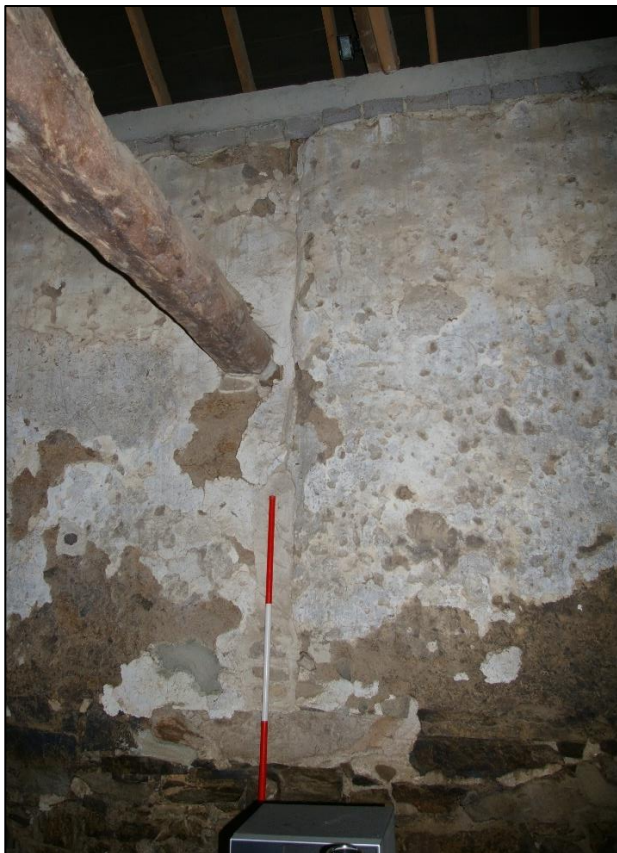
19. SITE OF SECOND CRUCK FROM WEST IN NORTH WALL, WITH LARGE ELM PAD UNDER VERTICAL PLASTERED GROOVE. VIEW FROM SOUTH.

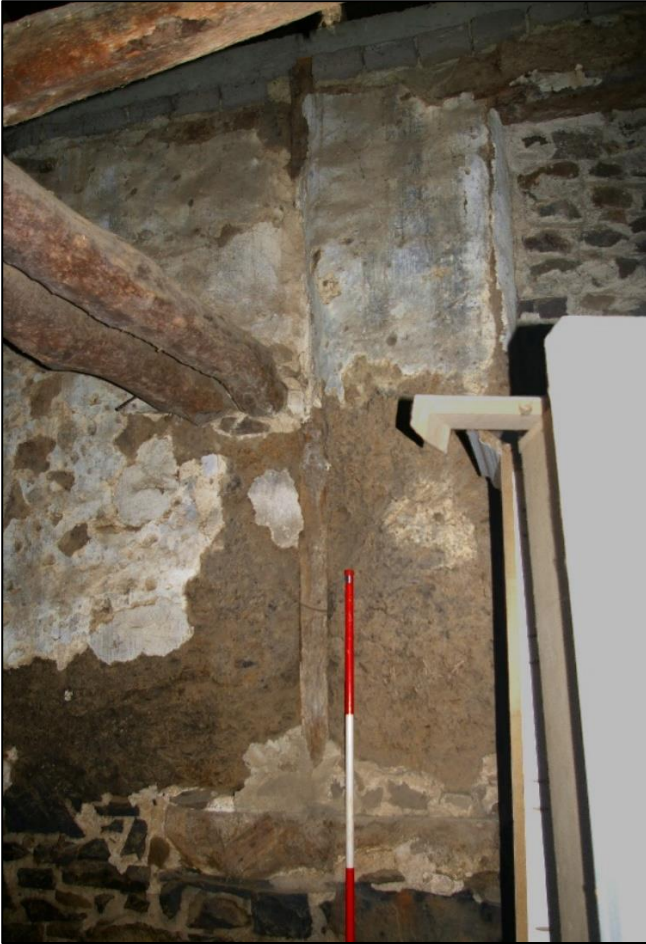
20. WEST JAMB OF NORTH THRESHING DOOR WITH CRUCK FOOT IN COB WALL. VIEW FROM SOUTH-EAST.

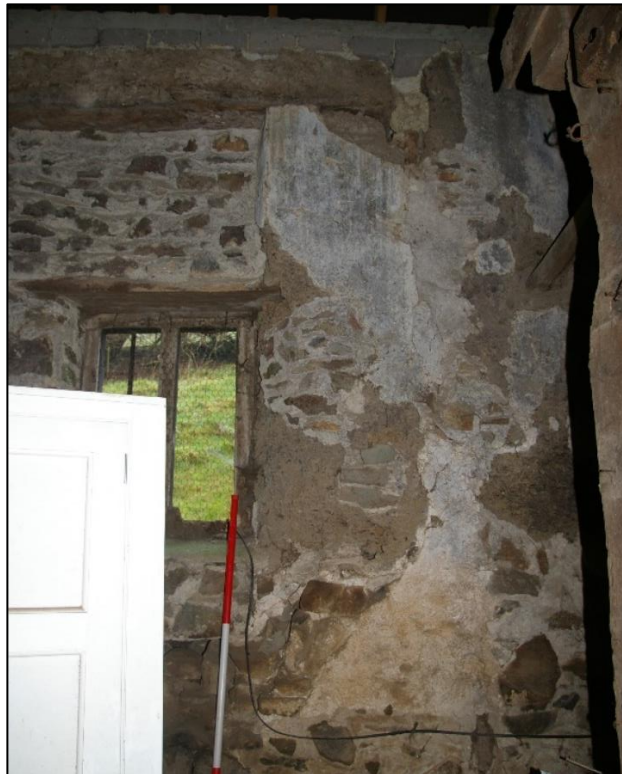
21. EAST JAMB OF NORTH THRESHING DOOR WITH EXTENSIVE C19 RUBBLE REPAIRS. VIEW FROM SOUTH.

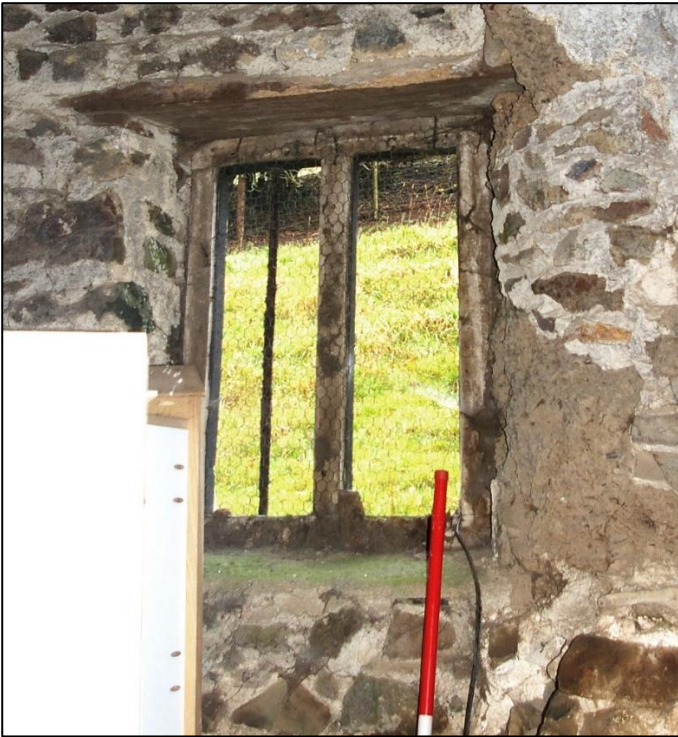
22. C18 WINDOW IN C19 RUBBLE FILL OF NORTH THRESHING DOOR. VIEW FROM SOUTH.

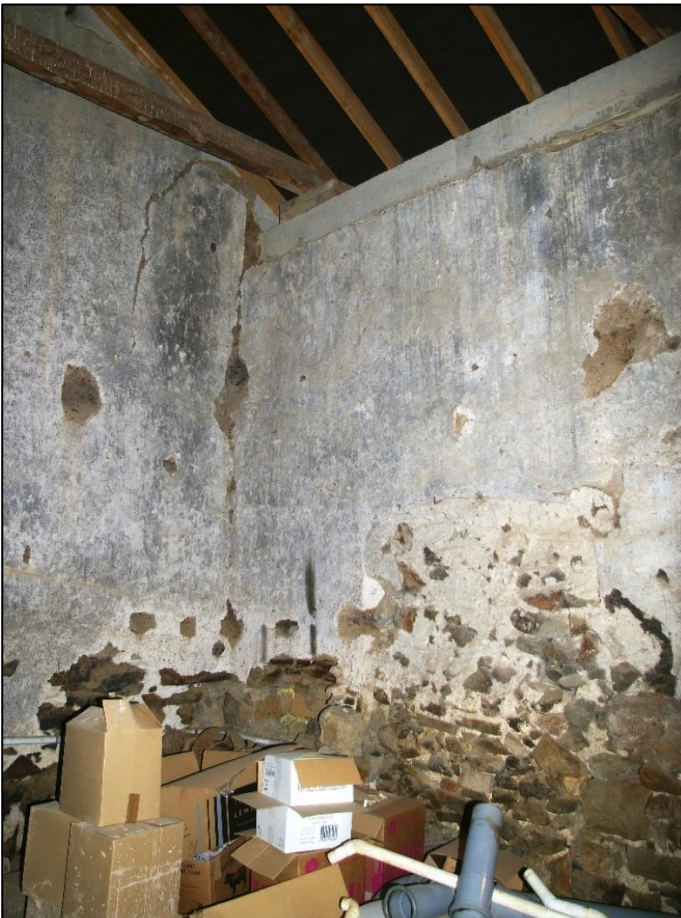
25. SOUTH-EAST CORNER OF BARN, FROM NORTH-WEST.
NOTE BLOCKED DOOR IN SOUTH WALL AT LOWER RIGHT.

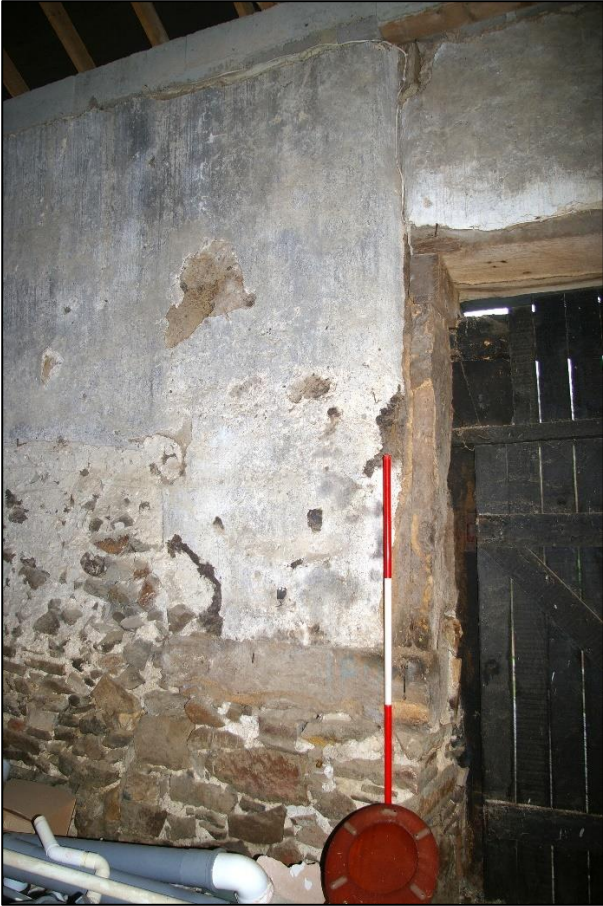
26. EAST JAMB OF THRESHING DOOR IN SOUTH WALL, FROM NORTH-WEST.
NOTE BLOCKED DOOR TO LEFT AND INSET WALL FACE OVER LINTEL.

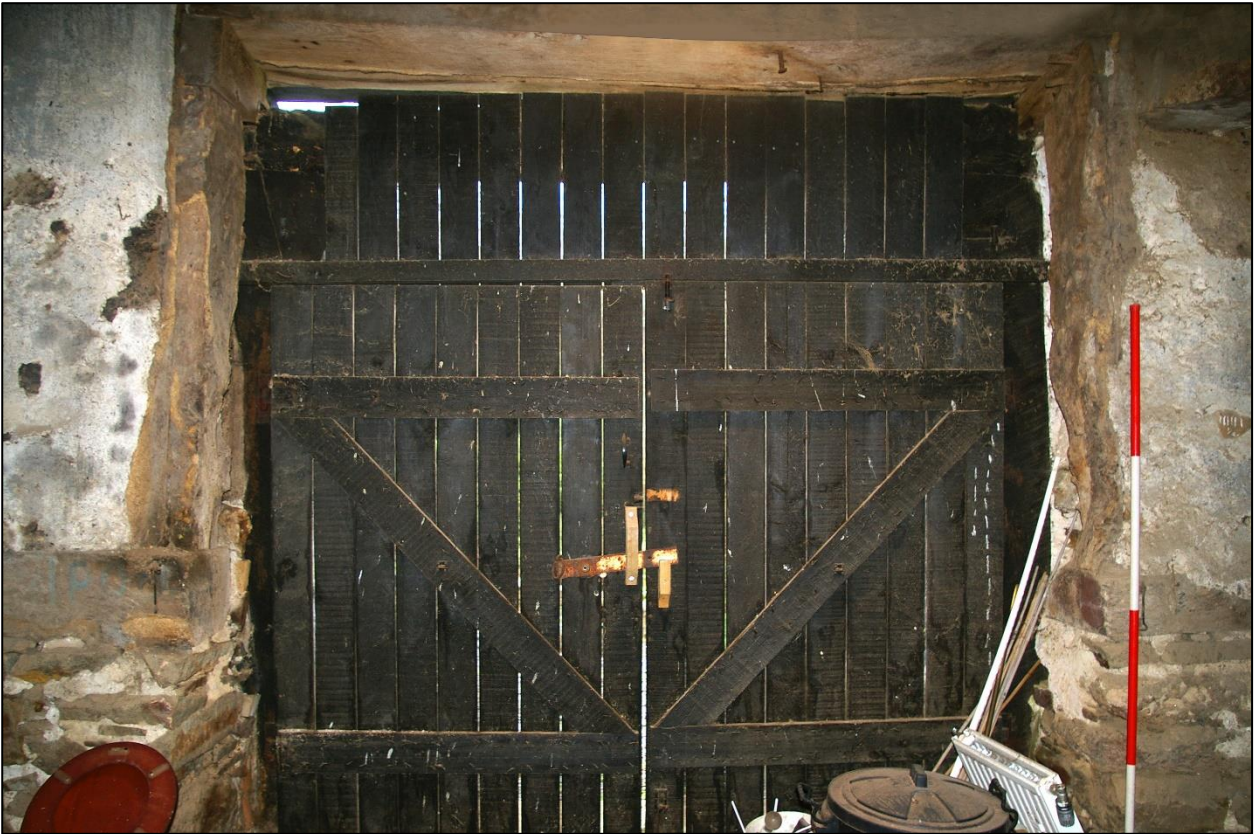
28. WIDE THRESHING DOOR IN SOUTH WALL, FROM NORTH. CHEEK-PIECES PEGGED TO INSIDE FACES OF CRUCK FEET ON EITHER SIDE.

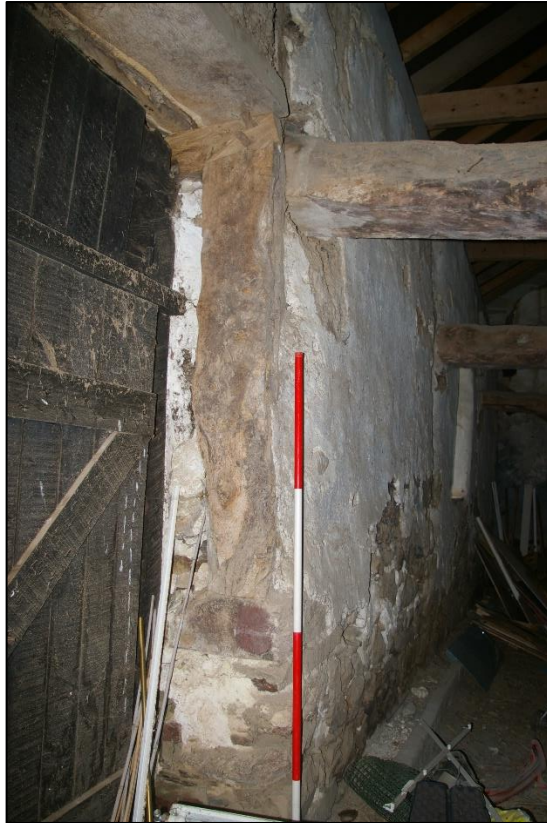
30. WEST JAMB OF THRESHING DOOR IN SOUTH WALL, WITH OAK CHEEK FORMERLY SUPPORTING DOOR LINTEL, FACE-PEGGED TO EAST FACE OF CRUCK FOOT. NOTE BARK AT BOTTOM RIGHT OF CHEEK.

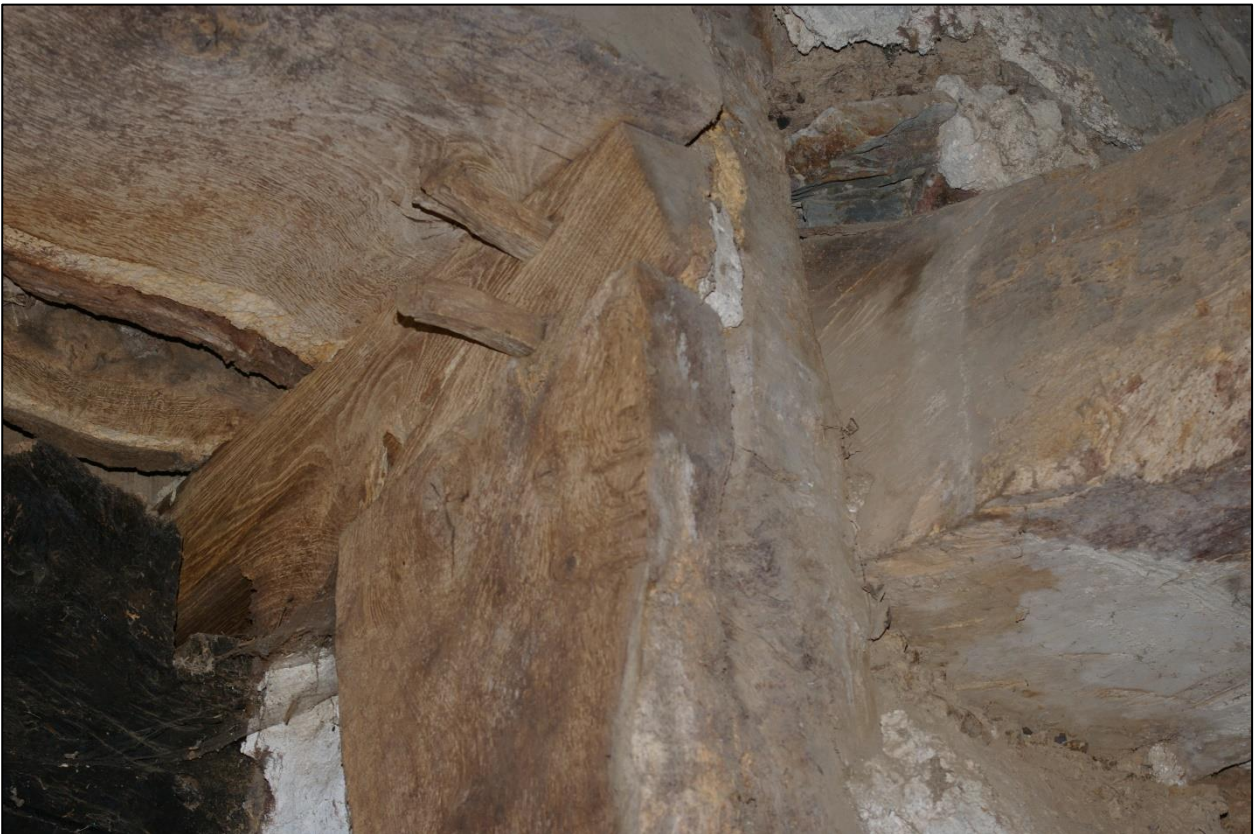
31. C18 RAISED LINTEL OVER WEST CHEEK OF THRESHING DOOR, ON CANTILEVERED SUPPORT FOR PENTICE ROOF, FACE-PEGGED TO CRUCK FOOT, SEEN VERTICALLY HERE AT MIDDLE RIGHT, WITH C18 INSERTED LOFT BEAM TO RIGHT. LOOKING UP FROM NORTH-EAST.

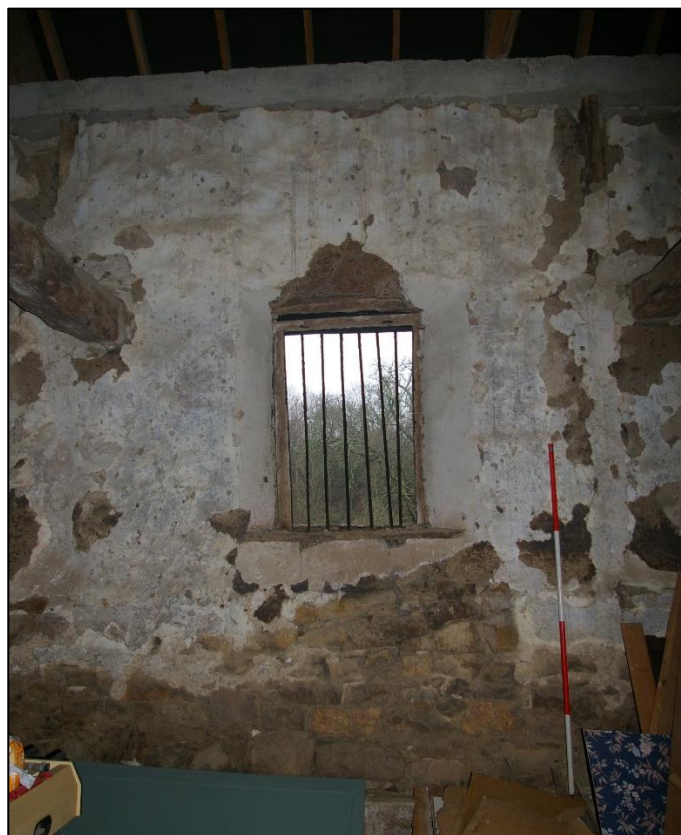
33. FORCED C18 WINDOW IN SOUTH WALL. VIEW FROM NORTH.

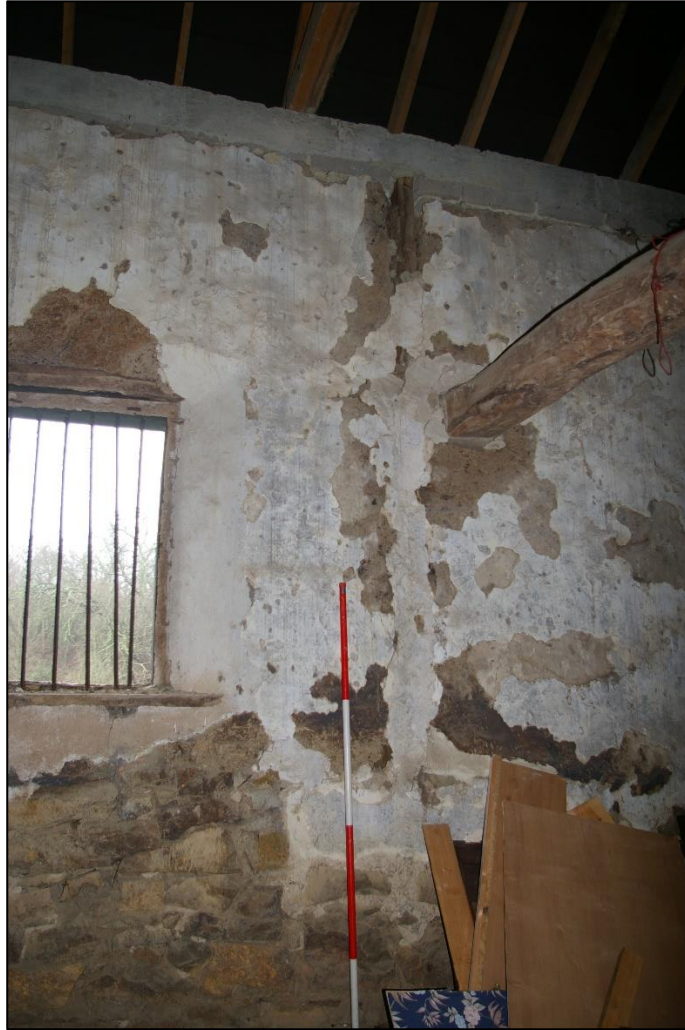
34. WESTERN CRUCK FOOT IN SOUTH WALL, VISIBLE AS VERTICAL MARK IN PLASTER. VIEW FROM NORTH.

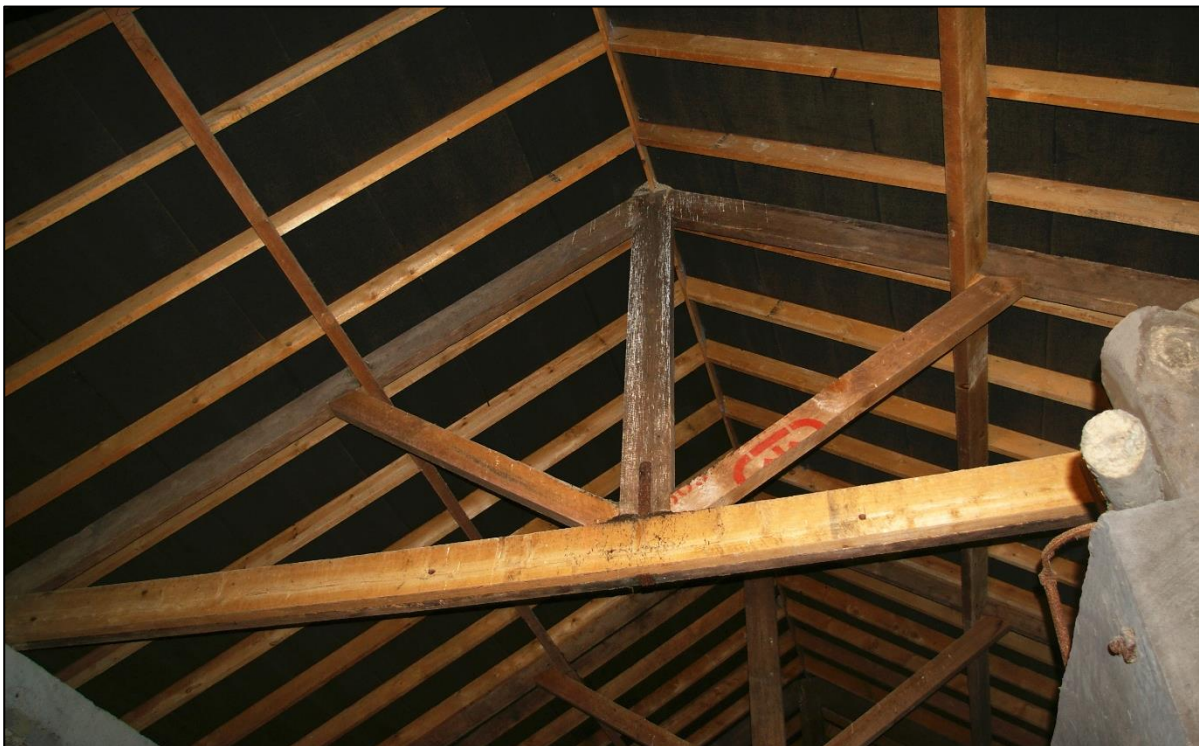
35. LATER C19 ROOF TRUSS WITH LATE C20 REPAIRS (IN PALER WOOD), LOOKING UP FROM EAST END OF BARN.

The present roof structure is largely modern, but retains the partial remains of four tie-beam and kingpost trusses with diagonal struts and bolted joints. These are of mid-late 19th century character and were presumably present before the modern reconstruction, which rests on cast concrete beams. Beneath these, the walls of the barn survive well, the cob being in general very solid and strong, although occasional cracks can be seen.

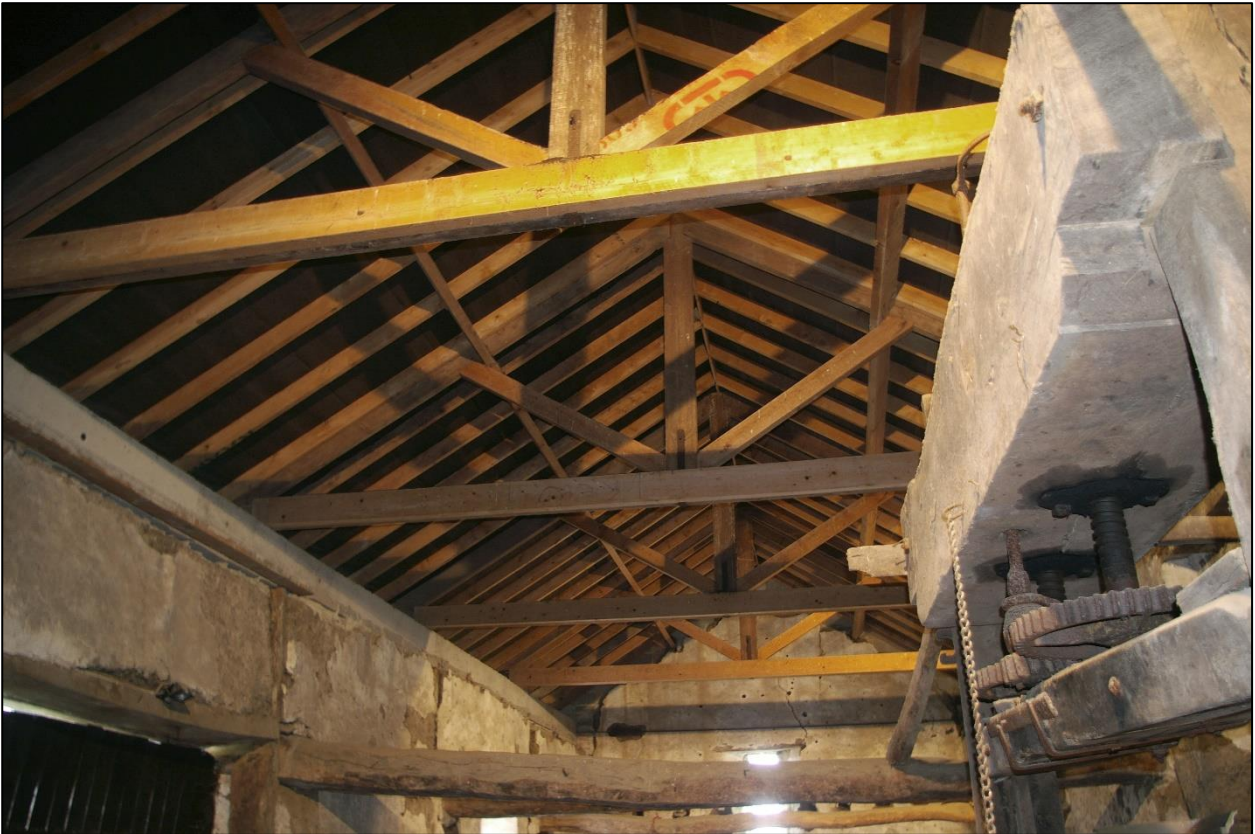
36. C19 ROOF STRUCTURE, REPAIRED AND REST ON CONCRETE EAVES COURSE IN LATE C20. LOOKING UP FROM EAST WITH C19 CIDER PRESS ON RIGHT.
