THE CIDER BARN RUGGADON FARM CHUDLEIGH DEVON

Historic Building Recording

South West Archaeology Ltd. report no. 200323

SITE NAME:	THE CIDER BARN, RUGGADON FARM
PARISH:	CHUDLEIGH
COUNTY:	DEVON
NGR:	SX 85903 81612
PLANNING APPLICATION No:	18/00563/FUL
OASIS NUMBER:	SOUTHWES1-348889
SWARCH REF:	CRB19

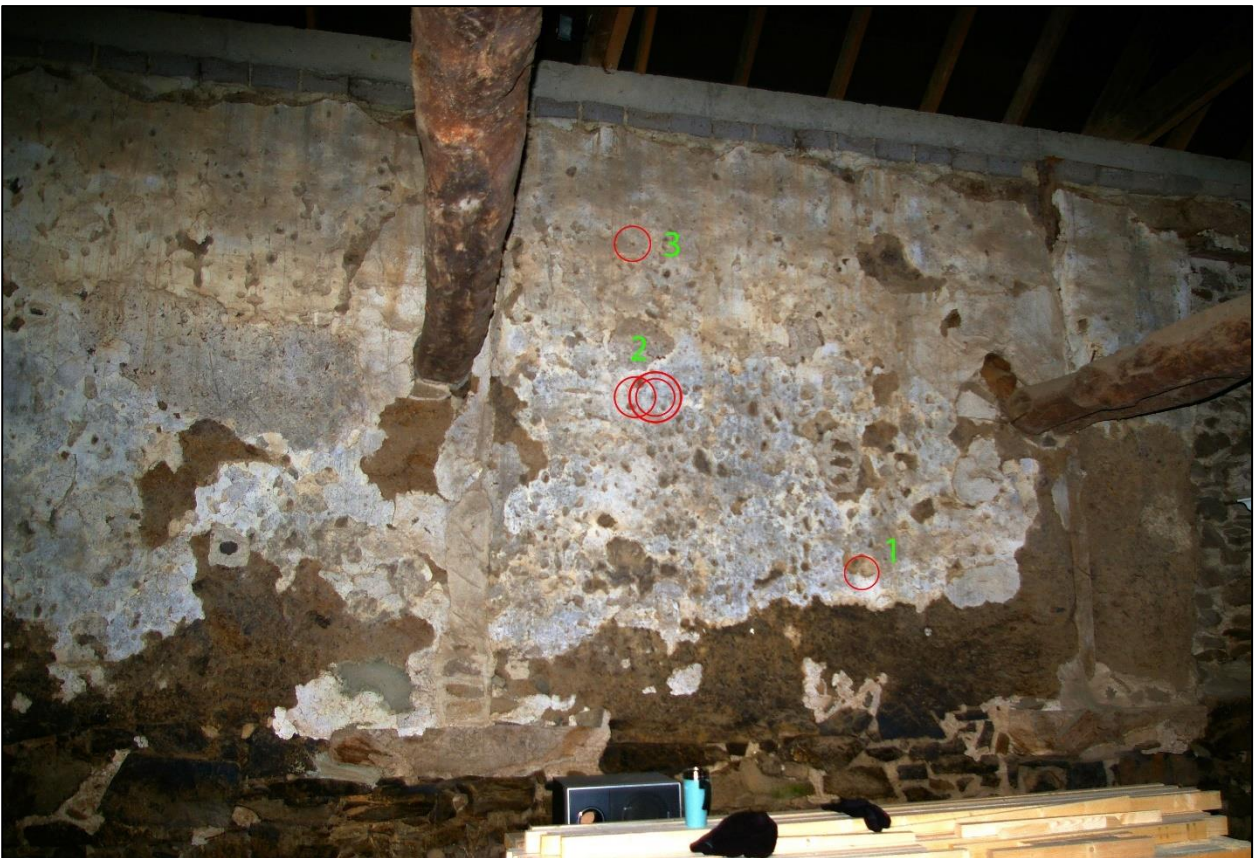
37. POSITIONS OF APOTROPAIC MARKS IN THIRD BAY FROM WEST ON NORTH WALL. VIEW FROM SOUTH. NOTE BLOCKED SOCKETS OF PROBABLE STAIR LADDER ABOVE AND TO RIGHT OF MARK 1.

Apotropaic (superstitious) marks:		<p>These are numbered 1-7 on the plan, scratched into the plastered faces of the north side and west end walls inside the barn, west of the threshing floor. Their details are as follows:</p> <p>1 – A scratched circle 17cm diameter at 1.90m above ground floor level. Circle is a broad groove c.5mm wide, its centre & upper half damaged with a single vertical scratch inside.</p> <p>2 – A pair of part-overlapping rings at 2.70m above ground floor level. A double concentric ring to right is of 19cm and 25cm diameter with a deep centre-hole; a single ring 20cm diameter overlaps horizontally to the left. This appears similar to the classic post-medieval 'spectacles' symbol, possibly to ward off the Evil Eye.</p> <p>3 – Double concentric ring at 3.50m above ground floor level, c.18cm and 20cm diameter with deep centre-hole.</p> <p>4-6 – very lightly incised 15cm, 18cm and c.18cm diameter single rings with small centre-holes in a vertical row at 1.67m, 2.80m and 3.60m above ground floor level.</p> <p>7 – At 1.70m above ground floor level and 0.83m east of north-west corner of Barn: a perfect six-petal 'daisy wheel' symbol, just under 15cm diameter. Lightly incised, centre-hole filled with plaster.</p>

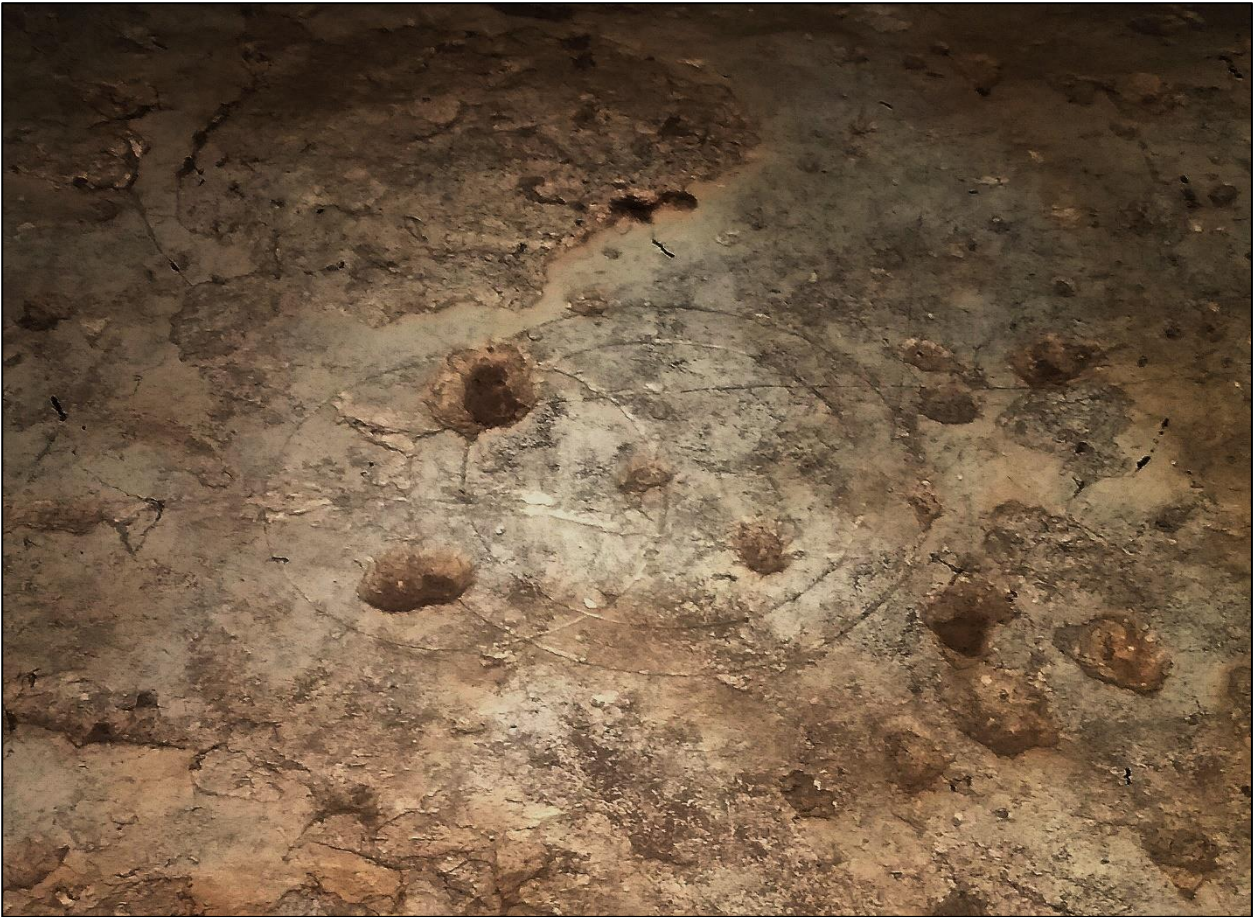
38. DETAIL OF APOTROPAIC MARK NO. 2, LOOKING UP FROM SOUTH. SINGLE CIRCLE OVERLAPPING DOUBLE CIRCLE.

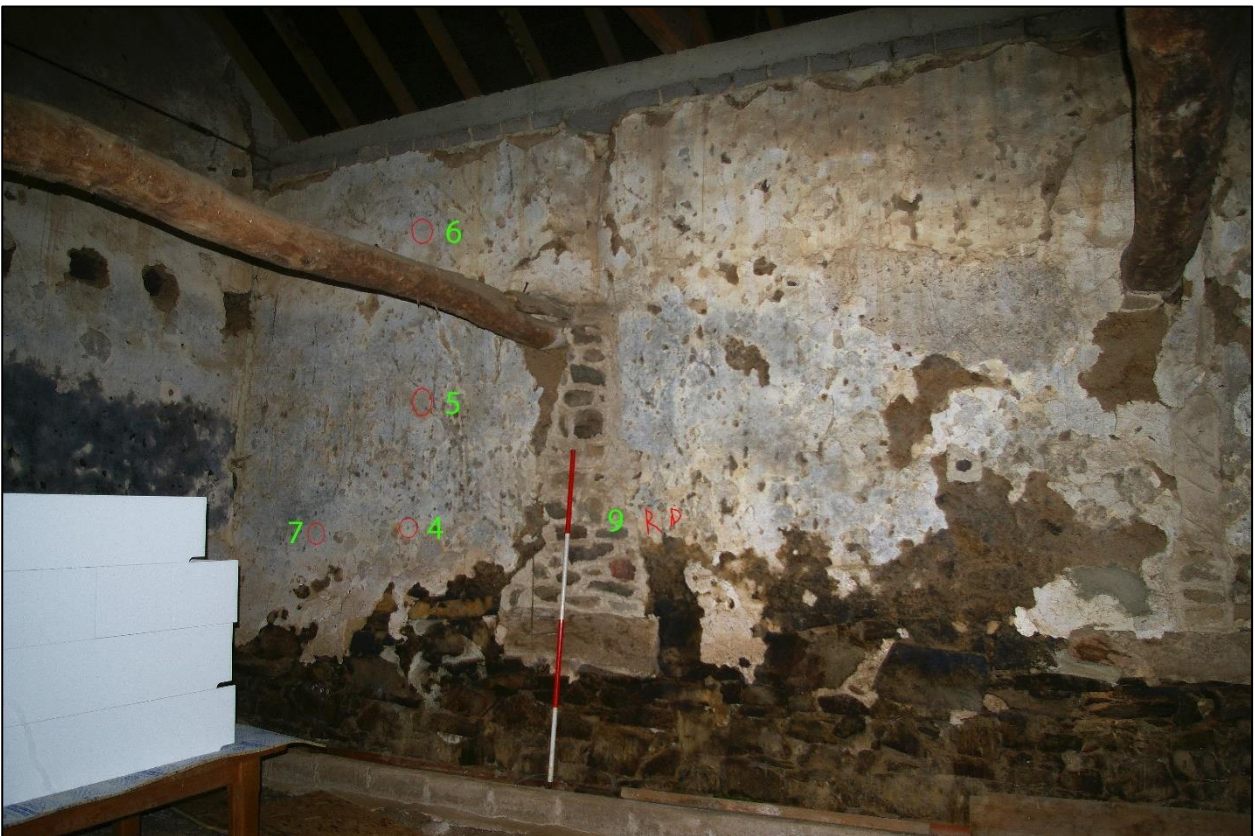
39. POSITIONS OF APOTROPAIC MARKS IN TWO WESTERN BAYS OF NORTH WALL. VIEW FROM SOUTH-SOUTH-EAST. MARK NO. 8 IS BEHIND WHITE SHELVES TO LEFT OF MARK NO. 7. NOTE EXTENSIVE PITCHFORK SCARS.

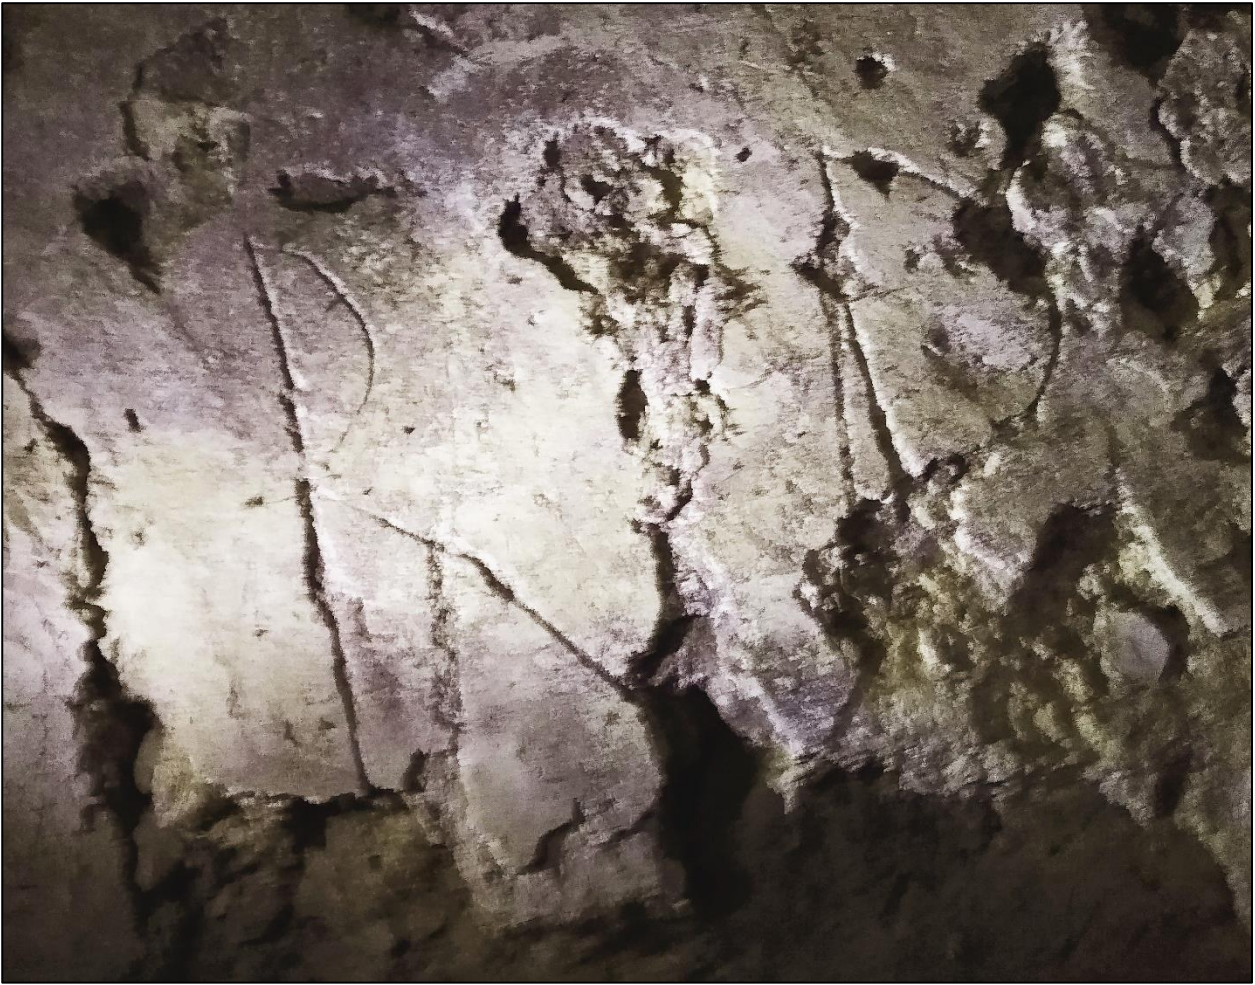
40. DETAIL OF MARK NO. 9, FROM SOUTH. THIS IS NOT AN APOTROPAIC MARK, BUT INITIALS OF 'R.P'.

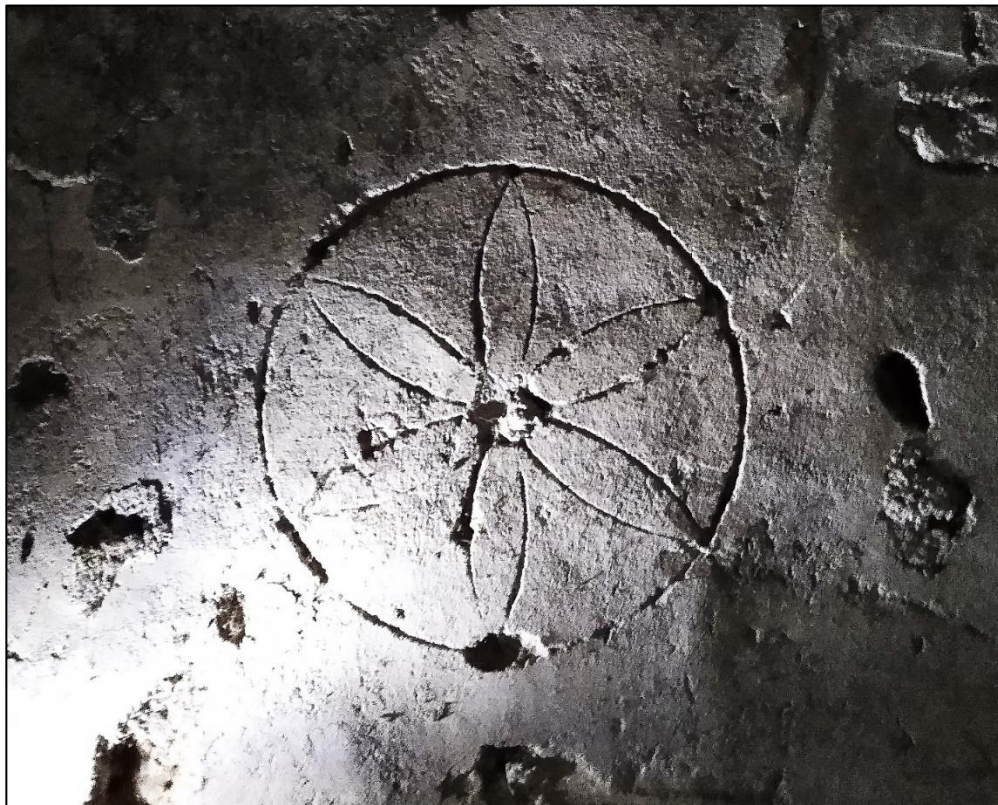
41. DETAIL OF 6-PETALLED 'DAISY WHEEL', MARK NO. 7, FROM SOUTH.

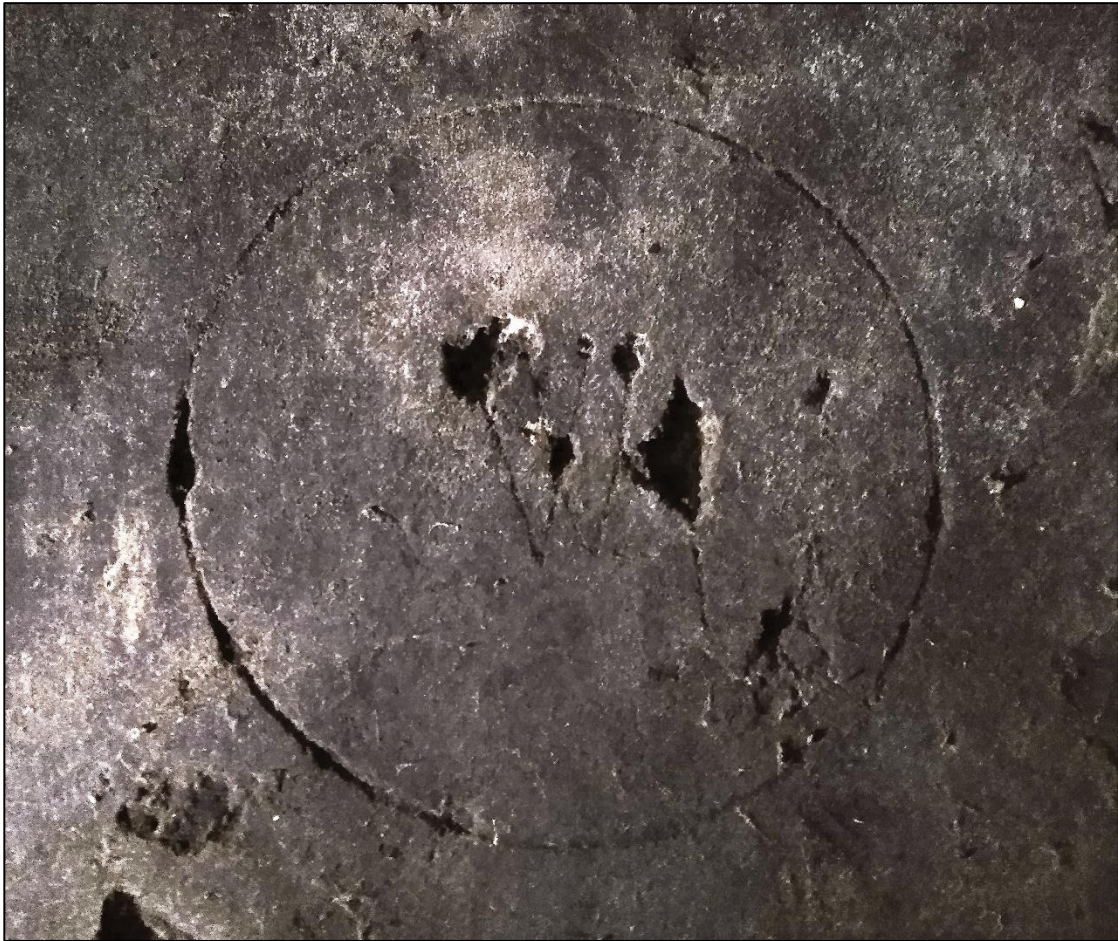
42. DETAIL OF APOTROPAIC MARK NO. 8 IN WEST GABLE, FROM EAST. SUPERIMPOSED VV IN CIRCLE, THE UPPER TERMINALS, CENTRE AND TOP OF A SECONDARY VERTICAL SCRATCH, DEEPLY GOUGED AFTER THEY WERE INSCRIBED.

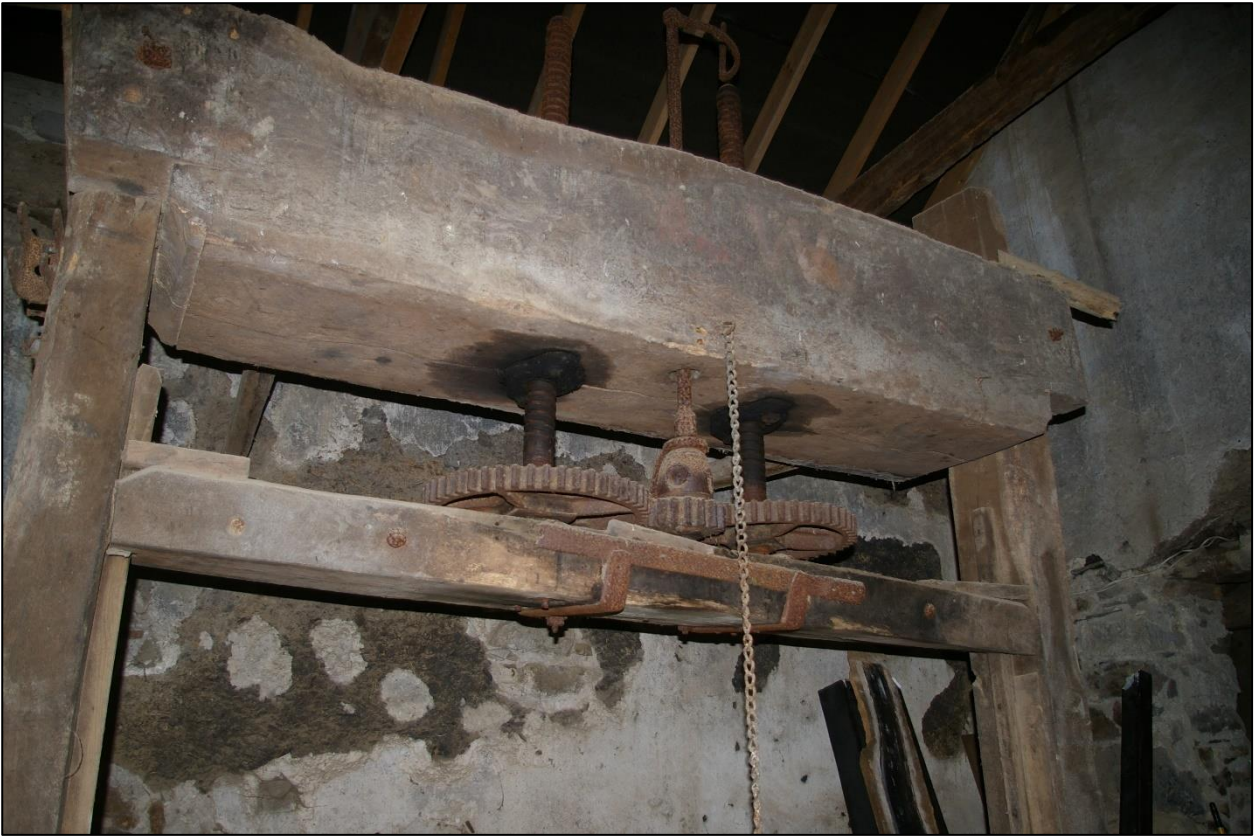
44. UPPER BEAM OF CIDER PRESS, LOOKING UP FROM SOUTH-SOUTH-WEST. THE PURPOSE OF THE LARGE CAPITAL W IS NOT KNOWN.

<p>swung into position. More coarse plaster in a large disturbance surrounds the beam end and extends up to 80cm above it; this has fallen away beneath it, exposing a mortared stone pad beneath it.</p> <p>Third bay from left has urine-blackening, pock-marks in plaster and grey bloom as second bay, but also has a group of three apotropaic marks (1-3, see above). Plaster worn away by animals for up to 2m above floor surface, first floor beam to right has forked ends and abuts cruck foot. Hole in cob has mortar and stone packing around beam end; larger area of coarse plaster above suggests that hole extends upwards. Two parallel holes blocked with mortar just below beam end to its left, possibly where a transverse stair to the loft was fixed.</p> <p>Fourth bay from left contains blocked draught door for threshing floor with threshold just above rubble plinth, with left jamb in plastered cob over elm pad for third cruck foot from west. Right jamb is of plastered cob with a patchwork of mortared rubble repairs, some patching-in decayed cruck foot and pad, others perhaps filling old joist holes associated with floor around cider press? Oak lintel with cob above is original to opening; filled in C19 with rough, flush-pointed rubble, integral window to lower right with oak lintel.</p> <p>Fifth bay from left has urine-blackened cob up to half-way up the wall, smooth-plastered with a number of sockets cut for joists, possibly for an earlier cider press or first floor structure, as they were blocked with mortared rubble after the present press was installed. Two joists in-situ brace the present press off the wall, significant wear in cob between and below these, probably caused by men barring the press down during cider-making.</p>

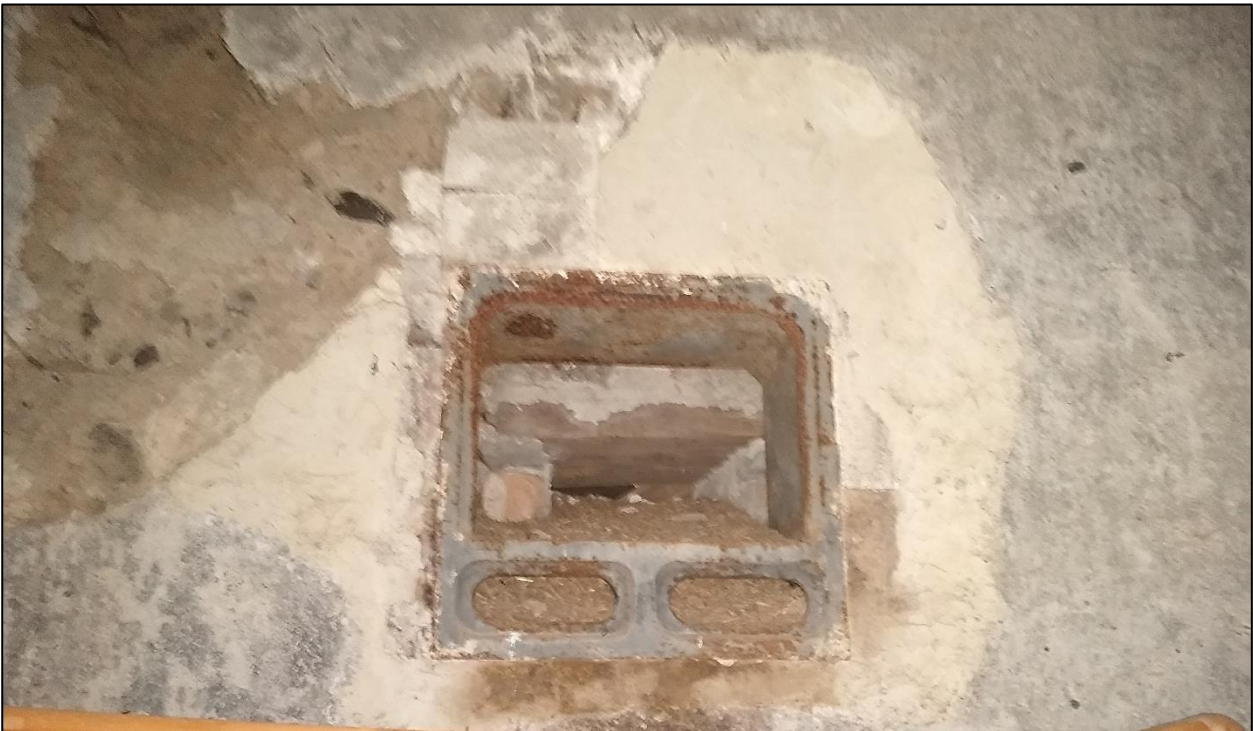
47. CAST IRON BEARING BOX FOR INTERMEDIATE PULLEY ON DRIVE-BELT TRAIN, INSERTED INTO EAST WALL OF BARN IN LATE C19/EARLY C20. NOTE BRICKS AND PALE HARD MORTAR SURROUNDING. VIEW LOOKING UP FROM WEST.

Line-shafting:		Evidence for the manner by which apple crushing and other labour-saving devices were mechanised in the late C19 or early C20 is provided by remains of three belt-drives against the east end of the barn. Belt 1 was driven by an external power source, entering the barn via a low hole (since blocked externally), roughly broken through the rubble plinth near the east end of the south wall. A cast concrete base here supported a surviving iron and timber frame, on which a pair of cast iron pulley-wheels are mounted. The central pulley carried Belt 1; a pulley to its east carried Belt 2 northwards at a sloping angle to a pulley (now gone) mounted on a cast iron bearing set in a hole forced in the cob east end wall of the barn at c.2m high, just south of D2. From here, a third drive-belt, Belt 3 rose steeply up to a pulley on a line-shaft set axially to the building on a tiebeam braced between the side walls. From here, the drive was taken across the first floor of the Pound House at eaves level, driving various machines there.

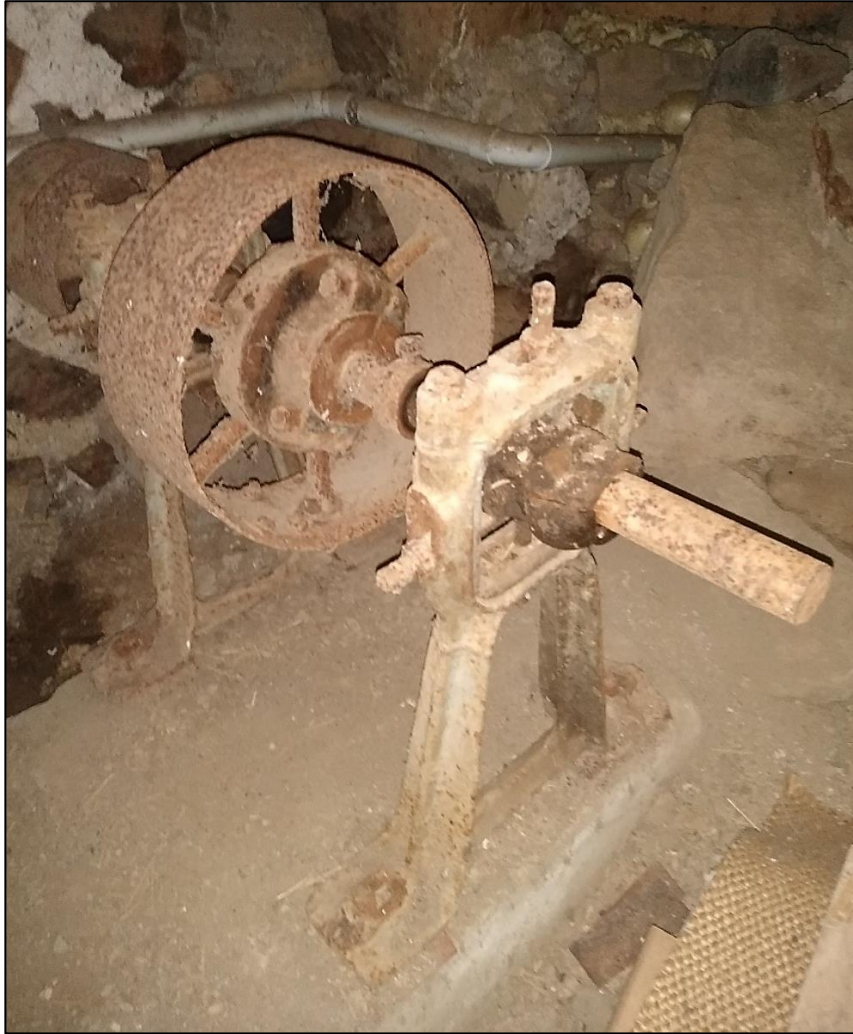
48. LATE C19/EARLY C20 CAST IRON PULLEY STAND ON CONCRETE BASE IN SOUTH-EAST CORNER OF CIDER BARN, VIEWED FROM NORTH-WEST.
