THE SMITHY FILLEIGH VILLAGE NORTH DEVON DEVON

Historic Building Recording

South West Archaeology Ltd. report no. 190606

The Smithy, Filleigh Village, North Devon, Devon Historic Building Recording

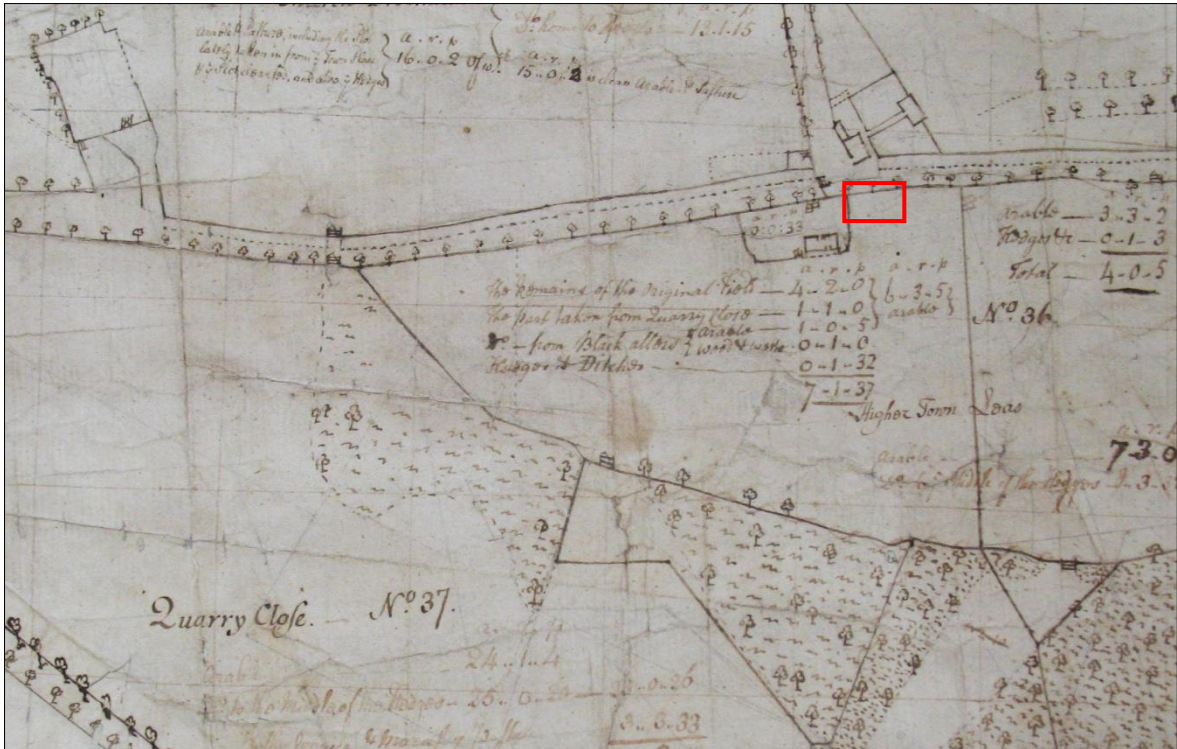
FIGURE 2: EXTRACT FROM AN 18TH CENTURY CASTLE HILL ESTATE MAP; THE APPROXIMATE LOCATION OF THE SITE IS INDICATED.

The later 18th century (post-1763) Castle Hill Estate Map shows Paynes Cottages in their enclosure, but shows no evidence of the smithy (Figure 2). By the publication of the Filleigh Tithe map in 1838, the smithy is represented and Payne’s Cottages are annotated *Pain’s Shippon* (Figure 3). Plot 14 is named in the accompanying Filleigh tithe apportionment as *Pain Shippon Smithy and Garden*. The other notable change on the tithe map is that the enclosure around Payne’s Cottages had been extended to include the smithy building.

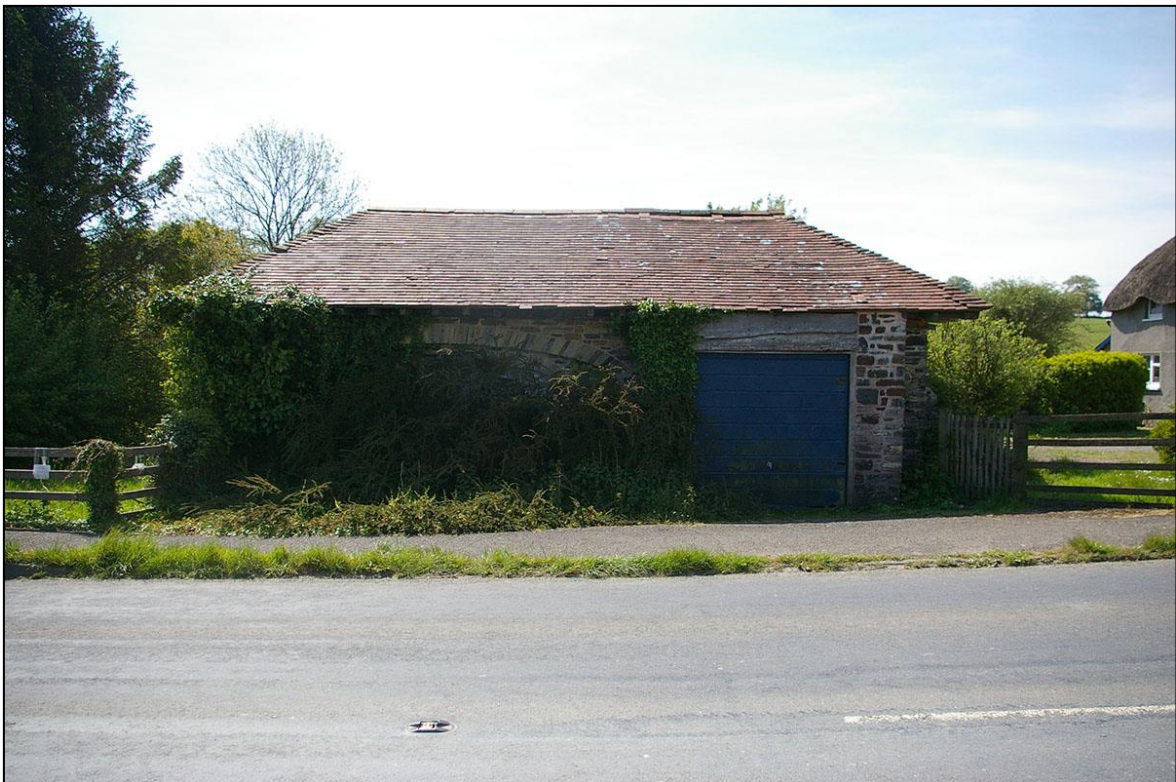
FIGURE 6: THE NORTH ELEVATION OF THE SMITHY; FROM THE NORTH.

The front (north) elevation, facing the road and across to the main estate complex, displays two large segmental basket-arches; one to the east intact but infilled, one to the west forced and rebuilt, only a header and small stub surviving to the north-west corner of the building. The infilled arch, of very fine form and carried on two shallow flat pilasters has two later basket-arched window openings inserted beneath, with smaller segmental stone arches and beaded window frames. To the west, in the forced arch, there is an inappropriately inserted garage door. The fine architectural details mark this out as having been 'designed' despite its seemingly meagre status, indicating its link to the other fine estate buildings at Castle Hill.

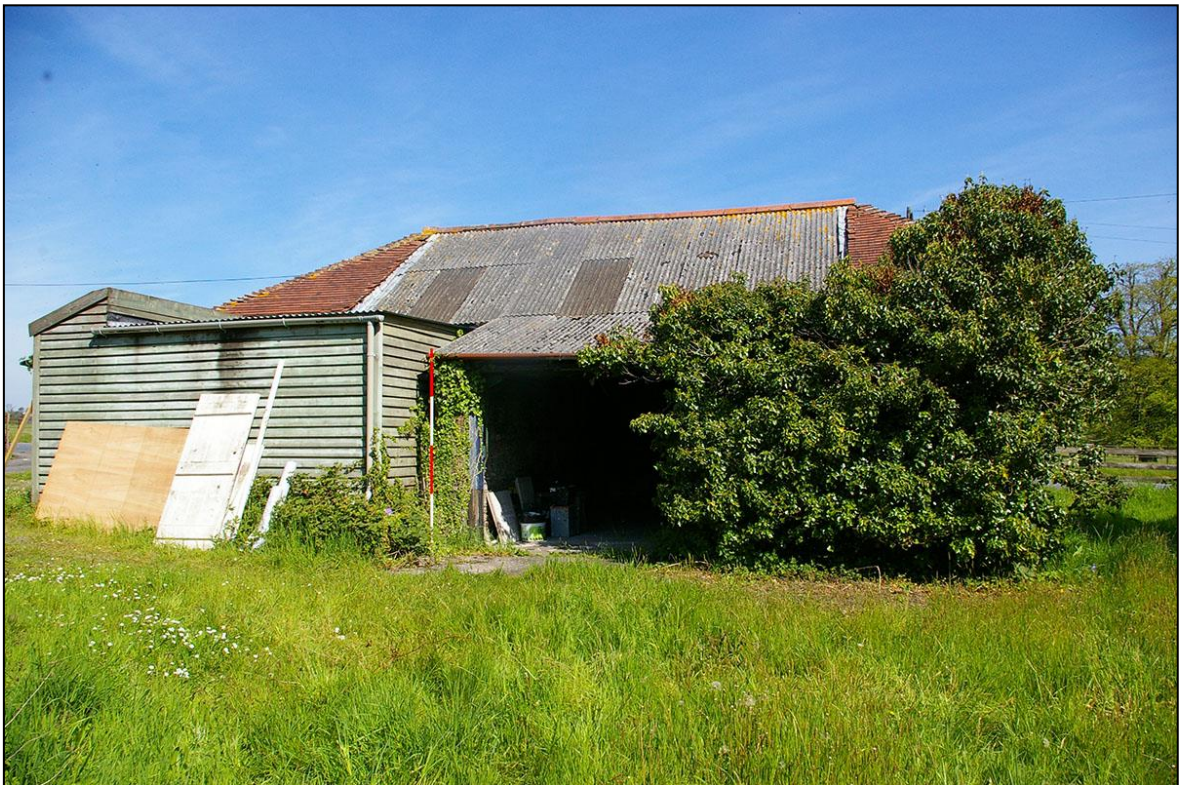
FIGURE 7: WIDE ANGLE OF THE SMITHY, WITH 2M SCALE; FROM THE SOUTH-EAST.

The west elevation is blind; the east elevation has a small timber door/hatch in a rectangular opening to the south end; the south-east corner of the building has a small projecting outshut, cohesive in build, truncated and rebuilt in brick, the former smoke-bay for the forge?

The south elevation is dog-legged in profile, set in to the west end, where it is abutted and obscured by a modern timber garage; the east end forced with another inappropriate large modern garage door.

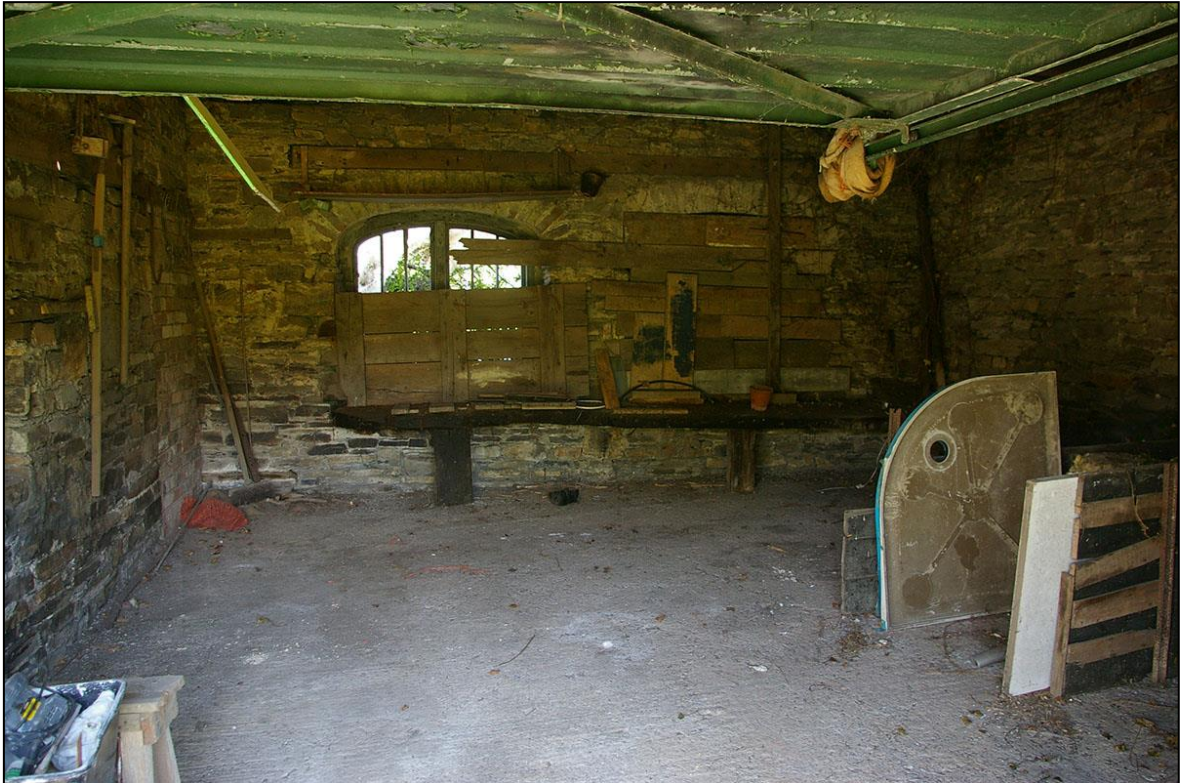
FIGURE 8: ROOM 1, THE MAIN FORMER SMITHY SPACE; FROM THE SOUTH-SOUTH-WEST.

The interior comprises two simple cells, one larger, to the east within the original block, Room 1; this is probably the former smithy. The smaller square cell to the west is an addition, Room 2; linked to the main cell via a former doorway to the north of the party wall. This may have been open to the front and merely provided a covered working area/workshop as there appear to be iron rings and loops and timber ties for possible fitments, indicating an area where animals may have been tethered (estate horses for shoeing?). The walls of both spaces display some former

whitewash but are largely of exposed stonework, the floors to both replaced with concrete. A large fine bench survives within Room1, along the north wall and returning to the north-west corner. This is low, very heavy and rustic in build, and smoke-blackened, so may date from the smithy use of the space. Otherwise the building has been completely stripped of fittings.

The roof structure is worthy of note, being of A-frames with spiked and pegged joints, fine half lapping and chamfered to timbers. There is also a heavy projected eaves structure. This roof presents as very traditional in form and build, far older than it actually is and strongly suggests that 'old-fashioned' crafts survived far longer on the estate than are seen within general trends in the region.

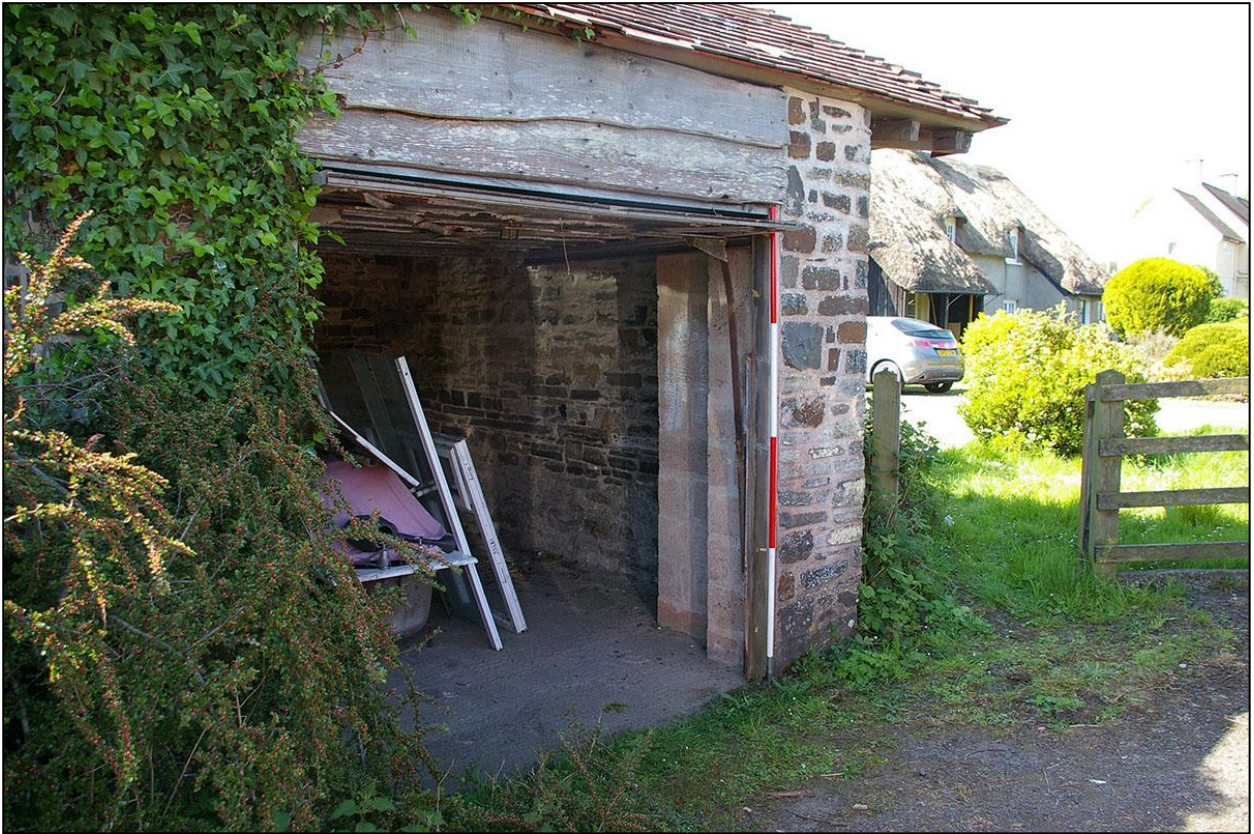
5. THE LARGE GARAGE OPENING, D2, FORCED INTO THE FRONT NORTH ELEVATION, WITH 2M SCALE; FROM THE NORTH-EAST.

Openings - Doors	1	D2 - Large garage door to the west end, forced into an arched opening, which had been blocked with brick. Either side the forced front wall is braced by two projecting concrete piers to each side, covered by a single outer skim of stonework. The door is an 'up and over' corrugated modern metal garage door.
Drainage/Guttering		N/A
Significant Details:		The main detail is a massive segmental stone basket arch which occupies the whole of the north front of the original block to the east. This is carried on shallow plat pilasters with a slate slab capitol, forming a header to the arch. The arch itself is very finely dressed slatestone slabs, with a slightly wider slab forming a kind of keystone. This initial arch has been infilled with regularised rubble in a whiter lime mortar at a later date, with two windows fitted. These also both have segmental stone basket arches, but not quite of the same quality. The arch was originally open. The fragment of header and arch to the west end is much cruder, with a chunky almost cavetto angle on the header, suggestive of this being an addition, but an attempt being made to copy the original. It is likely a covered but open workshop space was needed once the original arch was blocked.

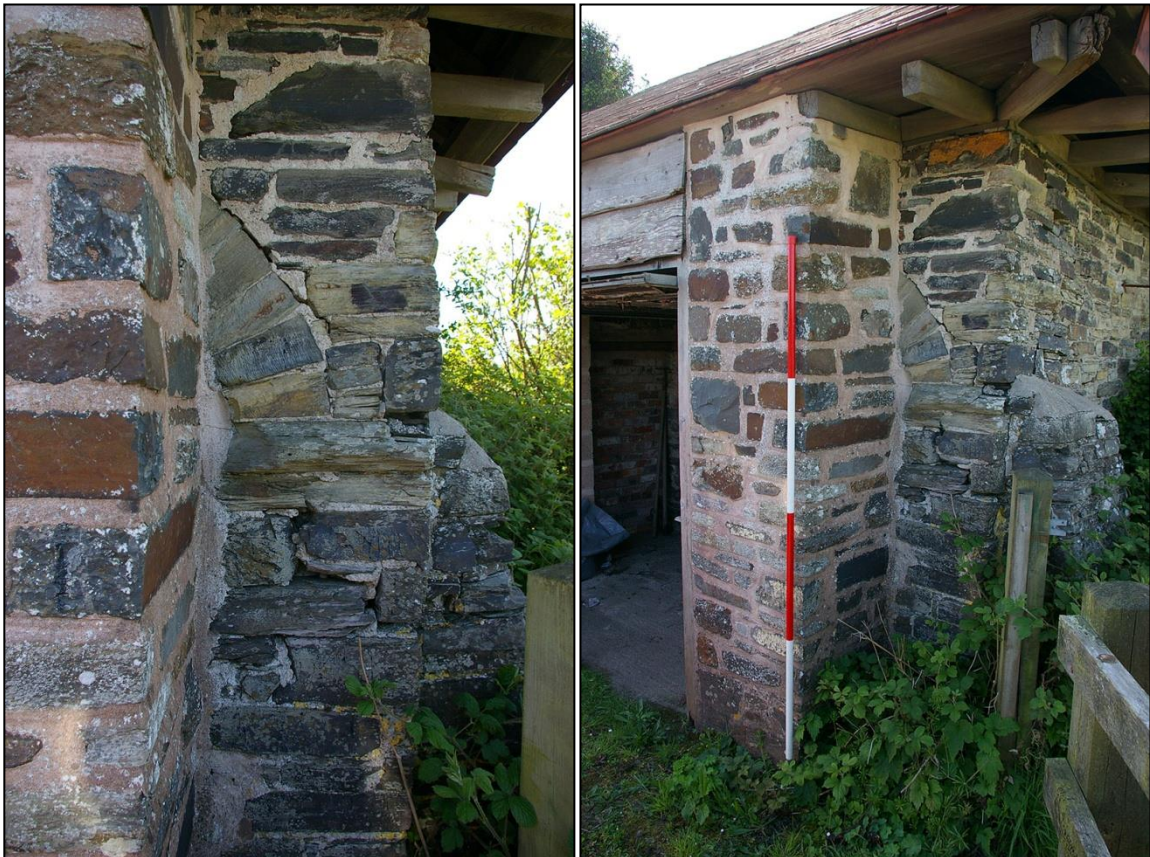
6. LEFT: THE SMALL SECTION OF THE SECOND ARCH TO THE NORTH ELEVATION, NORTH-WEST CORNER; FROM THE NORTH.

7. RIGHT: DETAIL OF THE NORTH-WEST CORNER, WITH REBUILT FRONT PIER, REMAINING ARCH AND THE NORTH-WEST BUTTRESS ON THE NORTH-WEST CORNER OF THE BUILDING, WITH 2M SCALE.

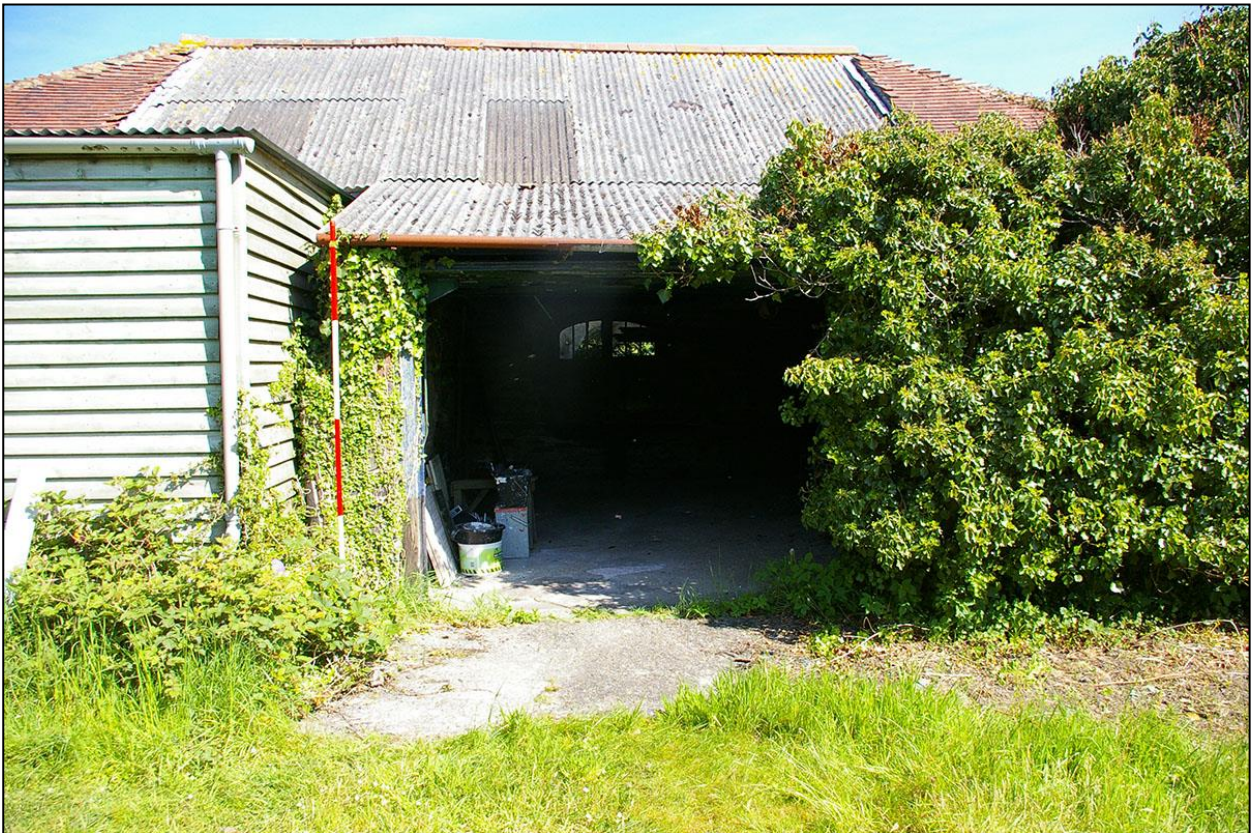
13. D1 THE GARAGE DOOR, LEADING INTO THE INTERIOR OF ROOM 1, WITH 2M SCALE; FROM THE SOUTH.

Openings – Doors:	1	D1 - One large modern garage door forced in to the east end. Modern corrugated metal garage door. Thick plain wooden frame.
Opening – Windows:		N/A

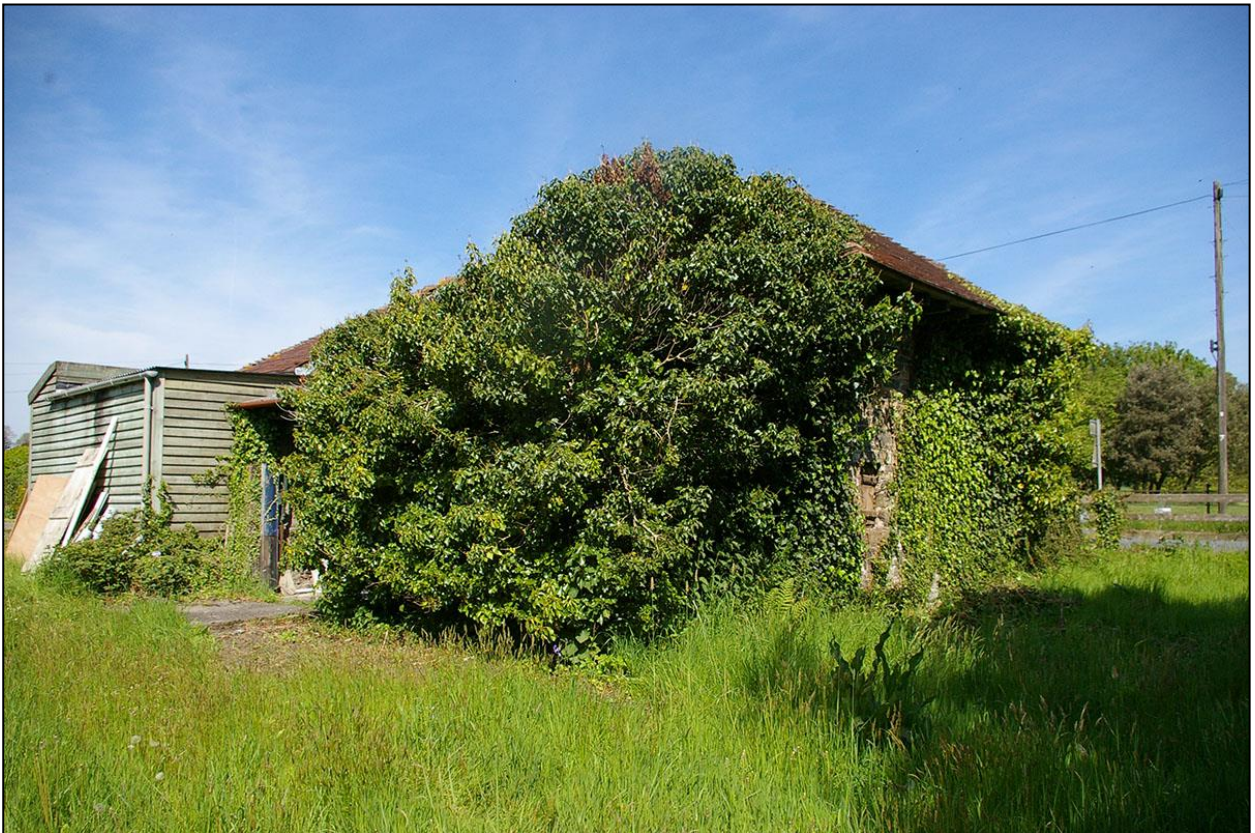
15. VIEW OF THE DOGLEGGED SOUTH-EAST CORNER.

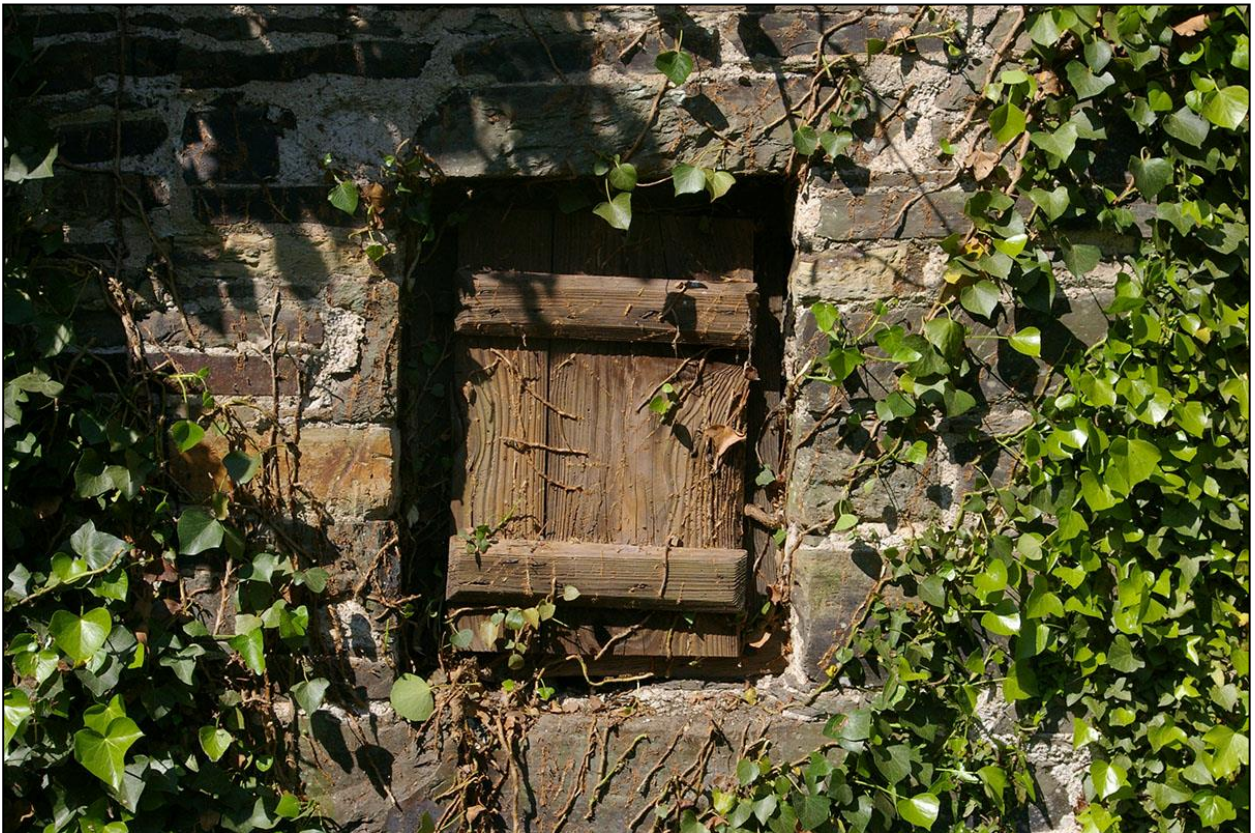
17. BD3 – DOOR/HATCH IN THE EAST ELEVATION; FROM THE EAST.

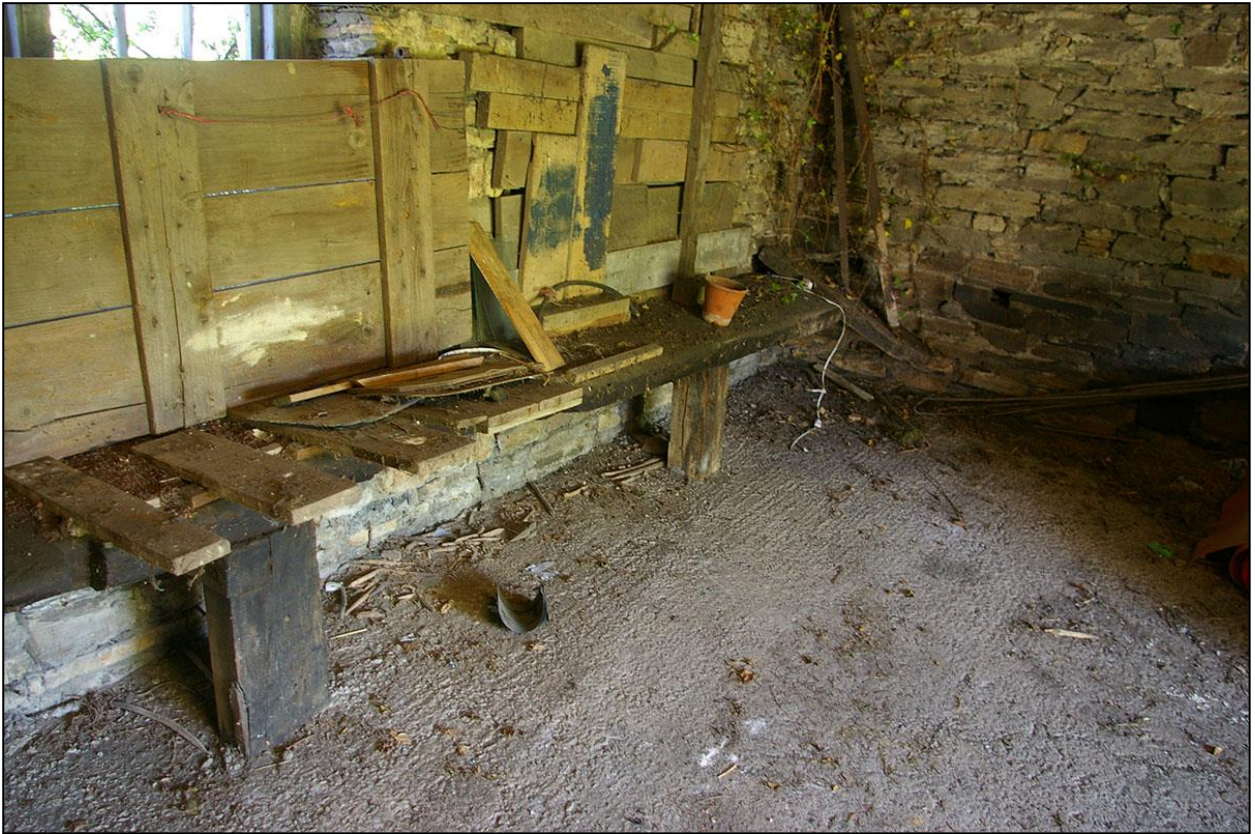
28. THE WORKBENCH, IN ROOM 1; FROM THE SOUTH-WEST.

Significant Details:		Fitted work bench, low to north wall under the windows and north-west corner. Oak, very thick and rustic, smoke-blackened. Some smoke blackening to the lower east and west walls. Some long timber boards nailed to walls, hooks and traditional tools still hung up on the walls. Large shallow socket to south end of central (west) wall. Stone sill and lintel. A keeping place?
Dating Evidence:		The windows and roof are later additions and both very traditional; the roof for example is probably c1920s or slightly later but is still spiked and ledged to trusses. Crafts were continued longer on the estate than generally it seems. The basket arch shape is typically associated with the 19 th century.
Interior – Room 2		Description
Function:		West additional room to smithy, covered area for shoeing horses/making repairs - workshop, hence the rings for tethers?
Figure Numbers:		
Walls:		Exposed stone, some evidence of former whitewash on upper walls.

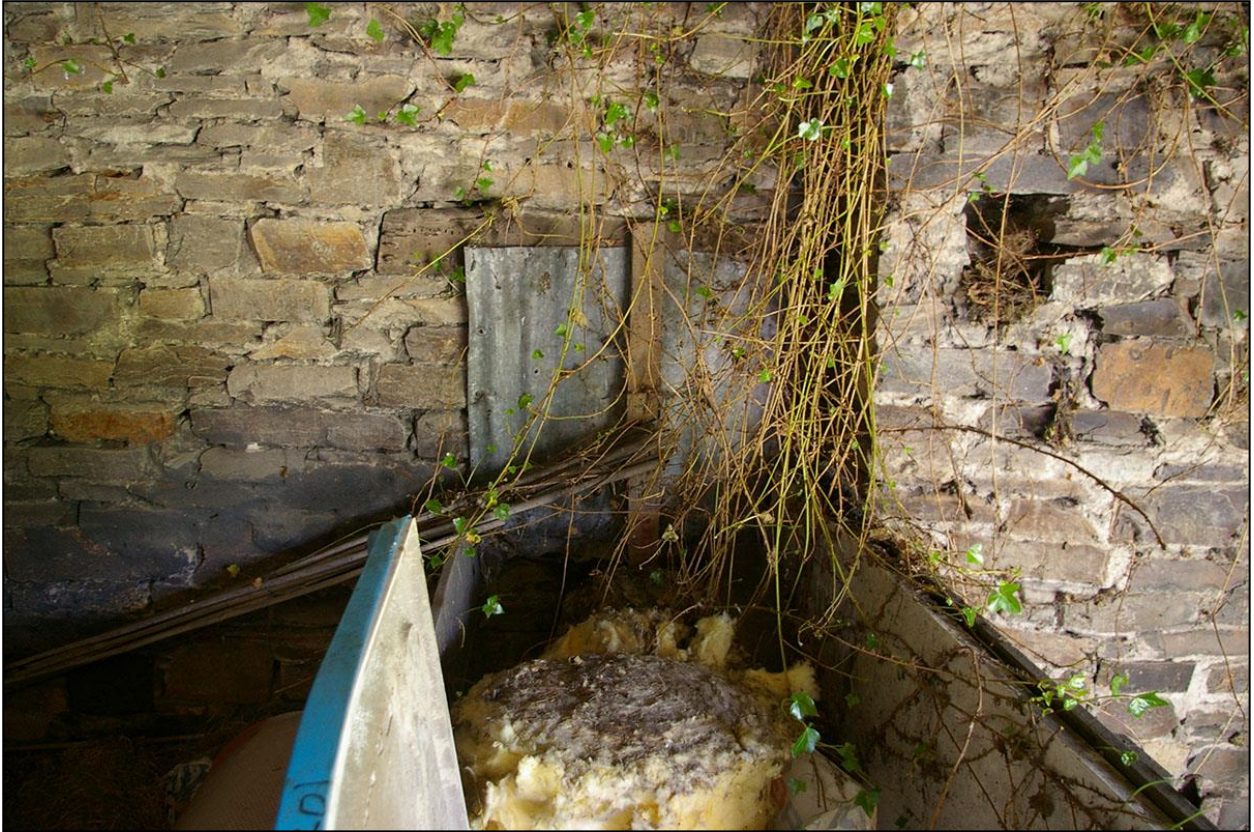
30. BD3 – THE BLOCKED OPENING IN THE EAST WALL, COVERED BY CORRUGATED SHEETING. DIRECTLY OPPOSITE BD2; FROM THE WEST.

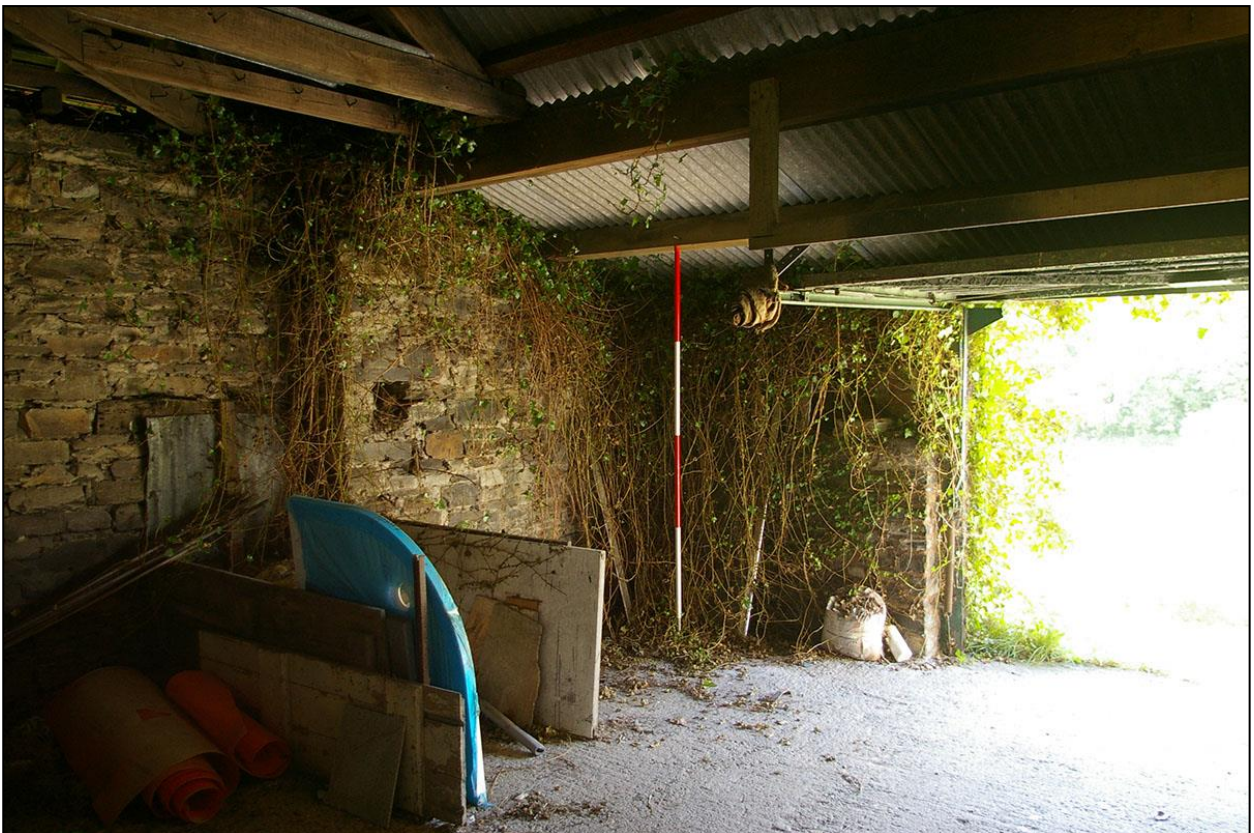
31. THE PROJECTING REBUILT ELEMENT IN THE SOUTH-EAST CORNER, WITH 2M SCALE, COVERED BY IVY; FROM THE NORTH-WEST.

Drainage/Guttering		Some lengths of rusted metal guttering, over the garage door to the east.
Significant Details:		The south-east corner has a low half height wall and thick rebuilt angled corner; possibly where the forge was removed when no longer needed.
Relationships:		The east end is cohesive with the east and north-east elevations. The west end abuts it being an addition, cohesive with the west elevation.
Elevation WEST		Description
Figure Numbers		
Fabric Description		Single storey elevation, slate and mudstone rubble stonework, yellow-brown in colour, in a lime and clay bond and mortar, larger dressed stones on corners. Large looser rubble stone buttress to north-west corner, cemented to top.
Roof Covering		Deep hipped end to roof; terracotta tiles, plain ridge tiles and hip ridge. Deep projecting eaves, almost sprocketed in style.
Openings - Doors		N/A
Openings – Windows:		N/A
Drainage/Guttering		N/A

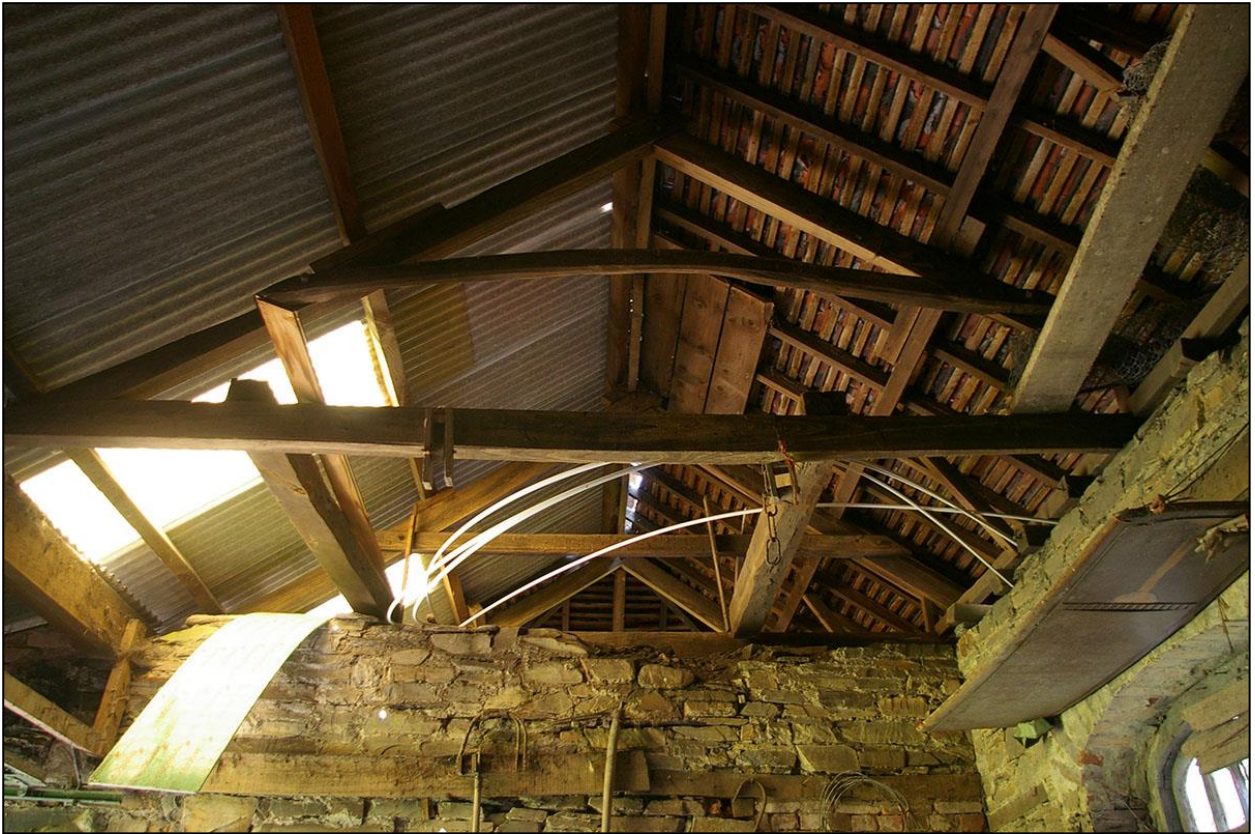
34. THE TRUSS OVER ROOM 1, BETWEEN THE TWO BAYS; FROM THE EAST.

Floor:		Concrete poured floor.
Ceiling:		N/A – open to roof.
Roof:		Two bay and hip roof structure. All are A-frames, with half lapped joints, pegged and spiked, overlap at ridge, narrow plank ridge. The A-frames have a collar and a thick plain tie beam. Two sets of purlins to each pitch. Thick rafters and battens

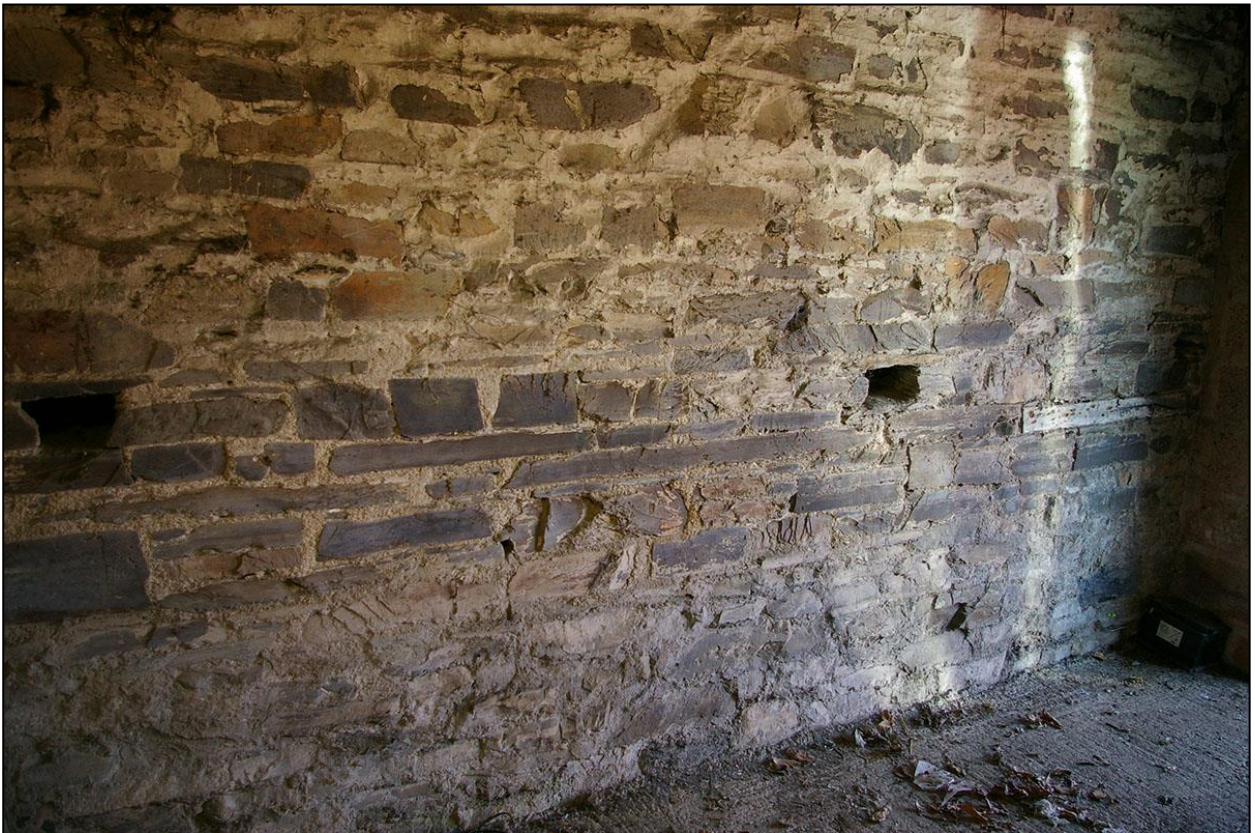
41. THE THREE SOCKETS SET LOW ON THE WEST WALL, TO NORTH, SOUTH AND CENTRE; FROM THE SOUTH-EAST.

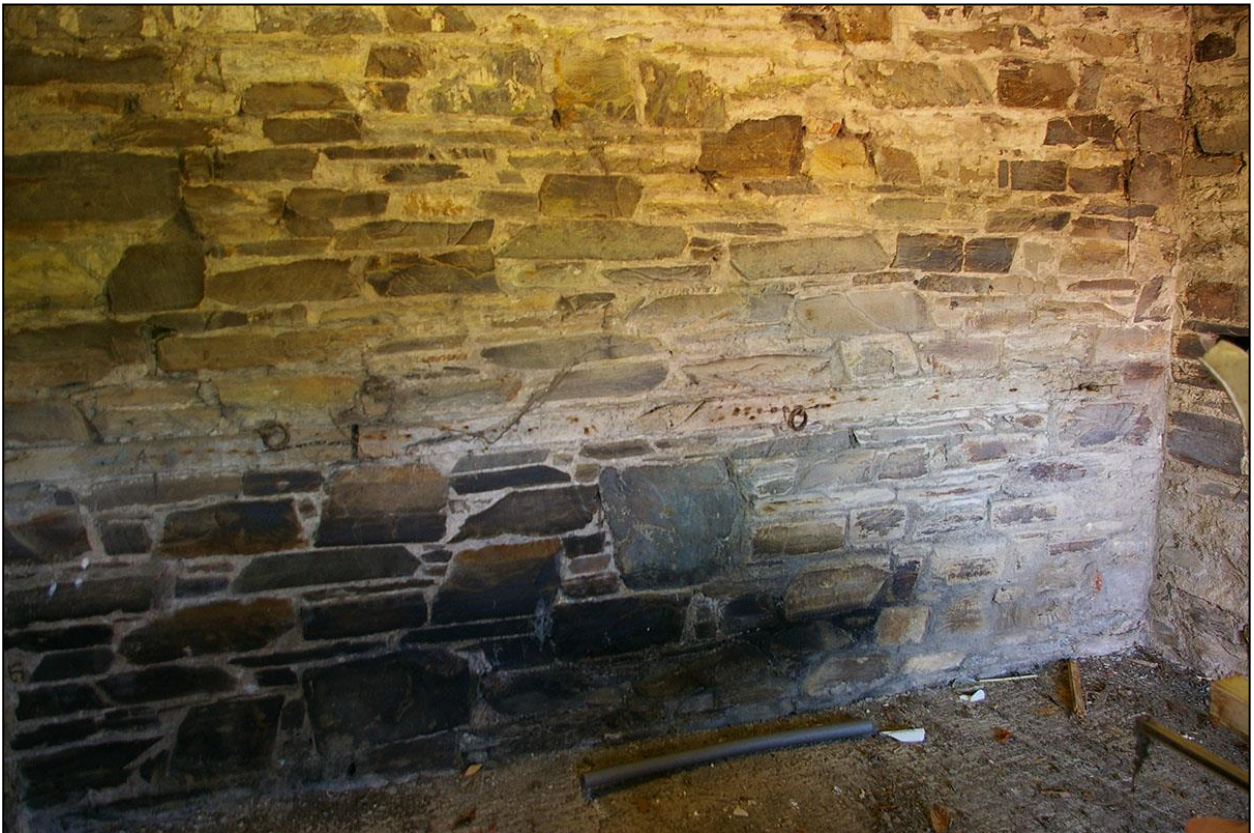
43. THE LONG TIMBER TIE SET LOW INTO THE SOUTH WALL, WITH ROW OF THREE RINGS; FROM THE NORTH-EAST.

Significant Details:		The south wall has a low set timber tie, with lots of nail mark staining, as if associated with a frame or fitment. Just above this set directly into the stone are three iron rings, with one to each the east and west walls in the corners above. Could these be tethers for animals and a rick or trough, for shoeing the estate horses, later all removed when the building was converted? There is a timber tie to the front wall, bracing the arch. Three small sockets are in the west wall, set quite low, for a frame or fitment?
Dating Evidence:		N/A

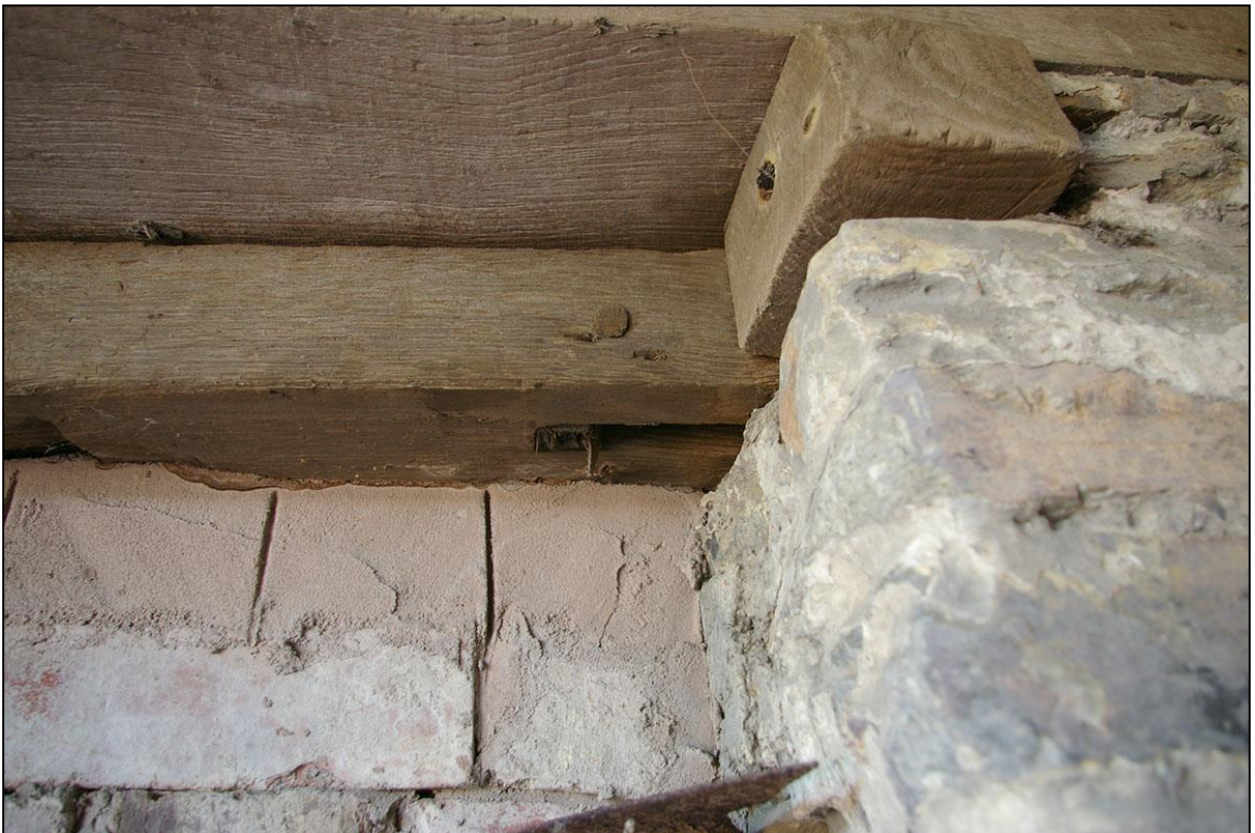
47. BD1 – DETAIL OF THE PEGGED FRAME; FROM THE WEST.
