COPPLESTONE FARM
WEST MANLEY
TIVERTON
DEVON

Results of an Archaeological Evaluation and Heritage Impact Assessment

Copplestone Farm, West Manley, Tiverton, Mid Devon Results of an Archaeological Evaluation and Heritage Impact Assessment

By Dr Bryn Morris
Report Version: FINAL
28th August 2019

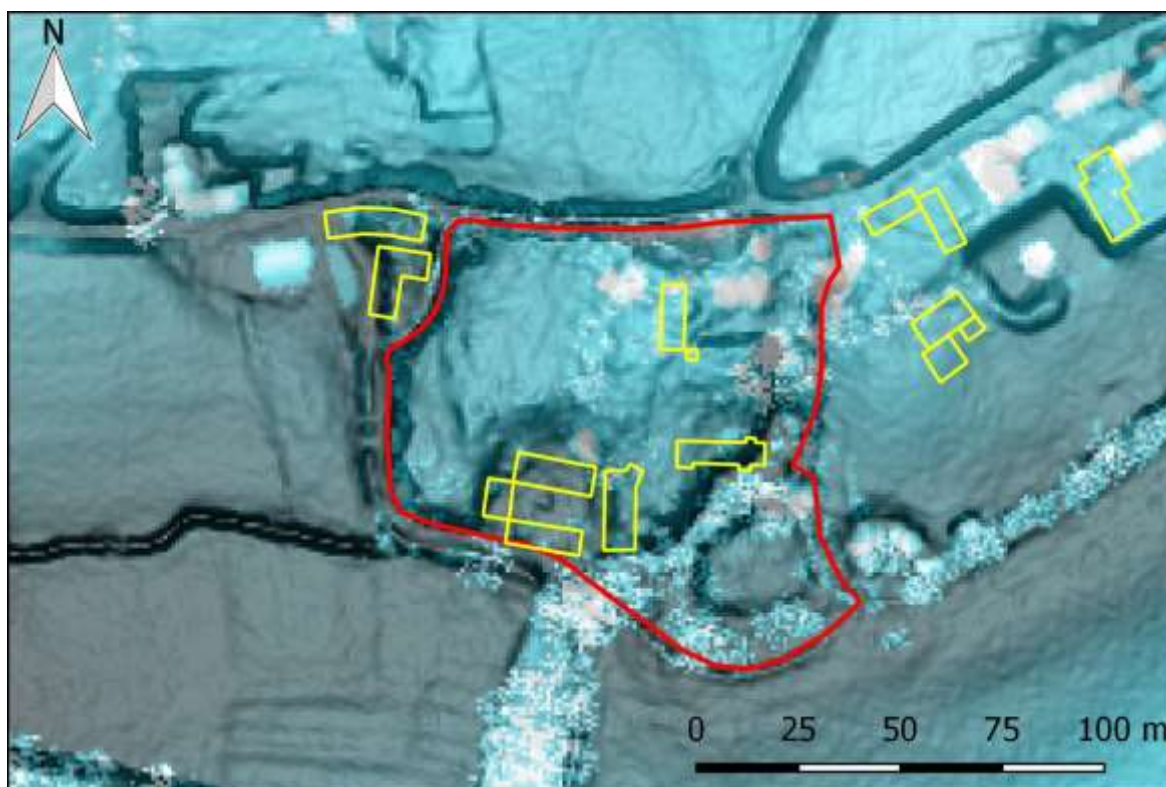
The readily available recent (post-2000) aerial photography for the site (not depicted) is of little value, showing only a site largely overgrown with trees and shrubs. Conversely, imagery derived from Environment Agency LiDAR data (Figure 9) clearly shows the pronounced earthworks on and adjacent to the site. The sunken yard to the south of B1, the eastern holloway, the raised area to the south-east and the deep hollow on the south-western side of the site, are clearly shown.

FIGURE 10: COMPOSITE LiDAR IMAGE BASED ON ENVIRONMENT AGENCY DTM (GREYSCALE) AND DSM (IN BLUE) DATA, WITH THE SITE BOUNDARY SHOWN IN RED, AND LOST BUILDINGS SHOWN IN YELLOW OUTLINE (DATA PROCESSED USING QGIS v2.18 TERRAIN ANALYSIS>SLOPE; DATA COPYRIGHT ENVIRONMENT AGENCY, OPEN GOVERNMENT LICENCE 3.0 © CROWN COPYRIGHT 2019).

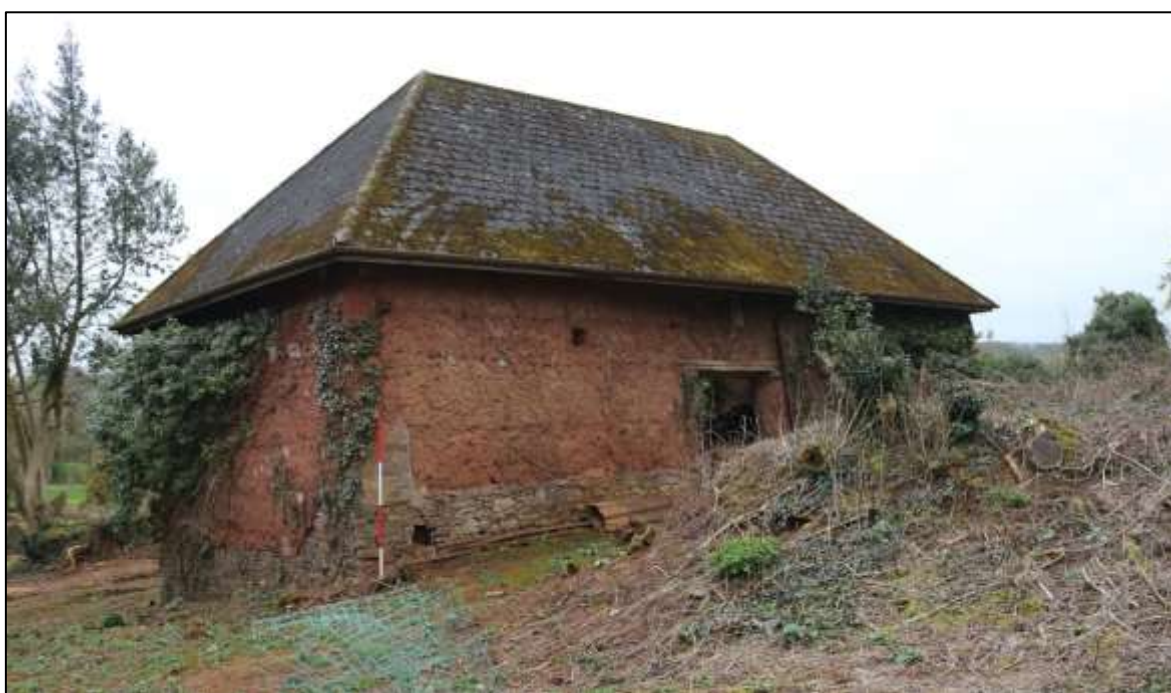
There are two standing buildings on the site. The surviving barn (B1) is a large rectangular cob-built structure on a stone plinth with a modern hipped roof. The south-west side was modified in the 19th century to form two large two-storey openings (i.e. a linhay) with brick quoins, and the end elevation has been rebuilt in stone. The lifts in the cob are clear and well defined (between 0.6m and 1m in height), and levels to the north and east of the structure have been lowered exposing the base of the walls. There is a single wide doorway with a heavy timber lintel in the middle of the north wall; the base of the doorway has been lowered through the stone plinth. The walls are otherwise blind. The interior forms a single space with an earth floor open to the roof, although there are sockets for joists indicating there was once a first floor. There are the remains of an internal wall separating the west bay from the rest of the building; the end bay has a concrete floor.

FIGURE 13: THE BARN (B1), VIEWED FROM THE NORTH-EAST (SCALE 2M).

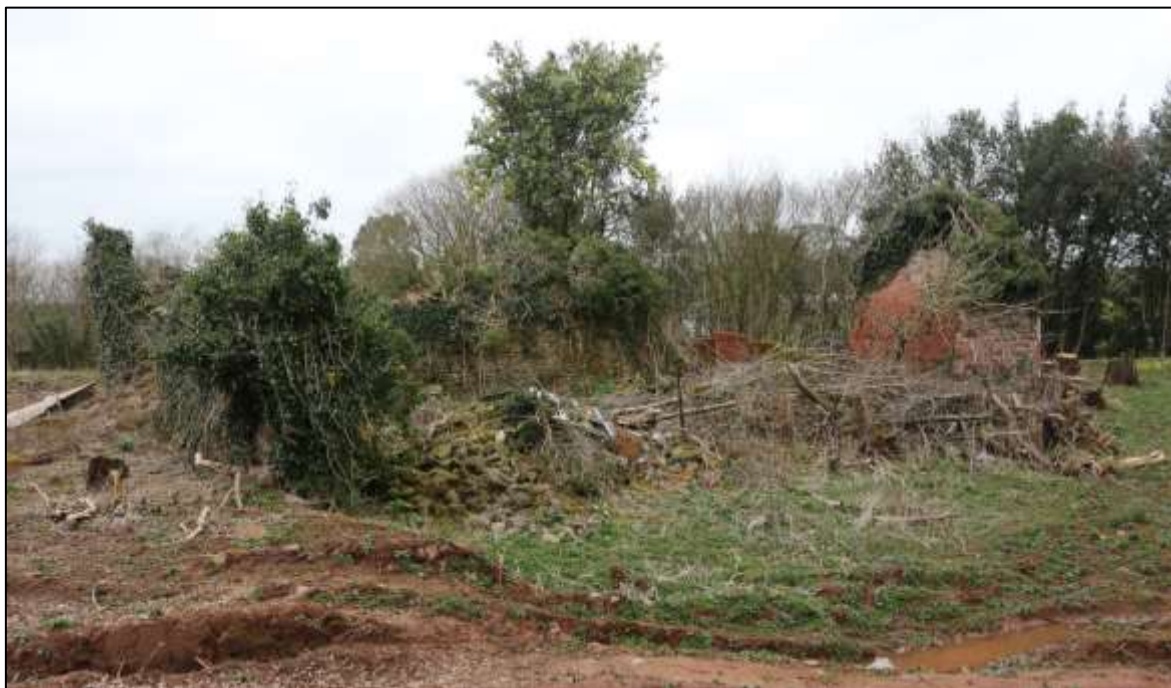
A ruined rectangular building (B2) stands to the west, similarly of cob on a stone plinth, but much repaired in stone and brick. The stone plinth is built of small rectangular (quarried) siltstone similar to the barn, but above this the rebuilt rear (west) wall is of a coarse purplish breccia which might have been reclaimed from one of the lost buildings on the site. The north gable is repaired in stone and brick, and the apex of the gable may have always been in brick, laid in a Flemish bond. Two kinds of brick are represented, with different sizes of frog, and the pitched roof was originally pantile (stamped BROWN BROS. BRIDGEWATER). The test pit (#3) excavated inside the building would suggest it had an earth floor. The structure now appears to have been open sided, but it is not

shown as such on the historic maps, and its current appearance has arisen because the wall has collapsed/been demolished.

FIGURE 14: THE RUINED STRUCTURE; VIEWED FROM THE SOUTH-EAST.

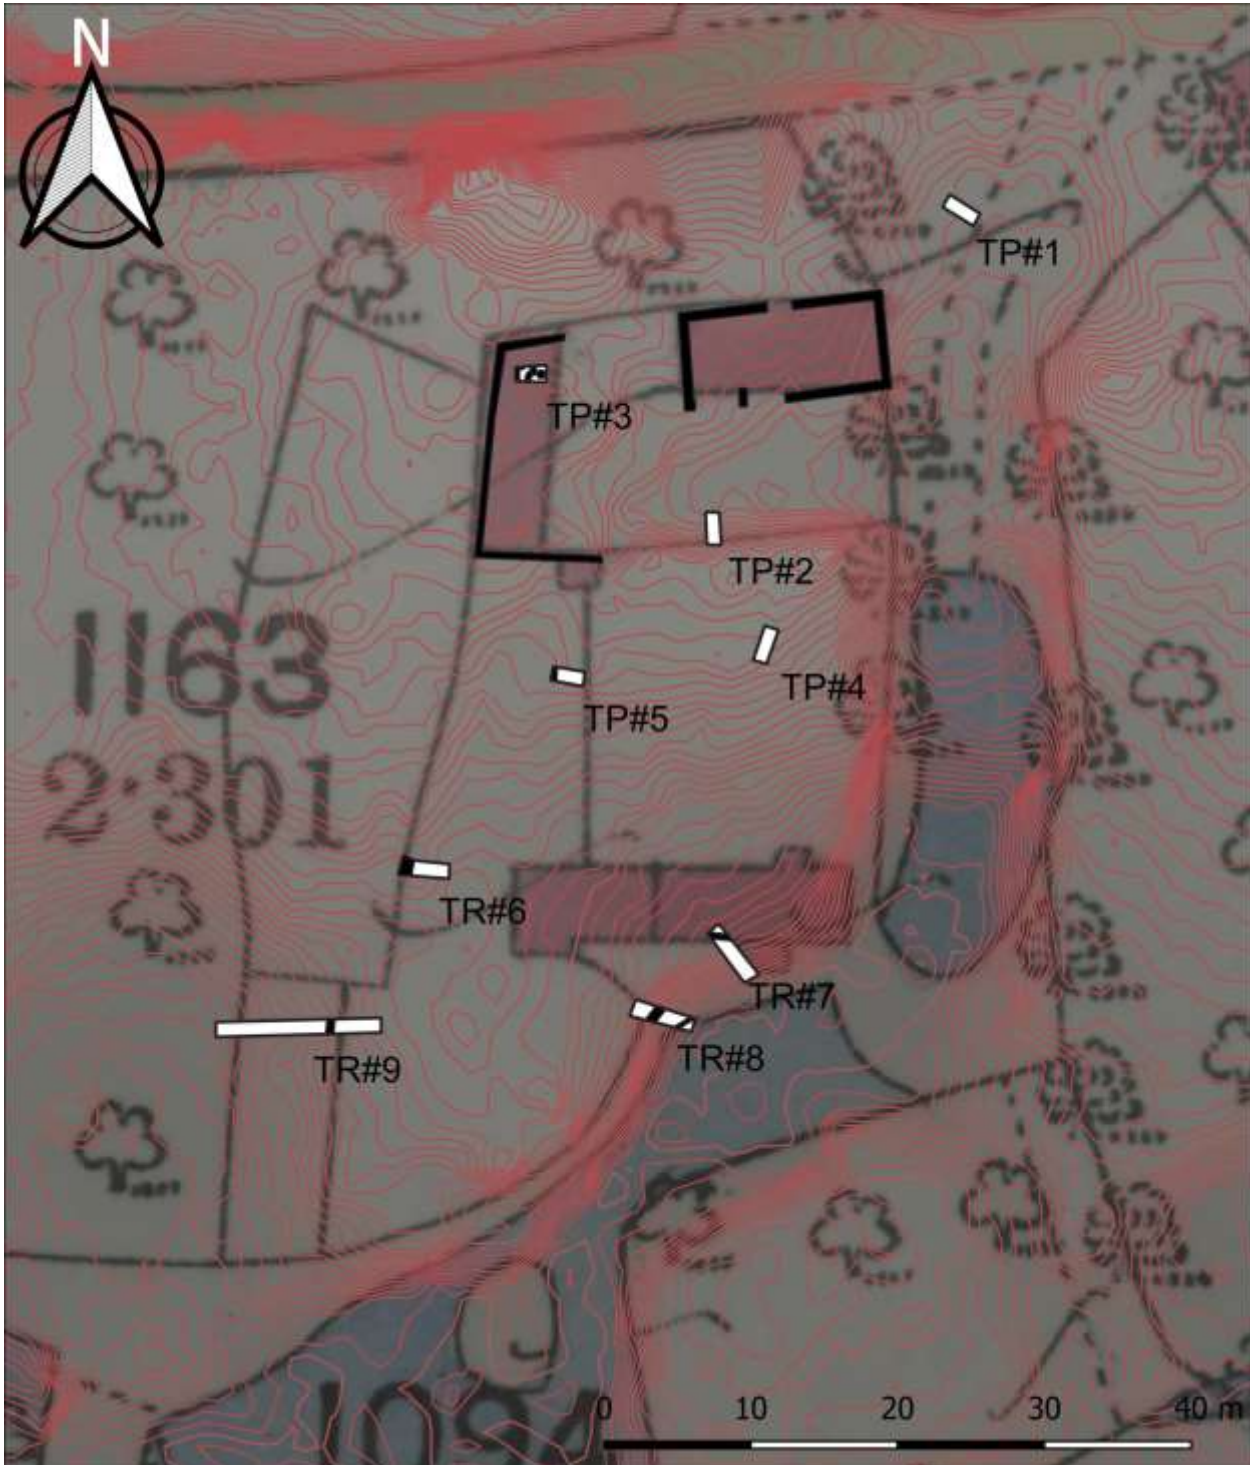
For the most part the trenching determined that the natural substrate (the weathered upper part of the Tidcombe Sand Member) lay relatively close to the surface (within the 'normal' range, i.e. 0.4-0.5m); this indicates levels across the site have not been artificially raised. The exception to this was in TP#7 and TP#8 on the southern edge of the site, where the farmhouse (F1) had been located. Here a greater thickness of made ground was encountered, but perversely, no clear evidence (i.e. walls, floors) for the farmhouse was uncovered. This dumped material was all 19th century or later in date.

FIGURE 15: SITE PLAN SHOWING THE LAYOUT OF THE TRENCHES AND PRINCIPAL FEATURES. 10CM CONTOURS BASED ON EA LIDAR DATA OVERLAIN WITH THE 1ST EDITION 25" MAP OF 1890.

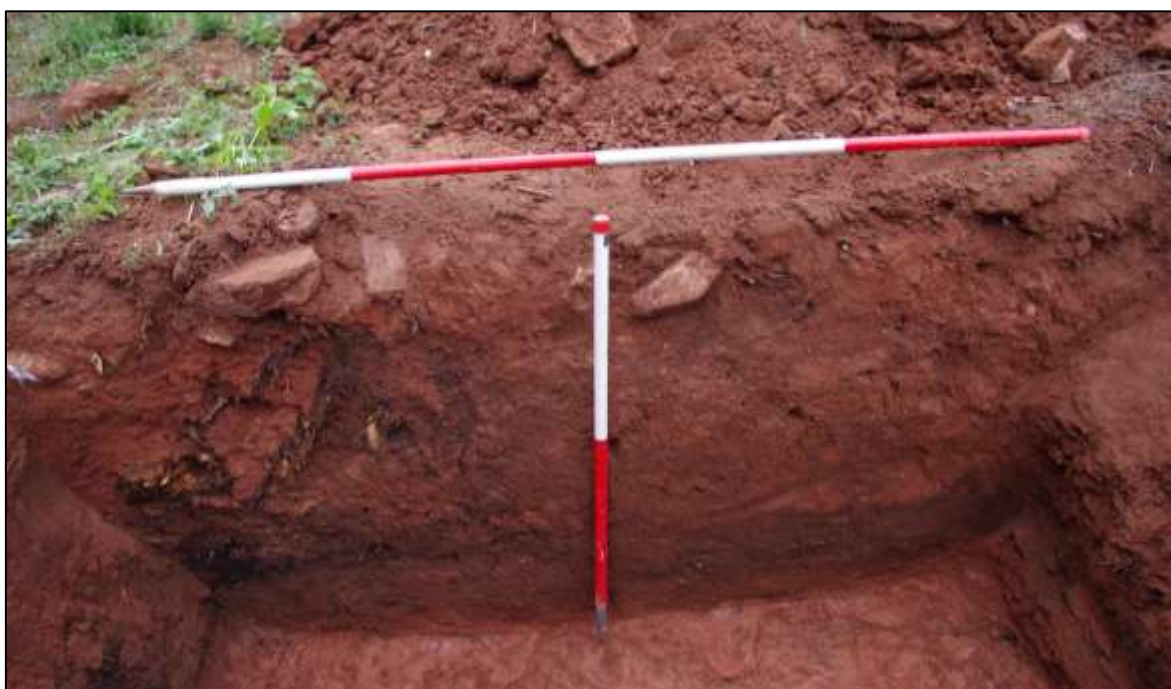
TP#1 (2.3×1m) was located close to the entrance of the site to the north-east, to investigate ground conditions below the proposed new access to the site. It determined that there was up to 0.8m of made ground over a buried soil c.0.3m thick; a disturbed area (101) filled with clean redeposited natural and rotted wood was probably the remains of a tree throw. The buried soil (103) was a slightly pinkish-grey sandy silt which sealed the hard, slightly brownish-pink sandstone natural (104). Tiny shards of transparent modern glass were recovered from the base of (101).

FIGURE 16: THE NORTH-EAST FACING SECTION OF TP#1; VIEWED FROM THE NORTH-EAST (SCALES 2M & 1M).

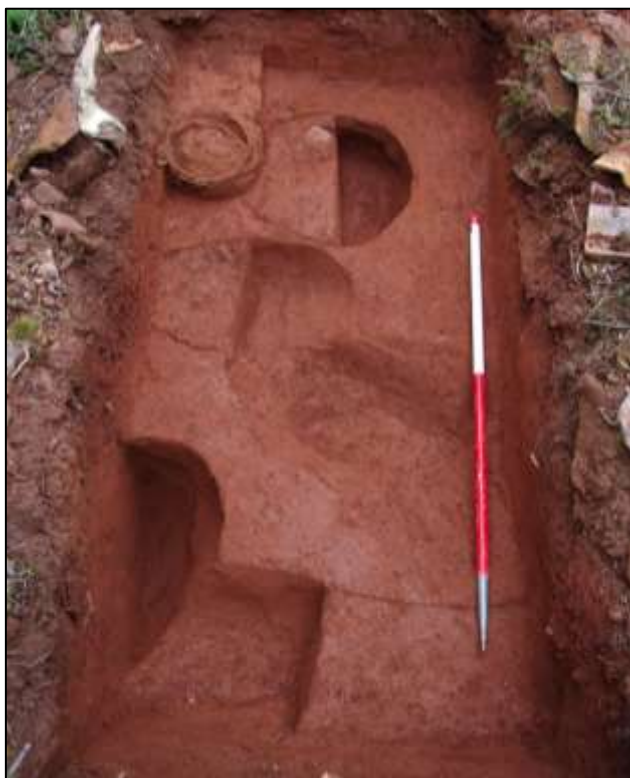
TP#3 (2.2×1m) was located within the footprint of the ruined building (B2), towards the northern end to avoid the piles of stone rubble. It was located to determine the character of the floor surfaces within B2, and it appears that, like B1, there was an earth floor. A large 19th century South Somerset jug <304> was found to be set into the floor, its shoulders missing but its neck and handle surviving within the base. In addition to this, four postholes and a shallow gully were exposed. Posthole [303] was 0.52m in diameter and 0.26m deep, with vertical or slightly undercut sides and a flat base. Fill (304) was a pale yellowish-pink sandy silt, very similar to the natural but distinguished by a slightly clayey texture. Posthole [306] was oval, 0.56×0.22m across and 0.15m deep, with sloping sides and a concave base. Fill (306) was similar to (304), and both featured probable but indistinct postpipes c.0.1m in diameter and marked by a couple of small (<80mm) sub-angular stones.

FIGURE 17: TP#3, VIEWED FROM THE WEST (SCALE 1M).

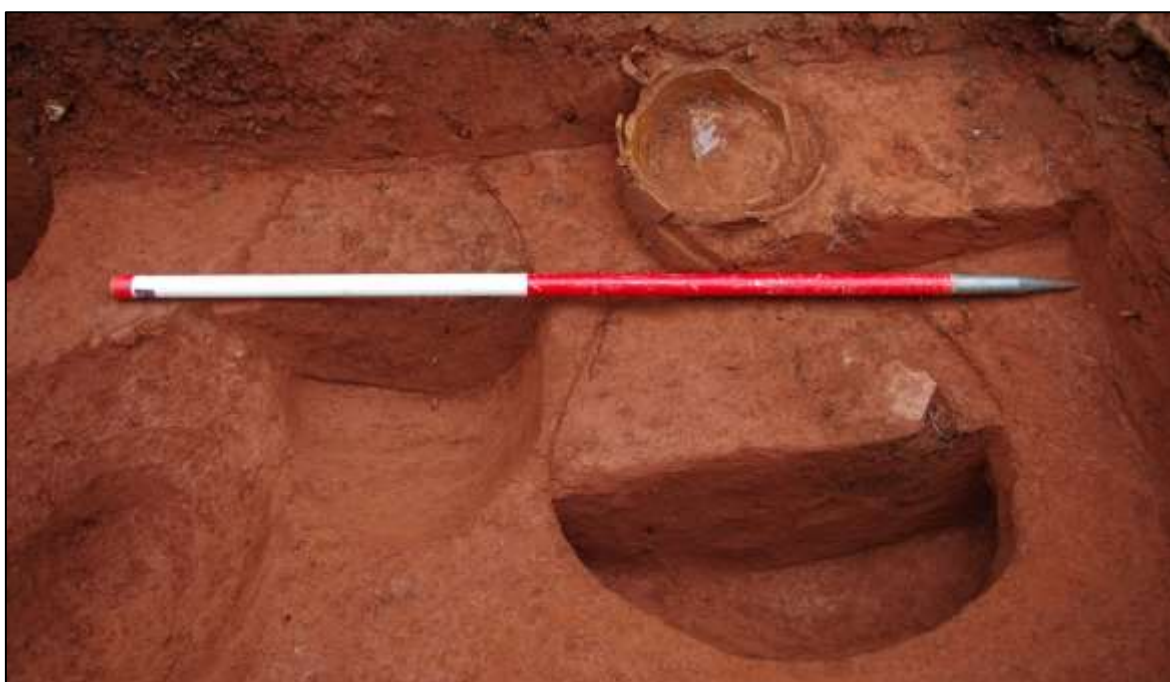
Posthole [307] was oval, 0.85×0.38m across and 0.13m deep, with a broad concave profile; it was filled by (308). Posthole [309] was 0.48m in diameter and 0.29m deep, with steep sides and a pointed base; it was filled by (310). Posthole [309] cut gully [311], which ran along the western side of the test pit; the gully was at least 0.16m wide and 0.1m deep, with sloping sides and a single fill. The fills of all the features were similar or identical to those of [303] and [305], but it appeared that posthole [[305] cut posthole [307], and gully [311] cut posthole [309]. Other than vessel <304> there were no finds.

FIGURE 18: TP#3, POSTHOLE [305] TO THE LEFT, POSTHOLE [303] TO THE RIGHT, AND VESSEL <302> TOP RIGHT; VIEWED FROM THE SOUTH (SCALE 1M).

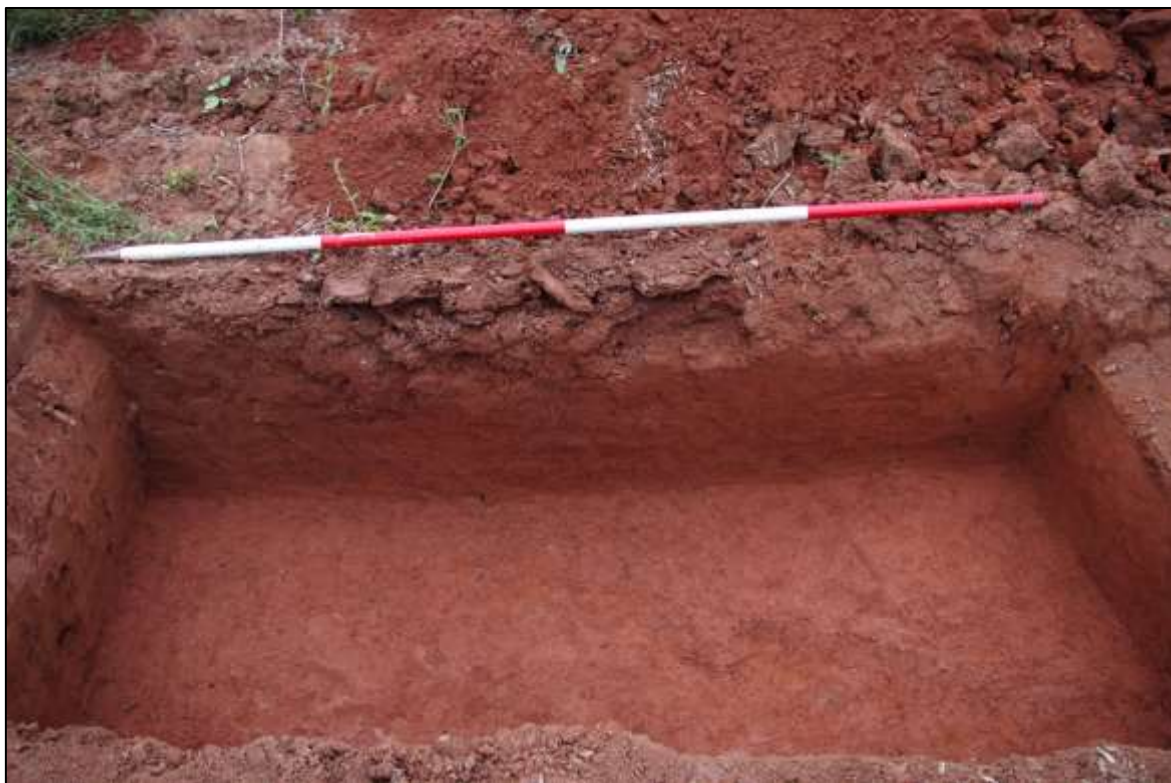
FIGURE 19: THE SOUTH-FACING SECTION OF TRENCH #5, WITH DITCH [503] TO THE LEFT; VIEWED FROM THE SOUTH (SCALE 2M).

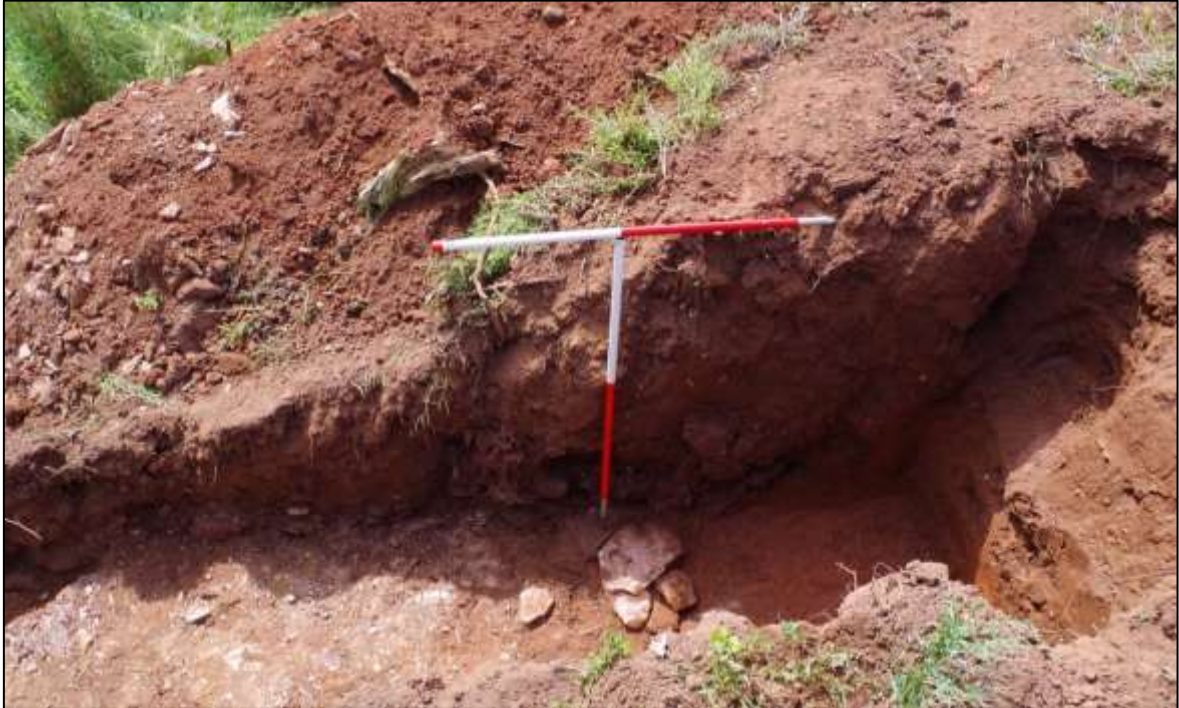
spread of angular shillet retained by a line of pitched shillet roughly parallel to (803). The latter could have been a path or narrow track along the side of the holloway.

FIGURE 22: THE NORTH-FACING SECTION OF TRENCH #8; VIEWED FROM THE NORTH (SCALE 1M).

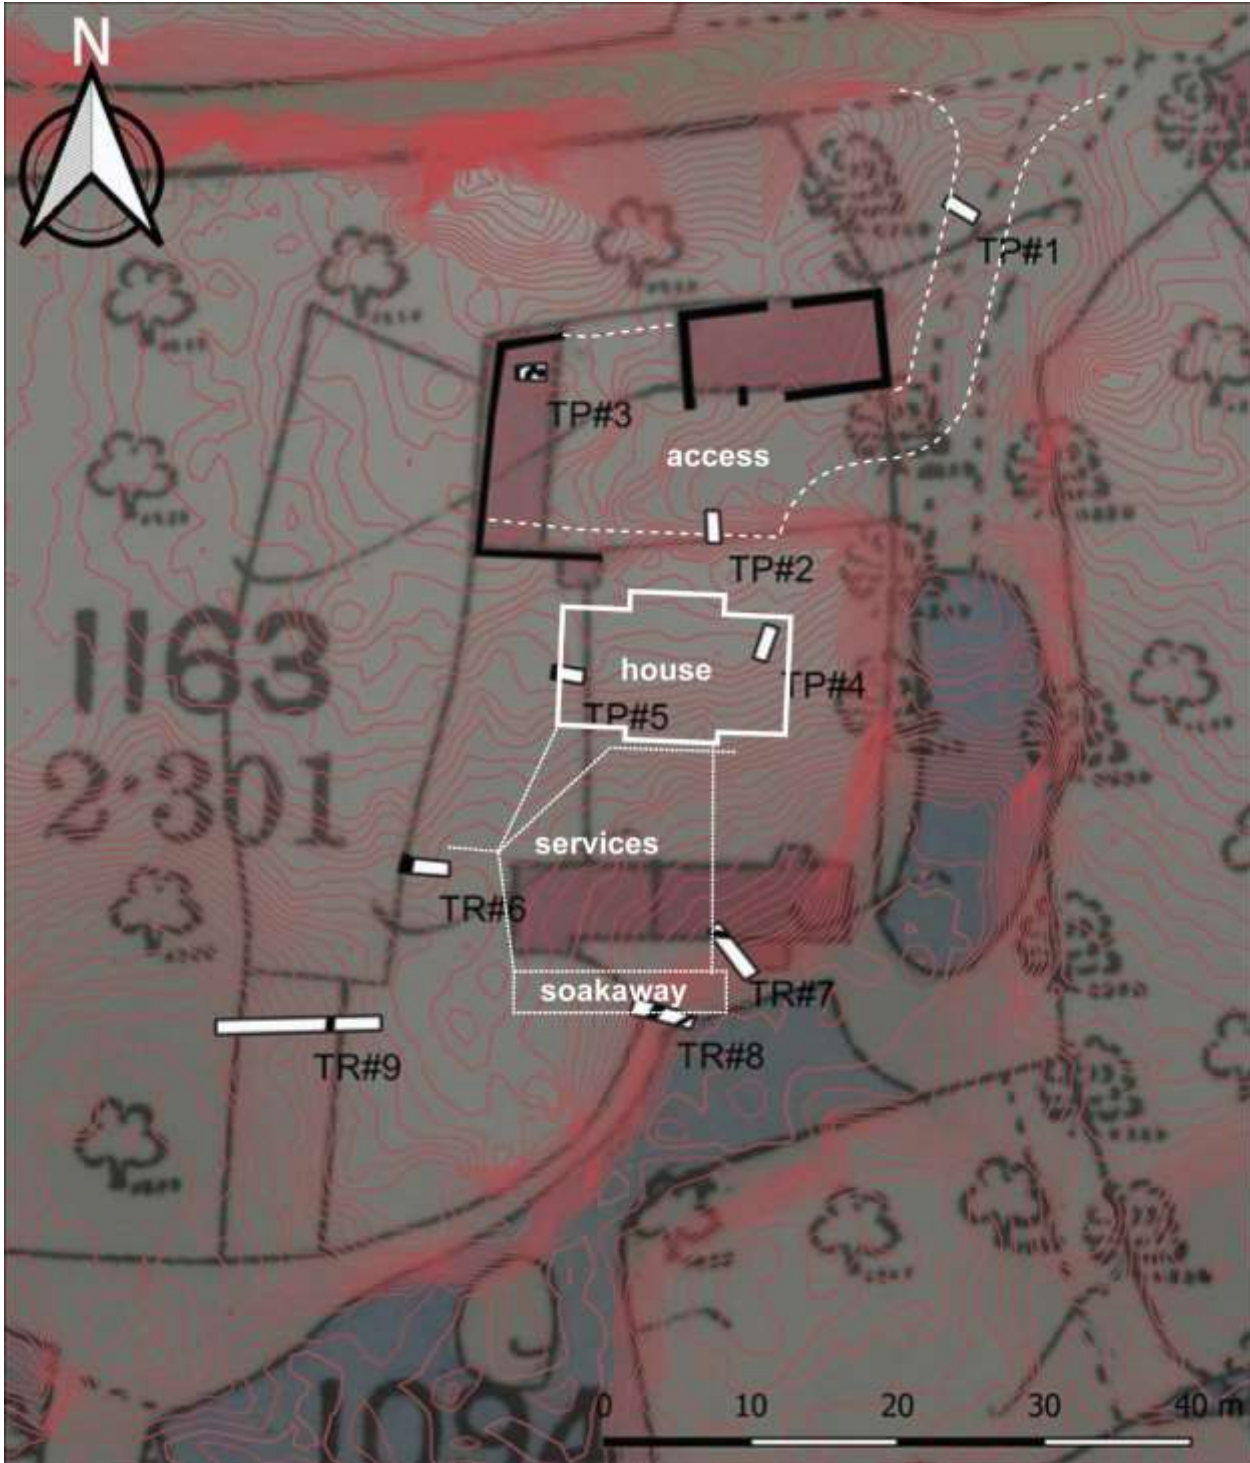
FIGURE 25: CURRENT DESIGN PROPOSALS.

The proposed development (Figure 25) would see the B1 and B2 repaired/rebuilt and a detached house built immediately to the south. A soakaway would be constructed to the south of the house, and there would be landscaping associated with the access. In terms of the impact of the proposals,

repairs to the standing building would affect their physical structure and the insertion of floors in B2 could expose more postholes. The house would be built in an area the evaluation suggests is largely devoid of features apart from ditch [503]. However, the associated soakaway/service trenches could impact on the lost farmhouse F1 and the boundary wall exposed in TP#6. Levels within the access road and most of the yard have either been built up or eroded down, so affect here would be less.

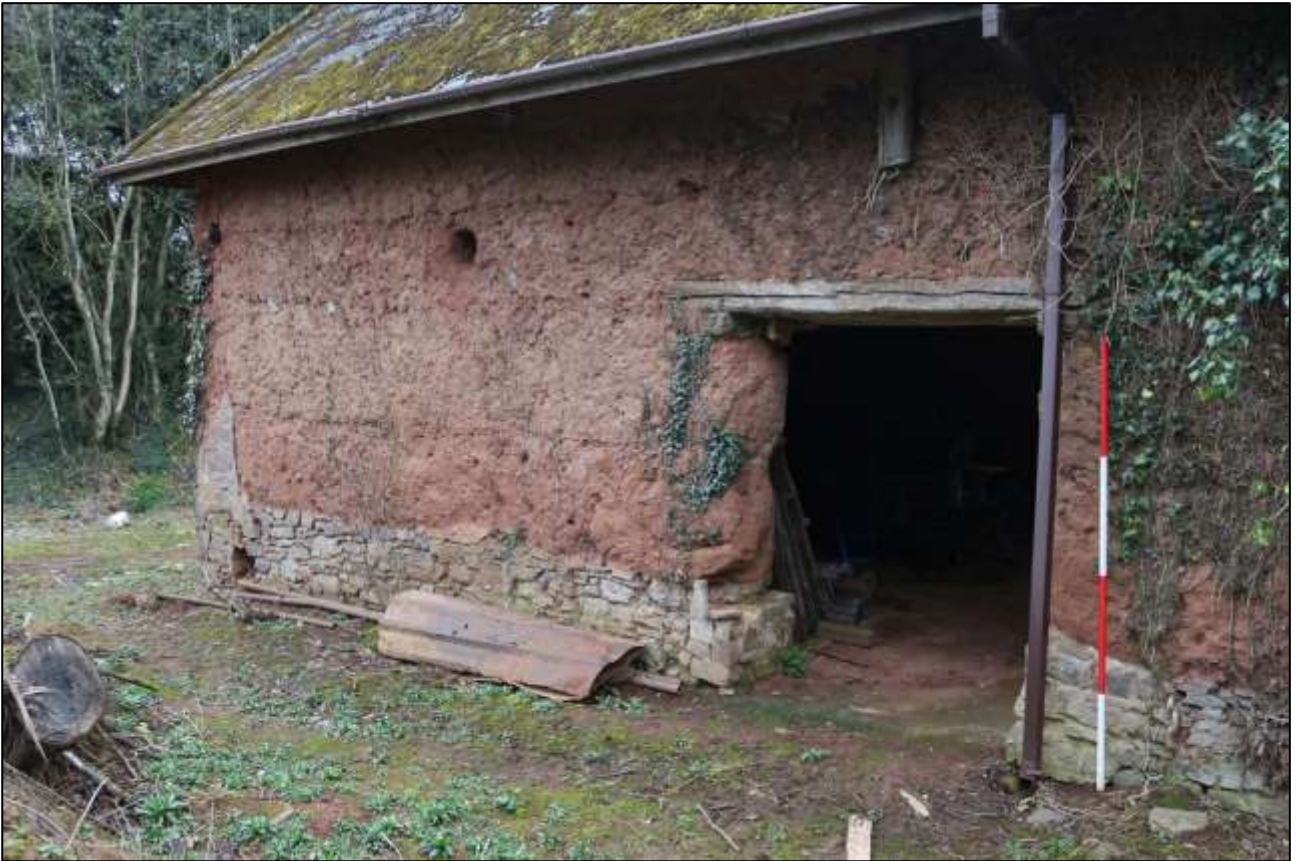
3. THE NORTH WALL OF B1, SHOWING THE RAISES IN THE COB; VIEWED FORM THE NORTH-WEST (SCALE 9M).

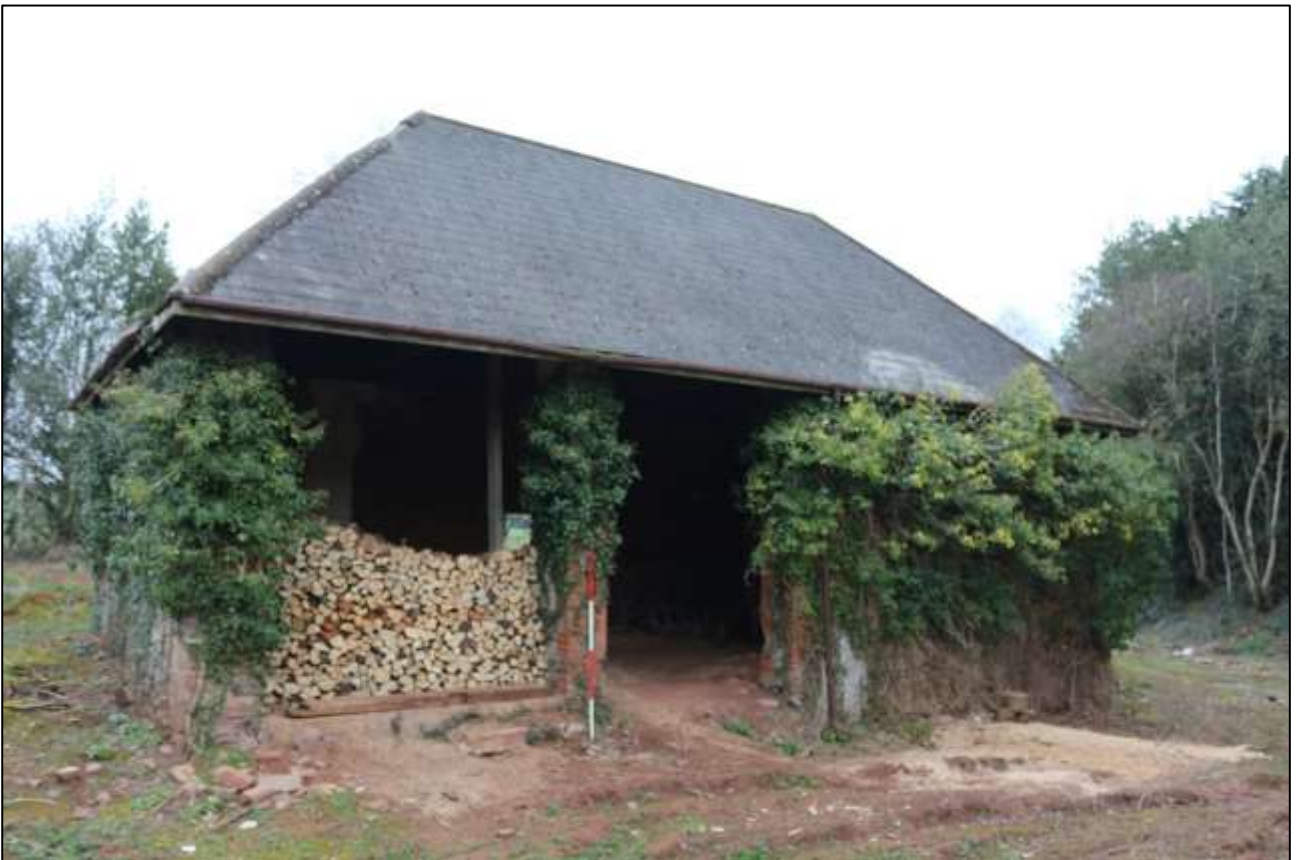
4. THE SOUTH WALL OF B1, SHOWING THE FORCED LINHAY OPENINGS; VIEWED FORM THE SSW (SCALE 2M).

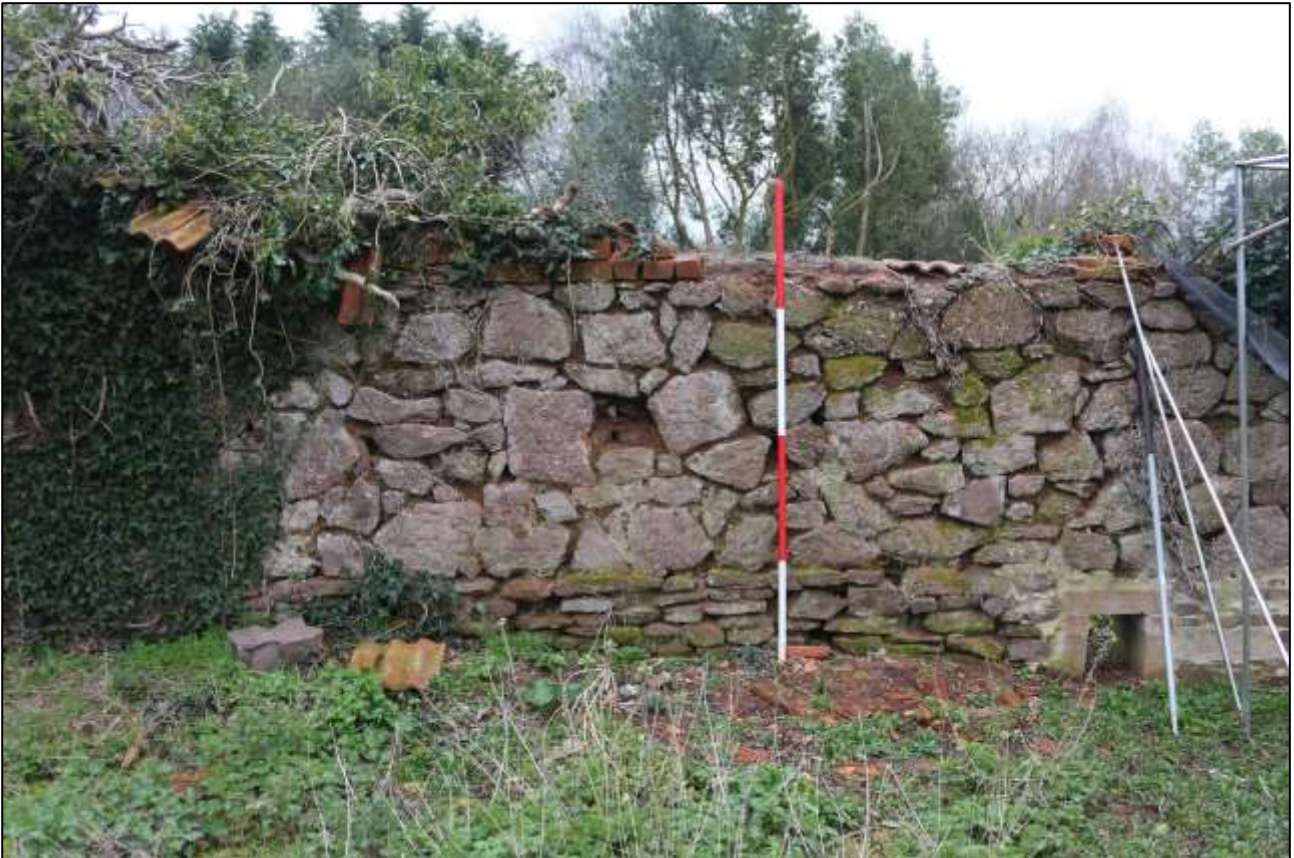
11. DETAIL OF THE REAR (WEST) WALL OF B2, SHOWING THE DIFFERENT STONE USED FOR THE RAISE; VIEWED FROM THE WEST (SCALE 2M).

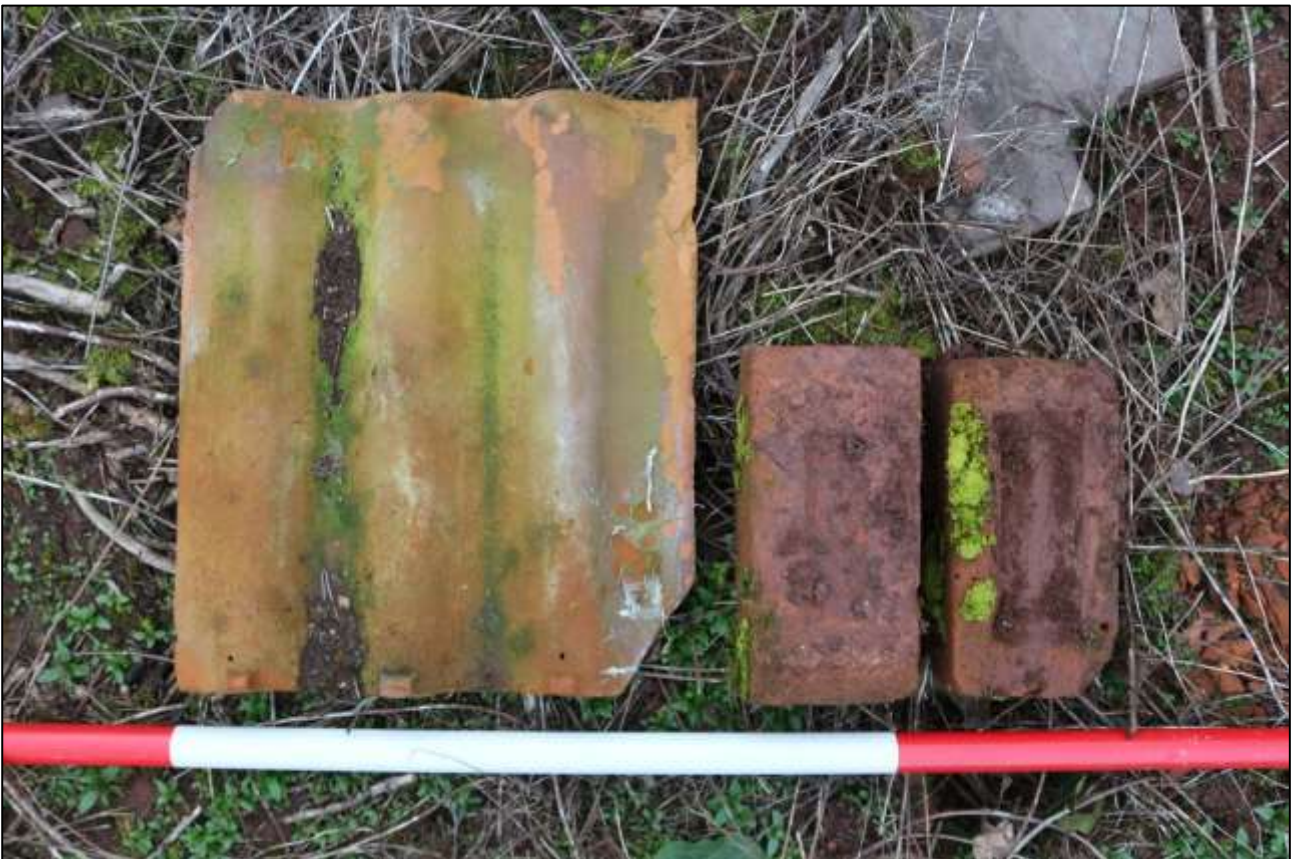
12. DETAIL OF THE BRICKS AND BRIDGWATER PANTILES USED IN THE (RE)CONSTRUCTION OF B2 (SCALE 2M).

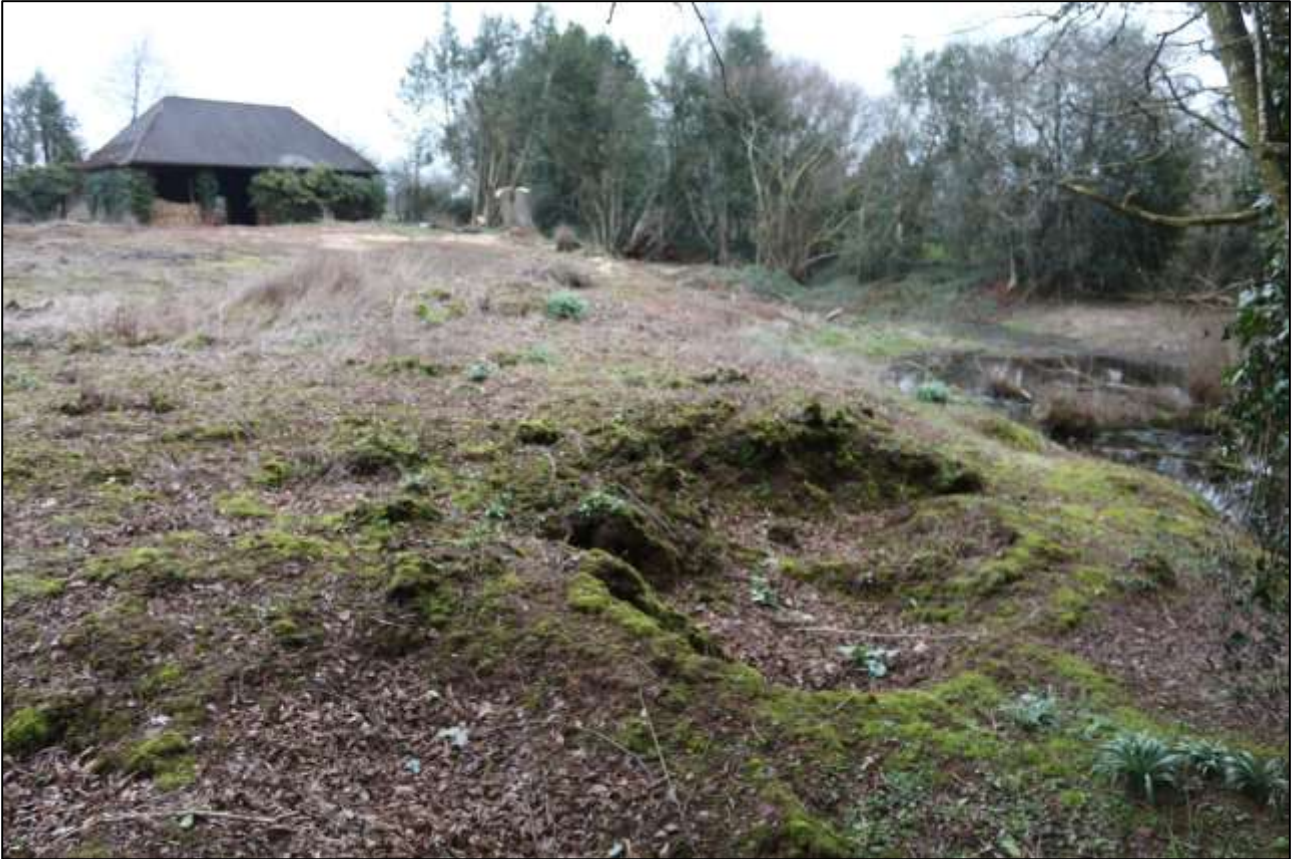
21. THE LOWER END OF THE SITE, SHOWING THE BADGER SETT DAMAGE; VIEWED FROM THE SOUTH.

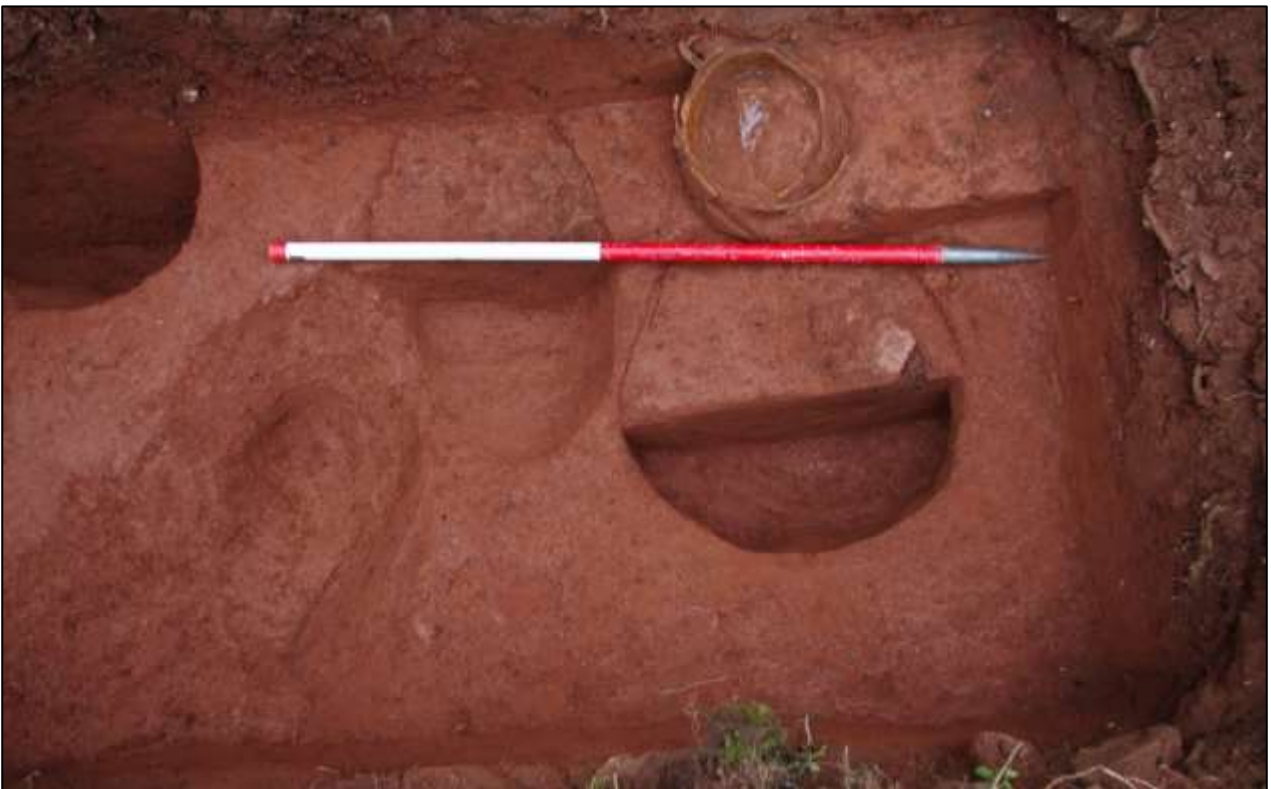
35. TP#3, VESSEL <302> AND POSTHOLES [303], [305], [307] AND [309]; VIEWED FROM THE SOUTH (SCALE 1M)

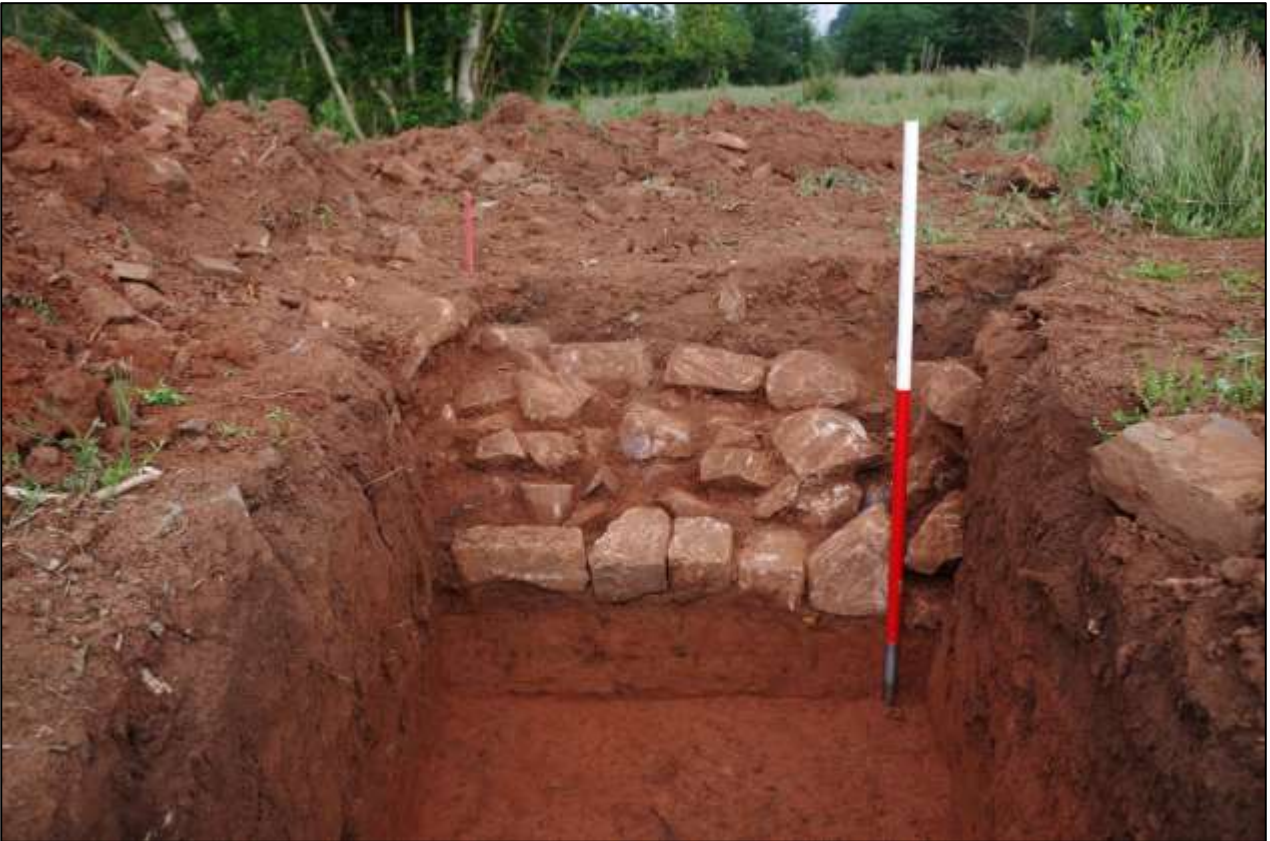
The stratigraphy in TP#6 (4×1m), to the south of TP#5, was identical to that of TP#4, save that at its western end the base of a wide stone wall {603} was encountered. Wall {603} was 0.95m wide and survived to a height of c.0.4m (3-4 courses). It was faced with fairly regular rectangular stone blocks, with a very haphazard core of mixed irregular and poorly sorted stone rubble in a loose earth bond; two of the stones in the core bore traces of a hard grey lime mortar. The stone rubble noted on the surface here is probably from this wall, which presumably was mostly built in cob. This wall is on the line of a historic boundary shown on historic maps until after 1934; this wall is on the line of the boundary between the tenements of Sellake and Hookley/Prowses, and the prebends of Priors and Clare. There were no finds.

41. WALL {603}; VIEWED FROM THE EAST (SCALE 1M).

The wall encountered in TR#6 was just over 1m wide and was on the line of the prebendal boundary between Priors and Clare. Its width and the careful use of semi-regular blocky facing stones could indicate a medieval date for this wall were it not for the haphazard core and the greyish mortar adhering to two of the stones there. Unless this represents a repair, it must be post-medieval in date, but its sheer size is at odds with a simple boundary. It is possible this was once a courtyard wall attached to F1, or possibly a retained wall from another lost structure. The scatter of rubble observed on the surface here, including the worked stone, are probably from this wall rather than F1 or F2.

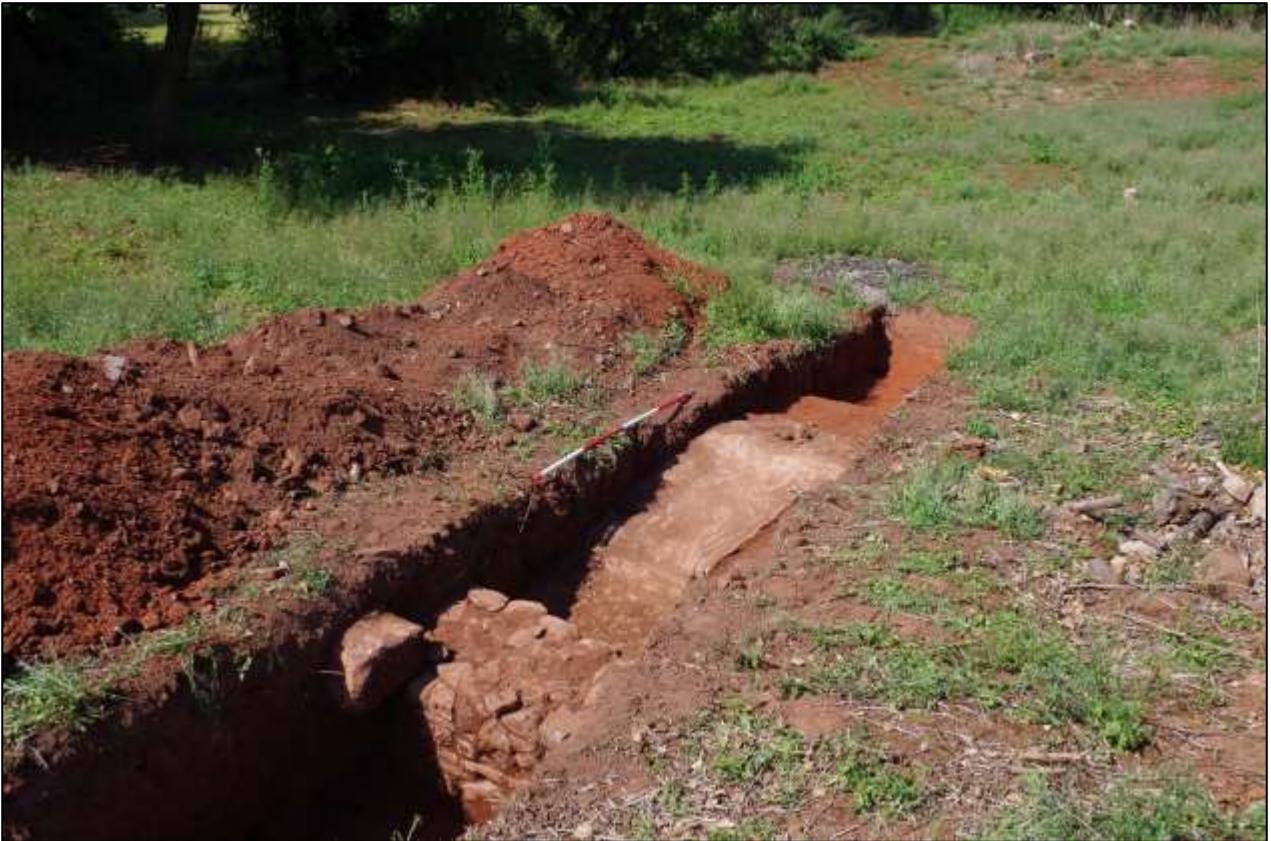
45. TR#9 SHOWING WALL {905} AND FLOOR (907); VIEWED FROM THE NORTH-EAST (SCALE 2M).
