Recorder: S.H. Walls, South West Archaeology Ltd		Date sent to DNP: 10/10/2019

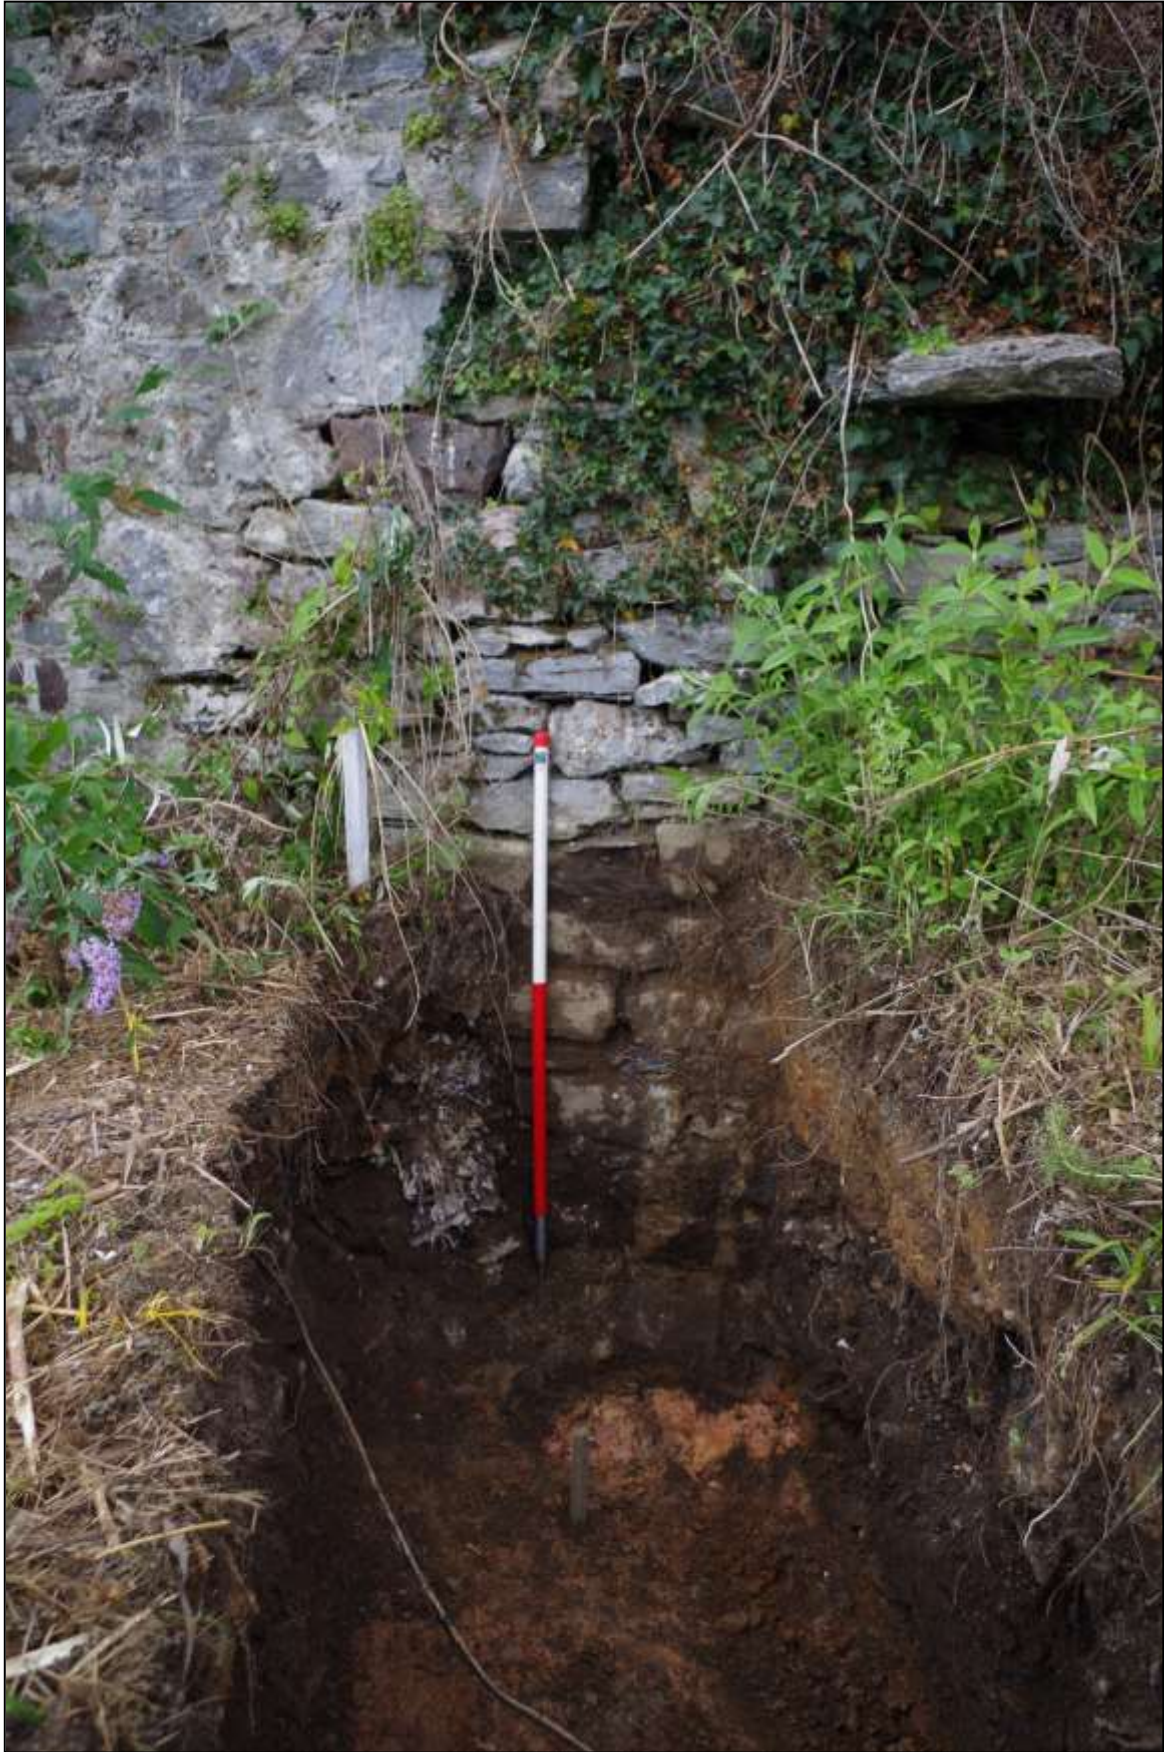
FIGURE 2: EXPOSED STONE WALL FOOTING, NOTE THE PROJECTING STONE IN THE BUILD ABOVE, POTENTIALLY FOR A SLUICE(?), VIEWED FROM THE EAST (1M SCALE).

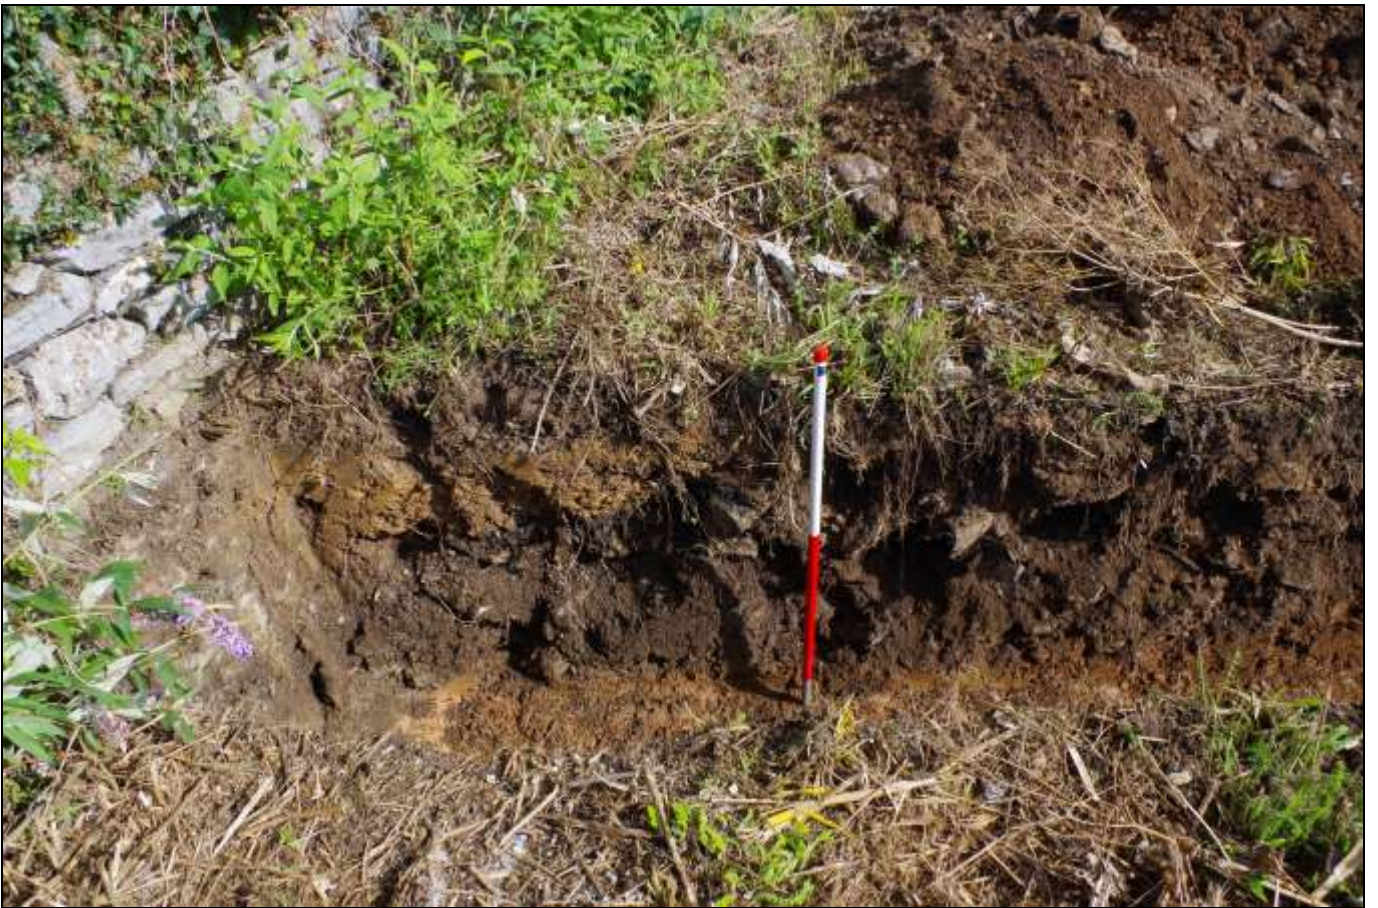
FIGURE 3: SOUTH FACING SECTION, SHOWING THE INFILLED LEAT DEPOSITS ABUTTING THE HISTORIC STONE WALL; VIEWED FROM THE SOUTH (1M SCALE).

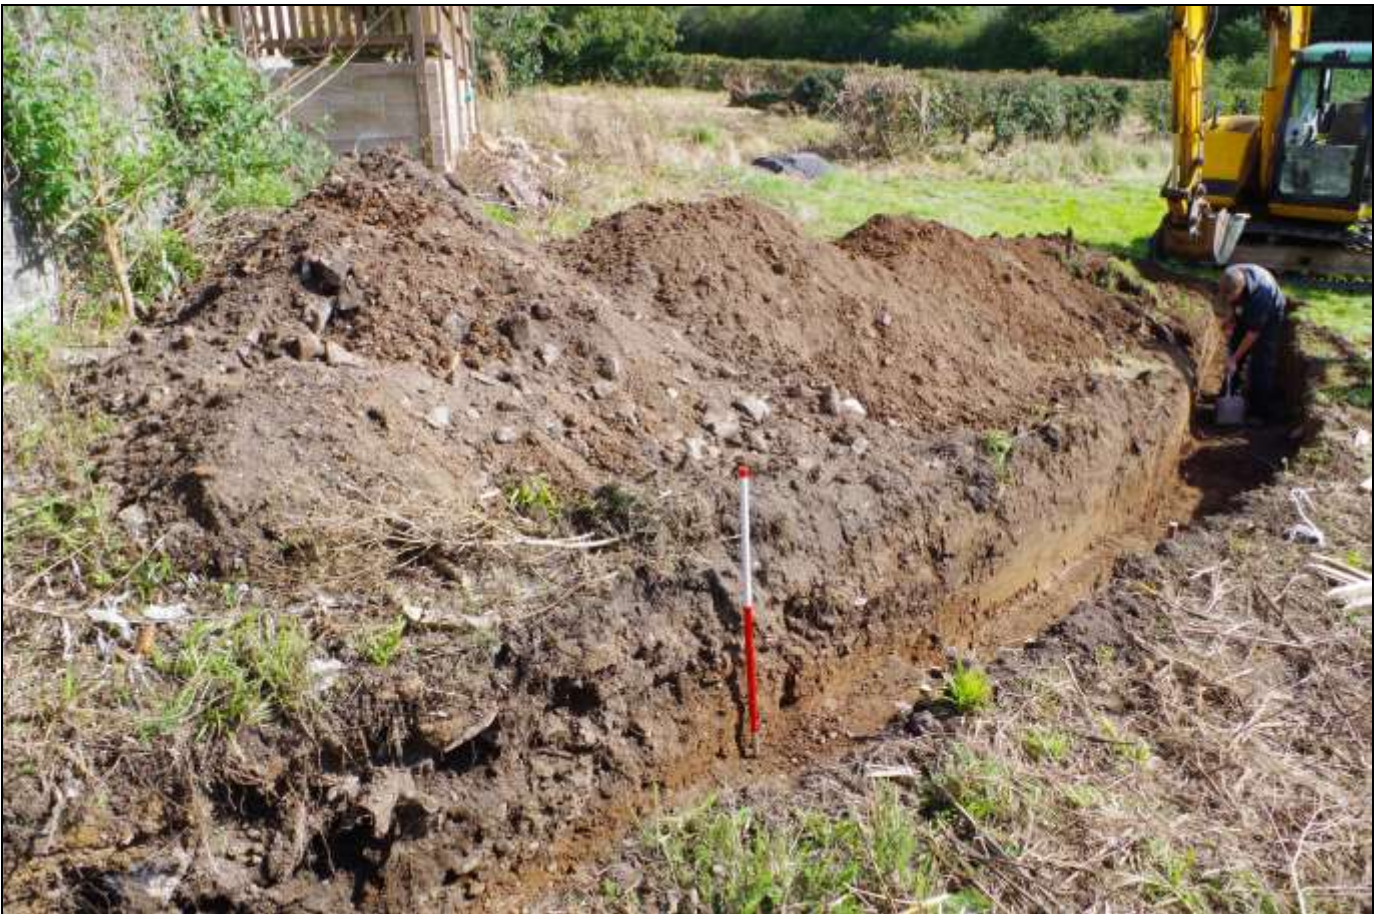
FIGURE 4: FOOTING TRENCH DURING EXCAVATION, THE SCALE LOCATED IN THE LOCATION OF THE BURIED BANK (106); VIEWED FROM THE NORTH-EAST (1M SCALE).
