Devon County Council Historic Environment Record

Civil Parish & District: Littleham, Torridge	National Grid Reference: SS 44353 23499		Number:	
Subject: Archaeological monitoring and recording during drainage works at St. Swithun's Church, Littleham, Bideford, Devon.				Photo attached? Yes
Faculty Reference: 2017-016249		Recipient museum: n/a		
OASIS ID: Southwes1-362981 Mus		Museum Accession no: n/a		
Contractor's reference number/code: LSS19		Dates fieldwork undertaken: 22 nd and 23 rd October 2019

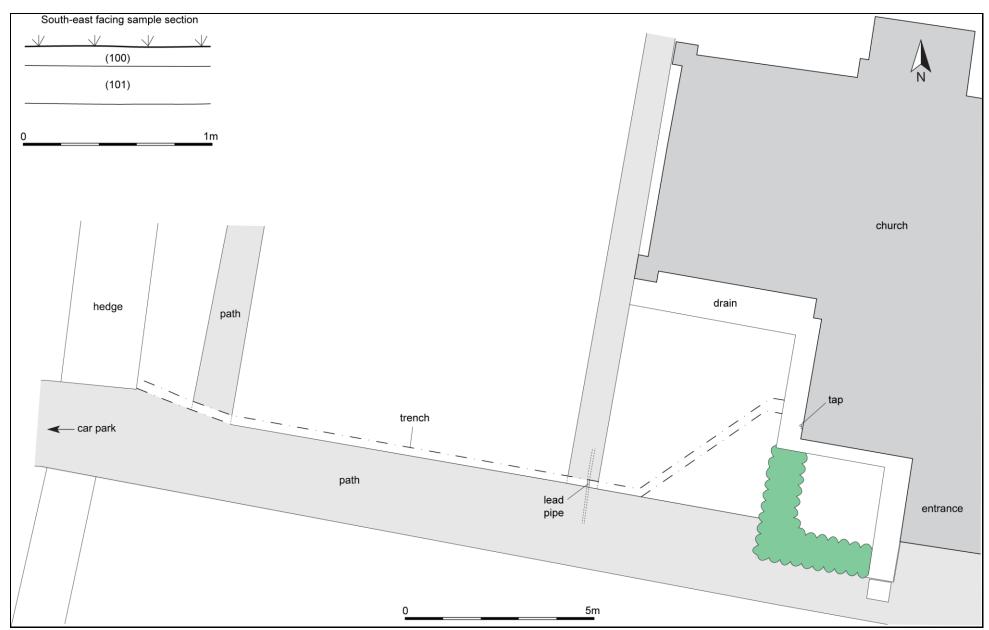
FIGURE 1: SAMPLE SECTION AND SITE PLAN SHOWING LOCATION OF TRENCH AND SURROUNDING AREA.

A 0.25m wide trench was excavated by hand, under archaeological supervision through the churchyard. The trench ran from just north of the water tap located at the corner of the body of the church, to the south of the tower and ran along the length of the main churchyard pathway to the north-west; both concrete footpaths were cut through using a powered saw. The trench measured approximately 18m in length, and was excavated to a depth of c.0.30m. The stratigraphy of the site comprised topsoil (100), a very dark grey-brown soft-friable silt-soil c.0.10m thick; overlying subsoil (101), a mid-light yellow-brown soft-firm clay-silt, with common sub-angular stone 5-10cm across, c.0.20m thick.

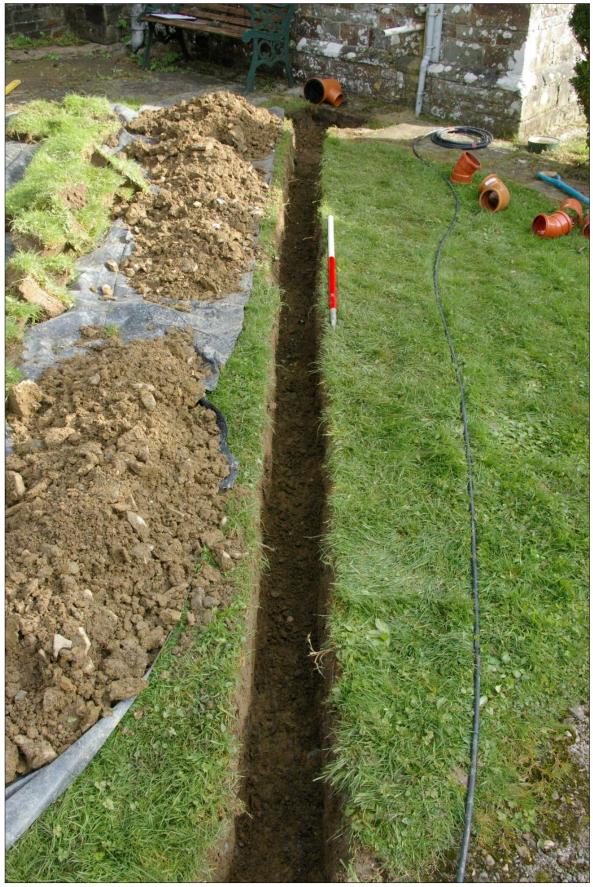
Figure 2: excavated trench with drilled holes in background; from the south-west (1m scale).

No features were identified within the trench; with the exception of a 1" lead water pipe which was orientated north-south and was found running underneath the eastern-most path next to the church and continuing beneath the main footpath access. In general as wold be expected near a footpath and within a churchyard, the soils encountered appeared to have been disturbed. However, a small assemblage of finds were found, all from subsoil (101), which included: x14 sherds of late medieval to post-medieval pottery (a mixture of local North Devon coarsewares and scraffito pottery types), x1 sherd of glass onion bottle, x1 20th century coin, x1 button and x 2 coffin nails. A small number of bone fragments were encountered and re-interred within the trench.
