ELECTRIC BINGO HALL SITE NEWPORT STREET TIVERTON DEVON

Results of a Desk-Based Assessment,
Archaeological Building Survey,
Archaeological Evaluation and Excavation

Report No.: 090204
Authors: M. Gillard
T. Green
C. Humphreys

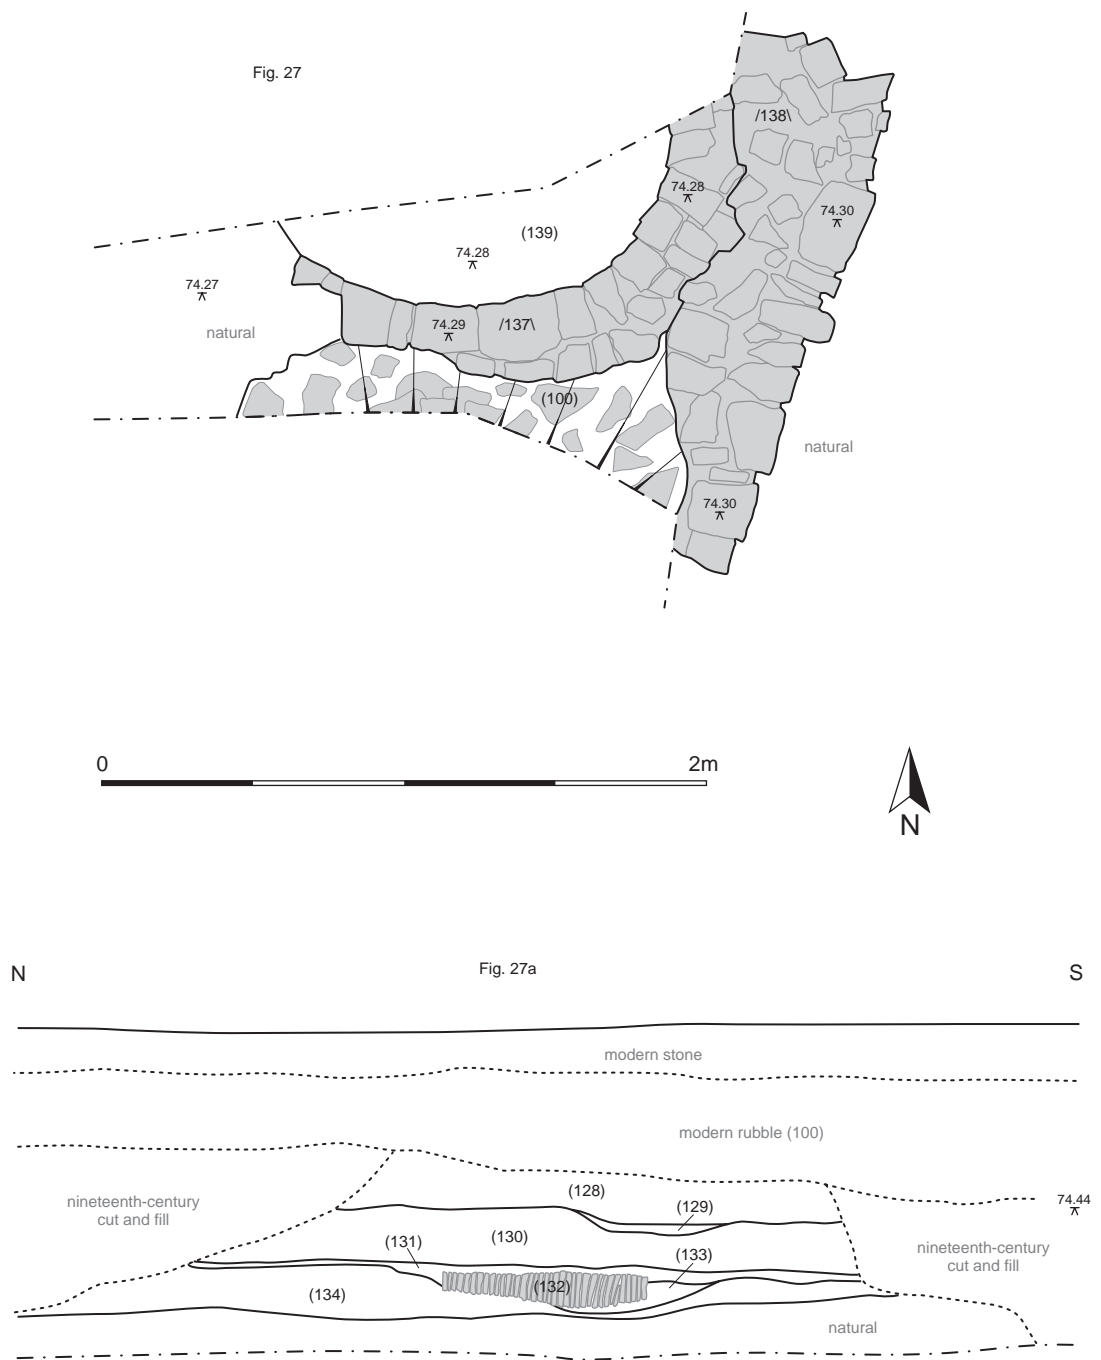
Fig. 27: Plan and section of features found in Western Area of the site; note that all levels are in metres above Ordnance Datum.

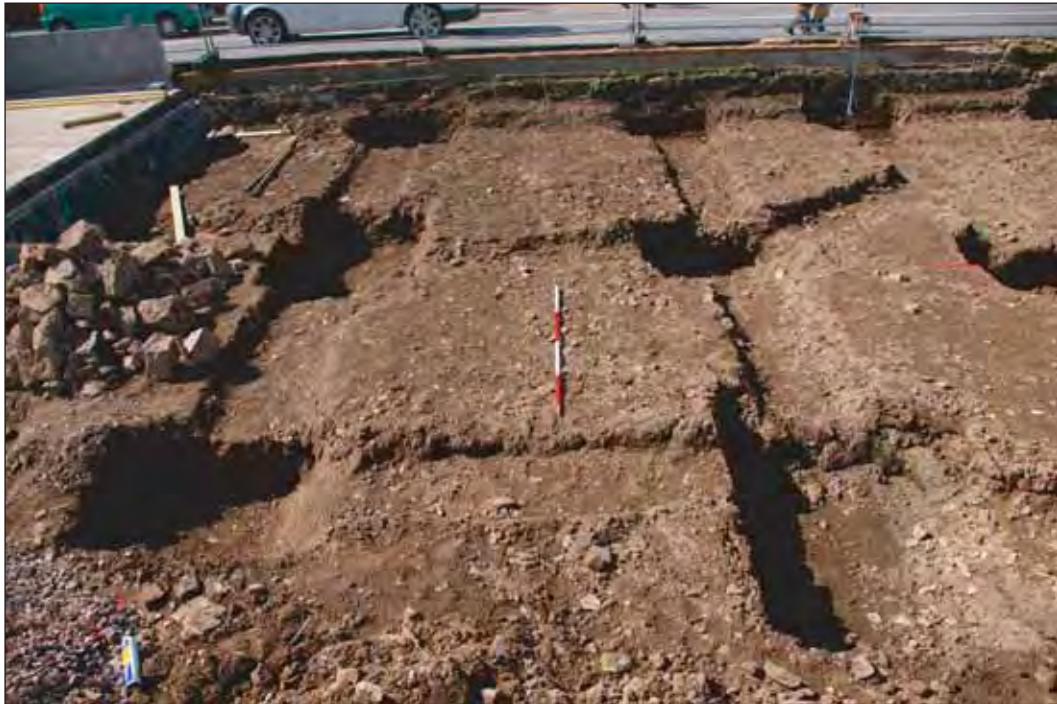
Plate 6: The north-west corner of the site, viewed from the south. The depth of trenching for pile caps and foundation beams is above the archaeological deposits revealed by the evaluation. 2m scale.

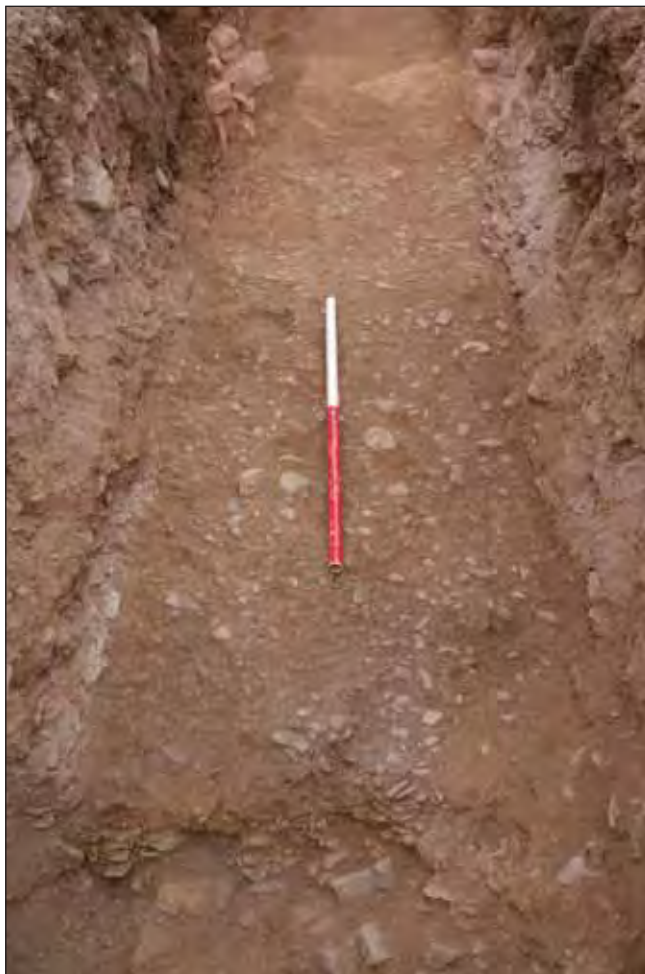
Plate 7: Surface (406), viewed from the south. This cobbling abutted wall /403\ to the north and was probably the floor of a medieval building. 1m scale.

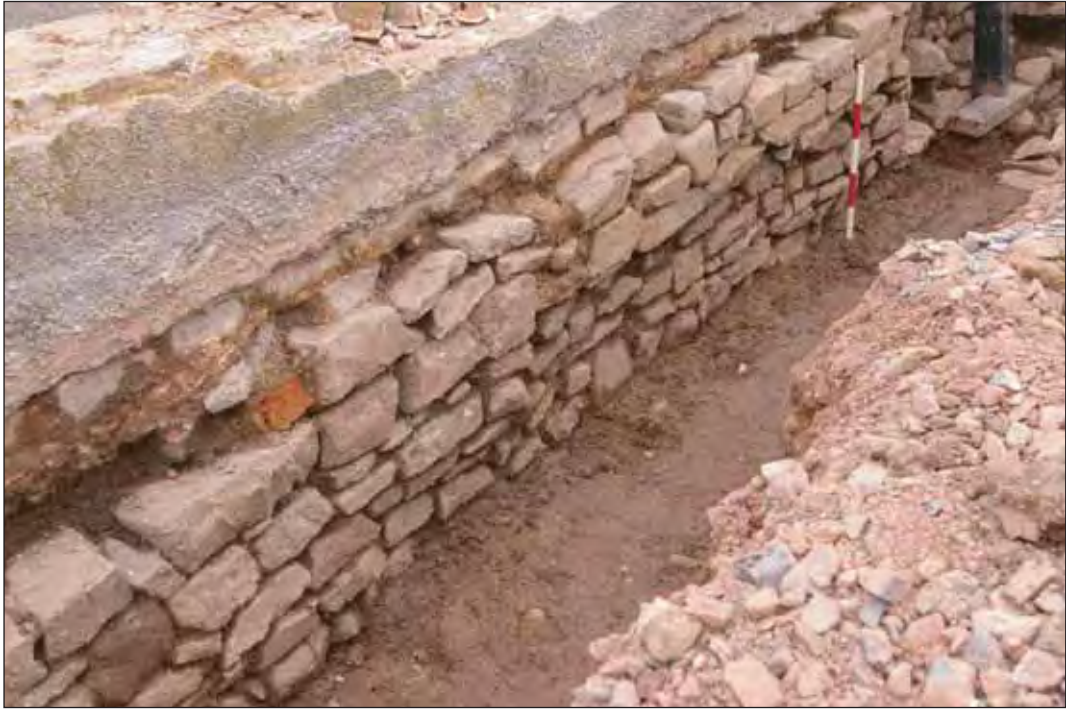
Plate 8: Walls /111\ (below) and /102\ (middle) overlain by a modern rendered wall, viewed from the northwest. These walls formed the eastern boundary of the site. 0.5m scale.

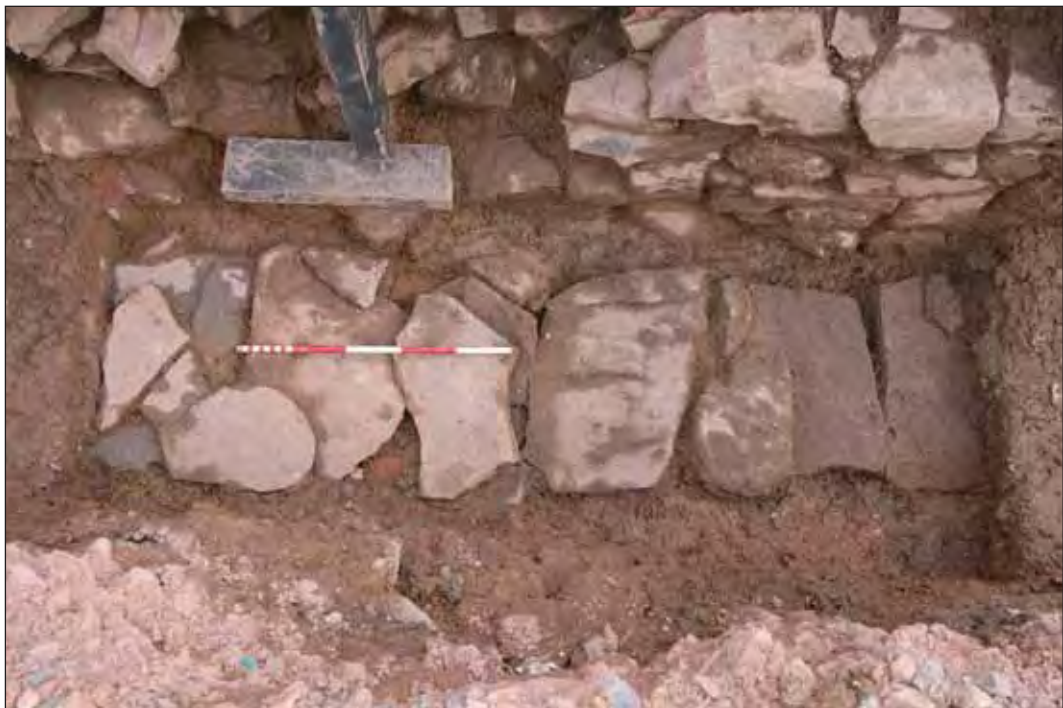
Plate 9: Victorian drain /109\ against the foot of wall /102\, viewed from the west. The cut for this drain [110] truncated all relationships between the layers on the site and the eastern boundary wall. 0.5m scale.

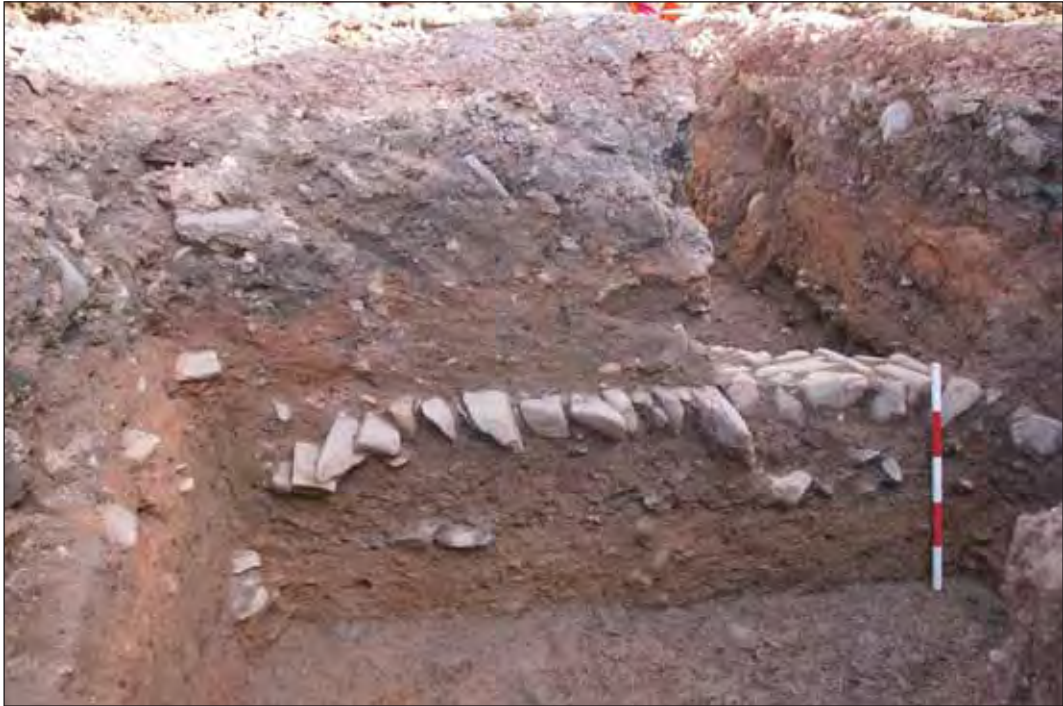
Plate 10: Cobbling (116), viewed from south. The lower surface at the base of the excavation is (153) a very compact layer of stones on the top of the natural. 0.5m scale.

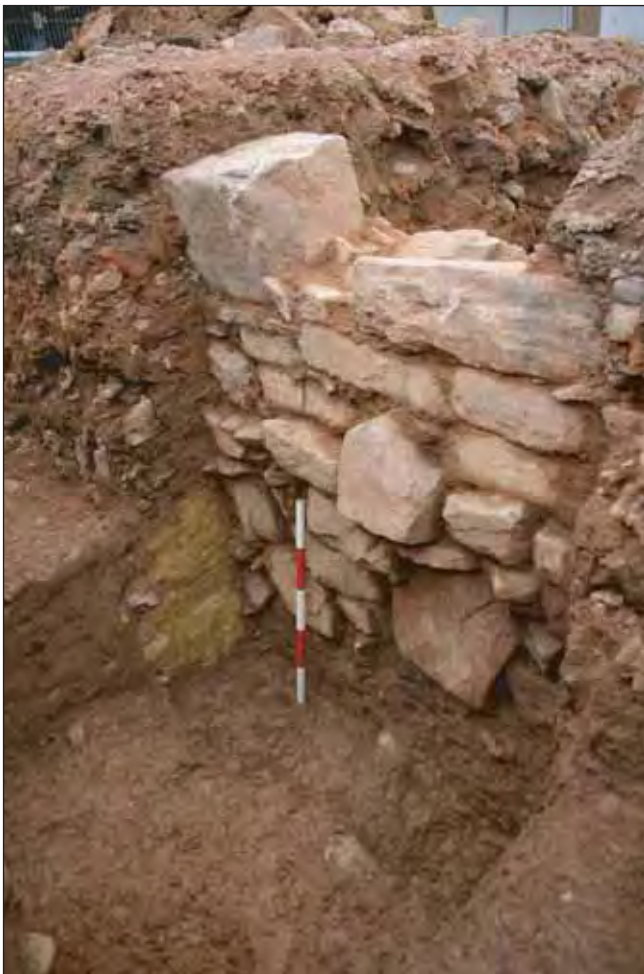
Plate 11: Wall /101\ (lower courses), /184\ (upper courses), viewed from the northwest. Note the yellow clay (170) plastered up the base of the wall within cut [169]. 0.5m scale.

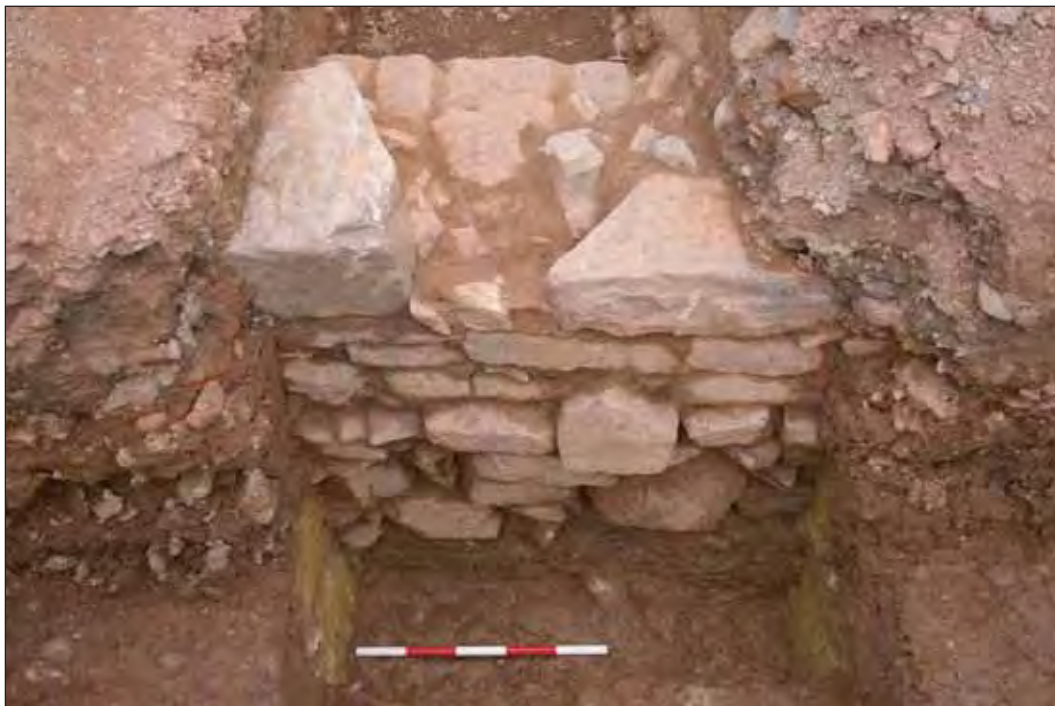
Plate 12: Wall /101\ (lower courses), /184\ (upper courses), viewed from the north. The stonework of /184\ is considerably more regular than that of /101\. 0.5m scale.

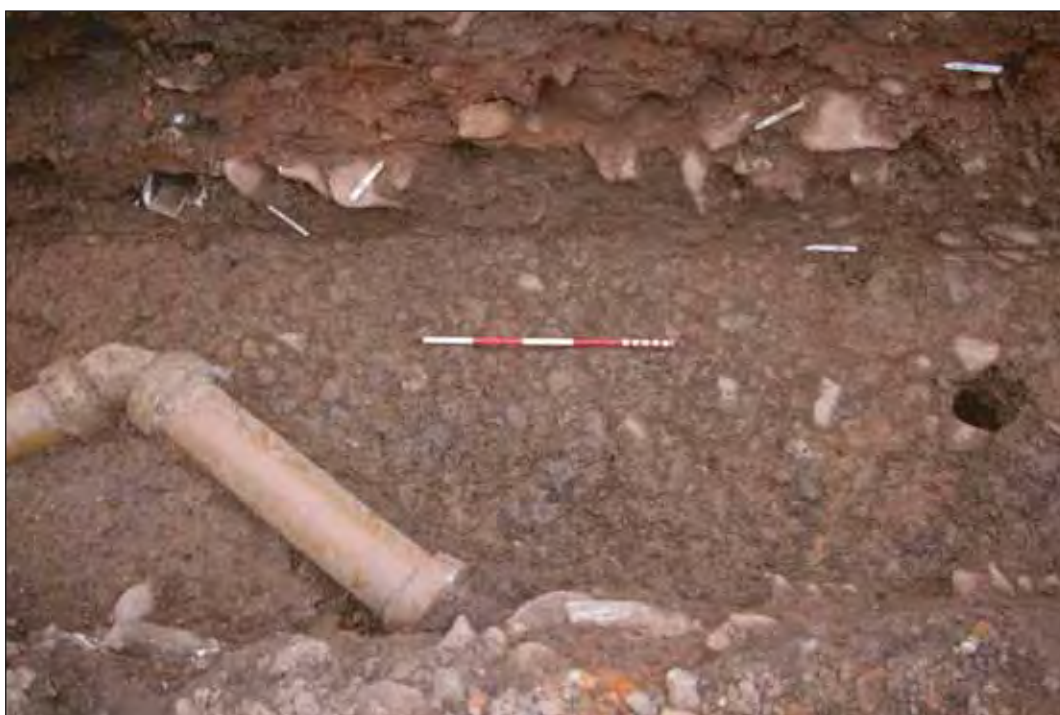
Plate 13: Compact surface (520) in the base of Trench (5), the pipe to the left is a modern service and the void to the east a recent borehole. 0.5m scale.

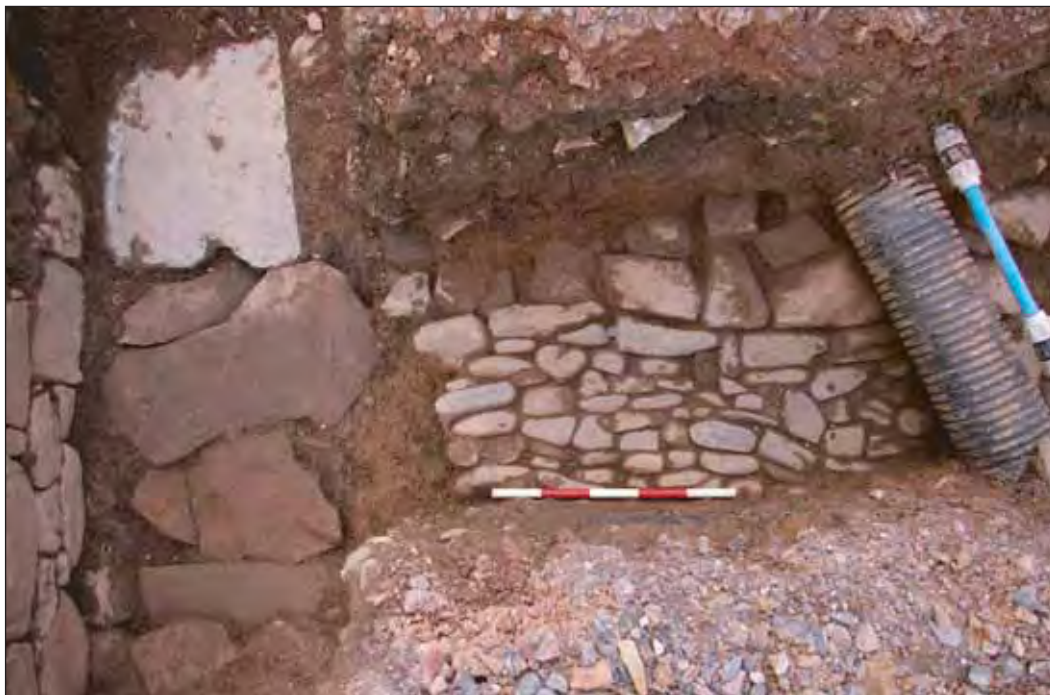
Plate 14: Wall /108\ (far left), Victorian drain /109\ (mid-left), 17th century cobbling (116) (lower right), later-medieval wall footing /141\ (upper right), modern services (far right). 0.5m scale.

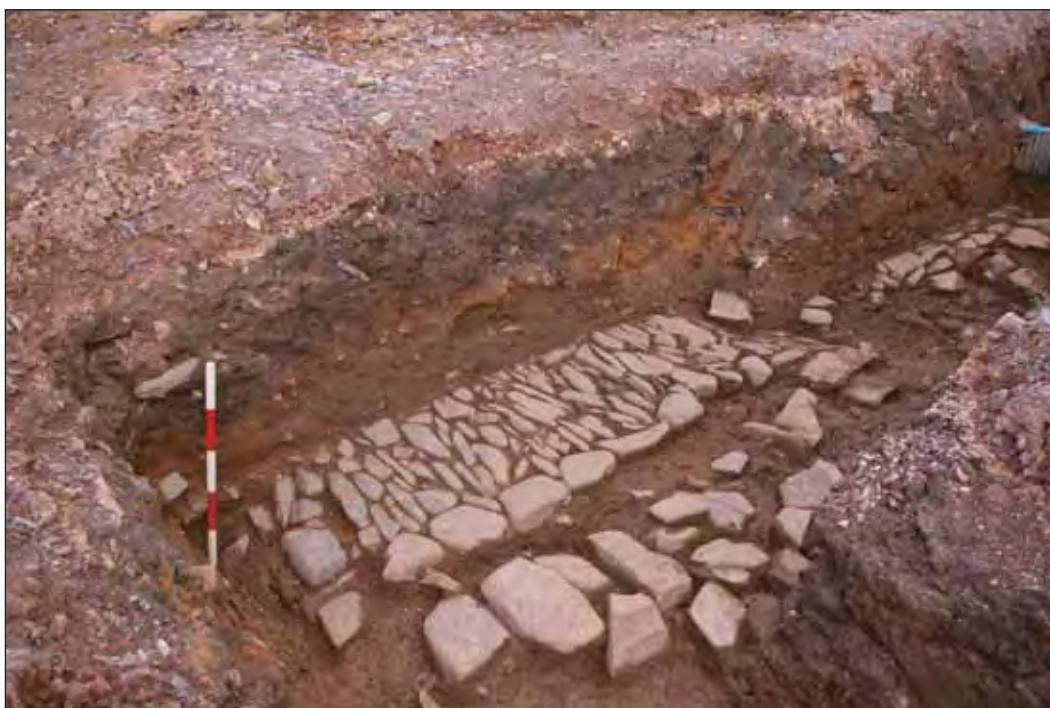
Plate 15: Cobbles (116) with wall footing /141\ in the foreground, viewed from the southwest. 0.5m scale.

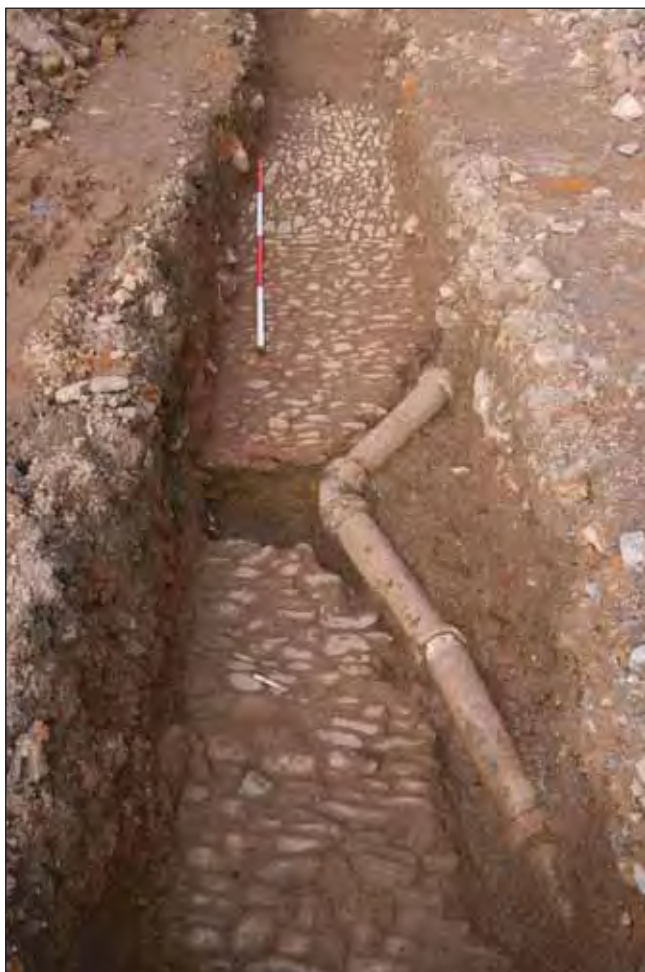
Plate 17: Cobbles (508) in Trench (5) - as (116) cut by Victorian services, viewed from the south. 2m scale.

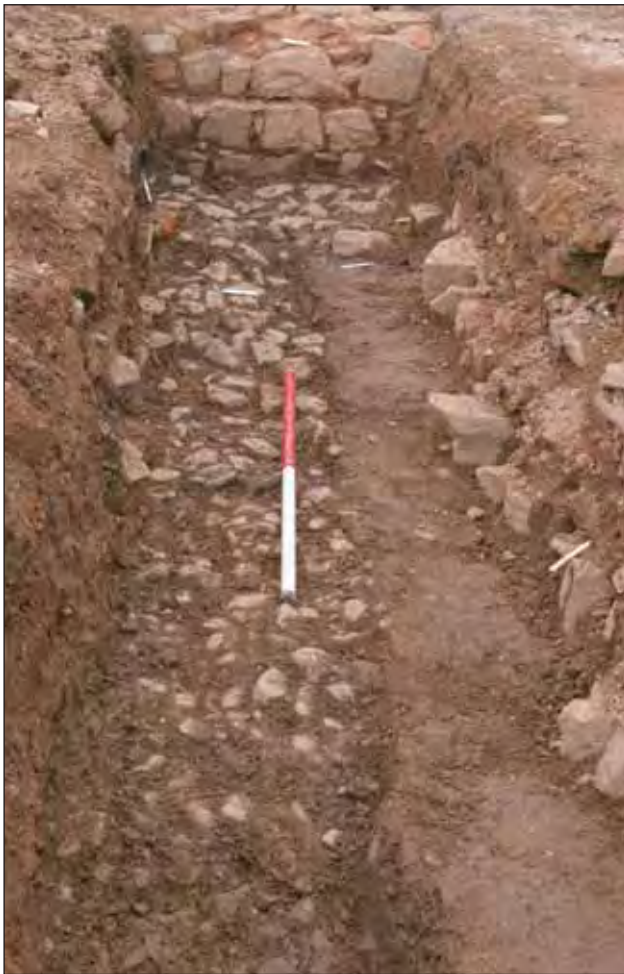
Plate 18: Stony layer (516) overlain by (514) (right) with wall /101\ in the background, viewed from the south. 1m scale.

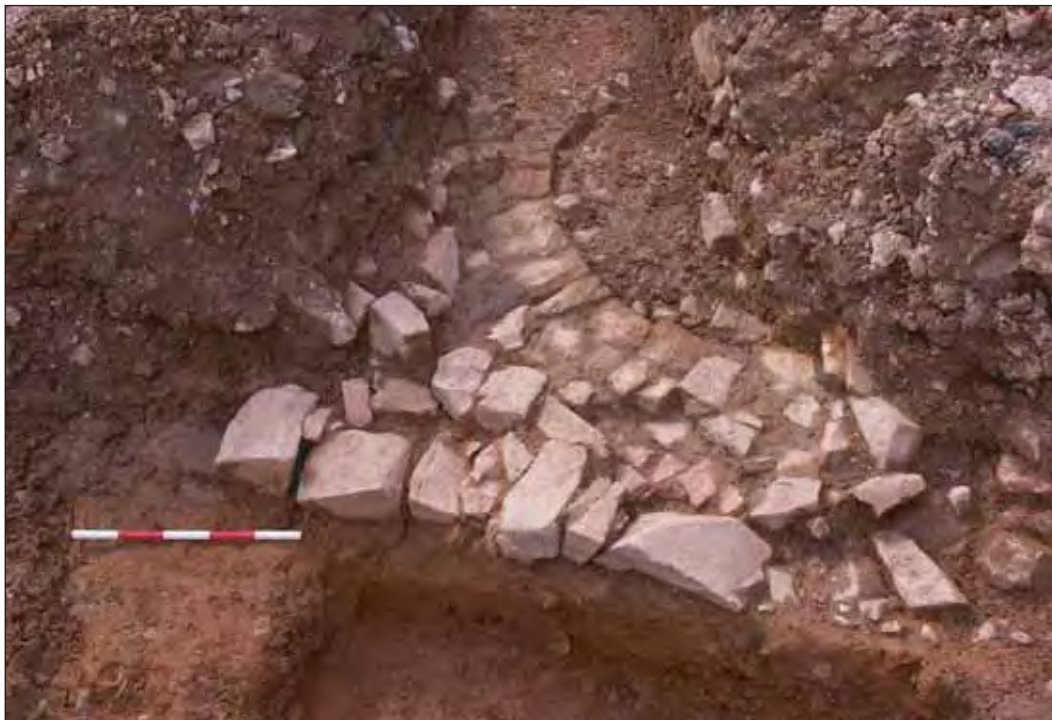
Plate 19: Wall footing /138\ with curving wall /137\ behind viewed from the east. 0.5m scale.

On the western edge of the wide trench, where another foundation beam trench joined it, stone structures were revealed (Plate 19). /137\ was a curving stone wall describing 120° of a circle with an internal diameter of approximately 1.5m; it extended beyond the northern limit of excavation and petered out to the west. It consisted of sub-angular stones 100-300mm across set in a flat course with a fairly flush inner face but very irregular outer edge; these were bonded with a soft grey-brown clay-silt. Within this lay (139), a soft red-brown slightly sandy clay-silt in which angular stone <150mm across was very common. Neither /137\ or (139) were excavated as they lay below the depth of excavation required by the development.
