PLAISTOW BARTON SHIRWELL DEVON

Results a Desk-Based Assessment,
Historic Building Recording & Archaeological Monitoring

Report No.: 116123
Date: 23.06.11
Authors: T. Green
D. Laing-Trengove
S. Walls

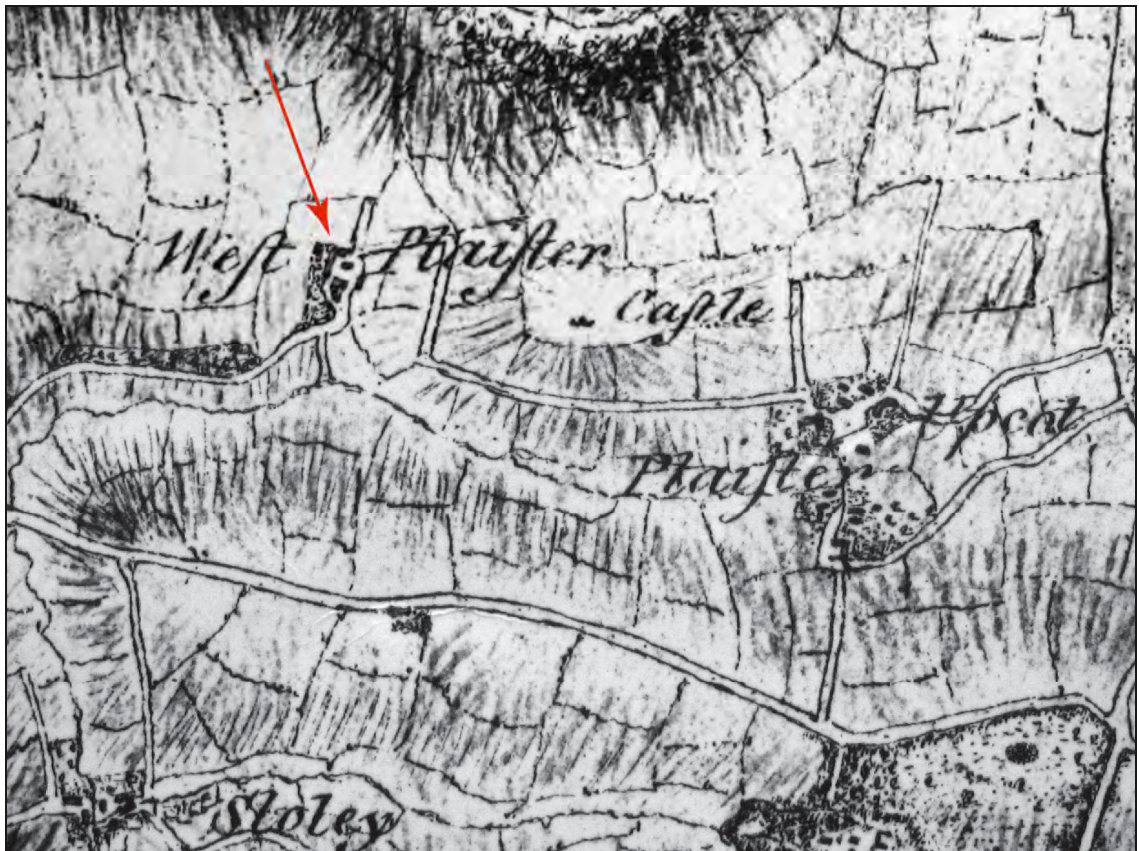
Figure 3: Extract from the Ordnance Survey Surveyor's Draft map of 1804-5 (WCSL).

The earliest available map of the site is the Ordnance Survey's Draft Map of 1804-5 (Figure 3) which shows a range of buildings labelled 'West Plaister' which represent what is later called Plaistow Barton. The map provides no specific detail of the lay-out of buildings, only indicating that there were several structures on the site at this time. The map does however hint at the ovoid enclosure within which the buildings and neighbouring paddocks are later seen to be contained within.

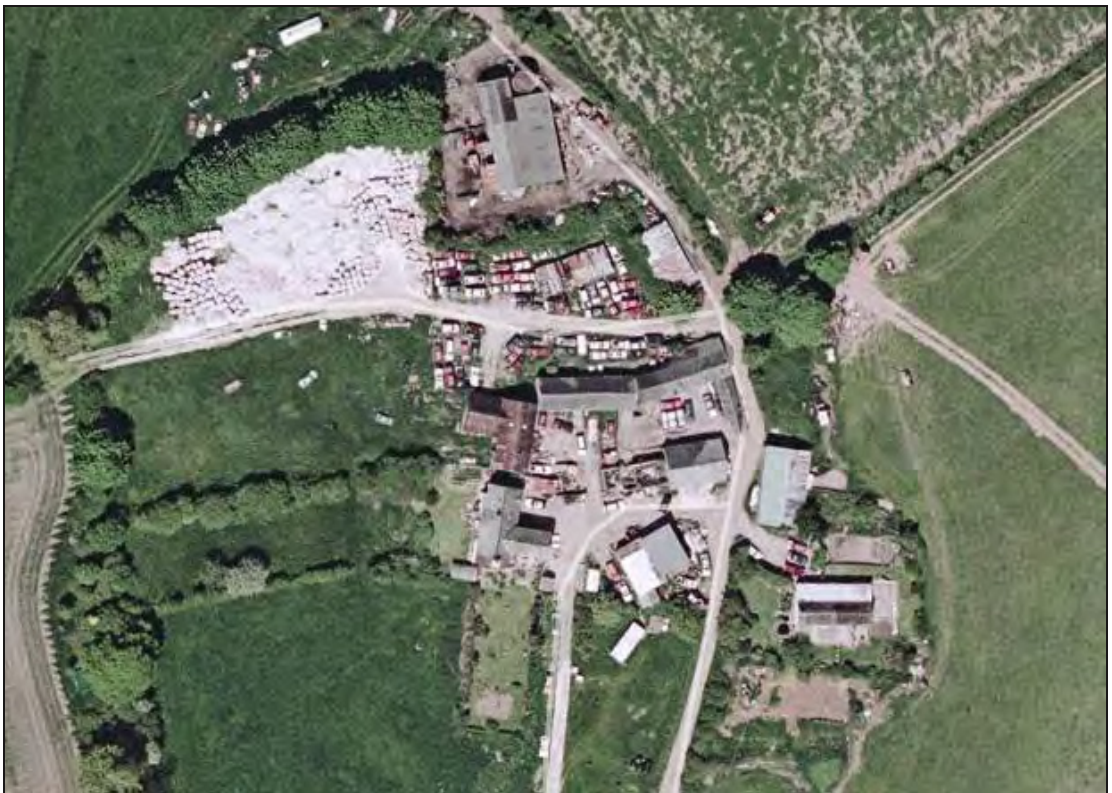
Figure 10: Recent aerial view (maps.google.co.uk accessed 21.4.08).

The aerial photograph of 1946 (Figure 9) suggests that there was no clear evidence of any significant further change during the early 20th century. But it is clear that since the mid-20th century the dwelling house has lost any wings that formerly existed on its western side (Figure 10). Also during the later 20th century the original ‘cattle shed and granary’ (building N in 1871), had been removed, as had the ‘fowl house’ (building B in 1871). The original gig house may have been enlarged during this time and in the location of the original cart shed and wagon linhay (buildings I and J in 1871) is a building on a different orientation (east-west rather than north-south). Other new buildings have been introduced to the north and to the south-east of the original group. The aerial shot of 2008 (Figure 10) also clearly shows that the field to the north of the buildings was being used as a scrap yard and shell waste dump from the late 20th century.

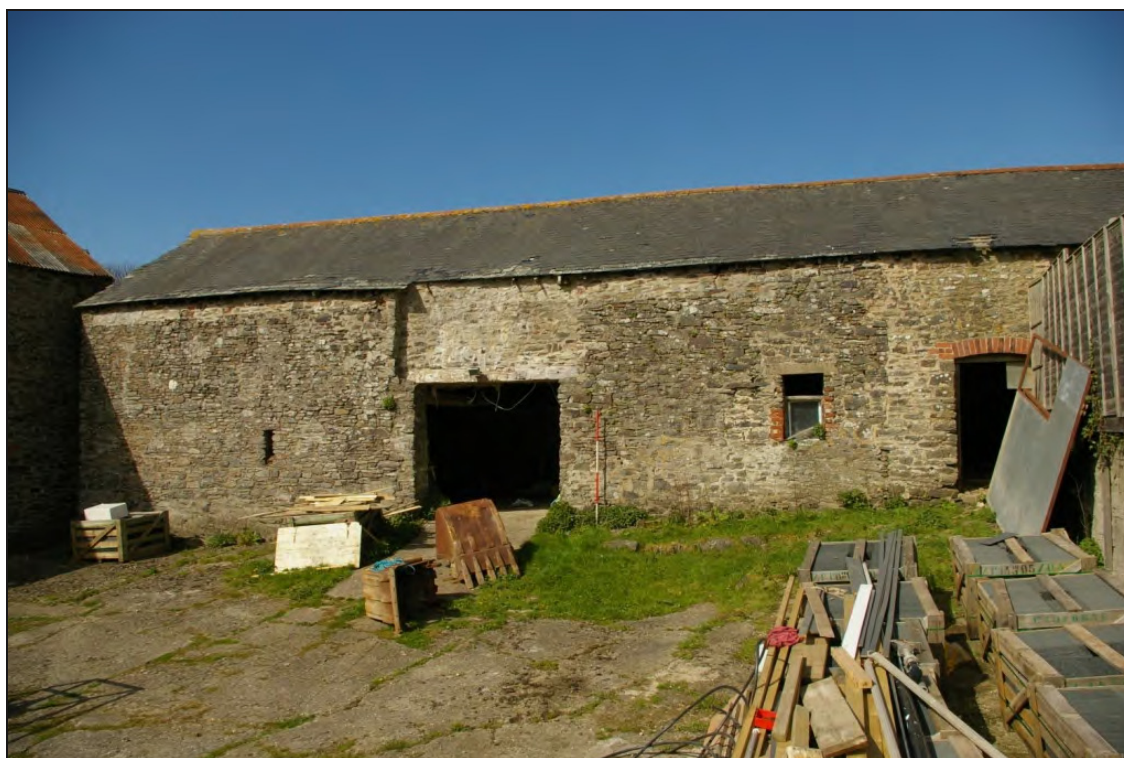
Figure 11: The yard and south facing elevations of Buildings 1 and 2 (2m scale).

The farm buildings at Plaistow Barton are sited on a gentle south western slope, to the north of the farmhouse (see Figure 16). The four buildings subject to this survey comprise the western part of a more extensive range of farm buildings now split into different ownerships. The buildings are cut into the slope of the higher ground to the north and access to the buildings has been achieved by levelling the area with a revetted retaining bank beyond. The ground around the farm has suffered considerable disturbance in the late 20th century and there is evidence of dumping to the rear (north and west) of the building complex. The yard to the south of these buildings is mostly concreted but where the ground rises slightly to the north cobbling is visible in front of the threshing barn (Building 1).

The range of semi coursed rubble stone buildings is comprised of a threshing barn (Building 1), with a shippon extension (Building 2). The building to the south-west of this is comprised of a ground floor shippon with a first floor threshing floor (Building 3) and an engine house (Building 4) to the east.

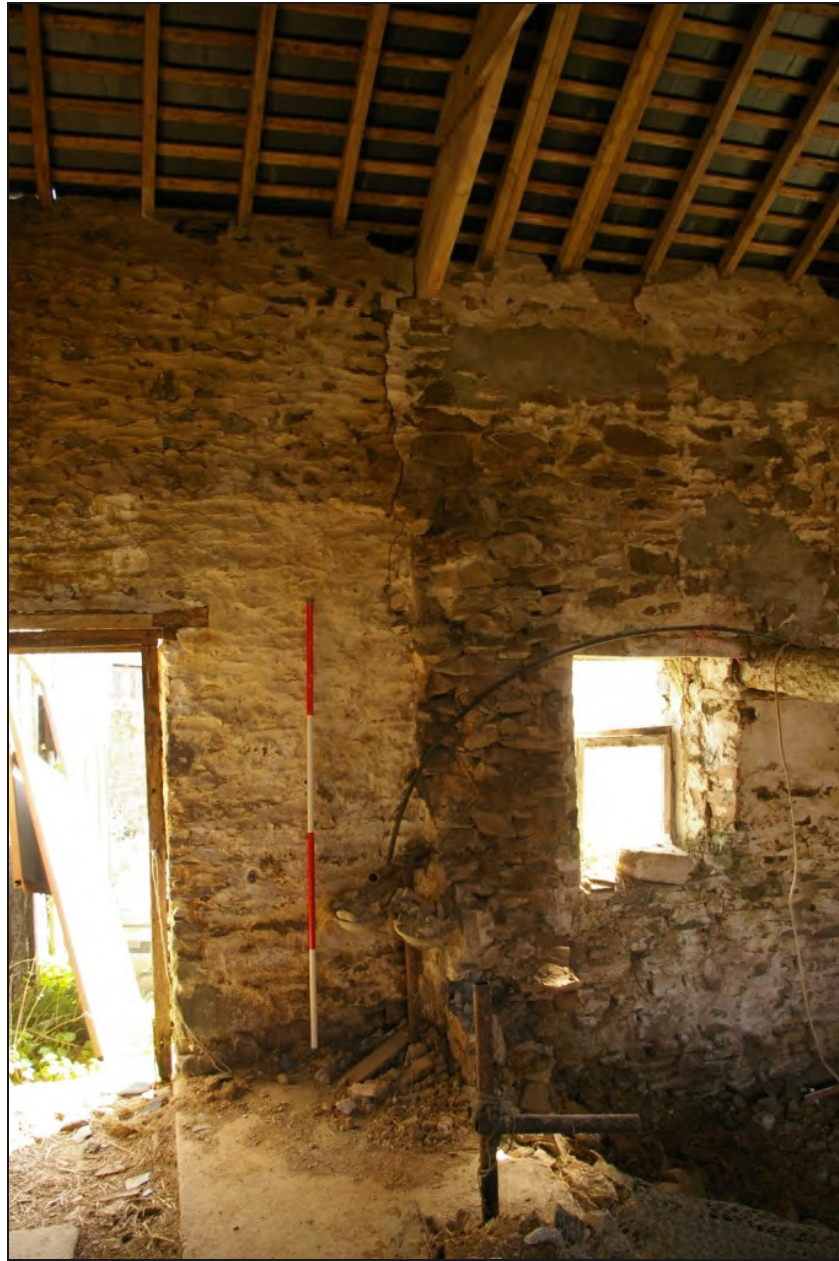
Figure 12: Vertical join in the south elevation between Buildings 1 and 2, viewed from the north (2m scale).

Building 2 is a one and half storey shippon extension to the eastern end of Building 1, which infilled the space between the threshing barn (Building 1) and the building to the east (a further shippon). Building 2 has rubble stone walls, with a door opening in the south wall with a segmental brick arch resting on stone jams. The segmental brick arch is similar, although not identical, to those in the eastern front of Building 3. There is an opposing door to the north with a two light window above in a rough frame. The interior south-east corner has a projecting block of masonry to roof height – which may be a possible buttress to the building (shippon) to the east?

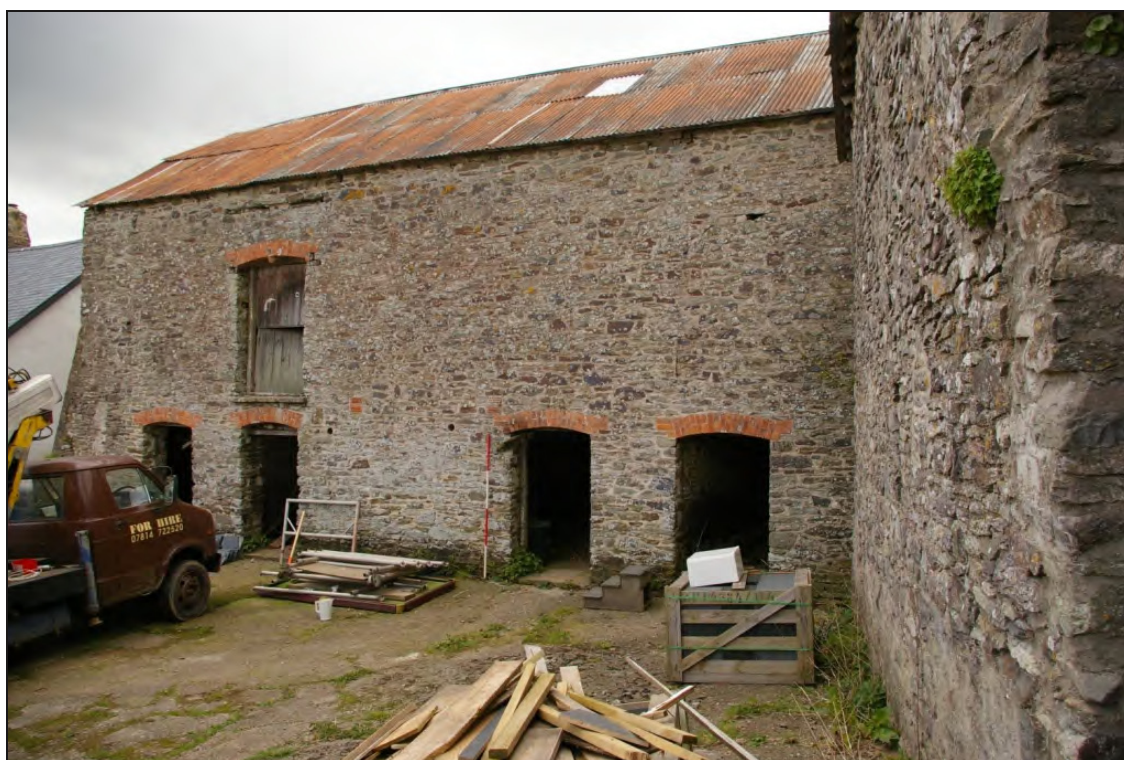
Figure 13: The eastern elevation of Building 3 (2m scale).

An east facing rectangular rubble stone agricultural building with ground floor shippon and first floor threshing floor under a galvanized roof (Figure 13).

The east front has four symmetrically placed ground floor door openings with segmental brick arches and a first floor draught or loading door with ledged and braced stable type doors (Figure 13). Between the central ground floor doors and those at the level of the first floor are two inserted lengths of ceramic pipe, while at a slightly higher level are two pairs of inserted air bricks. Their function is unclear, although one would expect them to be associated with airflow to the threshing floor, but they appear to be blocked by, and at the same level as the floor itself. The upper north gable has been rebuilt in concrete block with the window at first floor level also blocked at this time. The door opening at first floor level in the south elevation was also infilled with concrete blocks.

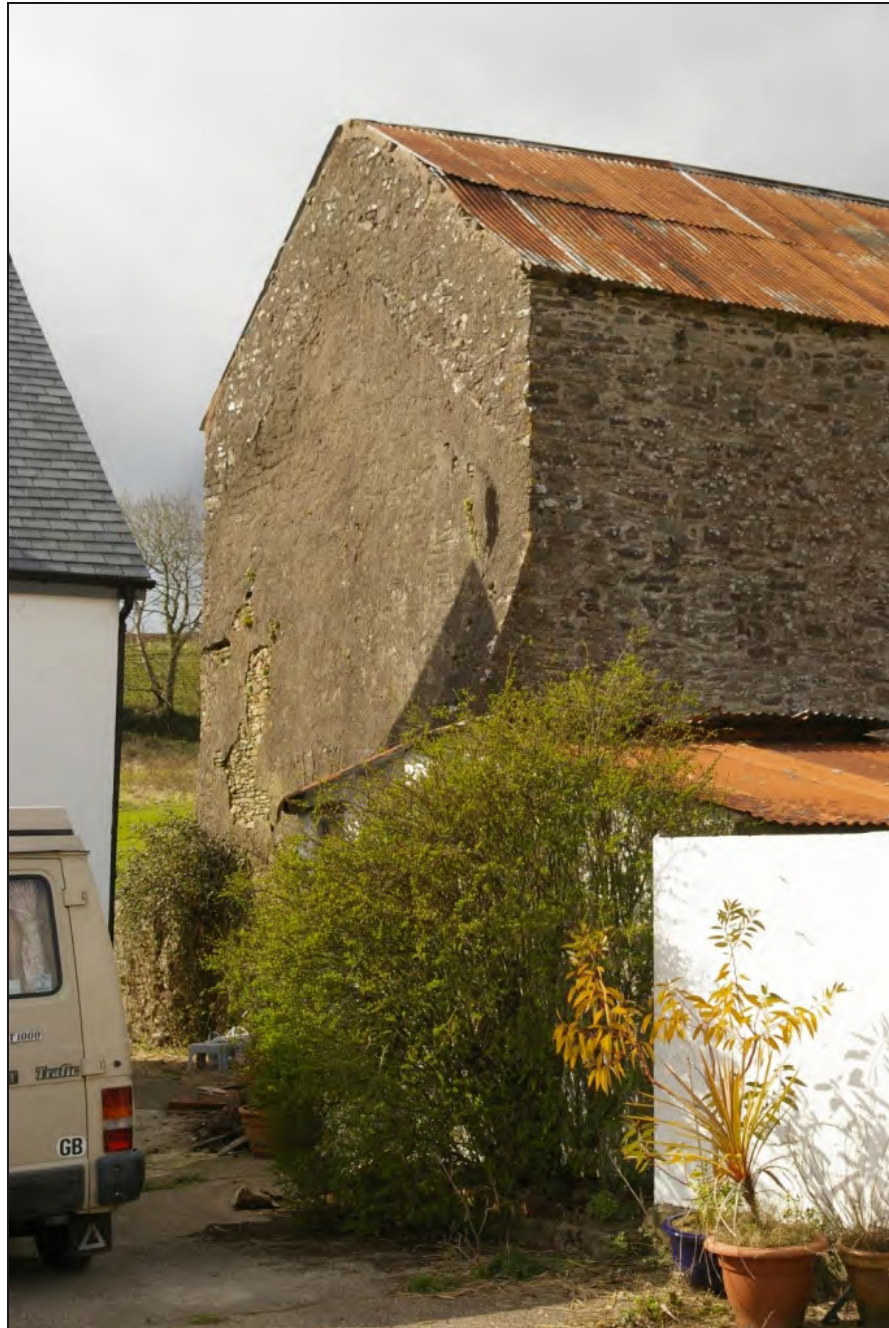
Figure 14: The ghost of a building on the south elevation of Building 3, which formerly filled the gap between the main farmhouse and this barn, viewed from the south-east.

The exterior south elevation retains the ghost of a former building which once infilled the space between the main house and Building 3 (Figure 14). The west elevation is built into the bank to the rear with an engine house (Building 4) at first floor level to the north of the building and a large single door opening on to the threshing floor with cheeks which have disturbed tops and a segmental brick arch. The ground is ramped up to the threshing door and riveted with stone to

The final phase of construction in the 20th century represents a series of changes in the use of these agricultural buildings, primarily this resulted in a number of structures being demolished, such as the building which formerly connected the domestic range with the southern end of Building 3 (Figure 14).

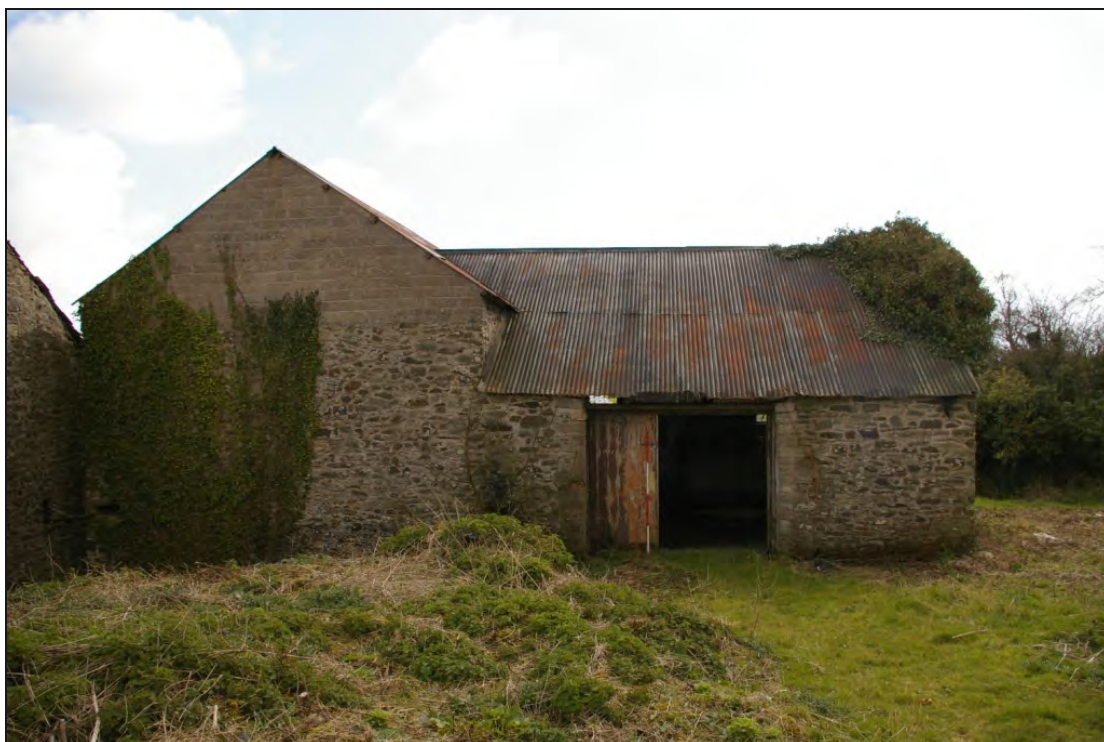
Figure 15: The north facing elevation of Buildings 3 and 4, viewed from the north (2m scale).

A single storey, square, three bay rubble stone engine house with a galvanised roof, gabled to the west and adjoining the west wall of Building 3 at first floor level. There are large sliding double doors in the north wall, the ground is ramped up to allow level access to the doors which suggests a later use as a garage. The exterior stonework of the jambs suggests that this opening was forced through. The south-east corner of south wall has a single door opening set above floor level with steps up to higher ground level to the south. There is also a two light window at the west end. The west wall has a circular opening high in the gable and the east wall contains a blocked opening north of centre and has the remains of the former drive for the engine remaining at the southern end. There is no clear evidence for a horse engine and it is probable that a motor was used. The floor is modern uneven concrete which slopes slightly to the south. The roof is a lightweight pine bolted kingpost structure built into the north and south walls and resting on wooden pads as in Building 3.

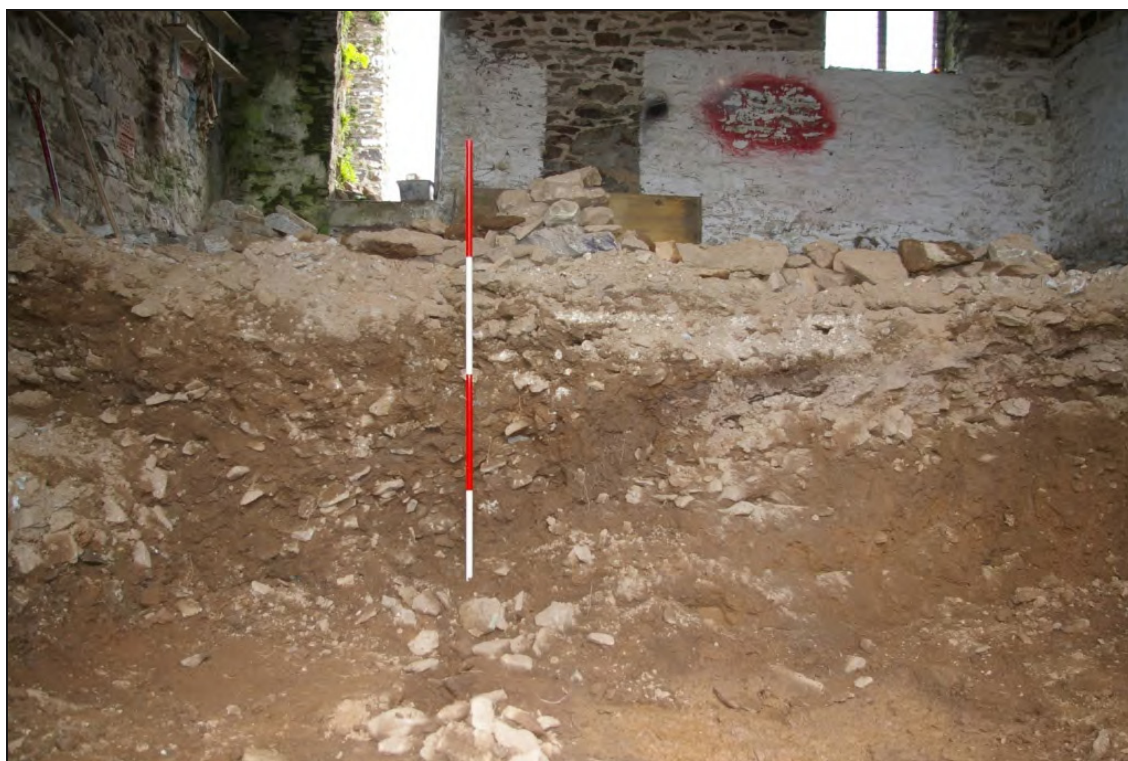
Figure 17: The raised floor with the engine house (Building 4) viewed from the north (2m scale).

The concrete floor within Building 4 revealed a much more complex history, with the concrete floor representing a complete change in the floor level of the building. This change in floor level probably occurred during the late 20th century and reflects the change of use of the building from an engine house to a garage. The concrete floor covered a 0.1m thick band of grey-brown gritty clay-silt predominantly composed of stone rubble, with frequent oil staining. This uniform rubble layer overlay a 1.5m (excavated) thick deposit of dumped material, which was comprised of a variety of dumps of stone rubble and soil, with at least six different tipping lines visible in section (Figure 17). The dumping of material within the building was similarly constructed, and presumably contemporary, with the earth and stone rubble ramp with roughly coursed stone wall revetments that abutted the forced northern opening to the Building. No earlier floor levels were identified within the excavated material, but a change in build was noticed 1.3m below the current floor level, with the upper dressed wall changing to a roughly coursed lower portion.

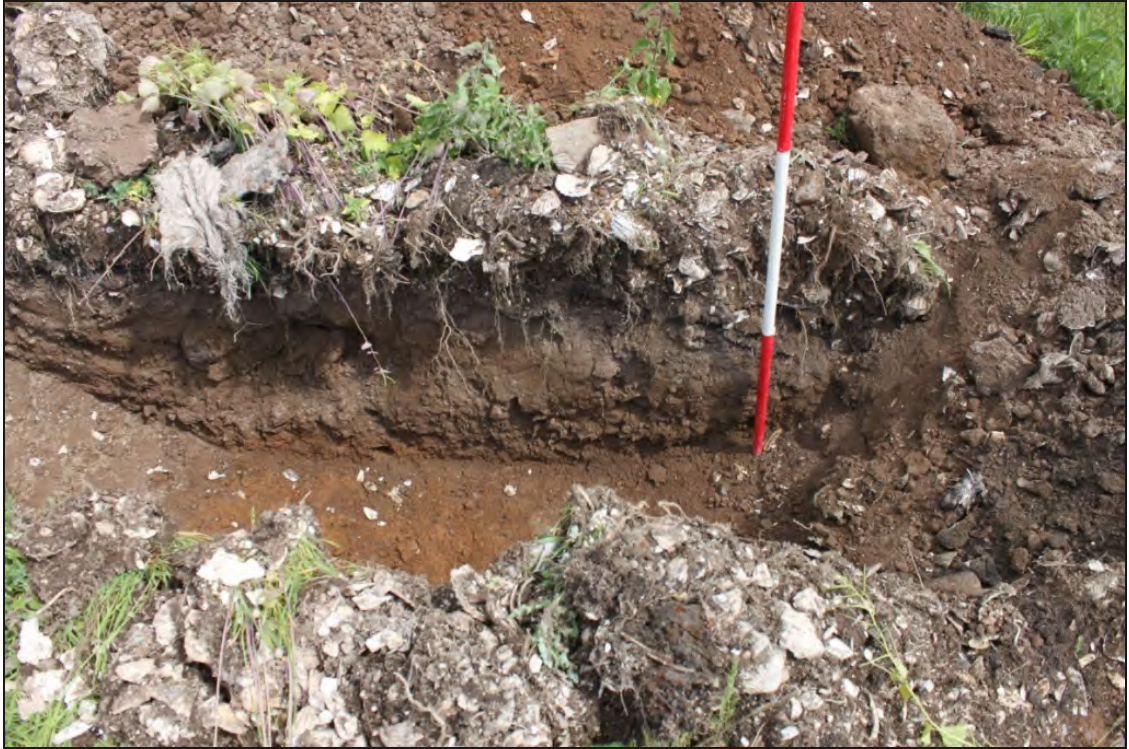
Figure 18: Southwest facing section of Trench 1 (2m scale).

Trench 1 was excavated to a depth of 0.9m, revealing a humic dark-brown silt-clay topsoil of 0.35m depth, containing large quantities of scallop shells, frequent plastic fragments and occasional large sub-angular stones (up to 130mm). The topsoil overlay a 0.13m deep deposit of grey-buff clay-silt which contained frequent small sub-angular stones (up to 60mm) and rare slate fragments. This overlay a 0.35m deep yellow-brown clay-silt with frequent large sub-angular stones (up to 250mm). Below this deposit containing large stones was the natural subsoil, a yellow-orange clay-silt.
