PROPOSED AGRICULTURAL BUILDING TO COVER AN OPEN YARD AT CHURCHSTYLE FARM, FARWAY, DEVON

Heritage Impact Assessment

Issued: 10.09.19

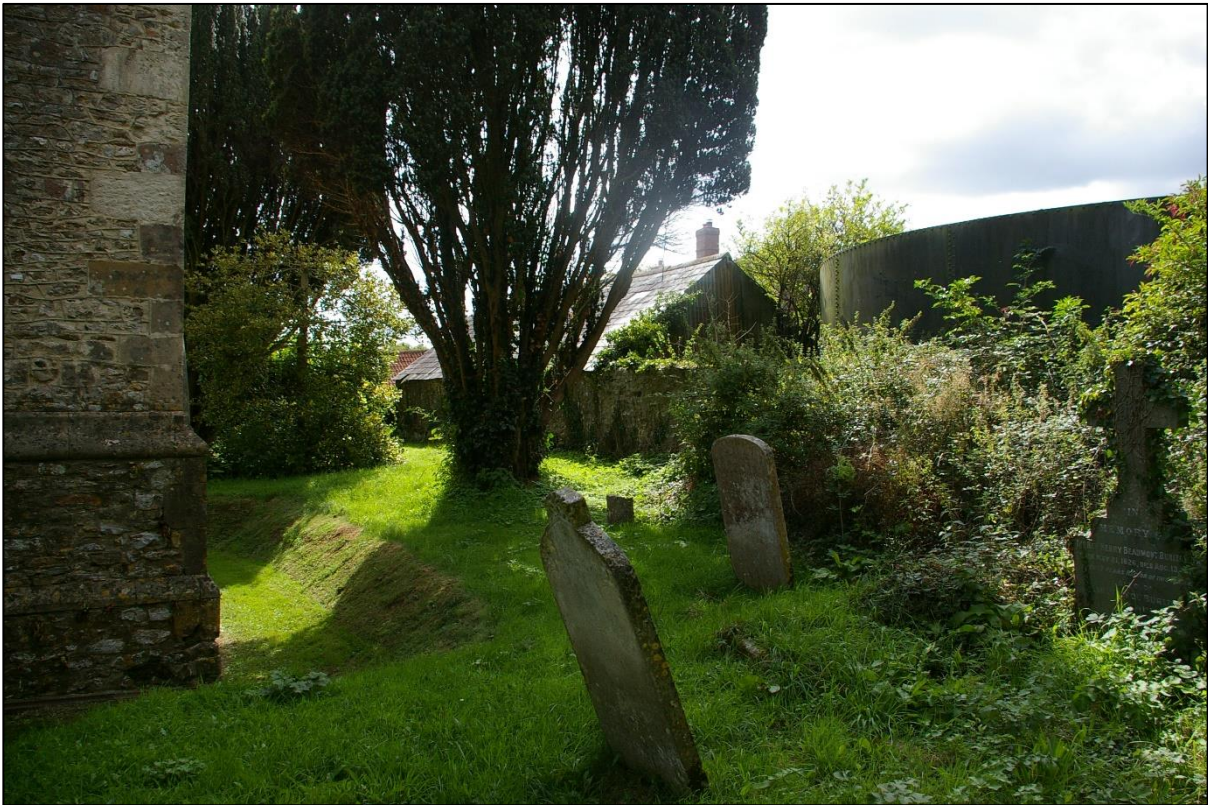
Figure 2: View along the west boundary of the churchyard, showing the barn and silo; from the north-north-east. [distance c.40m]  
(the site would lie behind the slurry silo).

Due to both the churchyard walls and high vegetation between the churchyard and the farmyard there is no intervisibility between the tombs and the proposed site. The slurry silo also features as a heavy visual boundary between the tombs and the proposed site. With this in mind the impact of the proposal on the immediate setting of the asset is **neutral**, and on the wider landscape setting is **neutral**.

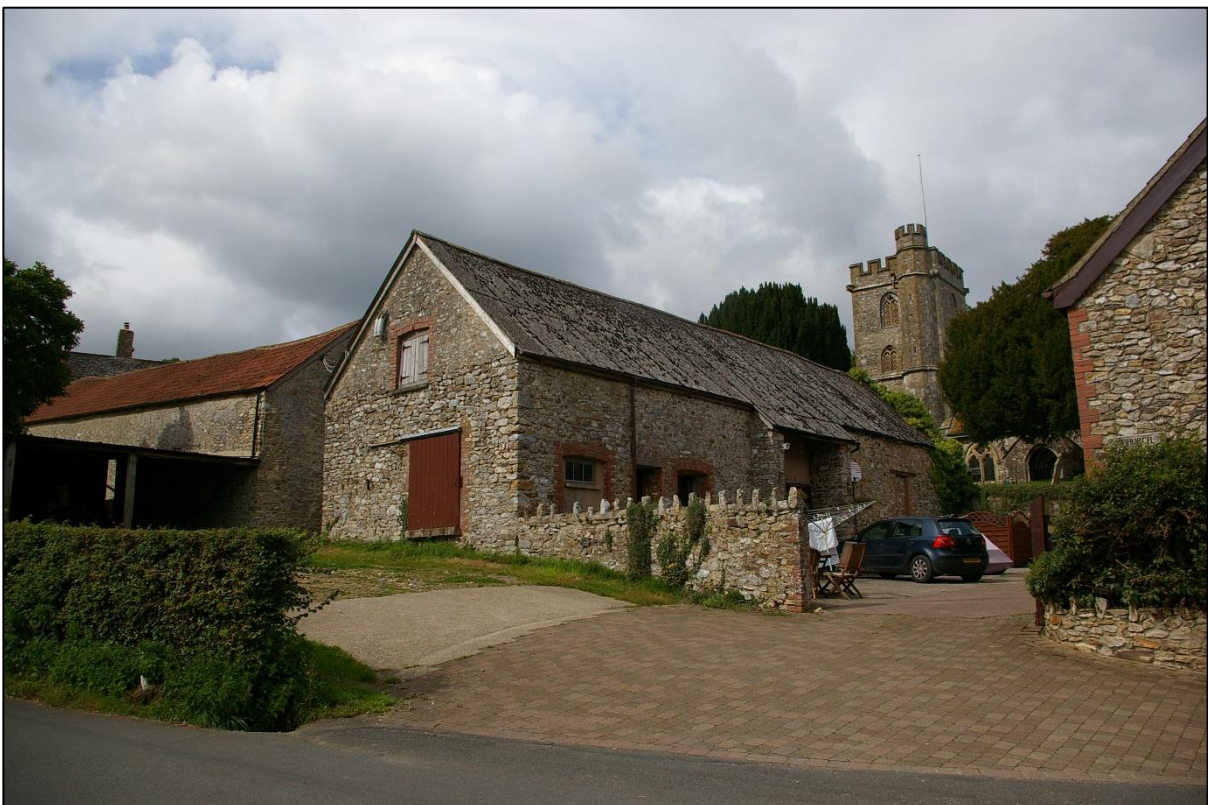
Figure 3: View of the church, from the lane, showing it enclosed and framed by the historic barns of Churchstyle Farm; from the south-south-east. [distance c.65m]

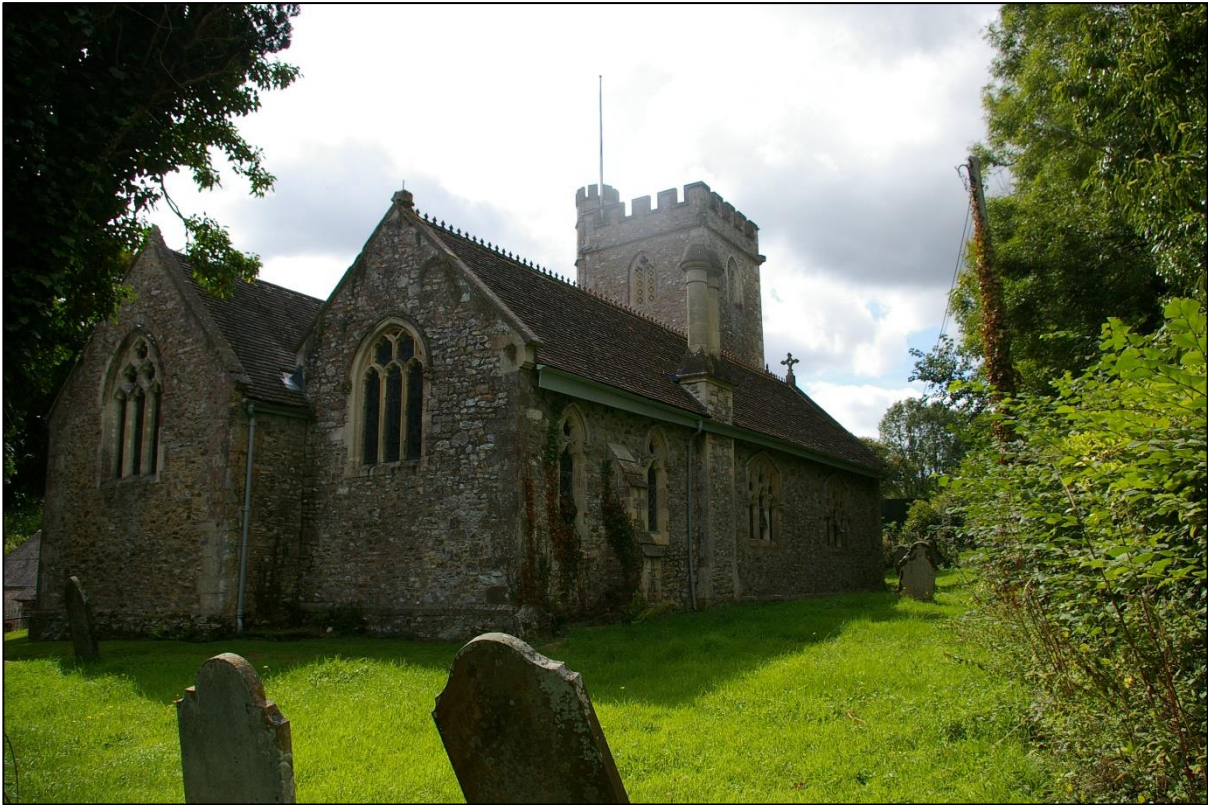
Figure 4: View of the church from the north-east, showing glimpses to the green painted silo behind, with trees beyond.

The church sits within a wider churchtown complex, and is likely best considered in conjunction with the GII tombstones that lie within the churchyard as well as the GII listed Old Rectory. The proposed structure would be partially visible from the church, though the majority of views would likely be blocked by the standing large round metal slurry silo, positioned between the 15<sup>th</sup> century tower and the proposed site. The planned structure would also be of a similar style to the current modern agricultural barns and likely not create further disturbance to the views from the church. As wider landscape views from the church to the west are already obstructed by the current barns, the addition of a new cover over the yard would be in character with its current and historic use. With this in mind, the impact on the immediate setting of the building is **negligible**, and on the wider landscape setting **neutral**.

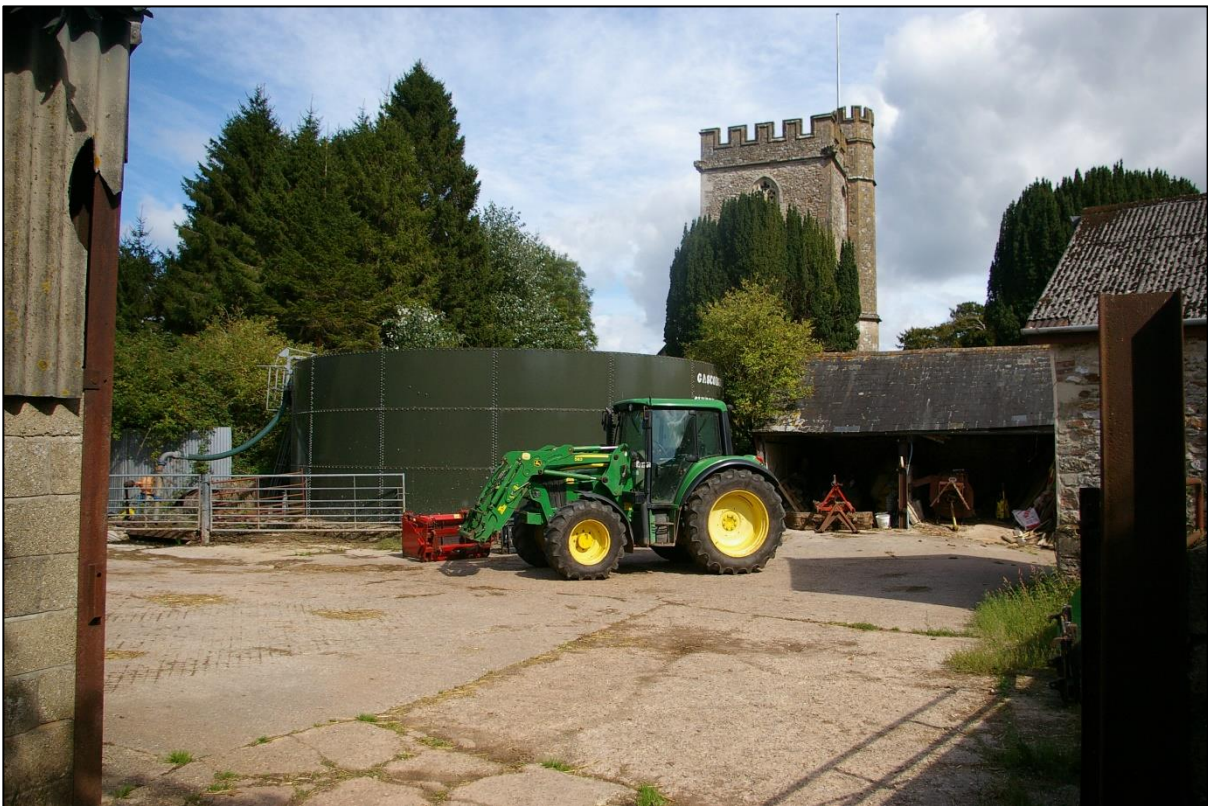
Figure 5: View through the modern farmyard to the church tower beyond, showing the silo and barn which lie on the immediate western boundary of the churchyard; from the south-west.

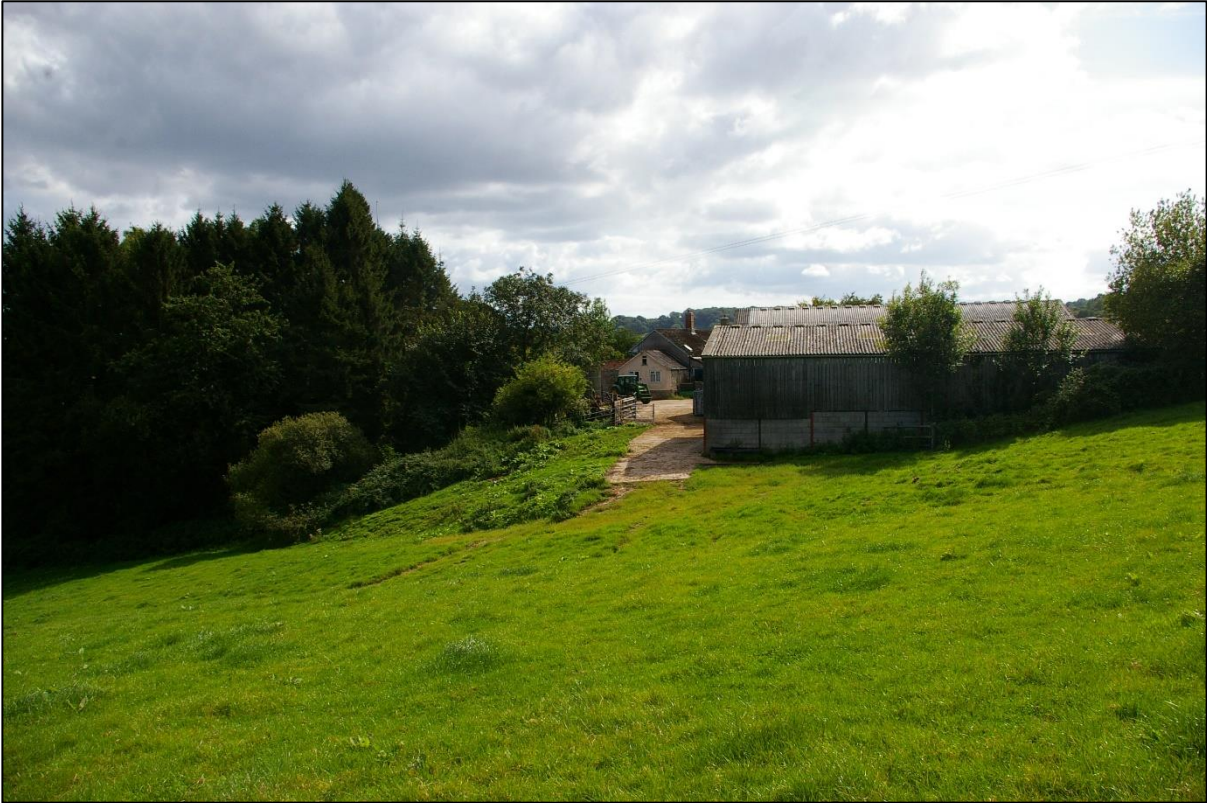
Figure 6: Wider landscape view back to the farmyard and churchyard, showing the tower subsumed into the conifer trees; from the north-west.
