## Brackenside, Bucks Cross, Bideford, Devon

### Walkover Assessment

By S Walls, South West Archaeology Ltd. 31.03.19

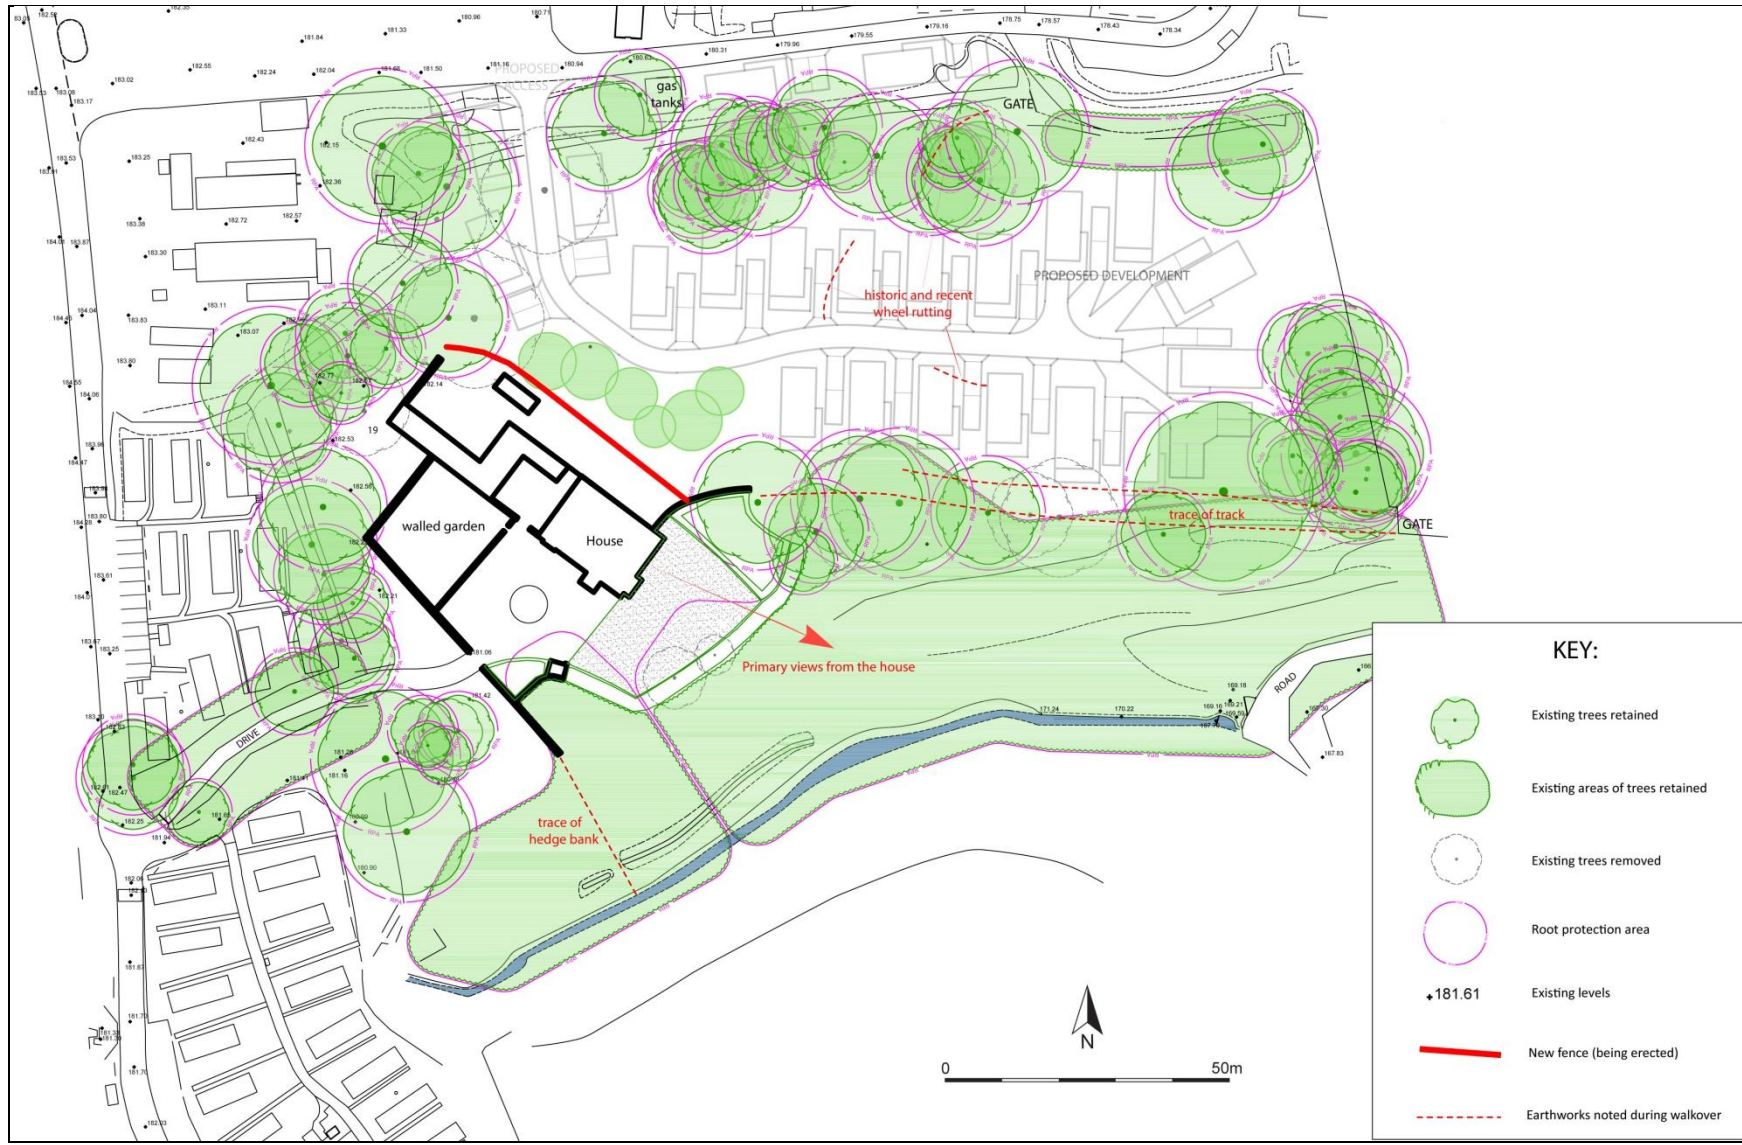
FIGURE 2: PLAN SHOWING THE PROPOSED AND EARTHWORKS AND FEATURES NOTED IN WALKOVER SURVEY.

The site itself is essentially flat, the only earthworks being associated with vehicular access. These have been exaggerated during the recent clearance of the site, but appear to correspond closely with the posited earthworks shown on the LiDAR (see Figures 2 and 3). At the time of the visit a fence was being erected to separate the outbuildings associated with the House from the site. Examination of the postholes demonstrated that the friable grey-brown clay-silt topsoil is fairly shallow (c.0.3m thick) and overlies a yellow-grey silt-clay natural.

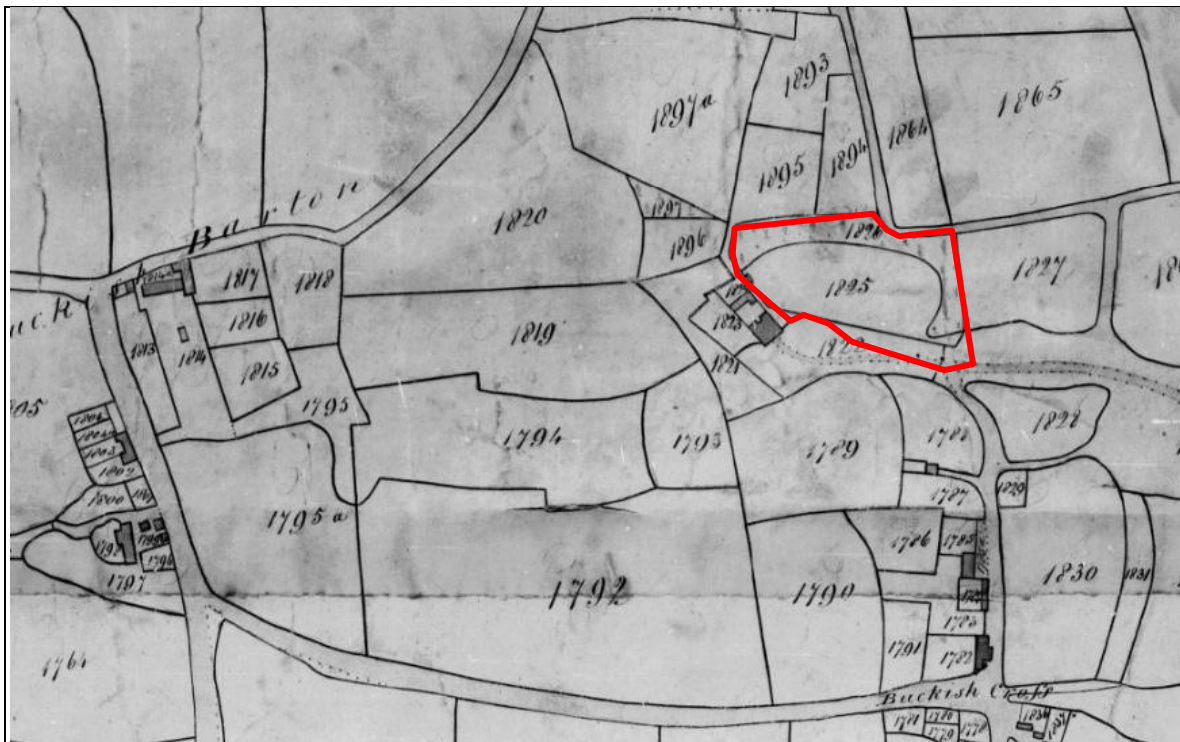
FIGURE 4: EXTRACT FROM THE WOOLFARDISWORTHY TITHE MAP, THE SITE IS INDICATED (THE GENEALOGIST).

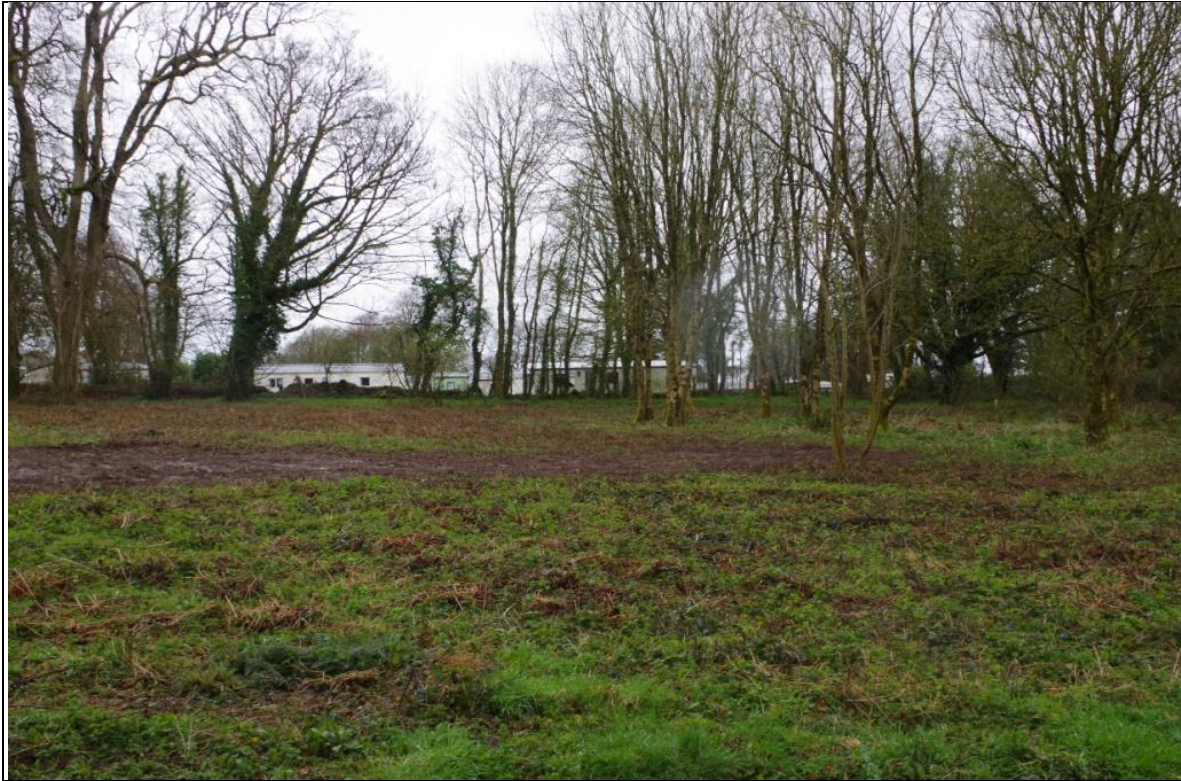
FIGURE 7: THE SITE OF EARTHWORKS SHOWN ON THE LIDAR; VIEWED FROM THE SOUTH (NO SCALE).

The site was visited by S. Walls on 18<sup>th</sup> March 2019 in overcast but largely dry conditions. The site was accessed via the current drive leading to Brackenside. The House, a rather fine mid-Victorian villa, appears to be in poor but relatively stable condition; it has a new roof and most of the windows and doors are boarded shut. The former stables, cart shed and other outbuildings are in a deteriorating condition. The gardens remain partly overgrown, but the former walled garden and areas to the north of the House have been recently cleared of brambles and scrub (see Figures 7-8).

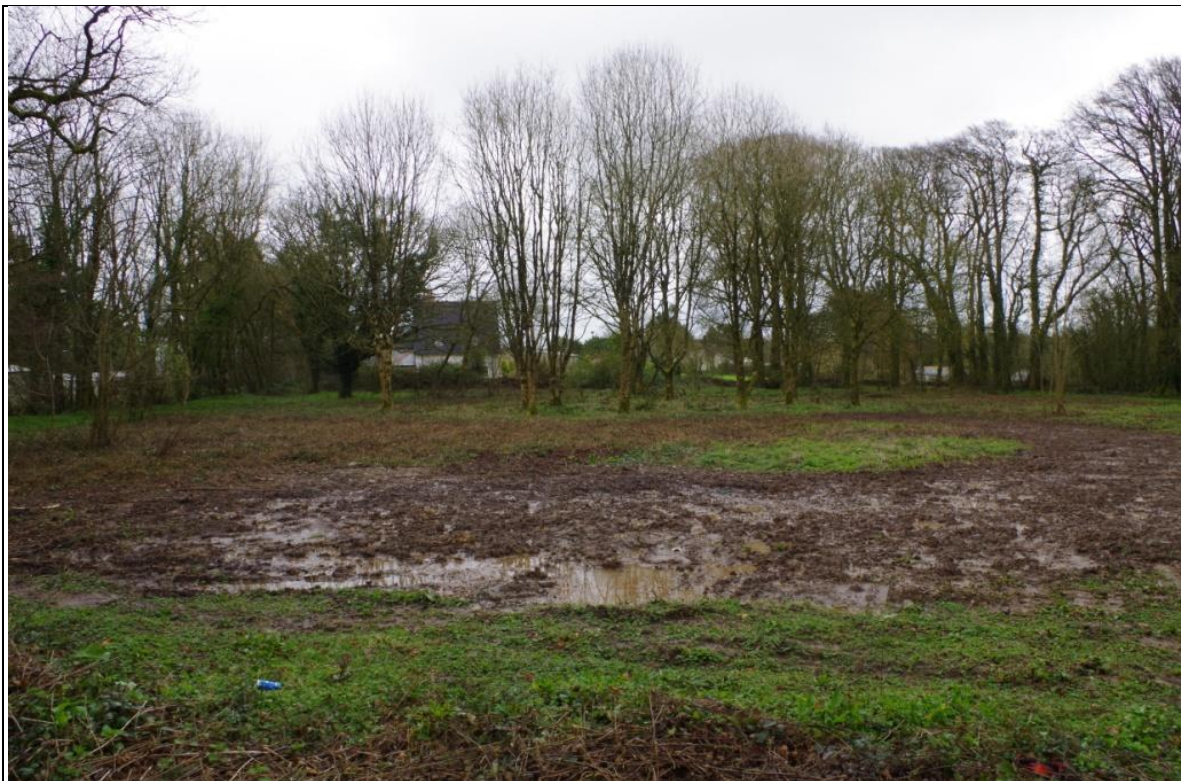
FIGURE 8: THE SITE OF THE EARTHWORKS SHOWN ON THE LIDAR; VIEWED FROM THE WEST (NO SCALE).
