# BATSON HALL FARM

Historic Building Assessment & Heritage Impact Assessment

South West Archaeology Ltd. report no. 190620

## Batson Hall Farm, Batson, Salcombe, Devon Historic Building Assessment and Heritage Impact Assessment

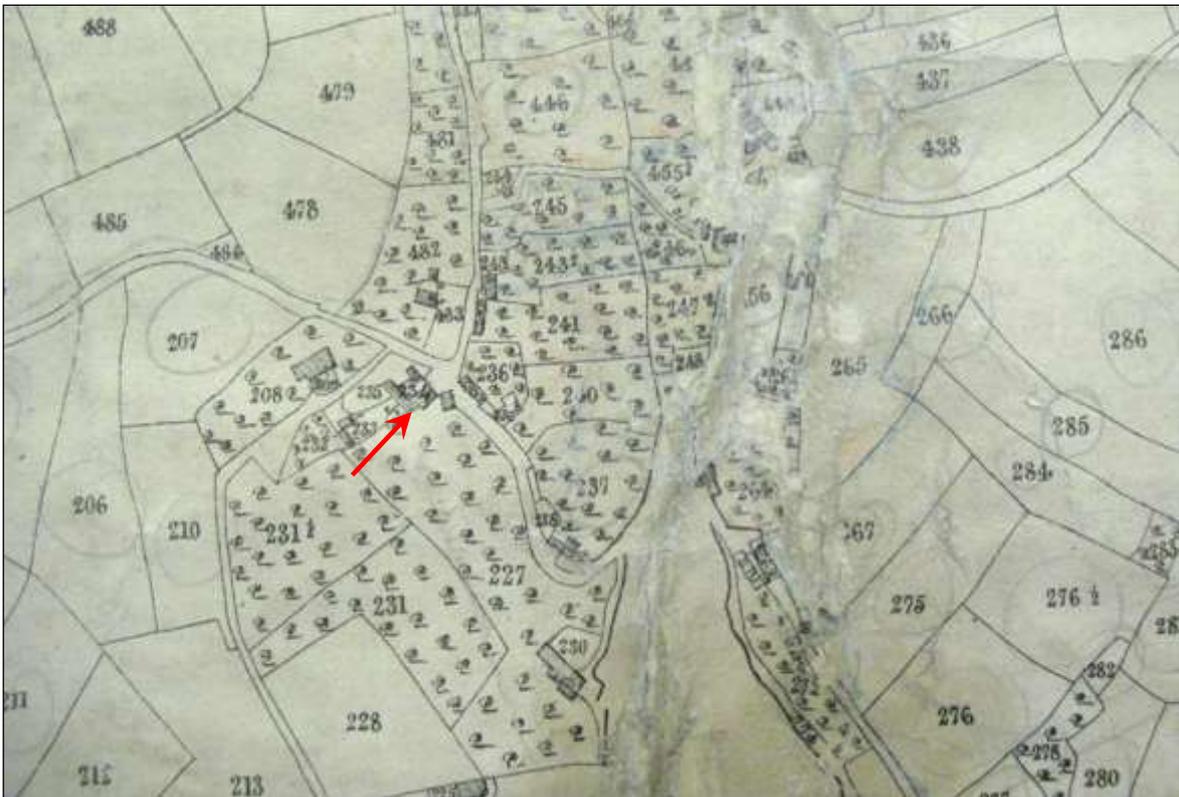
FIGURE 3: EXTRACT FROM THE 1841 TITHE MAP FOR MALBROUGH. THE FARMHOUSE IS INDICATED (DHC).

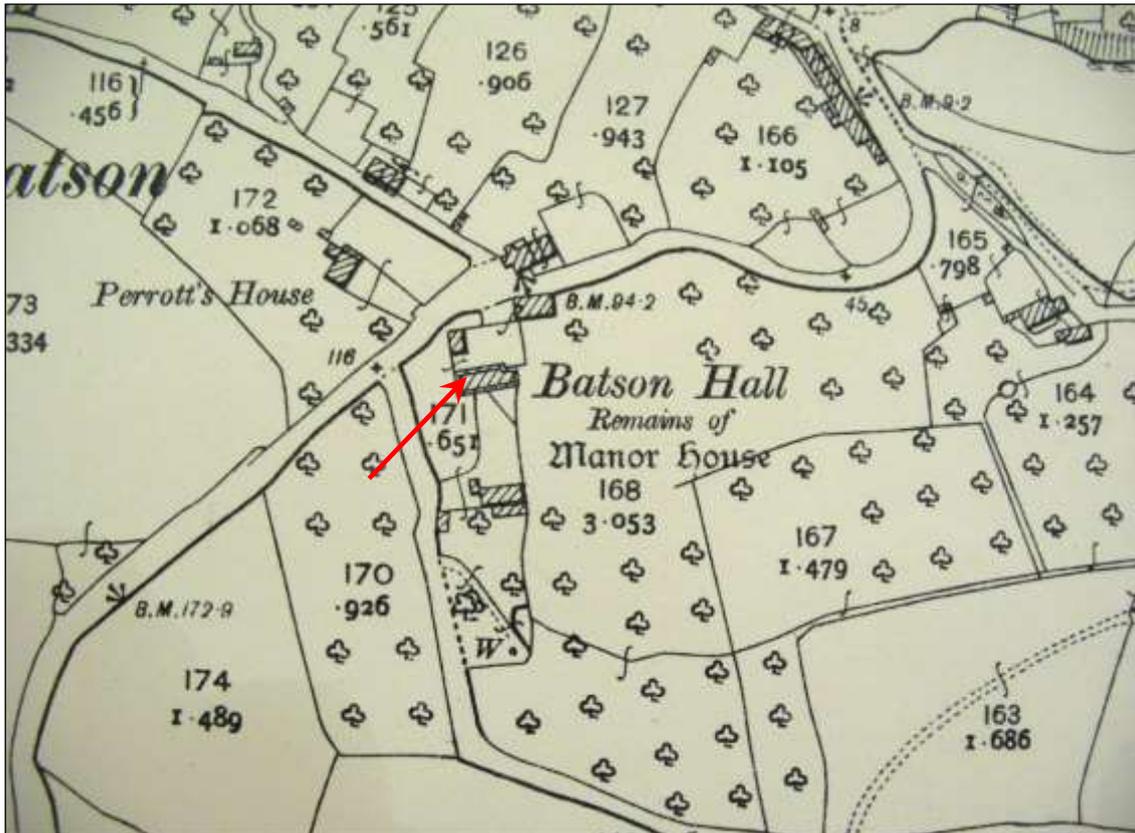
FIGURE 5: THE ORDNANCE SURVEY 2<sup>ND</sup> EDITION 1:2500 SCALE MAP OF BATSON, PUBLISHED 1906. SHEET 136.11 (DHC).

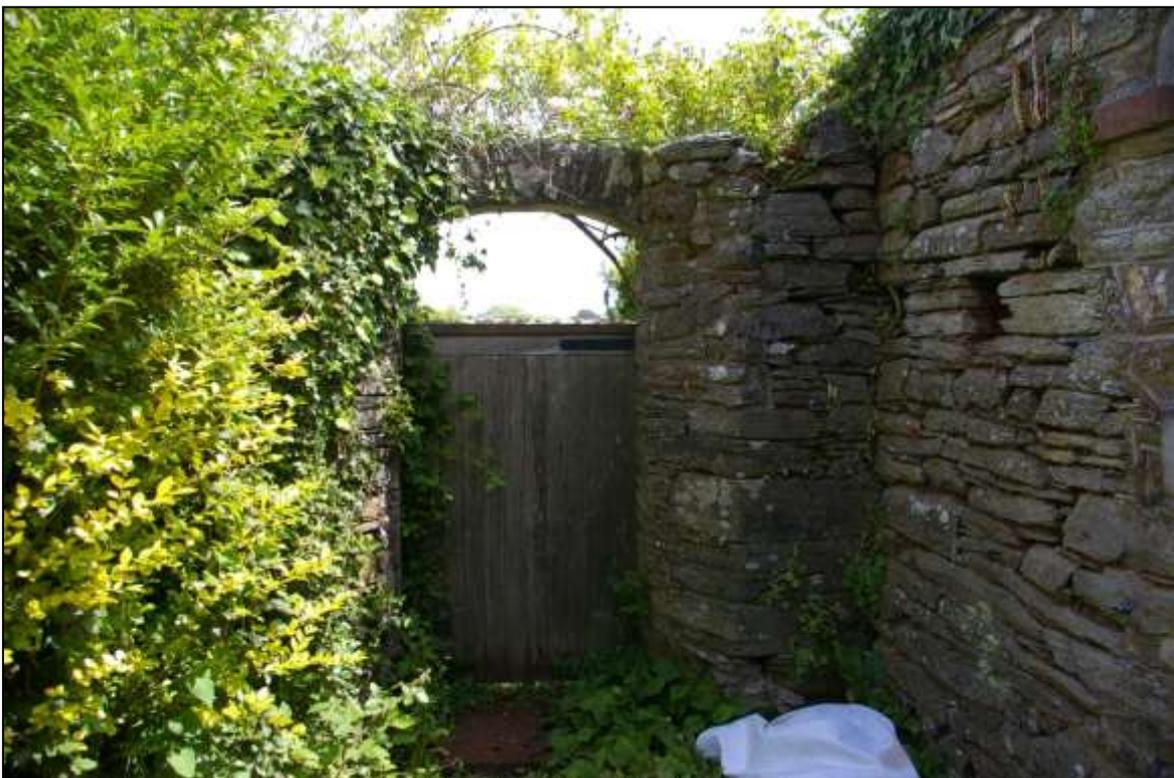
FIGURE 6: DETAILED VIEW OF THE FINE HEAVY SLATESTONE AND SOME DRESSED BLOCKS AND PUTLOGS, ALL OF WHICH IDENTIFY THESE GARDEN WALLS AS RUINS OF AN EARLIER QUITE FINE BUILDING.

The second ruins are those in front of the farmhouse, forming the current garden area. These stand to a low single storey height and are ragged to top, patched with crude cement mortar as coping in places. This is a heavier and more vernacular build than the square block, with heavier dressed corners. These walls are slightly battered and have a cob/clay bond. There is a potential blocked window to the east, obscured by planting, and a large stack to the north with stepped wall stubs which would have braced a large stone surround or heavy timber bresummer beam. To the south-east corner there is an opening with angled relieved reveals. This has been later adapted with an added crude arch as a garden gate. This wall is abutted by another short section of slatestone walling which contains a putlog hole. Of some age and vernacular in form, this short section of wall abuts the south side of the opening, now used as a gate, cutting the angled relieved reveals at an awkward angle and is evidence of a later phase, a partition wall, or a truncated end of a building being rebuilt?

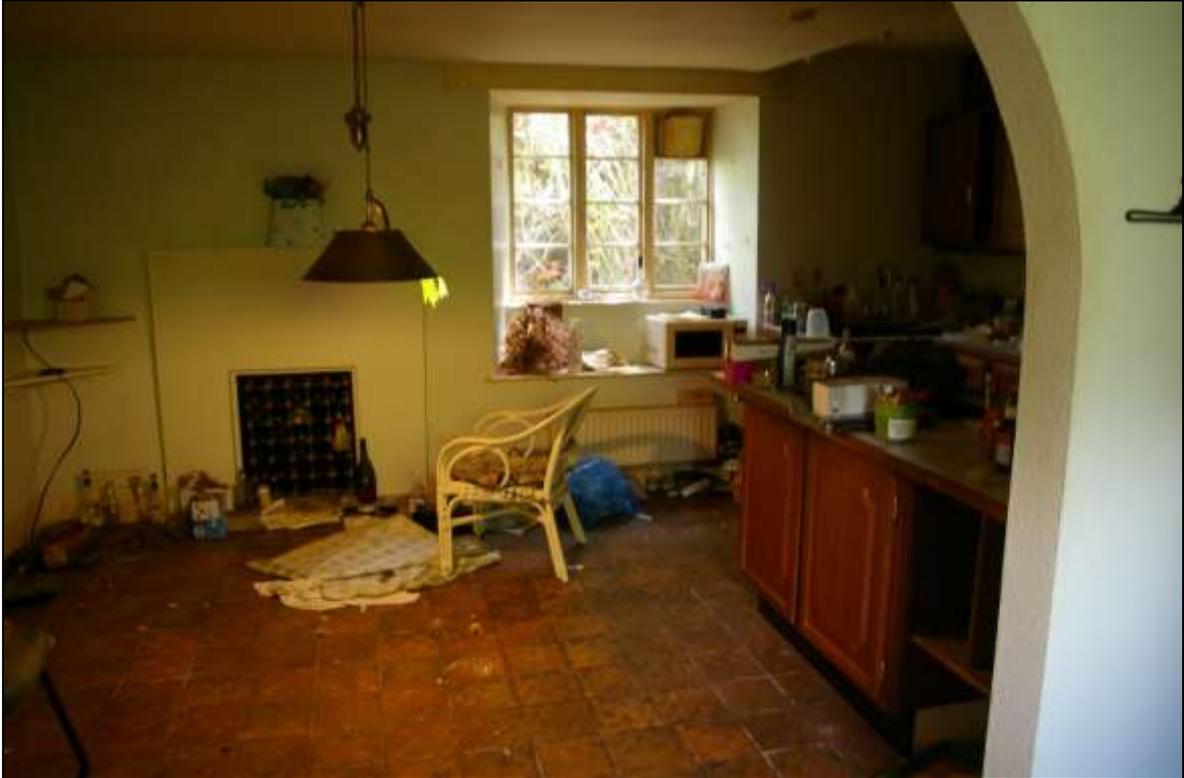
FIGURE 7: VIEW OF THE FITTED KITCHEN, WITH THE THREE LIGHT 19TH CENTURY CASEMENT AND WINDOW SEAT, BLOCKED FIREPLACE ON THE REAR WALL, MODERN QUARRY TILED FLOOR, BOARDED OUT CEILING; FROM THE NORTH, NORTH-EAST.

The interior of the main house displays significant modernisation dating to the 1970s or 80s, with cement plastered walls, modern plaster boarded partition with casement arches dividing original room spaces and altering the layout. There are low plain skirtings, modern quarry tiled floors or carpets and glazed modern internal doors. All the ceilings seem quite low, boarded out with plasterboard, possibly obscuring older beams and structural detail, or the interior may have been wholly reworked with new joists.

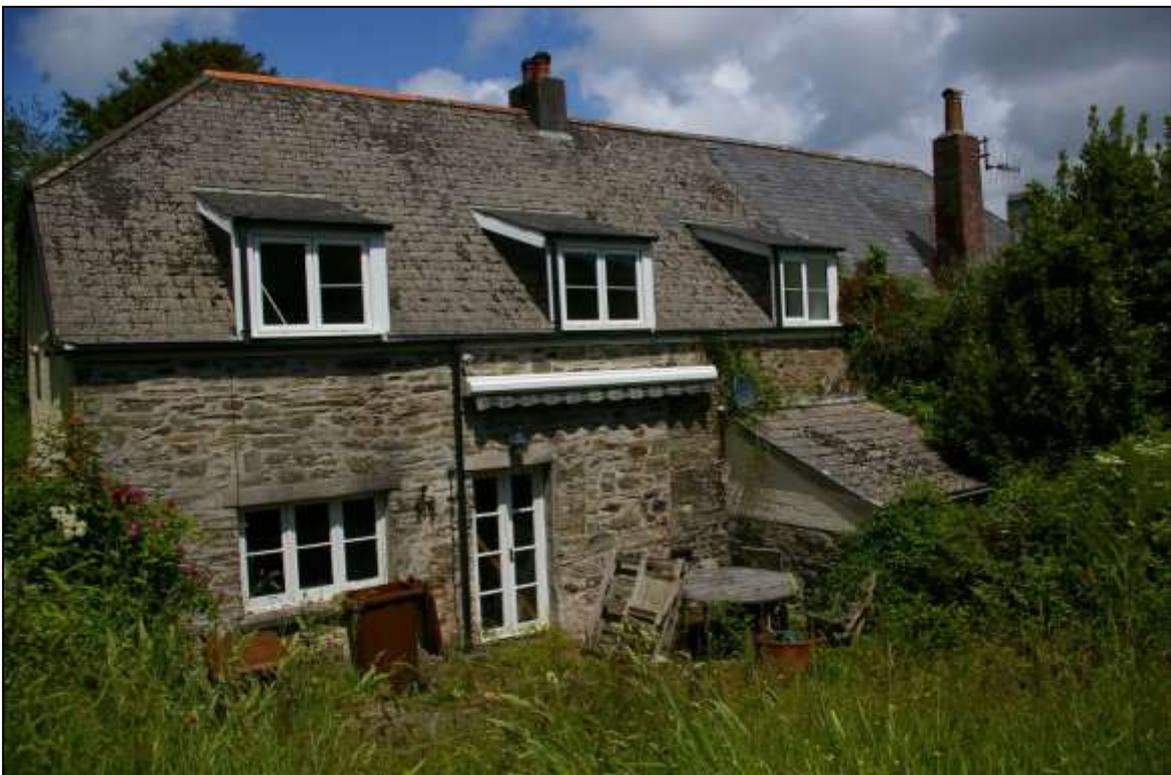
FIGURE 8: THE COTTAGE AND BATSON HALL FARM SOUTH ELEVATIONS AND ROOFLINE, SHOWING THE OBSCURING FOLIAGE; FROM THE SOUTH-WEST.

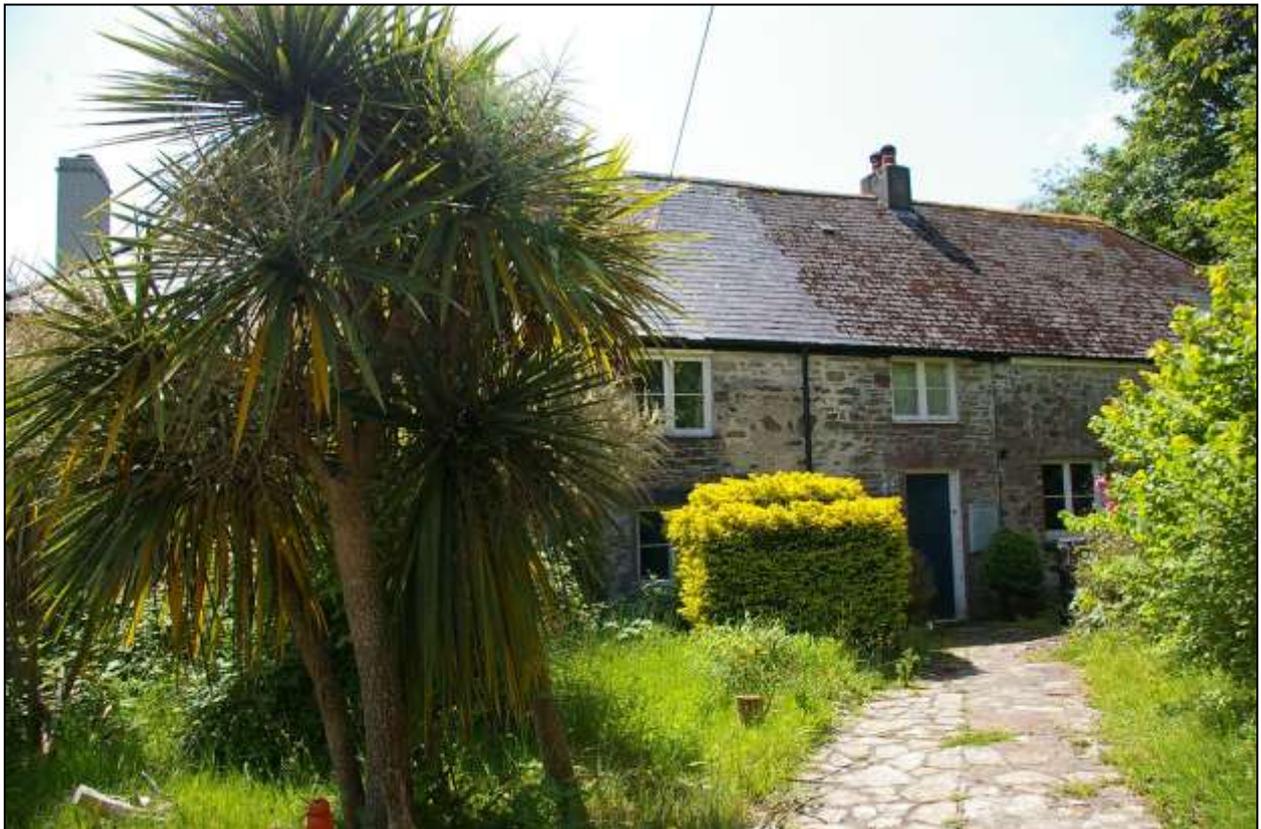
LONG OBLIQUE VIEW OF THE FARMHOUSE FROM WITHIN THE GARDEN, SHOWING THE MAJORITY OF THE NORTH ELEVATION OF IT AND THE COTTAGE; FROM THE NORTH-EAST.

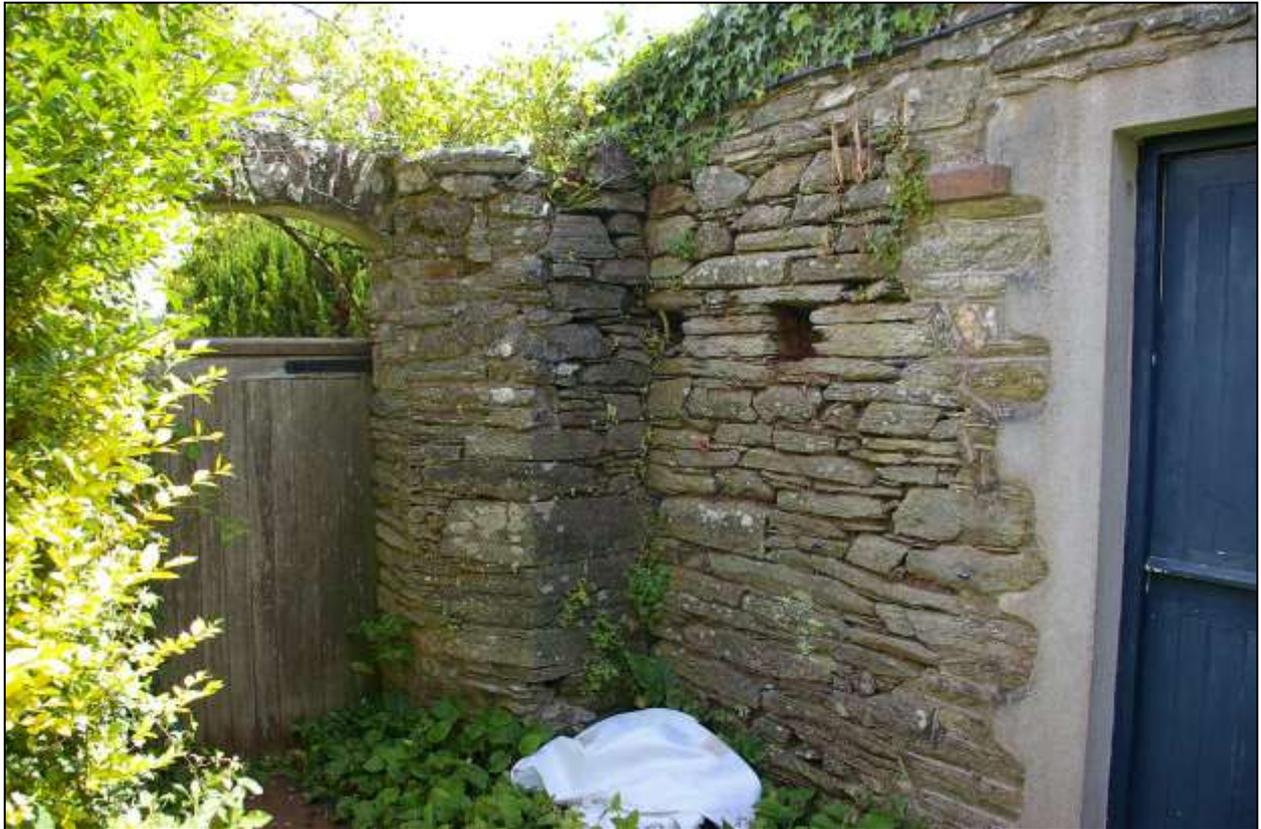
ONE OF THE OLDER SECTIONS OF WALLING INCORPORATED INTO THE FARMHOUSE AT THE EAST END, ATTACHED TO THE GARDEN WALL; FROM THE NORTH-WEST.

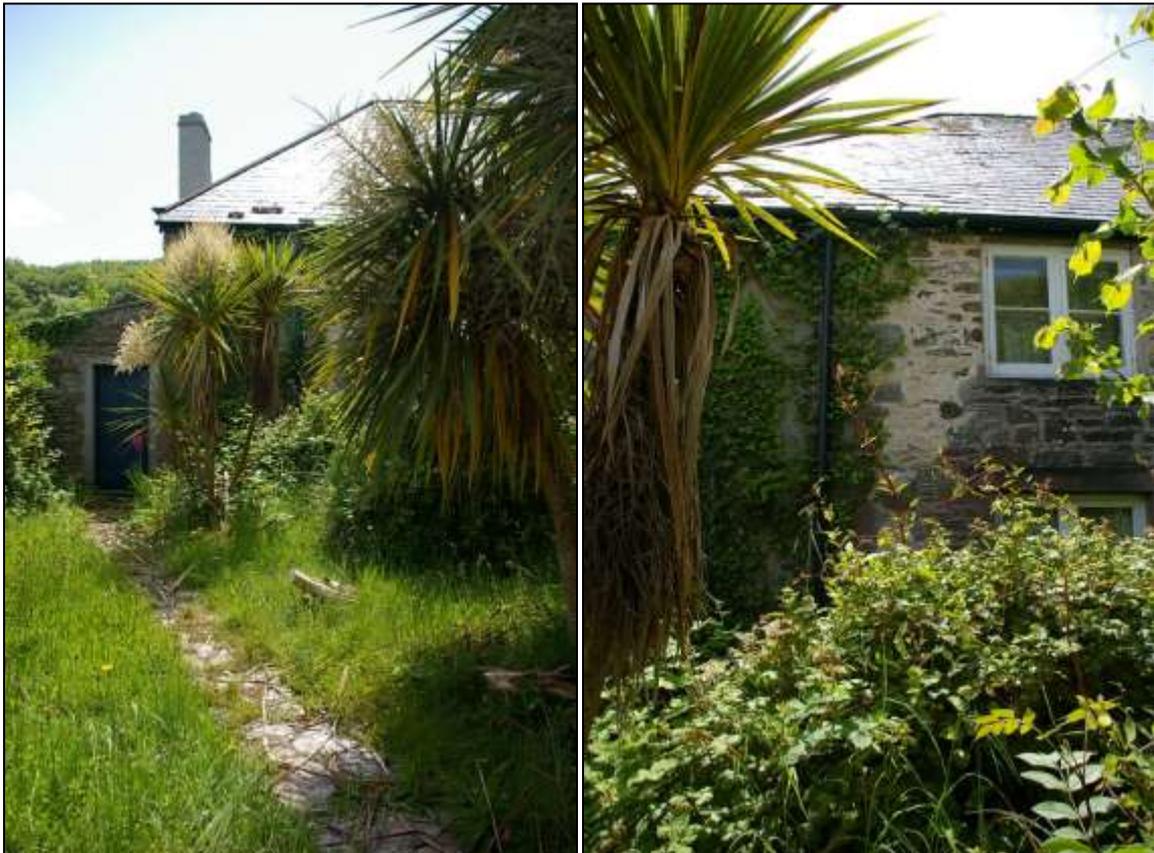
LEFT: THE LEAN-TO WITH AN OLD SECTION OF WALLING WHICH THE CONSERVATORY ABUTS FROM THE SOUTH SIDE; FROM THE NORTH, NORTH-WEST.

RIGHT: THE RENDERED NORTH-EAST CORNER OF BATSON HALL FARM AND THE BADLY REPOINTED STONEMWORK WHICH PARTLY OBSCURES A SET OF QUOINS, AT LEAST 1M INTO THE NORTH ELEVATION; FROM THE NORTH.

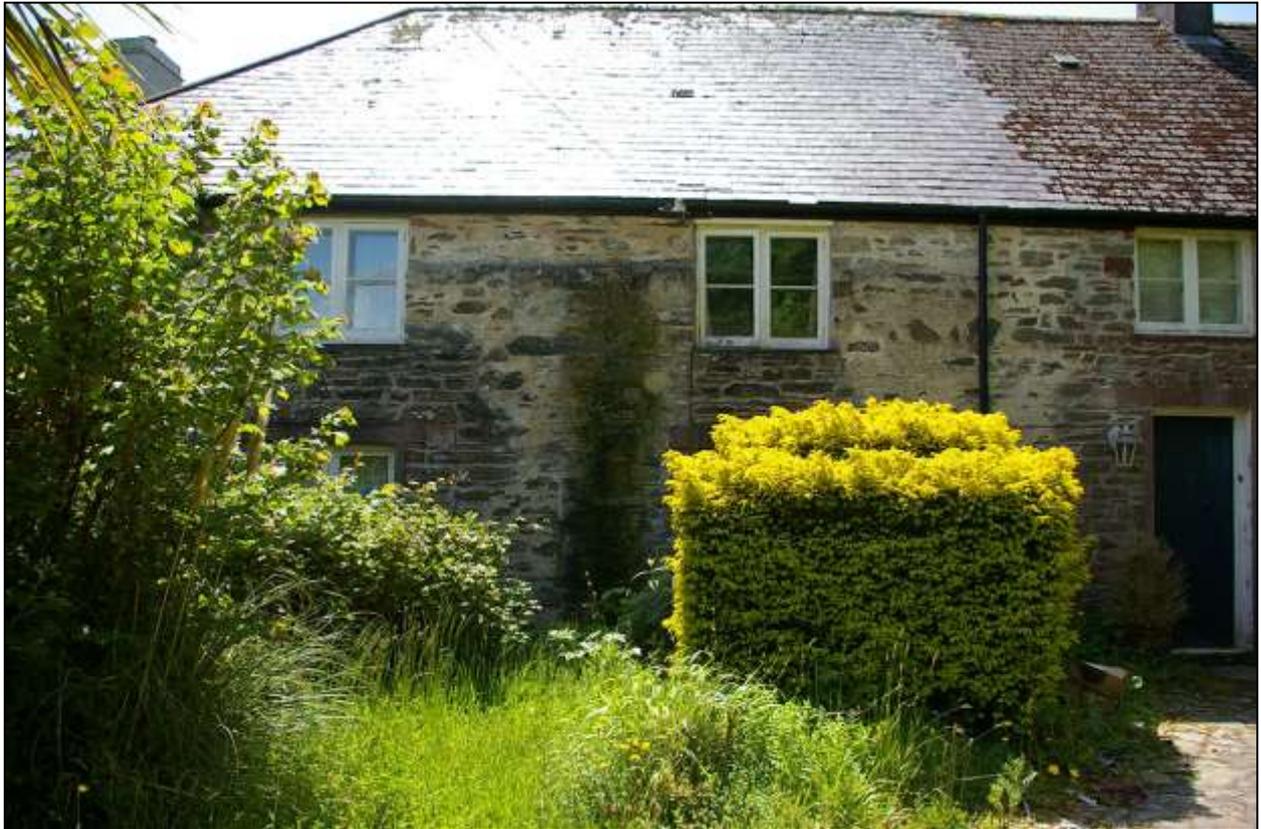
DETAILED VIEW OF THE THICKER LOWER SECTION OF WALLING WHICH DOMINATES THE NORTH FRONT OF THE FARMHOUSE, AT THE EAST END, THE REMAINS OF A RUINED EARLIER BUILDING; FROM THE NORTH.

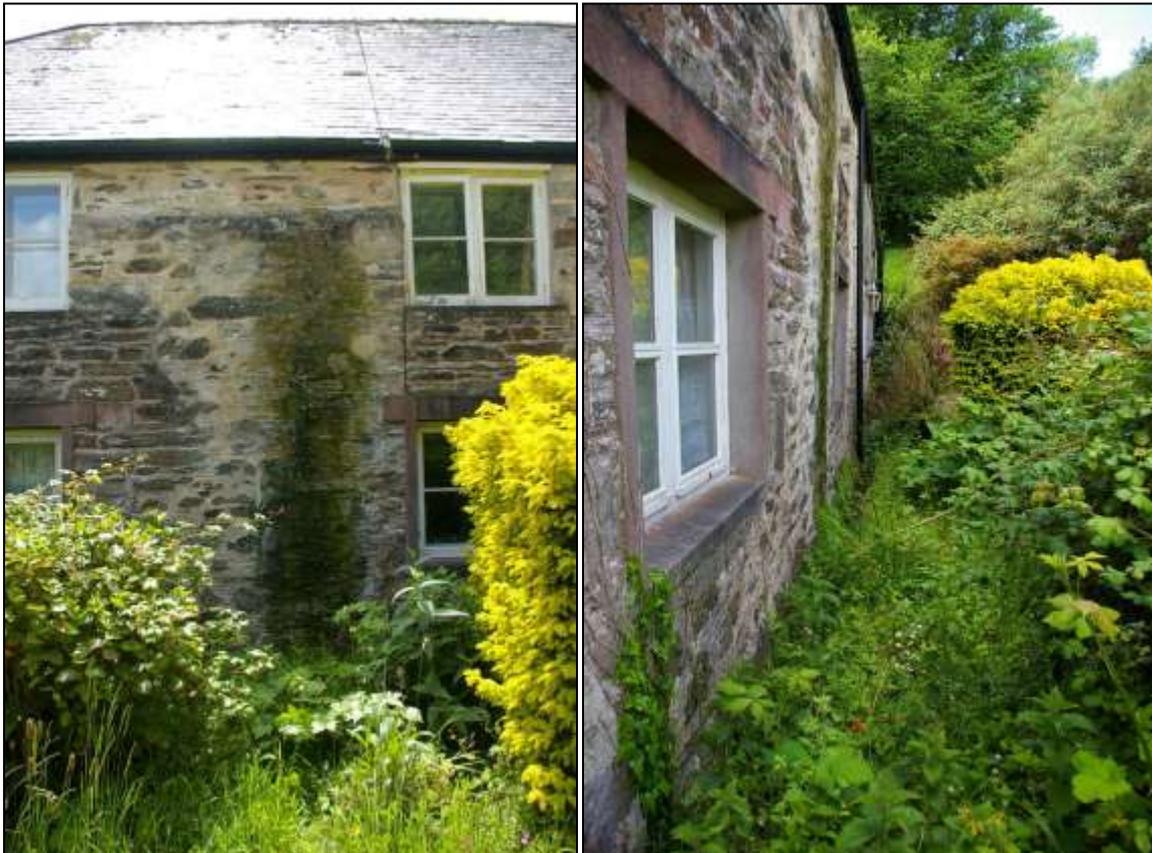
LEFT: DETAIL WITHIN THE RUINED WALL INCORPORATED INTO THE BUILDING SHOWING A POTENTIAL SET OF RAGGED LARGE SLAB QUOINS AND ALSO A POTENTIAL BLOCKED OPENING AT GROUND FLOOR; FROM THE NORTH.

RIGHT: VIEW ALONG THE FRONT OF THE BUILDING, SHOWING HOW THE RUINED SECTION OF WALL IS ANGLING OUTWARDS QUITE CONSIDERABLY AND HOW THE ALIGNMENT OF THE RANGE CHANGES; FROM THE EAST.

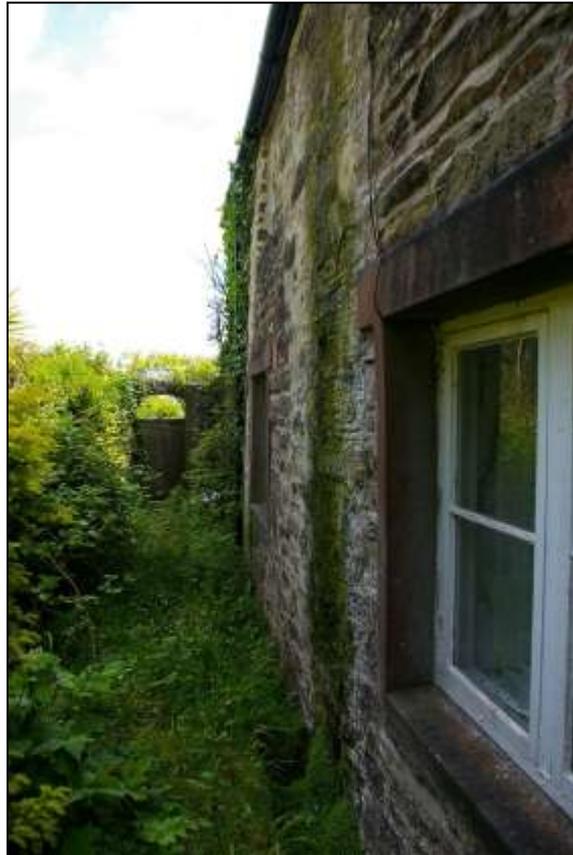
VIEW BACK ALONG THE INCORPORATED RUINED EARLIER BUILDING SHOWING THE SLIGHT BATTER TO THE WALL AND HOW THE WINDOWS AND RAISED EAVES ARE INSET BEHIND THE EARLIER WALLING, FORMING A LEDGE; FROM THE WEST.

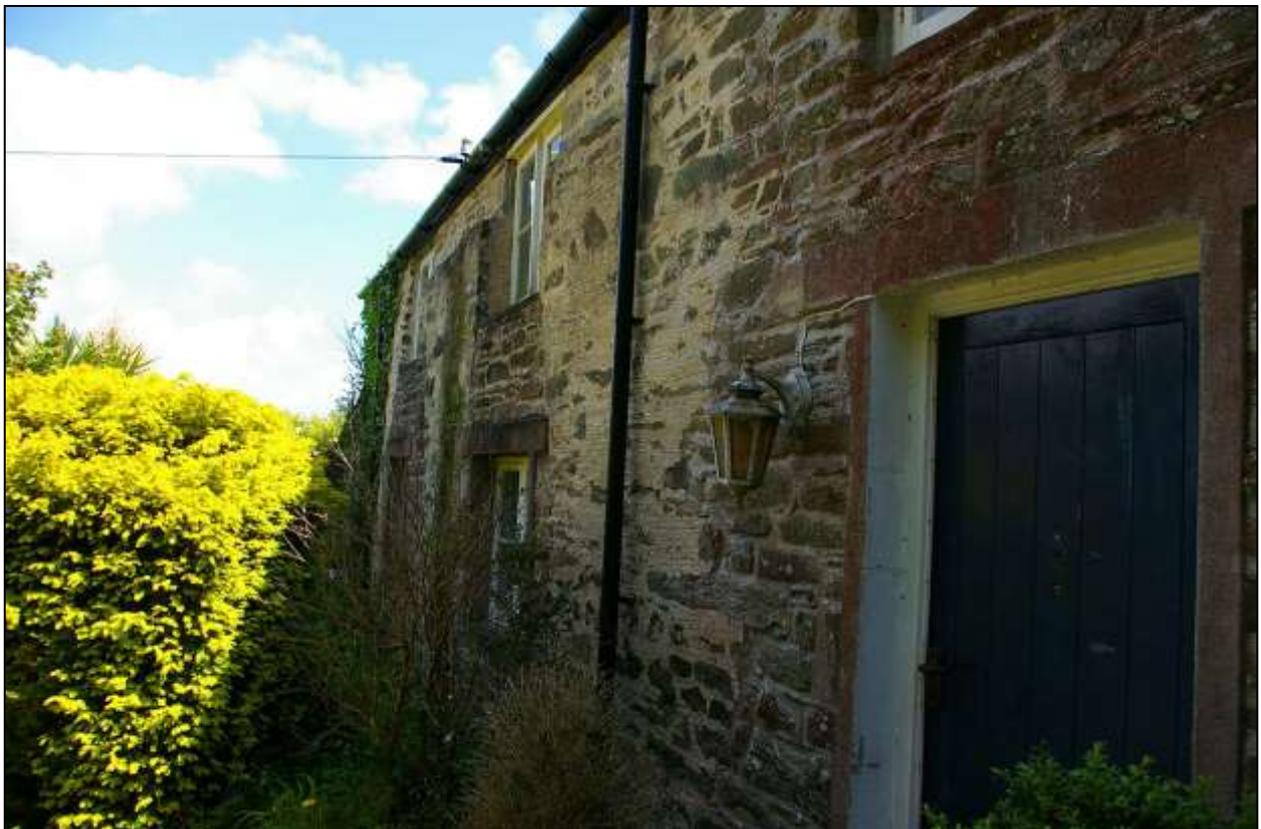
WIDER ANGLED VIEW SHOWING THE INCORPORATED RUINS AND FORCED FRONT DOOR, LEADING INTO THE INTERIOR; FROM THE WEST, NORTH-WEST.

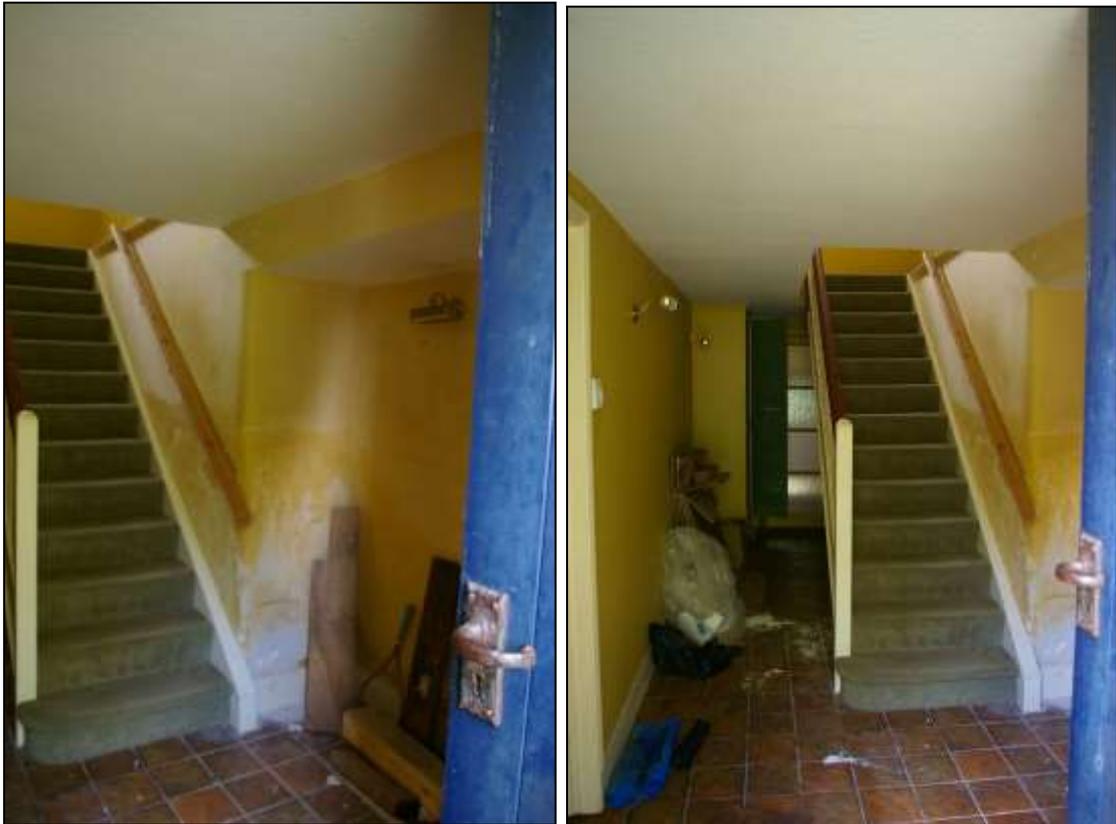
LEFT: INTO THE ENTRANCE HALLWAY AND STAIRS, ROOM 1, SHOWING HOW THIS DOOR HAS BEEN FORCED UP AGAINST THE PARTY WALL TO THE COTTAGE, WHICH HAS A LARGE BLOCKED DOORWAY WITHIN IT; FROM THE NORTH-EAST.

RIGHT: THE HALLWAY, ROOM 1, ENTRANCE AND STAIRS, QUARRY TILED FLOOR, MODERN PARTITIONS DIVIDING THE SPACE AND PLASTER BOARDED CEILING AND MODERN GLAZED DOORS; FROM THE NORTH.

The house is entered at the west end with a door forced near the party wall to the cottage. This enters a long, wide hallway (R1), with a set of modern stairs and plank banister rails; a classic 1970s design rising to the first floor to the west side against the party wall, leading to a large landing. To the rear of the hallway, a frosted modern glazed door leads into the outset (R5) on the south side, a small service space. Another glazed door leads east into a lobby (R2A), with modern partition and large archway dividing this from a small fitted kitchen (R2B), with oak-effect units and a dining area. This space, formerly one open room, was heated via the lateral stack; this now has a blocked fireplace with quarry tiled hearth. There is a good three light 19<sup>th</sup> century casement window, which matches those in the cottage, with bead mouldings and chamfered mullions to the rear wall. Beneath this is a plank boarded window seat. A further glazed door back

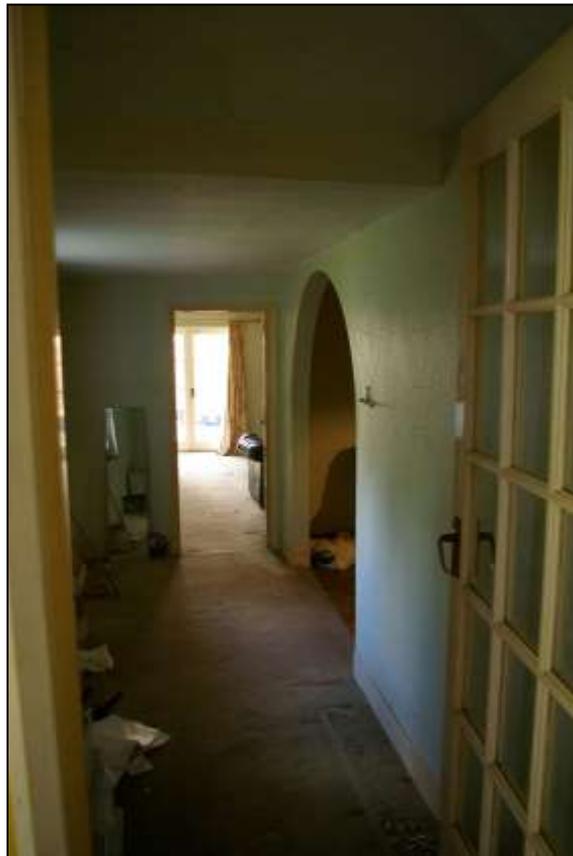
VIEW FROM THE HALLWAY INTO THE LOBBY/CORRIDOR CREATED BY ANOTHER MODERN PARTITION AND ARCHWAY, FORMING A FITTED KITCHEN, ALSO SHOWING FURTHER MODERN GLAZED DOORS AND MODERN FITTINGS; FROM THE WEST.

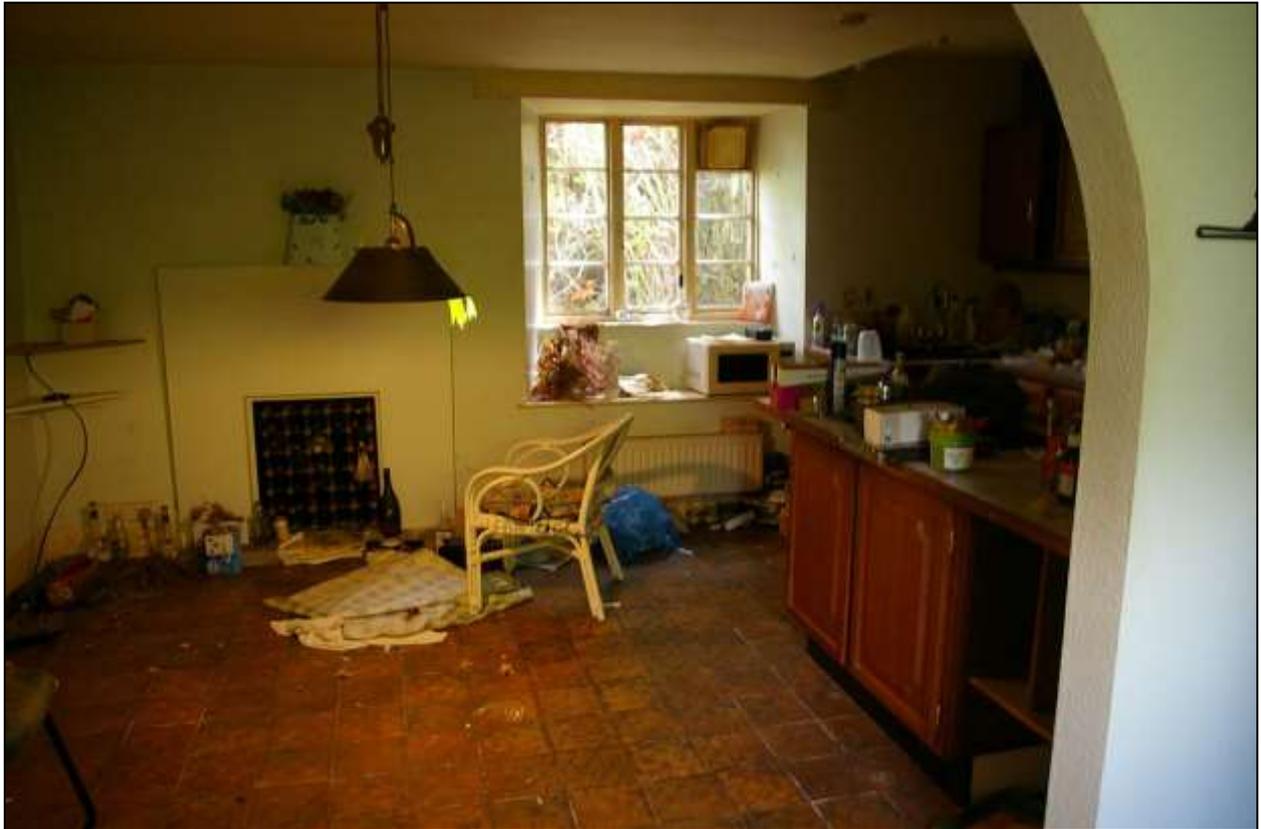
THE FITTED KITCHEN, WITH THE THREE LIGHT 19<sup>TH</sup> CENTURY CASEMENT AND WINDOW SEAT, BLOCKED FIREPLACE ON THE REAR WALL, MODERN QUARRY TILED FLOOR, BOARDED OUT CEILING WHICH OBSCURES A CHANGE IN CEILING HEIGHT; FROM THE NORTH, NORTH-EAST.

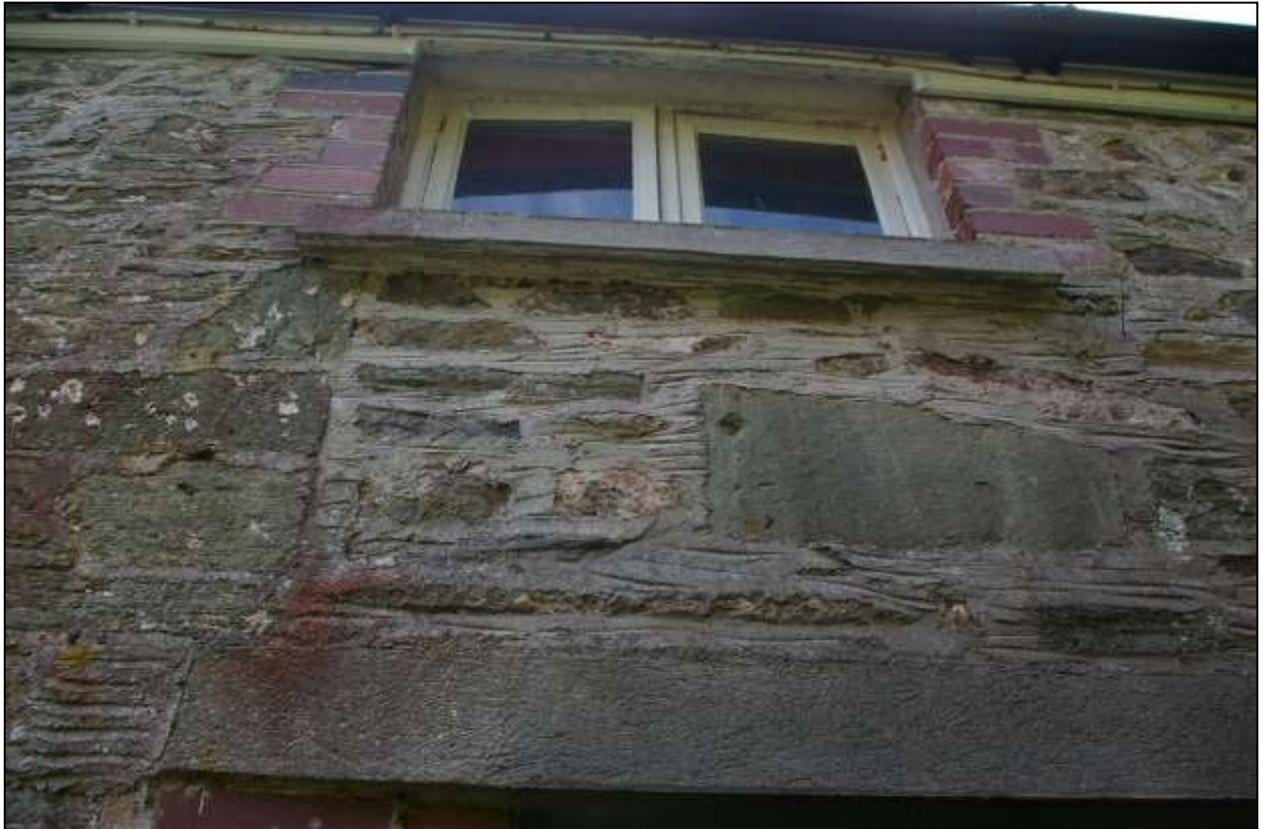
THE SMALL BLOCKED WINDOW WITH BRICK REVEALS SET INTO A LARGER OPENING, A LOADING DOOR ABOVE THE FORCED DOORWAY TO THE FRONT OF THE ATTACHED COTTAGE; FROM BELOW (NORTH-EAST).

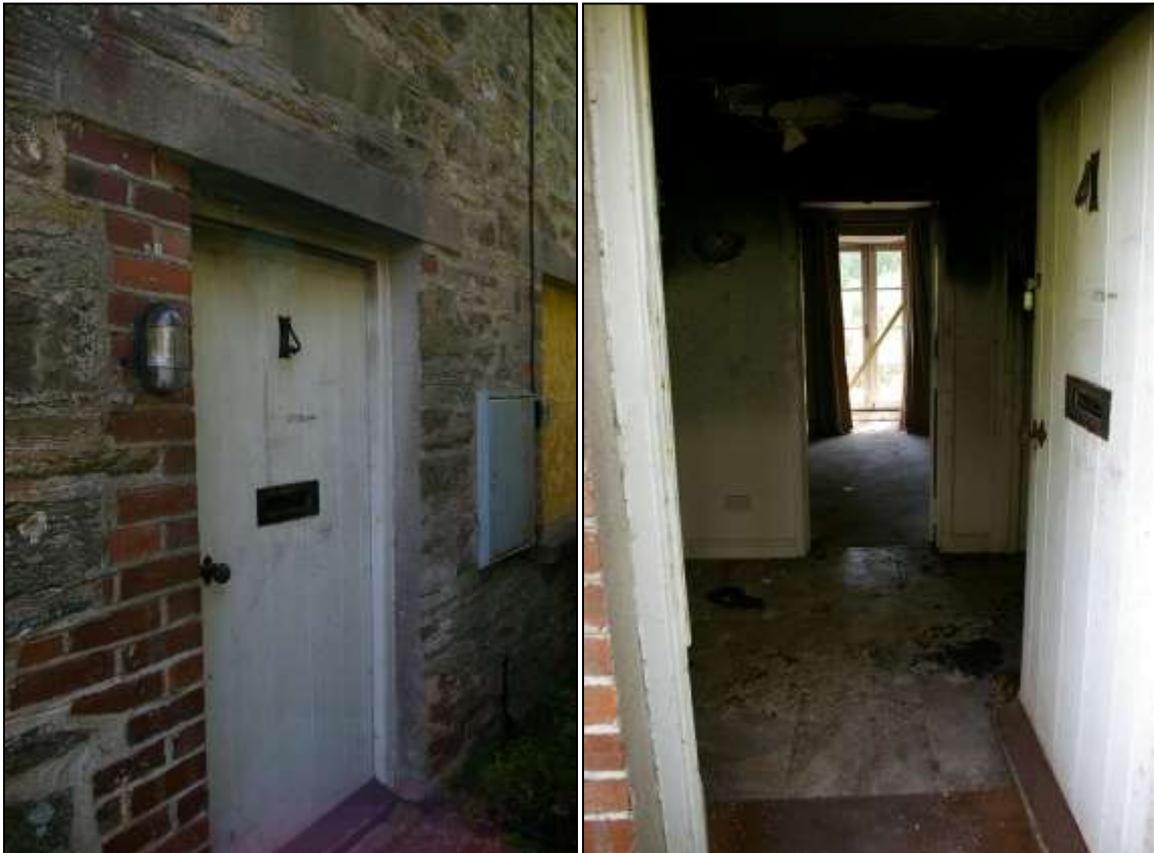
LEFT: THE FRONT DOOR TO THE COTTAGE, BRICK PATCHED REVEALS TO THE EAST, CONCRETE RENDER PATCHING TO THE WEST AND RENDERED LINTEL; FROM THE NORTH-EAST.

RIGHT: VIEW THROUGH THE FRONT DOOR, INTO THE HALLWAY OF THE COTTAGE CR1 AND THROUGH TO THE SITTING ROOM CR3; FROM THE NORTH.

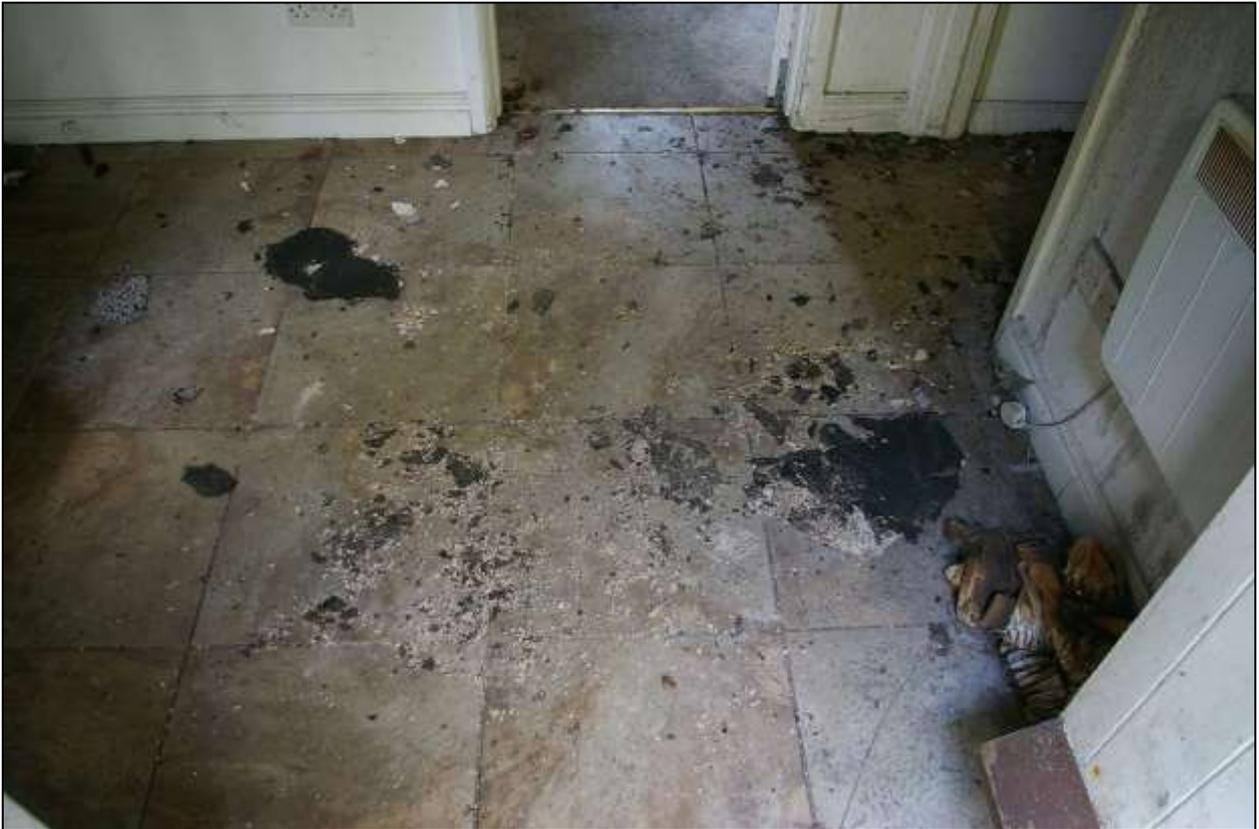
VIEW OF THE MODERN STONE TILED FLOOR IN CR1, THE HALLWAY; FROM THE NORTH.

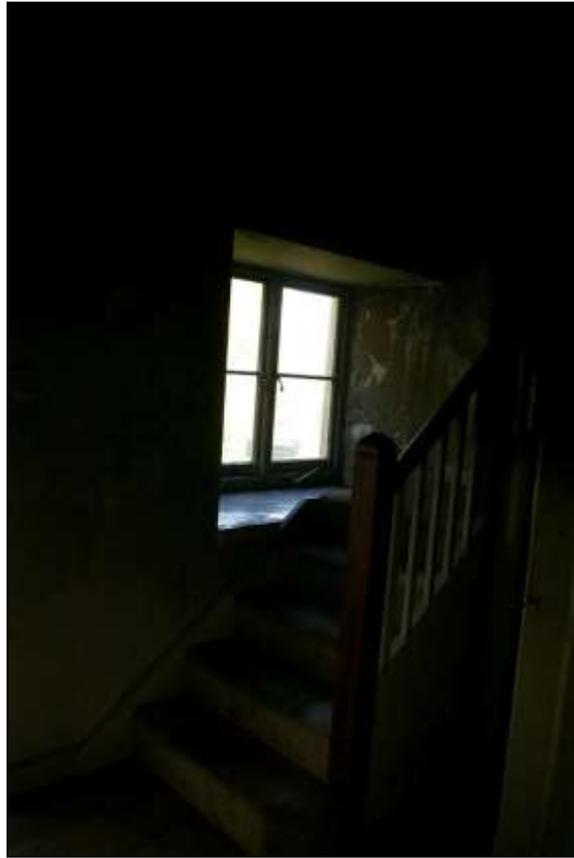
VIEW OF HOW THE STAIRCASE, MODERN CUTS THE HISTORIC WINDOW IN THE FRONT WALL OF THE COTTAGE IN CR1; FROM THE SOUTH-WEST.

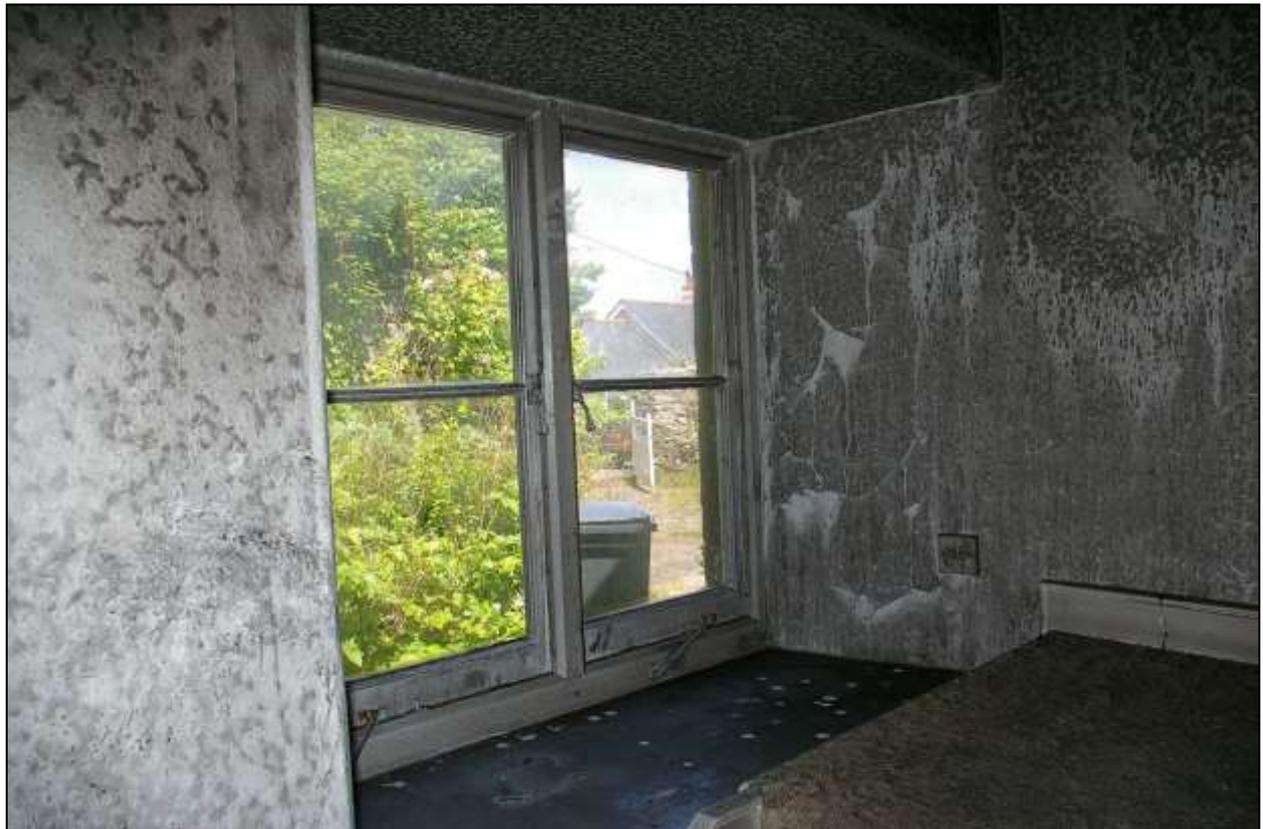
DEEP BEADED OPENING, PLANK SILL AND TWO LIGHT BEADED CASEMENT IN CHAMFERED PEGGED FRAME, A 19<sup>TH</sup> CENTURY FEATURE CW1; FROM THE SOUTH-WEST.

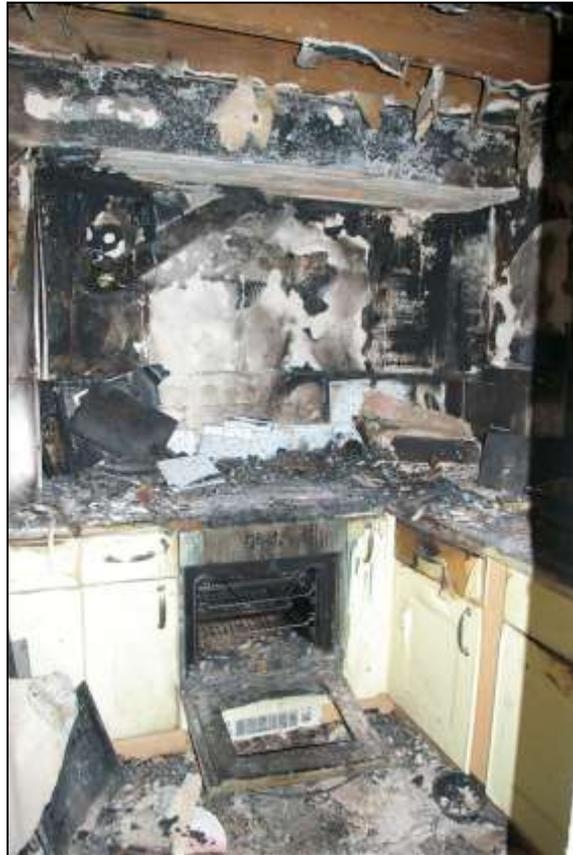
THE RUINED KITCHEN, CR2; FROM THE EAST.

The interior of the cottage displays significant modernisation, with cement plastered walls, modern 'heritage style' skirtings and thin plank boarded doors. This space has recently suffered a major internal fire, with severe smoke staining and damage, although still apparently structurally sound. A door (CD1) has been forced in the front wall of the cottage, forming a 'front door'; suggestive of this space having previously been accessed only from the rear elevation or from

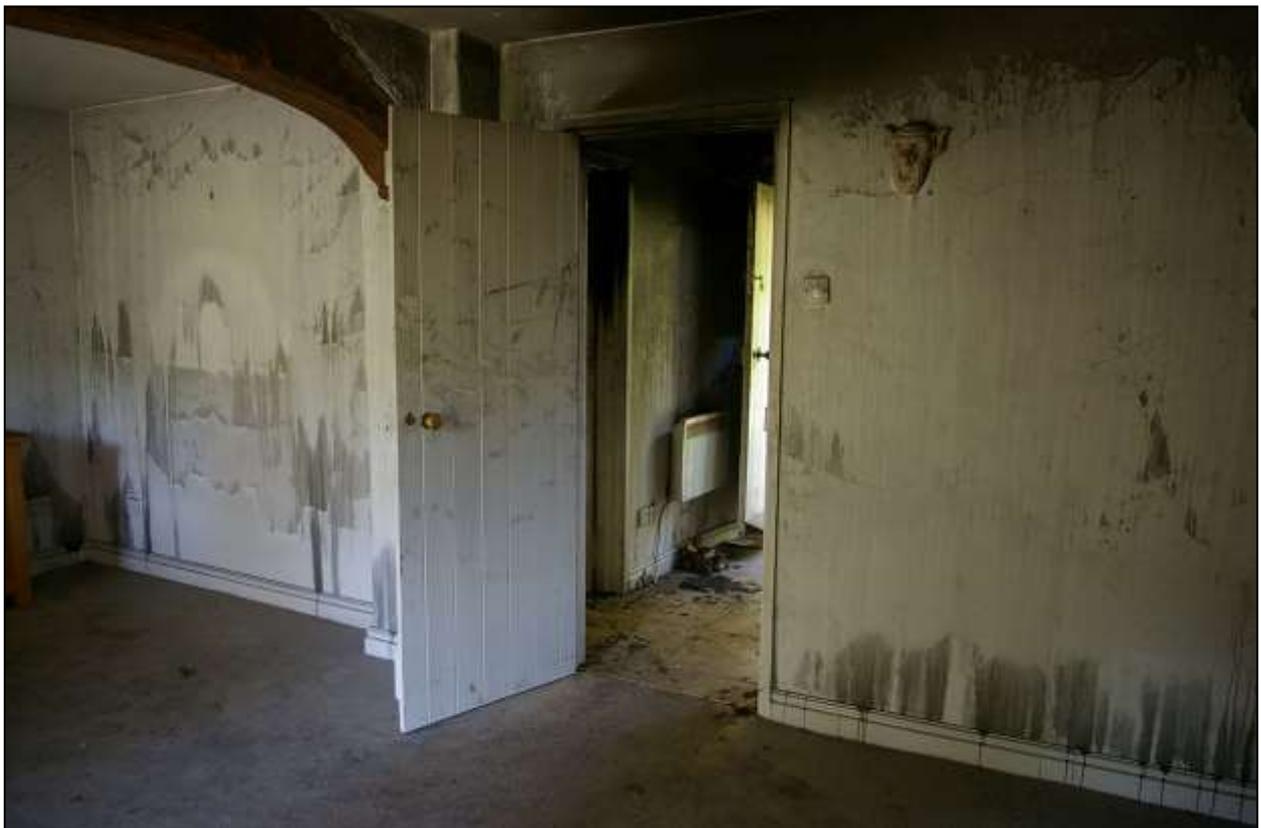
THE MODERN PARTITIONS, WITH A STUD OF EARLIER WALL BRACED BY A HACKED BACK BEAM IN CR3, THE SITTING ROOM, ALSO WITH DOOR BACK TO THE HALLWAY; FROM THE SOUTH-EAST.

A door in the south wall of the entrance hall and stairs leads into a long living room (CR3). This has a large beam bracing the space where a partition wall may have been removed. To the east end is a large fireplace, blocked with loose modern decorative rubble in cement, with modern bresummer beam and two alcoves to either side. This space has been replastered and 'rusticated' any 18<sup>th</sup> or 19<sup>th</sup> century character removed for a 'modern farmhouse' effect makeover when the cottage was converted. There is one good 19<sup>th</sup> century three light casement window (CW3) with bead moulding and chamfered mullions, pegged frame, with thick plank sill, in the south-east corner. Roughly to the centre of the south wall is a set of narrow 20<sup>th</sup> century French glazed patio doors (CD4). The solid floor is carpeted; when pulled up the floor appears to have been replaced with concrete. There is a large blocked doorway in the south-west corner of this room, for which there is no internal evidence due to wholesale replastering.
