# BATSON HALL FARM

Historic Building Assessment & Heritage Impact Assessment

South West Archaeology Ltd. report no. 190620

## Batson Hall Farm, Batson, Salcombe, Devon Historic Building Assessment and Heritage Impact Assessment

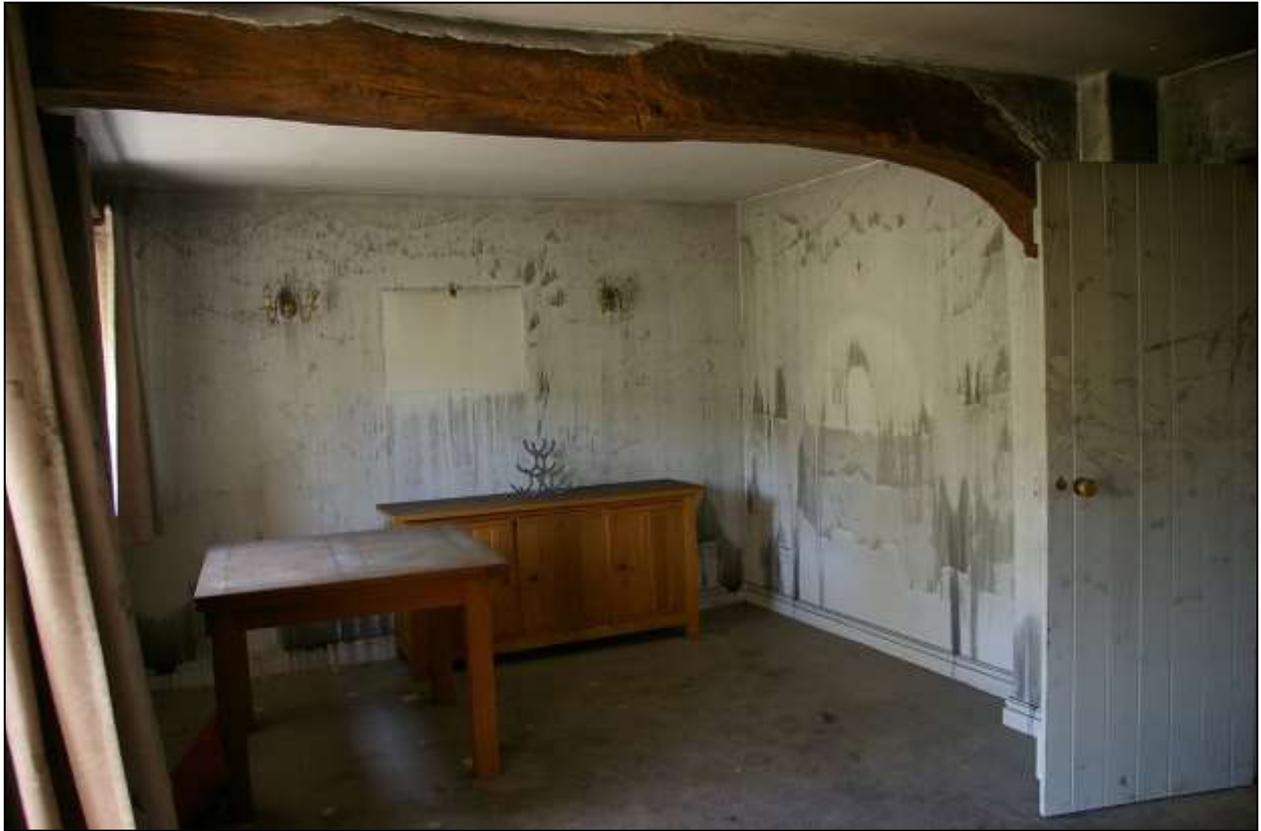
THE BEAM IN MORE DETAIL, BRACING A FORMER PARTITION LINE/WALL LINE; FROM THE SOUTH-EAST.

wall in the sitting room (CR3), replaced by a bracing beam. The walls which form the kitchen (CR2) and the bedrooms (CR6 & CR7) and bathroom (CR5) are all modern partitions.

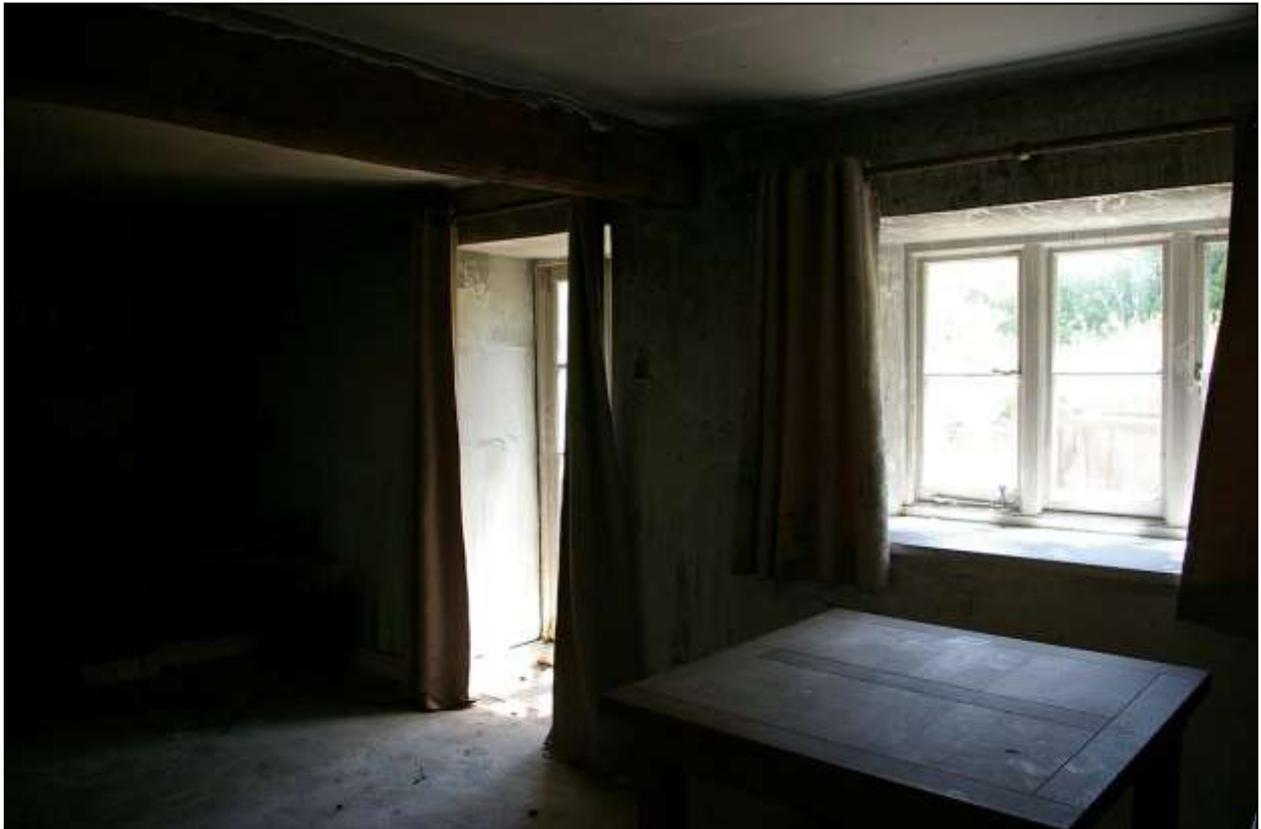
THE SOUTH WALL OF CR3, WITH FORCED PATIO DOORS AND 19<sup>TH</sup> CENTURY WINDOW; FROM THE NORTH-EAST.

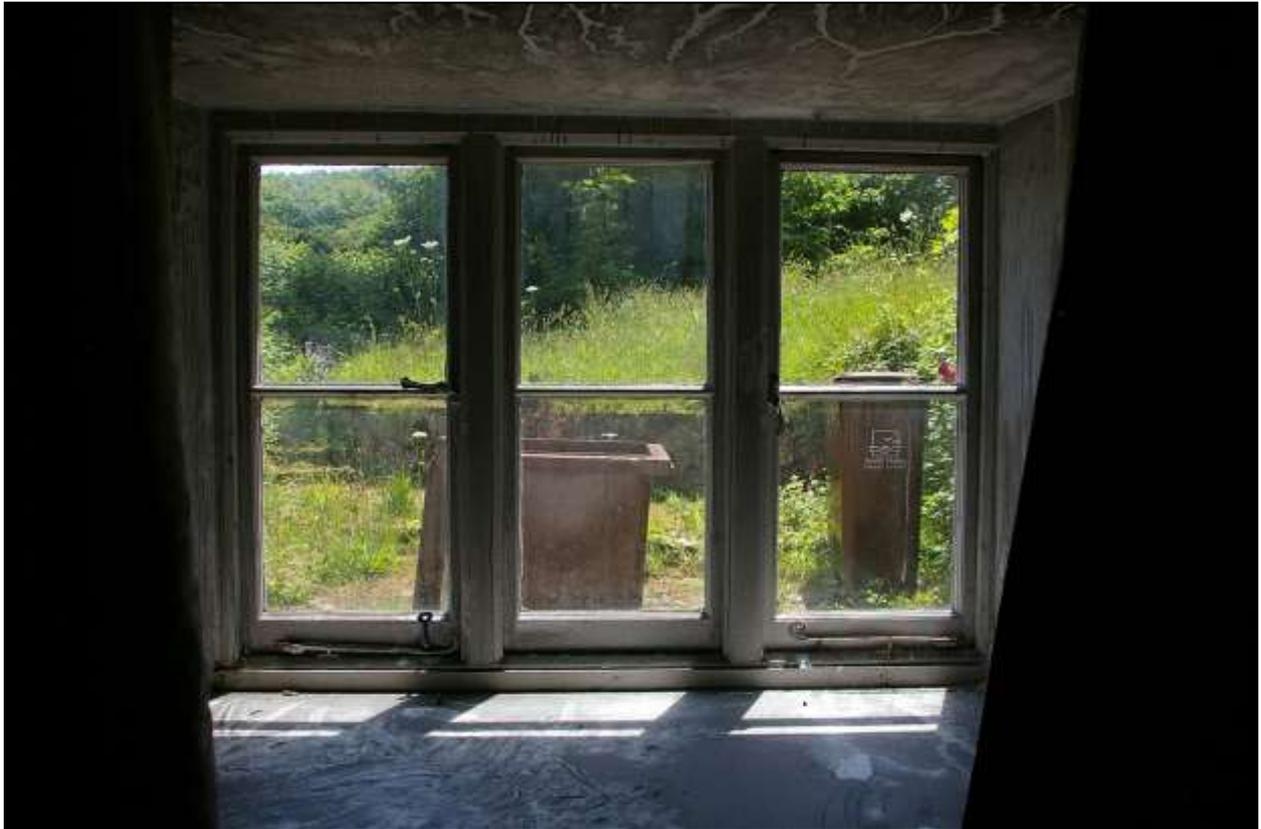
DETAIL OF THE GOOD 19<sup>TH</sup> CENTURY THREE LIGHT CASEMENT WINDOW CW3; FROM THE NORTH.

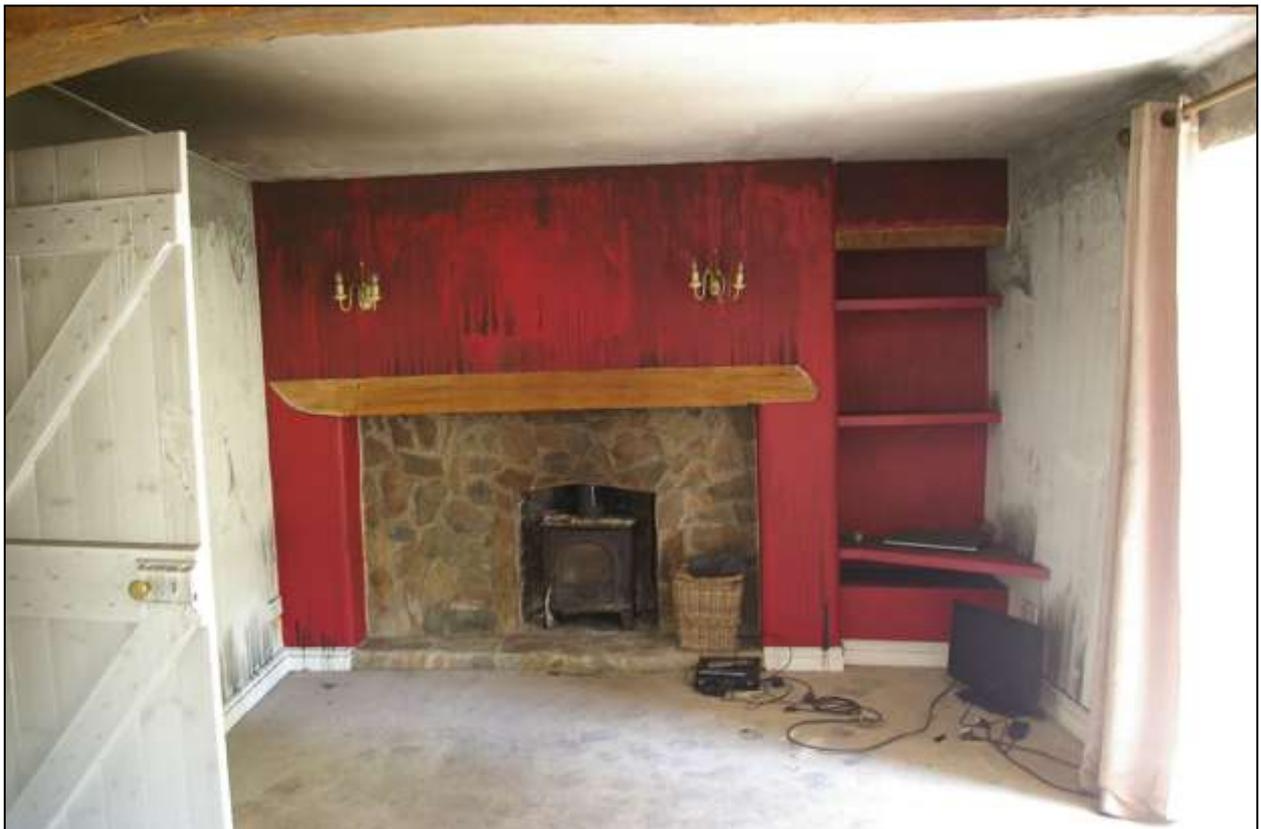
THE SHALLOW STACK AND BLOCKED FIREPLACE, WITH ALCOVE TO THE SOUTH, WITH TIMBER LINTEL; FROM THE WEST.

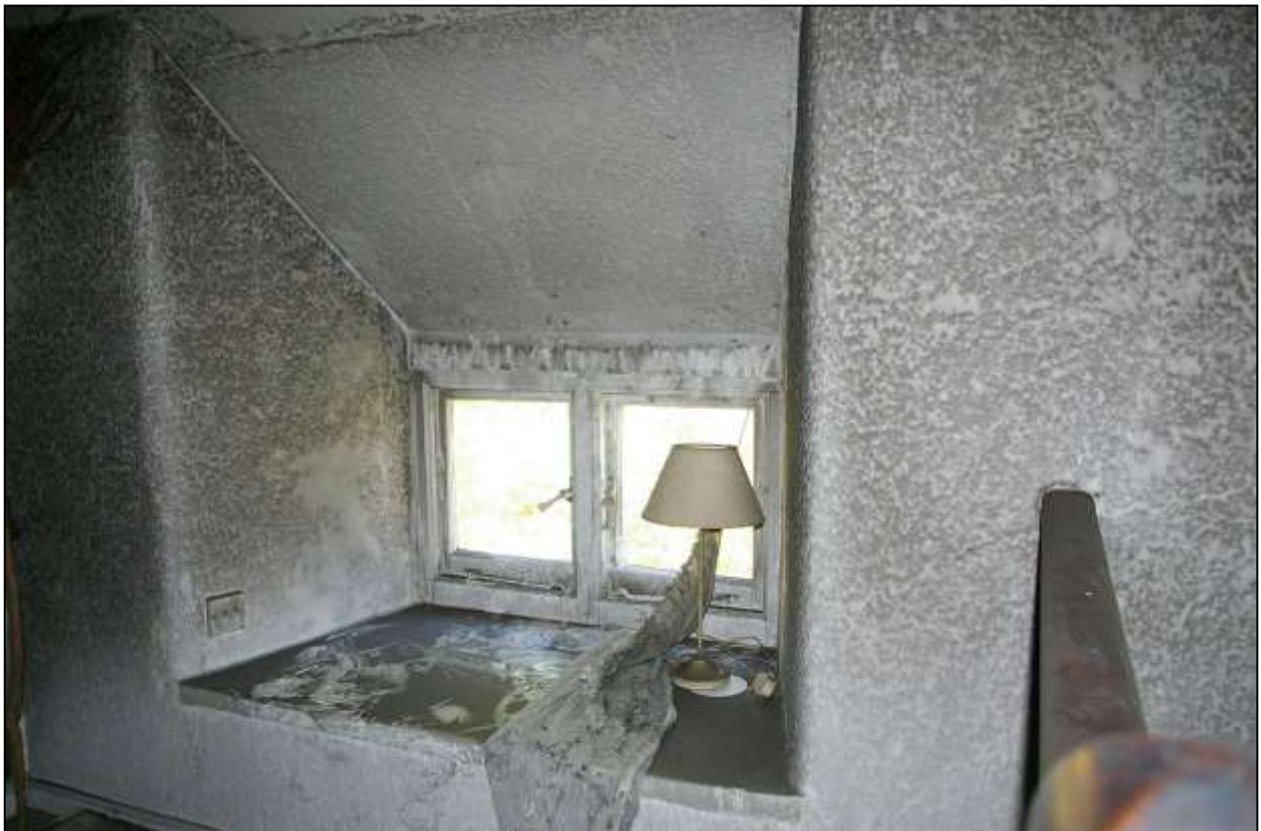
THE TWO LIGHT WINDOW SET INTO A BLOCKED LOADING DOOR IN THE FRONT WALL, CW4; FROM THE SOUTH-EAST.

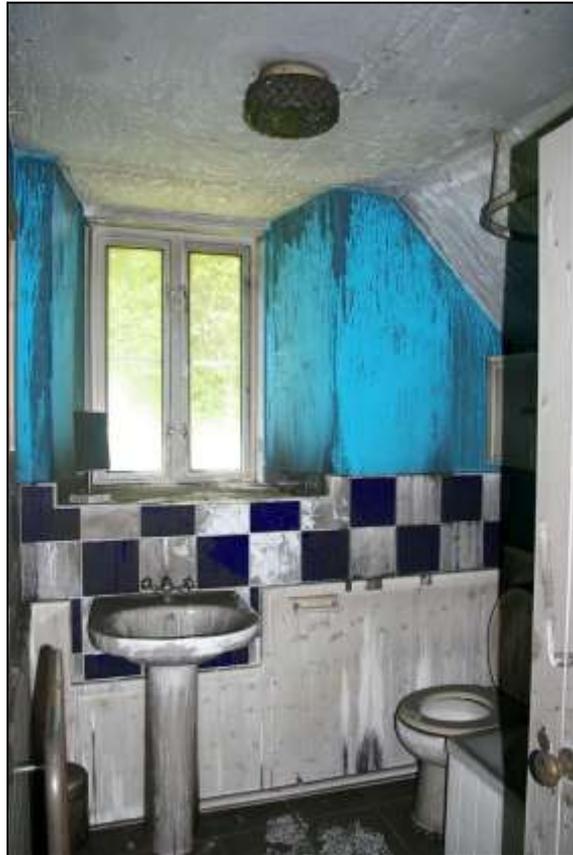
THE MODERN BATHROOM, CR5; FROM THE EAST.

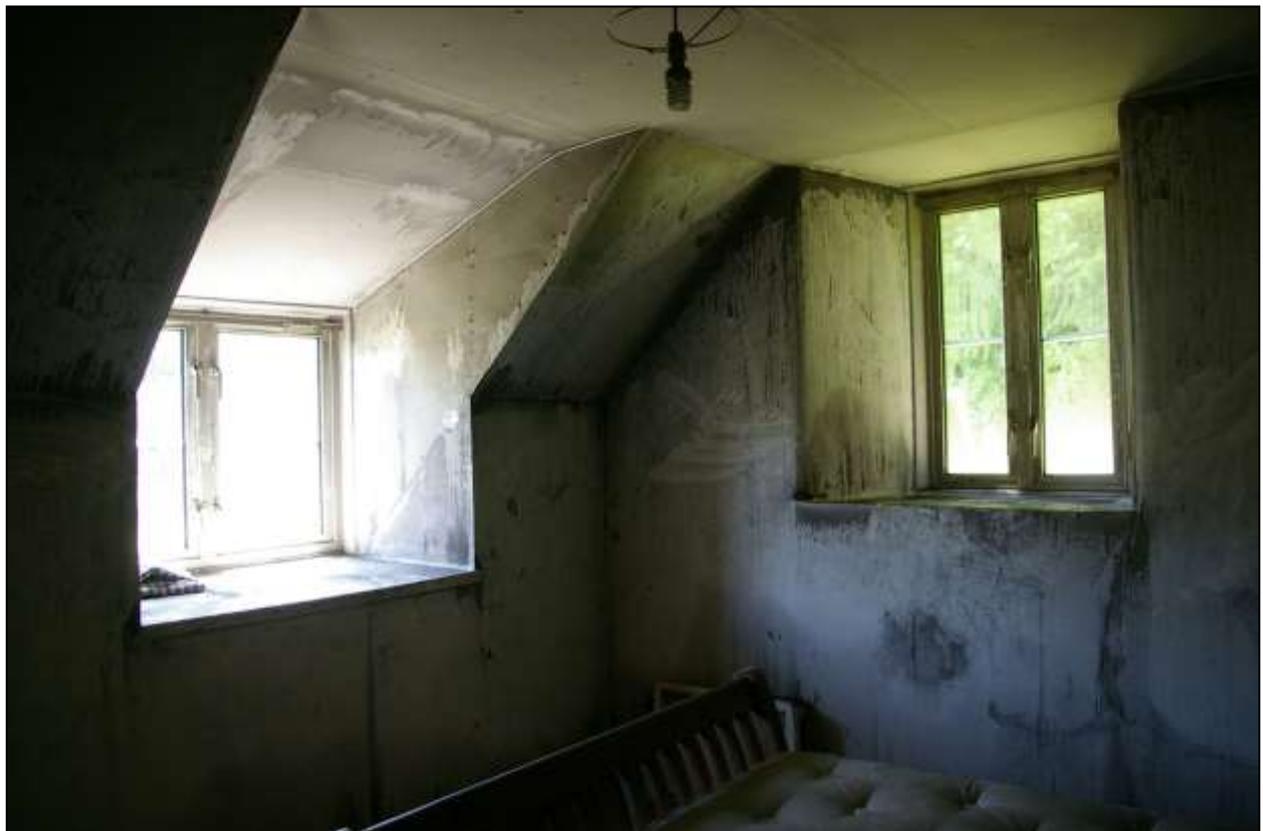
BEDROOM 1 WITH FORCED WINDOW OPENINGS AND PVC UNITS; FROM THE NORTH-EAST.

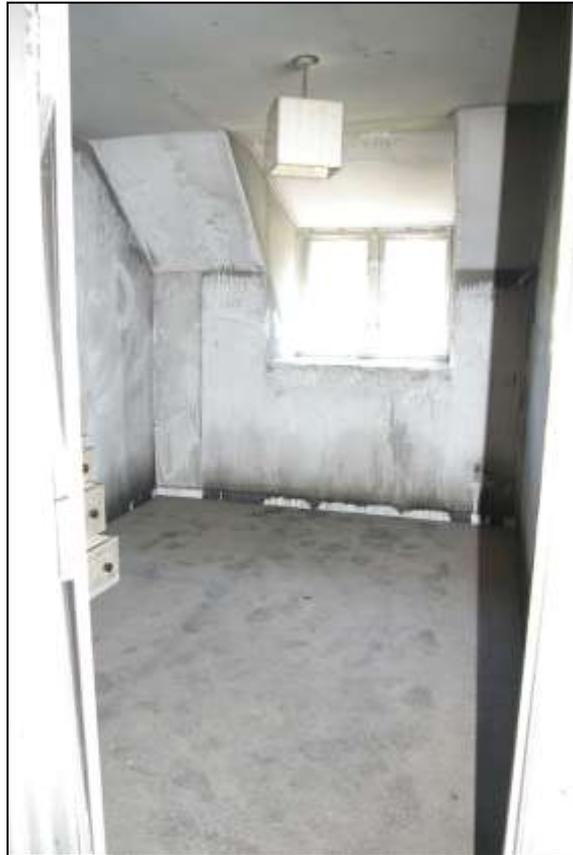
BEDROOM 2 WITH FORCED DORMER WINDOW TO THE REAR; FROM THE NORTH-WEST.

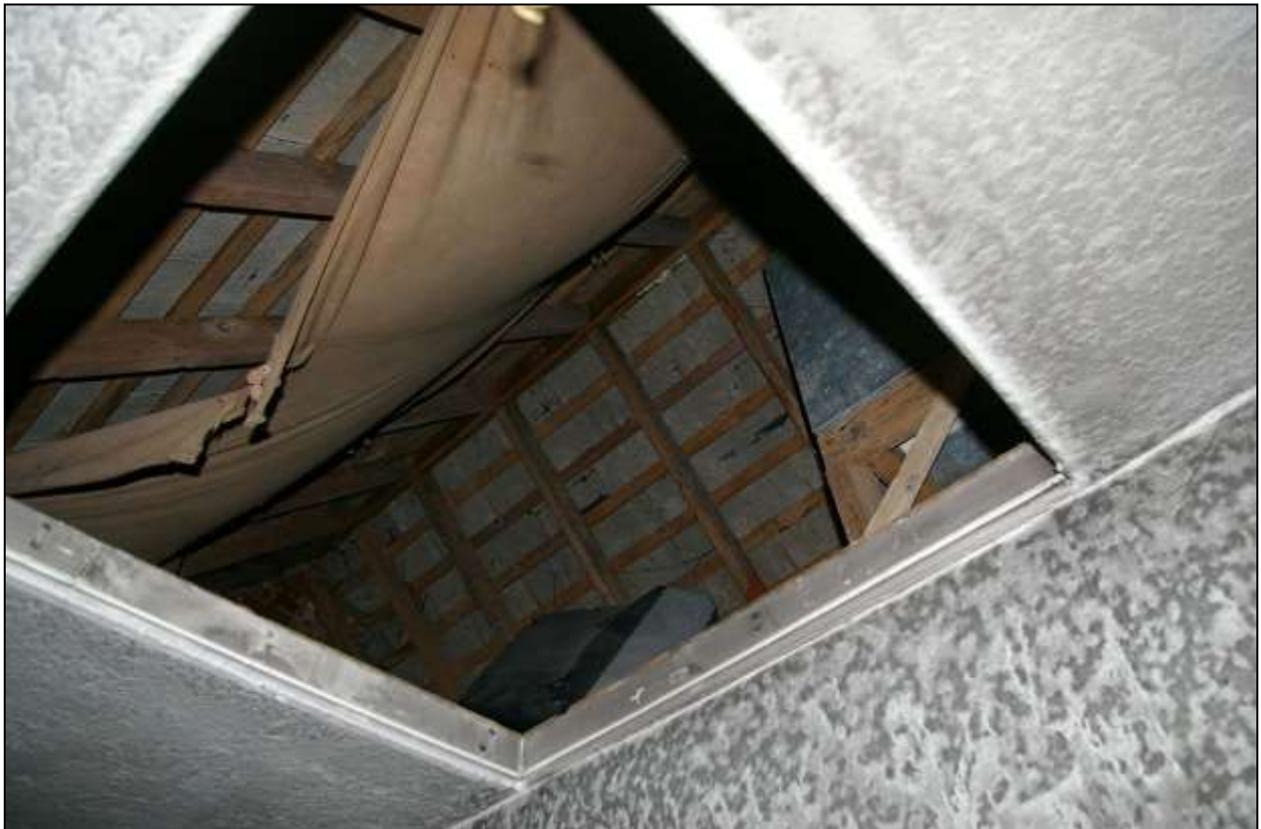
VIEW UP INTO THE LOFT, SHOWING THE MODERN COMMON RAFTER REPLACEMENT ROOF; FROM BELOW (NORTH-WEST).

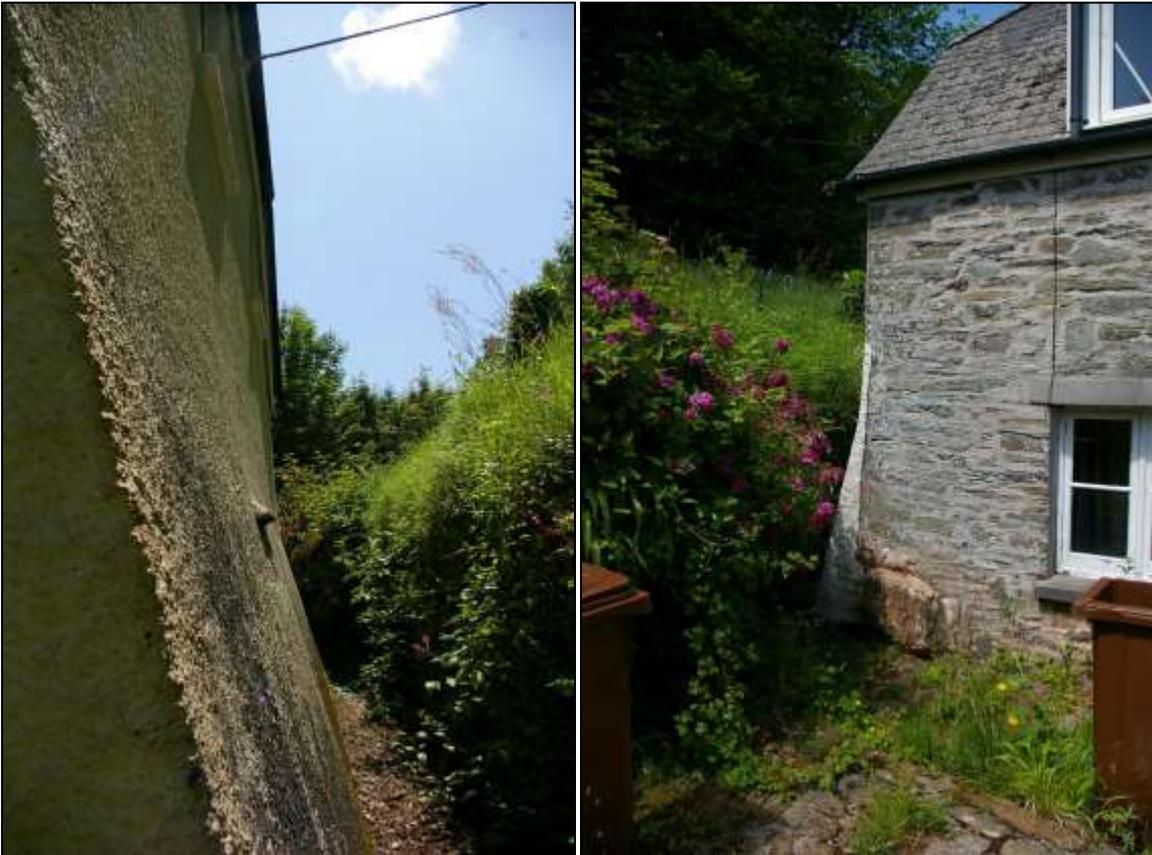
LEFT: THE WEST GABLE END OF THE COTTAGE, SHOWING HEAVY BUTTRESS AND FORCED WINDOWS SET HIGH IN APEX; FROM THE NORTH.  
RIGHT: VIEW OF THE SOUTH-WEST CORNER OF THE COTTAGE, SHOWING BRICK RENDERED BUTTRESS SUPPORTING THE WEST GABLE; FROM THE SOUTH-EAST.

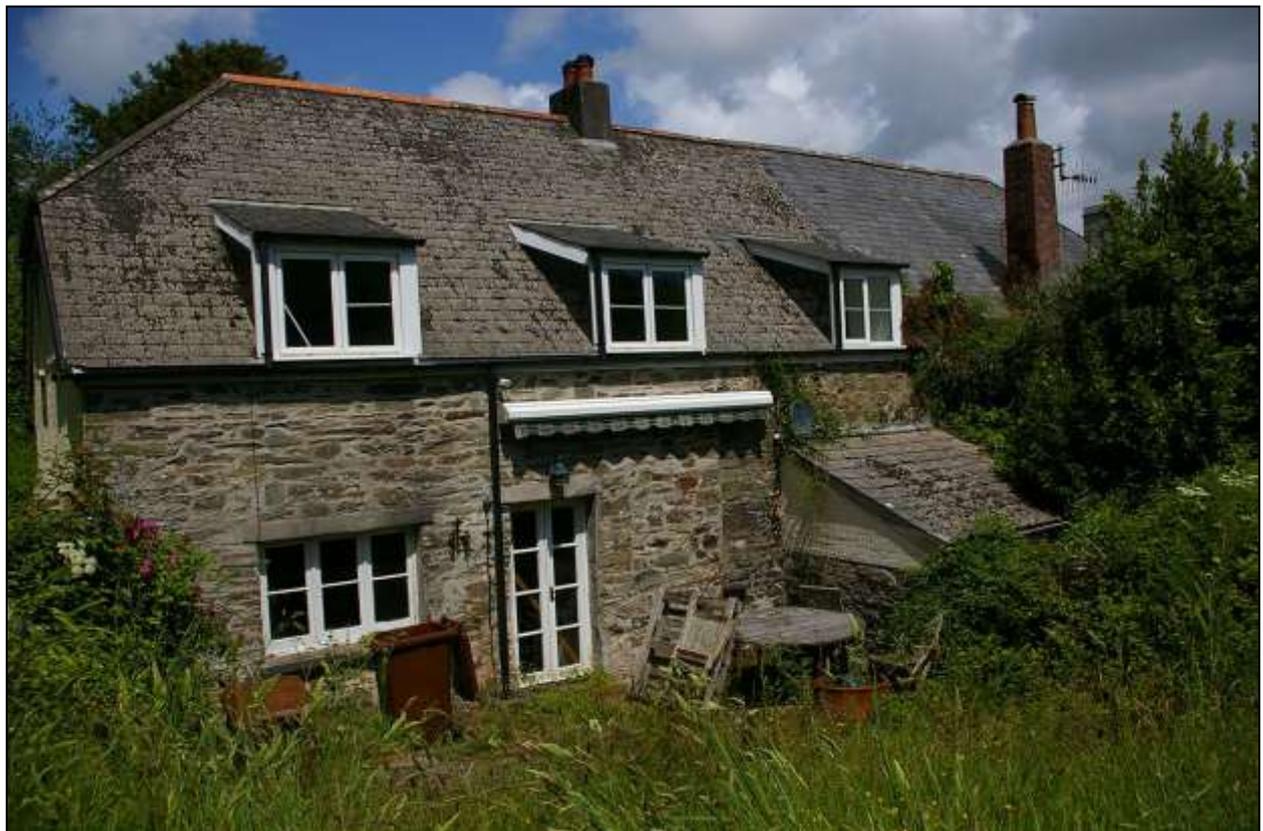
THE COTTAGE AND BATSON HALL FARM SOUTH ELEVATIONS AND ROOFLINE, SHOWING THE OBSCURING FOLIAGE; FROM THE SOUTH-WEST.

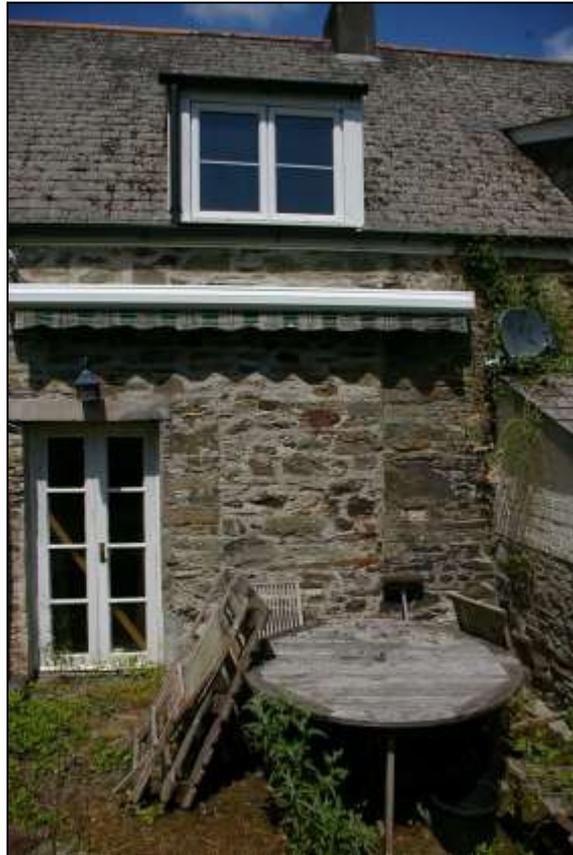
THE BLOCKED DOORWAY IN THE SOUTH ELEVATION OF THE COTTAGE IN THE SOUTH-EAST CORNER, SHOWING GOOD DRESSED REVEALS; FROM THE SOUTH.

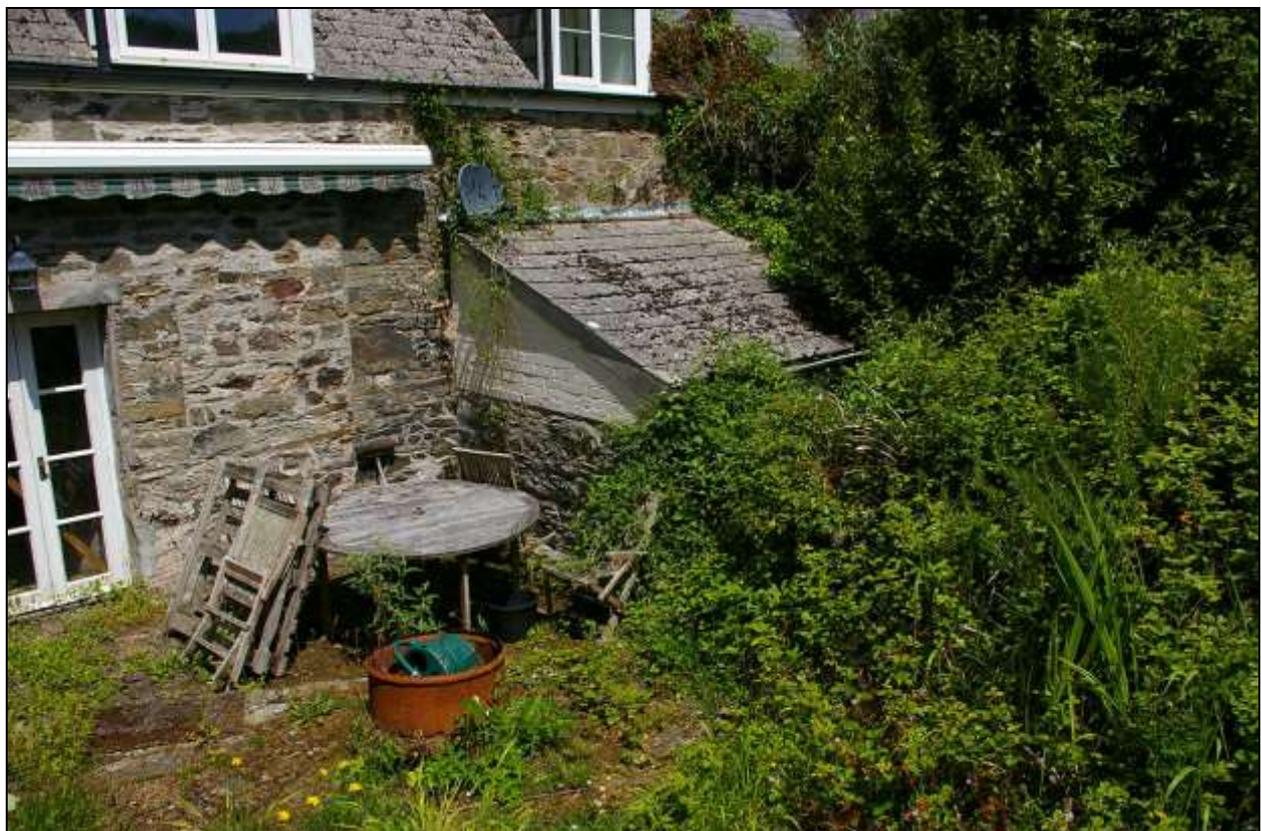
THE PROJECTING BLOCK, OF AN OLDER FORM OF PLATEY STONEMASONRY, OFF THE BACK OF THE SOUTH ELEVATION ACROSS THE JOIN BETWEEN COTTAGE AND FARMHOUSE; FROM THE SOUTH-WEST.

There is a small projecting lean-to block which braces the join between house and cottage, this is only half a storey high, ragged to top, much repaired in cement and raised in neat painted stretcher bond brickwork under a slate monopitch roof. The heavy grey slatestone slab stonework of this block and the stonework lower down along this rear wall is similar and of an older character. The stonework of the rear elevation of the main house seen continuing above, across and along the back of the cottage, would suggest a scrap of wall and the remains of a projecting block have been adapted and incorporated into a later build.

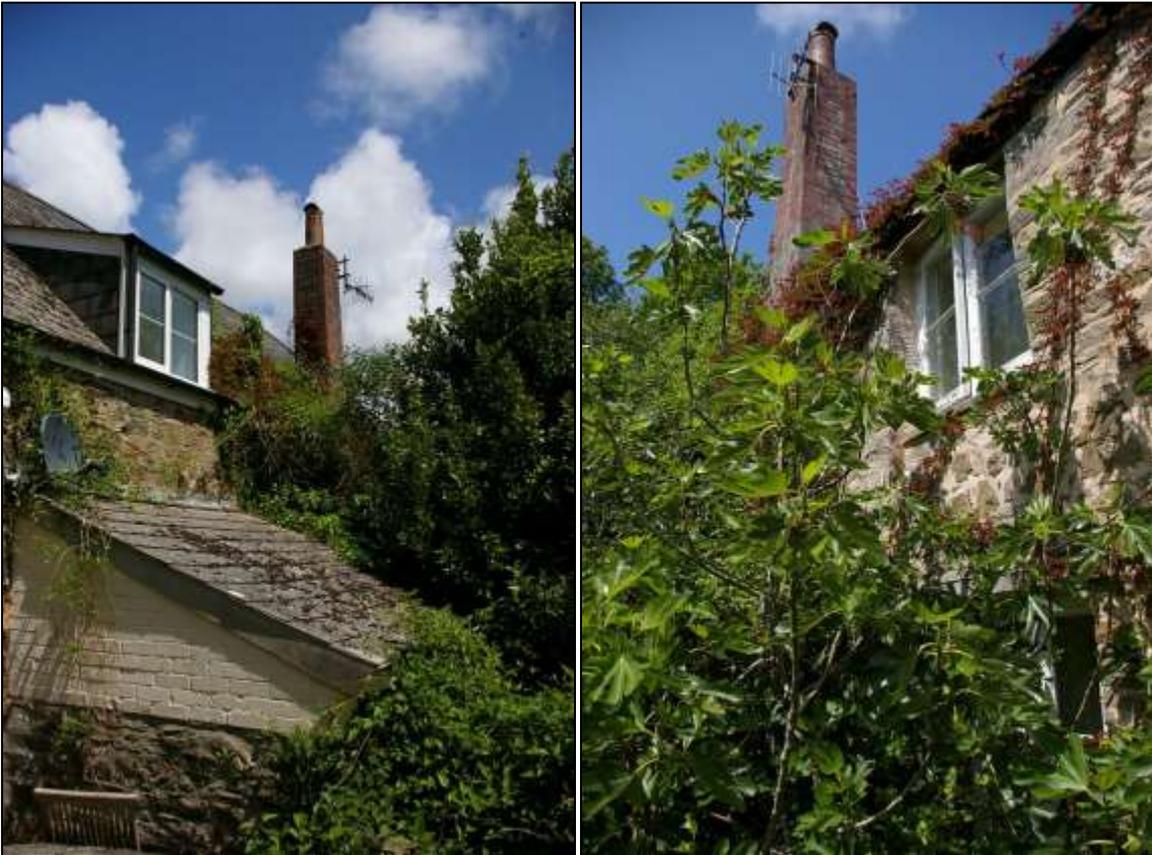
LEFT: VIEW BACK ALONG THE REAR OF THE FARMHOUSE, SHOWING LOOSE POST MEDIEVAL RUBBLE AT THE EAVES AND A REBUILT BRICK CHIMNEY SHAFT, AS WELL AS A DISTINCT CHANGE IN ALIGNMENT ON THE ROOF; FROM THE WEST, SOUTH-WEST.

The south 'rear' elevation has a clear build line and change in alignment near the lateral stack with some heavy slatestone quoins. There are two types of earlier grey platey slatestone stonework, returning to a more typical post medieval loose rubble and appearing contiguous with the cottage. There are four windows here, two to each ground and first floor. To the west end, the elevation is completely obscured by foliage, but a three light casement window lights the kitchen, a two light casement lights a further ground floor room, one to a bedroom. The other first floor window isn't visible, for foliage. The south-east corner, as to the north, is rendered, wrapping around from the east gable.

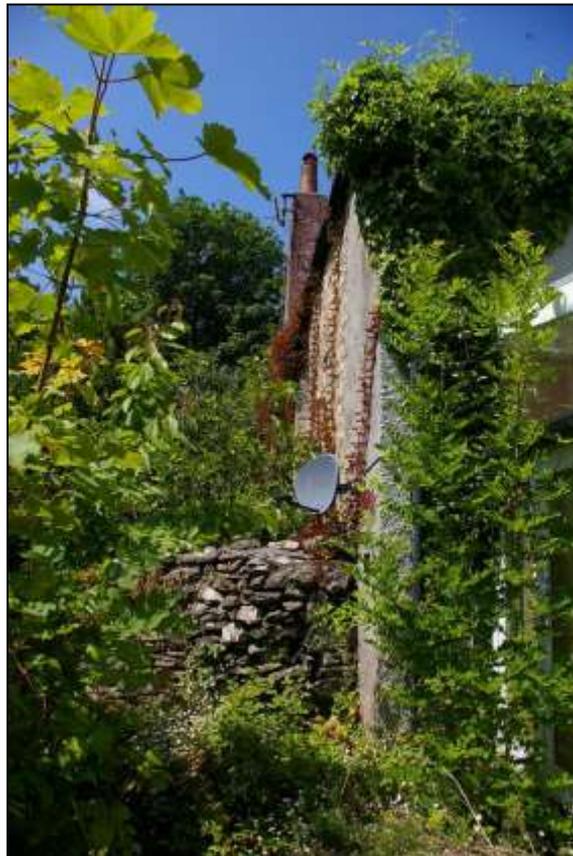
VIEW ALONG THE BACK OF THE FARMHOUSE, SHOWING HOW IT IS ALMOST TOTALLY OBSCURED BY OVERGROWTH; FROM THE EAST.

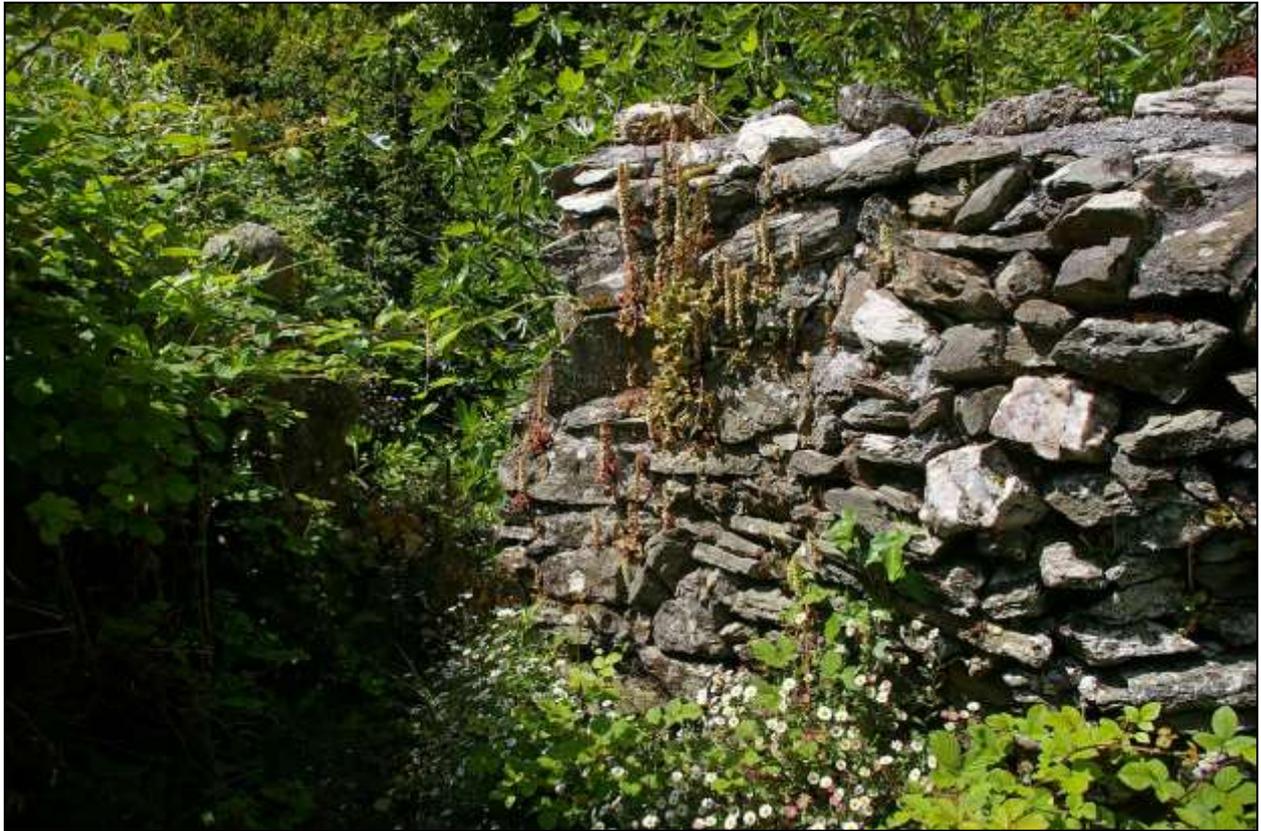
VIEW OF THE TWO DECORATIVE 19<sup>TH</sup> CENTURY GARDEN WALLS WHICH FRAME THE REAR TERRACE TO THE FARMHOUSE, WITH A BALL FINIAL AND BLOCK OF QUARTZ, DECORATIVE QUARTZ USED THROUGHOUT THE BUILD AS A FEATURE TYPICAL OF THE PERIOD; FROM THE EAST.

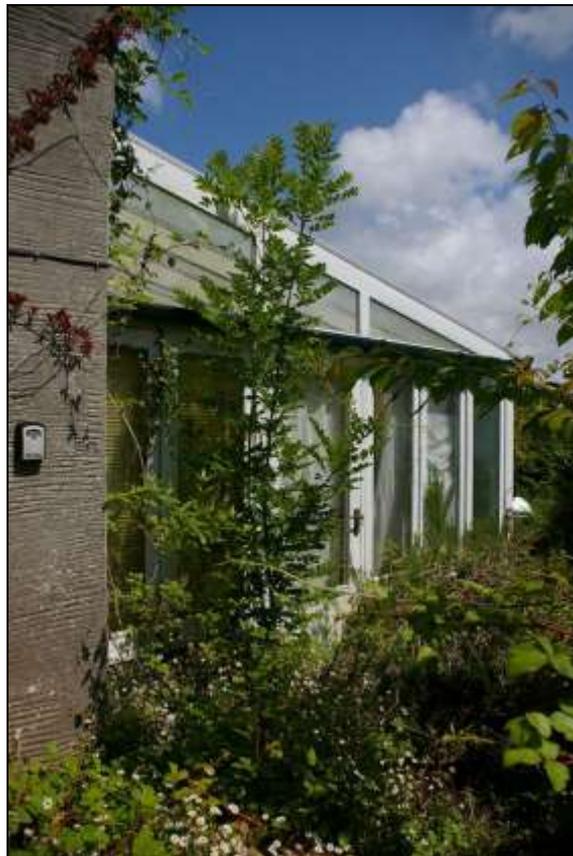
VIEW OF THE LARGE PLASTIC AND TIMBER CONSERVATORY WHICH DOMINATES THE EAST GABLE END OF THE FARMHOUSE AND THE GARDENS ON THIS SIDE; FROM THE SOUTH-WEST.

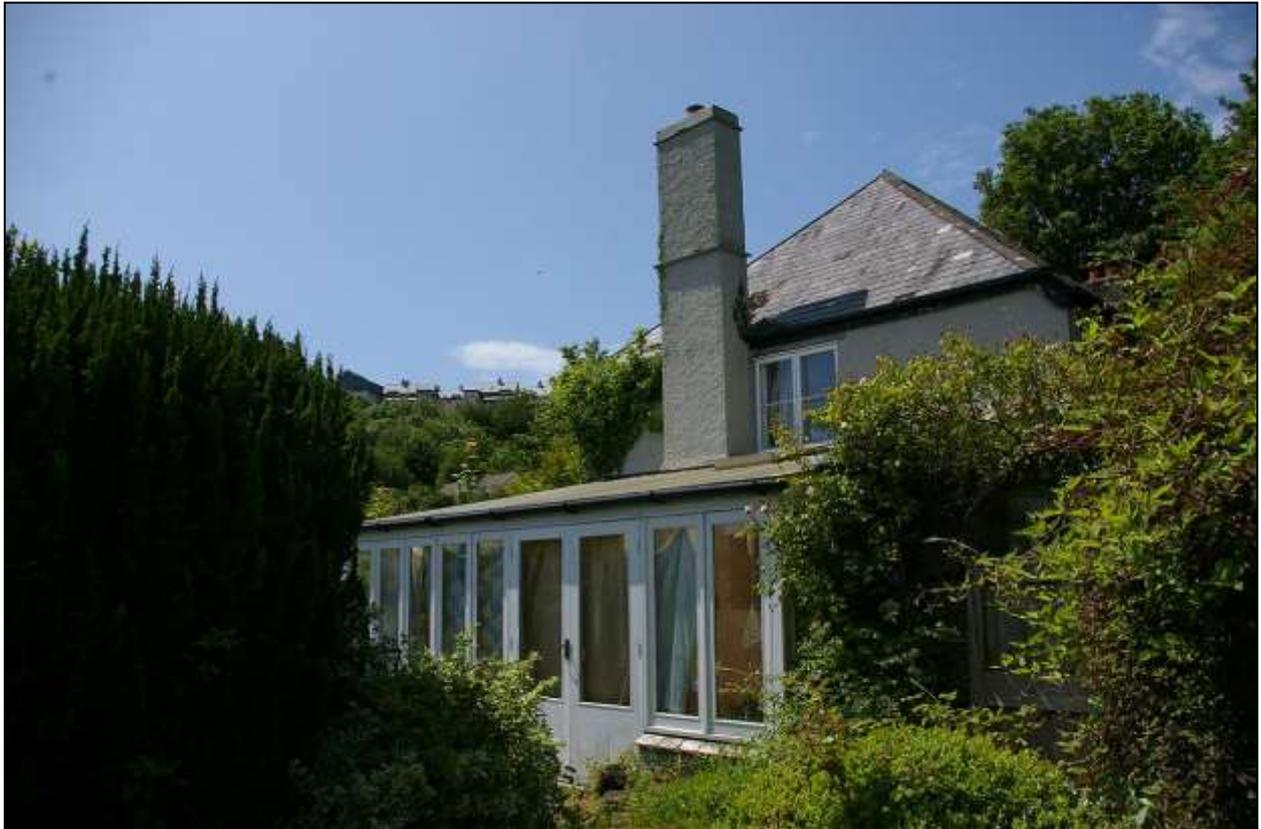
THE EAST GABLE END OF THE FARMHOUSE, WITH HIPPED ROOF, BOX STACK AND SHAFT AND LARGE MODERN CONSERVATORY; FROM THE NORTH-EAST.

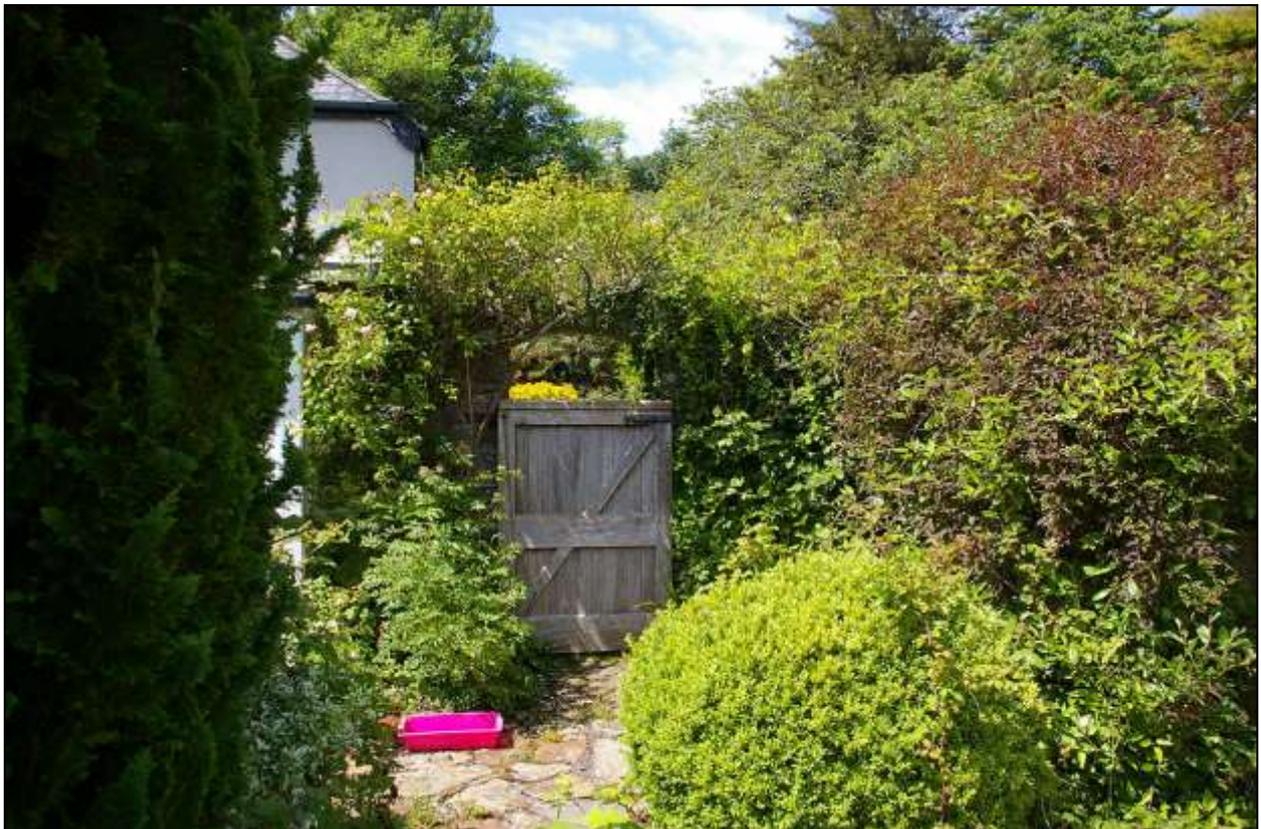
THE GARDEN WALL AND GATE TO THE NORTH ENCLOSED FRONT GARDEN; FROM THE EAST.

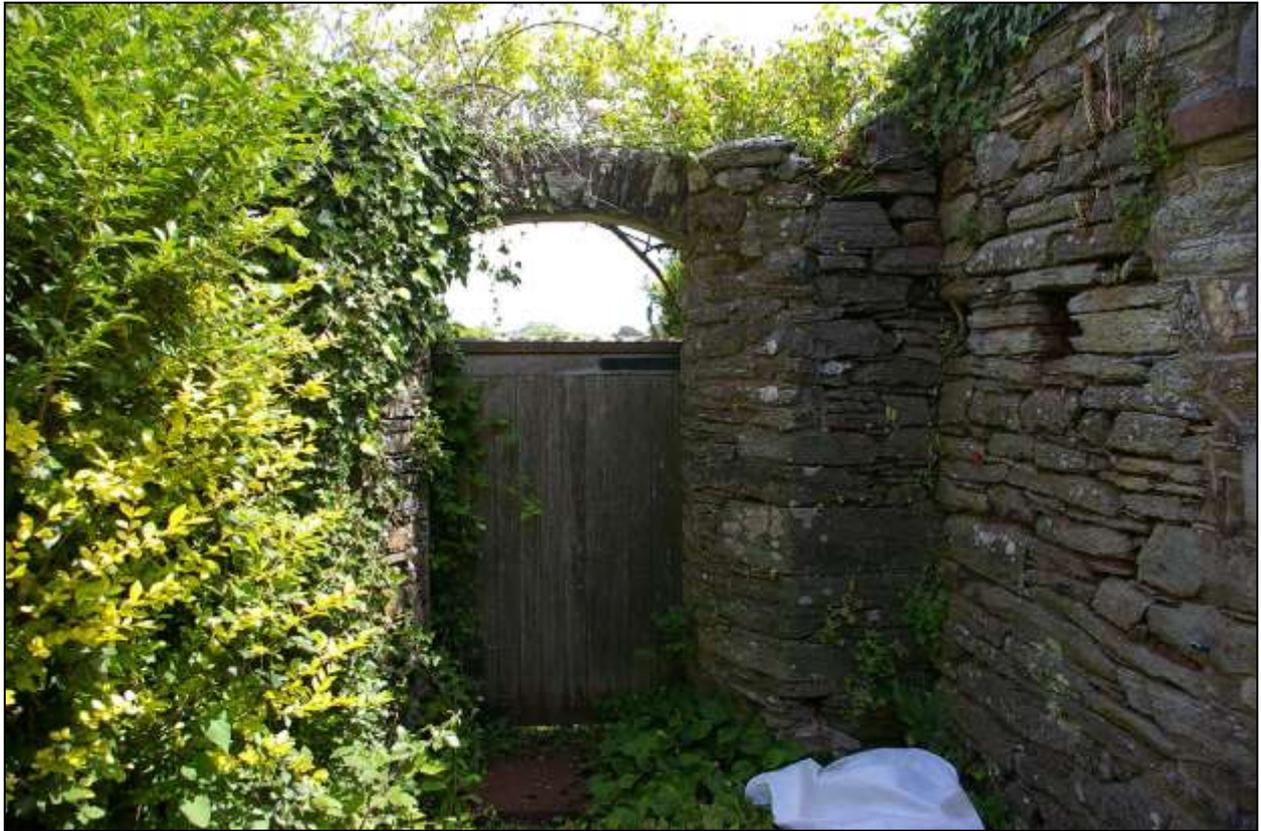
DETAILED VIEW OF THE FINE HEAVY SLATESTONE AND SOME DRESSED BLOCKS AND PUTLOGS, ALL OF WHICH IDENTIFY THESE GARDEN WALLS, AS IN FACT RUINS OF AN EARLIER QUITE FINE BUILDING, LIKELY PART OF THE COMPLEX WHICH SUPPORTED THE MANOR HOUSE WHICH STOOD ON THE SITE; FROM THE WEST.

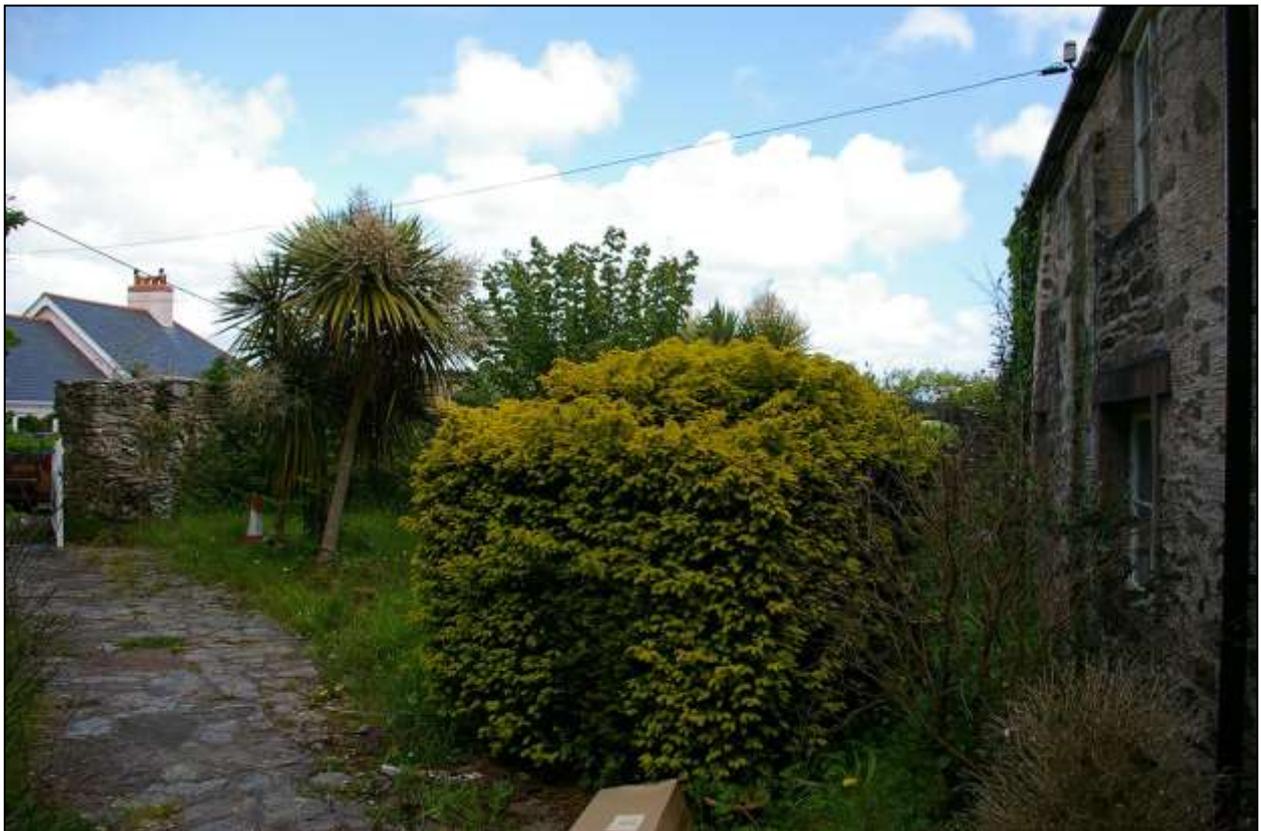
VIEW OF THE RECTANGULAR PLAN WALLS, OF SINGLE STOREY HEIGHT, WHICH ENCLOSE AND FRAME THE NORTH FRONT GARDEN, ACTUALLY MARKING OUT THE FOOTPRINT OF A RUINED MEDIEVAL BUILDING; FORM THE WEST.

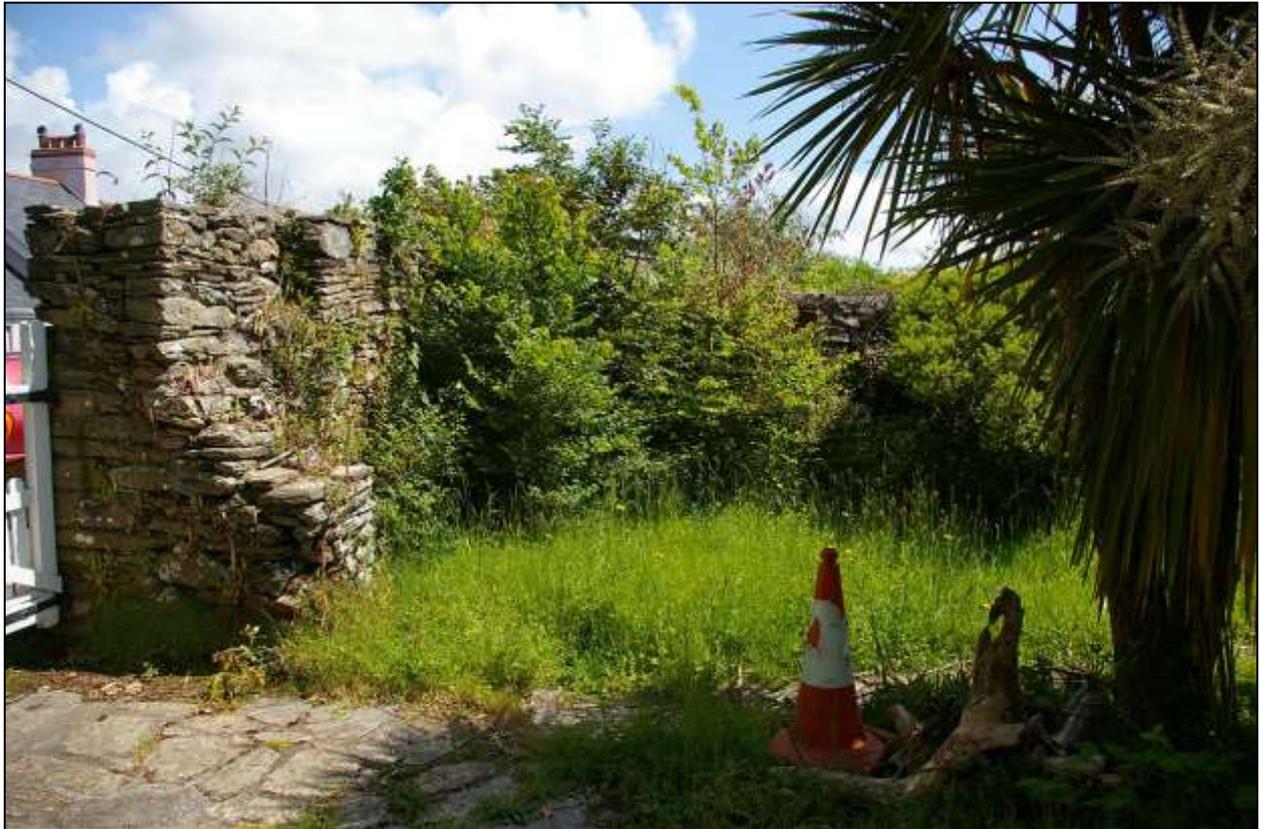
DETAIL OF THE NORTH GABLE END WALL OF THE EARLIER BUILDING, WHICH NOW FORMS THE GARDEN WALL, SHOWING A STUB RUNNING BACK TOWARDS THE HOUSE; FROM THE WEST, SOUTH-WEST.

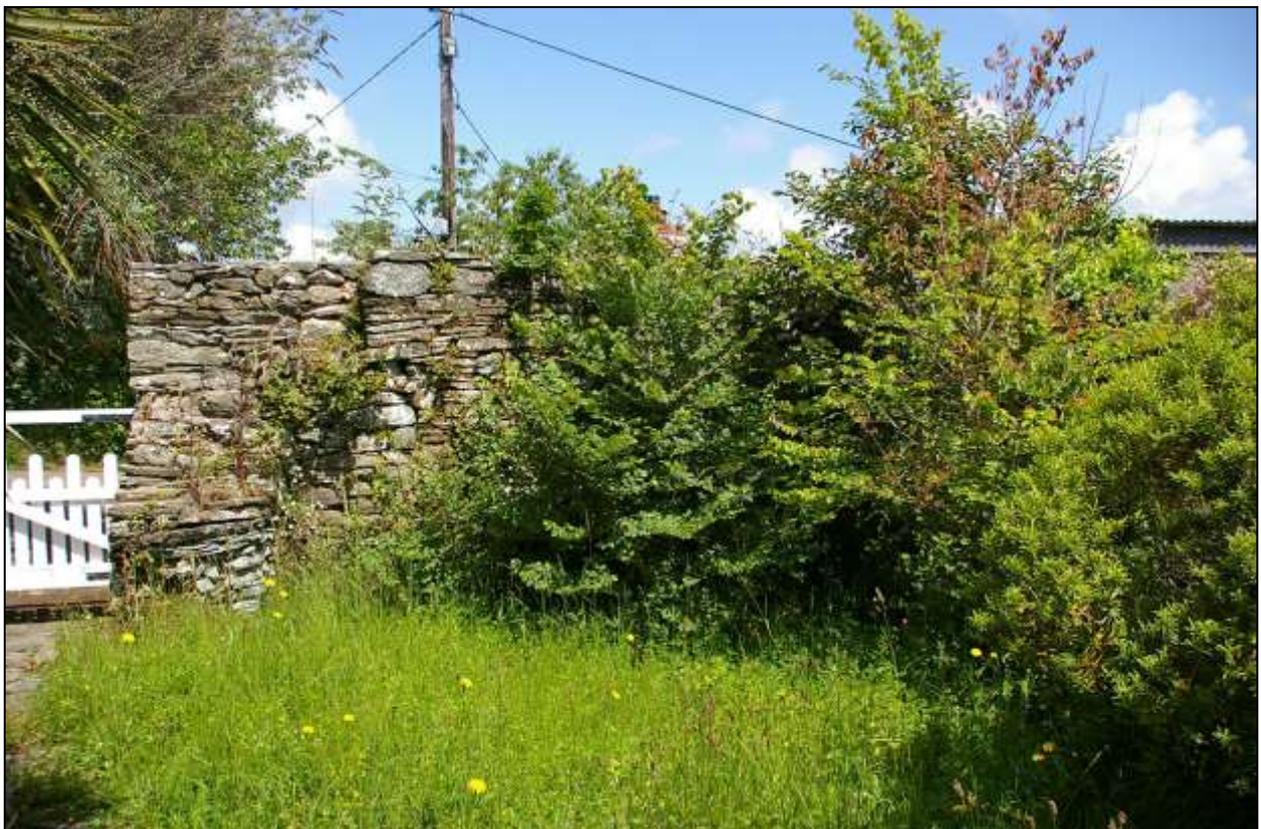
DIRECT VIEW OF THIS WALL, WHICH CONTAINS A RUINED STACK AND FIREPLACE, OBSCURED BY BUSHES; FROM THE SOUTH.
