# BATSON HALL FARM

Historic Building Assessment & Heritage Impact Assessment

South West Archaeology Ltd. report no. 190620

## Batson Hall Farm, Batson, Salcombe, Devon Historic Building Assessment and Heritage Impact Assessment

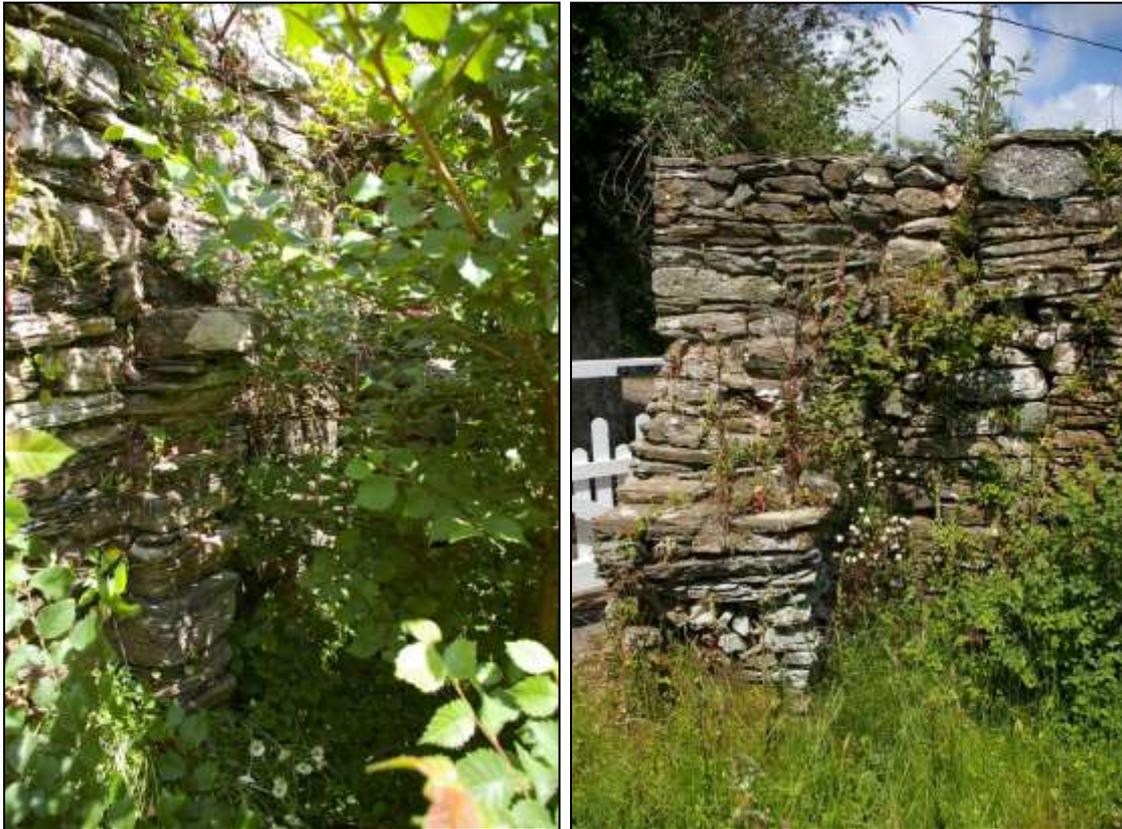
LEFT: VIEW OF THE RAISED FLAT BUILT PILASTERS AND PADSTONE WHICH WOULD HAVE CARRIED A STONE OR WOOD CORBELLED BRESUMMER OVER A LARGE OPEN FIREPLACE; FROM THE SOUTH-WEST.

RIGHT: DETAILED VIEW OF THE THICK STUB WALL, WHICH RUNS SOUTH FROM THE FORMER GABLE END, LAYING OUT THE FOOTPRINT OF THE EARLY BUILDING; FROM THE SOUTH, SOUTH-EAST.

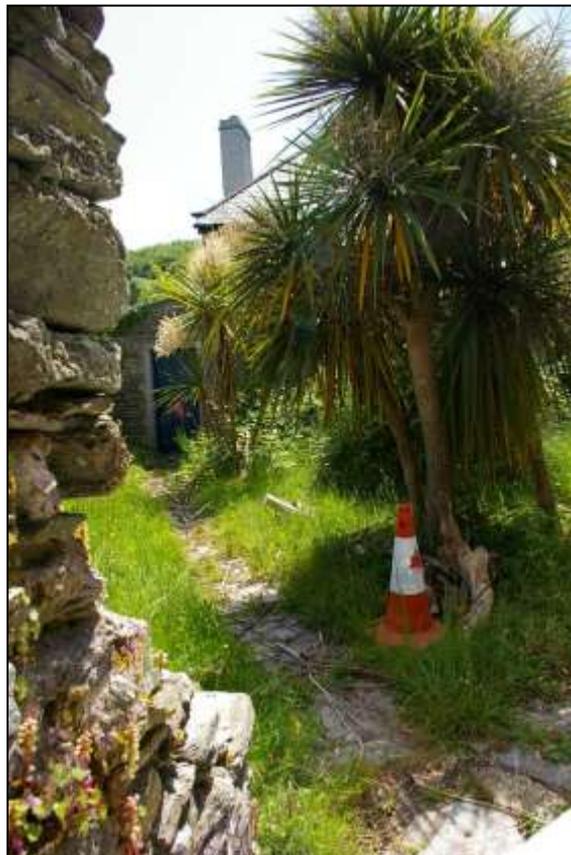
TIGHT ANGLED VIEW SHOWING THE LINE OF THE BUILDING AS IT PROJECTS BACK TOWARDS THE HOUSE, WHERE FURTHER REMAINS HAVE BEEN INCLUDED IN THE FRONT WALL OF THE EXISTING BUILDING; FROM THE NORTH, NORTH-WEST.

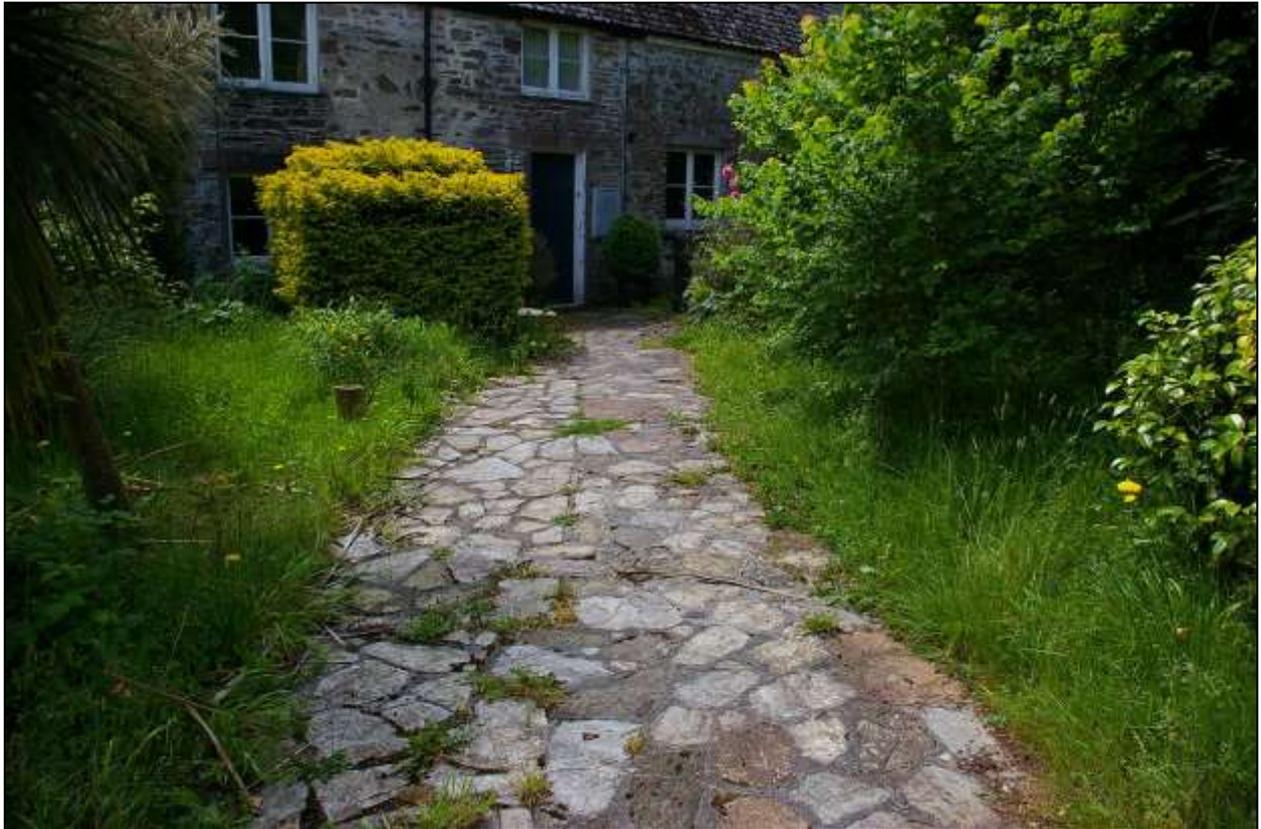
THE PAVED PATH, PART OF THE LANDSCAPE GARDENS, ACCESSING THE FORCED FRONT DOOR IN THE FARMHOUSE'S FACADE; FROM THE NORTH-EAST.

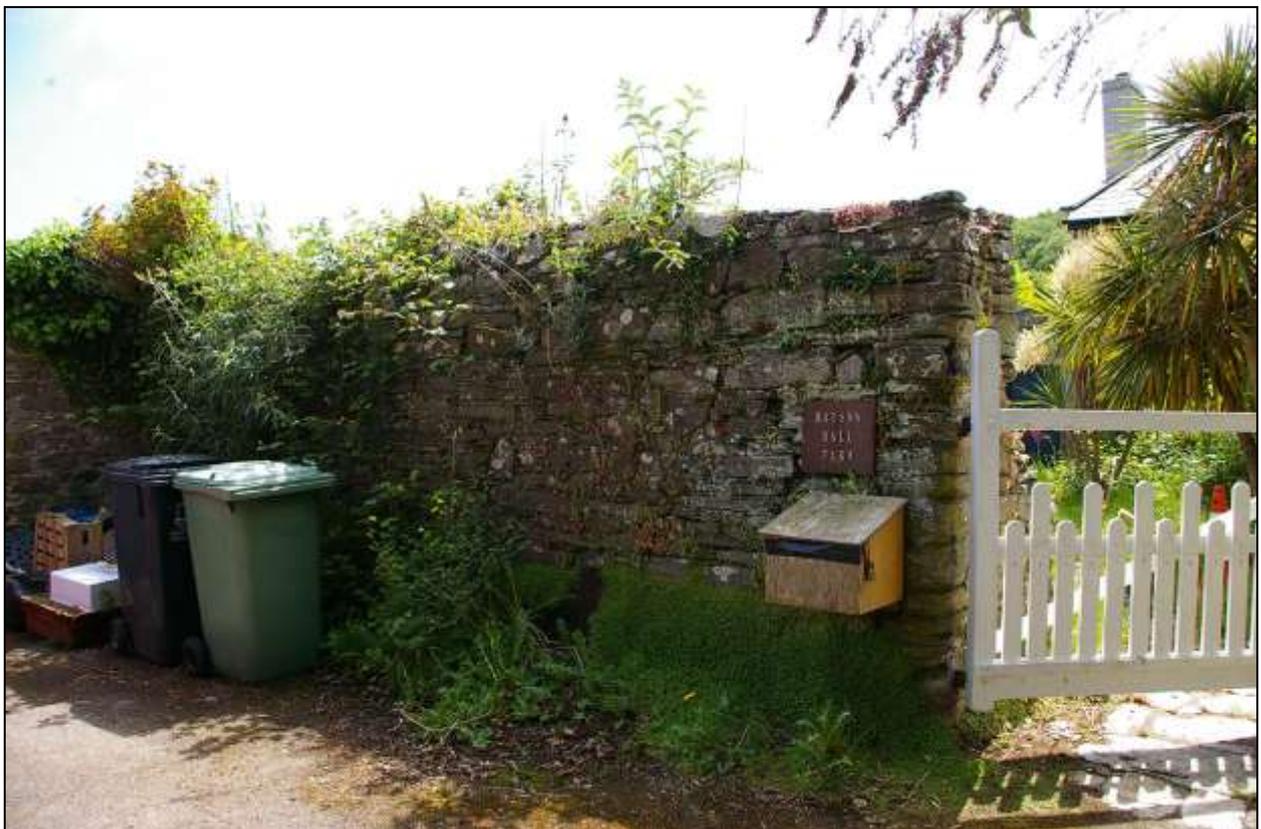
THE NORTH OUTER FACE OF THE HEAVY SLATESTONE WALL, WHICH IS THE FORMER GABLE END OF AN EARLY BUILDING; FROM THE NORTH-WEST.

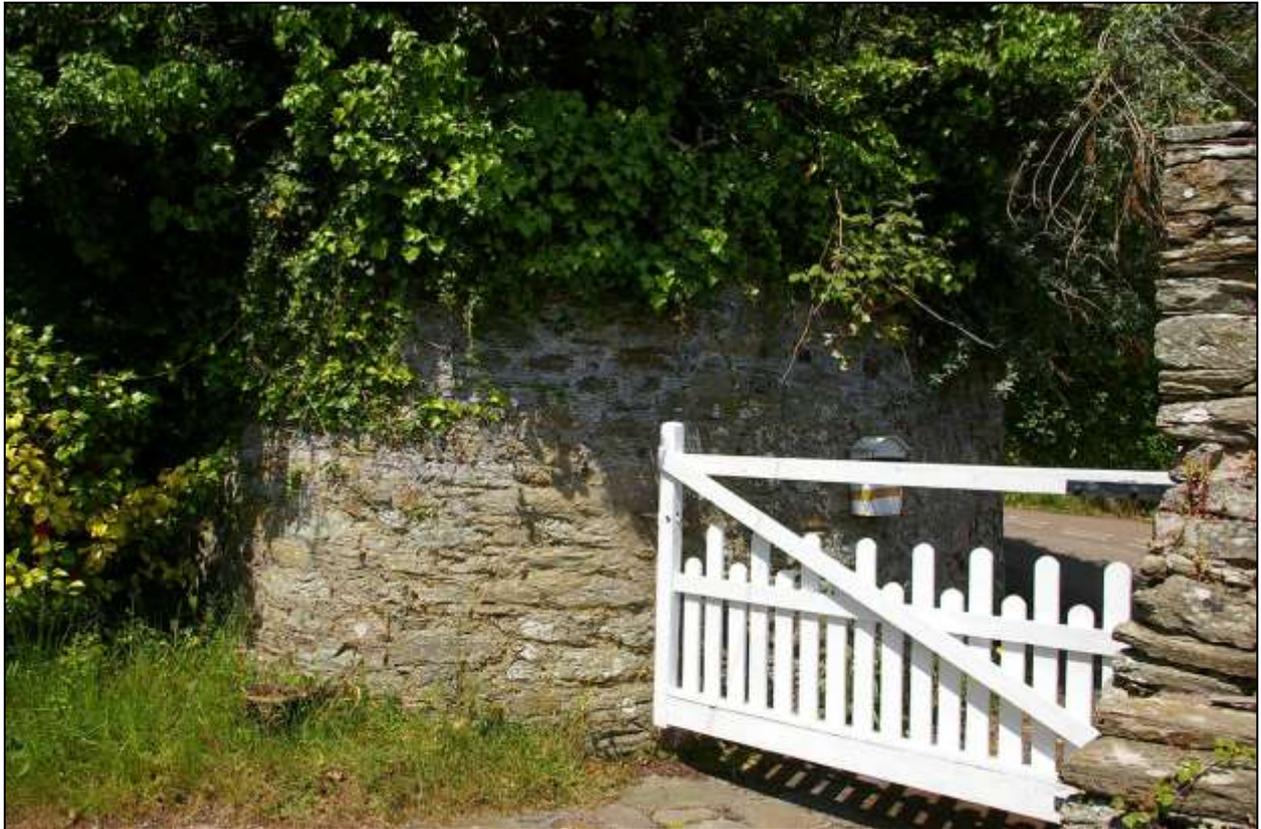
THE LOOSE RUBBLE 19<sup>TH</sup> CENTURY GARDEN WALL IN A LIME MORTAR, ENCLOSING AN EMBANKED AREA AND FLANKING THE HEDGEBANK ALONGSIDE THE ROAD; FROM THE EAST.

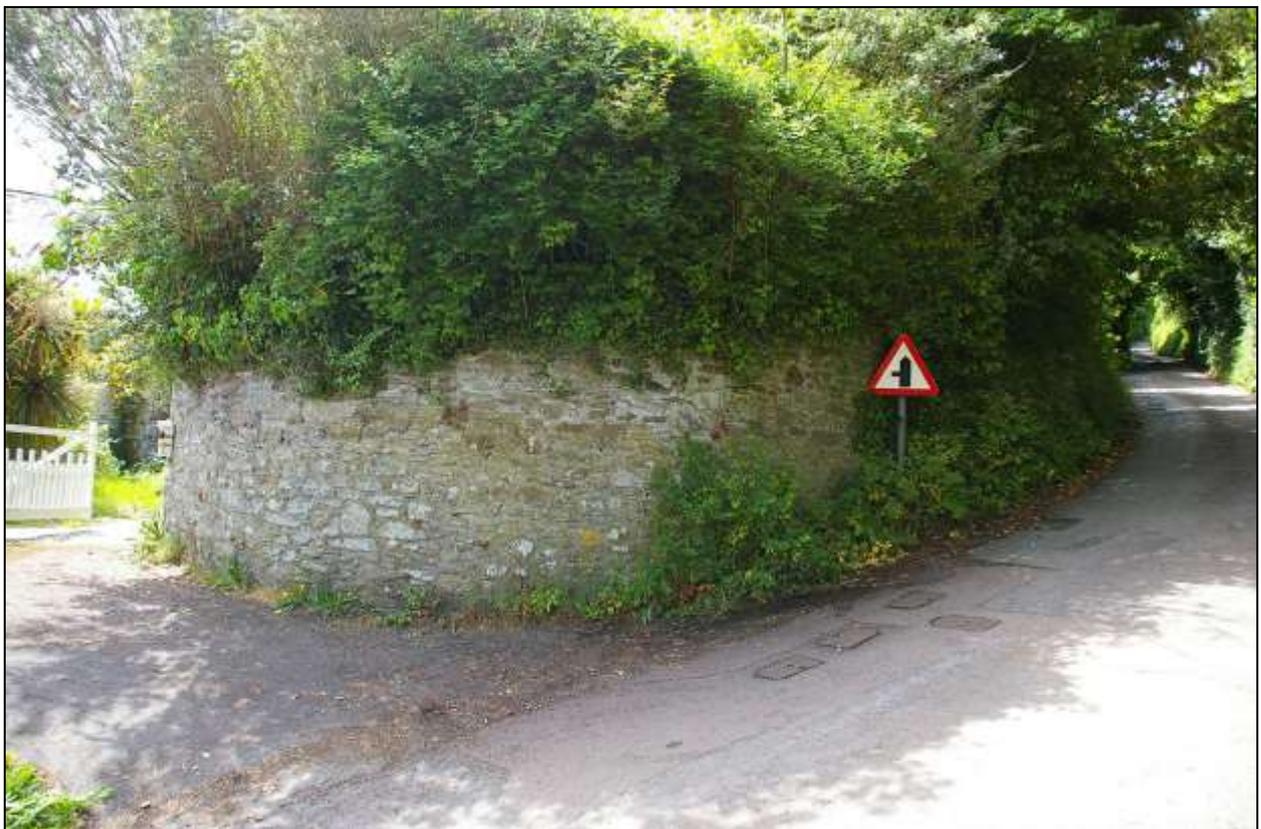
THE 19<sup>TH</sup> CENTURY WALL, WHERE IT SWEEPS AROUND ALONGSIDE THE ROAD; FROM THE EAST, NORTH-EAST.

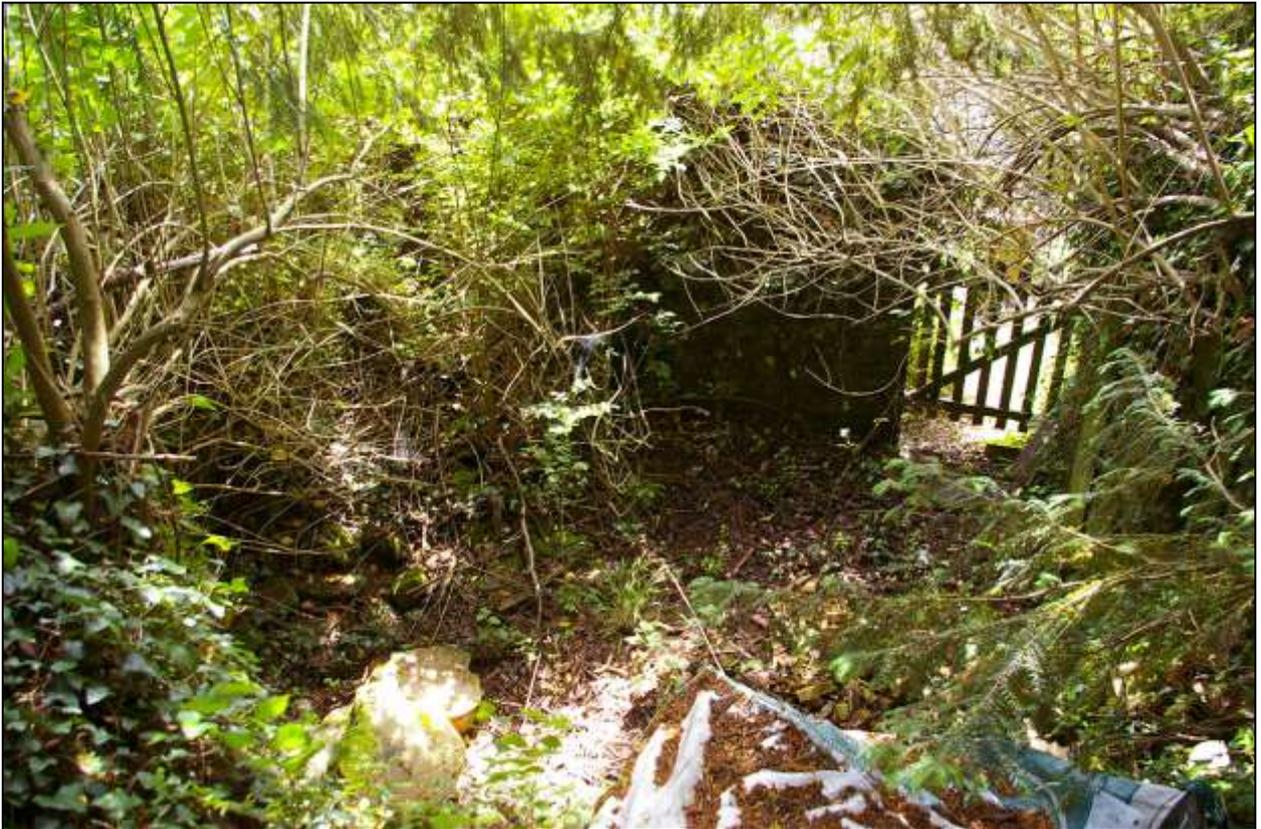
LOOKING DOWN INTO THE SQUARE RUINED BLOCK, SHOWING EARTH FLOOR, LOG STORE FUNCTION AND THE GATE AND WINDOW; FROM THE NORTH (ABOVE).

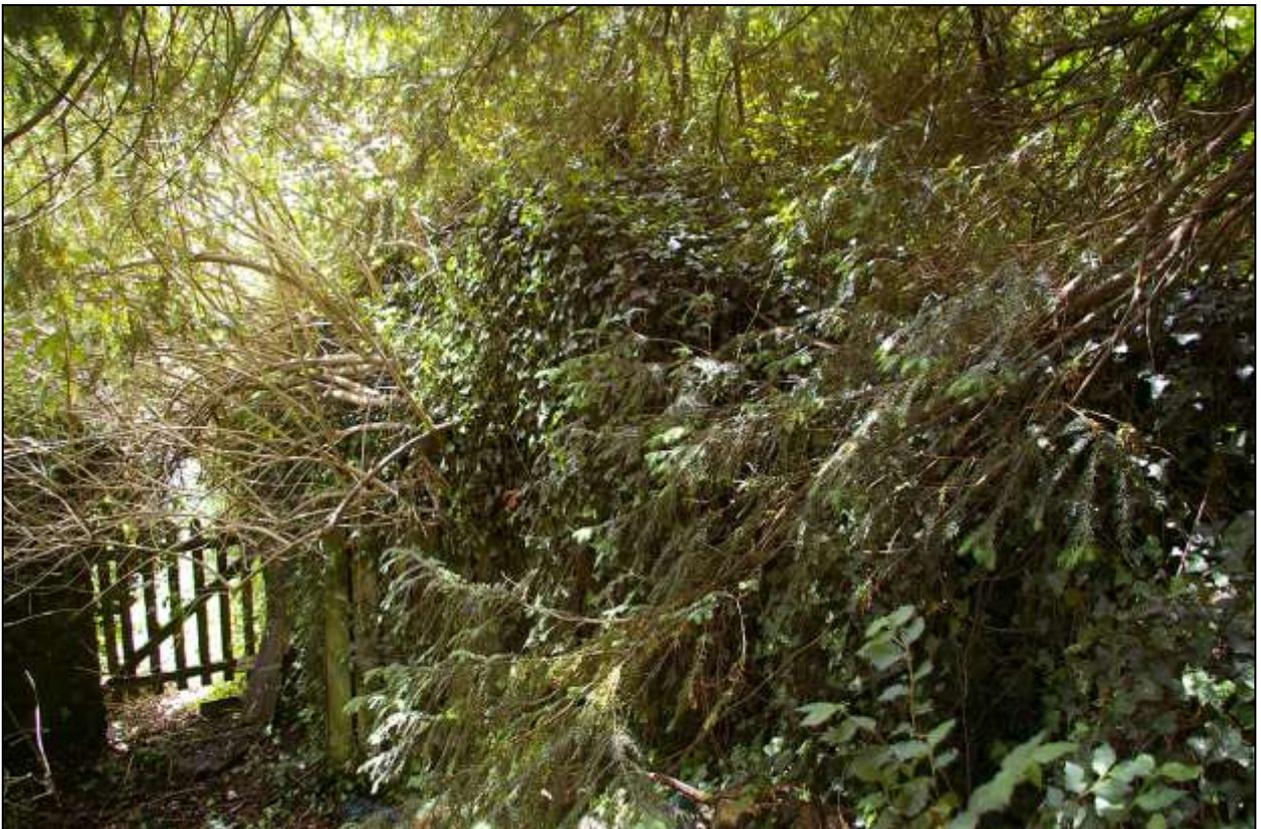
THE TALLER VERY THICK WEST WALL OF THE SQUARE BLOCK, WHICH LOOKS TO CONTAIN FURTHER OBSCURED FEATURES, POSSIBLY A STACK? FROM THE NORTH, NORTH-EAST.

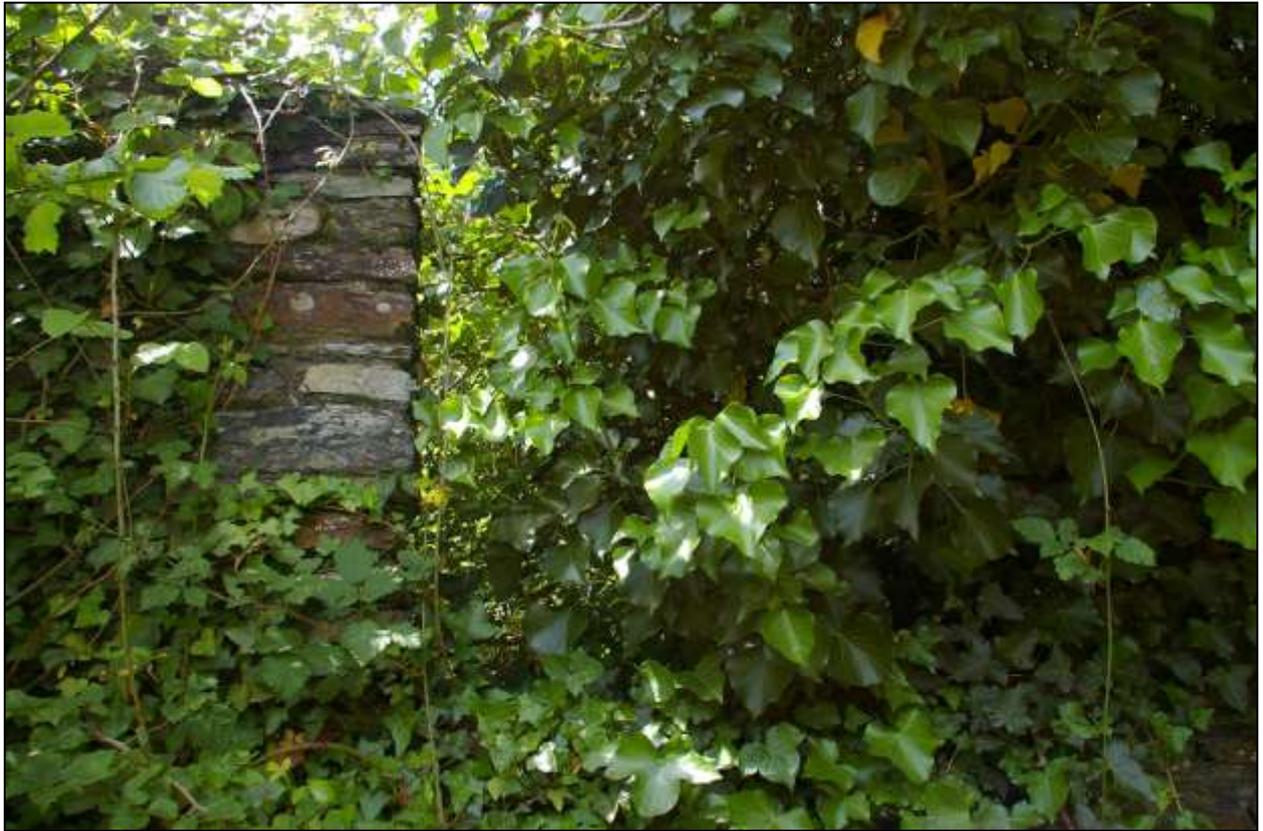
THE EAST WALL OF THE SQUARE BLOCK, WITH SMALL WINDOW SET HIGH IN THE WALL; FROM THE EAST.

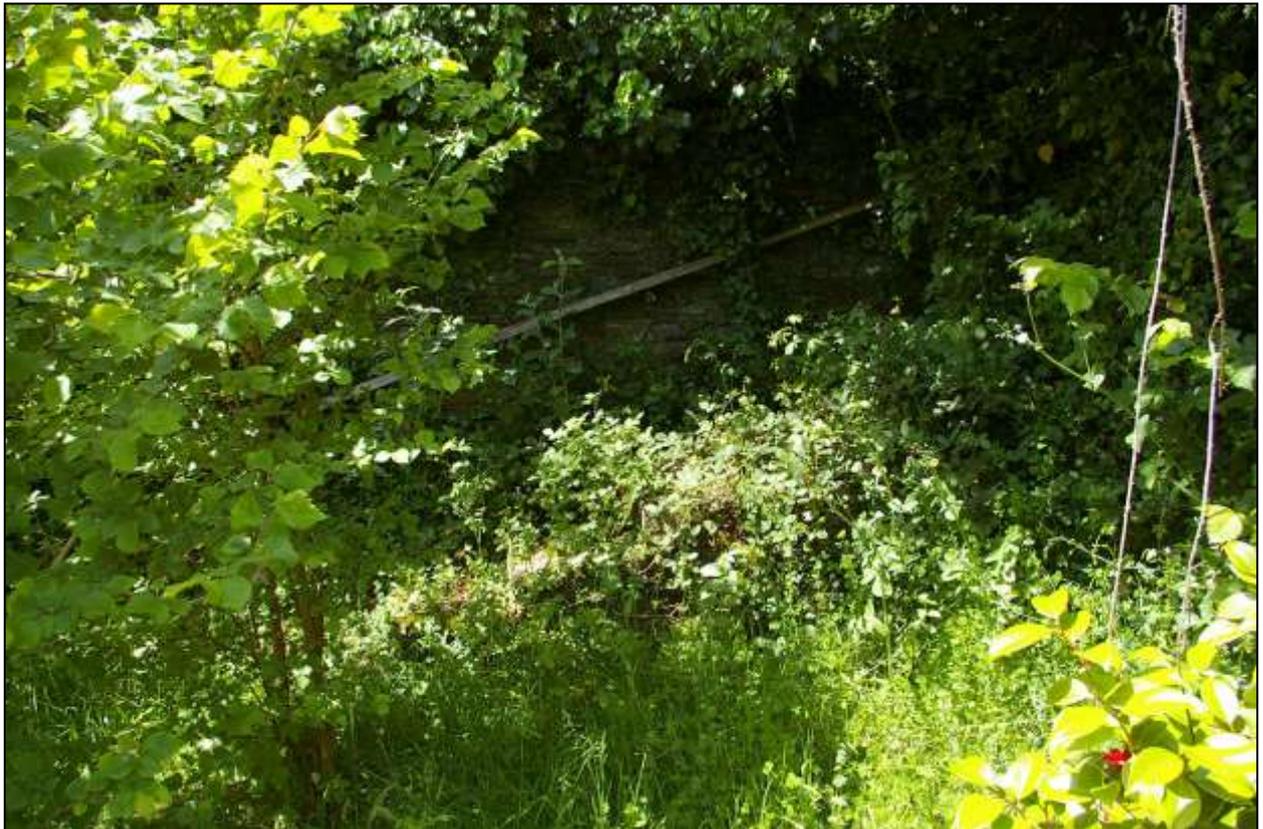
THE EAST WALL OF THE SQUARE BLOCK LARGELY OBSCURED BY IVY BUT ALSO WITH THE SET OF SATE GARDEN STEPS RISING ALONGSIDE IT; FROM THE EAST.

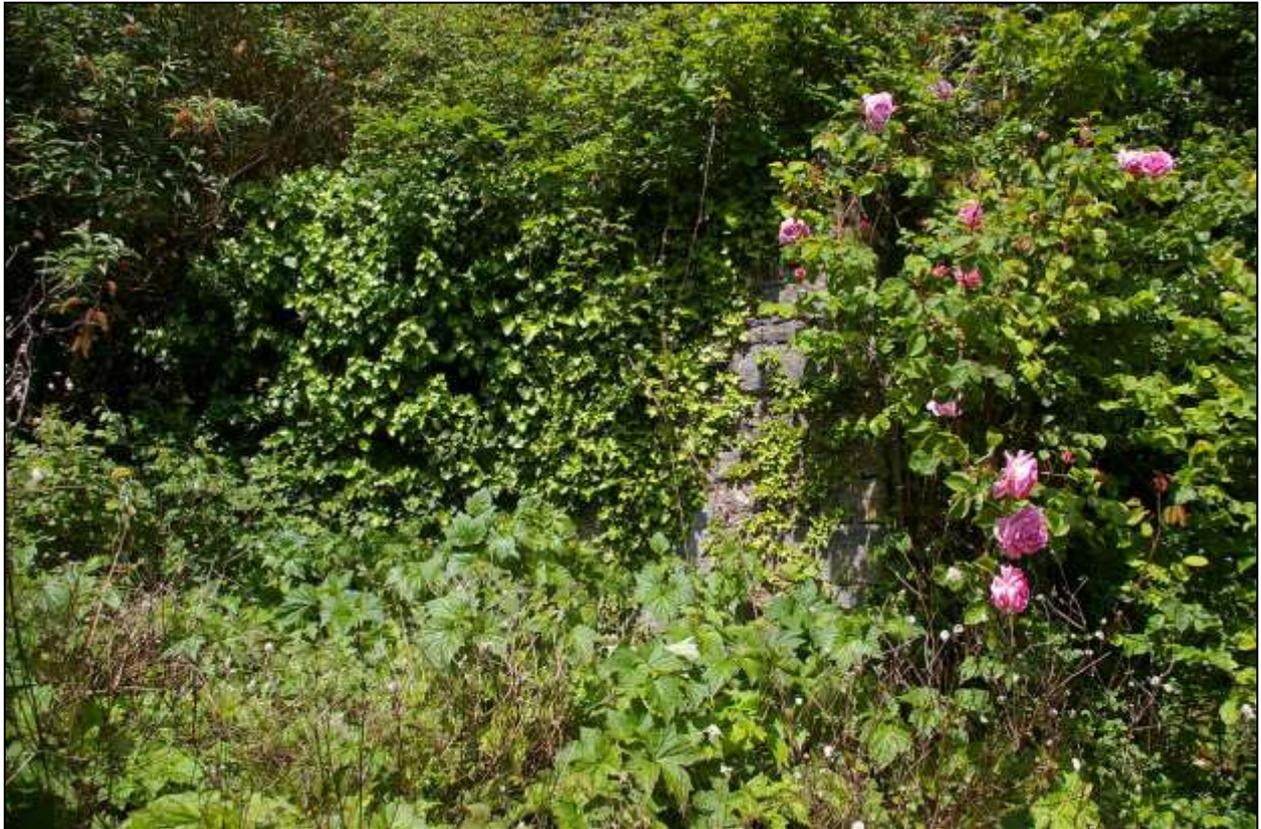
THE SOUTH-EAST CORNER OF THE SQUARE BLOCK, SHOWING ITS GOOD SHAPED BLOCK QUOINS; FROM THE SOUTH-EAST.

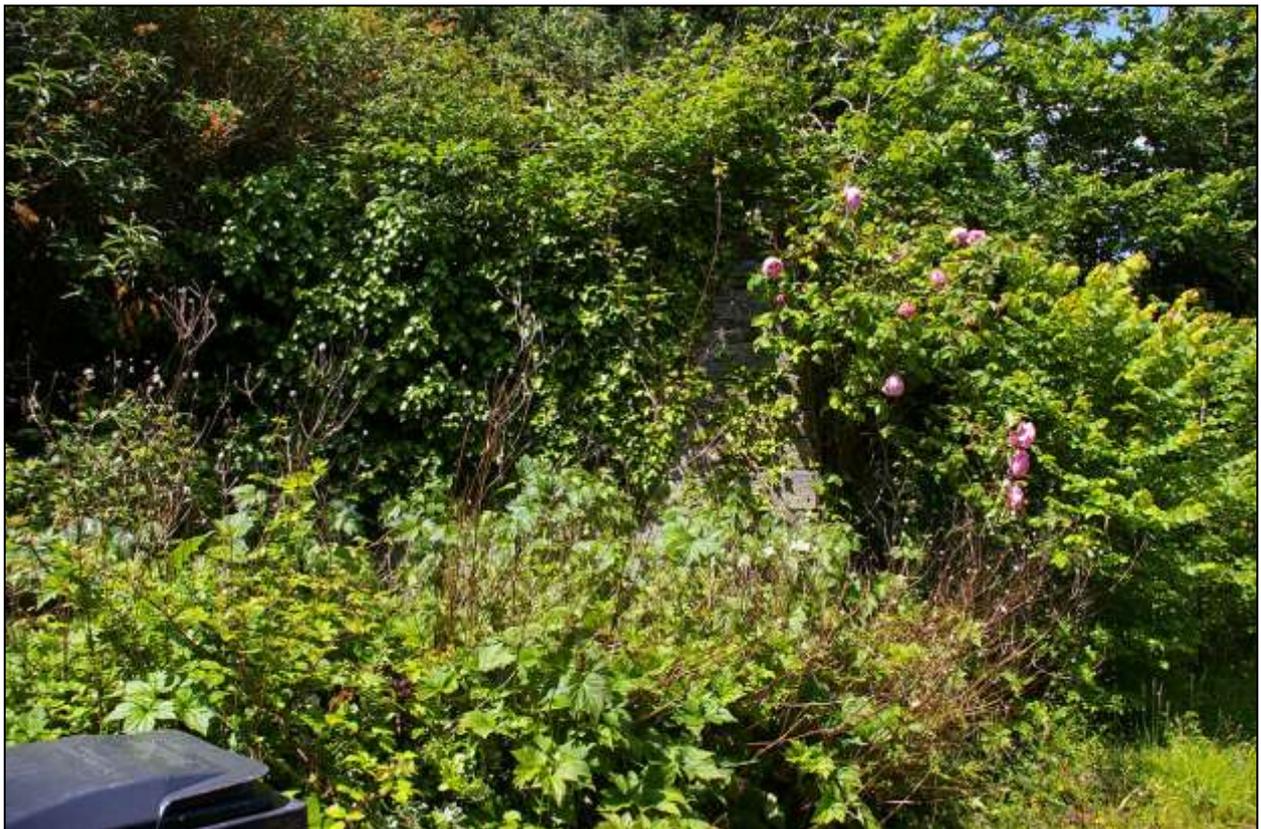
THE SQUARE RUIN, WHICH IS ALMOST COMPLETELY OBSCURED BY FOLIAGE; FROM THE SOUTH, SOUTH-EAST.

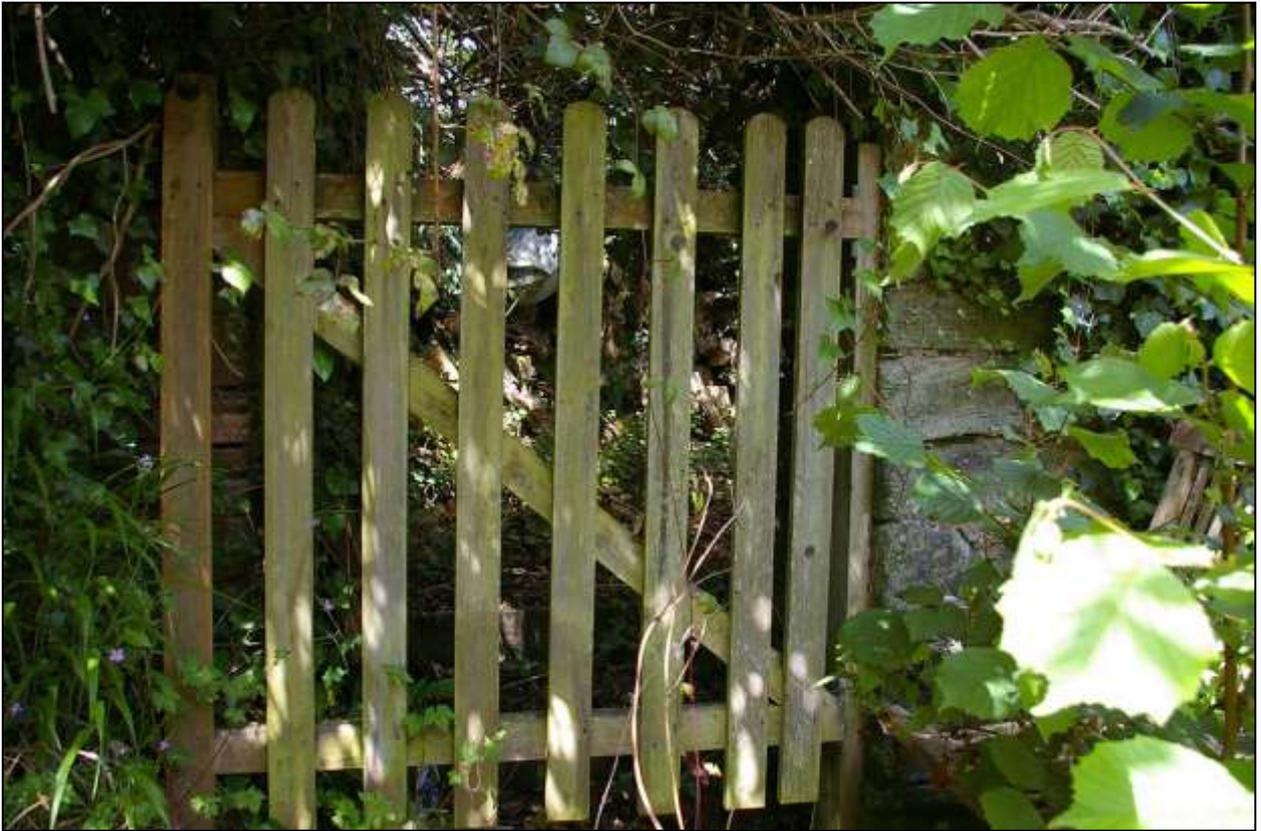
THE GATE IN THE SOUTH-WEST CORNER OF THE SQUARE RUINS, SHOWING FINE QUOINS TO THE EAST SIDE, BUT NARROW THIN BRICKS PATCHING THE WEST REVEALS; FROM THE SOUTH.

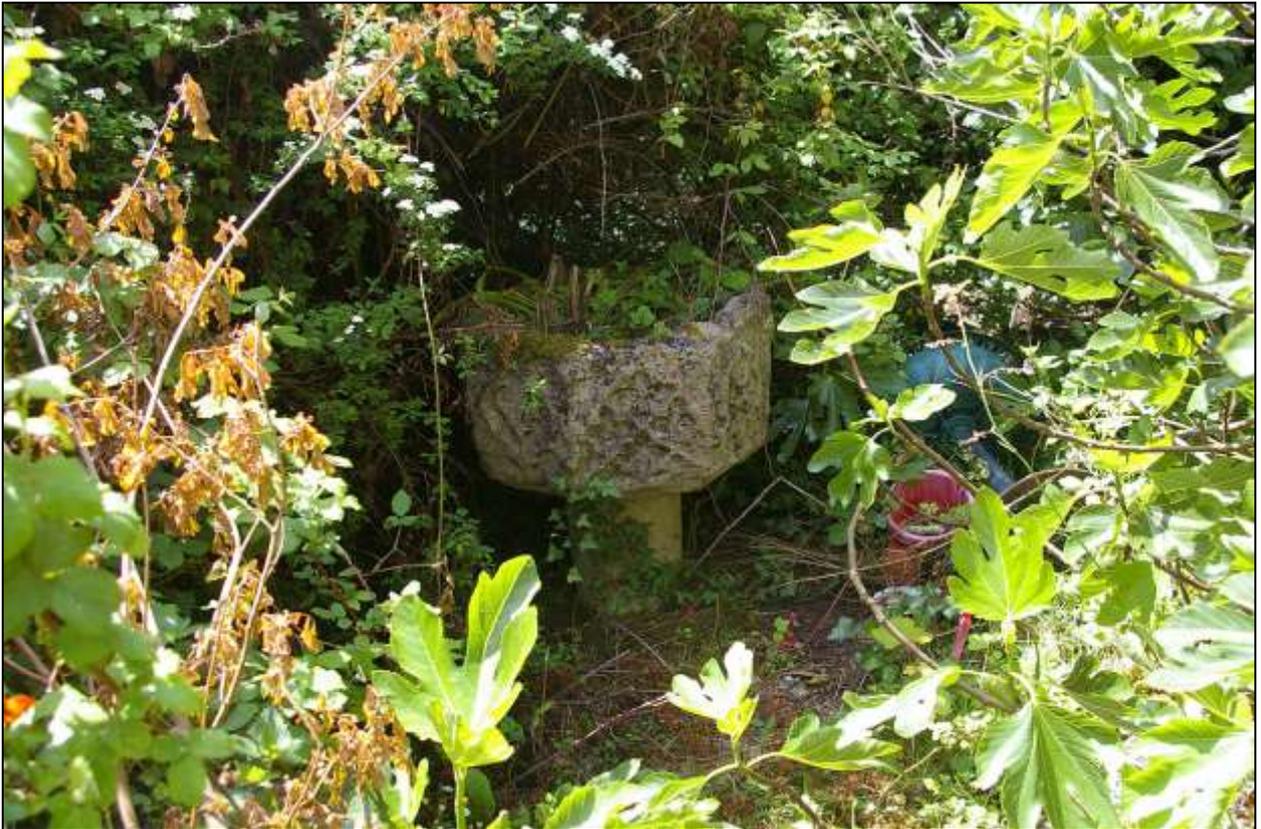
THE MEDIEVAL FONT, A PIECE OF ARCHITECTURAL SALVAGE WHICH HAS BEEN REUSED AS A BIRD BATH ON THE TERRACE BEHIND THE MAIN FARMHOUSE, NOW OBSCURED BY FOLIAGE; FROM THE NORTH-EAST.

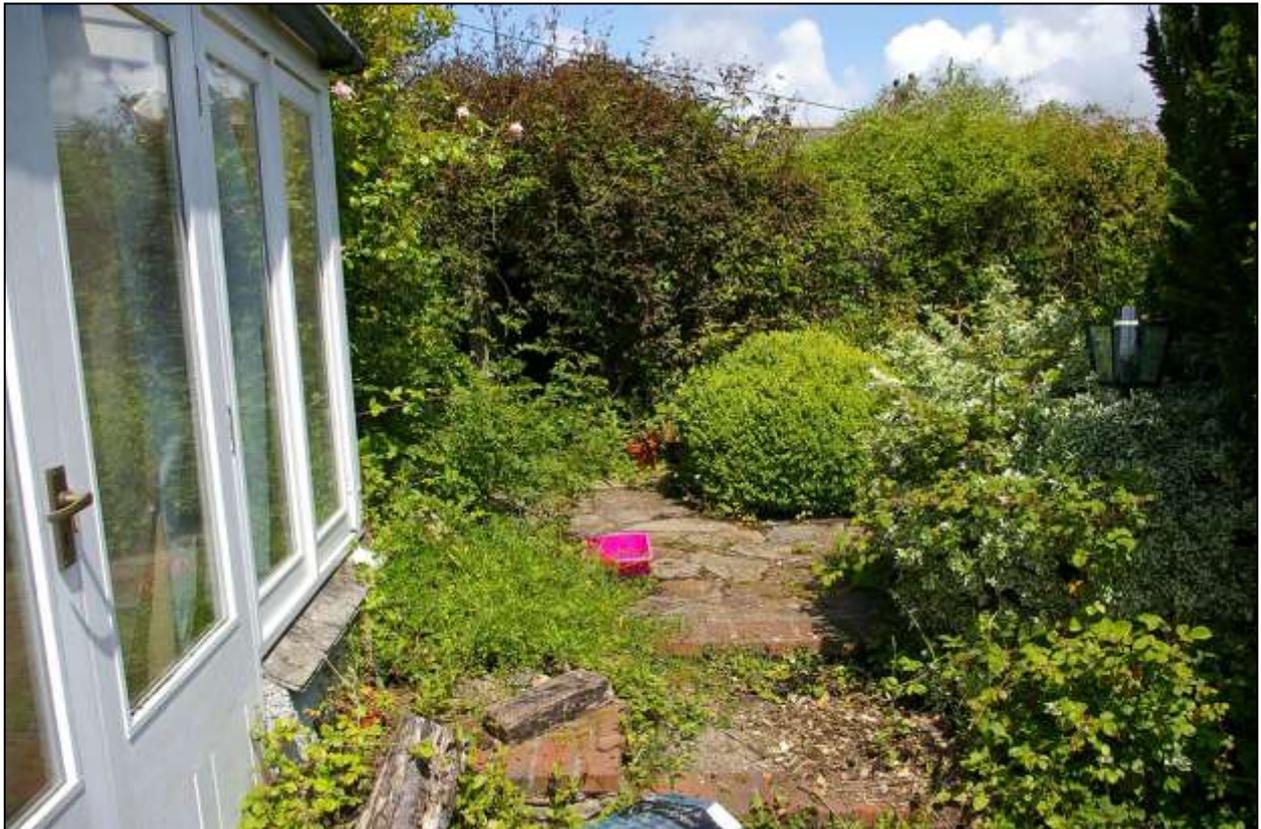
THE TERRACED AREA, PAVED STONE AND BRICK EDGING, OF MID TO LATE 20<sup>TH</sup> CENTURY DATE, TO THE NORTH-EAST OF THE MAIN HOUSE, ACCESSED BY THE CONSERVATORY; FROM THE SOUTH.

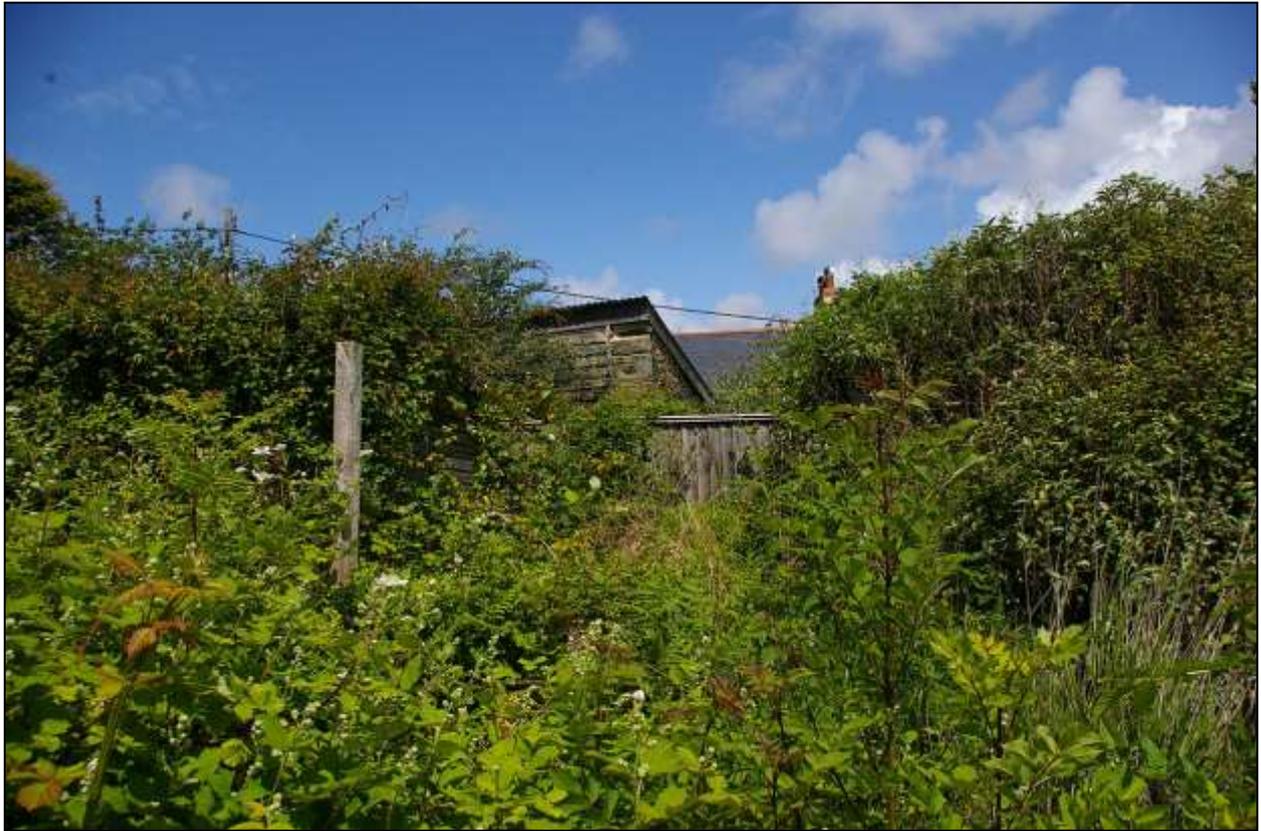
THE BACK OF THE CIDER BARN AND FURTHER TIMBER SHEDS, AS WELL AS A GLIMPSE OF THE ROOF OF THE ADJACENT HOUSE; FROM THE SOUTH.

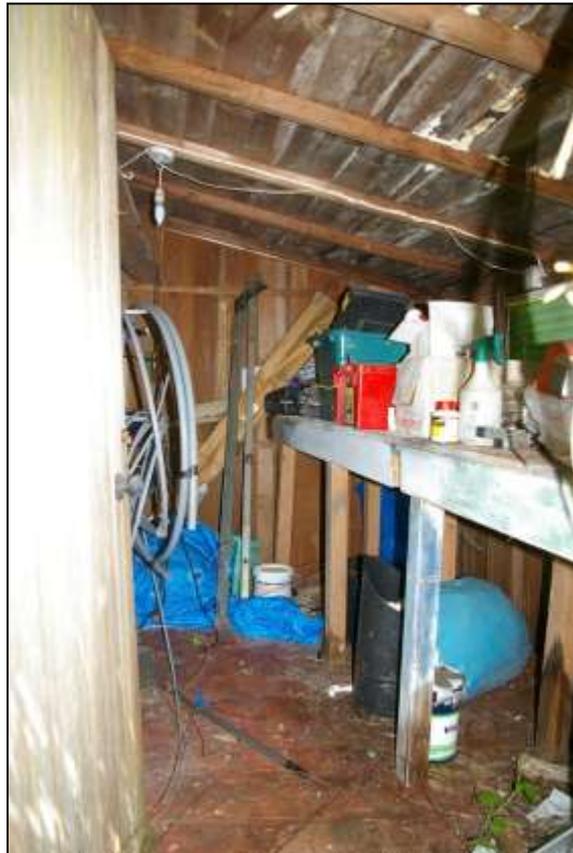
VIEW INSIDE ONE OF THE SHEDS; FROM THE SOUTH.

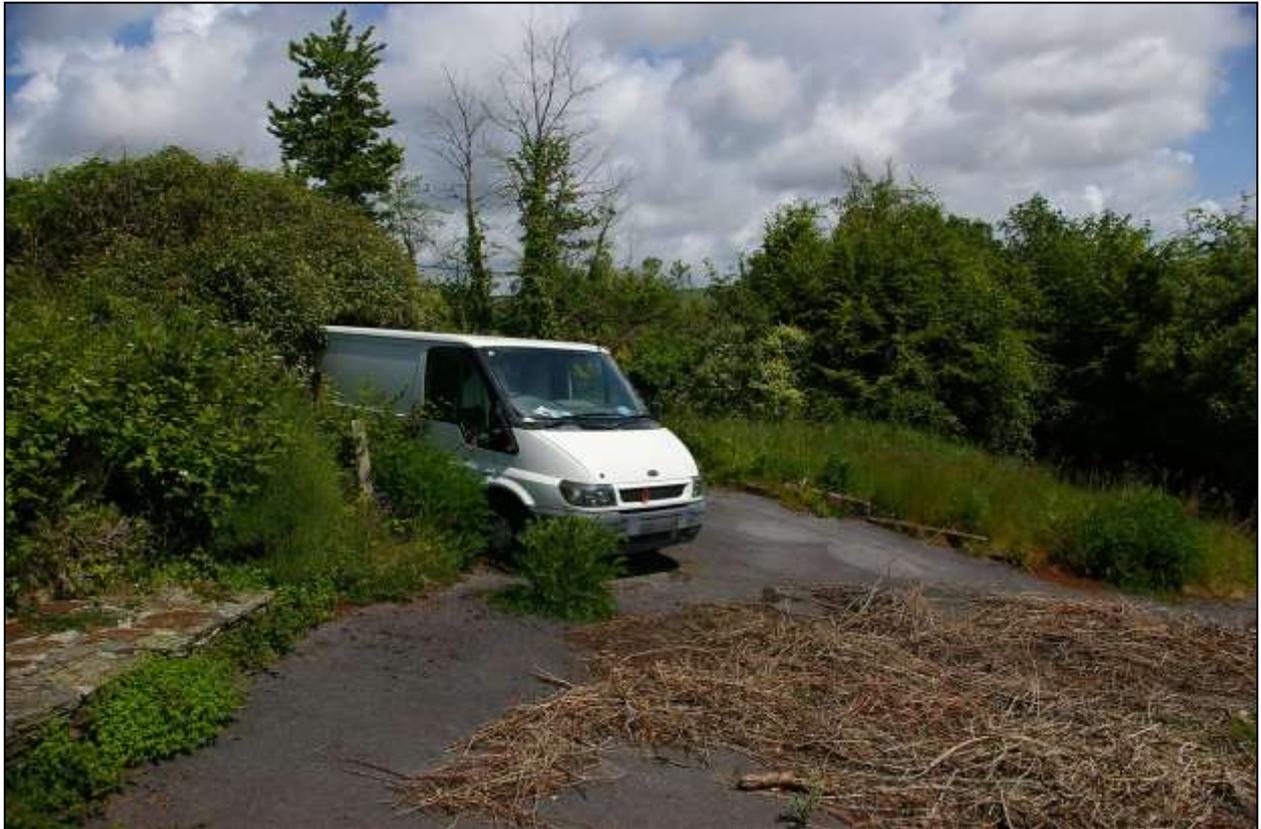
VIEW OF THE LANDSCAPE TARMAC PARKING AREA TO THE EAST OF THE SITE AND THE ENCLOSED SMALL TRIANGULAR PLOT WITH TALL HEDGES BEYOND TO THE NORTH-EAST, POSSIBLY A FORMER VEGETABLE PATCH; FROM THE SOUTH-WEST.

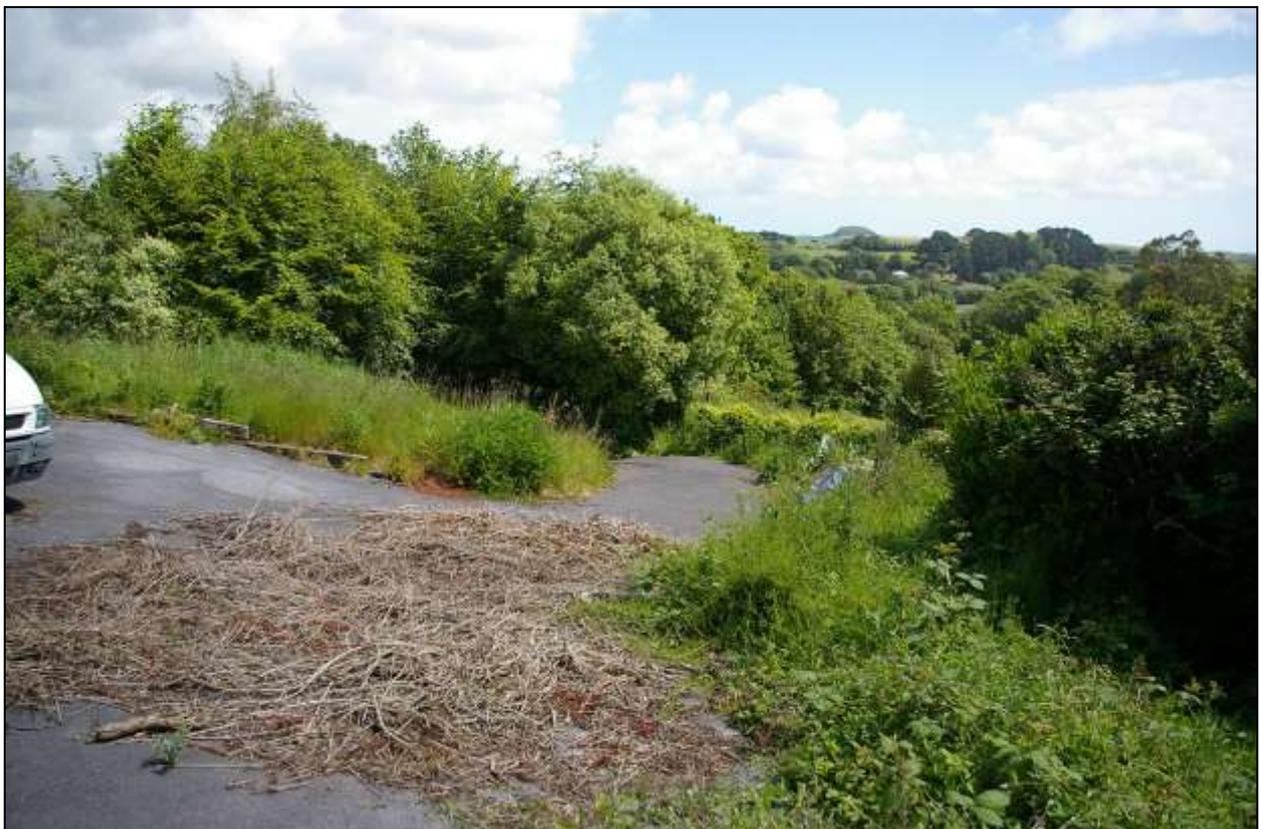
VIEW OF THE LANDSCAPE TARMAC DRIVE AND PARKING AREA, THE SITE OF THE PROPOSED NEW BUILD HOME ON THE SITE; FROM THE WEST.

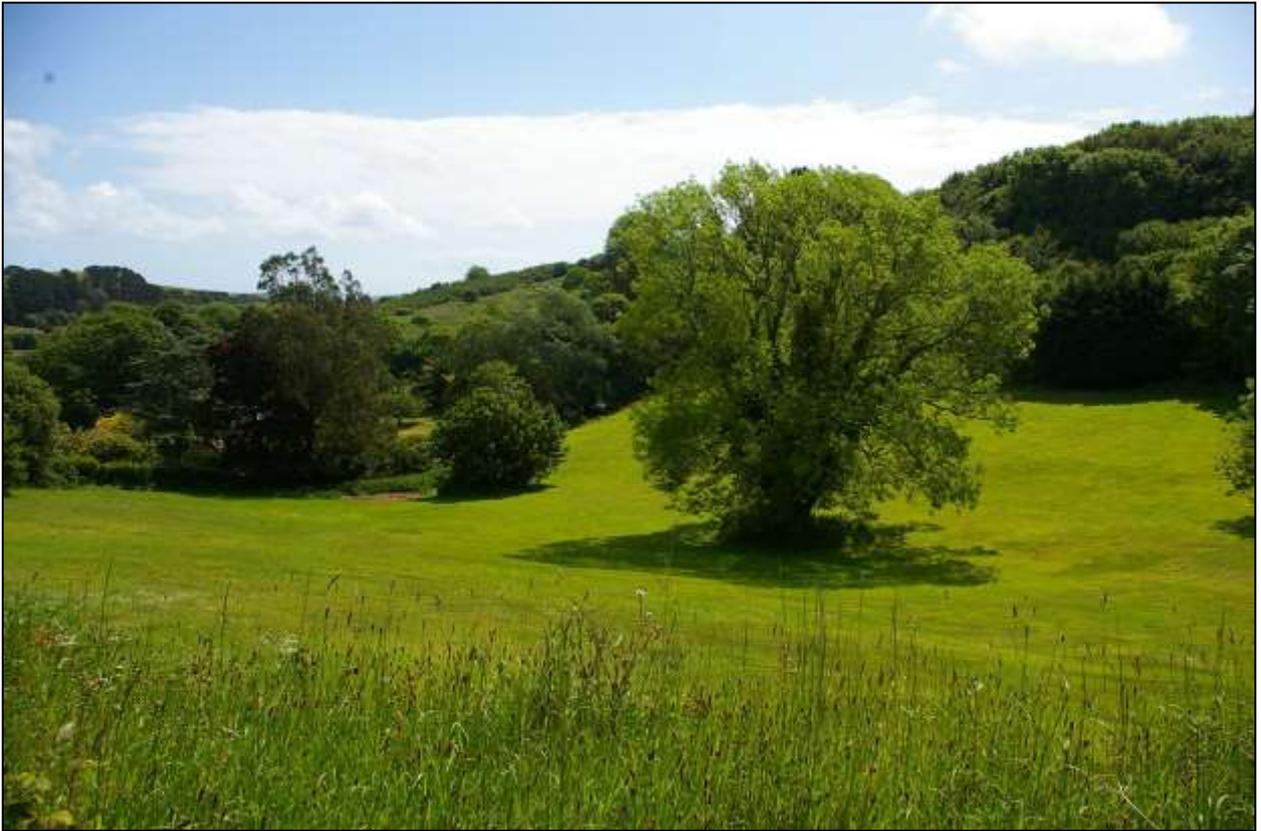
VIEW DOWN THE PARKLAND STYLE WIDER SETTING OF THE SITE, ASSOCIATED PRESUMABLY WITH THE FORMER HIGH STATUS MANOR HOUSE USE OF THIS LOCATION; FROM THE WEST, NORTH-WEST.

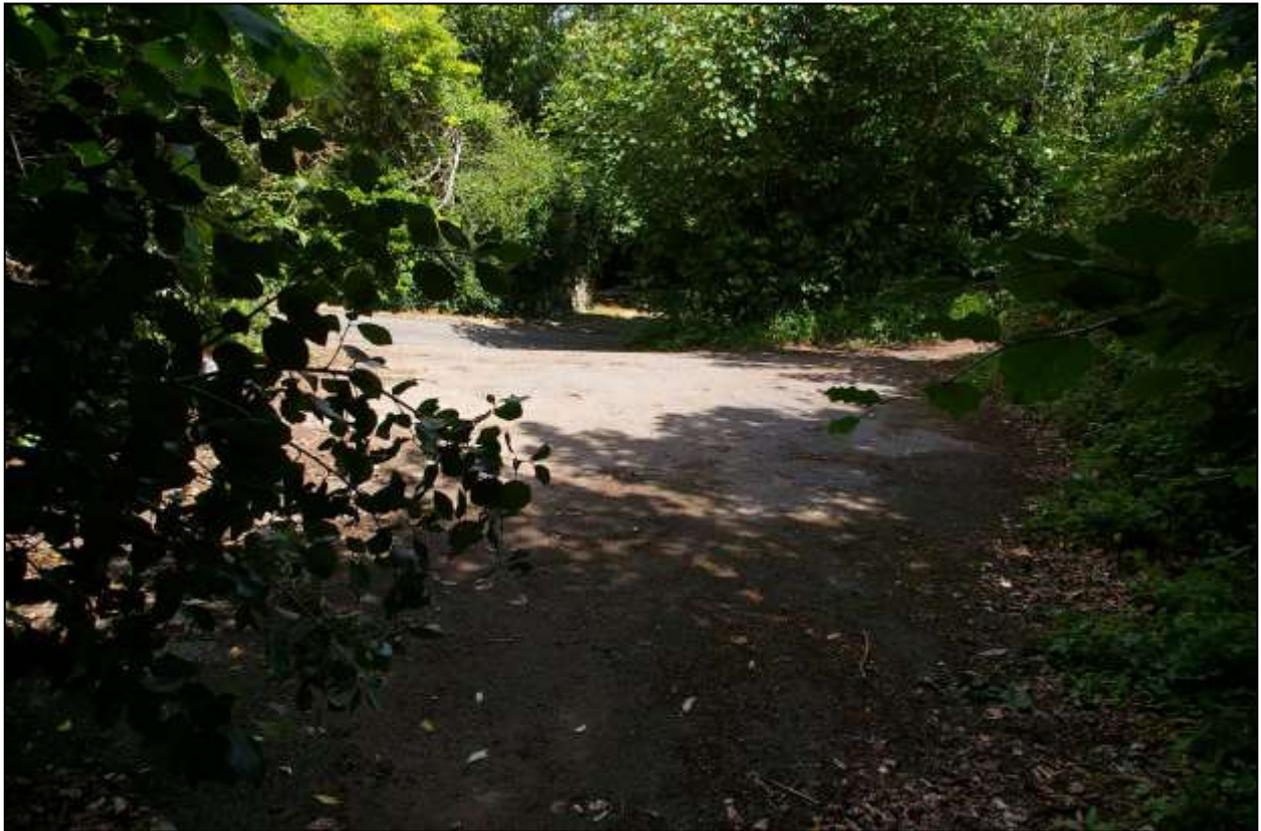
THE LARGE TERRACED/LEVELLED PARKING AREA LEADING OFF THE ROAD, POSSIBLY UTILISING A FORMER QUARRY; FROM THE SOUTH, SOUTH-WEST.
