LILLYCOMBE ESTATE
OARE
EXMOOR NATIONAL PARK
SOMERSET

Historic Building Appraisal and Impact Assessment

South West Archaeology Ltd. report no. 191119

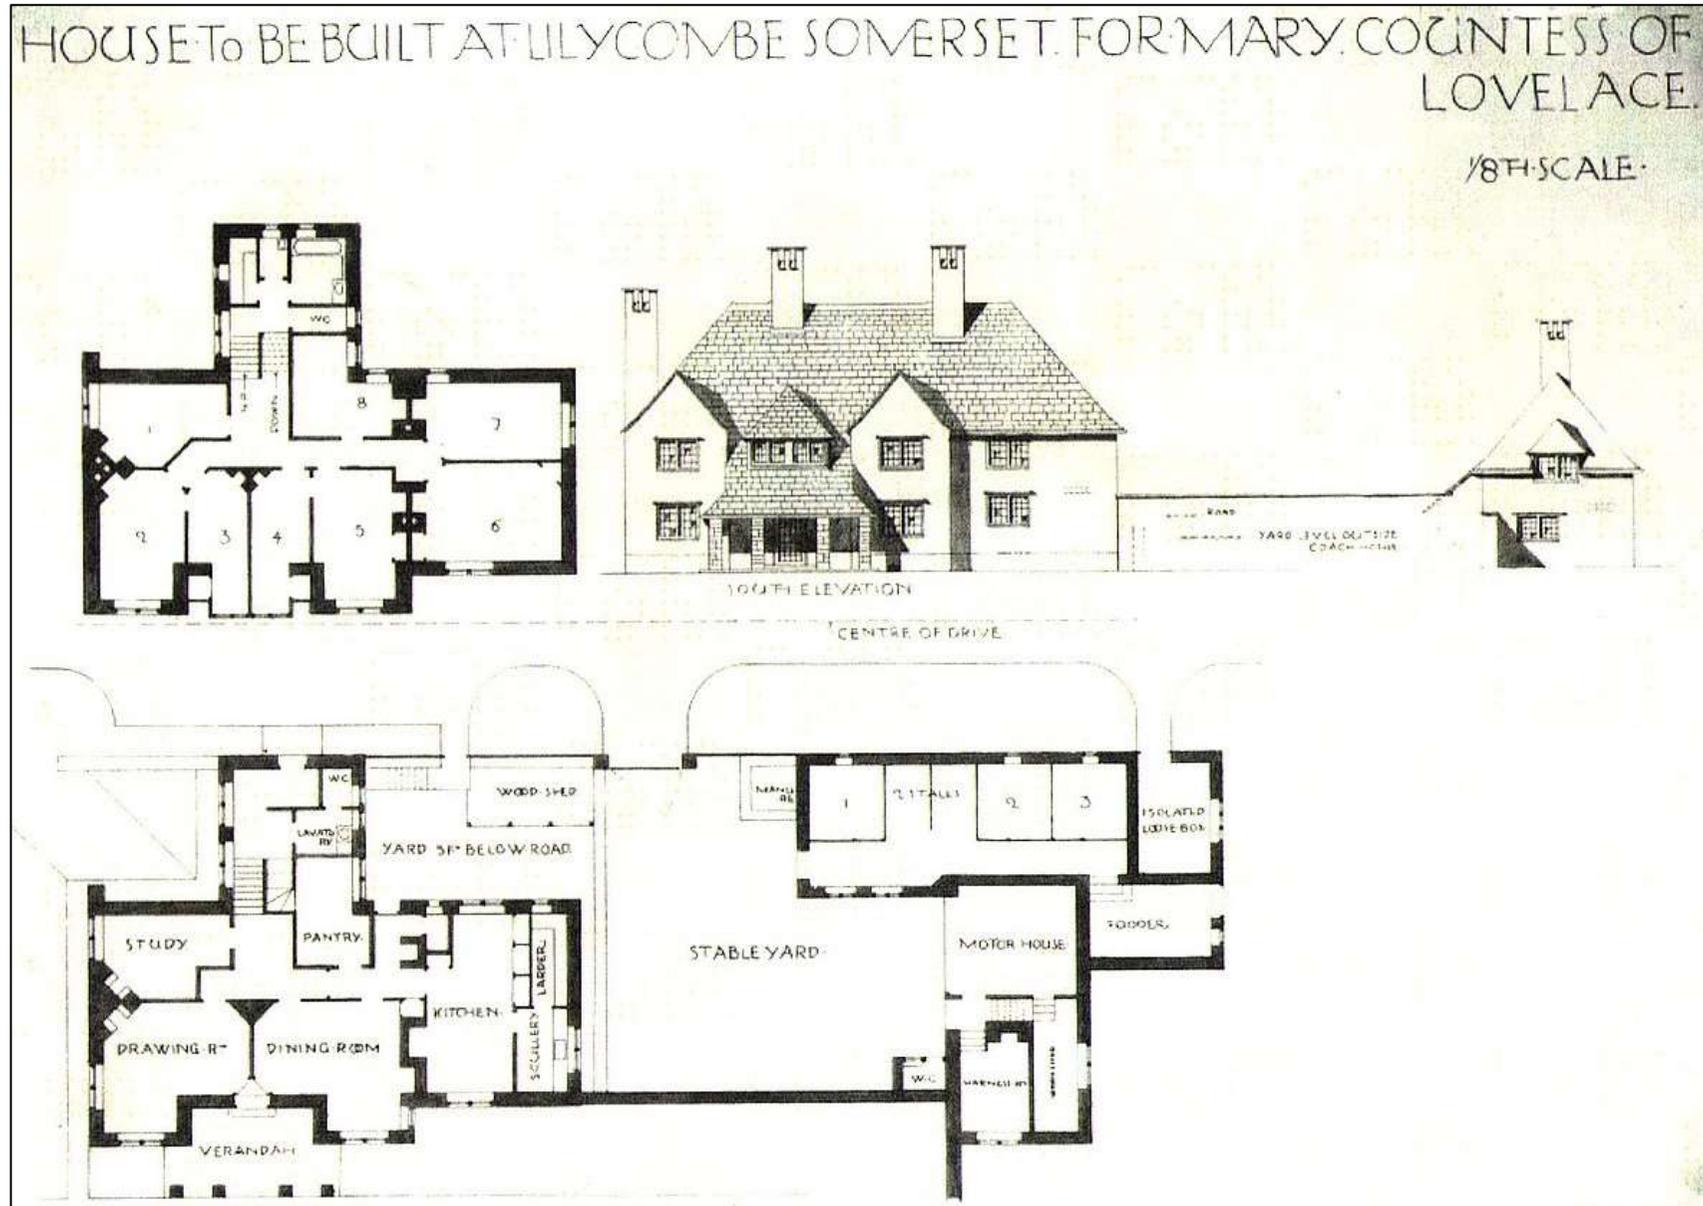
FIGURE 2: VOYSEY'S ORIGINAL 1912 PLANS FOR HIS REFINEMENTS TO LADY LOVELACE'S DESIGN (RIBA).

The RIBA image archive however contains some of Voysey's original 1912 plans for Lillycombe House (Figure 2). In these we can see the refinements of the 'Arts and Crafts' style, compromised in the current building by later alterations. The clients have then passed on documentation received from the solicitors upon purchase of the property which included the 1958 planning application which included a further set of historic plans, documenting some significant changes to the main house (Figures 3- 5). An overview of these changes, as analysed from these papers is dealt with in the Impact Assessment section of the report.

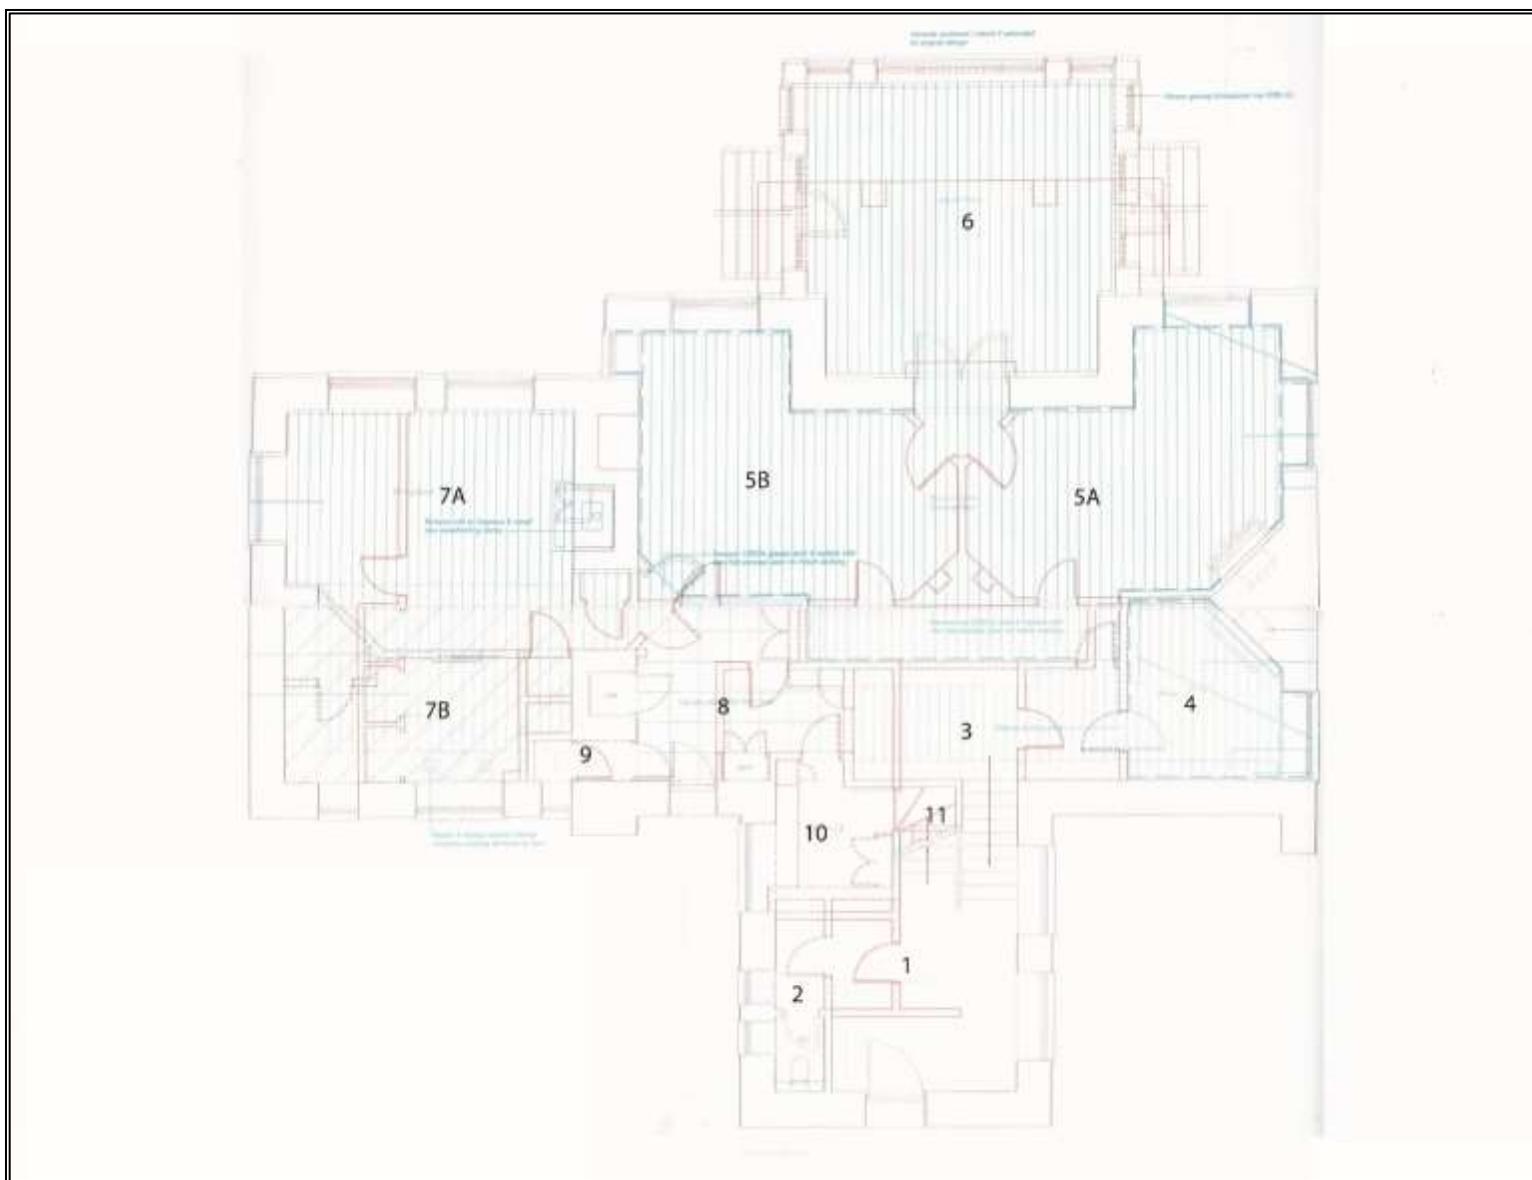
FIGURE 13: OVERLAY OF THE ORIGINAL GROUND FLOOR PLANS OF LILLYCOMBE HOUSE WITH THE 'PROPOSED WORKS' WHICH HAVE SINCE BEEN UNDERTAKEN IN BLUE, AND THE ORIGINAL LAYOUT ELEMENTS (RED MARKING) REMOVED IN THE 1950S WORKS; (BASED ON SUPPLIED DRAWINGS).

A table of features (Table 2) is included below to read in conjunction with the overlaid plans to gain a sense of the scale of the alterations which have occurred to the interior of this important 20th century house in the two main phases; the room numbers relate to the numbered current plans of the house for ease of reference. We can see that no single space within the ground floor of the house was spared from alteration, completely rearranging the layout and losing the Voysey scheme and flow through the building, as intended by Voysey and Lovelace.

Room Nos:	Current Function:	Historic Elements Removed in 1950s works
Ground Floor/Lower Ground Floor		
1	Entrance Hall	Partitions removed combining a cupboard, w.c and stair lobby into one larger entrance hall. The two windows to the west were replaced with very similar small-paned timber casements.
2	Toilet	Partitions removed combining a cupboard and w.c into one longer room
3	Stairs/Lower Lobby	The space was elongated by moving the partition forming room 4 to the west and cutting back the pantry and moving the door
4	Study	The east partition wall was truncated and moved, making this room much smaller. The fireplace was blocked/hearth altered. The window to the west was replaced with very similar small-paned timber casements.
5	Main reception space	The dividing partition wall was removed, opening up the space into one large room. The paired angled doorways to the loggia were lost within this change, when the wall was removed. The tiled skirting was disrupted, much lost or removed. The windows were replaced with very similar timber small-paned casements.

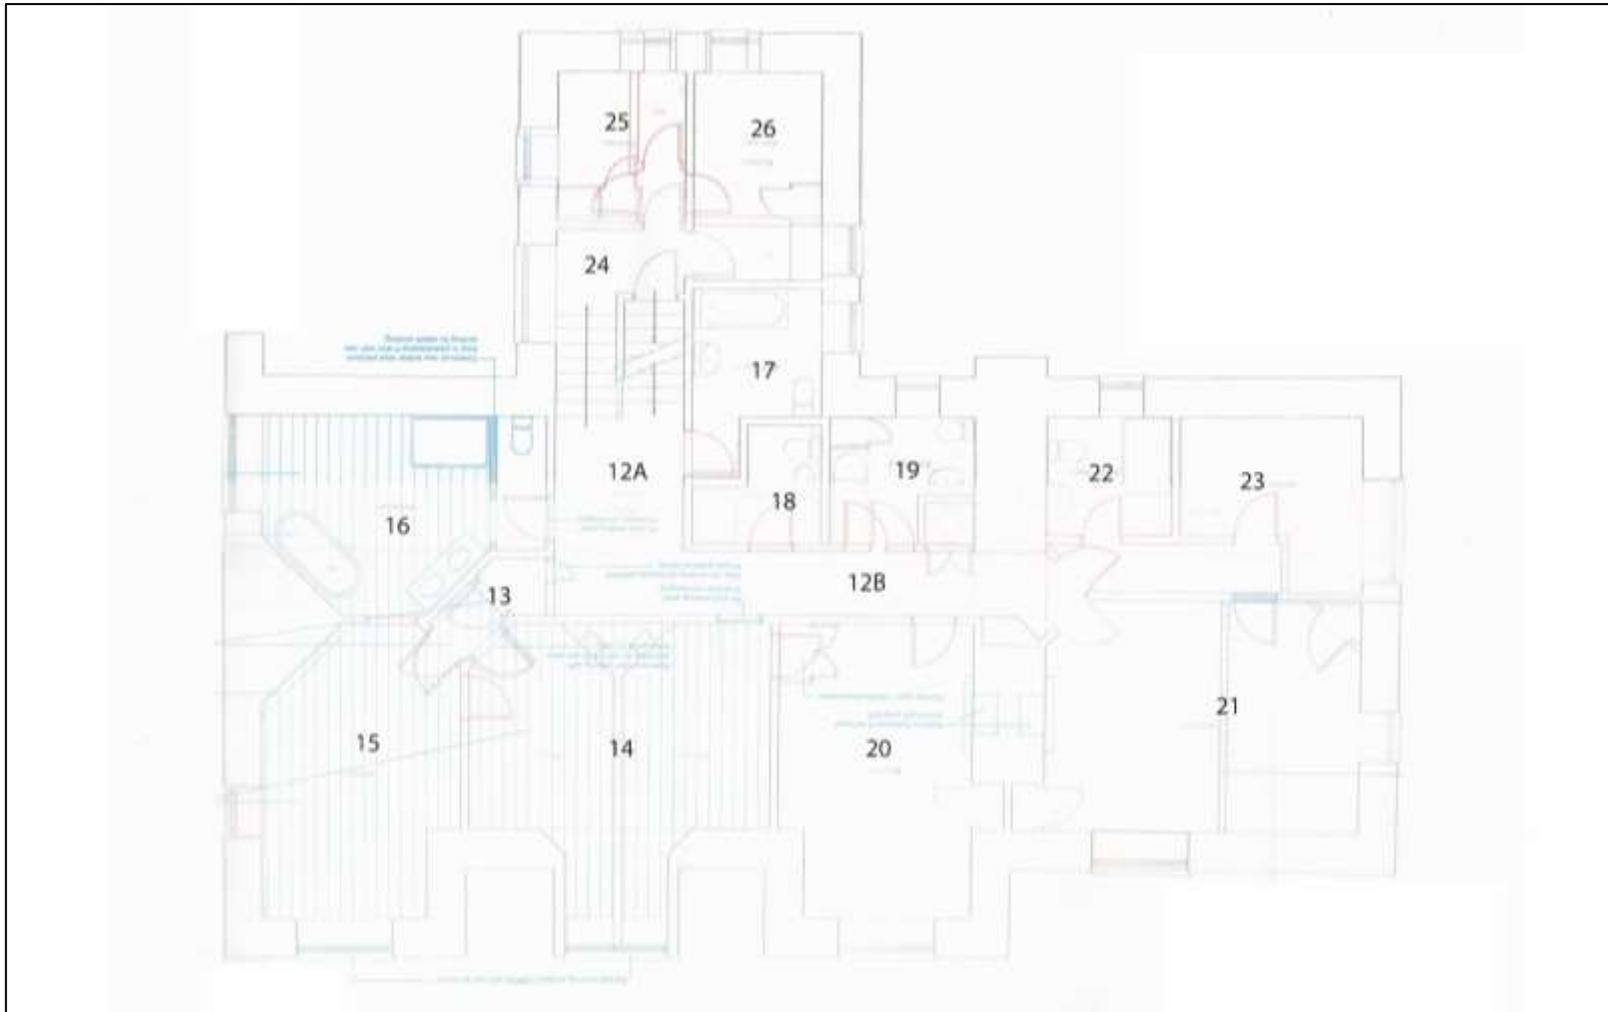
FIGURE 14: OVERLAY OF THE ORIGINAL FIRST FLOOR PLANS OF LILLYCOMBE HOUSE WITH THE 'PROPOSED WORKS' WHICH HAVE SINCE BEEN UNDERTAKEN IN BLUE, AND THE RED MARKING THE ORIGINAL LAYOUT AND ALTERED IN THE 1950S WORKS; (BASED ON SUPPLIED DRAWINGS).

Whilst the list below identifies features on a room-by-room basis this is most clearly illustrated by the annotated plans found in Figures 14 & 15.

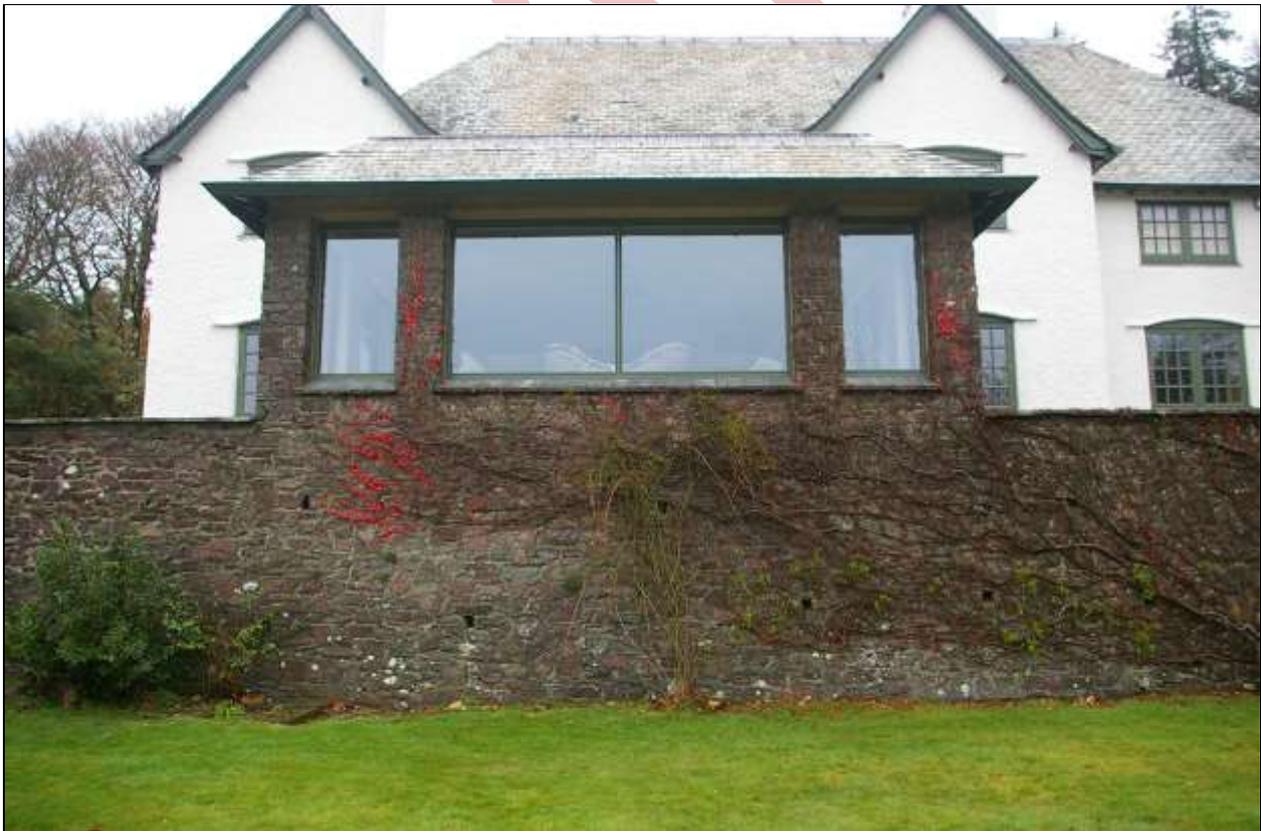
9. THE SUN-ROOM, BUILT OVER AND ACROSS THE TERRACE IN THE 1950S, SOMEWHAT OBSCURING VOYSEY'S VISION FOR THIS ELEVATION; FROM THE SOUTH.

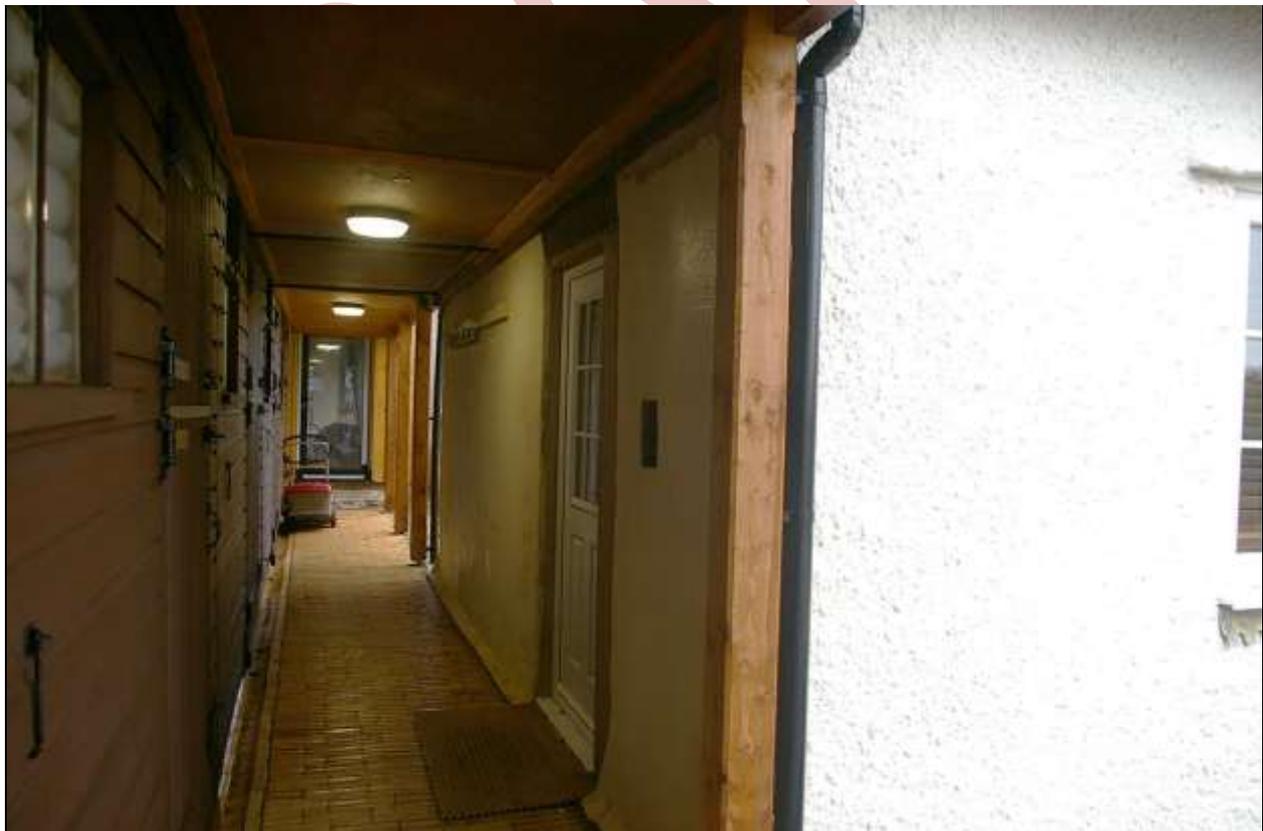
21. THE STABLES, BUILT ACROSS AND ABUTTING THE STABLES COTTAGE; FROM THE WEST.

- The attached stables range has largely been replaced with modern plank-boarded structure;
- The attached rear fodder house to the north-east has been demolished;

- The loose box to the north-east has been wholly replaced with a new timber clad building with sliding glazed doors;
- Metal flue pipe extends stack.

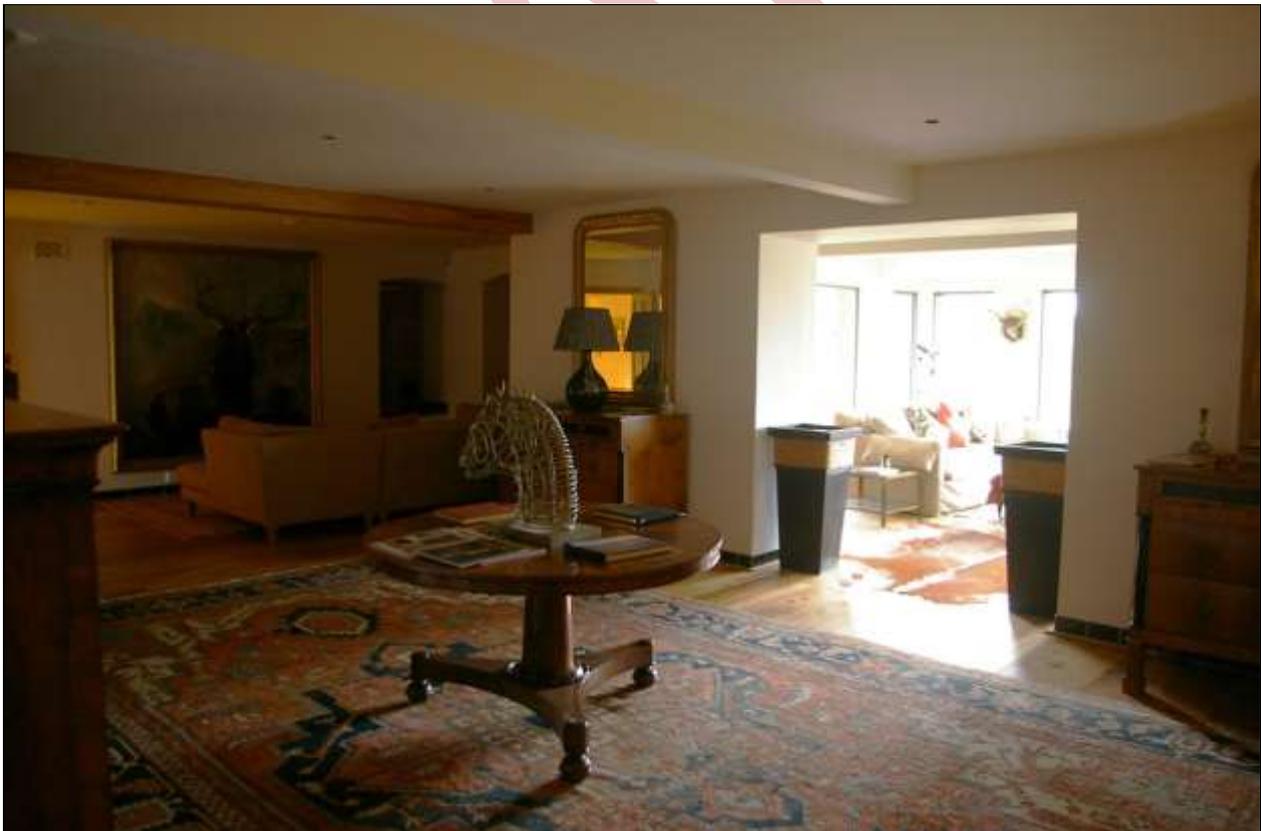
33. THE MAIN LIVING ROOM, ROOM 5, WITH SEPARATE ZONES IN SHORT WINGS TO EAST AND WEST, HERE 5B, TO THE EAST, OPENED UP BY THE REMOVAL OF PARTITION WALLS; FROM THE NORTH-WEST.

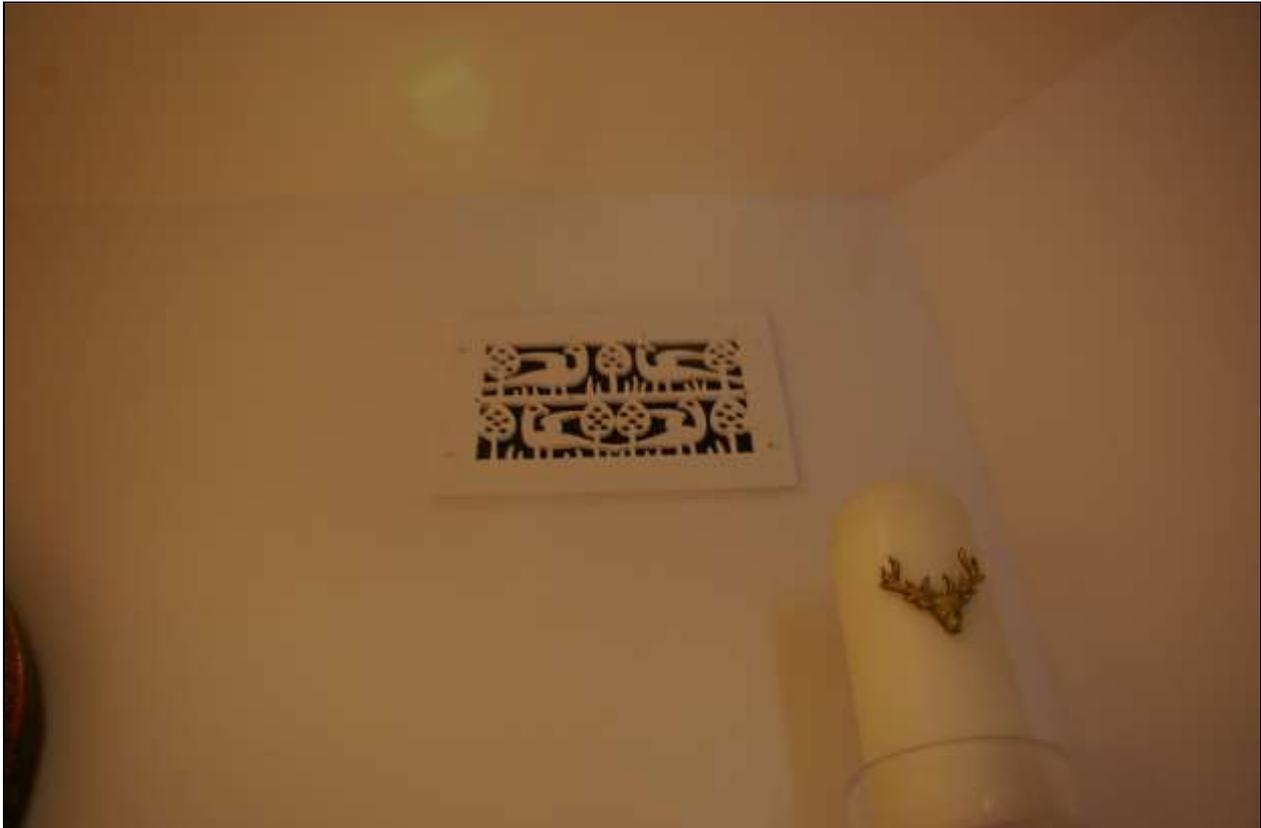
36. THE STYLISED AND VERY FINE 'ARTS & CRAFTS' AIR VENT IN THE STACK SERVING THE FIREPLACE IN AREA 5A, POTENTIALLY SHOWING 'PARTRIDGE IN A PEAR TREE' OR OTHER GAME BIRDS; FROM THE SOUTH-EAST.

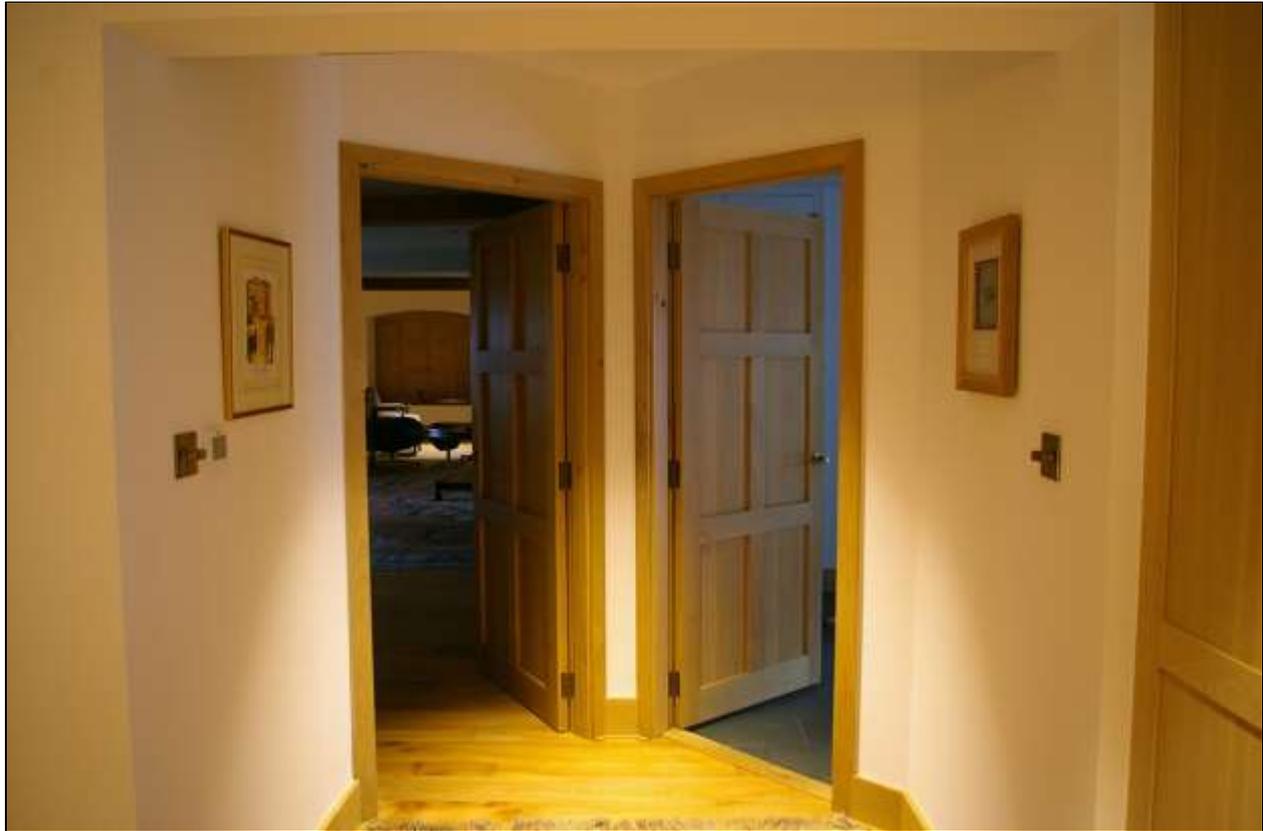
42. THE LOBBY TO THE COMBINED KITCHEN AND DINING ROOM, THE WALL BETWEEN REMOVED; FROM THE EAST.

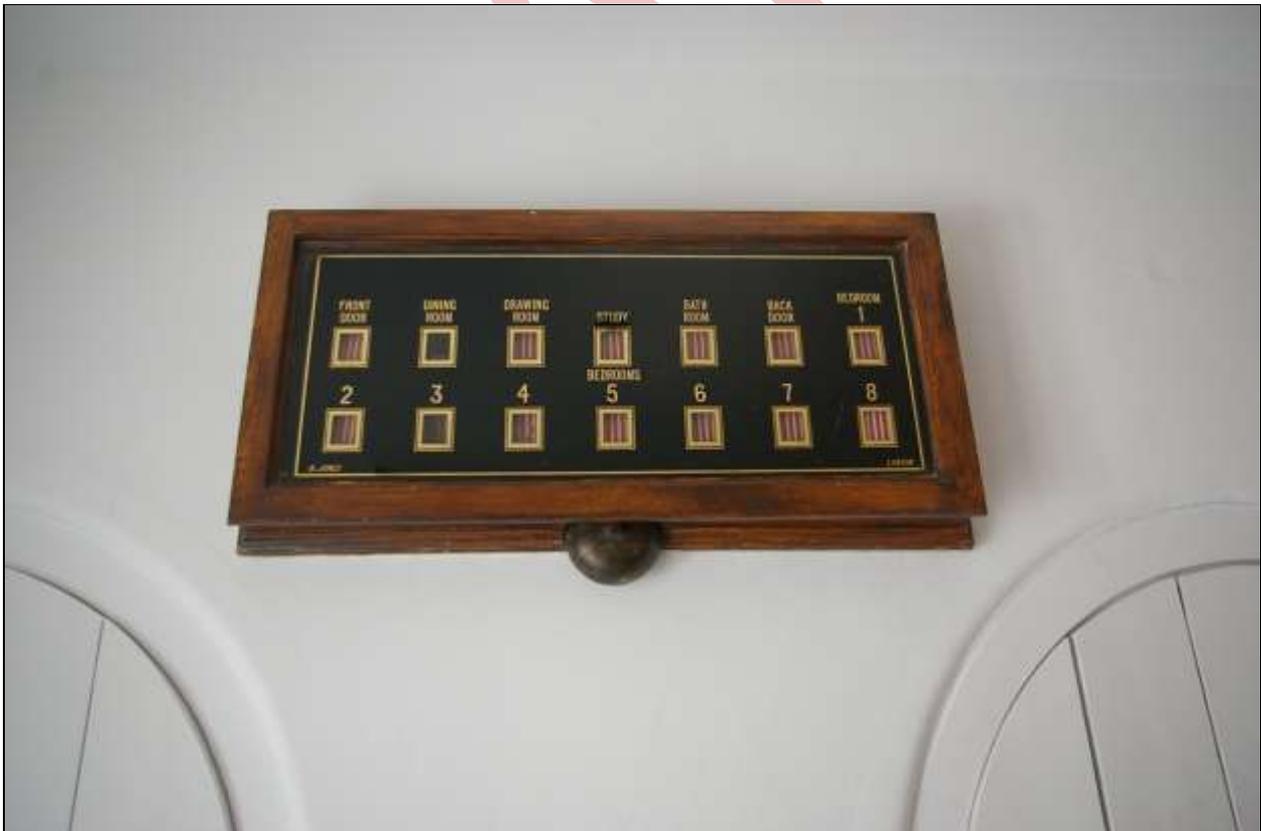
47. THE SERVANTS ELECTRIC BELL SYSTEM IN THE BOOT ROOM, ROOM 8; FROM THE WEST.

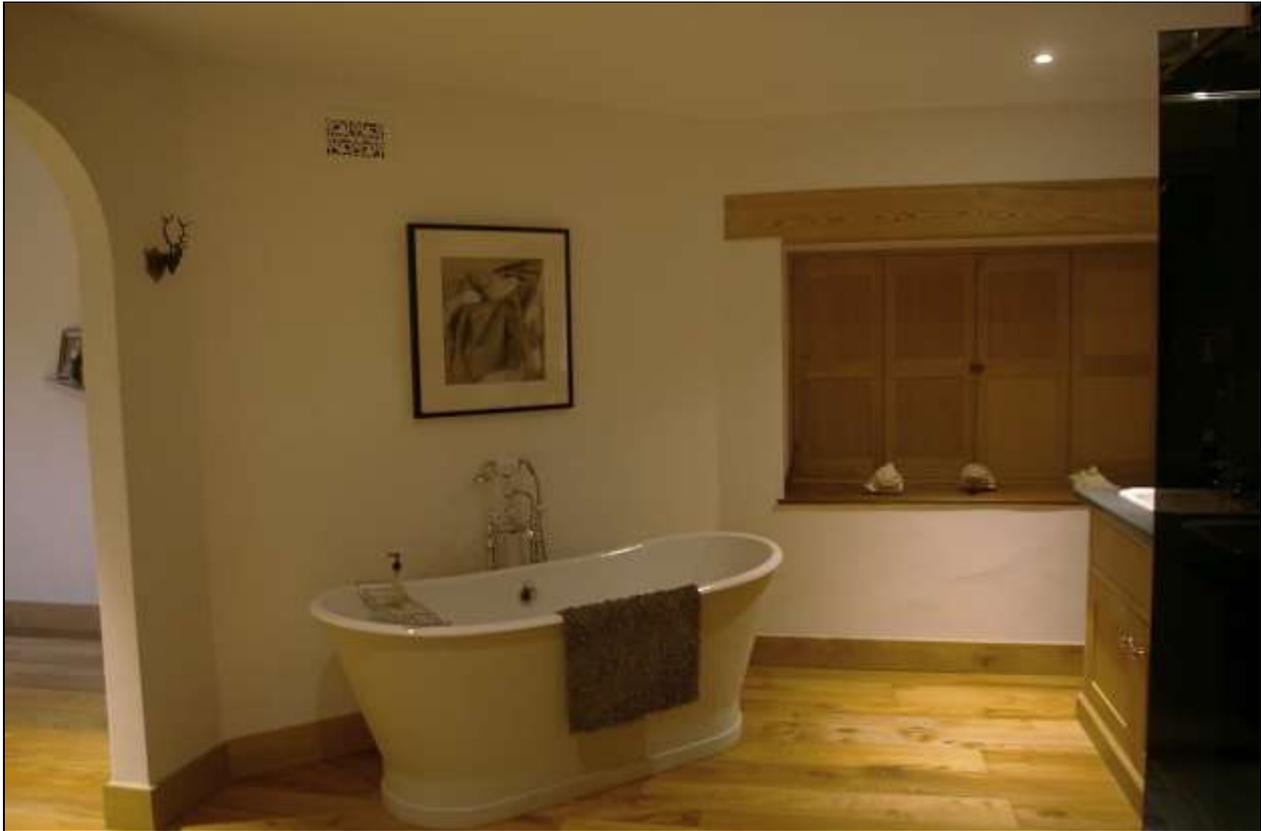
63. THE BATHROOM, ROOM 16, WITH THE FIREPLACE BLOCKED IN THE CORNER; FROM THE EAST.

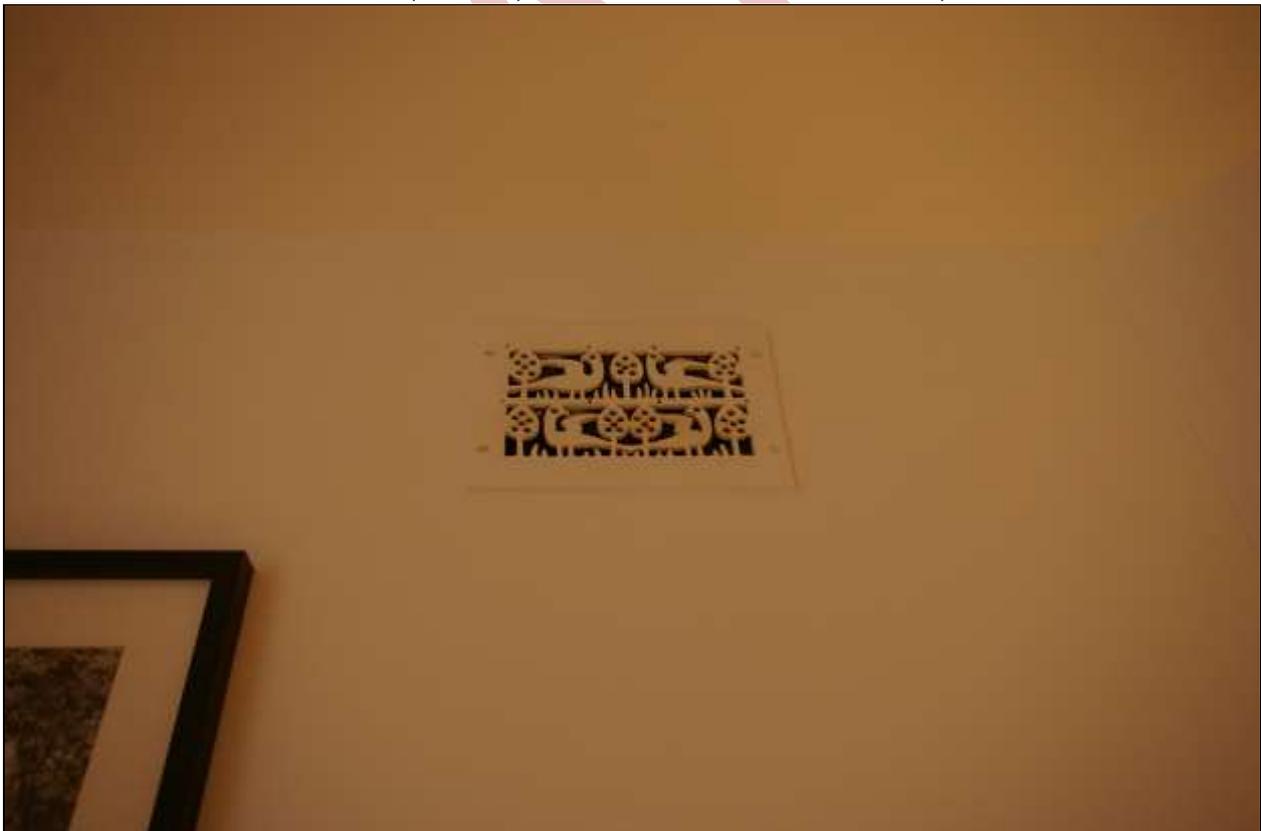
64. THE STYLISED AND VERY FINE 'ARTS & CRAFTS' AIR VENT IN THE STACK SERVING THE FIREPLACE IN ROOM 16, POTENTIALLY SHOWING 'PARTRIDGE IN A PEAR TREE' OR OTHER GAME BIRDS; FROM THE NORTH-EAST.

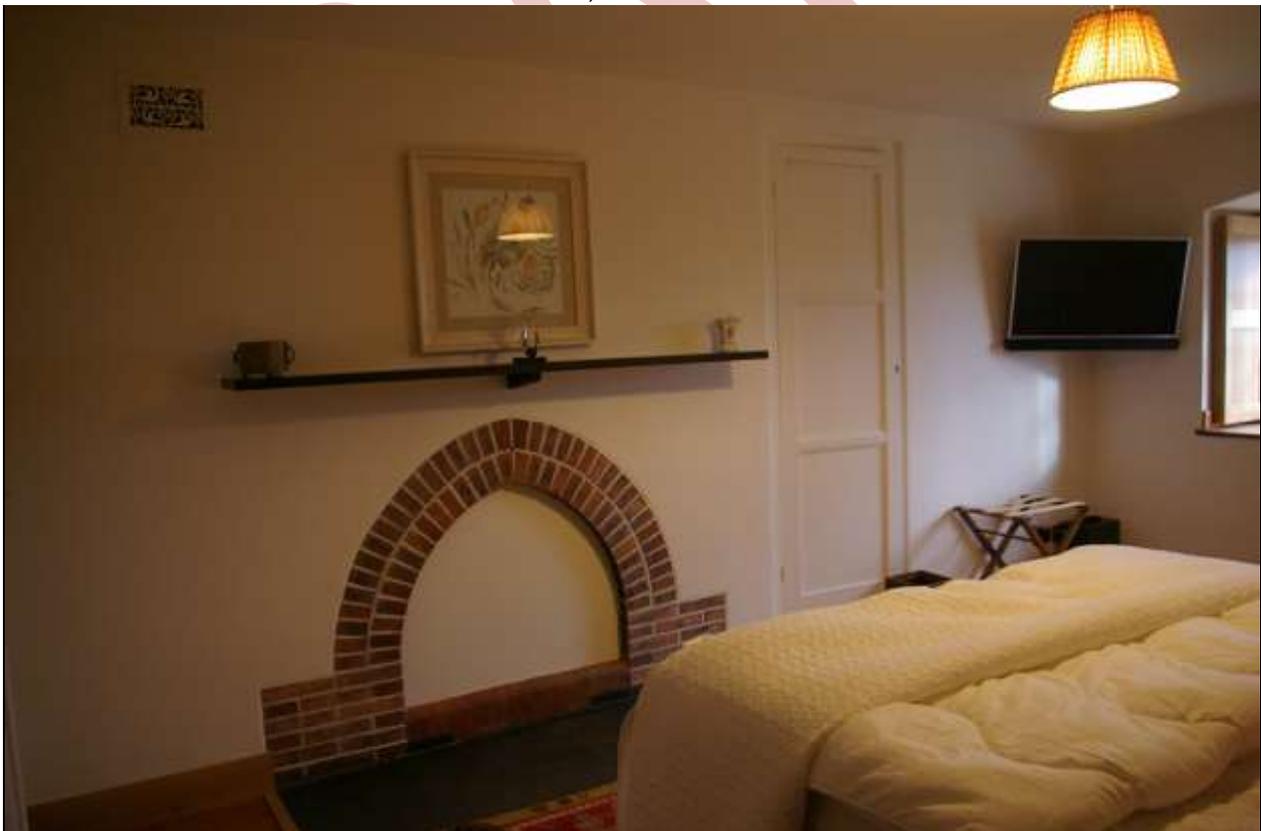
73. THE GOOD FIREPLACE IN ROOM 20, WITH SLATE MANTLE SHELF, ALSO WITH AIR VENT TO STACK; FROM THE NORTH-WEST.

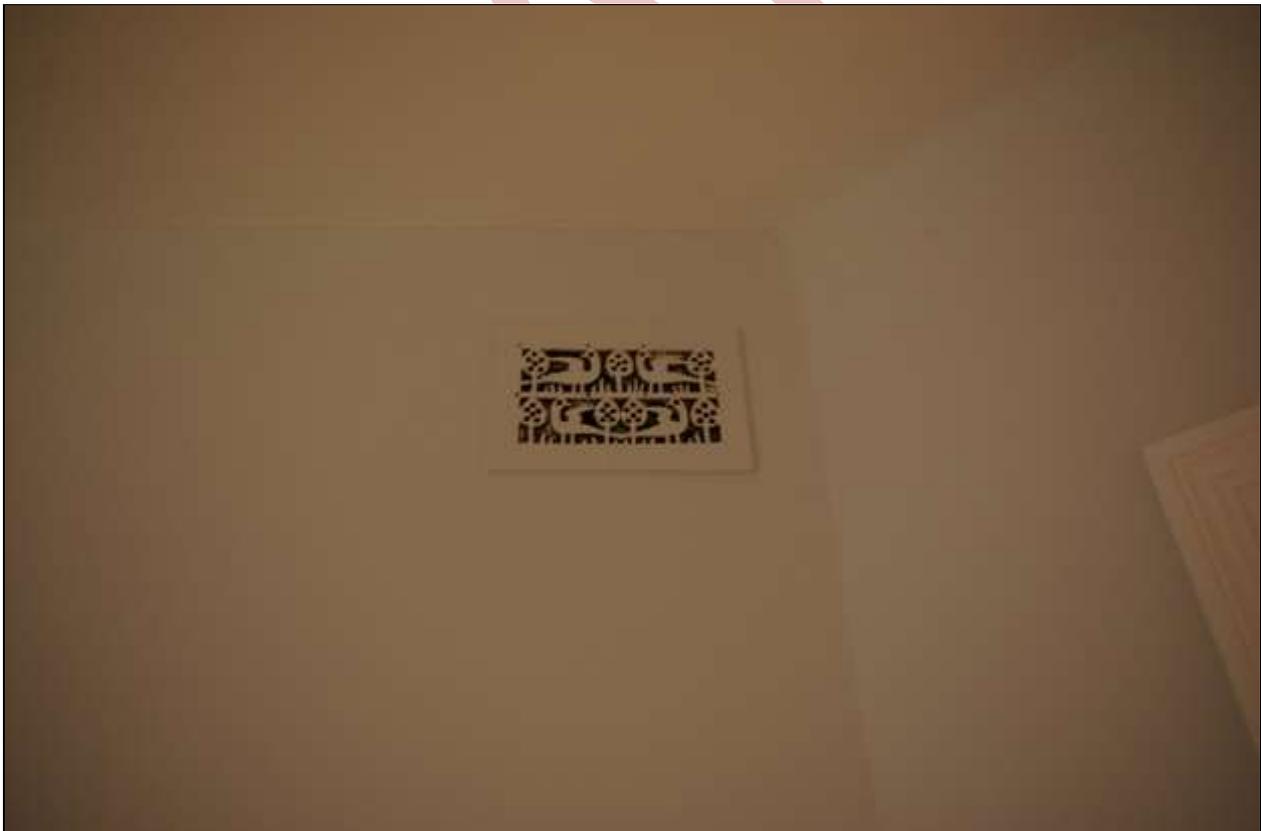
75. DETAIL OF ANOTHER OF THE GOOD MATCHED SET OF AIR VENTS TO THE STACK IN LILLYCOMBE HOUSE, IN ROOM 22; FROM THE EAST.

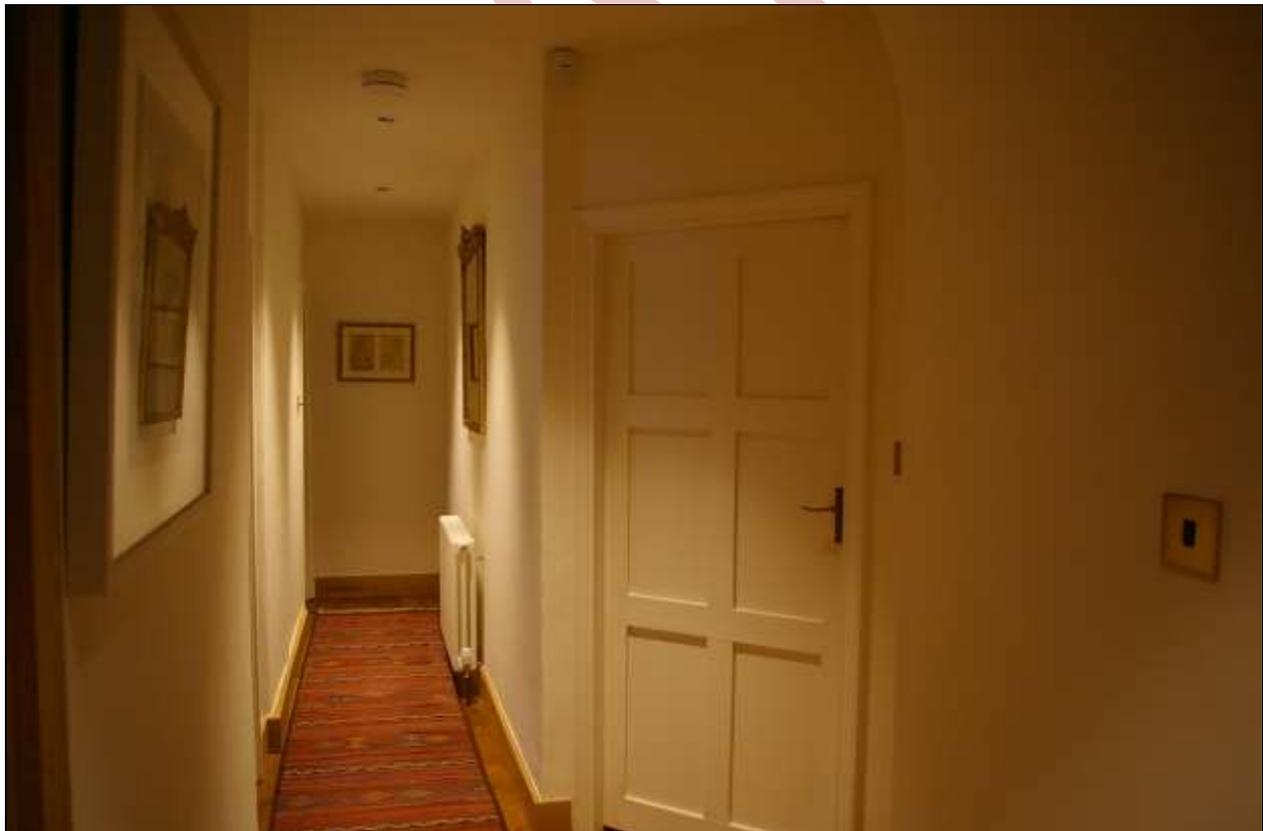
80. THE EAST END OF THE CORRIDOR, ROOM 12B, WHERE IT STEPS IN, IN WIDTH, OVER THE SERVICES, WITH FORMERLY SMALLER BEDROOMS; FROM THE WEST.
