# Devon County Council Historic Environment Record

<b>Civil Parish &amp; District:</b> Marldon, South Hams	<b>National Grid Reference</b> SX 86612 64876	<b>Number:</b>
<b>Subject:</b> Archaeological Monitoring for Installation of Lightning Protection System at Compton Castle, Marldon		<b>Photo attached?</b> Yes
<b>Scheduled Ancient Monument:</b> 1020569	<b>List Entry Number:</b> 1324886	
<b>Planning Application no:</b> N/A	<b>Recipient museum:</b> National Trust Archive, Killerton	
<b>OASIS ID:</b> southwes1-350028	<b>Museum Accession no:</b> N/A	
<b>Contractor's reference number/code:</b> MCC19	<b>Dates fieldwork undertaken:</b> 5 <sup>th</sup> May, 6 <sup>th</sup> November 2019

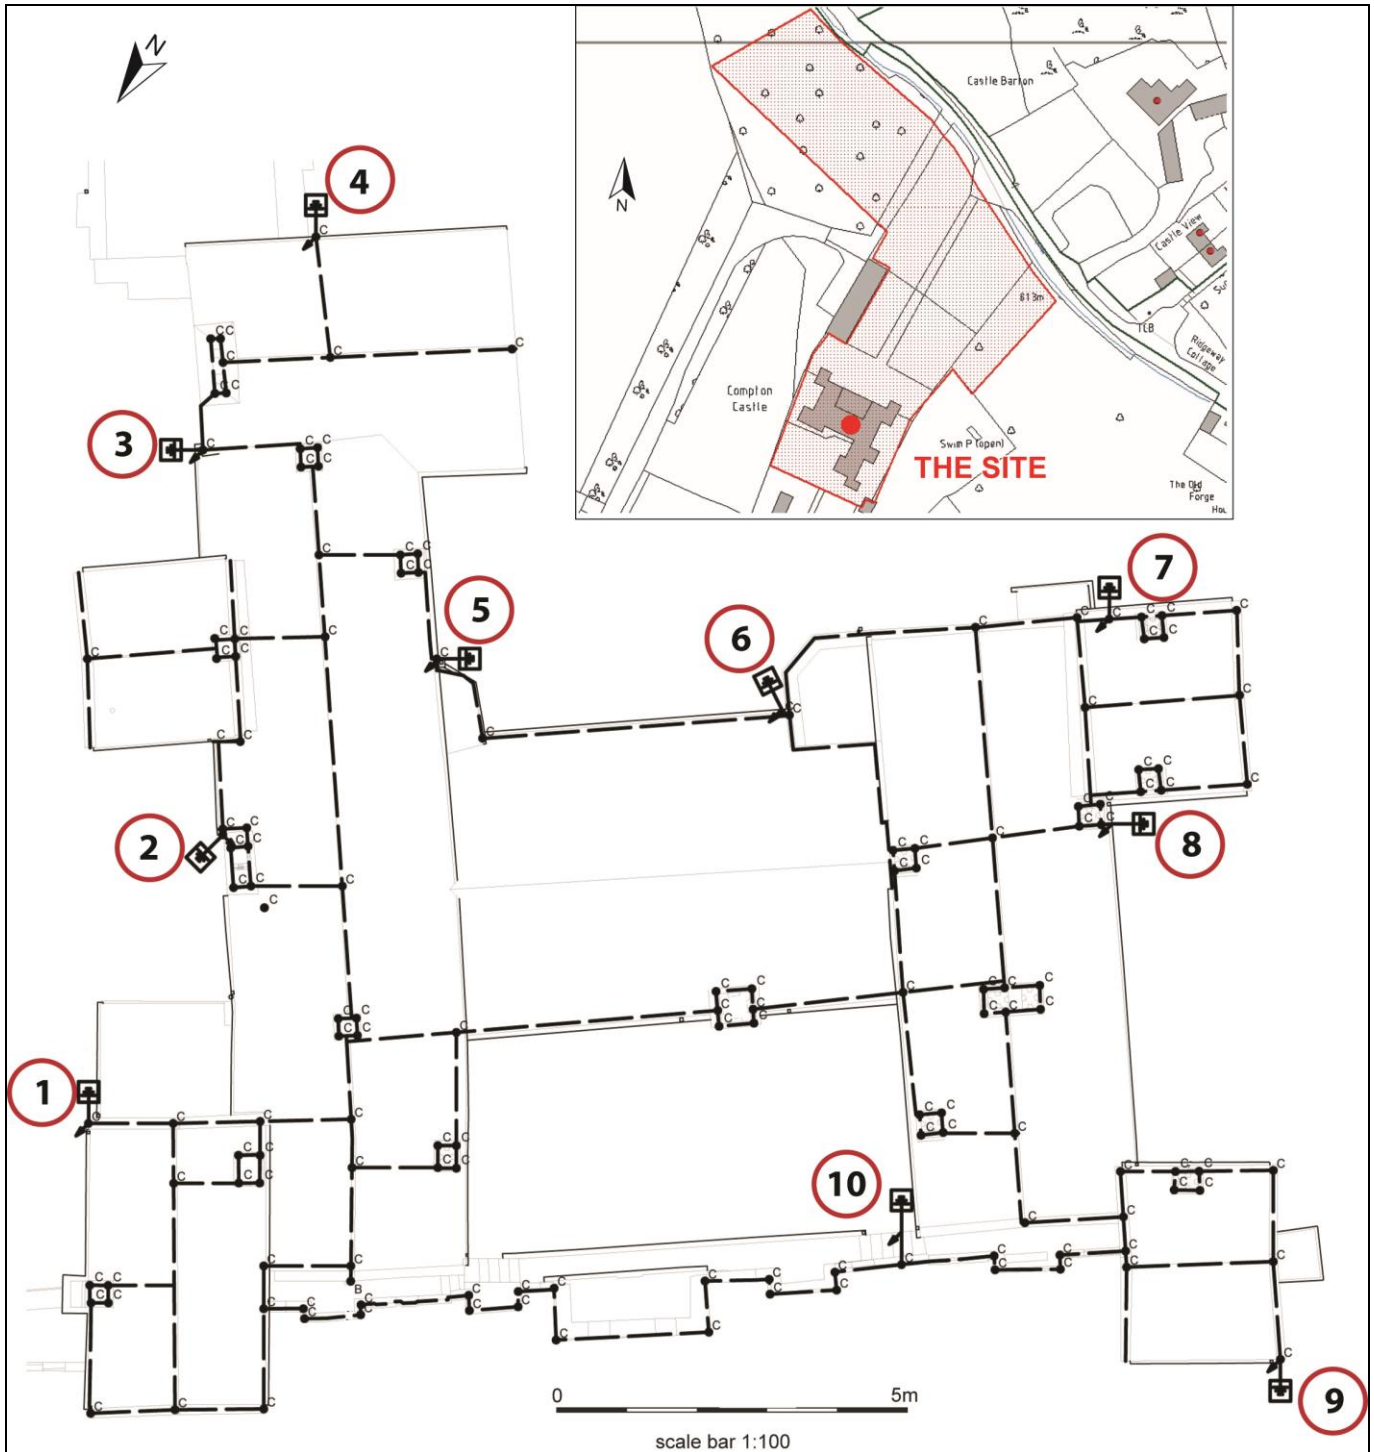
FIGURE 1: LOCATION PLAN, SHOWING THE NUMBERED CONDUCTOR EXCAVATIONS.

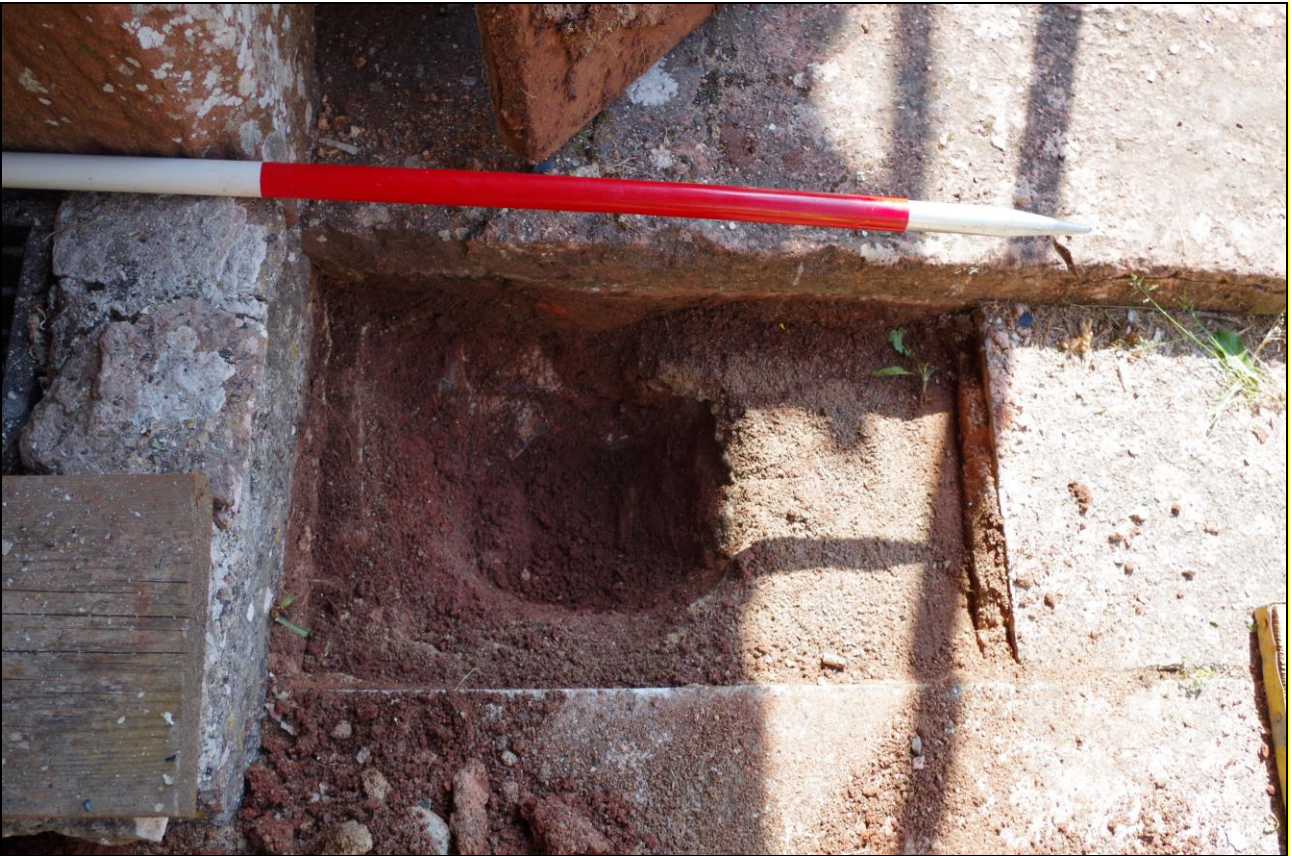
7. Conductor 7 is adjacent to abutment (of a stair turret to the Sub-Solar). A single concrete slab (0.05m thick) was lifted, this overlaid a 0.07m thick grey sand bedding, overlaying a 0.06m thick layer of clean red silt loam and overlaid a layer of demolition material in a slightly grey-red silt loam. The lime bonded stone rubble build footing for the demolished side entrance (into what would have been the Inner Court) was visible in the east section of the excavated (Figure 2).

FIGURE 2: CONDUCTOR PIT 7, SHOWING THE THRESHOLD STONE AND RUBBLE FOOTINGS TO THE DEMOLISHED ENTRANCE; VIEWED FROM WEST (1M SCALE).

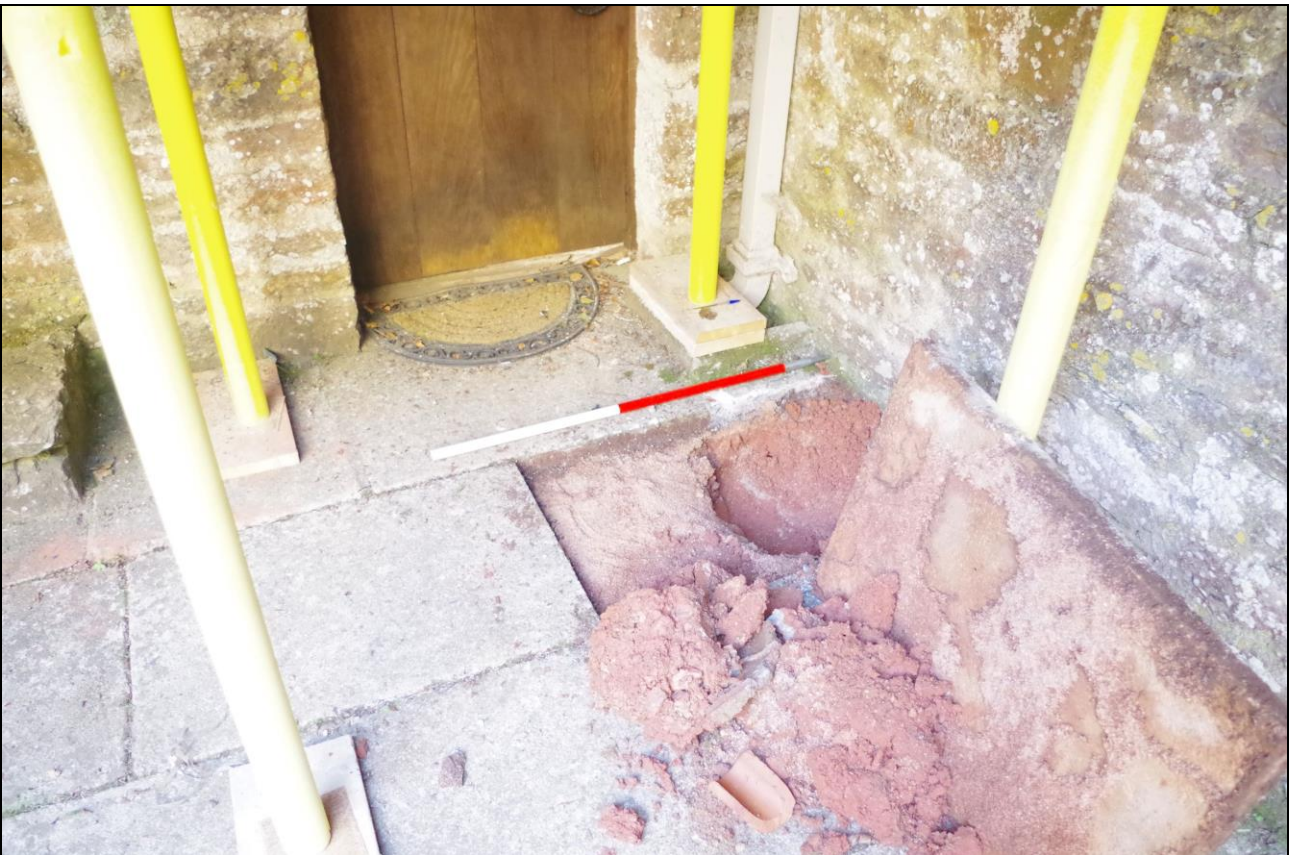
8. Conductor 8 is adjacent to the entrance into the Sub-Solar. A large concrete paving slab (0.06m thick) overlaid a bedding of yellow-pea gravel and sand (0.04m thick). Below this was a concrete/derelict drain which had been crushed by later drain runs. This crushed drain overlaid a clean, moist, reddish-purple silt-clay (probably the *Natural*), although the top of the deposit was exposed within the limits of excavation.

FIGURE 3: CONDUCTOR PIT 8; VIEWED FROM THE WEST (1M SCALE).
