**LAND ADJACENT TO HUTTON**

**LANGLEIGH LANE**

**ILFRACOMBE**

Results of an Archaeological Evaluation

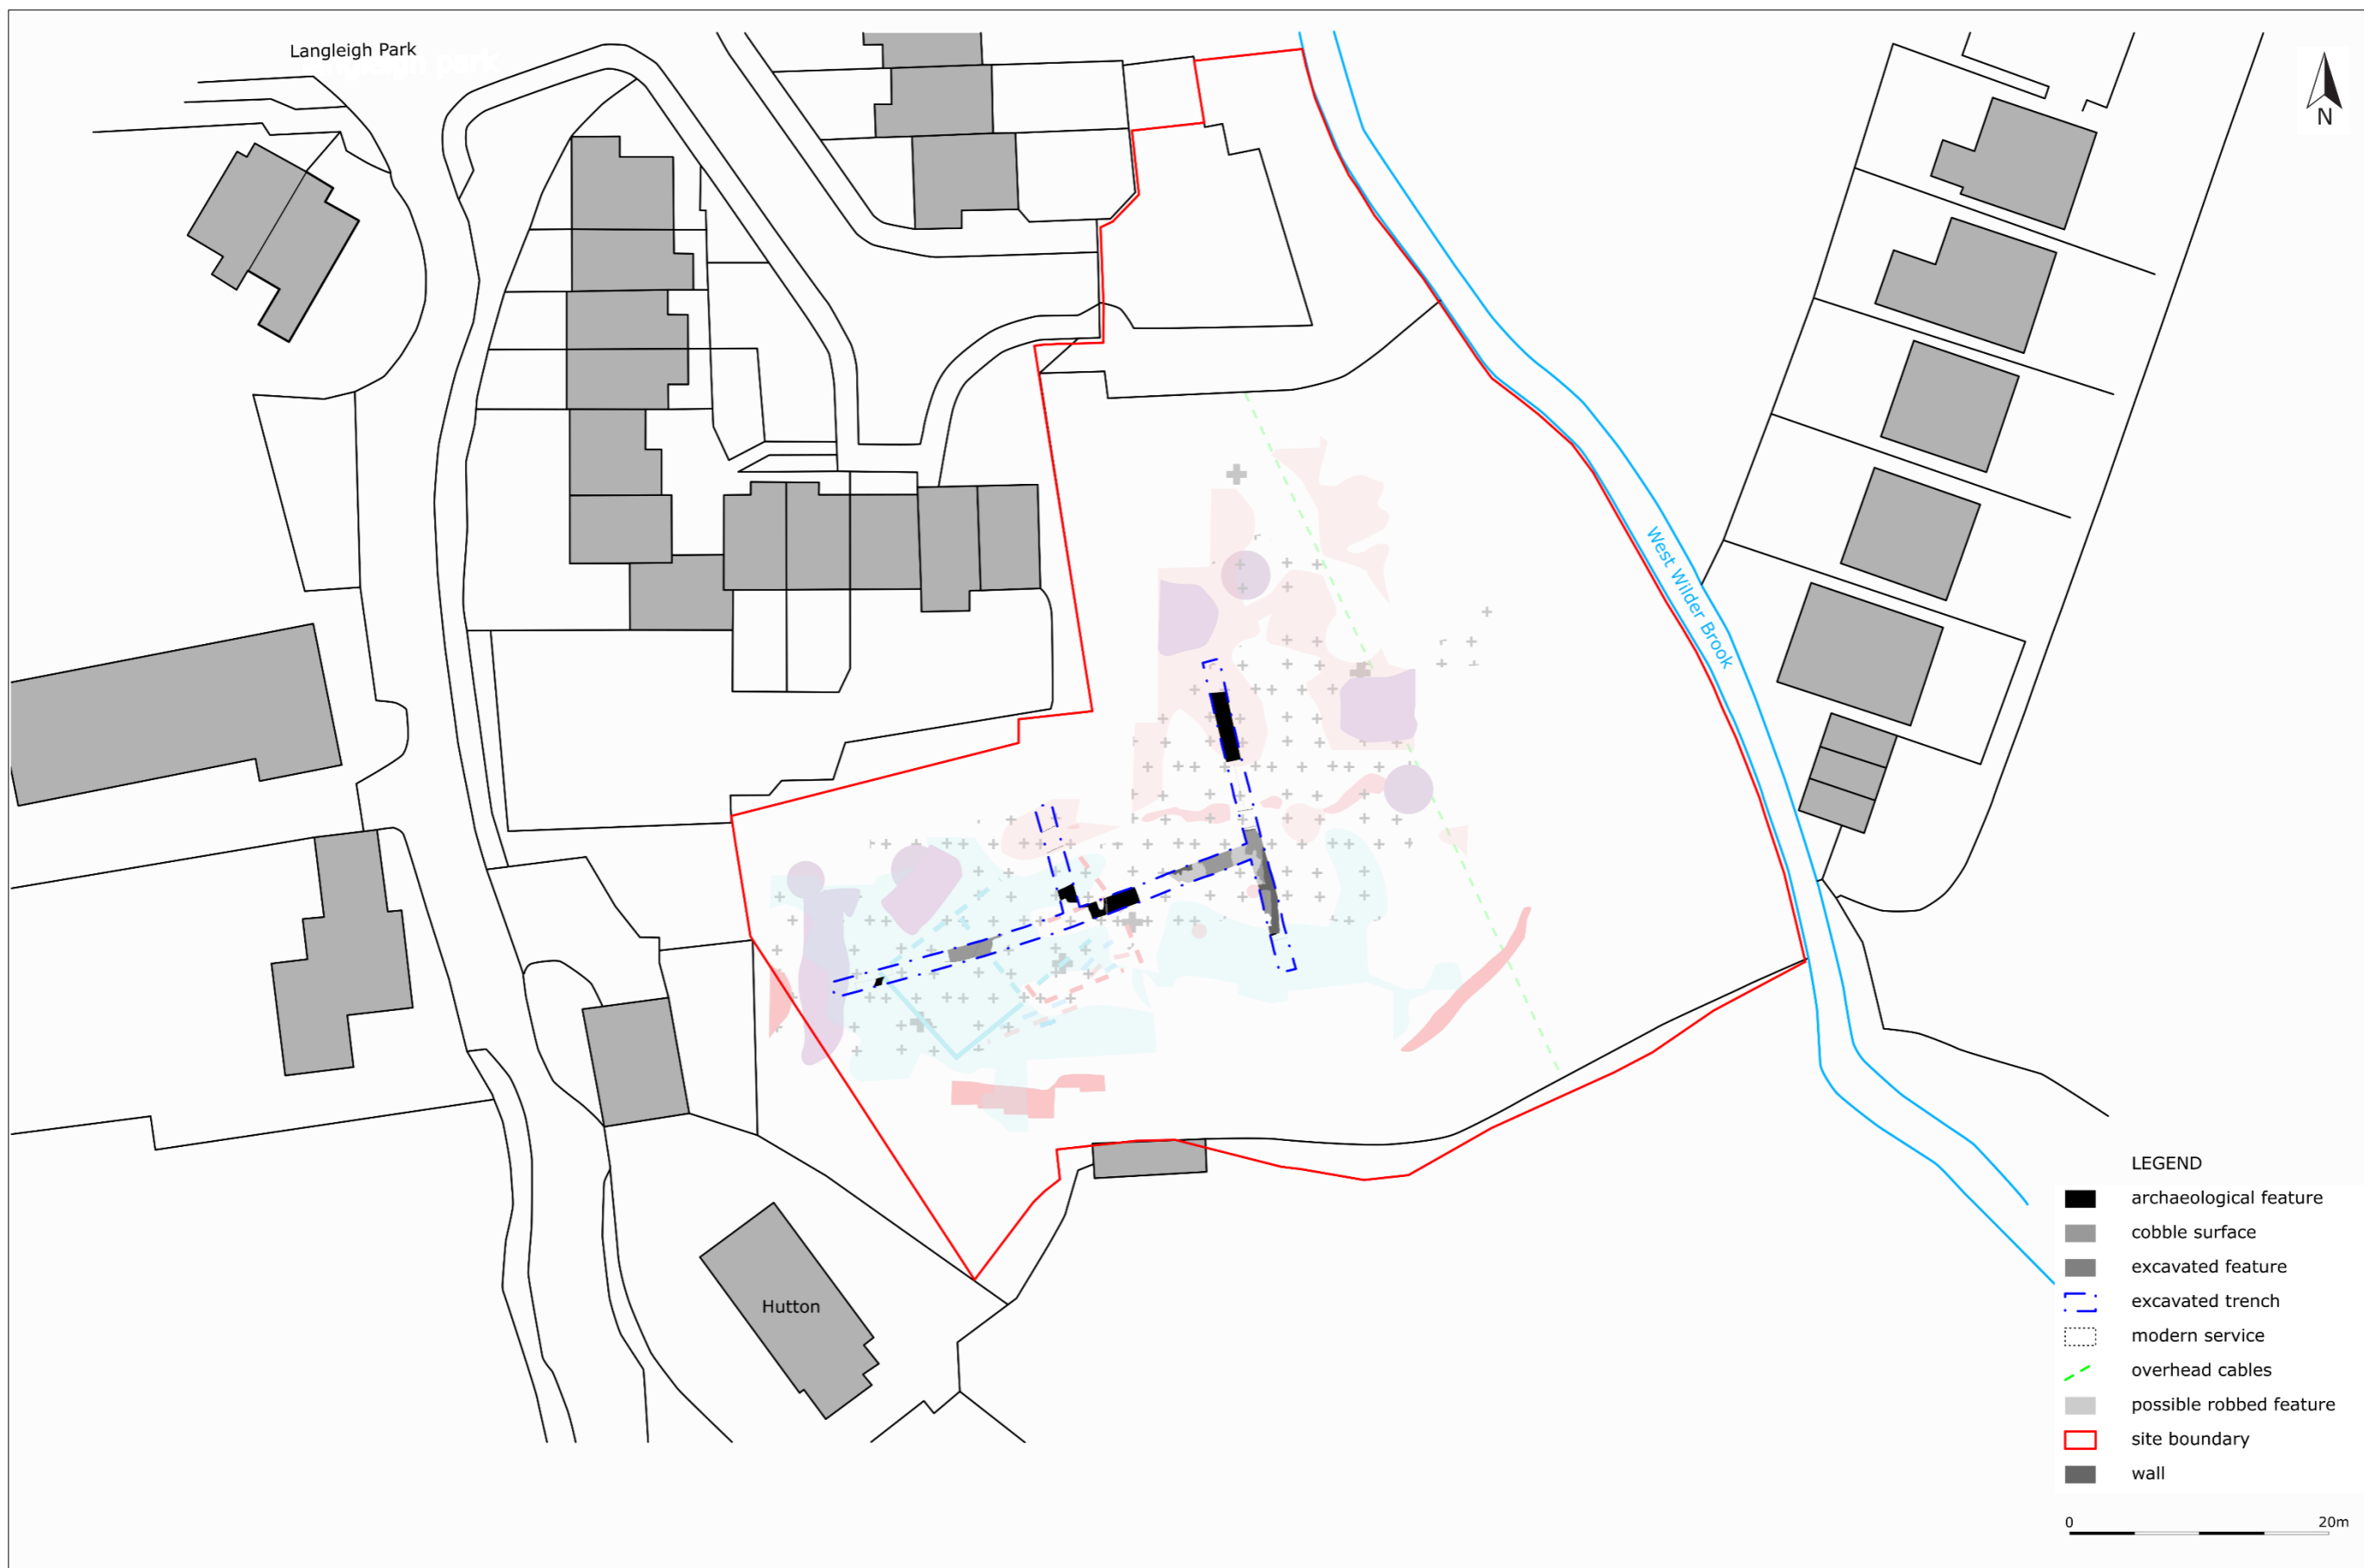
FIGURE 2: SITE PLAN SHOWING LOCATION OF IDENTIFIED ARCHAEOLOGICAL FEATURES OVERLAID ON THE INTERPRETATION RESULTS OF THE GEOPHYSICAL SURVEY.

The excavation identified a total of 31 archaeological features and to some extent validates the results of the geophysical survey, identifying a series of structural features associated with the presence of post-medieval buildings on the site. It also demonstrated that much of the site had been covered by demolition deposits which masked the clarity and survival of archaeological features; whilst modern disturbance was also identified across the site. The majority of the features did not produce dating evidence, the bulk of the artefacts being recovered from the overlying demolition deposits. The survival of structural remains, particularly at the southern end of trench 01, indicates that further structural remains are likely to be encountered in this area. Given the extent of robbing/demolition across the site and limiting nature of the evaluation trenches it is difficult to say with any certainty which of the structures and removed structures were associated with each other, and which represent different phases.

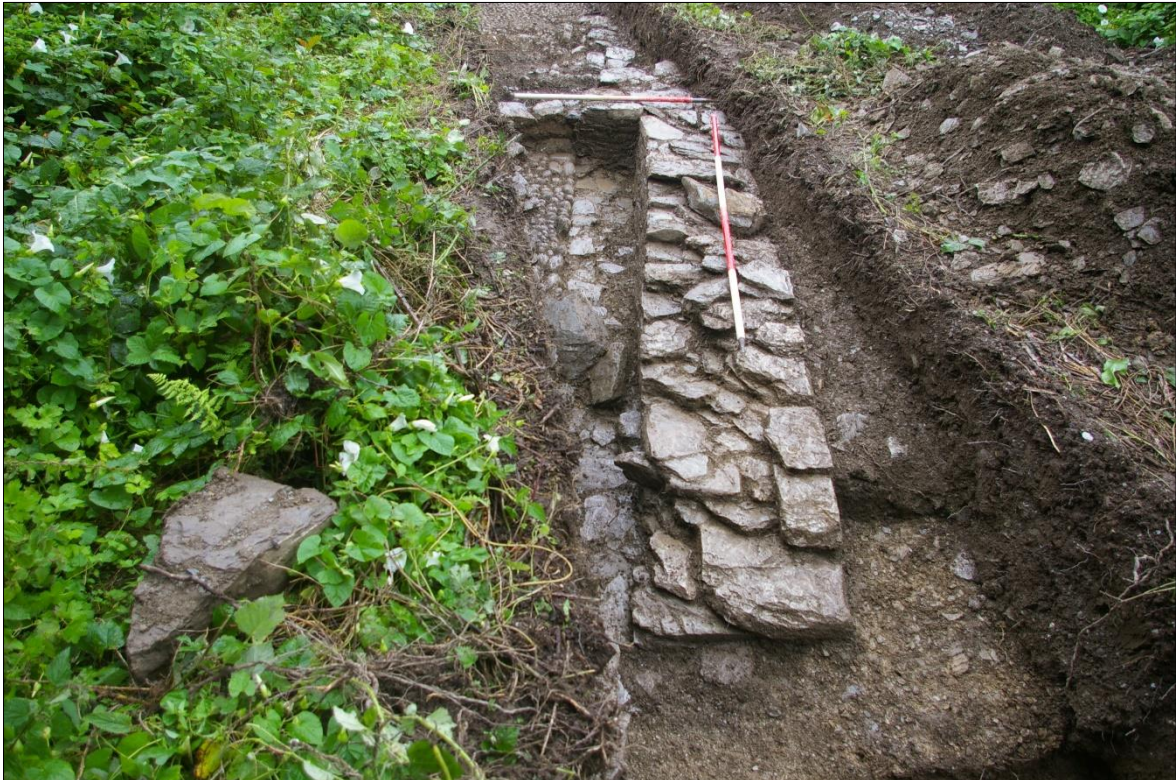
FIGURE 4: STRUCTURE <S1>; VIEWED FROM THE SOUTH (1M & 2M SCALES).

Structure <S1> was located at the southern end of the trench. It was orientated approximately north-north-east to south-south-west, measuring 3.90m x 1.20+m, the walls surviving up to a height of 0.40m. The initial construction of this structure was identified in three walls: {114} to the south, {115} to the east, and {116} to the north; each constructed of sub-angular and irregular slatestone with a mid grey-yellow-brown silt-clay bond and measuring 0.55-0.60m wide. A rough slatestone surface (117) formed the interior floor of this structure. The structure appears to have been re-built, wall {118} abutting the western end of wall {116} along the same alignment and using broadly the same stone construction, though there are traces of mortar on some of the stones. This re-build was also associated with the re-laying of the floor with cobble surface (119), comprising moderately tightly packed sub-rounded and rounded stone cobbles up to 0.15m in diameter set in rough lines following a north-north-east to south-south-west alignment within mid brown soft silt-clay over floor (117).

Stone-built walls {114}, {115}, and {116} and what appeared to be a stone floor (117), form the eastern end of structure <S1>. Whilst this corresponds with the southern range of the courtyard building it is unclear when this building originated. It does not appear to have been the earliest structure in this location, construction cut [125] pre-dating it; whilst multiple phases of construction are identifiable and it appears as though the structure was either re-modelled or significantly re-built, wall {116} truncated and replaced by wall {118} along with the internal floor being re-surfaced with cobbles (119).

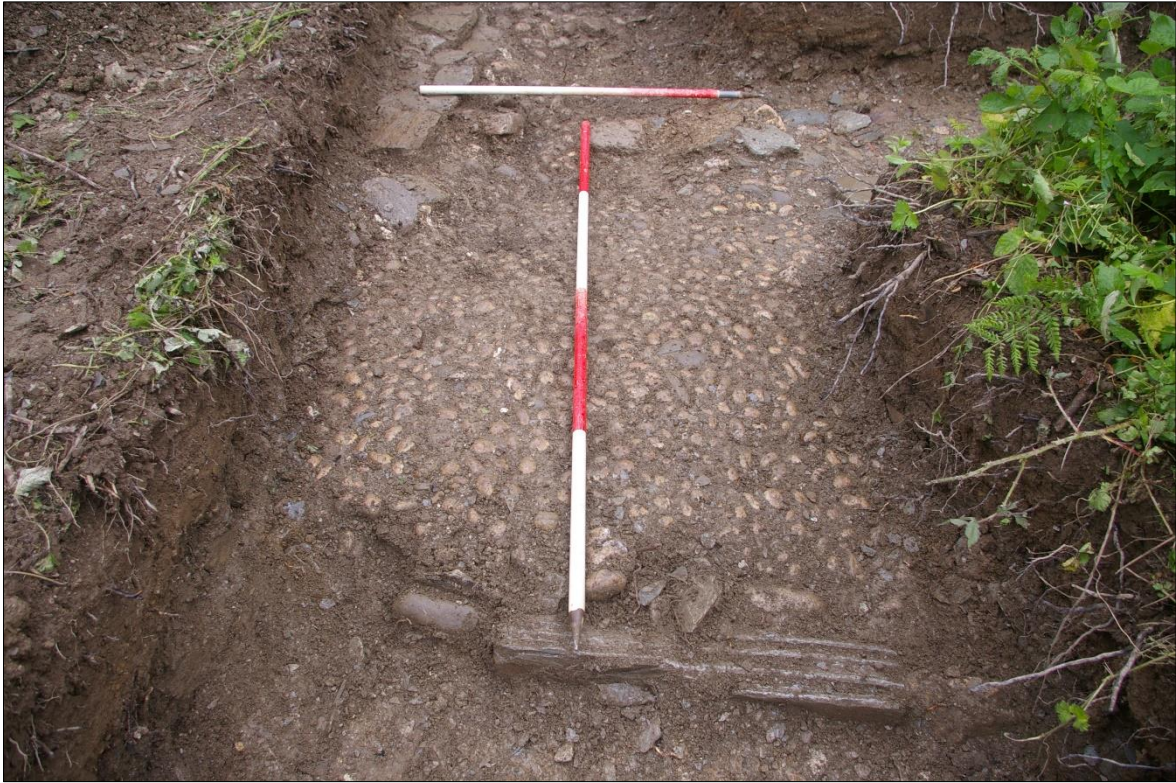
FIGURE 5: THE NORTHERN END OF STRUCTURE <S2>; VIEWED FROM THE NORTH (1M & 2M SCALES).

A second structure <S2> was located against and incorporating the northern wall of <S1>, and similarly appeared to comprise two phases. The initial construction consisted of three walls: {116} to the south, {121} to the east, and {123} to the north. Each wall was constructed of sub-angular to irregular slatestone with a mid grey-yellow-brown silt-clay bond measuring 0.20-0.55m wide, though the presence of a longer, thinner stone within {123} suggests that a threshold may have been situated here. These walls contained two areas of heavily disturbed cobble surface (122) and (124); both moderately tightly packed irregularly laid sub-rounded and rounded stone cobbles up to c.0.10m in diameter within mid brown soft silt-clay. Eastern wall {121} may have been rebuilt along a slightly different north-north-east to south-south-west alignment by wall {120}, though of the same construction and it may be that {121} forms slightly wider foundations to {120}.

To the north of this was structure <S2>, which if the buildings follow the footprints depicted on the tithe map, would have formed a courtyard area enclosed along its eastern edge by wall {121}, though whether this was associated with structure <S1> or an earlier phase of structure was not established. This was replaced by a slightly offset wall {120} at the same time as being cobbled by surface (122)/(124), possibly concurrently with the re-modelling/re-build of <S1> given the similarity in cobble surfaces. The presence of wall {123} at the northern edge of the cobble surface, which is not identified on the historic mapping, may indicate that these features pre-date those depicted, especially as the nature of the stonework of wall {123} suggests the position of a possible threshold. This aligns approximately with an 'irregularity' in the main courtyard building and it is possible that an earlier structure here was partially demolished, the remainder being retained in the later building. A possible robber cut [209] along the western edge of cobble surface (122)/(124) may indicate the western edge or an internal division of this structure, the nature of the cobble surface (205) suggesting likely contemporaneity of structure <S3> and is perhaps a continuation of the same structure.

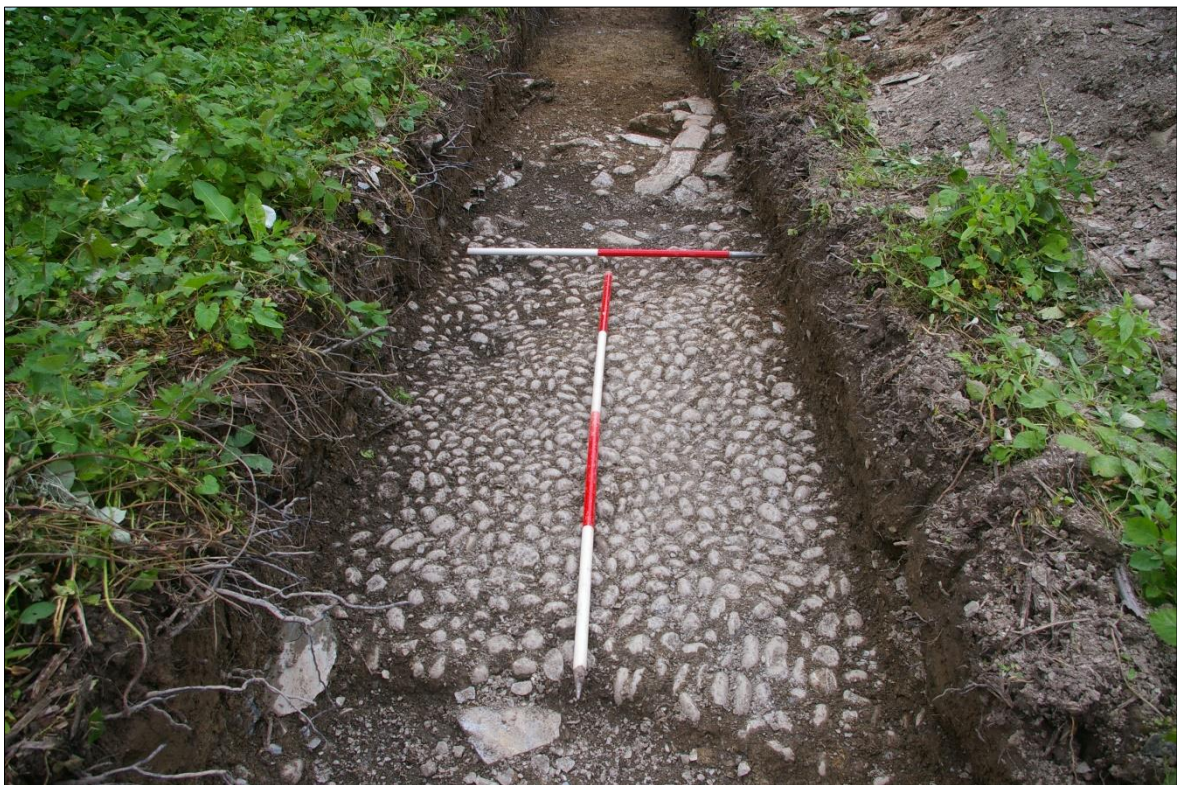
FIGURE 8: STRUCTURE <S3> SHOWING COBBLE FLOOR (205); VIEWED FROM THE EAST-NORTH-EAST (1M & 2M SCALES).

Structure <S3> may be a continuation of structure <S2> into trench 02, though heavily disturbed and primarily visible as a further section of cobble surface (205), moderately tightly packed irregularly laid sub-rounded to rounded stone cobbles up to 0.10m in diameter within mid brown soft clay. Two possible 'L'-shaped robber cuts [209] (to the east) and [210] (to the west), both orientated approximately north to south and measuring c.1m wide with approximate east to west orientated returns at the southern ends truncate surface (205) and suggest the position of former boundary walls defining the western extent of the structure. These were both in-filled by demolition spread (204).

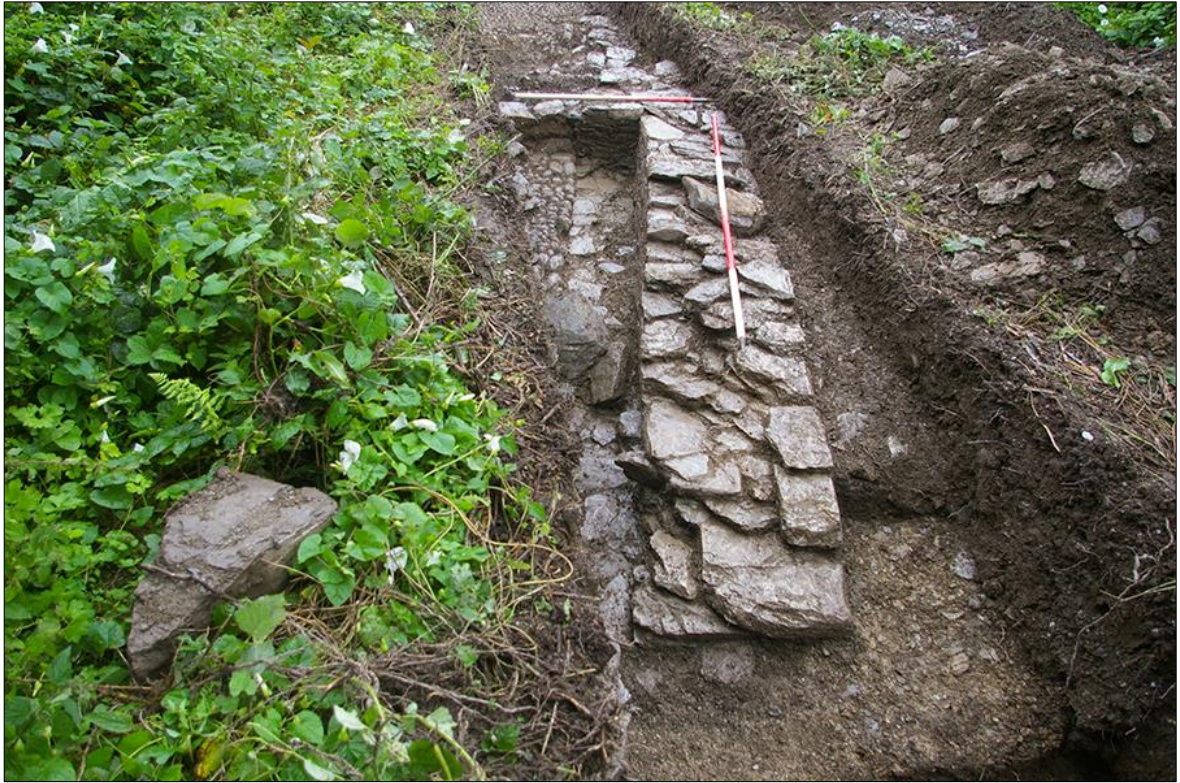
5. STRUCTURE <S1> SHOWING COBBLE FLOOR (119), STONE FLOOR (119), AND WALLS {114}, {115}, {116}/{118}; VIEWED FROM THE SOUTH (1M & 2M SCALES).

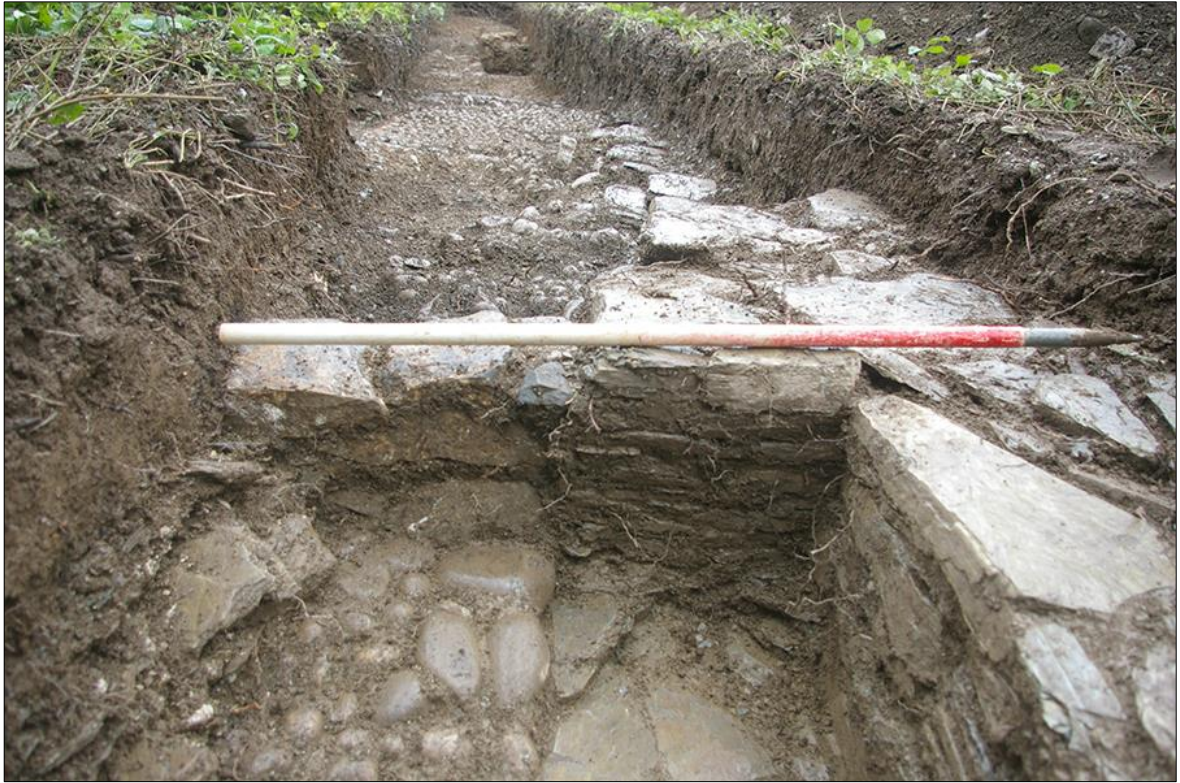
9. STRUCTURE <S1> DETAILING WALL {118} ABUTTING WALL {116} WITH COBBLE FLOOR (119) OVERLYING STONE FLOOR (117); VIEWED FROM THE SOUTH (1M SCALE).

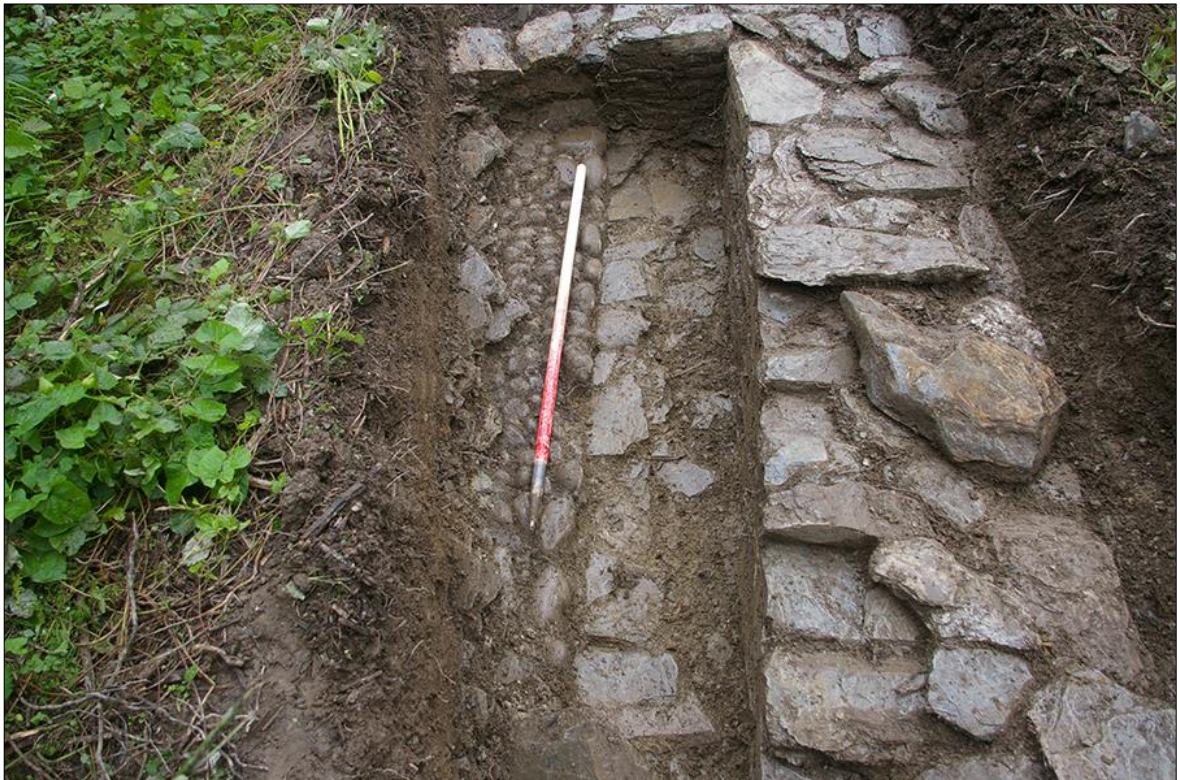
10. STRUCTURE <S1> SHOWING COBBLE FLOOR (119) OVERLYING STONE FLOOR (117); VIEWED FROM THE SOUTH (1M SCALE).

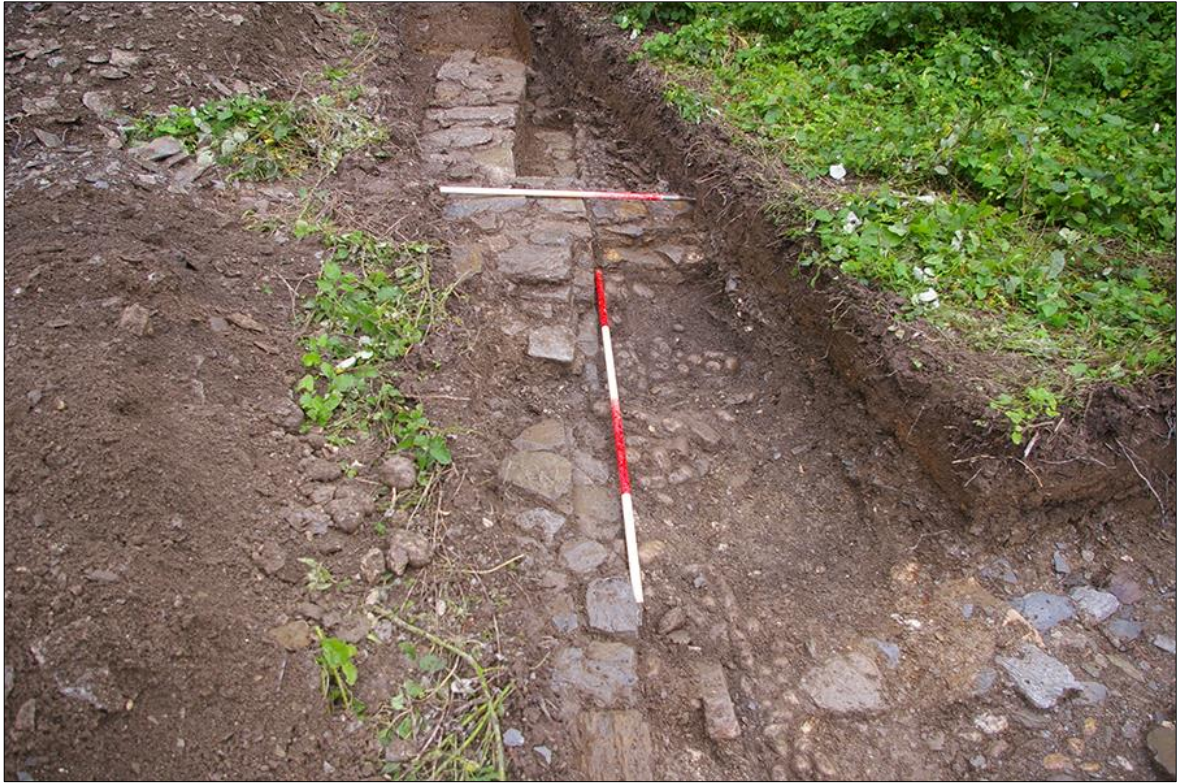
15. STRUCTURES <S2> SHOWING COBBLE SURFACE (122) WITH WALLS {120} AND {121} ABUTTING STRUCTURE <S1>; VIEWED FROM THE NORTH (1M & 2M SCALES).

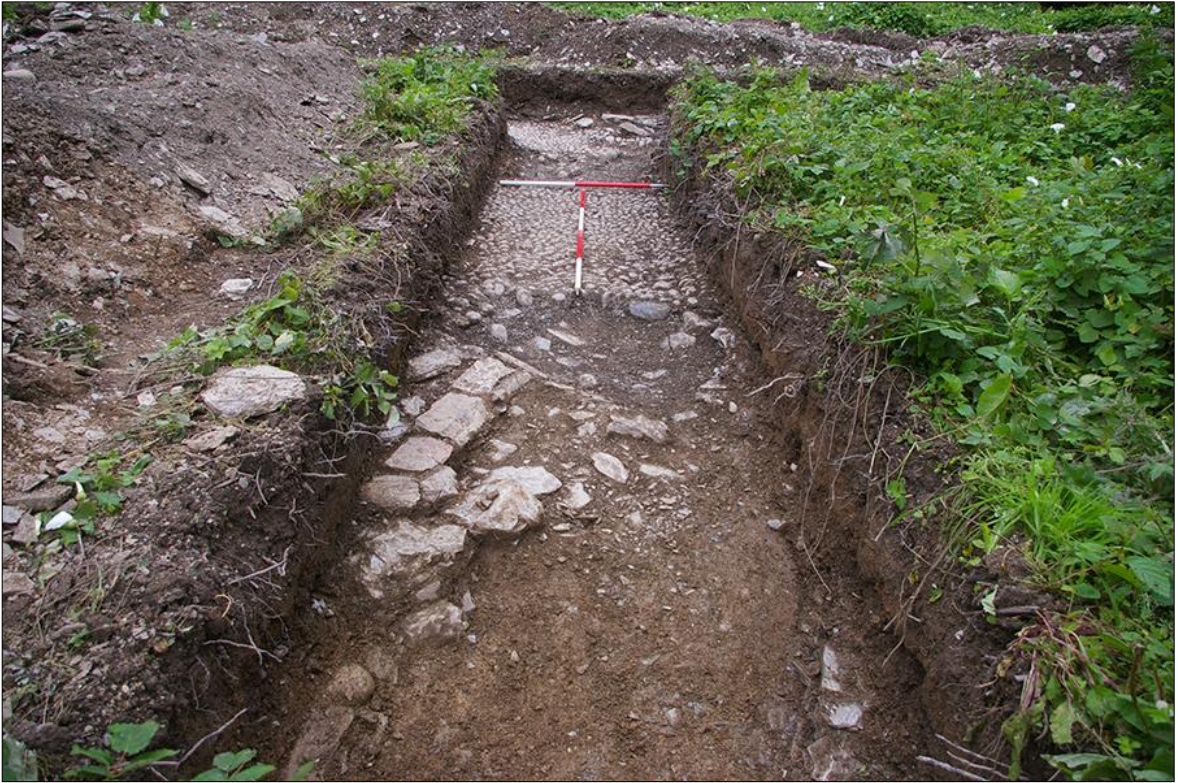
27. STRUCTURES <S3> AND <S4> SHOWING COBBLE FLOOR (205) WITH ROBBER CUT [210] AND WALLS {207} AND {208}; VIEWED FROM THE WEST-SOUTH-WEST (1M & 2M SCALES).

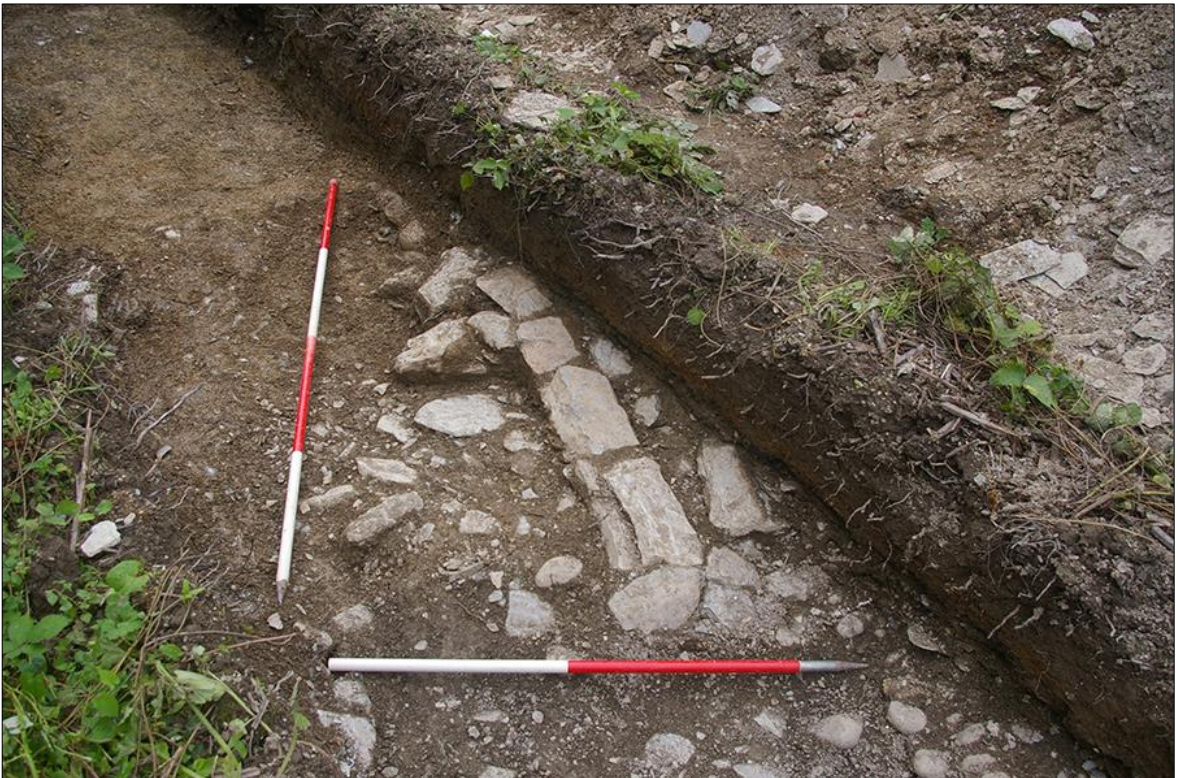
28. STRUCTURE <S4> SHOWING WALLS {207} AND {208}; VIEWED FROM THE EAST (1M & 2M SCALES).

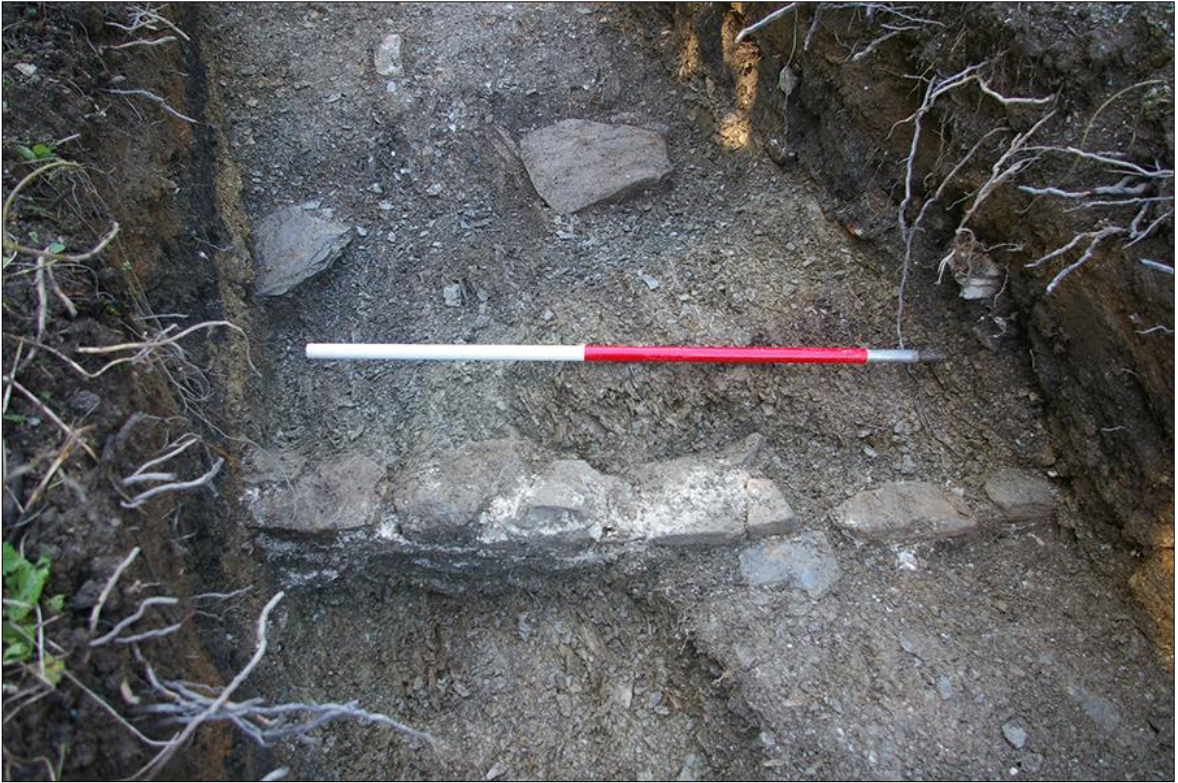
35. WALL {215} WITHIN CONSTRUCTION CUT [214]; VIEWED FROM THE EAST (1M SCALE).
