22 Broad Street, Penryn, Cornwall – Heritage Statement

SWARCH 08.01.20 by Robert Waterhouse

South West Archaeology Ltd. (SWARCH) was commissioned by Andrew Robertson of the Robertson partnership (the Agent) on behalf of a private client to undertake a produce a heritage statement for a former commercial premises at 22 Broad Street, Penryn, Cornwall; this structure is Listed Grade II. Planning application PA19/10468 concerns “Alteration of the dwelling frontage from the appearance of a shop to that of a dwelling”.

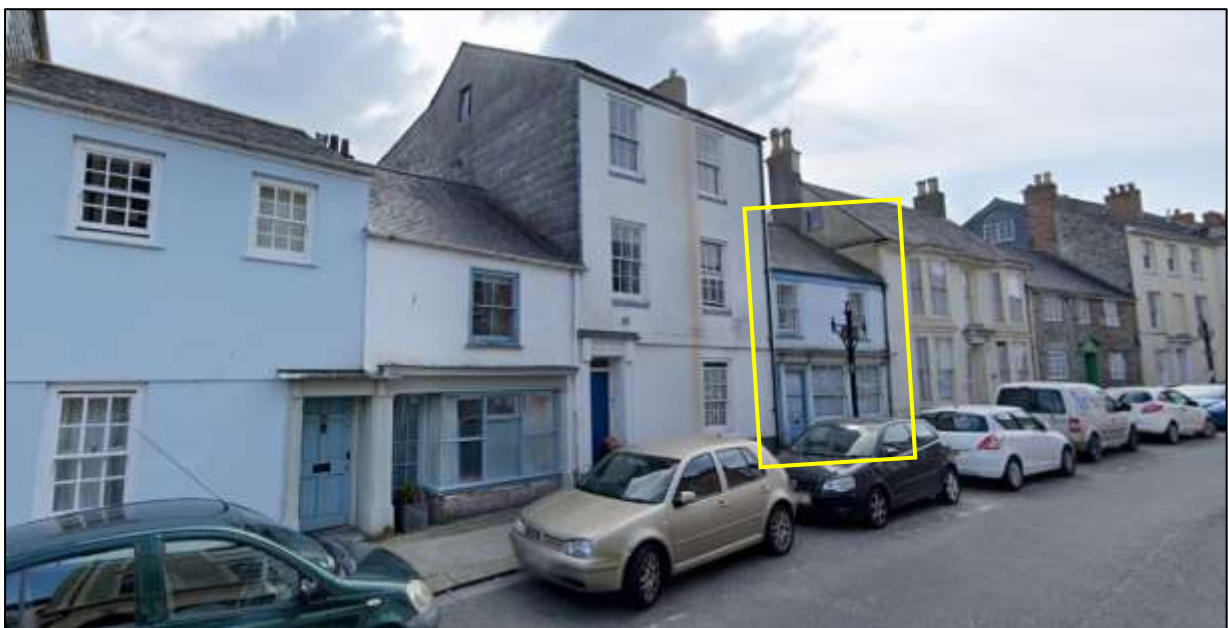
FIGURE 1: GENERAL VIEW OF THE BUILDINGS ALONG BROAD STREET; VIEWED FROM THE NORTH-EAST. NO.22 IS INDICATED. NOTE THE PRESENCE OF OTHER BUILDINGS WITH LOW EAVES AND SHOP FRONTS, BOTH INTACT (CENTRE LEFT) AND INFILLED (FAR LEFT), INDICATING A MIX OF RESIDENTIAL AND COMMERCIAL PREMISES IN THE 19TH CENTURY (©GOOGLE STREETVIEW).

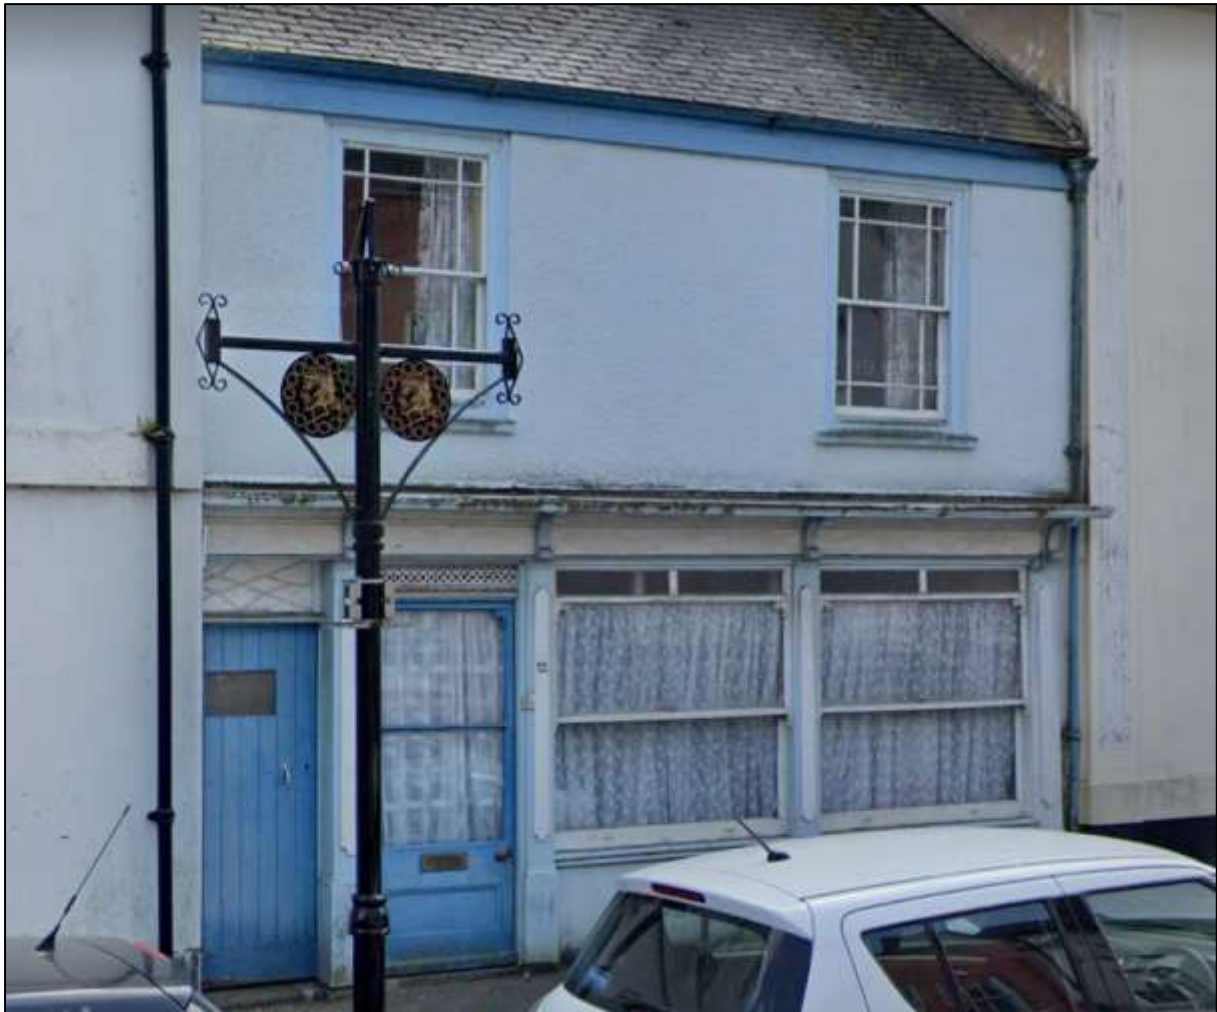
FIGURE 2: FRONT ELEVATION OF 22 BROAD STREET; VIEWED FROM THE NORTH (©GOOGLE STREETVIEW).

A two-storeyed two bay frontage to a building of double-pile plan, apparently of early-mid 19th century origins with mid and late 19th century modifications. A ridged slate roof is parallel with the street, rising at c.40° pitch from low eaves, plain tile ridge and no visible stacks; abuts taller mid-late 19th century buildings to right and left. The front façade is probably entirely of timber construction, as the first-floor windows are flush with their stuccoed wall face; the ground floor is visibly of timber construction.

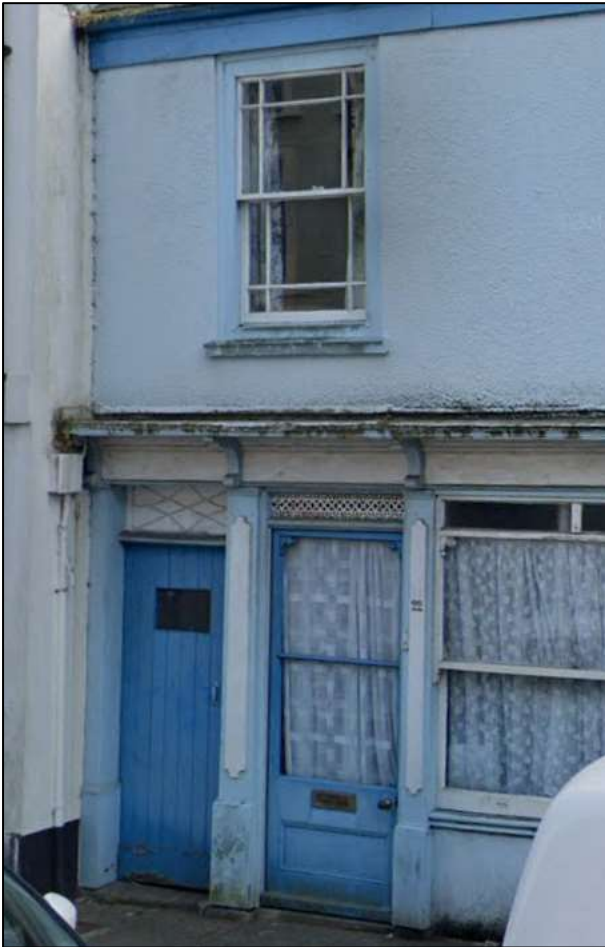
FIGURE 3: DETAIL OF EAST END OF FRONTAGE; VIEWED FROM THE NORTH-WEST. NOTE THE EARLIER 19TH CENTURY INTERLACED TOPLIGHT OVER THE HOUSE DOOR TO LEFT, AND MID-19TH CENTURY HORNLESS SASH WITH VERGE LIGHTS ABOVE. CAST IRON GRILLE OVER LATER 19TH CENTURY SHOP DOOR FORMERLY CONTINUED ACROSS THE SHOP WINDOWS, NOW GLAZED (©GOOGLE STREETVIEW).

To the left-hand end of the elevation there is a side door with a slightly raised granite step providing access to the domestic accommodation. The doorway is filled by a 20th century replacement door of vertical painted planks with thumb-latch, skirt and small glass pane at top, in an older opening with a fine late Georgian rectangular toplight with lightweight glazing bars forming a saltire cross, pleasingly interlaced with convex-radiused corner divisions to form concave-edged lozenges. All painted, so not possible to tell if this was a true glazed toplight or a faux toplight with decorative ribs on a painted board. A projecting horizontal rib beneath forms the door head. The date range for a toplight of this design could be 1810s-1830s.

The shop doorway adjoining to the right has a bead-moulded frame with a pierced cast iron toplight, containing a later 19th century panelled and glazed door. Its opening, however, is older, integrally designed with an adjoining timber framed two-bay shop frontage, continuous to the right-hand end of the façade.

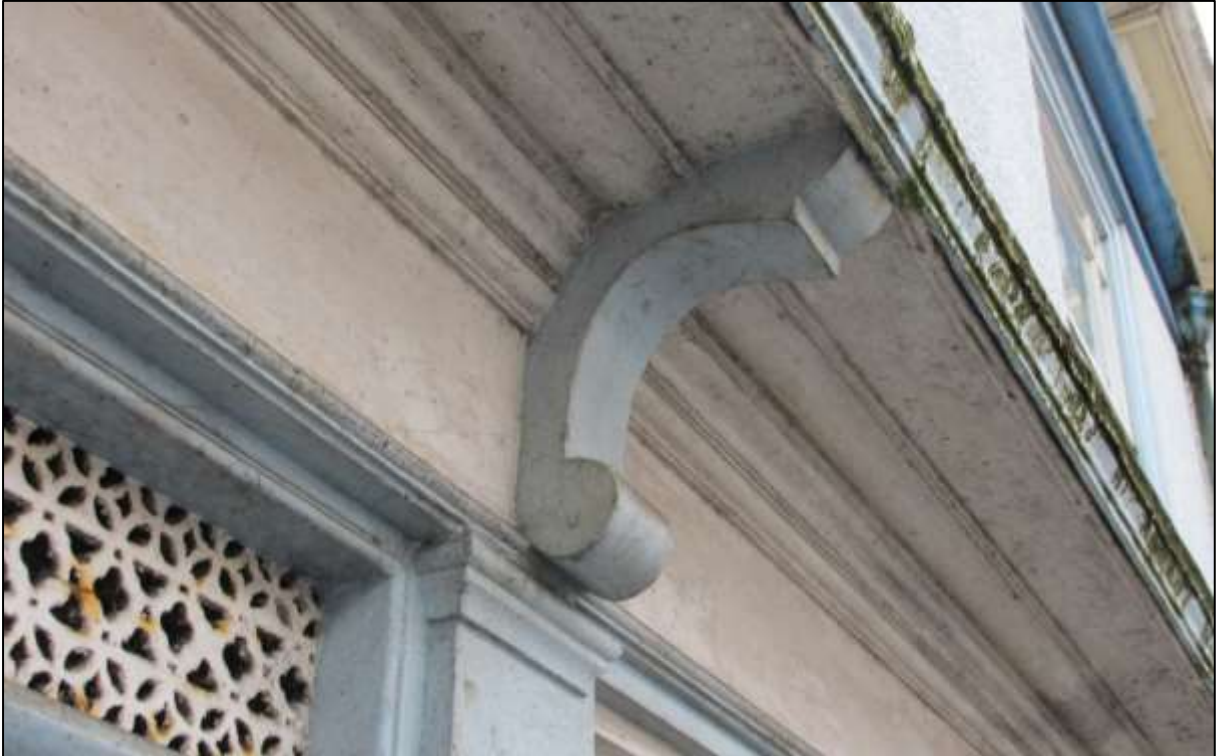
FIGURE 4: DETAIL OF THE 19TH CENTURY CORNICE WITH SUPPORT BRACKET AND SURVIVING CAST IRON GRILLE ABOVE SHOP DOOR.

The shop frontage and both doors are crossed by a shallow boarded fascia, abutting the slightly projecting house to the left and projecting slightly beyond the right end. This fascia is broken into two wide bays above the shop windows and two narrow bays over the doors by curved timber brackets, supporting a deep, projecting multiple-moulded cornice with leaded cap, built up from moulded planks and painted.

The general design of this shop frontage would fit a date in the 1840s-1860s, but the curved brackets especially evoke an Italianate feel, one which became common in South-West England from the mid-1830s after its adoption by IK Brunel in railway architecture and by Queen Victoria at Osborne House on the Isle of Wight, built from 1845-1851.

Both shop windows have a modern shallow glazed panel above them, divided by simple upright strips. It is evident that these replace a decorative cast iron ventilation plate, which survives above the shop door to their left. This suggests that the premises were a butcher's shop, which would have required ventilation for practical and public health reasons. By the later 19th century, provision of adequate ventilation was a legal requirement for butcher's premises.

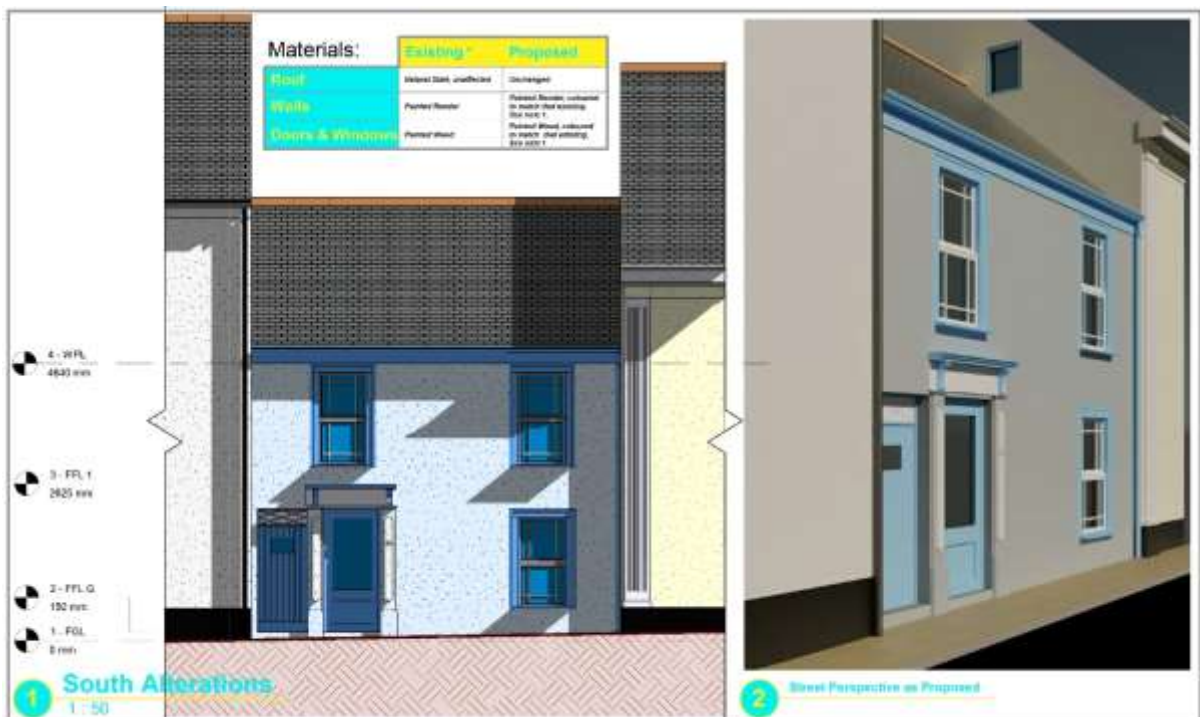
FIGURE 6: ELEVATION AND VISUALS, AS PROPOSED (SUPPLIED BY ARCHITECT).

Reference to Figure 6 shows that the present proposal will remove and infill the entirety of the shopfront but would retain the positions of the two existing doorways. A short length of cornice is proposed to be retained over the former shop doorway but removed over the former shop frontage to its right and the side door to its left. A single new sash window matching those of the first floor would be inserted into the blocked shop front, changing the appearance of the façade to a wholly domestic form. In this context it should be noted that other buildings along Broad Street were once shops with larger windows and these have also been infilled in the 20th century, some retaining the cornices and pilasters that framed their former shopfronts.
