**RAME BARTON**

HERITAGE IMPACT STATEMENT

SOUTH WEST ARCHAEOLOGY LTD. REPORT NO. 200120

## RAME BARTON, RAME, CORNWALL RESULTS OF A HERITAGE STATEMENT

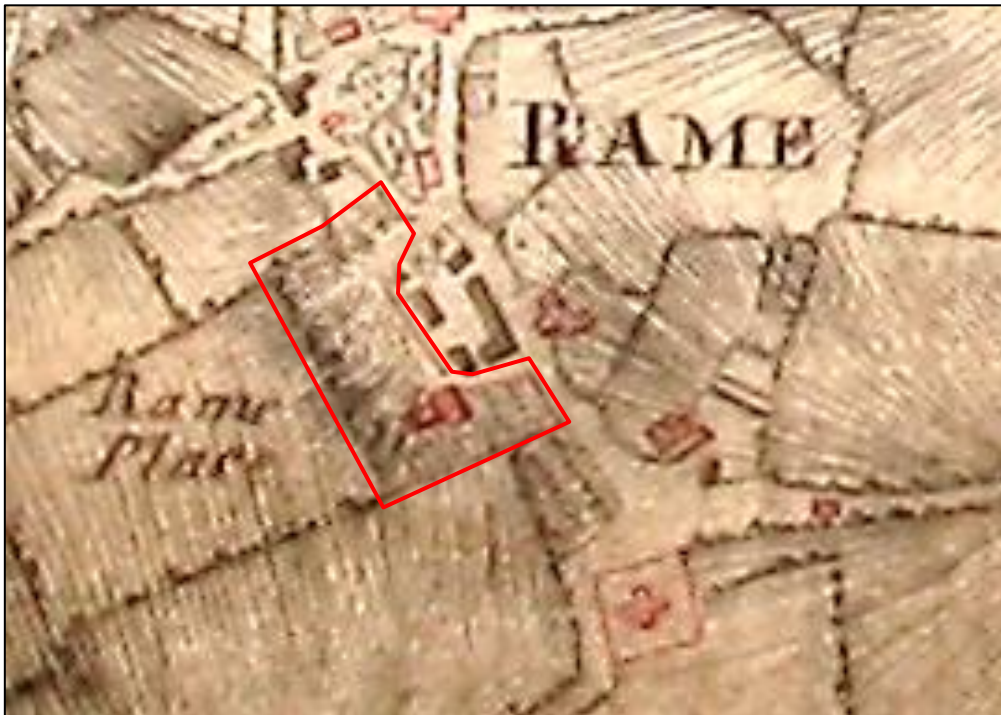
FIGURE 3: EXTRACT FROM THE DUKE OF RICHMOND'S MILITARY SURVEY OF PLYMOUTH SOUND BY WILLIAM GARDNER IN 1784 (BL); THE SITE IS INDICATED.

The earliest cartographic source available to this study is the military survey of the Tamar Estuary and Plymouth Sound, produced for the Duke of Richmond (then Master of the Board of Ordnance) in 1784 by William Gardner. This is reproduced below (Figure 3) and despite its small scale, bears comparison with the subsequent maps. It is important as it shows houses in red/pink and outbuildings in black/grey, enabling the identification of a T-plan house at Rame Place, which is named as such on the map. The Barton farmhouse is immediately east of the long agricultural range on the opposite side of the road. This has a complex plan which could be interpreted as a north-west to south-east main range with a porch facing into the road and a rear wing to the south-east end.

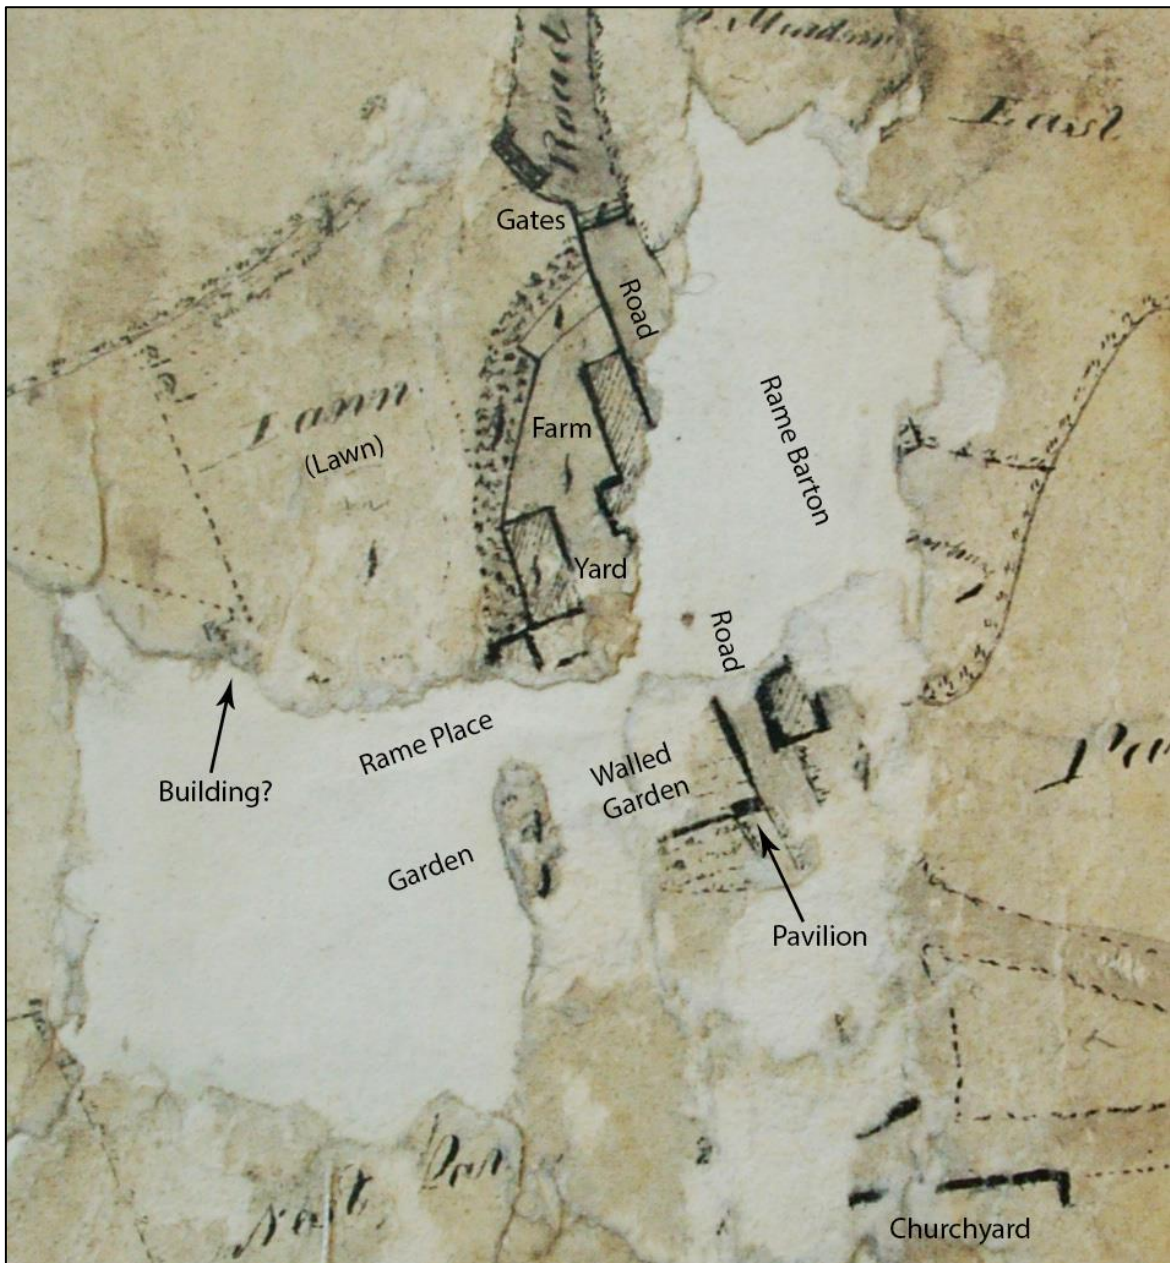
FIGURE 4: EXTRACT FROM EDWARDS ESTATE MAP, c.1797-1821, SHOWING PROJECT SITE (CRO). ANNOTATED TO SHOW POSITIONS OF MISSING FEATURES AND IDENTIFY VISIBLE STRUCTURES. 1 = 'LAWN, GARDENS, COURT & MOWHAY.' (KRESEN KENRNOW ME/2412).

An estate map was made in the early 19<sup>th</sup> century for Thomas Edwards (see Figure 4). Unfortunately, it is badly damaged where Rame Place is shown and only fragments survive. Most of the farm buildings, a small square outbuilding at the north-east corner of the house, and the possibly residential building to its north-east can be identified on the map, but Rame Place and the farmhouse at Rame Barton on the east side of the road have worn away. Figure 4 has been annotated to identify extant features and show the positions of missing ones.

No date is given, but it is unlikely to date from before 1797 when Thomas inherited the estate, and must predate his death in the early 1820s. The map includes an apportionment which lists field names and other information on the property which extended to the east and south along the coast, containing just over 283 acres at this time. The Apportionment identifies the area of Rame Place, the farm buildings and presumably Rame Barton, as "No 1 - Lawn, Gardens, Court, Mowhay", amounting to 3 acres.

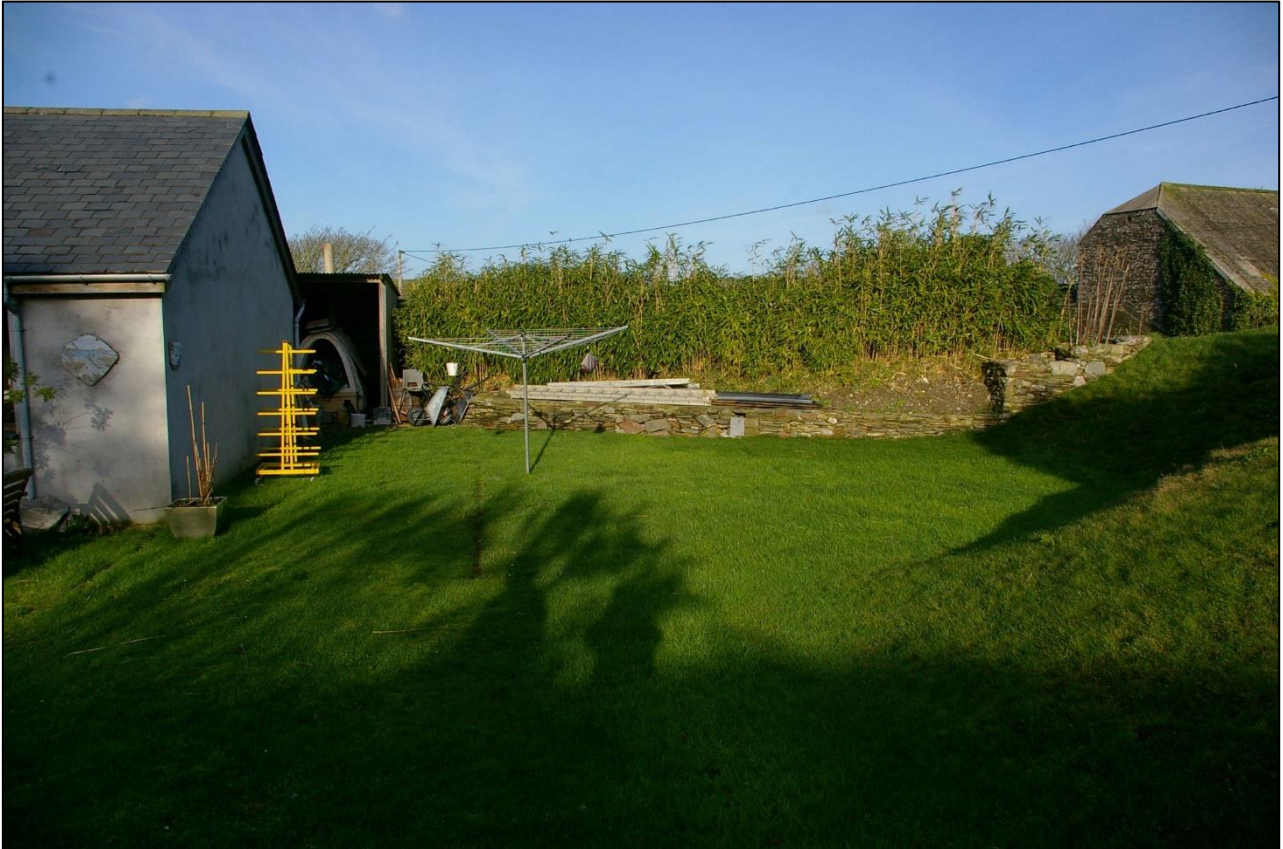
1. THE SITE, A TERRACE CUT FOR A 20<sup>TH</sup> CENTURY FARM BUILDING, NOW DEMOLISHED, VIEWED FROM THE SOUTH.

The site of the new dwelling lies next to the modern pottery studio; which was built on the site of a late 20<sup>th</sup> century concrete post-framed agricultural shed. Combining this with the recent landscaping and drainage works and it is expected that any deposits which may have been below ground would have been either completely dug away or significantly disturbed. The Cornwall HER records this area as 'busy' with potential archaeology. Rame is mentioned in the Domesday survey of 1086, being an early medieval settlement (HER:6219). The Rame Place name is noted as appearing in 'La Pleistowie' and this is believed to be a reference to a medieval 'Playing Place' (HER: 169301) although the actual location is unknown it is likely to be broadly in this area, due to the later name of the house. There is also the site of a Medieval priests house (HER: 6004), associated with the church on the site of the current Rectory, just up the hill. Rame Barton itself is also recorded as having 16<sup>th</sup> century remains (HER: 6007). Collectively, with the very fine early church this indicates an important and established settlement right out on the head of the peninsula. Consequently, there will always be very high evidential value within the historic core of Rame, upon which this site is to be developed.

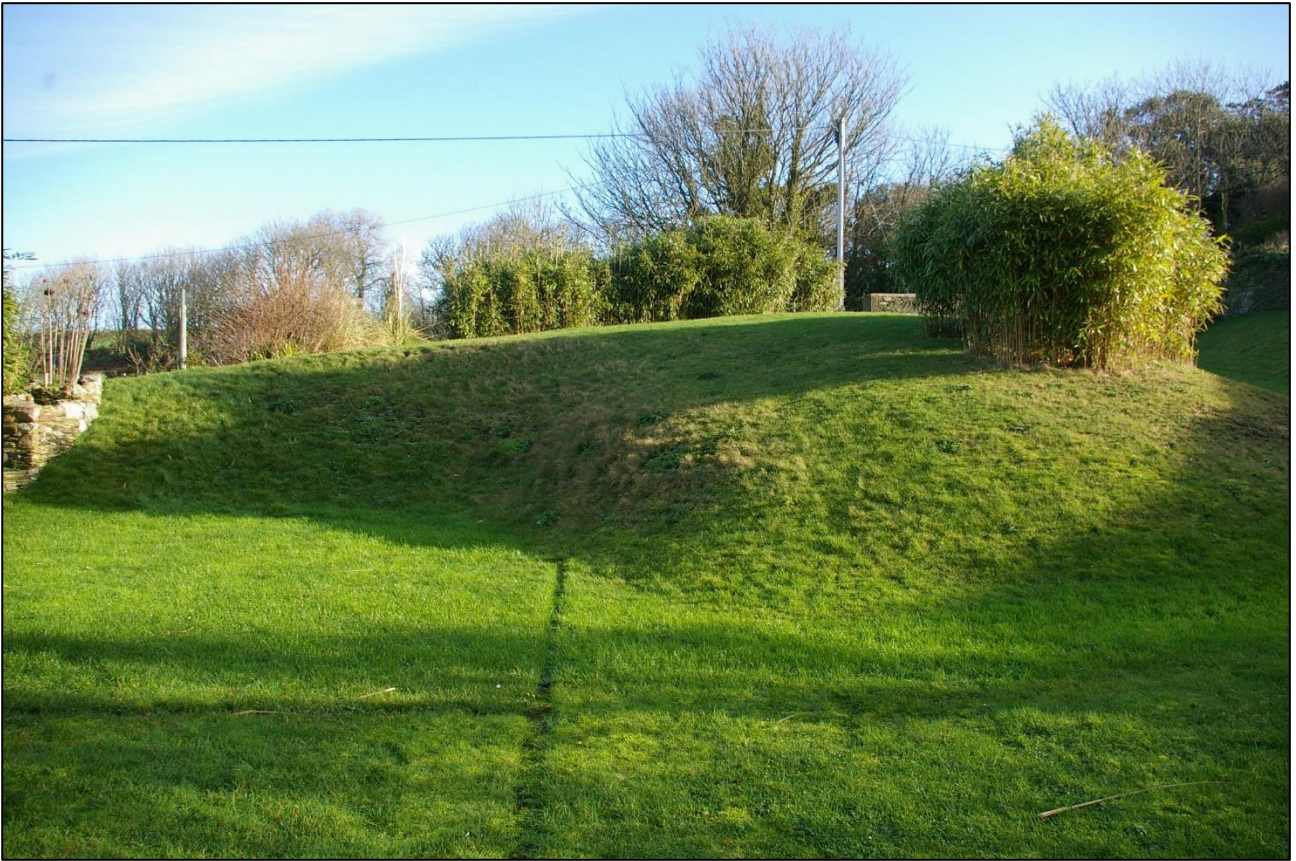
3. SLOPE, EMPHASISED LEVEL OF MODERN TERRACING FOR THE SITE, VIEWED FROM THE WEST.

Despite the high archaeological potential of the area, it is clear that due to modern terracing no programme of mitigation should be required to offset the harm of the proposed development caused to any below ground archaeological deposits, and the standing historic fabric of buildings on the site will not be impacted by the proposed developments.

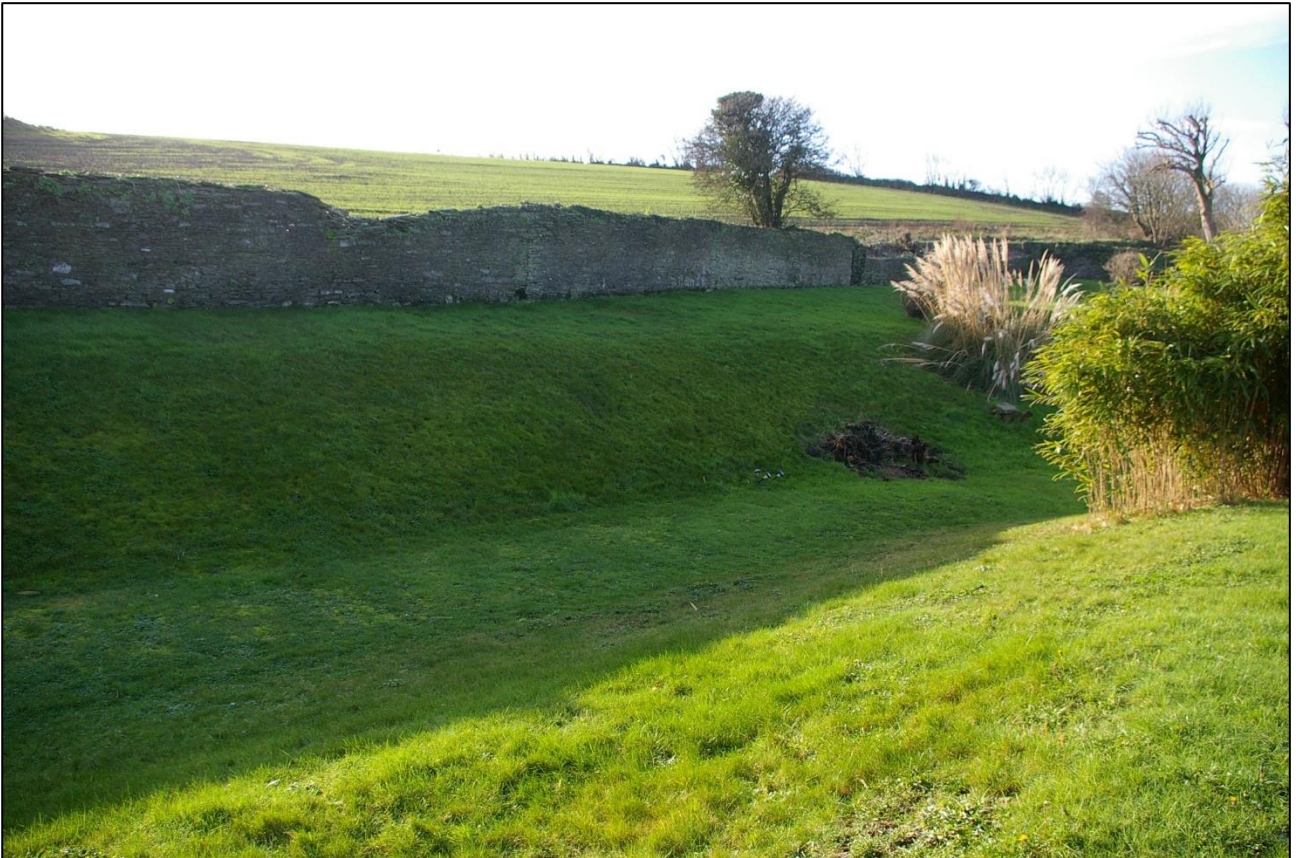
7. HISTORIC GARDEN WALLING, VIEWED FROM THE NORTH-EAST.

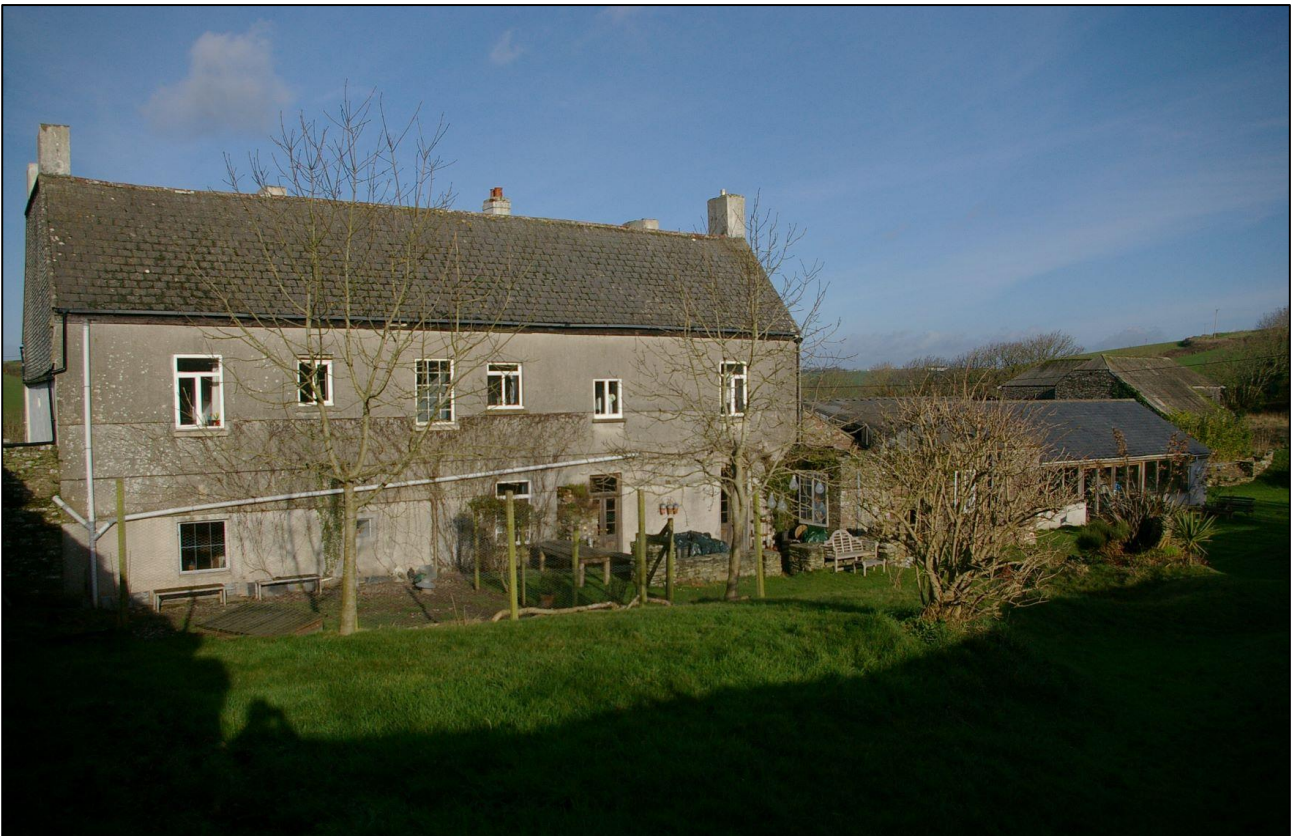
10. REAR (SOUTH) ELEVATION OF RAME BARTON, FROM THE SOUTH.
