THE THREE TUNS HIGH STREET BARNSTAPLE DEVON

Results of a Desk-Based Assessment,
Historic Building Recording &
Archaeological Watching Brief

Report No.: 110531
Date: 31.05.11
Authors: M. Gillard
T. Green
D. Laing-Trengove
S. Walls

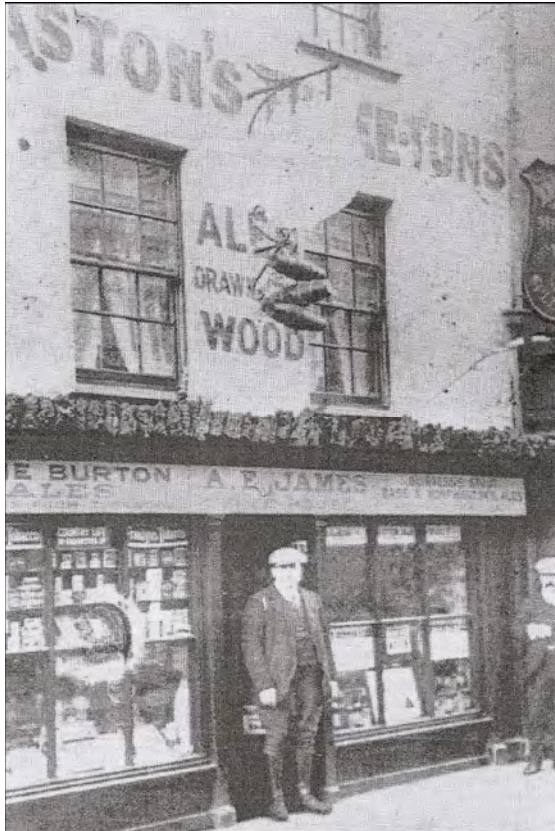
Figure 3: The Three Tuns c.1910.

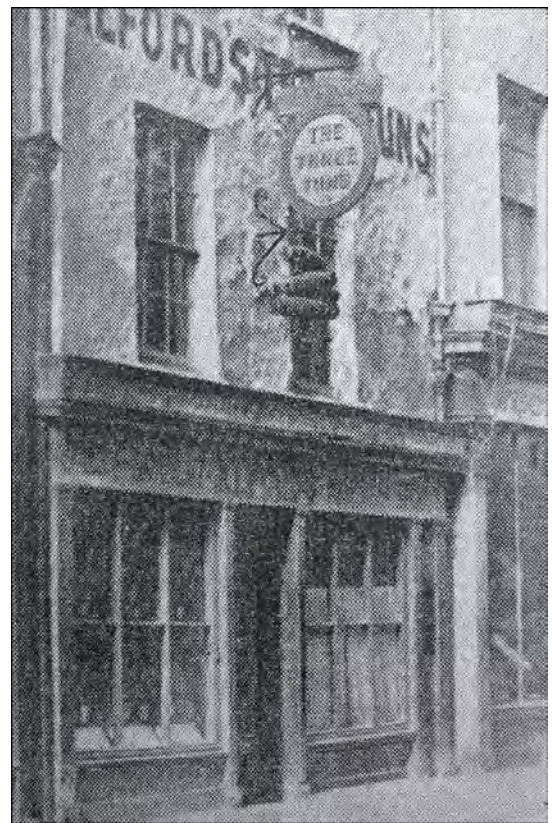
Figure 4: The Three Tuns in 1946 (Photograph from the Western Daily Press, 12th March 1946.)

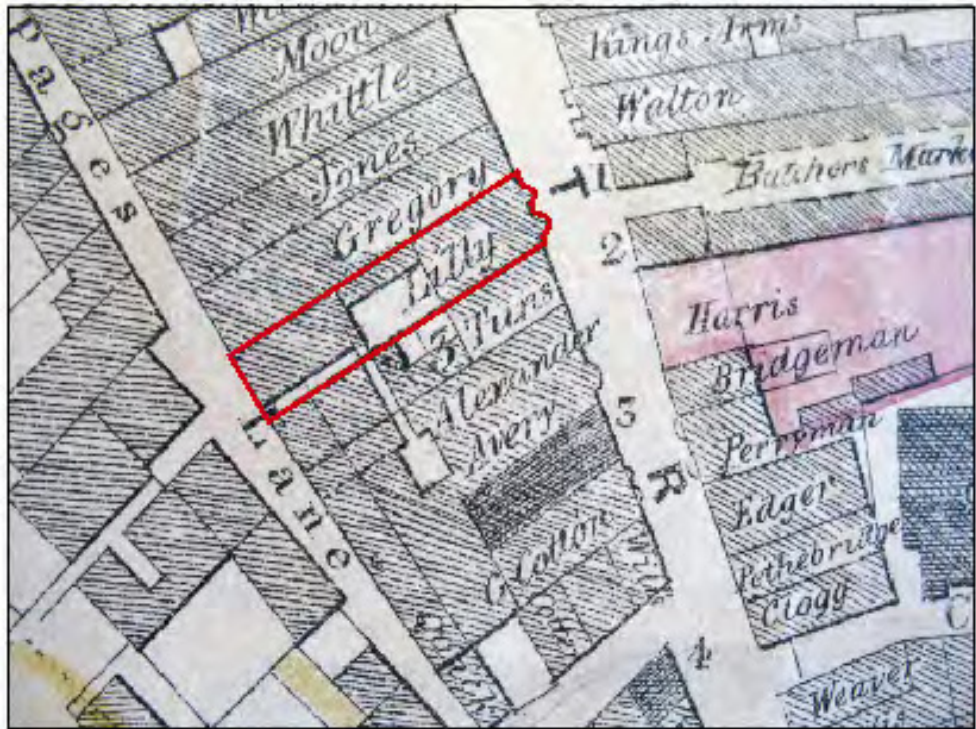
Figure 7: Extract from John Wood's plan of Barnstaple, 1843. The Three Tuns Inn, incorrectly labelled as Lilly, is outlined in red. (DRO)

Following this interpretation the Wood map shows the principal commercial premises of the Three Tuns occupying the full width of the plot at the High Street end (with double bay windows to the street). Immediately to the rear of this is a small open yard with a narrow building to the north of the plot. To the west of this is a long back block with a passage to the south giving access to Paiges Lane.

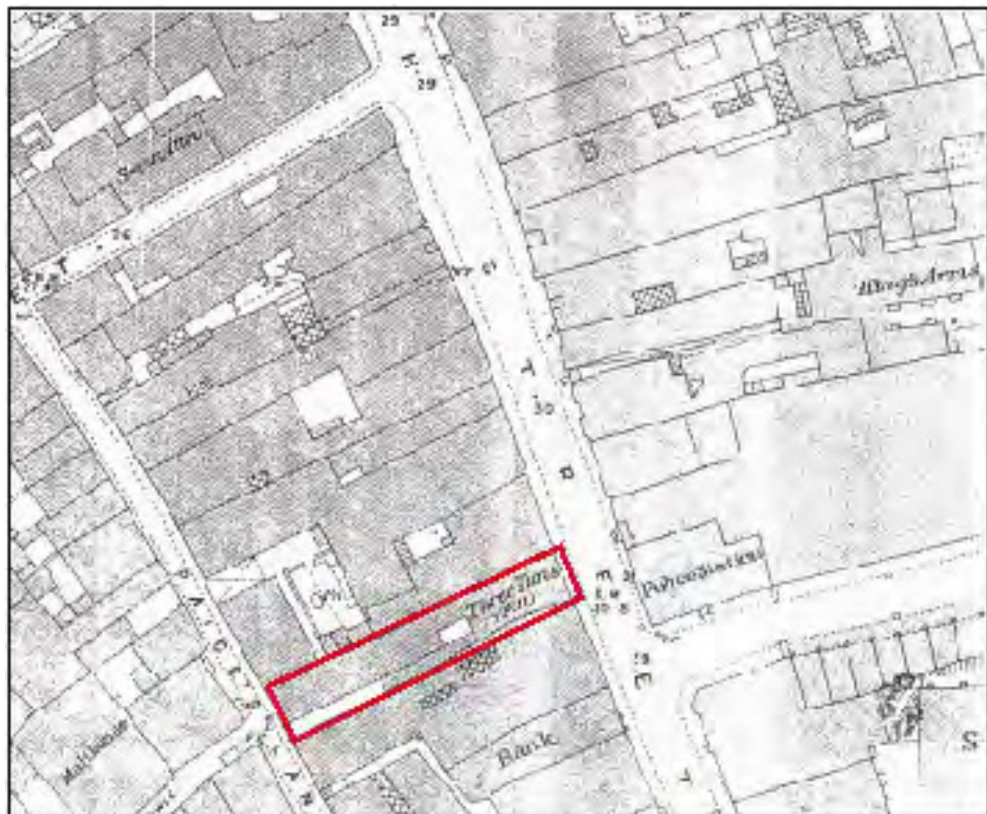
Figure 8: Extract from the Ordnance Survey first edition map at a scale of 1:500, 1889 (Sheet No.XIII.2.25). The Three Tuns Inn is outlined in red. (Distortion of the outline in the underlying image is due to the manner of recording) (NDRO)

In 1889 an Ordnance Survey mapping of Barnstaple at a scale of 1:500 (Figure 8) shows the Three Tuns in detail. On this map the open yard appears to have been roofed over to the south; the boundary between the yard and the narrow structure to the south is drawn as a dotted line implying an open structure – perhaps a gallery or covered walkway. This structure seems to have been extended over the north-eastern end of the passage beside the back block. The south-western side of the yard also appears to have been built upon (the yard seeming much smaller in comparison to the Wood map) although no subdivision is shown to the back block. The Ordnance Survey Second Edition map at 1:2500 published in 1905 (Figure 9) shows no further changes to the property.

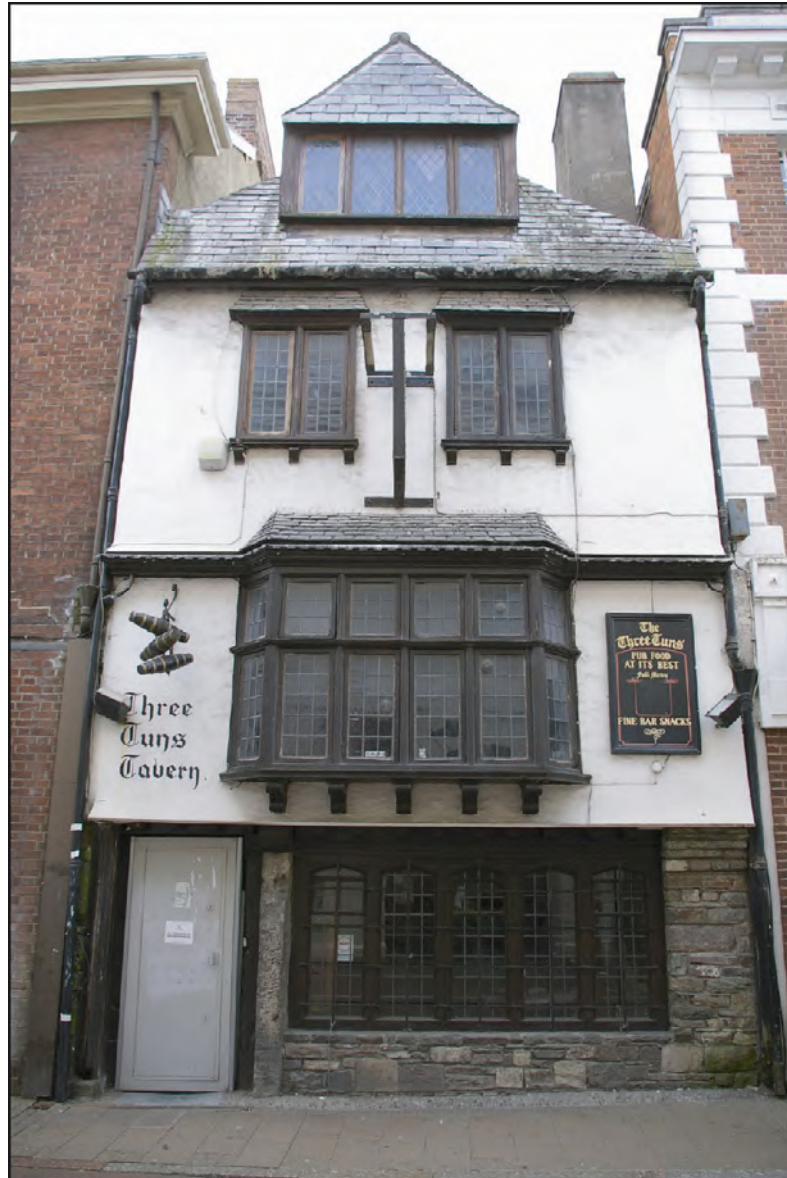
The High Street elevation is a faux-antique frontage created in 1946 using in part historic features from other buildings. The roof was raised at this time to accommodate a full height second floor and the former roof structure was completely removed.

Figure 12: The Three Tuns viewed from the High Street to the east.

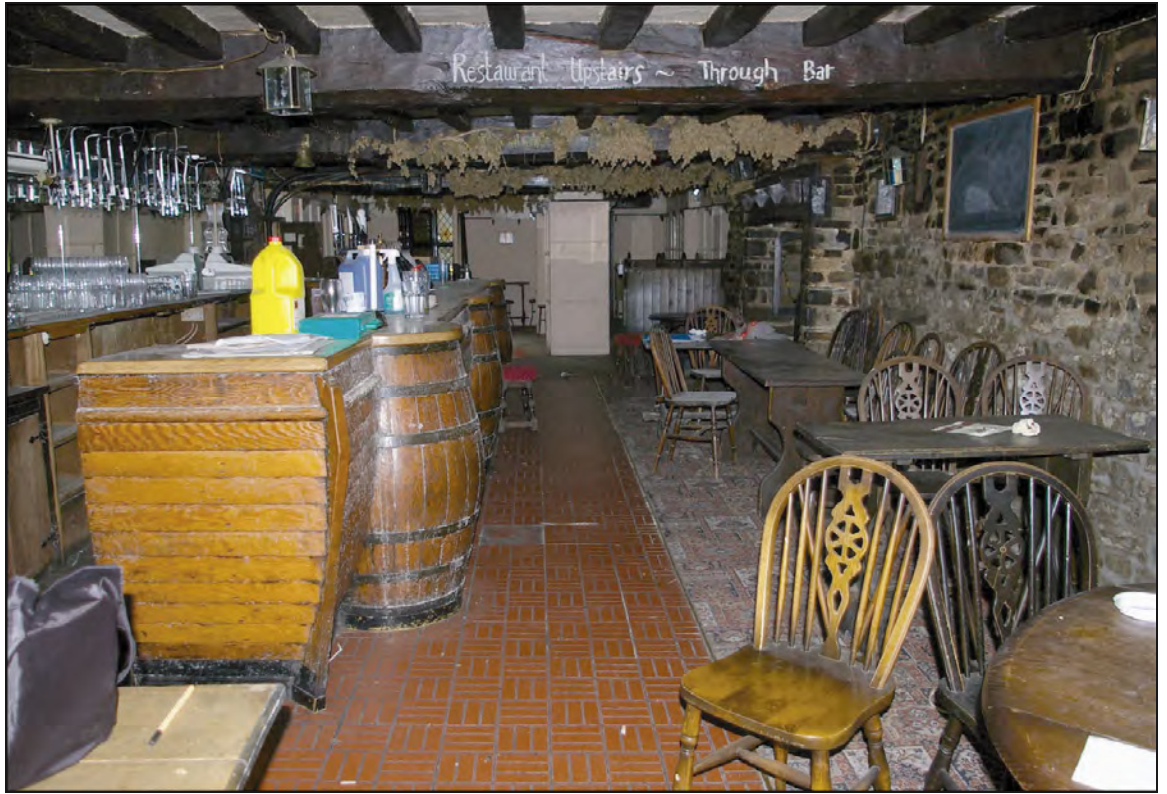
It would appear from the description by Oliver (Appendix 6) that the front block of the building was formerly divided into two rooms (Rooms 1 & 2) with a staircase located in the south-west corner of Room 2. There is no immediate evidence for this apart from the pair of fireplaces seen in the north wall. The fireplace on the High Street side (Room 1) is likely to be 19th century or later, while that to the west (Room 2) is likely to be of 17th century date, although the bread oven may be a later insertion.

There was no evidence of the partition between Rooms 1 & 2 or of the staircase as described by Oliver, suggesting that much alteration has been made to the ceiling structure in these rooms. Although the cross beams would appear to be a good 17th century set the floor joists between the beams are mixed, some are clearly re-used, while others are modern. Therefore, it is hard to suggest with confidence which parts of the structure are historic and which are part of the Oliver rebuild. This is a problem throughout the building.

Figure 13: The bar (Rooms 1 & 2), viewed from the east.

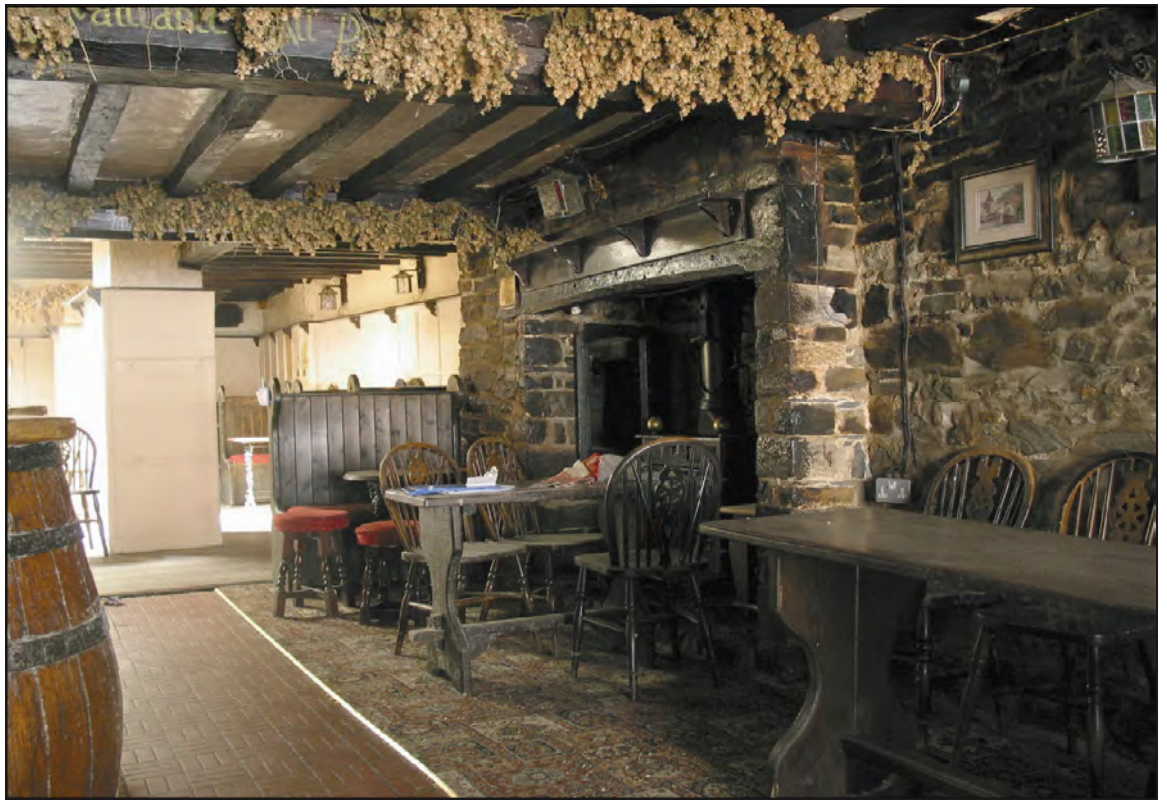
Figure 14: The fireplace at the rear of Room 2, viewed from the east.

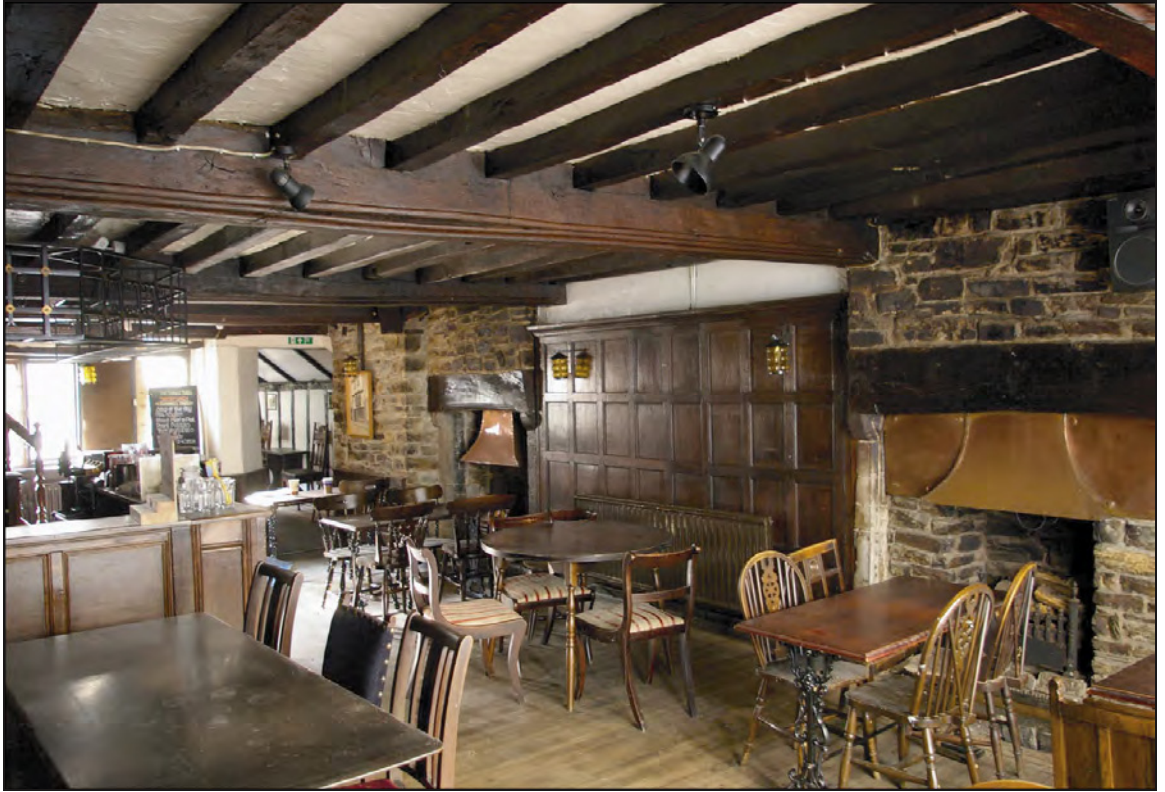
Figure 15: The first floor (Rooms 10 & 11), viewed from the south-east.

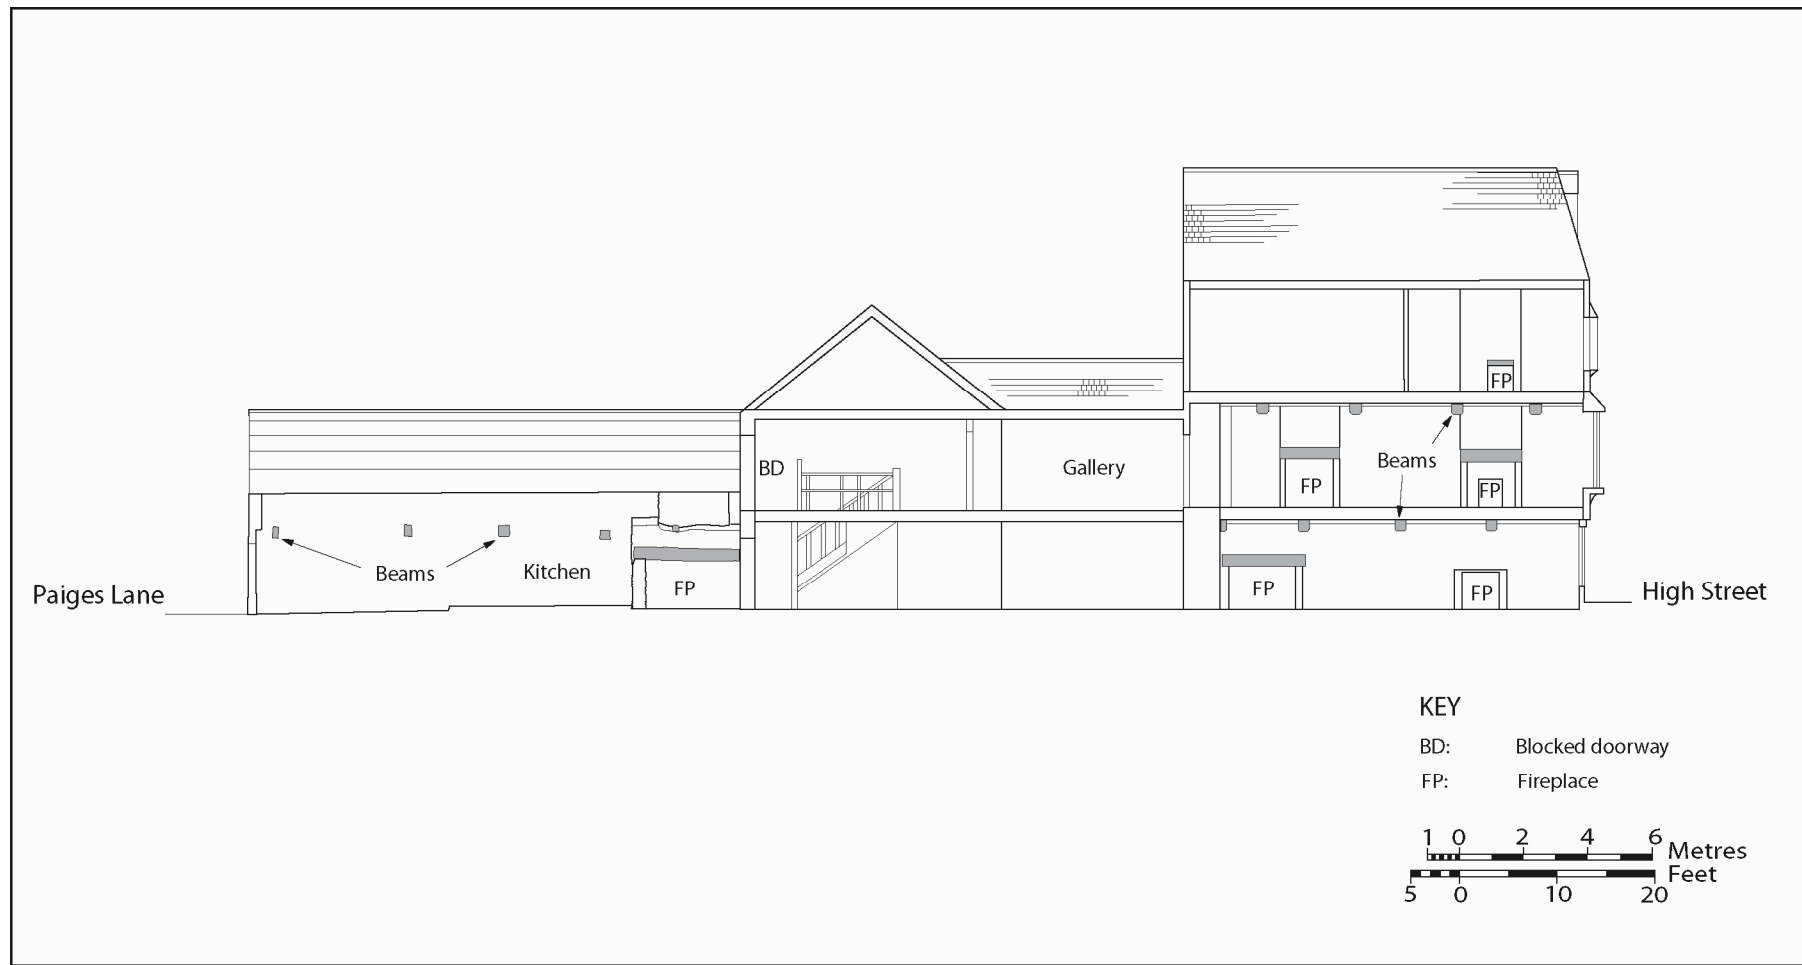
Figure 17: The Three Tuns, south-facing interior elevation, based on plans supplied by Butler Associates.

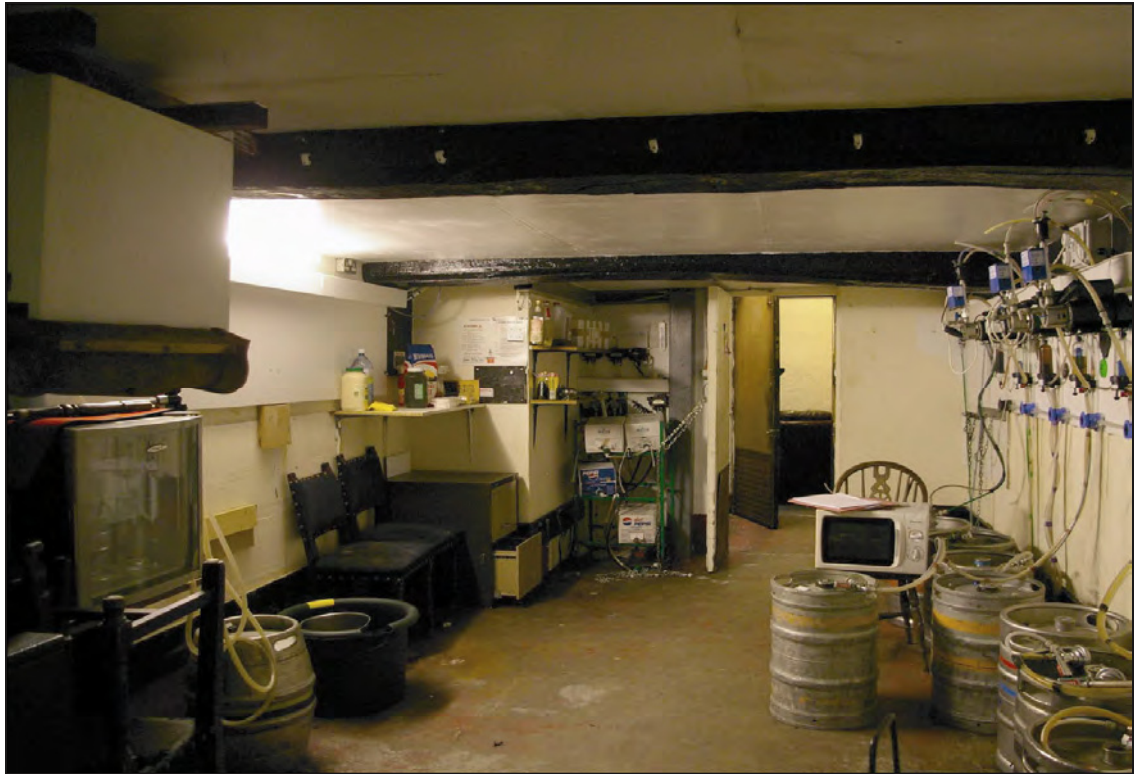
Formerly a two storey building dating to the 16th century which was probably originally unheated, with the fireplace against the north wall a later insertion.

The roof is comprised of a mixed set of beams all crudely chamfered with plain run-out stops except Beam 1 which has an ovolo moulding and is likely to be 16th/17th century in date and was possibly inserted with the fireplace.

Figure 18: The back block (Room 7), viewed from the west.

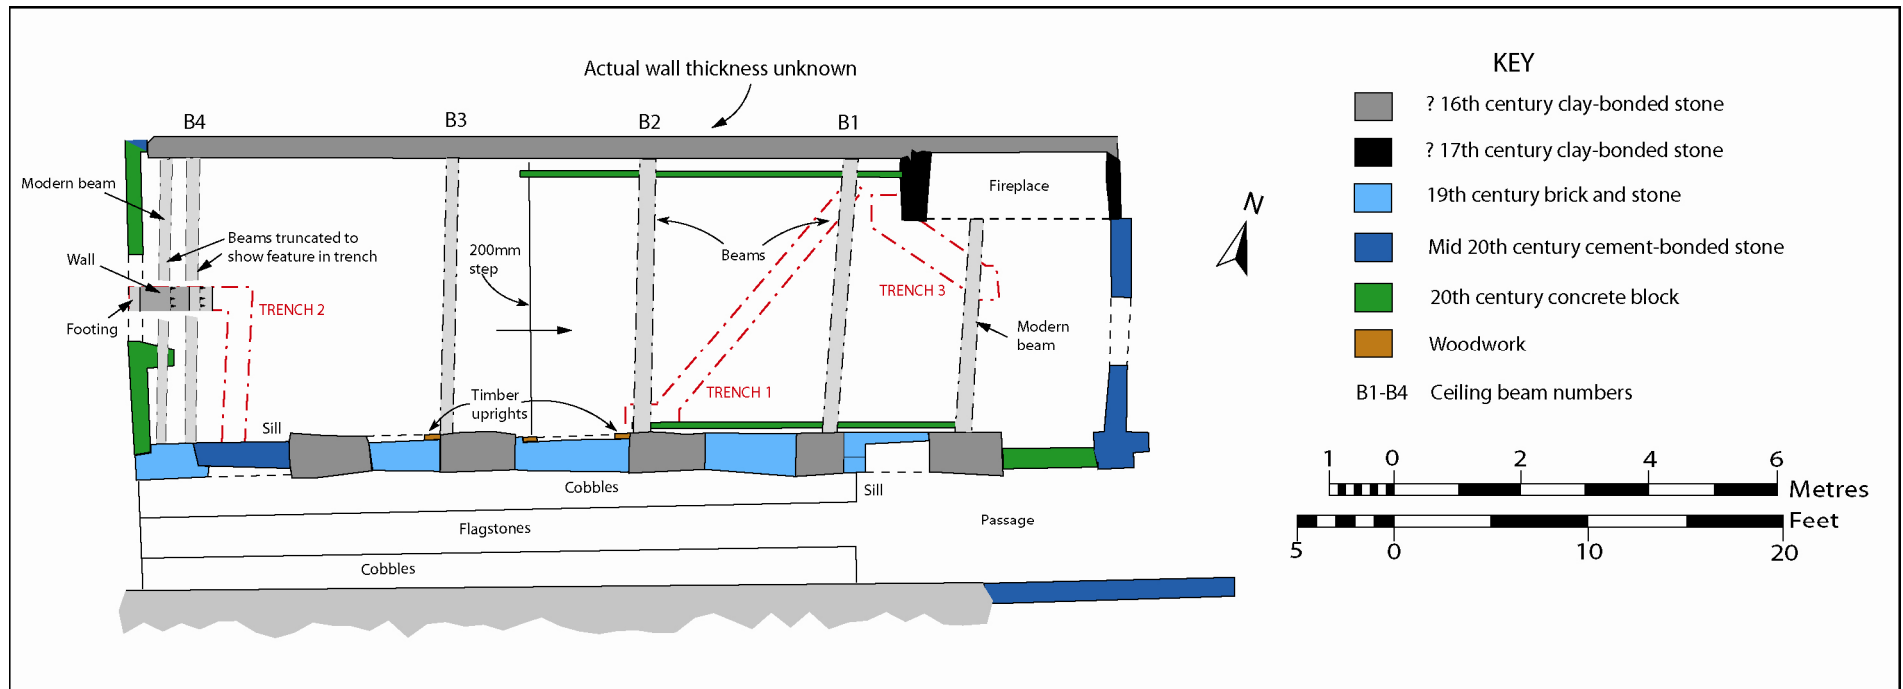
Figure 19: Plan of the back block (Room 7 to the east, Room 8 to the west) showing the position of the service trenches and types of construction.

Trench 2, located in Room 8, was 0.3m wide and 0.6m deep. It revealed approximately 0.15m of modern concrete over approximately 0.1m of hardcore. This overlay a deposit of loose, dark brown loam with abundant pottery, glass, and brick rubble dating to the 19th century or possibly the early-20th century. At around 0.6m below floor level this deposit overlay fine, soft, yellow-brown silt sand with some sub angular stone up to 0.15m across. At the western end of the trench the brick face of the end wall of the building extended to 0.55m below floor level and sat on the same yellow-brown silt sand.

Towards the western end of the trench a wall running approximately north to south was revealed. This wall was set in 0.15m from the modern western end wall. This was built of roughly-worked slate/shale bonded with a smooth yellow-brown silt-clay. At its highest the wall top lay just beneath the layer of hardcore noted above. It was 0.8m wide, although the north-east half of the top was somewhat damaged and at most it survived in four courses to a height of 0.4m. The lowest of these sat on flat, stone footings set into the layer of yellow-brown silt sand mentioned above. The stonework was roughly faced and fairly well coursed; the blocks seen were 0.1-0.15m thick and 0.1-0.3m across. It looked similar in places to the much altered north and south walls of the backblock. It also had a similar thickness (around 0.5m) as the south (and north?) walls. The deposit to the west side of the wall was a stony grey silt-clay very different to the material inside the eastern side of the wall.

This trench located in Room 7 was 0.4m wide and 0.3m deep. The top 0.15m was made up of modern concrete flooring, which sat on 0.15m of modern hardcore with a loose sand-silt matrix. The base of the trench consisted of a surface of sub-rounded to rounded cobbles 0.05-0.15m across set in a firm, white lime mortar. This surface was cleaned but not disturbed by the development work. The west jamb of the fireplace in Room 7 was revealed by the trench and had a roughly built footing that appeared to have been disturbed, perhaps when the concrete floor was inserted. The cobbled flooring did not extend under this footing, suggesting that it post-dated the fireplace

The modern concrete floor and its bedding was all that was evident in Trench 1. Trench 2 by contrast revealed what was probably the original 16th century west wall of the back block marking the rear of the burgage plot. It should be noted that above its footing this wall was around 0.5m thick and therefore of similar to the thickness to the south (and north?) wall of the building. The other material within Trench 2 and under the modern floor was comprised of a dump of 19th- or 20th-century rubbish and rubble about 0.4m thick. Trench 3 contained what was evidently a historic cobbled floor surface, but as it was not excavated no dating evidence was gathered, although it appeared to be later than the late 16th century fireplace.

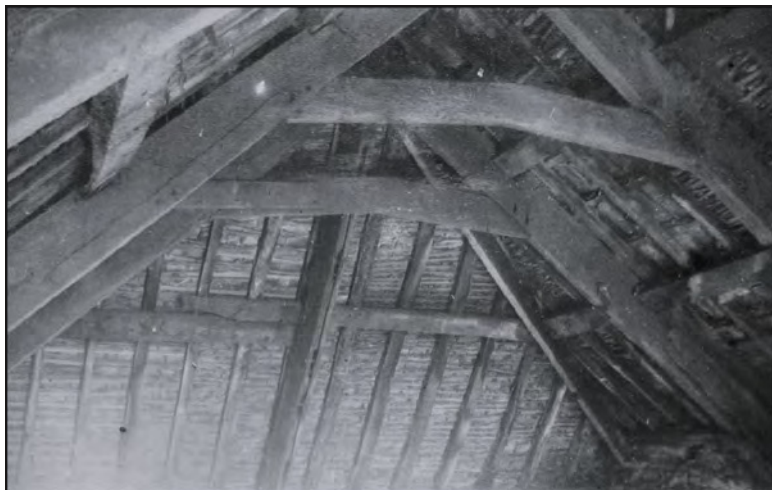
Figure 21: The roof timbers of the main building as found in 1946 (exact location unknown)

Condition – Roof original, old scantle slating many times tarred. Timbers original, morticed into floor beams of the loft. Hipped front probably done when front set back and the sash windows inserted. Loft staircase of oak 2" slabs on carriages, no risers.

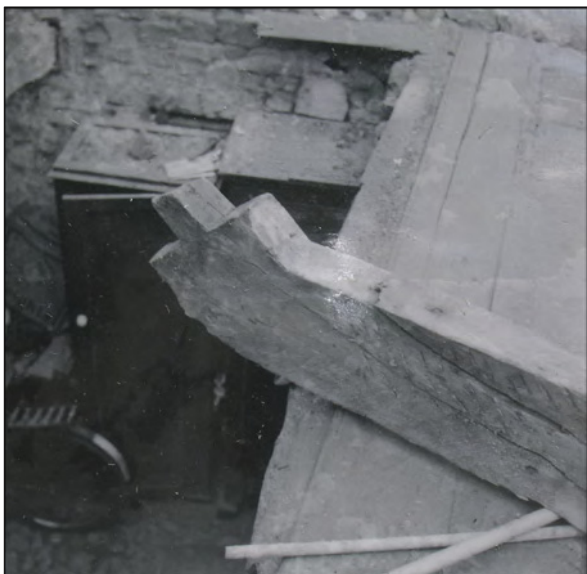
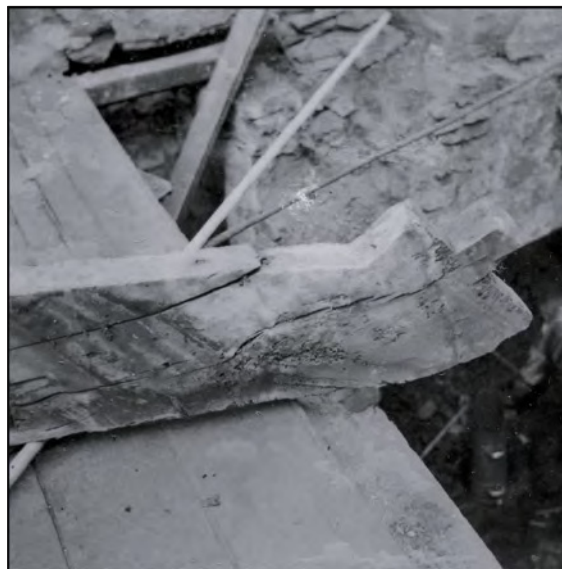
Figure 22: Foot of roof timber after removal.

Figure 23: Foot of roof timber after removal.

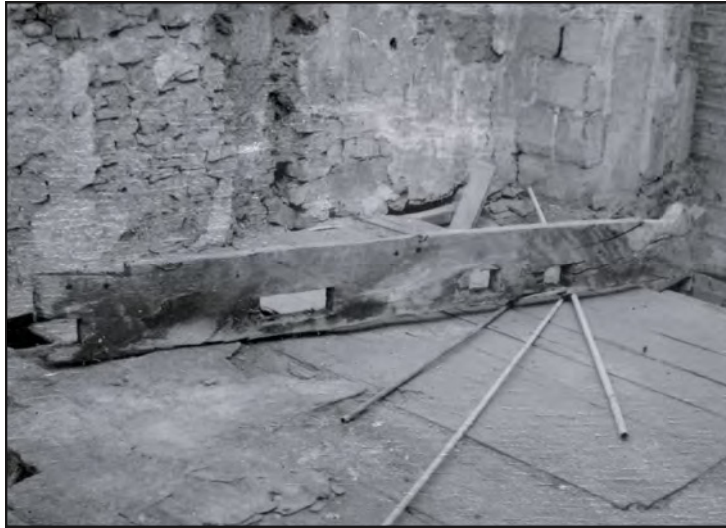
Figure 24: The same timber showing holes for purlins.

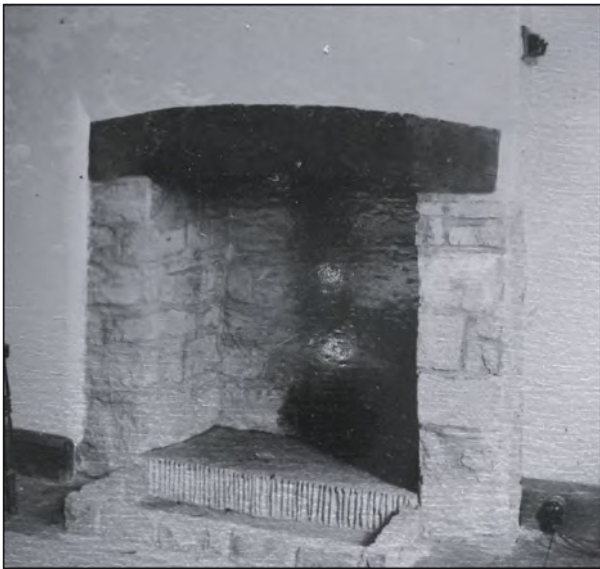
Figure 25: Fireplace in the second floor front bedroom.

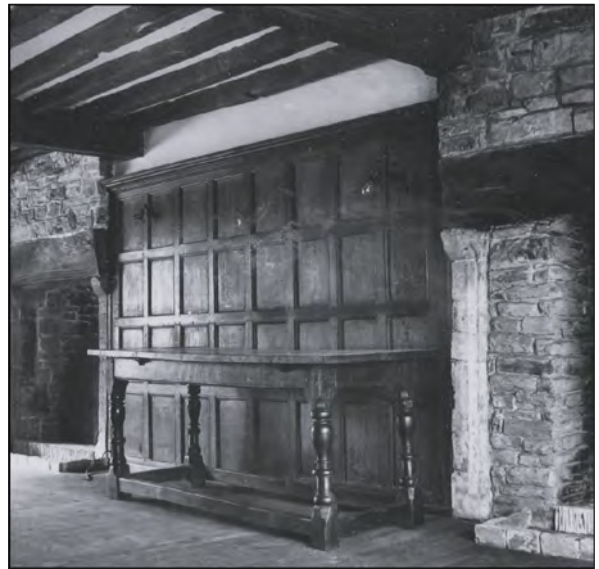
Figure 26: Panelling and fireplaces, first floor.

Panelling of Front 1st Fl Room ab. 1600 probably indicates date of subdivision.

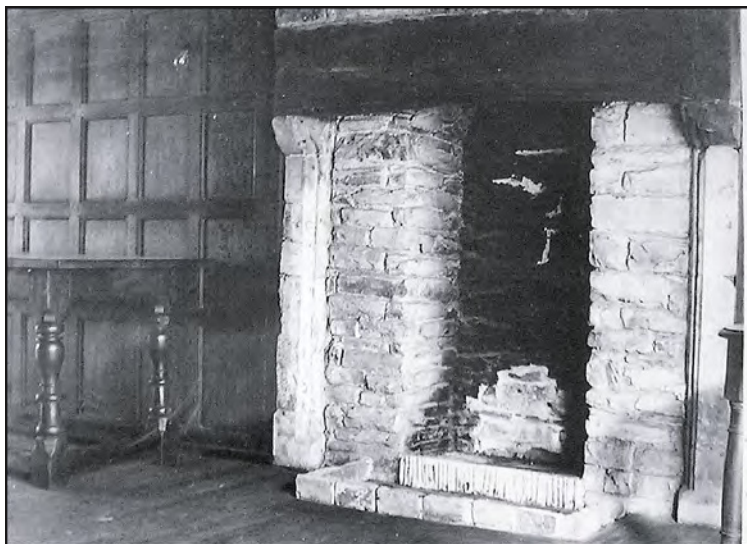
9. Removal of the panelling revealed another fireplace. The surround of this had one complete stone jamb with corbel and bottom stop and was thought by Oliver to be of mid-14th century date. The other jamb had a carved oak replacement corbel. Comparison of the two fireplaces (here and in the back living room) suggested that this was the earlier. Both had oak lintels.

- The earlier fireplace surround was thought to have been re-inserted from an earlier building (during which process a corbel and an original stone lintel had been broken).

Figure 27: First floor front fireplace.

Front first floor fireplace evidence of earlier building, prob. 1350-75. May be in original position, but the one timber corbel suggests re-building when one corbel was broken or lost.

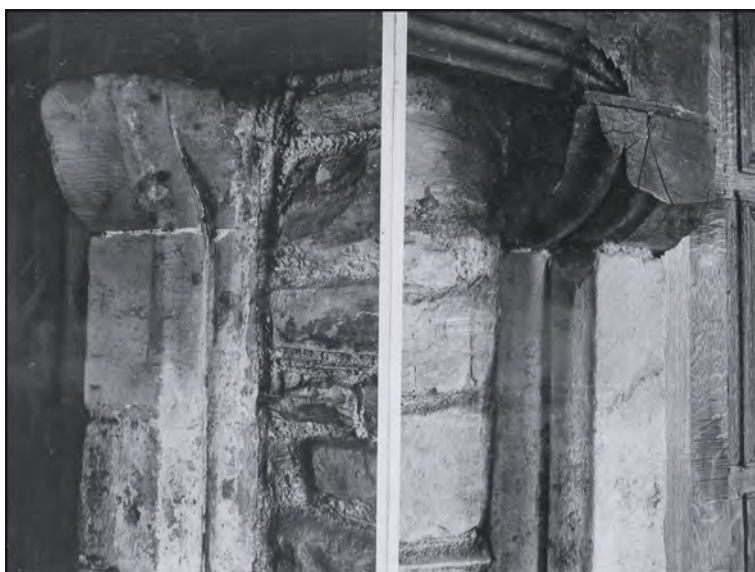
Figure 28: The corbels of the first floor front fireplace.

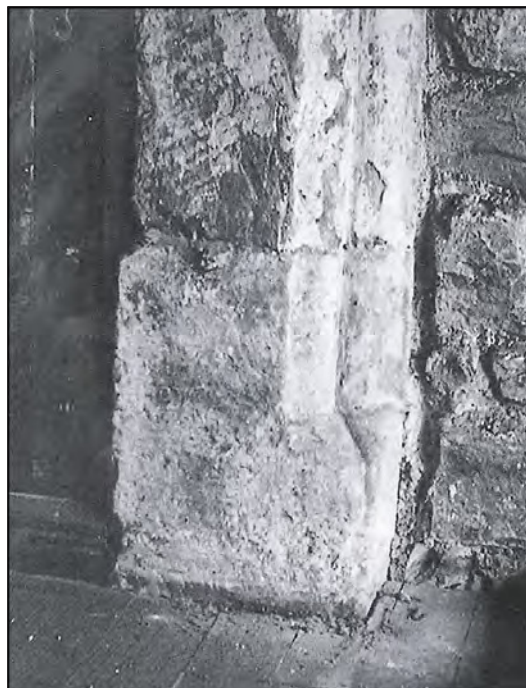
Figure 29: Foot of the left-hand jamb of the first floor front fireplace.

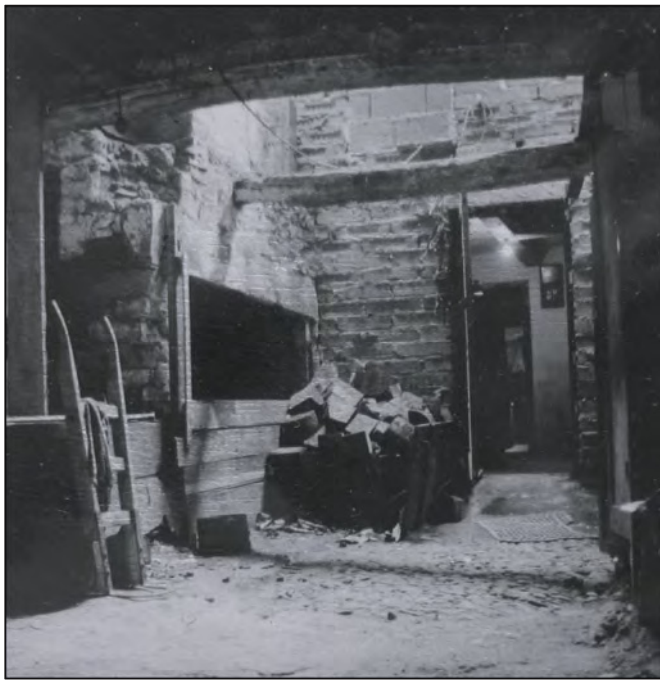
Figure 30: Back block interior.

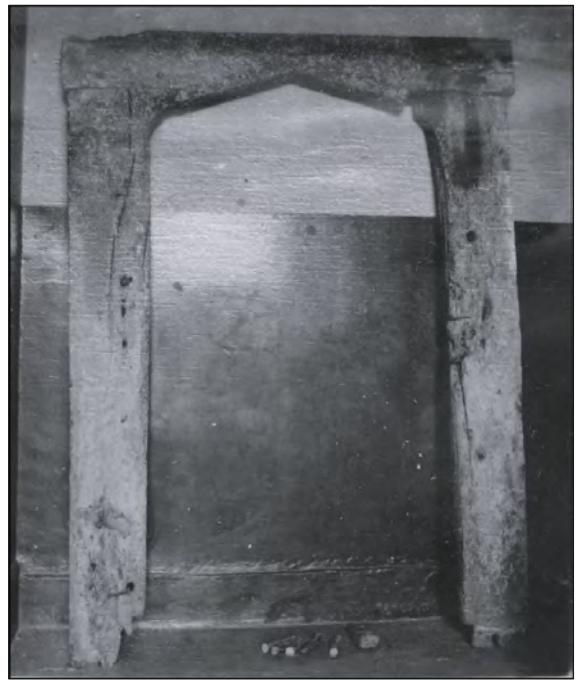
Figure 31: Door frame - provenance not given.

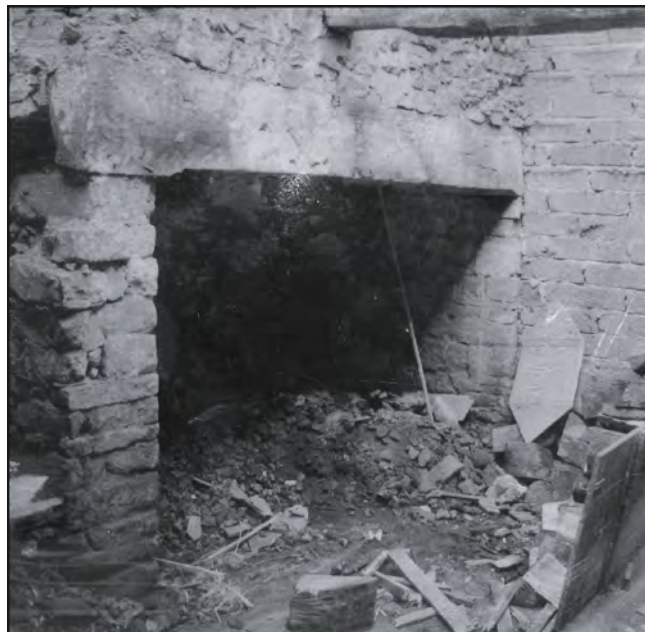
Figure 32: Fireplace in the back block.
