THE WORKING HORSE STABLE  
VENN FARM  
EAST PUTFORD  
DEVON

Results of a Historic Building Survey  
and  
Monitoring and Recording  
During Development Works

A Supplement to  
Keystone Historic Buildings Consultants  
Report K721

Report No.: 081105  
Authors: M. Gillard  
C. Humphreys  
D. Laing-Trengove

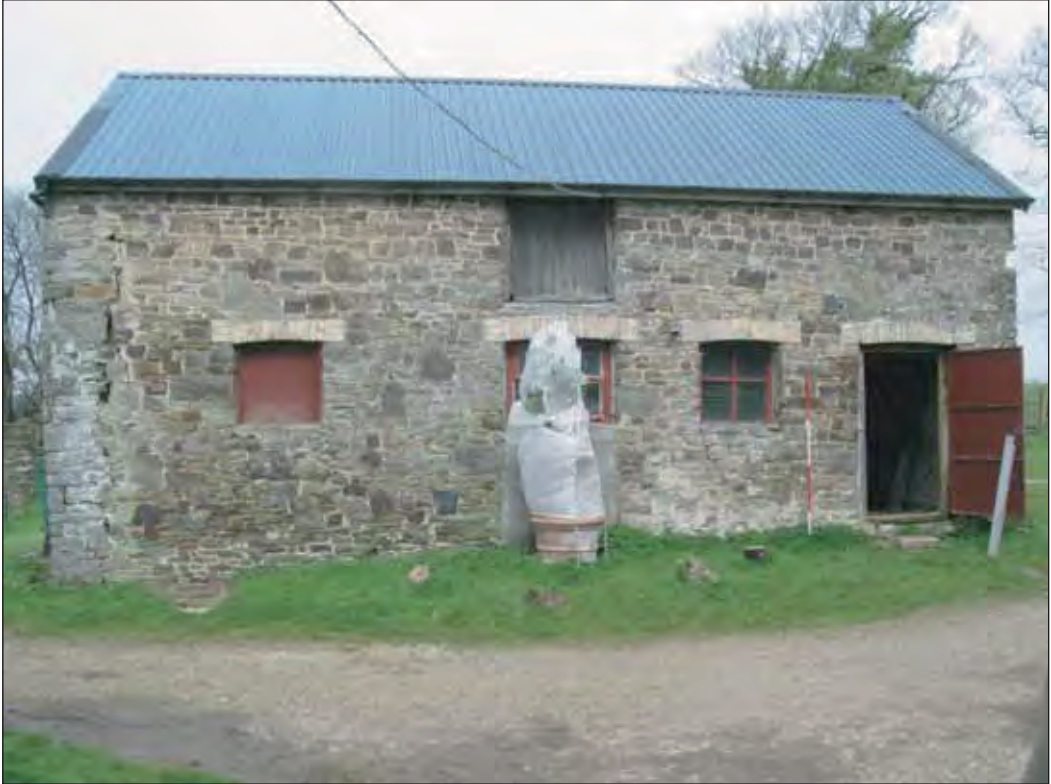
Plate 1. The south front of the former working-horse stable.

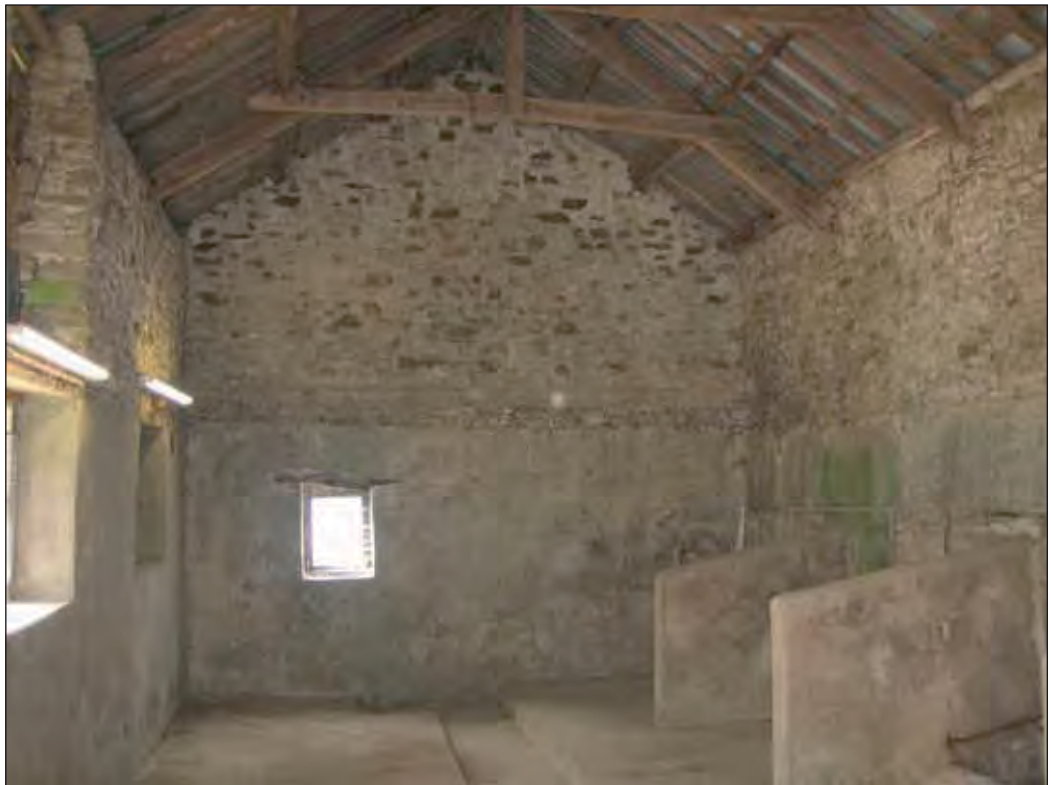
Plate 2: The interior west end of the former stable before the removal of the modern concrete.

An initial survey of the building revealed little of significance that could be added to the original Keystone report. However, removal of the 20<sup>th</sup> century concrete cow stalls and concrete floor in the former stable (Plate 2) revealed a cobbled floor (Plate 3). The cobbles varied in size (100-300mm) and shape; the larger stones tended to be angular and the smaller ones rounded, and they were generally laid on edge running north-south. To south-of-centre there was a shallow gully or drain composed of stones laid east-west with larger kerb stones to the southern and northern edges. The centre of the drain lay approximately 1.75m from the south front wall and ran east to west for the length of the building with an approximate width of 0.5m. The drain had been partially truncated to the north by the insertion of the 20<sup>th</sup> century concrete drainage channel, but the northern kerbstones were still *in situ* to the west. The position of the drain corresponded with an opening in the base of the west wall containing a ceramic drainage pipe. This opening had also been utilised for the modern concrete drain. The cobbled surface to the north of the drain had been significantly disturbed by the insertion of the concrete floor and stalls of the modern cattle accommodation and no evidence for the demarcation of earlier stalls was visible. The cobbles were laid directly onto natural – a greyish-yellow clay – and there were no finds.

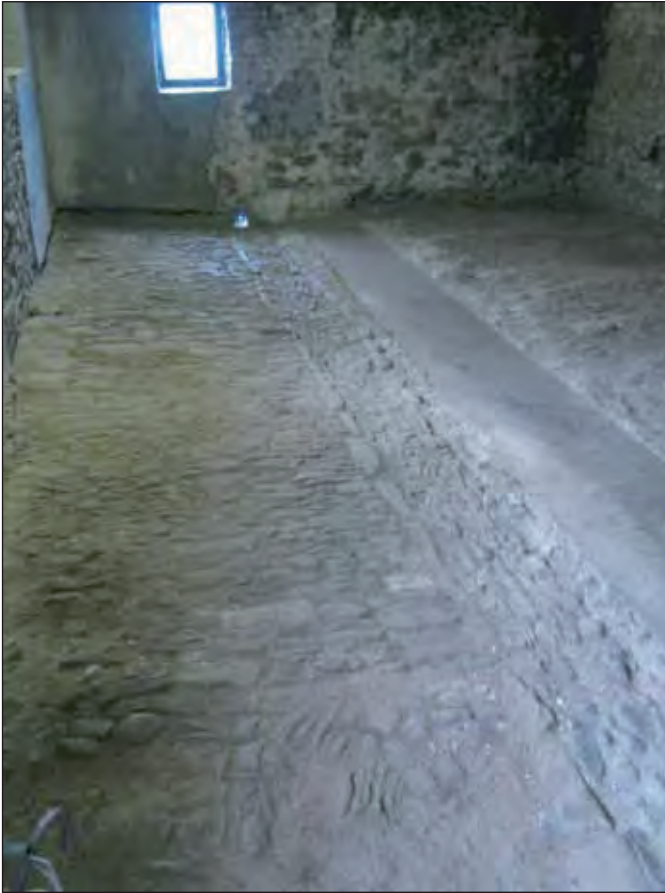
Plate 3: The interior west end of the former stable showing the cobbled floor and drain.

The layout of the floor and the position of the drainage channel supports an interpretation of the former use of the building as a stable with stalls to the north.

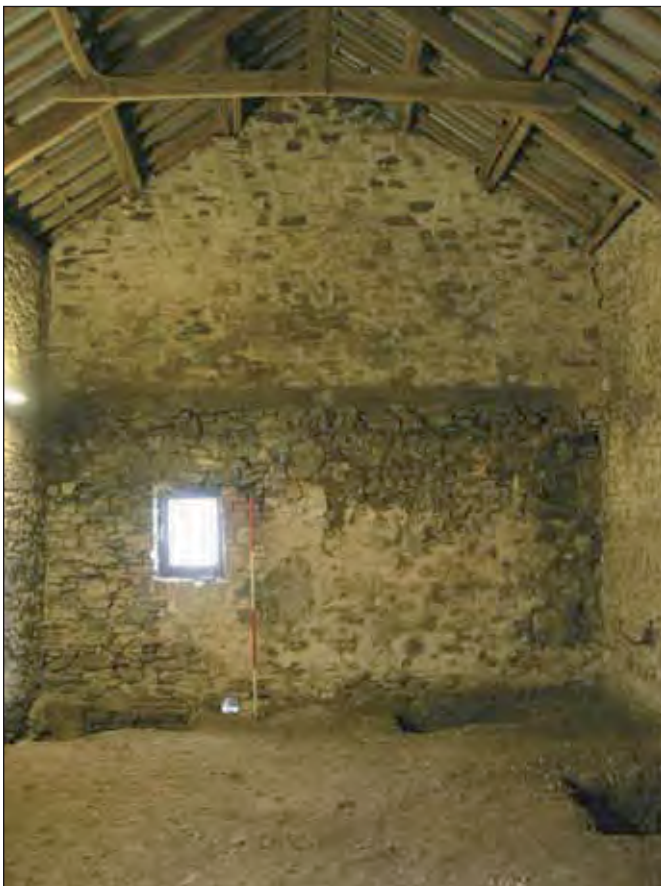
Plate 4: The interior west wall of the former stable after removal of the cobbled floor, showing brick repair to window reveal.

When the render was removed from the internal walls various features became visible. This included the rebuild, in brick, of the right hand reveal of the small west window (Plate 4), suggesting that this may represent the insertion of a new opening or the alteration of an earlier feature. Also, a straight join in the corner between the north and west walls, and the footings of the north wall that appeared to be on a slightly different alignment to the standing wall. Both of these features were also visible in the external elevation of the building (see Plates 5 & 6).

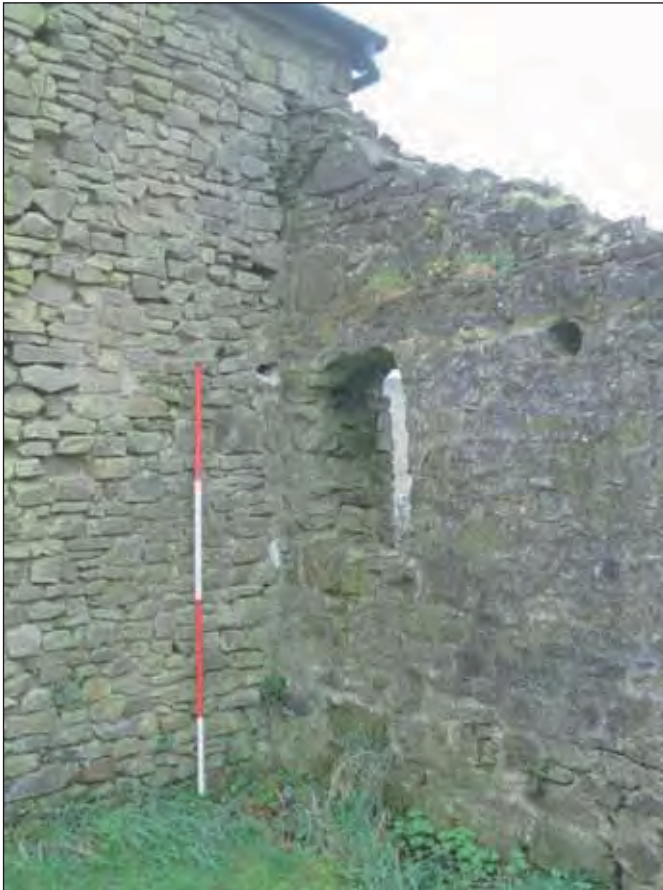
Plate 5: Western corner of the north wall of the stable abutting the west wall of the former shippon, viewed from the north.

1. Differences in the style of build and mortar of parts of the building suggest either different phases of build or a large amount of repair.
2. A straight join between the north and west walls of the stable suggest they were built in different phases.
3. The drain and a roughly cobbled surface recorded in the shippon were significantly different to the cobbled floor in the stable.
4. The drain in the shippon did not align with the larger drain hole visible in the west wall and could relate to an earlier structure.

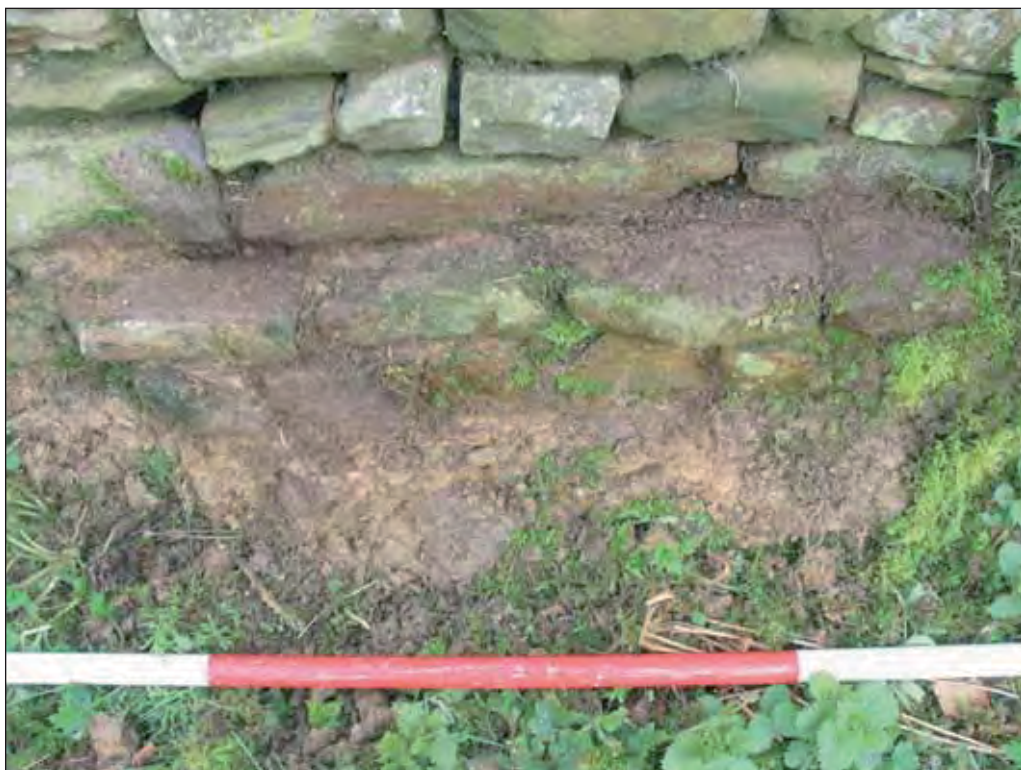
Plate 6: Detail of the rear north wall of the former stable showing the projecting base, viewed from the north.

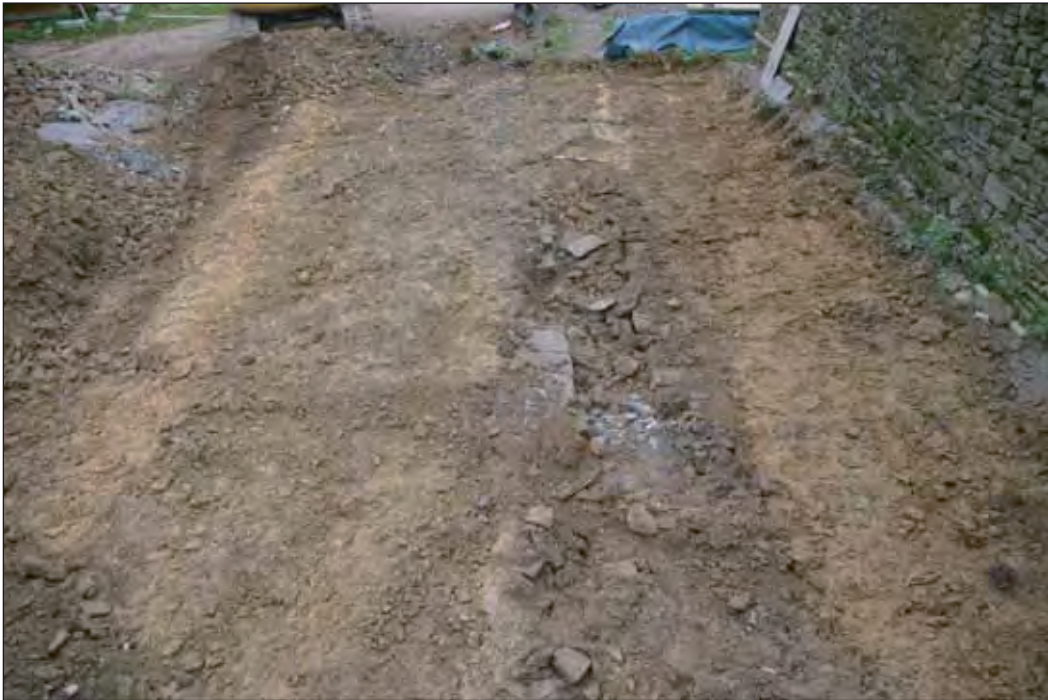
Plate 7: Stripped area of former shippon showing the orange soil indicating the position of the former rear wall and the former position of drain [508].

The surface of the natural (506) was cut by [508], an east-west linear extending 7.15m from the western wall. This was 1-1.2m wide, 0.25m deep at the east end and 0.6m deep at the west end; the base was flat and the sides nearly vertical. The sides and east end were lined with roughly coursed stonework /501\ forming a wall 0.1m high at the east end increasing to 0.5m high to the west. It consisted of sub-angular stones 0.1-0.4m across with a fairly good face on the inside of the feature; these faces were 0.5m apart. There was some soft grey-brown clay-silt matrix between and behind these stones. The structure /501\ was interpreted as a drain (see Figs. 3 & 4 and Plate 8). In the base of cut [508], and between the two faces of /501\, a cobbled surface (503) had been laid; the stones were 50-200mm across, sub-rounded to sub-angular in shape and closely packed into the natural. They formed a flat surface sloping gently downward to the west. About 1m from the eastern end of /501\ the feature had been blocked by a single course of stone /509\ laid on top of (503). To the east of this the feature had been filled with a soft grey-brown clay-silt in which stone <300mm across was very common (510). A single, much abraded sherd of medieval or post-medieval North Devon ware was found in this fill, although this was probably residual. To the west of /509\ the base of the drain was filled with (505), a mid-brown silt-clay with voids and common stone; above this lay (504), a firm yellow-orange clay with some stones. Neither context contained any finds. The whole was overlain with (500): topsoil mixed with rubble. At its western end the drain sides, base and fills abutted the base of wall /502\, and the drain seems to have discharged through a small aperture in that wall. A ceramic pipe had been inserted into this aperture from the other side and fixed in place with cement.

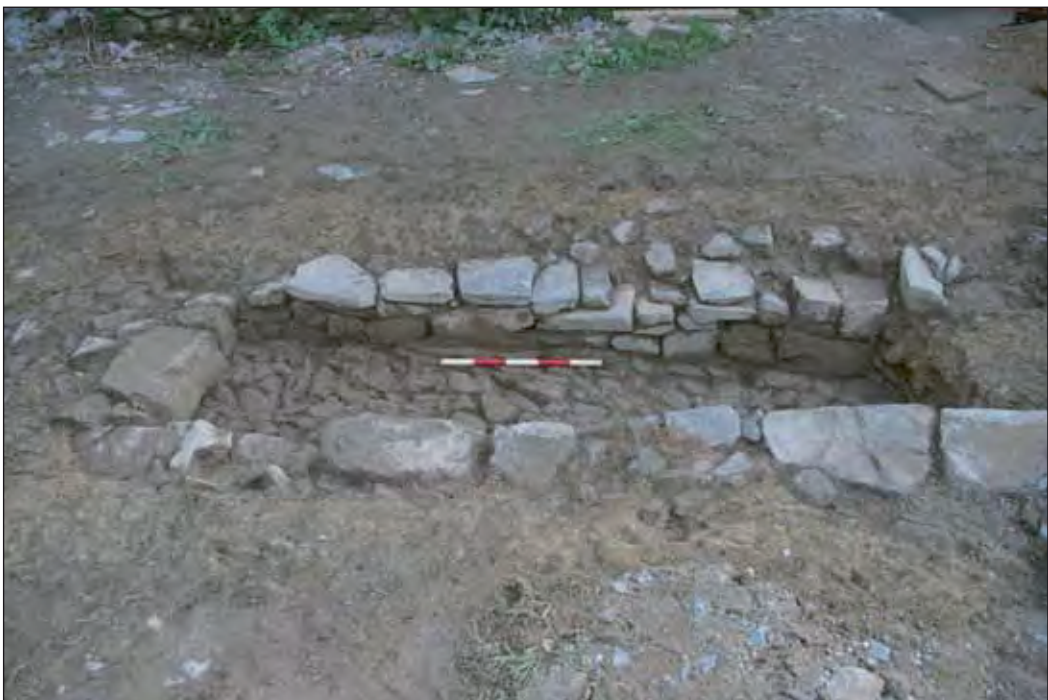
Plate 8: The south west end of drainage feature/linear [508] showing cobbled surface (503) and before removal of /509\ viewed from the north west.

Drain /501\ would seem to have had two phases of use, with the original build being foreshortened and the eastern end infilled some time before the western end fell out of use and was backfilled. Both phases were related to the post-medieval/modern agricultural building that formerly stood on this site. Apart from this, all the other features in this area were modern in origin.
