**THE OLD COALYARD
DUPORTH ROAD
CHARLESTOWN
CORNWALL**

Results of Archaeological Monitoring & Recording

South West Archaeology Ltd. report no. 210118

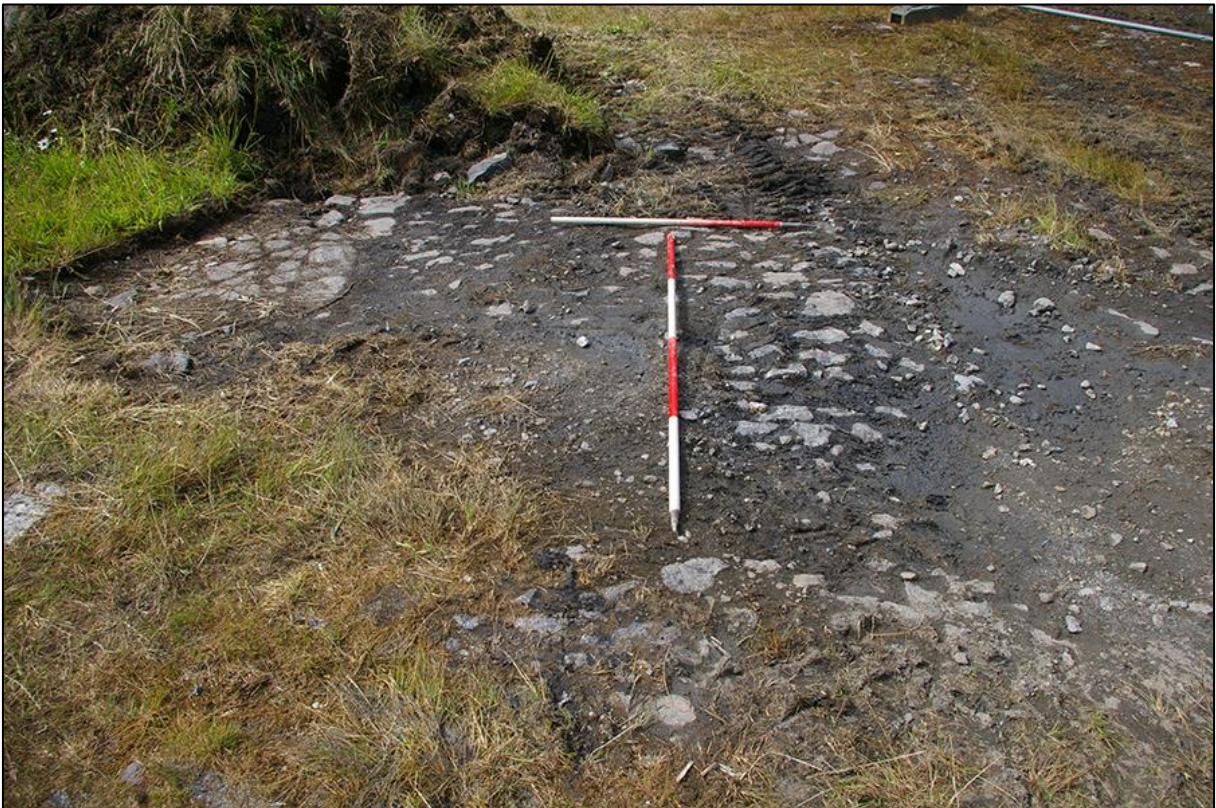
21. DETAIL OF SMALL PATCH OF BURNT BRICK (164) WITHIN COBBLE SURFACE (103); VIEWED FROM THE WEST (1M SCALE).

(164)	Surface	Brick surface – sub-rectangular area orientated approximately east to west. Measures c.1m x 0.50m and 0.10m deep. Constructed of red brick. Possible evidence of burning. May indicate presence of later structure in the north-west corner of the site? Or evidence of burning within the cooperage.	Overlain by {101}; abuts {103}	0.10m thick	Post-medieval / modern
[165]	Cut	Service trench – linear feature orientated approximately north-west to south-east. Measures c.0.50m wide. Not excavated.	Filled by {166}; cuts {105}	-	Modern

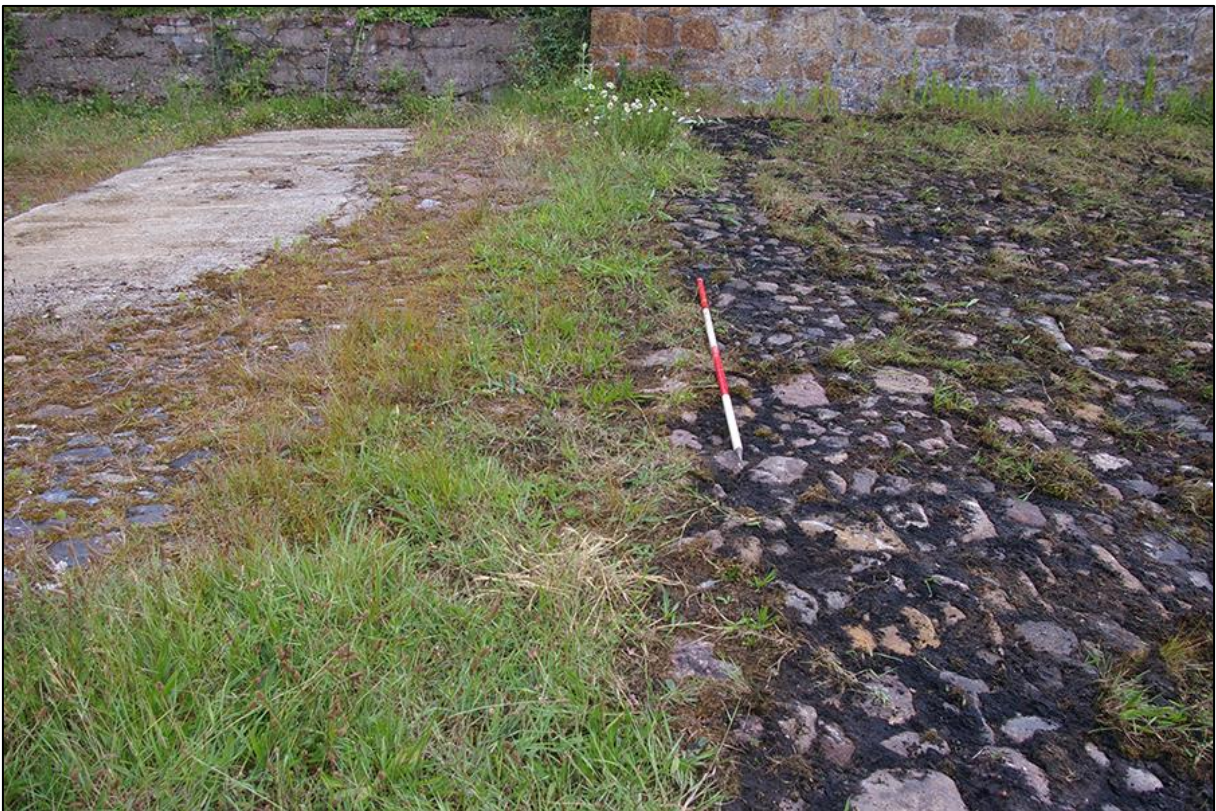
34. DETAIL OF A POSSIBLE WALL SCAR WITHIN THE COBBLE SURFACE OF THE SURVIVING ORE FLOOR IN THE NORTH-EAST CORNER OF THE SITE; VIEWED FROM THE SOUTH (2M SCALE).

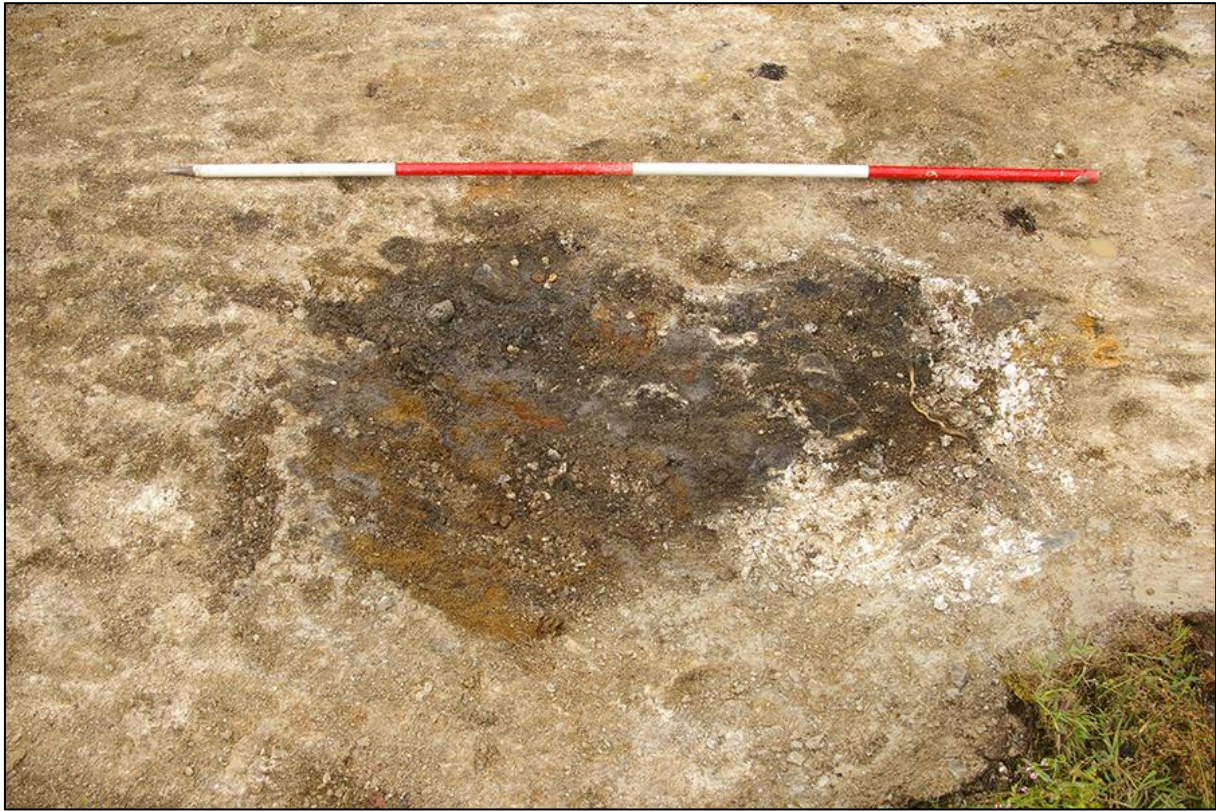
43. POST-HOLES [106]-[111], PRE-EXCAVATION; VIEWED FROM THE WEST (2M SCALE).

A total of six post-holes [106]-[111], and one post-pit [118] were identified spread across the site (Figures 2-3), though predominantly towards the north-western corner, and all within the area of the northern terrace. The westernmost of these, [106] was sub-oval to sub-circular in plan, measuring up to 0.20m in diameter and 0.05m deep with moderate sloping sides, sharp break of slope and concave base. To the east, post-hole [107] was sub-oval in plan, measuring up to 0.20m in diameter, and 0.05m deep with moderate sloping sides, sharp break of slope and concave base.

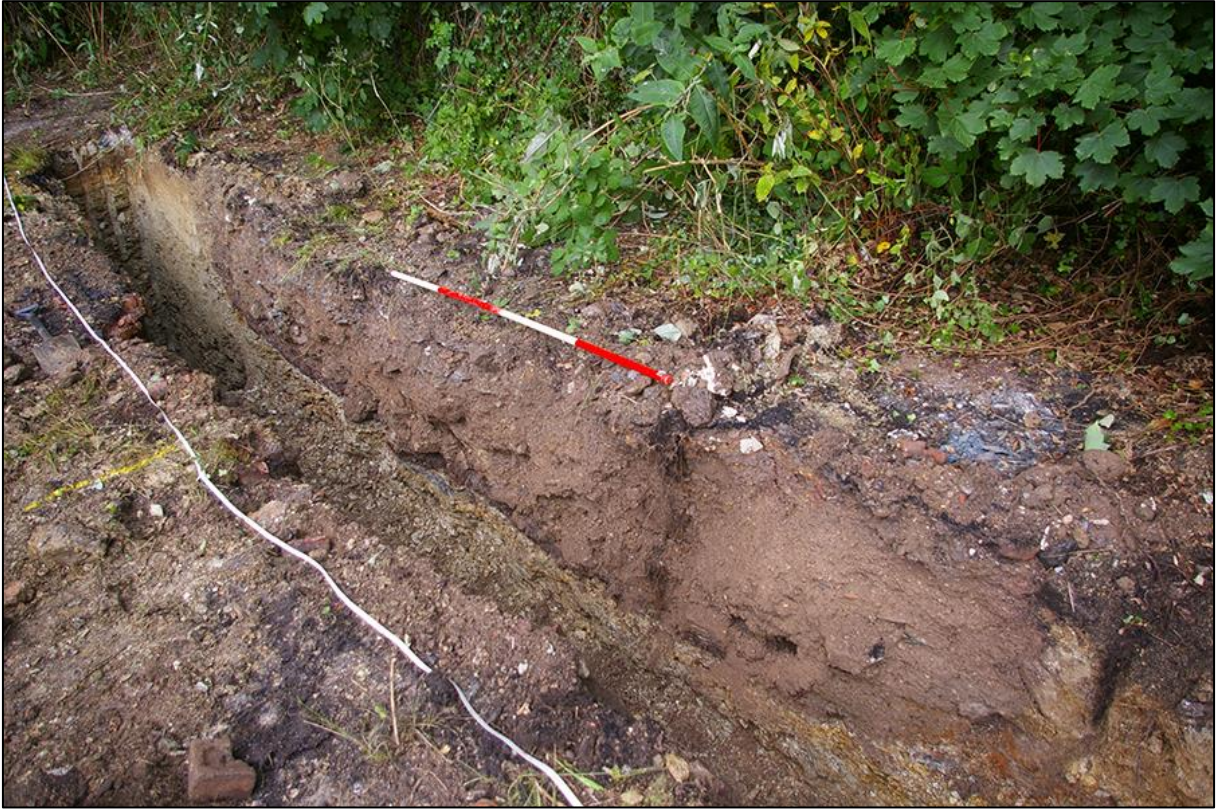
51. PIT [121], SOUTH FACING SECTION; VIEWED FROM THE SOUTH-WEST (2M SCALE).

Two pits, [121] and [130] were located in the north-western corner of the site and both appeared to have been used as settling tanks. Pit [121] was sub-rectangular in plan on an approximate east-north-east to west-south-west alignment. It measured 6.50m × 2.30m wide and 0.90m deep with steep to near vertical sides, clear to sharp break of slope and broadly flat base. It appeared to have been lined along its northern, eastern and western edges by stone-built walls {134}, {128} and {129} respectively, each measuring 0.20m thick and surviving up to 0.70m high and constructed of large sub-angular stone blocks with an earth bond. No trace of a wall was identified along the southern edge of the feature. Confined within the walls of the tank were five fills: (122), compact light grey-brown clay and shillet; (123), loose rounded gravel within light brown sand and silt; (124) light brown-grey clay banded within orange-brown sand; (125) light grey-brown sand; (126), light grey-brown coarse sand within mid grey-brown silt-clay; and (127), heavily decayed wood.

Within the north-western corner of the site two pits were cut through the cobble surface. The earliest of the two [130], shows traces of having been wood lined, at least across the base, and contains lower deposits (133) that are indicative of possible ore processing activities, including settling, with multiple thin bands of clay and gritty material. This appears to have been replaced by pit [121], which was lined to the north, east and west by stone-built walls {128}, {129}, and {134}; and which contained similar fills to pit [130], again suggestive of its use during ore processing, possibly as a settling tank.

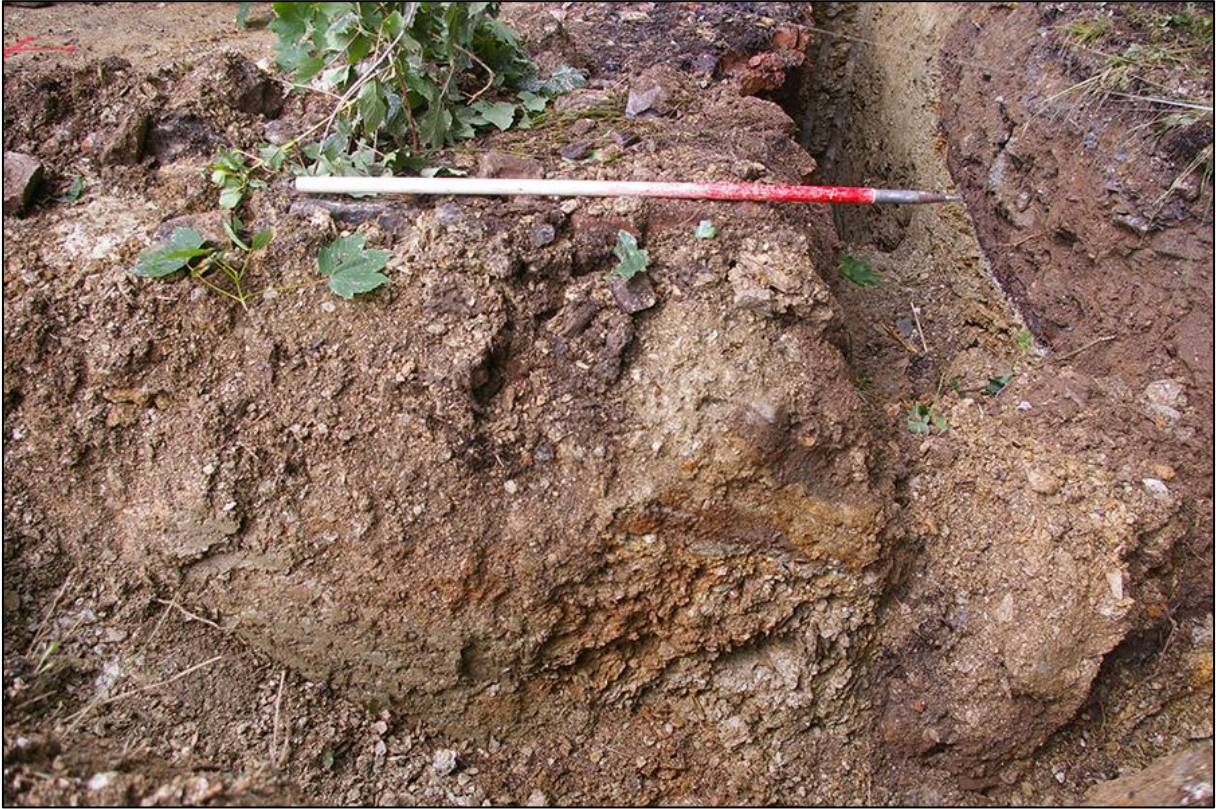
53. PIT [121] WITH WALL {134}, EAST FACING SECTION, NORTH END; VIEWED FROM THE EAST (1M SCALE).

(127)	Fill	Possible lining of pit [121] – decayed wood.	Overlain by (126); overlies {128}, {129}, {134}	Up to 0.02m thick	Post-medieval
{128}	Structure	Wall lining along eastern edge of pit [121] – linear wall orientated approximately north-west to south-east. Measures 0.20m thick and survives to a height of 0.70m. Constructed of large sub-angular stone with an earth bond.	Overlain by (127); fill of [121]	Up to 0.70m high	Post-medieval
{129}	Structure	Wall lining along western edge of pit [121] – linear wall orientated approximately north-west to south-east. Measures 0.20m thick and survives to a height of 0.30m. Constructed of large sub-angular stone with an earth bond.	Overlain by (127); fill of [121]	Up to 0.30m high	Post-medieval
[130]	Cut	Pit - sub-rectangular feature orientated approximately north-east to south-west. Measures 2m x 2.30m wide and 0.70m deep with moderate to steep sloping sides, clear break of slope and broadly flat base. Clay banding within fills suggests possible settling tank. May form part of pit [121], or be cut by it.	Filled by (131), (132), (133); cuts (103)?, (105)	0.70m deep	Post-medieval?

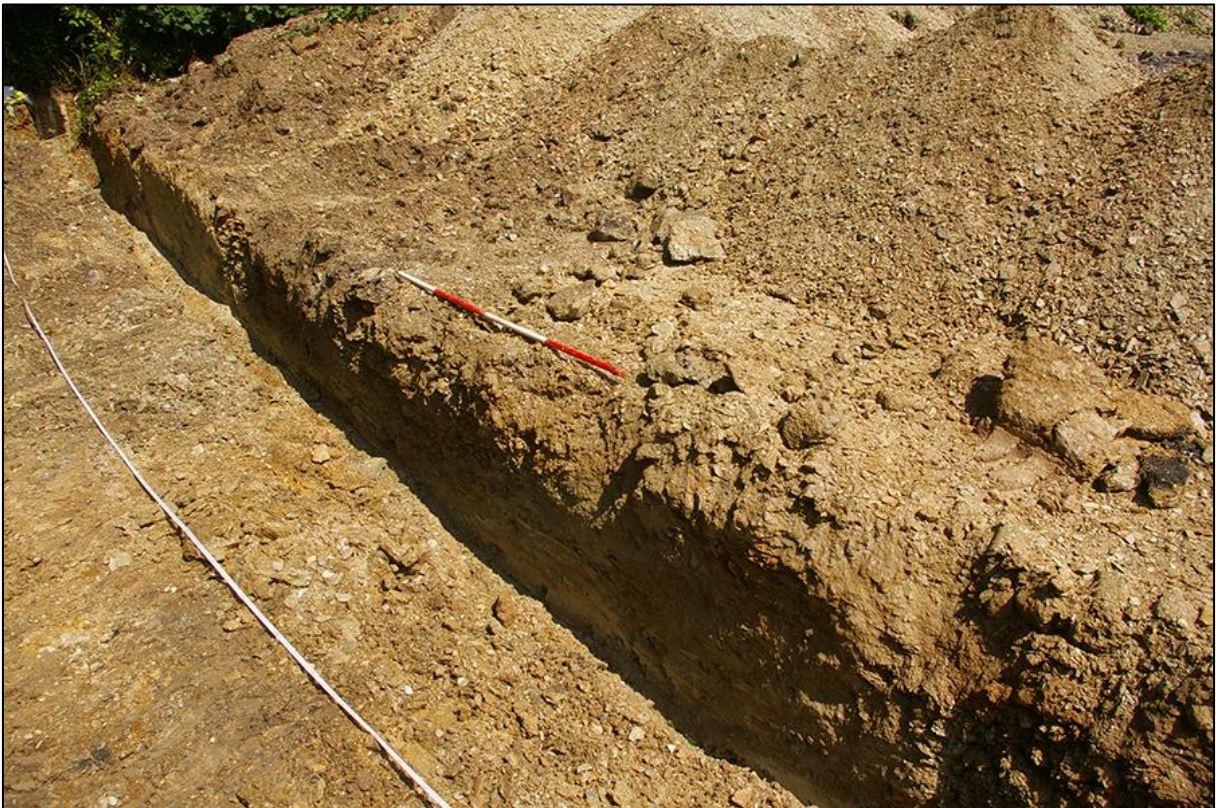
58. CONSTRUCTION/ROAD ACCESS CUT [135], WEST FACING SECTION; VIEWED FROM THE WEST (2M SCALE).

Along the southern edge of Area 01, where a concreted access track to the reservoir runs, road construction cut [135] was orientated approximately east-north-east to west-south-west; and measured c.3m wide and 0.45m deep with a moderately sloping northern edge that was stepped towards the base with sharp breaks of slope. It contained two fills: (136) and (137), compacted/concreted tarmac and stone.

A track is depicted dividing the ore floor on the 1882 Ordnance Survey 1st edition map, and it is likely that feature [135] reflects this alteration to the layout of the site; though the upper fills indicate that it has since been re-laid at least once, with perhaps multiple episodes of re-surfacing in concrete.

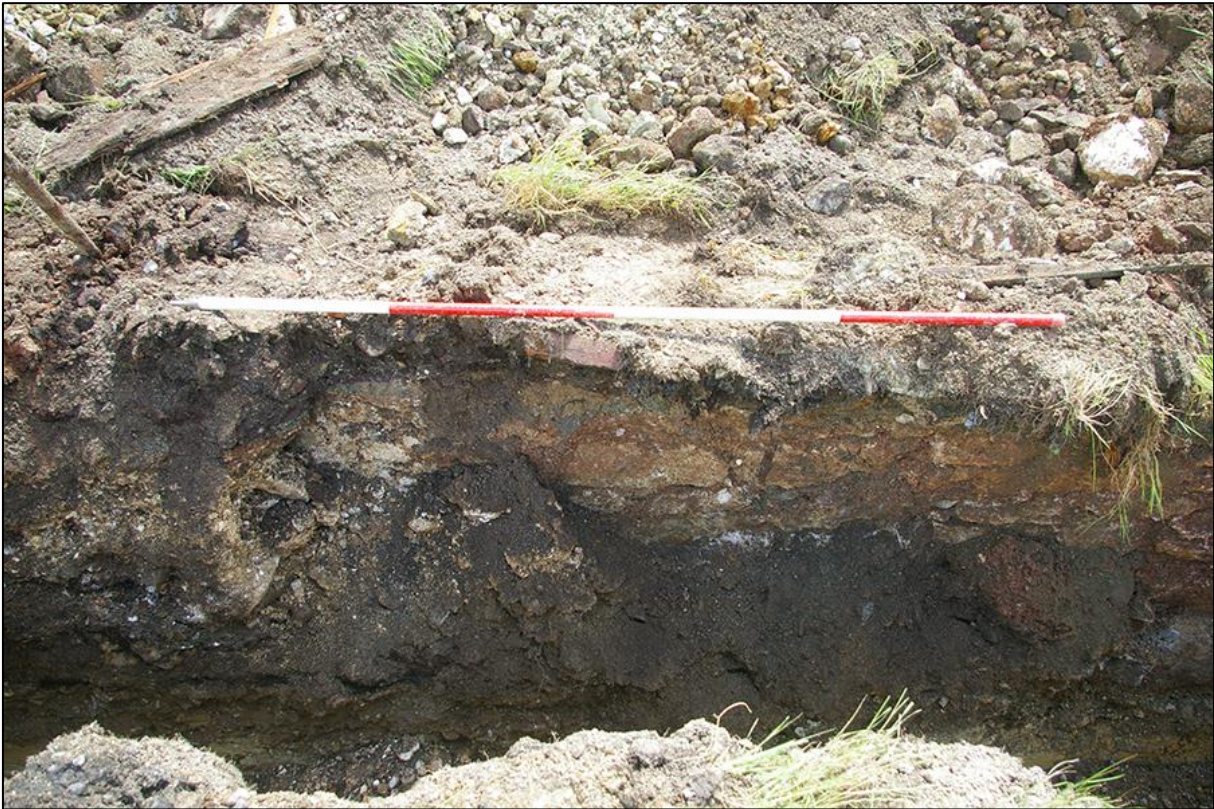
61. WALL {148}/{149} WITH REPAIR {147}, NORTH FACING ELEVATION; VIEWED FROM THE NORTH (2M SCALE).

Several sections of linear wall {147}-{150}, {157}, {167} and {168} were identified, all within Area 02. Along the southern edge of the area, wall {148}/{149} was set within construction cut [151] and ran the length of Trench 03 on an approximate east to west alignment. It measured 0.50m thick, surviving to a height of 0.90m, and was constructed of sub-angular and angular roughly coursed stone blocks with a clay bond. A short section of this wall had been repaired/replaced towards its eastern end with {147}, concreted sub-angular stone when a service pipe had been cut through. A c.2m stretch of wider possible foundation stones {150} were identified mid-way along the length of the wall, and may indicate the position of a wall running to the south, though no further evidence of such as structure was identified.

(146)	Layer	Made-ground – compacted-concreted mid grey-brown clay with frequent sub-rounded stone.	Overlain by (145); overlies (105)	c.0.20m thick	-
{147}	Structure	Wall repair – linear wall section orientated approximately east to west. Measures 0.40m high and 0.30m thick. Constructed of concreted sub-angular stone. Forms repair/re-build to wall following insertion of modern drain and service pipe.	Overlain by (100); abuts {148}; fill of [151]	0.40m high.	Modern
{148}	Structure	Wall – linear wall orientated approximately east to west for almost full length of site. Measures 0.50m thick and survives to a height of 0.90m. Constructed of sub-angular and angular roughly	Abutted by {147}; same as {149}; fill of [151]	0.90m high	-

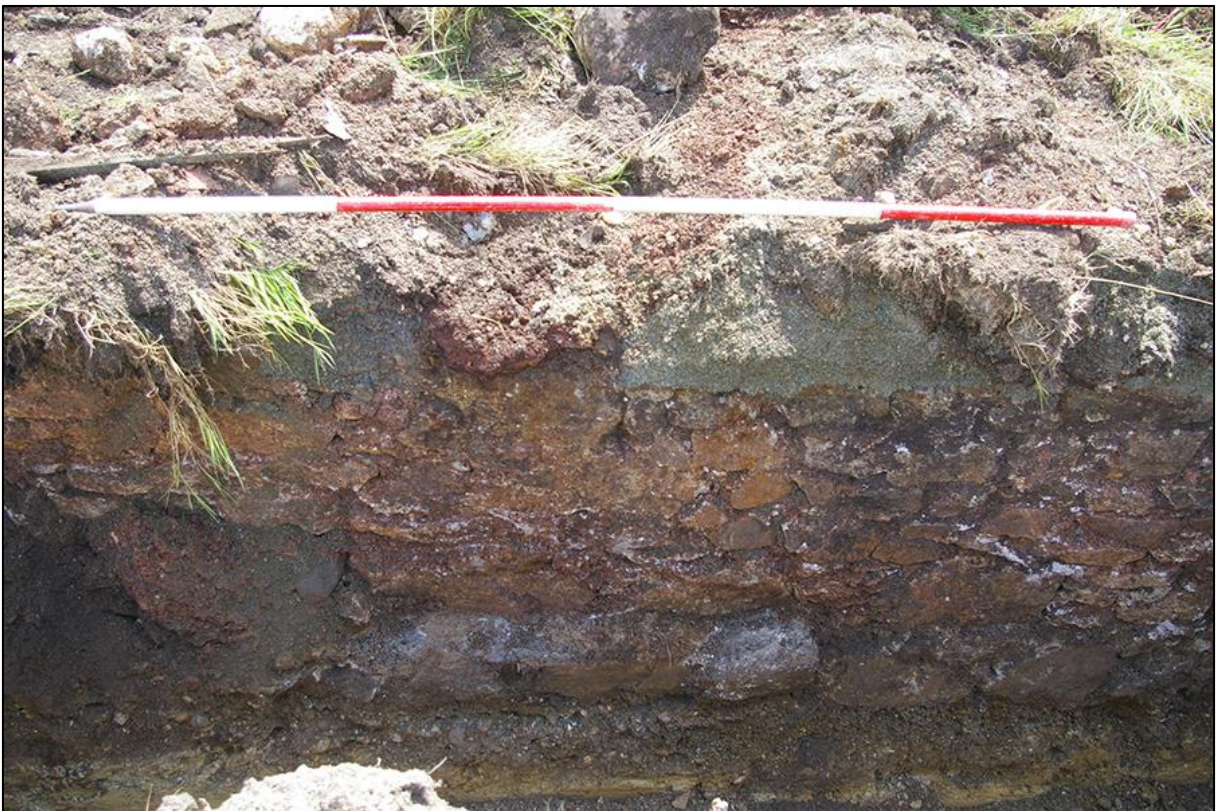
64. WALL {148}/{149} WITH POSSIBLE FOUNDATION STONES {150}, NORTH FACING ELEVATION; VIEWED FROM THE NORTH-WEST (2M SCALE).

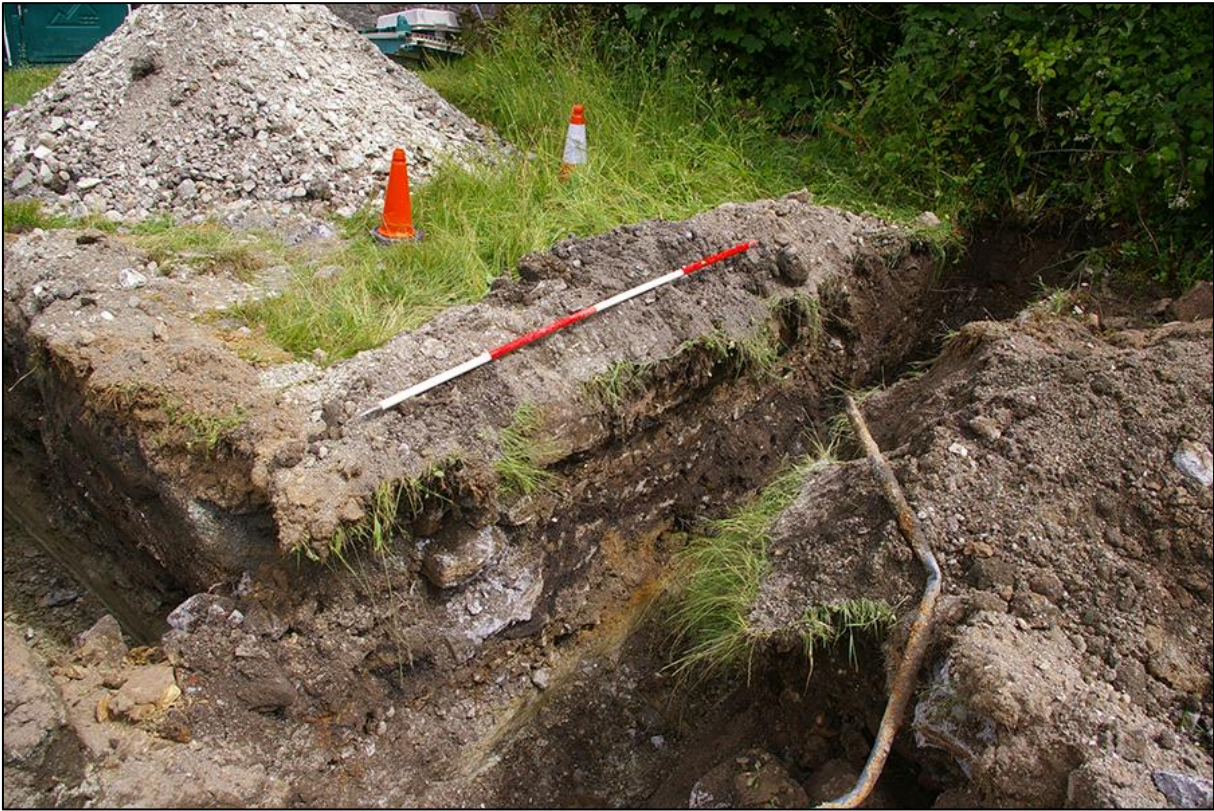
71. WALL {157}, WEST FACING ELEVATION; VIEWED FROM THE WEST (2M SCALE).

Towards the eastern end of wall {148}/{149}, a second linear wall {157} was identified extending to the south. This was constructed of concreted brick and sub-angular stone with a lime mortar bond and survived to a height of 0.80m.
