# **THE SLIPWAY**

## **WESTWARD HO!**

Results of an Archaeological Evaluation

South West Archaeology Ltd. Report no.200919

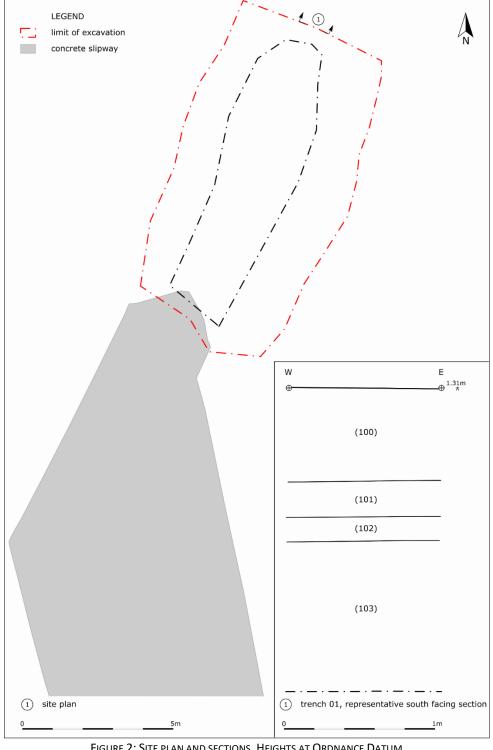
FIGURE 2: SITE PLAN AND SECTIONS. HEIGHTS AT ORDNANCE DATUM

Trench 01 was located at the northern end of the slipway, measuring 11.20m long on an approximate north-north-east to south-south-west alignment. The stratigraphy comprised beach sand deposits (100), layered mid slightly brown-yellow and yellow coarse sands *c*.0.60m thick; overlying (101), mid slightly brown-yellow coarse sand with common large rounded pebbles *c*.0.20m thick; (102), mid brown-yellow coarse sand with abundant sub-angular to rounded stone/gravel inclusions; and (103), mid red-yellow (orange) soft clay-sand 1+m thick.

The archaeological evaluation comprised the intended excavation of a single trench, though battering and trench collapse resulted in the works comprising a site strip across the area of groundworks for the proposed slipway extension, totalling 12m in length × 6m wide (Figure 2) by tracked mechanical excavator to a depth of up to c.2m using a toothless grading bucket under archaeological supervision. This was below the depth at which groundworks are proposed to occur and the maximum depth at which it was safe to excavate and at which deposits were visible before complete inundation with water and sand 'wash-out' of deposits occurred.

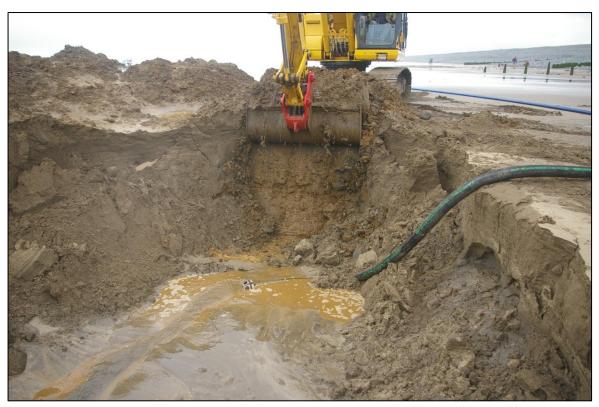
1. Trench 01, working shot demonstrating the level of water inundation and sand 'wash-out' and collapse; viewed from the south.

The work was undertaken over the course of two separate days in July. Battering and trench collapse resulted in the works comprising a site strip across the area of groundworks for the proposed slipway extension, totalling 12m in length  $\times$  6m wide rather than the single trench intended in the WSI. The excavation exceeded the proposed depth and reached c.2m, the maximum depth at which it was safe to excavate and at which deposits were visible before complete inundation with water and sand 'wash-out' of deposits occurred. These conditions made identifying features more difficult and meant that detailed examination of deposits was not possible.

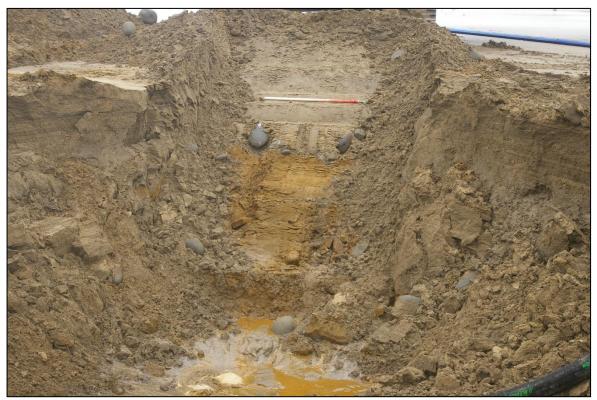
2. TRENCH 01, SOUTH FACING SECTION PRIOR TO WATER INUNDATION AND SAND 'WASH-OUT'; VIEWED FROM THE SOUTH (1M SCALE).
