# THE ANNEXE CREMYLL MAKER-WITH-RAME CORNWALL

Heritage Statement

# The Annex, Cremyll, Maker-with-Rame, Cornwall

## Heritage Statement and Heritage Impact Assessment

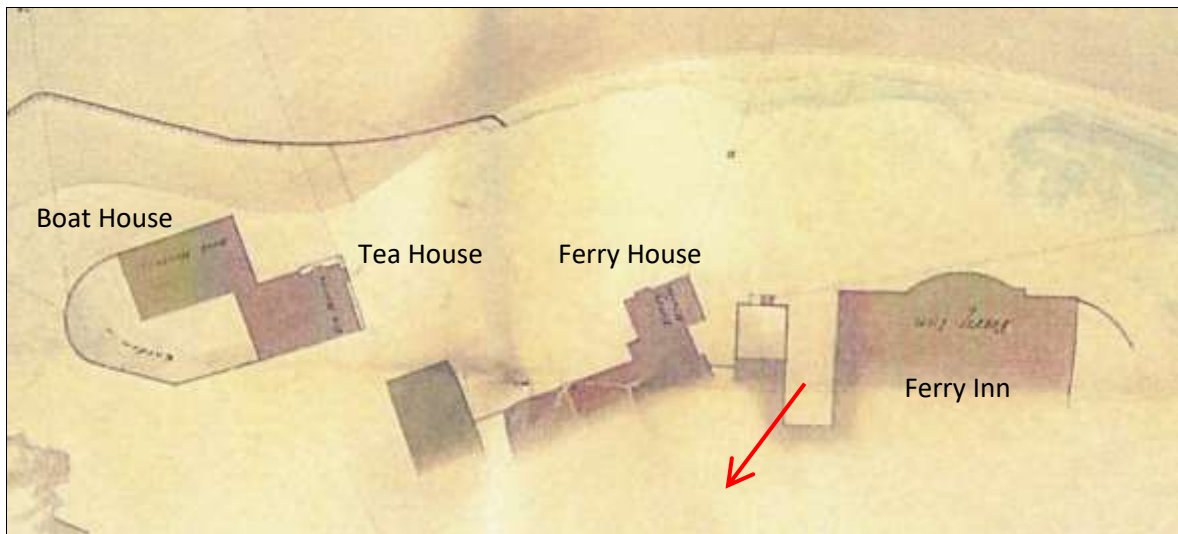
FIGURE 8: EXTRACT FROM RENDALL'S 1837 PLAN OF WORKS TO CREMYLL QUAY (CRO: ME/2312) (LABELS ADDED FOR CLARITY); THE ANNEX IS INDICATED.

The 1837 Rendall map (Figure 8) shows the layout of the buildings at Cremyll in some detail, and helpfully labelled. The Cottage is labelled *Ferry House*, and this appellation appears to be specific to the 18<sup>th</sup> century crossing at the front of the property. The map is detailed enough to show the

bow window, porch and external gable stack. The building shown to the west of The Cottage is shown in grey, which would suggest it was non-domestic, perhaps a boat house.

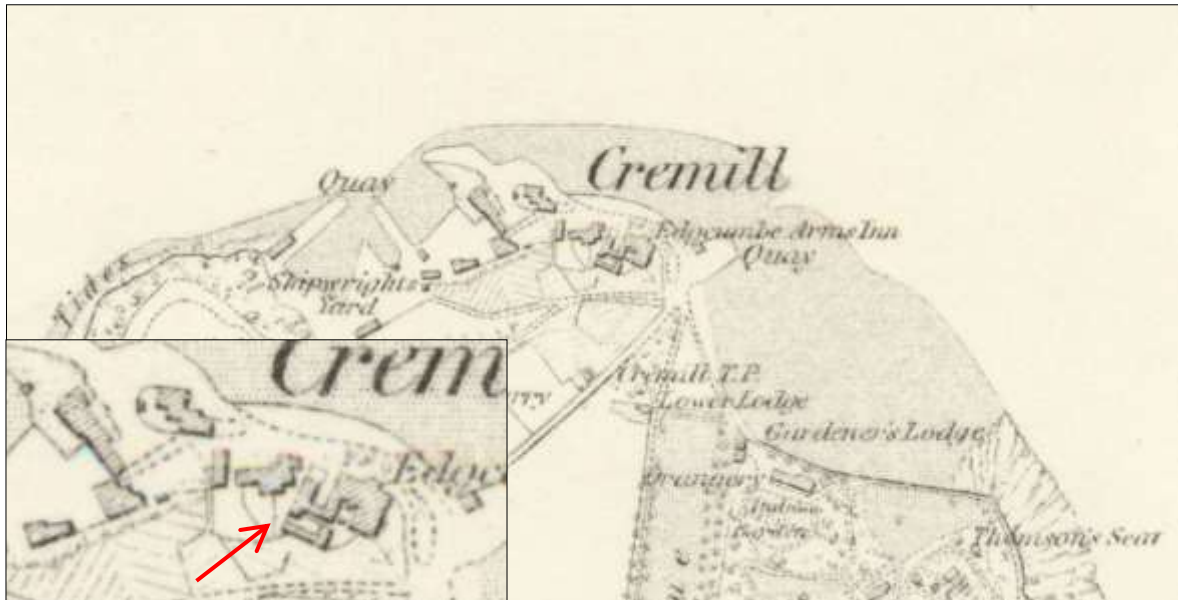
FIGURE 10: EXTRACT FROM THE 1867×69 6 INCH OS MAP (SURVEYED 1856×66; CORNWALL SHEET LV), WITH INSET (CRO).

By 1856-66, a block had been constructed to the rear of The Cottage (Figure 10). From the later 19<sup>th</sup> century, the external shape of the building – and the internal subdivisions – are shown in some detail through the 1:25 inch scale OS maps of 1894, 1906 and 1914. The 1894 map (Figure 11) is the first to show a structure on the approximate site of the Annexe, and it appears to be an outbuilding associated with the Cottage or the property adjoining to the east.

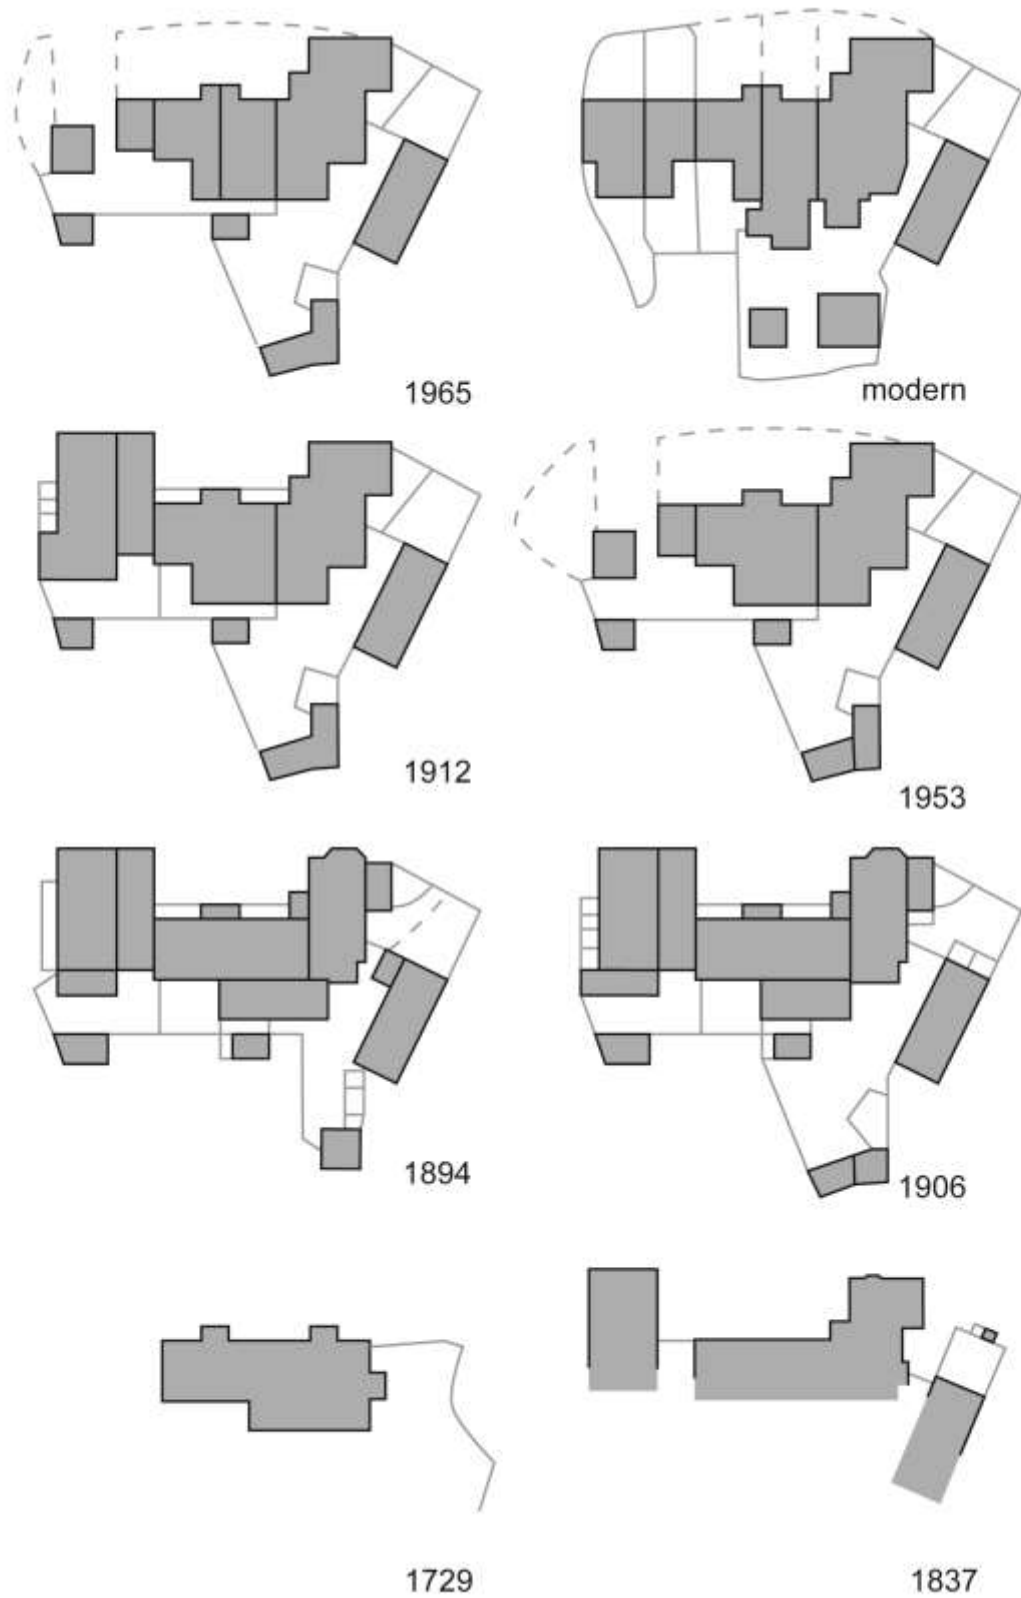
FIGURE 14: THE DEVELOPMENT OF THE COTTAGES AT CREMYLL ANTIQUES FROM 1729 TO 2018 (SOURCES: HISTORIC MAPS).

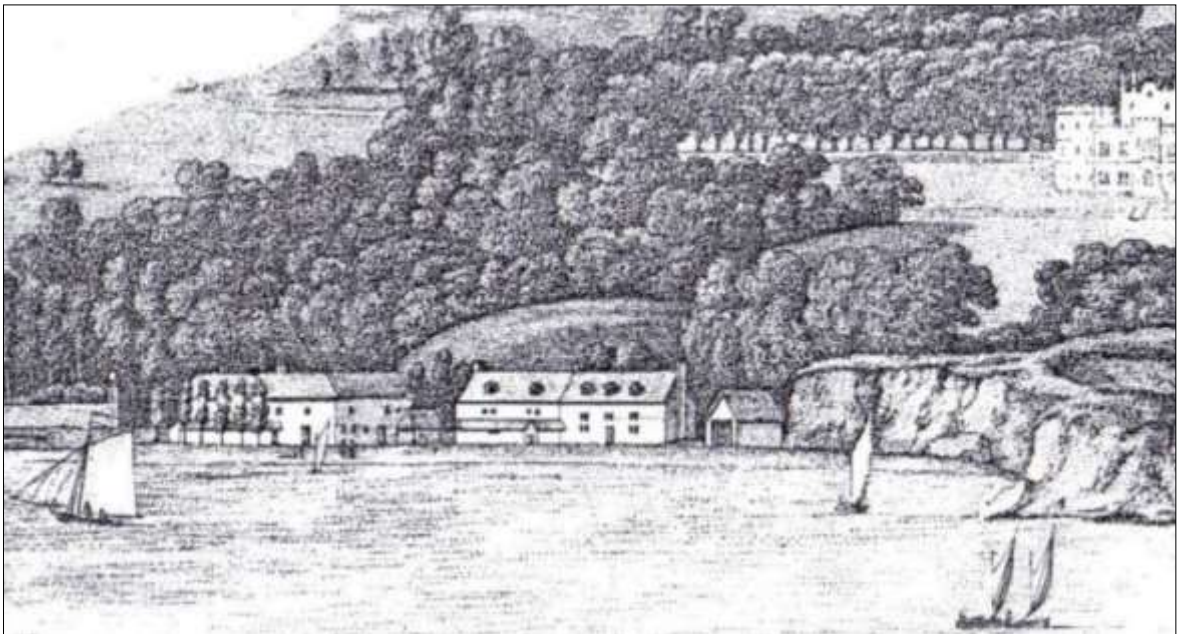
FIGURE 17: DETAIL FROM THE TOMKINS PRINT OF MOUNT EDGCUMBE IN 1790; THE INN IS TO THE LEFT, THE FERRY COTTAGES TO CENTRE, WITH OPEN BOAT HOUSE TO THE RIGHT. NOTE THE SYMMETRICAL FAÇADES OF THE COTTAGES (PLYMOUTH LIBRARY SERVICES).

The historic images of Cremyll show a settlement at Cremyll in 1686 (Figures 15-16), but that the Ferry Cottages had yet to be built (though see below). The 1790 print shows the Ferry Cottages in some detail. The western cottage is shown with a central doorway, axial stack, and a symmetrical 2/1/2 arrangement of windows – similar to the layout today – with dormers above. The eastern cottage – which includes The Cottage – is quite different in character with two windows and dormers, with an off-centre door and what looks like an enclosed veranda across the front. Both images are of clear interest, but conflict with the built evidence, which would imply the main range was built before 1686, and the crosswing was built before 1790.

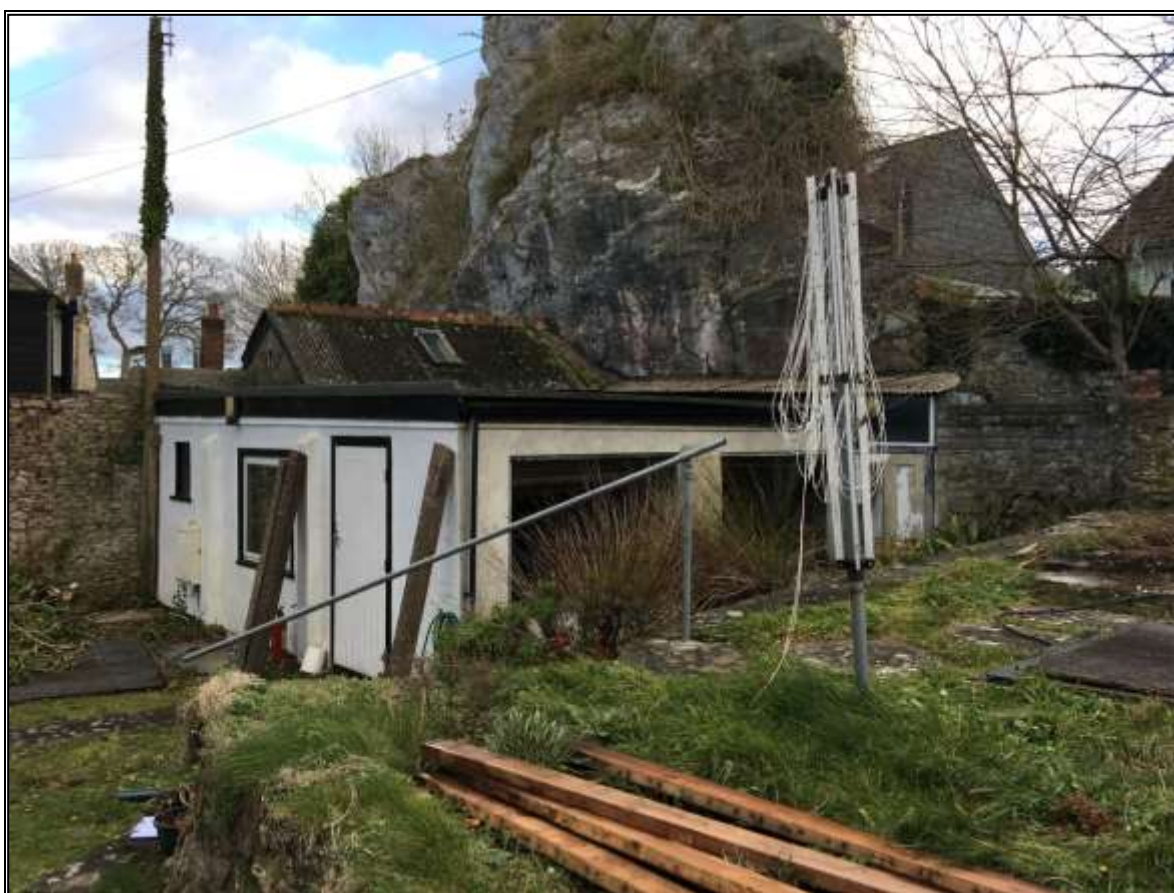
FIGURE 18: THE CURRENT ANNEXE BUILDING IN THE SOUTH-EAST CORNER OF THE GARDEN, WITH ROCK OUTCROP BEHIND; VIEWED FROM THE NORTH-WEST.

In the south-east corner of the garden is a single-storey, flat-roofed building (the current Annexe). This is a small rectangular workshop-style building built of rendered block and brick. It has a door and two windows in the north elevation and two large windows in the west elevation. The door is a modern plank affair; the windows are a mix of mid-20<sup>th</sup> century timber and white nPVC units. Its flat roof is sealed by bitumen/roofing felt, with black and grey plastic guttering. This building was built after 1965 and appears to be modern. It possesses no architectural value. It wraps around an earlier single-storey building with a pitched roof of corrugated asbestos with terracotta ridge tiles. This structure first appears on the 1912 OS map and may have been a privy or coal house. The east boundary of the garden is a poor-quality stone rubble wall. The gap between the workshop and the rocky outcrop is covered by a narrow mono-pitch roof of corrugated asbestos sheet; this conceals a space c.2m wide as the uneven rockface is cut back in beneath. Entry to this space is via a reset modern four-panel door. Internally, the west wall of the earlier building has been removed to unify the space; the north gable wall has been retained to form a toilet. The floor is of poured concrete.

The Annexe is a 20<sup>th</sup> century workshop built of modern materials with a flat roof. It incorporates part of an earlier building, but even this was built between 1894-1912. It lies within the curtilage of the Listed Cottage but is of no individual historical or architectural value and does not contribute to the setting of the Cottage in a positive way.

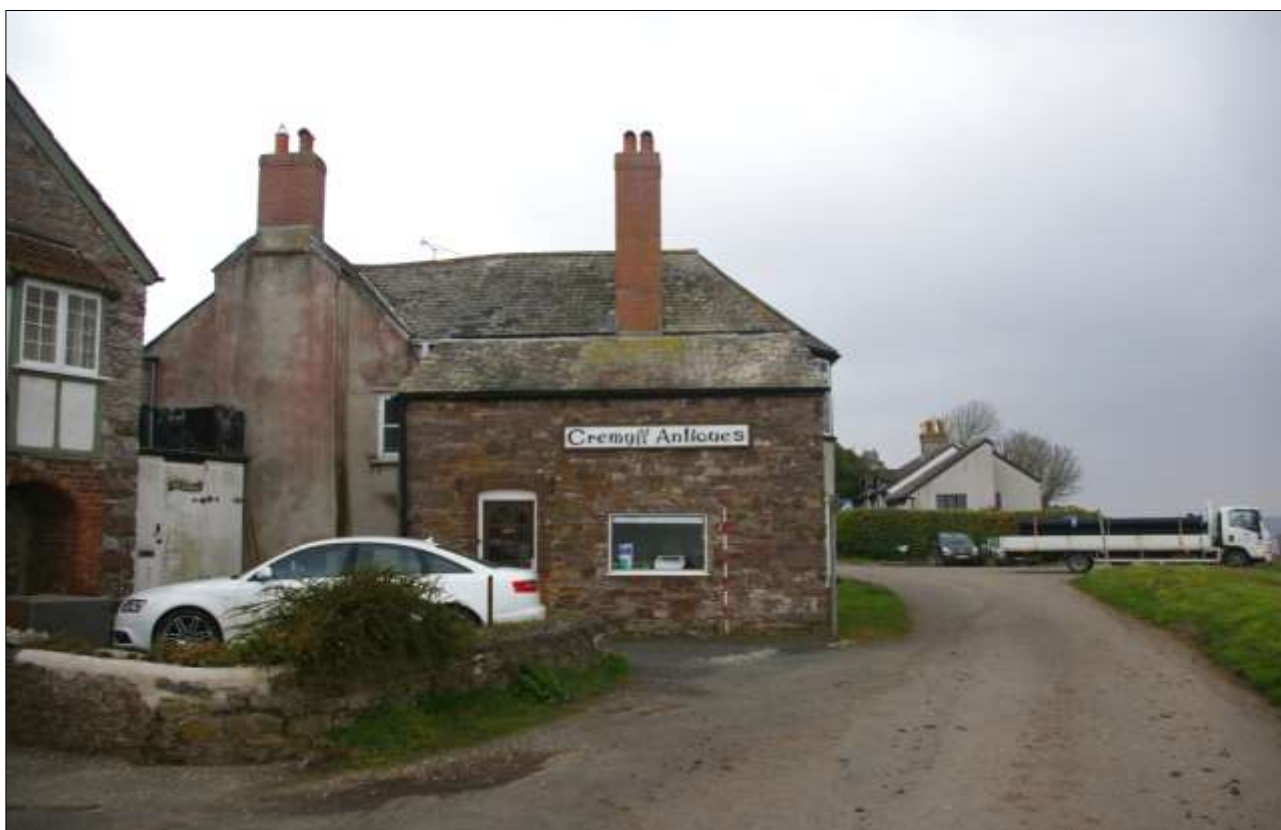
1. EAST ELEVATION OF THE EARLY 19<sup>TH</sup> CENTURY EXTENSION; VIEWED FROM THE EAST-NORTH-EAST.

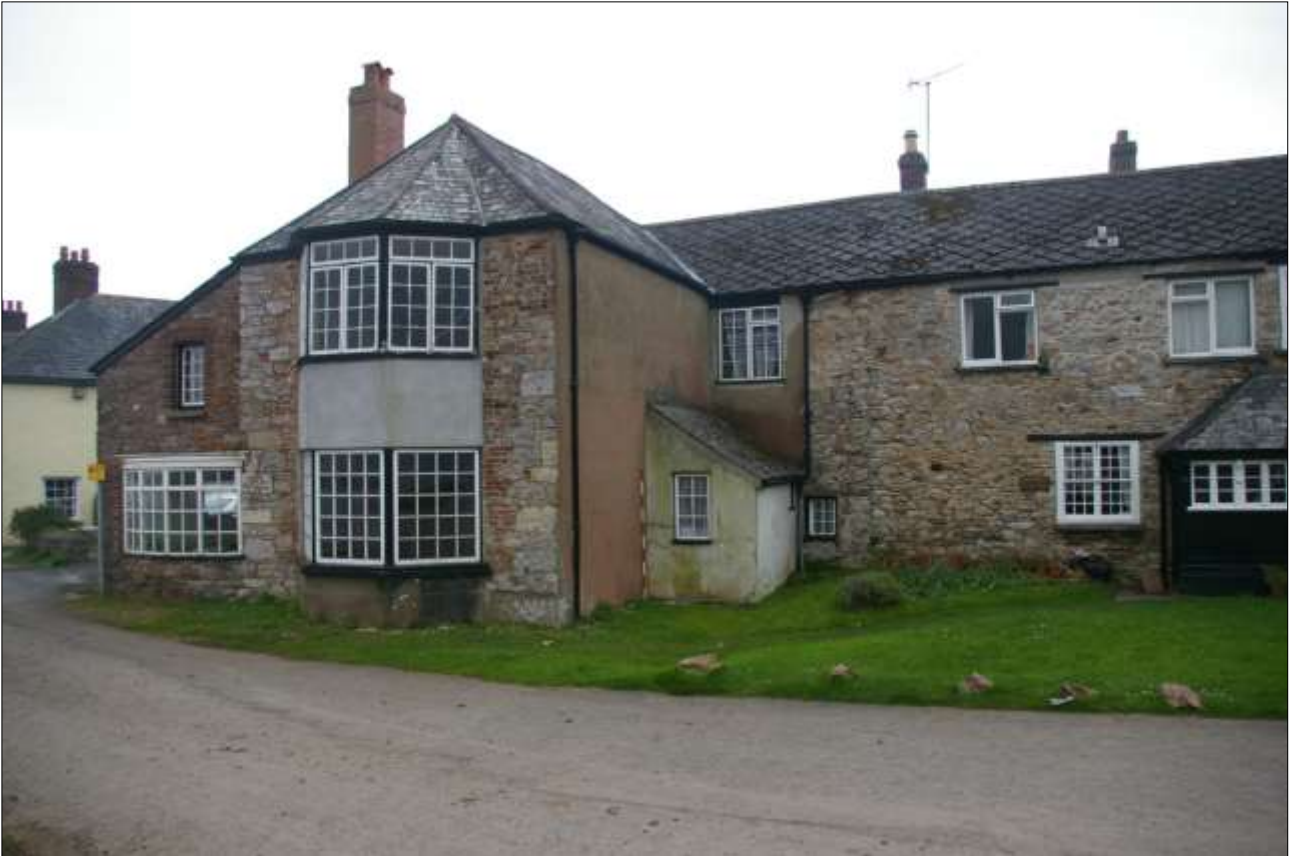
3. THE NORTH AND WEST ELEVATIONS OF THE CROSSWING, WITH PORCH AND NORTH ELEVATION OF THE MAIN RANGE; VIEWED

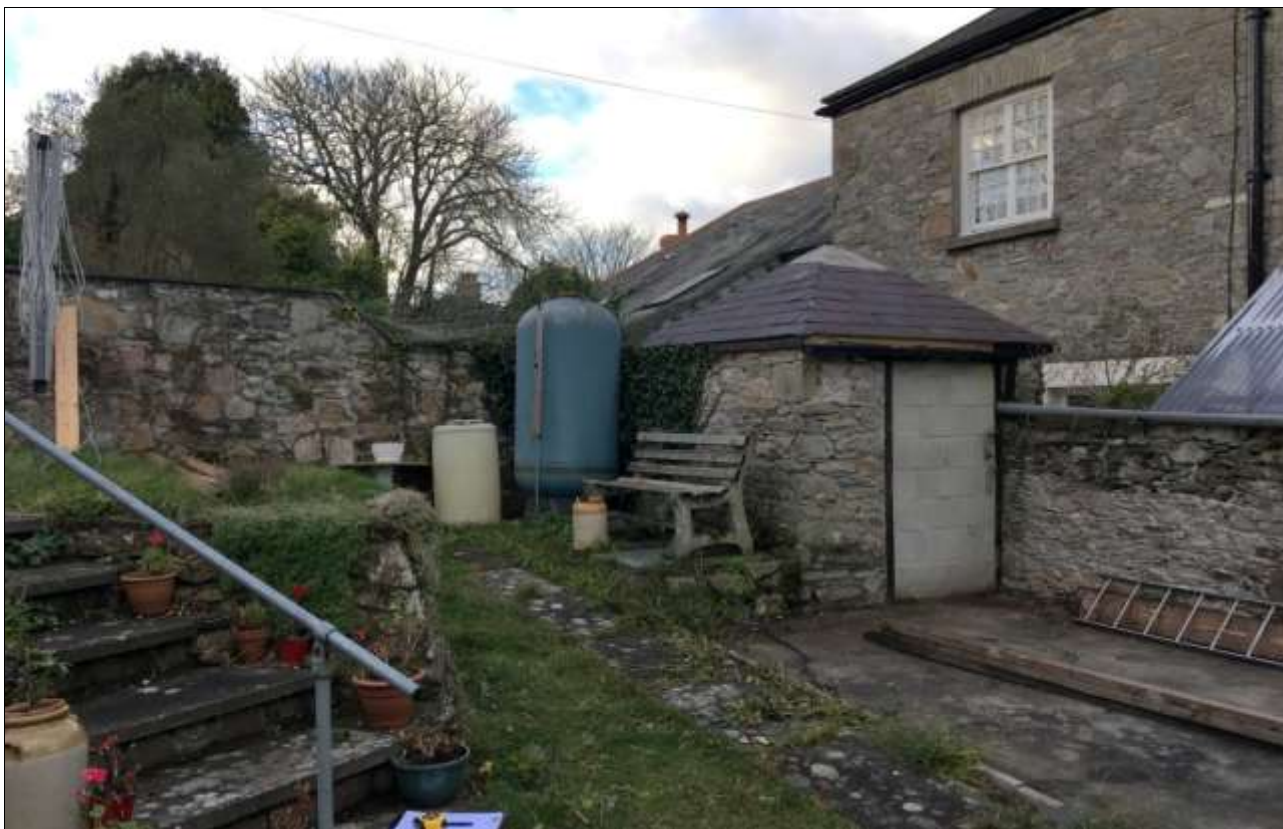
6. THE NORTH-WEST CORNER OF THE GARDEN, WITH STONE BUILT SHED AND GARDEN WALL; VIEWED FROM THE SOUTH-EAST.

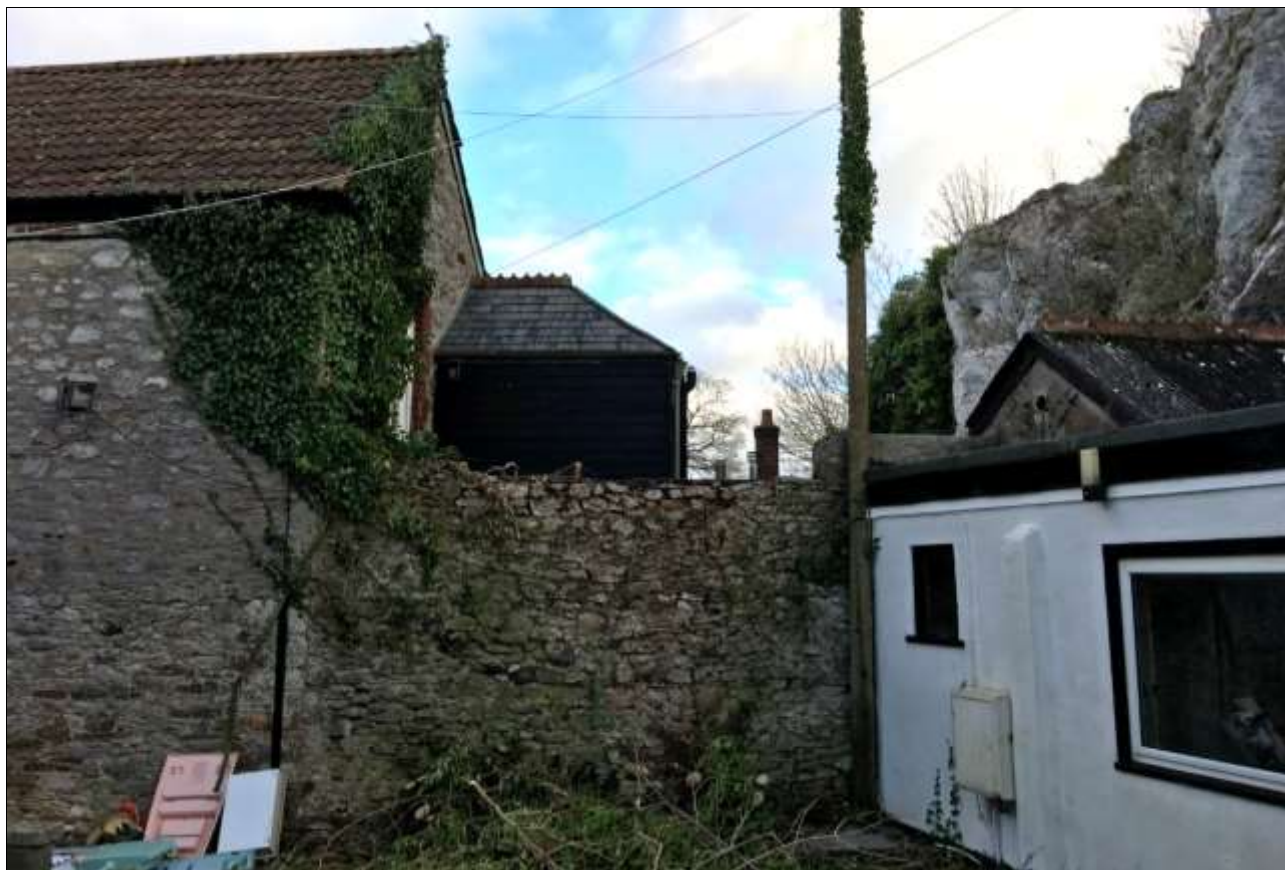
8. THE EASTERN BOUNDARY OF THE GARDEN, LOOSE RUBBLE STONE WALL AND ADJACENT CONVERTED OUTBUILDING; FROM THE WEST.

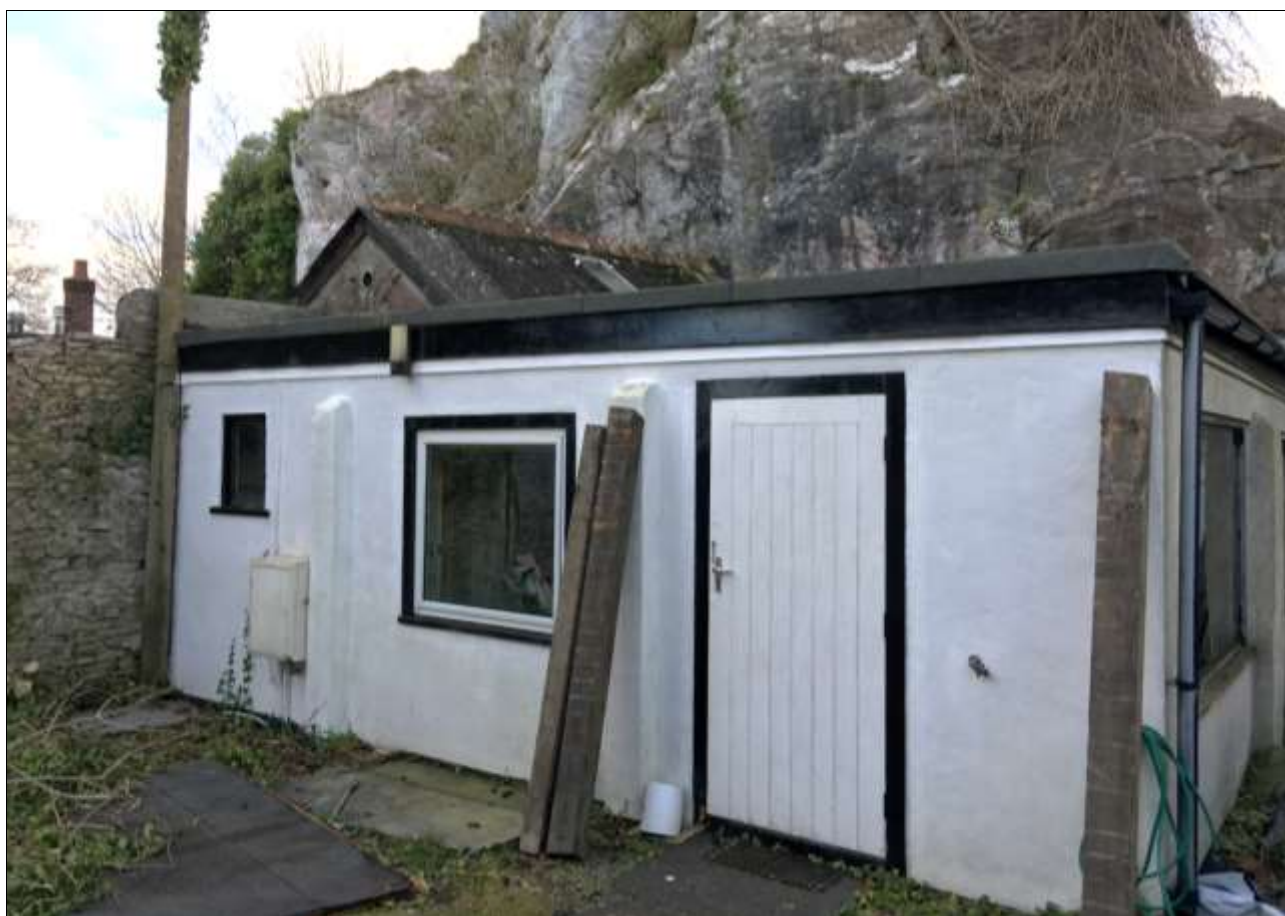
9. THE WORKSHOP IN MORE DETAIL, SHOWING IT ENVELOPING EARLIER SHED BEHIND; VIEWED FROM THE NORTH-WEST.

The appraisal indicates the Annexe retains older fabric within its footprint, of early 20<sup>th</sup> century date. This shed is likely to have been a privy, a coal store or similar additional service building. There is, therefore, *low* evidential value.
