# LAND AT LONG ROCK

Results of an Archaeological Evaluation

South West Archaeology Ltd. report no. 200930

By J. Bampton  
Report Version: DRAFT 01  
Draft issued: 29<sup>th</sup> September 2020  
Finalised: 2<sup>nd</sup> October 2020

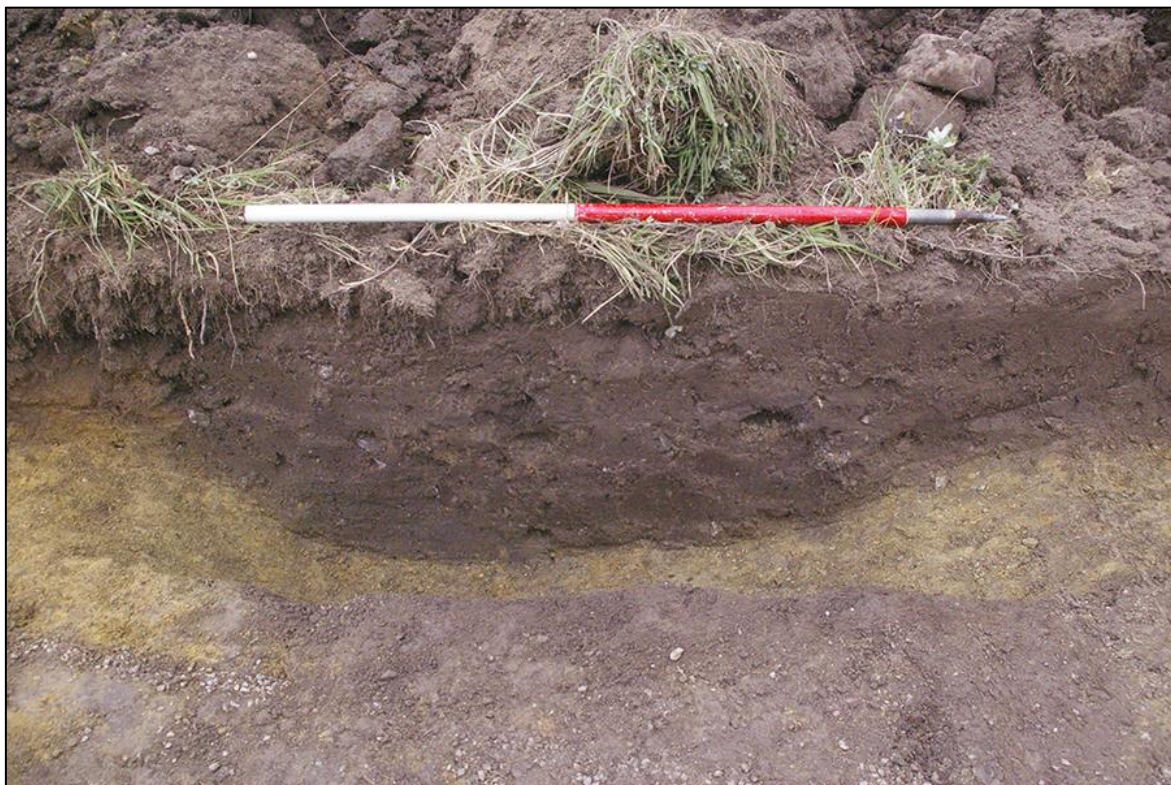
Ditch [103] was aligned north-east by south-west with a near vertical south slope with a concave break of slope and a gentle north slope with a flat base. It was c.1.70m wide and c.0.34m deep. It contained a two fills: upper fill (104), which contained 20<sup>th</sup> century finds; and lower fill (105). Both fills contained moderate medium angular and sub-angular stones. A patch of slightly disturbed

natural on the south side of this feature may allude to a truncated boundary feature such as a bank or hedgeline or other parallel feature.

FIGURE 2: DITCH [103]; VIEWED FROM THE NORTH-EAST (1M SCALE).

Two features on the site equate to historical boundaries; Ditches [103] and [406], which were depicted on mapping from c.1838 to c.1993. The depiction of the site as marsh on 1809 mapping implies that the ground had perhaps not been drained, or not significantly drained by that date, which may suggest that the site was enclosed between 1809 and 1838. Ditch [406] was ostensibly an open drain that contained fills indicative of silting-up and then subsequent purposeful backfilling. Ditch [103] contained a relatively large amount of medium stones indicative of a field drain, although its shape is indicative of a ditch and an adjacent area of disturbed natural may have alluded to a grubbed-out/truncated boundary bank. It may have been repurposed as an in-filled stony land drain in the 20<sup>th</sup> century. Both features only contained probably 20<sup>th</sup> century finds.

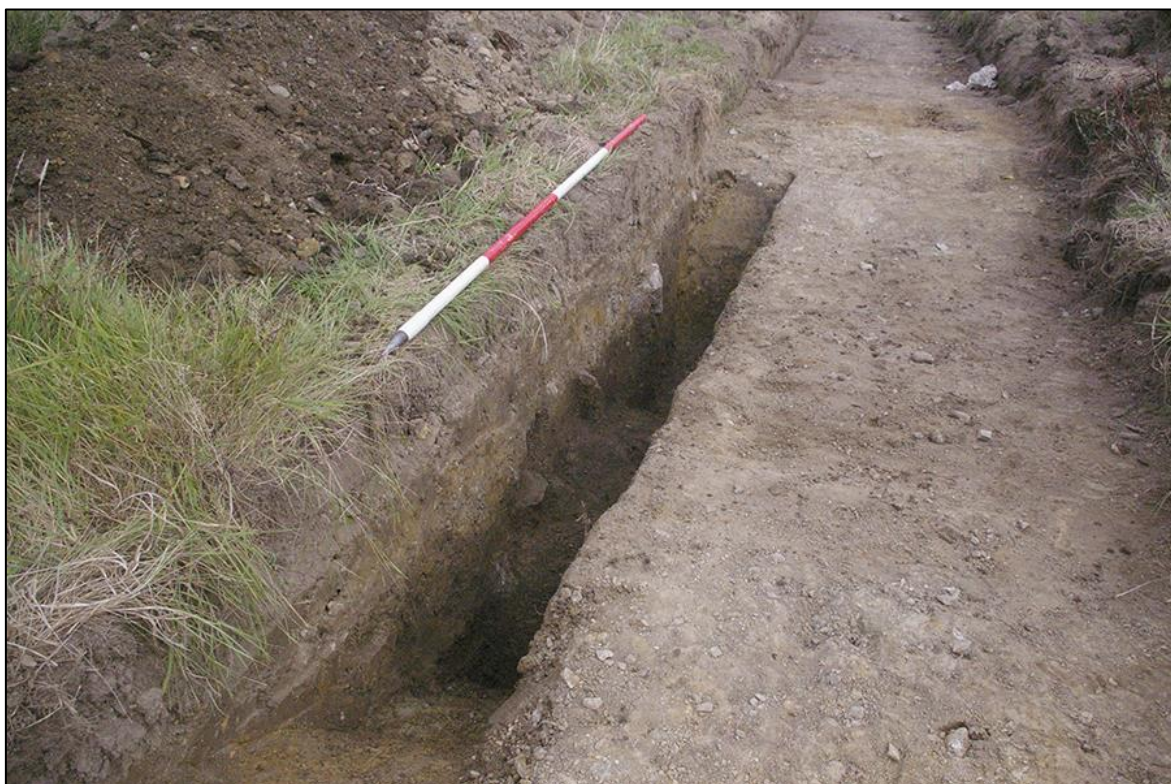
Ditch [404] was aligned north-west by south-east with gentle even slopes that become near vertical and concave to a concave base. It was <1.50m wide and c.0.25m deep. It contained a single fill, (405), which contained modern plastic debris.

Ditch [406] was aligned north-west by south-east, parallel to Ditch [404], with an uneven steep west slope and very steep east slope with sharp concave breaks of slope and a flat base. It was <3.80m wide and c.0.80m deep. It contained five fills, including mostly a silting-up deposit, (409), and a layer of redeposited natural, (408), which buried some modern debris.

FIGURE 3: DITCH [406] (FOREGROUND) AND DITCH [404], MID-EXCAVATION; VIEWED FROM THE SOUTH-WEST (2M SCALE).

As well as containing 20<sup>th</sup> century finds in its upper fills, Ditch [406] had an adjacent parallel ditch/drain, [404], which contained later 20<sup>th</sup> century finds and the base of another parallel ditch/drain, [412] also ran across this part of the site and contained stones indicative of a stone-filled land drain.

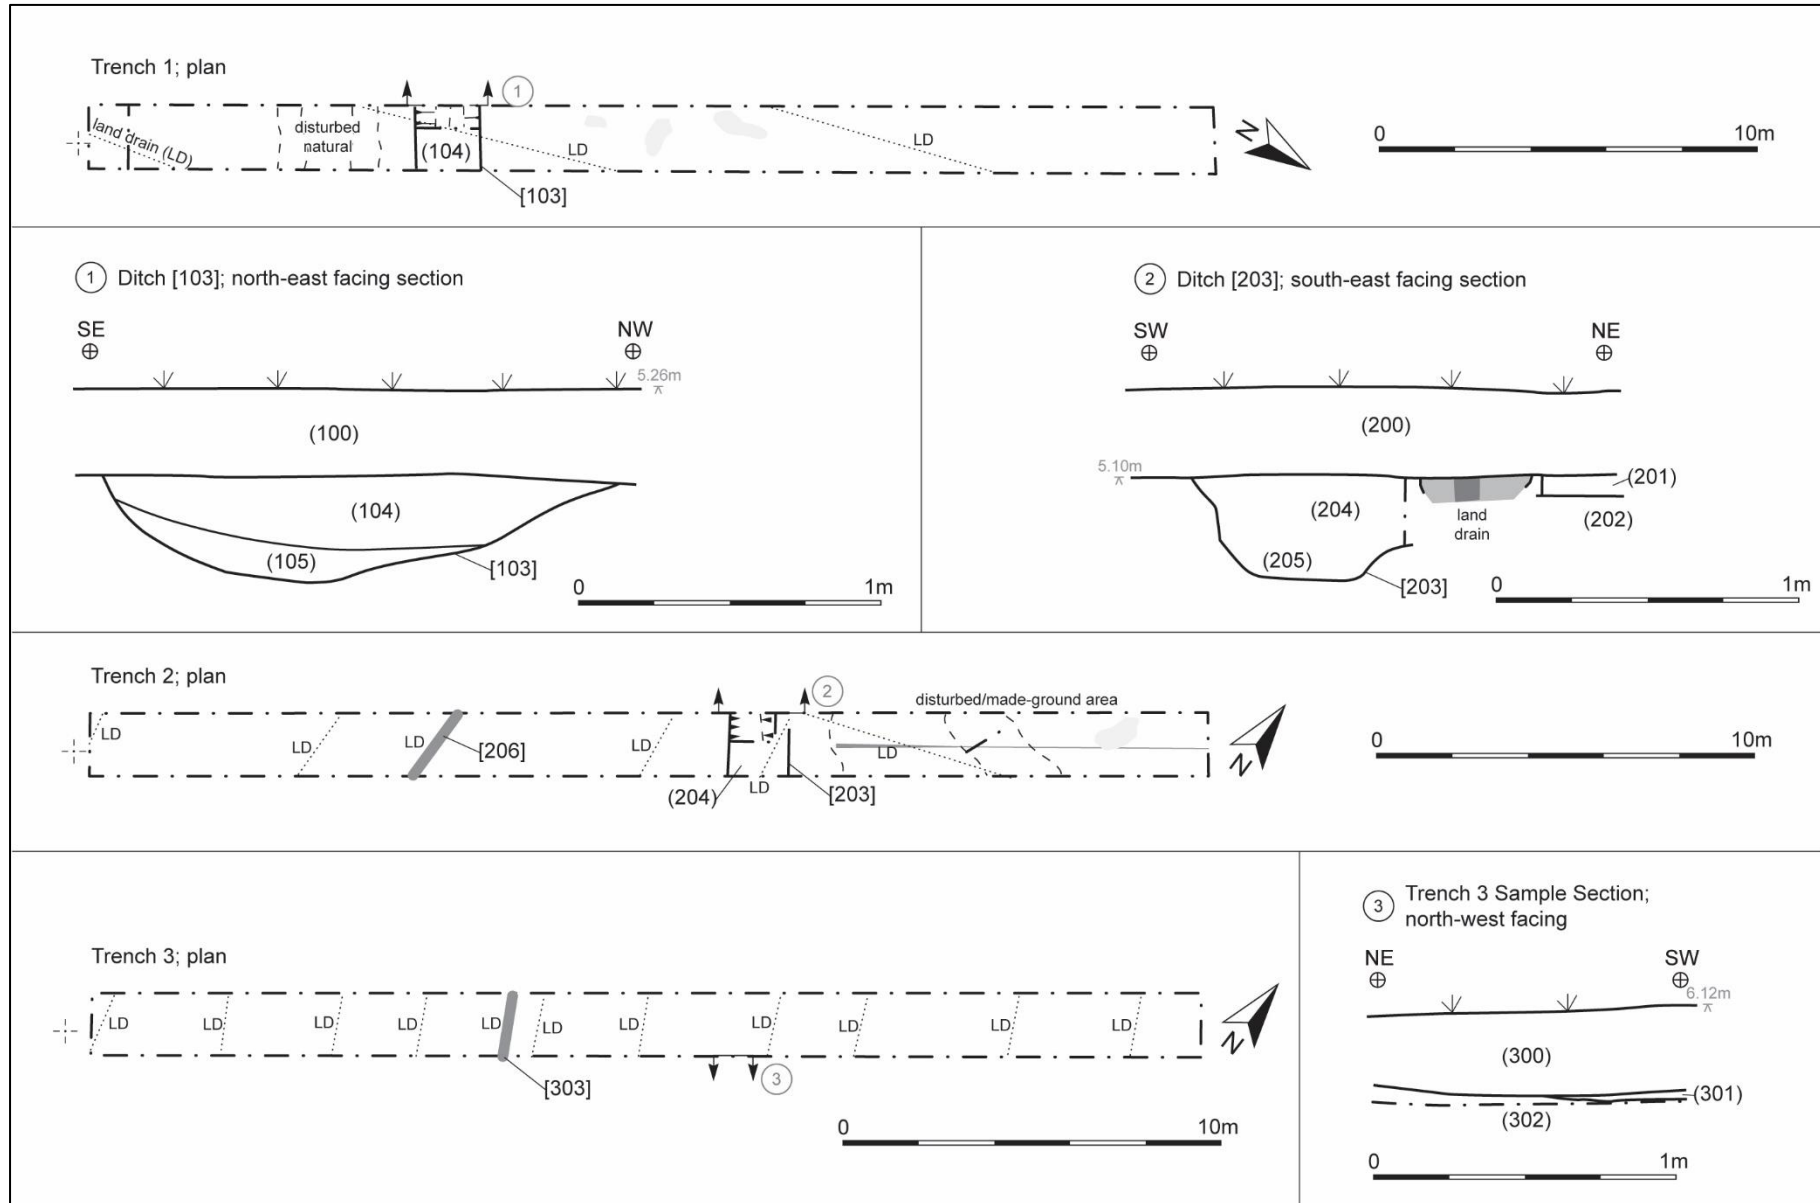
Trench 1 (Figure 6) was aligned north-west by south-east and measured 29.70mx1.60m; the topsoil was c.0.29m thick. It was located at the south end of the site to target a linear geophysical anomaly identified as a probable ditch equating to a historical field boundary. The trench revealed a single ditch (Figure 2) that equated to the targeted geophysical anomaly and a series of gravel filled land drains.

Trench 2 (Figure 6) was aligned north-east by south-west and measured 29.60m x 1.60m; the topsoil was c.0.25m thick. A subsoil/made-ground was present at the east end of the trench and was up to c.0.19m thick. It was located at the south end of the site to target two linear geophysical anomalies identified as probable ditches. The trench revealed a single ditch that equated to the eastern geophysical anomaly and a large number of gravelly land drains including one stonier example that equated to the western anomaly.

Trench 3 (Figure 6) was aligned north-east by south-west and measured 29.30m x 1.60m; the topsoil was c.0.29m thick. It was located near the middle of the site to target a linear anomaly. The trench revealed no significant archaeological features. A frequent number of land drains ran across the trench, including a slightly stonier, example, as in Trench 1, which corresponded to the targeted anomaly. An additional modern trench-line aligned approximately east-west was also present.

FIGURE 6: TRENCHES 1, 2 AND 3; PLANS AND SECTION DRAWINGS.

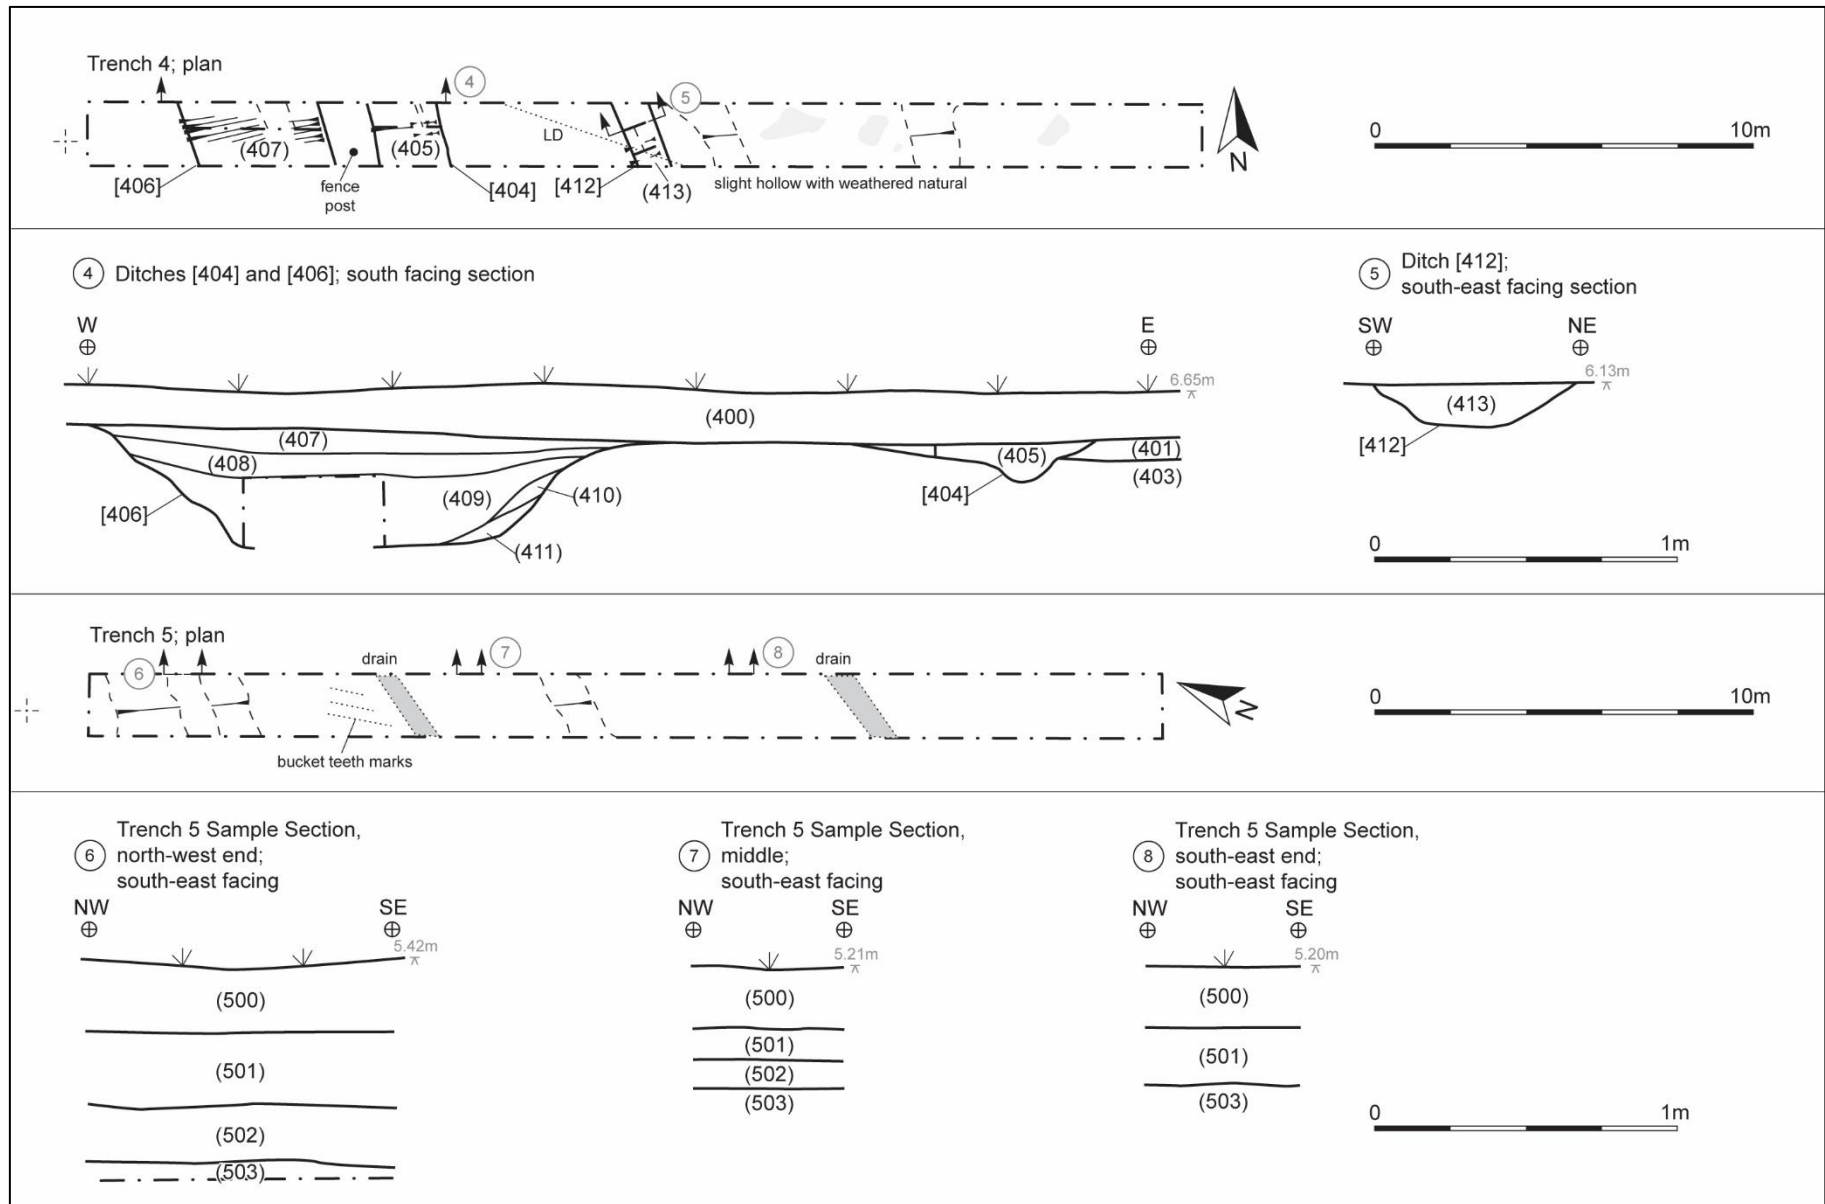
Trench 4 (Figure 7) was aligned approximately east-west and measured 29.35m x 1.60m; the topsoil was c.0.21m thick. A subsoil was present along most of the east part of the trench, which was c.0.17m thick and filled a slight natural hollow, at the bottom of which was some weathered

natural indicative of occasional water-logging on the site. It was located at the north-east corner of the site to target a linear geophysical anomalies identified as a historical boundary and probable drainage ditches. The trench revealed two ditches equating to the historical boundary (Figure 7), a drainage ditch and land drains and a slight hollow all of which equate to the geophysical anomalies. The wooden post of a modern fence stake was also present between the ditches equating to the removed historical boundary.

Trench 5 (Figure 7) was aligned north-west by south-east and measured 28.25mx1.60m; the topsoil was c.0.22m thick, which overlaid made-ground (501) that was 0.10-0.25m thick and in-turn overlaid made-ground (502) that was 0.10-0.18m thick across the north half of the trench. It was located in the south-east part of the site to target two linear geophysical anomalies. Two 20<sup>th</sup> century drains filled with 20<sup>th</sup> century debris and ostensibly contemporary with made-ground (502) were present in the trench and equated to the geophysical anomalies. Teeth marks from the bucket of a mechanical excavator were visible in the base of the trench. The overlaying made-grounds contained relatively large and frequent finds from approximately the mid-20<sup>th</sup> century.

FIGURE 7: TRENCHES 4 AND 5; PLANS AND SECTION DRAWINGS.

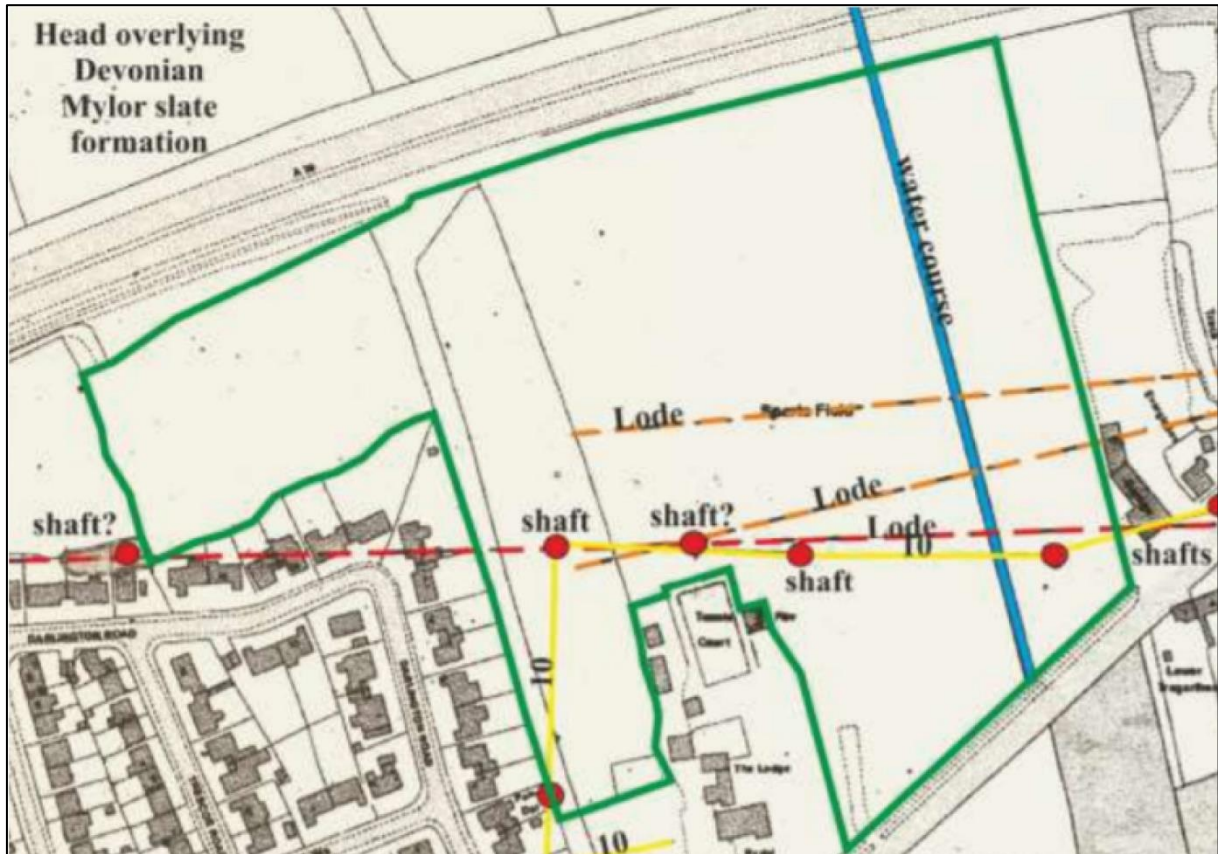
FIGURE 12: COMPOSITE IMAGE SHOWING THE LODES AND PROBABLE SHAFTS ON THE SITE (FROM WM 2018).

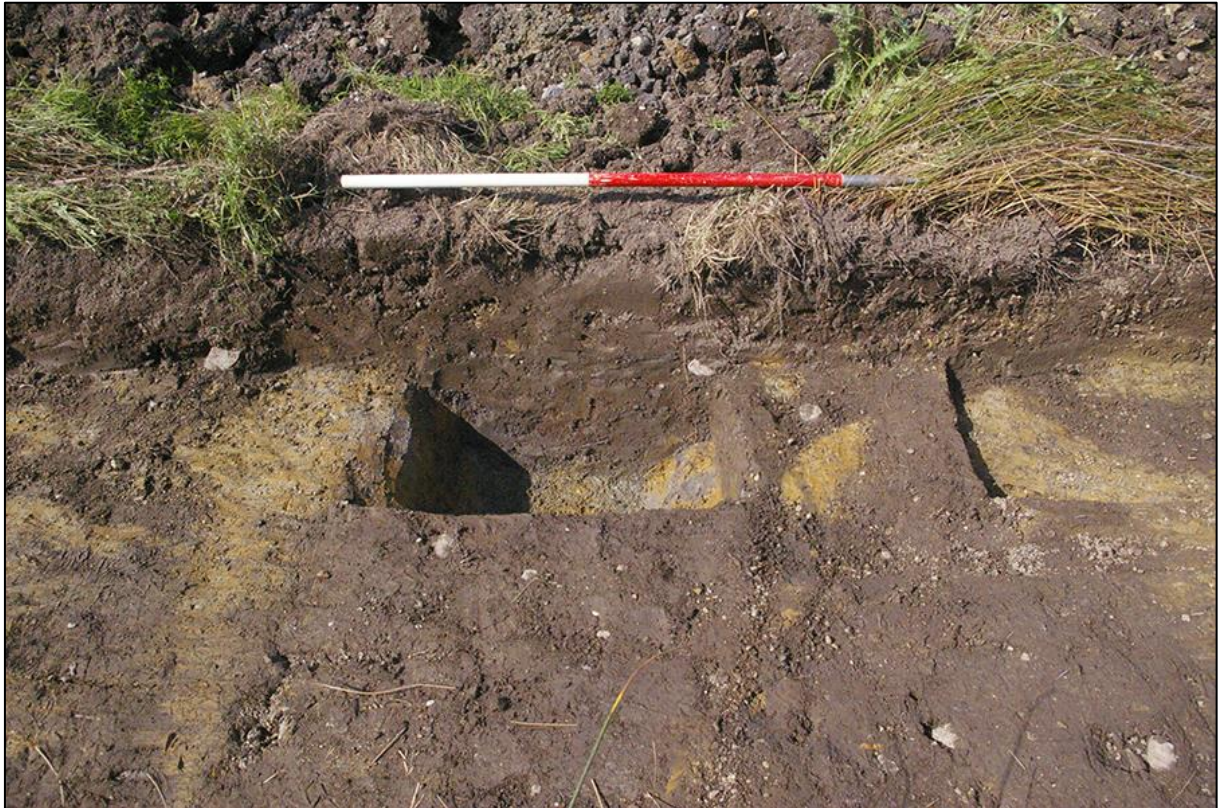
Ditch [203] was aligned approximately north-west by south-east with a vertical west slope, sharp break of slope and a flat base; its east slope was cut by a parallel later land drain. It was c.1m wide and c.0.33m deep. It contained two fills: upper Fill (204), which contained 20<sup>th</sup> century finds; and lower fill (205).

3. DITCH [203]; VIEWED FROM THE SOUTH-EAST (1M SCALE).

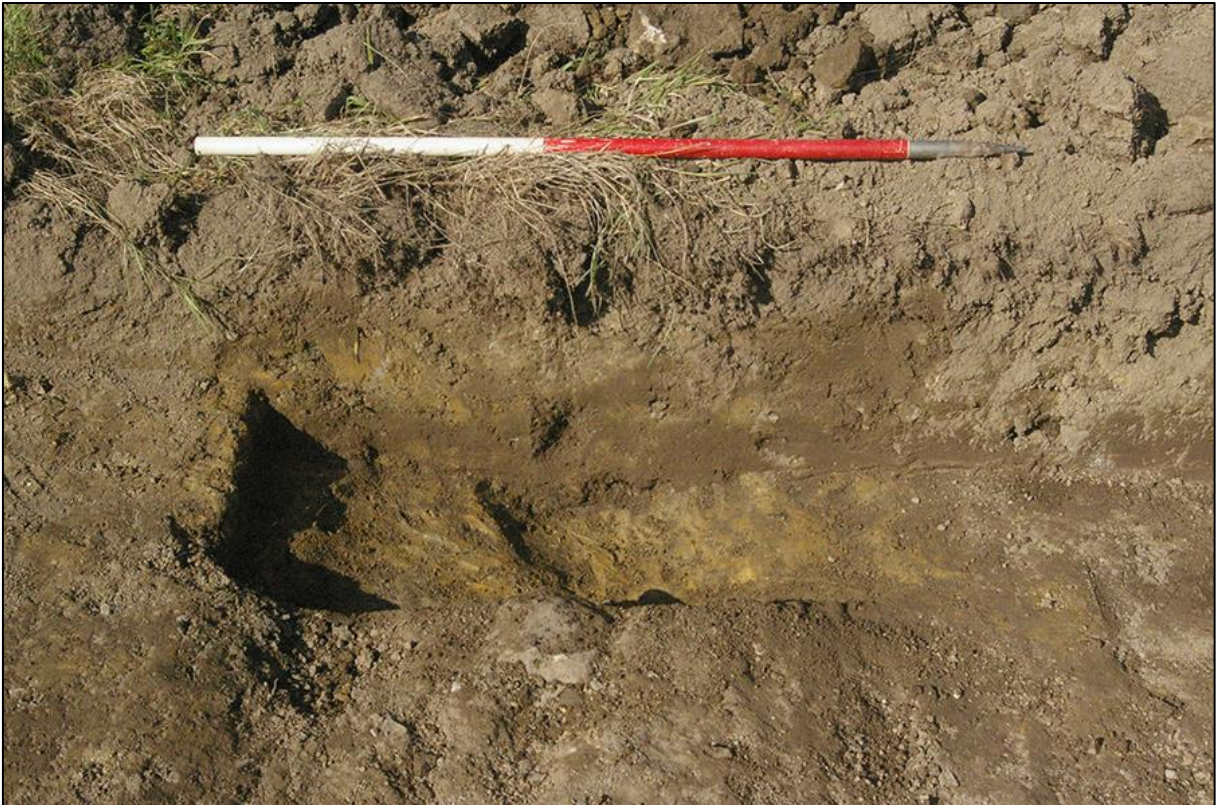
8. DITCH [404]; VIEWED FROM THE SOUTH (1M SCALE).

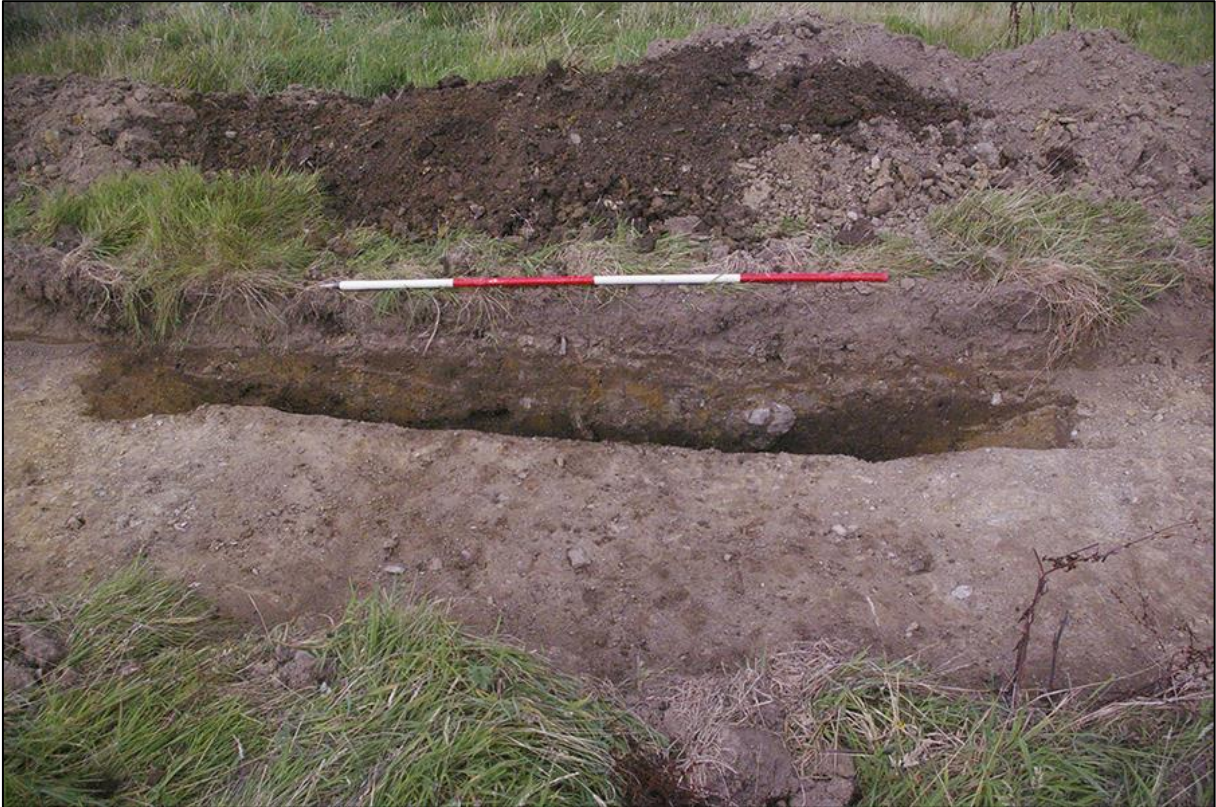
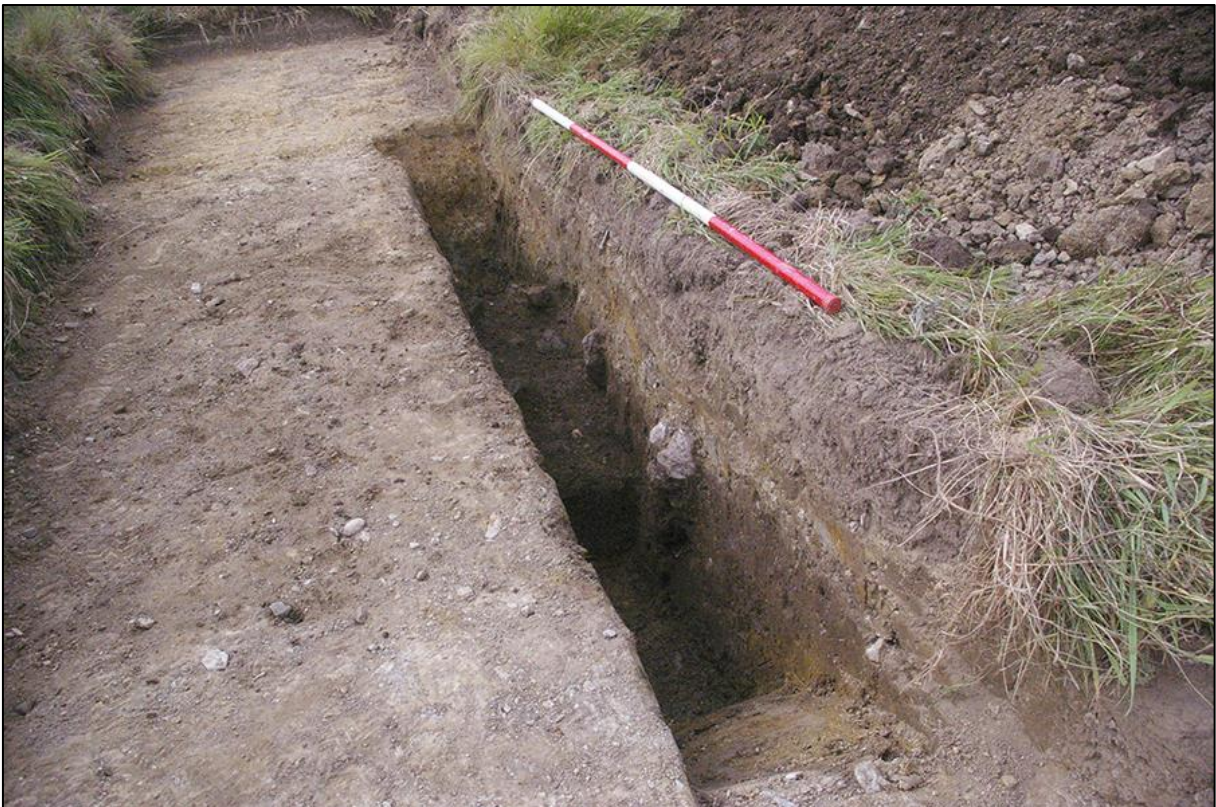
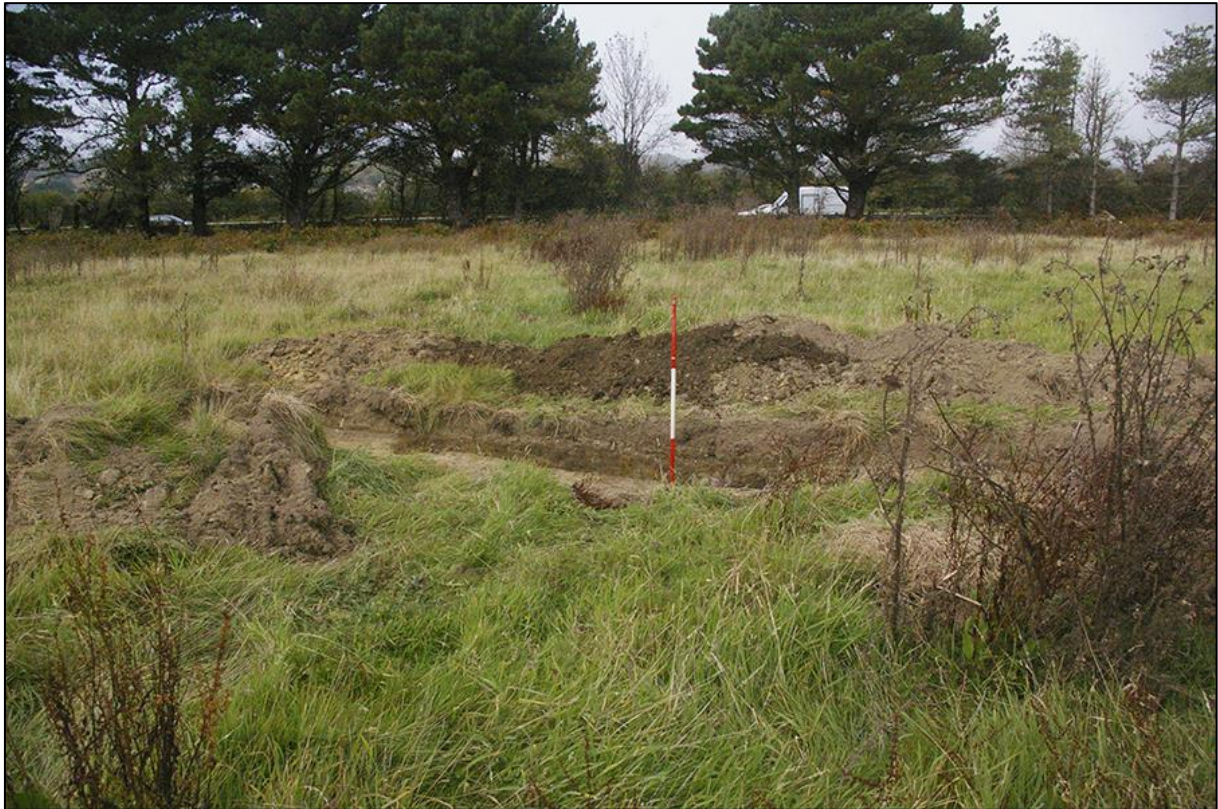
9. DITCH [406]; VIEWED FROM THE SOUTH (2M SCALE).

10. DITCH [406]; VIEWED FROM THE SOUTH-EAST (2M SCALE).

11. LINE OF DITCH [406]; VIEWED FROM THE SOUTH-EAST (PARTIAL 2M SCALE).

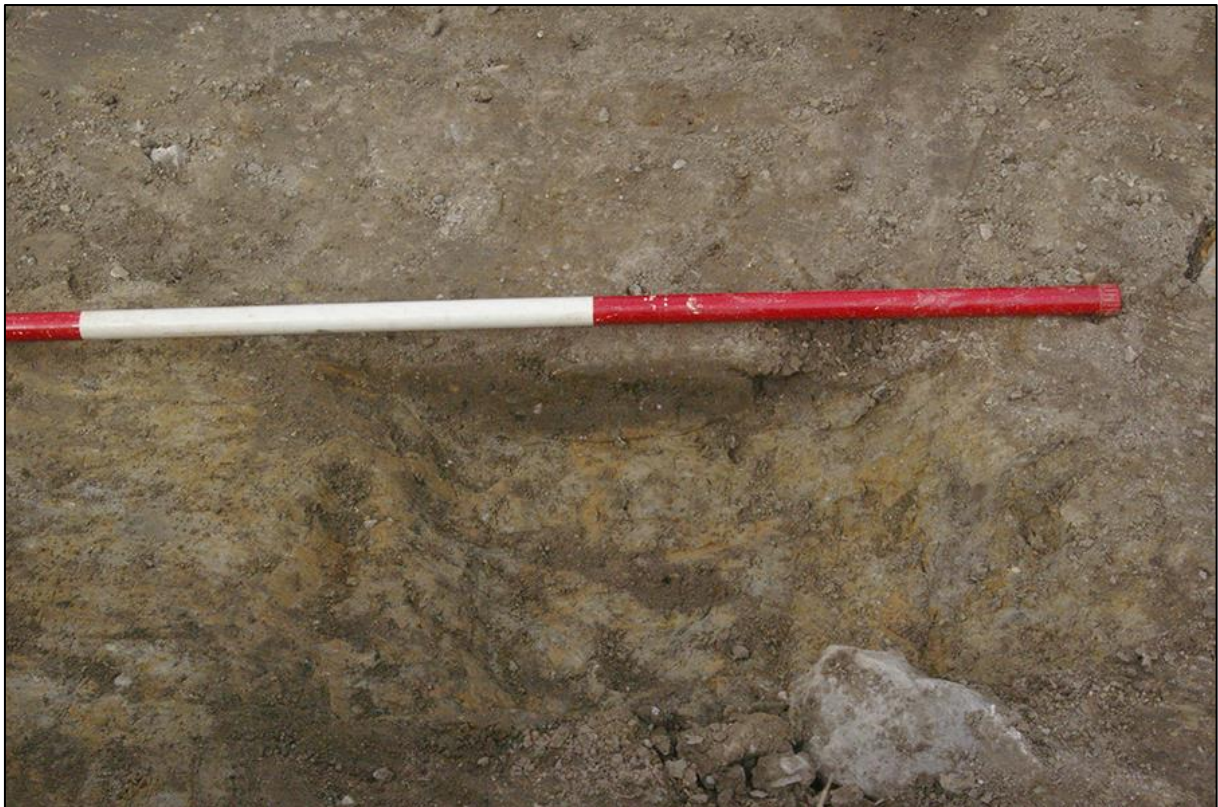
Ditch [412] was aligned north-west by south-east, parallel to Ditch [404], with a steep west slope and moderate east slope with sharp breaks of slope and a flat base. It was 0.64m wide and 0.12m deep. It contained a single fill, (413) that contained moderate medium angular stones.

12. DITCH [412]; VIEWED FROM THE SOUTH-EAST (1M SCALE).

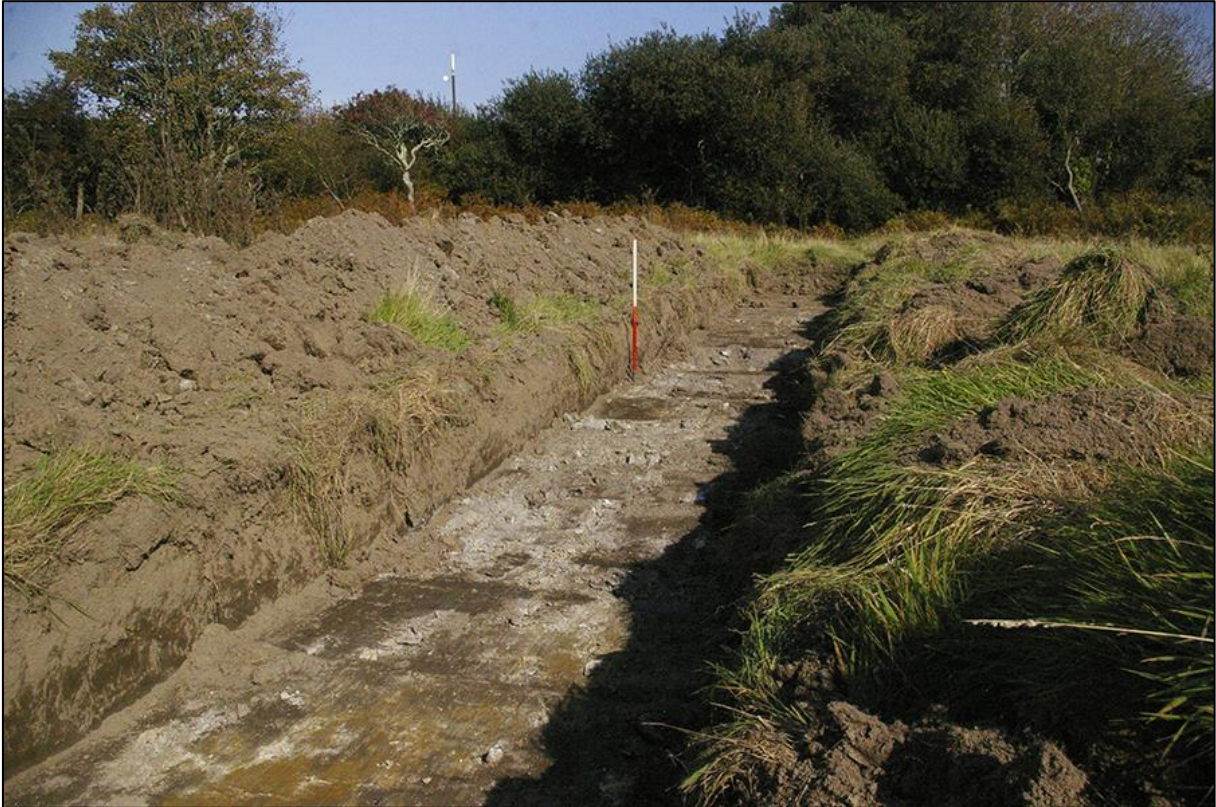
13. HOLLOW AND WEATHERED NATURAL AT EAST END OF TRENCH 4; VIEWED FROM THE SOUTH-WEST (1M SCALE).

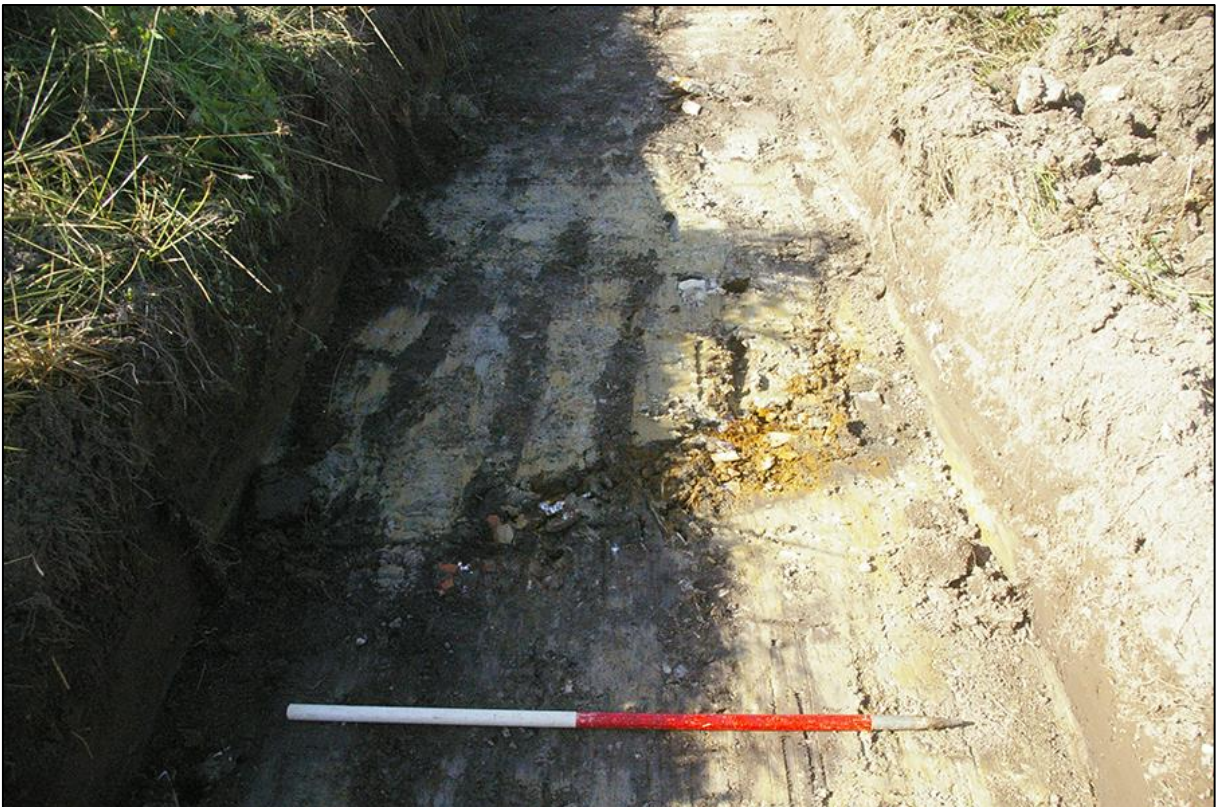
16. NORTHERN DRAIN IN TRENCH 5 AND HISTORICAL BUCKET TEETH MARKS; VIEWED FROM THE SOUTH-EAST (1M SCALE).
